# June 2023 – Reactive Tree Works Programme

## Introduction

Dated 16.6.2023

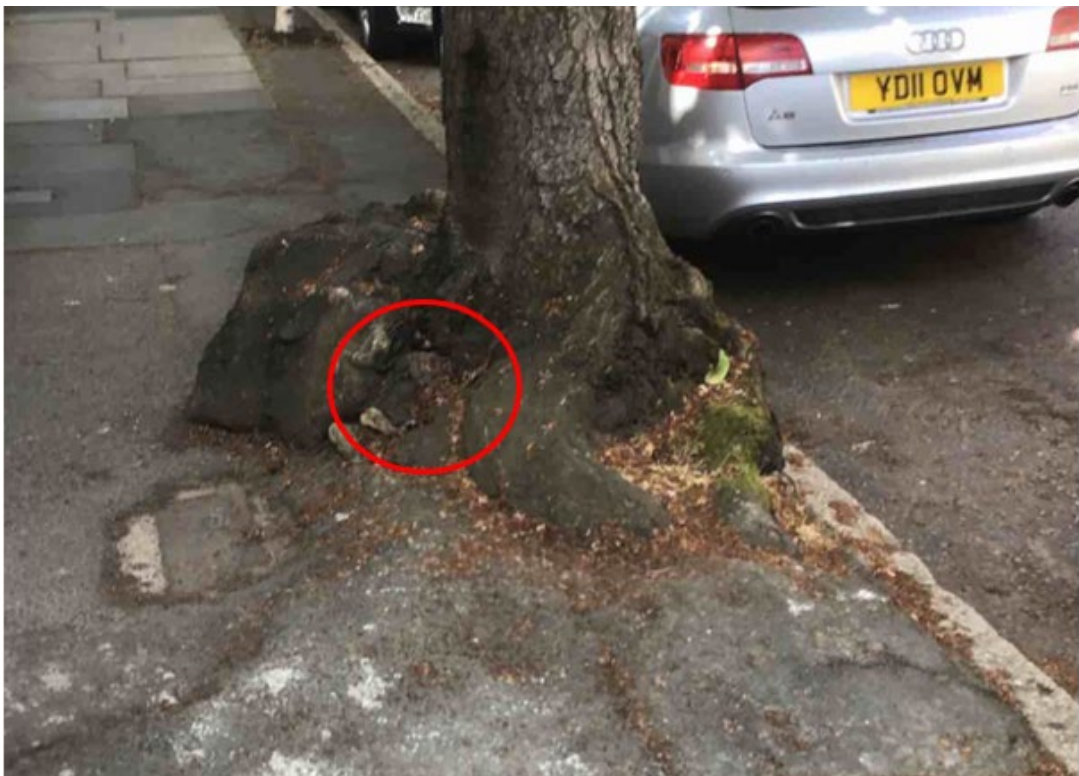
*Image shows tree with location of cavities and fungal fruiting body and decay circled*

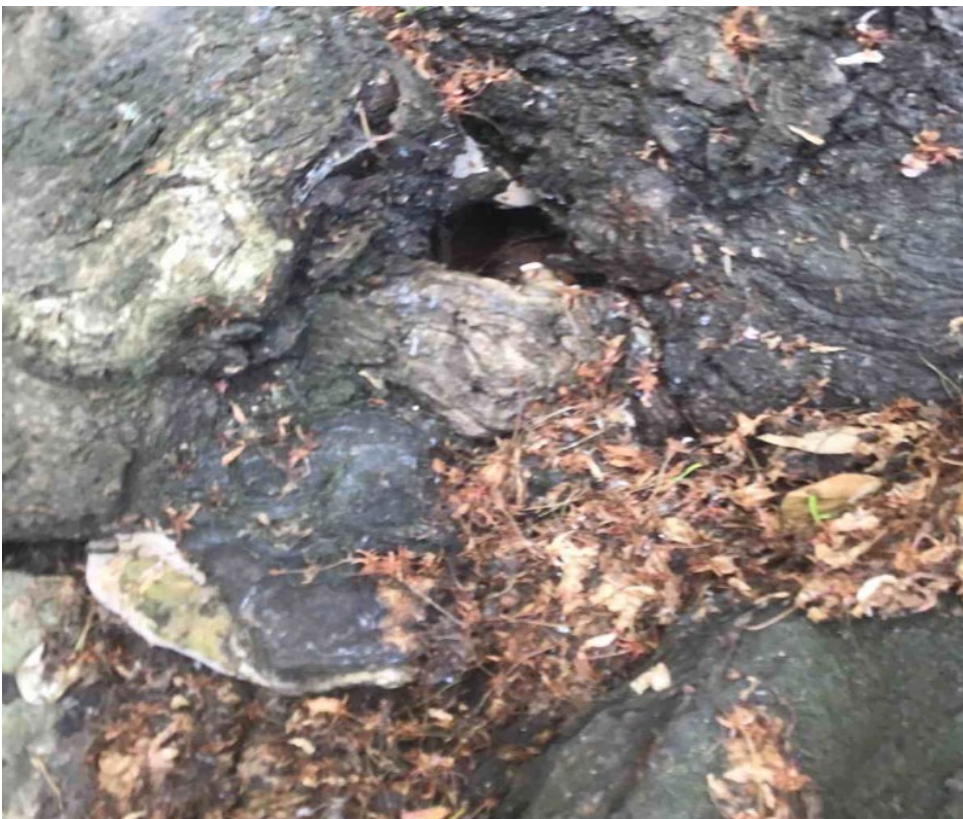
*Image shows close up of previous photo with fungal fruiting bodies in cavity*

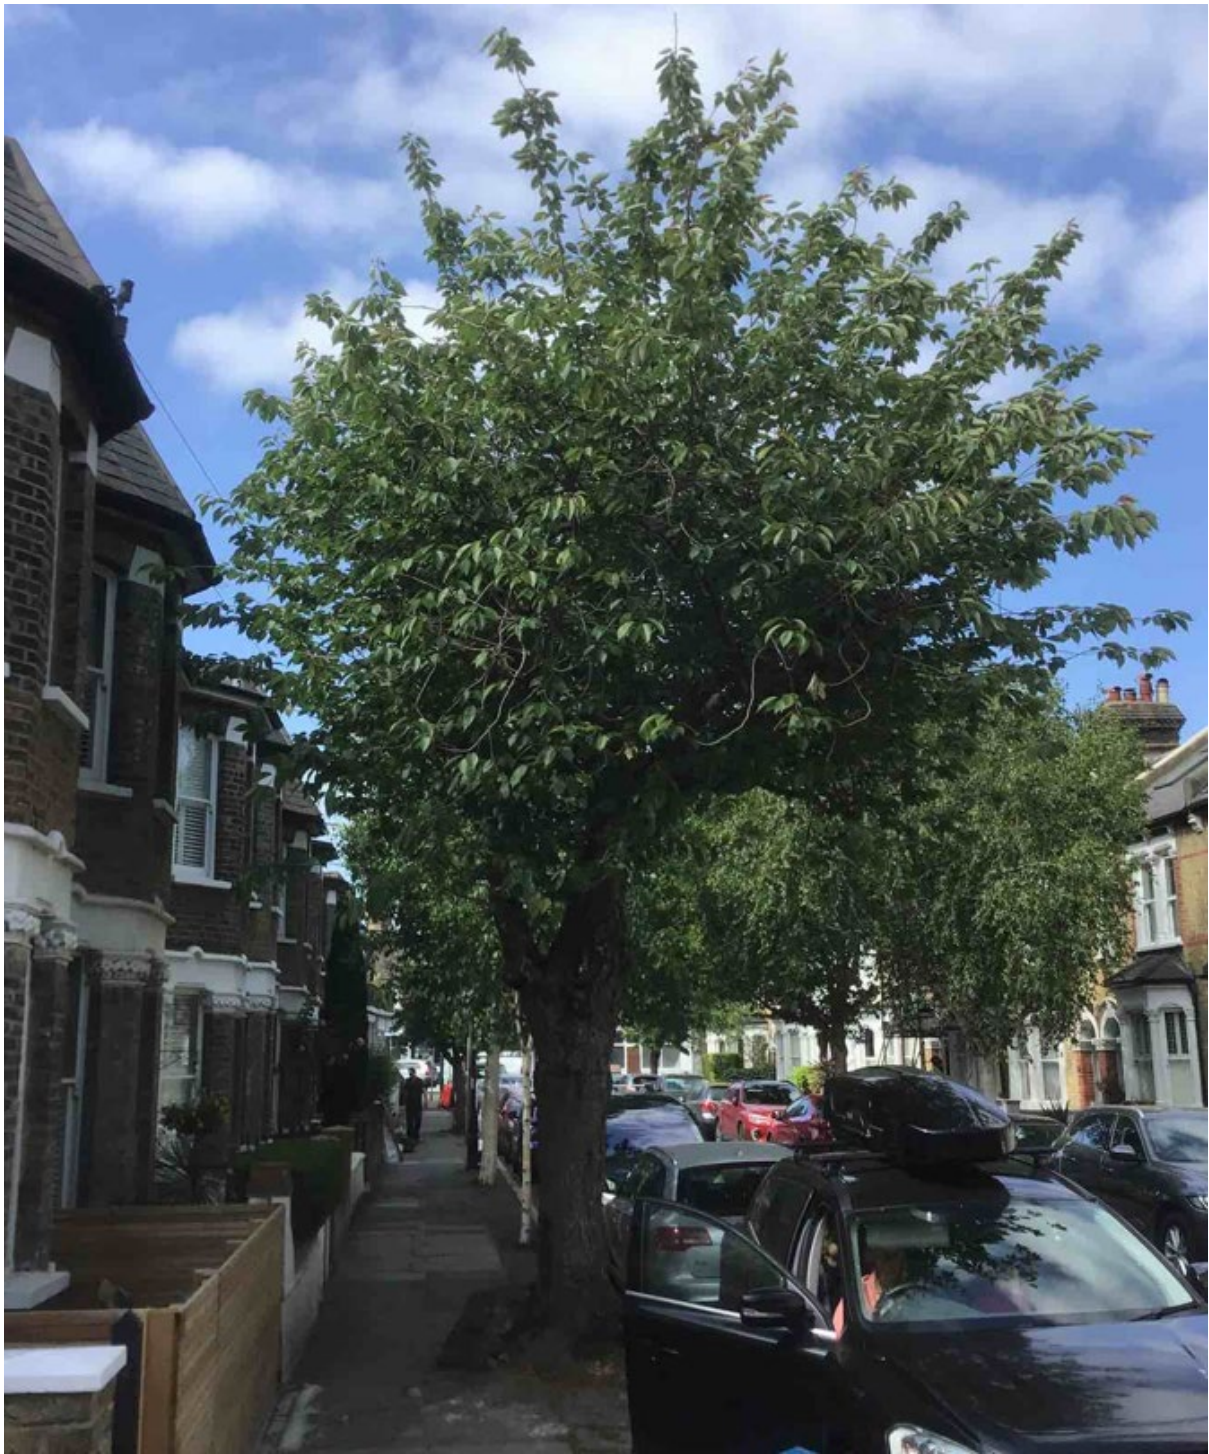
*Image shows tree in street scene*

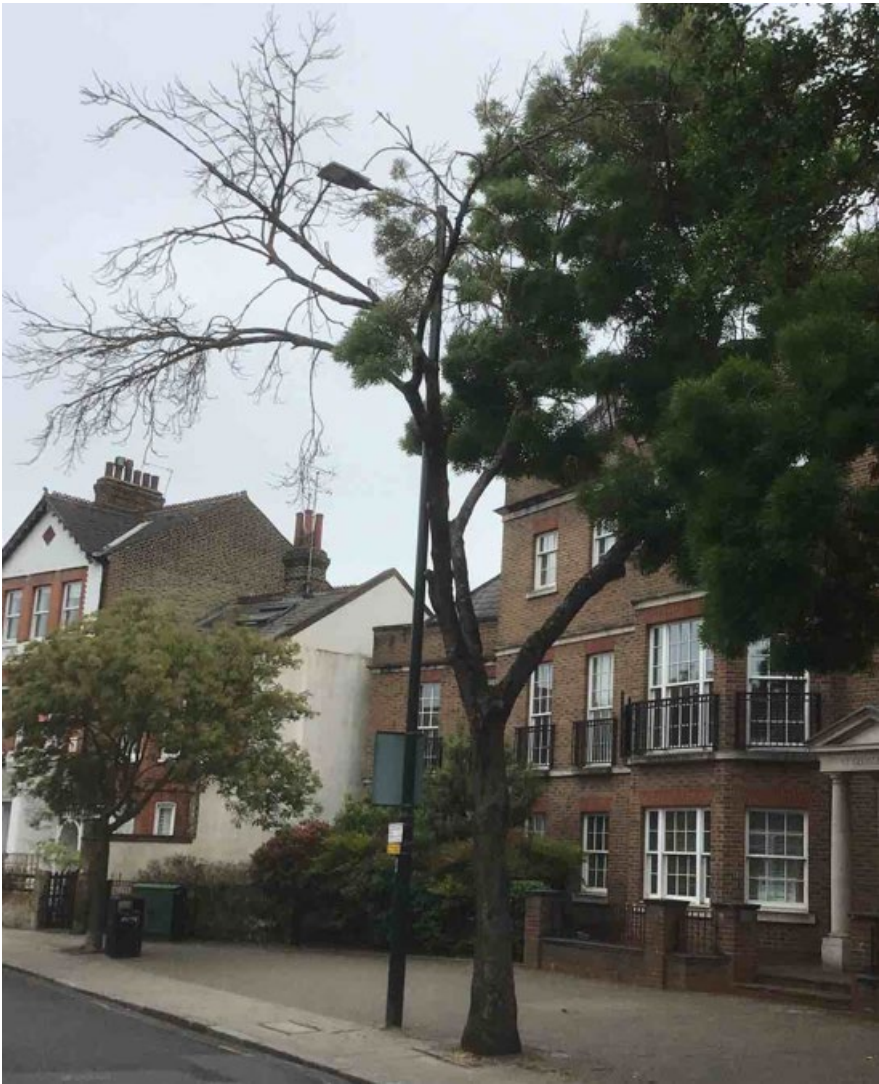
| Inspection findings | Tree crown is displaying advanced symptoms of physiological decline associated with Ash Die Back. This is serious fungal disease of the European Ash, characterized by the progressive decline of the tree's branches and will eventually lead to the death of the tree. |

Image shows tree advanced symptoms of physiological decline associated with Ash Die Back.

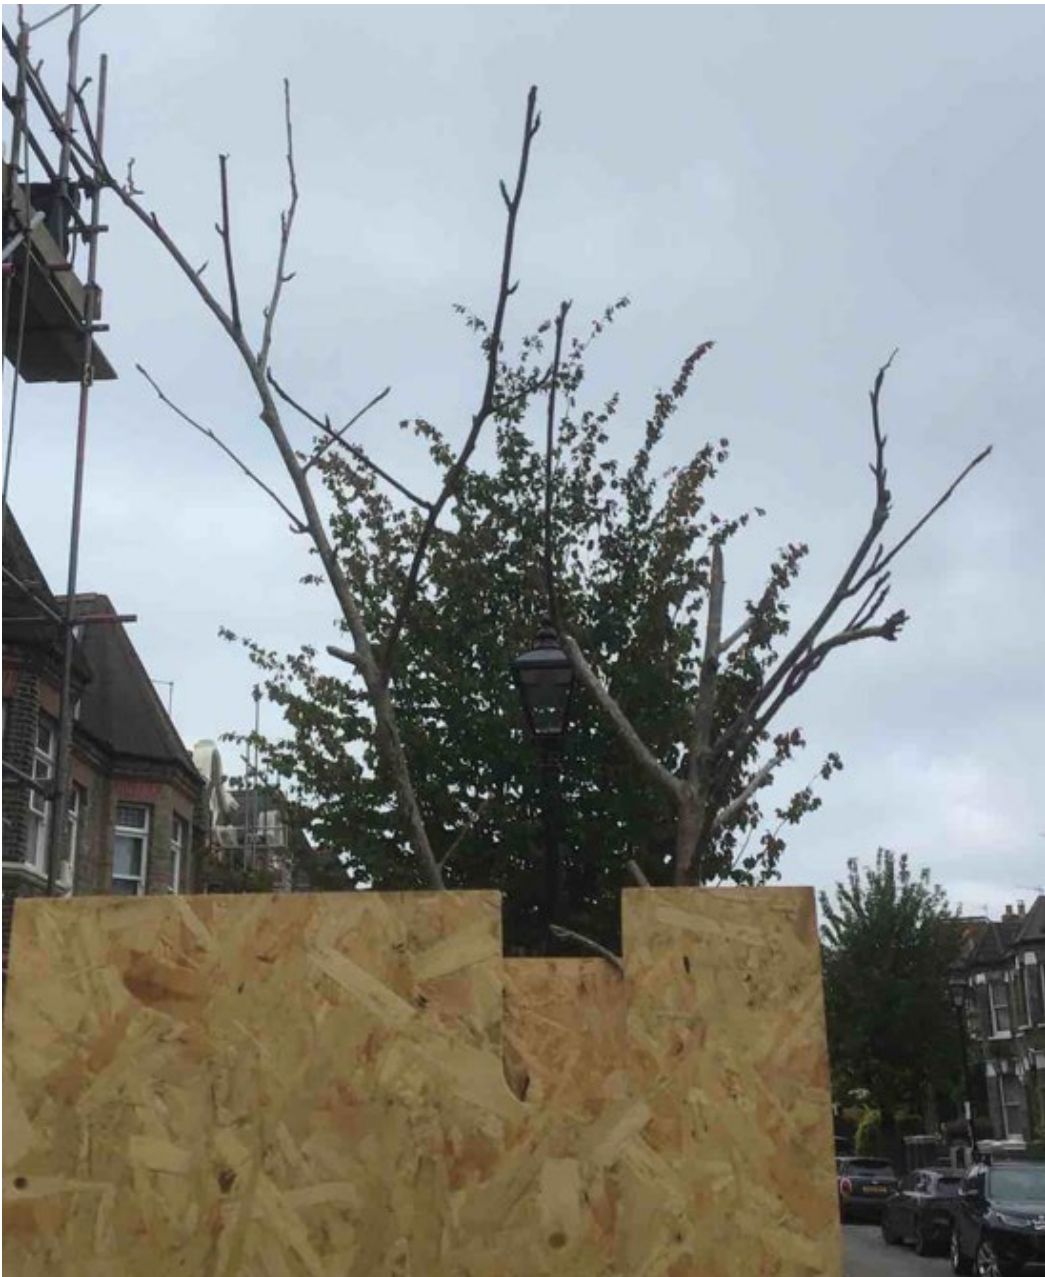
| Inspection findings | This tree is dead; removal is required to prevent natural failure and facilitate replanting |

Image shows dead tree

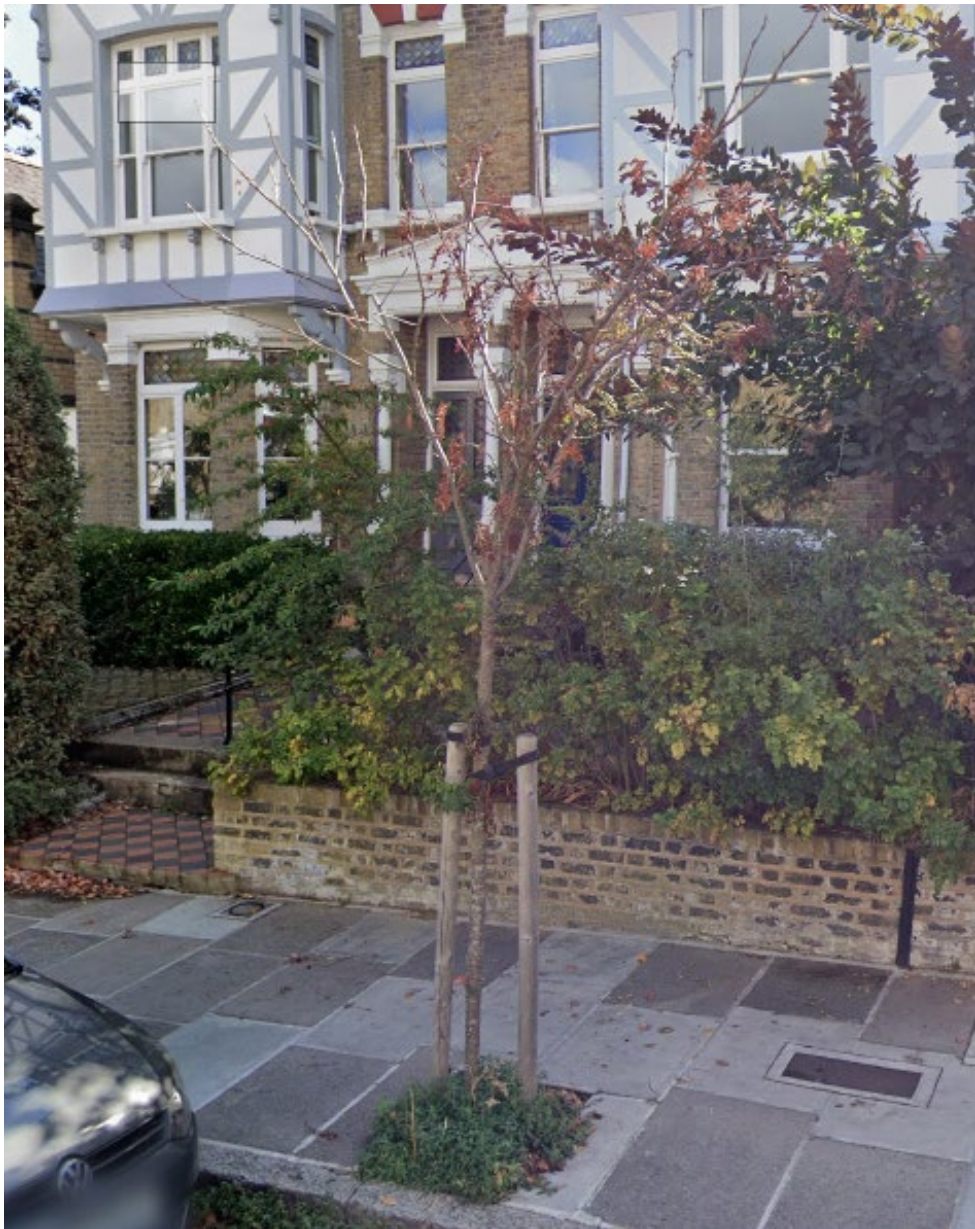
*Image taken from Google Maps showing tree in street scene*

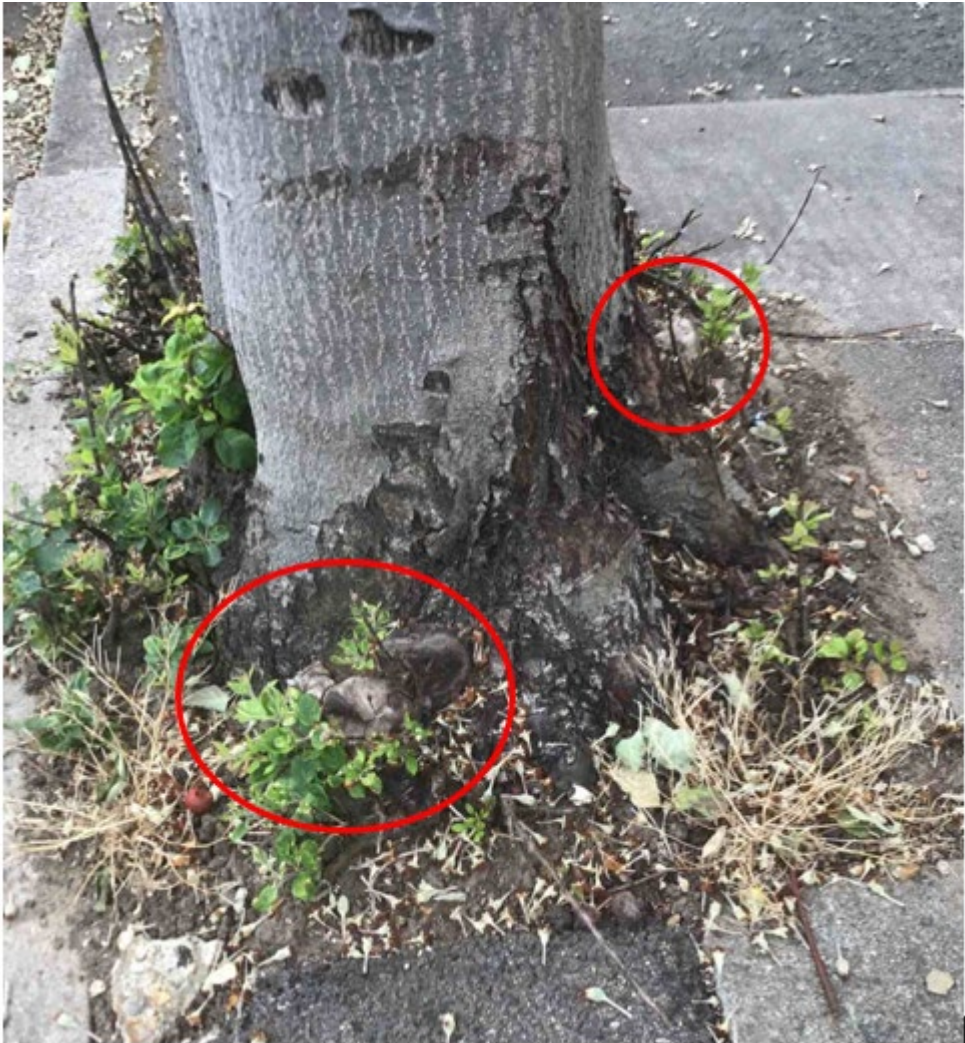
| Inspection findings | A fungal fruiting body of the decay pathogen <i>Ganoderma</i> sp. is present at the stem base. Colonisation by this fungus causes a white rot of the stem and root system that can cause entire trees to collapse through fracture or windthrow. Multiple <i>Ganoderma</i> brackets around base of stem indicating root and lower stem decay is present at the base of this tree. A resonance test revealed an unacceptable degree of decay in the lower trunk of this tree, removal is required to prevent natural failure and manage risk. |

Image shows tree with location of fungal fruiting body and decay circled

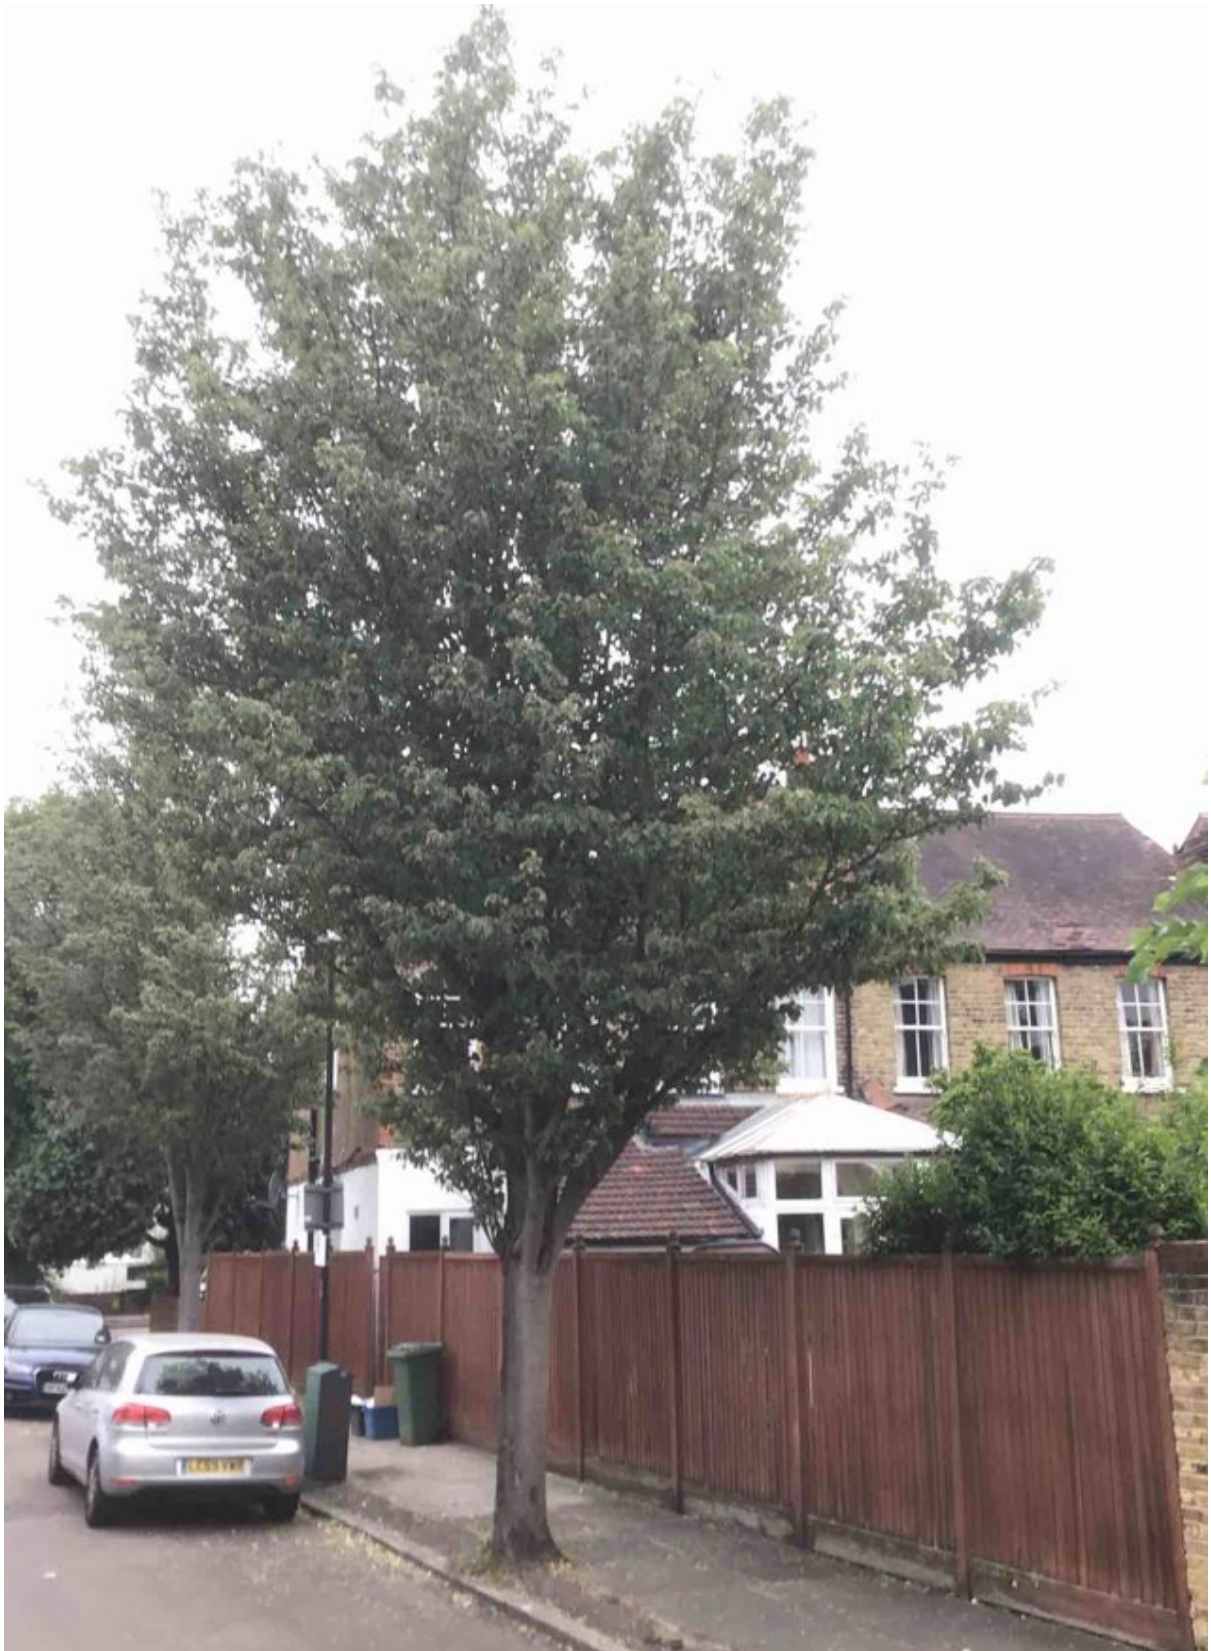
***Image shows tree in street scene***

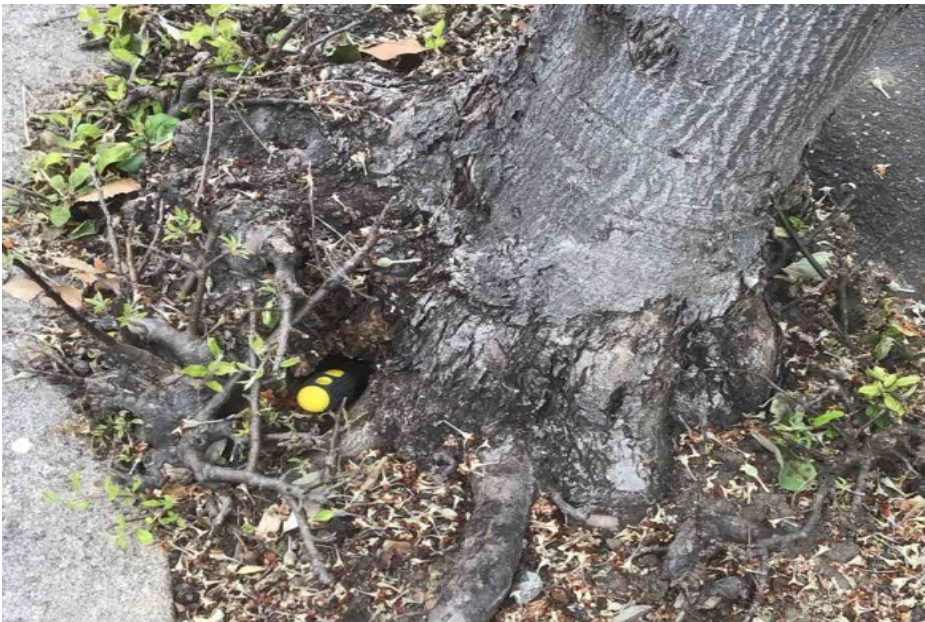
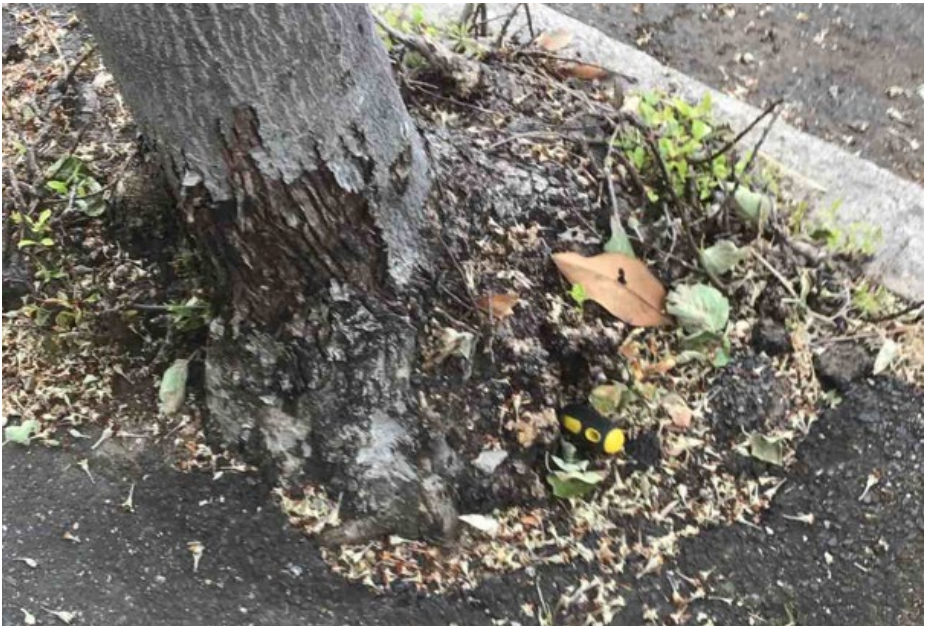
| Inspection findings | Cavities indicating root and lower stem decay are present at the base of this tree. A resonance test revealed an unacceptable degree of decay in the lower trunk of this tree, removal is required to prevent natural failure and manage risk. |

Images shows probe highlighting cavities at base of stem

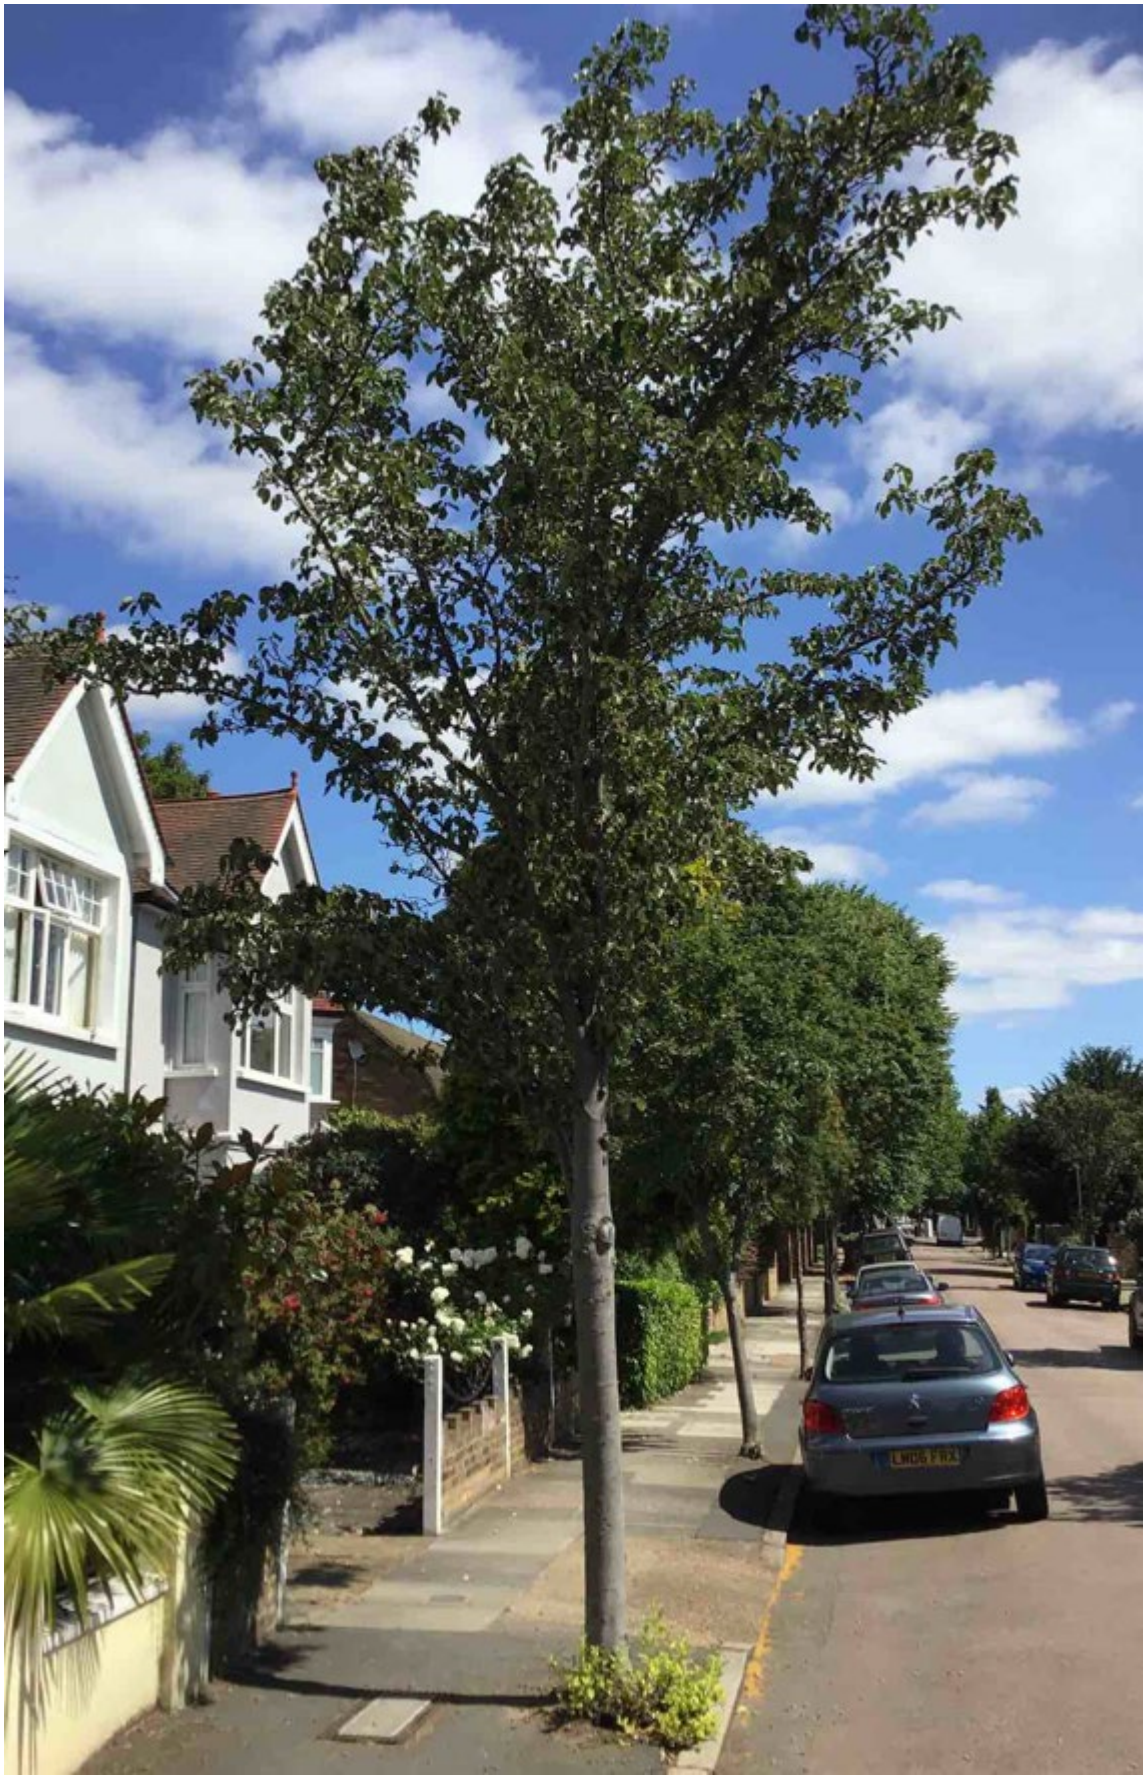
*Image shows tree in street scene*

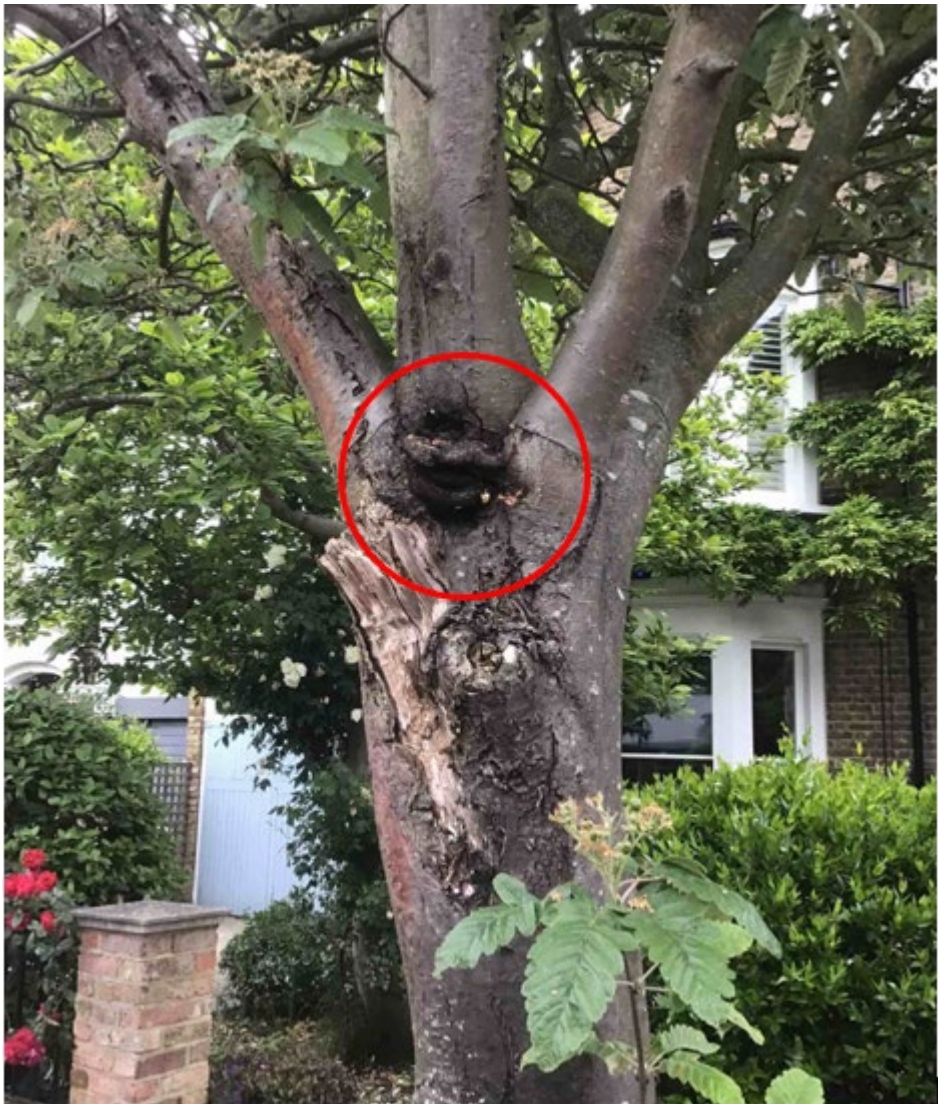
| Inspection findings | A fungal fruiting body of the species Shaggy Polypore ( <i>Inonotus hispidus</i> ) is present on the main stem or trunk on first major union, this fungus causes a simultaneous white rot which can cause snapping of tree parts in this particular species. The presence of the fruiting body on the union possesses an unacceptable degree of risk, removal is required to prevent natural failure. |

Image shows main union on tree with location of fungal fruiting body and decay circled

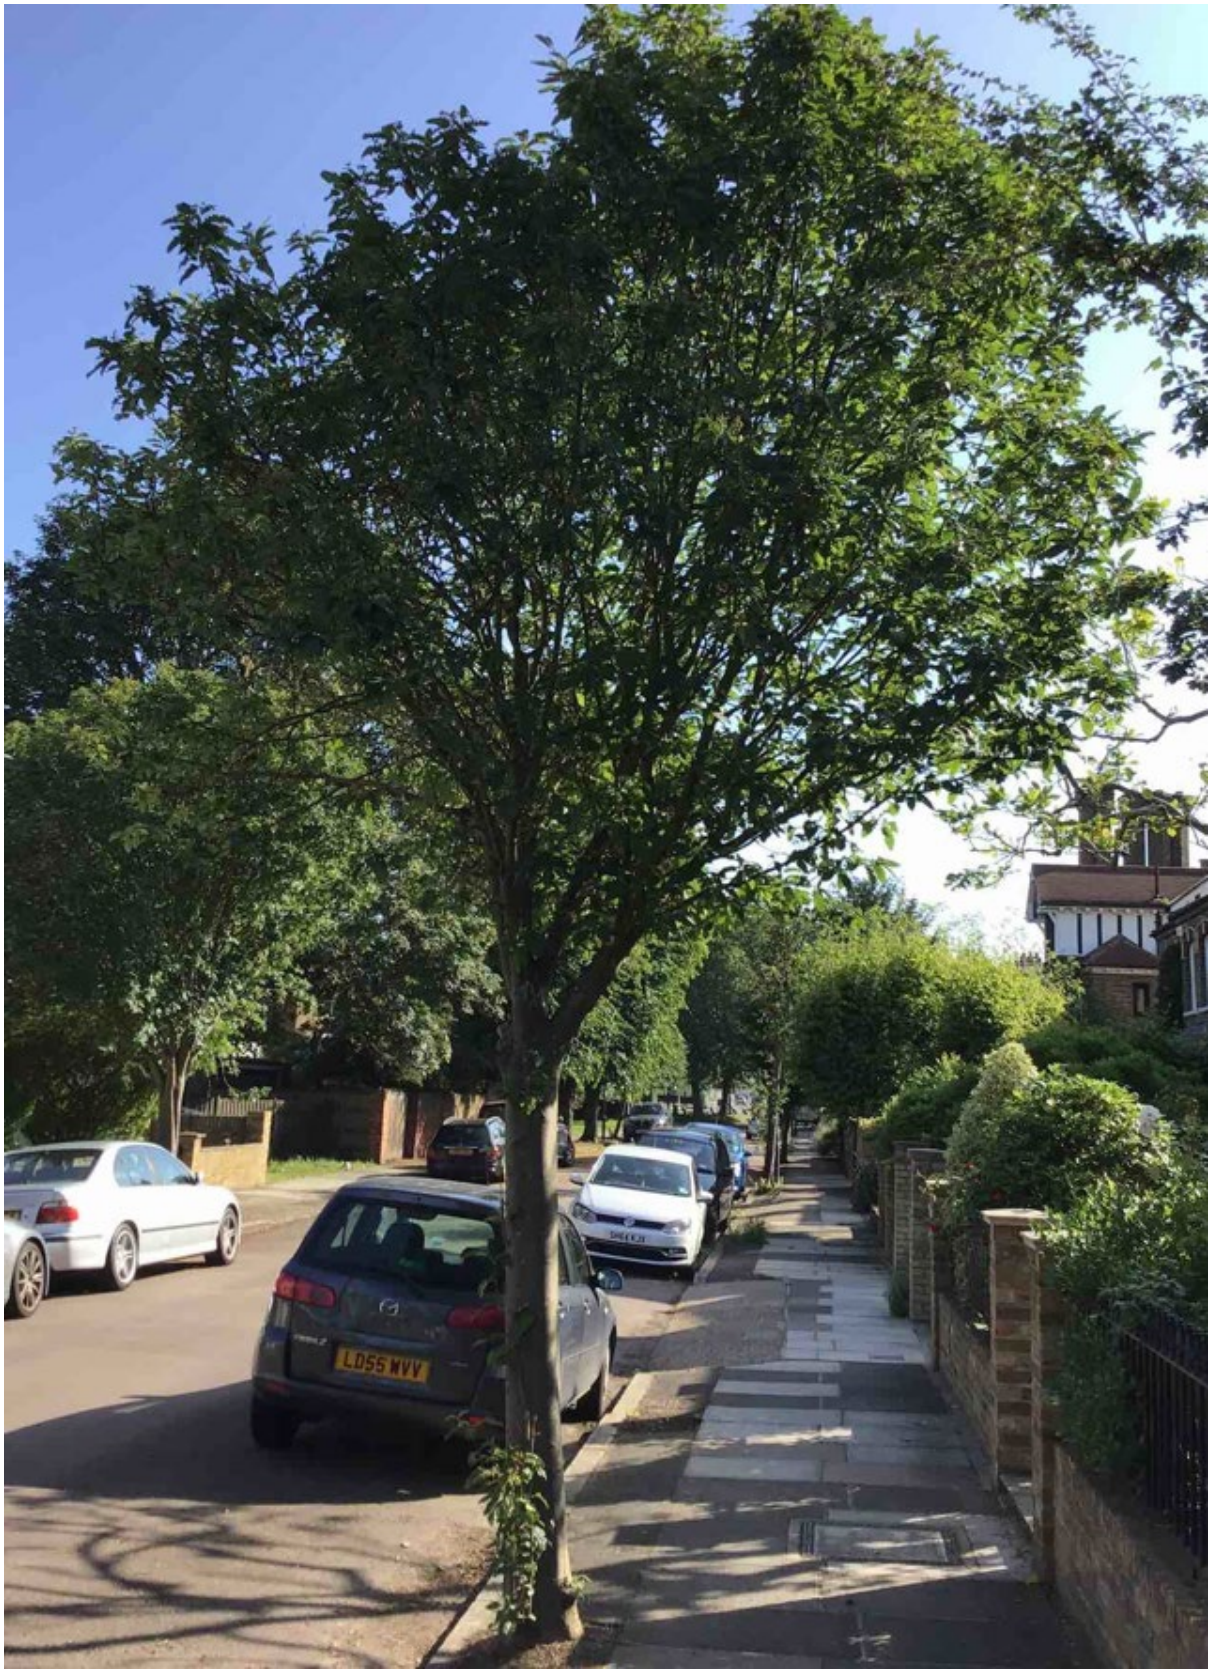
**Image shows tree in street scene**

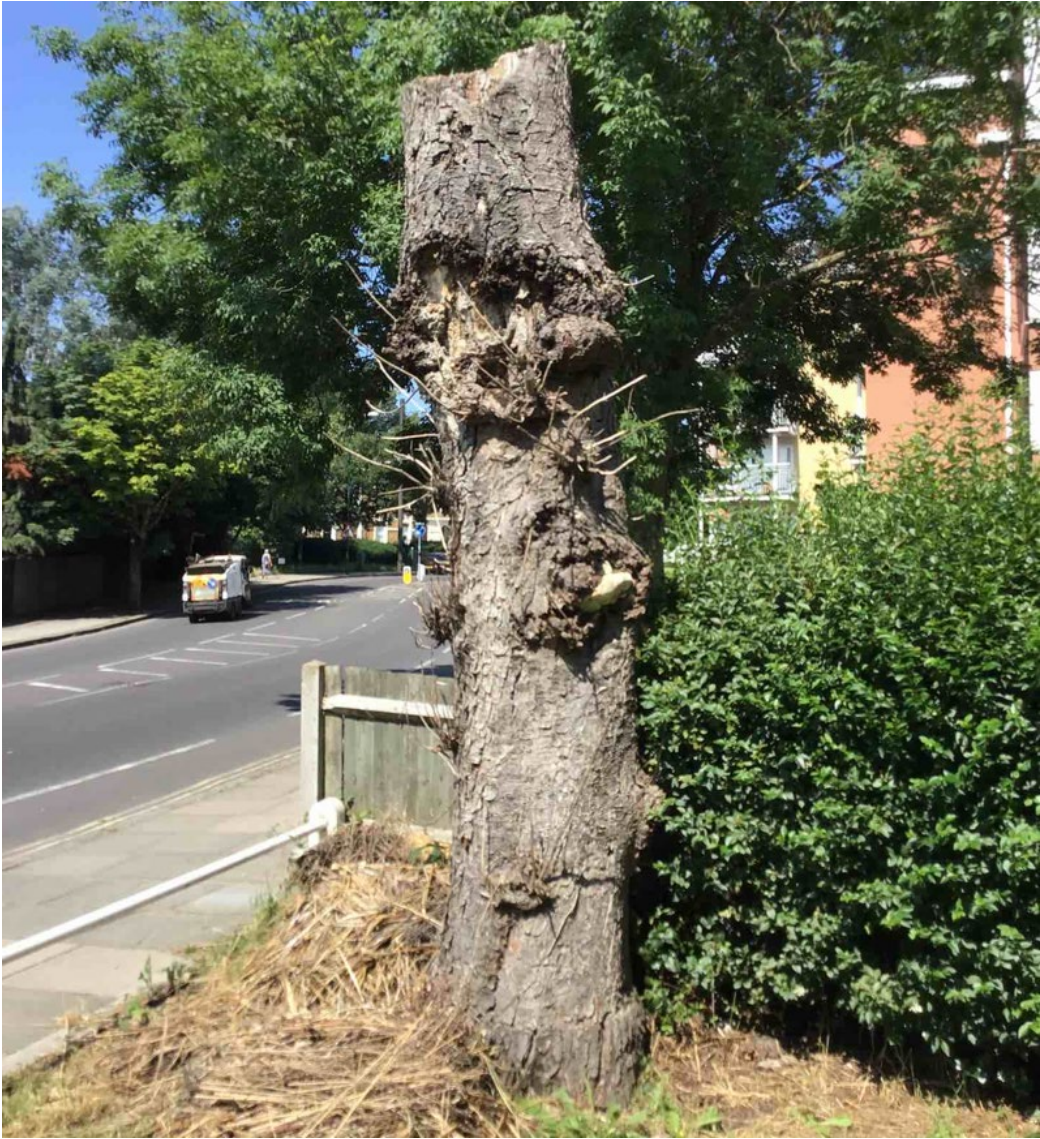
| Inspection findings | This tree was retained as a monolith for its habit value. However, it has now decayed to an unacceptable degree and removal is required to prevent natural failure. |

Image shows dead tree

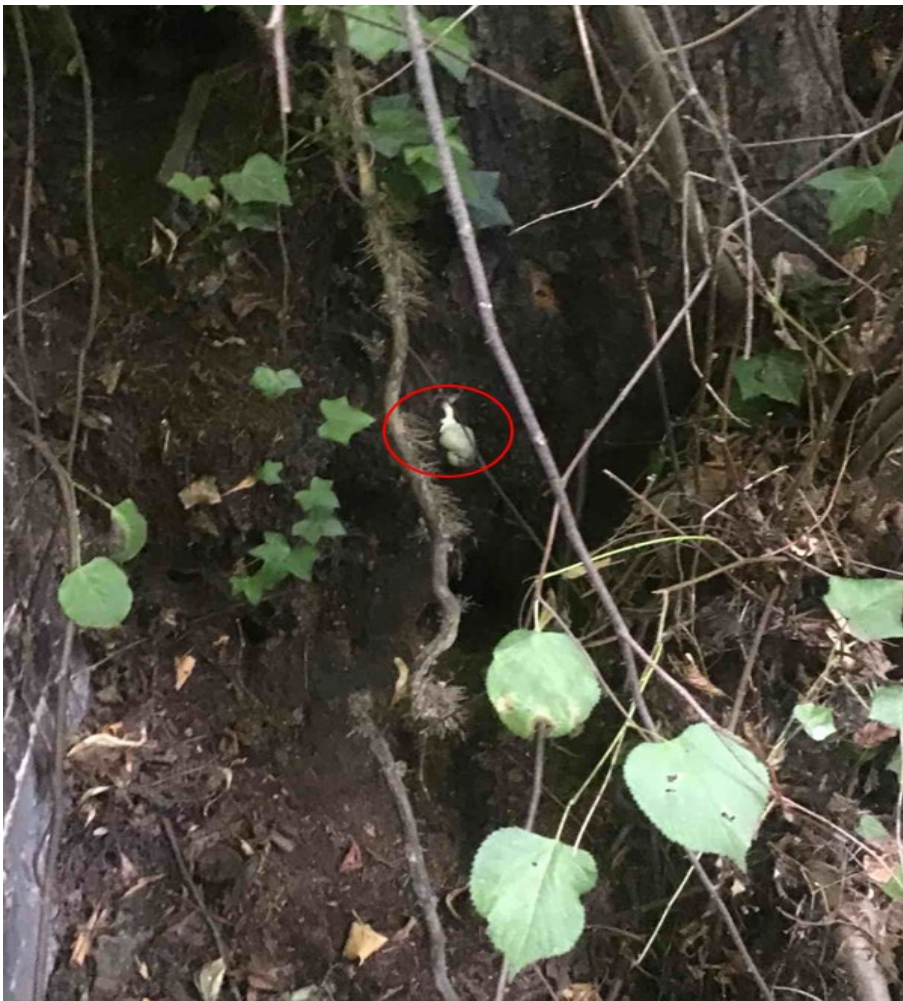
| Inspection findings | Fungal fruiting bodies of the decay pathogen <i>Kretzschmaria deusta</i> are present on the base of this tree. This fungus causes a white rot that can cause whole tree failure through a ceramic like fracture of the base. A probe and resonance test revealed an unacceptable degree of decay in the lower trunk around fruiting bodies, removal is required to prevent natural failure and manage risk. |

Image shows base of with extensive decay and Kretzschmaria fruiting body circled at base of trunk

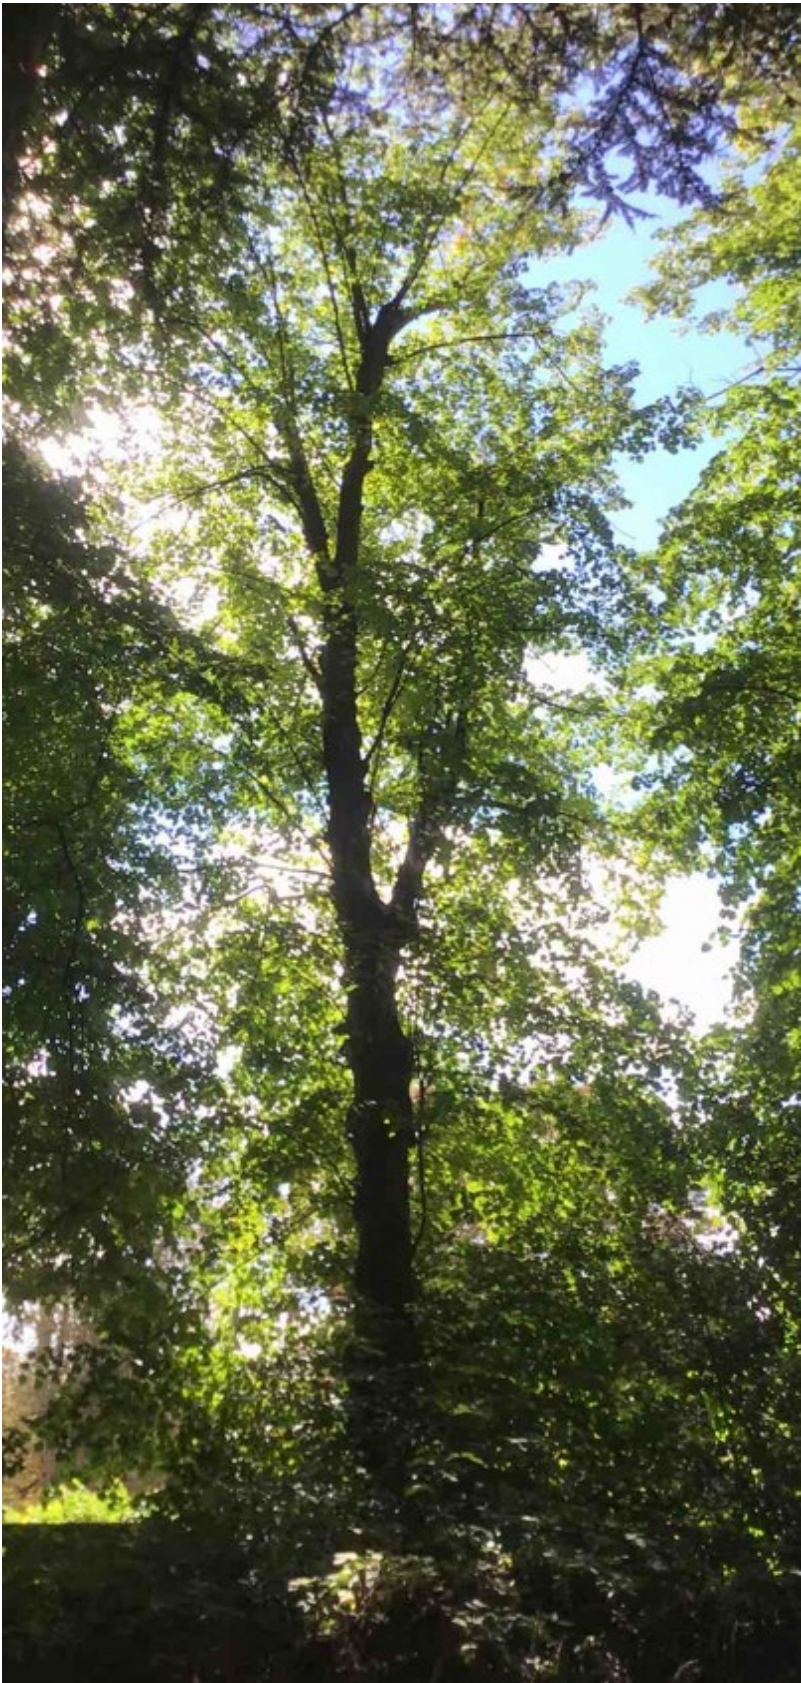
*Image shows tree in situ against boundary wall and overhanging road*

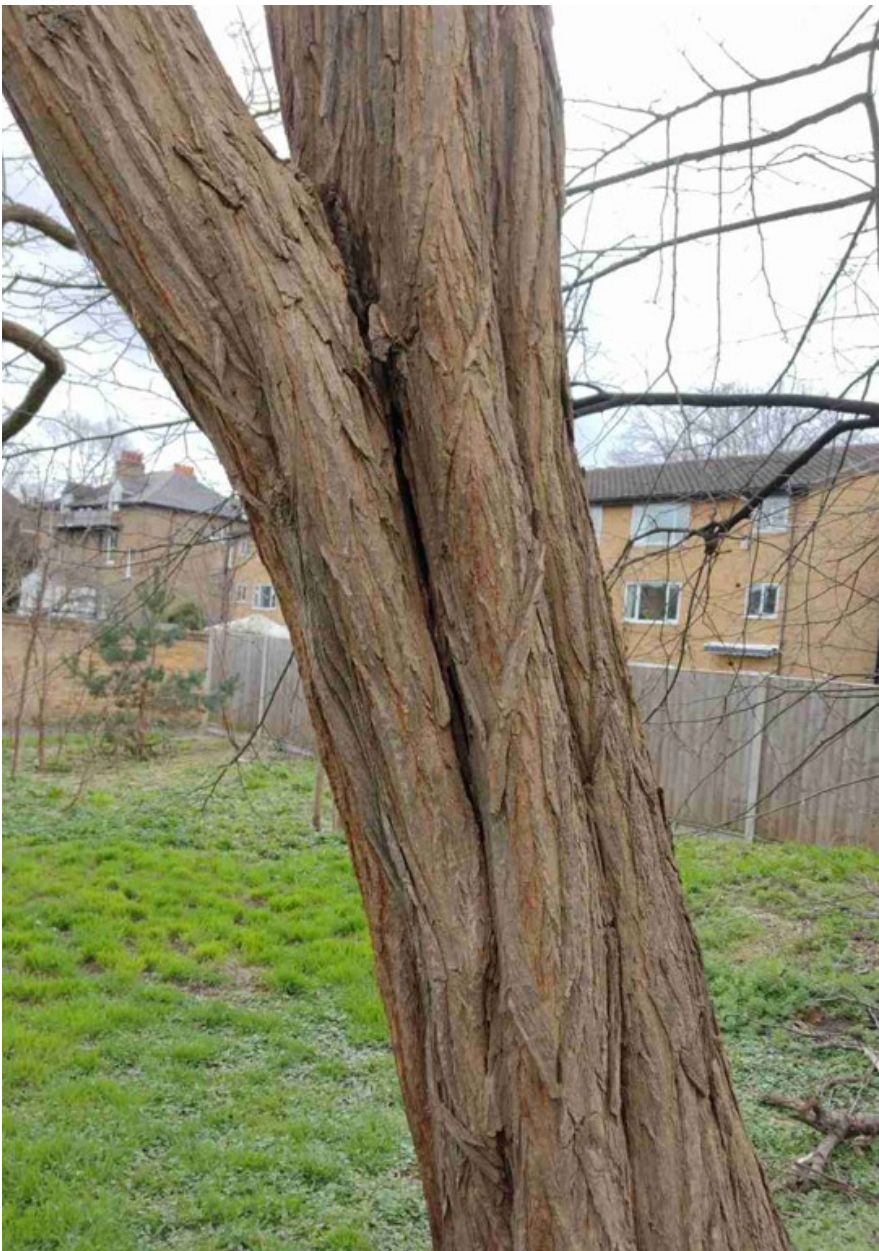
| Inspection findings | This tree main union has part failed and presented an immediate hazard. |

Images shows tree part failed union

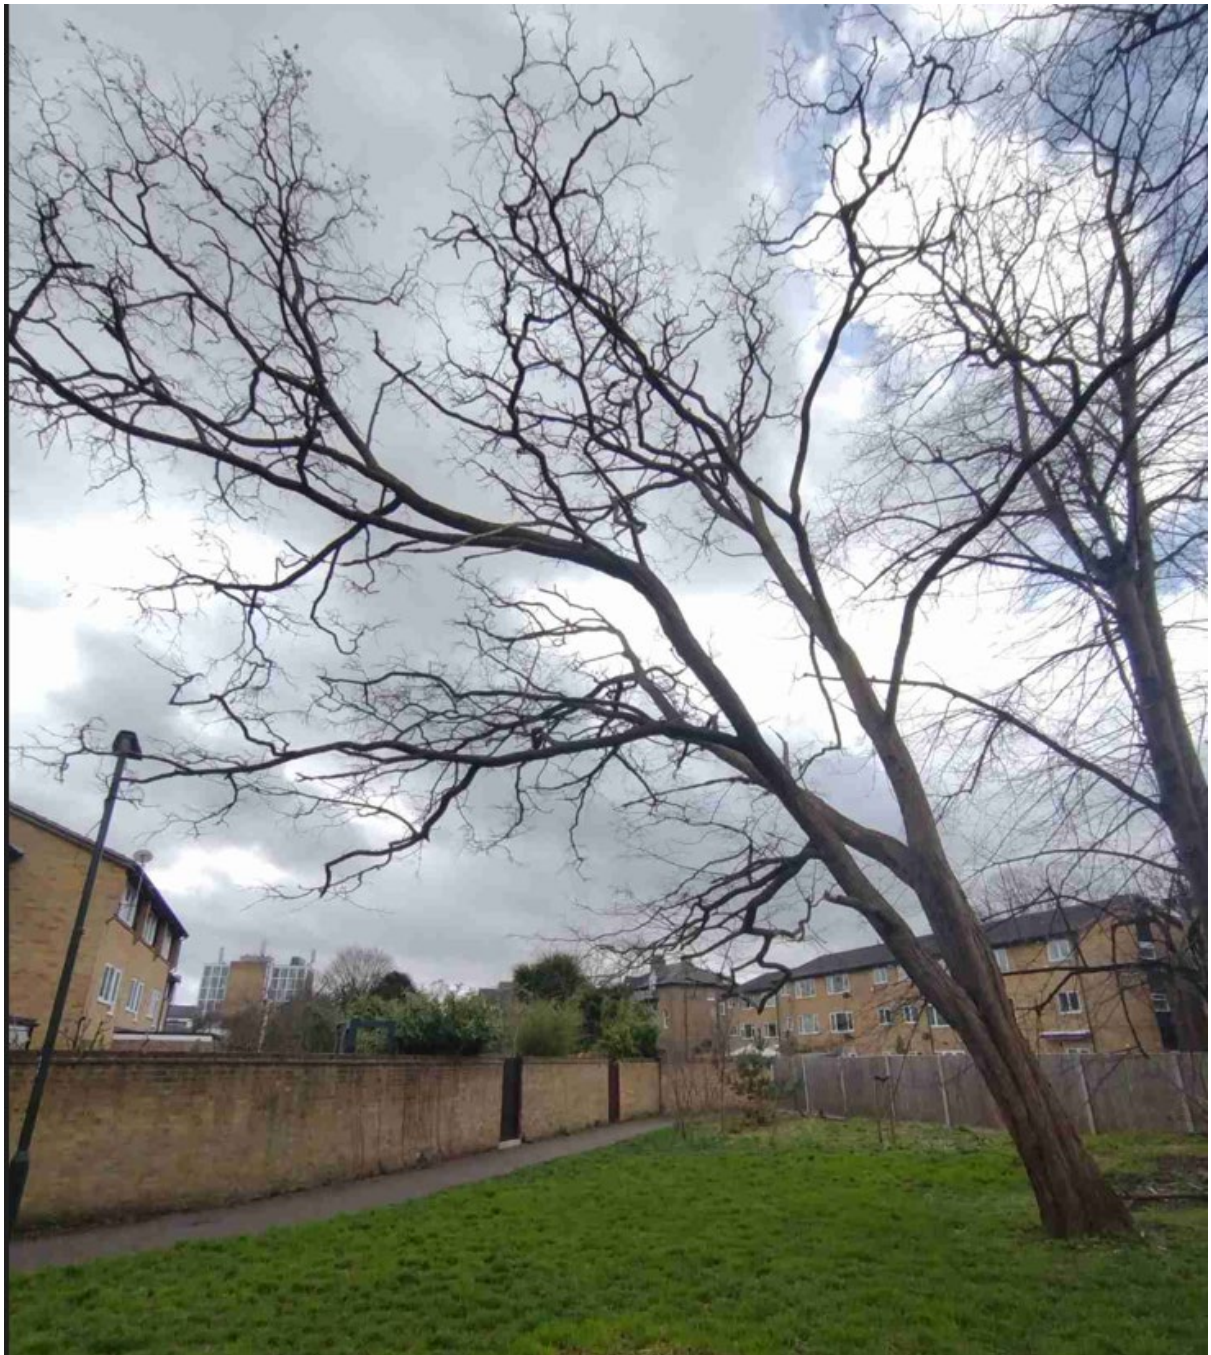
***Images show tree in park setting***
