# June 2023 – Reactive Tree Works Programme

## Introduction

Dated 16.6.2023

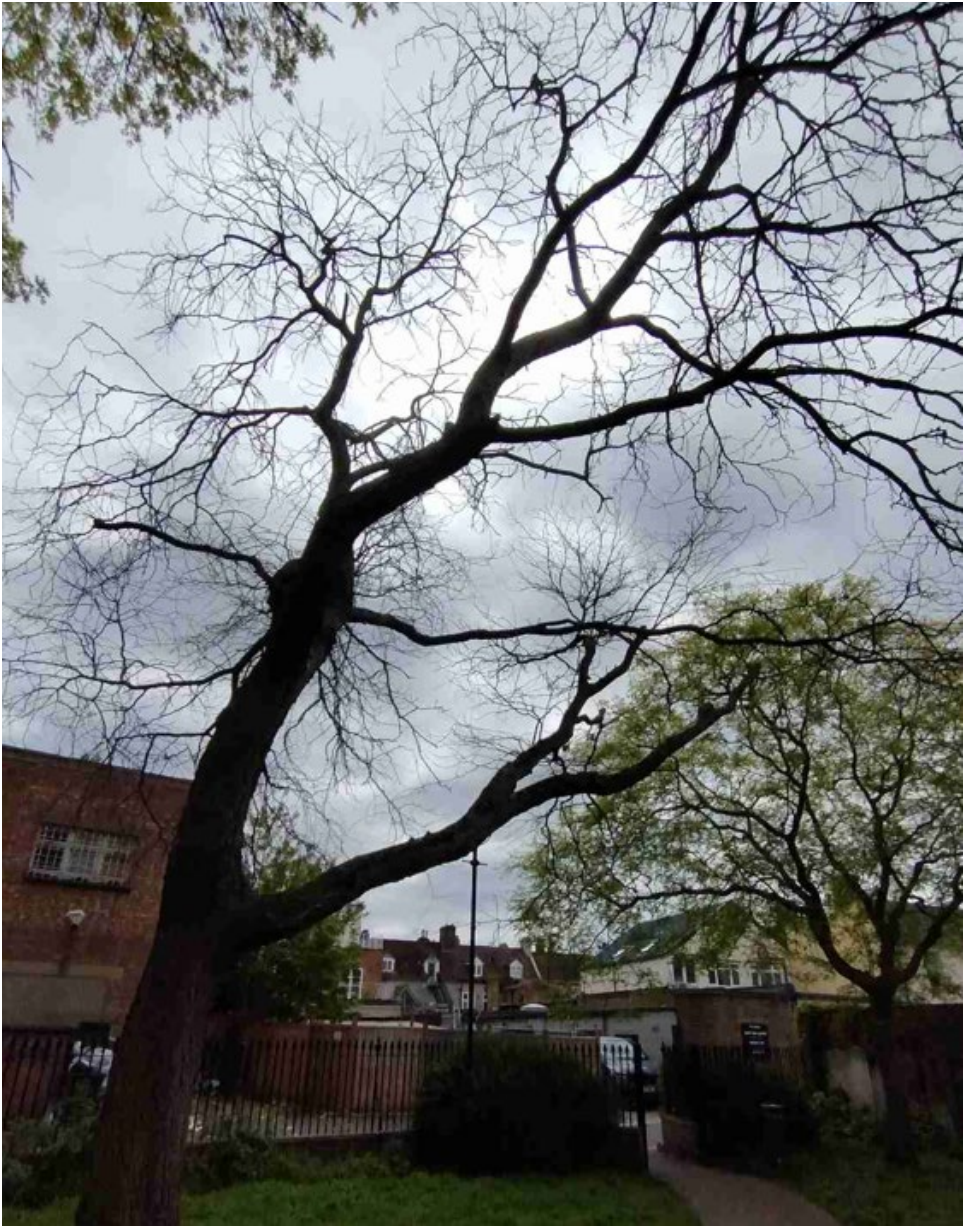
| Inspection findings | This tree is dead and requires removal to facilitate replanting and prevent natural failure |

Image shows dead tree

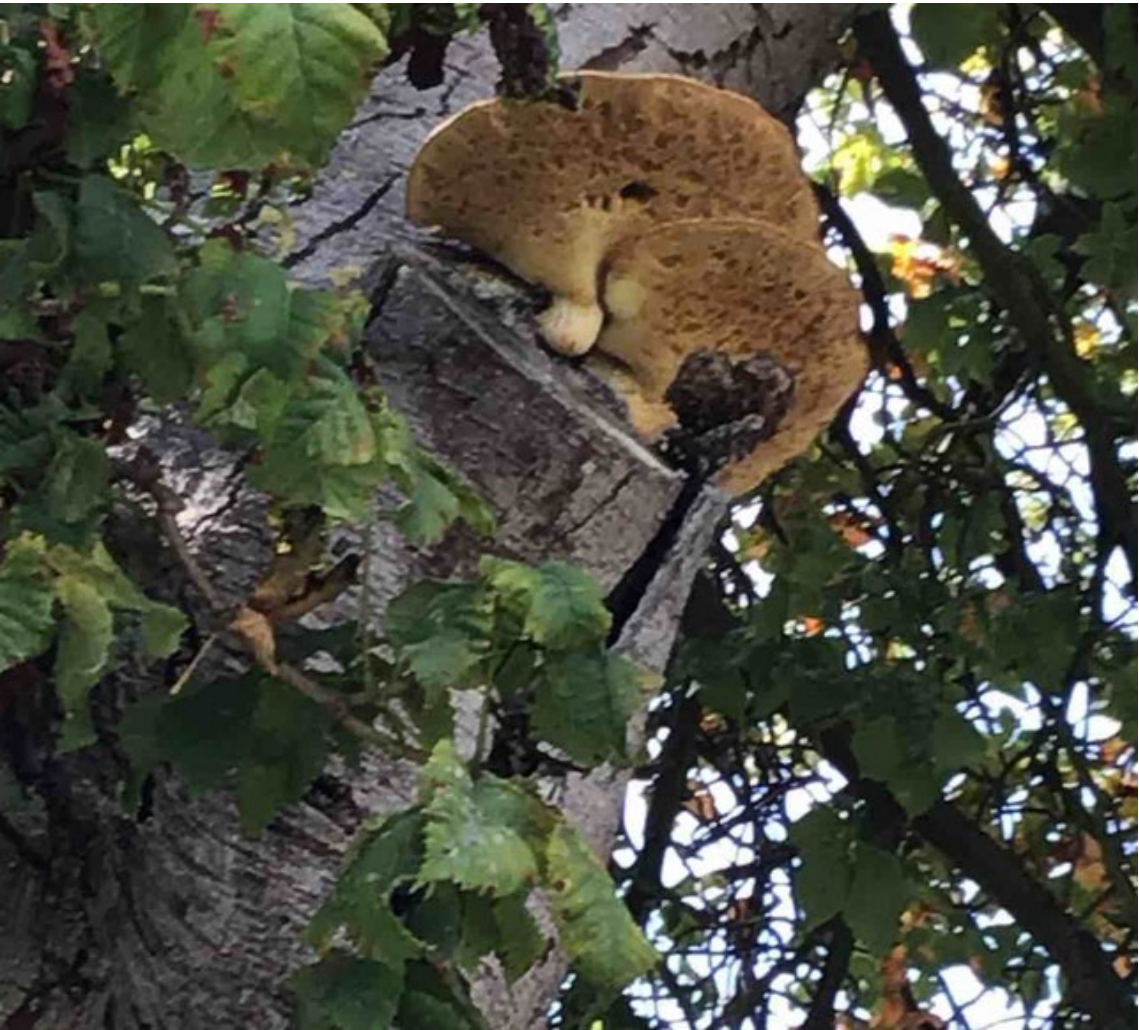
| Inspection findings | A fungal fruiting body of the species Shaggy Polypore ( <i>Inonotus hispidus</i> ) is present on the main stem or trunk, this fungus causes a simultaneous white rot which can cause snapping of tree parts in this species. With This tree has cracked, peeling bark indicating necrosis and dysfunction of the trees vascular system to bark on lower stem and apical die back to upper crown tree is in terminal decline and requires removal to facilitate replanting and prevent natural failure |

Image shows tree with fungal fruiting body stem

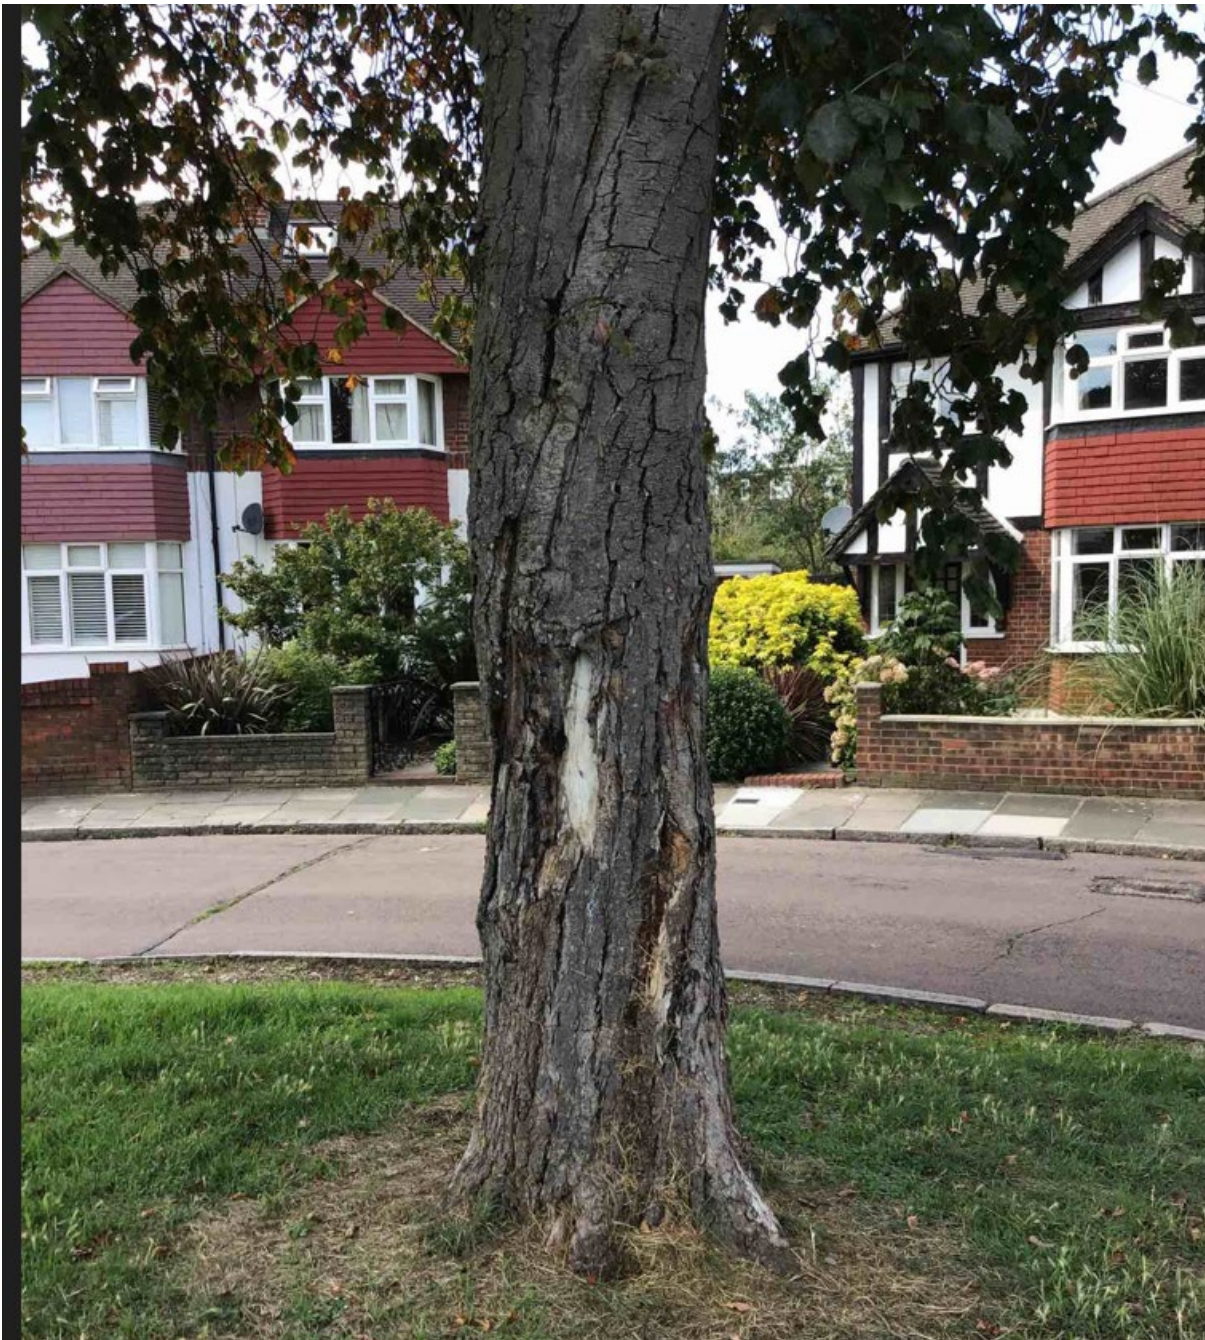
*Images show tree in with area of necrosis and decay at base at stem*

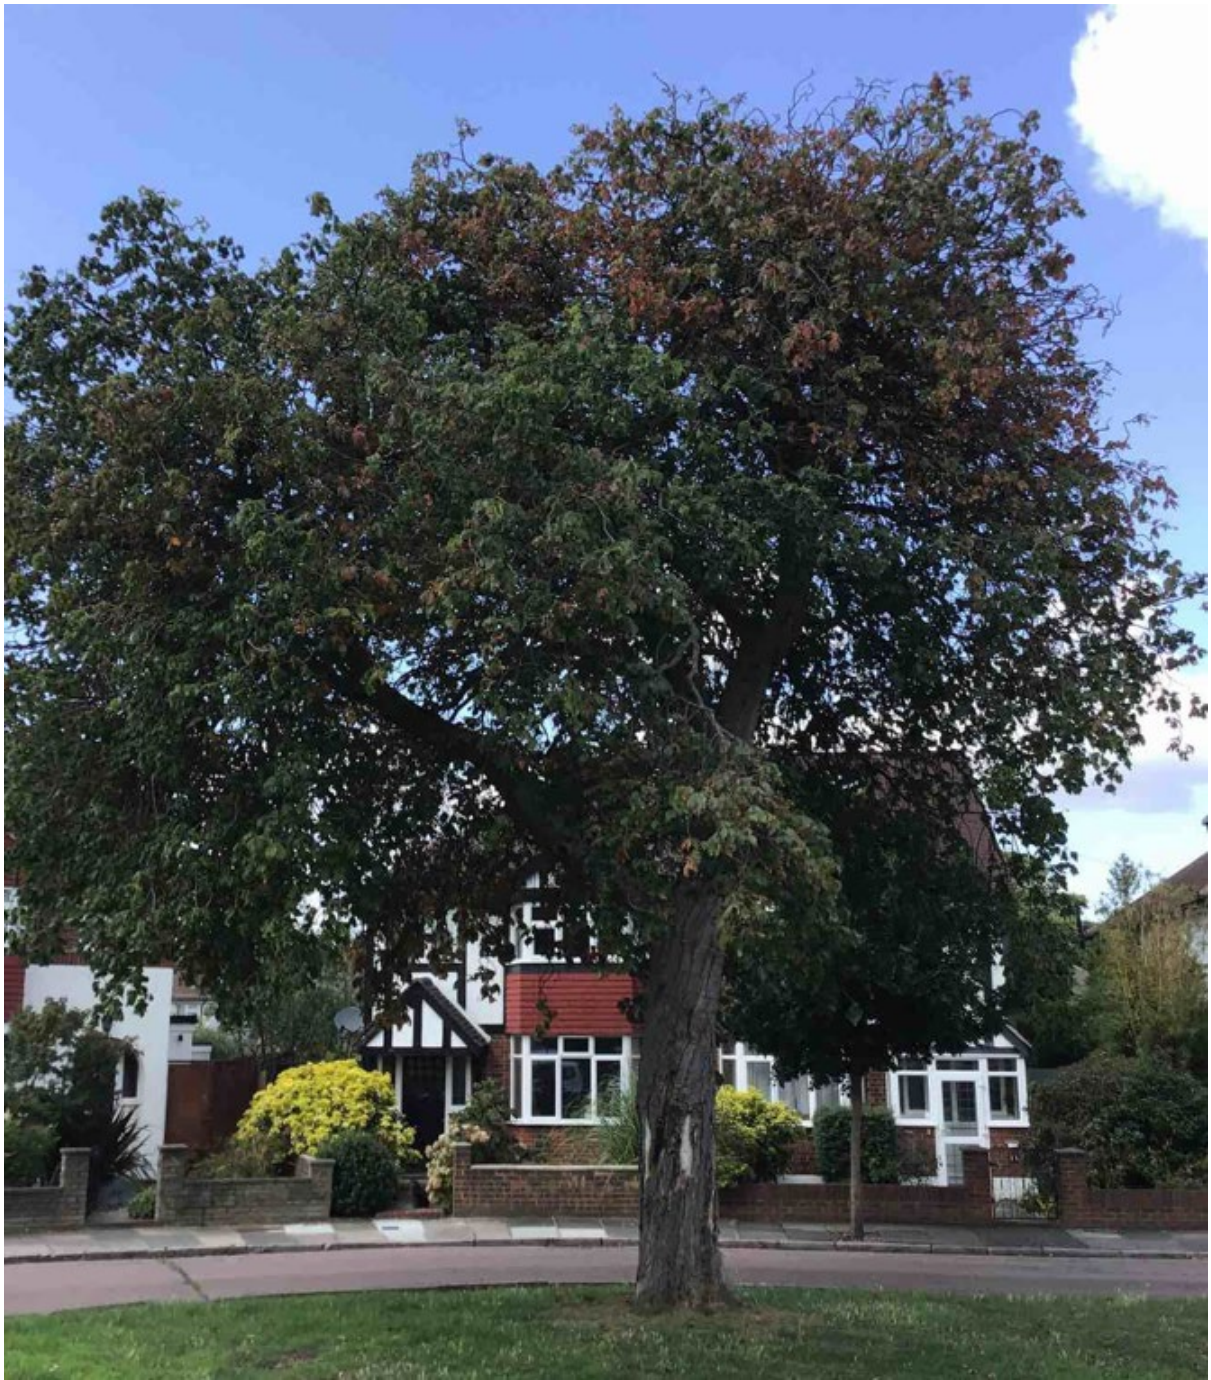
***Images show tree in street scene***

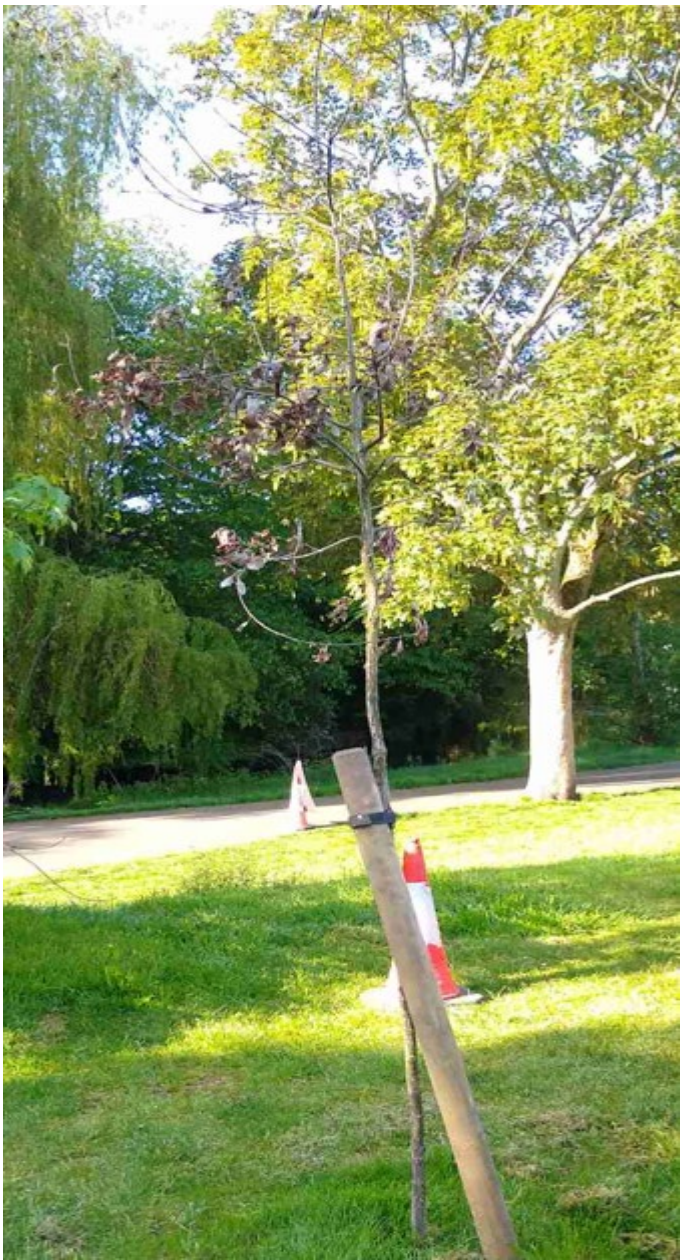
| Inspection findings | This tree is dead and requires removal to facilitate replanting and prevent natural failure |

Image shows dead tree

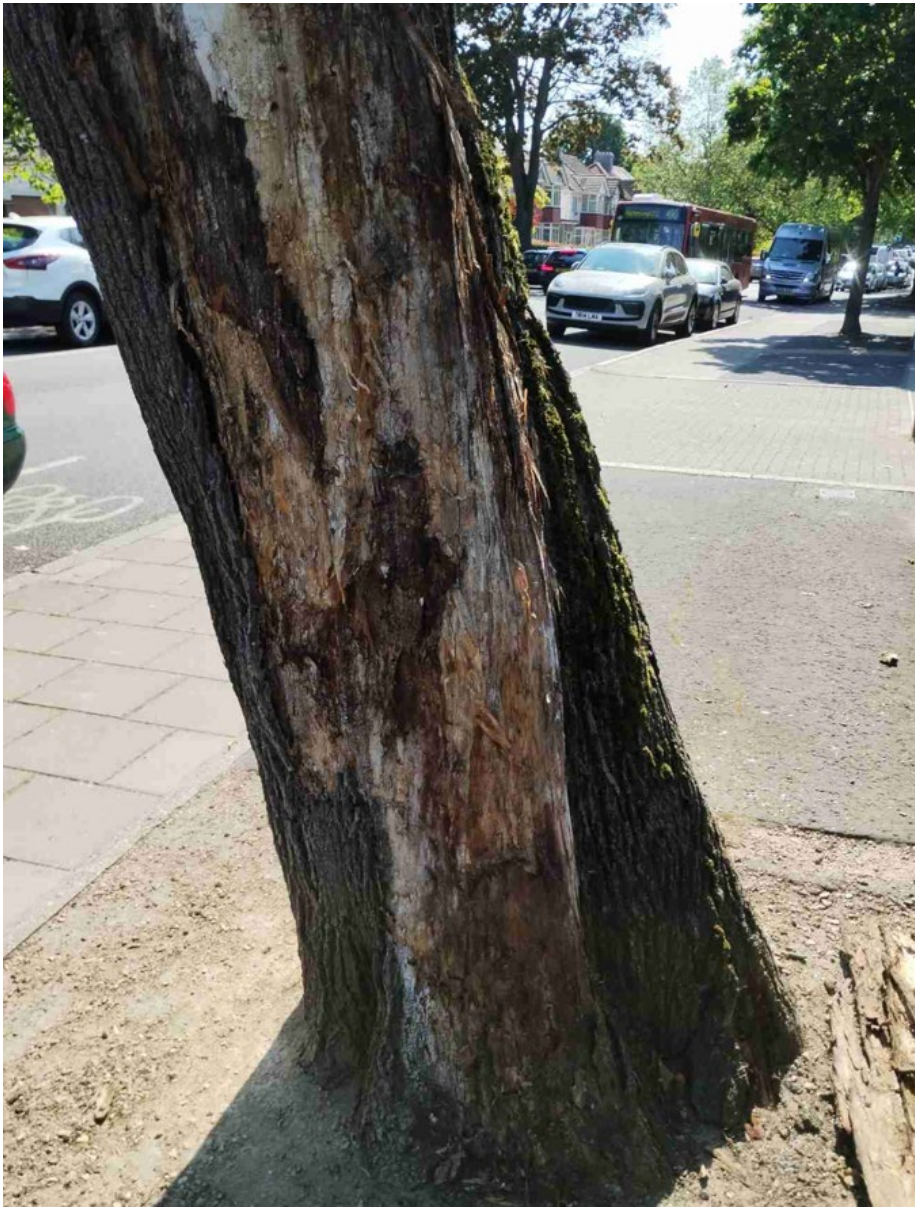
| Inspection findings | Necrosis is present on the lower stem of this tree; the decline of the trees vascular system correlates with dieback within the crown of this declining specimen. This tree is in terminal decline and requires removal to facilitate replanting and prevent natural failure |

Image shows necrosis at base of stem

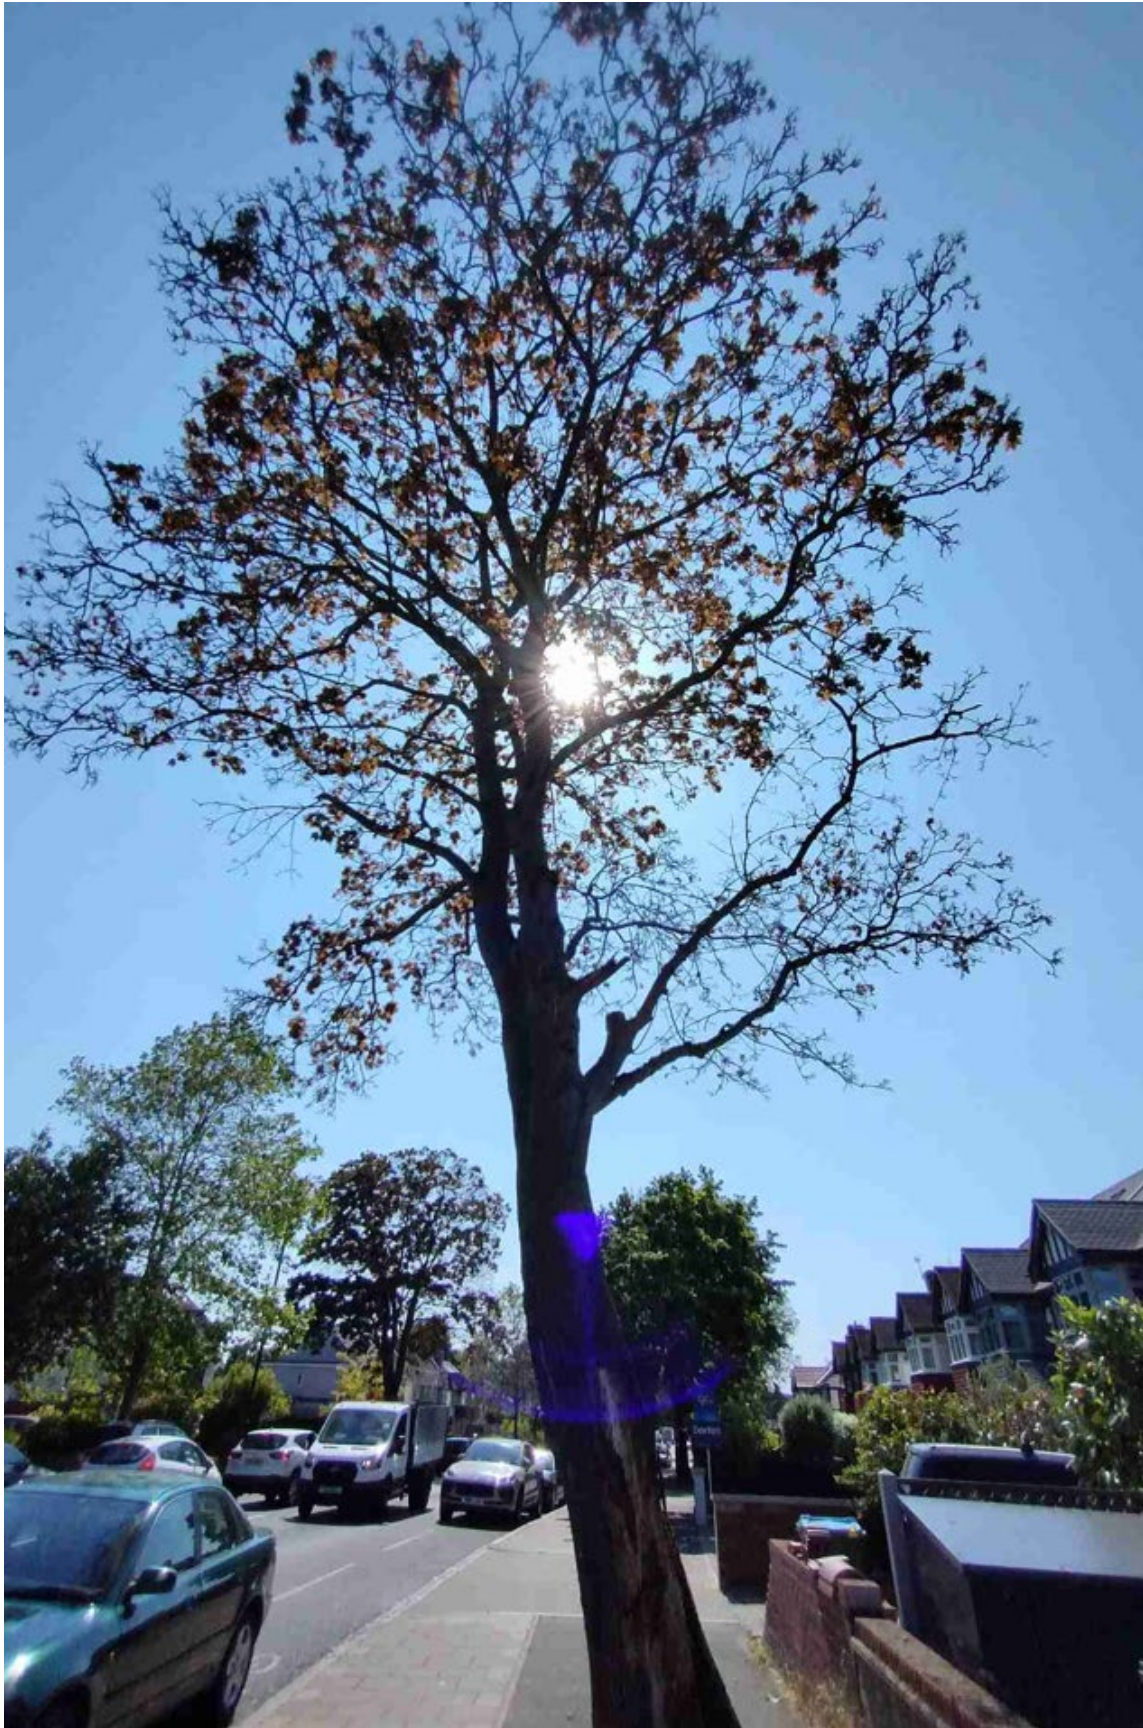
**Image shows crown in decline**

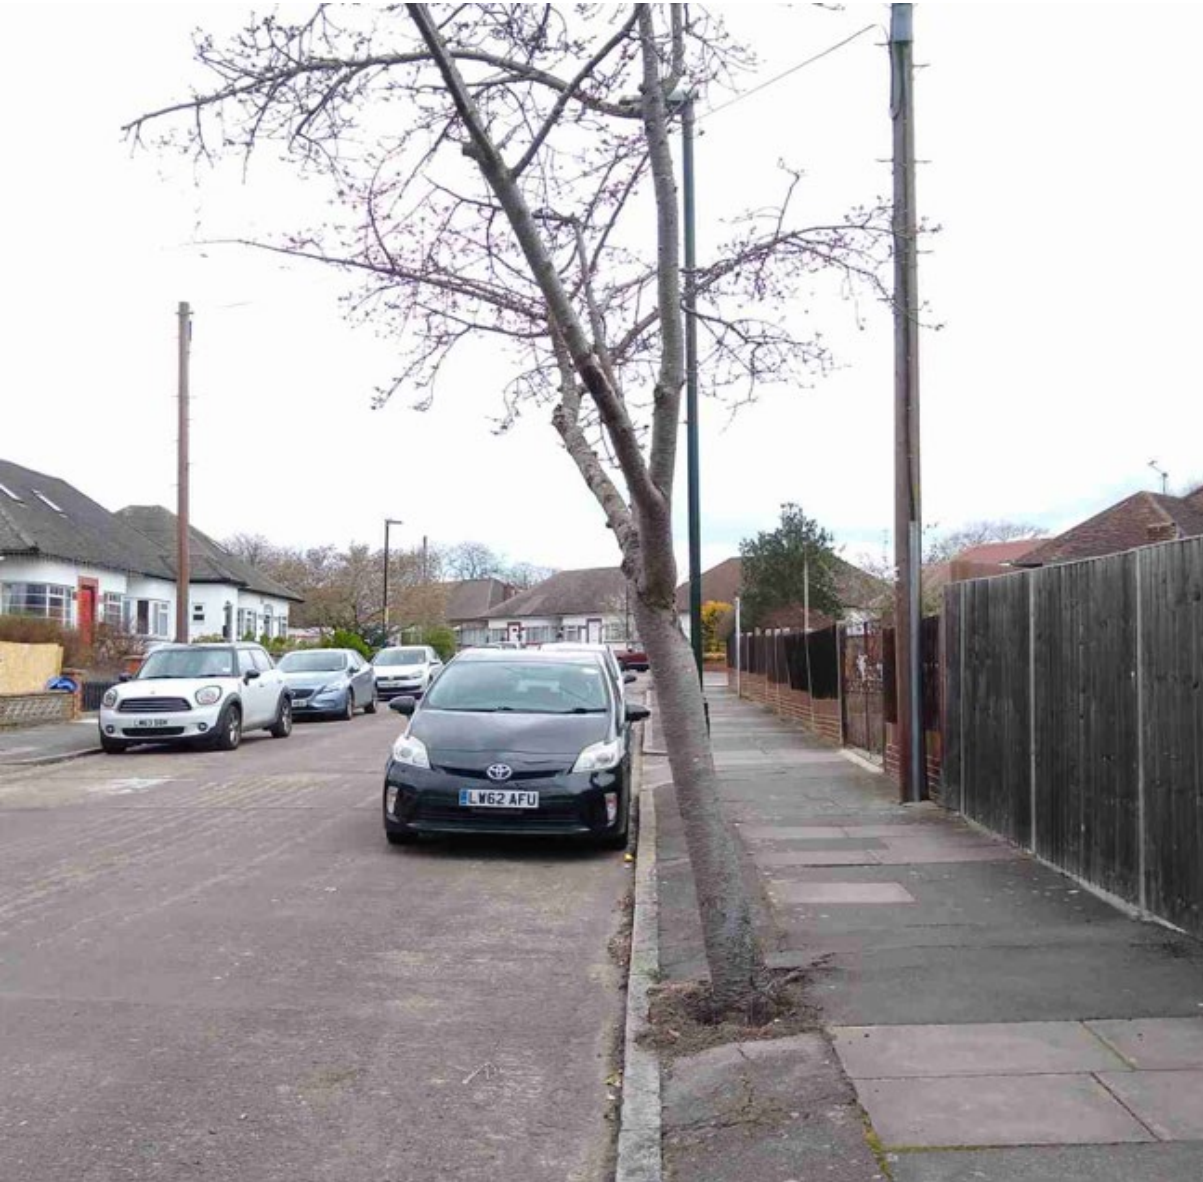
| Inspection findings | Tree roots failure: tree is moving in such a way that indicates that the structure is compromised presenting increased risk of failure |

Image shows tree in street scene with signs of movement around base of trunk

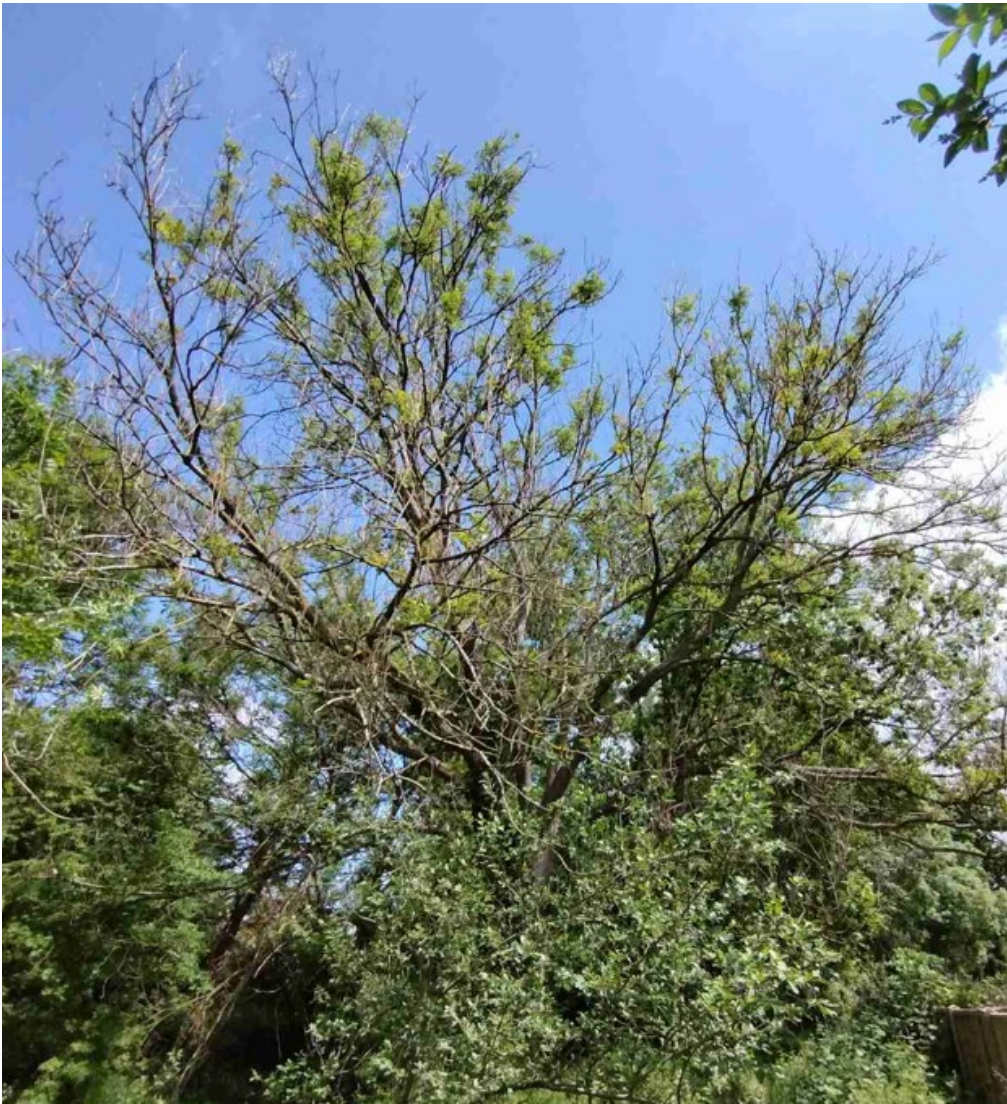
| Inspection findings | Tree crown is displaying advanced symptoms of physiological decline associated with Ash Die Back. This is serious fungal disease of the European Ash, characterized by the progressive decline of the tree's branches and will eventually lead to the death of the tree. |

Image shows tree advanced symptoms of physiological decline associated with Ash Die Back.

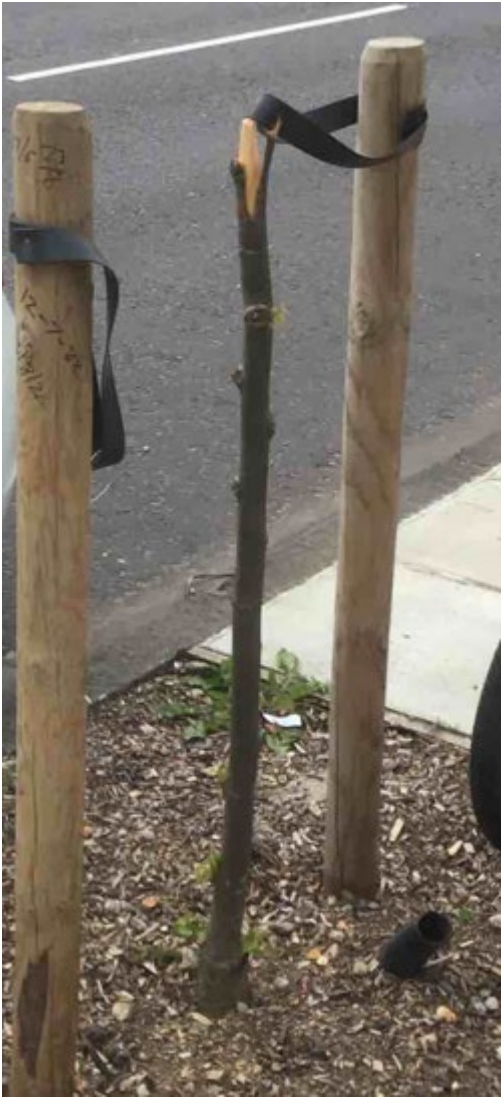
| Inspection findings | This tree has been vandalised and requires removal to facilitate replanting and prevent natural failure |

**Images shows vandalised tree**
