RICHMOND SECTION 19 FLOOD INVESTIGATION

PREPARED FOR LONDON BOROUGH OF
RICHMOND UPON THAMES

Authored by Michael McCarthy
Reviewed by: Tom Whitworth
Approved by Mike Mair
Date June 2023
Version 2.0

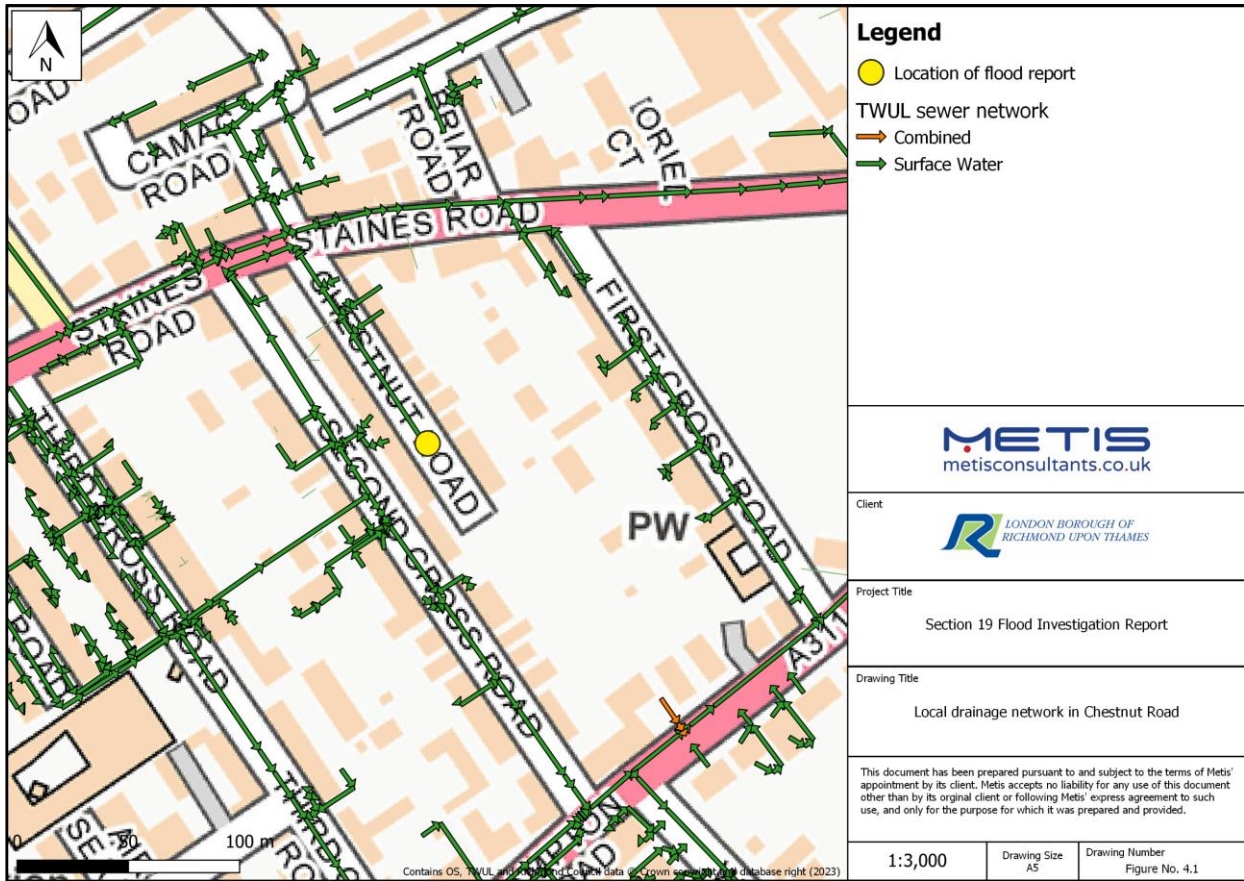
Figure 4-1 Local drainage network in Chestnut Road

Surface water on Chestnut Road and its surrounding roads all drain to the local TWUL surface water drainage network as shown below in *Figure 4-1*. Chestnut Road is a cul-de-sac which has no upstream surface water drainage inputs joining it. All surface water on Chestnut Road drains to a 225mm diameter pipe which then drains North-West and joins a larger Eastward flowing 375mm diameter pipe on Staines Road.

The most likely source of flooding on Chestnut Road during the 12th of July 2021 was sewer flooding. The estimated return period at Chestnut Road was a 1 in 20 year event as seen in *Figure 3-1*. However, it should be noted that the return period at this location may have been greater since Chestnut Road is located close to the border of the 1 in 50 year return period grid square to the South. The limitations to data such as the RaRa data is further discussed in the methodology in 1.2. The flooding report made to Richmond by a resident living on Chestnut Road suggested that the “drains” on Chestnut Road back up quickly during heavy rain, implying that either the surface water sewer on Chestnut Road was surcharging, or that the gullies on Chestnut Road were not free flowing. TWUL surface water sewers are typically designed with a return period of up to a 1 in 30 year event, therefore it should be less likely to surcharge in a 1 in 20 year rainfall event. However, without any specific design records available for the sewer network Chestnut Road this is not possible to confirm either way. Therefore, it is likely that the flooding to Chestnut Road stemmed from a blockage or capacity issue within the surface water sewer or to gullies on the surface. As mentioned in 4.1.2, the topography of Chestnut Road slopes away from Staines Road which suggests that surface water would pond on the surface of the road and not dissipate until the sewer system could receive it, exacerbating the flooding. The resident’s report did not provide details to suggest that groundwater would have contributed as a source of flooding to Chestnut Road in this event. However, Chestnut Road is located in an area of medium to high susceptibility to groundwater flooding, and as mentioned in 4.1.3.2, Chestnut Road is located in the Strawberry Hill Throughflow Catchment, which may have implications to groundwater flooding. Further investigation into the geology and groundwater flow paths is required to quantify the risk of groundwater flooding at Chestnut Road. Whilst it is not possible to conclude with certainty that sewer flooding was the source of flooding at Chestnut Road, the local flood risk information discussed, in combination with the details from the flooding report, suggest that a blockage or capacity issue within the sewer is likely to be the cause.

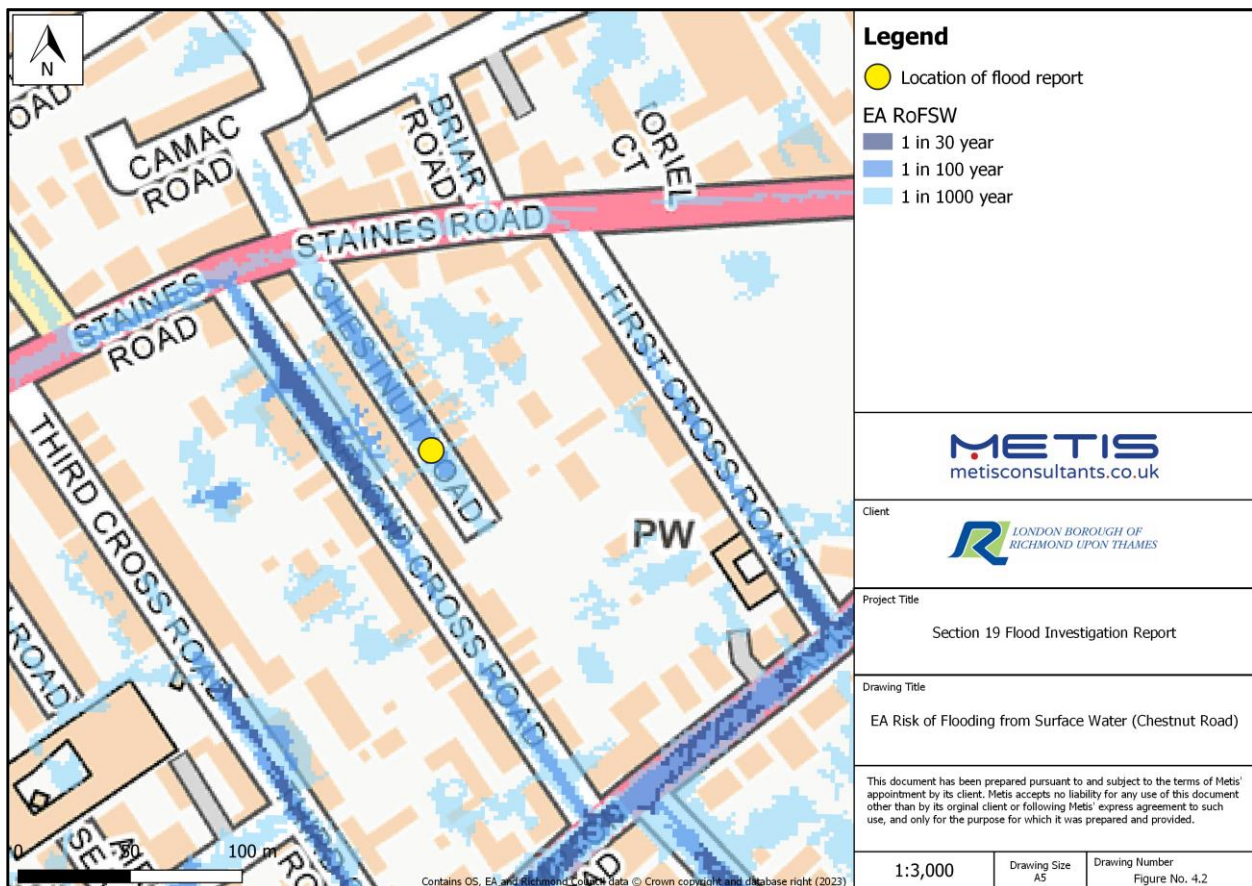
Figure 4-2 EA RoFSW (Chestnut Road)

The EA’s RoFSW mapping in *Figure 4-2* predicts Chestnut Road to be at medium to low risk of surface water flooding. The mapping also predicts that Second Cross Road which runs parallel to Chestnut Road is at higher risk of surface water flooding, while Staines Road is at low risk.

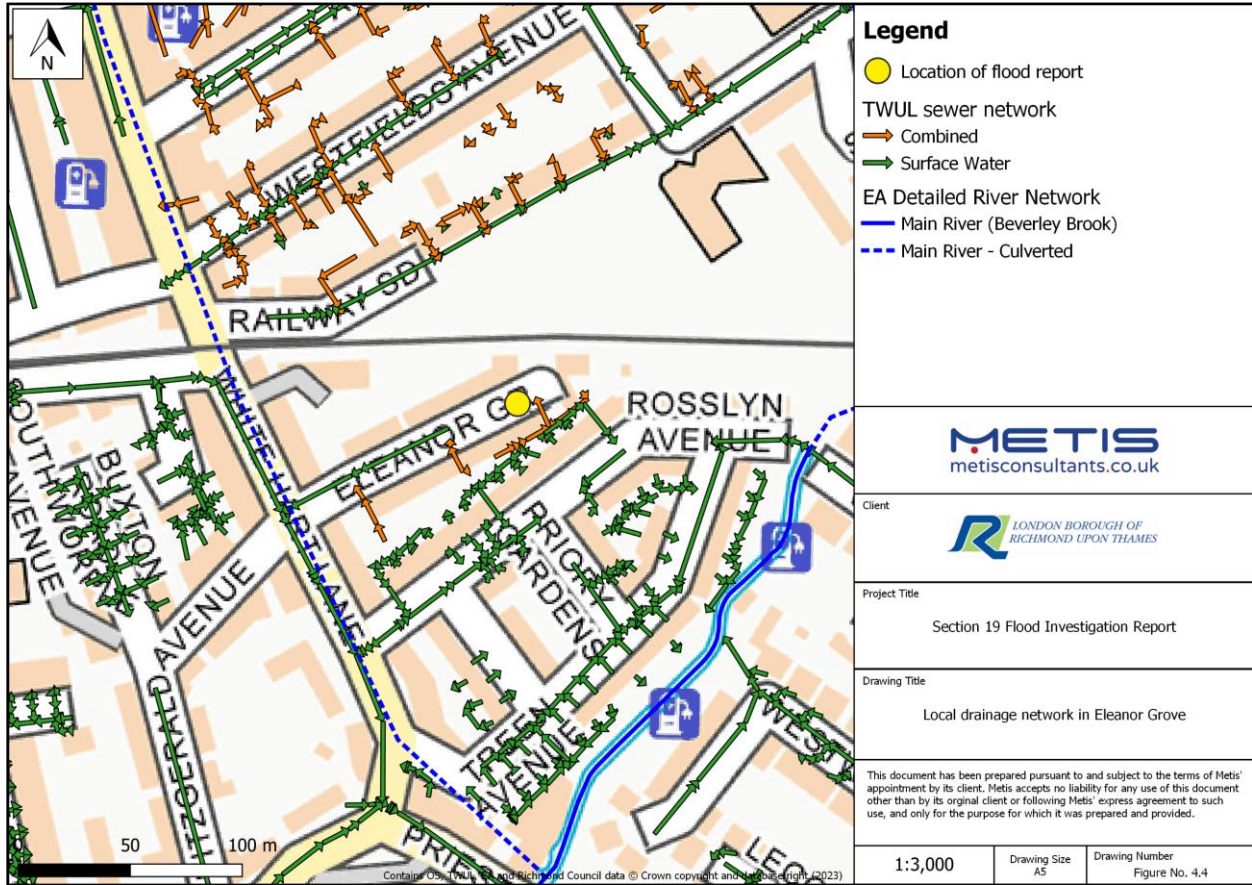
Figure 4-4 Local drainage network in Eleanor Grove

The local drainage network on Eleanor Grove consists of a 150mm diameter surface water pipe which runs the length of the cul-de-sac from East to West. This pipe then joins a larger 225mm surface water pipe on White Hart Lane which flows South, as seen below in *Figure 4-4*. There are also three combined sewer pipes which appear to join a foul sewer pipe which runs to White Hart Lane. The foul sewer pipe is not included in *Figure 4-4* since it should not have been directly influenced by the rainfall on 12th of July 2021, and including the foul network would overcomplicate the mapping. However, foul flooding is considered within this report since the combined sewer pipes serving the foul sewer would be storm responsive, and thus likely would influence the volume of water within the foul sewer during extreme rainfall events.

The resident report does not confirm whether the contaminated water was reaching the property from the highway, or from within where it was described that there was water coming up through the shower drain. It is possible that a blockage within, or a leak from the private drainage within the property boundary, or the TWUL combined sewers which serve the properties on Eleanor Grove, could have resulted in foul sewage backing up and flooding the property.

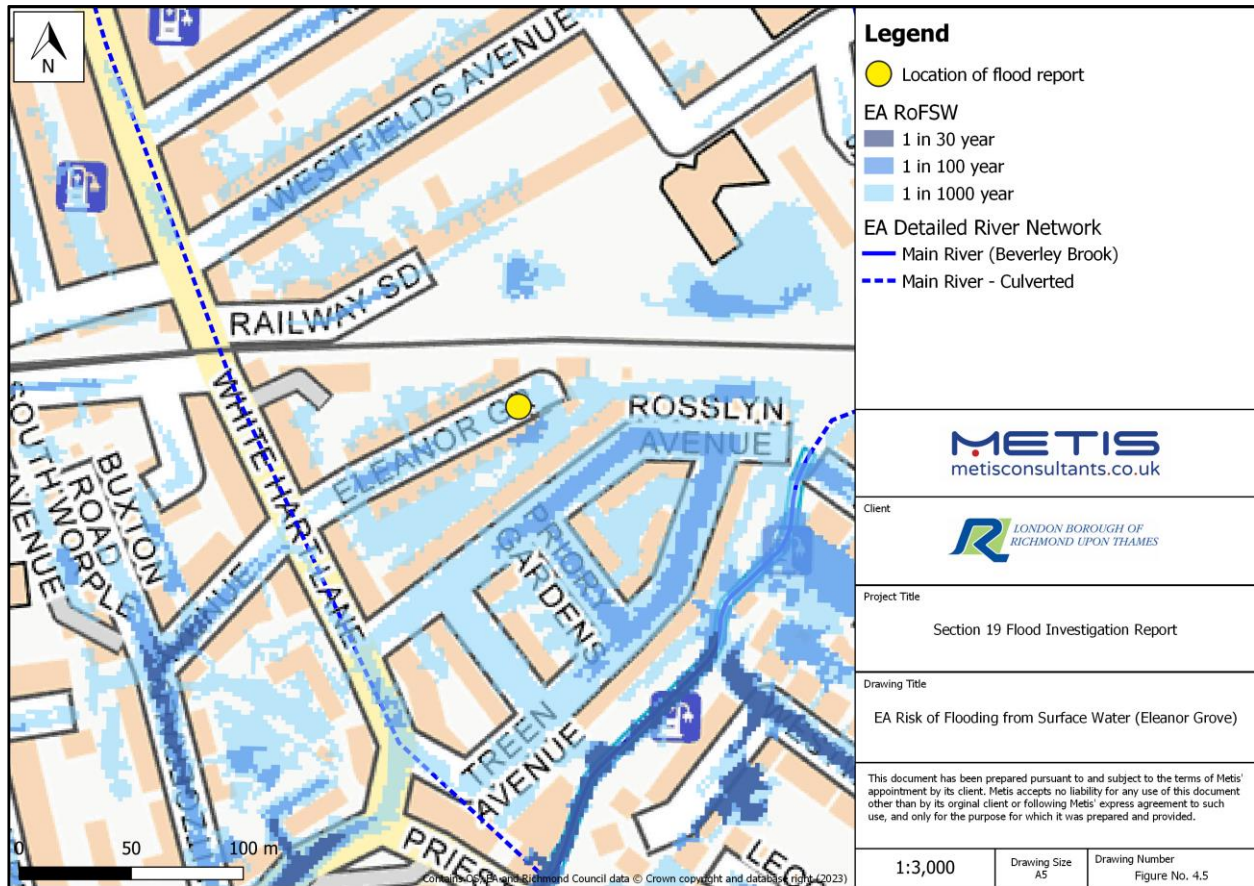
Figure 4-5 EA RoFSW (Eleanor Grove)

As defined earlier in 4.1.3.1 surface water flooding occurs when the volume and intensity of rainfall exceeds both the capacity of the local drainage network and the ability of the ground to infiltrate. The EA’s RoFSW mapping shown below in Figure 4-5 predicts that Eleanor Grove is largely at low risk of surface water flooding, with some patches at medium risk. There are however areas of very high risk of surface water flooding to the South-West of Eleanor Grove in the vicinity of the Beverley Brook.

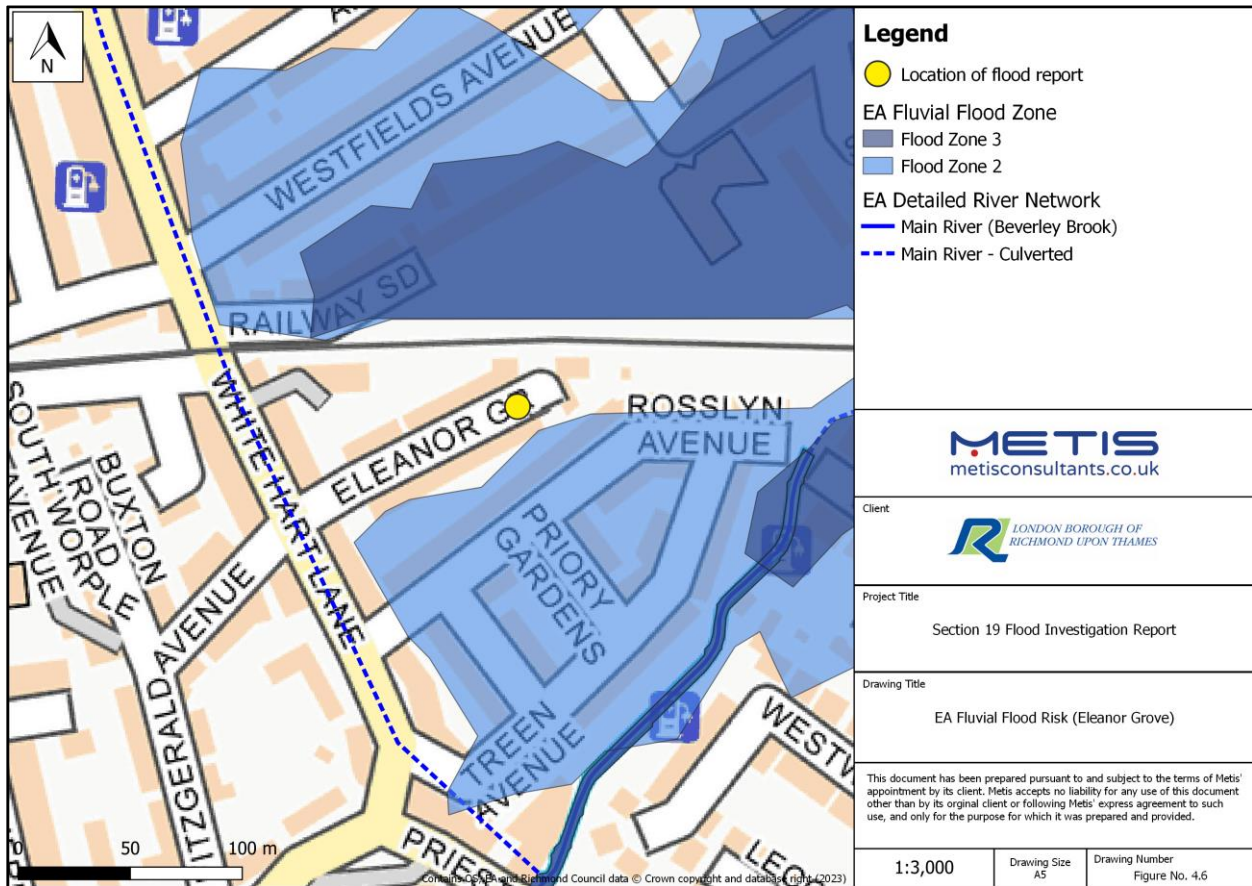
Figure 4-6 EA Fluvial flood risk (Eleanor Grove)

As seen in *Figure 4-6*, Eleanor Grove is not located within Flood Zone 2 or Flood Zone 3, despite the Beverley Brook flowing nearby (approximately 100m to the South-East of Eleanor Grove). Its location within Flood Zone 1 implies that the site is predicted to be at very low risk of fluvial flooding. A culverted watercourse is shown to run from South to North beneath White Hart Lane. This could lead to flooding if not appropriately maintained, albeit this would likely increase risk of flooding at the openings of the culvert by the River Thames to the North, or at the Beverley Brook to the South, rather than at Eleanor Grove. Richmond is a tidally influenced borough, however none of the locations considered in this investigation are influenced or impacted by tidal flood risk.

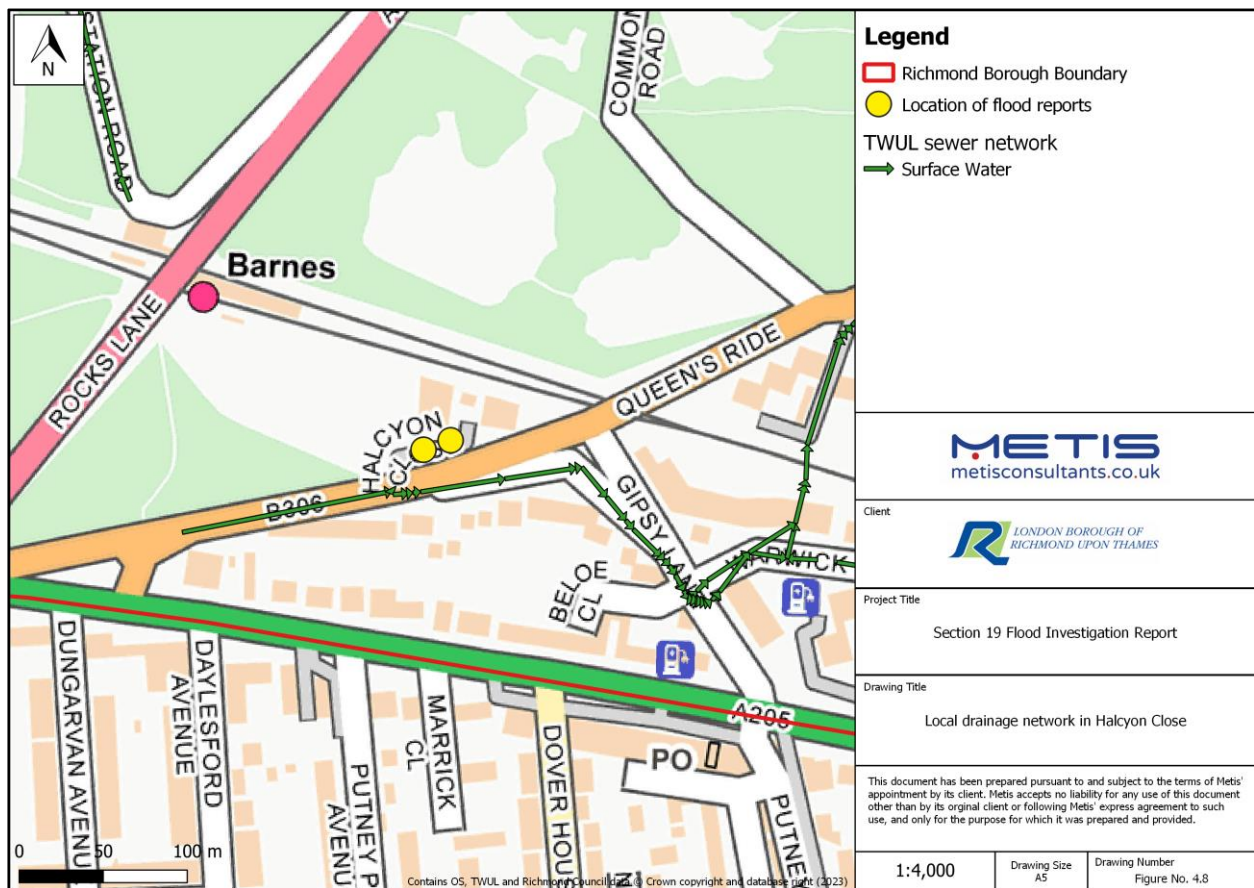
Figure 4-8 Local drainage network in Halcyon Close
*The pink circle is part of the base map and represents Barnes Train Station

The local drainage network in the vicinity of Halcyon Close consists of a single surface water sewer pipe to the South of Halcyon Close which flows from West to East along Queen’s Ride (B306). This surface water pipe has a 150mm diameter to the West of Halcyon Close, although this increases to a 225mm diameter pipe continuing Eastward as it passes the entrance to Halcyon Close. As seen below in *Figure 4-8*, there are no recorded TWUL sewer assets within Halcyon Close, which suggests that Halcyon Close may be supplied by a private drainage network.

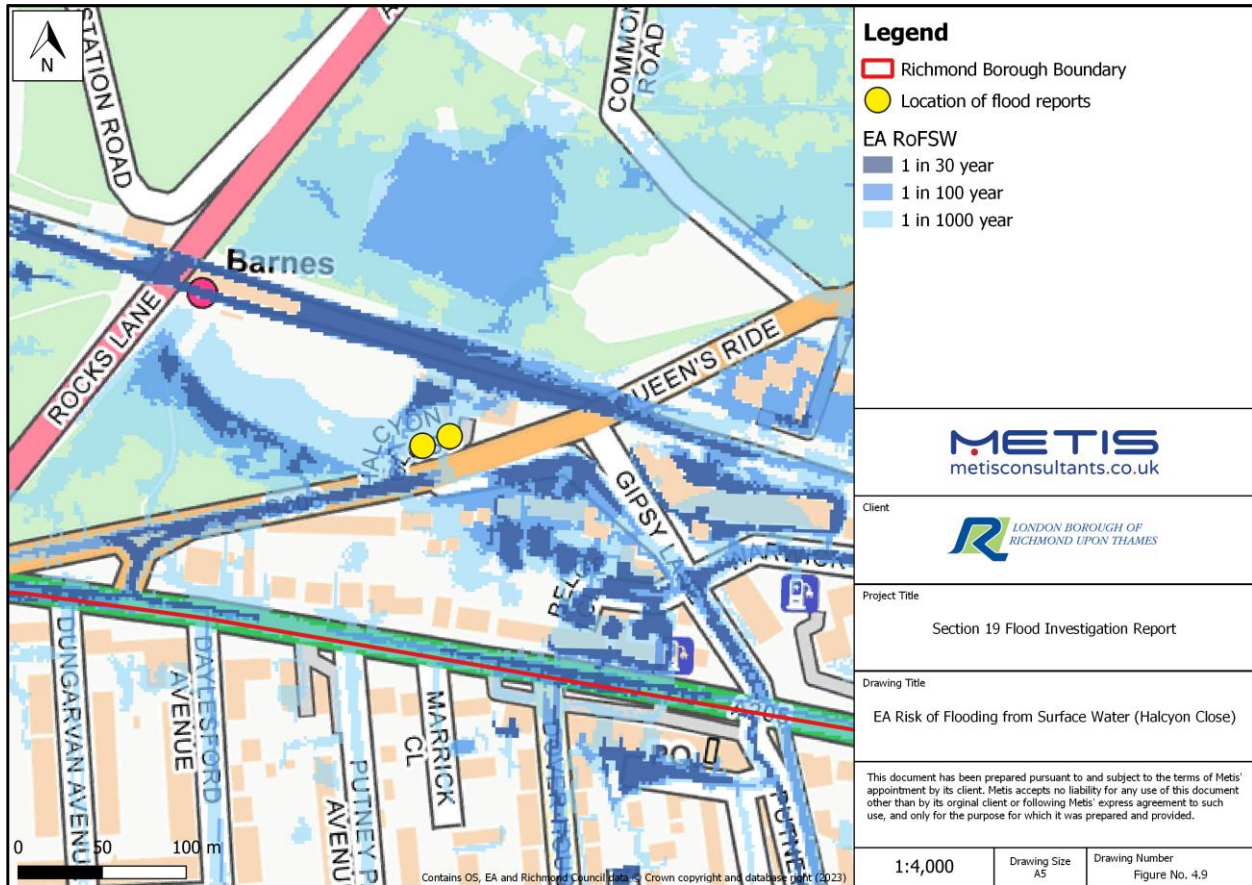
Figure 4-9 EA RoFSW (Halcyon Close)

As defined earlier in 4.1.3.1 surface water flooding occurs when the volume and intensity of rainfall exceeds both the capacity of the local drainage network and the ability of the ground to infiltrate. The EA's RoFSW mapping shown below in *Figure 4-9* predicts that Halcyon Close is at varied risk of surface water flooding. The majority of Halcyon Close is predicted to be at low to medium risk of surface water flooding, although the North-West corner is shown to be at high risk. Queen's Ride (B306) is also shown to be at high risk of surface water flooding at the entrance and to the West of Halcyon Close, which is reflective of the topography discussed in 4.3.2. There is also a high risk of surface water flooding predicted to the railway behind Halcyon Close, although this is at a significantly lower elevation than Halcyon Close and hence does not pose a risk to the properties here.

The most likely cause of flooding to Halcyon Close on 12th of July 2021 was a combination of surface water conveyance from Queen’s Ride, and sewer flooding. Halcyon Close is shown to be at medium to high risk of surface water flooding which implies that surface water would be a likely source of flooding during a 1 in 100 year rainfall event, as is suggested in *Figure 3-1*. Whilst the railway behind Halcyon Close is also at high risk of flooding there were no flooding reports received on the railway. In such a significant rainfall event surface water overflows from Queen’s Ride would have conveyed substantial volumes of surface water into Halcyon Close, which resides at the low point of the road. It is likely that in a 1 in 100 year rainfall event the TWUL surface water sewer on Queens Ride would have been overwhelmed by the volume of rainfall and surcharge, which would have amplified the volumes of surface water flowing into Halcyon Close.

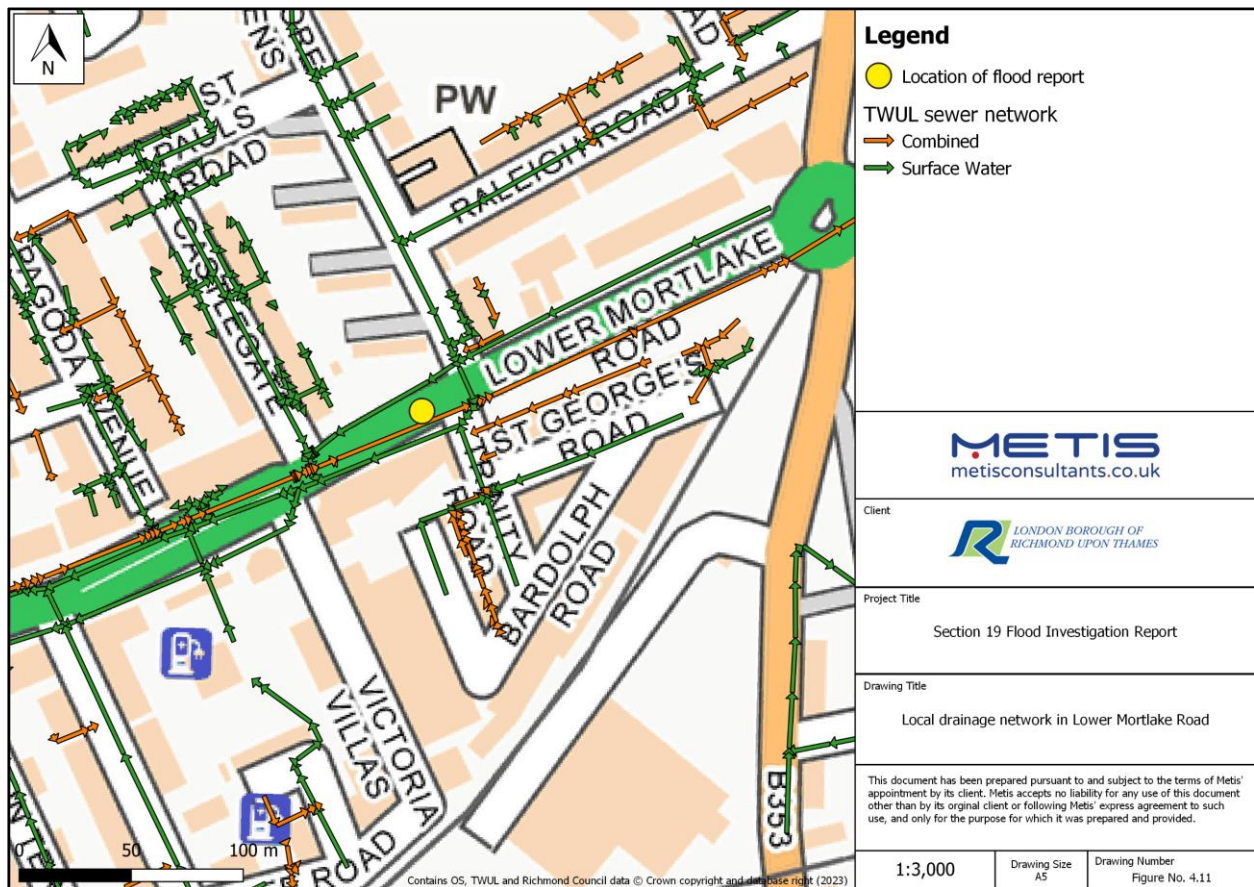
Figure 4-11 Local drainage network in Lower Mortlake Road

Lower Mortlake Road is managed by both surface water and combined sewers as shown by the TWUL drainage asset data in *Figure 4-11*. There is a 300mm diameter surface water pipe which flows from East to West beneath the Southern footway, which drains a number of surrounding roads from both the North and South. These roads include St George’s Road, Bardolph Road and Trinity Road which contribute from the South, and Raleigh Road and the Southern half of Stanmore Gardens which contribute from the North. There is also another 225mm diameter surface water sewer which flows from East to West beneath the Northern footway of Lower Mortlake Road which carries water from the Manor Circus roundabout. The 760mm diameter combined sewer on Lower Mortlake Road flows beneath the highway in the opposite direction to the surface water sewers, from West to East. This combined sewer travels a significant distance, from as far as the River Thames almost 2km away in a South-Westerly direction.

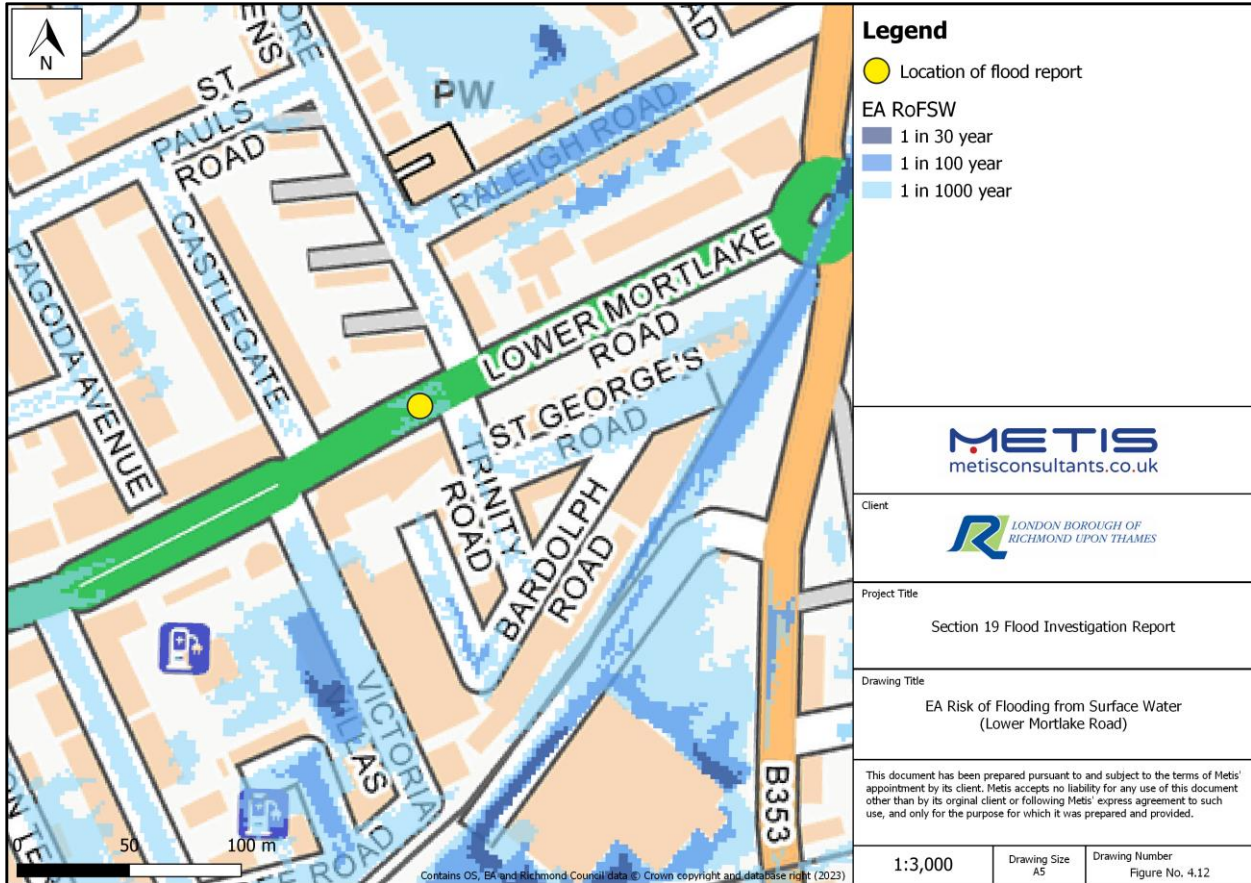
Figure 4-12 EA RoFSW (Lower Mortlake Road)

As defined earlier in 4.1.3.1 surface water flooding occurs when the volume and intensity of rainfall exceeds both the capacity of the local drainage network and the ability of the ground to infiltrate. The EA's RoFSW mapping shown below in *Figure 4-12* predicts that Lower Mortlake Road and the majority of its neighbouring roads are at low risk of surface water flooding.

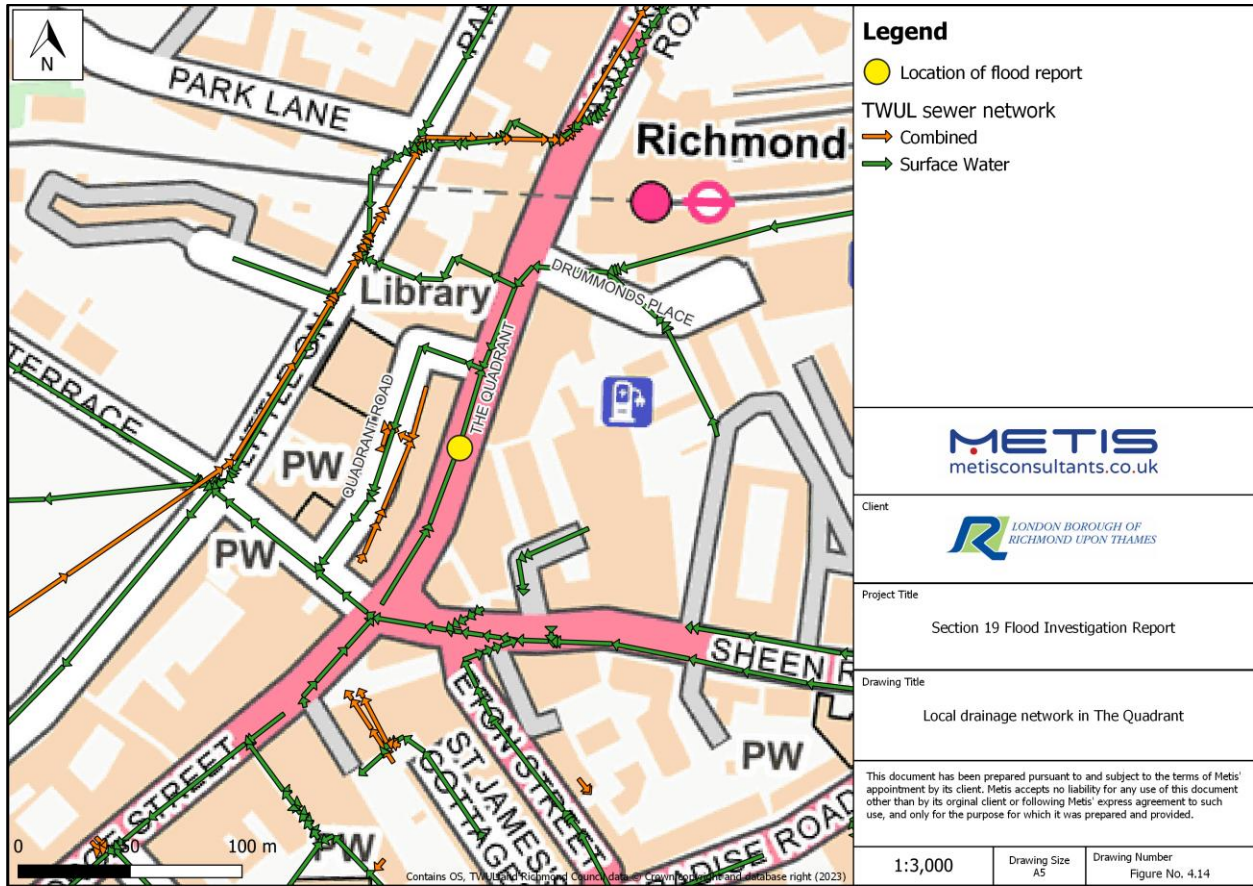
Figure 4-14 Local drainage network in The Quadrant

The Quadrant is surrounded by both surface water and combined sewers as shown in *Figure 4-14*. A 225mm diameter surface water pipe flows North along The Quadrant, which appears to converge with another larger 450mm surface water pipe flowing in the opposite direction. A 225mm pipe then flows West and then South beneath Quadrant Road to the West of The Quadrant. There is also a junction of three 225mm diameter combined sewers behind the flooded property, which resides between The Quadrant and Quadrant Road. These combined sewers appear to serve the flooded property and other neighbouring properties on this stretch of The Quadrant.

The TWUL sewer network implies that there are two converging 450mm diameter surface water sewers at the turning into Quadrant Road. However, the surface water sewer on Quadrant Road is of lesser capacity, only 225mm diameter. Therefore, with larger volumes of surface water being funnelled into a smaller pipe, it would suggest that sewer overflows at this location are likely. It should be noted however that the TWUL sewer network data may have inaccuracies. The CAF indicates that the Southern end of The Quadrant is at risk of foul sewer surcharge from 2030 onwards in line with the latest climate change projections.

An alternative suggestion could be that the 225mm surface water sewer behind the property on Quadrant Road surcharged which caused flooding to the back of the property. It is possible that the reported surcharging manhole from the 2020 event may have been located on Quadrant Road behind the property, although this is not evidenced within the flooding report in August 2020. If this was the case, the flooding in July 2021 could have resulted from a blockage which had not been fully cleared since the August 2020 event. Alternatively, it may be indicative of a sewer capacity issue on Quadrant Road which has not yet been addressed.

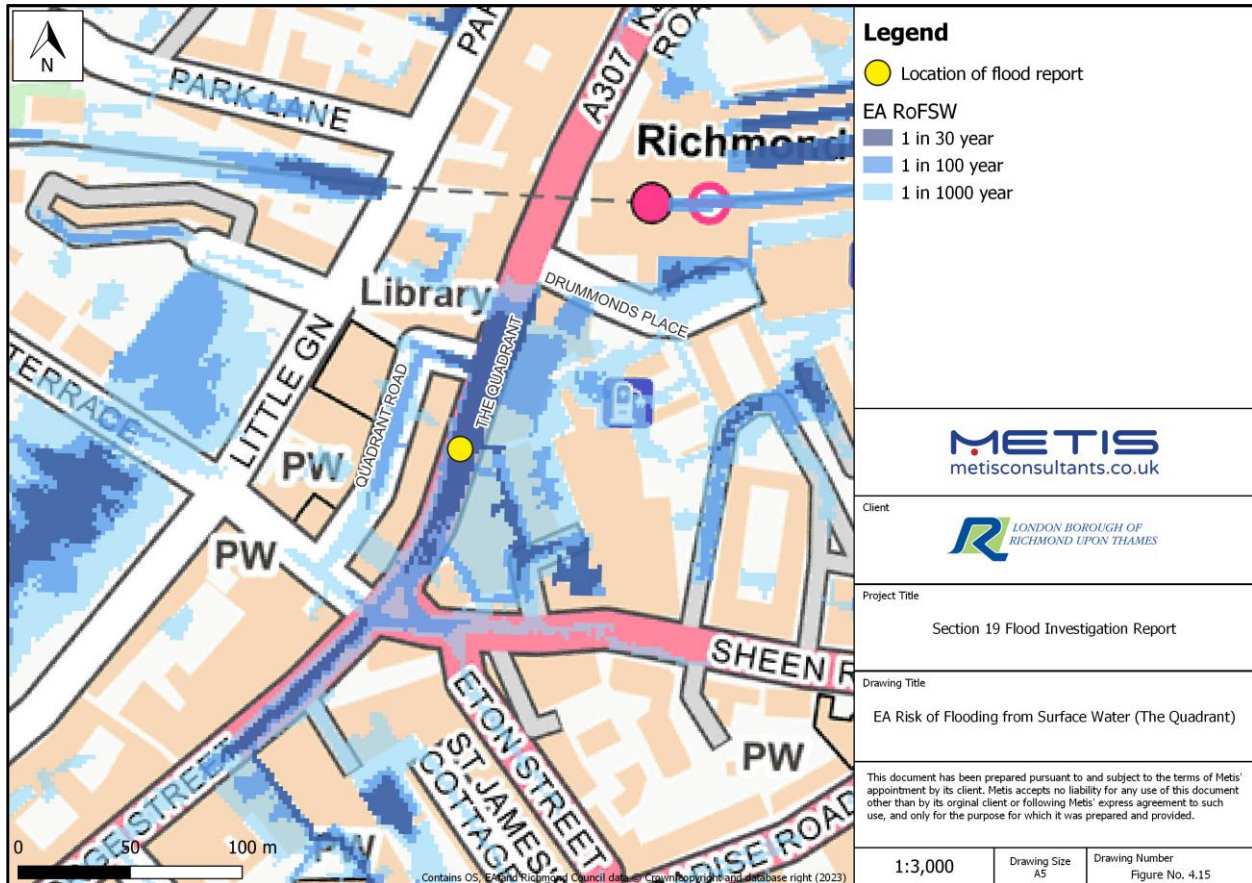
Figure 4-15 EA RoFSW (The Quadrant)
 *The pink circle is part of the base map and represents Richmond Train Station

As defined earlier in 4.1.3.1 surface water flooding occurs when the volume and intensity of rainfall exceeds both the capacity of the local drainage network and the ability of the ground to infiltrate. The EA’s RoFSW mapping shown below in *Figure 4-15* shows that the section of The Quadrant outside the flooded property is predicted to be at high risk of surface water flooding. There is also a medium risk of surface water flooding along Quadrant Road to the West of The Quadrant and at the junction of The Quadrant with Sheen Road, George Street and Duke Street.
