April 2026 - Reactive Tree Works Programme

Introduction

Dated 26/04/2026

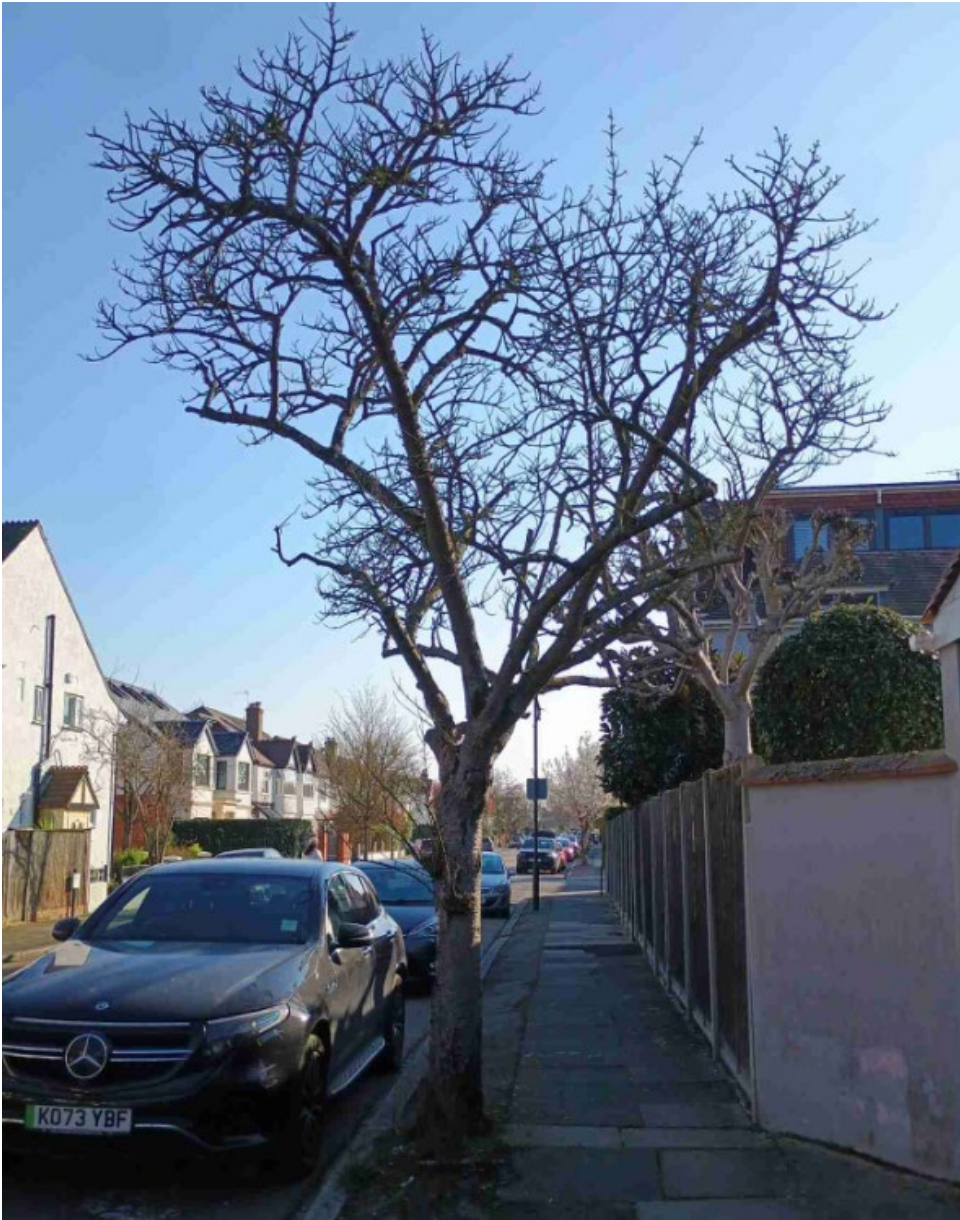
Ward	Barnes
Road	Lowther Road
Location	Side of 48 Suffolk Road rear garden by garage
Species	Wild Cherry (<i>Prunus avium</i>)
Height	5.5m
Physiological Condition	Dead
Structural Condition	Fair
Inspection findings/reason for exemption	This tree is dead; removal is required to prevent natural failure and facilitate replanting

Image shows dead tree in street scene

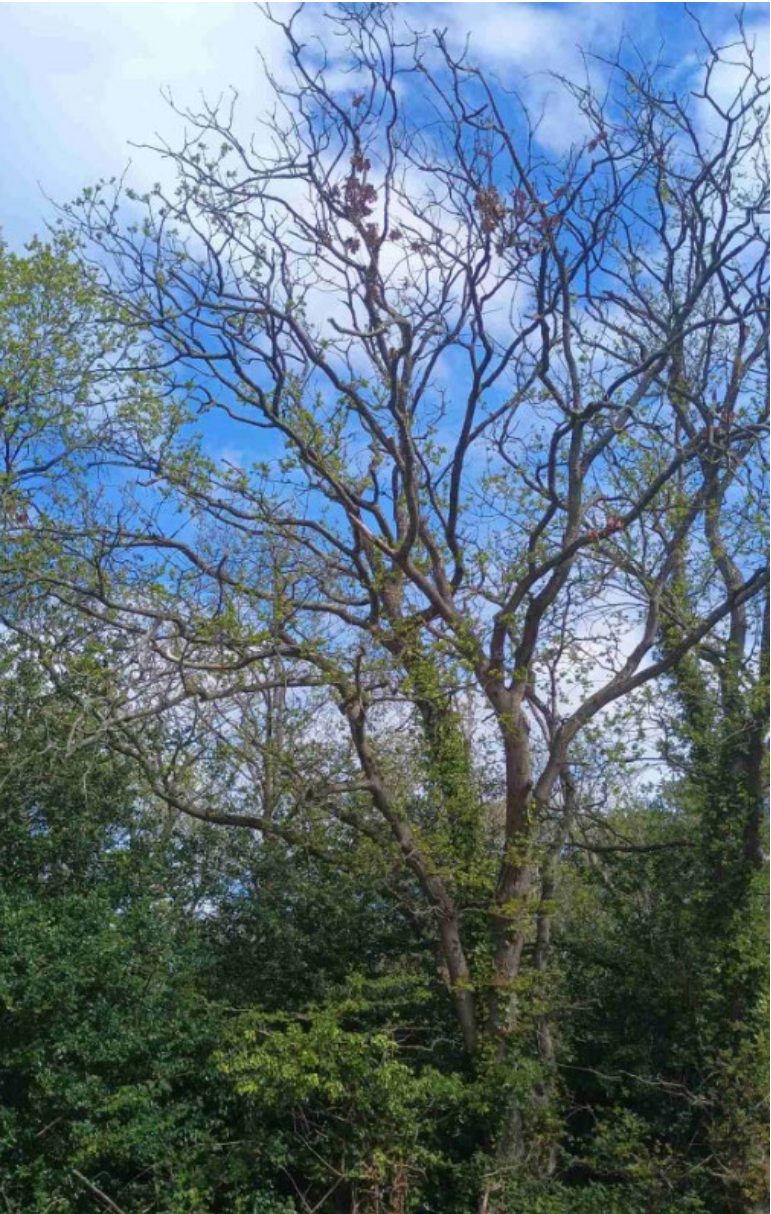
Ward	Fulwell and Hampton Hill
Road	Burtens Road
Location	Opposite 167
Species	English oak (<i>Quercus robur</i>)
Height	13.5m
Physiological Condition	Poor
Structural Condition	Fair
Inspection findings/reason for exemption	This tree is moribund; removal is required to prevent natural failure and facilitate replanting

Image shows moribund tree in street scene.

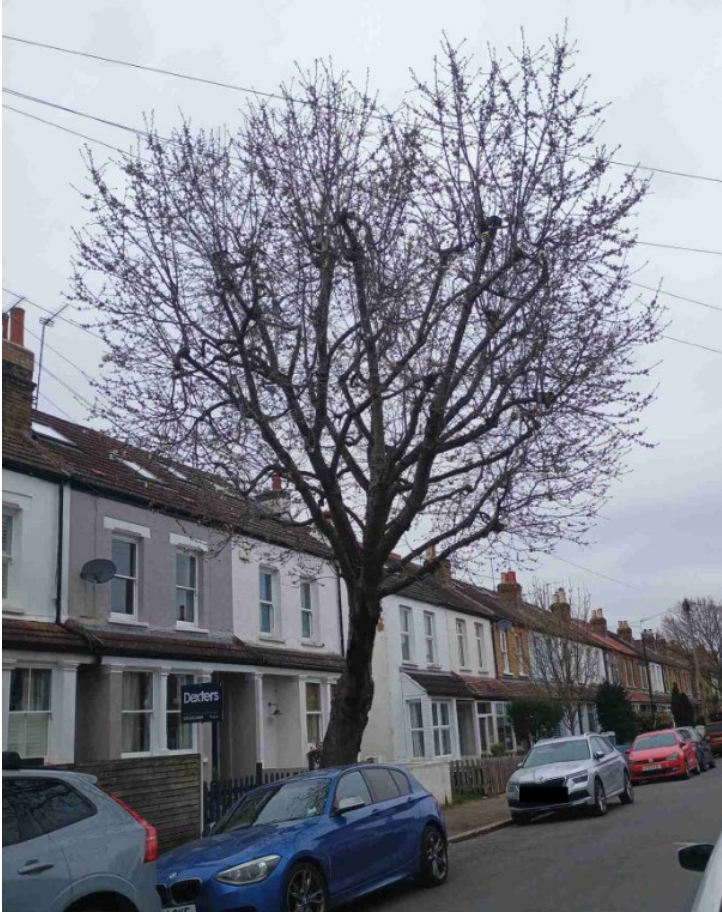
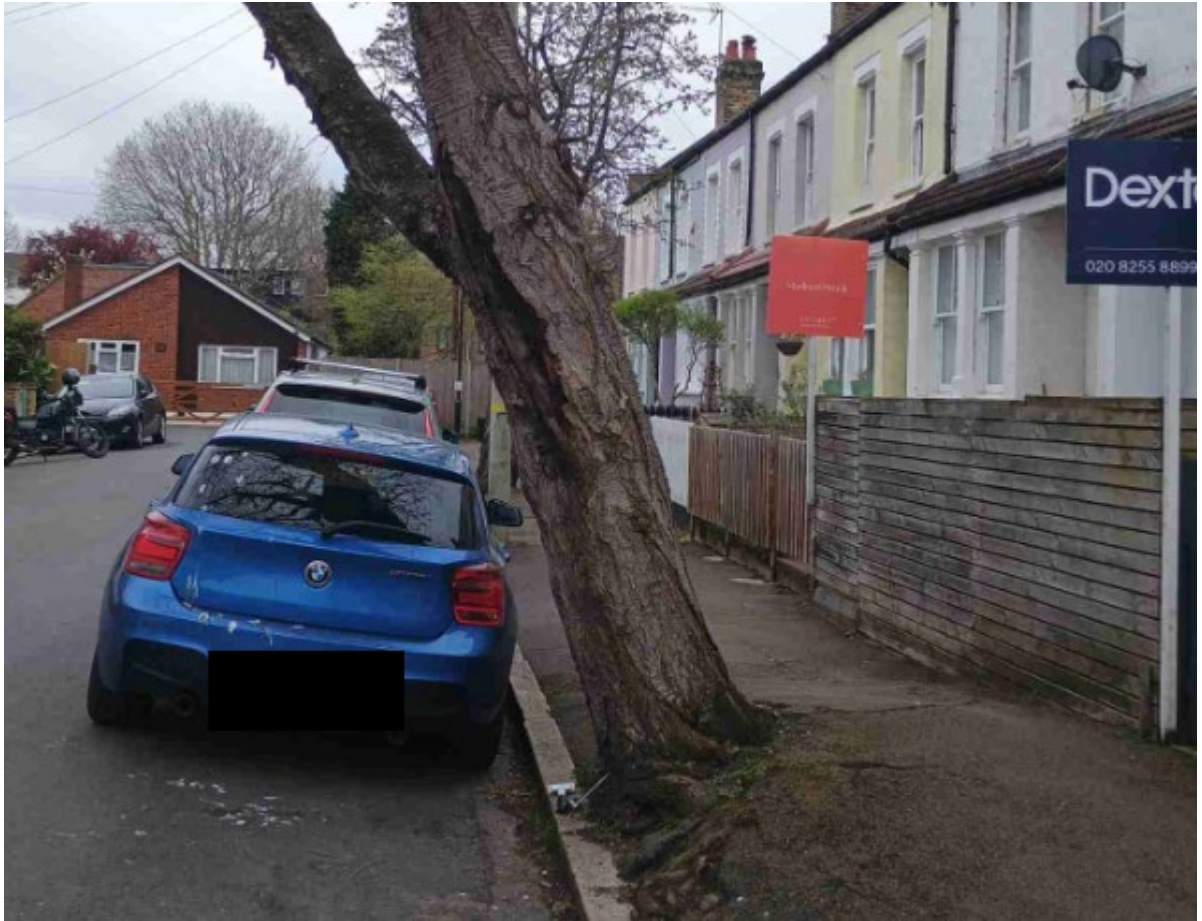
Ward	Hampton
Road	Malvern Road
Location	Outside 46-48
Species	Wild cherry (<i>Prunus avium</i>)
Height	9.0m
Physiological Condition	Fair
Structural Condition	Poor
Inspection findings/reason for exemption	This tree is leaning into the road, creating an unacceptable obstruction to highway users. Removal is required to eliminate the obstruction and facilitate replanting.

Images show tree in street scene.

Images show leaning trunk.

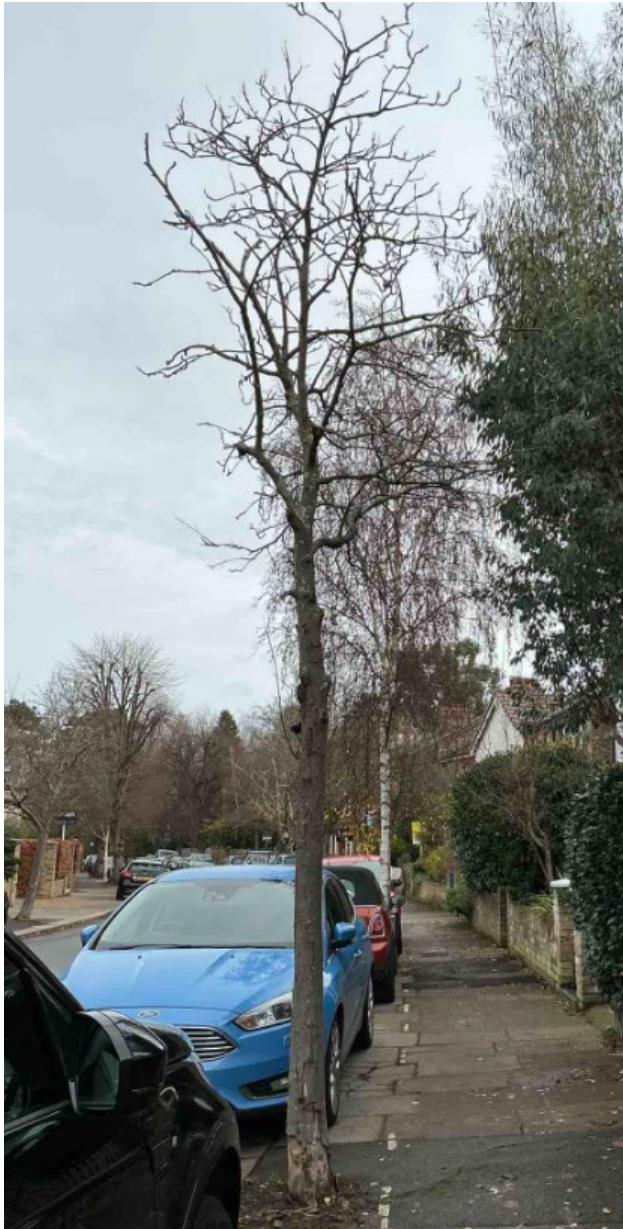
Ward	Hampton Wick and South Teddington
Road	Fairfax Road
Location	Outside 17/19
Species	Swedish whitebeam (<i>Sorbus x intermedia</i>)
Height	3.5m
Physiological Condition	Dead
Structural Condition	Fair
Inspection findings/reason for exemption	This tree is dead; removal is required to prevent natural failure, manage risk, and facilitate replanting

Image shows dead tree in street scene.

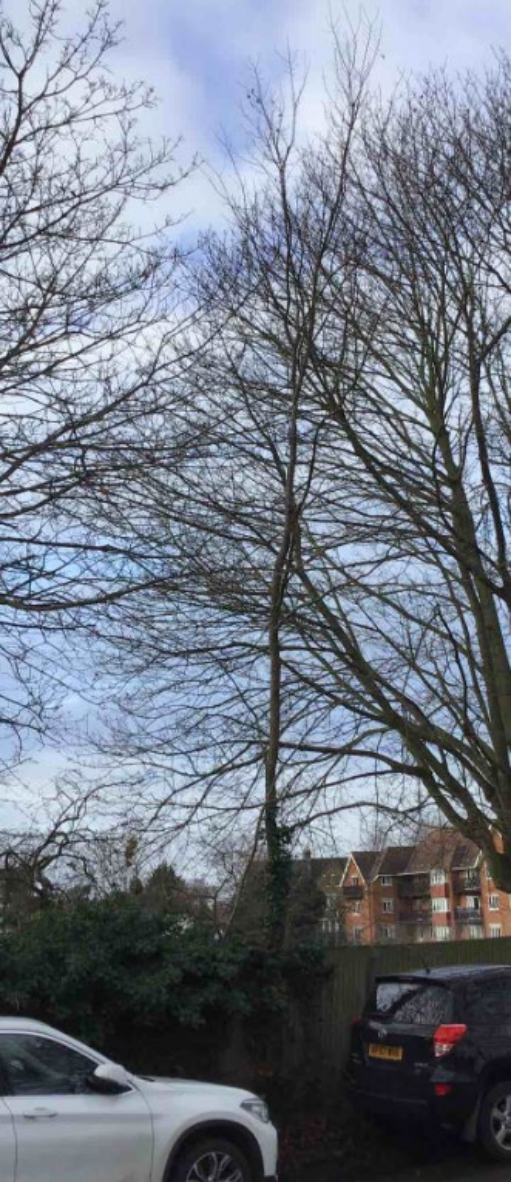
Ward	Hampton Wick and South Teddington
Road	Kingston Lane
Location	Opposite 23
Species	Elm (<i>Ulmus</i> sp.)
Height	12.0m
Physiological Condition	Dead
Structural Condition	fair
Inspection findings/reason for exemption	This tree is dead; removal is required to prevent natural failure, manage risk, and facilitate replanting

Image shows dead tree in street scene.

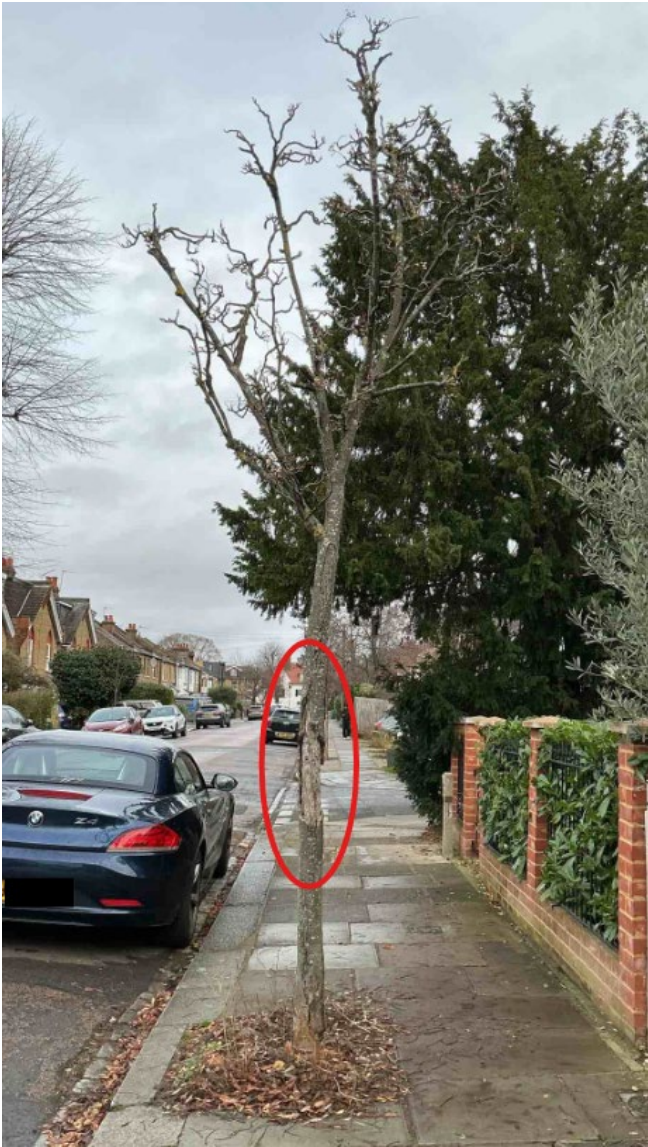
Ward	Hampton Wick and South Teddington
Road	Munster Road
Location	Outside 78/80
Species	Rowan (<i>Sorbus aucuparia</i>)
Height	3.0m
Physiological Condition	Poor
Structural Condition	Poor
Inspection findings/reason for exemption	This tree has cracked, peeling bark on the trunk, indicating necrosis and dysfunction of the trees vascular system. Removal is required to prevent natural failure, manage risk, and facilitate replanting

Image shows tree in street scene with bark damage circled.

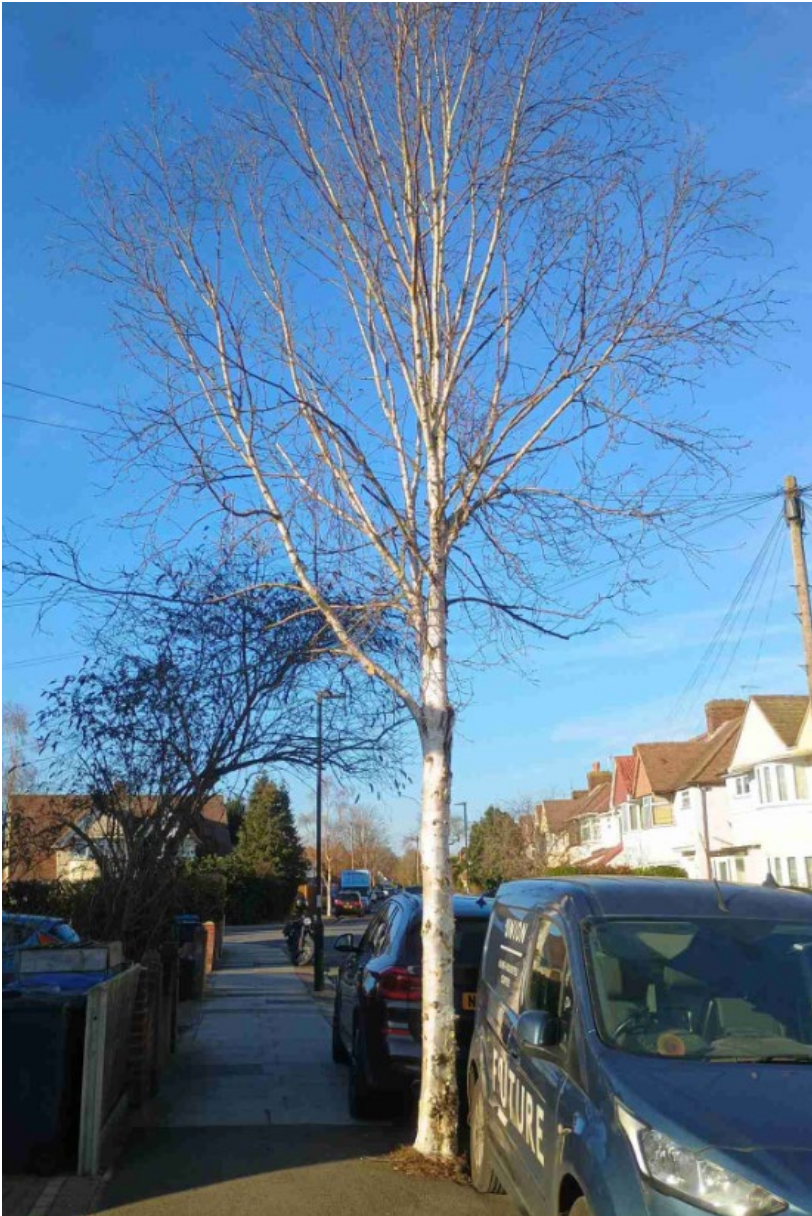
Ward	Whitton
Road	Whitton Way
Location	Adjacent to 137-139 Constance Road
Species	Birch (<i>Betula sp.</i>)
Height	8.5m
Physiological Condition	Dead
Structural Condition	Fair
Inspection findings/reason for exemption	This tree is dead; removal is required to prevent natural failure, manage risk, and facilitate replanting

Image shows moribund tree in street scene.

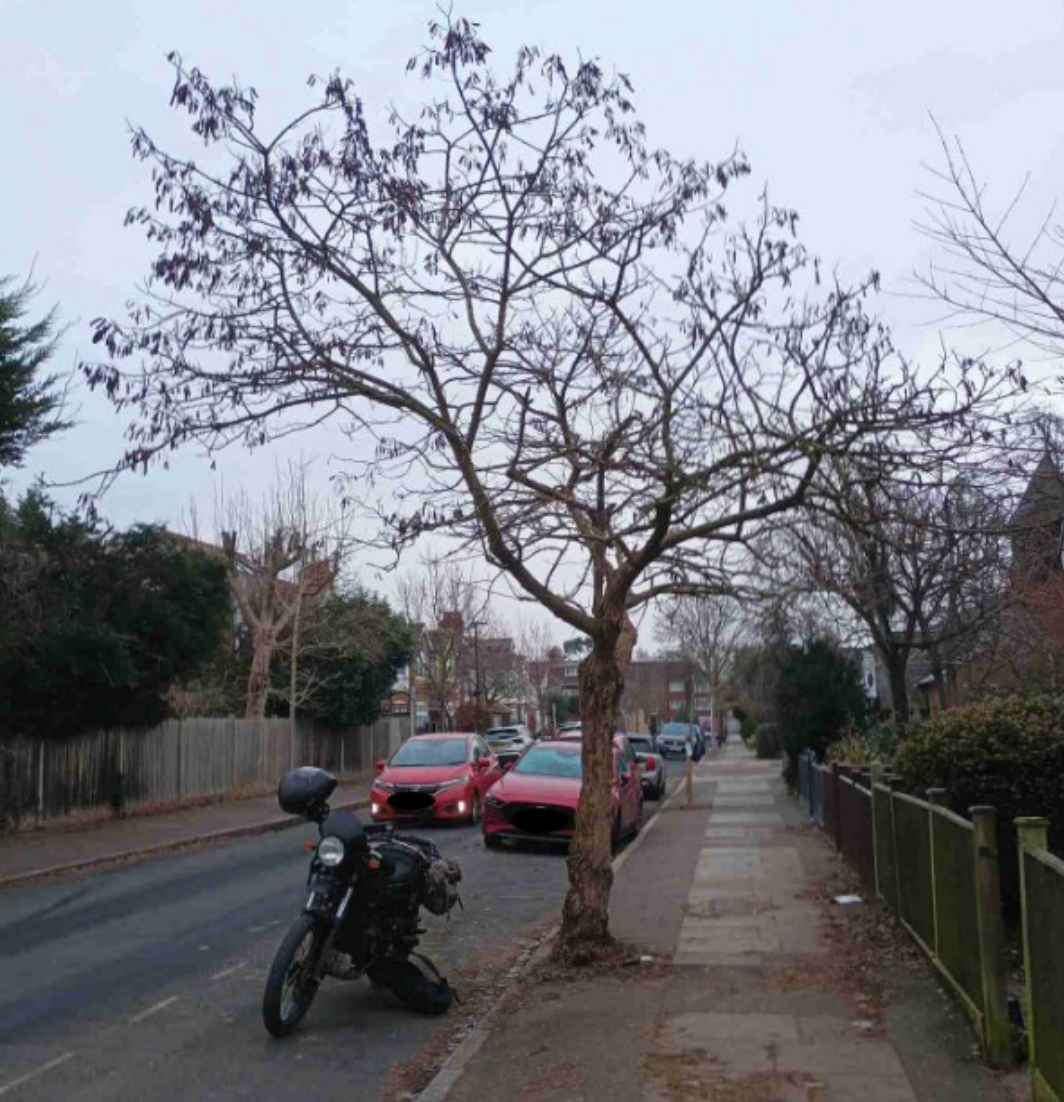
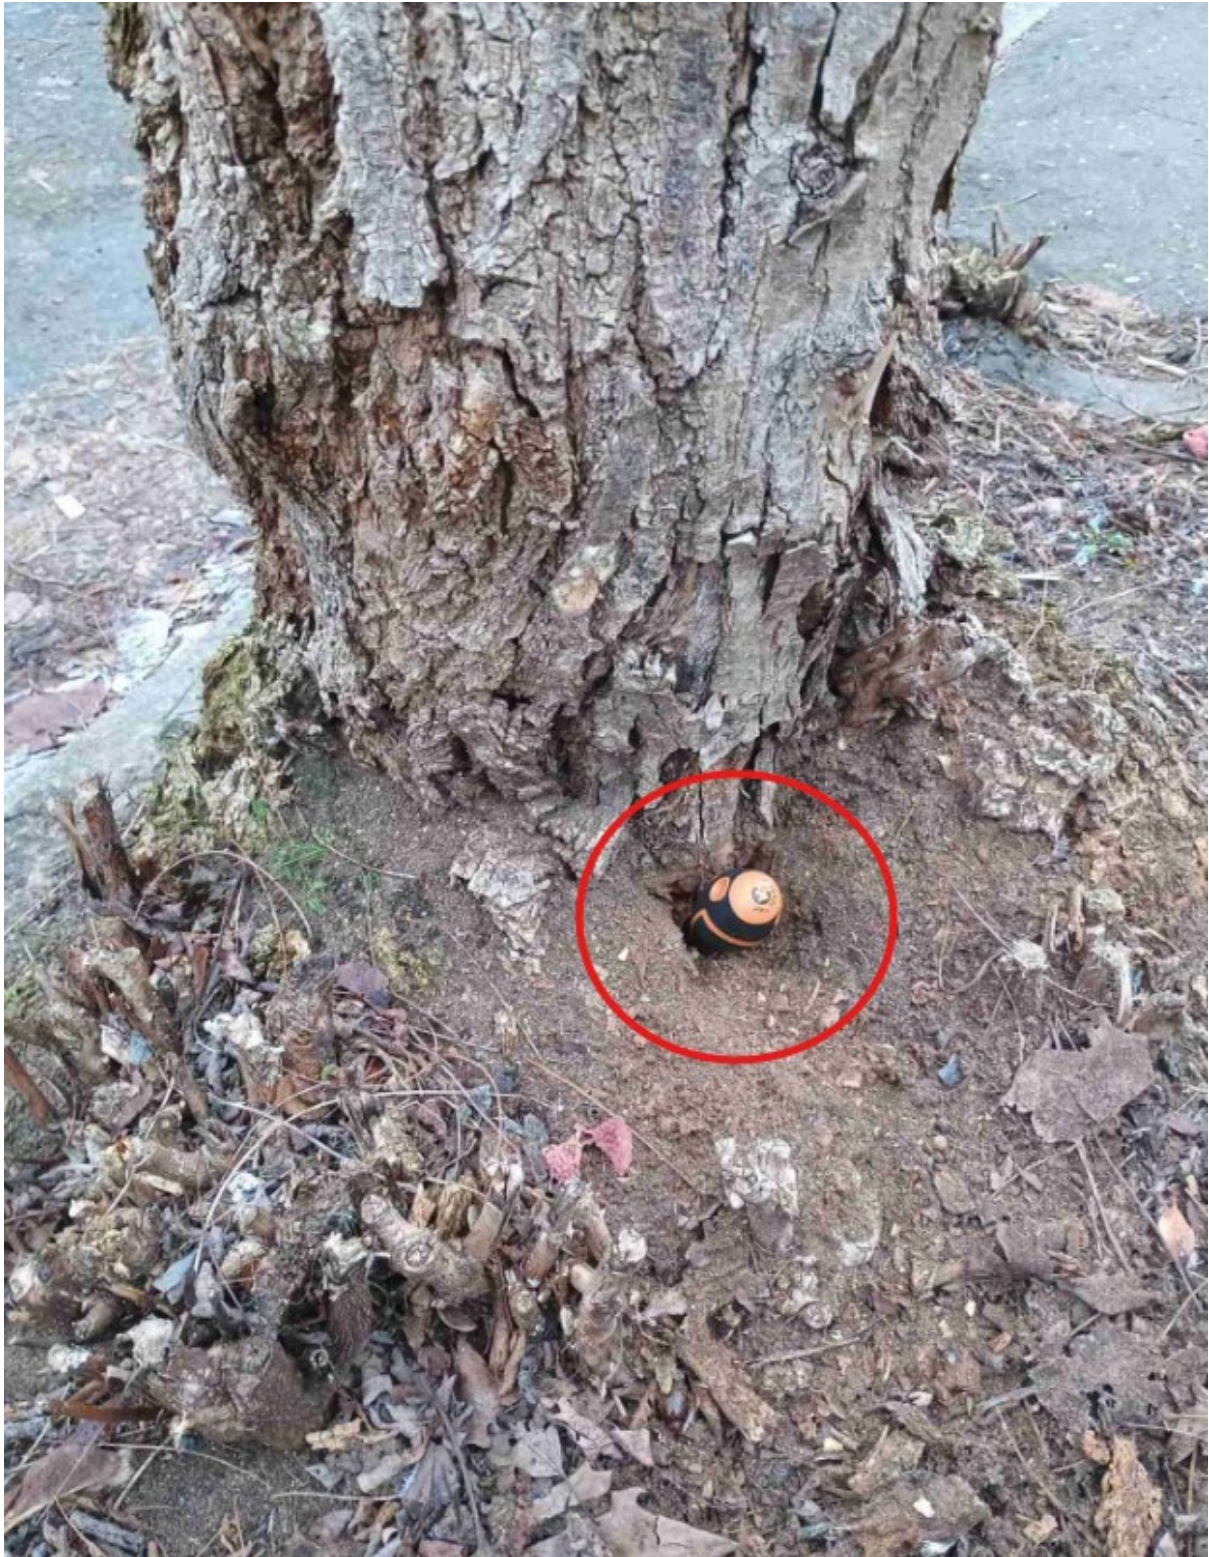
Ward	Kew
Road	Atwood Avenue
Location	Outside 33
Species	False acacia (<i>Robinia sp.</i>)
Height	6.0m
Physiological Condition	Good
Structural Condition	Poor
Inspection findings/reason for exemption	Investigation with a probe and a resonance test with a sounding hammer has revealed an unacceptable amount of decay beyond the visible cavities at the base of the trunk. Removal is required to prevent natural failure, manage risk, and facilitate replanting.

Image shows cavity with probe circled.

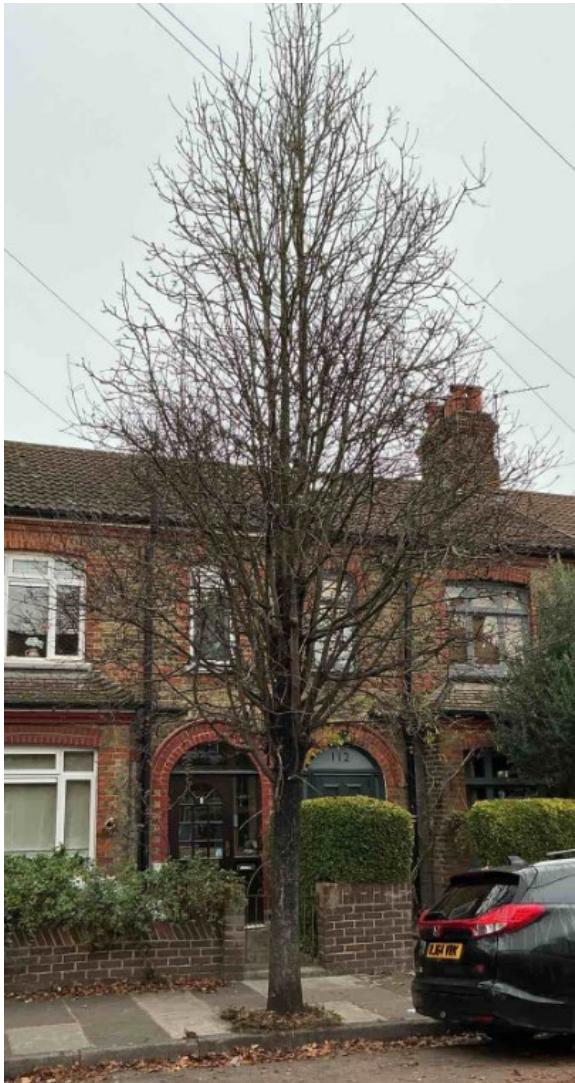
Ward	North Richmond
Road	Manor Grove
Location	Outside 110
Species	Lebanese wild apple (<i>Malus trilobata</i>)
Height	9.5m
Physiological Condition	Poor
Structural Condition	Fair
Inspection findings/reason for exemption	This tree is moribund; removal is required to prevent natural failure, manage risk, and facilitate replanting

Image shows moribund tree in street scene.

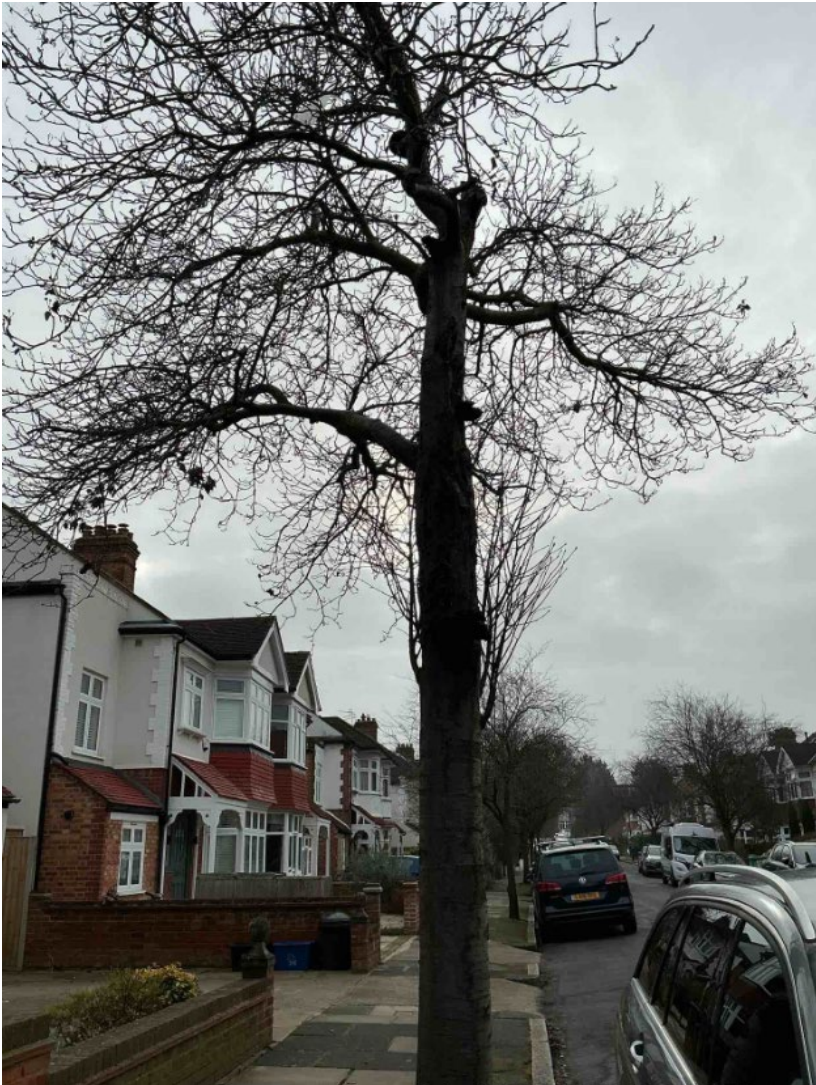
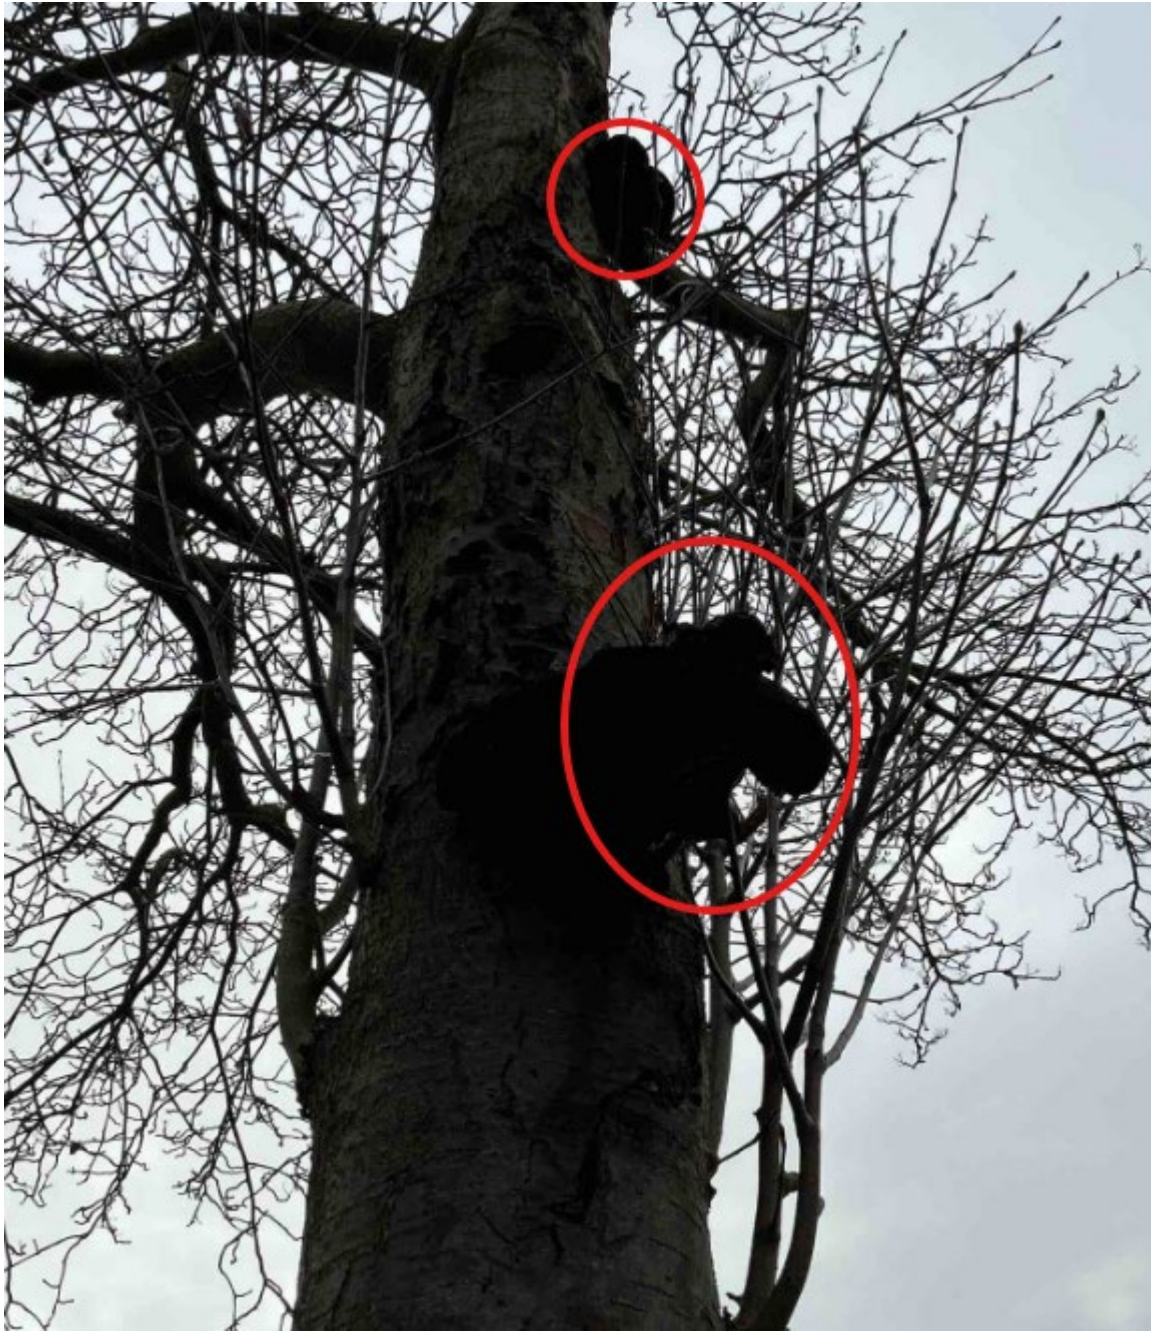
Ward	North Richmond
Road	Clydesdale Gardens
Location	Outside 26/28
Species	Swedish whitebeam (<i>Sorbus x intermedia</i>)
Height	7.5m
Physiological Condition	Poor
Structural Condition	Poor
Inspection findings/reason for exemption	A fungal fruiting body of the species Shaggy Polypore (<i>Inonotus hispidus</i>) is present on the main trunk; this fungus causes a simultaneous white rot which can cause snapping of tree parts in this particular species. Removal is required to prevent natural failure, manage risk, and facilitate replanting

Image shows fungal fruiting bodies circled.

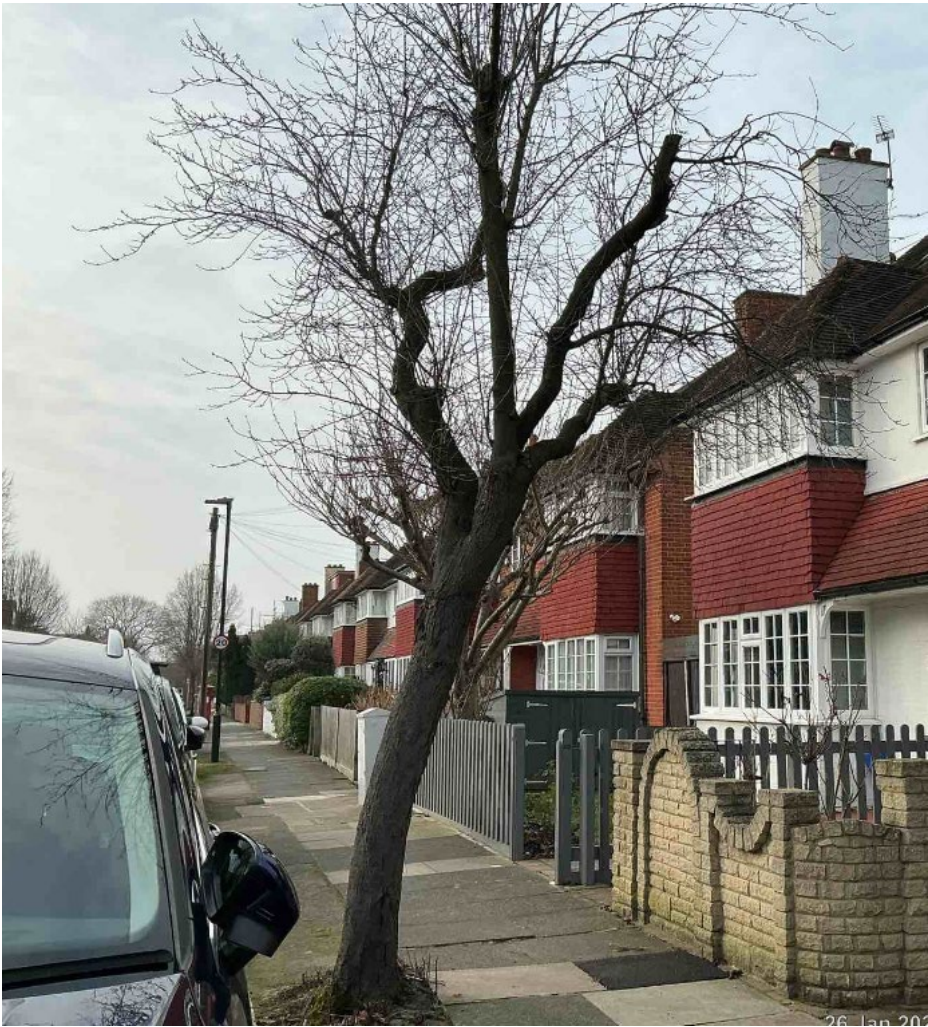
Ward	North Richmond
Road	Tangier Road
Location	Outside 30
Species	Purple leaf plum (<i>Prunus cerasifera</i>)
Height	9.5m
Physiological Condition	Fair
Structural Condition	Poor
Inspection findings/reason for exemption	A fungal fruiting body of the decay fungus <i>Ganoderma sp.</i> is present on the trunk. Colonisation by this fungus results in white rot affecting the stem and root system, which can lead to structural failure through fracture or windthrow. Investigation with a probe and a resonance test with a sounding hammer has revealed an unacceptable amount of decay which correlates with the presence of the decay fungi. Removal of the tree is recommended to prevent natural failure, manage risk, and facilitate replanting.

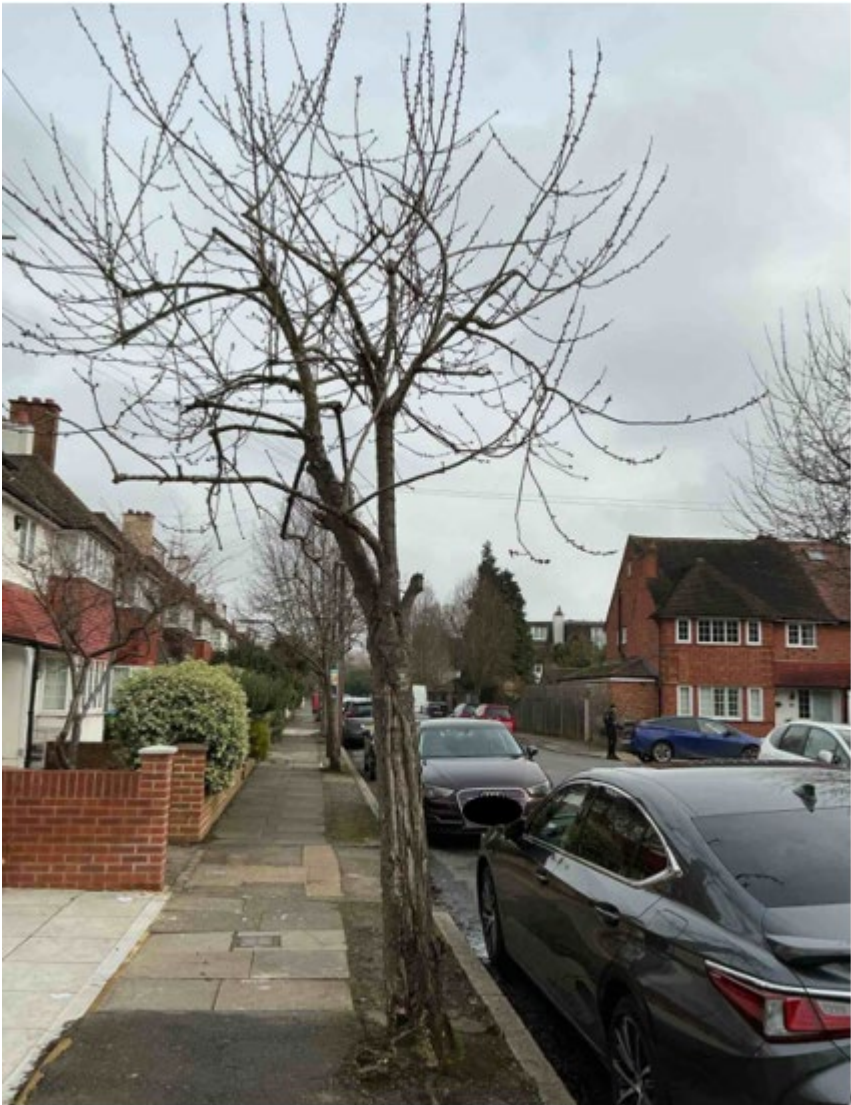
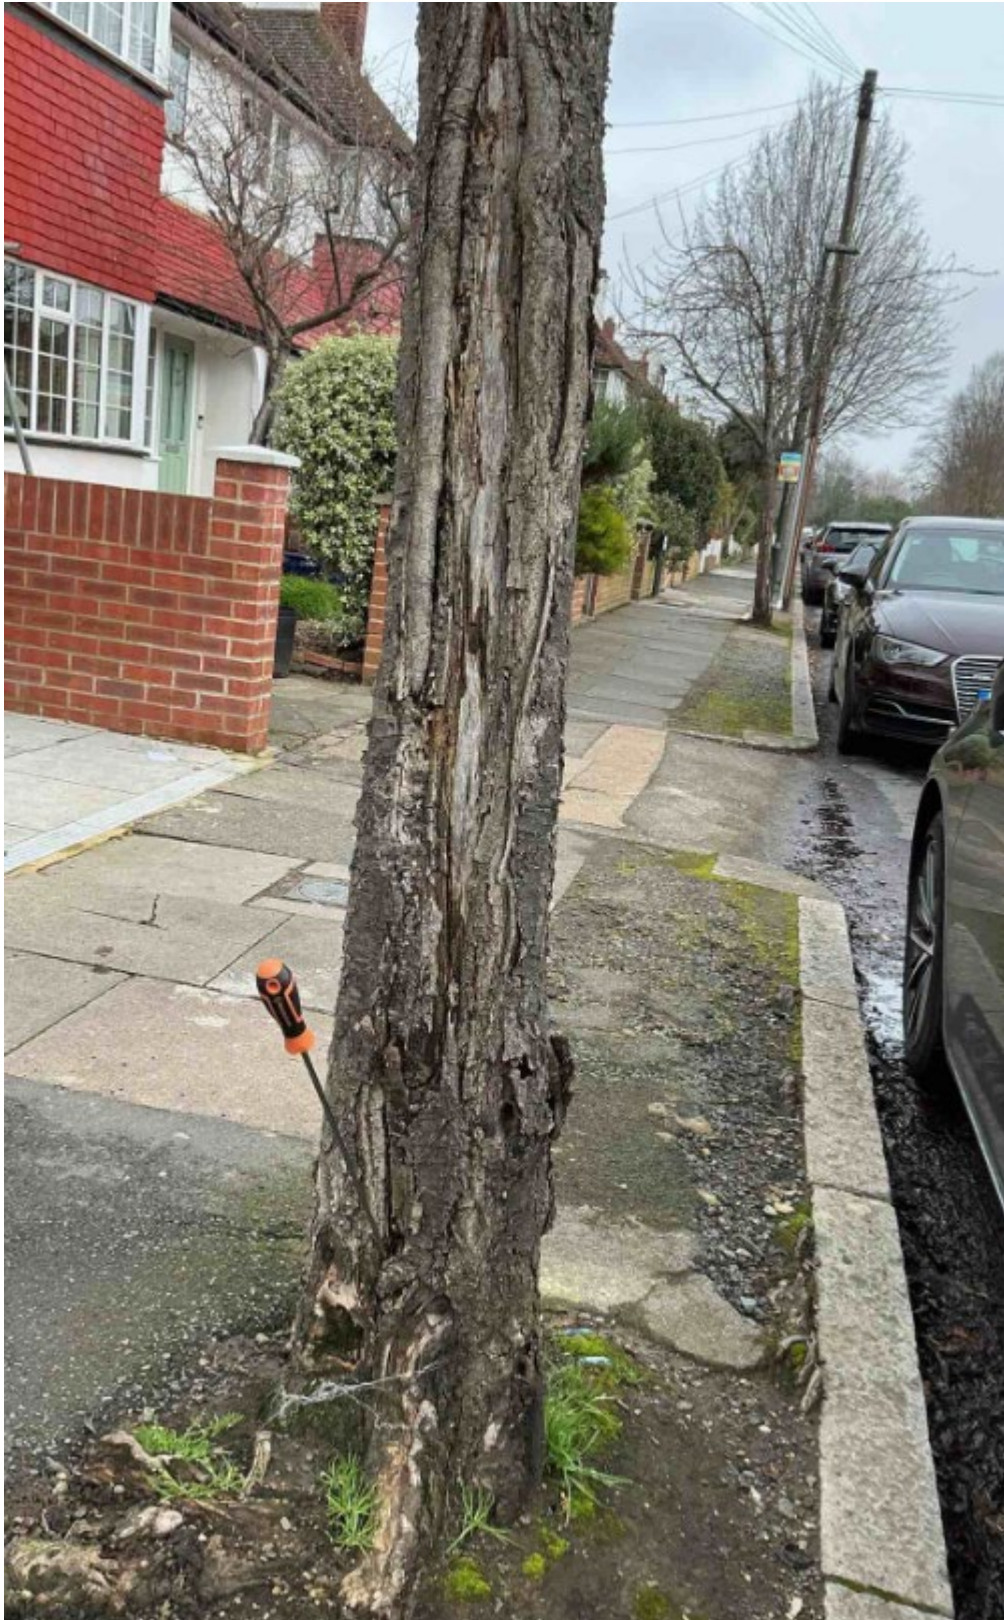
Ward	North Richmond
Road	Tangier Road
Location	Outside 58
Species	Wild cherry (<i>Prunus avium</i>)
Height	4.0m
Physiological Condition	Fair
Structural Condition	Poor
Inspection findings/reason for exemption	Bark damage is present on the trunk of this tree; the decline of the trees vascular system correlates with dieback within the crown. Removal is required to prevent natural failure, manage risk, and facilitate replanting.

Image shows damage bark on trunk.

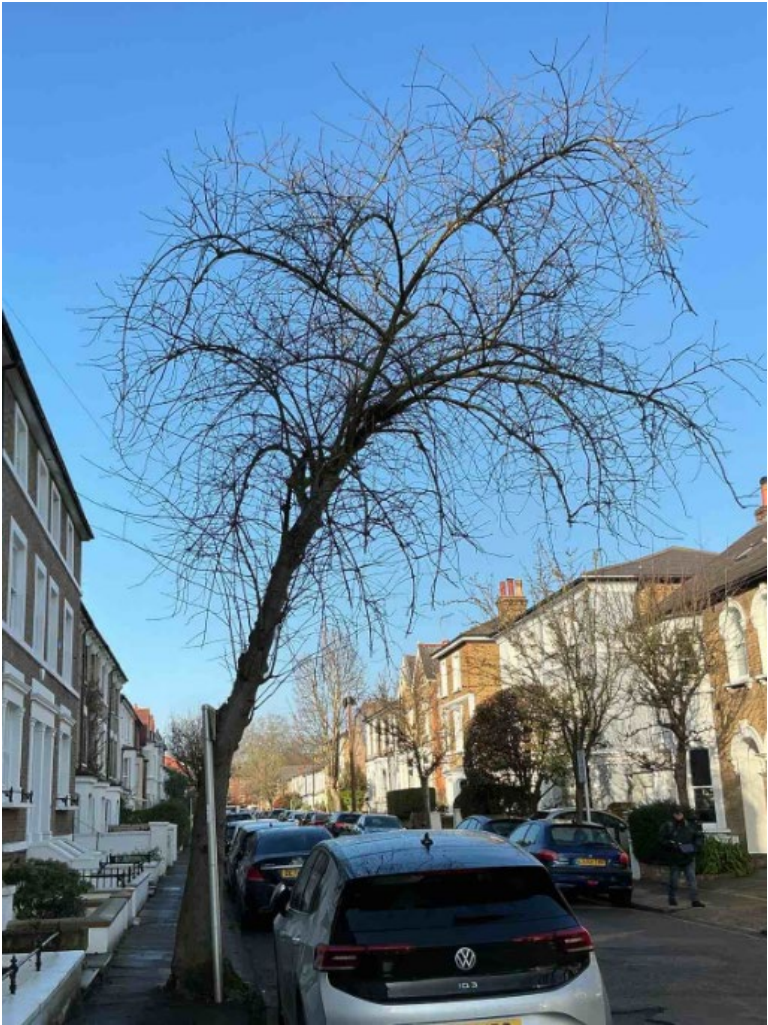
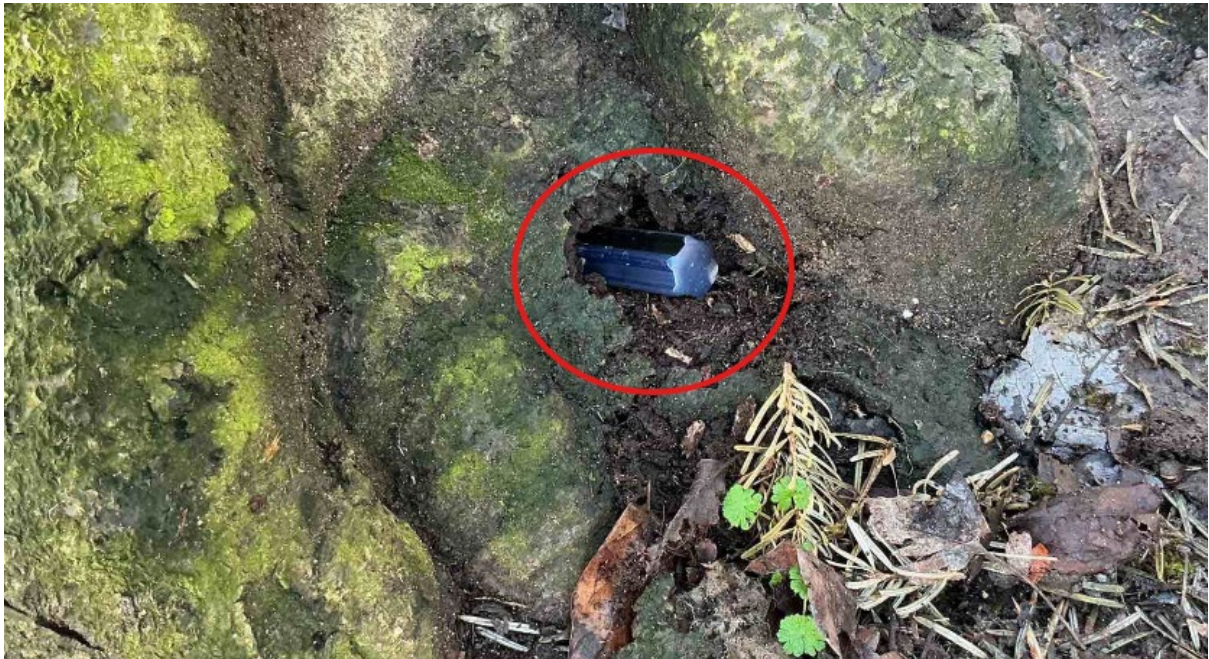
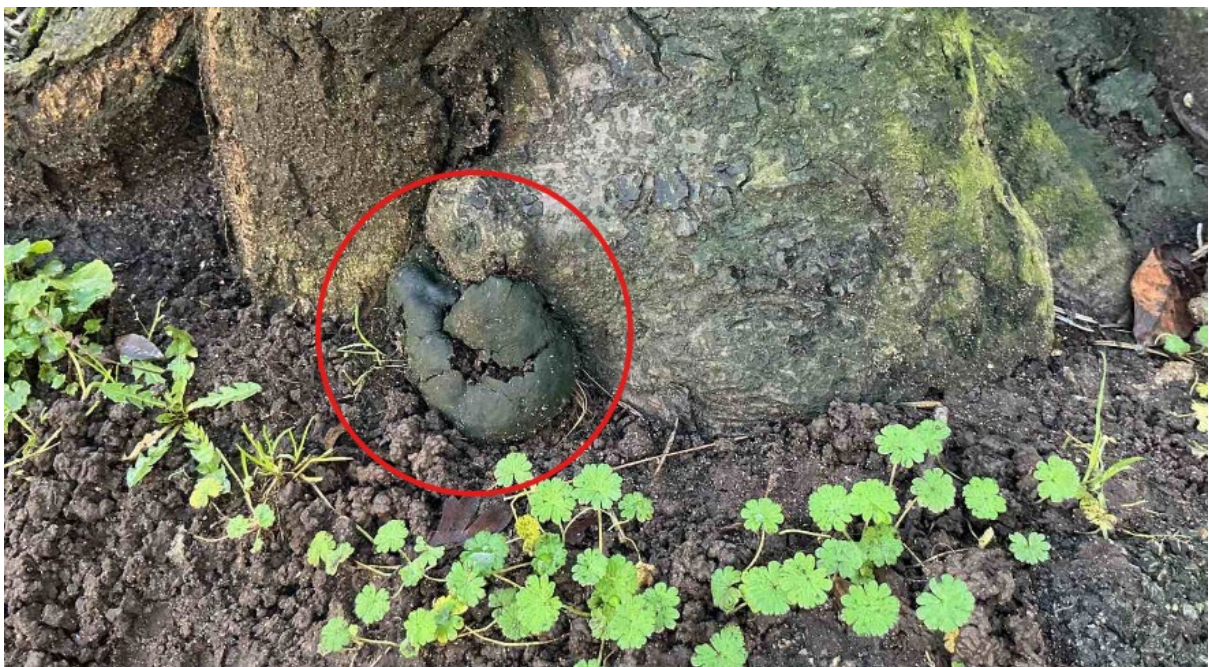
Ward	North Richmond
Road	Jocelyn Road
Location	Outside 60
Species	Bird cherry (Prunus padus)
Height	7.5m
Physiological Condition	Fair
Structural Condition	Poor
Inspection findings/reason for exemption	A fungal fruiting body of the decay fungus <i>Ganoderma sp.</i> is present on the trunk. Colonisation by this fungus results in white rot affecting the stem and root system, which can lead to structural failure through fracture or windthrow. Investigation with a probe and a resonance test with a sounding hammer has revealed an unacceptable amount of decay which correlates with the presence of the decay fungi. Removal of the tree is recommended to prevent natural failure, manage risk, and facilitate replanting.

Image shows probe circled.

Image shows fungal fruiting bodies circled.

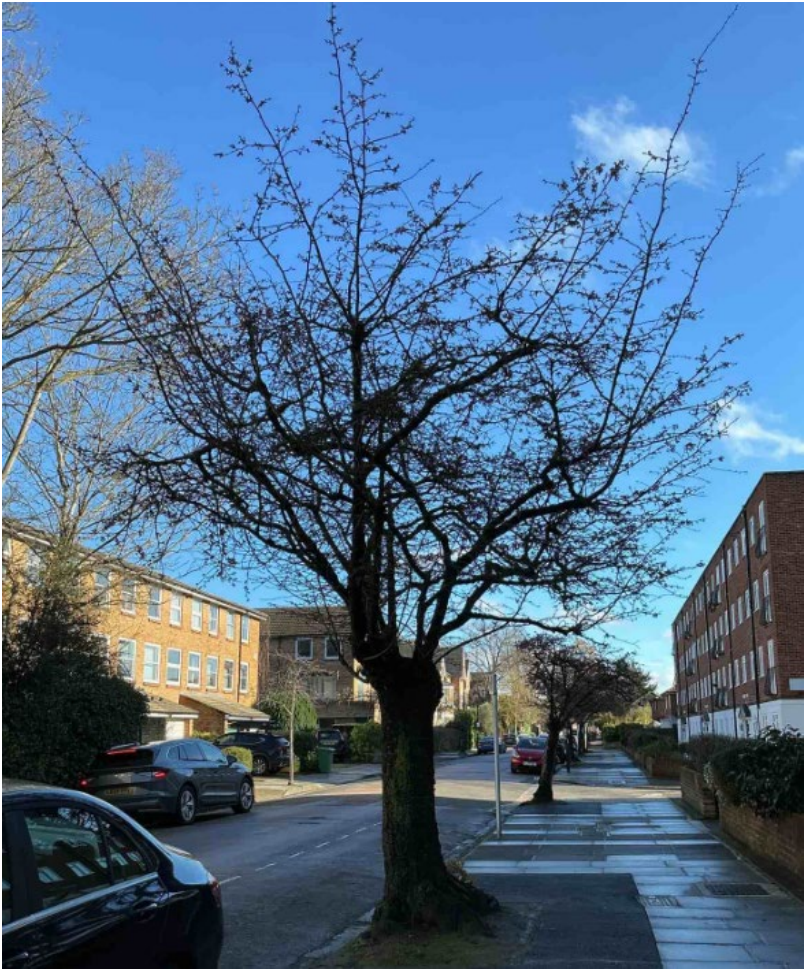
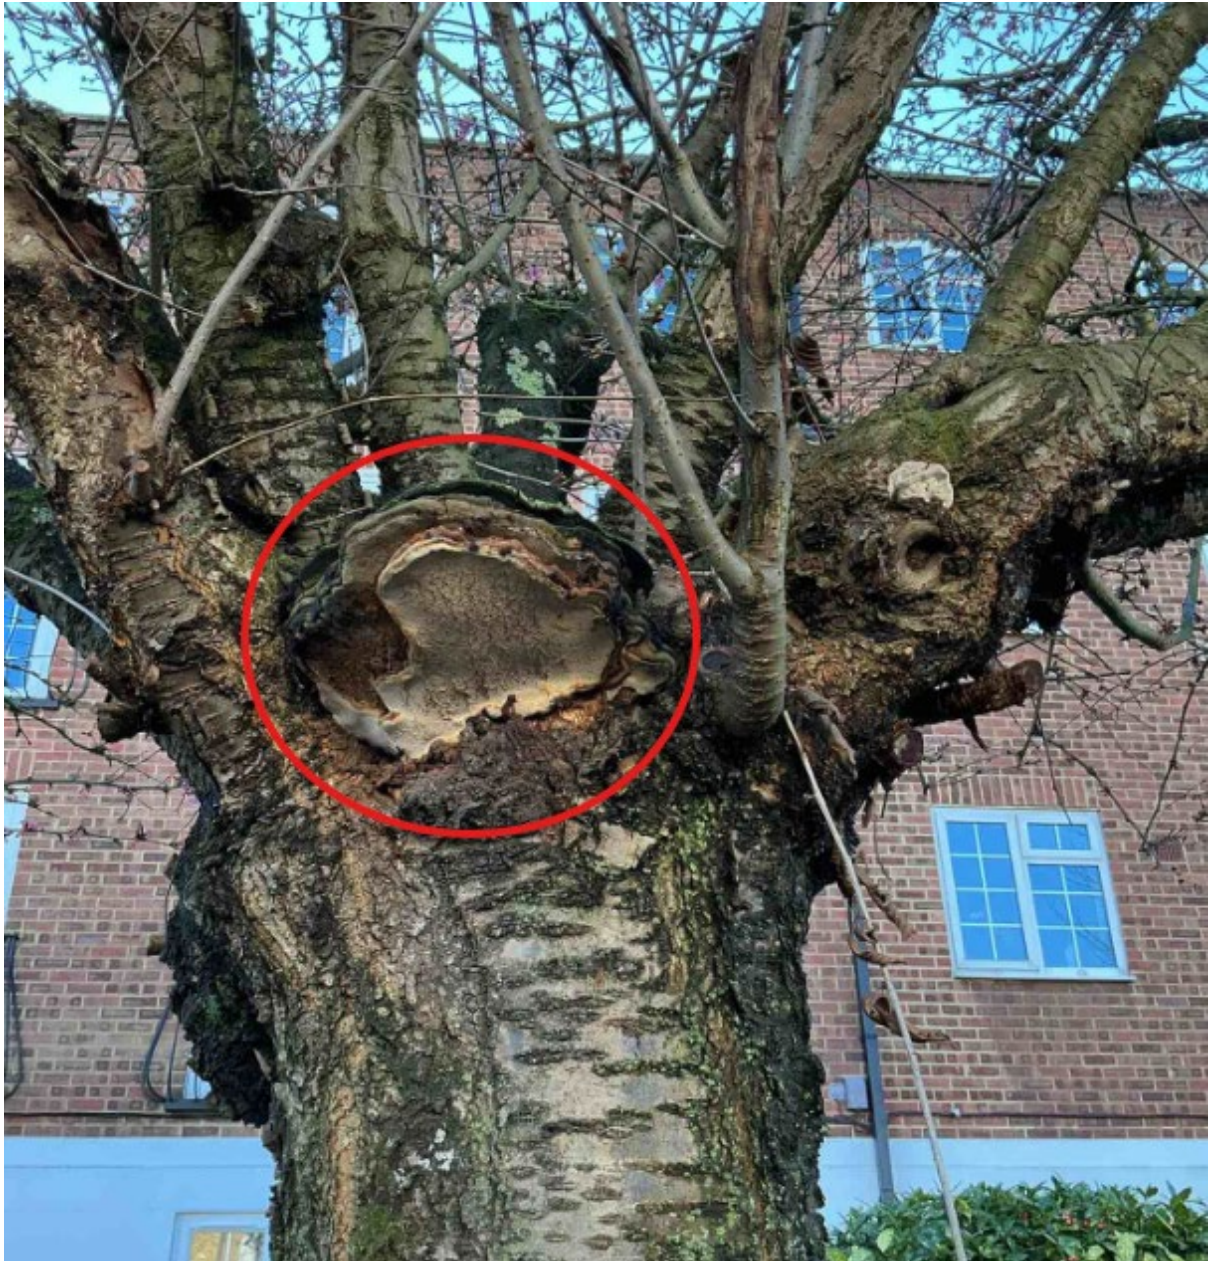
Ward	North Richmond
Road	Stanmore Road
Location	Opposite lamppost 001
Species	Cherry (<i>Prunus sp.</i>)
Height	5.0m
Physiological Condition	Fair
Structural Condition	Poor
Inspection findings/reason for exemption	A fungal fruiting body of the decay fungus <i>Ganoderma sp.</i> is present on the trunk. Colonisation by this fungus results in white rot affecting the stem and root system, which can lead to structural failure through fracture or windthrow. Investigation with a probe and a resonance test with a sounding hammer has revealed an unacceptable amount of decay which correlates with the presence of the decay fungi. Removal of the tree is recommended to prevent natural failure, manage risk, and facilitate replanting.

Image shows fungal fruiting body circled.
