April 2026 - Reactive Tree Works Programme

Introduction

Dated 26/04/2026

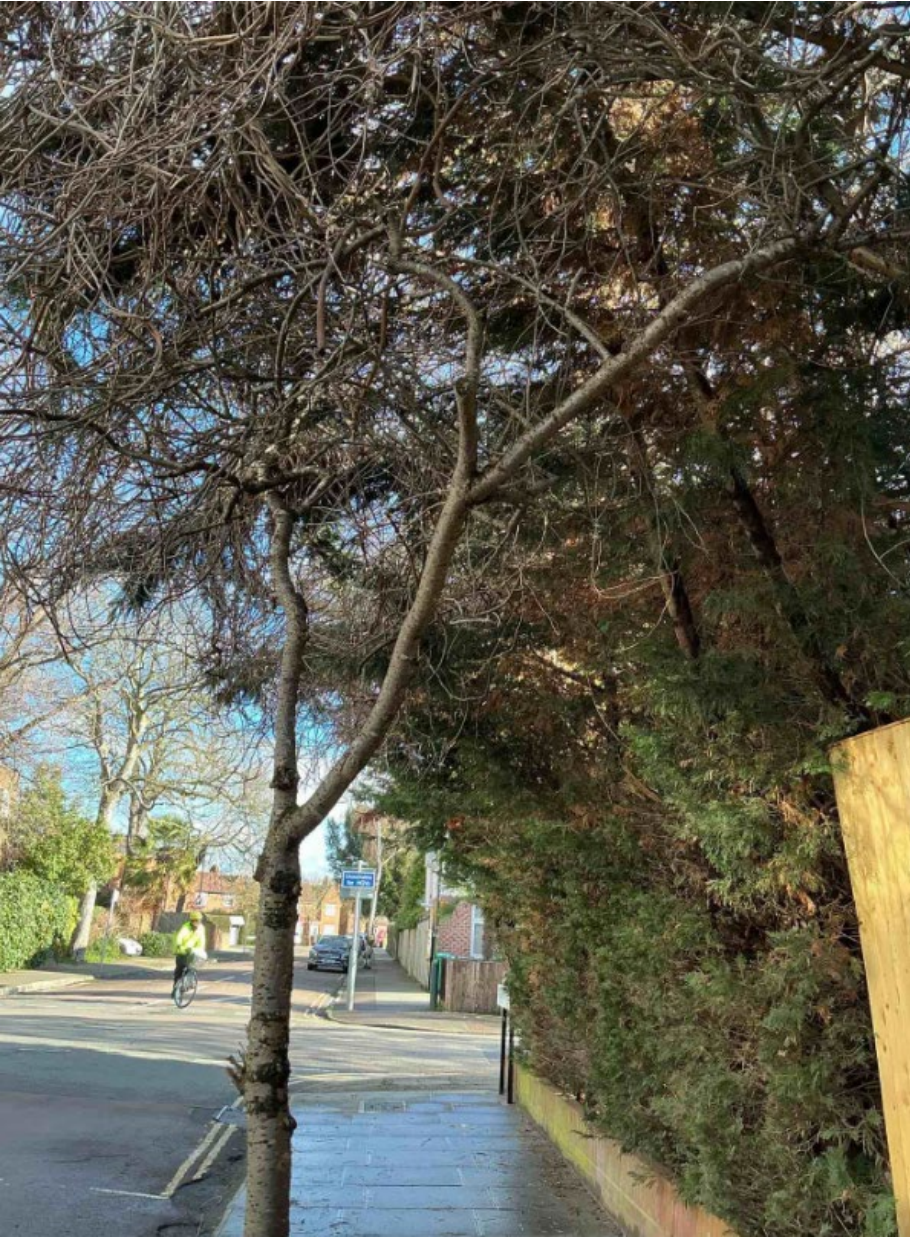
Ward	North Richmond
Road	Stanmore Road
Location	Opposite 16
Species	Higan cherry (<i>Prunus x subhirtella</i>)
Height	3.0m
Physiological Condition	Dead
Structural Condition	Fair
Inspection findings/reason for exemption	This tree is dead; removal is required to prevent natural failure, manage risk, and facilitate replanting

Image shows dead tree in street scene.

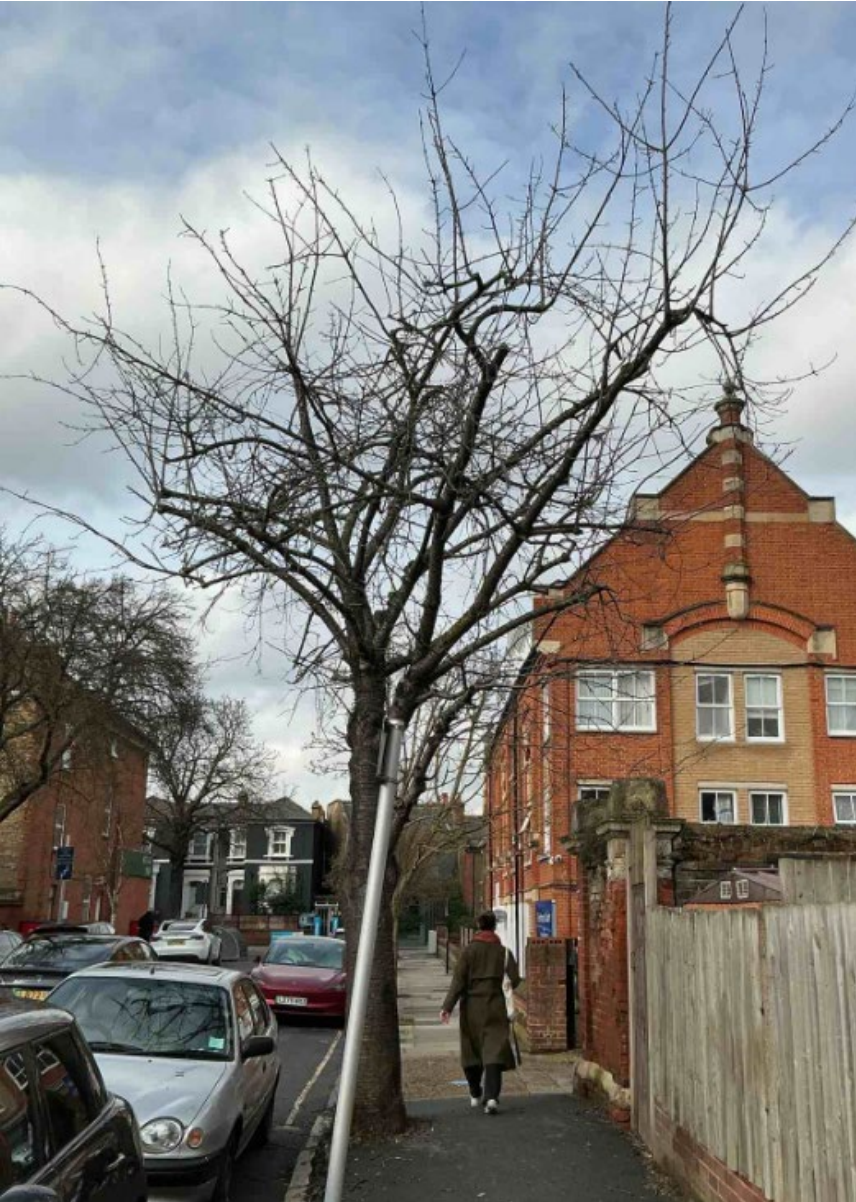
Ward	North Richmond
Road	Selwyn Avenue
Location	Outside 8/10
Species	Cherry (<i>Prunus sp.</i>)
Height	7.0m
Physiological Condition	Dead
Structural Condition	Fair
Inspection findings/reason for exemption	This tree is dead; removal is required to prevent natural failure, manage risk, and facilitate replanting

Image shows dead tree in street scene.

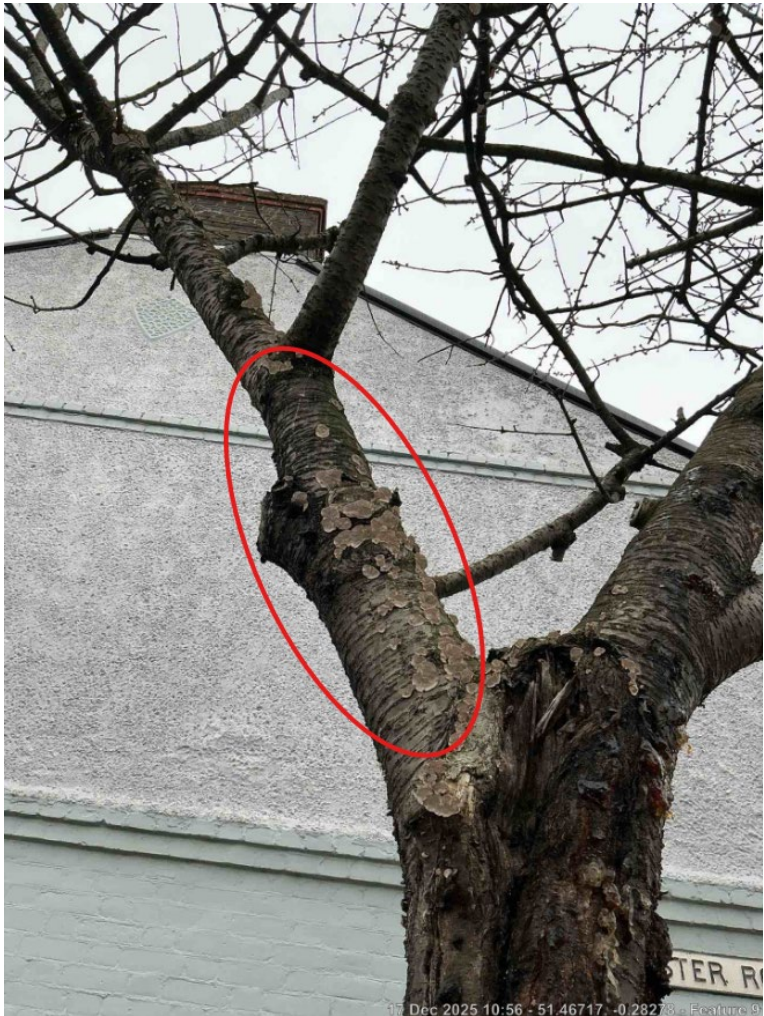
Ward	North Richmond
Road	Bicester Road
Location	Adjacent 189 Manor Grove main building
Species	Wild cherry (<i>Prunus avium</i>)
Height	8.5m
Physiological Condition	Fair
Structural Condition	Poor
Inspection findings/reason for exemption	Fruiting bodies of the decay fungus Turkey Tail (<i>Trametes versicolor</i>) are prolific on the trunk and within the crown of this tree. This fungus causes a selective white rot of the wood and, when prolific, is indicative of wider physiological dysfunction, which correlates with crown dieback. Removal is required to prevent natural failure, manage risk, and facilitate replanting

Image shows fungal fruiting bodies circled.

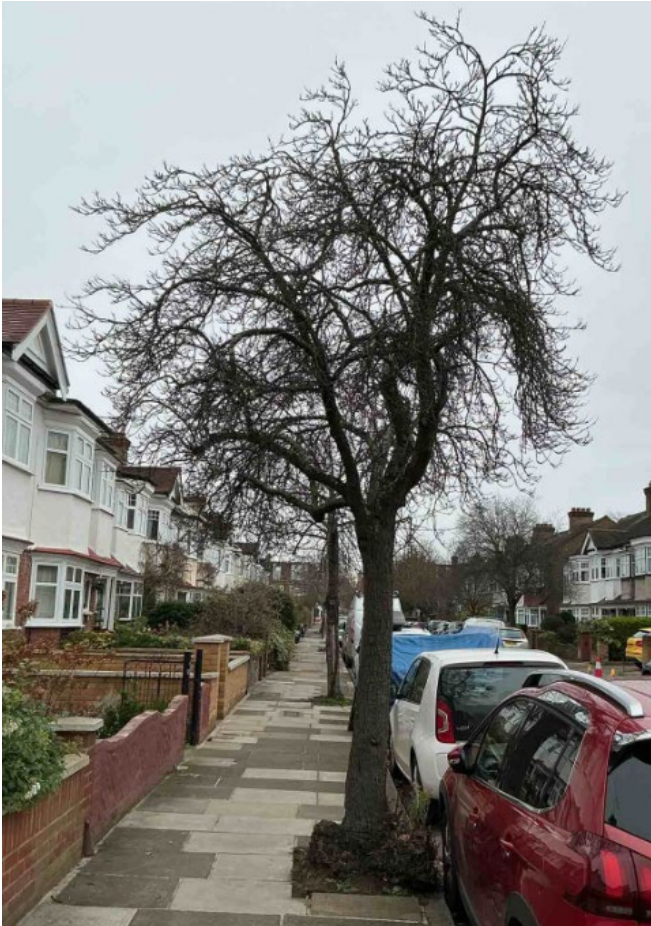
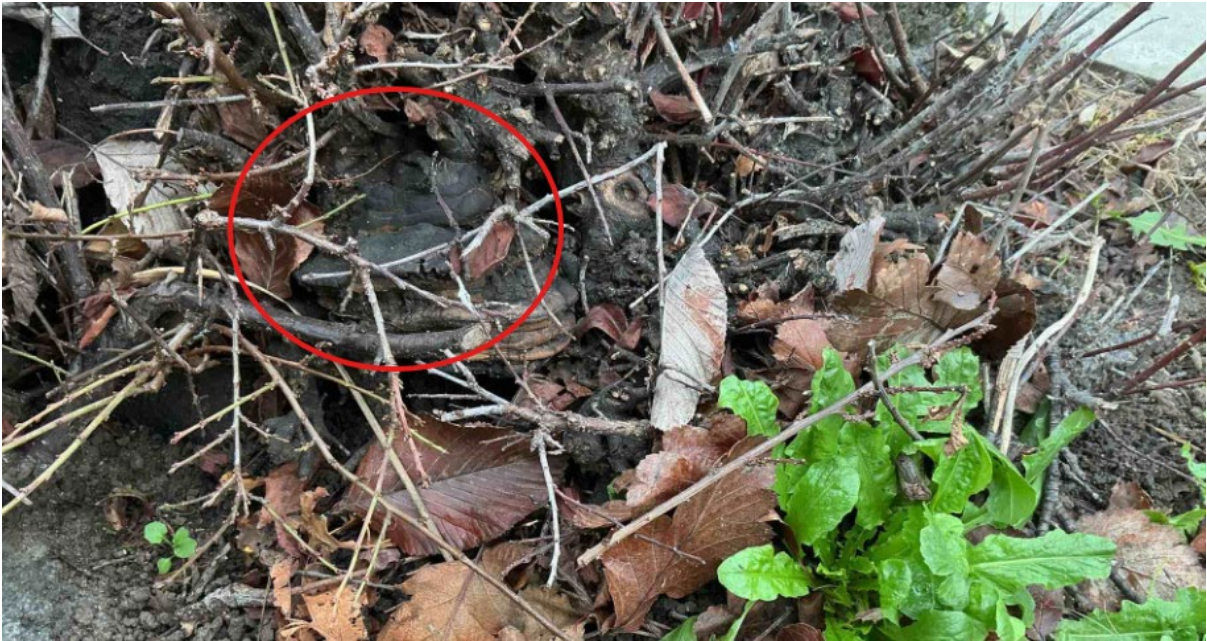
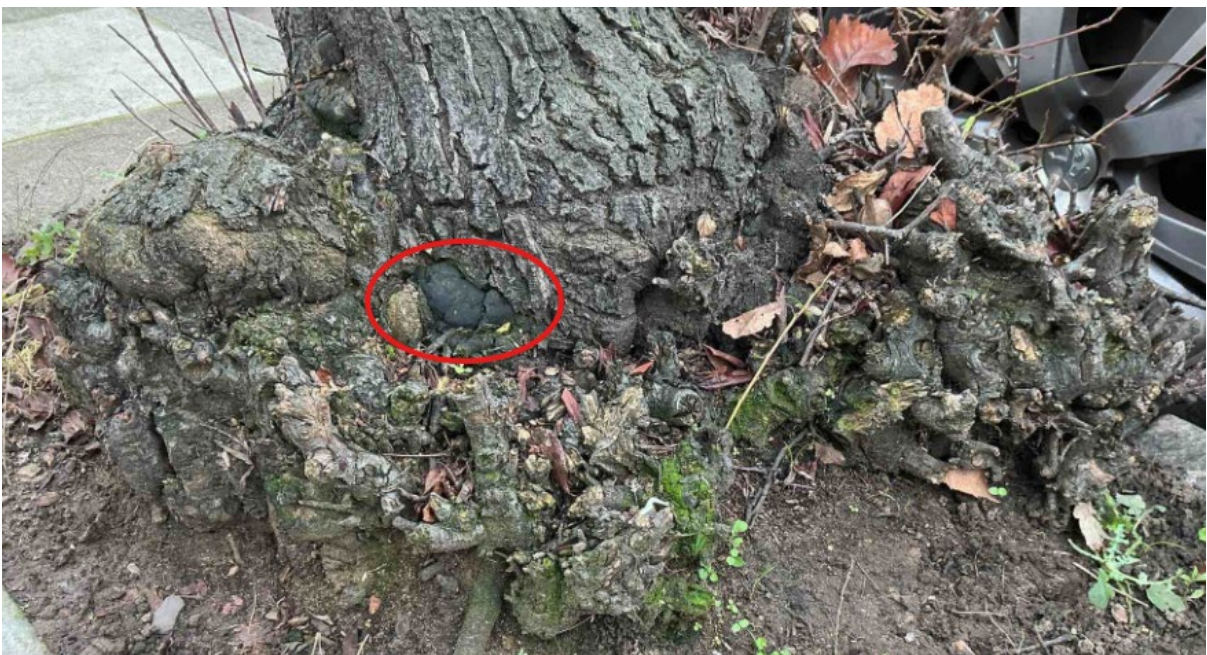
Ward	North Richmond
Road	Somerton Avenue
Location	Outside 30/32
Species	Purple leaf plum (<i>Prunus cerasifera</i>)
Height	6.0m
Physiological Condition	Fair
Structural Condition	Poor
Inspection findings/reason for exemption	A fungal fruiting body of the decay fungus <i>Ganoderma sp.</i> is present on the trunk. Colonisation by this fungus results in white rot affecting the stem and root system, which can lead to structural failure through fracture or windthrow. Investigation with a probe and a resonance test with a sounding hammer has revealed an unacceptable amount of decay which correlates with the presence of the decay fungi. Removal of the tree is recommended to prevent natural failure, manage risk, and facilitate replanting.

Image shows fungal fruiting body circled.

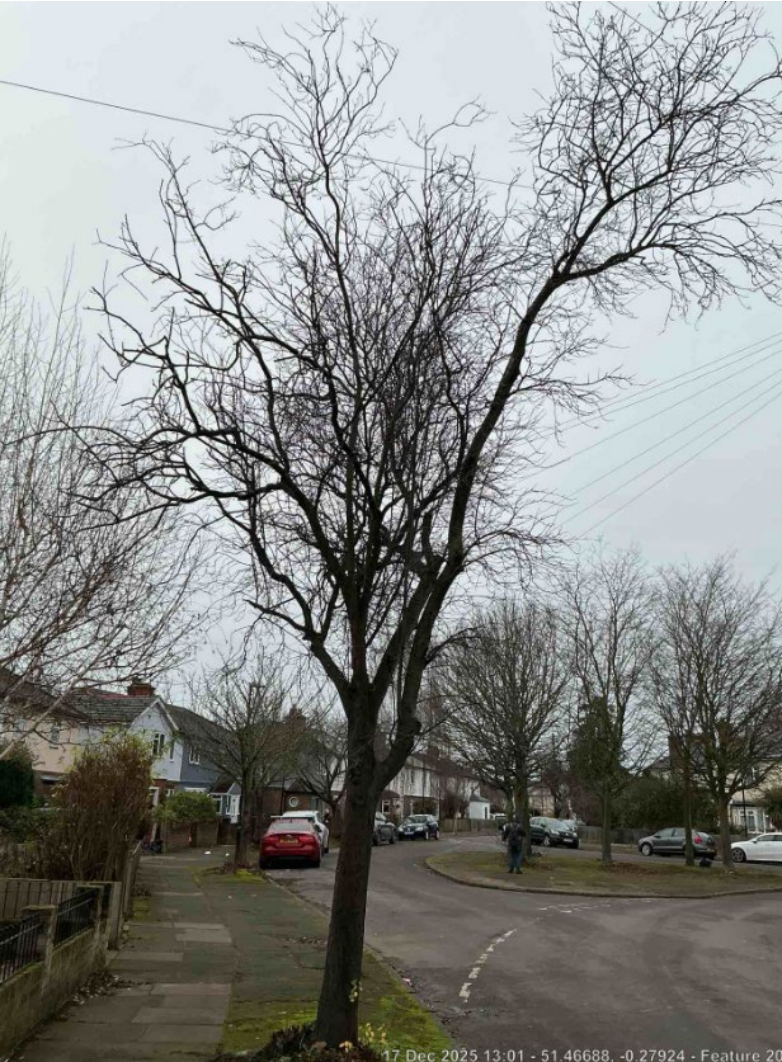
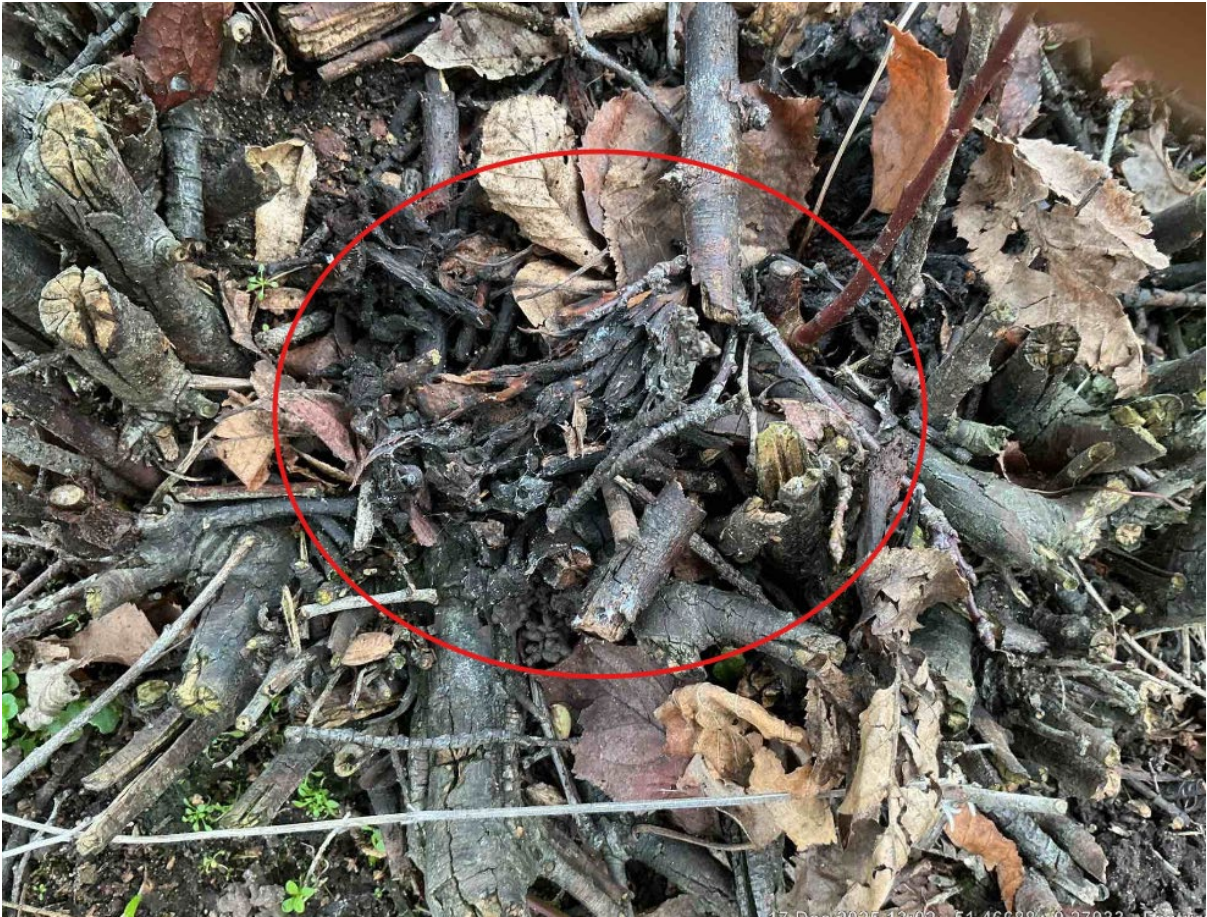
Ward	North Richmond
Road	Lambert Avenue
Location	Outside 35
Species	Purple-leaf plum (<i>Prunus cerasifera</i>)
Height	7.0m
Physiological Condition	Poor
Structural Condition	Fair
Inspection findings/reason for exemption	Fungal fruiting bodies of the decay fungi 'Honey fungus' <i>Armillaria sp.</i> are present at the base of this tree. Colonisation by this fungus causes a white rot of the roots and butt that can cause entire tree failure. Crown dieback could correlate with the parasite present. Removal is required to prevent natural failure, manage risk, and facilitate replanting

Image shows moribund tree in street scene.

Image shows fungal fruiting bodies circled.

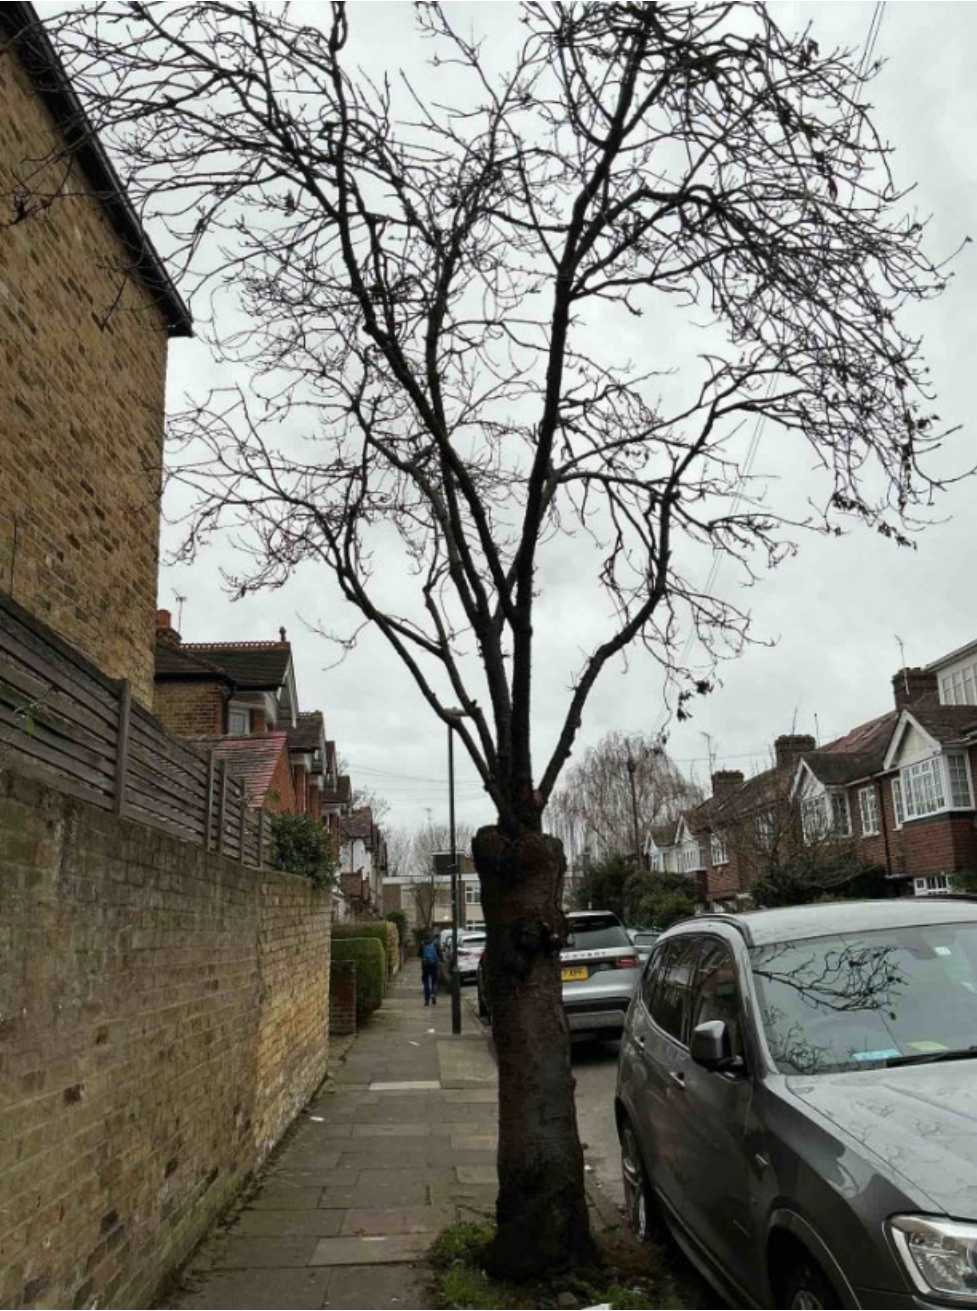
Ward	North Richmond
Road	Manor Park
Location	Opposite 4
Species	Cherry (<i>Prunus sp.</i>)
Height	5.0m
Physiological Condition	Poor
Structural Condition	Fair
Inspection findings/reason for exemption	This tree is moribund; removal is required to prevent natural failure, manage risk, and facilitate replanting

Image shows moribund tree in street scene.

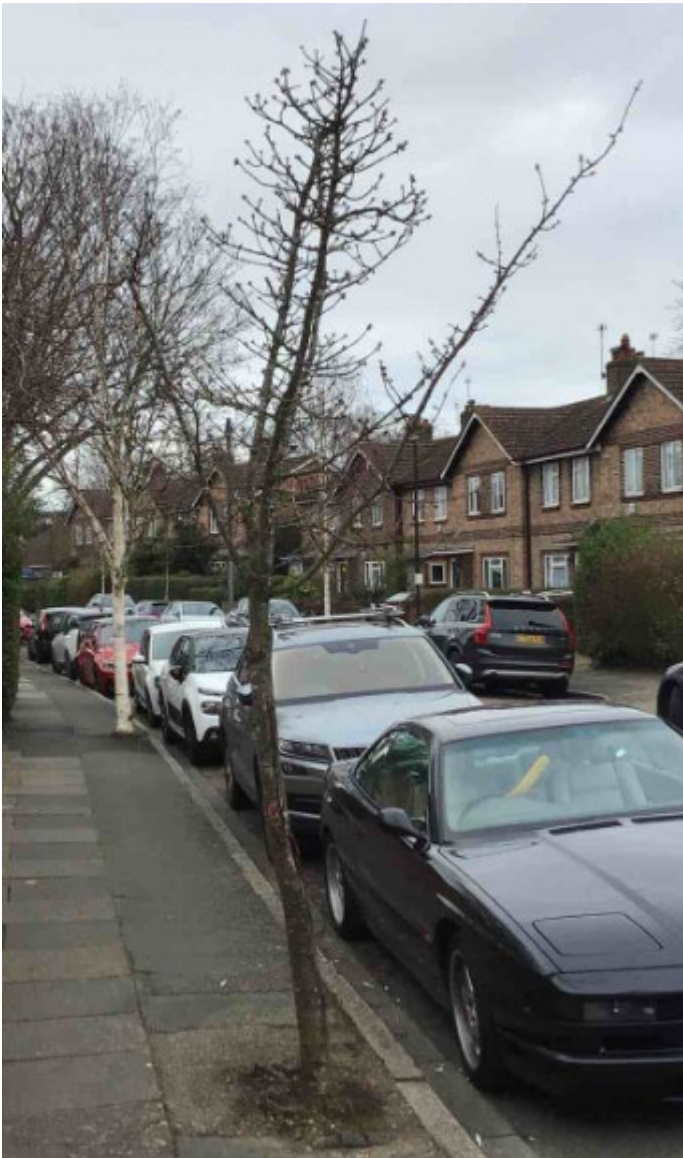
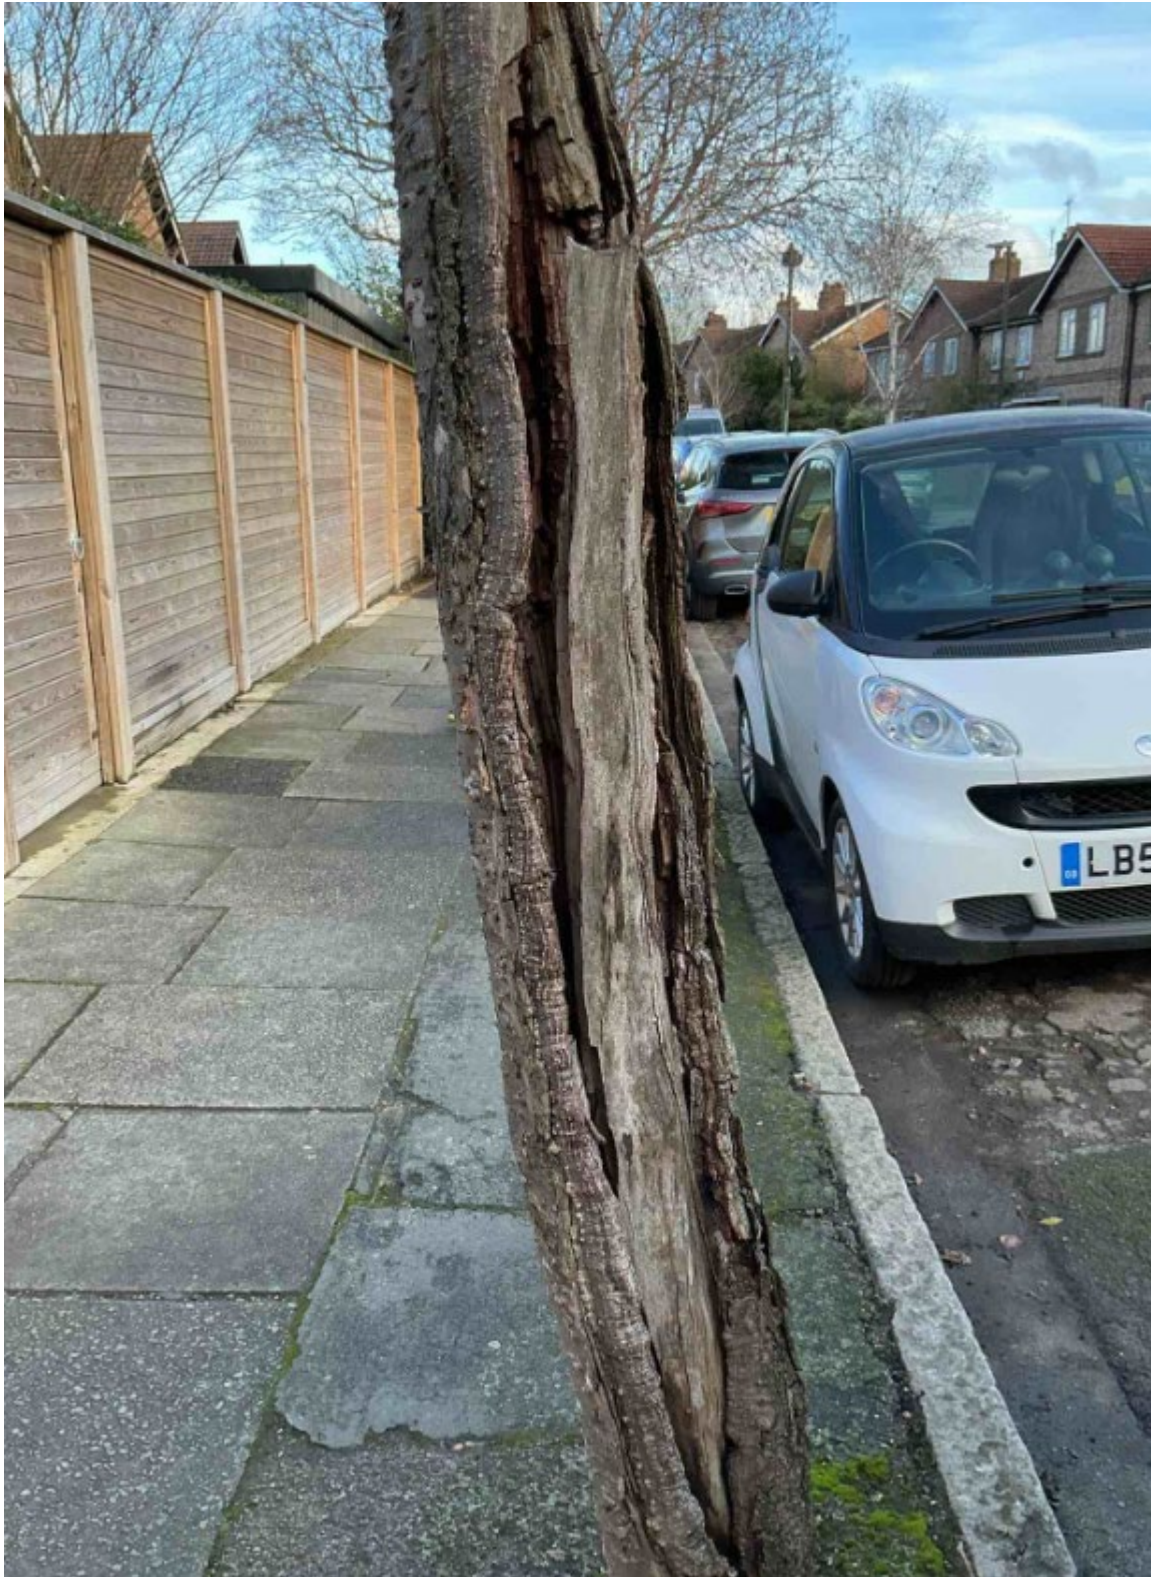
Ward	North Richmond
Road	Carrington Road
Location	Adjacent to 20 Kings Farm Avenue
Species	Higan cherry (<i>Prunus x subhirtella</i>)
Height	3.5m
Physiological Condition	Fair
Structural Condition	Poor
Inspection findings/reason for exemption	This tree has an unacceptable amount of structural damage on the trunk. Removal is required to prevent natural failure, manage risk, and facilitate replanting

Image shows structural damage to stem.

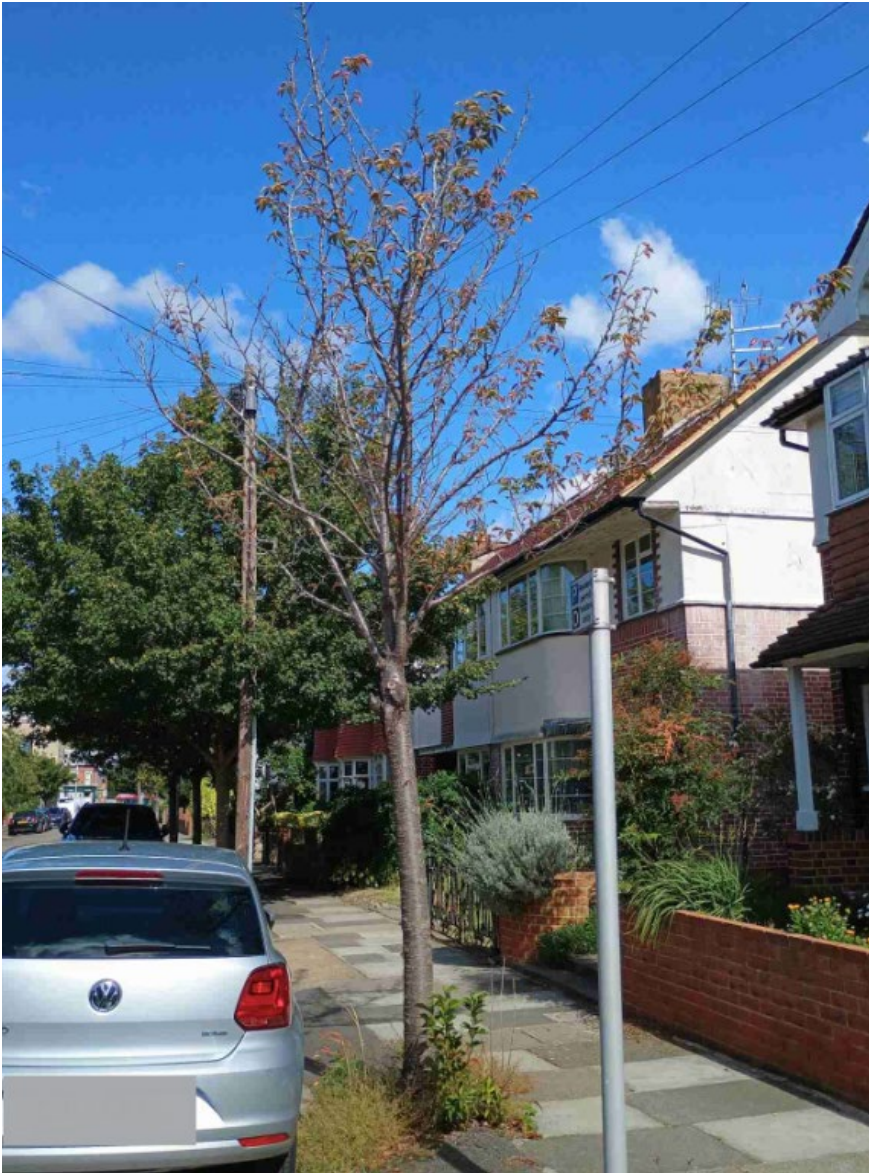
Ward	South Twickenham
Road	Saville Road
Location	Outside 29
Species	Wild cherry (<i>Prunus avium</i>)
Height	7.0m
Physiological Condition	Poor
Structural Condition	Fair
Inspection findings/reason for exemption	This tree is moribund; removal is required to prevent natural failure, manage risk and facilitate replanting

Image shows moribund tree in street scene.

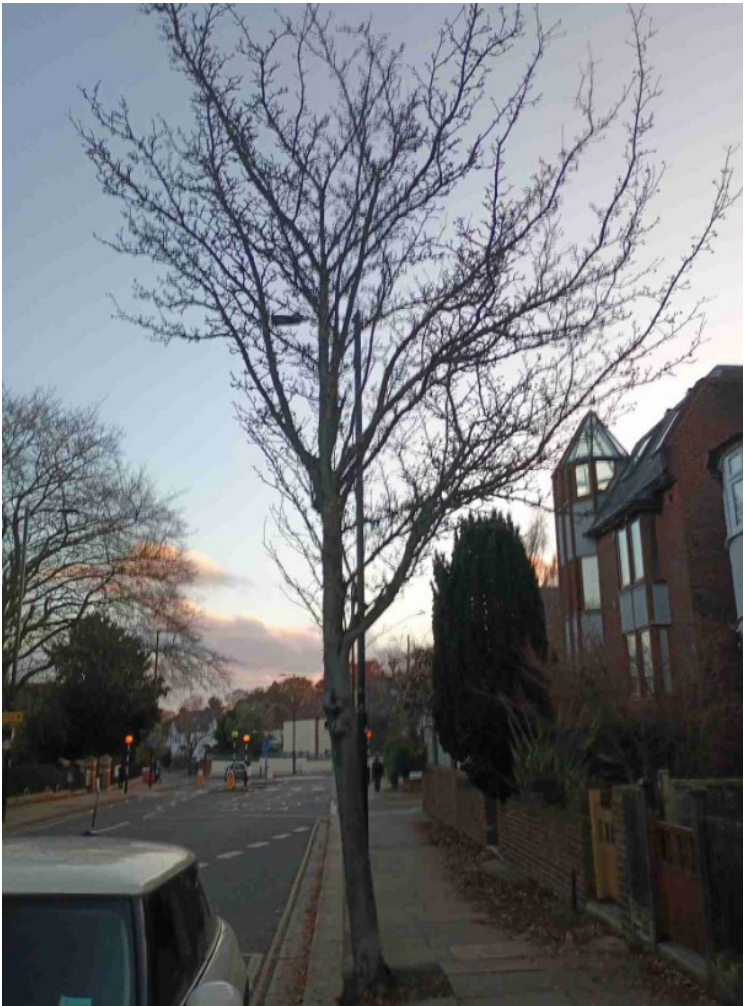
Ward	South Twickenham
Road	Cross Deep
Location	Outside 96
Species	Apple (<i>Malus sp.</i>)
Height	9.0m
Physiological Condition	Good
Structural Condition	Good
Inspection findings/reason for exemption	This tree is causing an unreasonable obstruction to buses due to the truck's proximity to the kerb line and the narrow bus lane, and there are no viable pruning options. Removal is required to manage risk and facilitate replanting in a more suitable location.

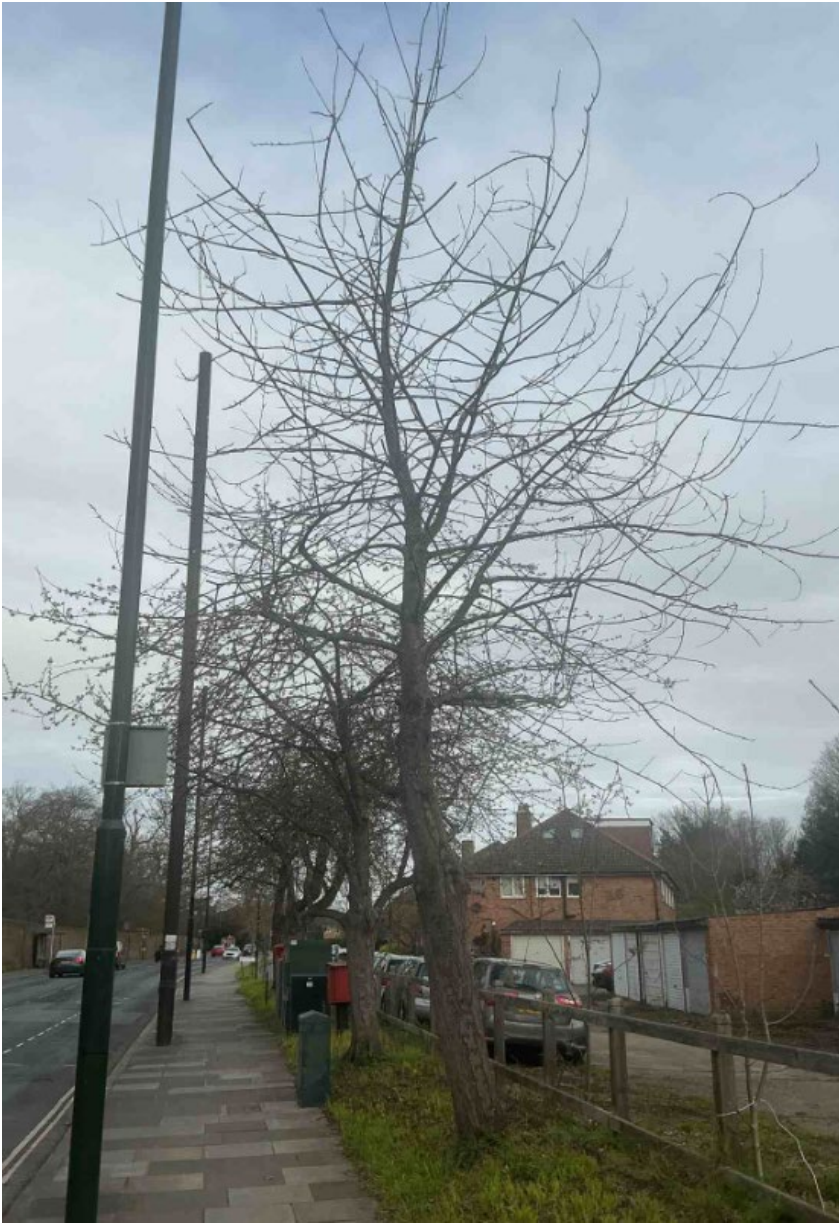
Ward	Teddington
Road	Shaef Way
Location	W3W - ///pilots.thing.zebra
Species	Wild cherry (<i>Prunus avium</i>)
Height	12.0m
Physiological Condition	Dead
Structural Condition	Fair
Inspection findings/reason for exemption	This tree is dead; removal is required to prevent natural failure, manage risk, and facilitate replanting

Image shows dead tree in street scene.

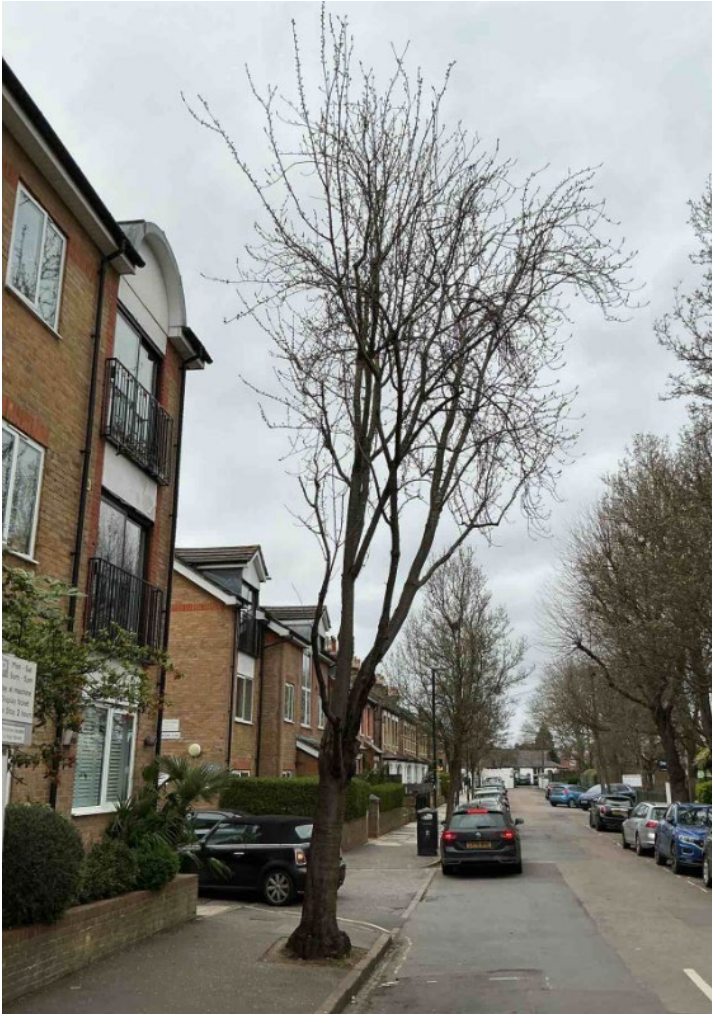
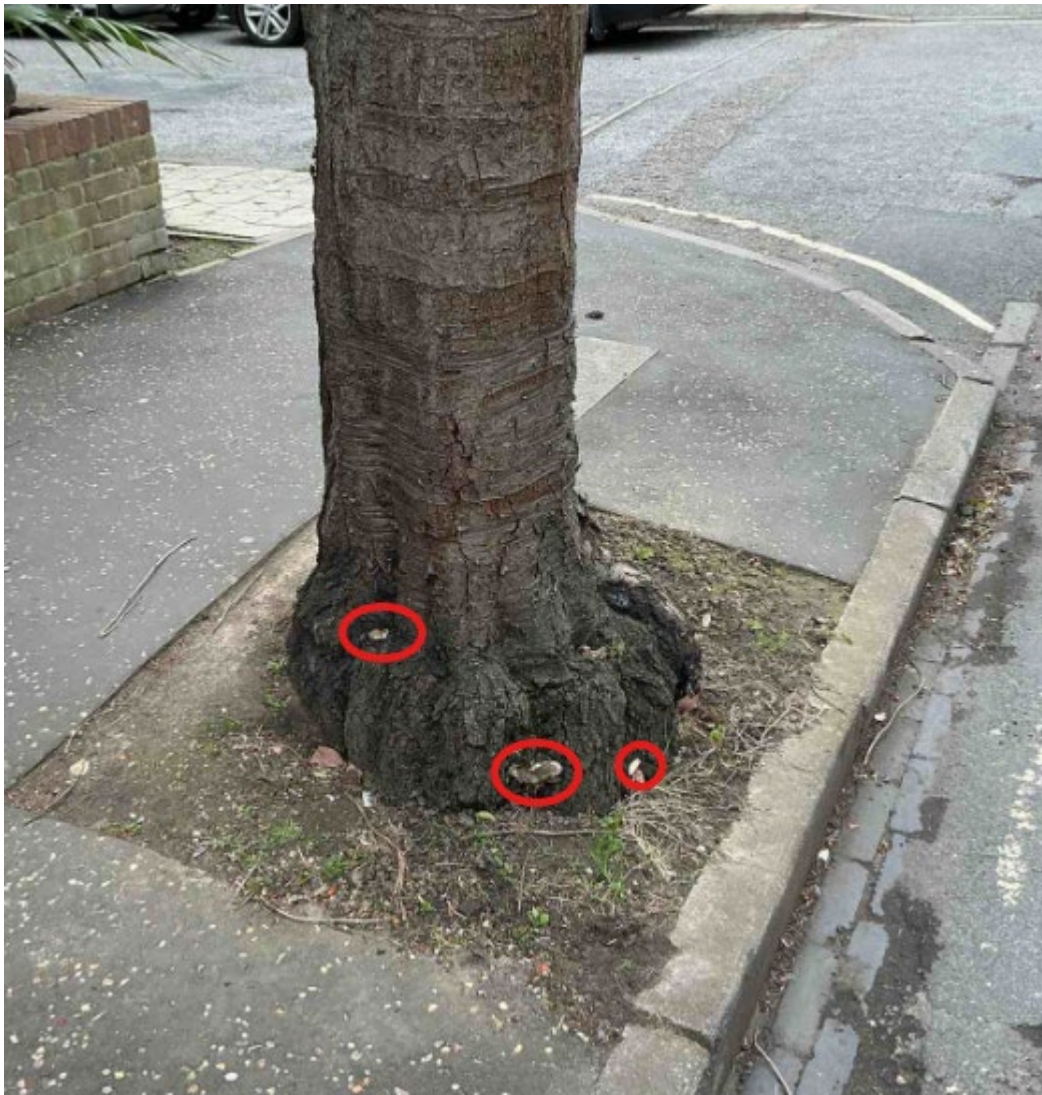
Ward	Teddington
Road	Vicarage Road
Location	Opposite 4
Species	Cherry (<i>Prunus sp.</i>)
Height	14.0m
Physiological Condition	Fair
Structural Condition	Poor
Inspection findings/reason for exemption	A fungal fruiting body of the decay fungus <i>Ganoderma sp.</i> is present on the base of the trunk. Colonisation by this fungus results in white rot affecting the stem and root system, which can lead to structural failure through fracture or windthrow. Investigation with a probe and a resonance test with a sounding hammer has revealed an unacceptable amount of decay which correlates with the presence of the decay fungi. Removal of the tree is recommended to prevent natural failure, manage risk, and facilitate replanting.

Image shows fungal fruiting bodies circled. [?]

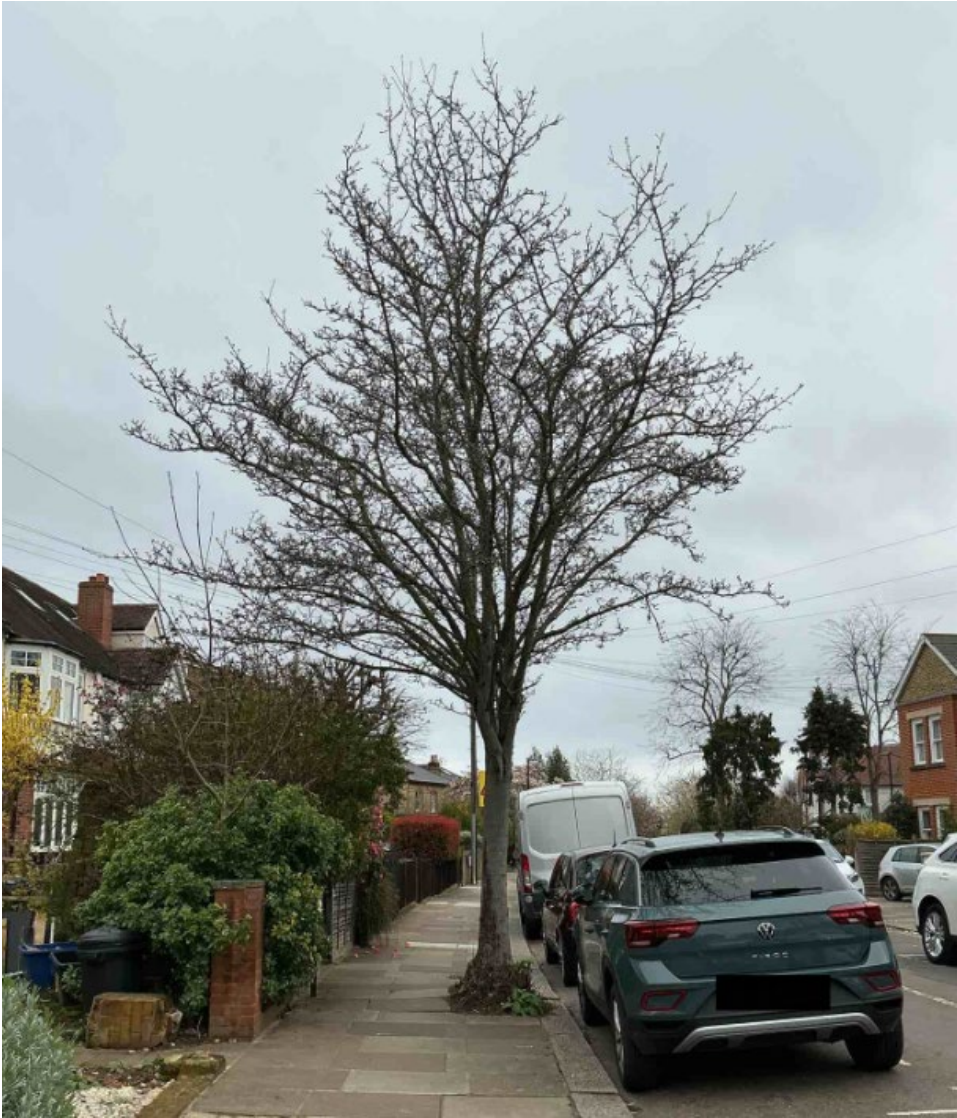
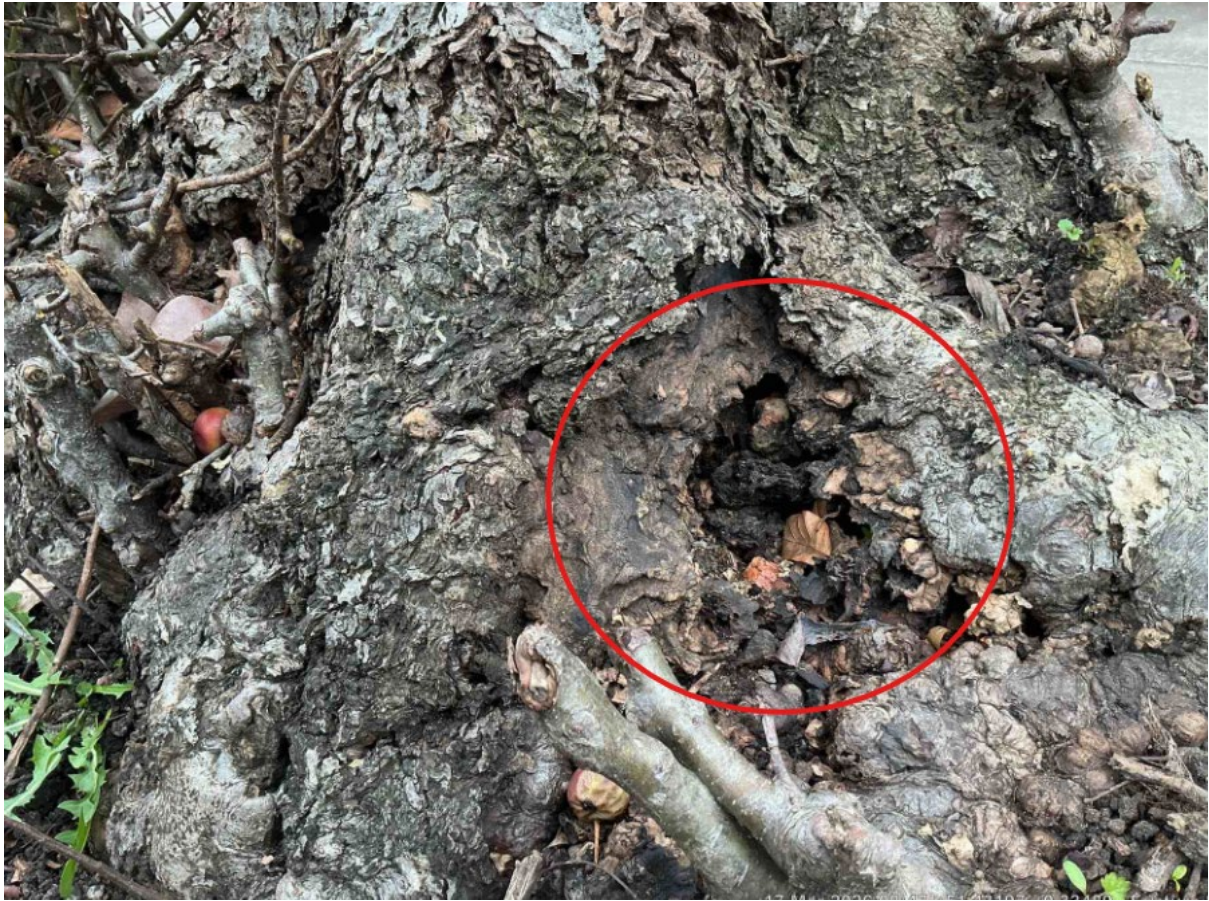
Ward	Teddington
Road	Teddington Park Road
Location	Outside 61-63
Species	Apple (<i>Malus sp.</i>)
Height	9.0m
Physiological Condition	Poor
Structural Condition	Poor
Inspection findings/reason for exemption	Investigation with a probe and a resonance test with a sounding hammer has revealed an unacceptable amount of decay beyond the visible cavities at the base of the trunk. Removal is required to prevent natural failure, manage risk, and facilitate replanting.

Image shows cavity at base of trunk.

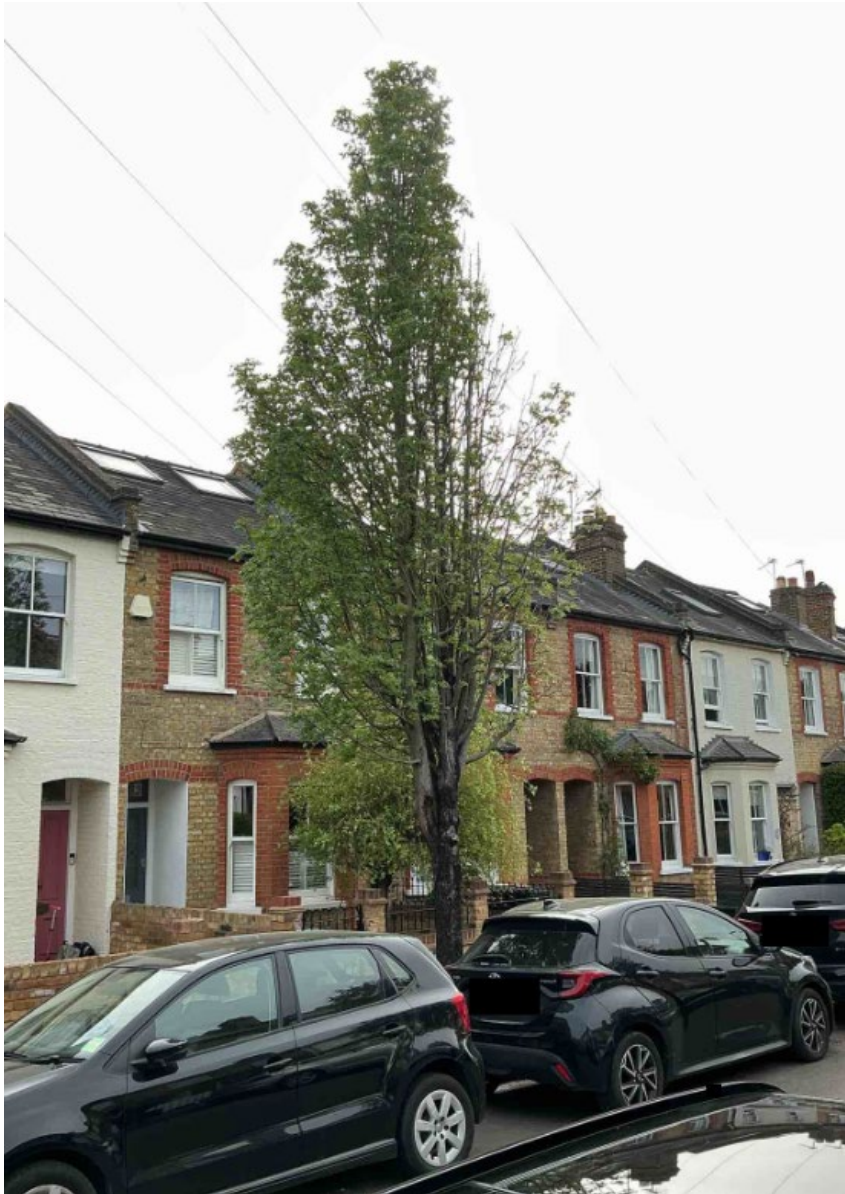
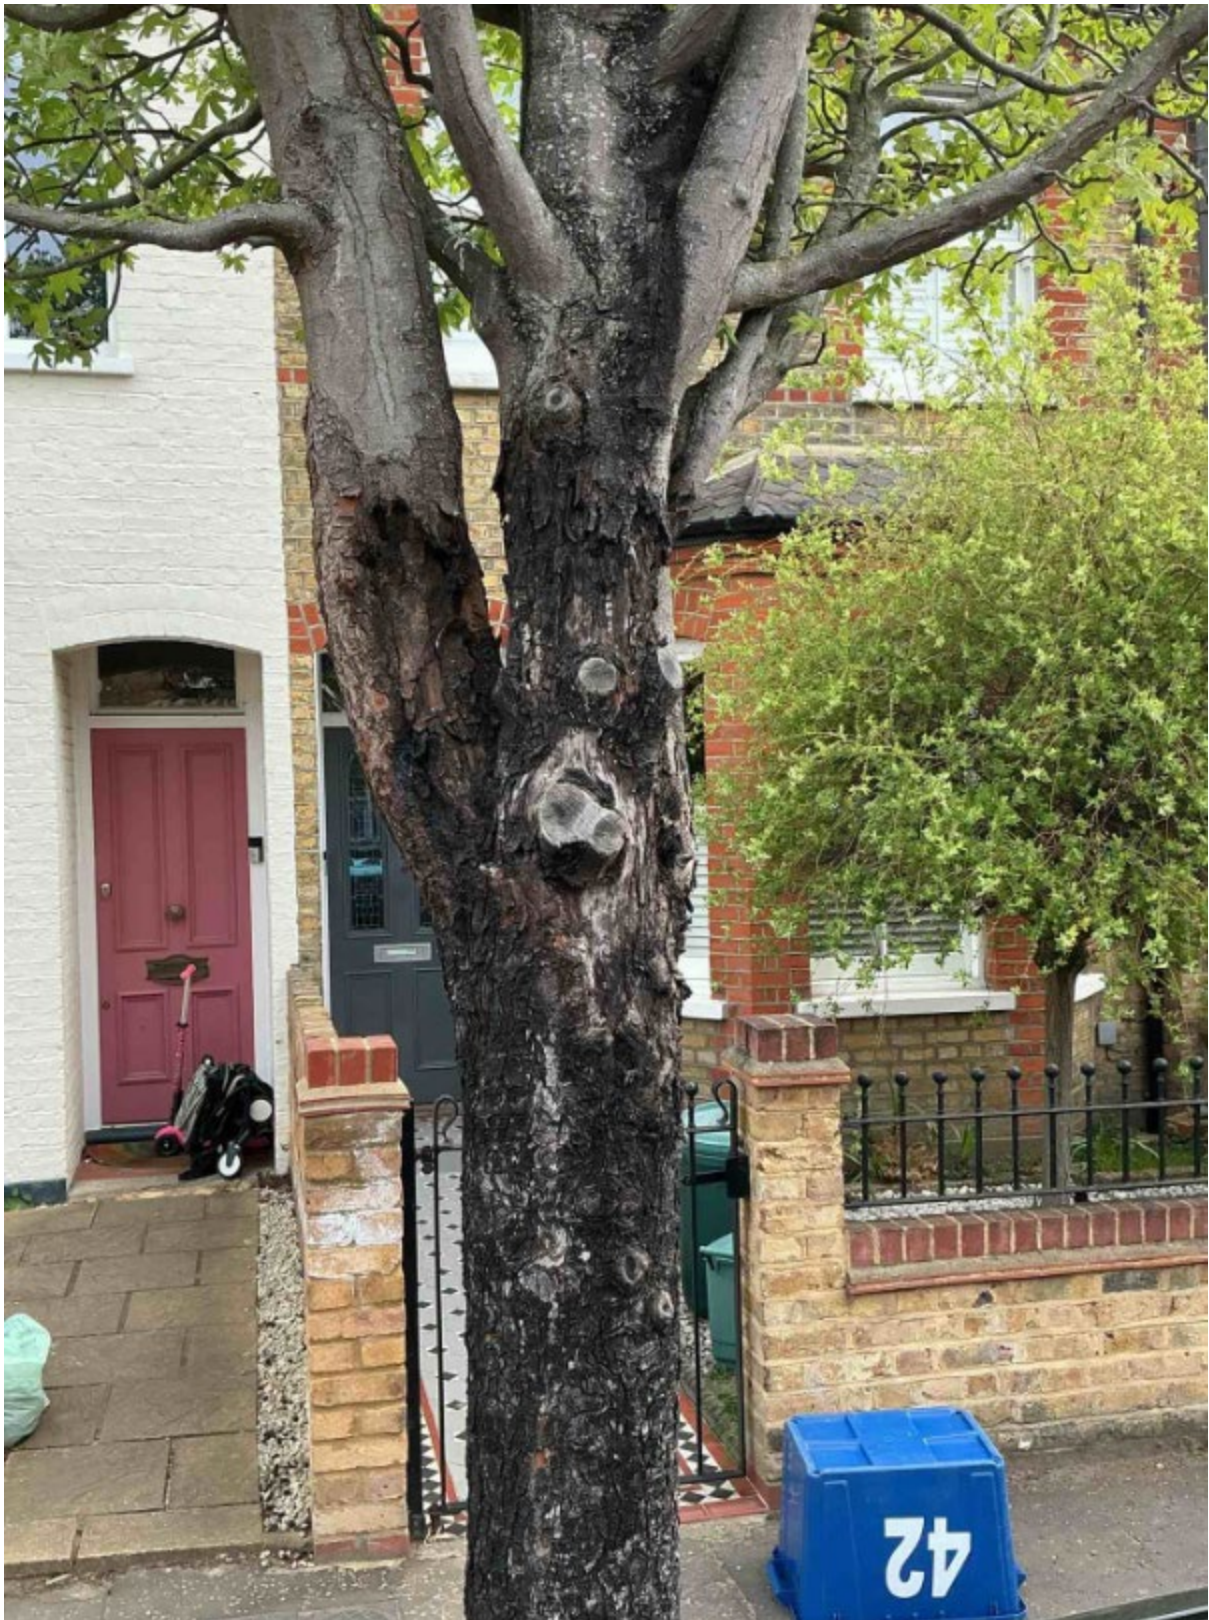
Ward	Teddington
Road	Arlington Road
Location	Outside 42-44
Species	Lebanese wild apple (<i>Malus trilobata</i>)
Height	8.0m
Physiological Condition	Poor
Structural Condition	Fair
Inspection findings/reason for exemption	Bark necrosis is present on the trunk of this tree; the decline of the trees vascular system correlates with dieback within the crown. Removal is required to prevent natural failure, manage risk, and facilitate replanting.

Image shows moribund tree in street scene

Image shows bark necrosis on trunk.
