April 2026 - Reactive Tree Works Programme

Introduction

Dated 26/04/2026

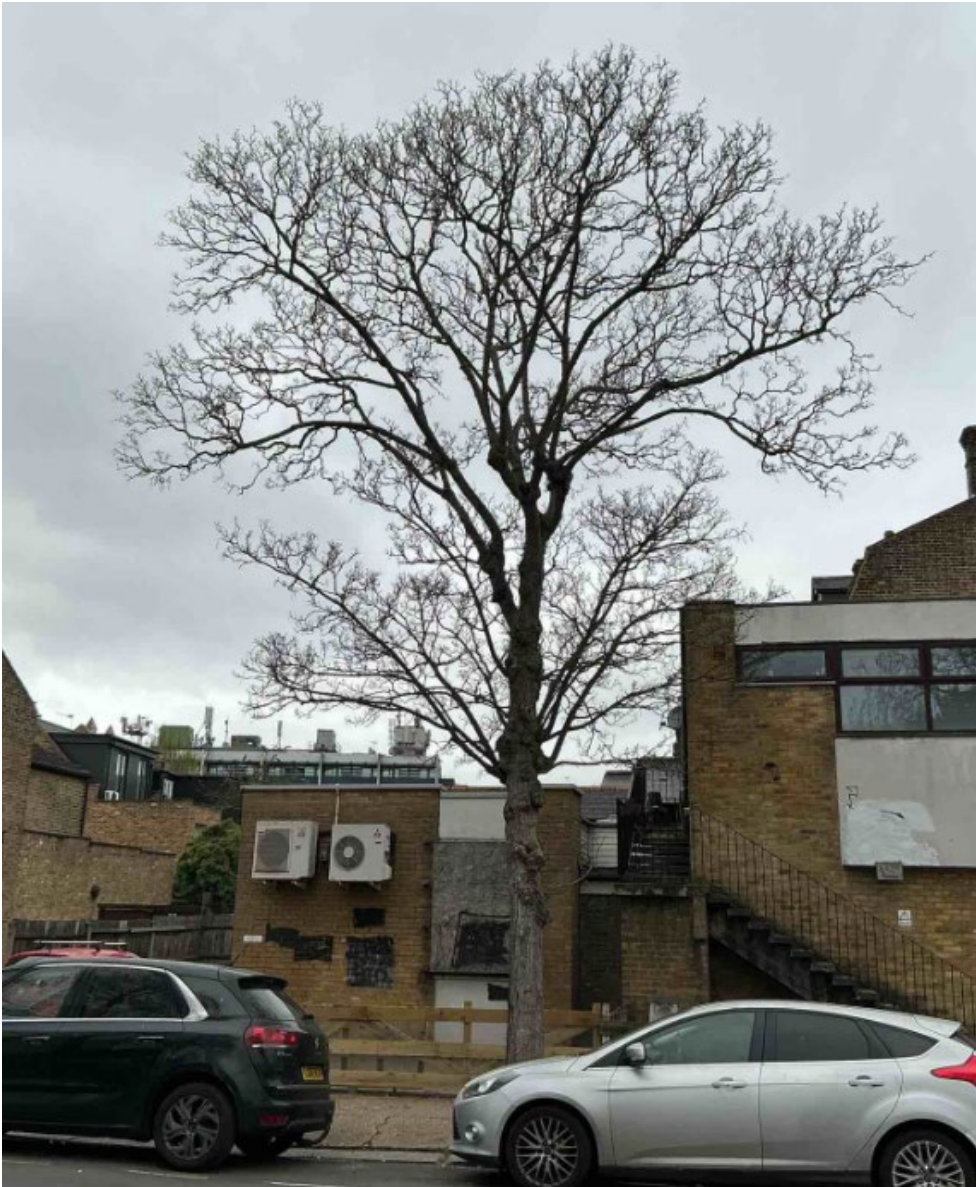
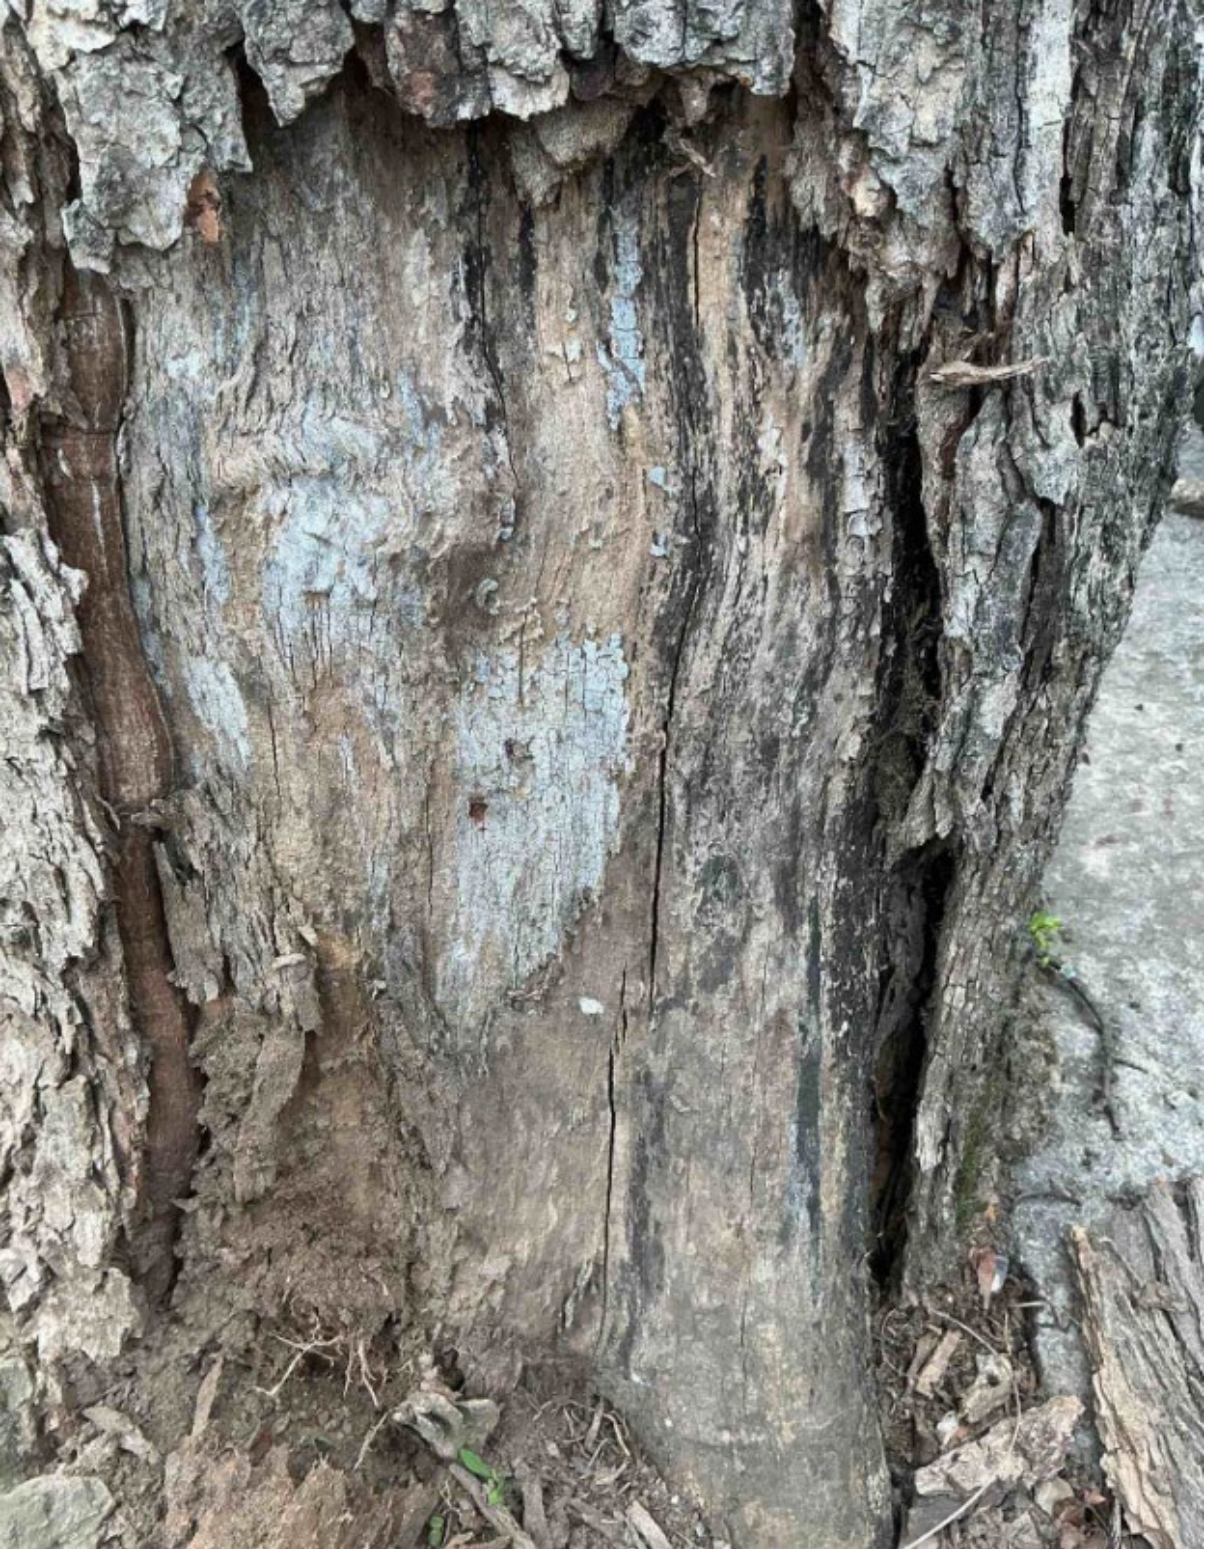
Ward	Teddington
Road	Cedar Road
Location	Adjacent to 42 High Street
Species	Sycamore (<i>Acer pseudoplatanus</i>)
Height	11.5m
Physiological Condition	Poor
Structural Condition	Fair
Inspection findings/reason for exemption	This tree has an unacceptable amount of bark delamination at the base of the trunk which will cause dysfunction of the trees vascular system. Removal is required to prevent natural failure, manage risk, and facilitate replanting.

Image shows bark delamination at bas of trunk.

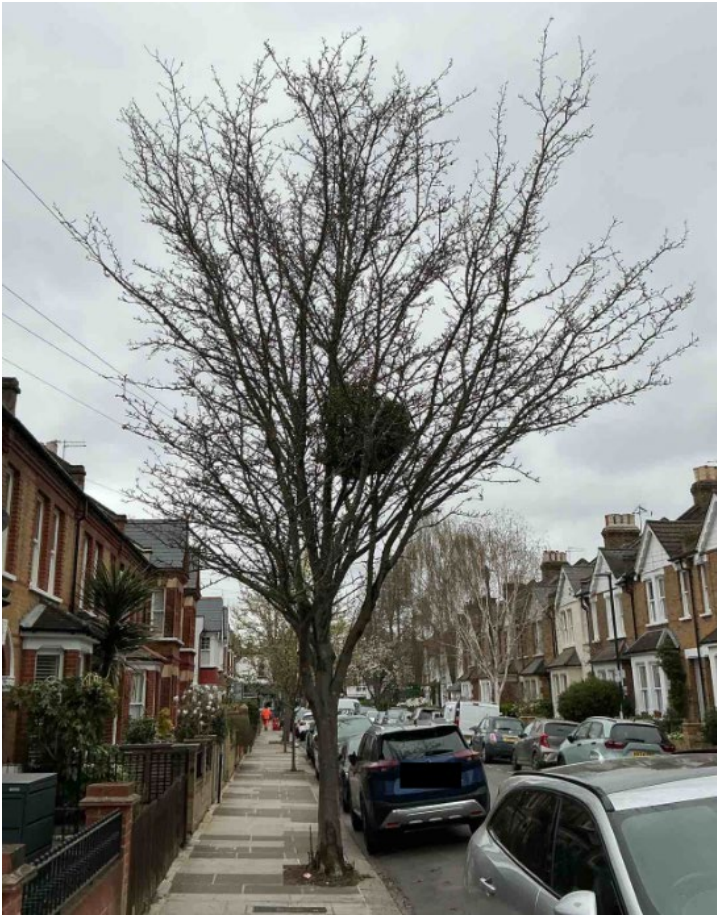
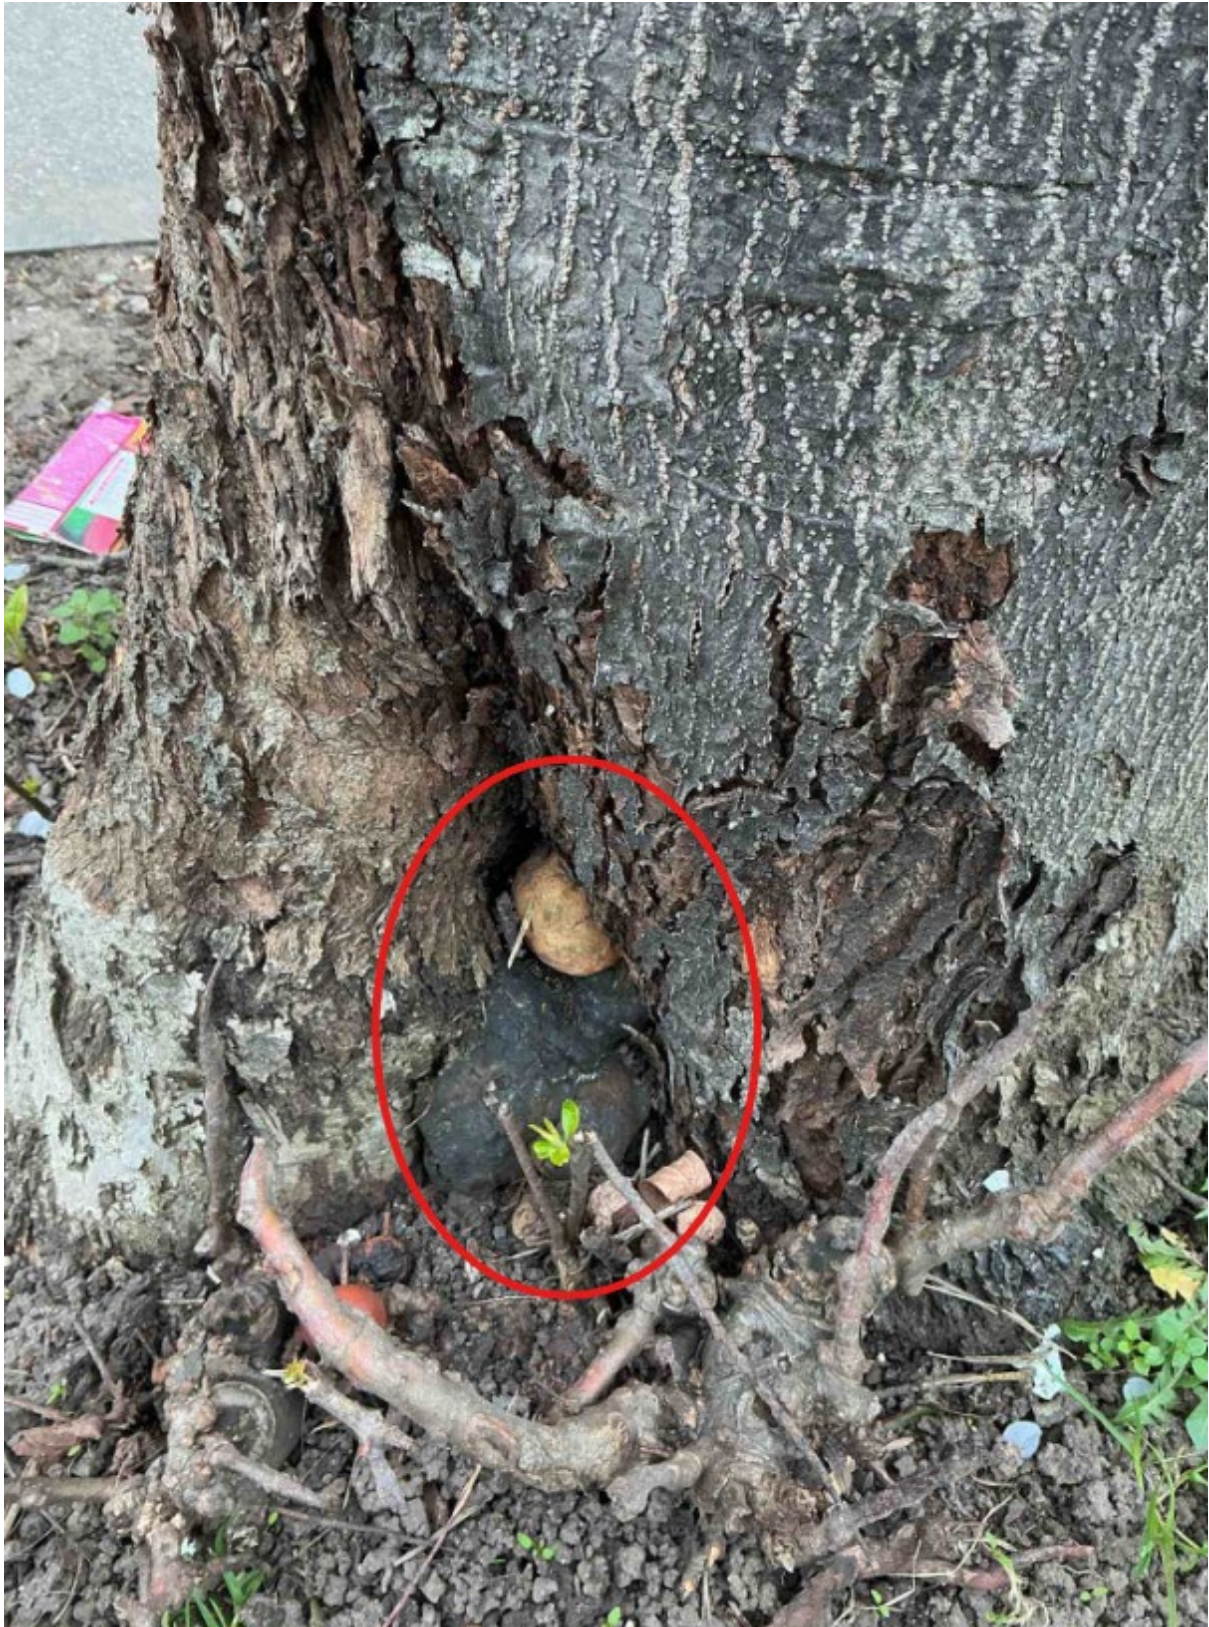
Ward	Teddington
Road	Cedar Road
Location	Outside 28
Species	Apple (<i>Malus sp.</i>)
Height	9.0m
Physiological Condition	Good
Structural Condition	Poor
Inspection findings/reason for exemption	A fungal fruiting body of the decay fungus <i>Ganoderma sp.</i> is present on the base of the trunk. Colonisation by this fungus results in white rot affecting the stem and root system, which can lead to structural failure through fracture or windthrow. Investigation with a probe and a resonance test with a sounding hammer has revealed an unacceptable amount of decay which correlates with the presence of the decay fungi. Removal of the tree is recommended to prevent natural failure, manage risk, and facilitate replanting.

Image shows fungal fruiting body circled at base of trunk.

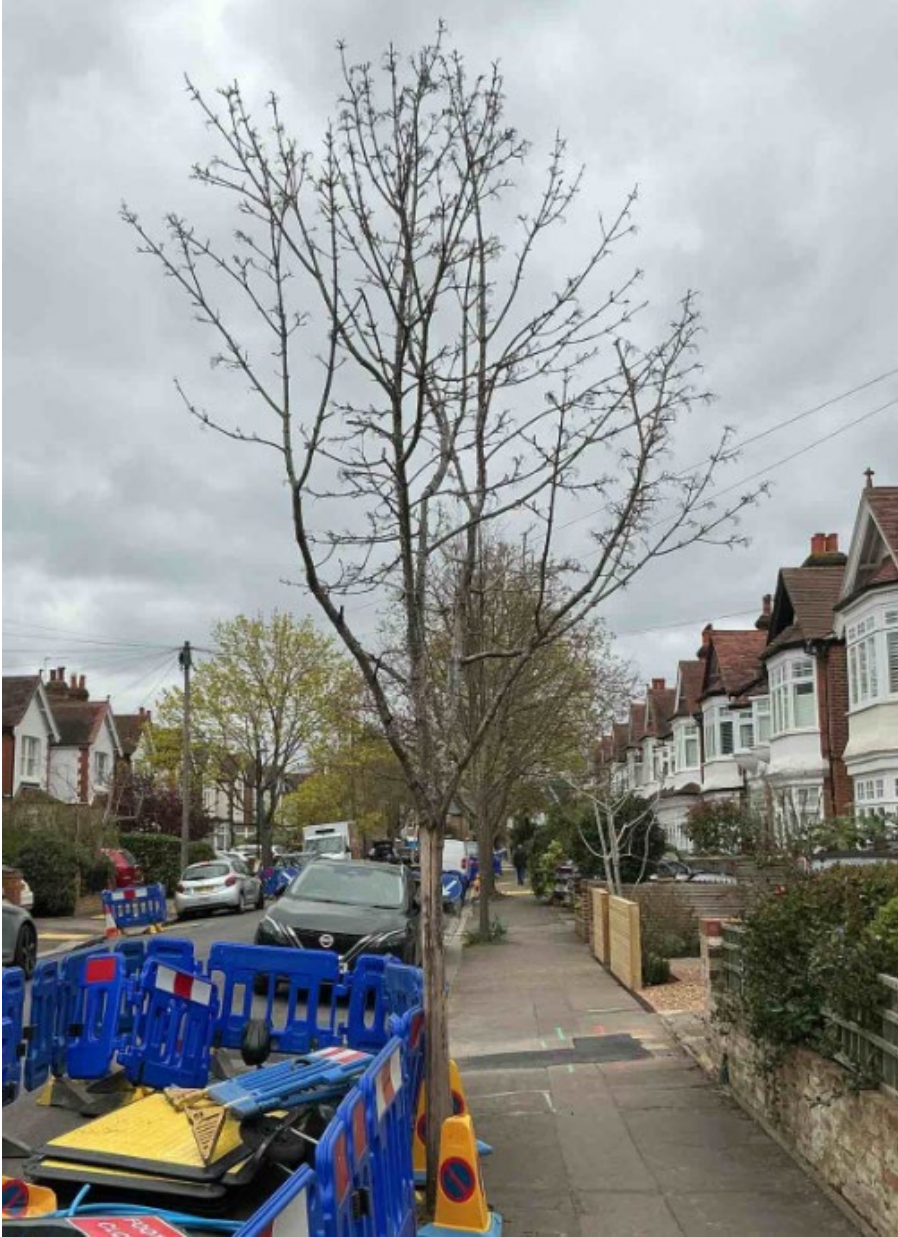
Ward	Teddington
Road	Bolton Gardens
Location	Outside 29
Species	Apple (<i>Malus sp.</i>)
Height	6.0m
Physiological Condition	Dead
Structural Condition	Fair
Inspection findings/reason for exemption	This tree is dead; removal is required to prevent natural failure, manage risk, and facilitate replanting

Image shows dead tree in street scene

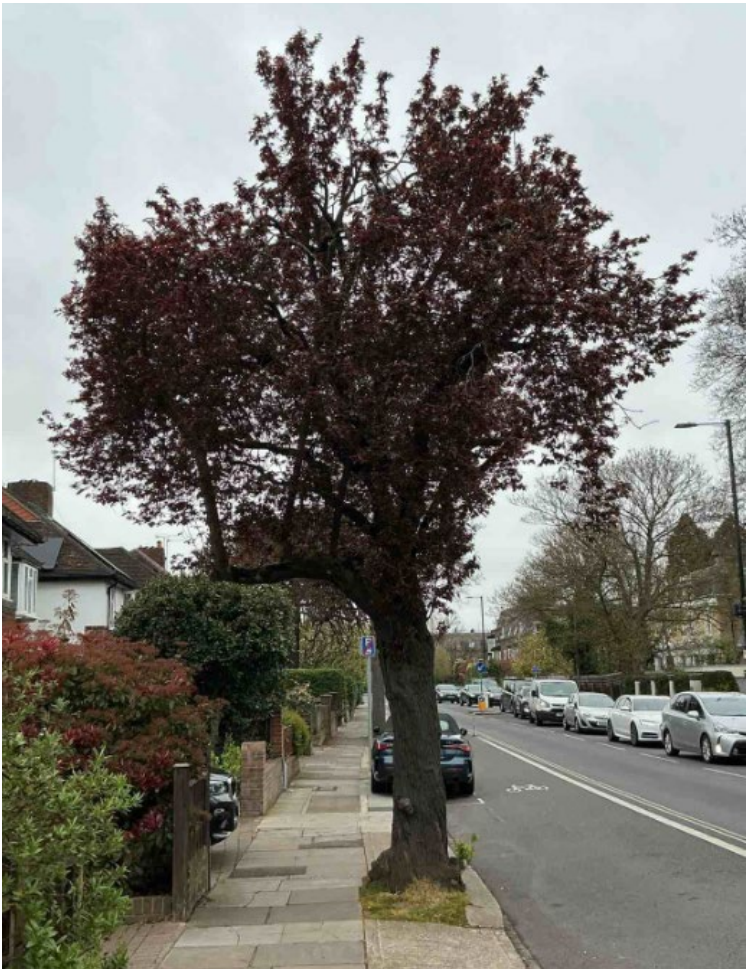
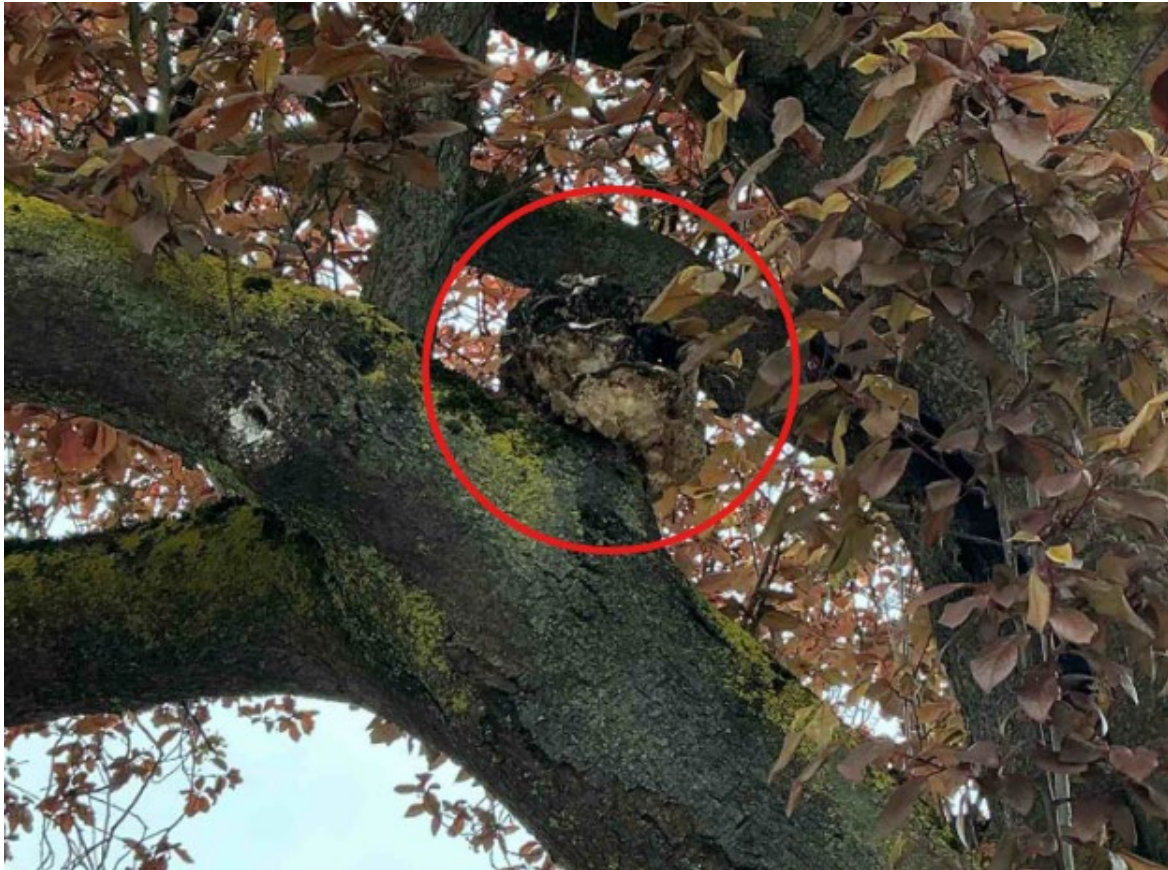
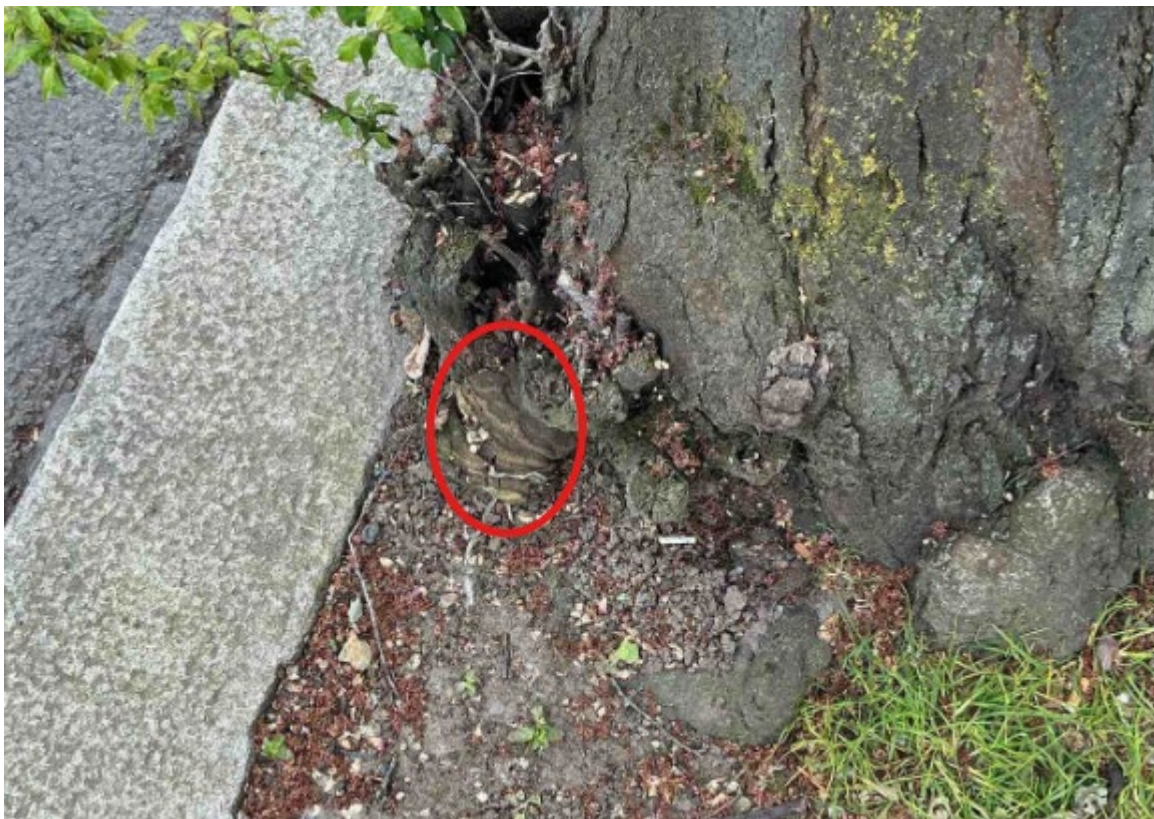
Ward	Teddington
Road	Church Road
Location	Outside 61/63
Species	Purple leaf plum (<i>Prunus cerasifera</i>)
Height	9.0m
Physiological Condition	Fair
Structural Condition	Poor
Inspection findings/reason for exemption	A fungal fruiting body of the decay fungus <i>Ganoderma sp.</i> is present on the base of the trunk. Colonisation by this fungus results in white rot affecting the stem and root system, which can lead to structural failure through fracture or windthrow. Fungal fruiting bodies of the wood decay fungus <i>Laetiporus sulphurous</i> are present in the crown of this tree. This fungus causes a brown rot which can rapidly reduce wood strength and cause branch or whole tree failure through brittle fracture. Removal of the tree is recommended to prevent natural failure, manage risk, and facilitate replanting.

Image shows fungal fruiting body (*Laetiporus sulphureus*) circled in crown.

Image shows fungal fruiting body (*Ganoderma* sp.) circled at base of trunk.

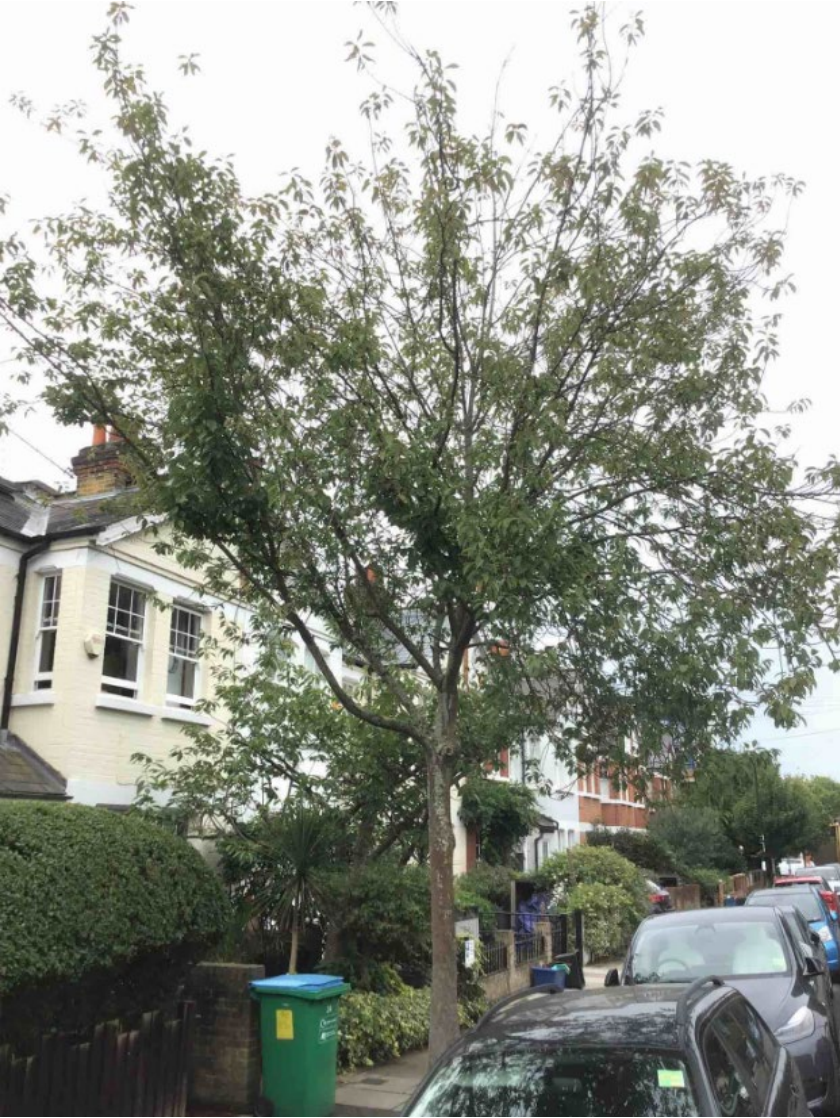
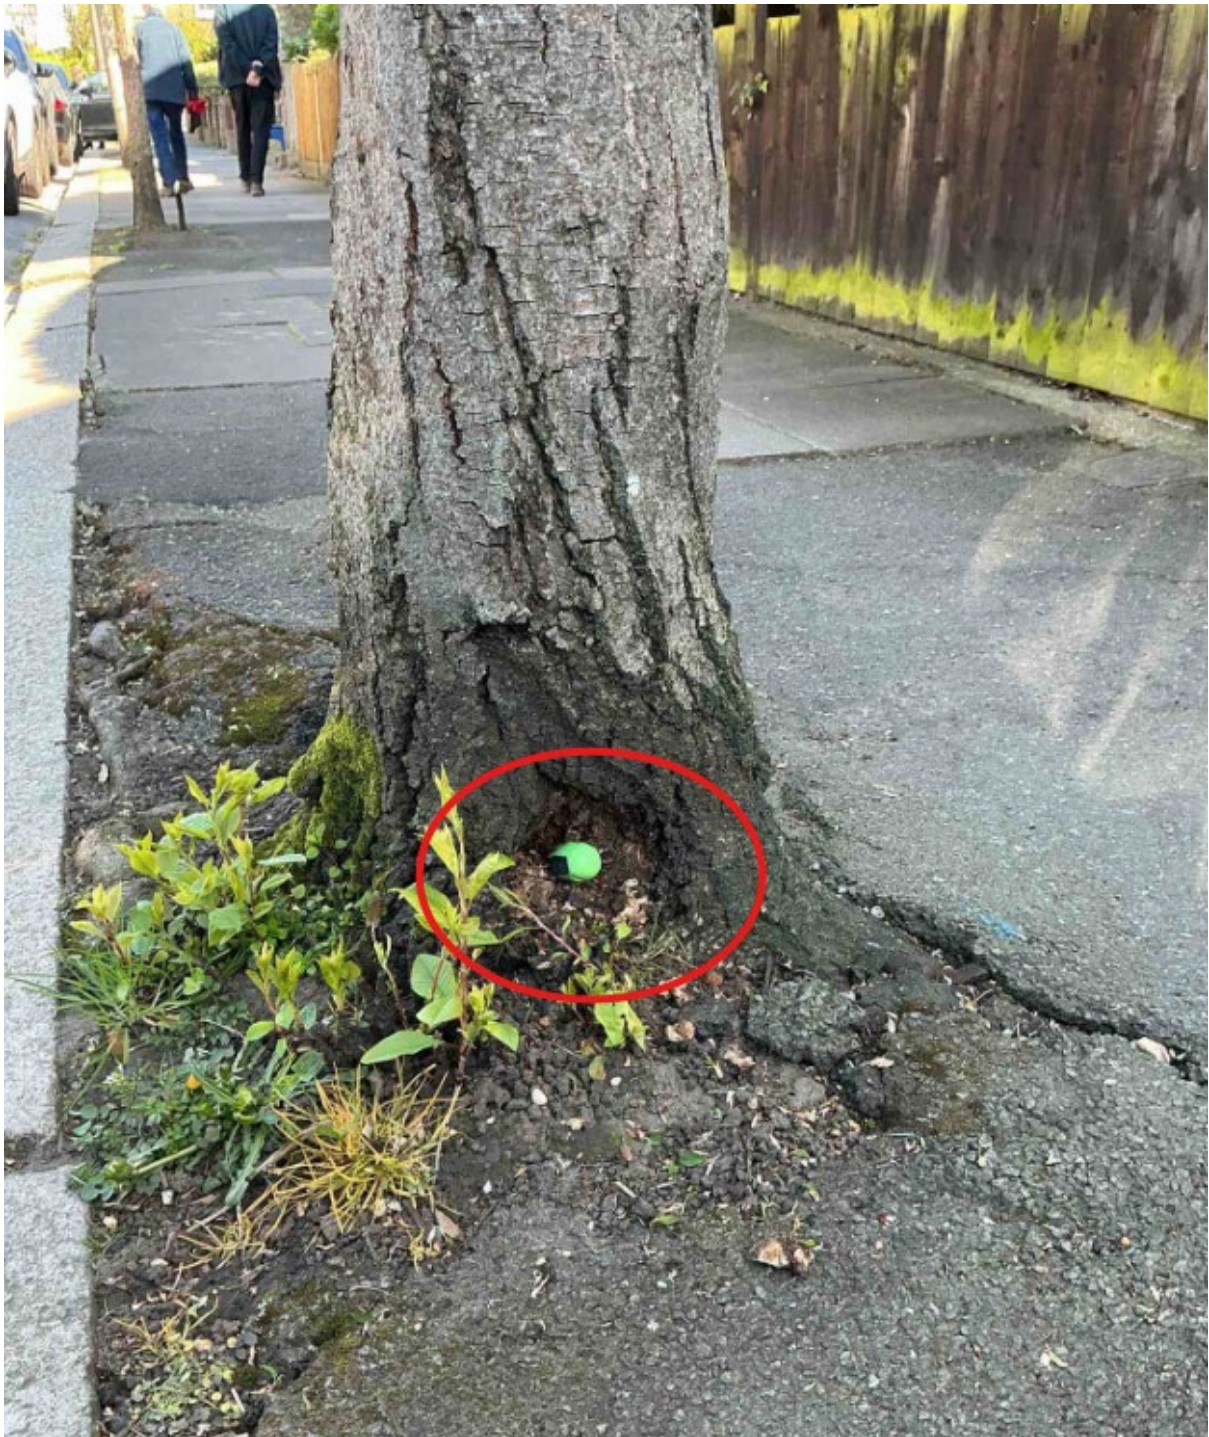
Ward	Teddington
Road	Bridgeman Road
Location	Outside 22/24
Species	Bird cherry (<i>Prunus padus</i>)
Height	9.0m
Physiological Condition	Fair
Structural Condition	Poor
Inspection findings/reason for exemption	Investigation with a probe and a resonance test with a sounding hammer has revealed an unacceptable amount of decay beyond the visible cavities at the base of the trunk. Removal is required to prevent natural failure, manage risk, and facilitate replanting.

Image shows cavity with probe circled at base of trunk.

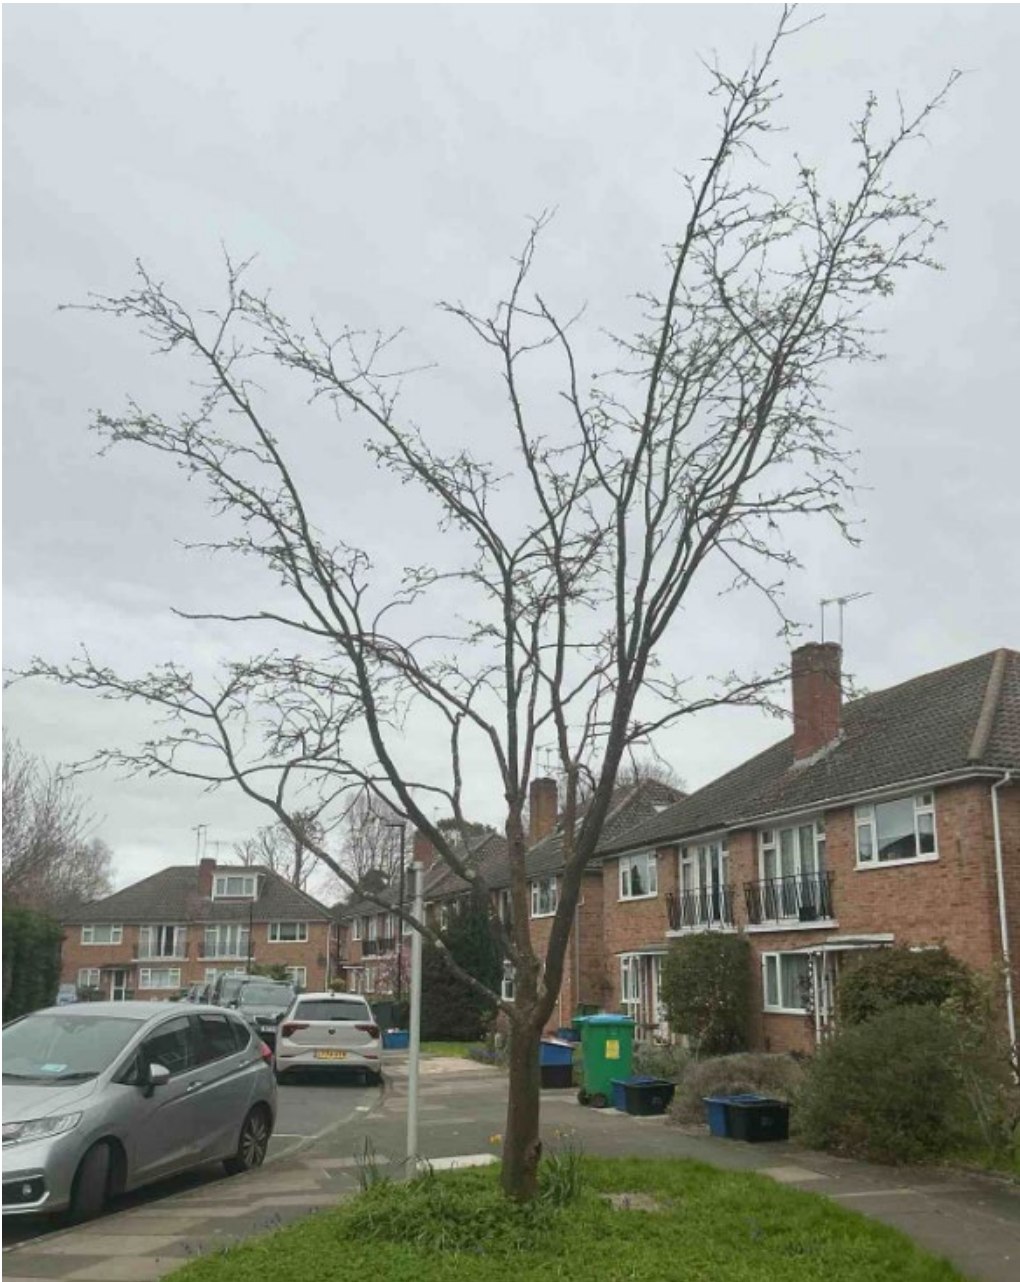
Ward	Teddington
Road	Shaef Way
Location	On Grass Area Outside 28
Species	Common laburnum (<i>Laburnum anagyroides</i>)
Height	4.5m
Physiological Condition	Poor
Structural Condition	Poor
Inspection findings/reason for exemption	This tree is moribund; removal is required to prevent natural failure, manage risk, and facilitate replanting

Image shows moribund tree in street scene

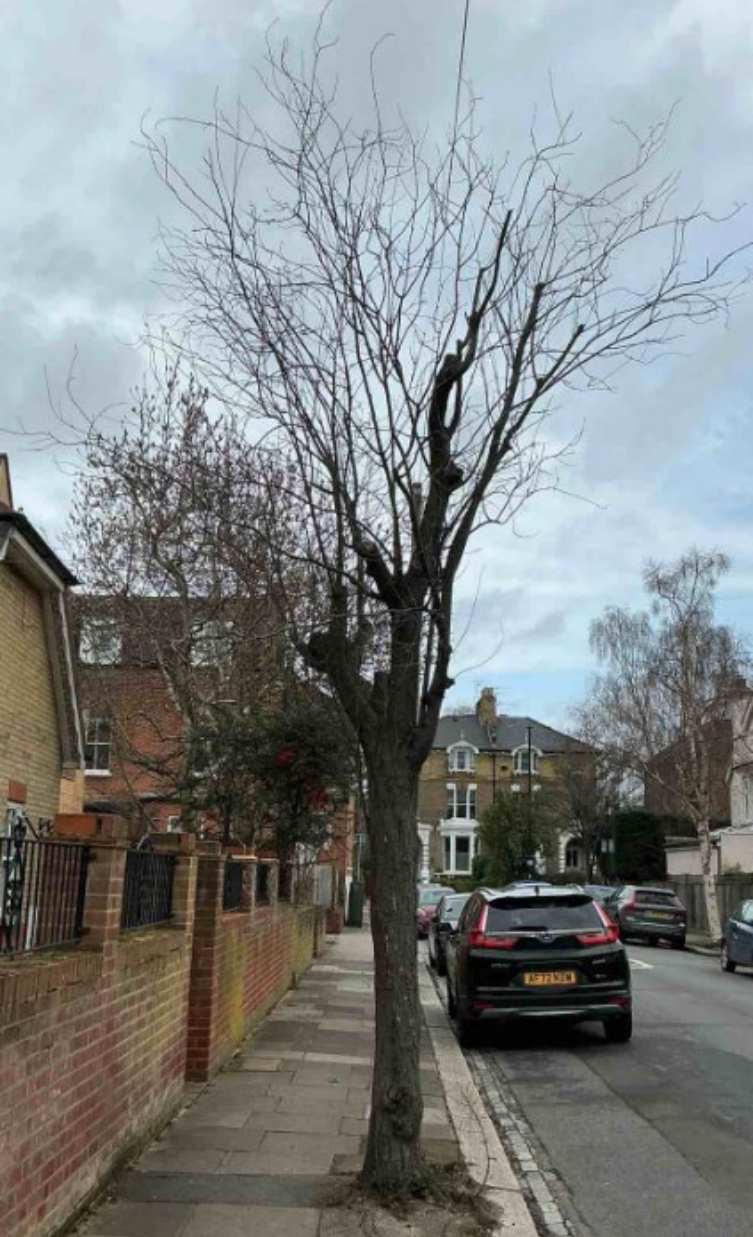
Ward	Teddington
Road	Coleshill Road
Location	Outside 2
Species	Purple leaf plum (<i>Prunus cerasifera</i>)
Height	5.0m
Physiological Condition	Poor
Structural Condition	Poor
Inspection findings/reason for exemption	This tree is moribund; removal is required to prevent natural failure, manage risk, and facilitate replanting

Image shows moribund tree in street scene

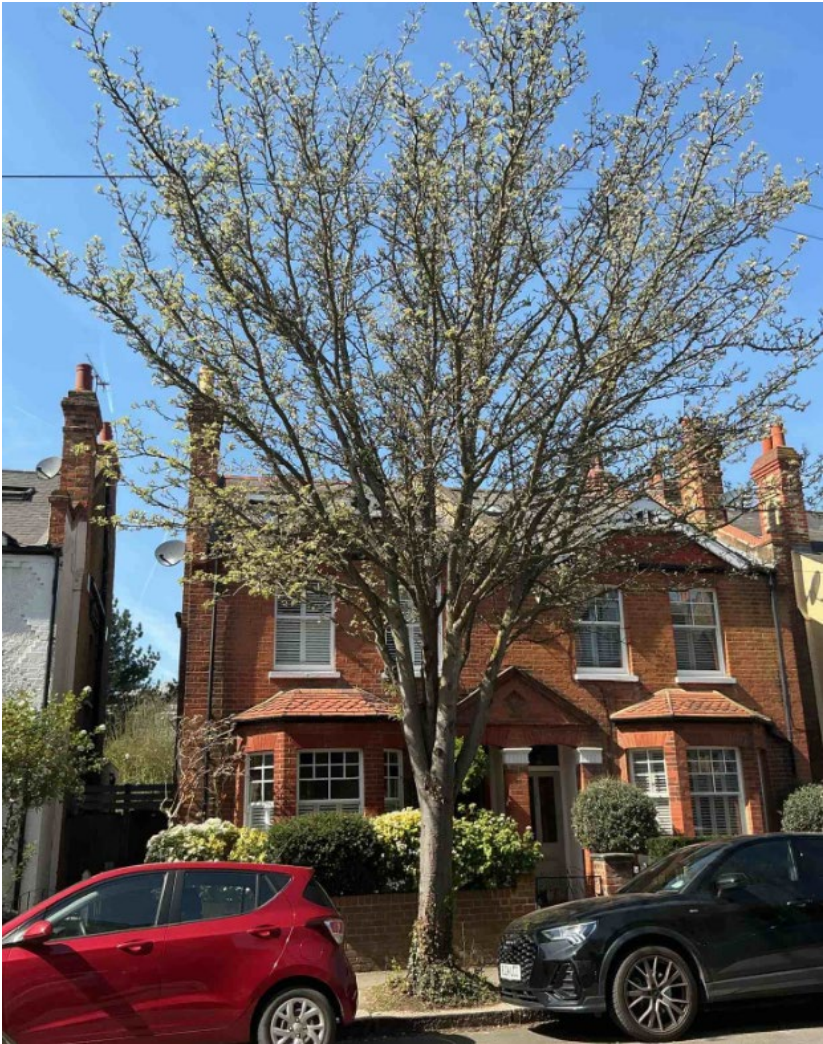
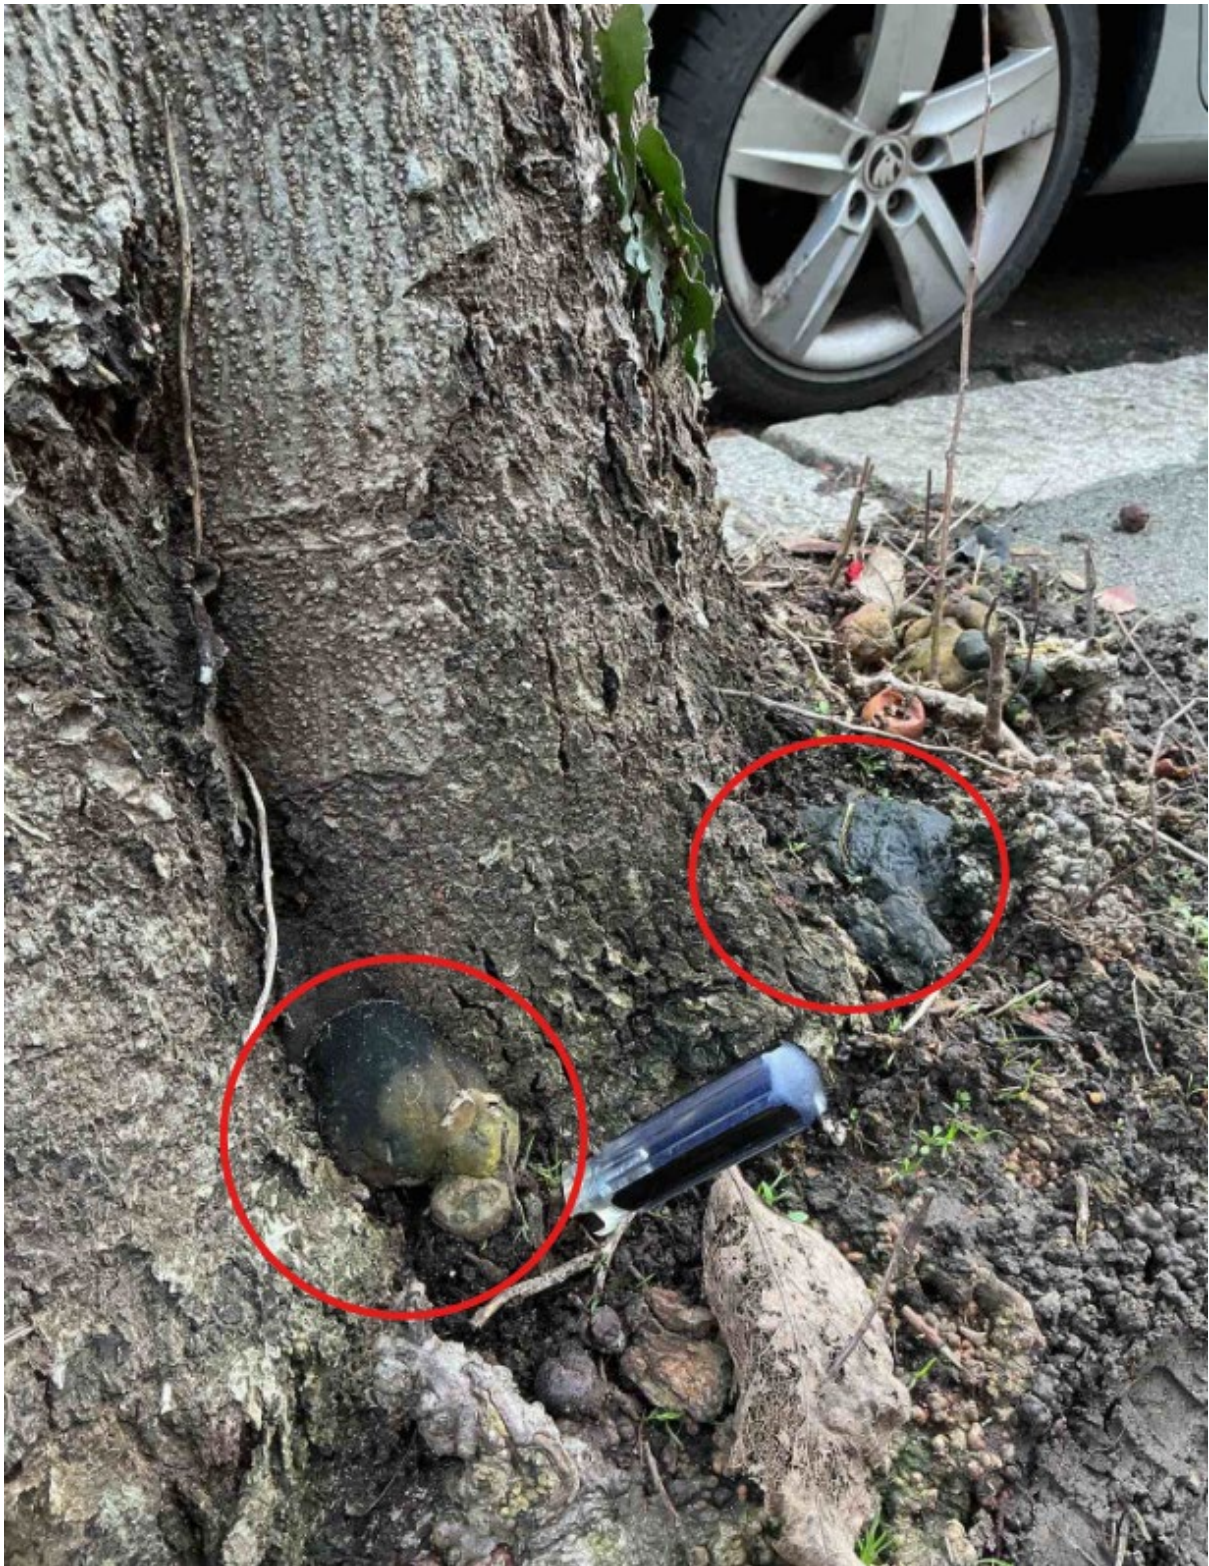
Ward	Teddington
Road	Coleshill Road
Location	Outside 18
Species	Chonosuki crab (<i>Malus tschonoskii</i>)
Height	8.0m
Physiological Condition	Fair
Structural Condition	Poor
Inspection findings/reason for exemption	A fungal fruiting body of the decay fungus <i>Ganoderma sp.</i> is present on the base of the trunk. Colonisation by this fungus results in white rot affecting the stem and root system, which can lead to structural failure through fracture or windthrow. Investigation with a probe and a resonance test with a sounding hammer has revealed an unacceptable amount of decay which correlates with the presence of the decay fungi. Removal of the tree is recommended to prevent natural failure, manage risk, and facilitate replanting.

Image shows fungal fruiting bodies circled at base of trunk.

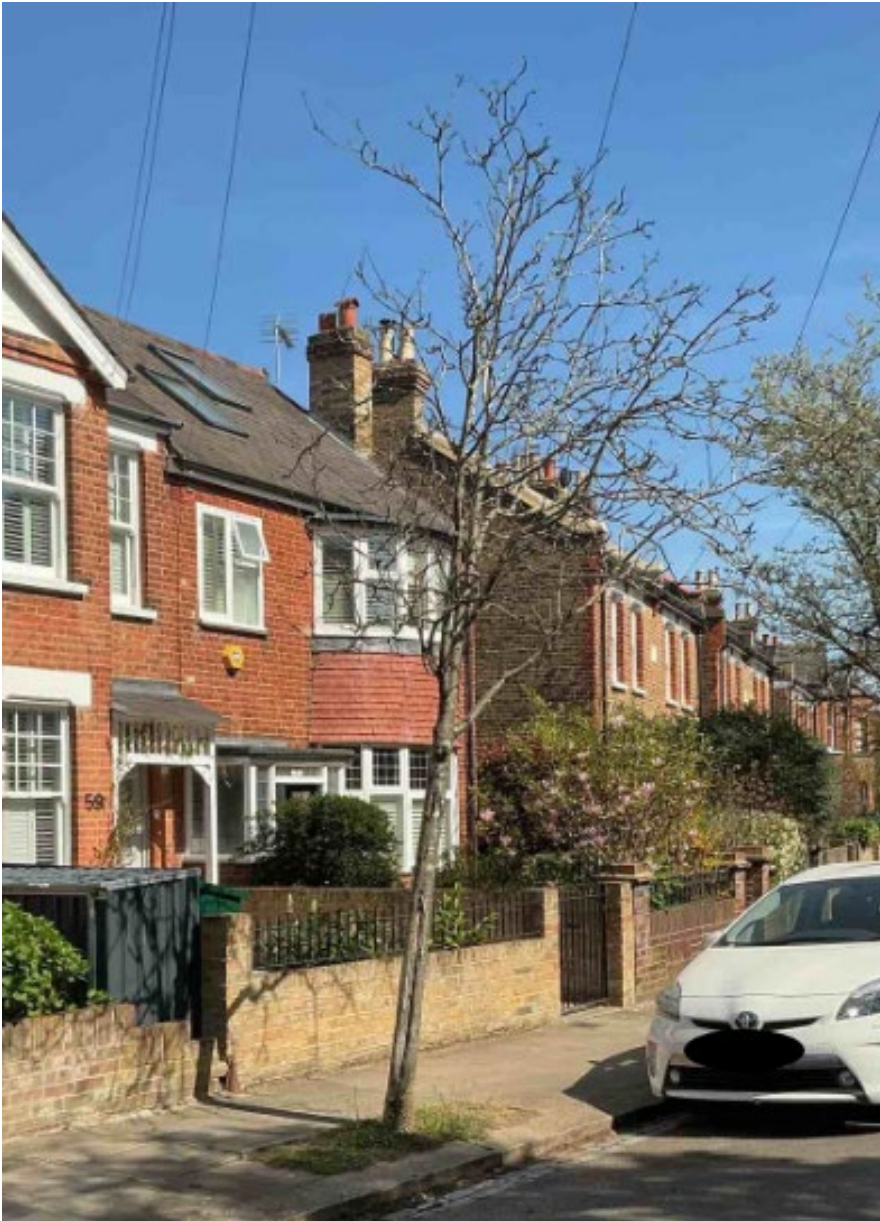
Ward	Teddington
Road	Coleshill Road
Location	Outside 57/59
Species	Rowan (<i>Sorbus aucuparia</i>)
Height	5.0m
Physiological Condition	Poor
Structural Condition	Fair
Inspection findings/reason for exemption	This tree is moribund; removal is required to prevent natural failure, manage risk, and facilitate replanting

Image shows moribund tree in street scene

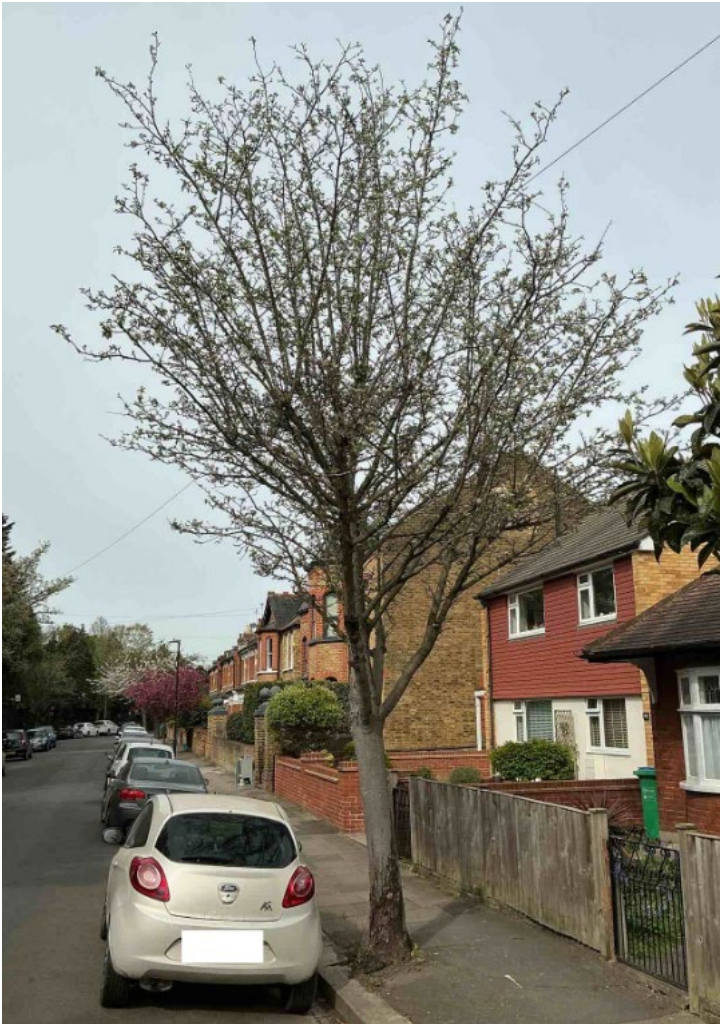
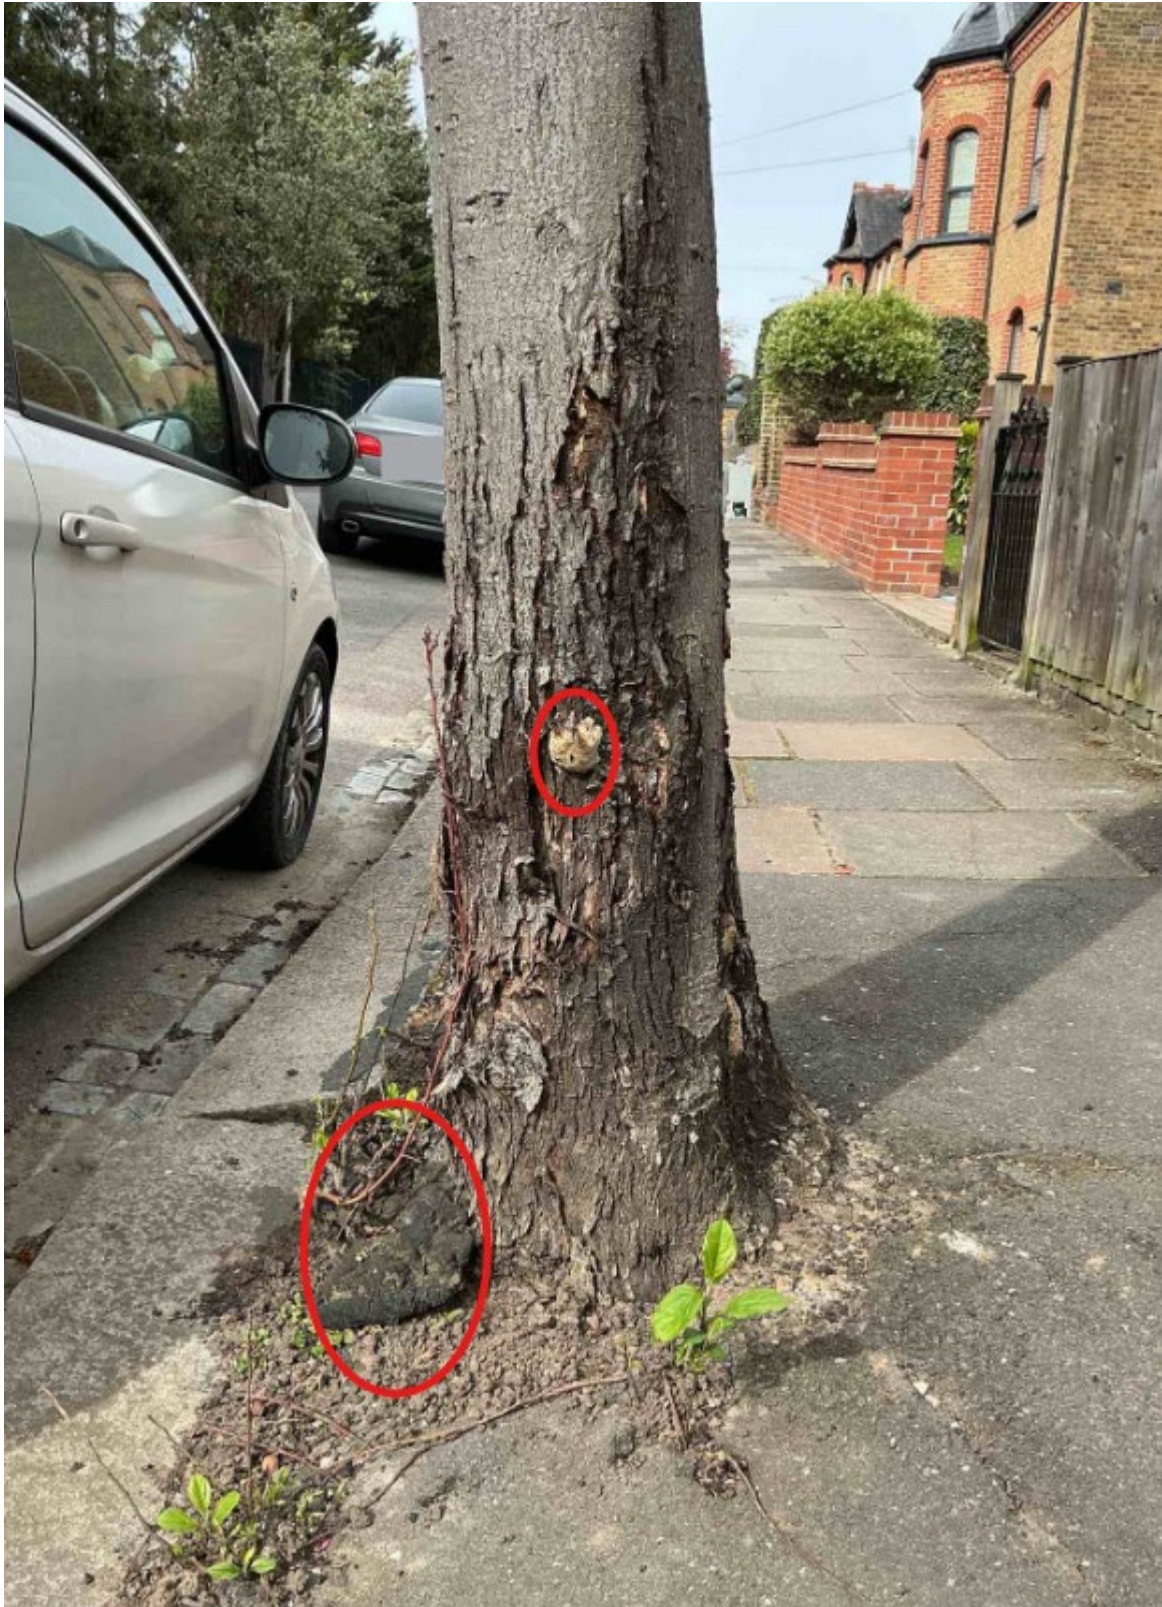
Ward	Teddington
Road	Coleshill Road
Location	Outside 79
Species	Chonosuki crab (<i>Malus tschonoskii</i>)
Height	7.0m
Physiological Condition	Fair
Structural Condition	Poor
Inspection findings/reason for exemption	A fungal fruiting body of the decay fungus <i>Ganoderma sp.</i> is present on the base of the trunk. Colonisation by this fungus results in white rot affecting the stem and root system, which can lead to structural failure through fracture or windthrow. Investigation with a probe and a resonance test with a sounding hammer has revealed an unacceptable amount of decay which correlates with the presence of the decay fungi. Removal of the tree is recommended to prevent natural failure, manage risk, and facilitate replanting.

Image shows fungal fruiting bodies circled at base of trunk.
