April 2026 - Reactive Tree Works Programme

Introduction

Dated 26/04/2026

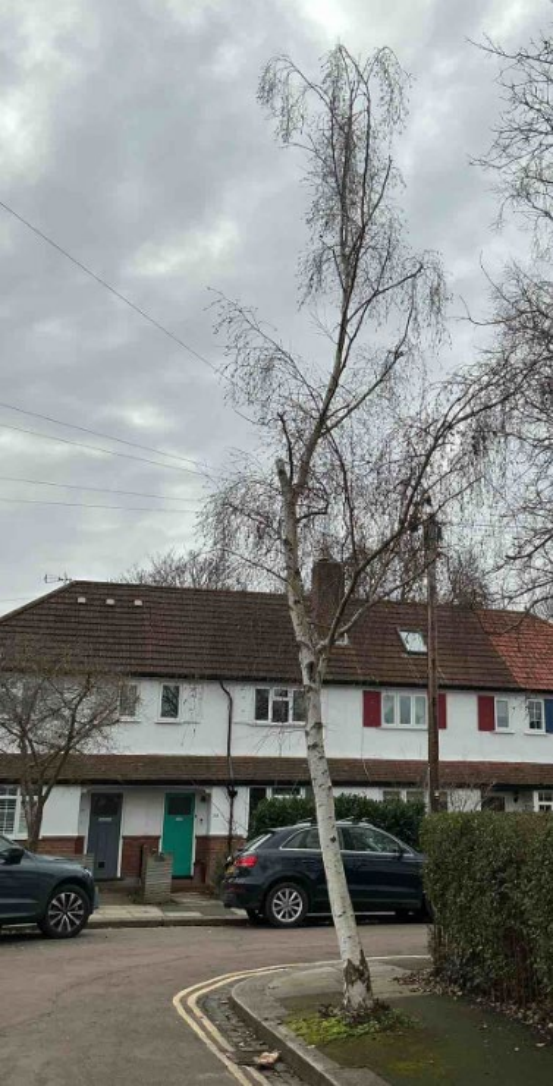
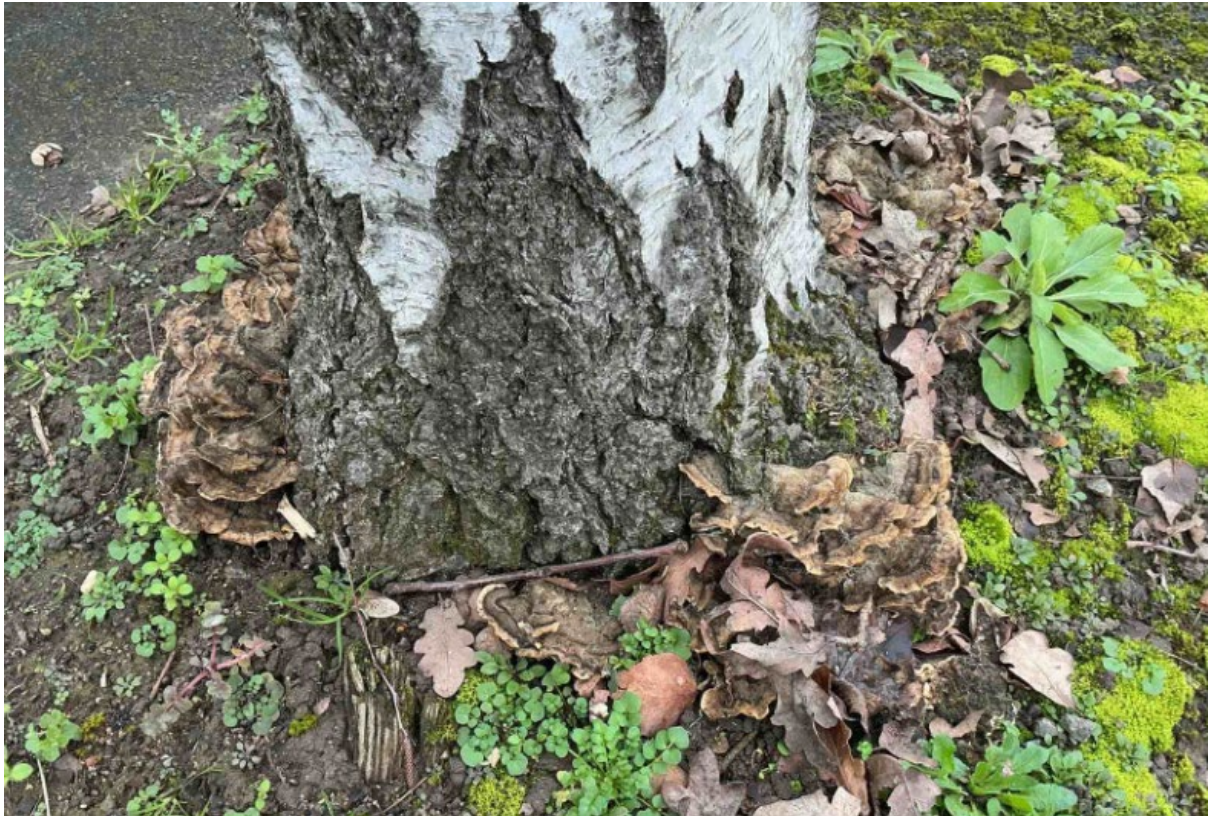
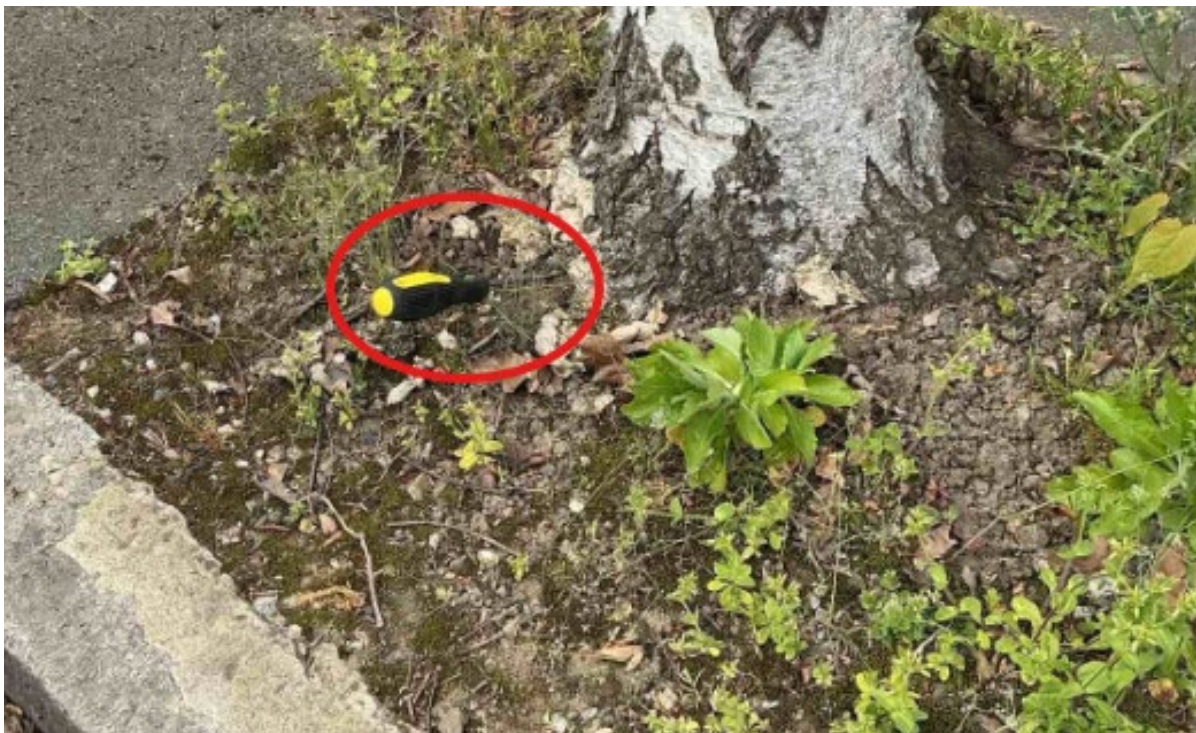
Ward	Teddington
Road	Coleshill Road
Location	Outside 57/59
Species	Rowan (<i>Sorbus aucuparia</i>)
Height	5.0m
Physiological Condition	Poor
Structural Condition	Fair
Inspection findings/reason for exemption	Fruiting bodies of the decay fungus Turkey Tail (<i>Trametes versicolor</i>) are prolific on the trunk of this tree. This fungus causes a selective white rot of the wood and when prolific is indicative of wider physiological dysfunction. Crown die back corollate with the presence of these fungi. Removal is required to prevent natural failure, manage risk, and facilitate replanting

Image shows fungal fruiting bodies circled at base of trunk.

Image shows probe showing decay circled at base of trunk.

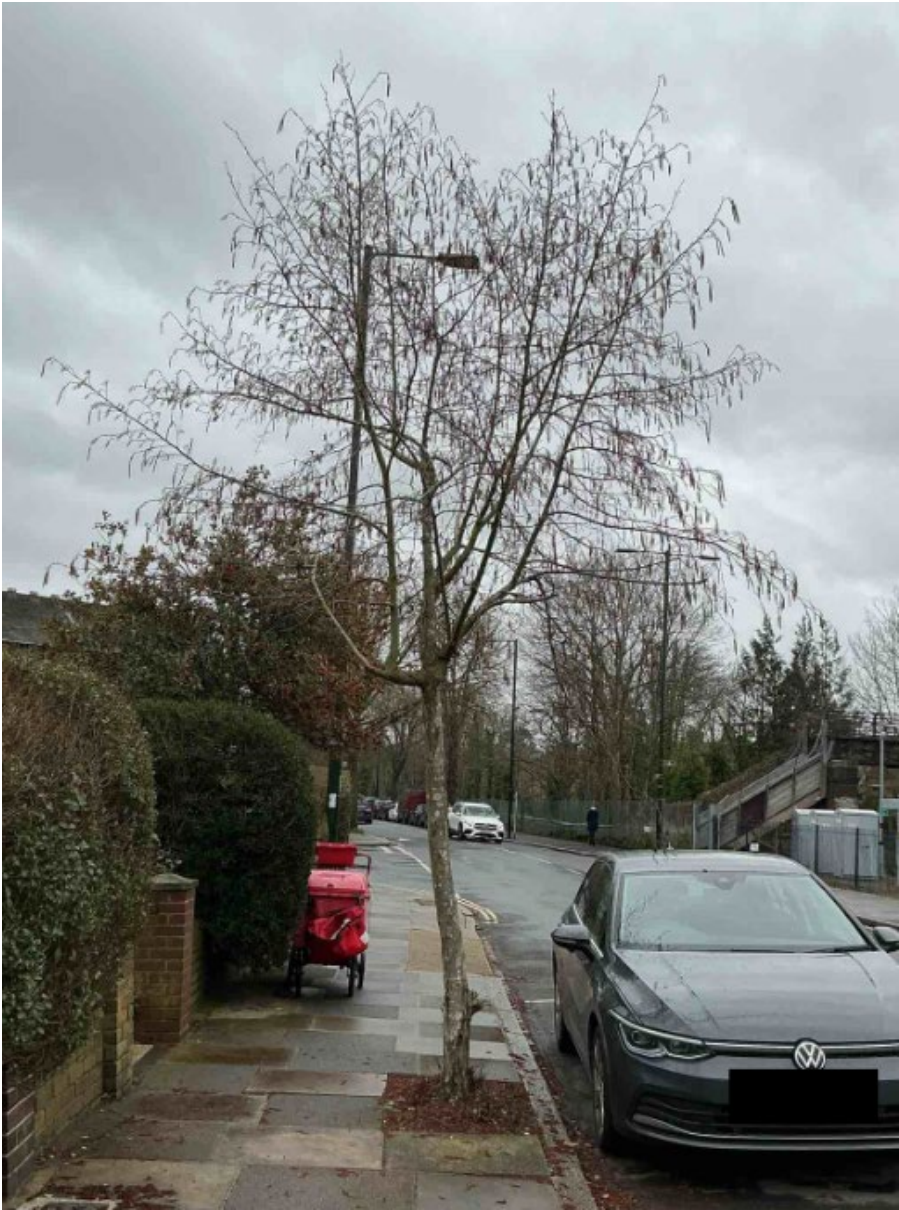
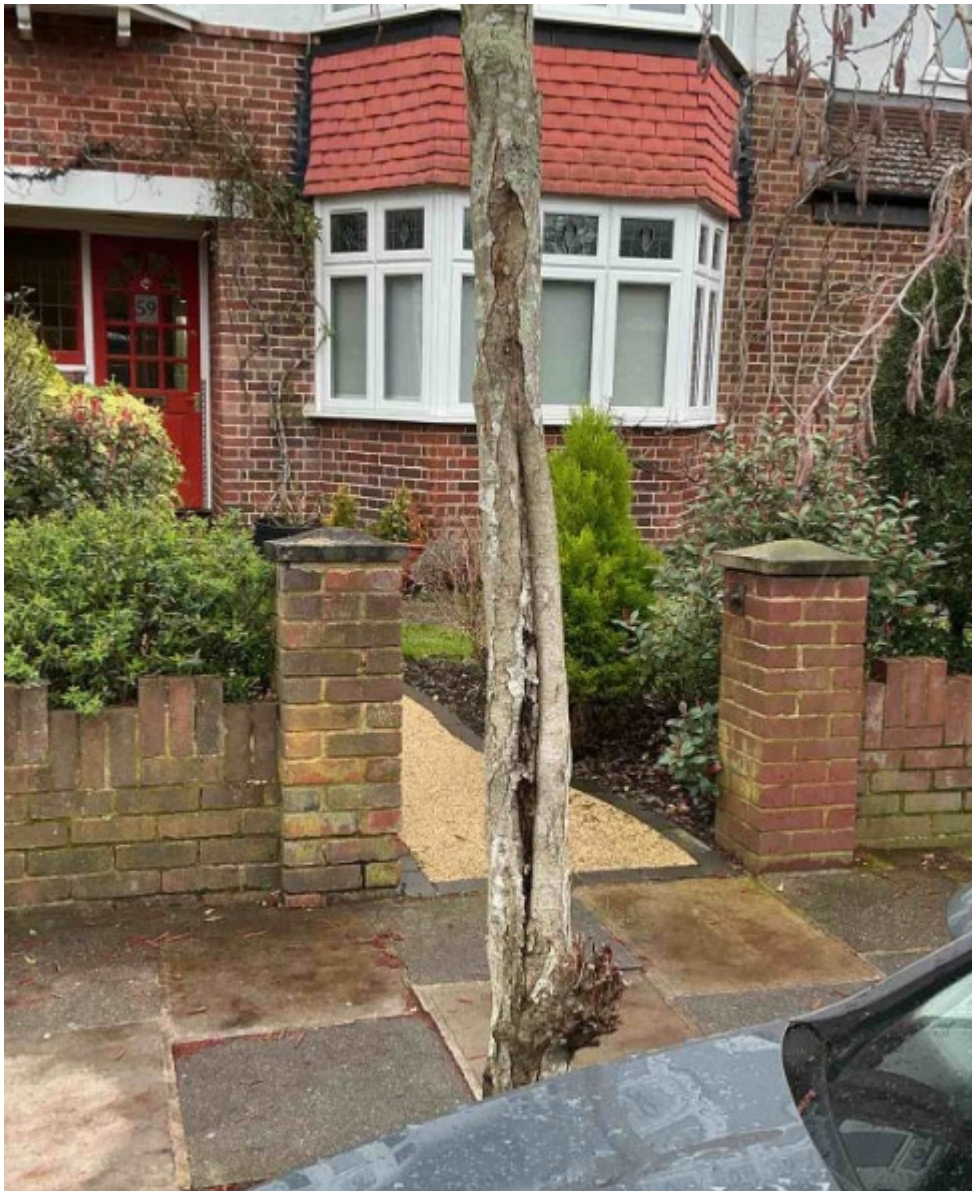
Ward	Teddington
Road	Station Road
Location	Outside 59
Species	Grey alder (<i>Alnus incana</i>)
Height	4.5m
Physiological Condition	Fair
Structural Condition	Poor
Inspection findings/reason for exemption	Investigation with a probe and a resonance test with a sounding hammer has revealed an unacceptable amount of decay beyond the visible cavity on the trunk. Removal is required to prevent natural failure, manage risk, and facilitate replanting.

Image shows cavity on trunk.

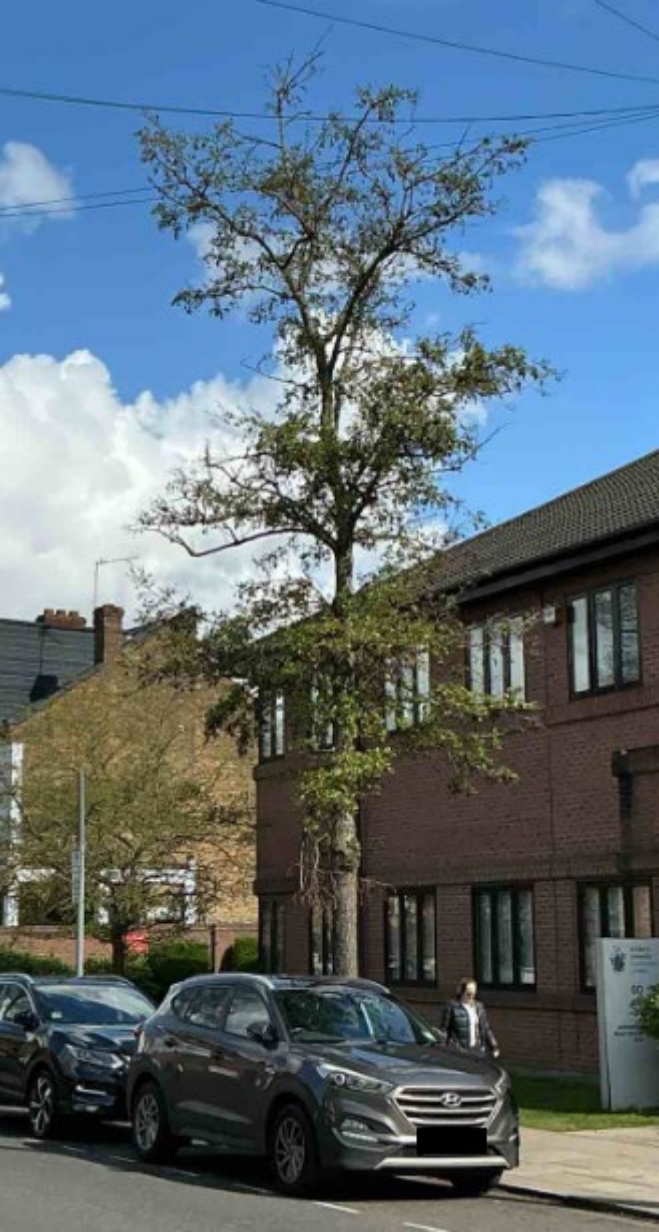
Ward	Teddington
Road	Waldegrave Road
Location	Outside 95-97
Species	Alder (<i>Alnus sp.</i>)
Height	11.0m
Physiological Condition	Poor
Structural Condition	Fair
Inspection findings/reason for exemption	This tree is moribund; removal is required to prevent natural failure, manage risk, and facilitate replanting

Image shows moribund tree in street scene

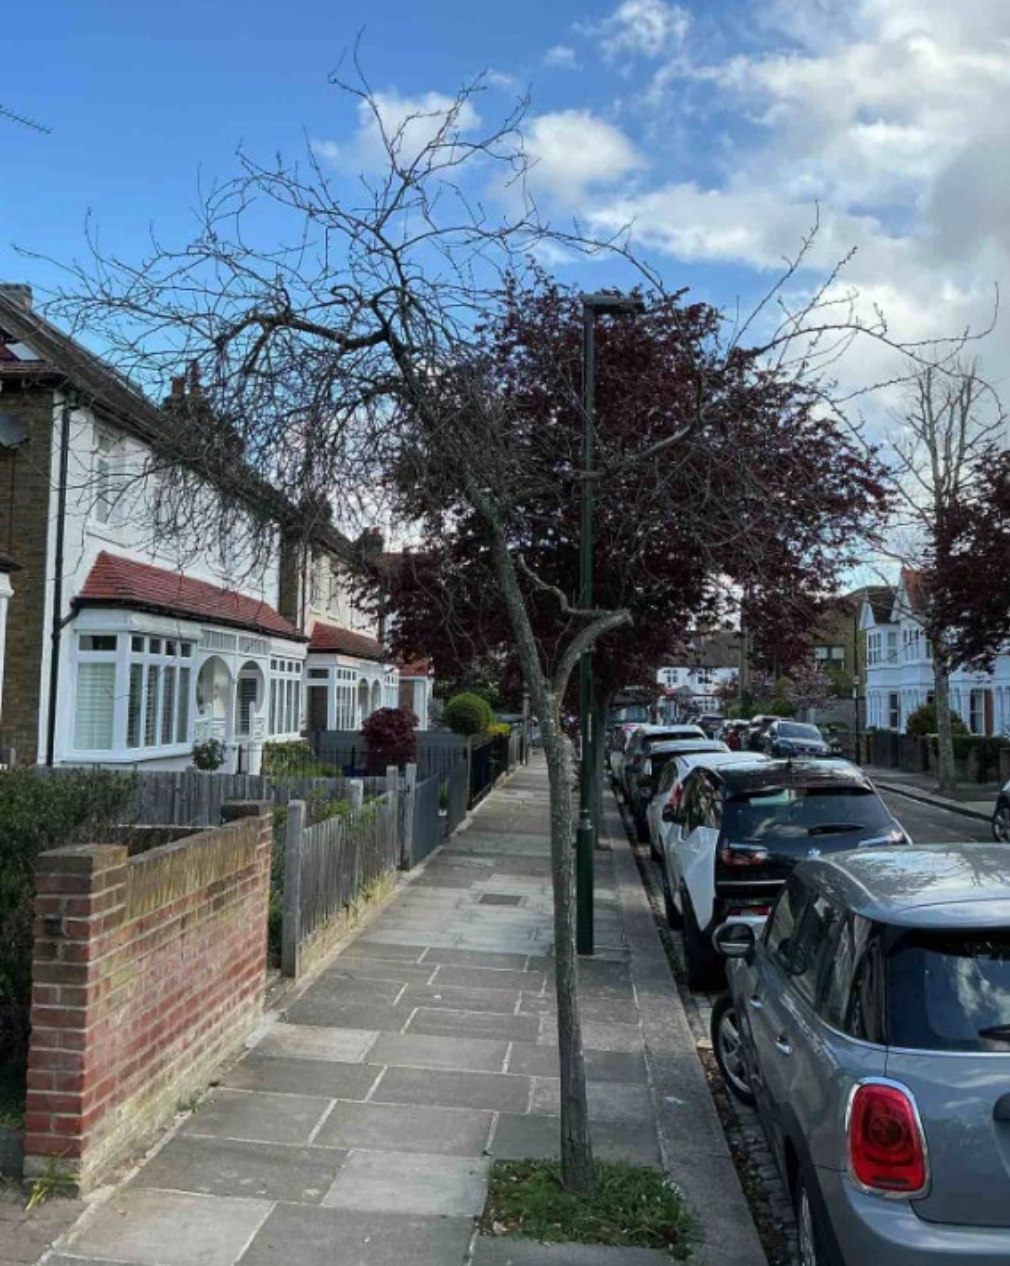
Ward	Teddington
Road	Claremont Road
Location	Outside 37
Species	Purple leaf plum (<i>Prunus cerasifera</i>)
Height	4.0m
Physiological Condition	Dead
Structural Condition	Fair
Inspection findings/reason for exemption	This tree is dead; removal is required to prevent natural failure, manage risk, and facilitate replanting

Image shows dead tree in street scene

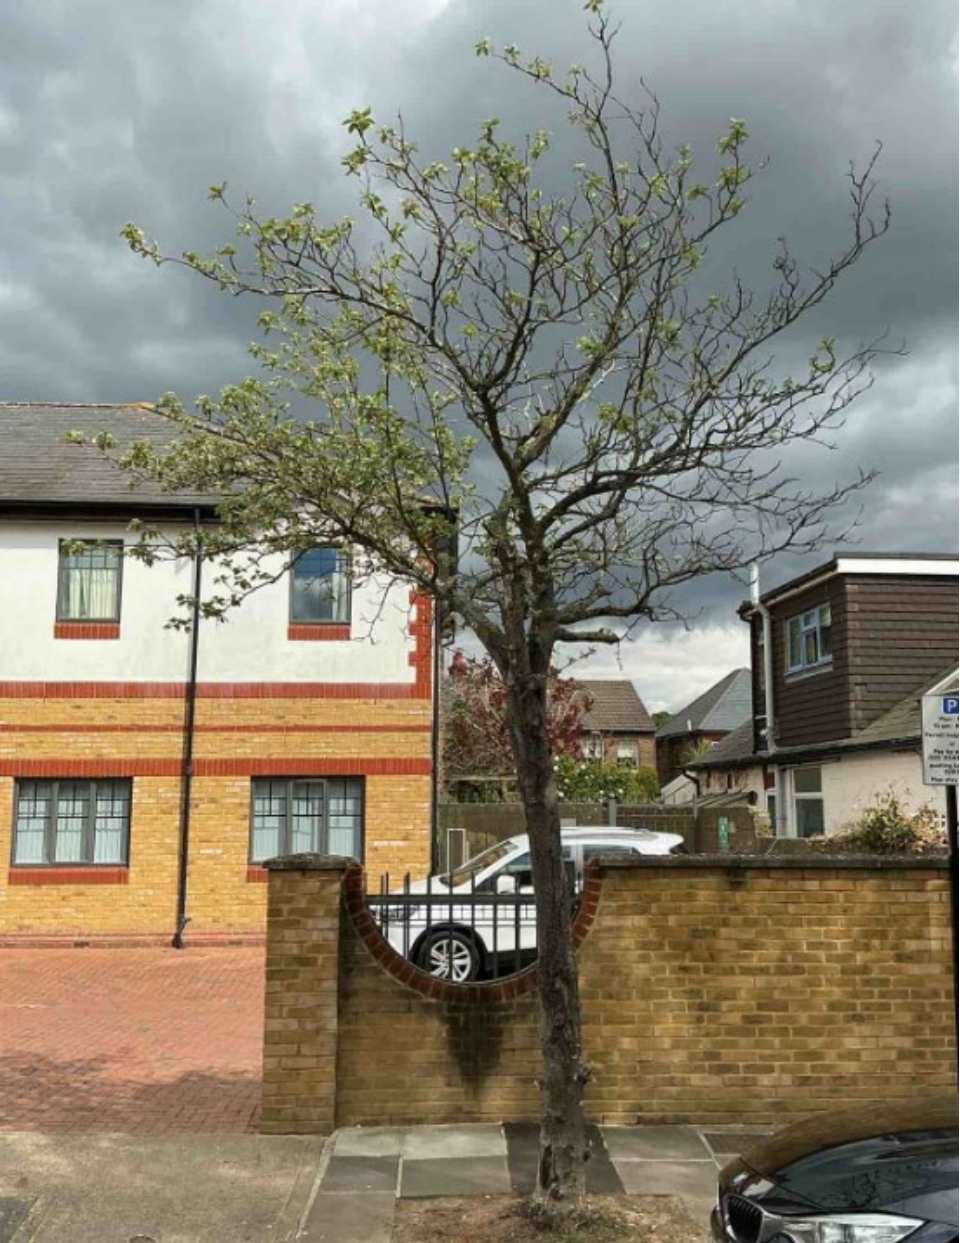
Ward	Teddington
Road	Church Road
Location	Opposite 125
Species	Swedish whitebeam (<i>Sorbus x intermedia</i>)
Height	5.0m
Physiological Condition	Poor
Structural Condition	Fair
Inspection findings/reason for exemption	This tree is moribund; removal is required to prevent natural failure, manage risk, and facilitate replanting

Image shows moribund tree in street scene

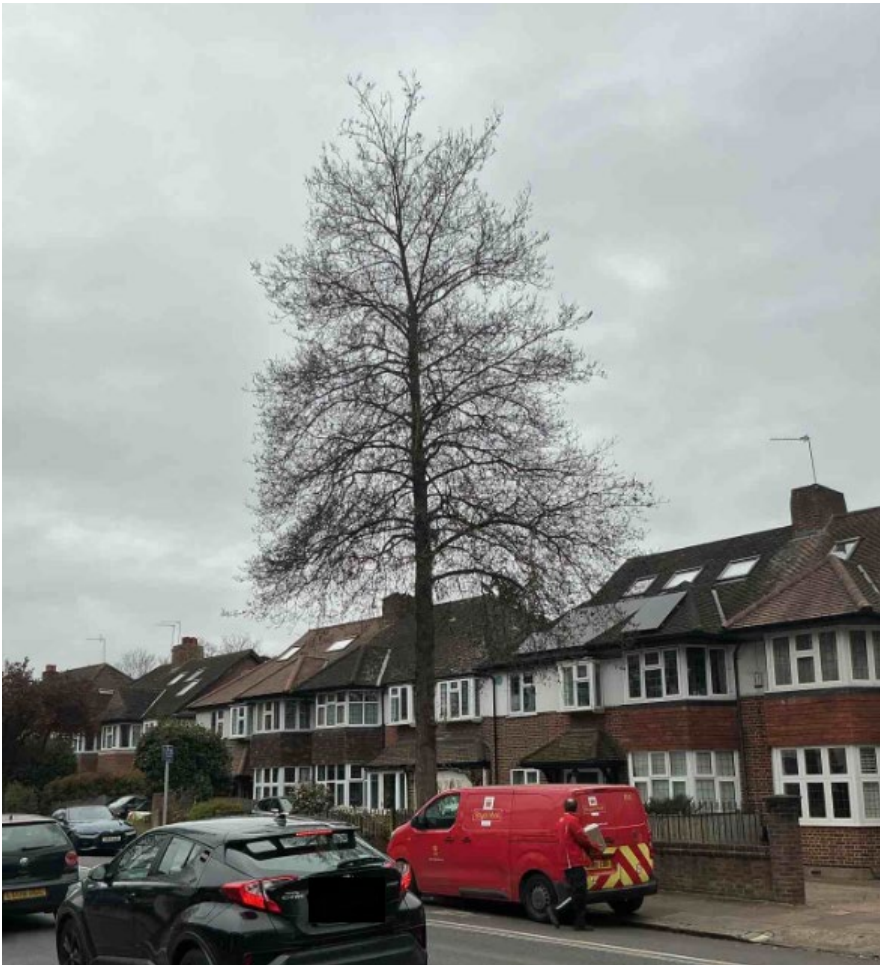
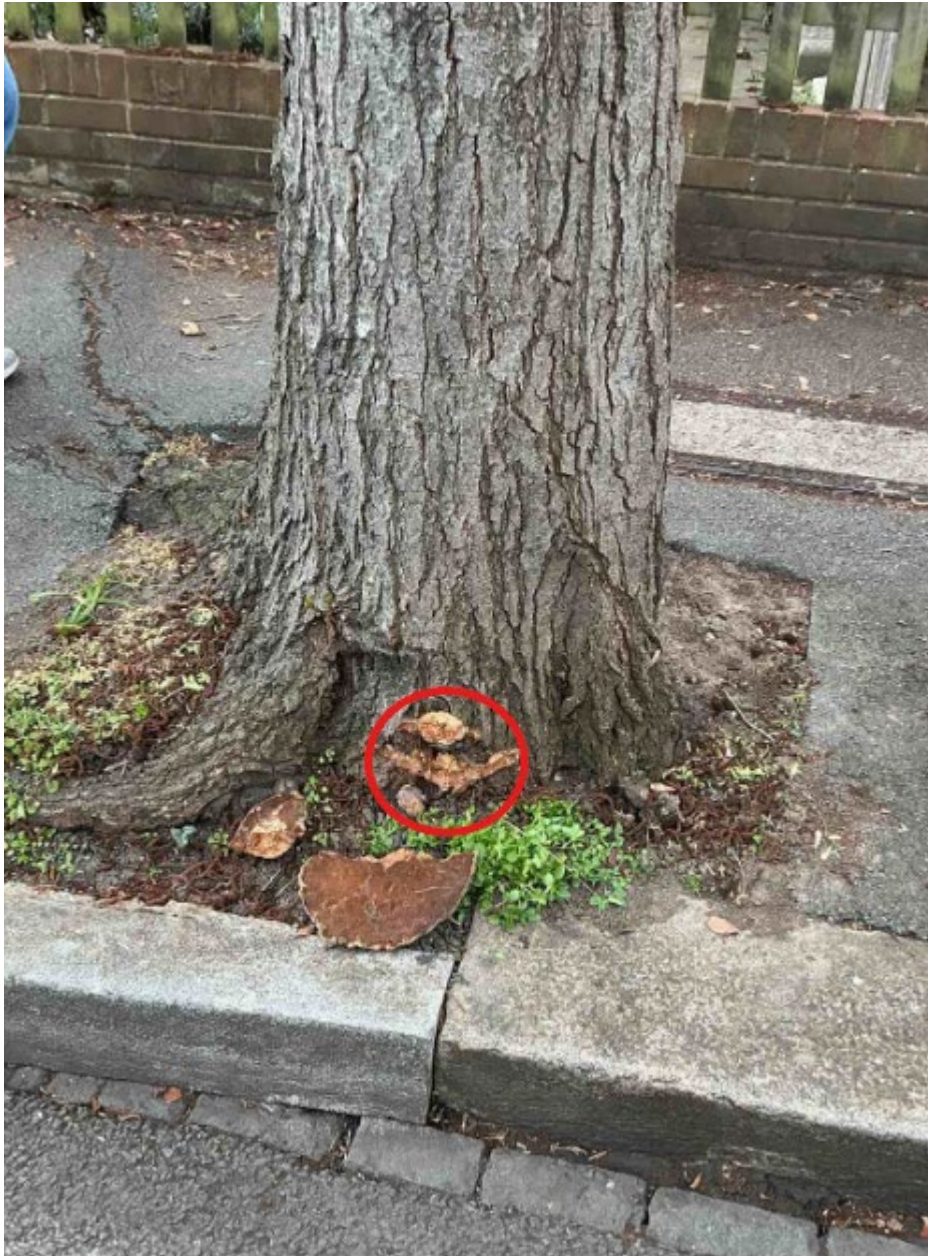
Ward	Teddington
Road	Twickenham Road
Location	Outside 67
Species	Italian alder (<i>Alnus cordata</i>)
Height	16.0m
Physiological Condition	Fair
Structural Condition	Poor
Inspection findings/reason for exemption	A fungal fruiting body of the decay fungus <i>Ganoderma sp.</i> is present on the base of the trunk. Colonisation by this fungus results in white rot affecting the stem and root system, which can lead to structural failure through fracture or windthrow. Investigation with a probe and a resonance test with a sounding hammer has revealed an unacceptable amount of decay which correlates with the presence of the decay fungi. Removal of the tree is recommended to prevent natural failure, manage risk, and facilitate replanting.

Image shows fungal fruiting bodies circled at base of trunk.

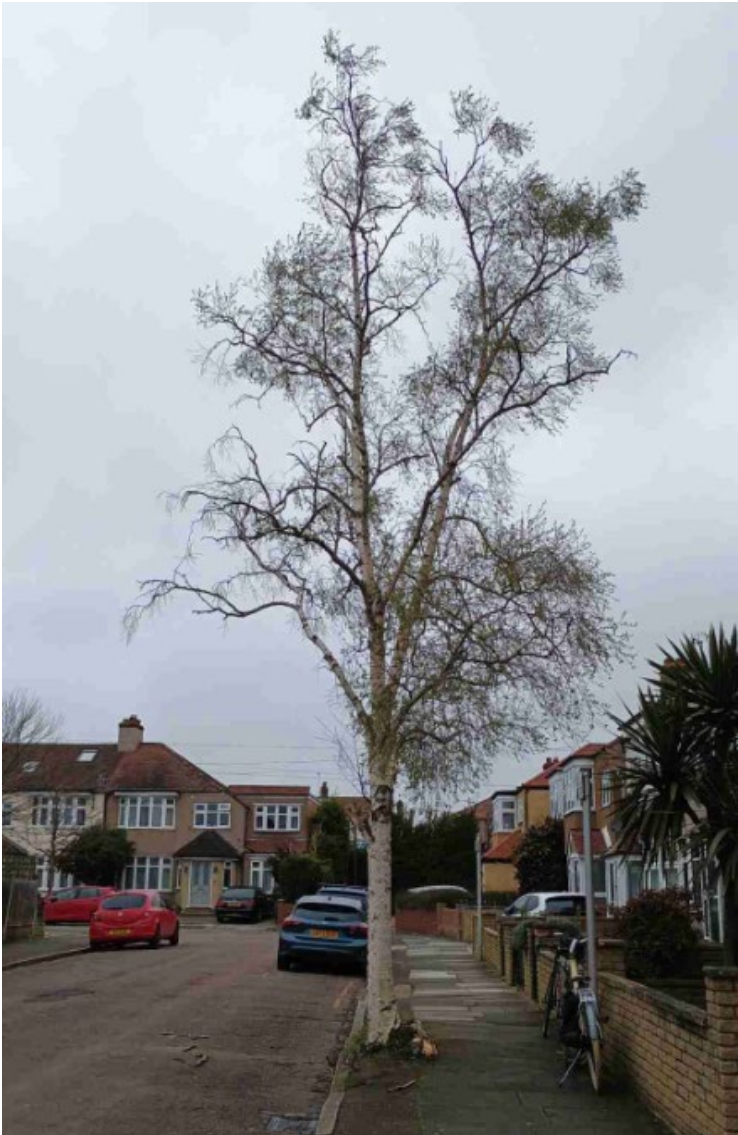
Ward	Whitton
Road	Godfrey Avenue
Location	Outside 6/8
Species	Birch (<i>Betula sp.</i>)
Height	11.0m
Physiological Condition	Poor
Structural Condition	Poor
Inspection findings/reason for exemption	This tree is moribund; removal is required to prevent natural failure and facilitate replanting

Image shows moribund tree in street scene.
