August 2025 - Reactive Tree Works Programme

Dated 19.8.2025

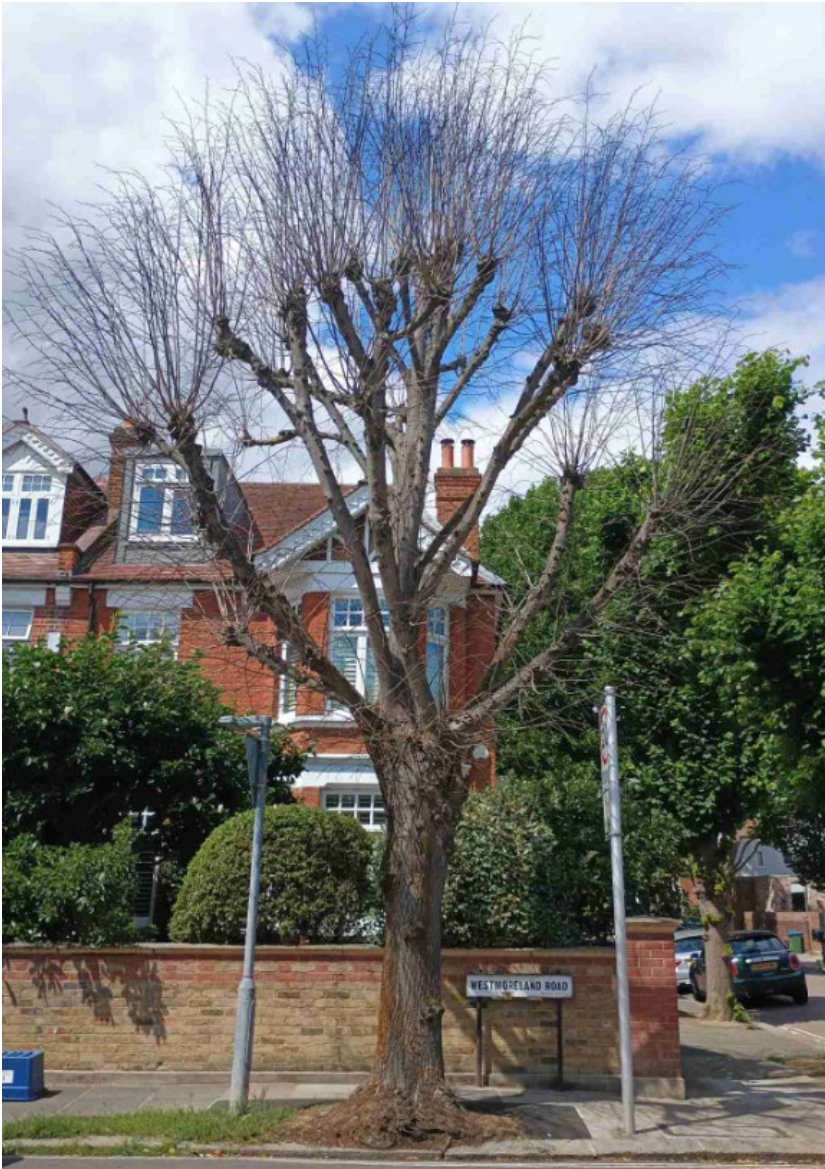
Ward	Barnes
Road	Westmoreland Road
Location	Outside 1
Species	Common lime (<i>Tilia x europaea</i>)
Height	10.0m
Physiological Condition	Dead
Structural Condition	Dead
Inspection findings/reason for exemption	This tree is dead; removal is required to prevent natural failure, manage risk, and facilitate replanting.

Image shows dead tree in street scene.

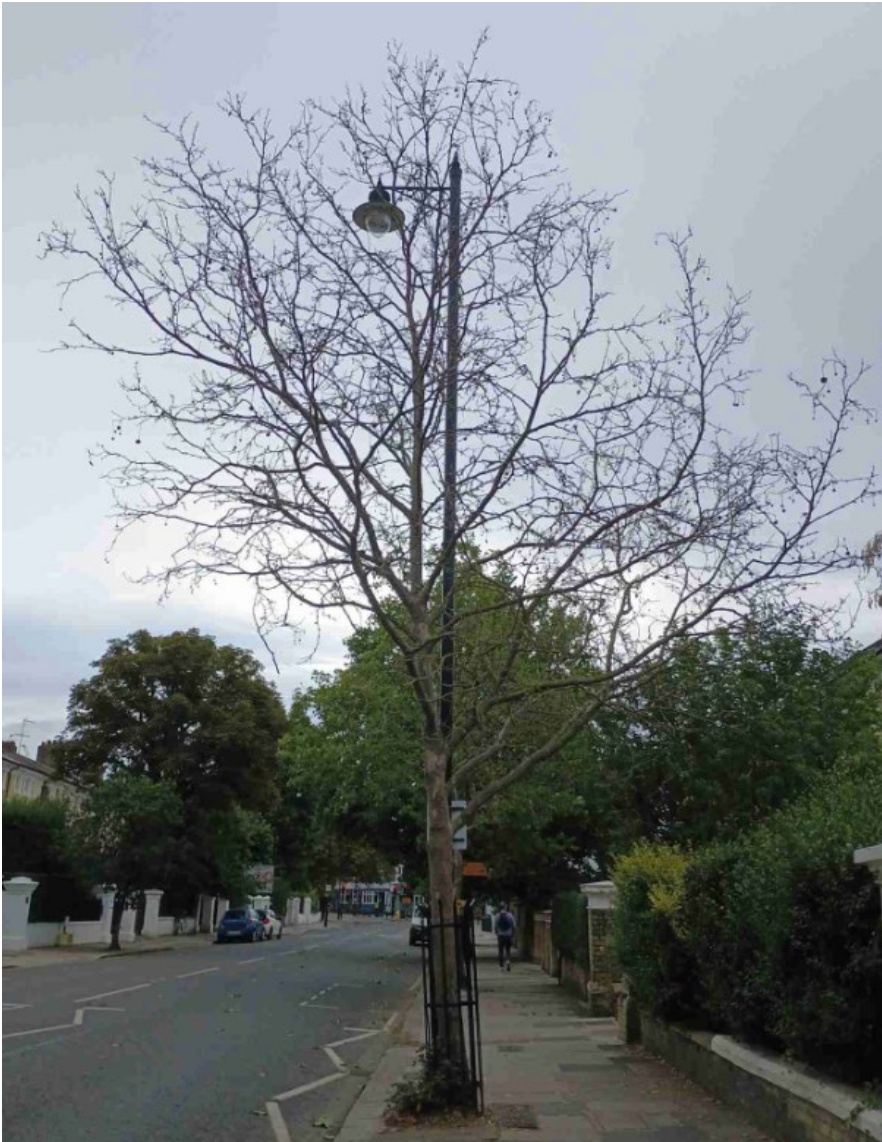
Ward	Barnes
Road	Lonsdale Road
Location	Outside 11/14
Species	London plane (<i>Platanus x hispanica</i>)
Height	11.0m
Physiological Condition	Dead
Structural Condition	Dead
Inspection findings/reason for exemption	This tree is dead; removal is required to prevent natural failure, manage risk, and facilitate replanting

Image shows dead tree in street scene.

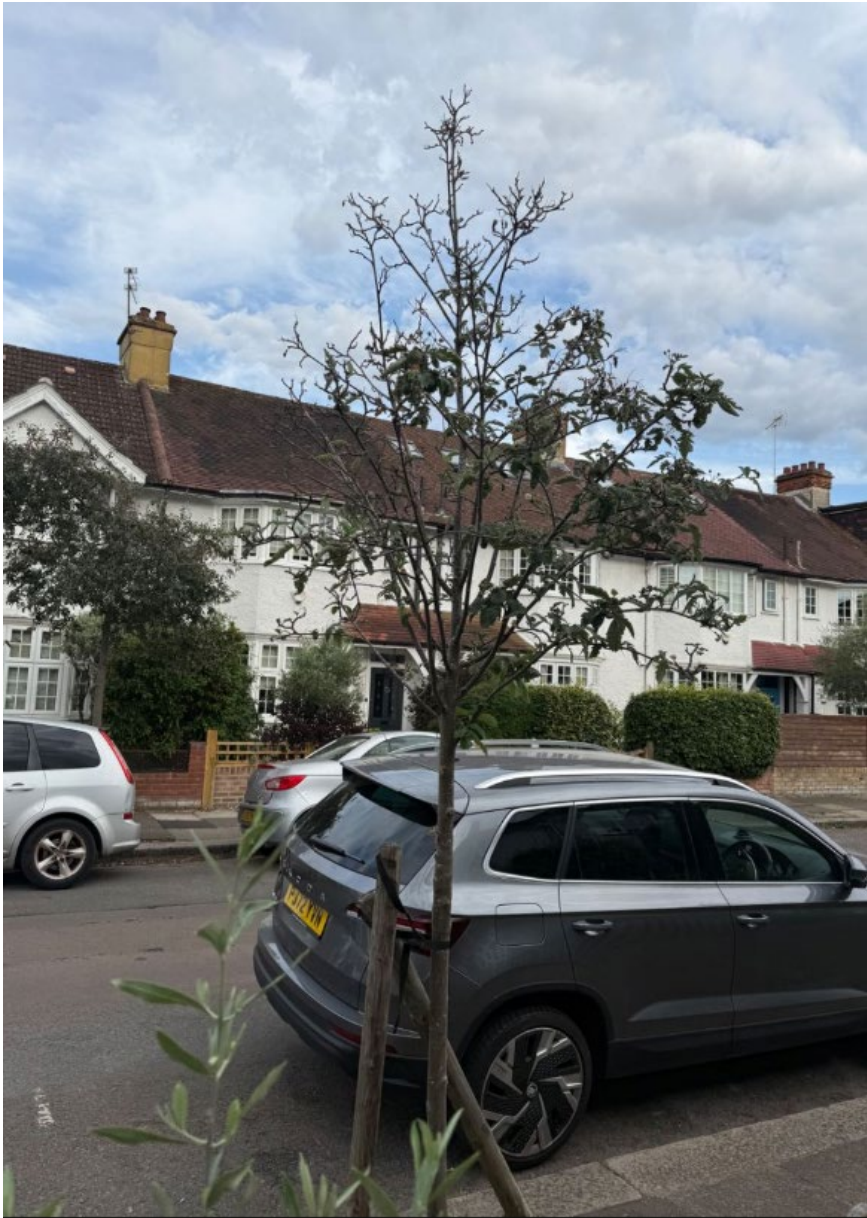
Ward	East Sheen
Road	Enmore Gardens
Location	Outside 20
Species	Swedish Whitebeam (<i>Sorbus x intermedia</i>)
Height	3.5m
Physiological Condition	Poor
Structural Condition	Fair
Inspection findings/reason for exemption	This tree is moribund; removal is required to prevent natural failure, manage risk, and facilitate replanting

Image shows moribund tree in street scene.

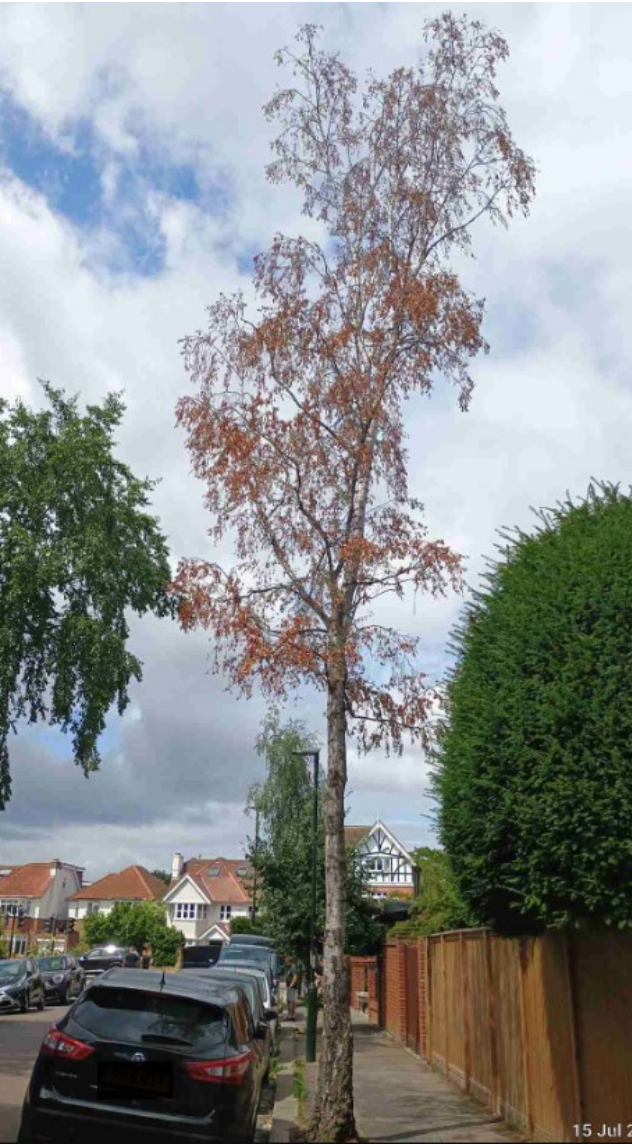
Ward	Fulwell and Hampton Hill
Road	Princes Road
Location	Adjacent to 18 Wellington Road rear garden
Species	Silver birch (<i>Betula pendula</i>)
Height	14.5m
Physiological Condition	Dead
Structural Condition	Dead
Inspection findings/reason for exemption	This tree is dead; removal is required to prevent natural failure, manage risk, and facilitate replanting

Image shows dead tree in street scene.

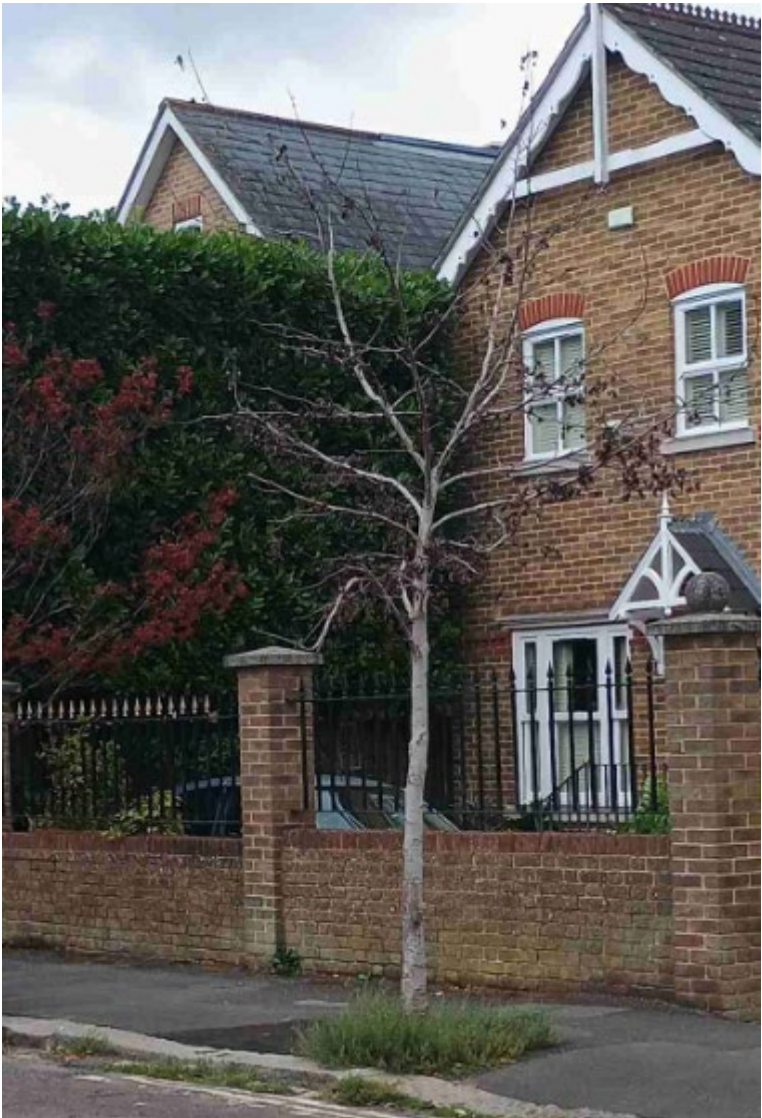
Ward	Fulwell and Hampton Hill
Road	Connaught Road
Location	Outside 95/97
Species	American sweetgum (<i>Liquidambar styraciflua</i>)
Height	5.0m
Physiological Condition	Dead
Structural Condition	Dead
Inspection findings/reason for exemption	This tree is dead; removal is required to prevent natural failure, manage risk, and facilitate replanting

Image shows dead tree in street scene.

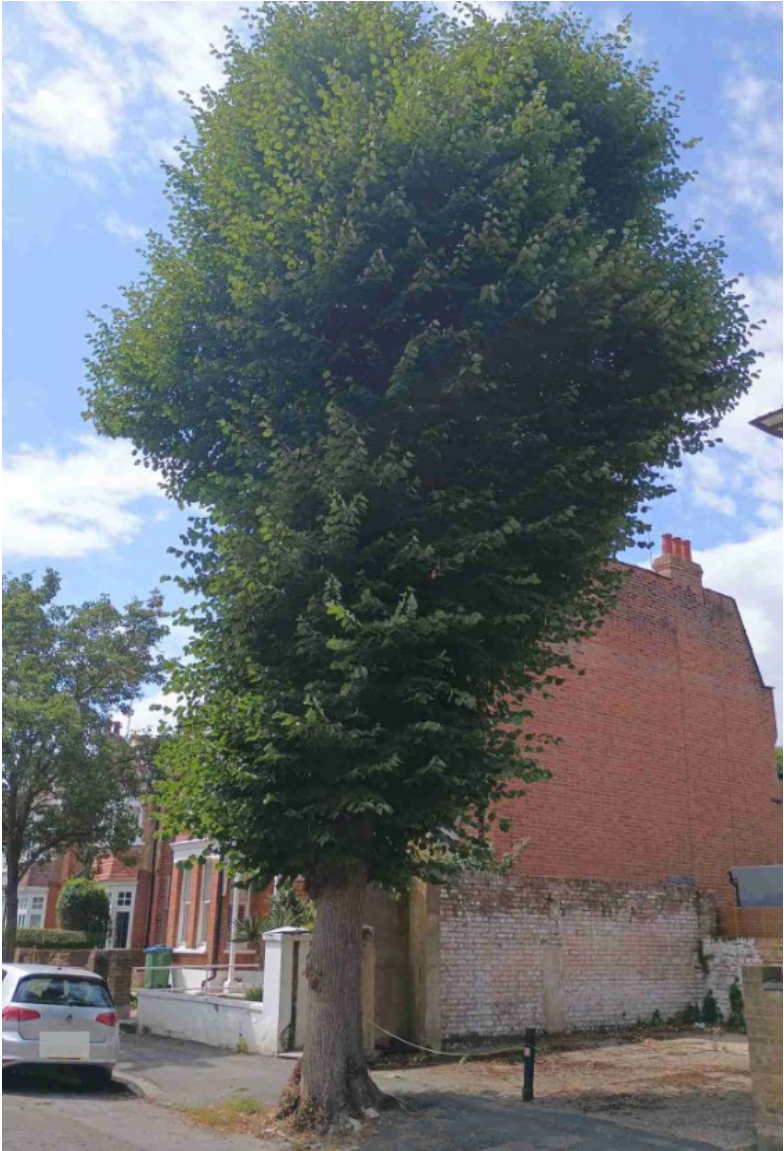
Ward	Fulwell and Hampton Hill
Road	Kings Road
Location	Outside parking area between 23 and 25
Species	Common lime (<i>Tilia x europaea</i>)
Height	15.0m
Physiological Condition	Good
Structural Condition	Poor
Inspection findings/reason for exemption	Investigation with a probe and a resonance test with a sounding hammer has revealed an unacceptable amount of decay beyond the visible cavities at the base of the trunk. Removal is required to prevent natural failure, manage risk, and facilitate replanting.

Image shows tree in street scene

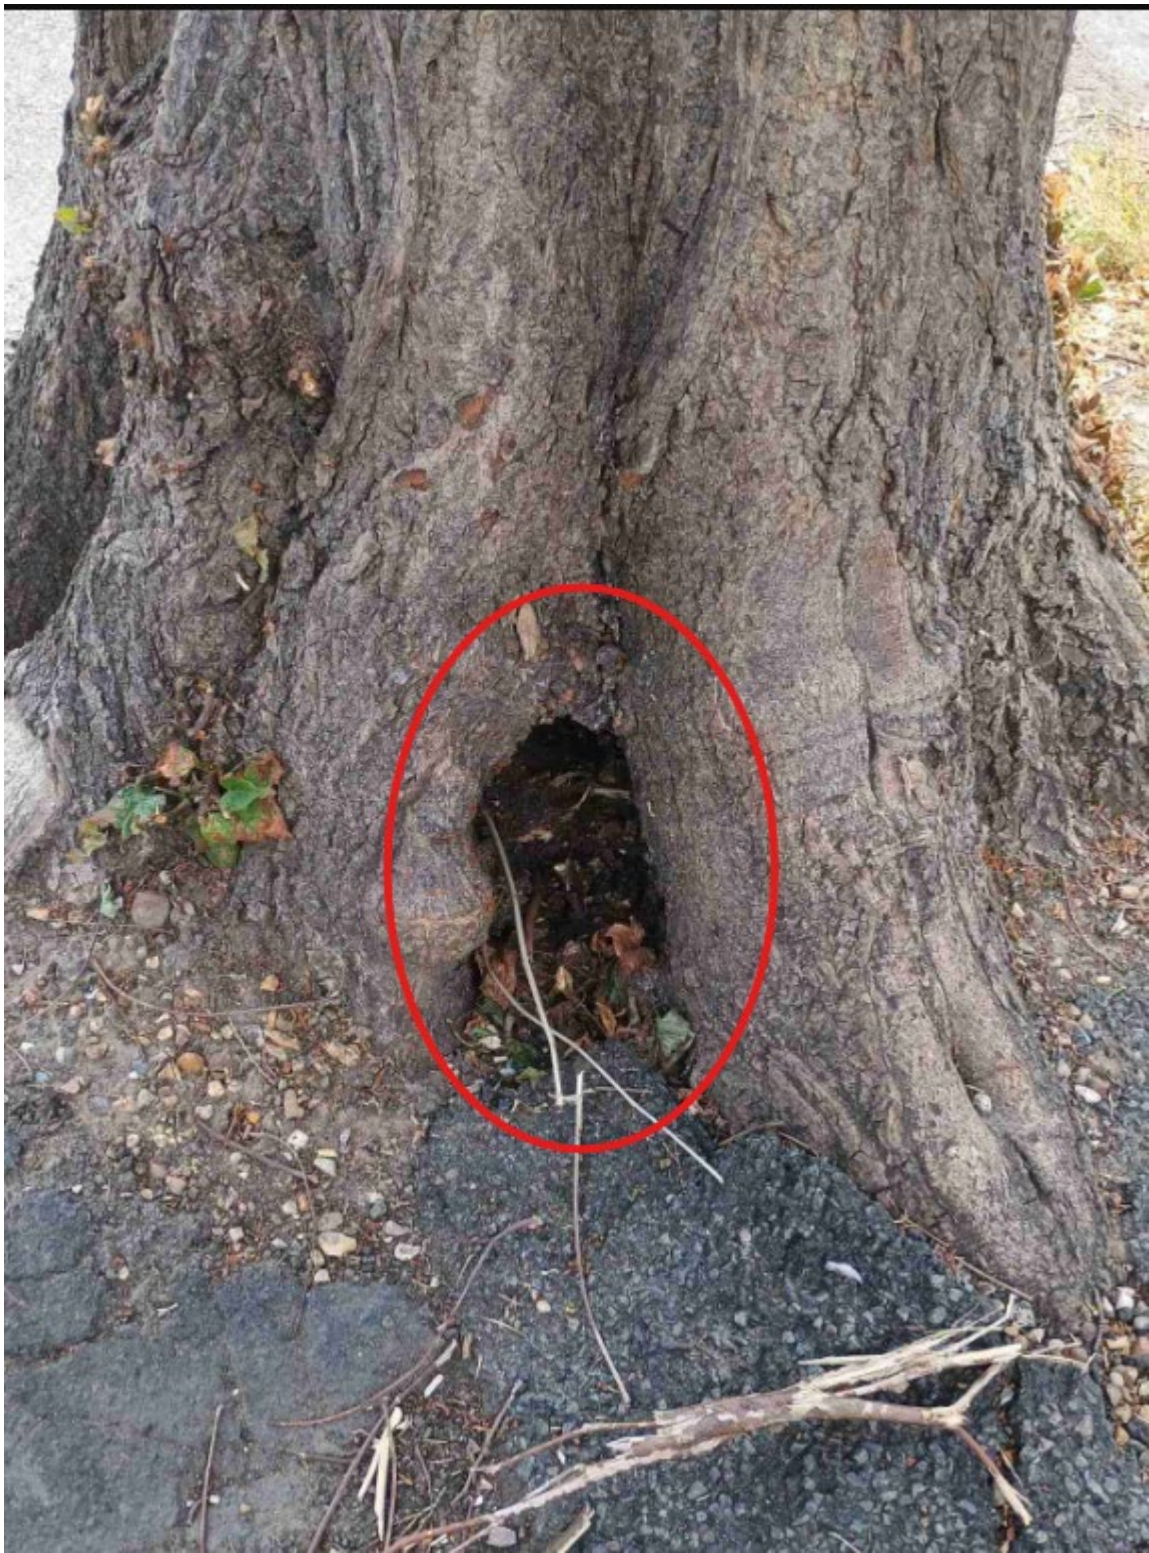
Image shows cavity at base of trunk circled.

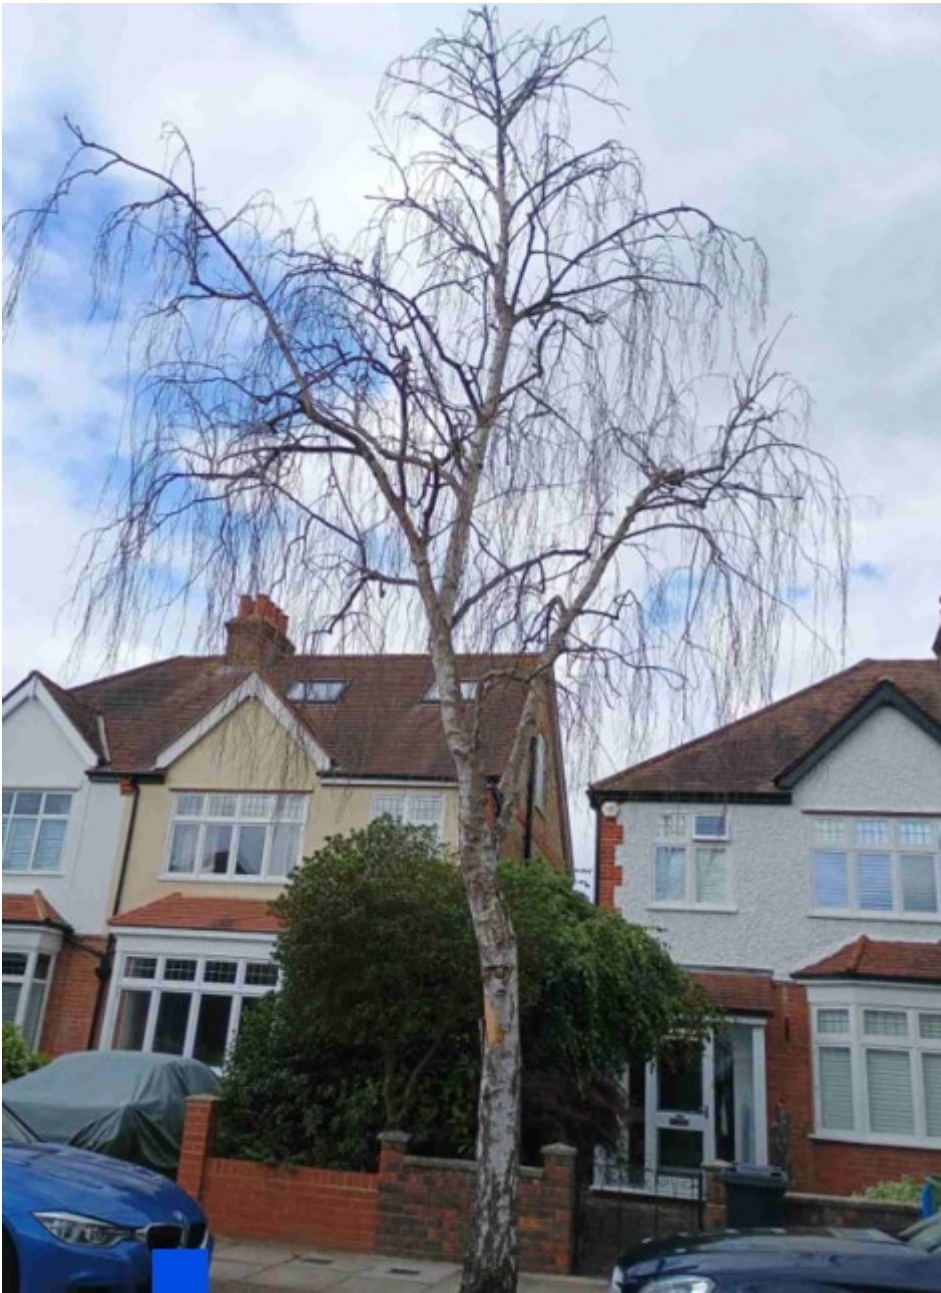
Ward	Fulwell and Hampton Hill
Road	Anlaby Road
Location	Outside 48/50
Species	Silver birch (<i>Betula pendula</i>)
Height	9.0m
Physiological Condition	Dead
Structural Condition	Dead
Inspection findings/reason for exemption	This tree is dead; removal is required to prevent natural failure, manage risk, and facilitate replanting

Image shows dead tree in street scene

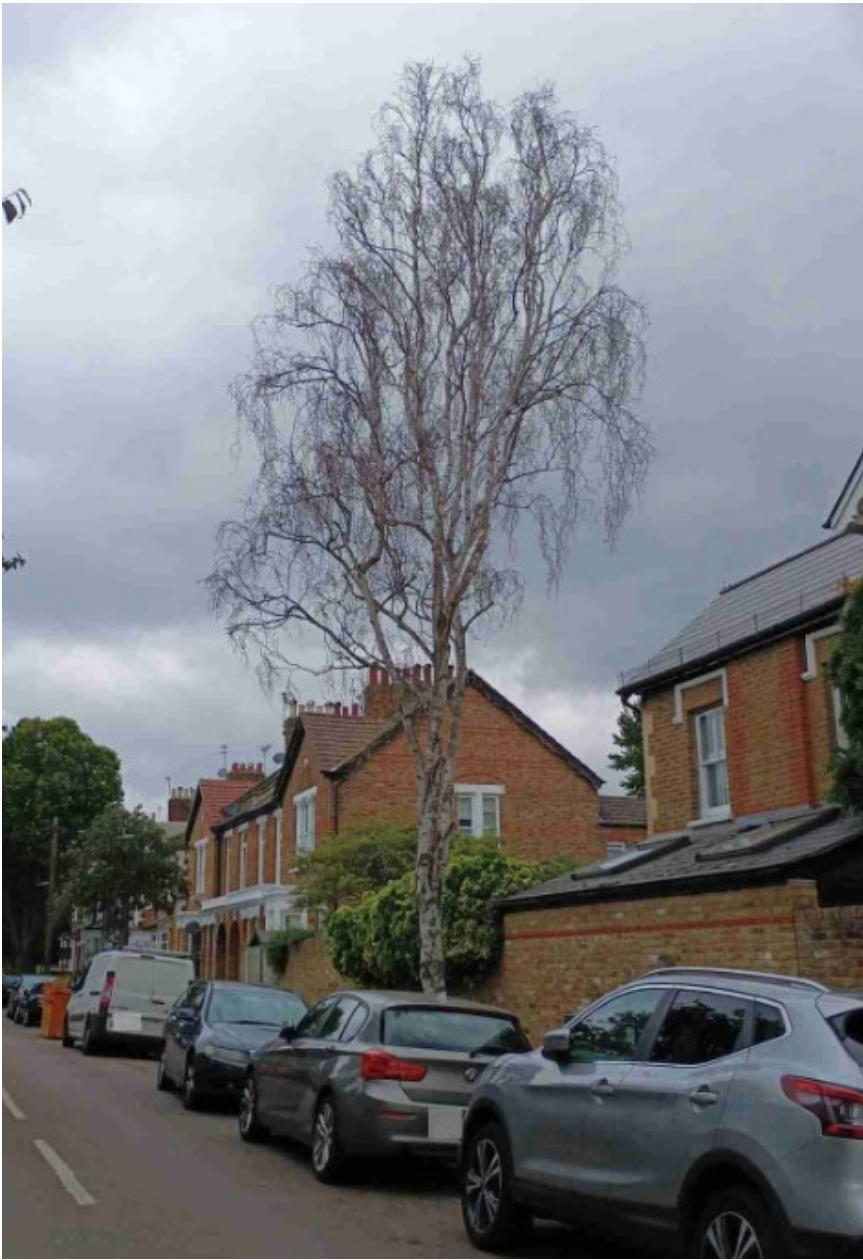
Ward	Fulwell and Hampton Hill
Road	Royal Road
Location	Adjacent to 12 Anlaby Road rear edge of building
Species	Silver birch (<i>Betula pendula</i>)
Height	13.5m
Physiological Condition	Dead
Structural Condition	Dead
Inspection findings/reason for exemption	This tree is dead; removal is required to prevent natural failure, manage risk, and facilitate replanting

Image shows dead tree in street scene

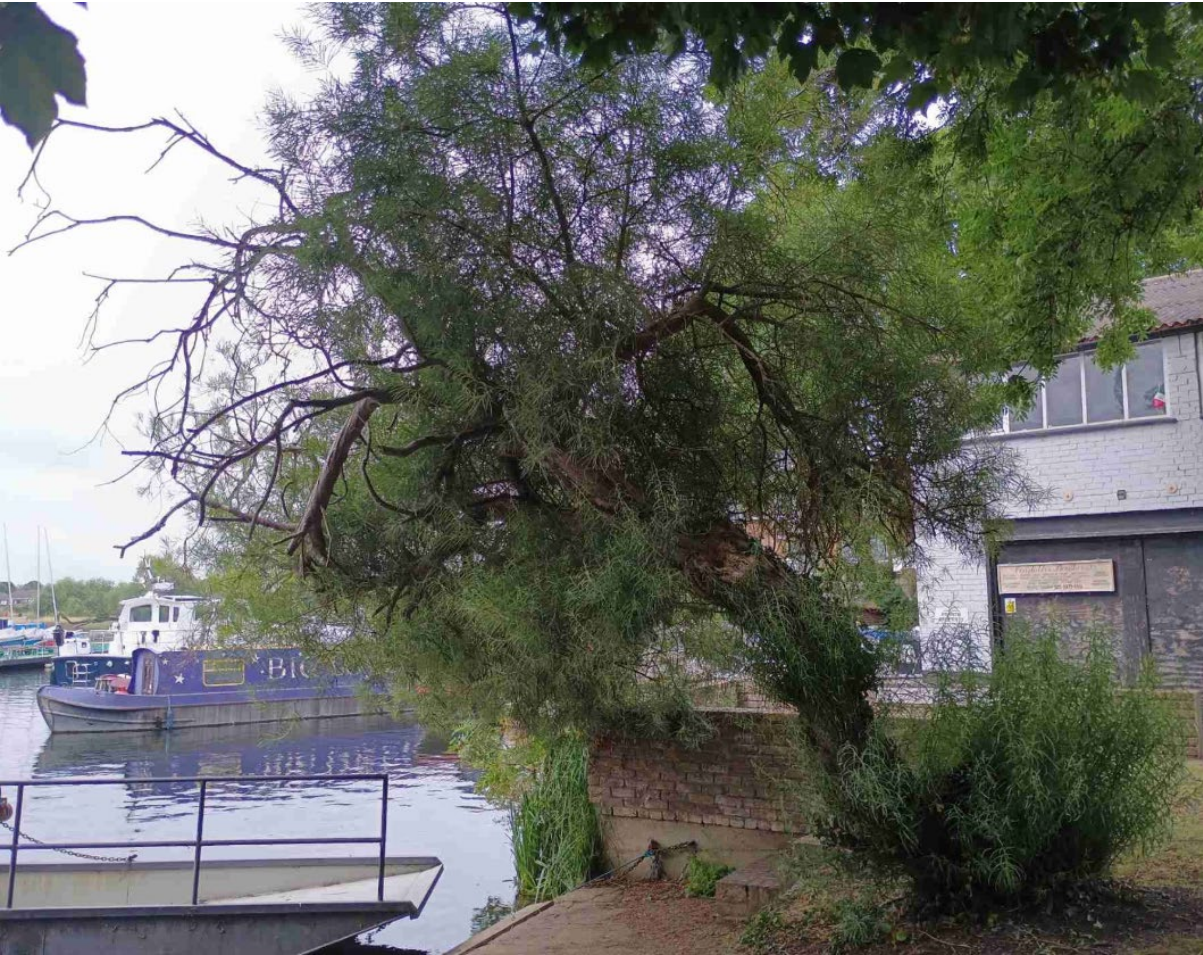
Ward	Hampton
Road	Benns Alley
Location	///pest.intelligible.struck
Species	Willow (<i>Salix sp.</i>)
Height	5.0m
Physiological Condition	Poor
Structural Condition	Poor
Inspection findings/reason for exemption	The tree shows extensive longitudinal cracking on the trunk, linked to an old tear wound. Crown dieback is also present, which suggests the tree’s vascular system is no longer functioning effectively. Removal is required to prevent natural failure, manage risk, and facilitate replanting.

Image shows tree in street scene.

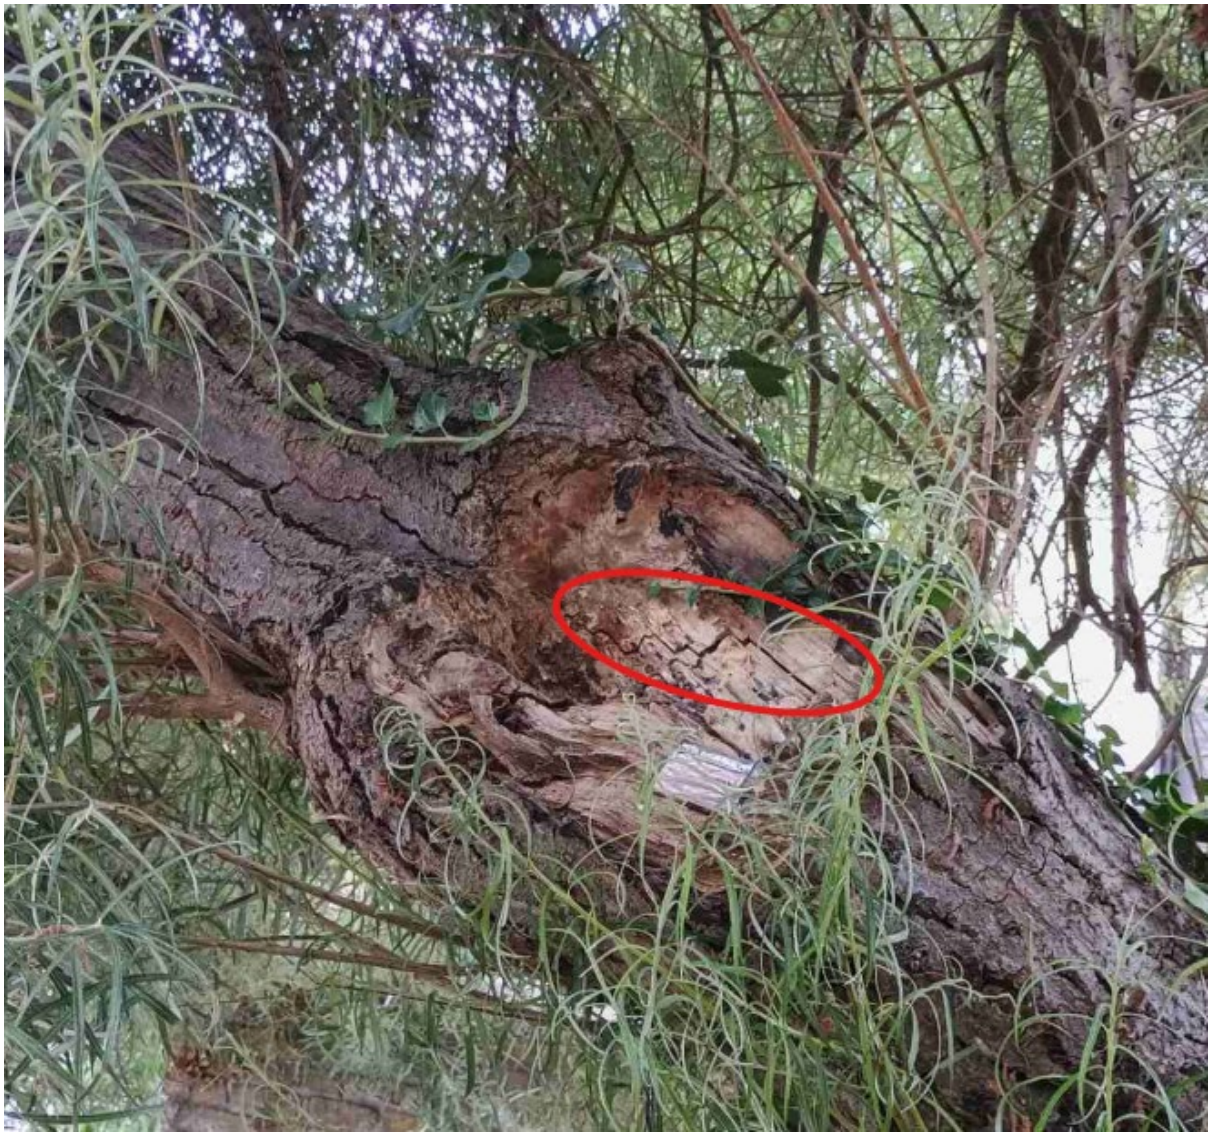
Image shows longitudinal cracking on the trunk circled.

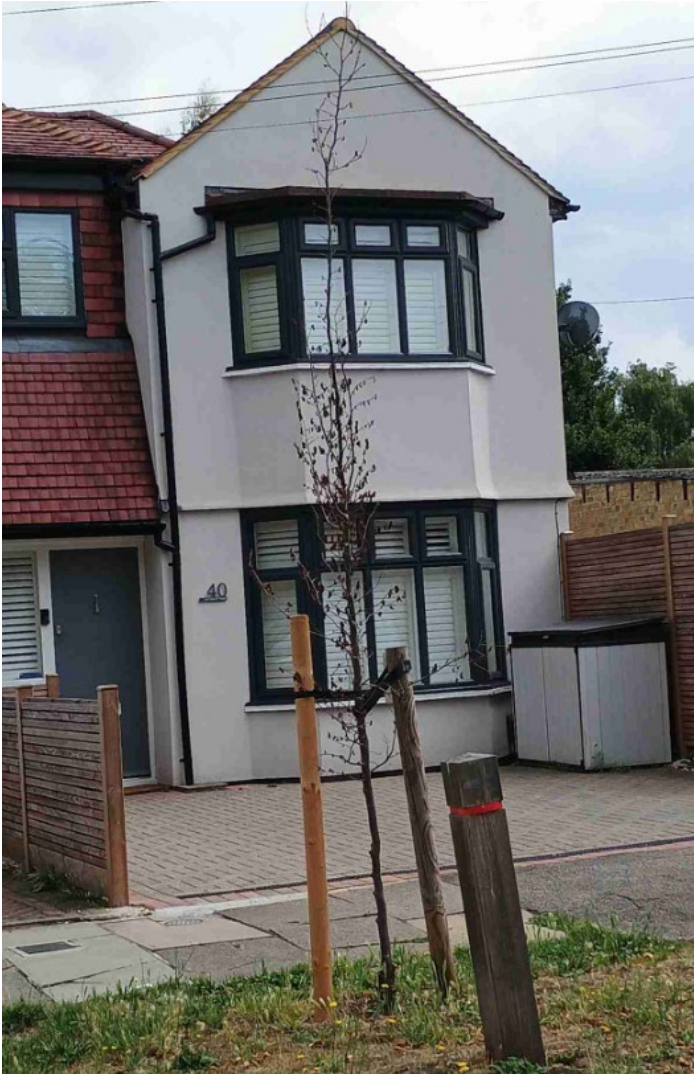
Ward	Hampton
Road	Hatherop Road
Location	Outside 40-42
Species	Persian Ironwood (<i>Parrotia persica</i>)
Height	3.5m
Physiological Condition	Dead
Structural Condition	Dead
Inspection findings/reason for exemption	This tree is dead; removal is required to prevent natural failure, manage risk, and facilitate replanting

Image shows dead tree in street scene.

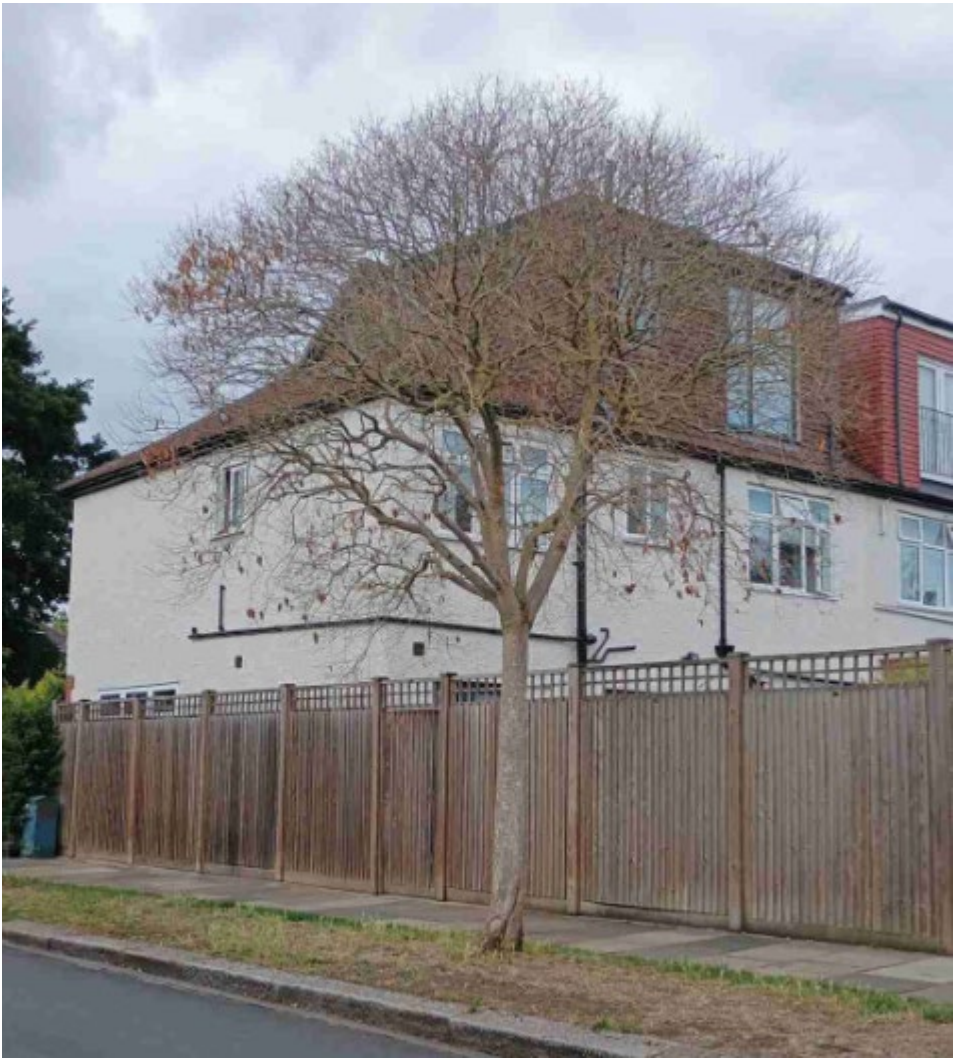
Ward	Hampton
Road	Holly Bush Lane
Location	Opposite 63
Species	Privet (<i>Ligustrum sp.</i>)
Height	6.0m
Physiological Condition	Dead
Structural Condition	Dead
Inspection findings/reason for exemption	This tree is dead; removal is required to prevent natural failure, manage risk, and facilitate replanting

Image shows dead tree in street scene.

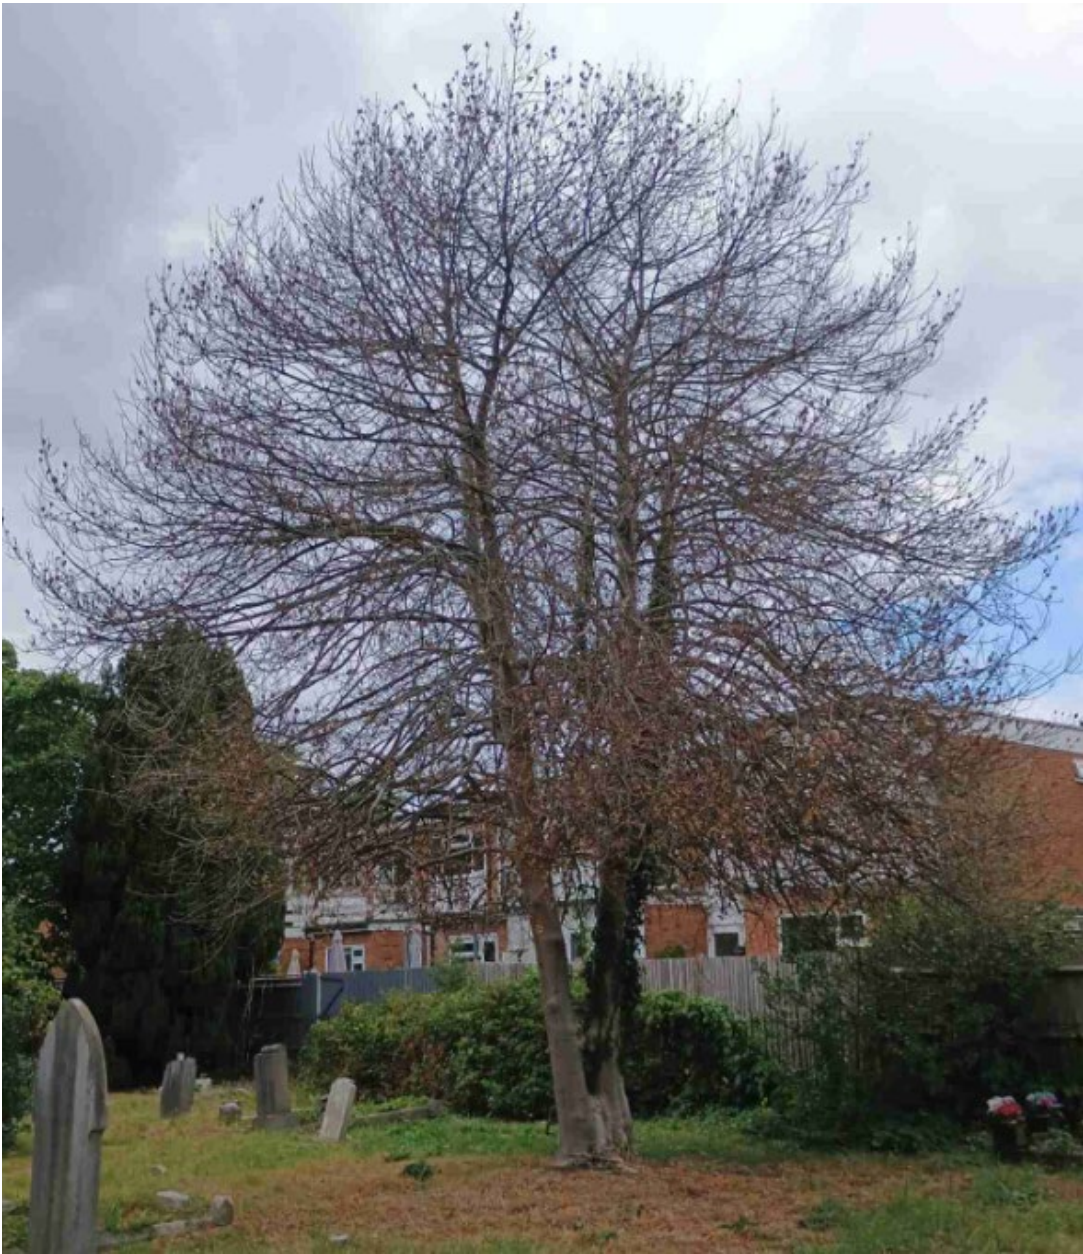
Ward	Hampton
Road	Holly Bush Lane
Location	Hampton Cemetery- ///taped.souk.tilt
Species	English Holly (<i>Ilex aquifolium</i>)
Height	10.0m
Physiological Condition	Dead
Structural Condition	Dead
Inspection findings/reason for exemption	This tree is dead; removal is required to prevent natural failure, manage risk, and facilitate replanting

Image shows dead tree in cemetery scene

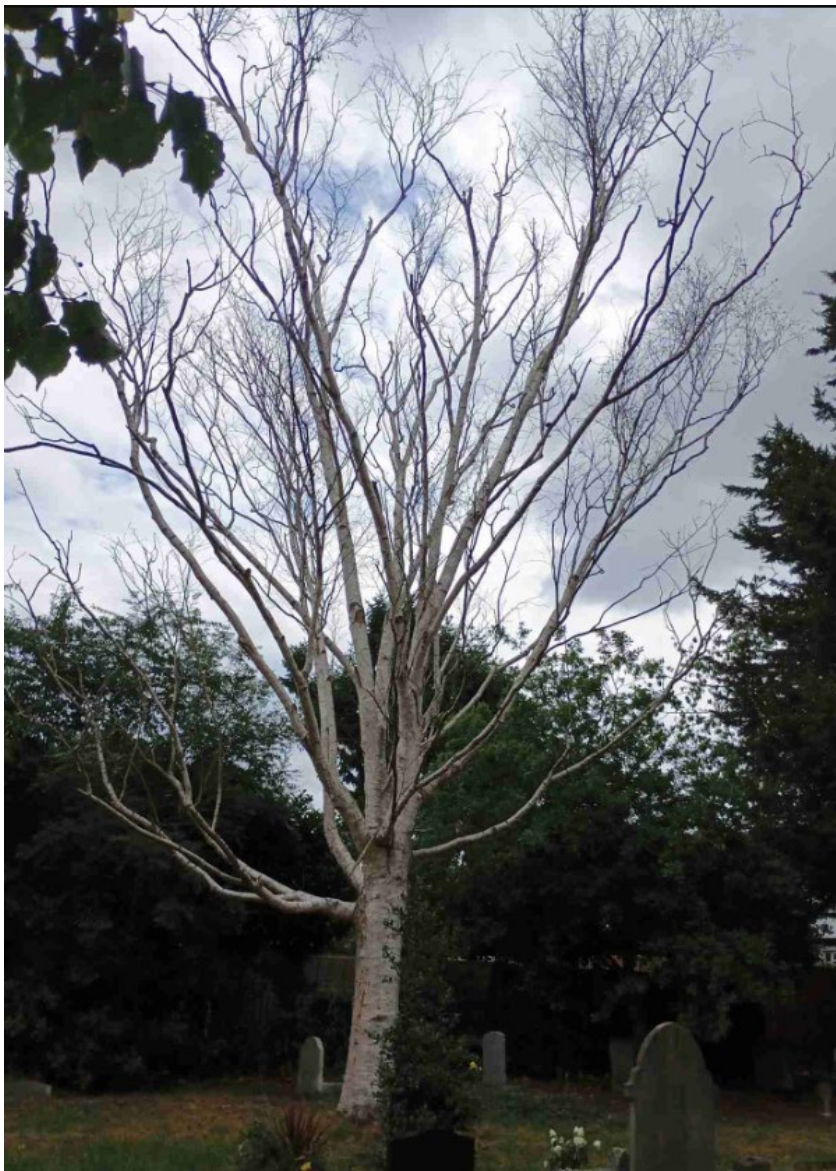
Ward	Hampton
Road	Holly Bush Lane
Location	Hampton Cemetery- ///pens.fence.basket
Species	Himalayan Birch (<i>Betula utilis</i> var. <i>Jaquemontii</i>)
Height	19.0m
Physiological Condition	Dead
Structural Condition	Dead
Inspection findings/reason for exemption	This tree is dead; removal is required to prevent natural failure, manage risk, and facilitate replanting

Image shows dead tree in cemetery scene

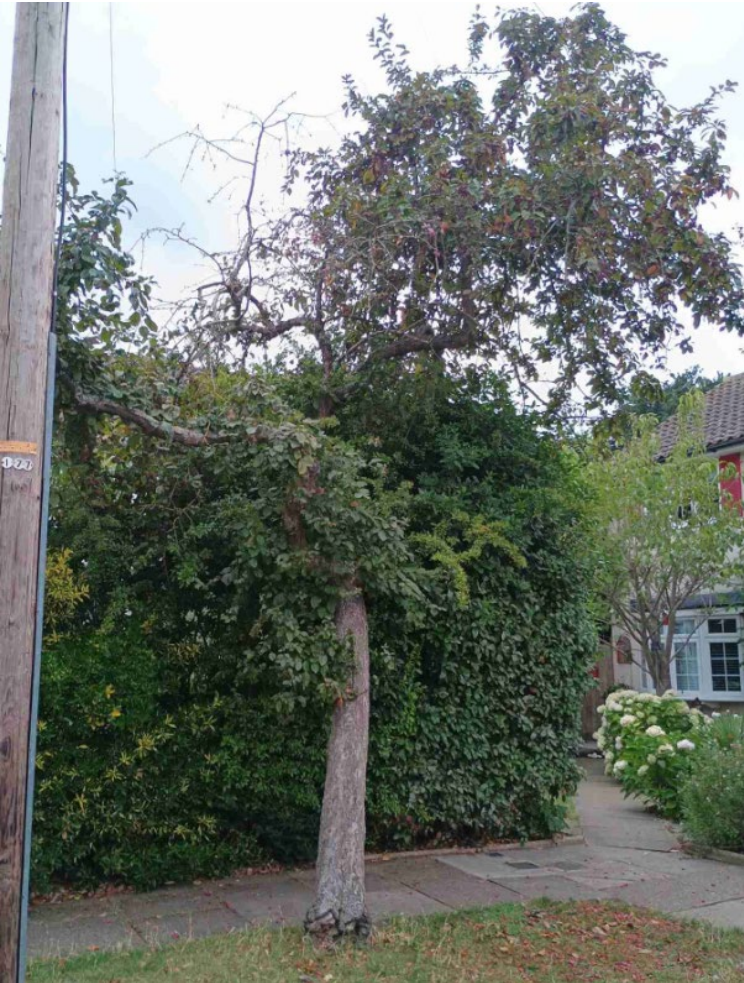
Ward	Hampton North
Road	Regency Close
Location	Outside 20
Species	Eley Crabapple (<i>Malus x purpurea v eleyi</i>)
Height	6.5m
Physiological Condition	Fair
Structural Condition	Poor
Inspection findings/reason for exemption	Investigation with a probe and a resonance test with a sounding hammer has revealed an unacceptable amount of decay beyond the visible cavities at the base of the trunk. Crown dieback could correlate with the degradation at the base of the trunk. Removal is required to prevent natural failure, manage risk, and facilitate replanting.

Image shows tree in street scene.

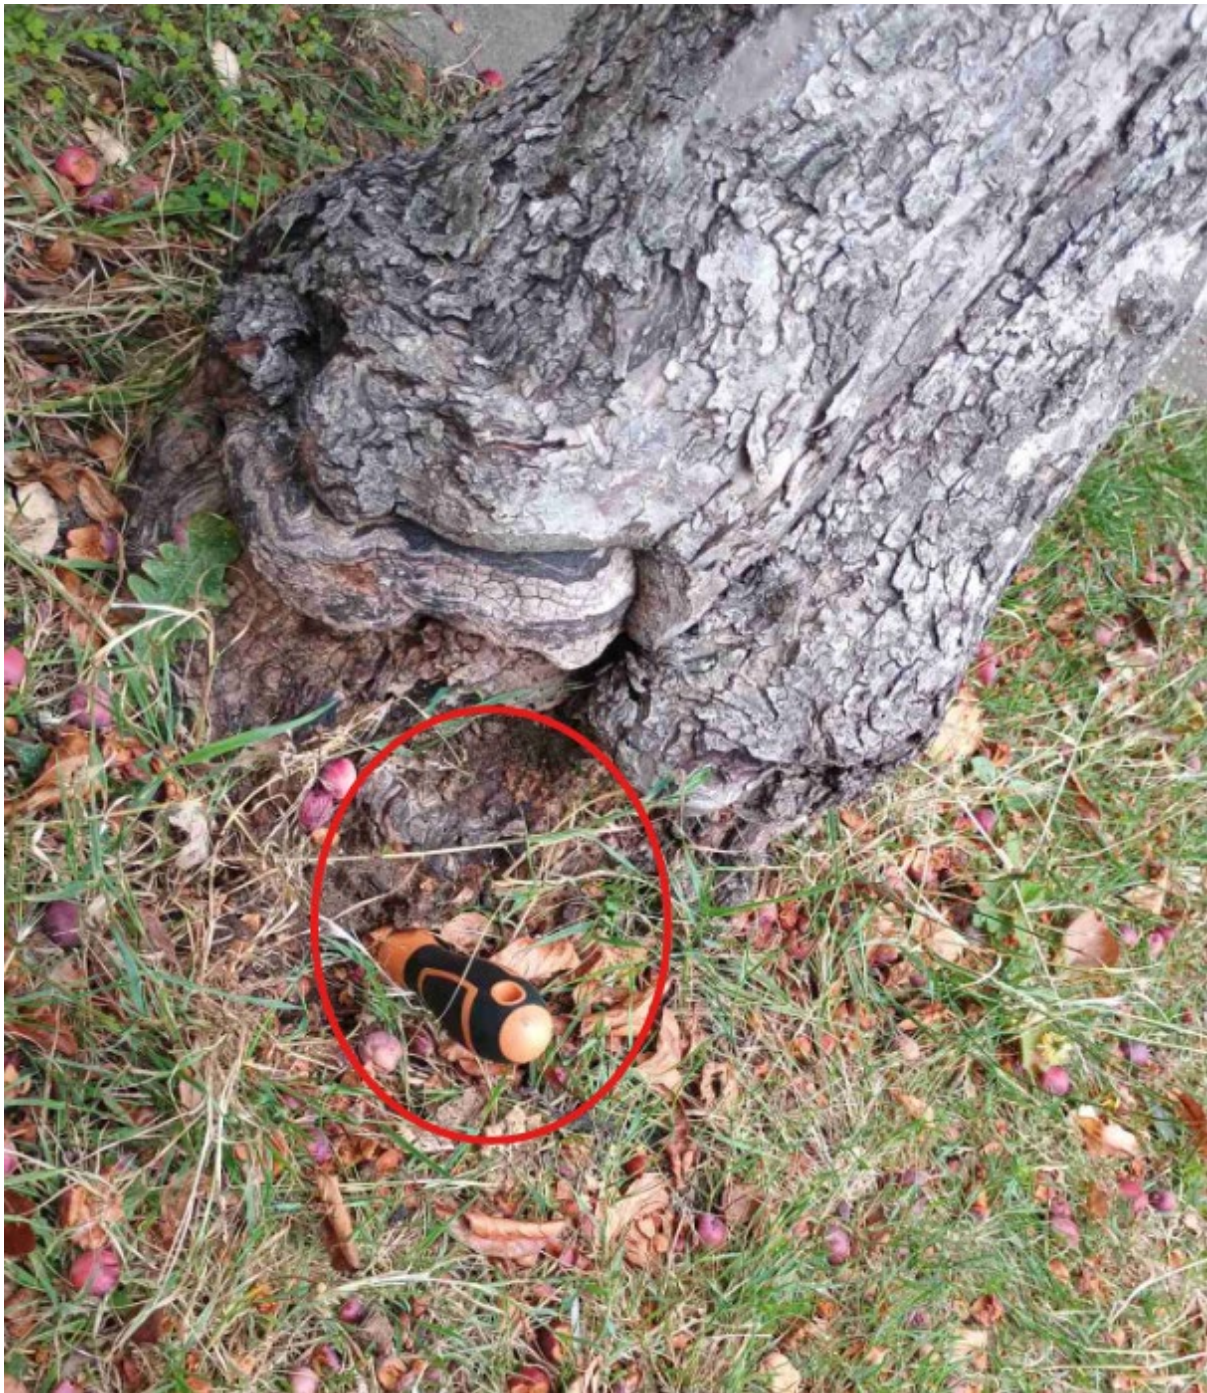
Image shows probe circled highlighting decay at base of trunk.

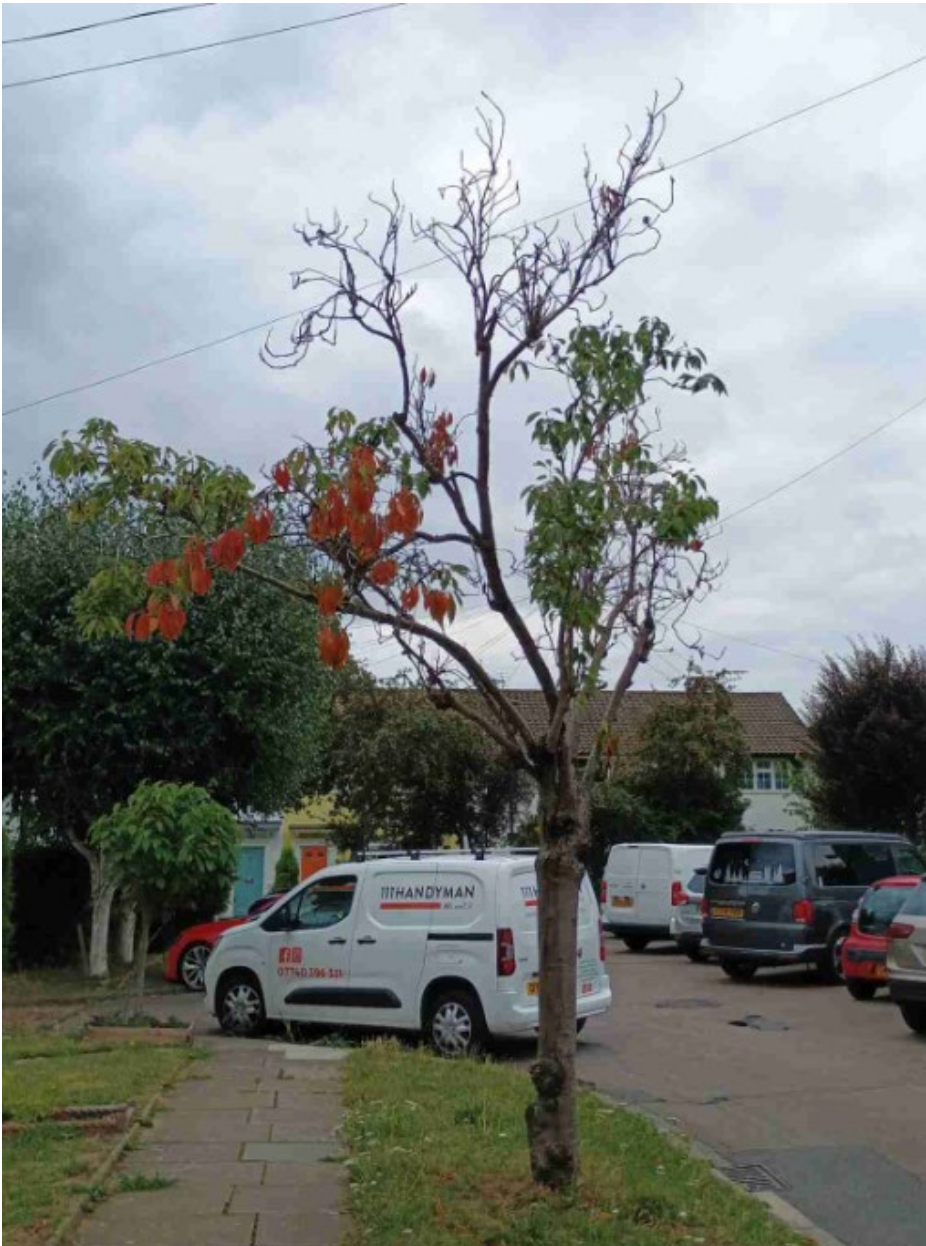
Ward	Hampton North
Road	Regency Close
Location	Outside 5
Species	Cherry (<i>Prunus sp.</i>)
Height	6.5m
Physiological Condition	Poor
Structural Condition	Fair
Inspection findings/reason for exemption	This tree is moribund; removal is required to prevent natural failure, manage risk, and facilitate replanting

Image shows moribund tree in street scene.

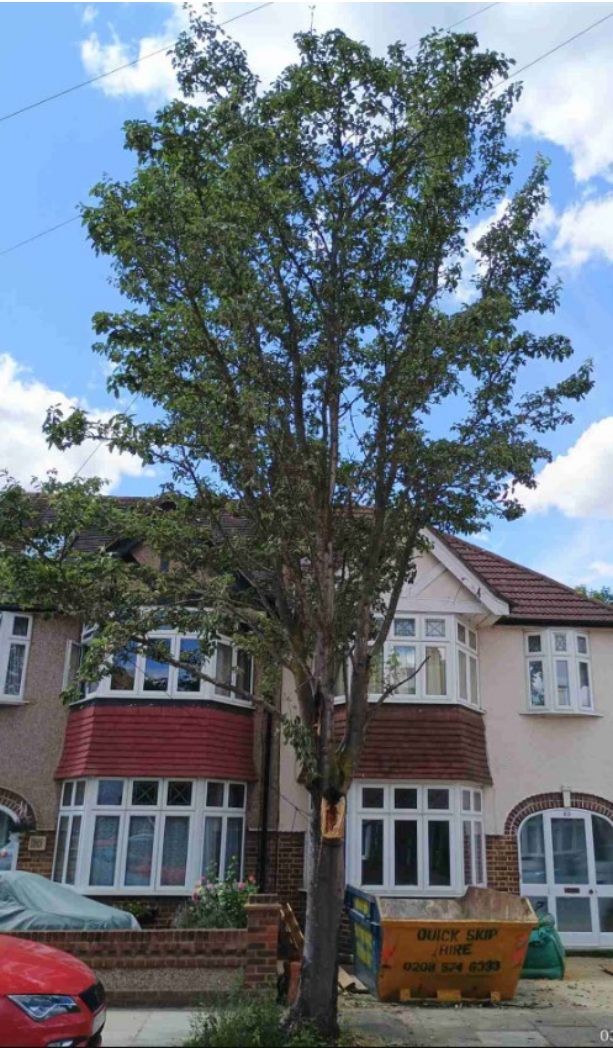
Ward	Heathfield
Road	Ryecroft Avenue
Location	Outside 68-70
Species	Apple (<i>Malus sp.</i>)
Height	10.0m
Physiological Condition	Good
Structural Condition	Poor
Inspection findings/reason for exemption	This tree has sustained impact damage from a vehicle, resulting in the loss of a major stem causing extensive wounding to the main trunk. The severity of the damage will impair both the vascular function and structural stability of the tree over time. Removal is required to prevent natural failure, manage risk, and facilitate replanting.

Image shows tree in street scene.
