August 2025 - Reactive Tree Works Programme

Dated 19.8.2025

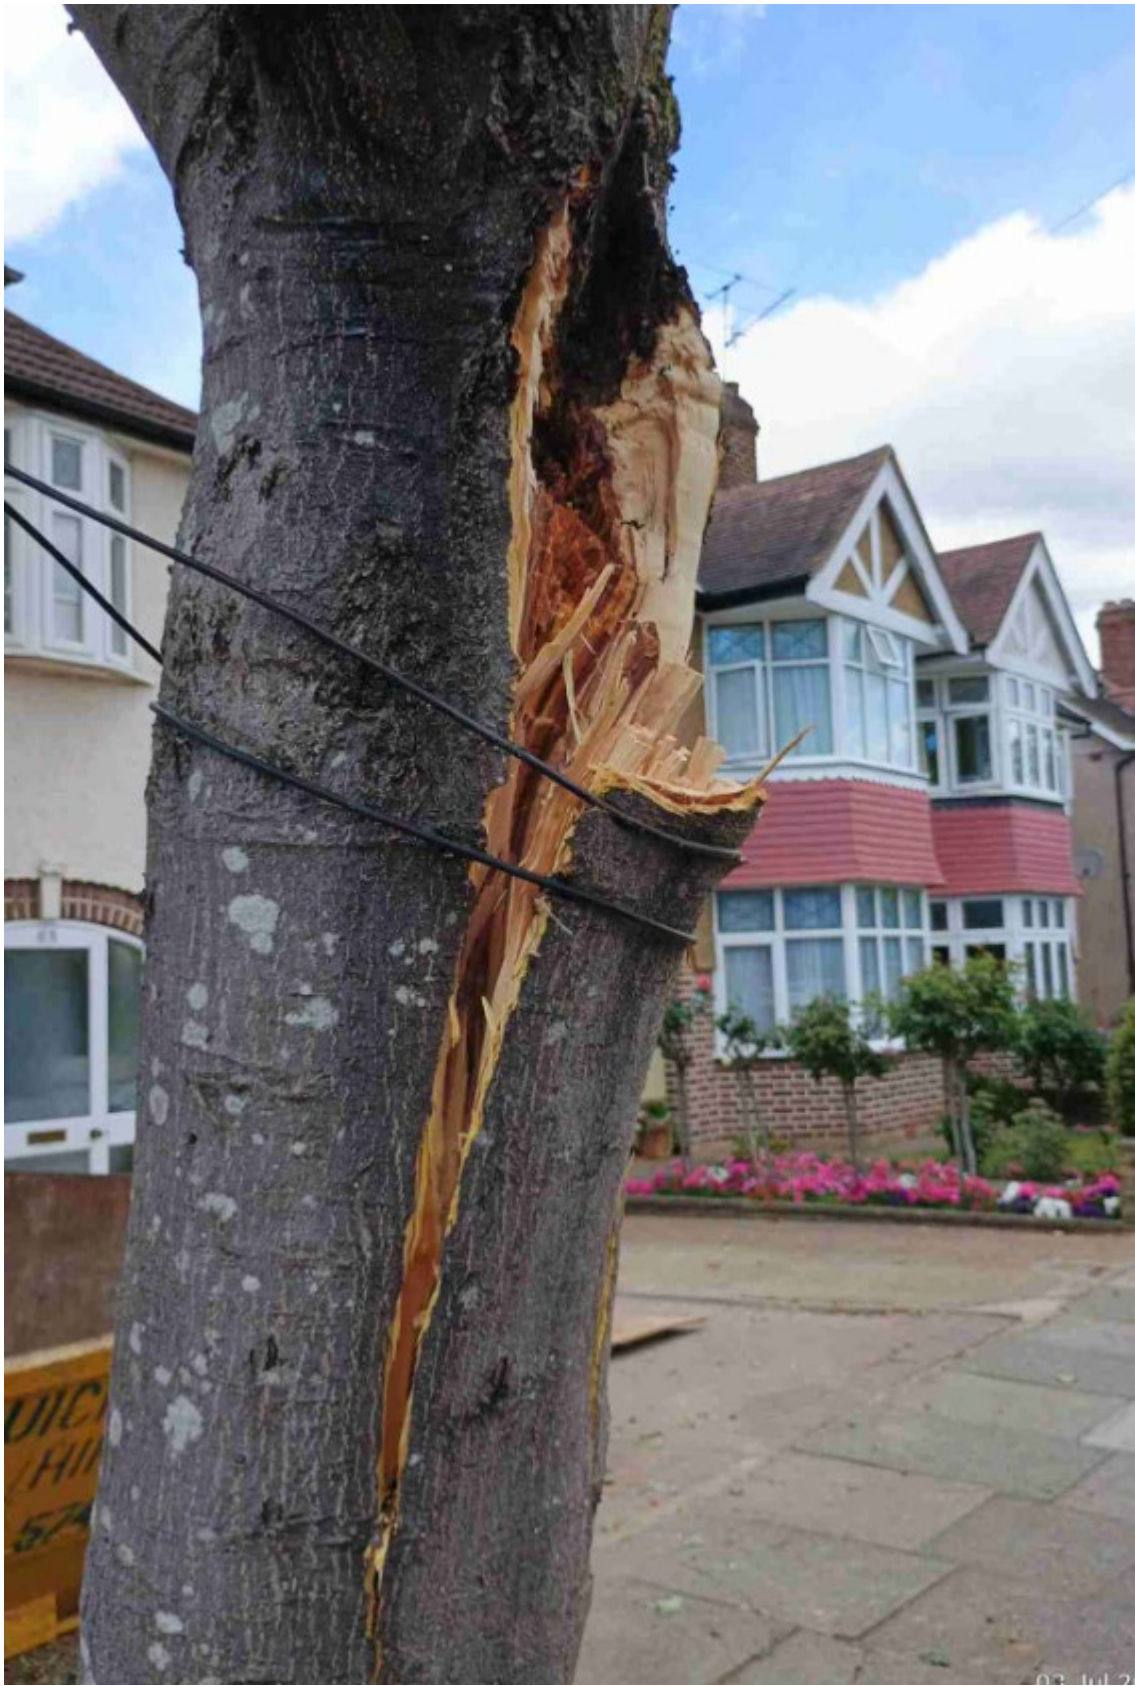
Ward	Heathfield
Road	Ryecroft Avenue
Location	Outside 68-70
Species	Apple (<i>Malus sp.</i>)
Height	10.0m
Physiological Condition	Good
Structural Condition	Poor
Inspection findings/reason for exemption	This tree has sustained impact damage from a vehicle, resulting in the loss of a major stem causing extensive wounding to the main trunk. The severity of the damage will impair both the vascular function and structural stability of the tree over time. Removal is required to prevent natural failure, manage risk, and facilitate replanting.

Image shows wound on trunk as a result of the failed stem.

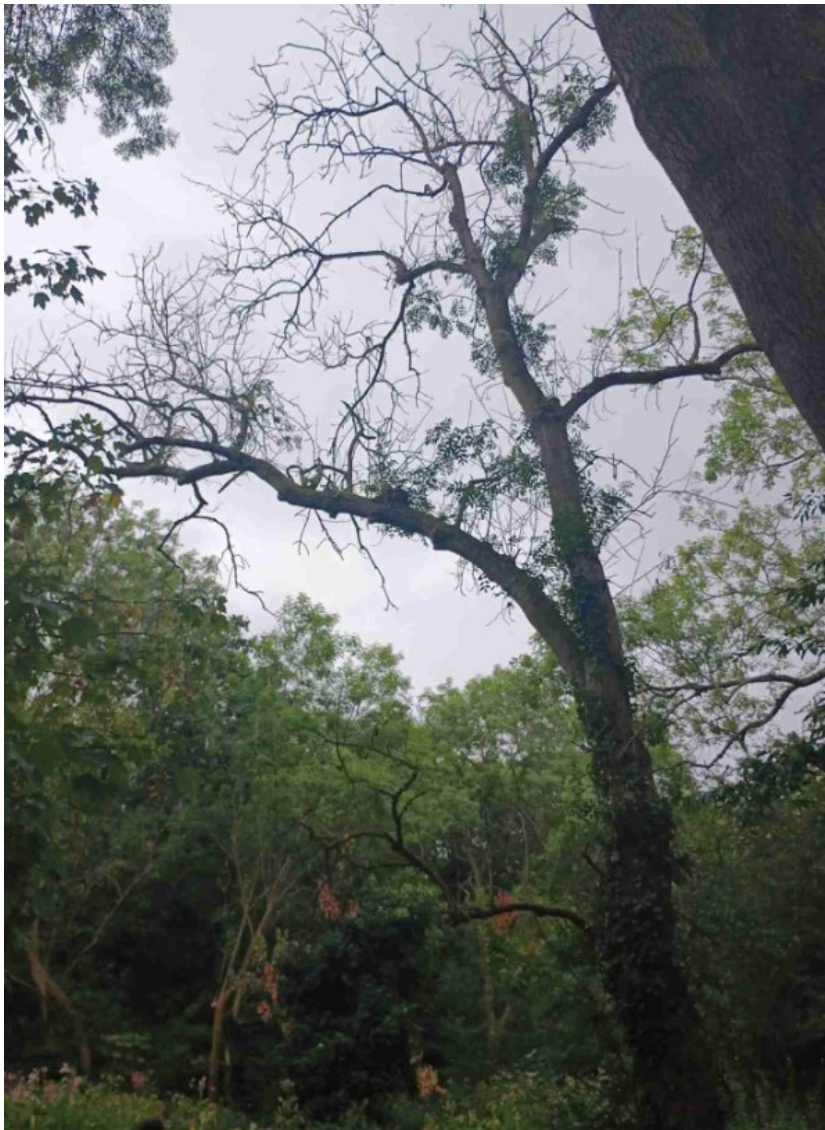
Ward	Heathfield
Road	Hospital Bridge Road
Location	Crane park - ///limp.reds.shovels
Species	Common ash (<i>Fraxinus excelsior</i>)
Height	18.0m
Physiological Condition	Poor
Structural Condition	Poor
Inspection findings/reason for exemption	Tree crown is displaying advanced symptoms of physiological decline associated with Ash Die Back (<i>Hymenoscyphus fraxineus</i>). This is serious fungal disease of the European Ash, characterized by the progressive decline of the tree's branches and will eventually lead to the death of the tree. Removal is required to prevent natural failure and manage risk.

Image shows moribund tree in park scene.

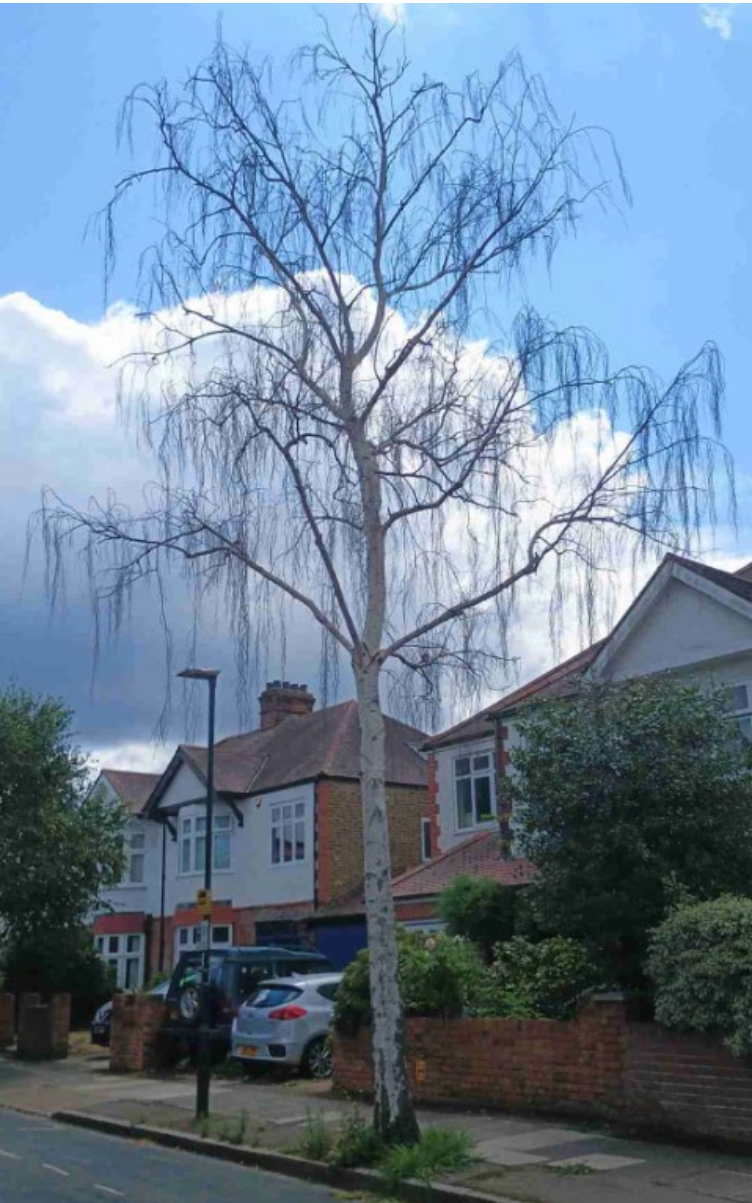
Ward	Kew
Road	Nylands Avenue
Location	Outside 11/13
Species	Birch (<i>Betula sp.</i>)
Height	13.5m
Physiological Condition	Dead
Structural Condition	Dead
Inspection findings/reason for exemption	This tree is dead; removal is required to prevent natural failure, manage risk, and facilitate replanting.

Image shows dead tree in street scene.

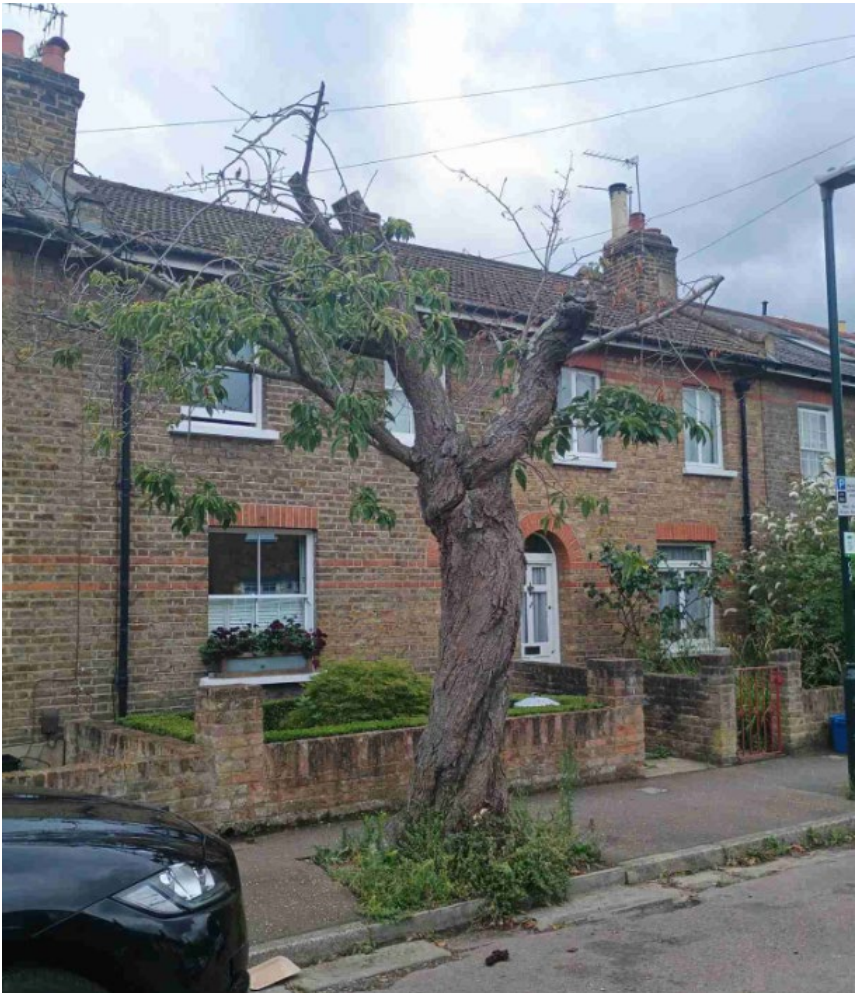
Ward	Kew
Road	Alexandra Road
Location	Outside 45/47
Species	Cherry (<i>Prunus sp.</i>)
Height	6.0m
Physiological Condition	Poor
Structural Condition	Poor
Inspection findings/reason for exemption	A fungal fruiting body of the decay fungus <i>Ganoderma sp.</i> is present at the base of the trunk. Colonisation by this fungus results in white rot affecting the stem and root system, which can lead to structural failure through fracture or windthrow. Crown dieback is evident and correlates with the presence of the decay fungi. Removal is required to prevent natural failure, manage risk, and facilitate replanting.

Image shows moribund tree in street scene.

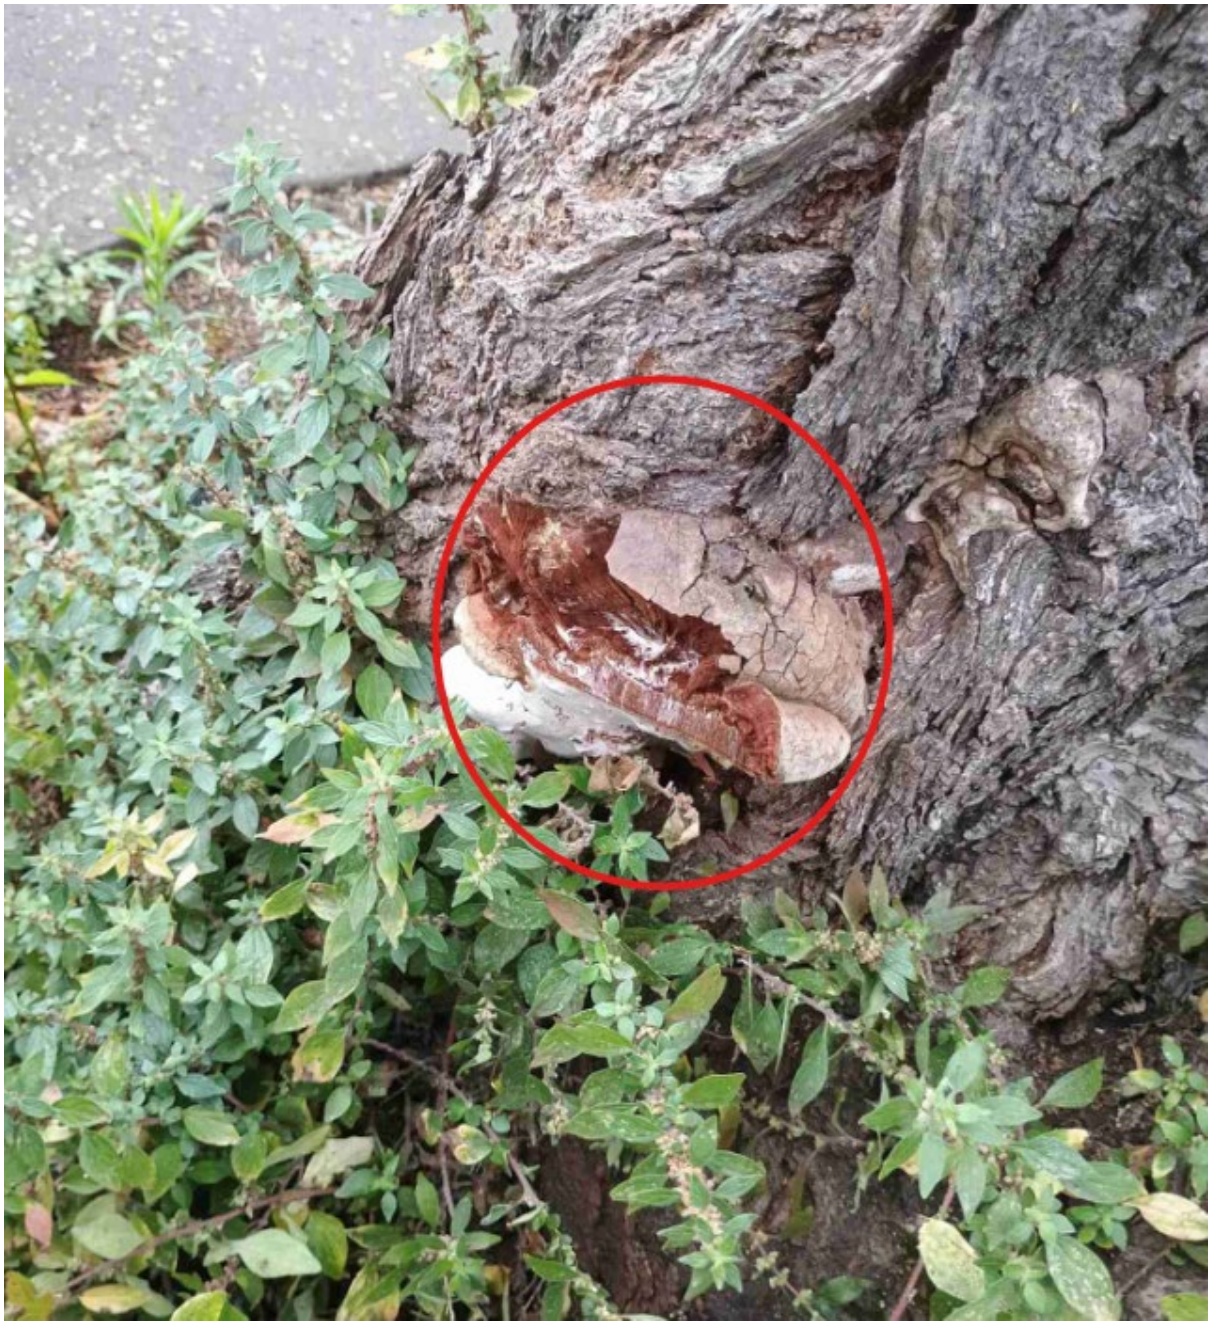
Image shows fungal fruiting body circled.

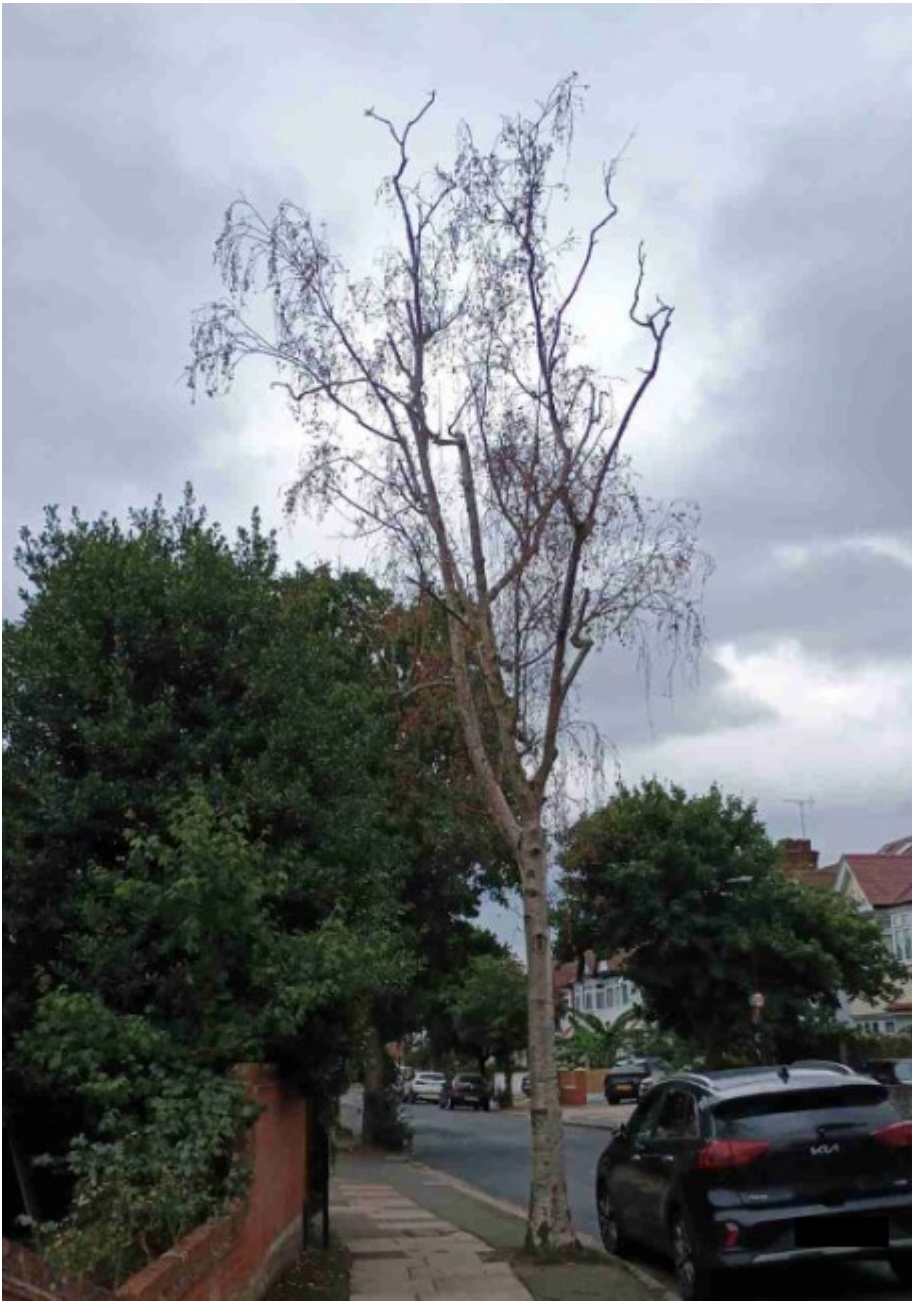
Ward	Kew
Road	Taylor Avenue
Location	Outside 27
Species	Silver birch (<i>Betula pendula</i>)
Height	10.5m
Physiological Condition	Dead
Structural Condition	Dead
Inspection findings/reason for exemption	This tree is dead; removal is required to prevent natural failure, manage risk, and facilitate replanting

Image shows dead tree in street scene.

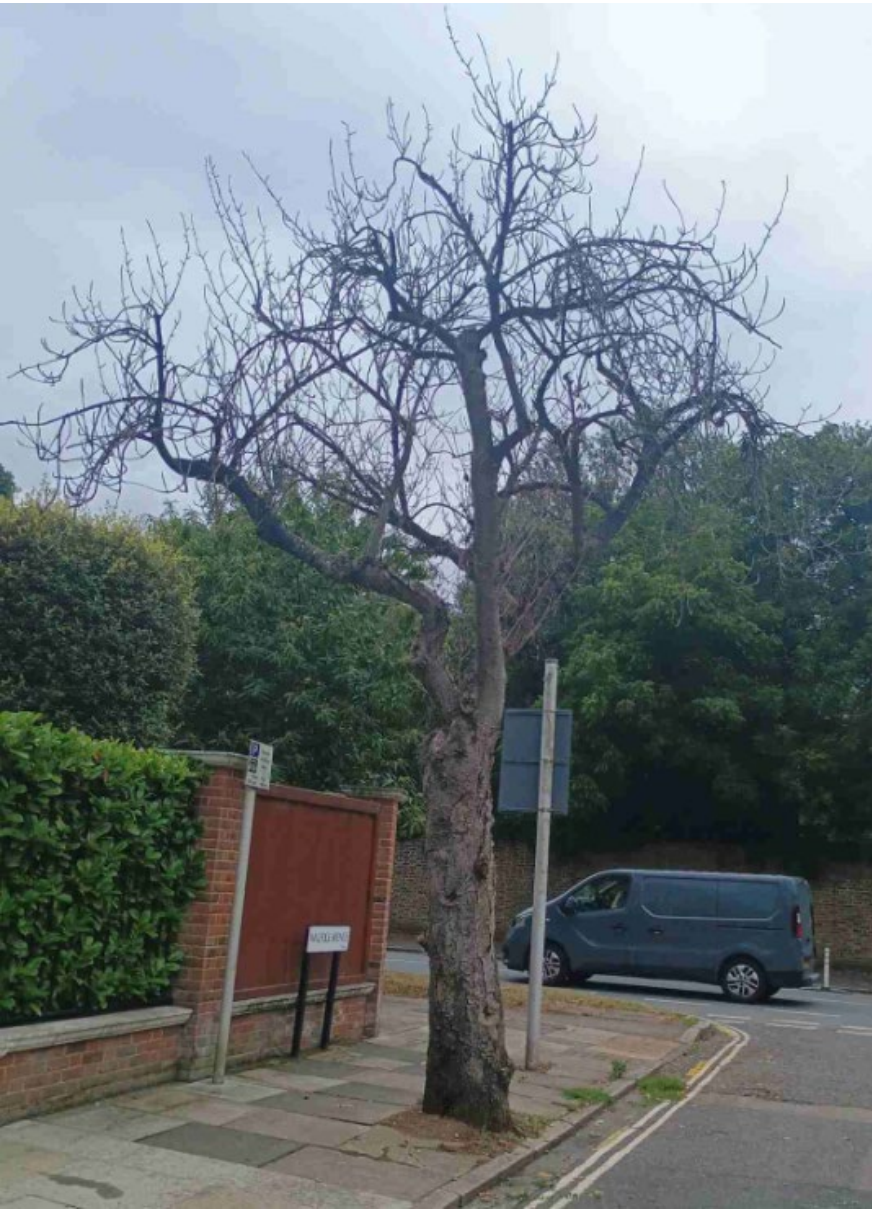
Ward	North Richmond
Road	Walpole Avenue
Location	Adjacent to 196 Kew Road front driveway
Species	Cherry (<i>Prunus sp.</i>)
Height	6.0m
Physiological Condition	Dead
Structural Condition	Dead
Inspection findings/reason for exemption	This tree is dead; removal is required to prevent natural failure, manage risk, and facilitate replanting

Image shows dead tree in street scene.

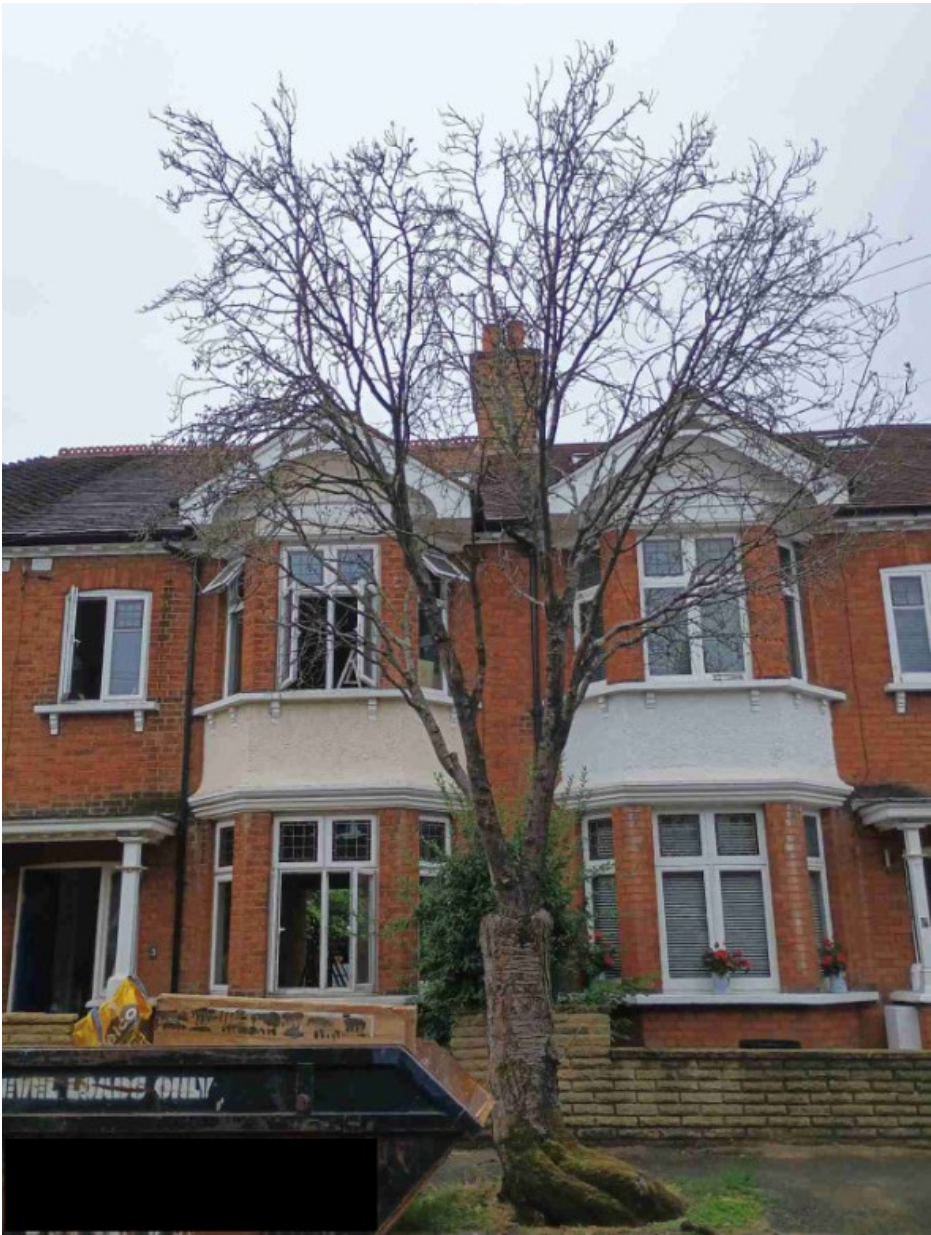
Ward	North Richmond
Road	Manor Park
Location	Outside 3/5
Species	Cherry (<i>Prunus sp.</i>)
Height	9.0m
Physiological Condition	Dead
Structural Condition	Dead
Inspection findings/reason for exemption	This tree is dead; removal is required to prevent natural failure, manage risk, and facilitate replanting

Image shows dead tree in street scene.

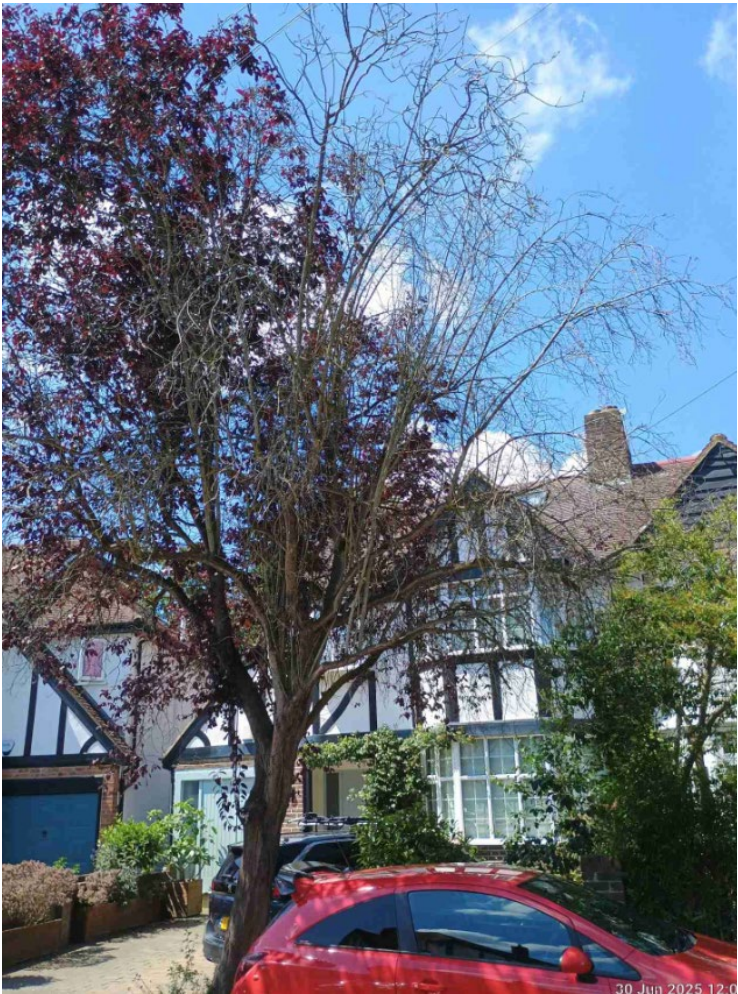
Ward	South Twickenham
Road	Michelham Gardens
Location	Outside 16
Species	Cherry plum (<i>Prunus cerasifera</i>)
Height	11.0m
Physiological Condition	Poor
Structural Condition	Fair
Inspection findings/reason for exemption	A fungal fruiting body of the decay fungus <i>Ganoderma sp.</i> is present at the base of the trunk on this tree. Colonisation by this fungus results in white rot affecting the stem and root system, which can lead to structural failure through fracture or windthrow. Crown dieback is evident and correlates with the presence of the decay fungi. Removal of the tree is recommended to prevent natural failure, manage risk, and facilitate replanting.

Image shows moribund tree in street scene.

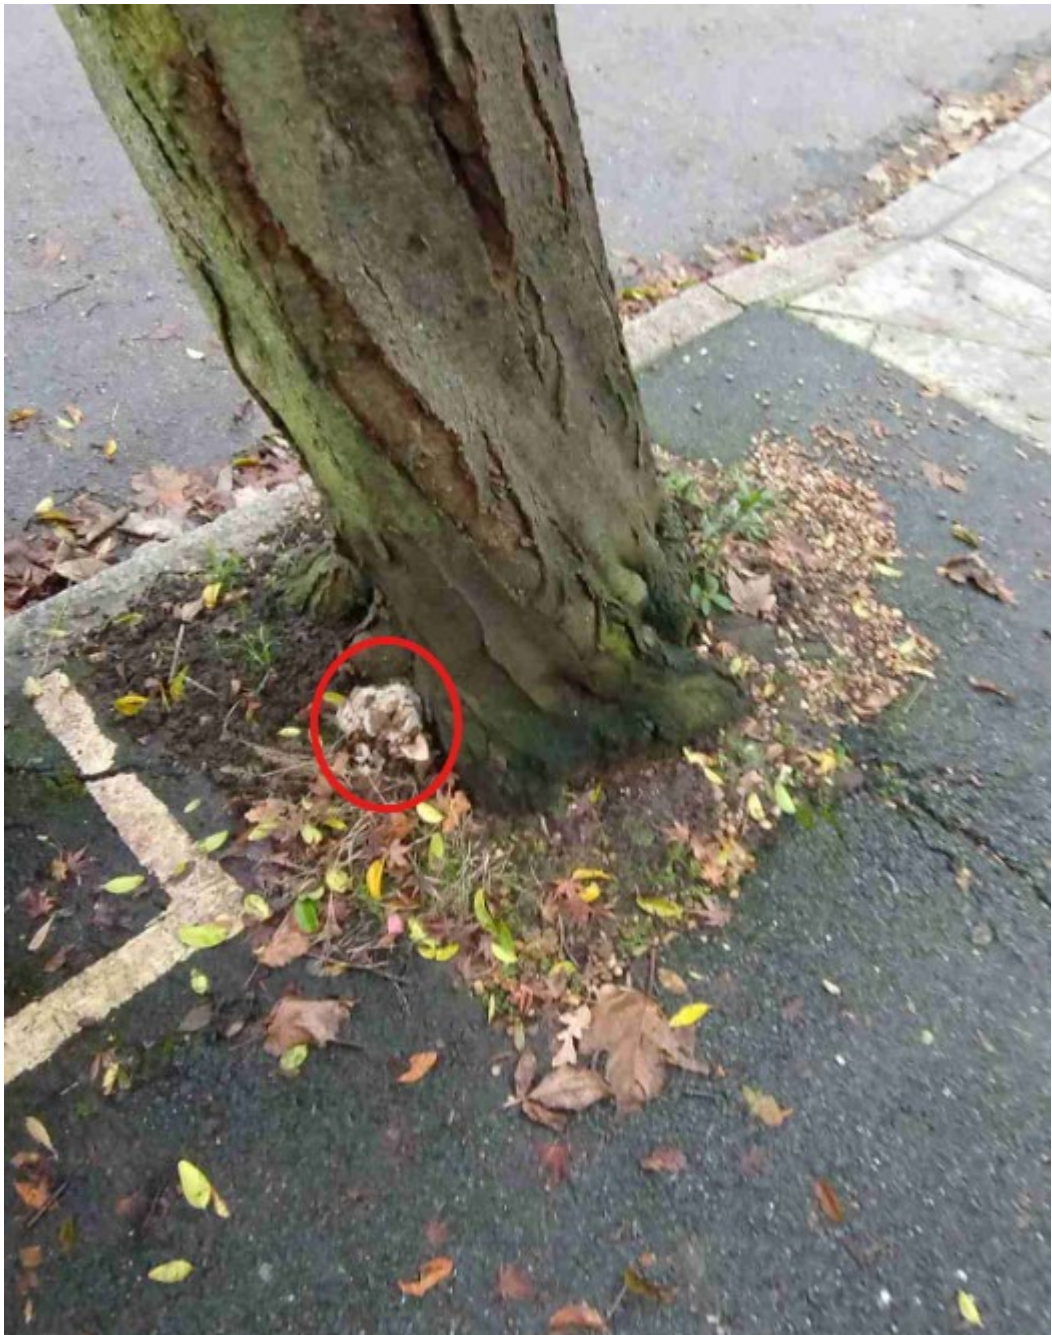
Image shows fungal fruiting body circled.

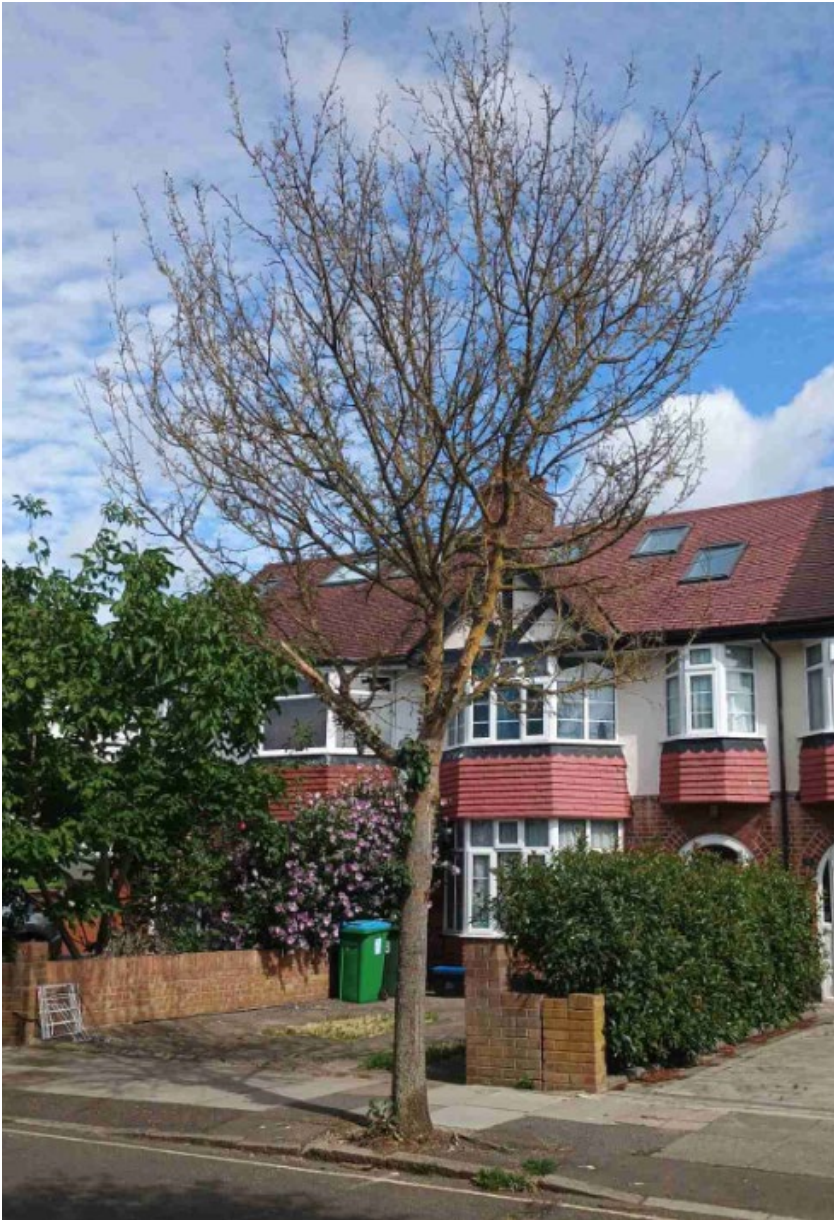
Ward	St Margarets and North Twickenham
Road	Court Way
Location	Outside 76/78
Species	Field maple (<i>Acer campestre</i>)
Height	7.5m
Physiological Condition	Dead
Structural Condition	Dead
Inspection findings/reason for exemption	This tree is dead; removal is required to prevent natural failure, manage risk, and facilitate replanting

Image shows dead tree in street scene.

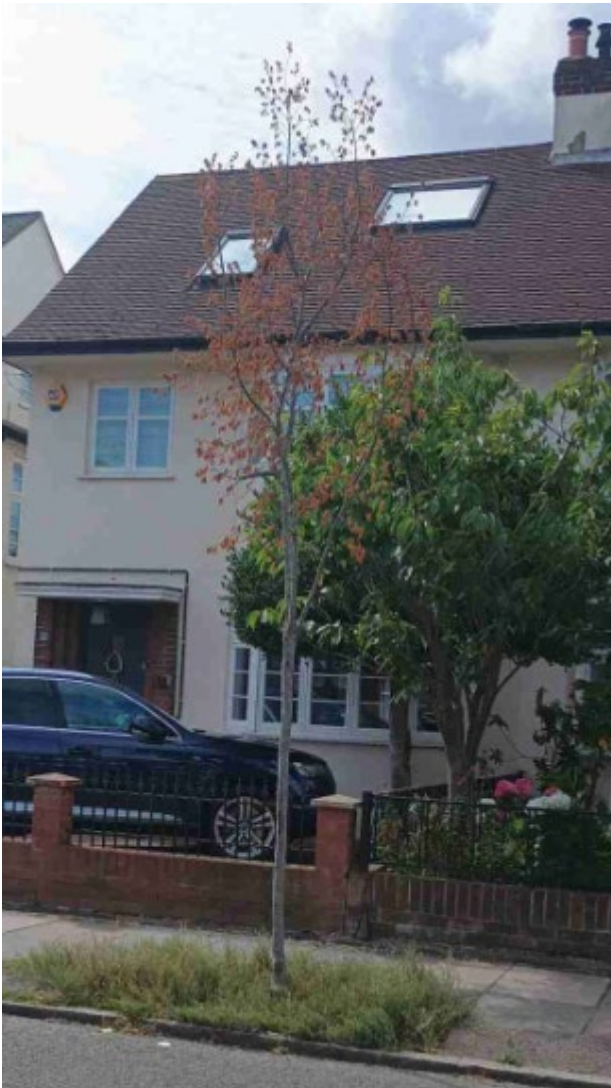
Ward	St Margarets and North Twickenham
Road	Court Way
Location	Outside 33/35
Species	Hornbeam (<i>Carpinus betulus</i>)
Height	5.0m
Physiological Condition	Dead
Structural Condition	Dead
Inspection findings/reason for exemption	This tree is dead; removal is required to prevent natural failure, manage risk, and facilitate replanting

Image shows dead tree in street scene.

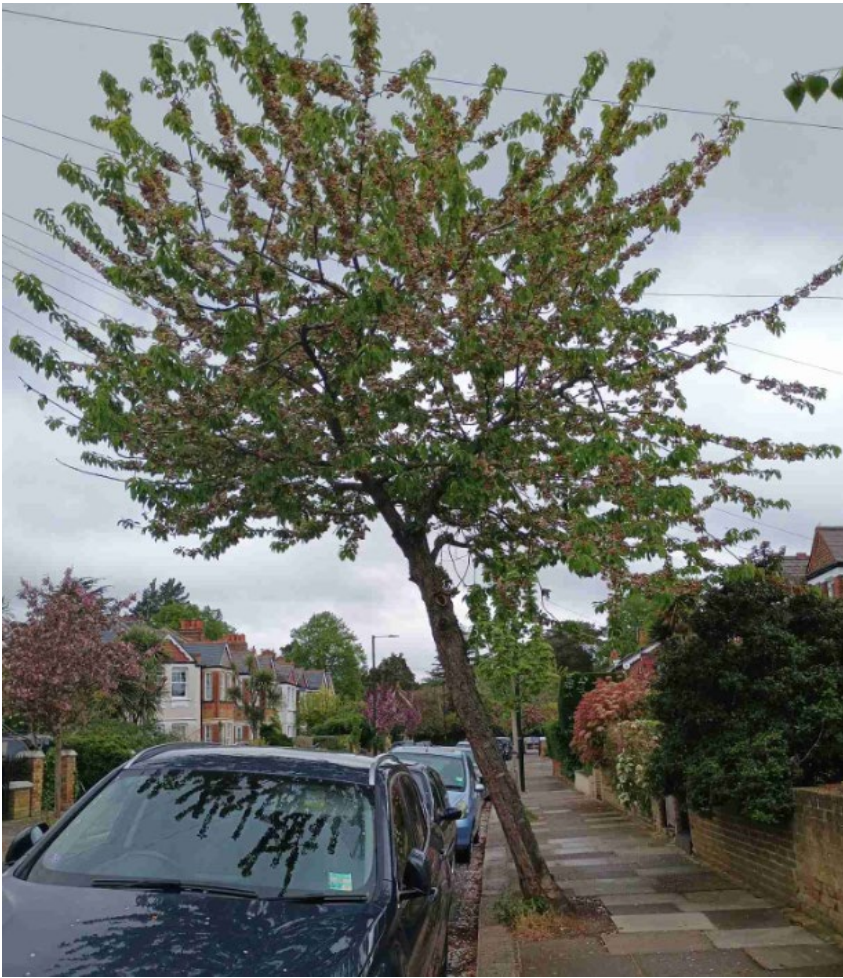
Ward	Teddington
Road	Church Road
Location	Outside 172-174
Species	Cherry (<i>Prunus sp.</i>)
Height	6.5m
Physiological Condition	Good
Structural Condition	Good
Inspection findings/reason for exemption	This tree is leaning into the road, creating an unacceptable obstruction to highway users. Removal is required to eliminate the obstruction and facilitate replanting.

Image shows tree in street scene.

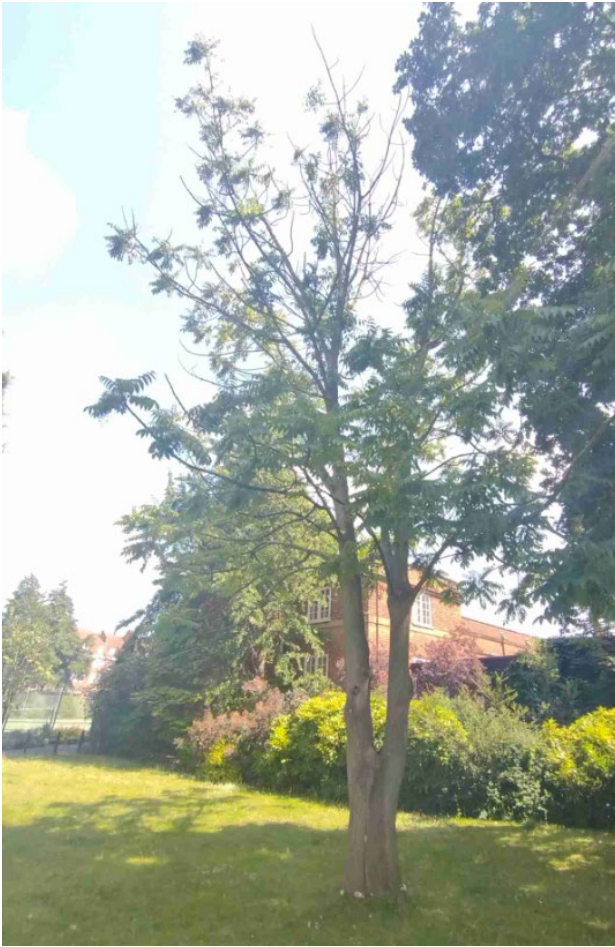
Ward	Twickenham Riverside
Road	York House Gardens
Location	///miles.forms.care
Species	Varnish tree (<i>Toxicodendron vernicifluum</i>)
Height	14.0m
Physiological Condition	Poor
Structural Condition	Poor
Inspection findings/reason for exemption	A fungal fruiting body of the decay fungus Ganoderma sp. is present at the base of the trunk. Colonisation by this fungus results in white rot affecting the stem and root system, which can lead to structural failure through fracture or windthrow. Crown dieback is evident and correlates with the presence of the decay fungi. Removal is required to prevent natural failure, manage risk and facilitate replanting

Image shows tree moribund tree in park scene.

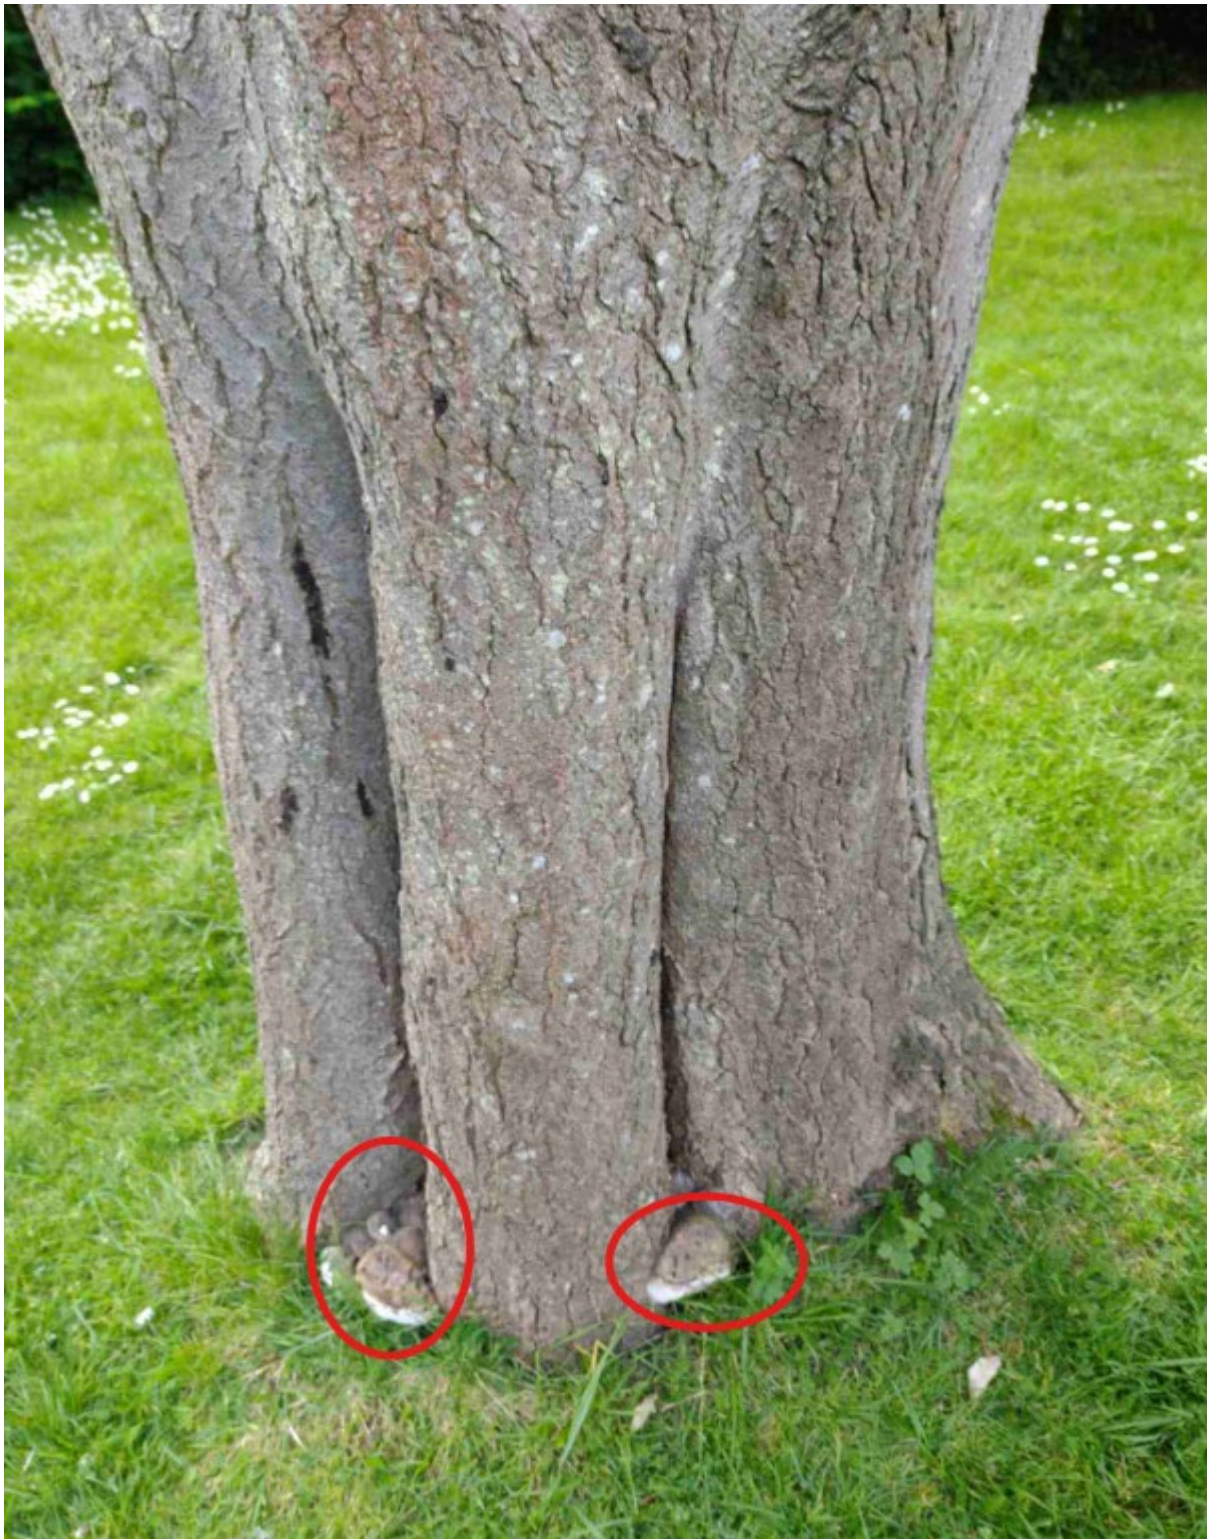
Image shows fungal fruiting body circled.

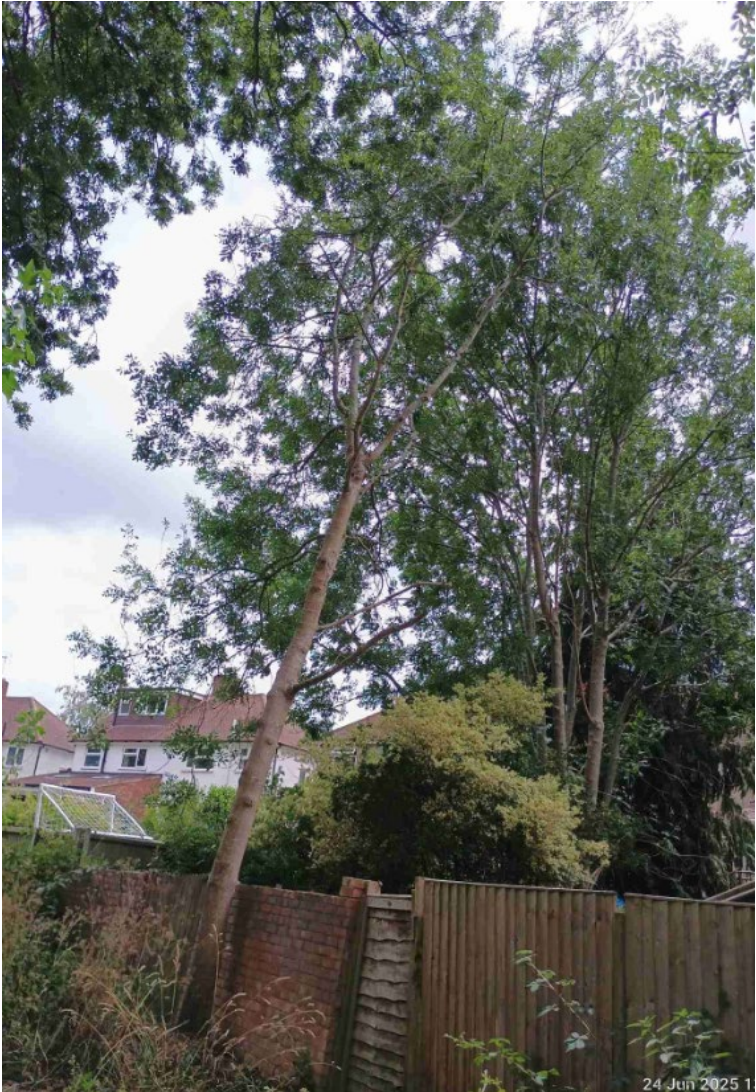
Ward	West Twickenham
Road	Hospital Bridge Road
Location	Crane park - ///snap.hugs.asserts
Species	Common ash (<i>Fraxinus excelsior</i>)
Height	12.0m
Physiological Condition	Good
Structural Condition	Good
Inspection findings/reason for exemption	This tree is growing in a location where it is impacting a privately owned wall. While the tree itself is in good condition, its proximity is contributing to structural damage. Removal is required to prevent further deterioration of the wall which will lead to its failure.

Images show tree in park scene in proximity to private wall

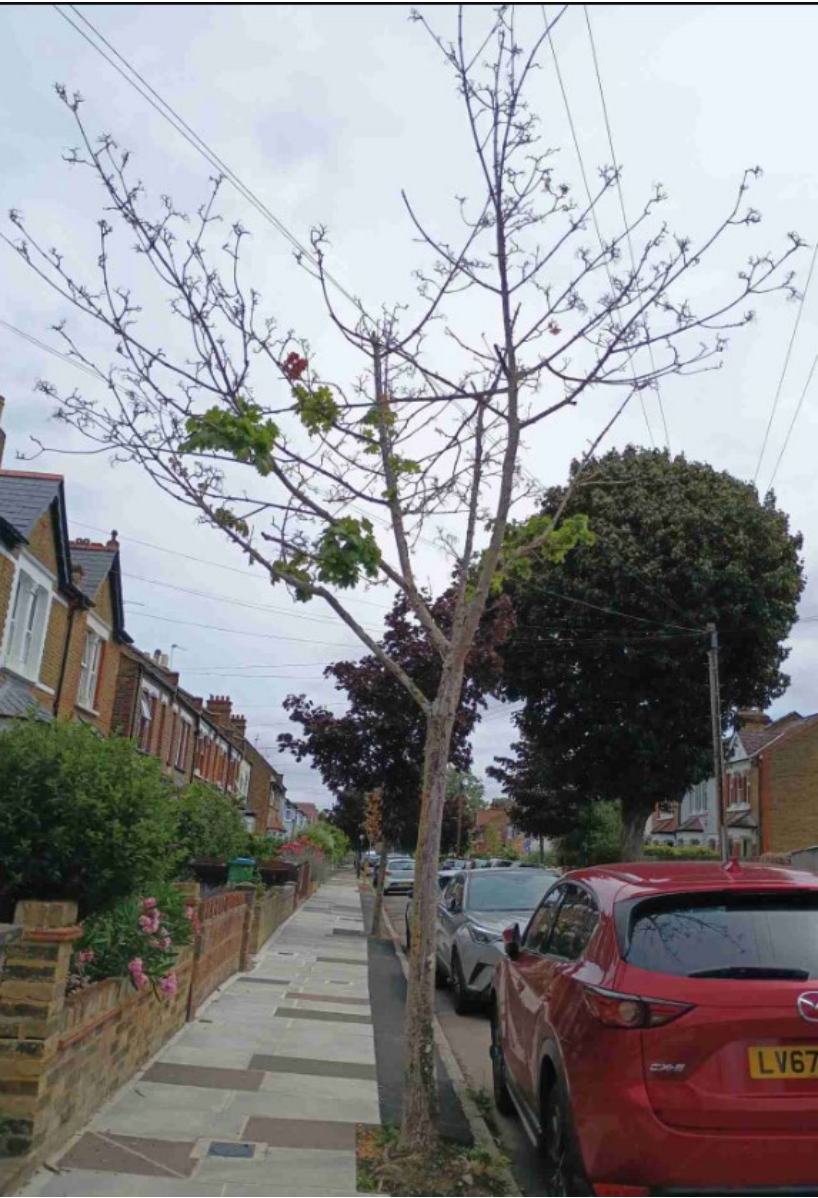
Ward	Whitton
Road	Cedar Avenue
Location	Outside 2
Species	Norway maple (<i>Acer platanoides</i>)
Height	7.0m
Physiological Condition	Poor
Structural Condition	Fair
Inspection findings/reason for exemption	This tree is moribund; removal is required to prevent natural failure and facilitate replanting

Image shows moribund tree in street scene.
