# August 2026 - Reactive Tree Works Programme

A survey of trees in the Kew, South Richmond and Whitton wards are currently being undertaken; this is being conducted by specialist arboricultural officers as part of the scheduled 4 yearly detailed inspection regime that has been devised for all Council highway and parks trees.

Recent reactive inspections have identified the need for 106 individual tree work operations to take place. This work will now be issued to the Council’s Arborist Contractor KPS, for completion over the Autumn period.

The following pages provide the locations of each tree that is to be removed, in addition photographs and descriptions of the inspection findings have been provided.

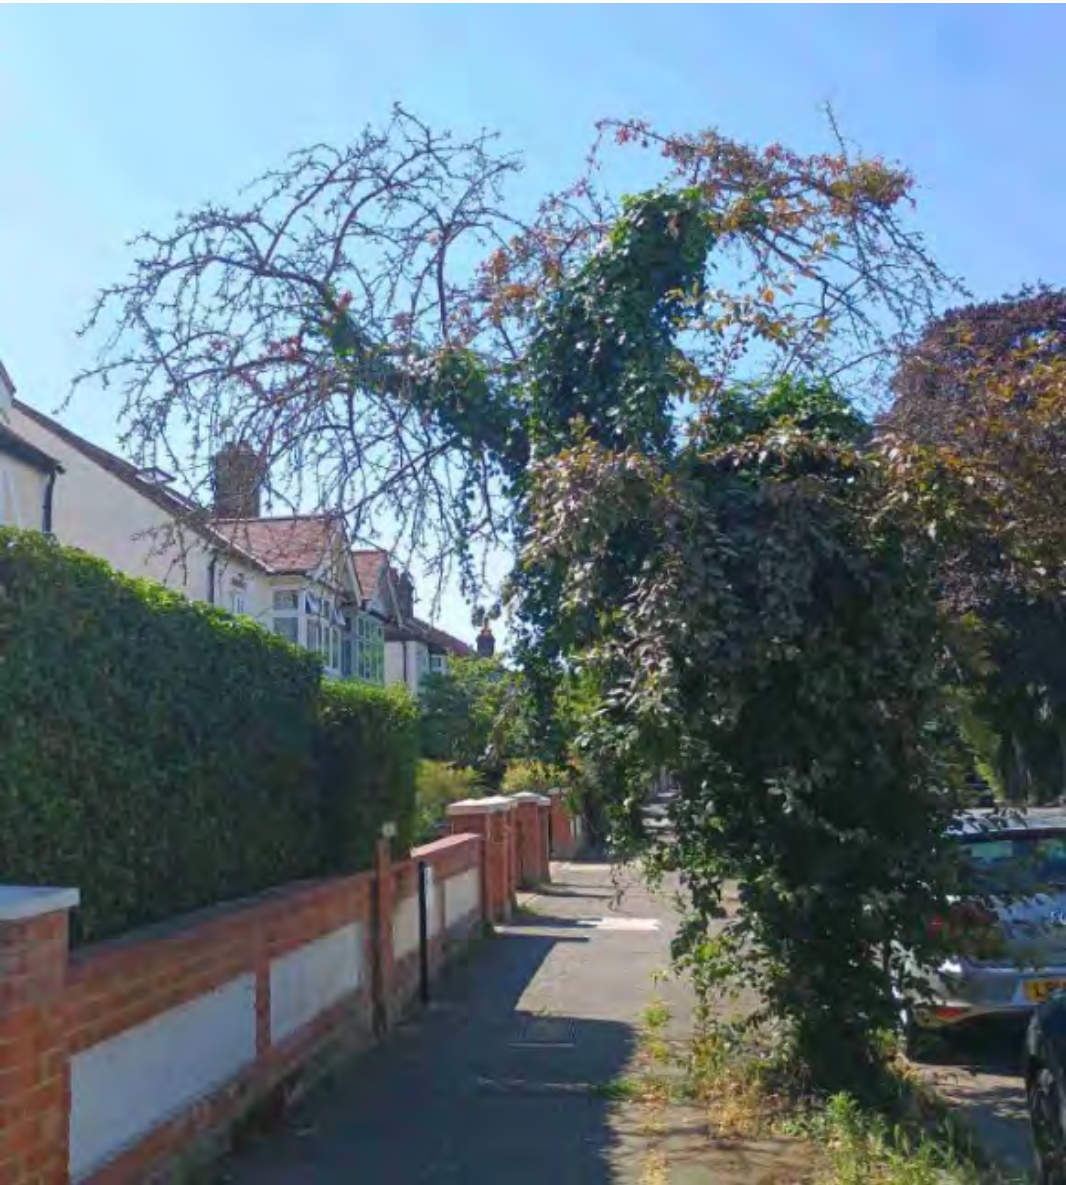
| Physiological Condition | Poor |
| Structural Condition | Fair |
| Inspection findings/reason for exemption | This tree is moribund; removal is required to prevent natural failure, manage risk, and facilitate replanting. |

Image shows moribund tree in street scene.

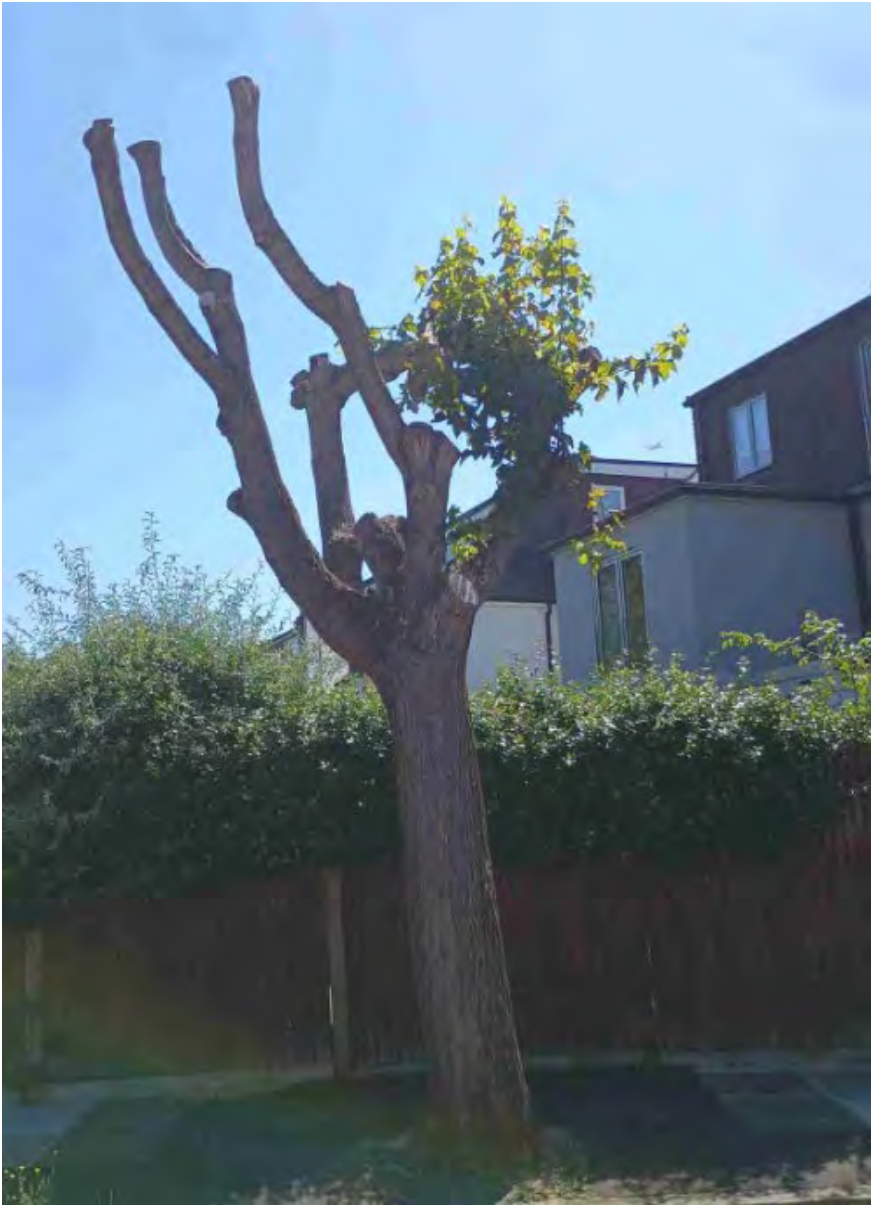
| Physiological Condition | Poor |
| Structural Condition | Fair |
| Inspection findings/reason for exemption | This tree is moribund; removal is required to prevent natural failure, manage risk, and facilitate replanting. |

Image shows moribund tree in street scene

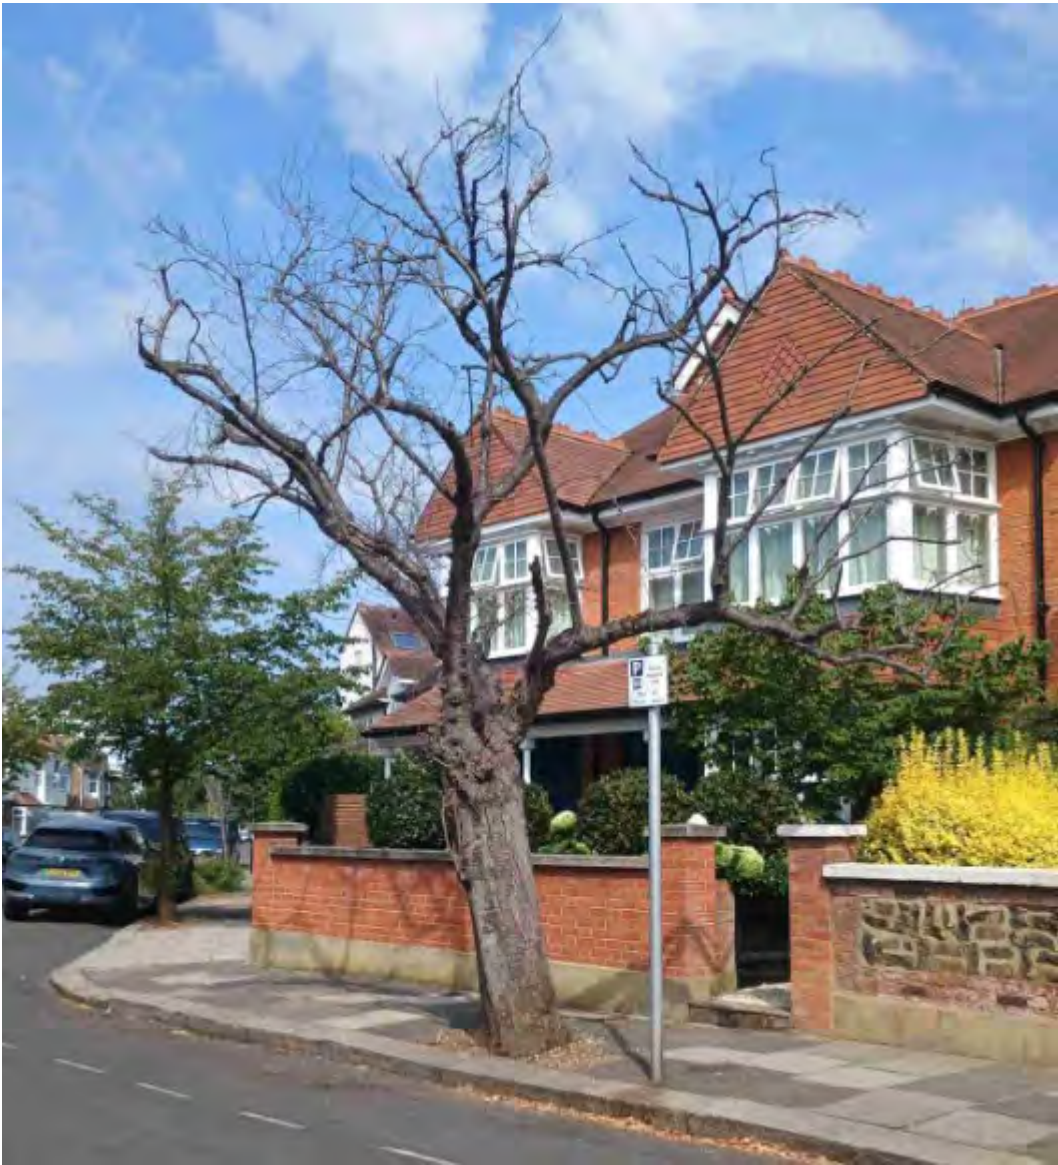
| Physiological Condition | Dead |
| Structural Condition | Poor |
| Inspection findings/reason for exemption | This tree is dead; removal is required to prevent natural failure, manage risk, and facilitate replanting. |

Image shows dead tree in street scene.

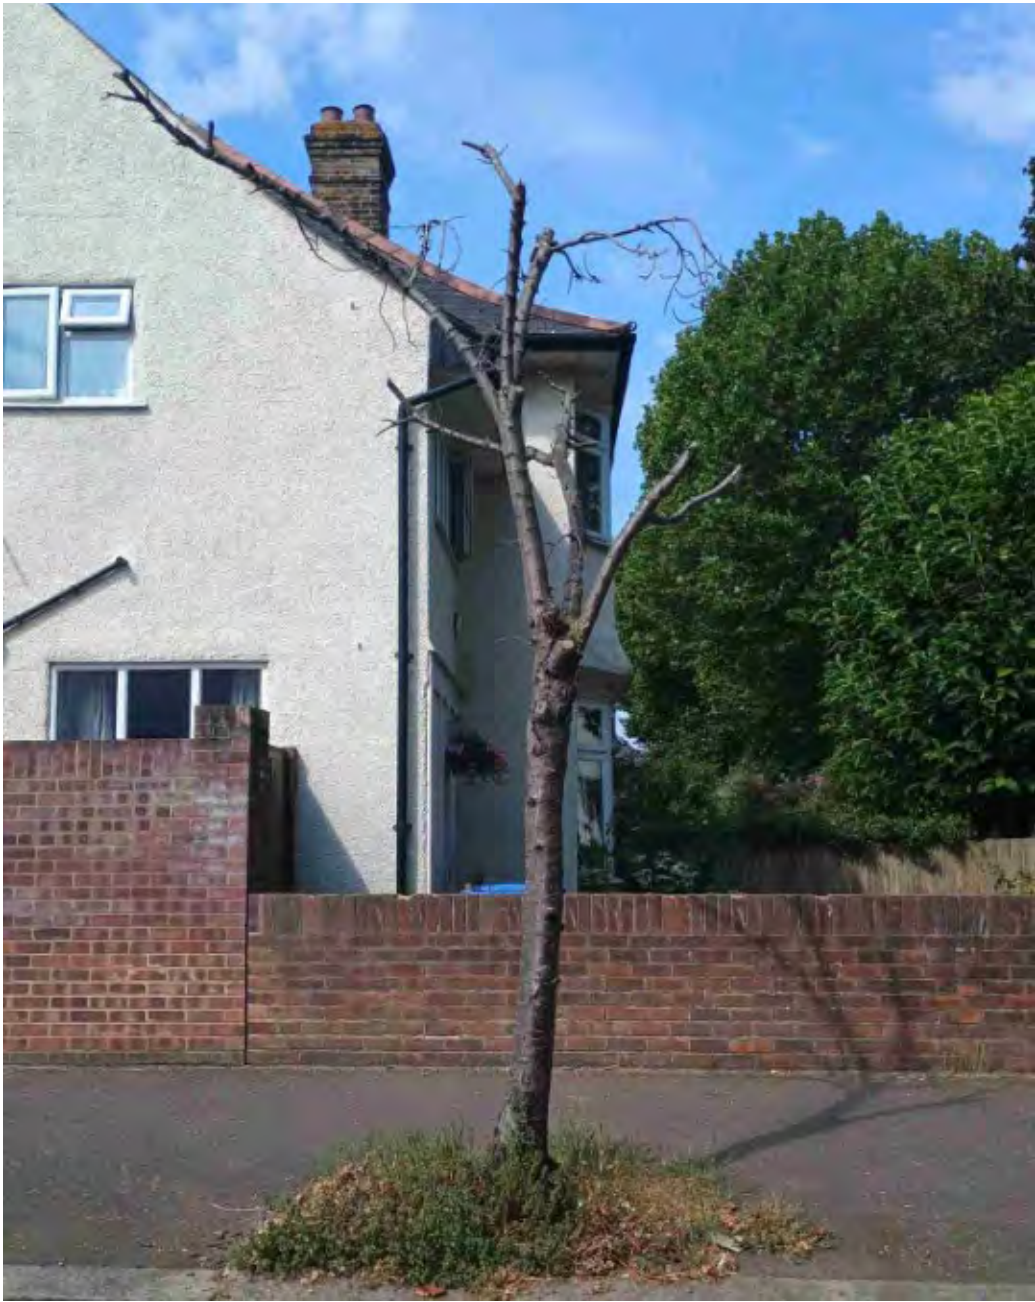
| Physiological Condition | Dead |
| Structural Condition | Poor |
| Inspection findings/reason for exemption | This tree is dead; removal is required to prevent natural failure, manage risk, and facilitate replanting. |

Image shows dead tree in street scene.

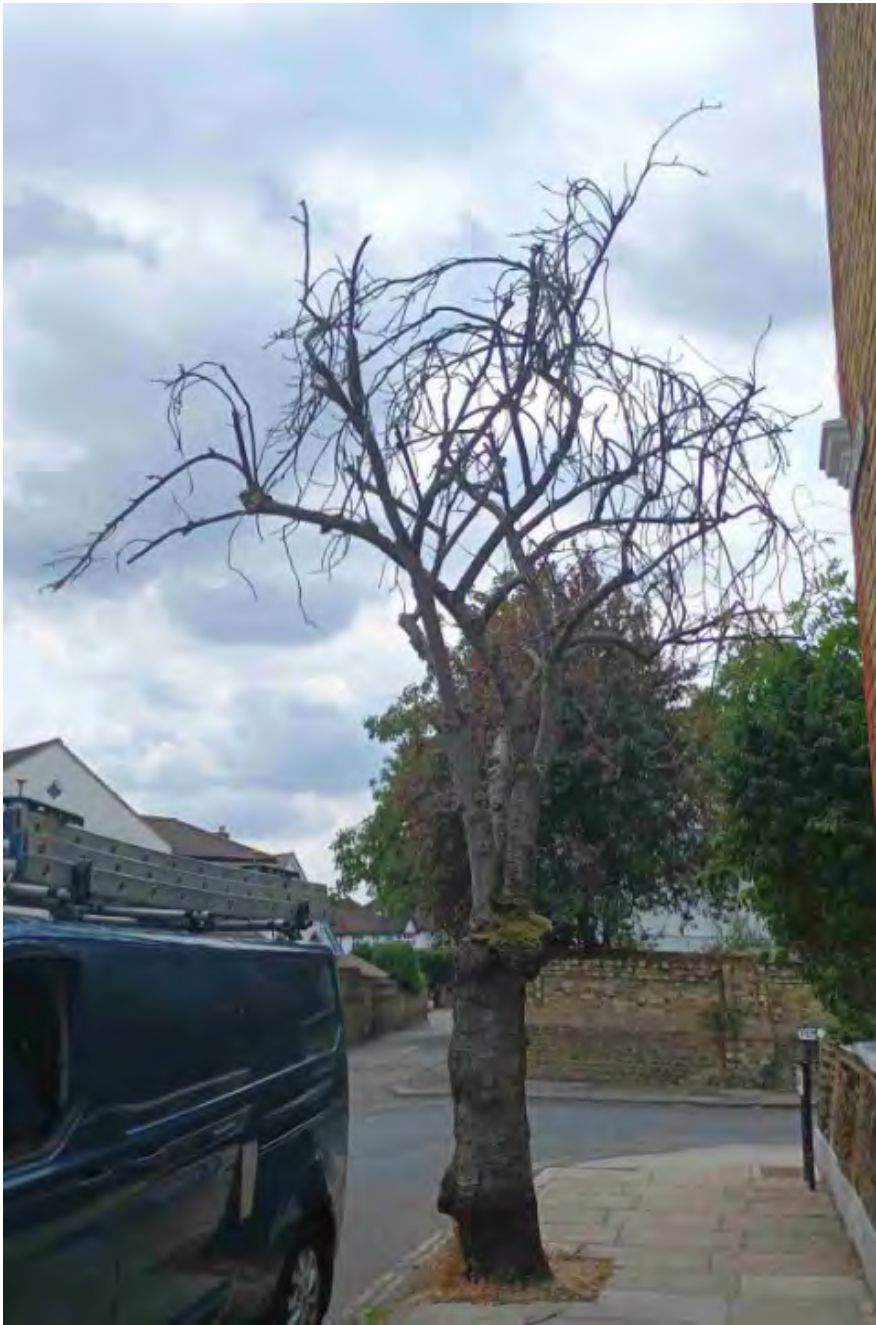
| Physiological Condition | Dead |
| Structural Condition | Poor |
| Inspection findings/reason for exemption | This tree is dead; removal is required to prevent natural failure, manage risk, and facilitate replanting. |

Image shows dead tree in street scene.

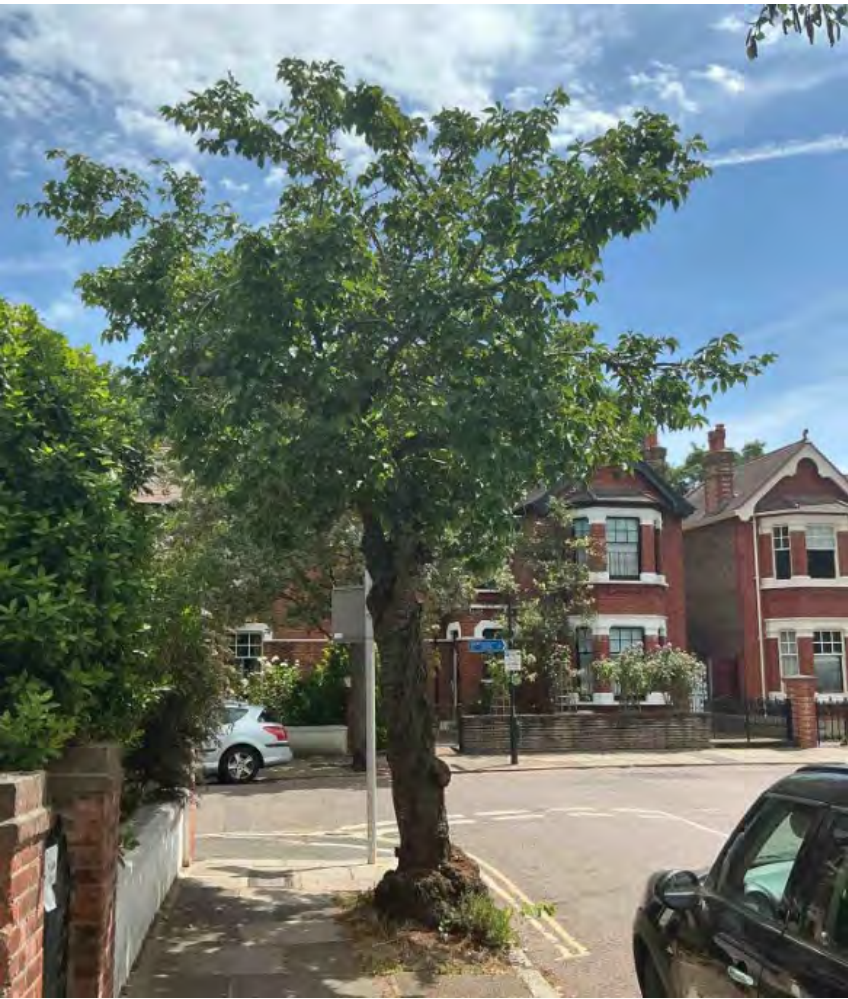
| Inspection findings/reason for exemption | A fungal fruiting body of the decay fungus <i>Ganoderma sp.</i> is present on the base of the trunk. Colonisation by this fungus results in white rot affecting the stem and root system, which can lead to structural failure through fracture or windthrow. A resonance test with a sounding hammer has revealed an unacceptable amount of decay around the bracket. Removal of the tree is recommended to prevent natural failure, manage risk, and facilitate replanting. |

Image shows tree in street scene.

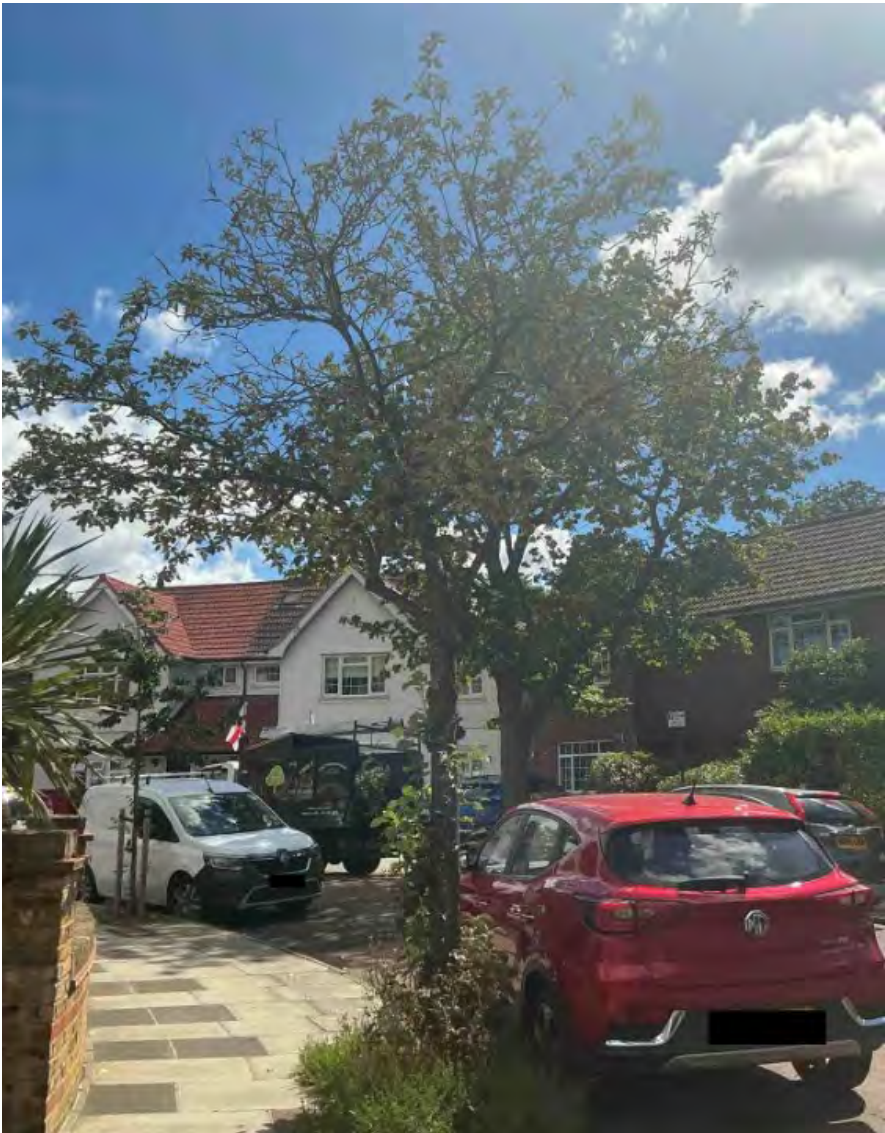
| Inspection findings/reason for exemption | A fungal fruiting body of the species Shaggy Polypore ( <i>Inonotus hispidus</i> ) is present on the trunk; this fungus causes a simultaneous white rot which can cause snapping of tree parts in this particular species. Removal of the tree is recommended to prevent natural failure, manage risk, and facilitate replanting. |

Image shows tree in street scene.

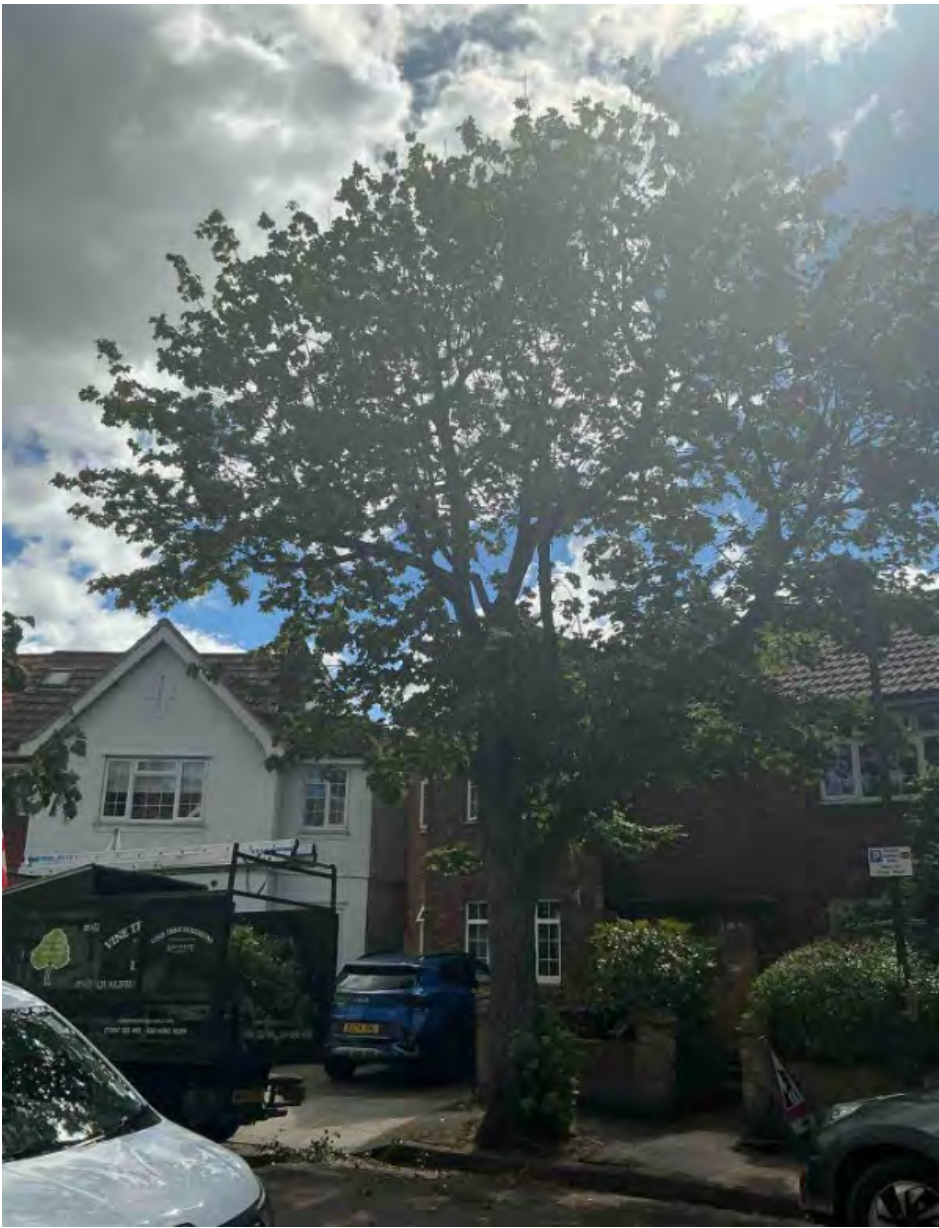
| Inspection findings/reason for exemption | Investigation by a resonance test with a sounding hammer has revealed an unacceptable amount of decay beyond the visible damage on the trunk. Removal is required to prevent natural failure, manage risk, and facilitate replanting. |

Image shows tree in street scene.

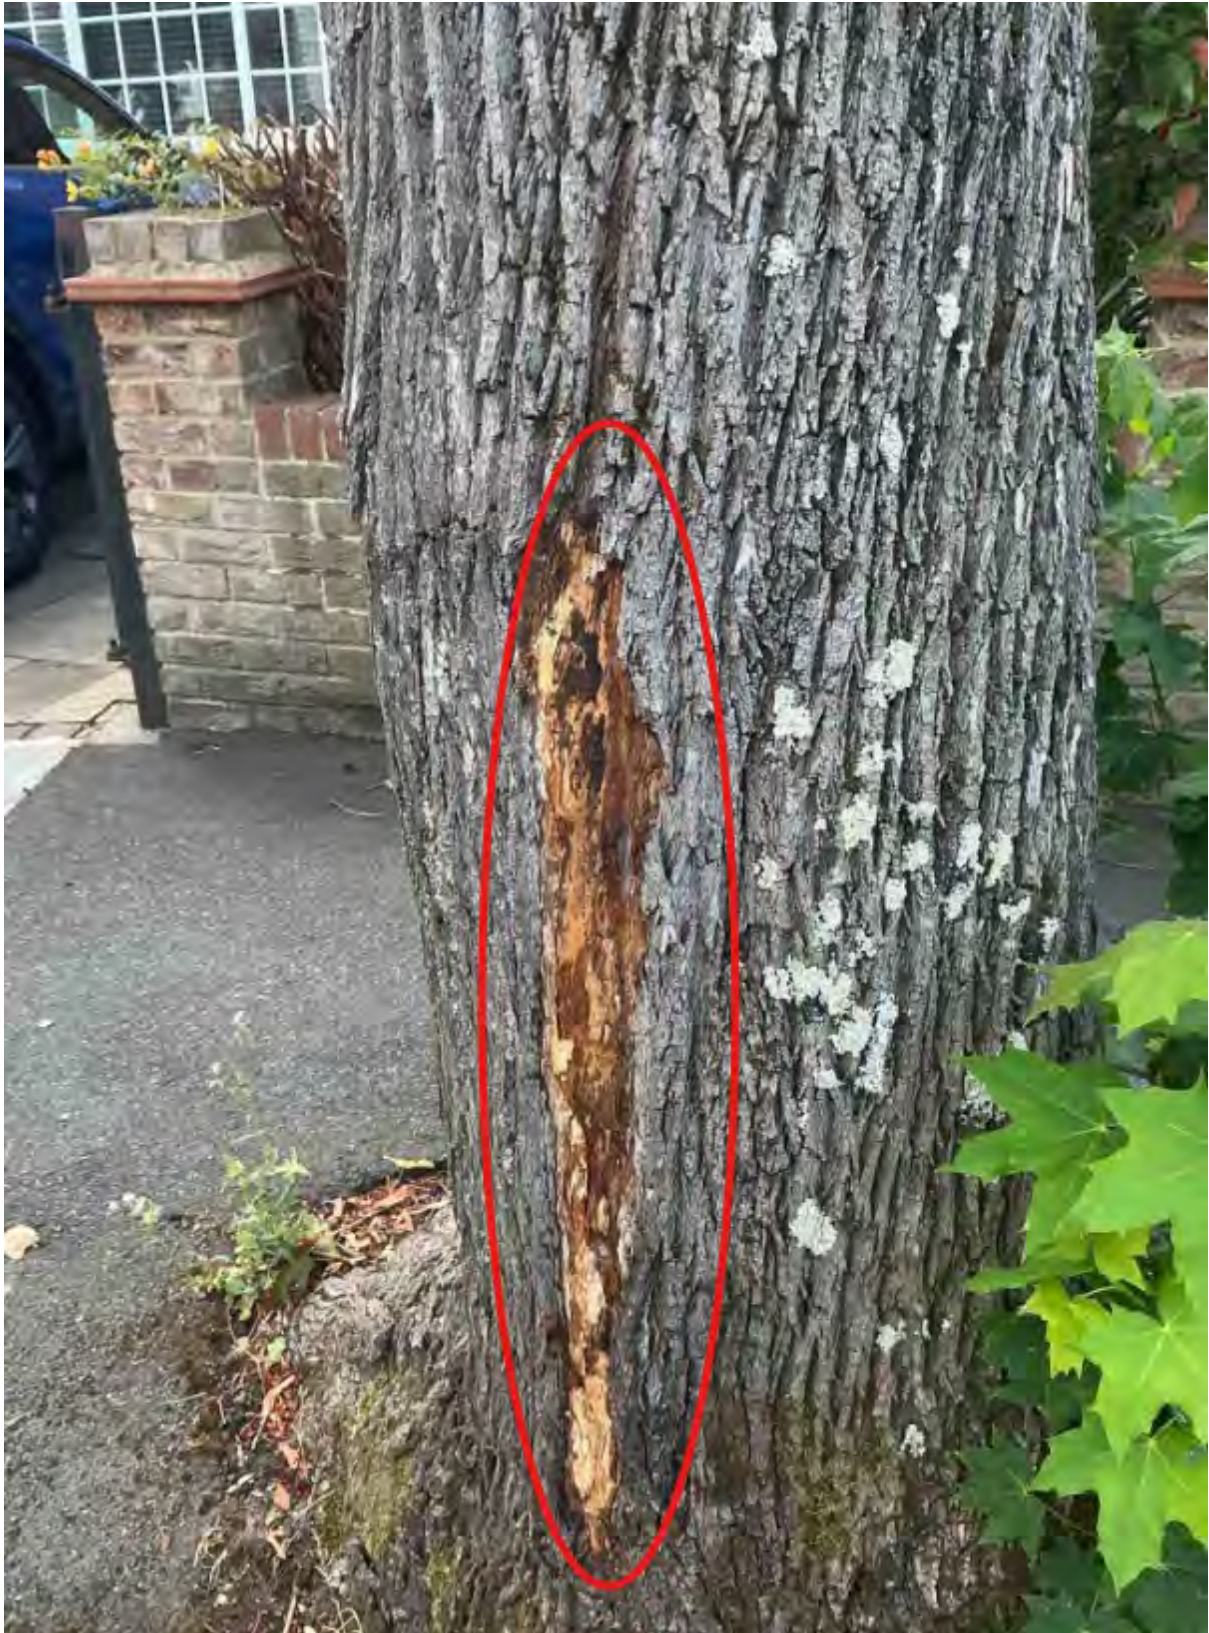
***Image shows damage on trunk circled.***

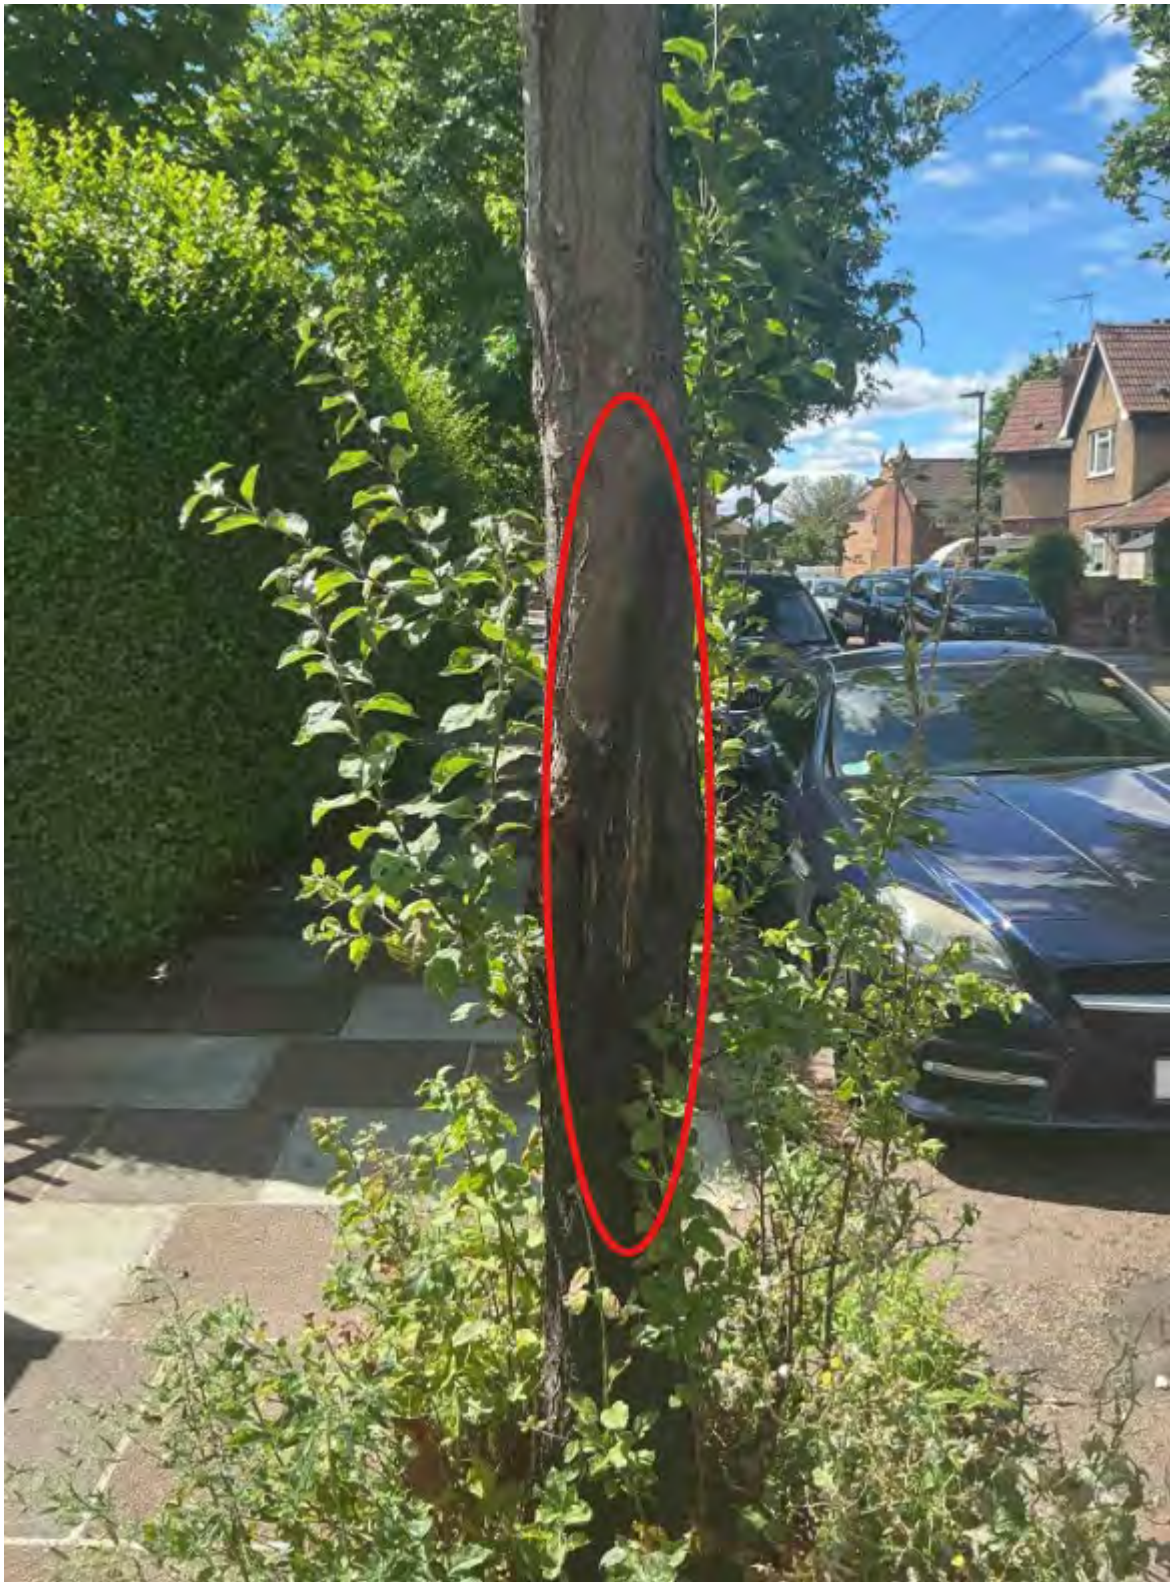
| Inspection findings/reason for exemption | Substantial wounding has occurred on the trunk and associated bark/vascular necrosis has taken place. Removal of the tree is recommended to prevent natural failure, manage risk, and facilitate replanting. |

***Image shows damage on trunk circled.***

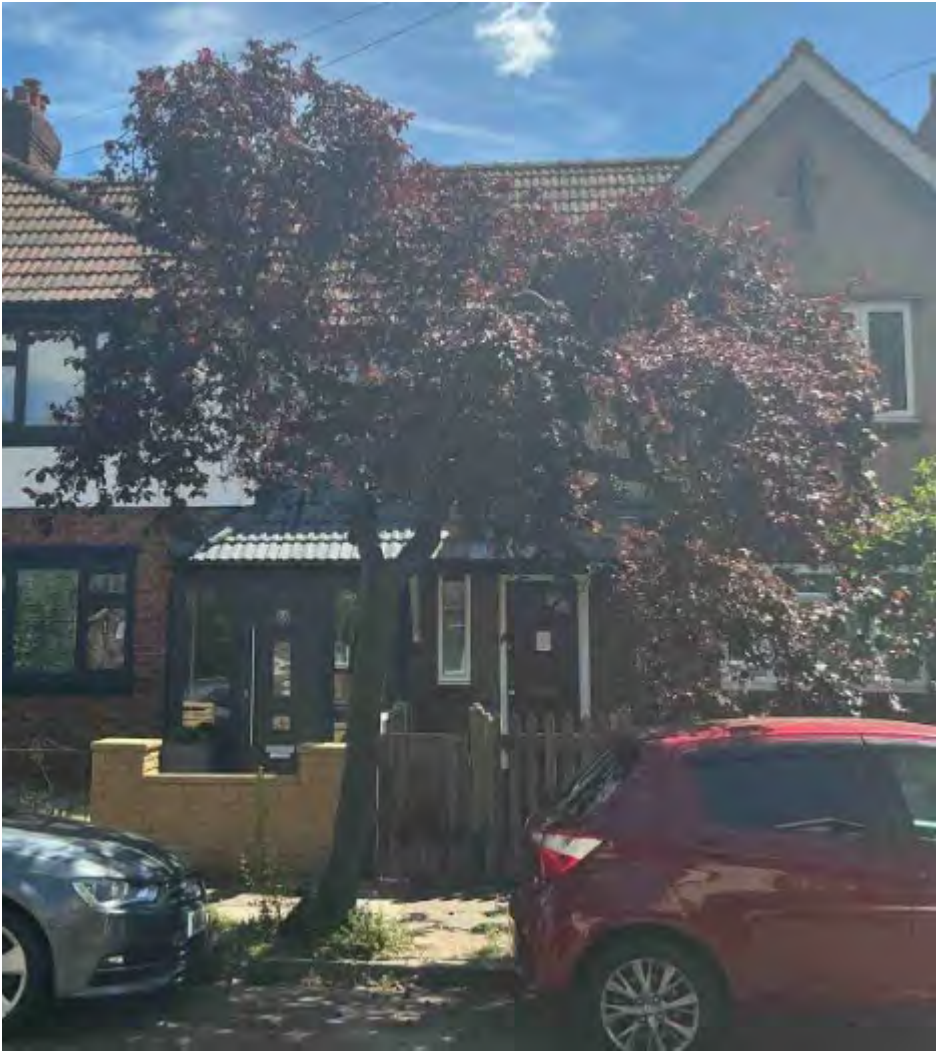
| Inspection findings/reason for exemption | Investigation with a probe and a resonance test with a sounding hammer has revealed an unacceptable amount of decay beyond the visible cavities at the base of the trunk. Removal is required to prevent natural failure, manage risk, and facilitate replanting. |

Image shows tree in street scene.

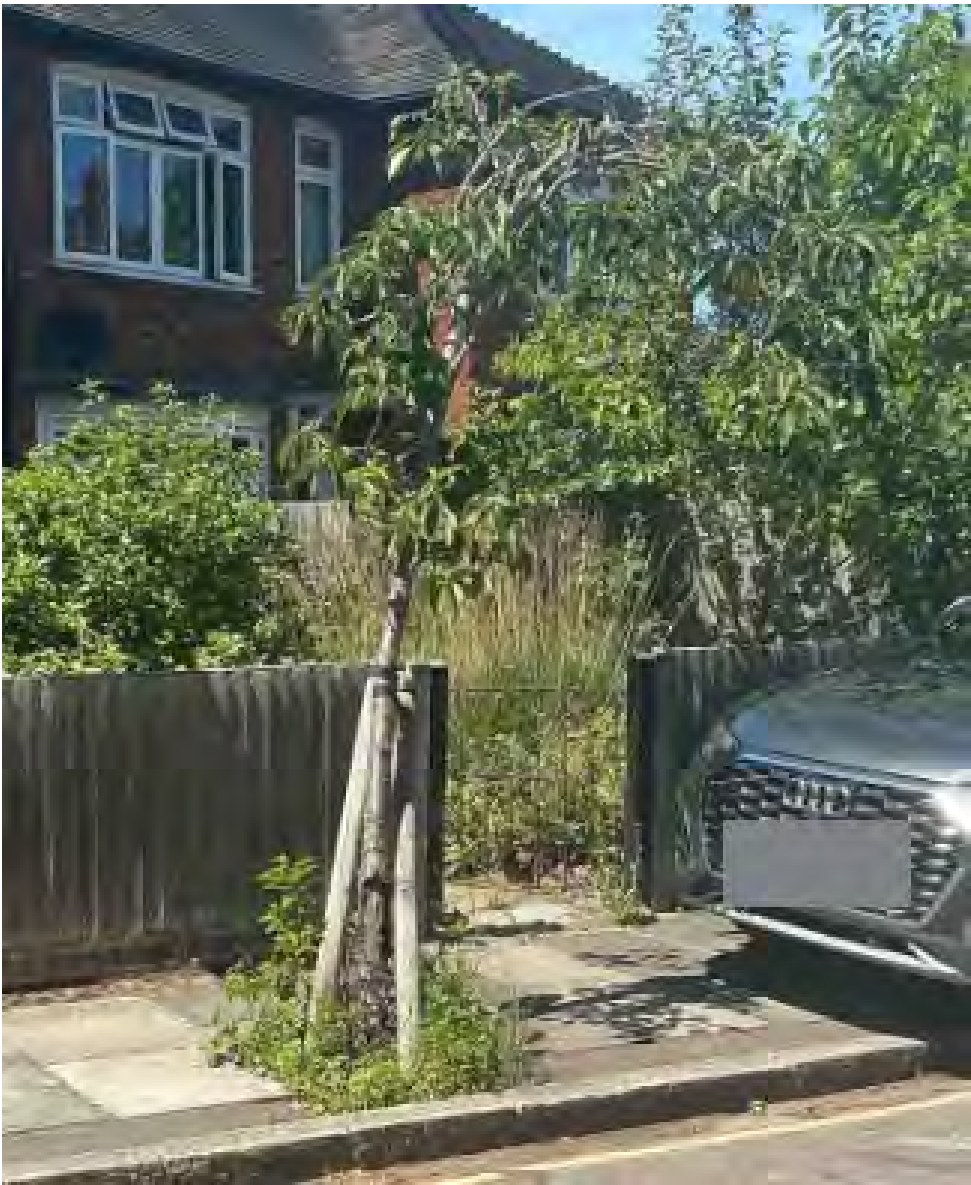
| Inspection findings/reason for exemption | This tree has an unacceptable movement at root plate and has become unstable. Removal is required to prevent natural failure, manage risk, and facilitate replanting |

Image shows tree in street scene.

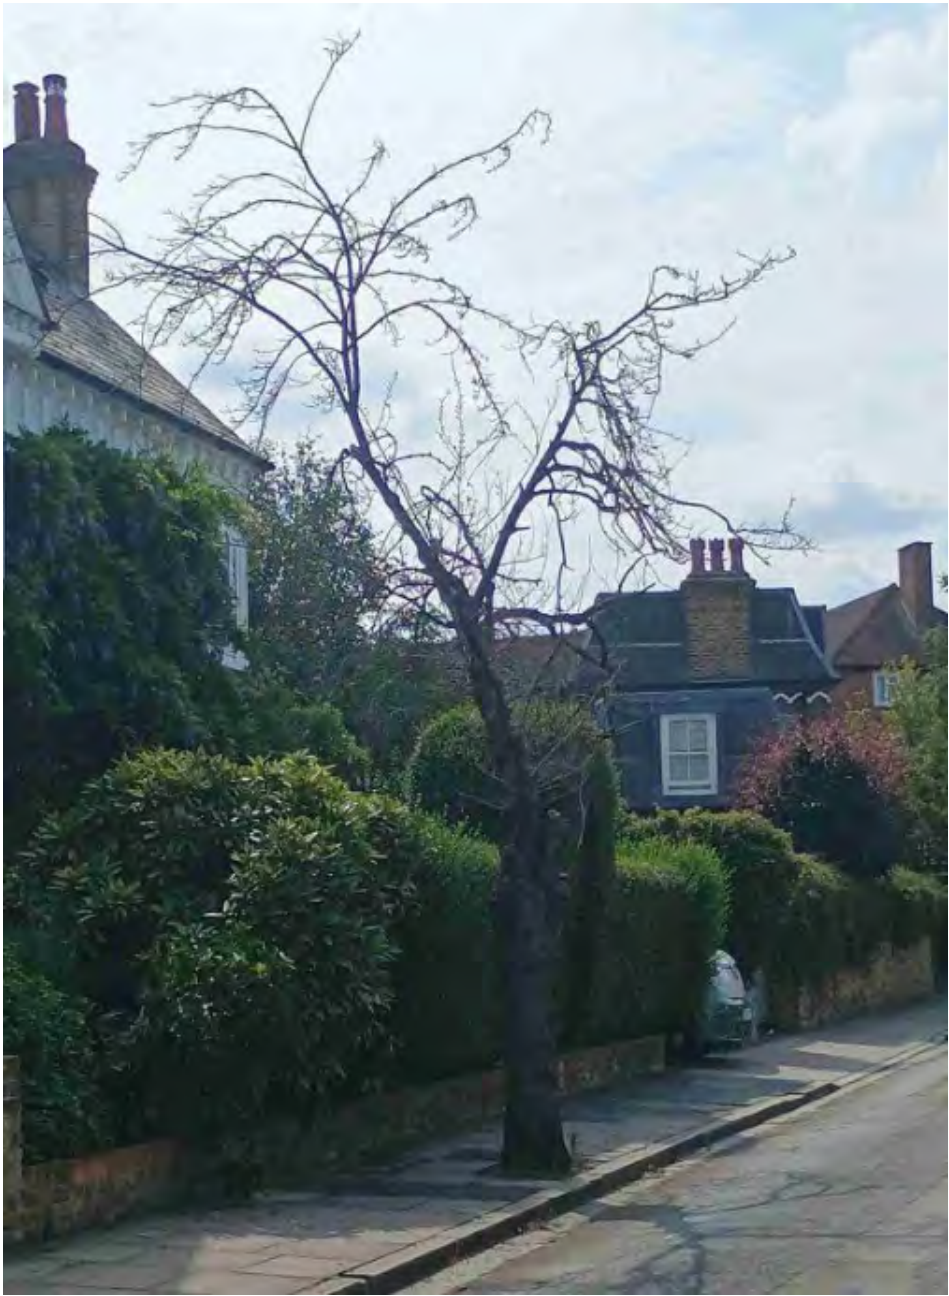
| Inspection findings/reason for exemption | This tree is dead; removal is required to prevent natural failure, manage risk, and facilitate replanting |

Image shows dead tree in street scene.

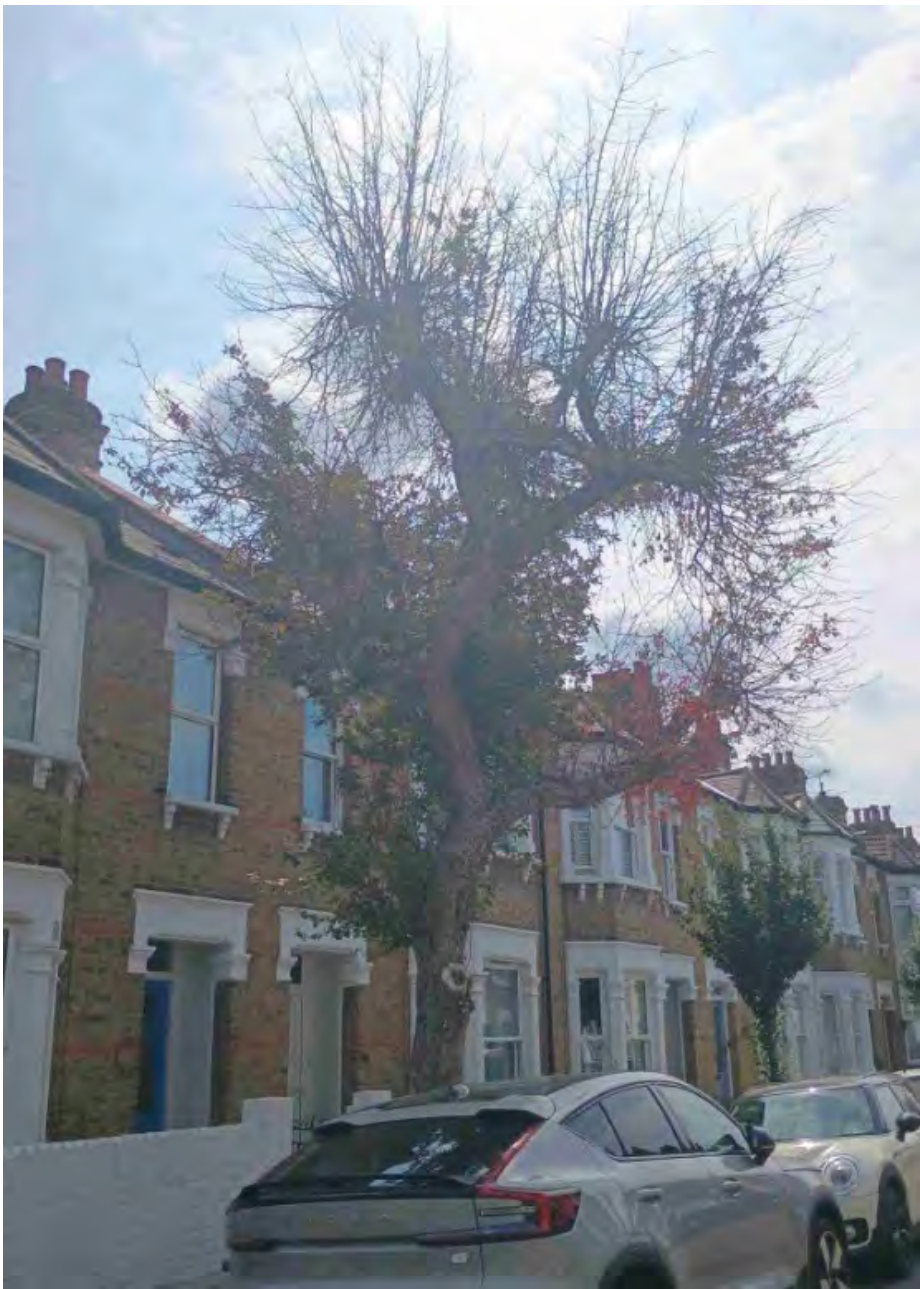
| Inspection findings/reason for exemption | This tree is moribund; removal is required to prevent natural failure, manage risk, and facilitate replanting |

Image shows moribund tree in street scene.

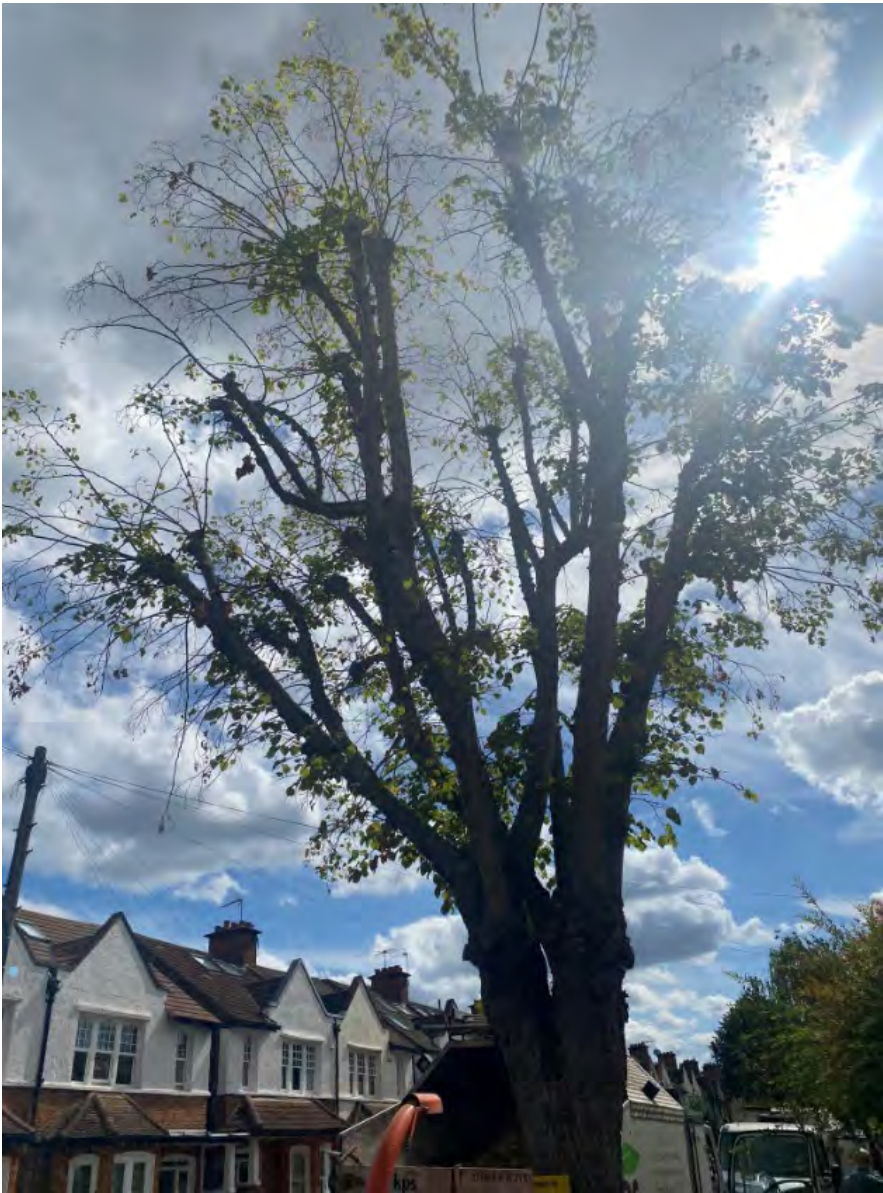
| Inspection findings/reason for exemption | This tree is moribund; removal is required to prevent natural failure, manage risk, and facilitate replanting |

Image shows moribund tree in street scene.

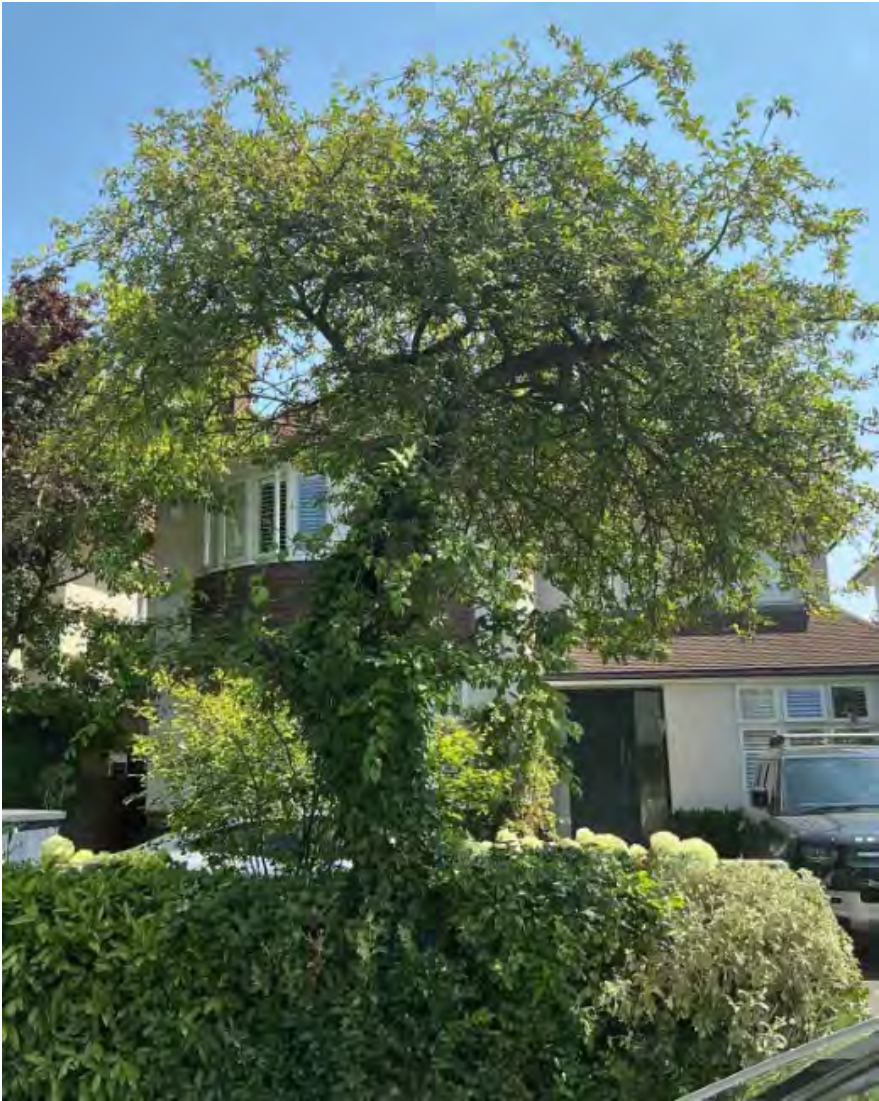
| Inspection findings/reason for exemption | A fungal fruiting body of the species Shaggy Polypore ( <i>Inonotus hispidus</i> ) is present on the main stem; this fungus causes a simultaneous white rot which can cause snapping of tree parts in this particular species. Removal is required to prevent natural failure, manage risk, and facilitate replanting |

Image shows tree in street scene.

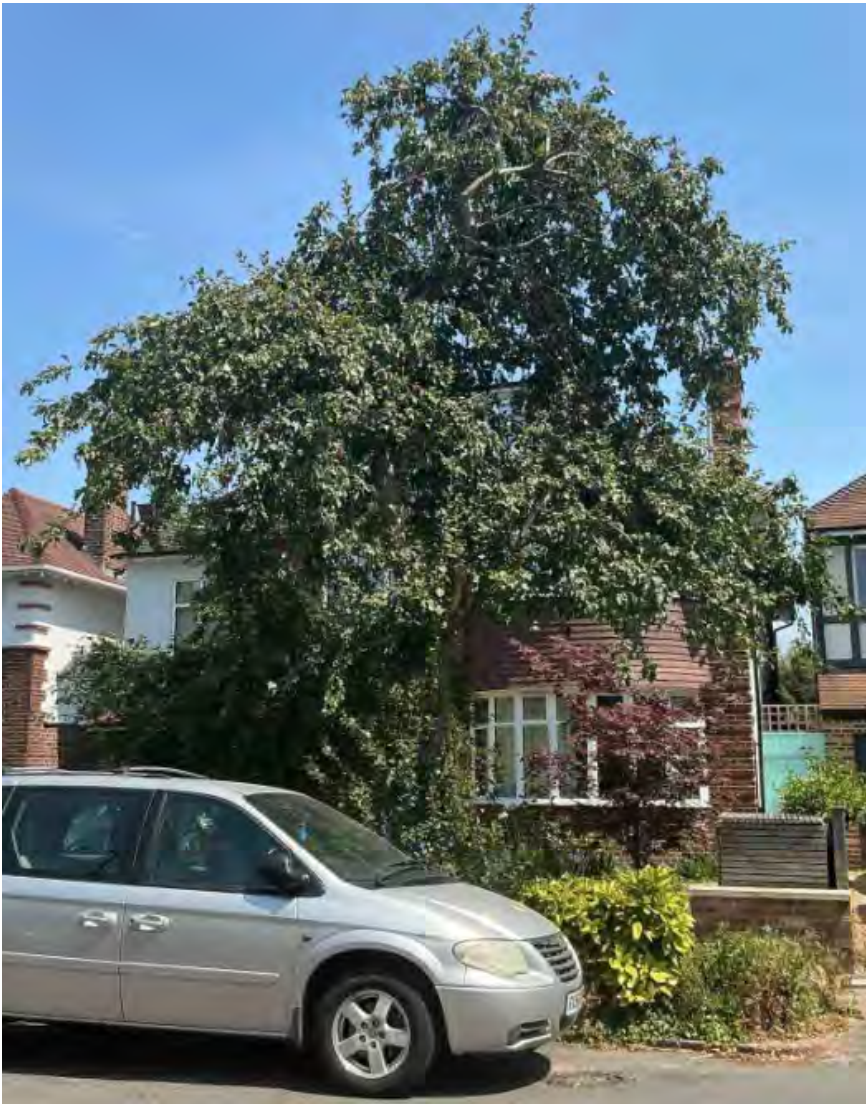
| Inspection findings/reason for exemption | A fungal fruiting body of the species Shaggy Polypore ( <i>Inonotus hispidus</i> ) is present within the crown. This fungus causes a simultaneous white rot which can result in the failure of branches and other tree parts in this species. Following a previous branch failure and the extent of fungal colonisation, removal is required to manage the risk of further failure and facilitate replanting. |

Image shows dead tree in street scene.
