# August 2026 - Reactive Tree Works Programme

A survey of trees in the Kew, South Richmond and Whitton wards are currently being undertaken; this is being conducted by specialist arboricultural officers as part of the scheduled 4 yearly detailed inspection regime that has been devised for all Council highway and parks trees.

Recent reactive inspections have identified the need for 106 individual tree work operations to take place. This work will now be issued to the Council’s Arborist Contractor KPS, for completion over the Autumn period.

The following pages provide the locations of each tree that is to be removed, in addition photographs and descriptions of the inspection findings have been provided.

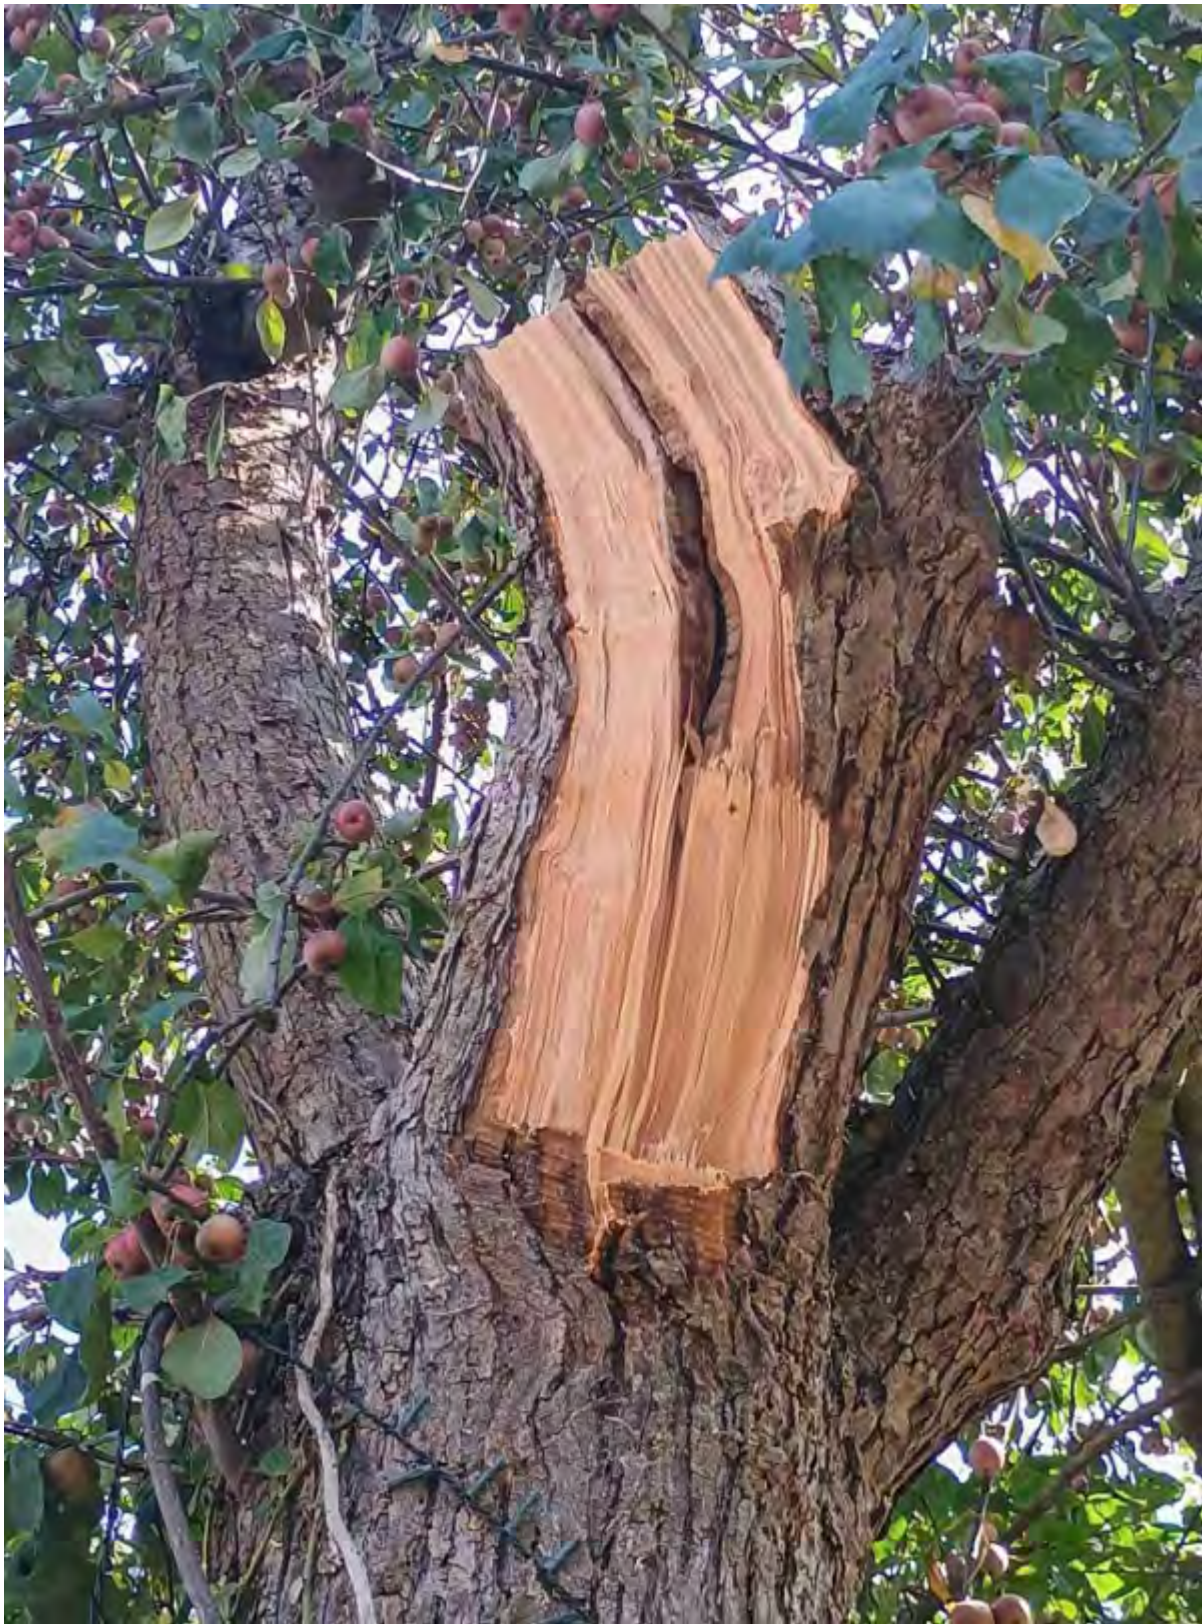
*Image shows fracture wound from branch failure.*

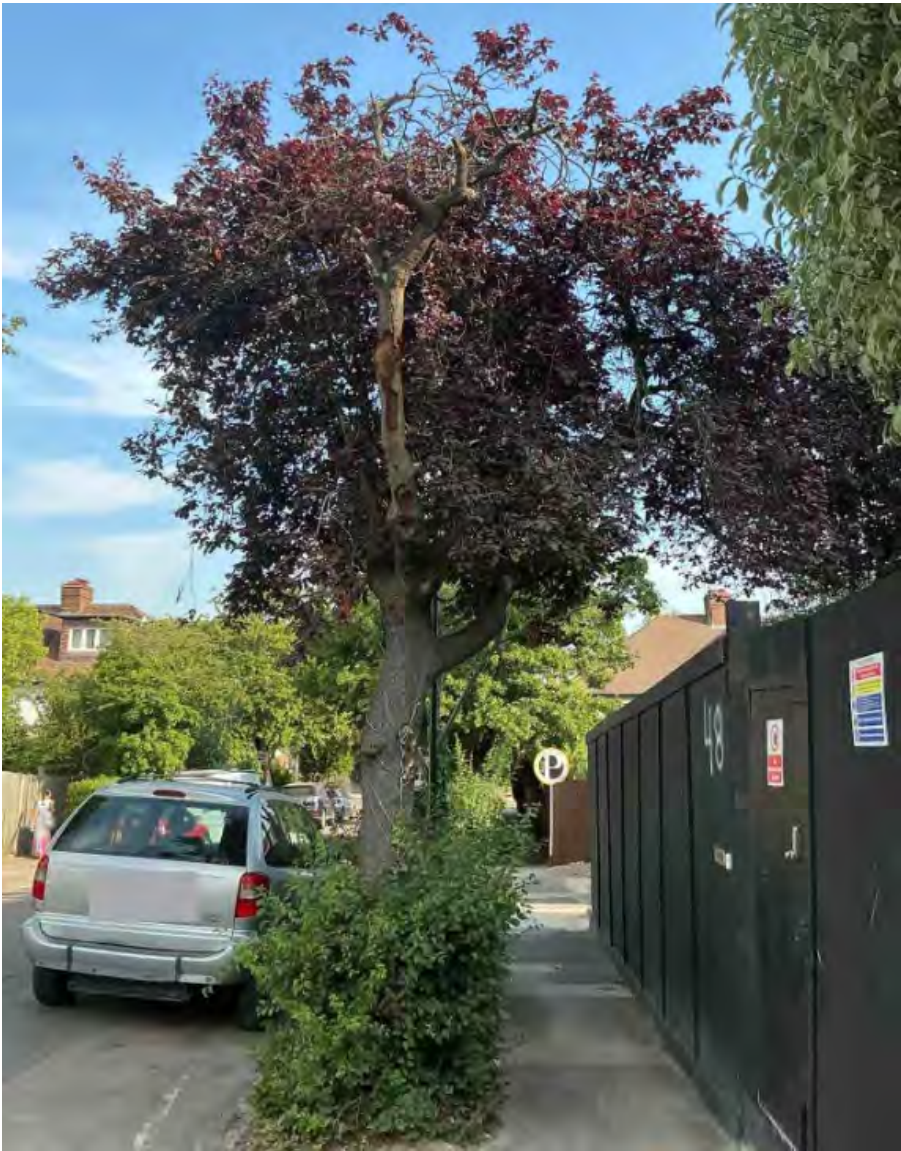
| Inspection findings/reason for exemption | Investigation using a probe and a resonance test with a sounding hammer has revealed an unacceptable extent of decay beyond the visible cavities on the trunk. The presence of crown dieback is consistent with this condition. Removal is required to prevent natural failure, manage risk, and facilitate replanting. |

Image shows tree in street scene.

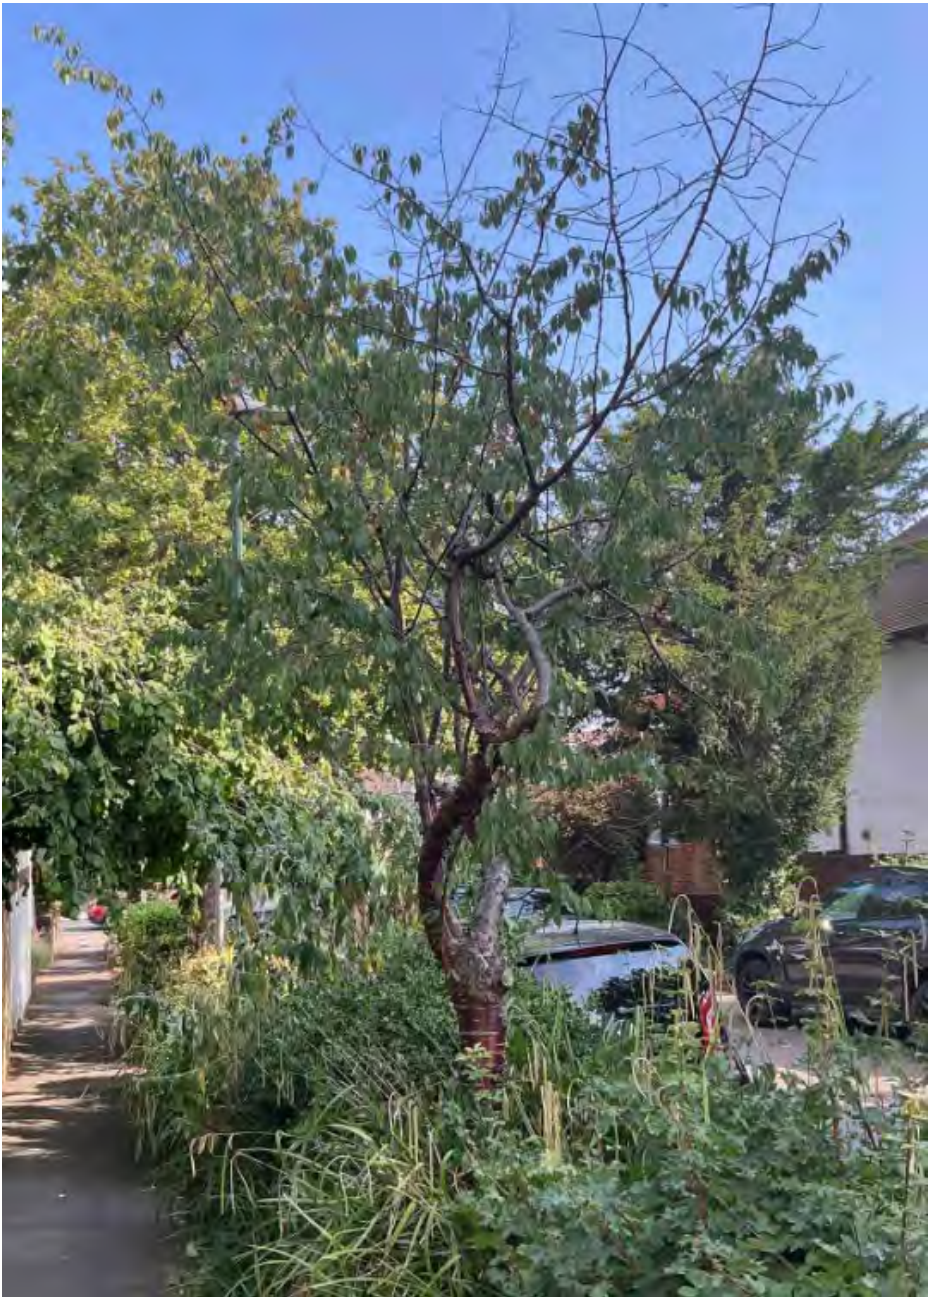
| Inspection findings/reason for exemption | This tree is moribund; removal is required to prevent natural failure, manage risk, and facilitate replanting |

Image shows moribund tree in street scene.

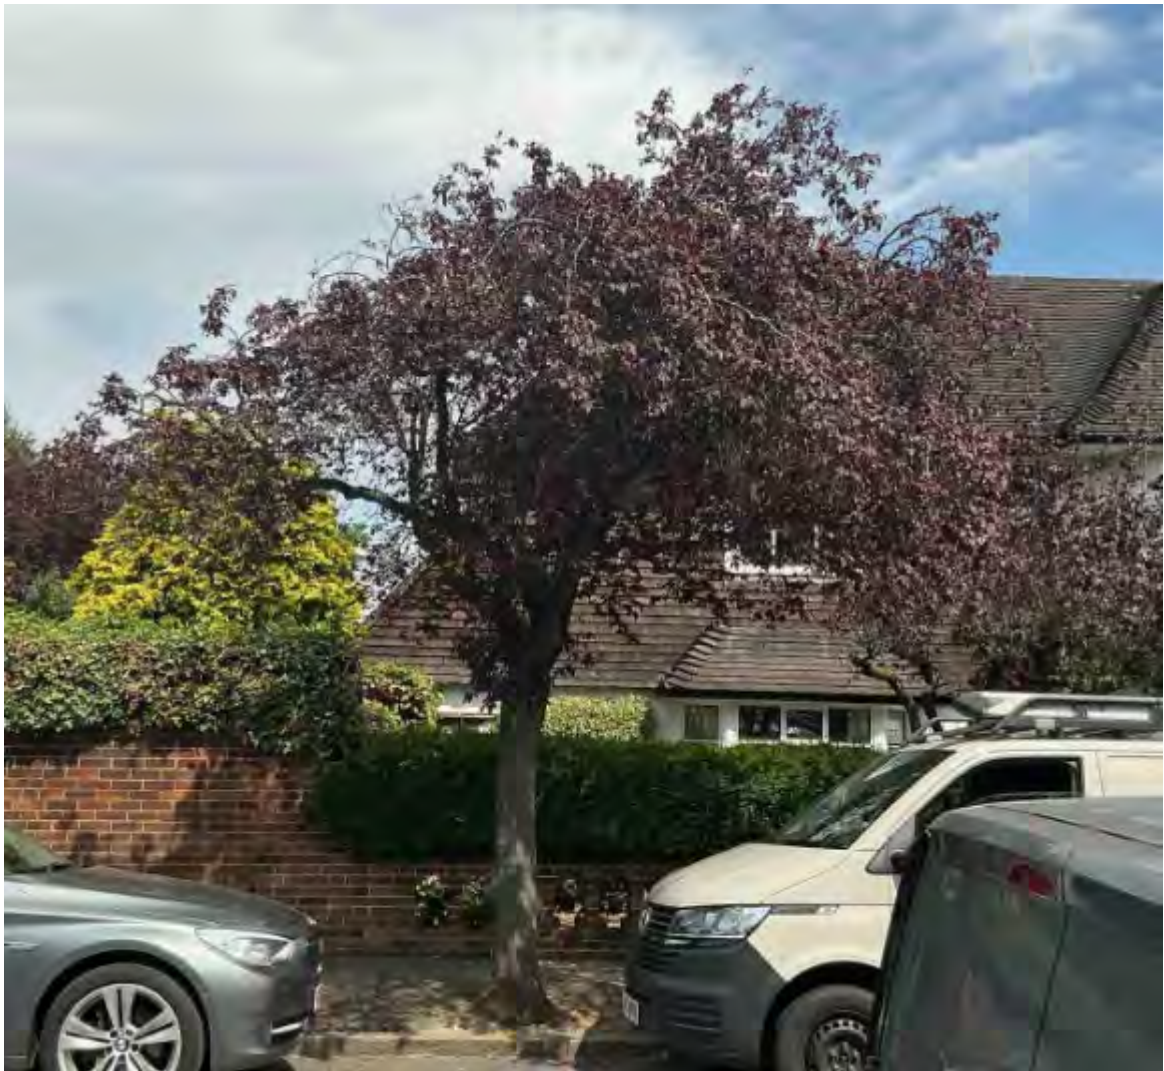
| Inspection findings/reason for exemption | Investigation with a probe and a resonance test with a sounding hammer has revealed an unacceptable amount of decay beyond the visible cavities at the base of the trunk. Removal is required to prevent natural failure, manage risk, and facilitate replanting. |

Image shows in street scene.

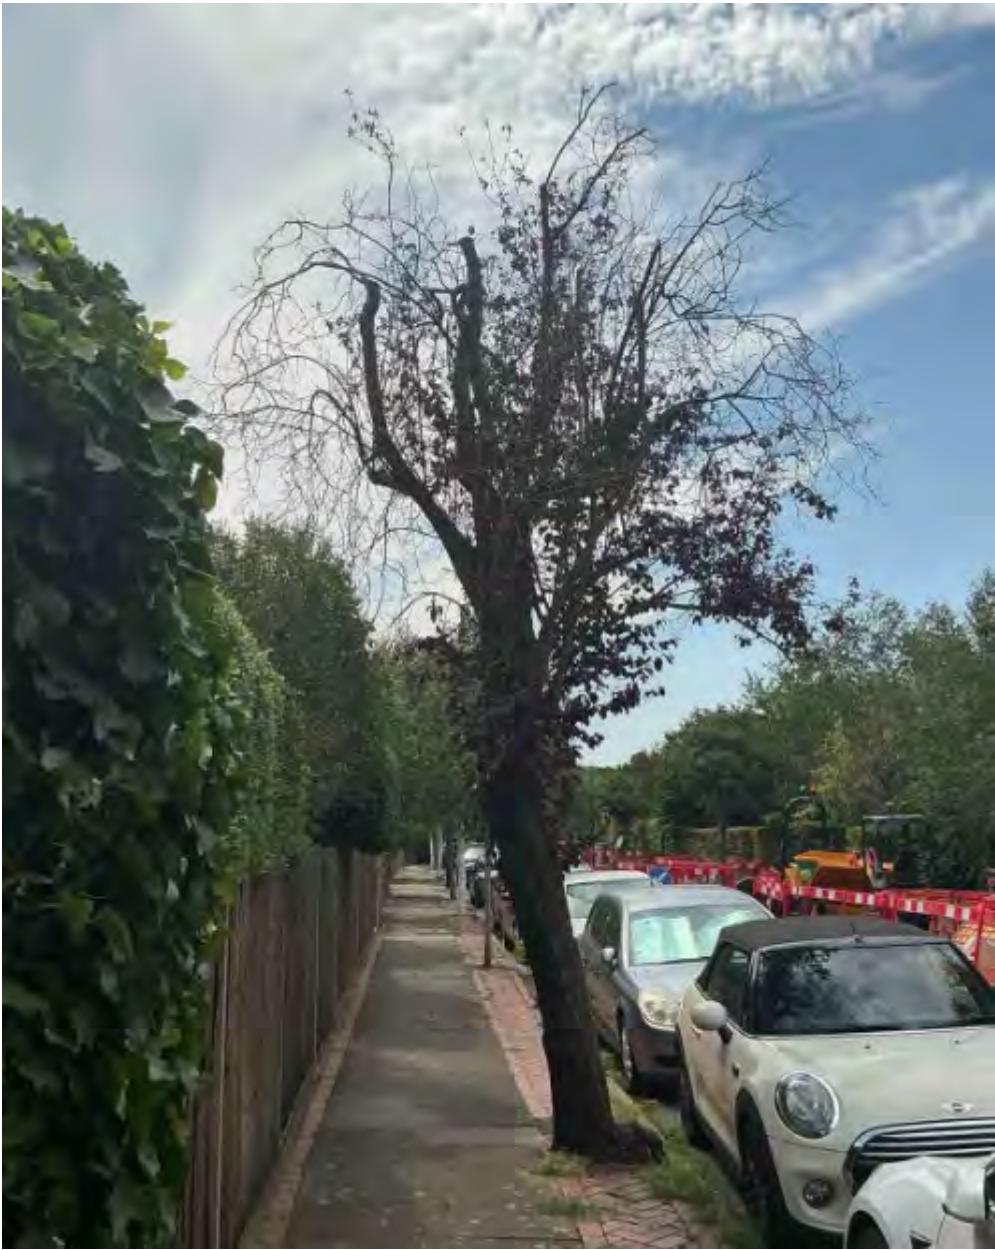
| Inspection findings/reason for exemption | This tree is moribund; removal is required to prevent natural failure, manage risk, and facilitate replanting. |

Image shows dead tree in street scene.

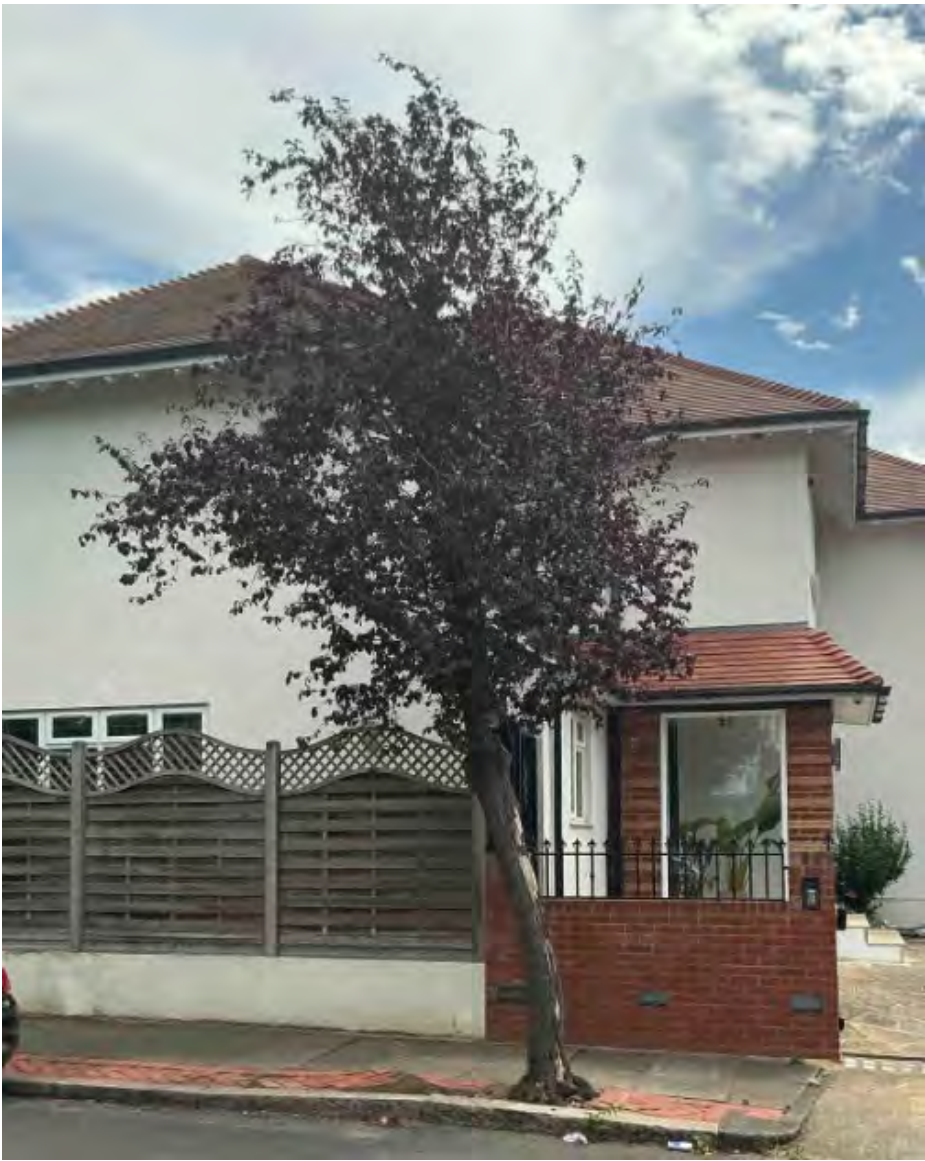
| Inspection findings/reason for exemption | Bark necrosis is present on the stem of this tree; the decline of the trees vascular system correlates with crown dieback. Removal is required to prevent natural failure, manage risk, and facilitate replanting |

Image shows moribund tree in street scene.

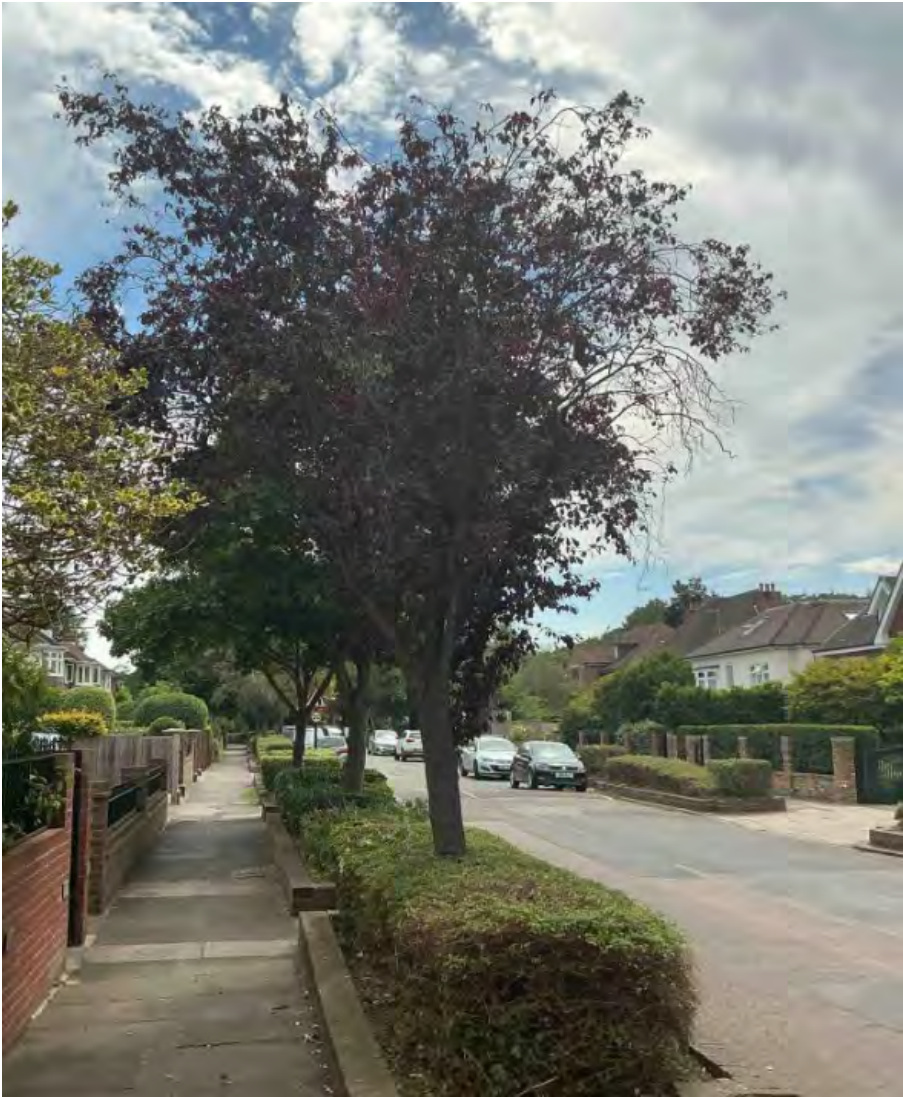
| Inspection findings/reason for exemption | Fungal fruiting bodies of the cushion fungus ( <i>Phellinus pomaceus</i> ) is present throughout the crown of this tree. This fungus causes a crumbly white rot that commonly causes this species of tree to snap. Crown dieback also correlates with this. Removal is required to prevent natural failure, manage risk, and facilitate replanting |

Image shows tree in street scene.

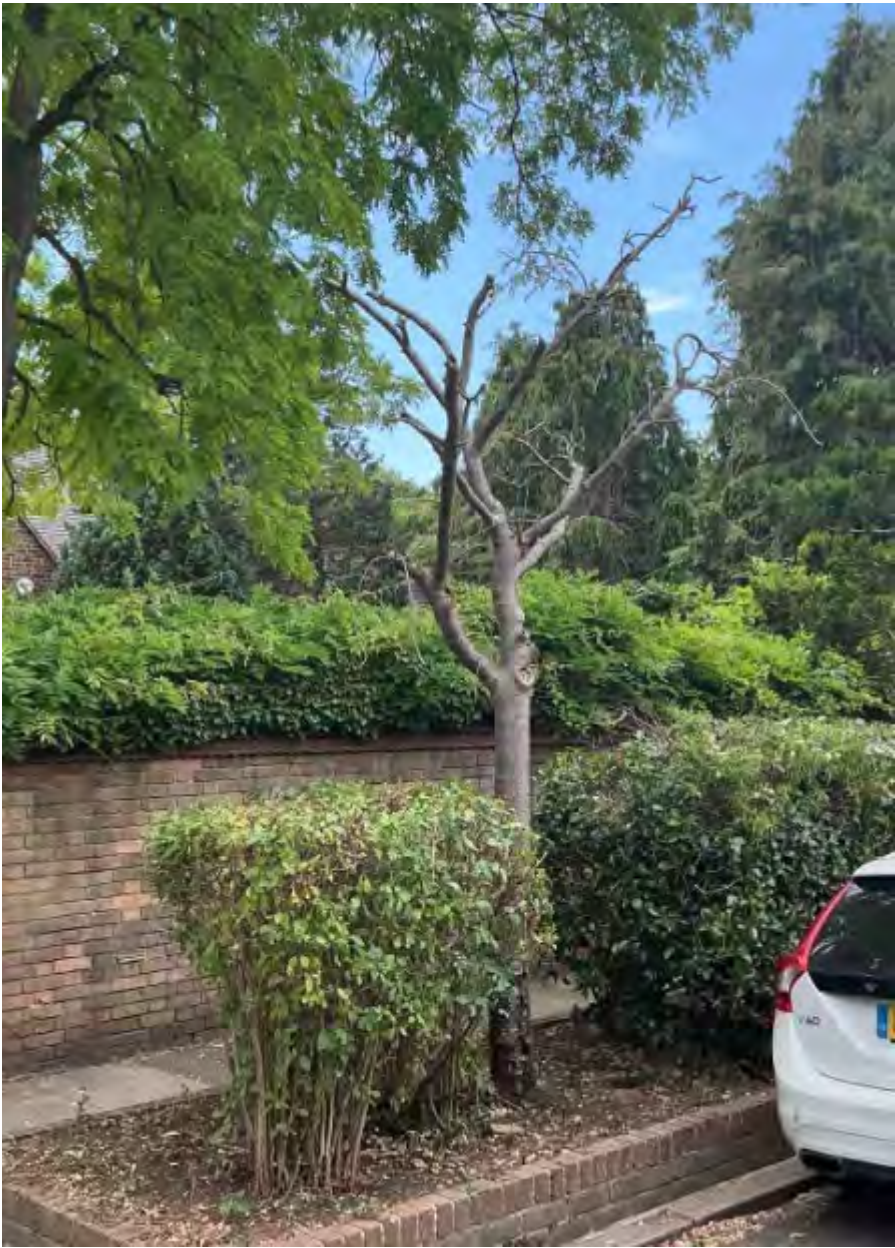
| Inspection findings/reason for exemption | This tree is dead; removal is required to prevent natural failure, manage risk, and facilitate replanting |

Image shows dead tree in street scene.

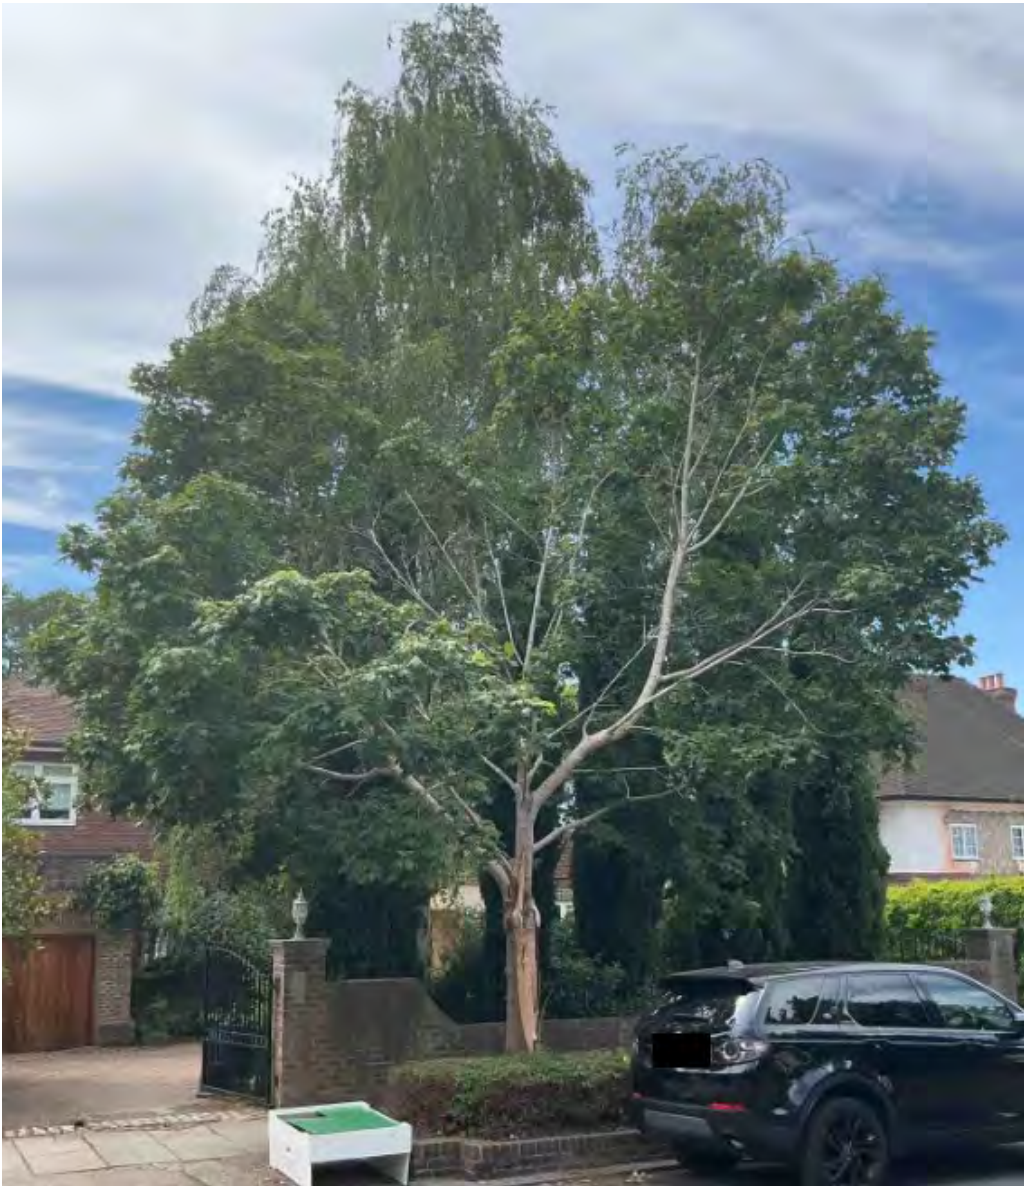
| Inspection findings/reason for exemption | This tree has had trunk failure. Removal is required to prevent further natural failure, manage risk, and facilitate replanting |

Image shows tree in street scene.

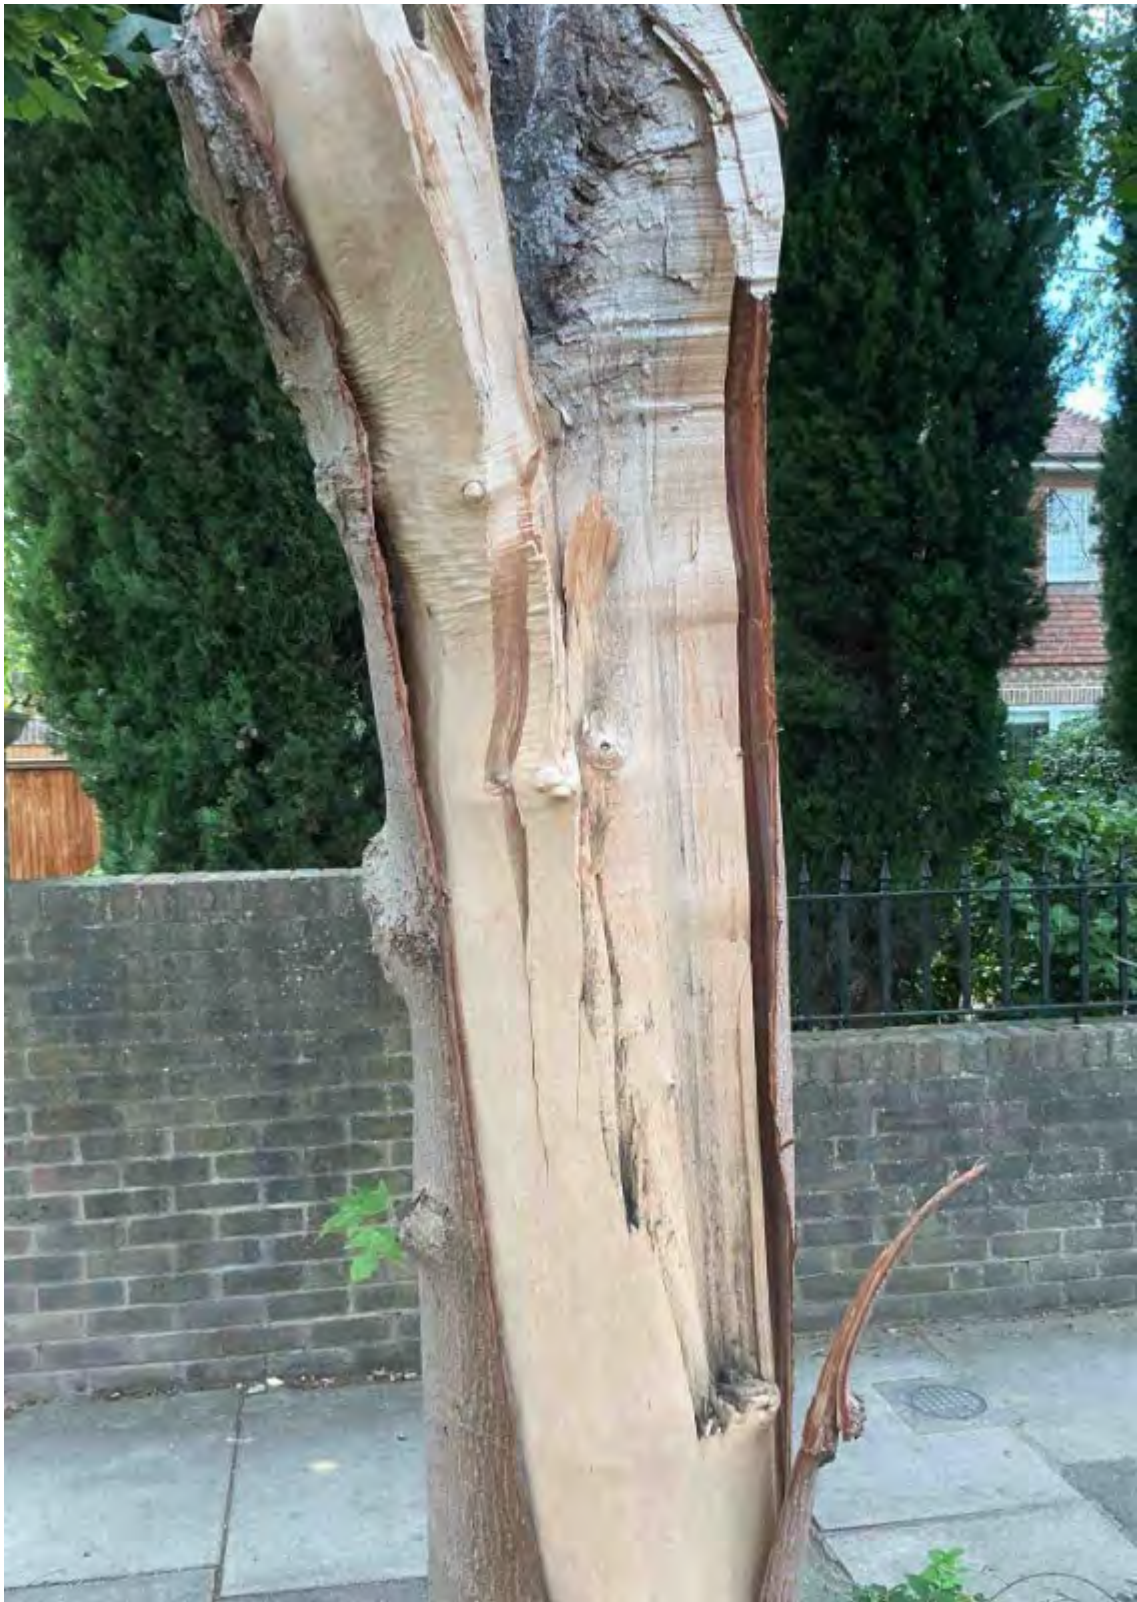
*Image shows tear wound on trunk from union failure.*

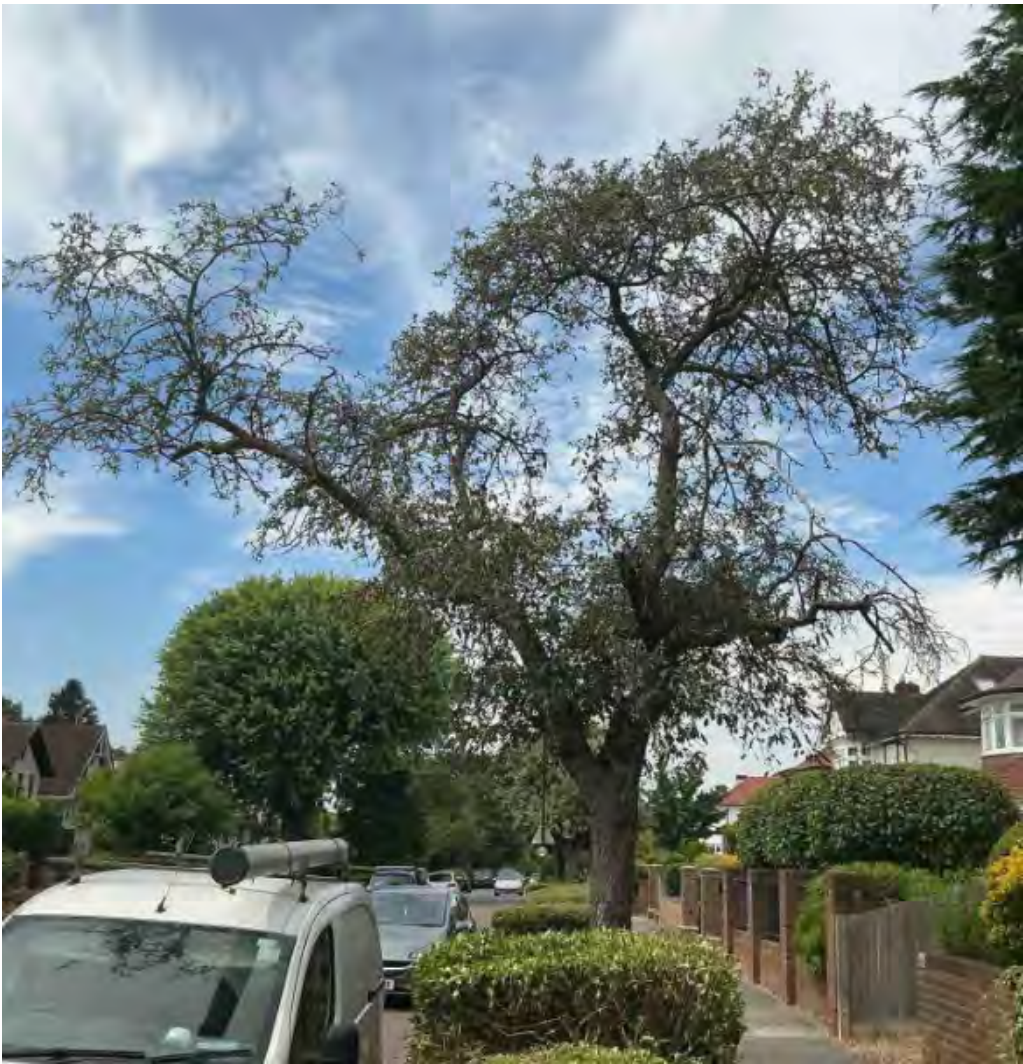
| Inspection findings/reason for exemption | A fungal fruiting body of the species Shaggy Polypore ( <i>Inonotus hispidus</i> ) is present within the crown. This fungus causes a simultaneous white rot which can result in the failure of branches and other tree parts in this species. There is die back of the crown indicating poor condition which correlates with the presence of the pathogen. Removal is required to manage the risk of further failure and facilitate replanting. |

Image shows tree in street scene with die back of the crown.

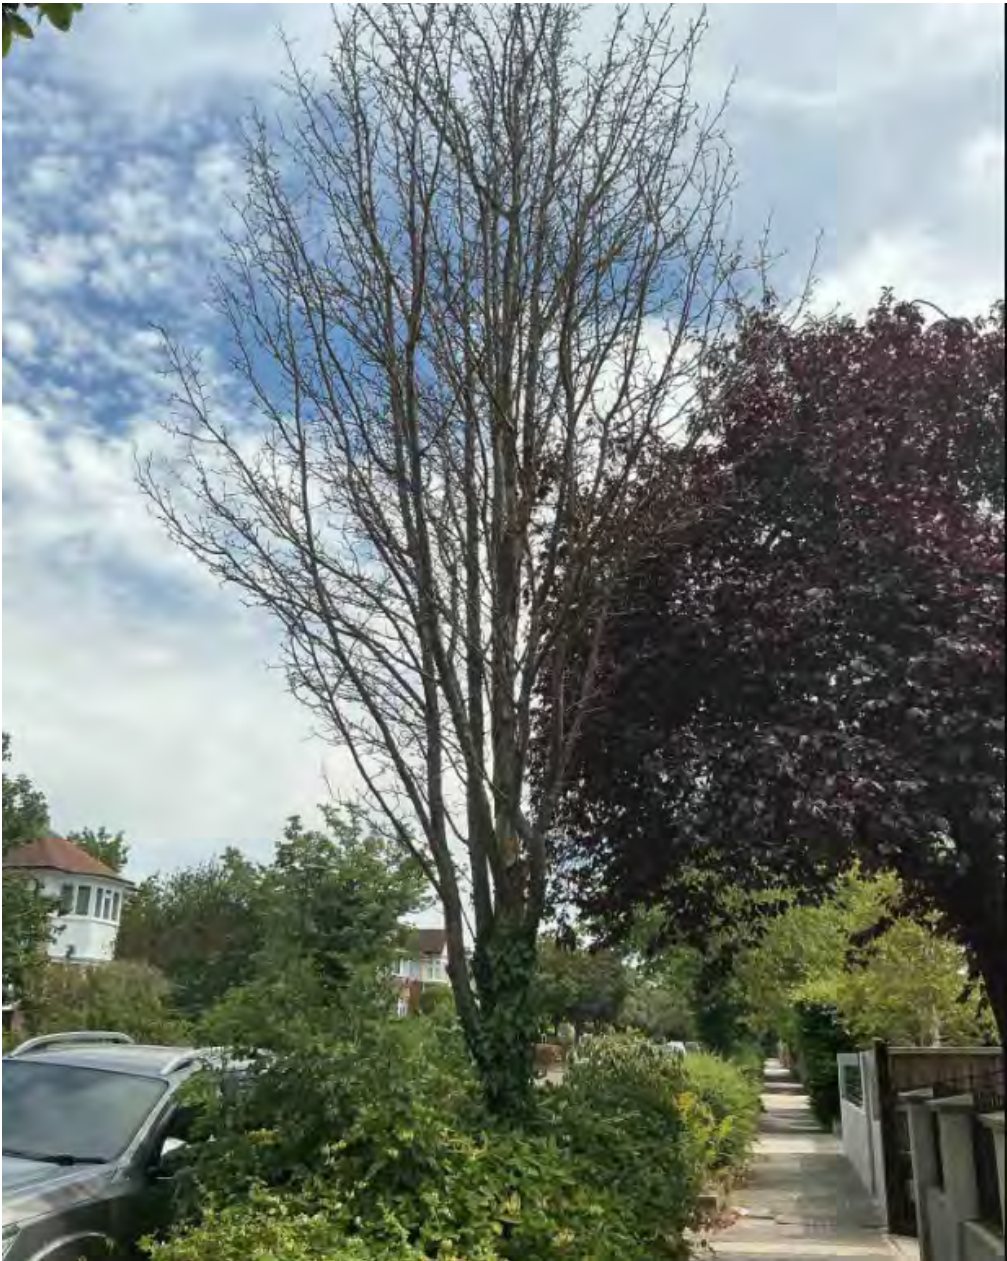
| Inspection findings/reason for exemption | This tree is dead; removal is required to prevent natural failure, manage risk, and facilitate replanting |

Image shows dead tree in street scene.

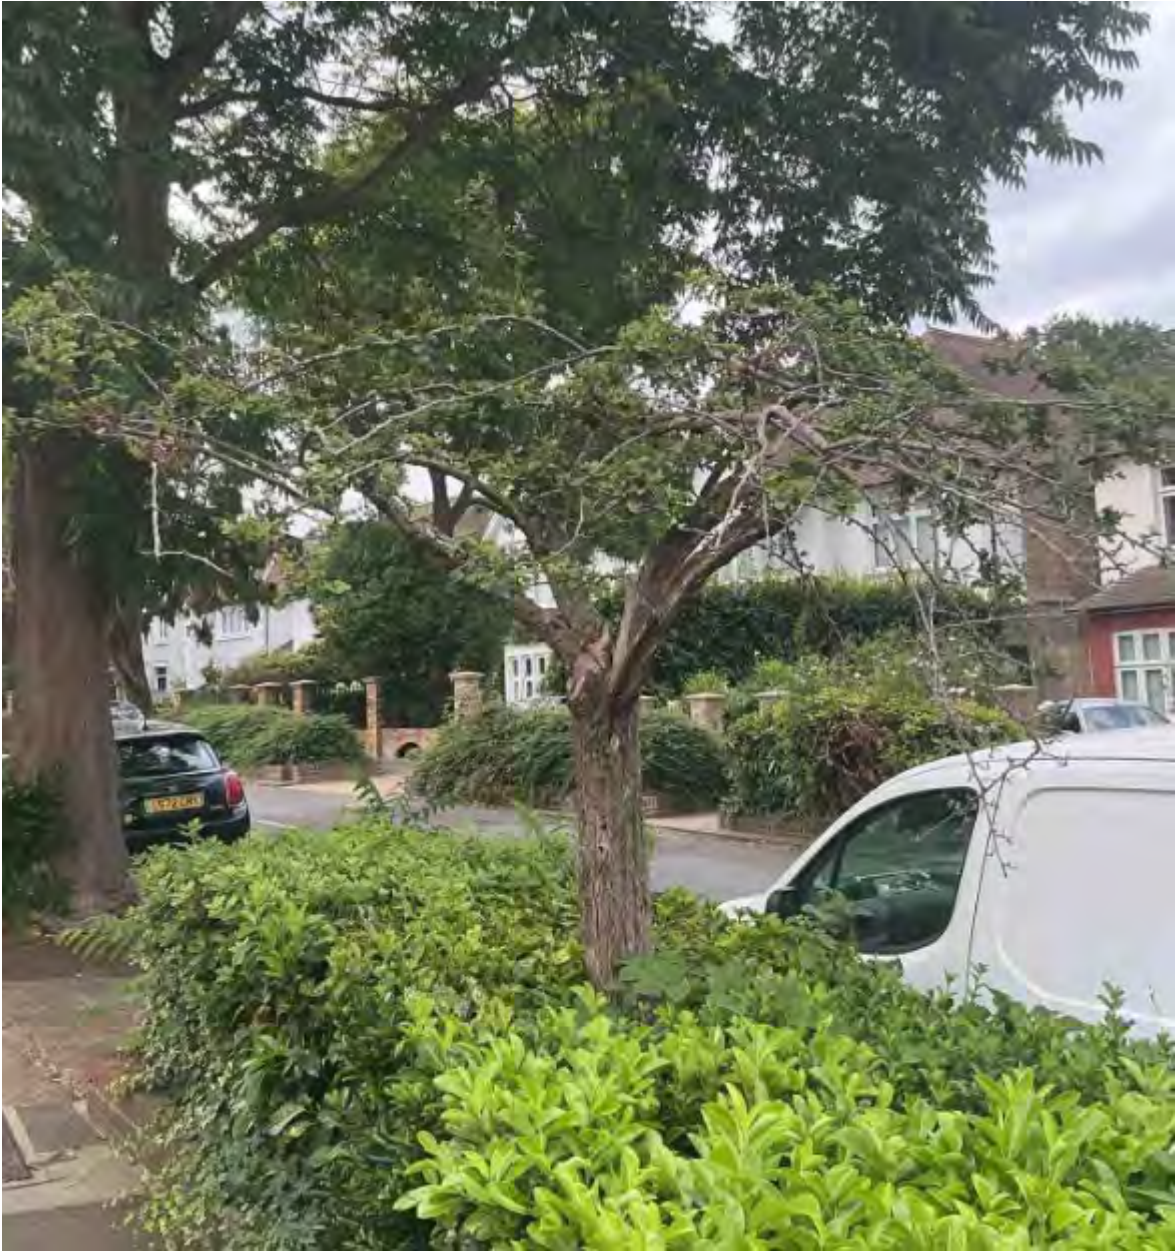
| Inspection findings/reason for exemption | This tree is moribund; removal is required to prevent natural failure, manage risk, and facilitate replanting |

Image shows moribund tree in street scene.

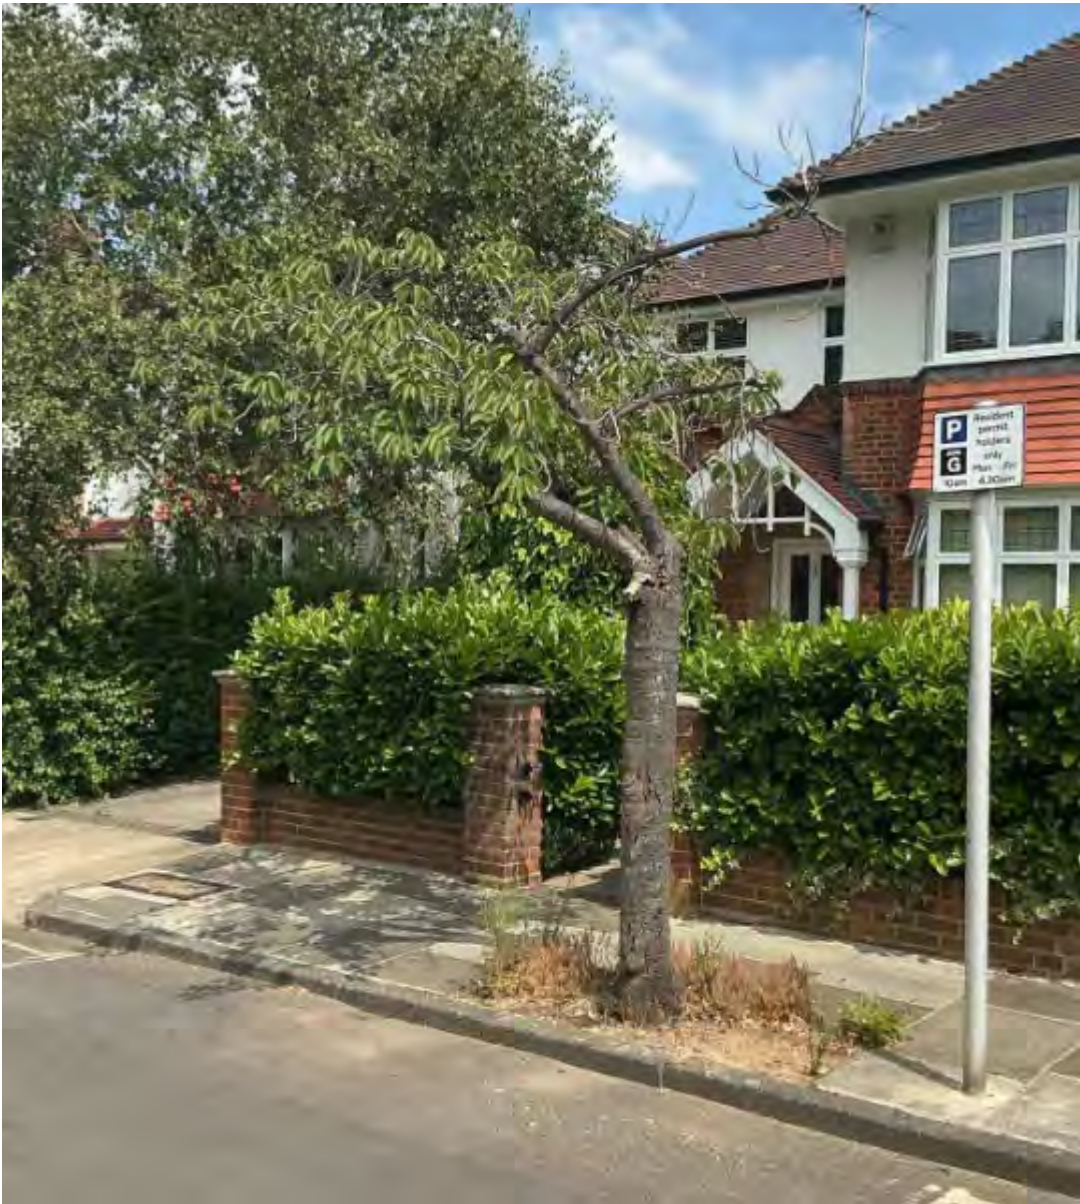
| Inspection findings/reason for exemption | This tree is moribund; removal is required to prevent natural failure, manage risk, and facilitate replanting |

Image shows moribund tree in street scene.

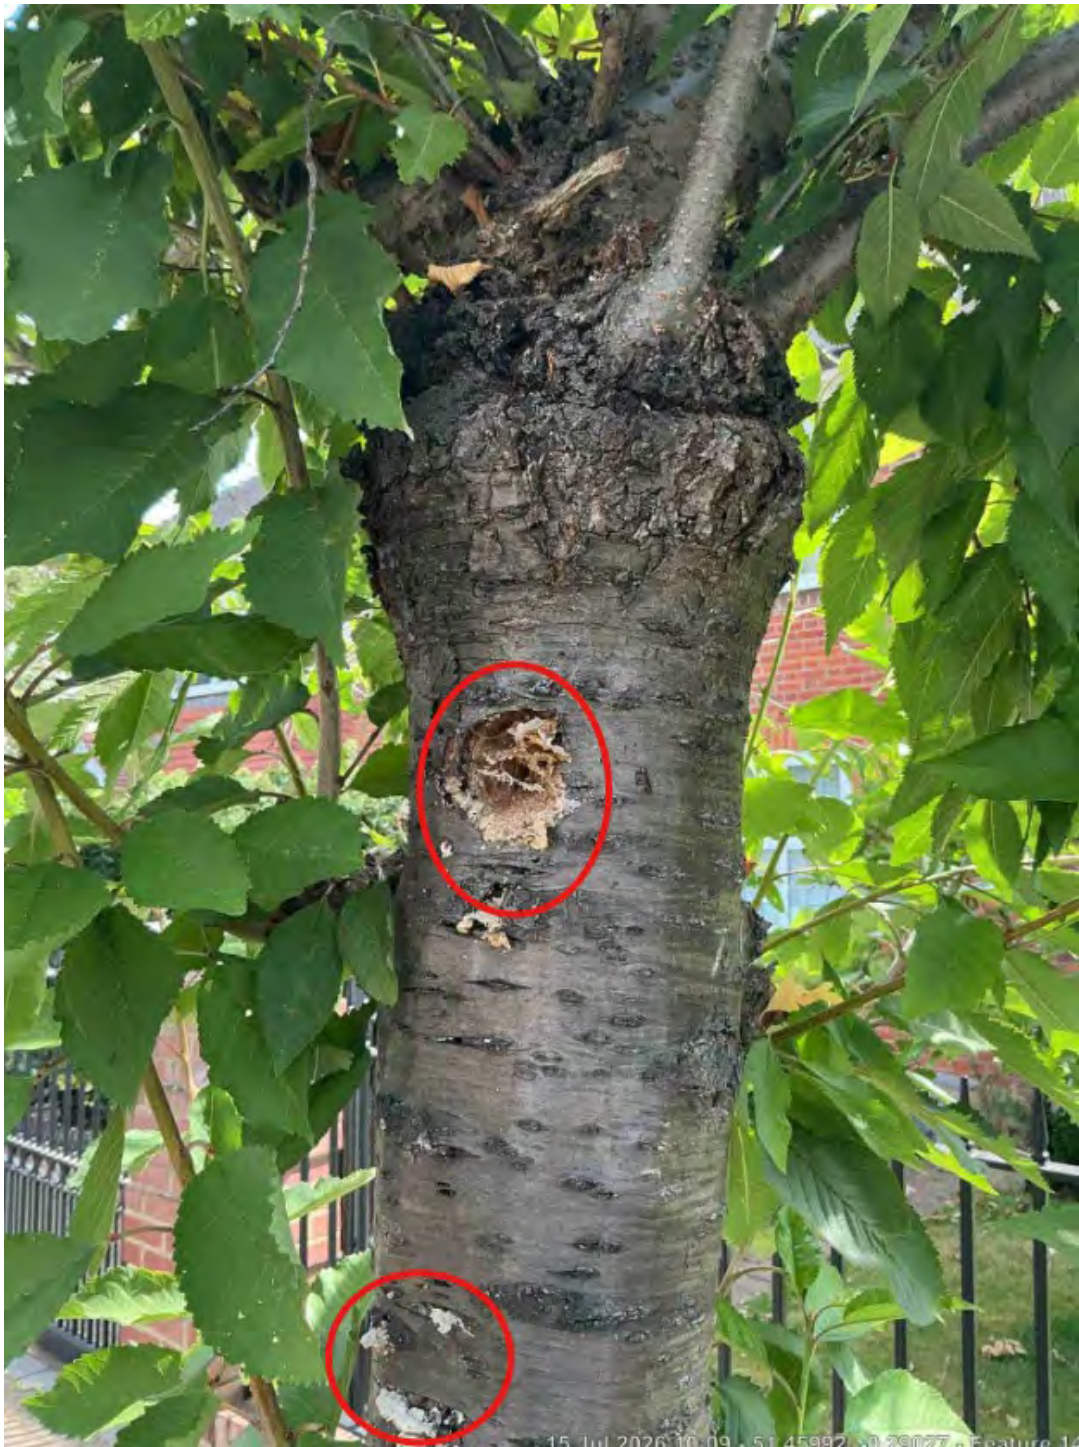
| Inspection findings/reason for exemption | Fruiting bodies of the decay fungus Turkey Tail ( <i>Tramates versicolor</i> ) are prolific on the trunk of this tree. This fungus causes a selective white rot of the wood and when prolific is indicative of wider physiological dysfunction. This correlates with crown dieback and decay pockets on trunk. Removal is required to prevent natural failure, manage risk, and facilitate replanting |

***Image shows fungal fruiting bodies and decay pocked in trunk circled.***

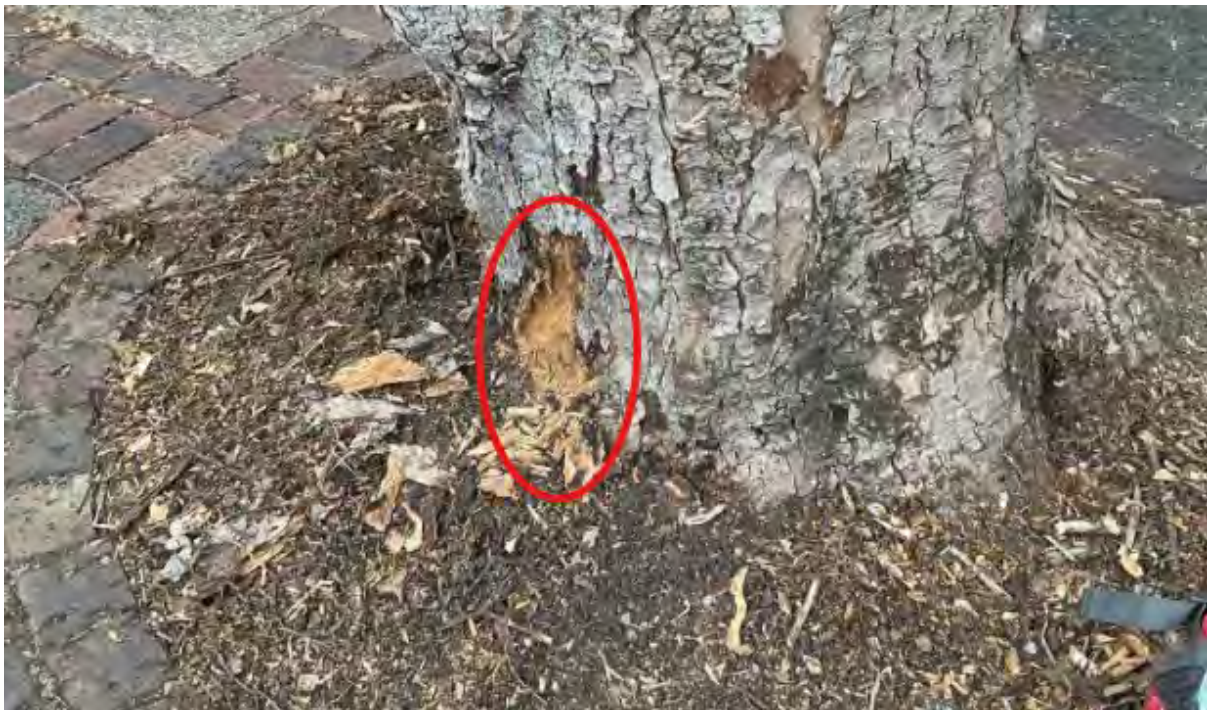
| Inspection findings/reason for exemption | Fungal fruiting bodies of the decay pathogen <i>Kretzschmaria deusta</i> are present on the base of this tree. This fungus causes a white rot that can cause whole tree failure through a ceramic like fracture of the base. Removal is required to prevent natural failure, manage risk, and facilitate replanting |

***Image shows decay in trunk circled.***

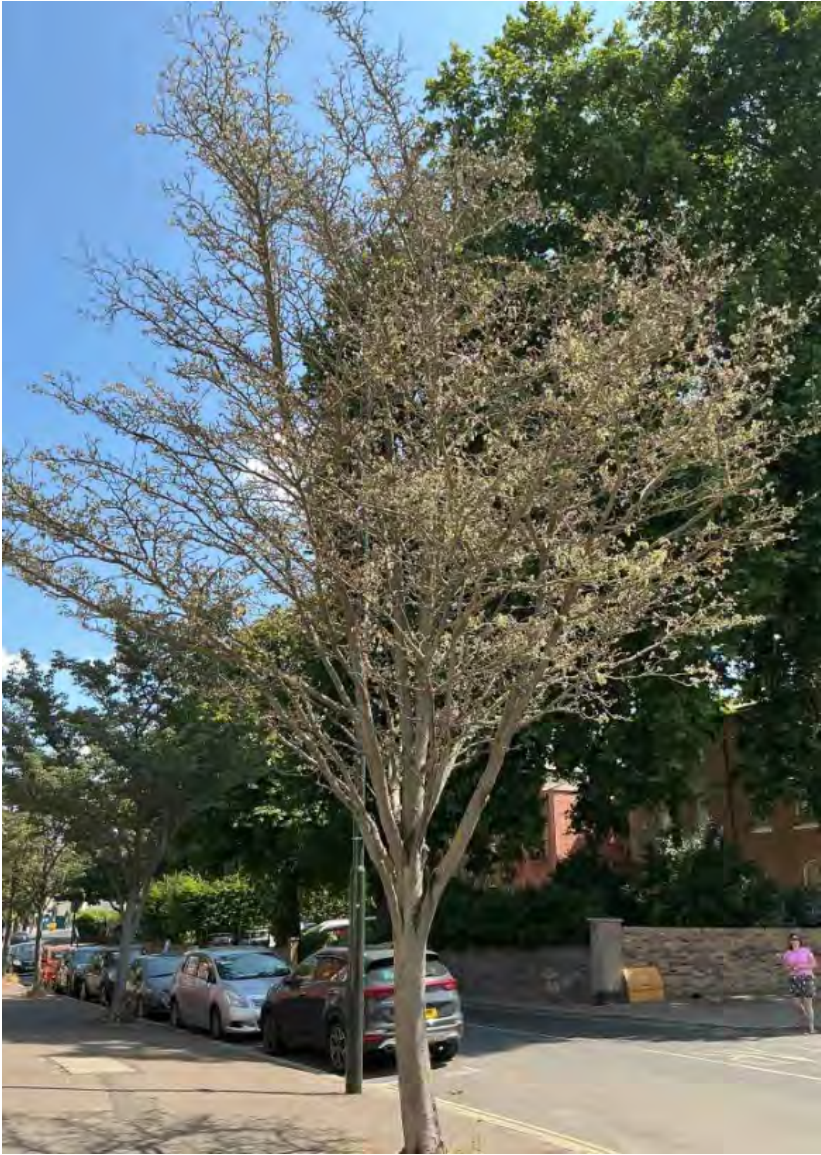
| Inspection findings/reason for exemption | This tree is moribund; removal is required to prevent natural failure, manage risk, and facilitate replanting |

Image shows moribund tree in street scene.
