# August 2026 - Reactive Tree Works Programme

A survey of trees in the Kew, South Richmond and Whitton wards are currently being undertaken; this is being conducted by specialist arboricultural officers as part of the scheduled 4 yearly detailed inspection regime that has been devised for all Council highway and parks trees.

Recent reactive inspections have identified the need for 106 individual tree work operations to take place. This work will now be issued to the Council’s Arborist Contractor KPS, for completion over the Autumn period.

The following pages provide the locations of each tree that is to be removed, in addition photographs and descriptions of the inspection findings have been provided.

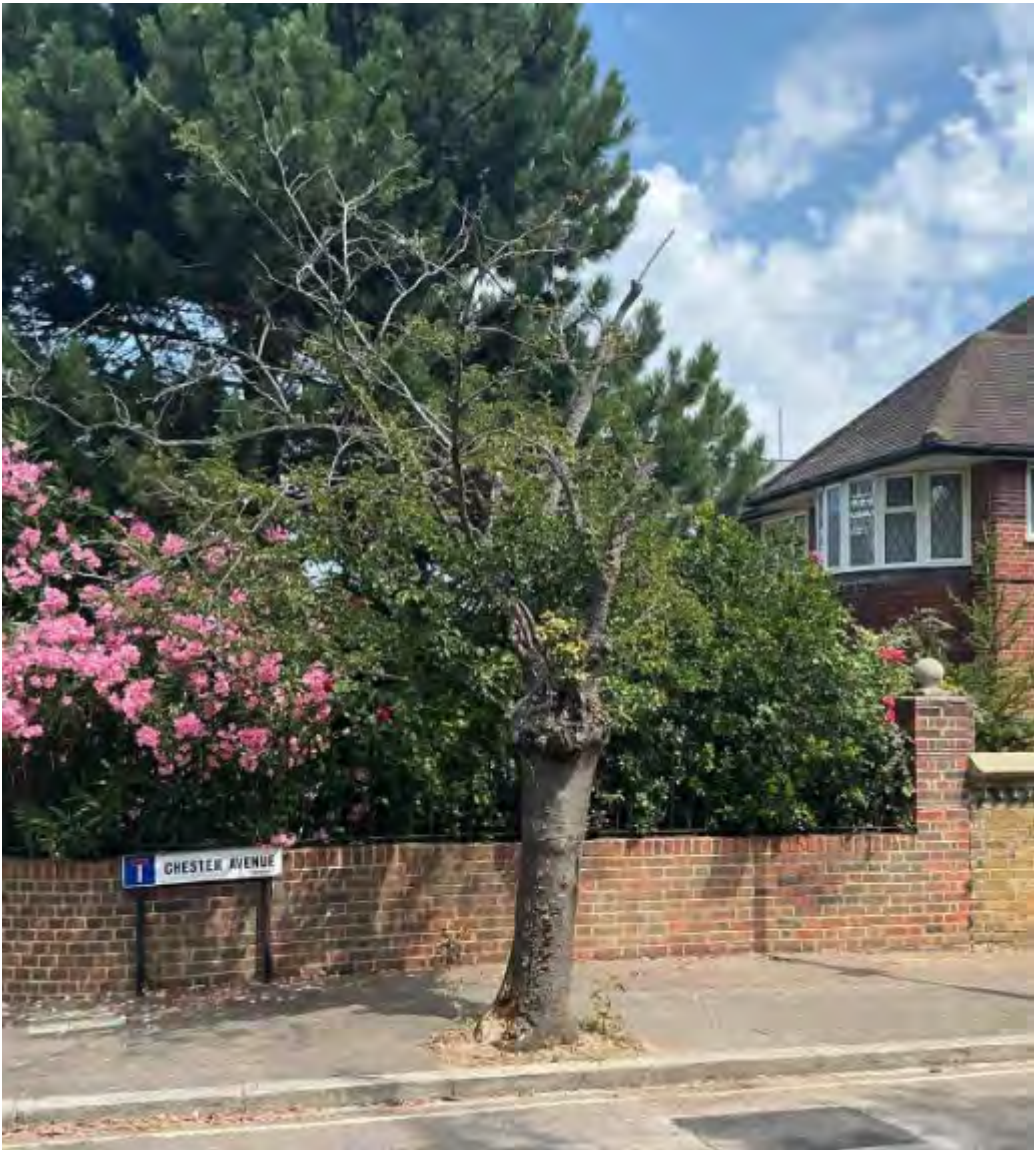
| Inspection findings/reason for exemption | This tree is moribund; removal is required to prevent natural failure, manage risk, and facilitate replanting |

Image shows moribund tree in street scene.

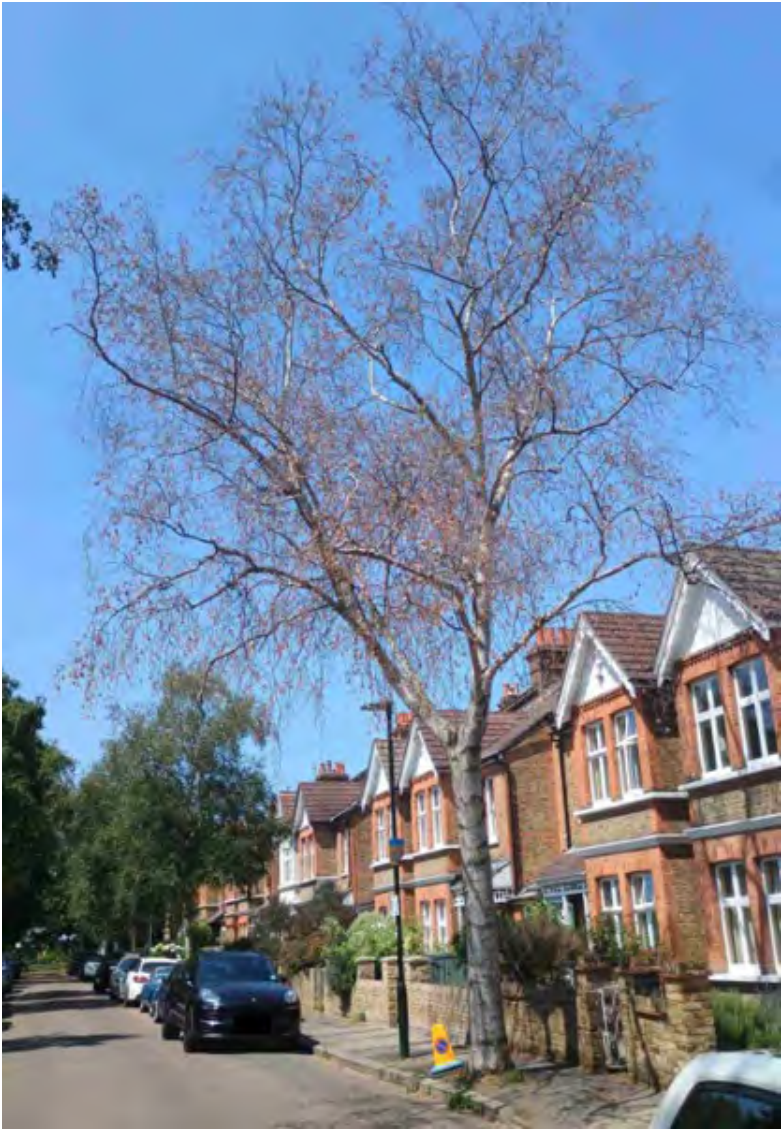
| Inspection findings/reason for exemption | This tree is dead; removal is required to prevent natural failure, manage risk, and facilitate replanting |

Image shows dead tree in street scene.

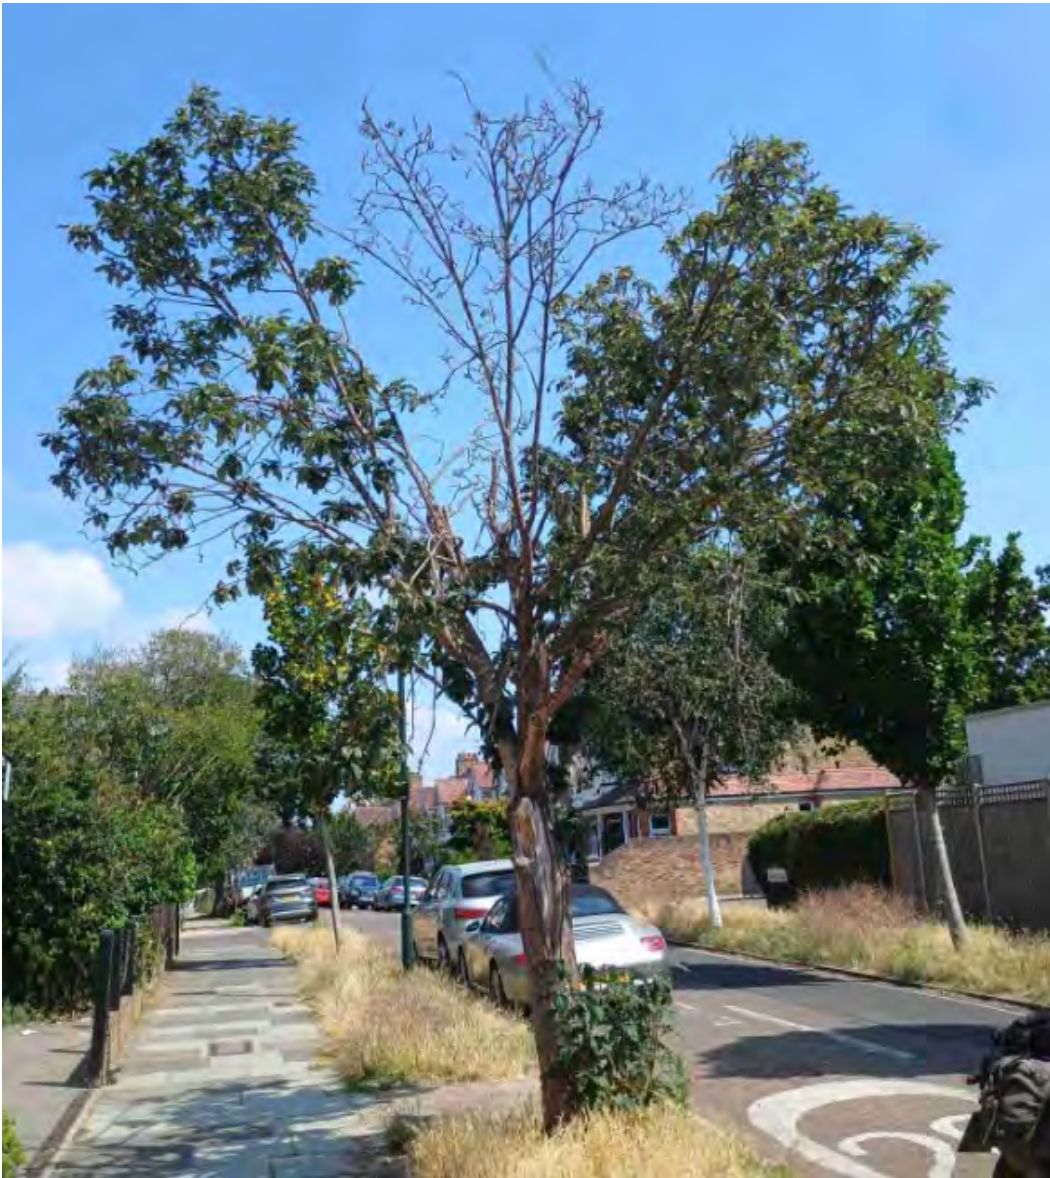
| Inspection findings/reason for exemption | This tree is moribund; removal is required to prevent natural failure, manage risk, and facilitate replanting |

Image shows moribund tree in street scene.

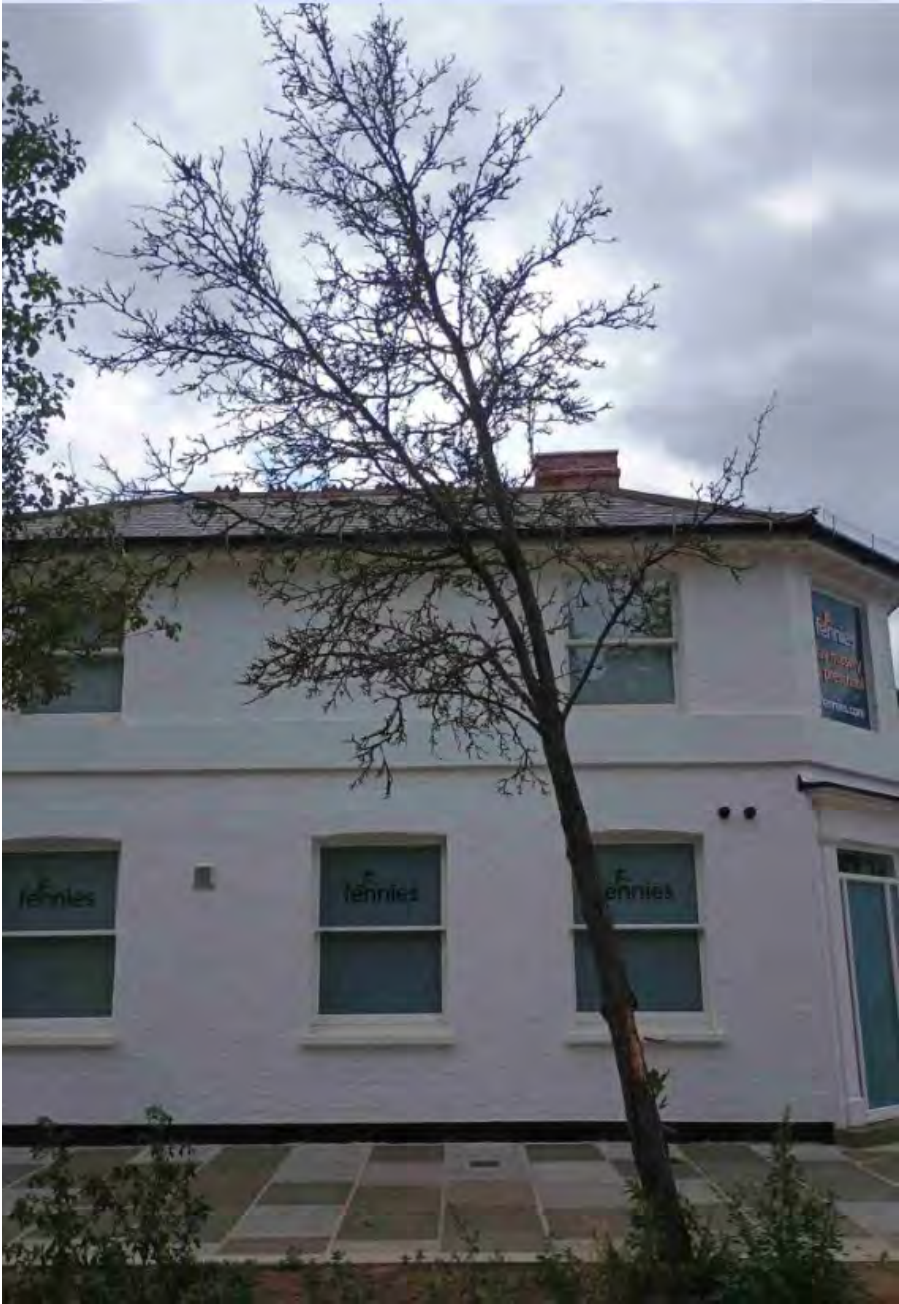
| Inspection findings/reason for exemption | This tree is dead; removal is required to prevent natural failure, manage risk, and facilitate replanting |

Image shows dead tree in street scene.

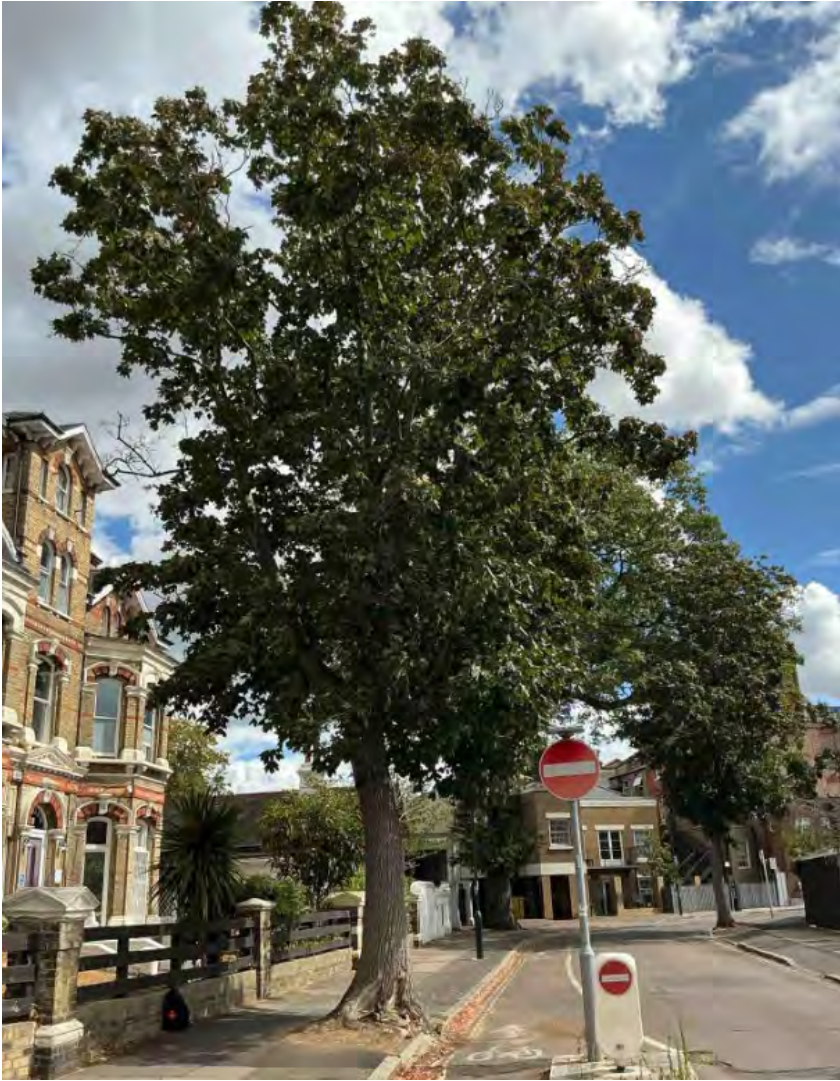
| Inspection findings/reason for exemption | Investigation with a probe and a resonance test with a sounding hammer has revealed an unacceptable amount of decay beyond the visible cavities at the base of the trunk. Removal is required to prevent natural failure, manage risk, and facilitate replanting. |

Image shows tree in street scene.

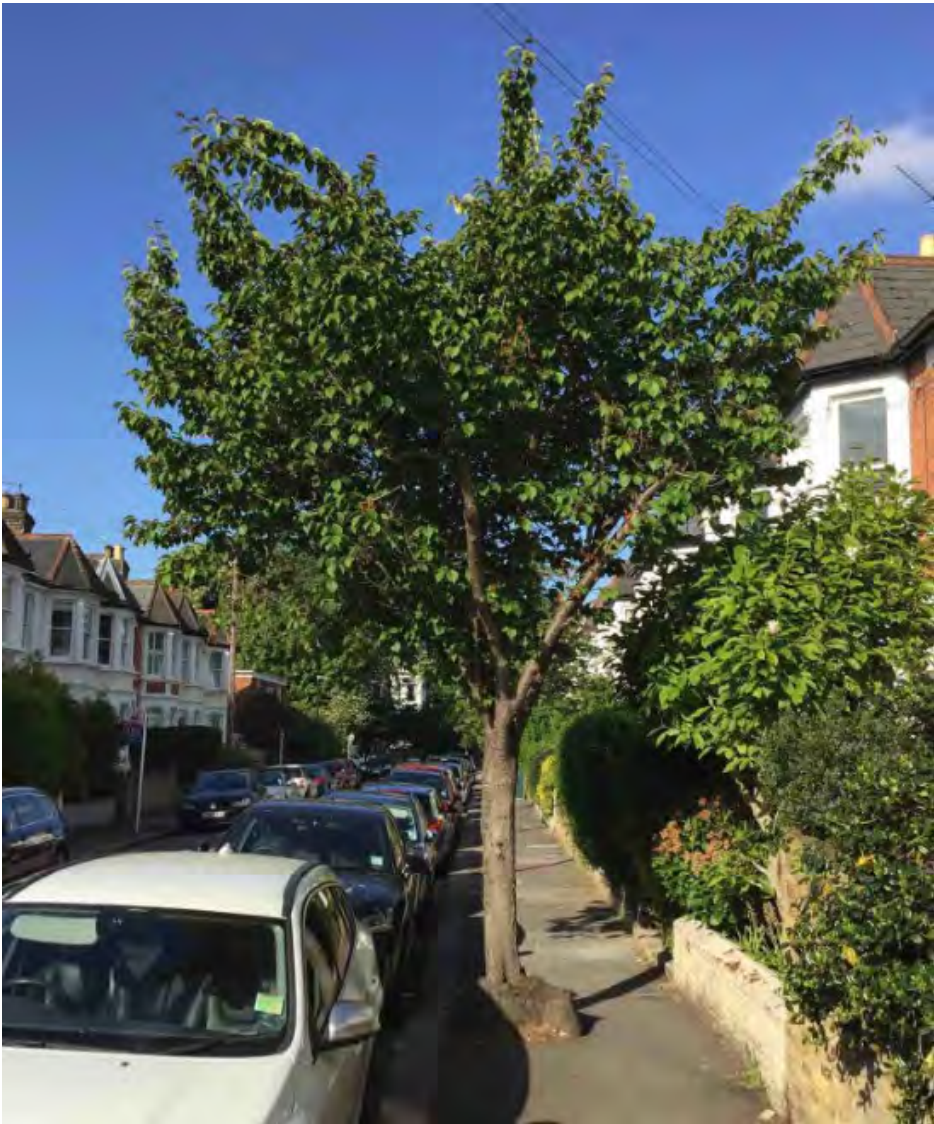
| Inspection findings/reason for exemption | Tree has raised and damaged root collar causing trip hazards and an unacceptable obstruction to the pavement making an impasse for prams & wheelchairs to safely pass. With no engineering solution available to resolve this issue, we are unable to meet our duties under the Equality Act 2010. For this reason, removal is required to manage risk and facilitate replanting. |

Image shows tree in street scene.

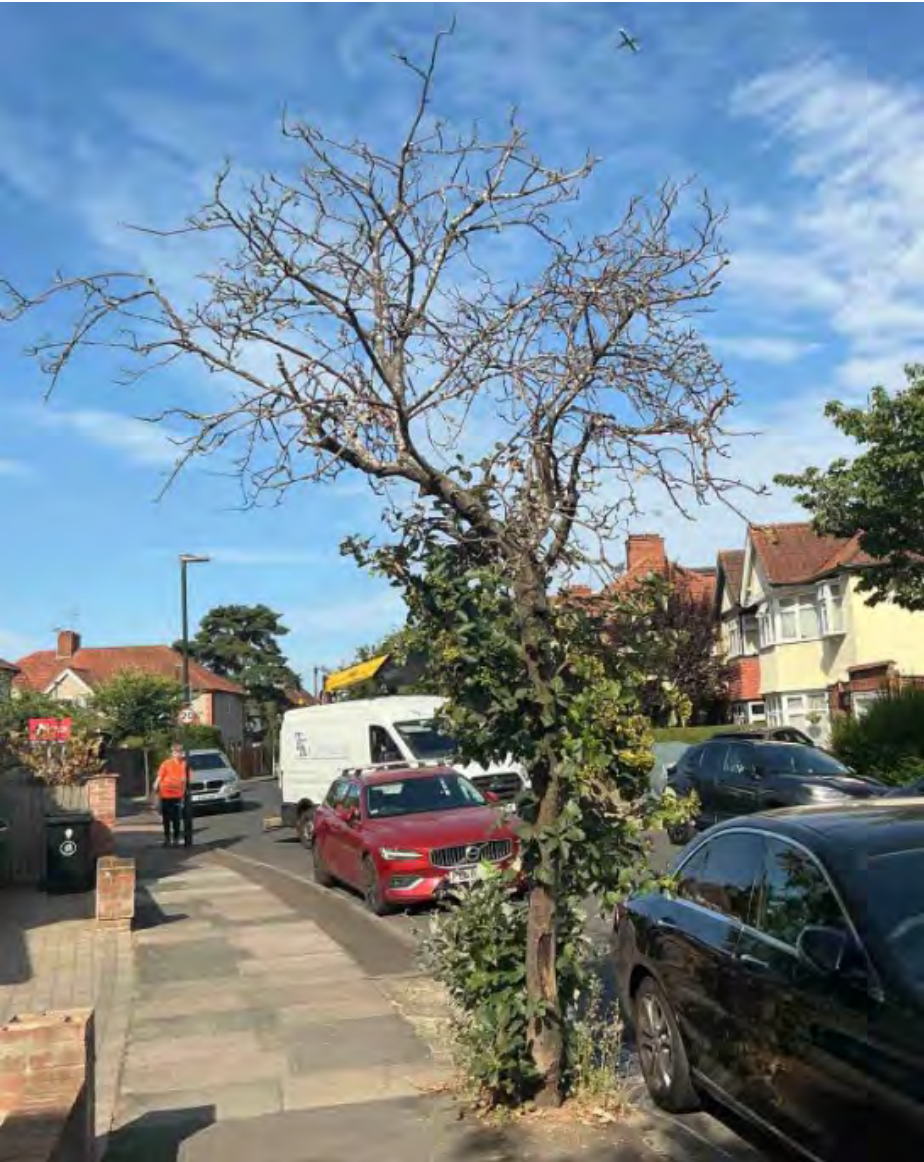
| Inspection findings/reason for exemption | This tree is dead; removal is required to prevent natural failure, manage risk, and facilitate replanting |

Image shows dead tree in street scene.

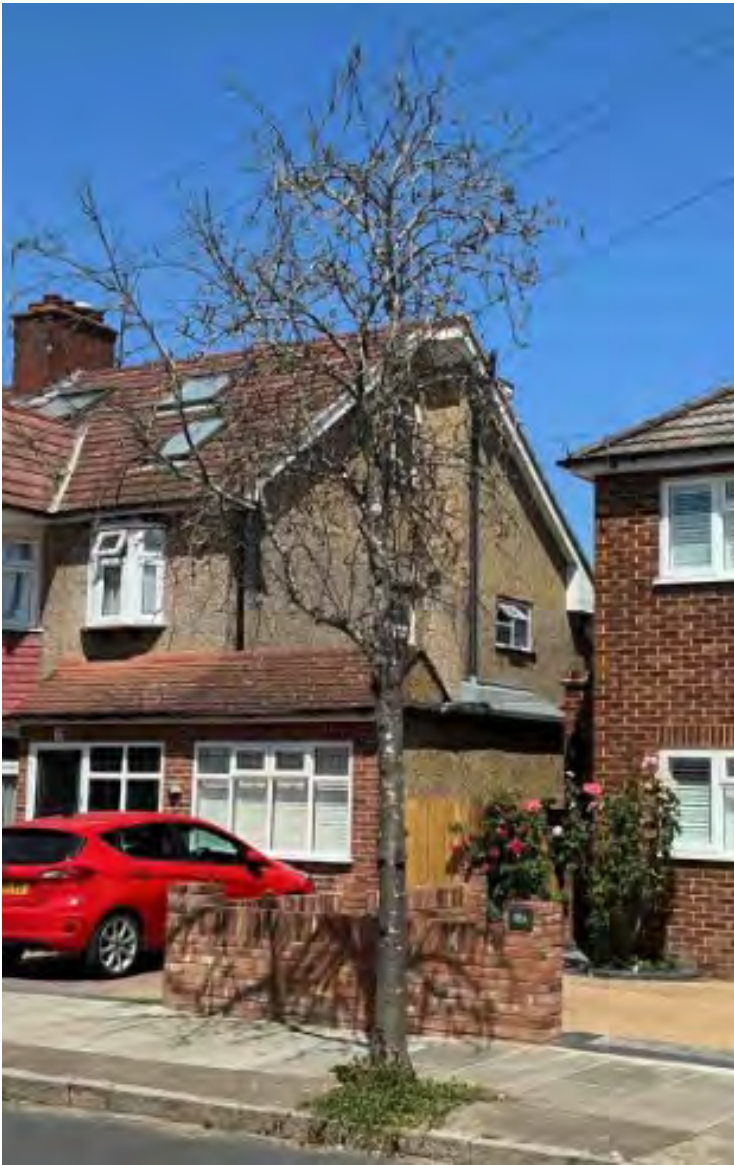
Image shows dead tree in street scene.

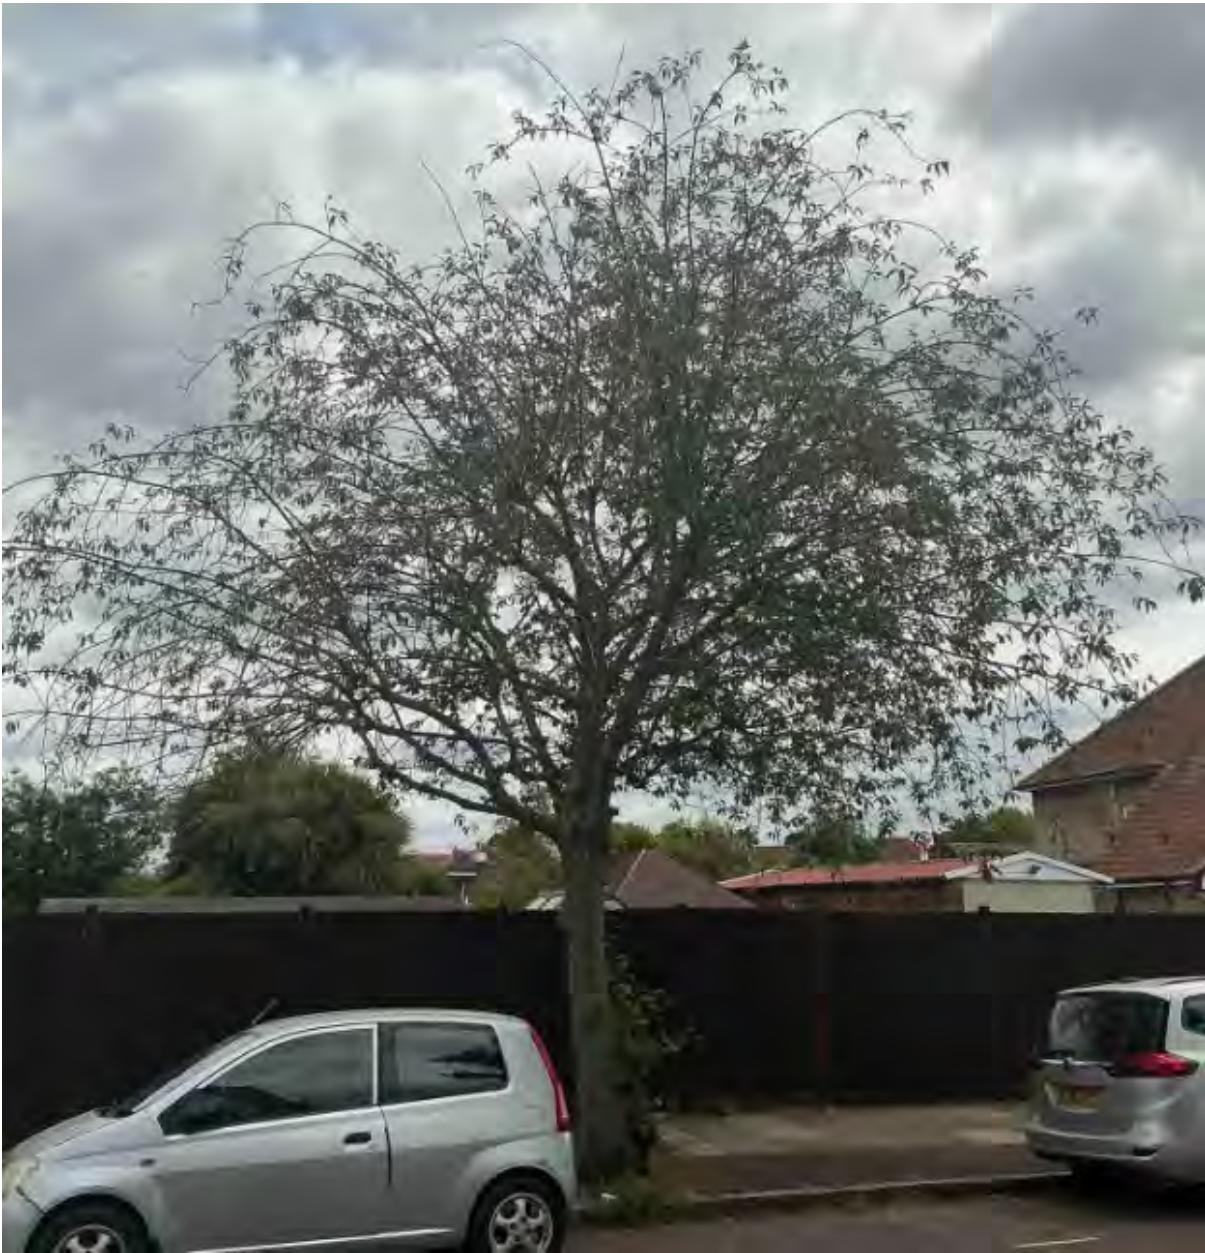
Image shows moribund tree in street scene.

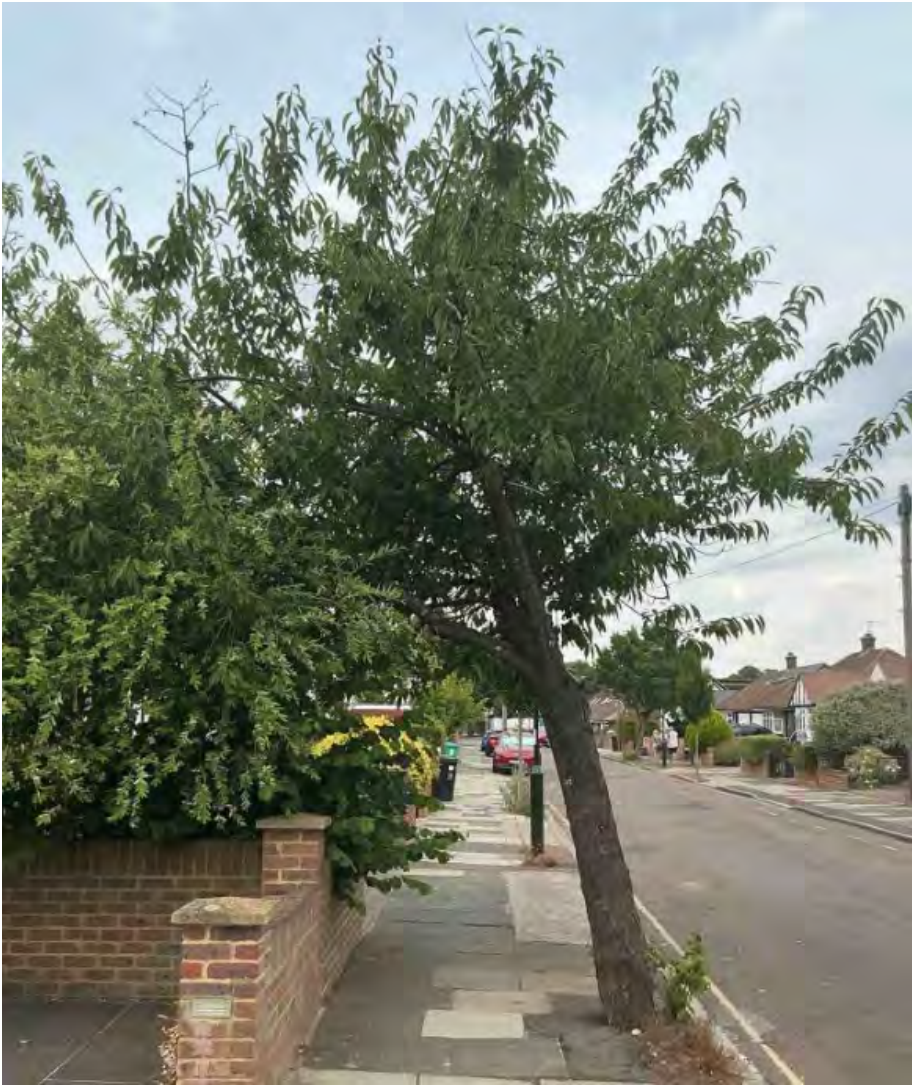
Image shows leaning tree in street scene.

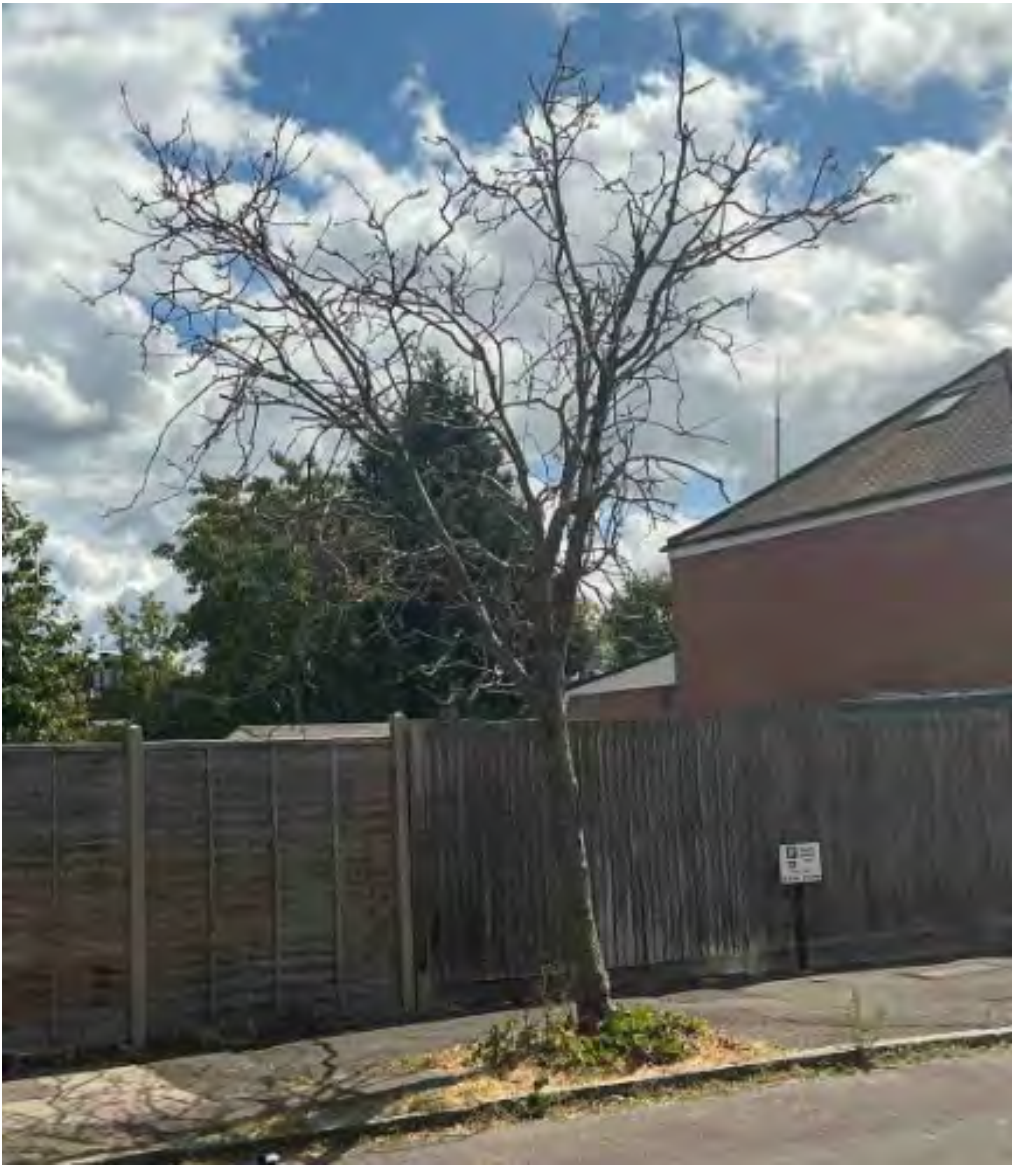
Image shows dead tree in street scene.

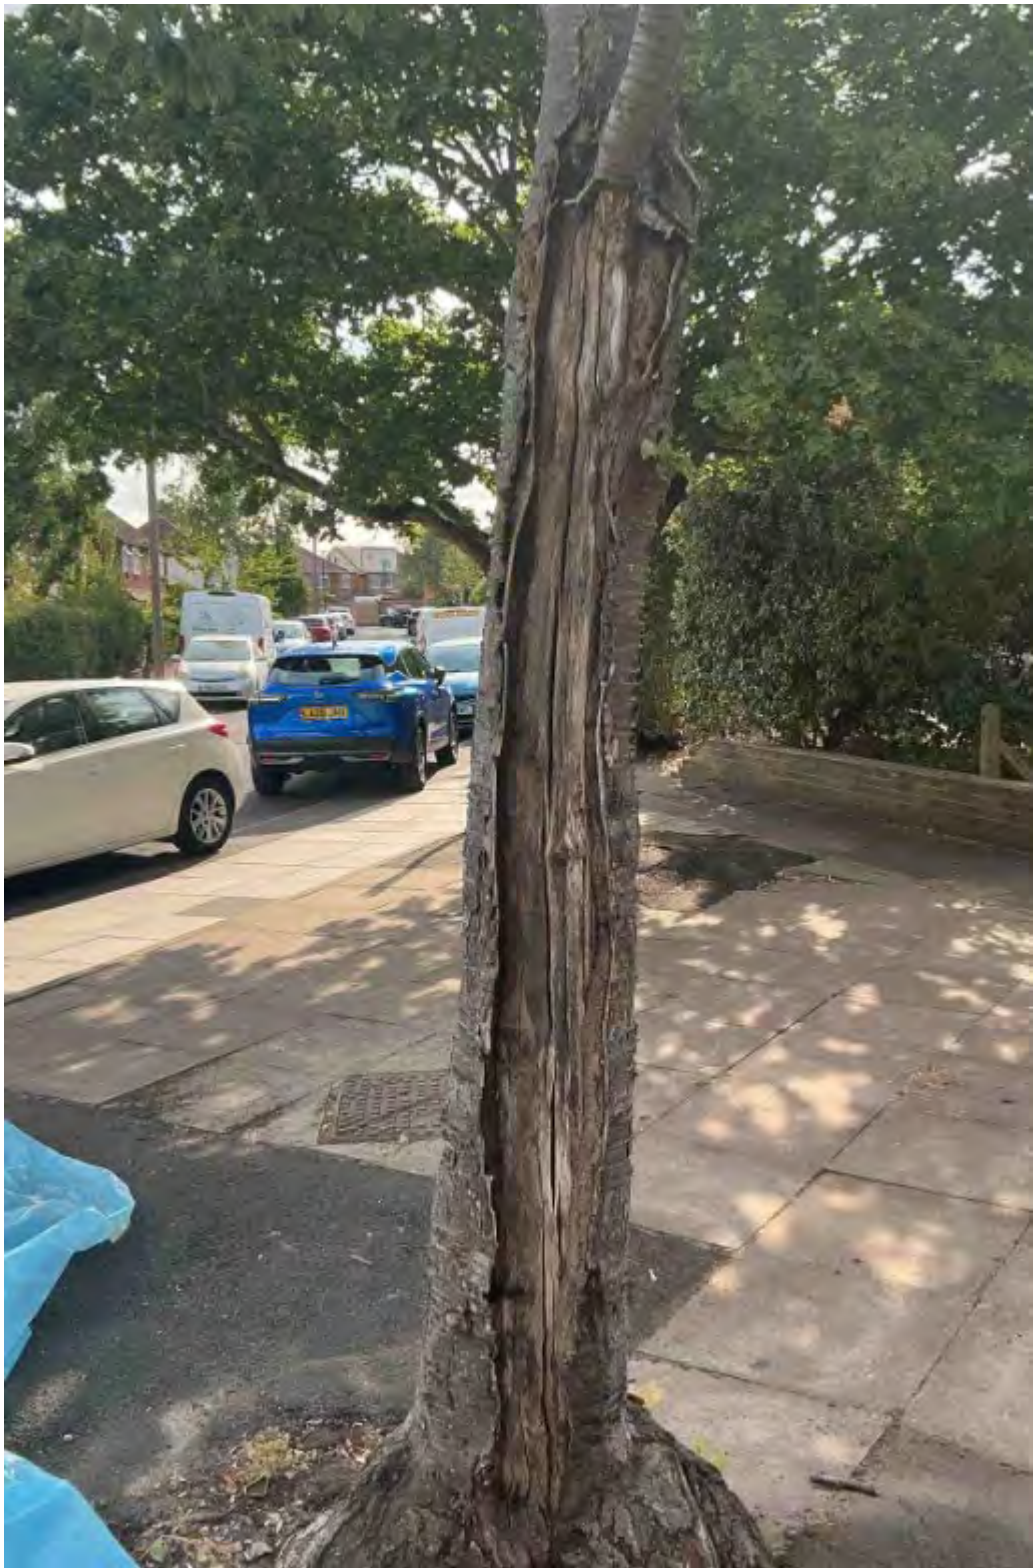
***Image shows bark damage on trunk.***

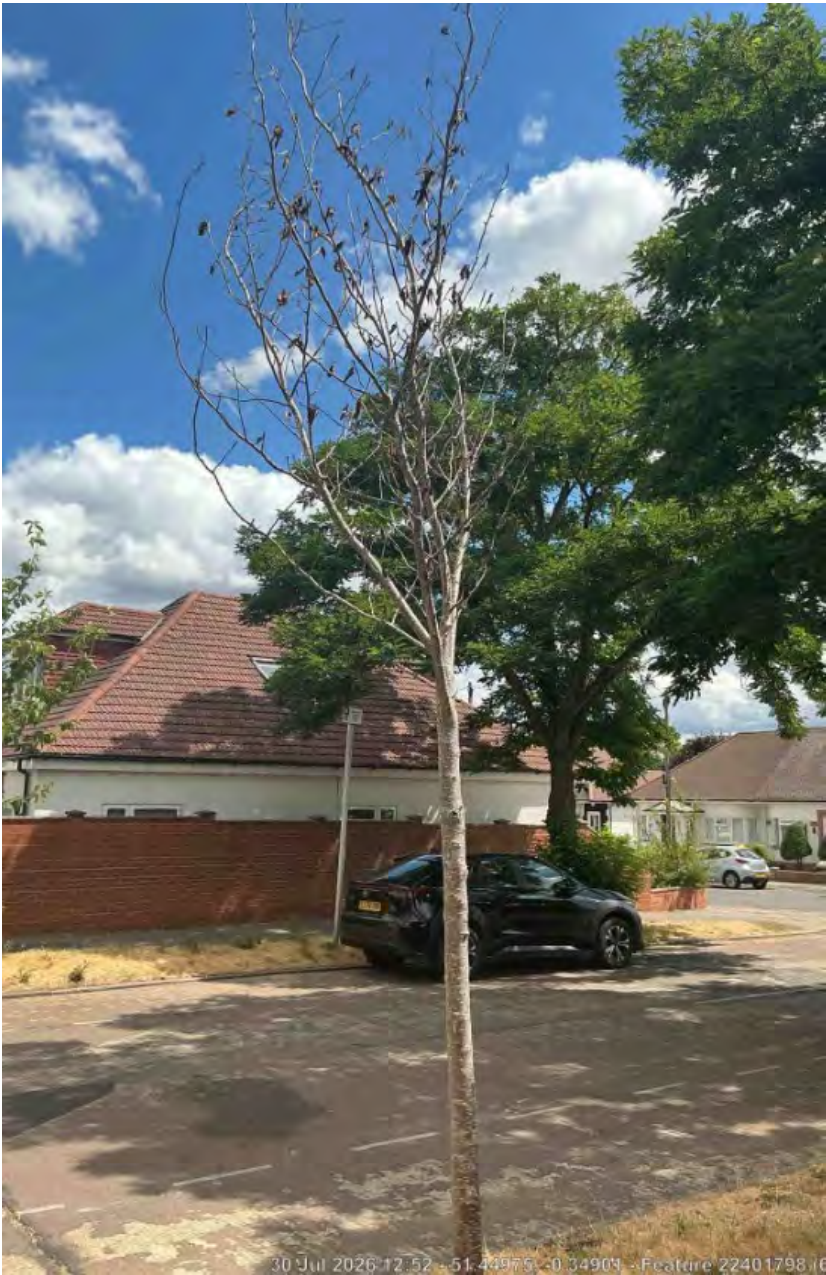
Image shows dead tree in street scene.
