## **Twickenham Riverside - 2023 Ward Works and Tree Removals Programme**

### Introduction

Dated 23.05.2023

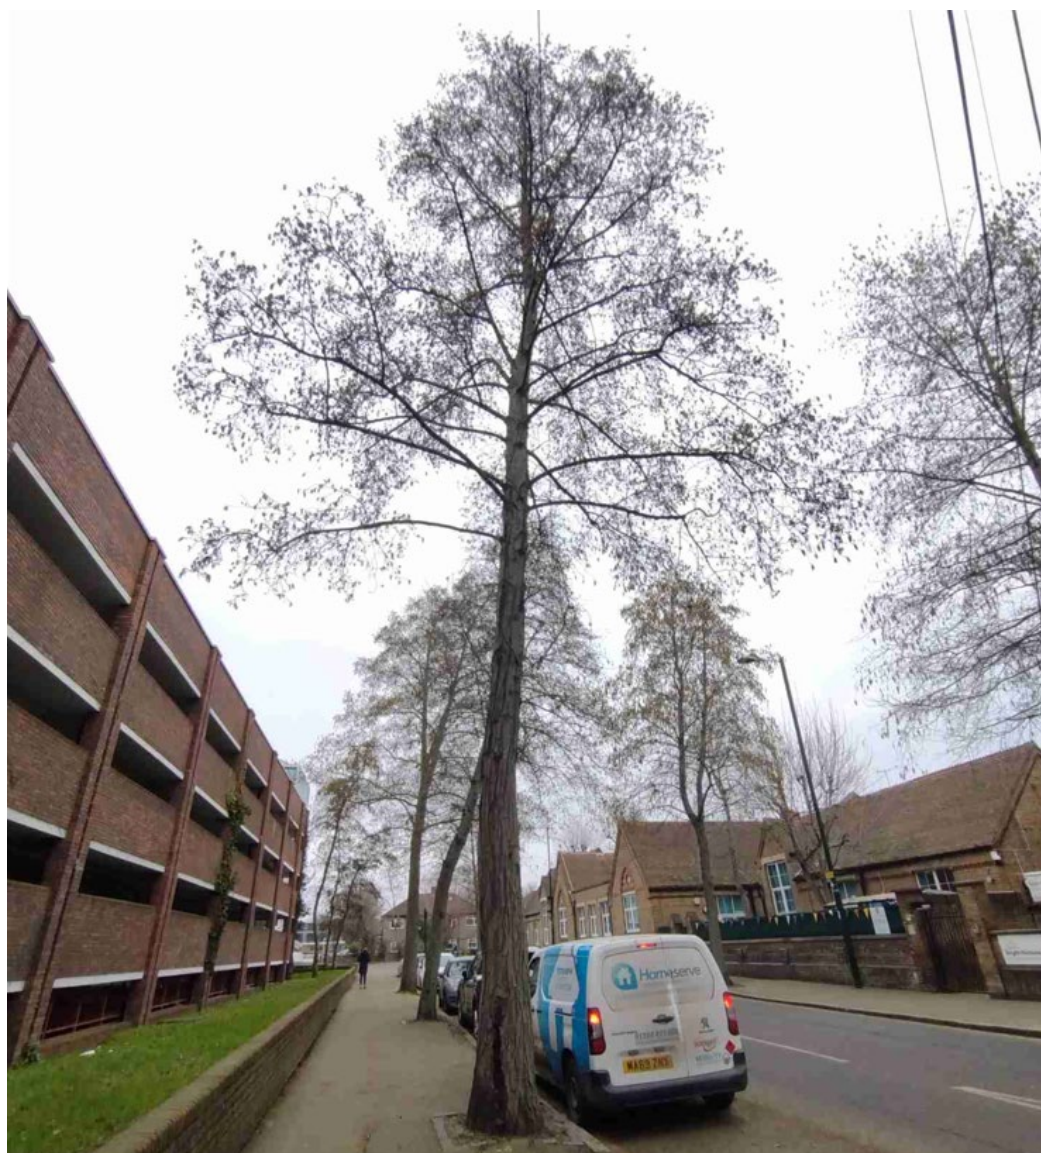
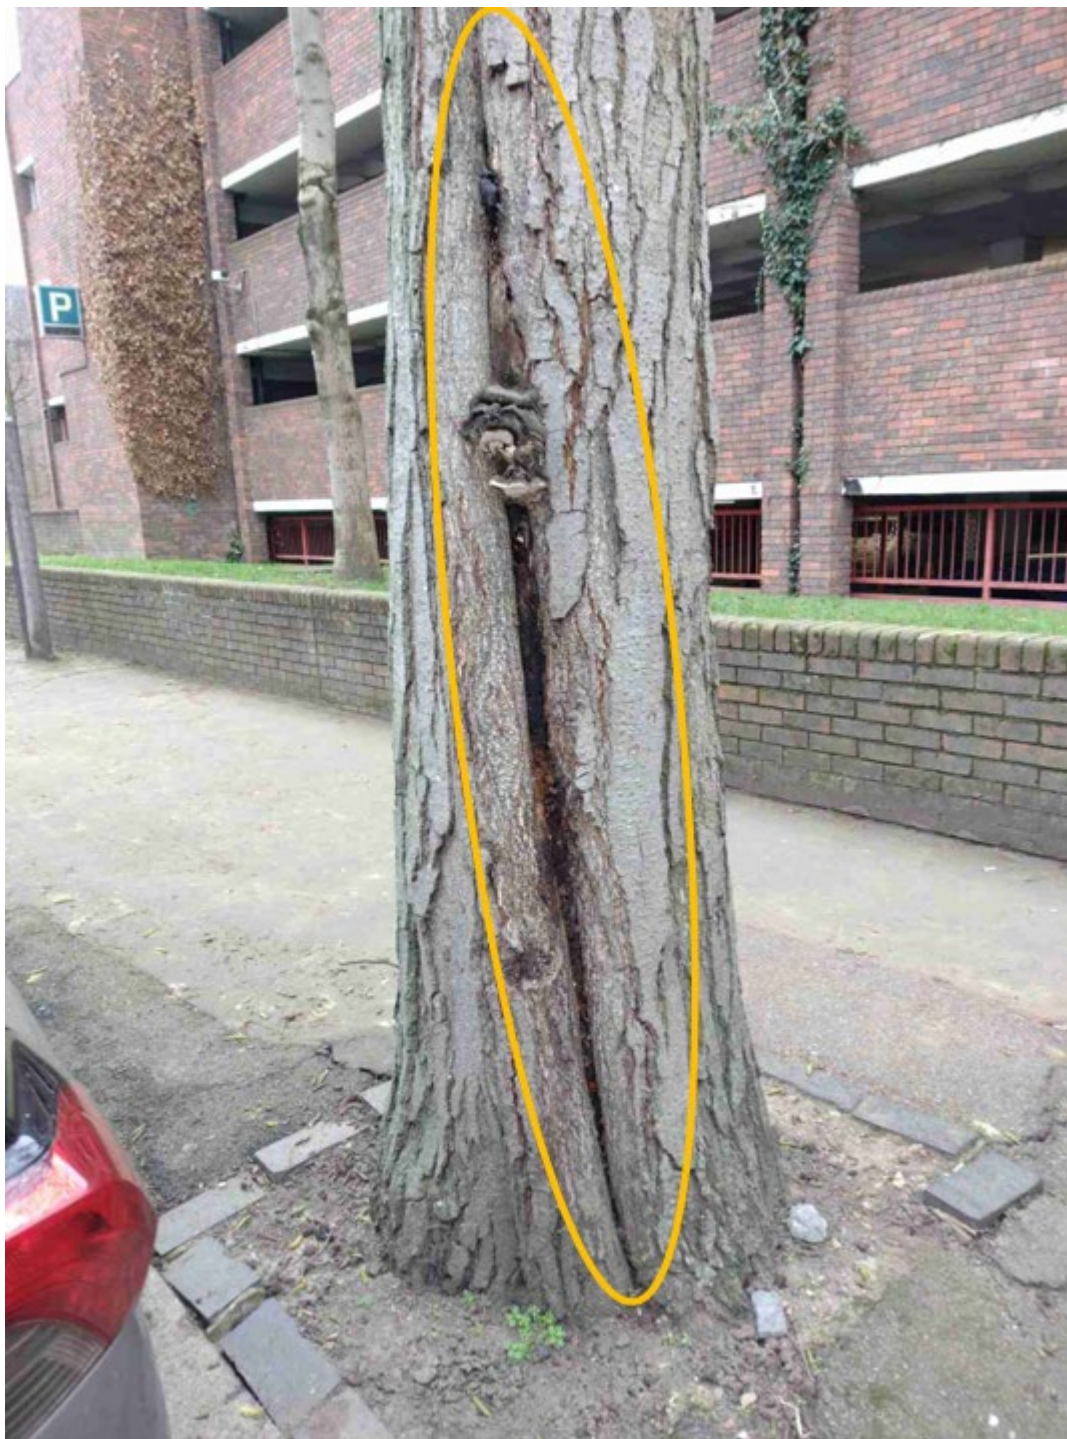
Tree number	21
Road	Arragon Road
Location	Opposite 63-63
Species	Italian Alder ( <i>Alnus cordata</i> )
Height	18.5m
Physiological Condition	Good
Structural Condition	Poor
Inspection findings	A fungal fruiting body of the decay pathogen <i>Ganoderma</i> sp. is present at the stem base. Colonisation by this fungus causes a white rot of the stem and root system that can cause entire trees to collapse through fracture or windthrow. A resonance test revealed an unacceptable degree of decay in the trunk of this tree, removal is required to prevent natural failure and manage risk.

***Image shows crack in trunk where decay and Ganoderma fungal fruiting bodies are located***

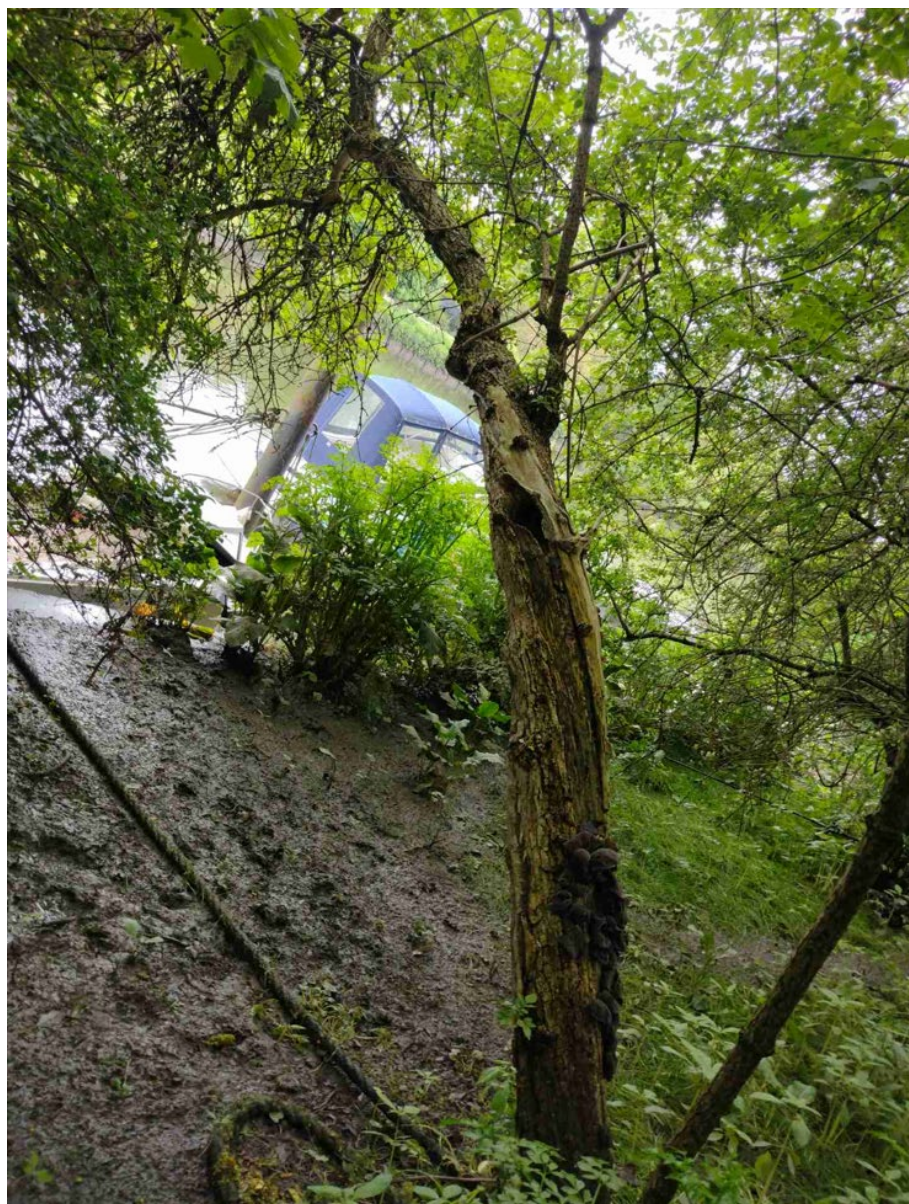
Tree number	600002.00
Road	Cambridge Park Footpath
Location	What3Words-///voting.sends.patrol
Species	Elder ( <i>Sambucus nigra</i> )
Height	3.5m
Physiological Condition	Dead
Structural Condition	Dead
Inspection findings	Cavities indicating root and lower stem decay are present at the base of this tree. Investigation with a probe revealed an unacceptable degree of decay

Image shows tree with missing bark and jelly ear fungus

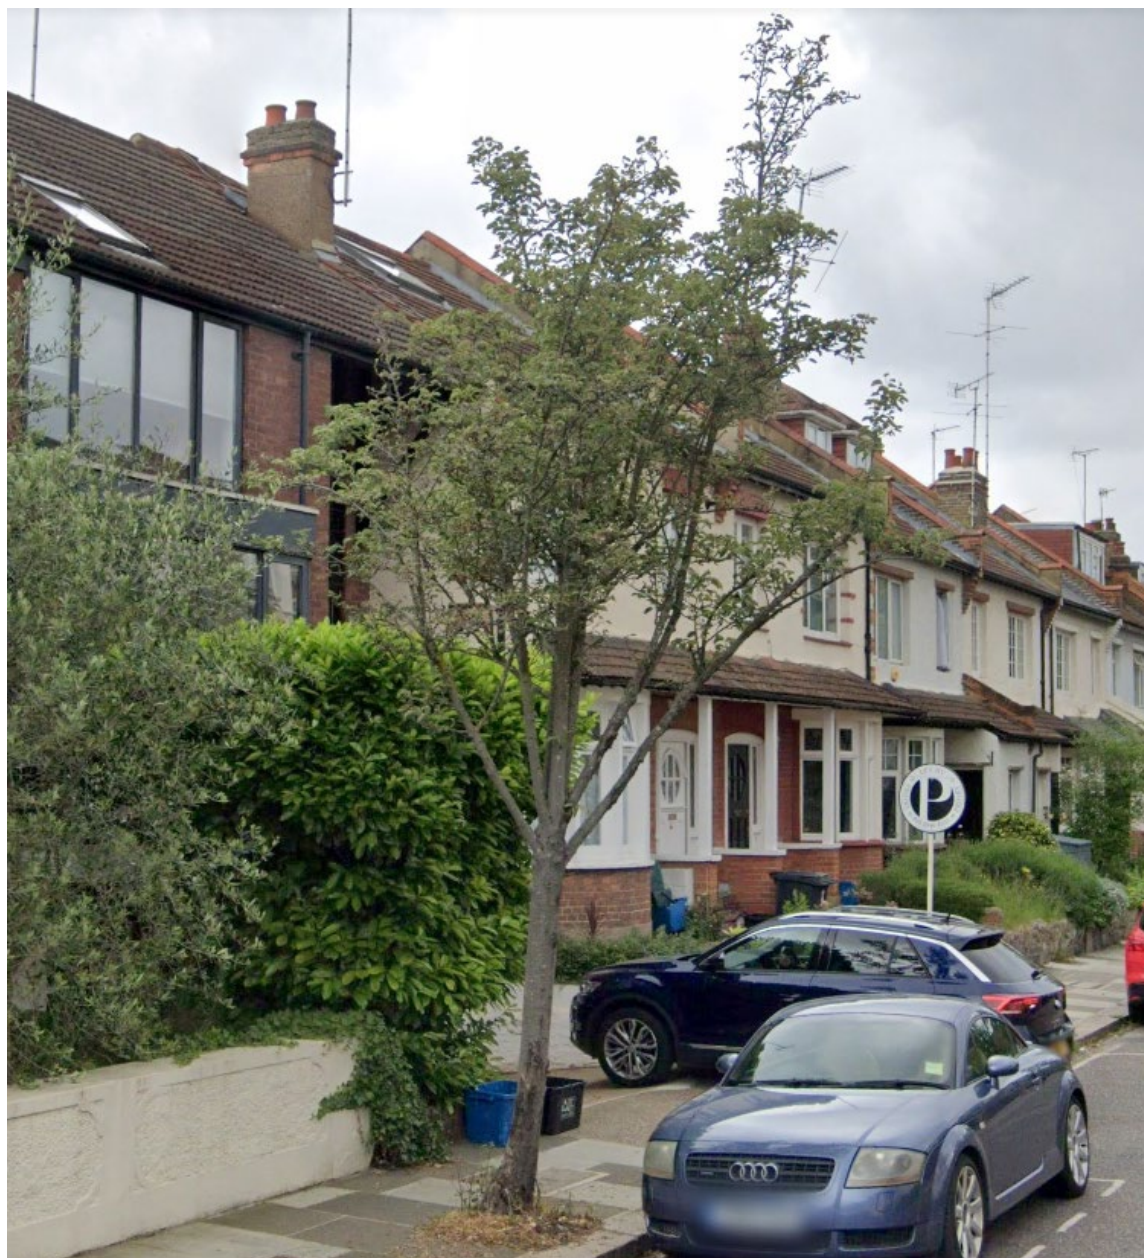
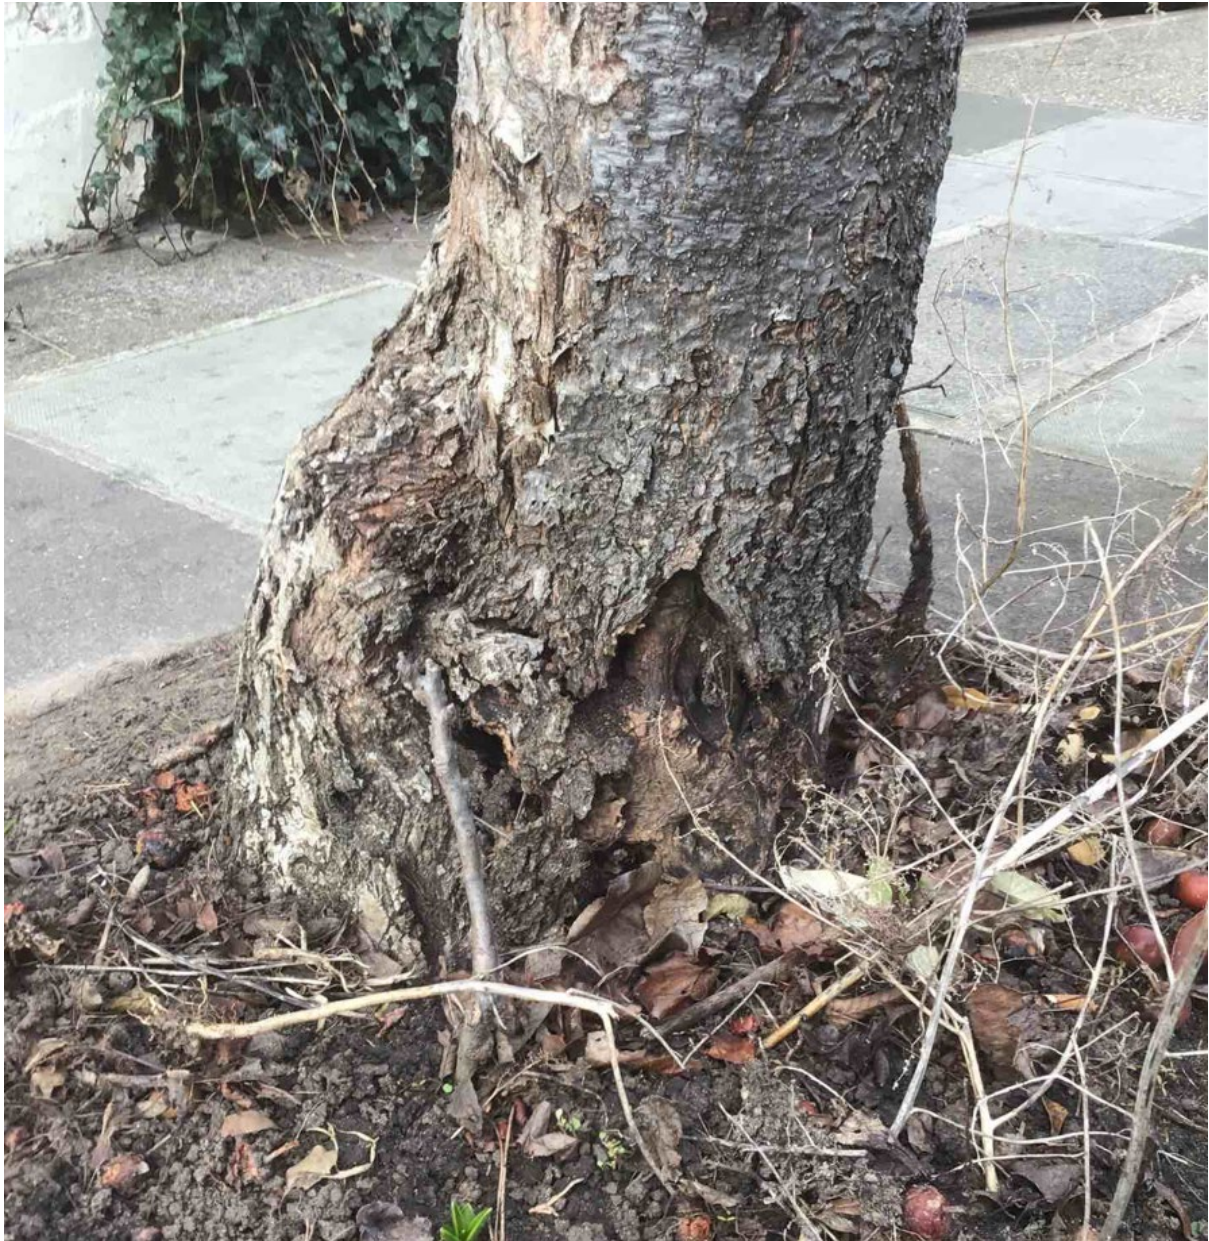
Tree number	11
Road	Cambridge Road
Location	Outside 44
Species	Tschonoski Crab-apple ( <i>Malus tschonoskii</i> )
Height	6.0m
Physiological Condition	Poor
Structural Condition	Poor
Inspection findings	The main stem or trunk and roots are extensively decayed; the tree is moving in such a way that indicates that the structure is compromised presenting an unacceptable risk of failure.

***Image shows base of tree with decay visible***

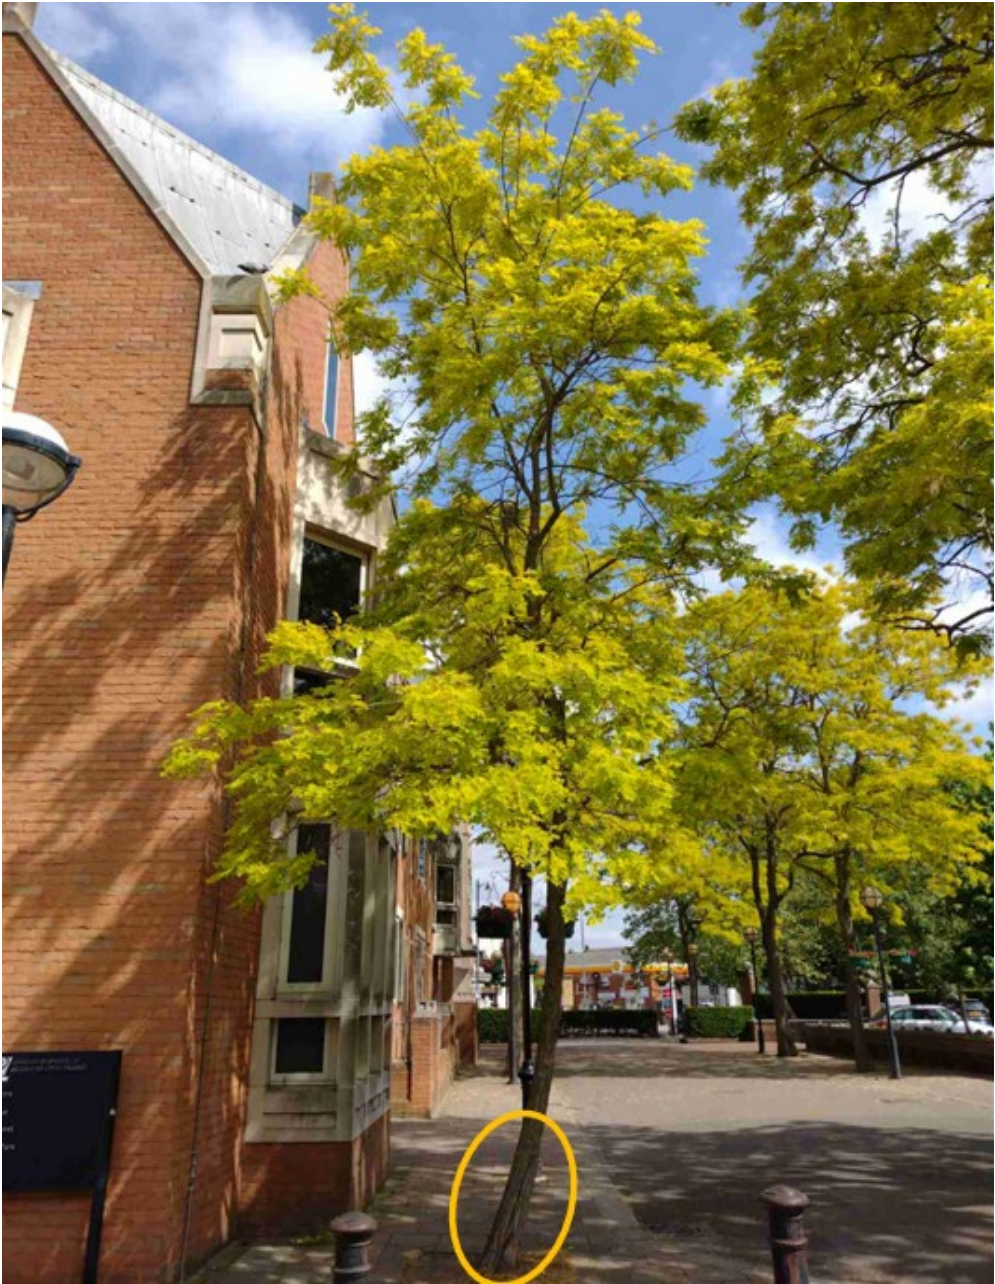
Tree number	23
Road	Church Street
Location	Side of lamppost 105
Species	Black Locust ( <i>Robinia pseudoacacia</i> 'Frisia')
Height	7.5m
Physiological Condition	Good
Structural Condition	Poor
Inspection findings	This tree has a crack in the main stem which is a weak point for failure to occur from.

Image shows tree with location of crack circled

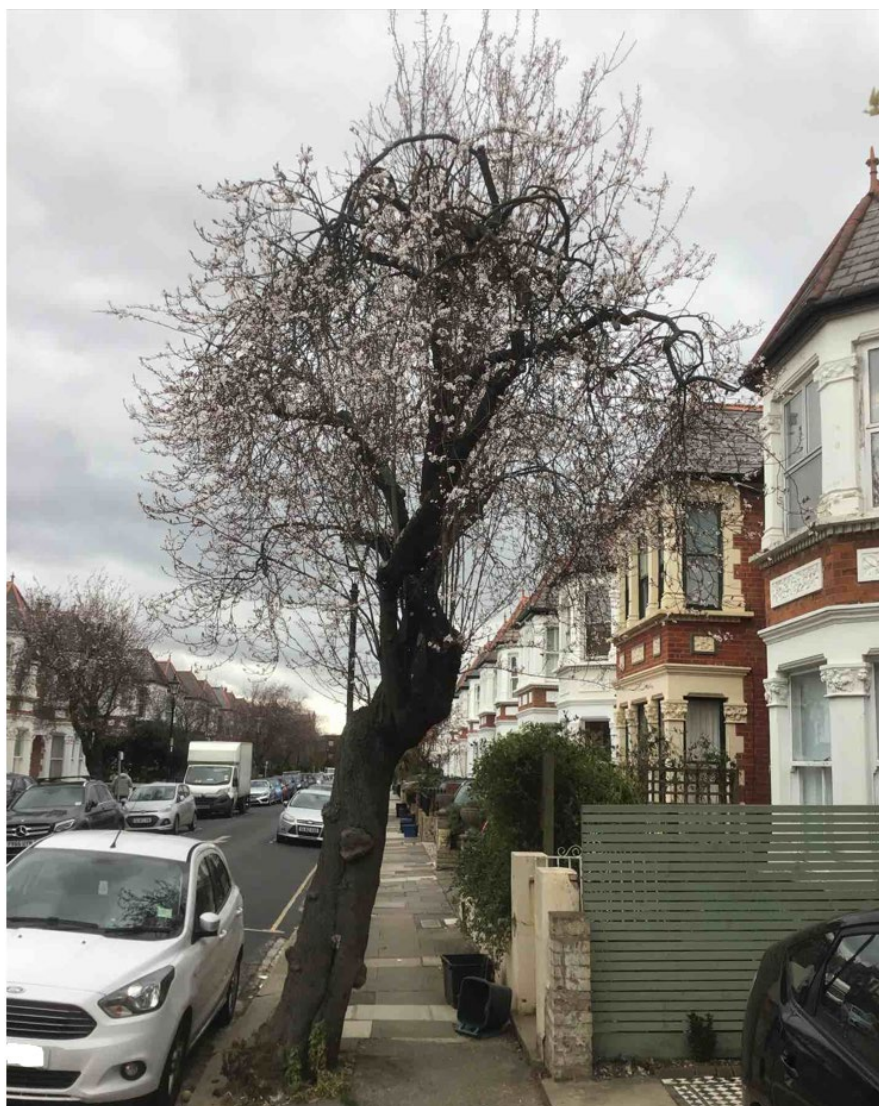
Tree number	5
Road	Cresswell road
Location	Outside 41-43
Species	Purple Plum ( <i>Prunus cerasifera</i> )
Height	6.5m
Physiological Condition	Good
Structural Condition	Poor
Inspection findings	Remnants of fungal fruiting bodies of the wood decay fungus <i>Laetiporus sulphureus</i> are present on the trunk of this tree. This fungus causes a brown rot which can rapidly reduce wood strength and cause branch or whole tree failure through brittle fracture. The tree presents an unacceptable risk of failure and removal is required.

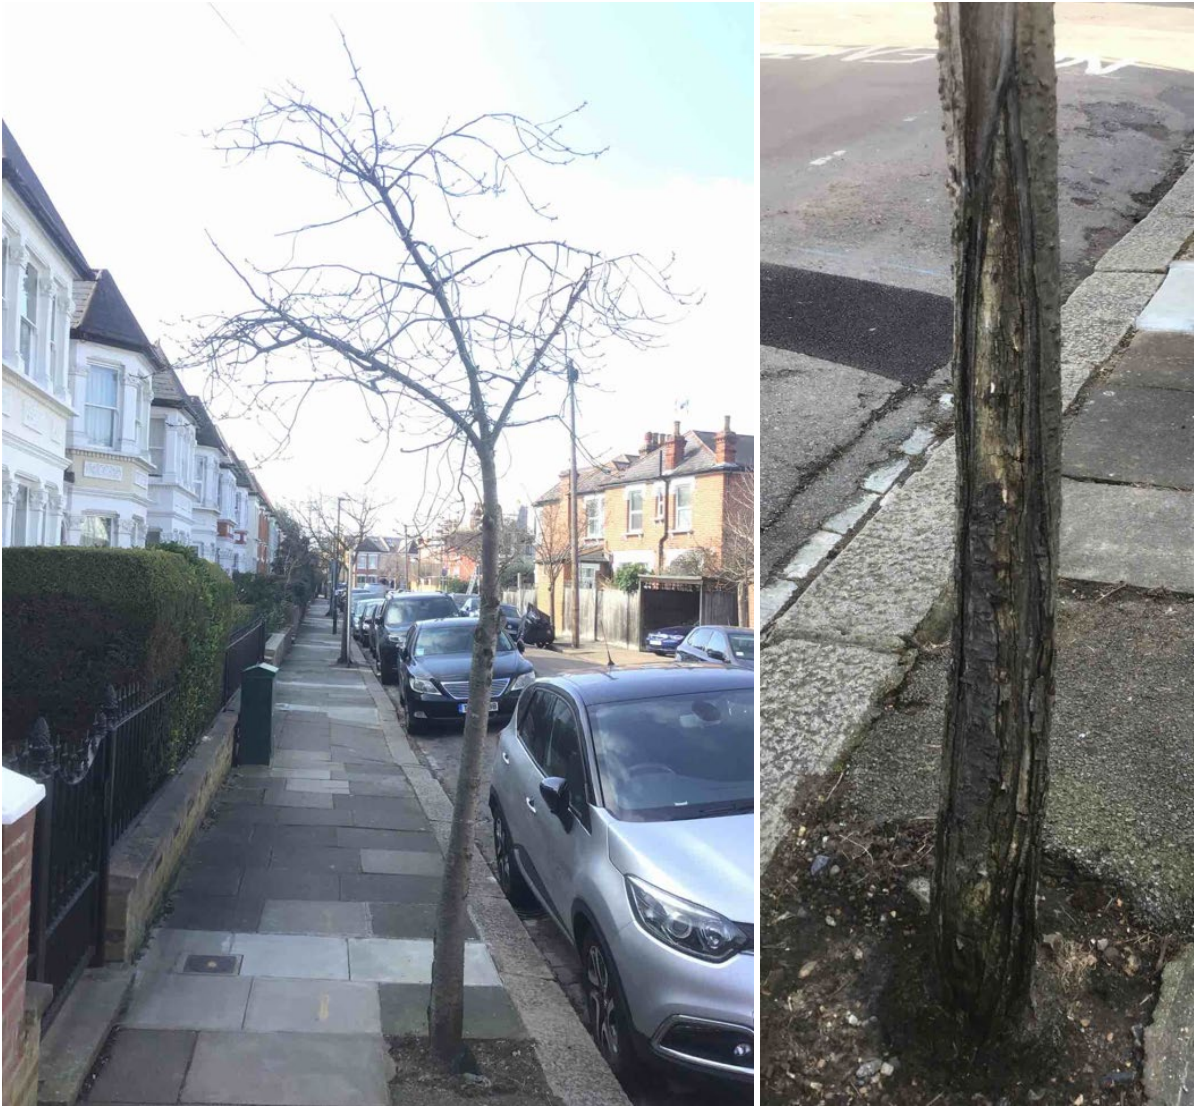
Tree number	6
Road	Denton Road
Location	Outside 38
Species	Wild Cherry ( <i>Prunus avium</i> )
Height	3.5m
Physiological Condition	Poor
Structural Condition	Poor
Inspection findings	This tree has cracked, peeling bark indicating necrosis and dysfunction of the trees vascular system. The main stem or trunk and roots are extensively decayed; the tree is moving in such a way that indicates that the structure is compromised presenting an unacceptable risk of failure.

Left image shows tree in street scene, right image shows stem with bark peeled.

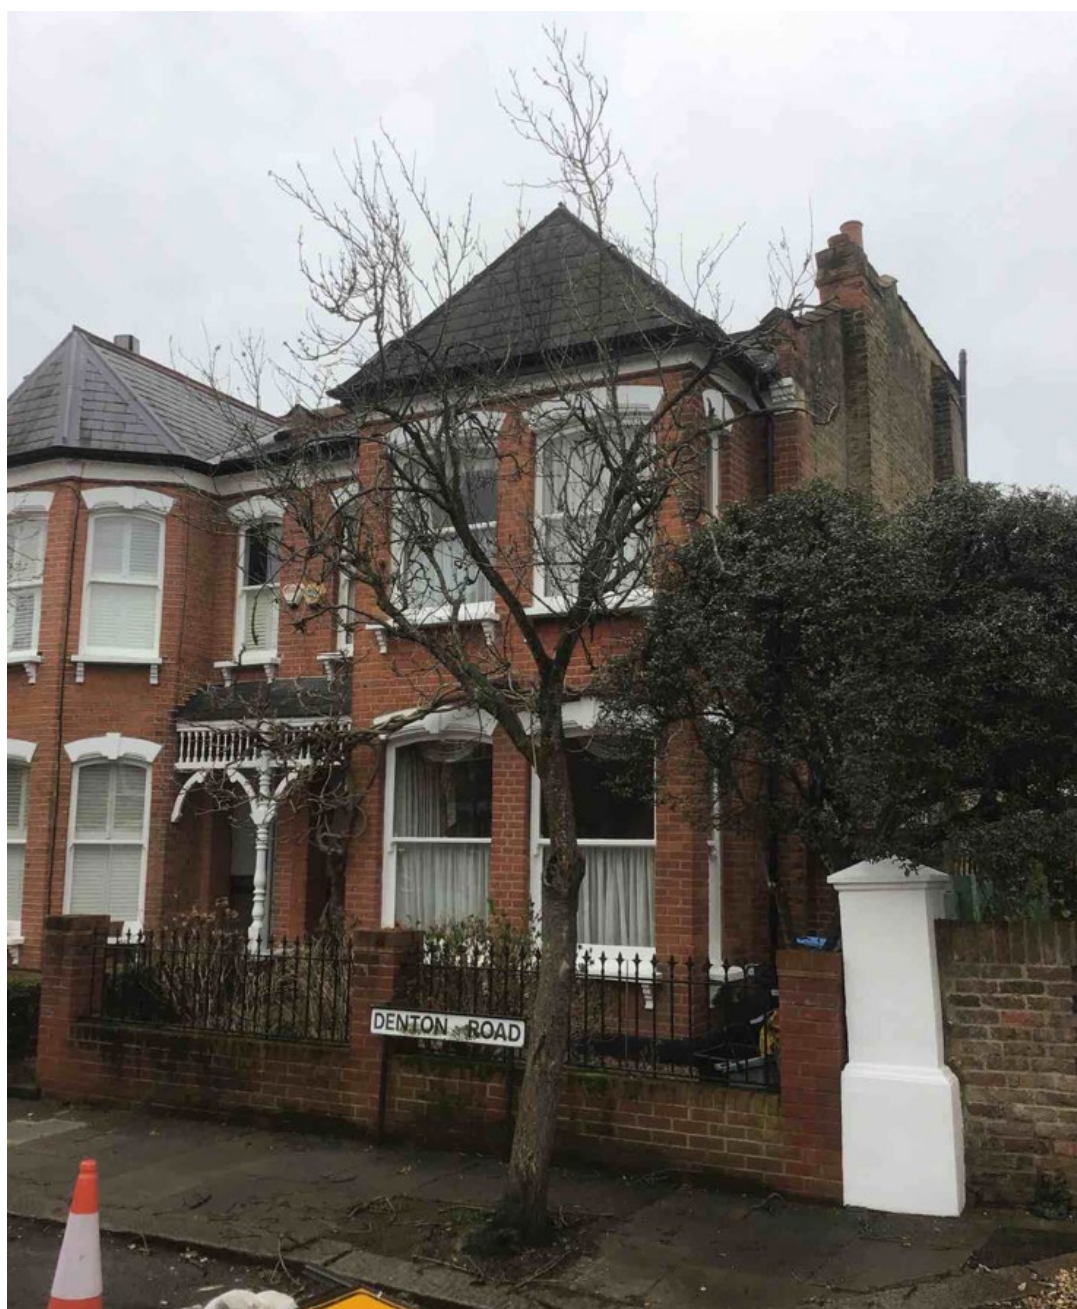
Tree number	1
Road	Denton Road
Location	Outside 2
Species	Wild Cherry ( <i>Prunus avium</i> )
Height	6.0m
Physiological Condition	Dead
Structural Condition	Dead
Inspection findings	This tree is dead; removal is required to prevent natural failure and facilitate replanting

Image shows dead tree

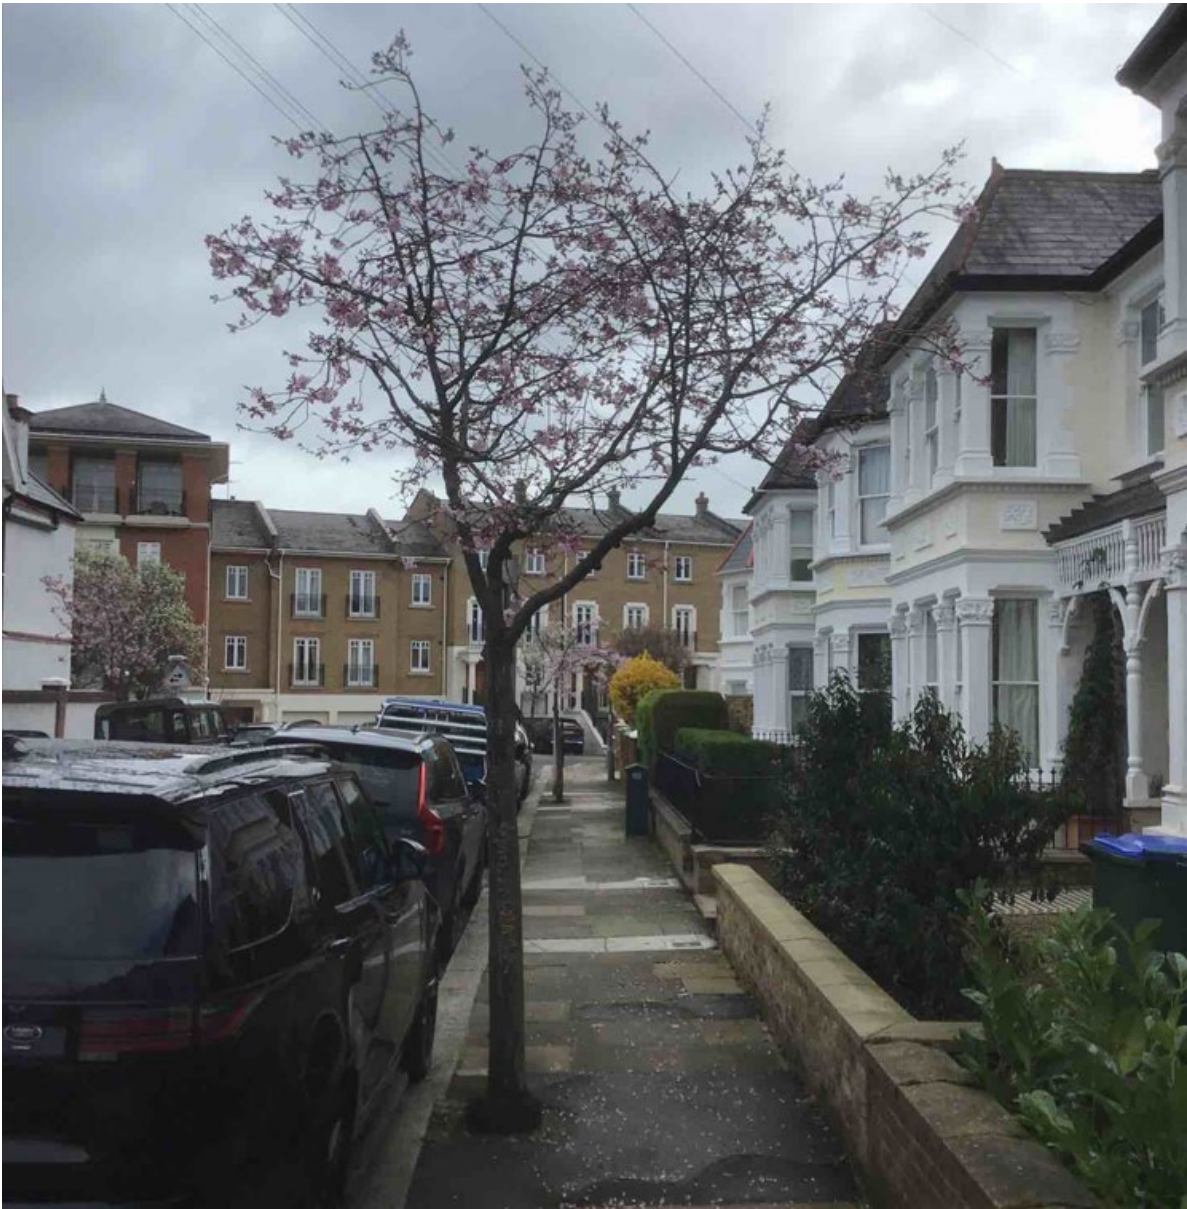
Tree number	5
Road	Denton Road
Location	Outside 32
Species	Wild Cherry ( <i>Prunus avium</i> )
Height	4.5m
Physiological Condition	Good
Structural Condition	Poor
Inspection findings	This tree has cracked, peeling bark indicating necrosis and dysfunction of the trees vascular system. The main stem or trunk and roots are extensively decayed; the tree is moving in such a way that indicates that the structure is compromised presenting an unacceptable risk of failure.

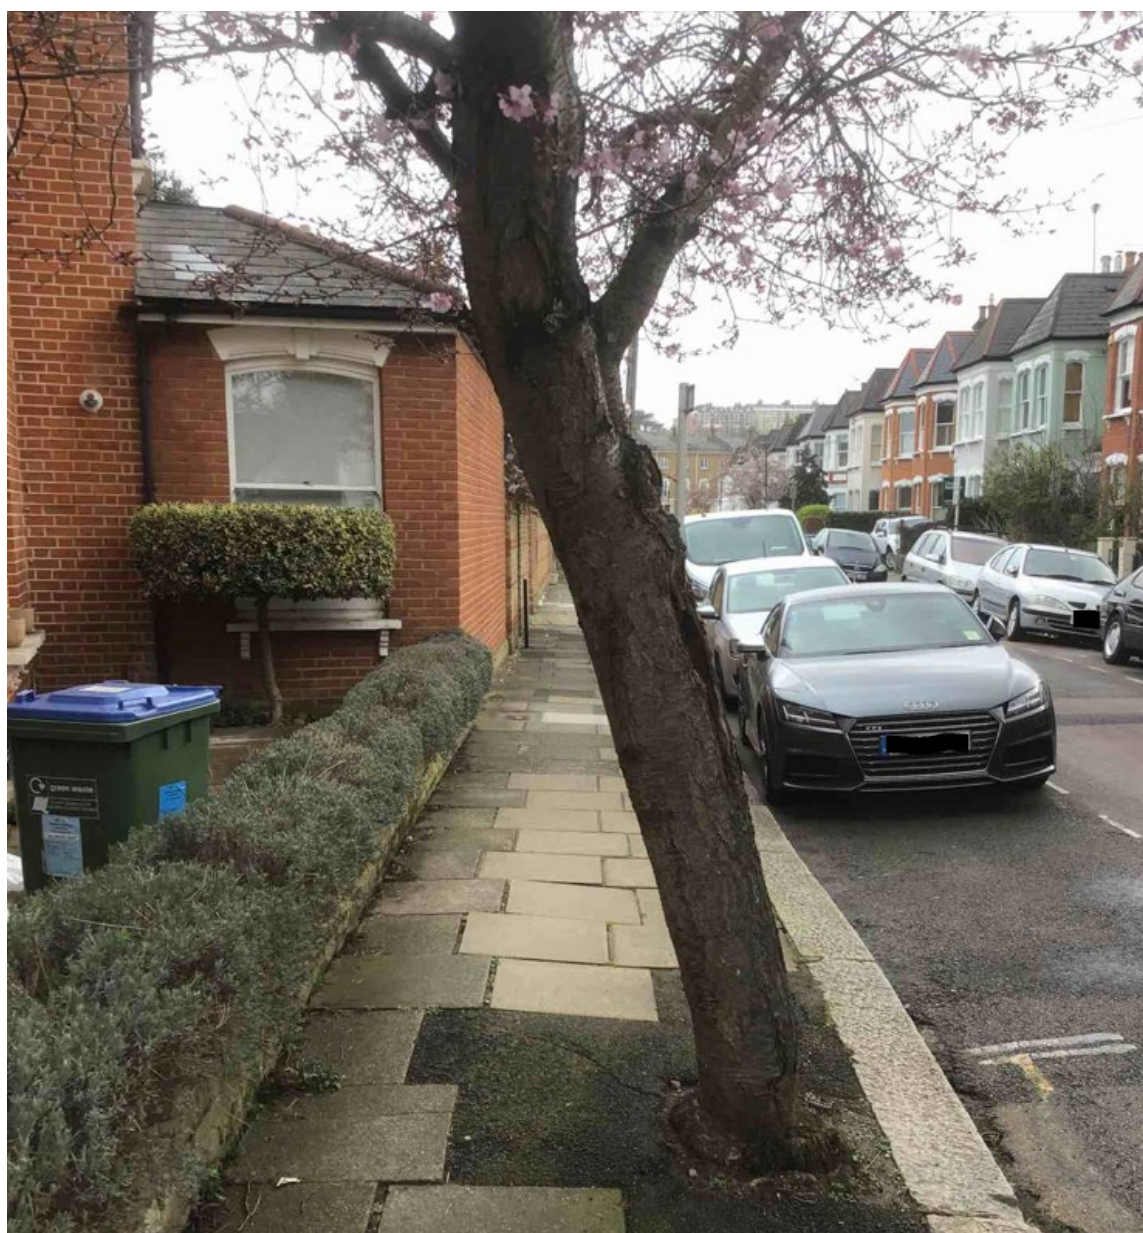
Tree number	14
Road	Denton Road
Location	Opposite 4
Species	Wild Cherry ( <i>Prunus avium</i> )
Height	7.0m
Physiological Condition	Good
Structural Condition	Fair
Inspection findings	This tree is causing an unacceptable degree of obstruction to the footway that cannot be reasonably managed with engineering solutions; removal and replanting of the tree has been identified as the most appropriate course of action.

**Image shows tree in relation to footway.**

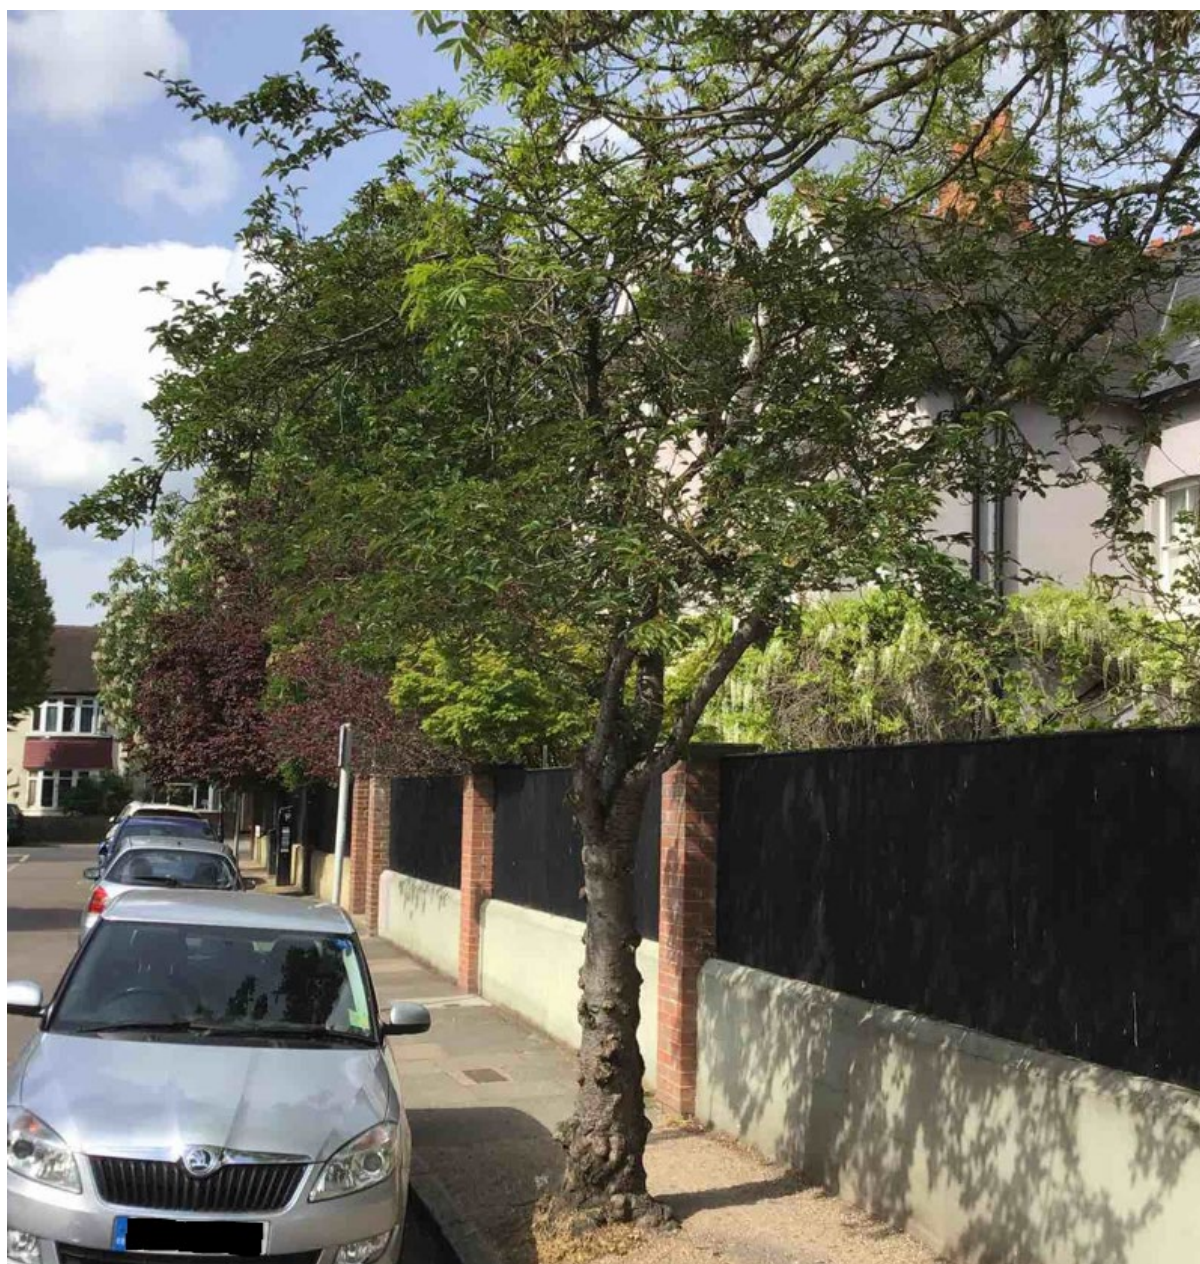
Tree number	18
Road	Haggard Road
Location	Adjacent to 12 Strafford Road
Species	Wild Cherry ( <i>Prunus avium</i> )
Height	4.5m
Physiological Condition	Good
Structural Condition	Poor
Inspection findings	The main stem or trunk and roots are extensively decayed; the tree is moving in such a way that indicates that the structure is compromised presenting an unacceptable risk of failure

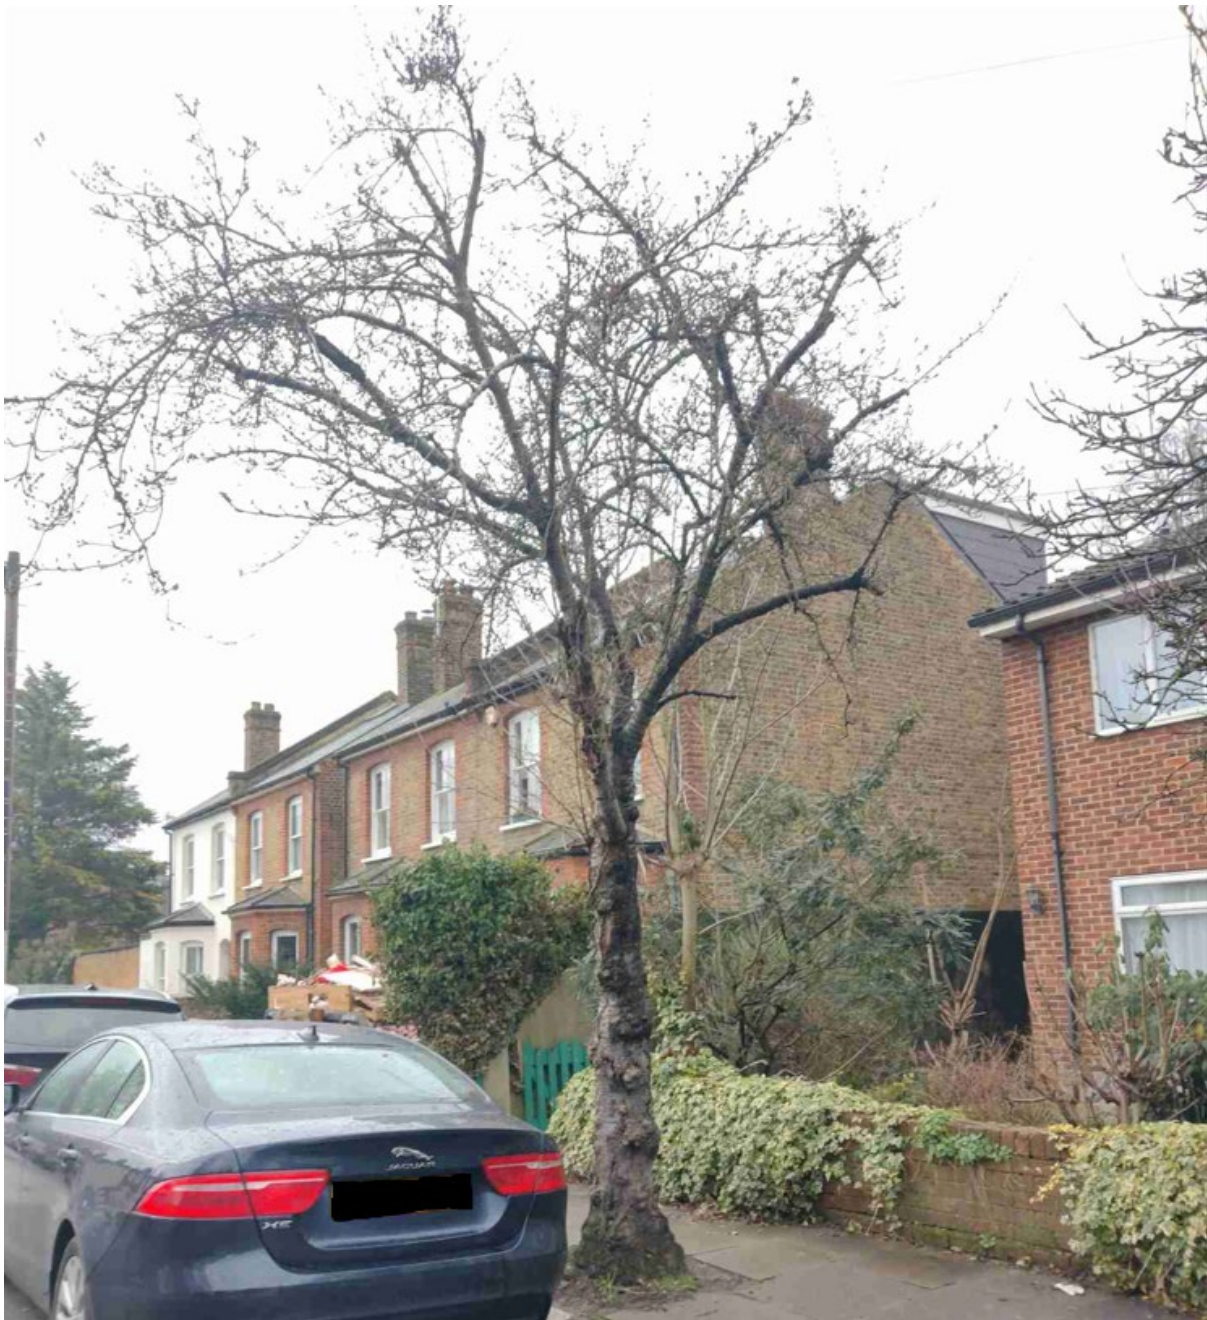
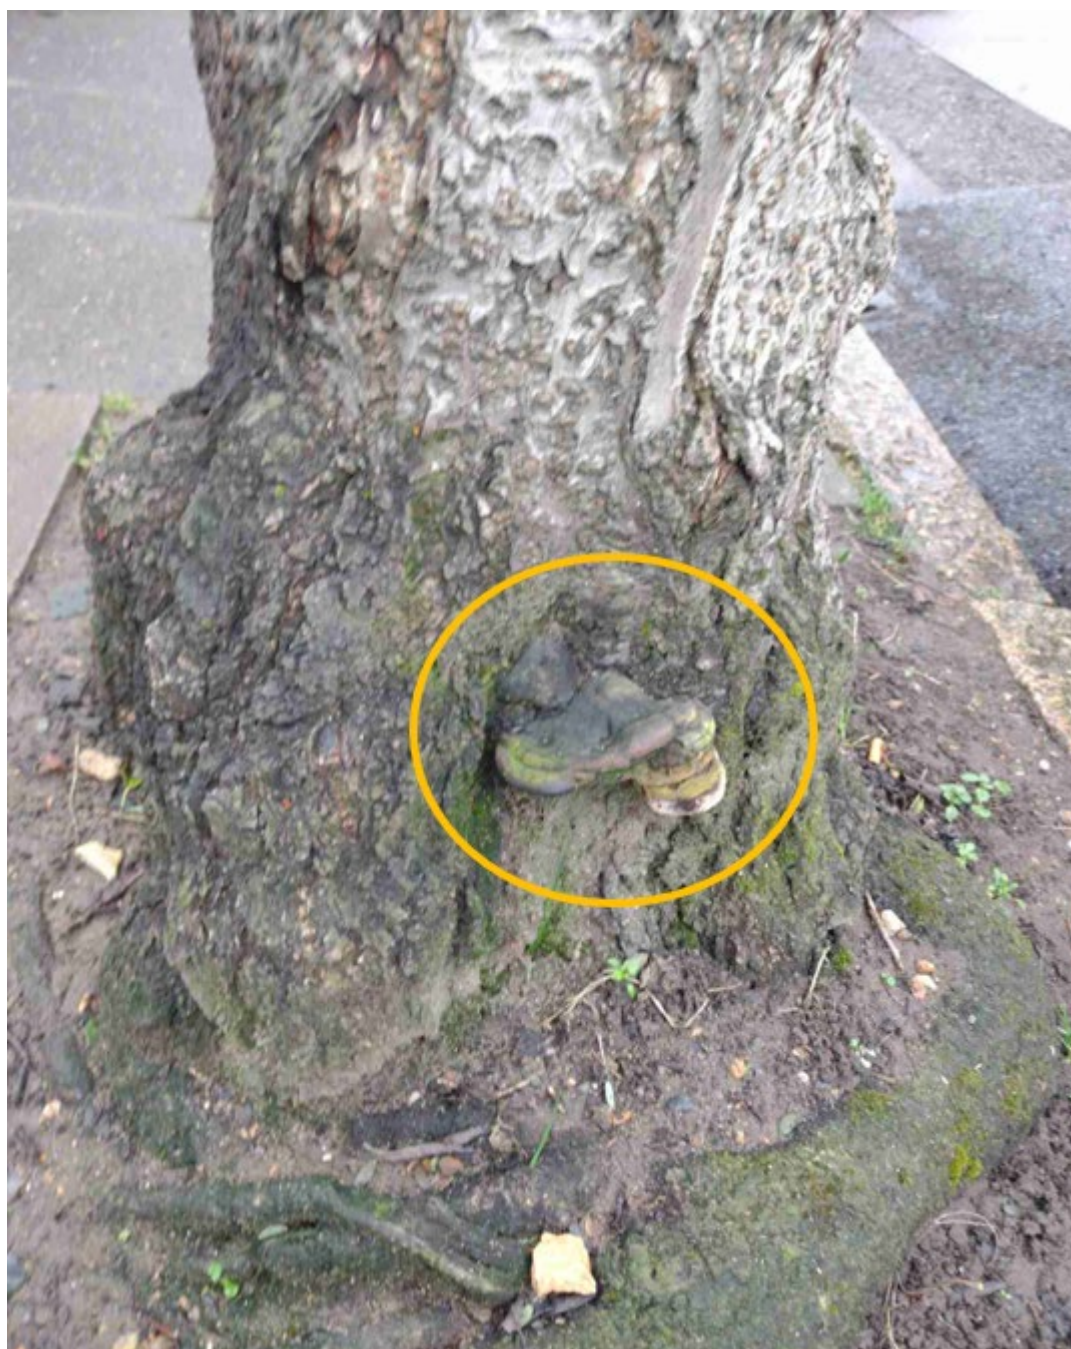
Tree number	2
H	Haggard Road
Location	Outside Nightingale Court
Species	Wild Cherry ( <i>Prunus avium</i> )
Height	5.5m
Physiological Condition	Fair
Structural Condition	Poor
Inspection findings	A fungal fruiting body of the decay pathogen <i>Ganoderma</i> sp. is present at the stem base. Colonisation by this fungus causes a white rot of the stem and root system that can cause entire trees to collapse through fracture or windthrow.

***Image shows Ganoderma fungal fruiting body at base of tree***

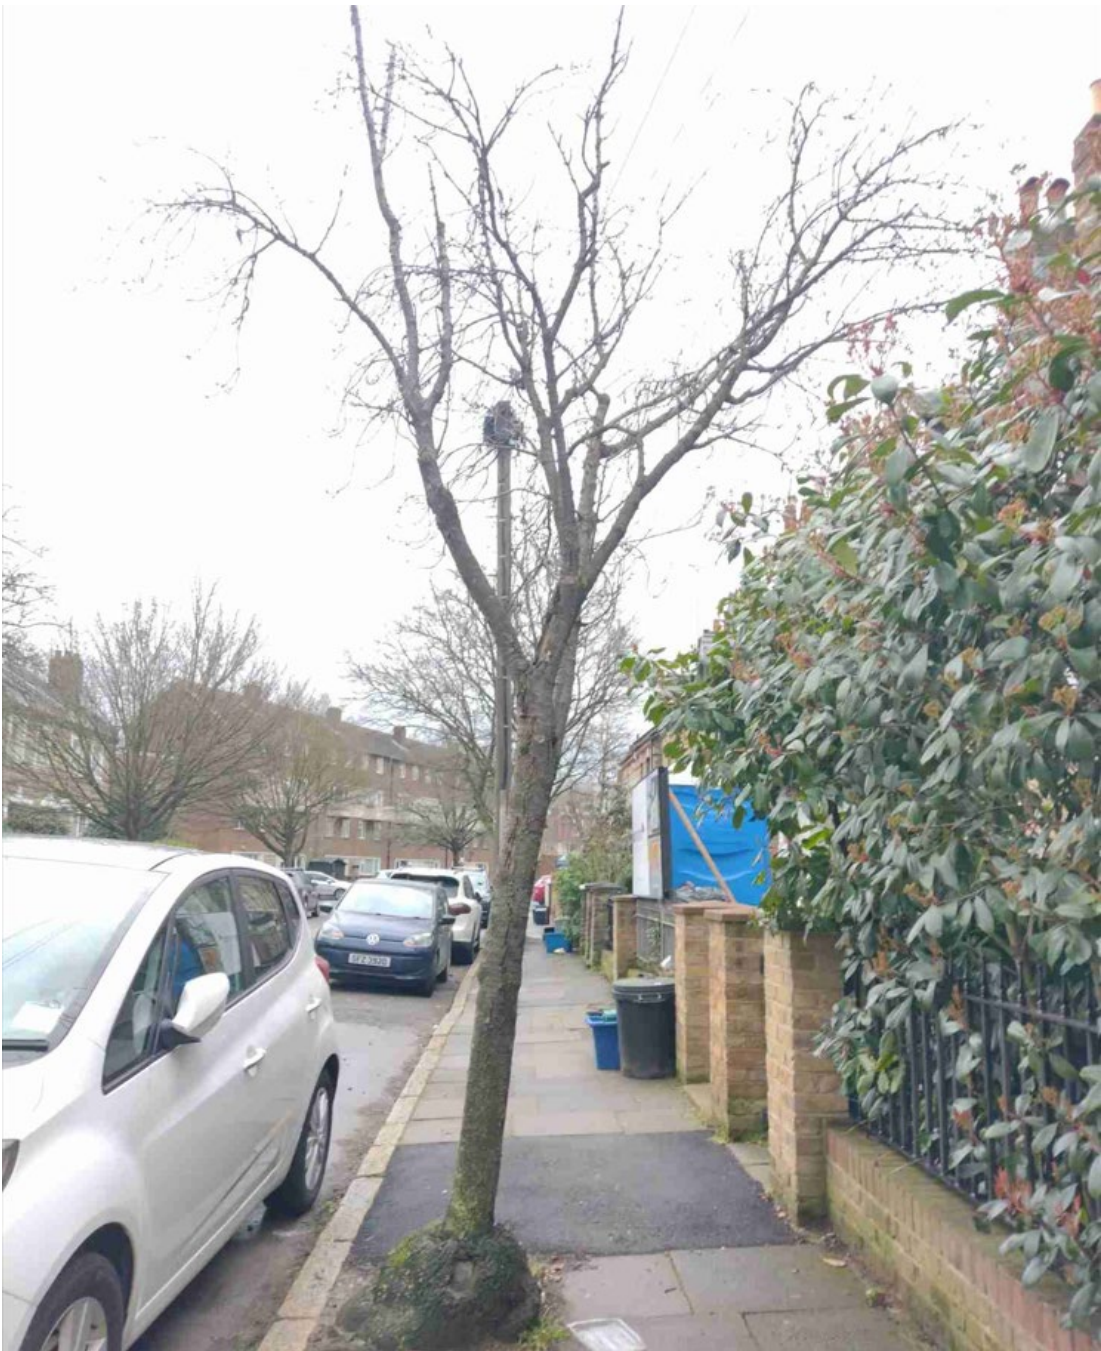
Tree number	7
Road	Haggard Road
Location	Outside 37
Species	Wild Cherry ( <i>Prunus avium</i> )
Height	6.0m
Physiological Condition	Fair
Structural Condition	Poor
Inspection findings	The main stem or trunk and roots are extensively decayed; the tree is moving in such a way that indicates that the structure is compromised presenting an unacceptable risk of failure
