## **Twickenham Riverside - 2023 Ward Works and Tree Removals Programme**

### Introduction

Dated 23.05.2023

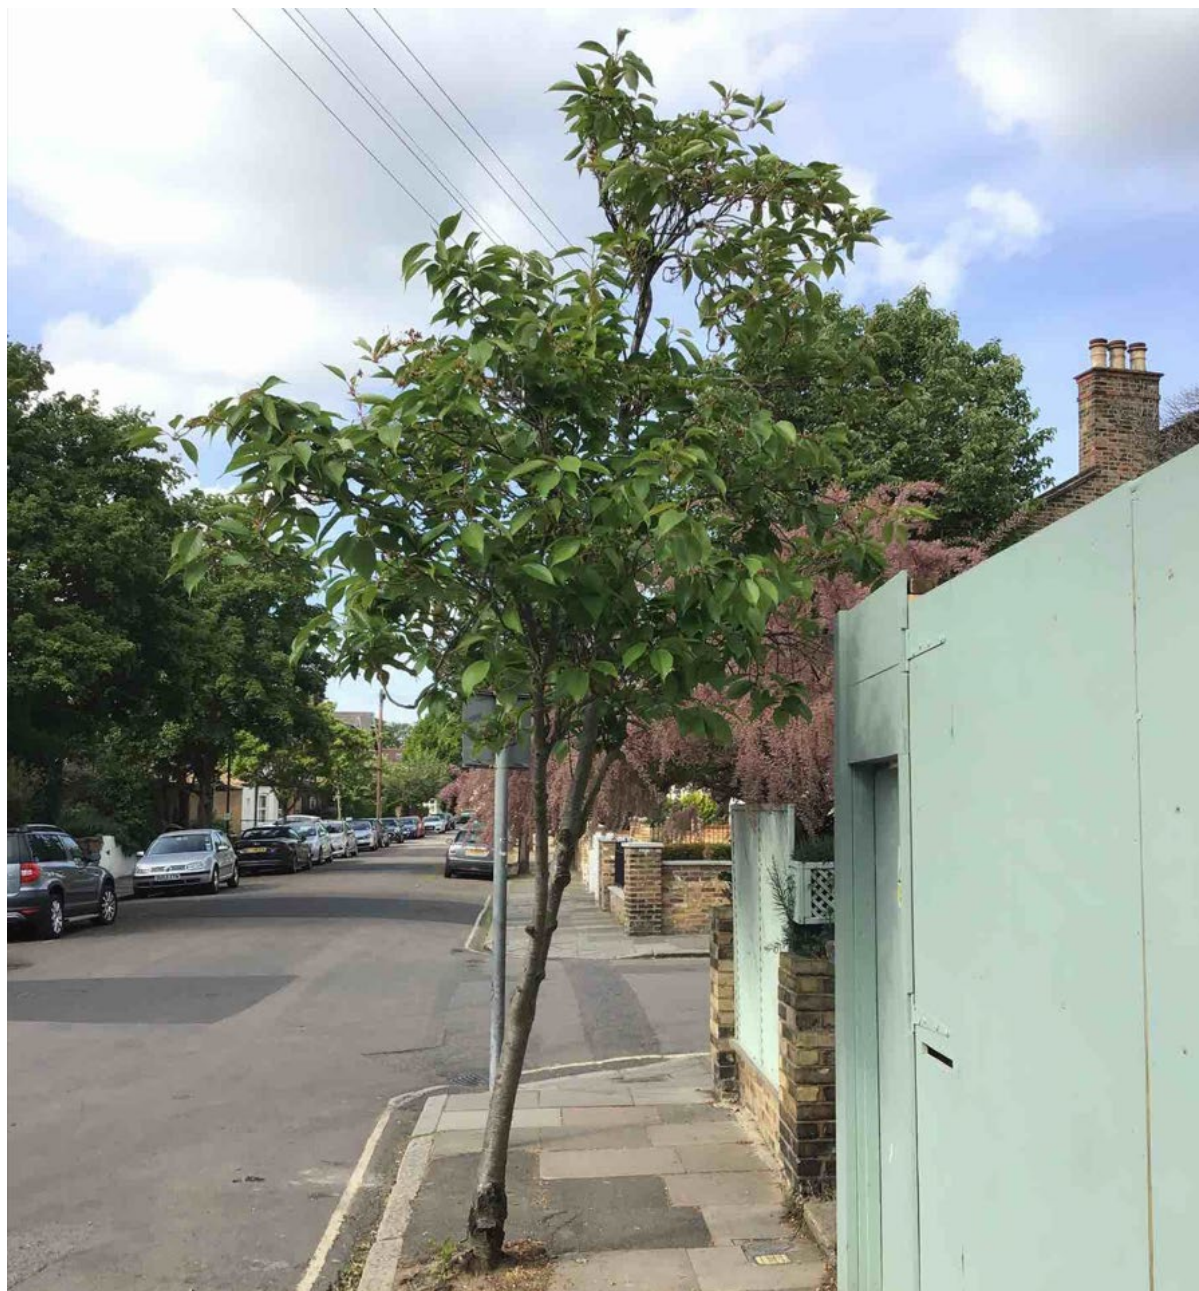
Tree number	14
Road	Haggard Road
Location	Outside 26
Species	Wild Cherry ( <i>Prunus avium</i> )
Height	4.0m
Physiological Condition	Fair
Structural Condition	Fair
Inspection findings	This tree is causing an unacceptable degree of obstruction to the footway.

**Image shows tree in relation to footway**

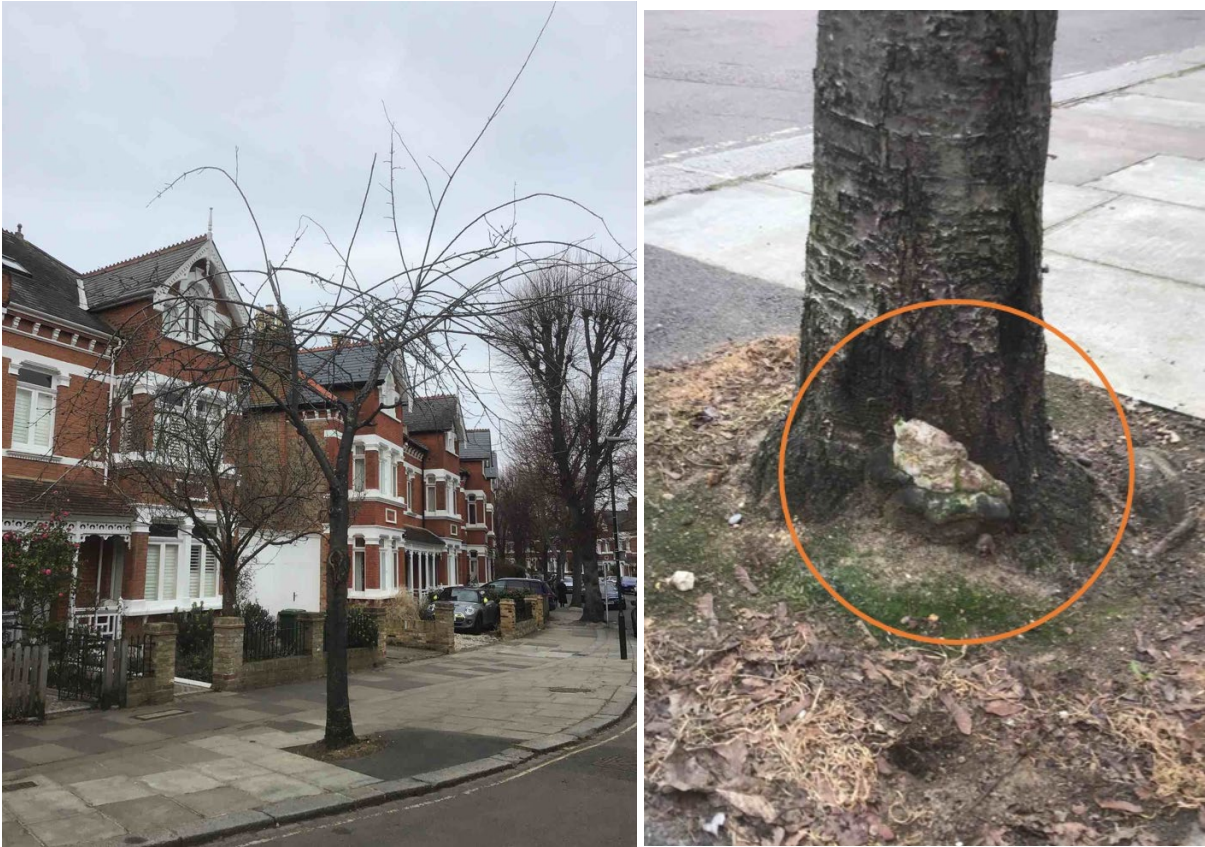
Tree number	22
Road	Lebanon Park
Location	Outside 49
Species	Wild Cherry ( <i>Prunus avium</i> )
Height	7.0m
Physiological Condition	Poor
Structural Condition	Fair
Inspection findings	A fungal fruiting body of the decay pathogen <i>Ganoderma</i> sp. is present at the stem base. Colonisation by this fungus causes a white rot of the stem and root system that can cause entire trees to collapse through fracture or windthrow. Tree crown is displaying symptoms of physiological decline in the crown which correlate with degradation of the supporting root system.

Left image shows tree in street scene, right image shows base of tree with fungen fruiting body circled.

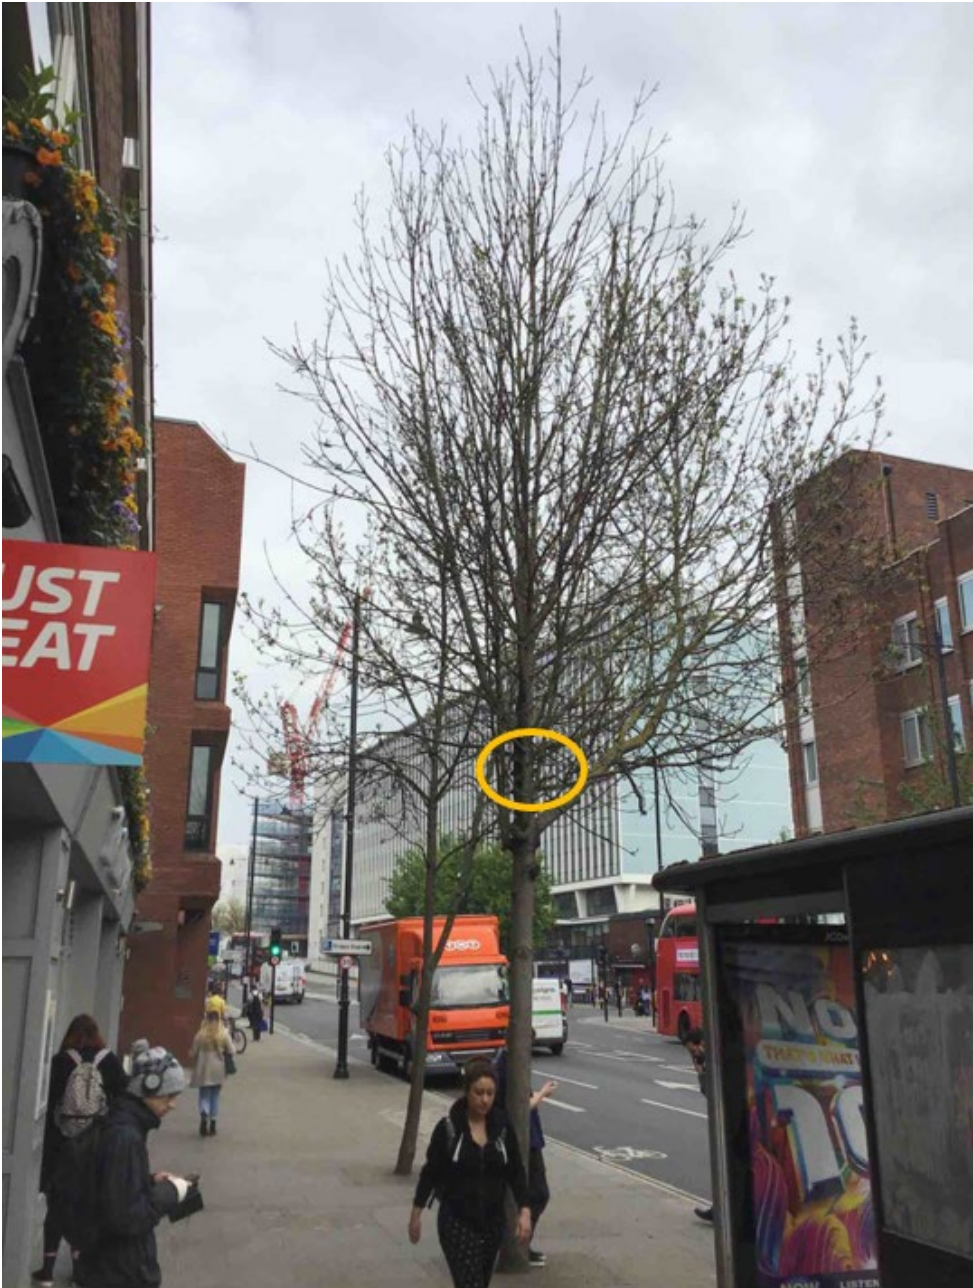
Tree number	5
Road	London Road
Location	Outside 53
Species	Raywood Ash ( <i>Fraxinus angustifolia</i> 'Raywood')
Height	11.5m
Physiological Condition	Poor
Structural Condition	Poor
Inspection findings	The main stem of this tree has been damaged by girdling, creating a point for failure to occur and an unacceptable risk of harm.

Image shows tree in street scene with location of girdling circled

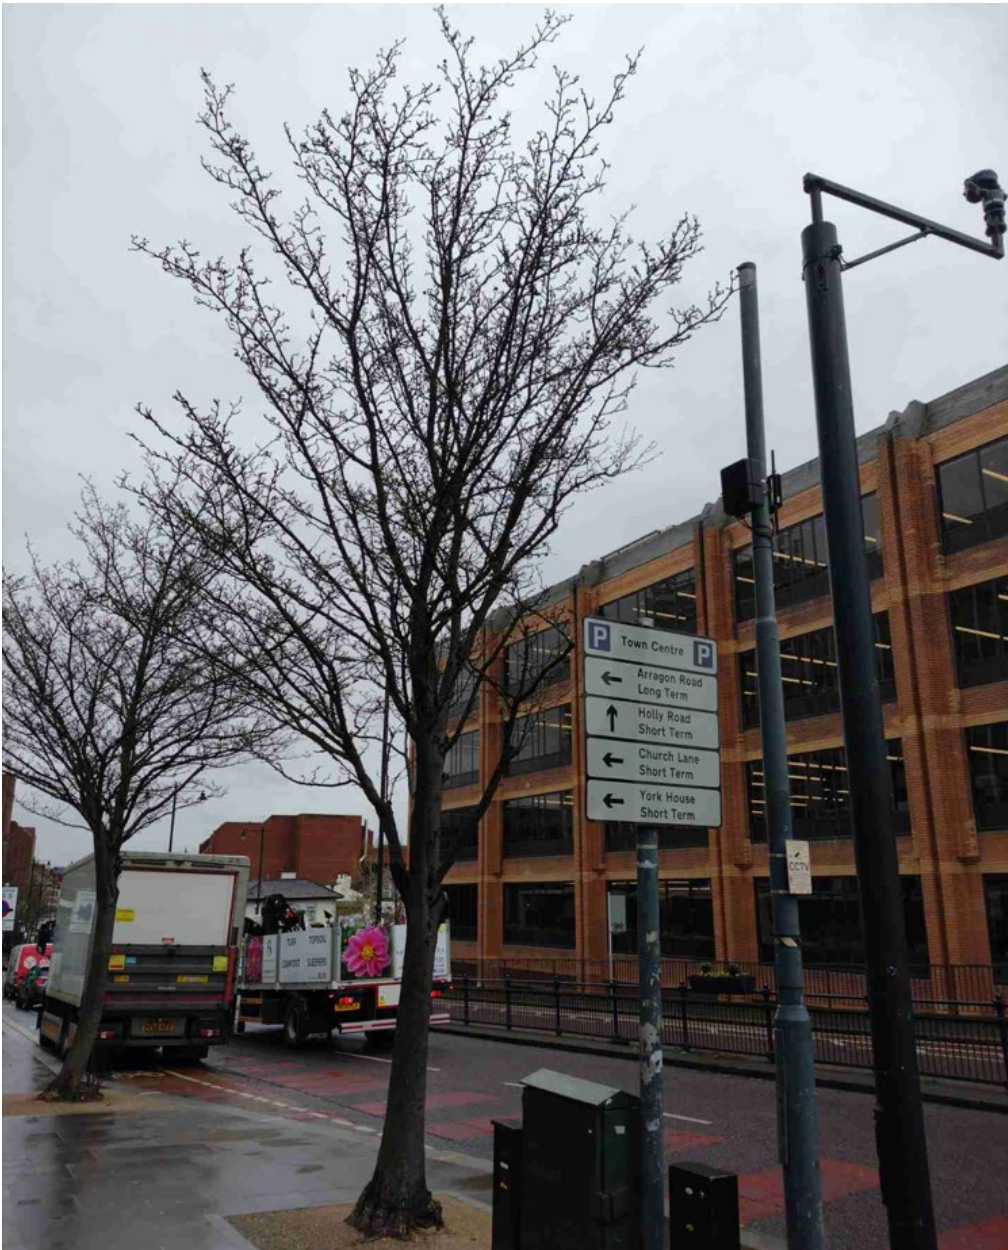
Tree number	10
Road	London Road
Location	Outside Travel Lodge
Species	Crab Apple ( <i>Malus sp.</i> )
Height	8.0m
Physiological Condition	Fair
Structural Condition	Poor
Inspection findings	A fungal fruiting body of the decay pathogen <i>Ganoderma</i> sp. is present at the stem base. Colonisation by this fungus causes a white rot of the stem and root system that can cause entire trees to collapse through fracture or windthrow. A resonance test revealed an unacceptable degree of decay in the trunk of this tree, removal is required to prevent natural failure and manage risk.

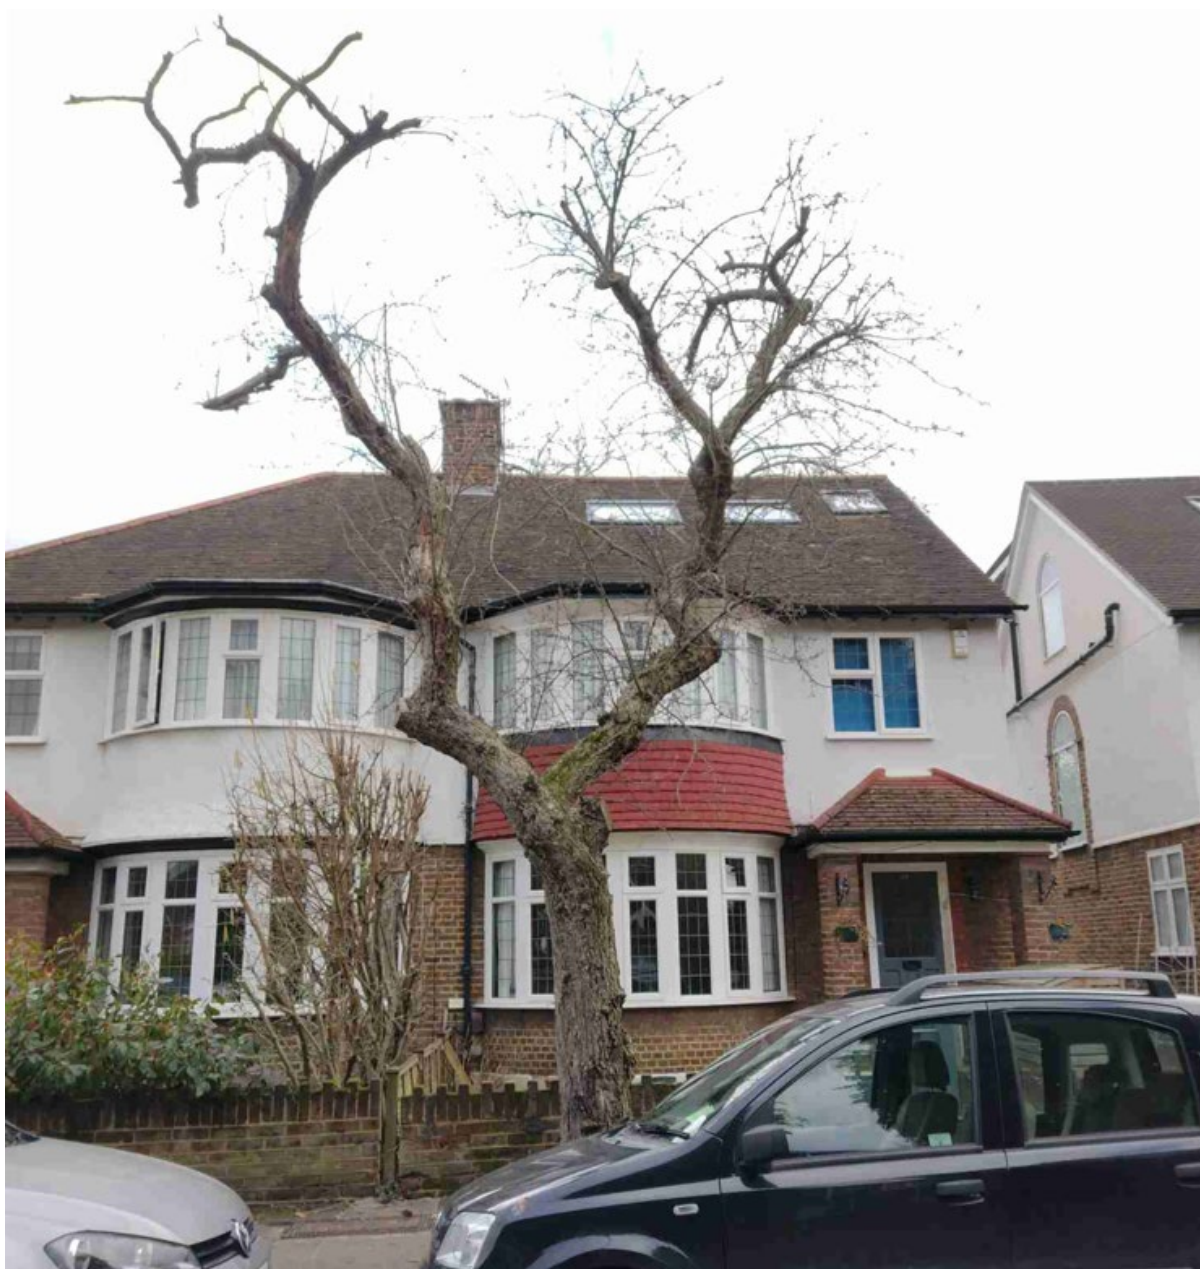
Tree number	12
Road	Marble Hill Gardens
Location	Outside 43
Species	Crab Apple ( <i>Malus sp.</i> )
Height	8.0m
Physiological Condition	Poor
Structural Condition	poor
Inspection findings	This tree is dying; deadwood is ubiquitous.

**Image shows tree with bark loss and extensive dieback.**

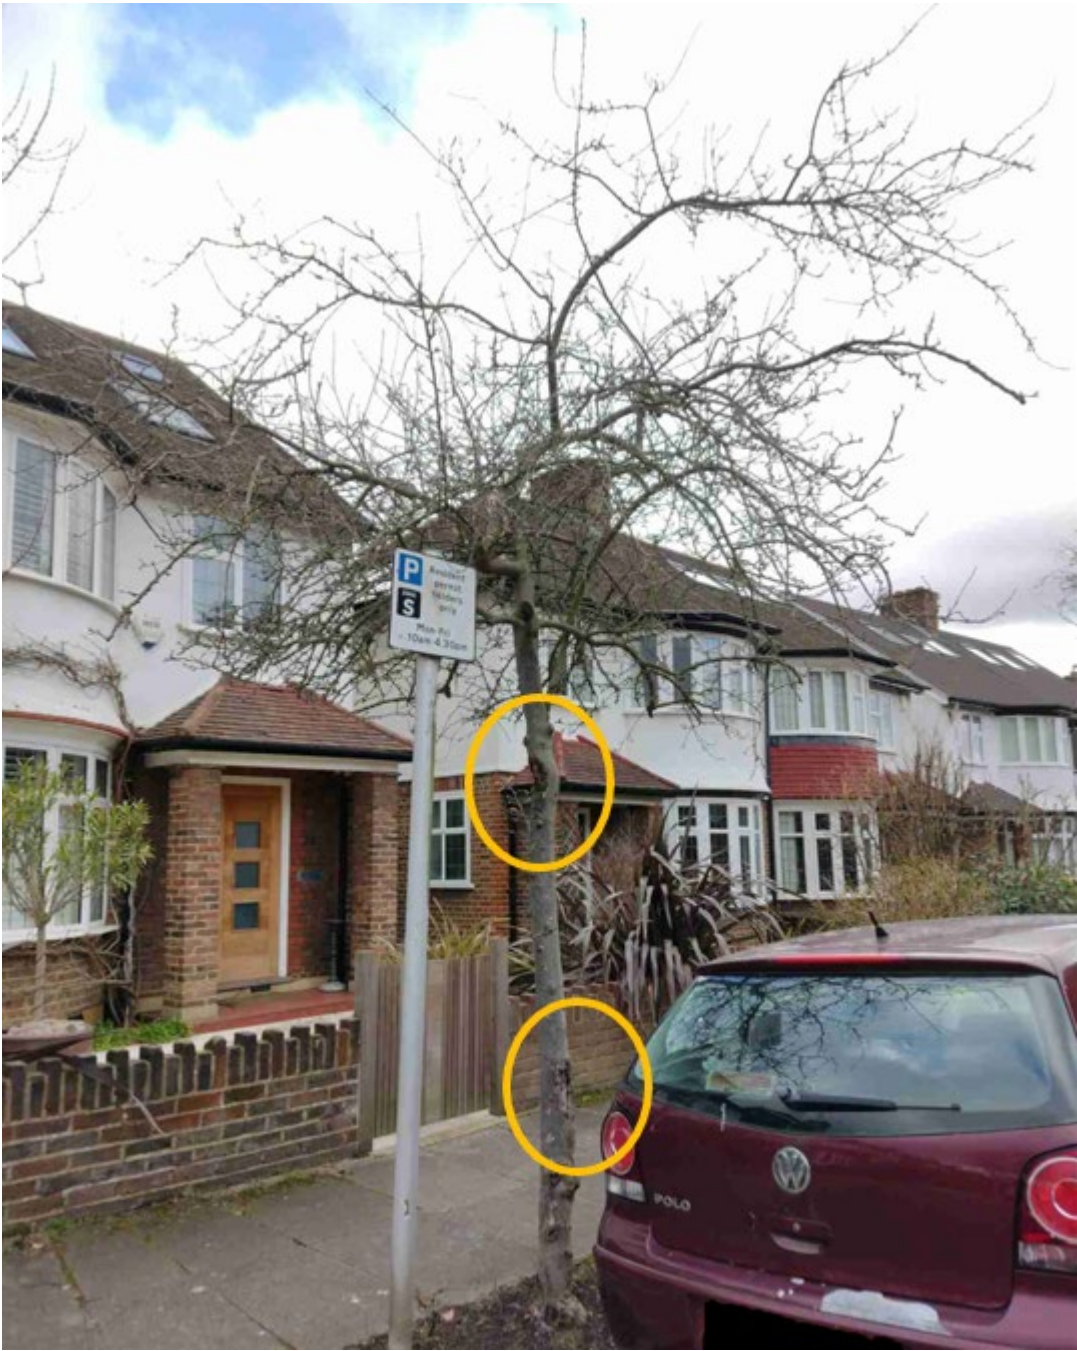
Tree number	11
Road	Marble Hill Gardens
Location	Outside 39
Species	Crab Apple ( <i>Malus sp.</i> )
Height	4.5m
Physiological Condition	Good
Structural Condition	Poor
Inspection findings	This trunk of this tree has been damaged in a way that is likely to lead to failure.

Image shows tree in street scene with areas of trunk damage circled

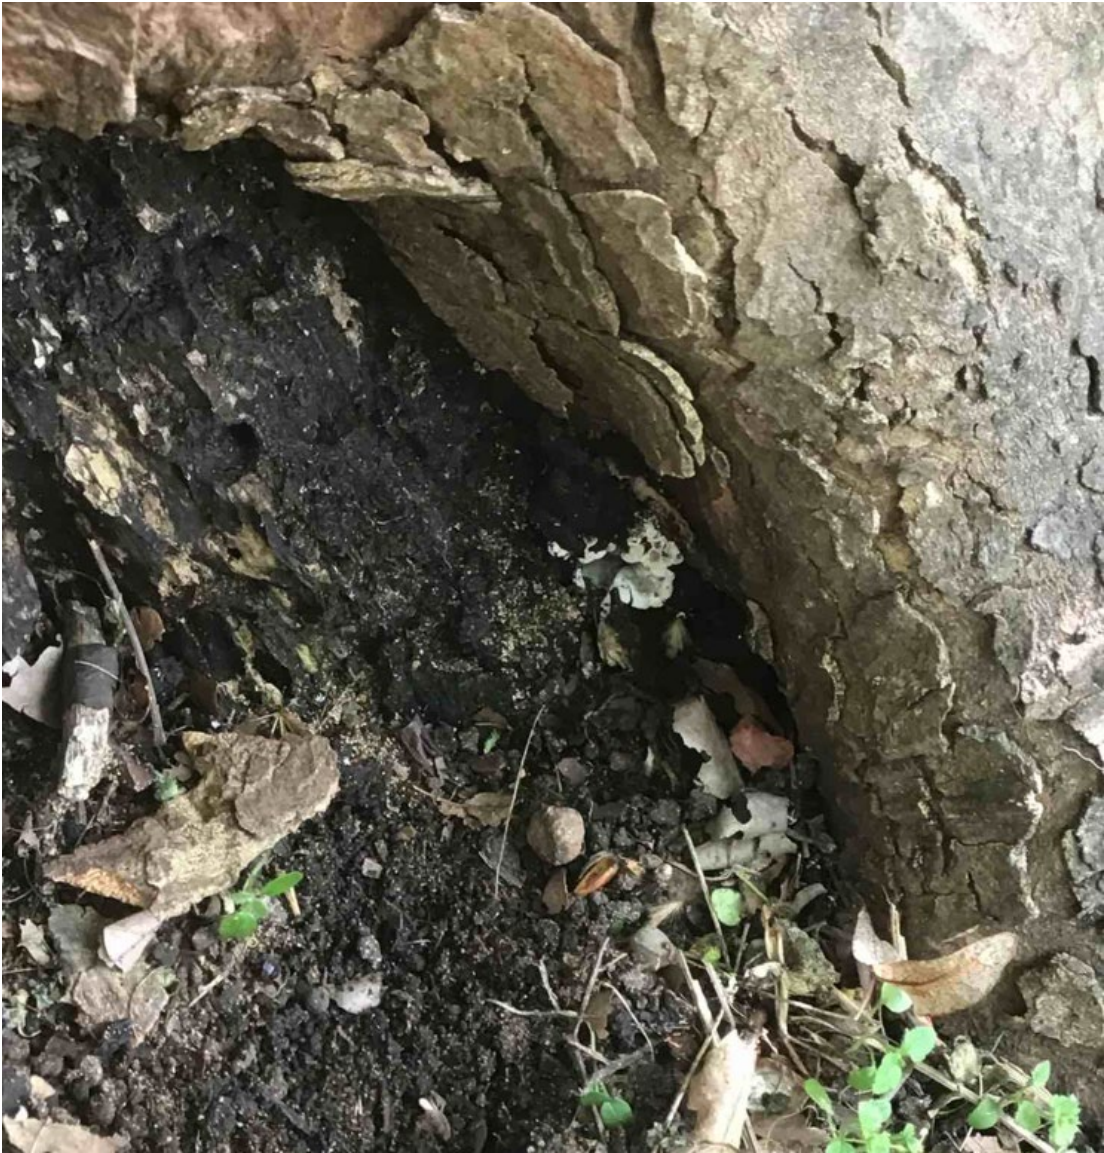
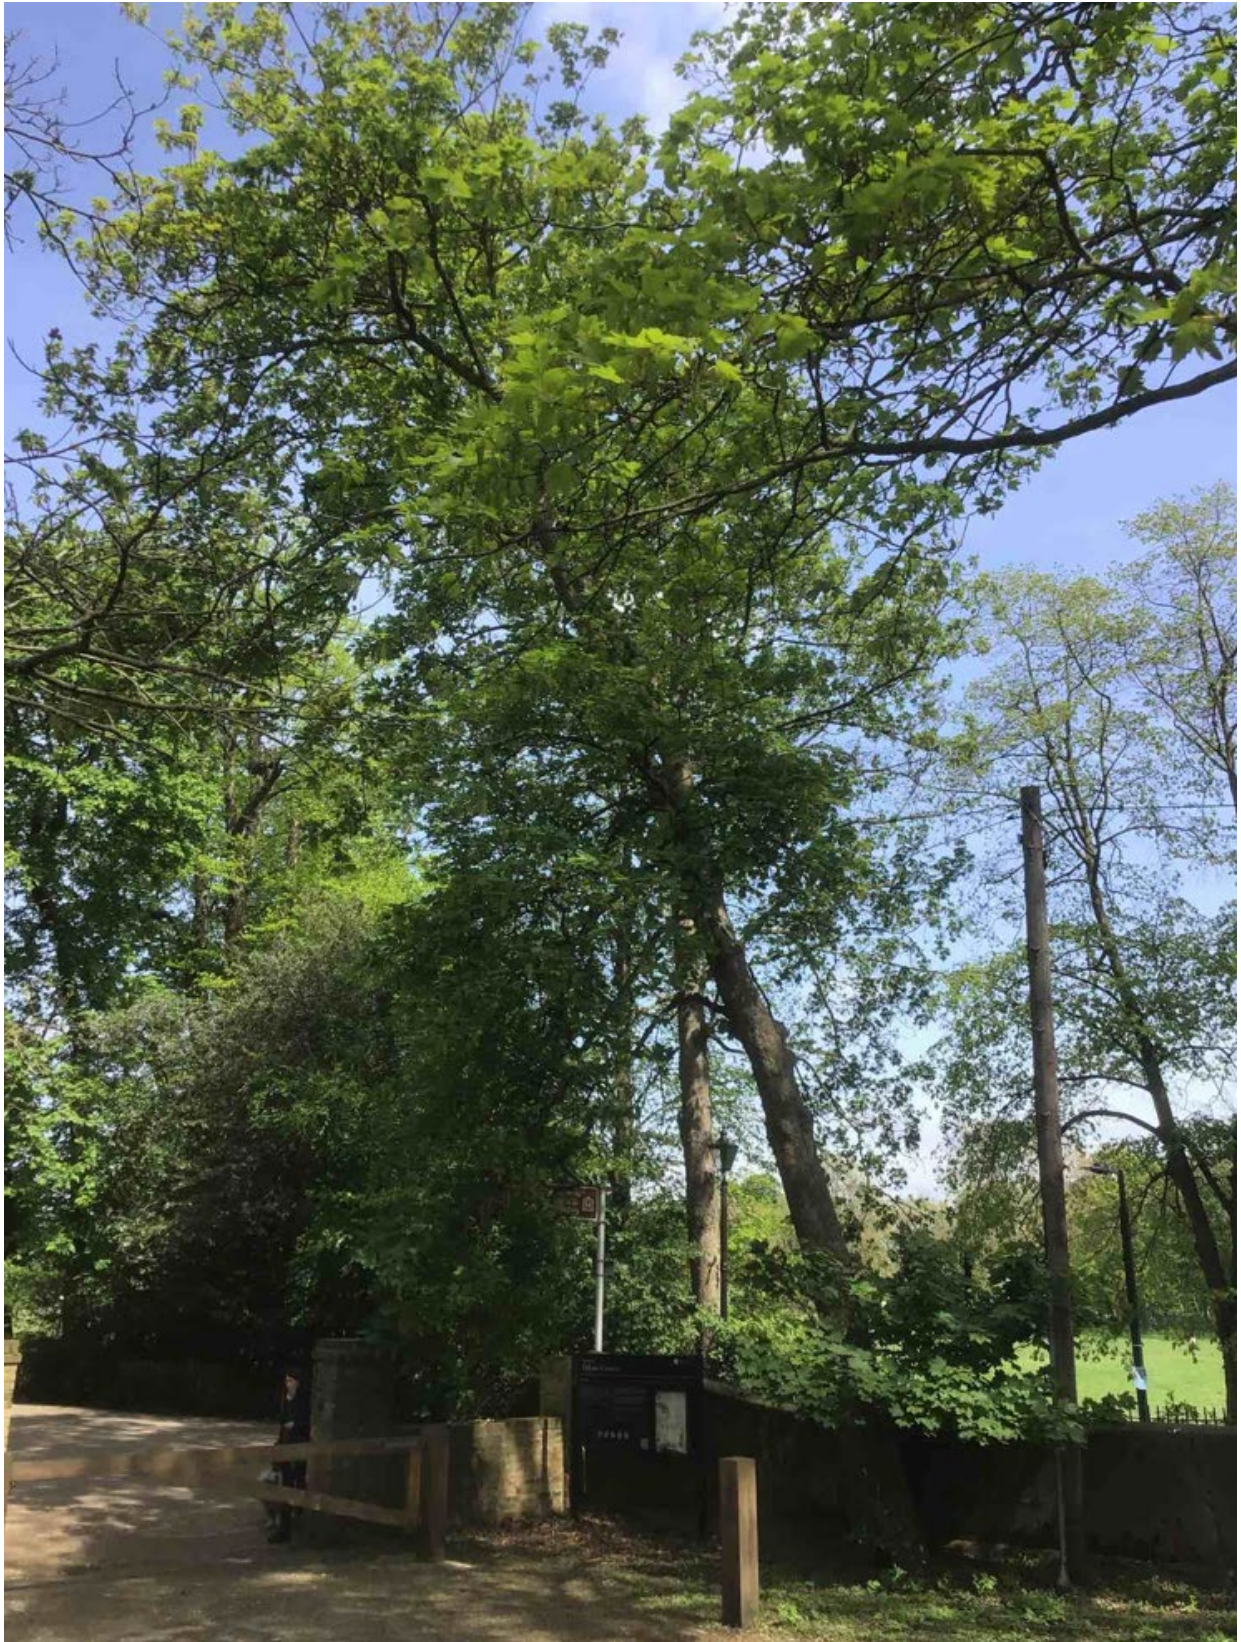
Tree number	382
Road	Orleans Gardens
Location	Near entrance to gardens - What3Words- export.statue.junior
Species	Sycamore ( <i>Acer pseudoplatanus</i> )
Height	18.0m
Physiological Condition	Poor
Structural Condition	Poor
Inspection findings	Fungal fruiting bodies of the decay pathogen <i>Kretzschmaria deusta</i> are present on the base of this tree. This fungus causes a white rot that can cause whole tree failure through a ceramic like fracture of the base. A resonance test revealed an unacceptable degree of decay in the trunk of this tree, removal is required to prevent natural failure and manage risk.

Image shows cavity with fungal fruiting body near centre (in white) and decayed wood

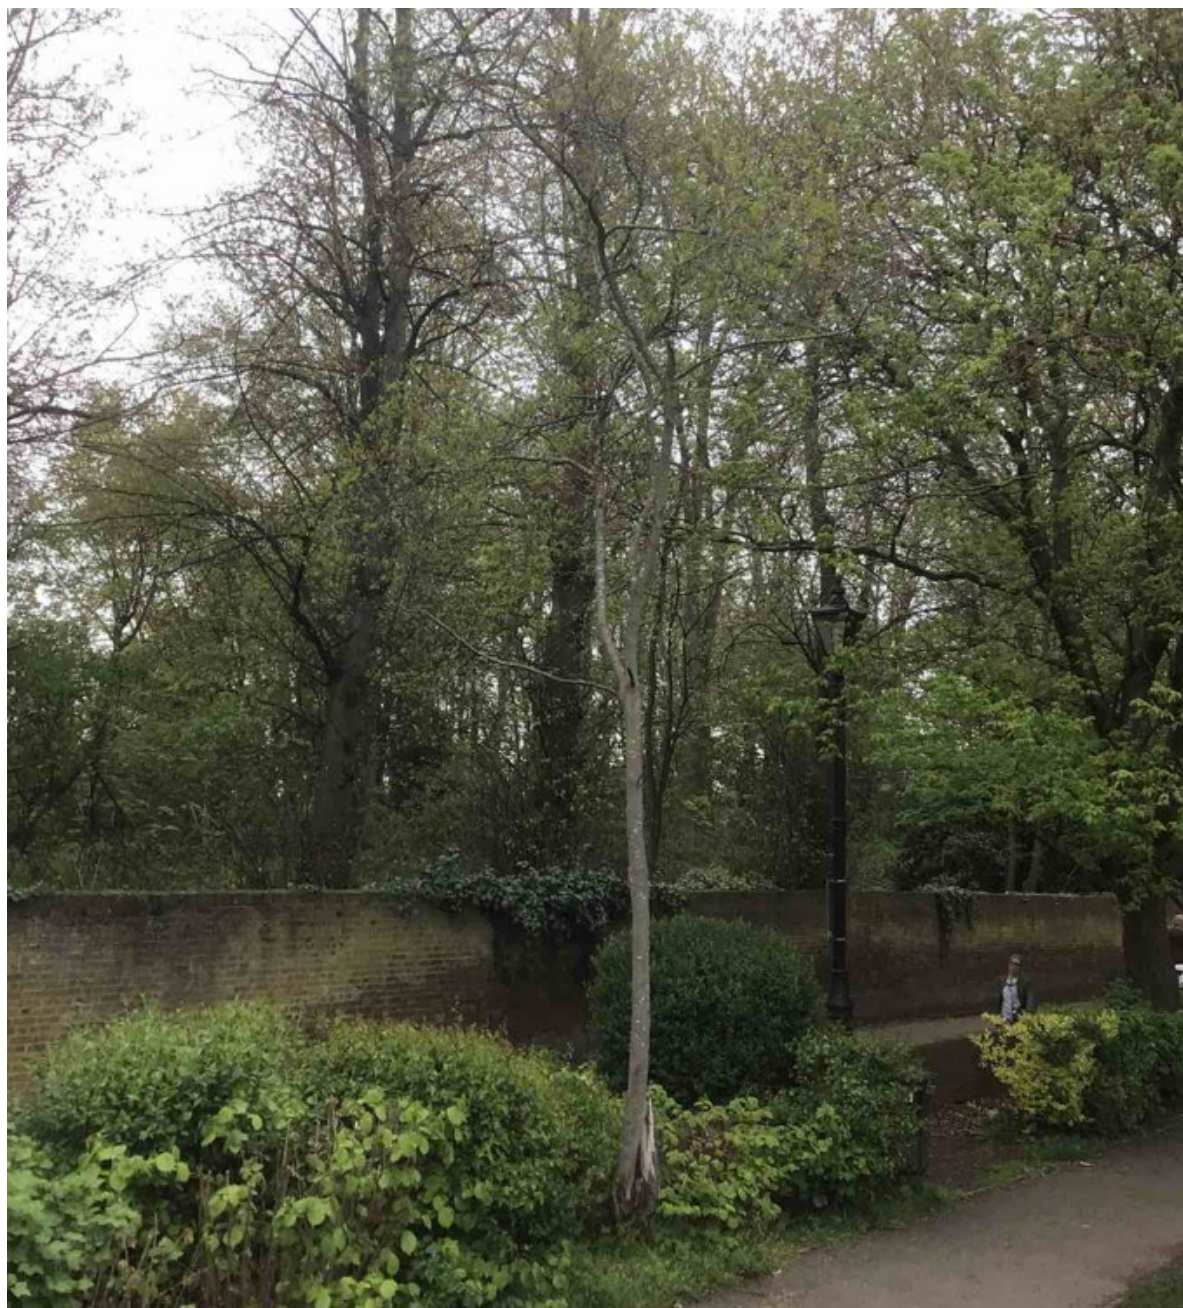
<b>Tree number</b>	601170.00
<b>Road</b>	Orleans Gardens
<b>Location</b>	Orleans Gardens- ///What3Words- bonus.grows.burn
<b>Species</b>	Alder ( <i>Alnus glutinosa</i> )
<b>Height</b>	6.0m
<b>Physiological Condition</b>	Fair
<b>Structural Condition</b>	Poor
<b>Inspection findings</b>	The main stem or trunk and roots are extensively decayed; the tree is moving in such a way that indicates that the structure is compromised presenting an unacceptable risk of failure

**Image shows tree in with extensive canopy die back**

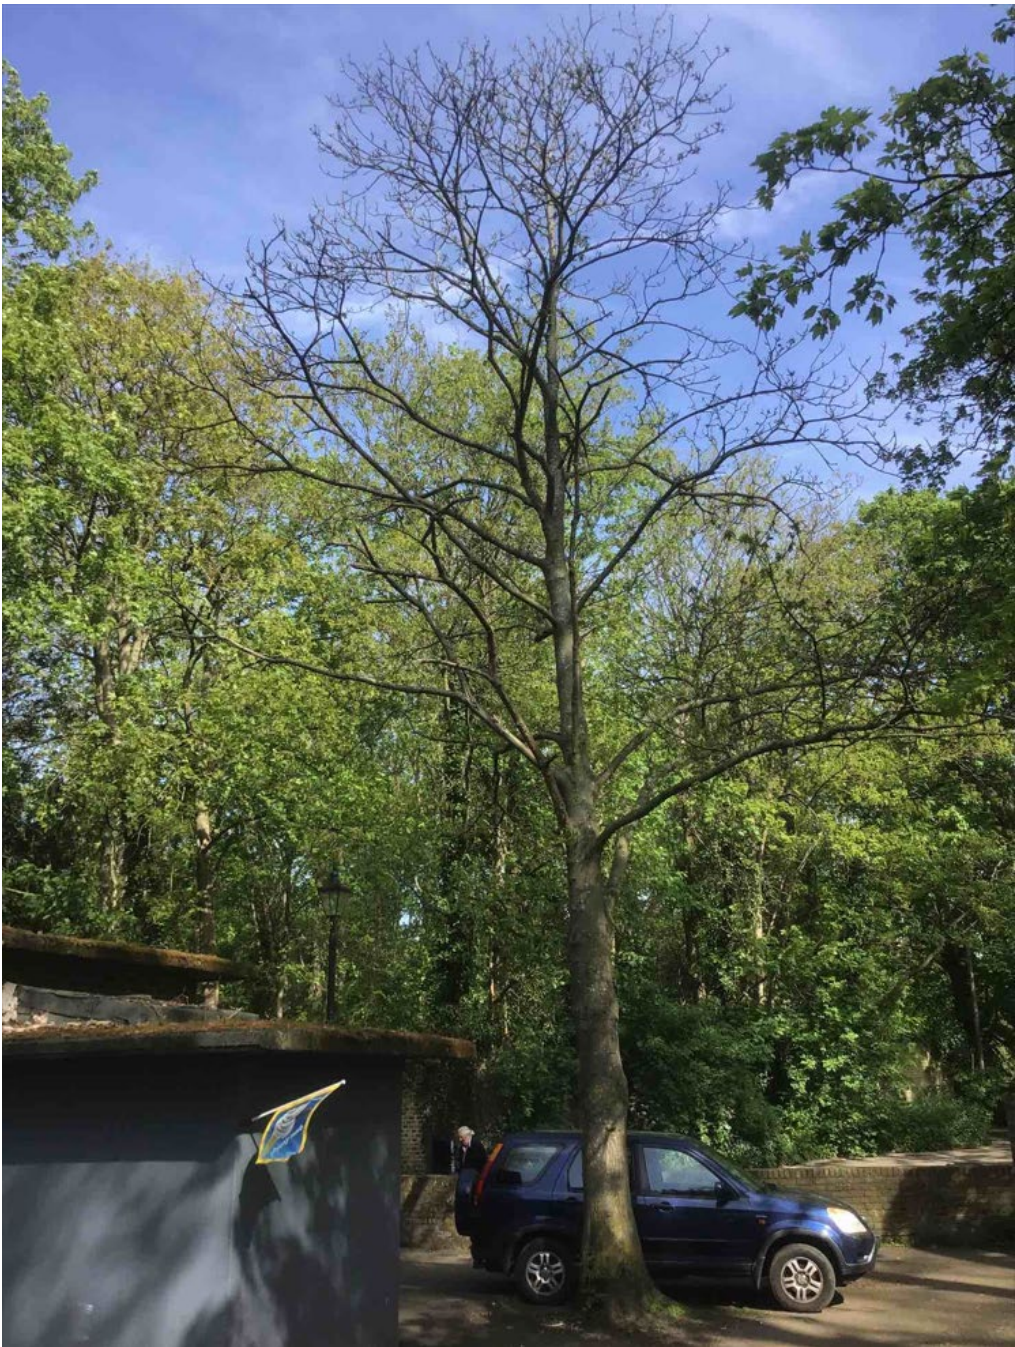
Tree number	383
Road	Orleans Gardens
Location	Orleans Gardens- ///What3Words- still.taps.crops
Species	Sweet Chestnut ( <i>Castanea sativa</i> )
Height	15.0m
Physiological Condition	Poor
Structural Condition	Poor
Inspection findings	This tree is dying; deadwood is ubiquitous.

Image shows tree in with extensive canopy die back

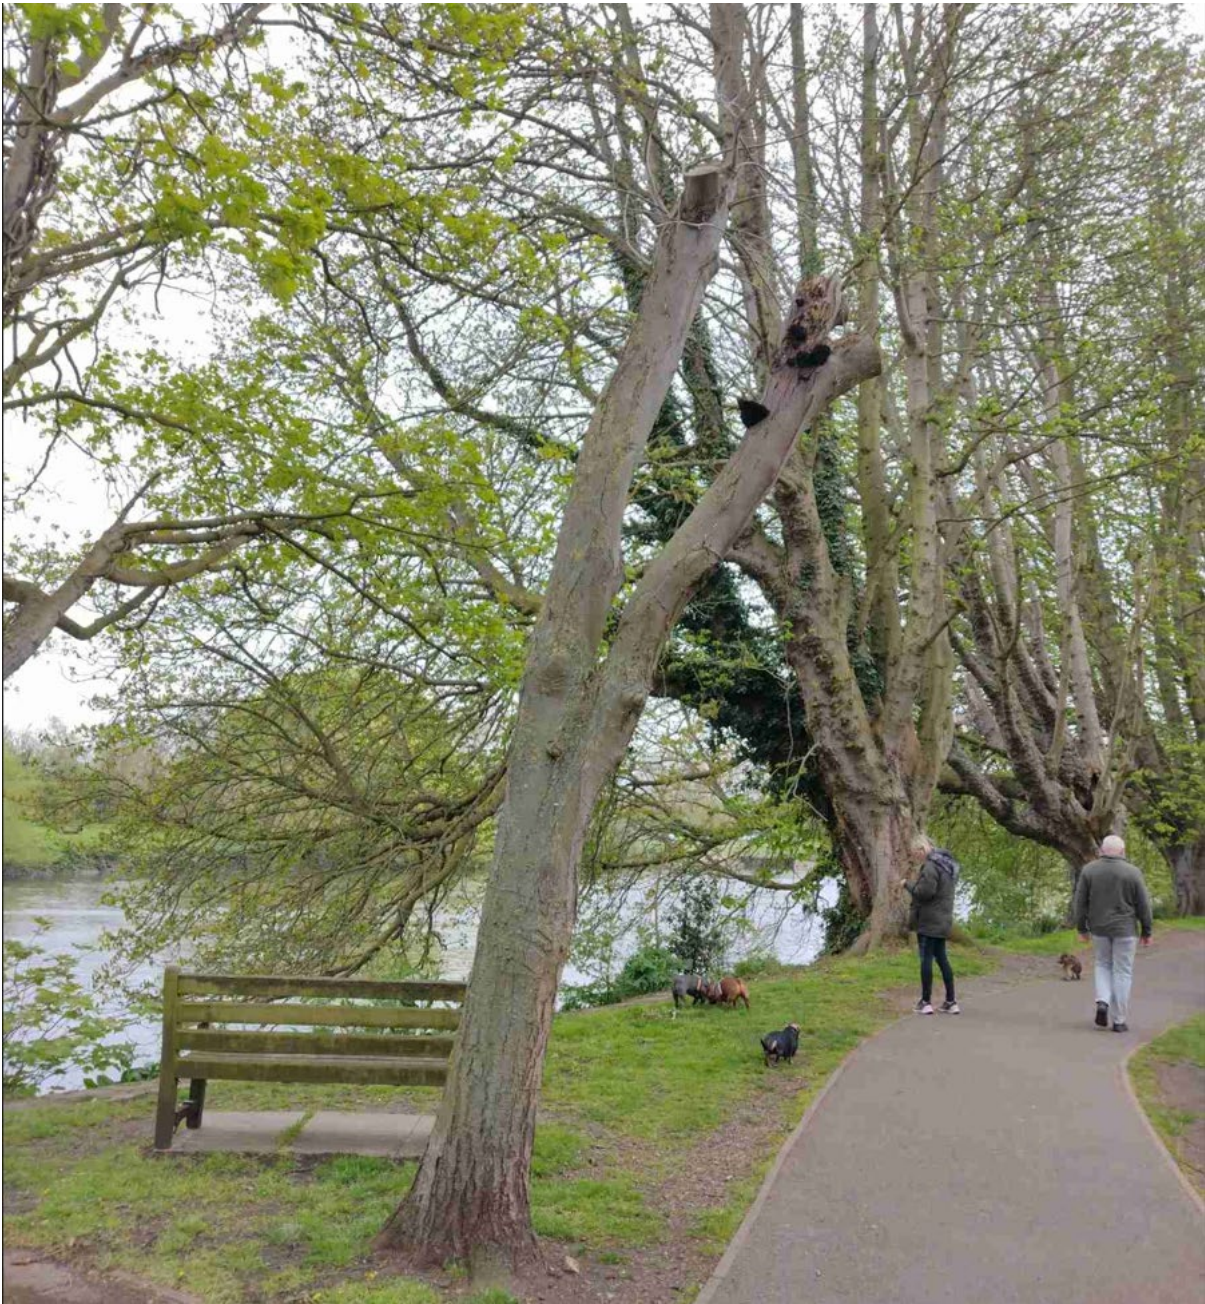
Tree number	601054.01
Road	Orleans Gardens
Location	What3Words-///patch.carbon.lied
Species	Whitebeam ( <i>Sorbus aria</i> )
Height	6.0m
Physiological Condition	Poor
Structural Condition	Poor
Inspection findings	This tree is dead; removal is required to prevent natural failure and facilitate replanting.

Image shows moribund tree

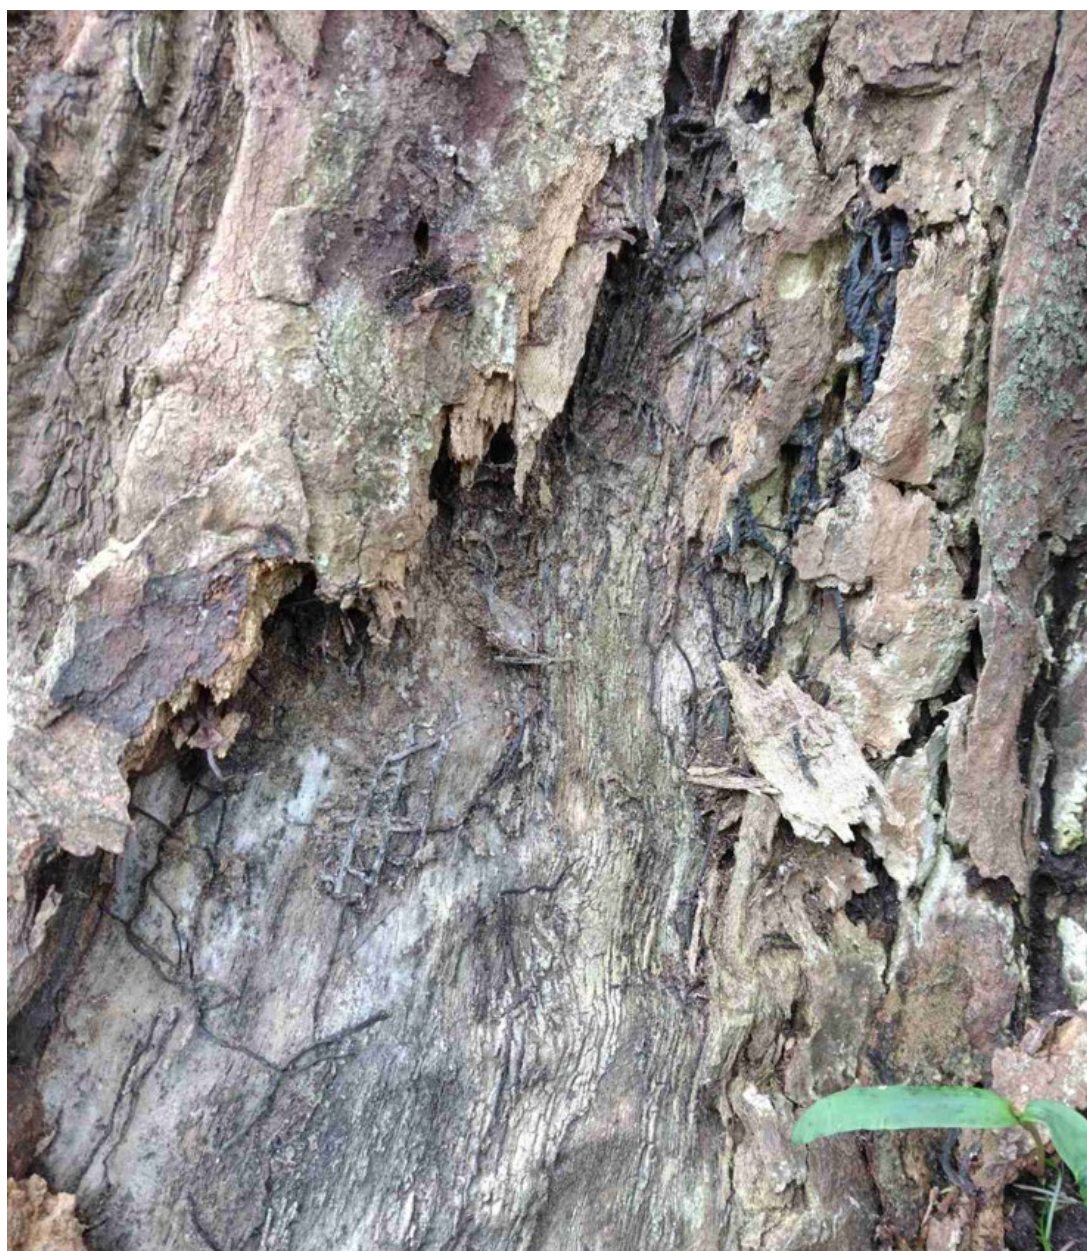
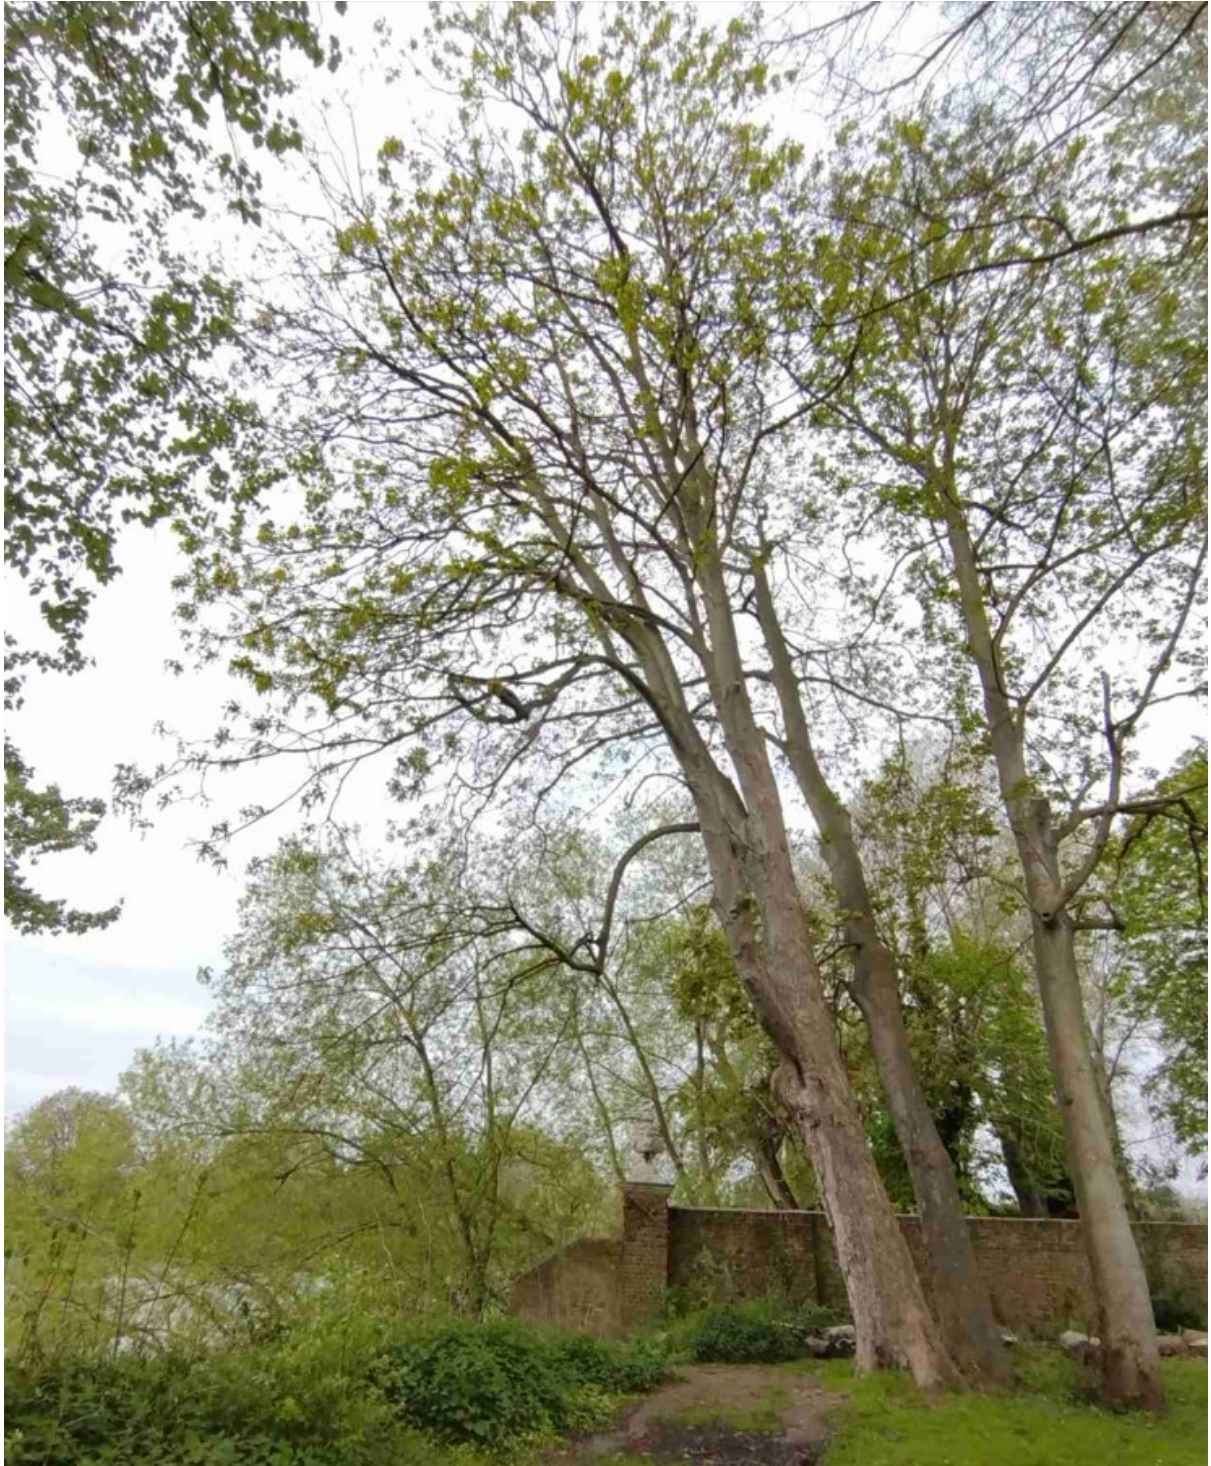
Tree number	601073.01
Road	Orleans Gardens
Location	What3Words-///slap.vanish.rift
Species	Sycamore ( <i>Acer pseudoplatanus</i> )
Height	25.0m
Physiological Condition	Poor
Structural Condition	Poor
Inspection findings	Rhizomorphs of the decay pathogen <i>Armillaria</i> sp. are present at the base of this tree. Colonisation by this fungus causes a white rot of the roots and butt that can cause entire tree failure. A resonance test revealed an unacceptable degree of decay in the trunk of this tree, removal is required to prevent natural failure and manage risk.

Image shows 'bootlace' like rhizomorphs

***Image shows 'bootlace' like rhizomorphs***

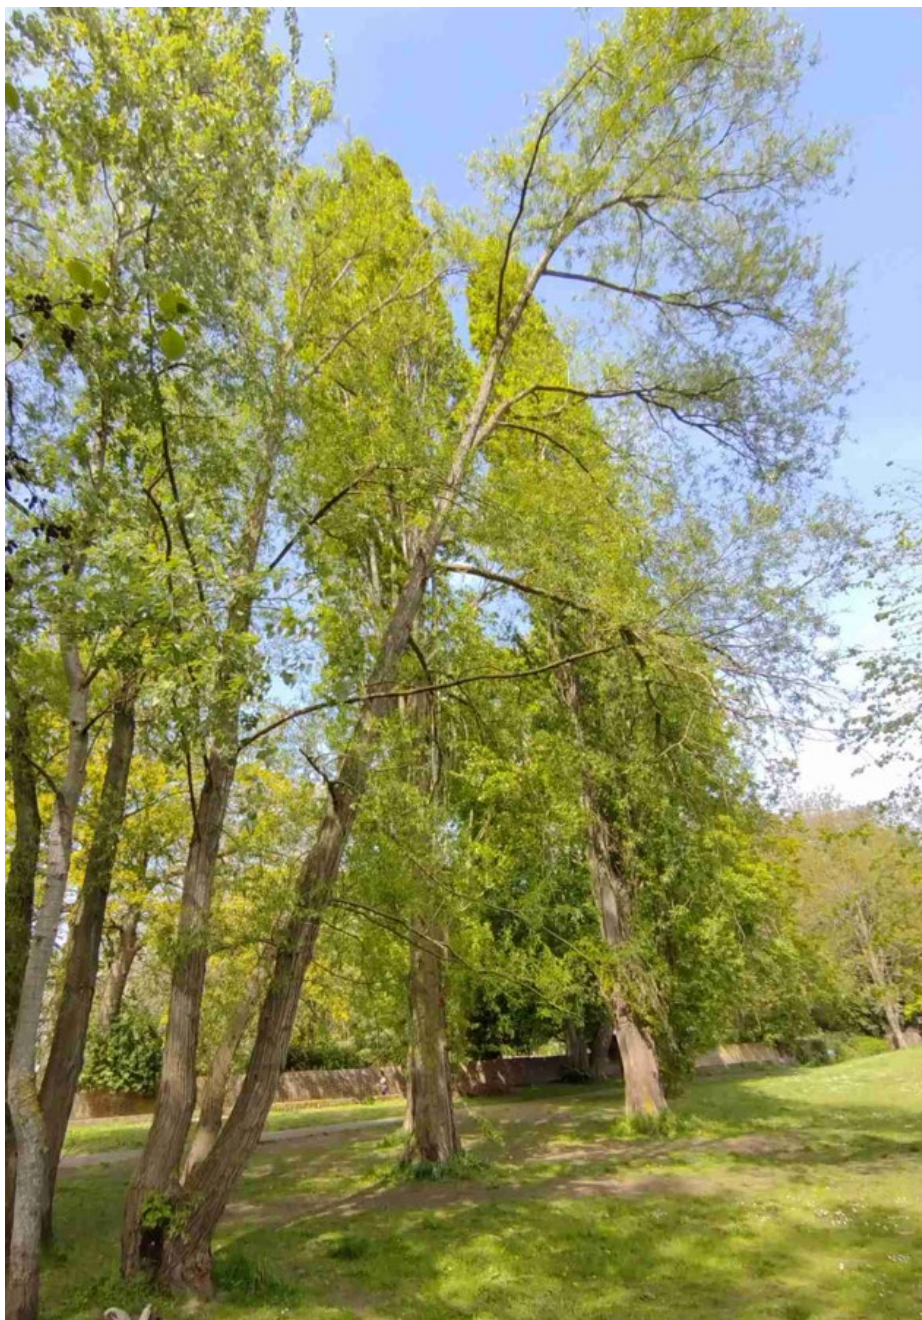
Tree number	600086.01
Road	Orleans Gardens
Location	What3Words-///landed.linked.hugs
Species	Crack Willow ( <i>Salix fragilis</i> )
Height	5.0m
Physiological Condition	Good
Structural Condition	Poor
Inspection findings	A fungal fruiting body of the decay pathogen <i>Ganoderma</i> sp. is present at the stem base. Colonisation by this fungus causes a white rot of the stem and root system that can cause entire trees to collapse through fracture or windthrow.

**Image shows tree with decay at base**
