## **Twickenham Riverside - 2023 Ward Works and Tree Removals Programme**

### Introduction

Dated 23.05.2023

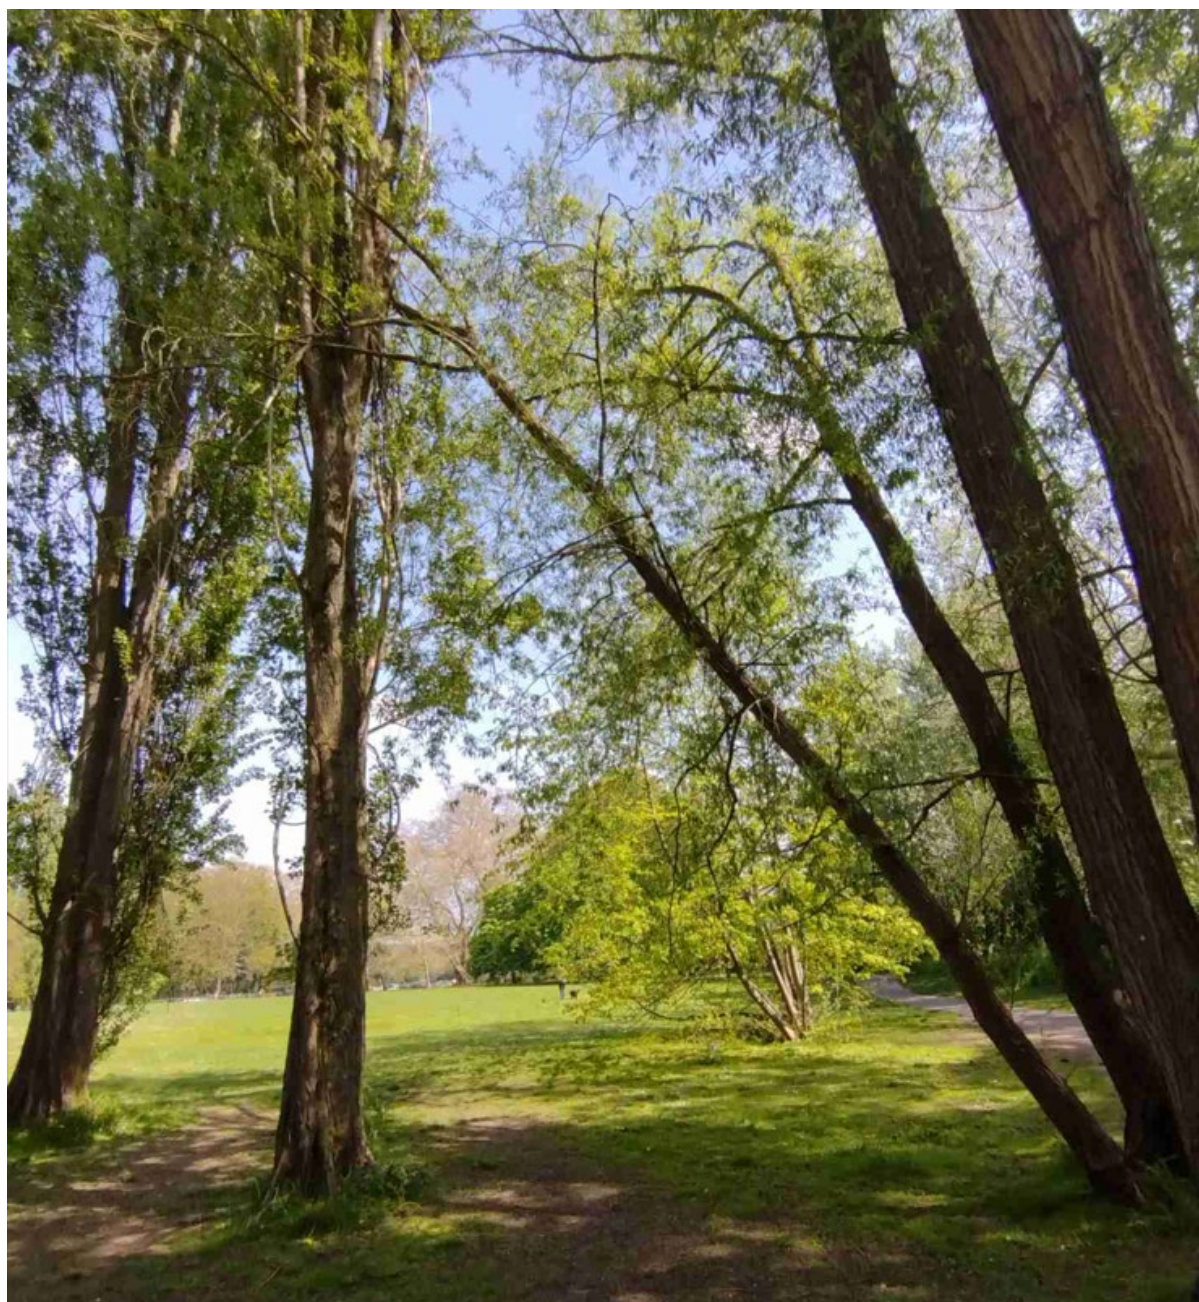
Tree number	601087.01
Road	Orleans Gardens
Location	What3Words-///drum.shin.buck
Species	Willow ( <i>Salix fragilis</i> )
Height	16.0m
Physiological Condition	Good
Structural Condition	Poor
Inspection findings	Gall is present at the base of this tree. This is caused by the bacterium <i>Rhizobium radiobacter</i> and results in disorganised growth that acts as a point for failure to occur from. This tree has failed at the base and hung up in its neighbour.

**Image shows tree hung up in neighbour**

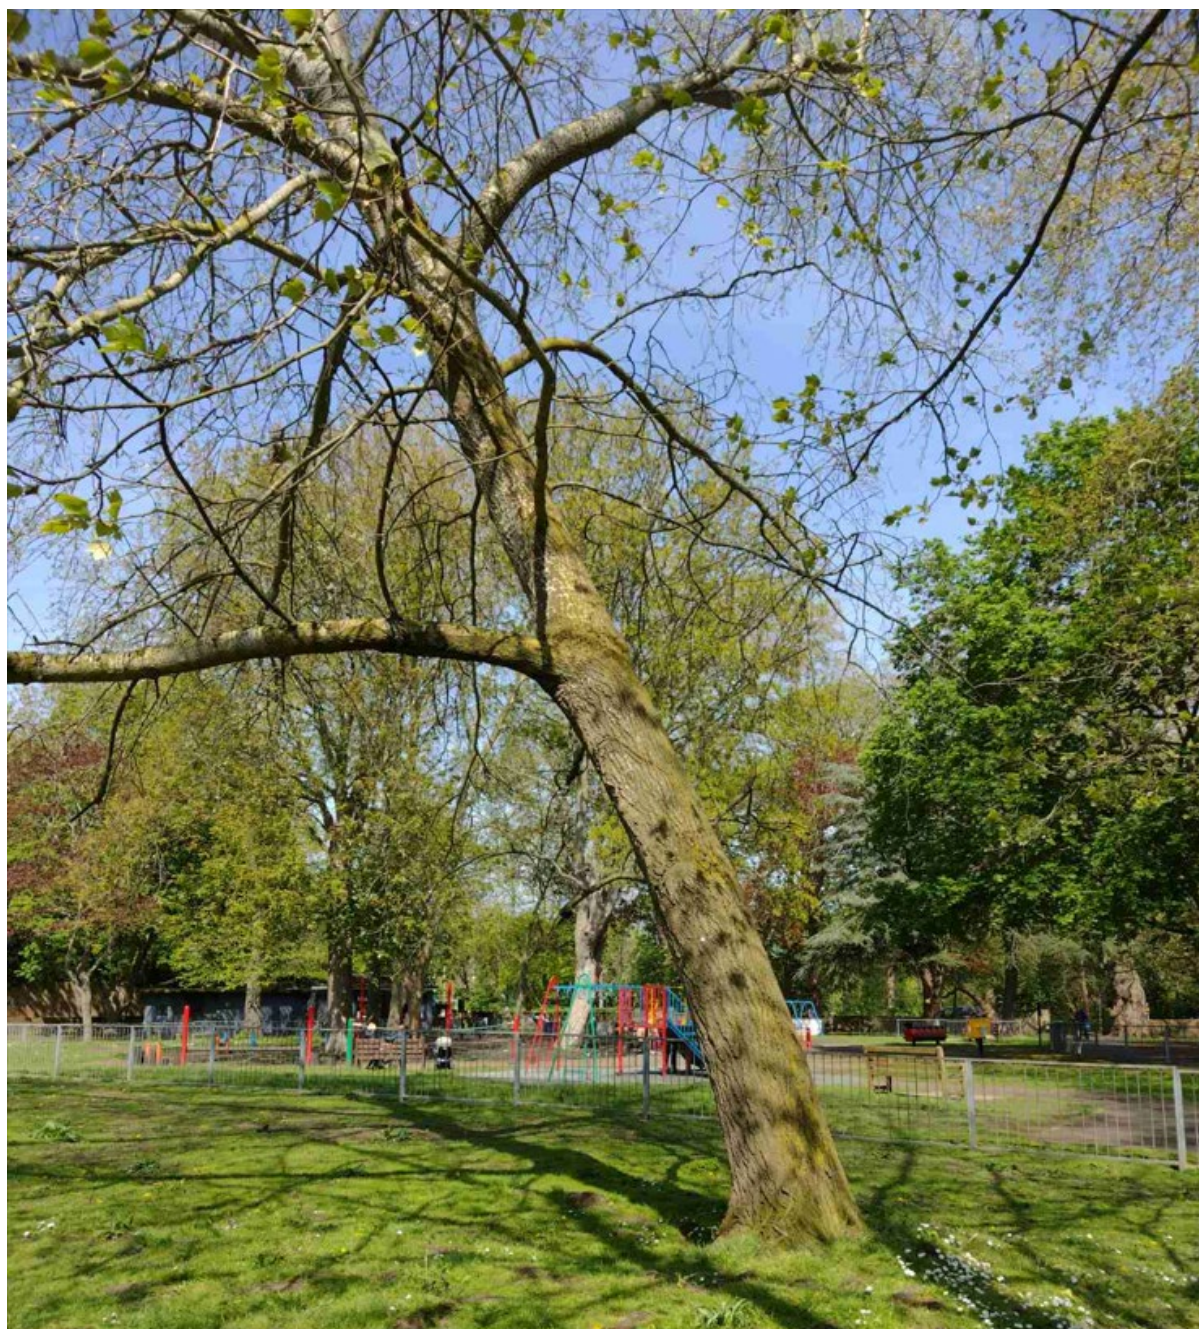
Tree number	600055.01
Road	Orleans Gardens
Location	What3Words-///taking.face.paints
Species	Poplar ( <i>Populus sp.</i> )
Height	17.0m
Physiological Condition	Dead
Structural Condition	Dead
Inspection findings	Crown Gall is present at the base of this tree. This is caused by the bacterium <i>Rhizobium radiobacter</i> and results in disorganised growth that acts as a point for failure to occur from.

**Image shows tree in park scene with lean that appears progressive**

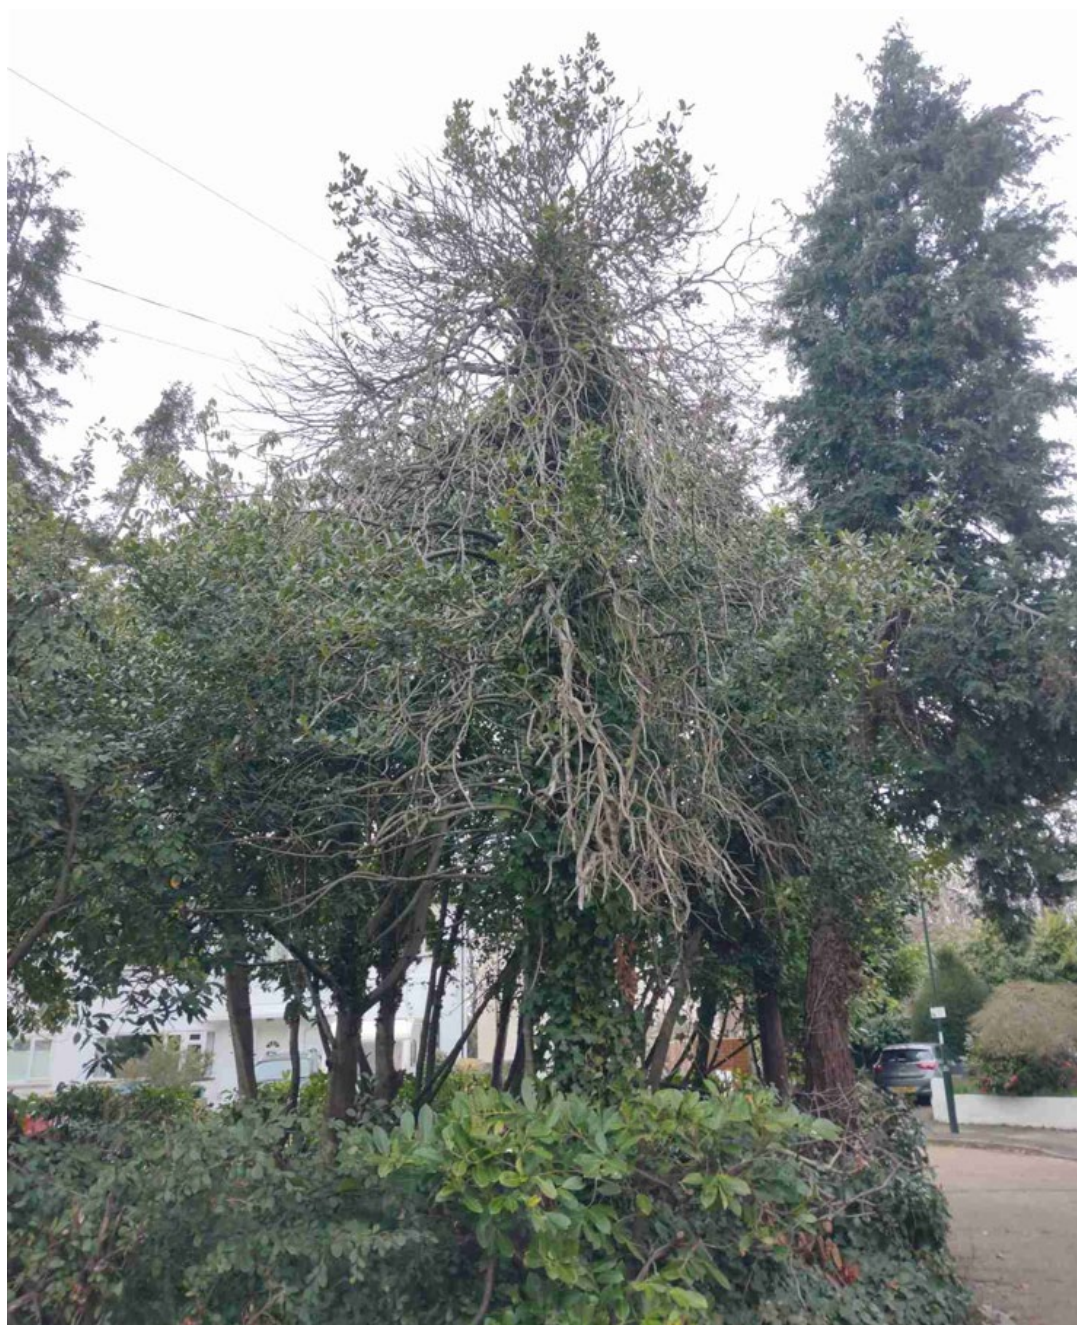
Tree number	650002
Road	Park House Gardens
Location	Opposite 52
Species	Holly ( <i>Ilex aquifolium</i> )
Height	8.2m
Physiological Condition	Poor
Structural Condition	Poor
Inspection findings	This tree is moribund; removal is required to prevent natural failure.

**Image shows tree in moribund condition**

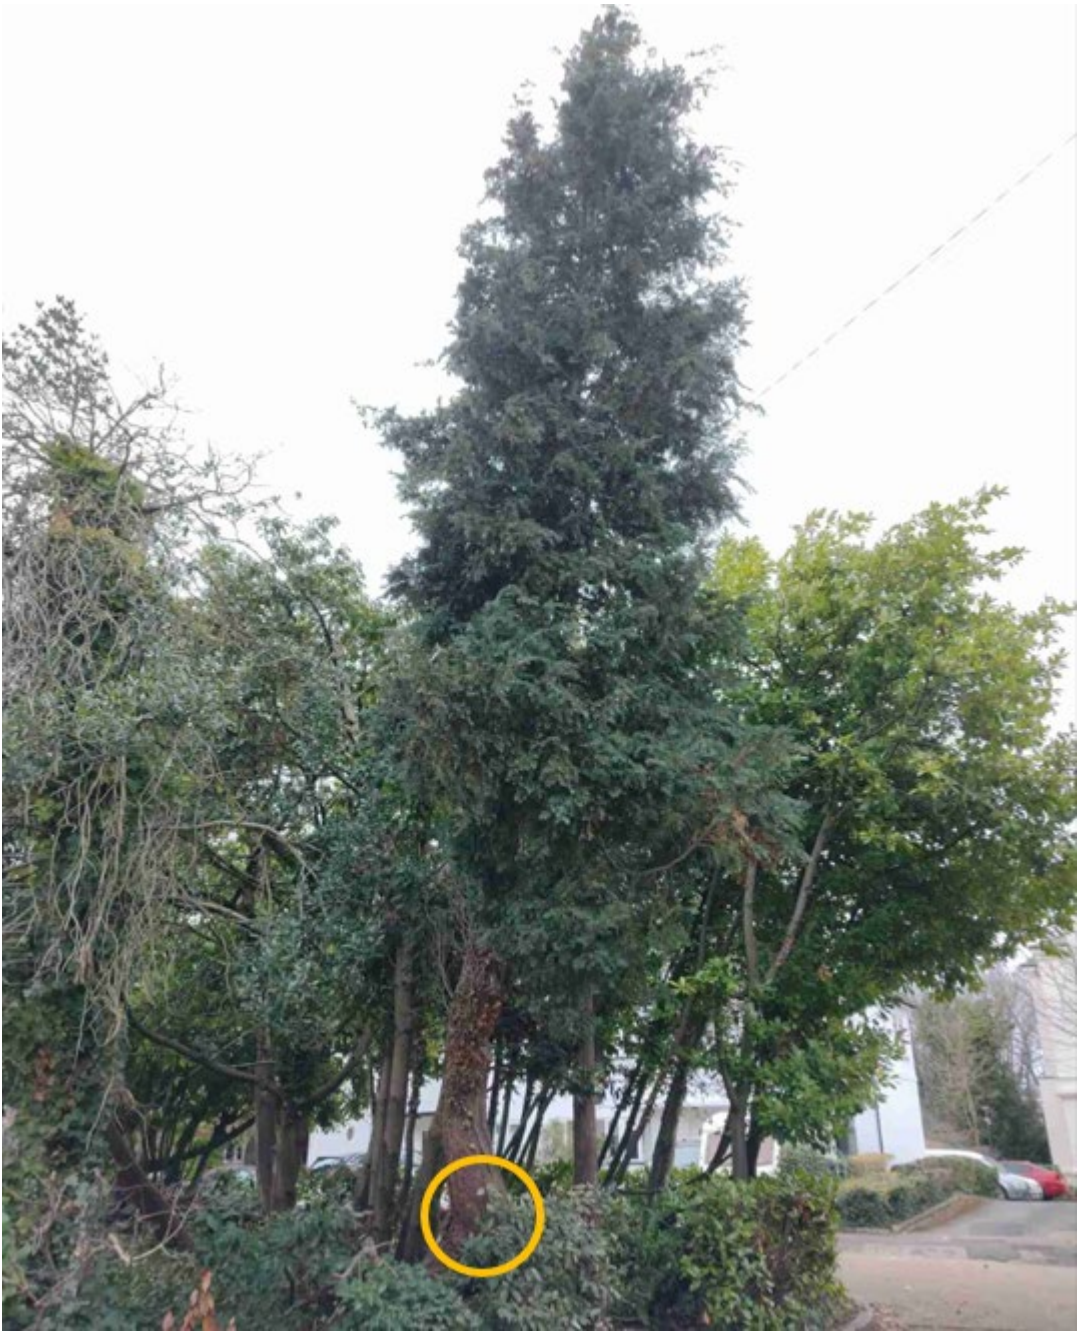
Tree number	650005
Road	Park House Gardens
Location	Eastern corner of island area. What3Words///safe.tops.dollar
Species	Cypress ( <i>Cupressus sp.</i> )
Height	11.5m
Physiological Condition	Fair
Structural Condition	Poor
Inspection findings	A cavity indicating decay is present in the trunk of this tree. Investigation with a probe revealed an unacceptable degree of decay.

Image shows tree in street scene with location of cavity circled

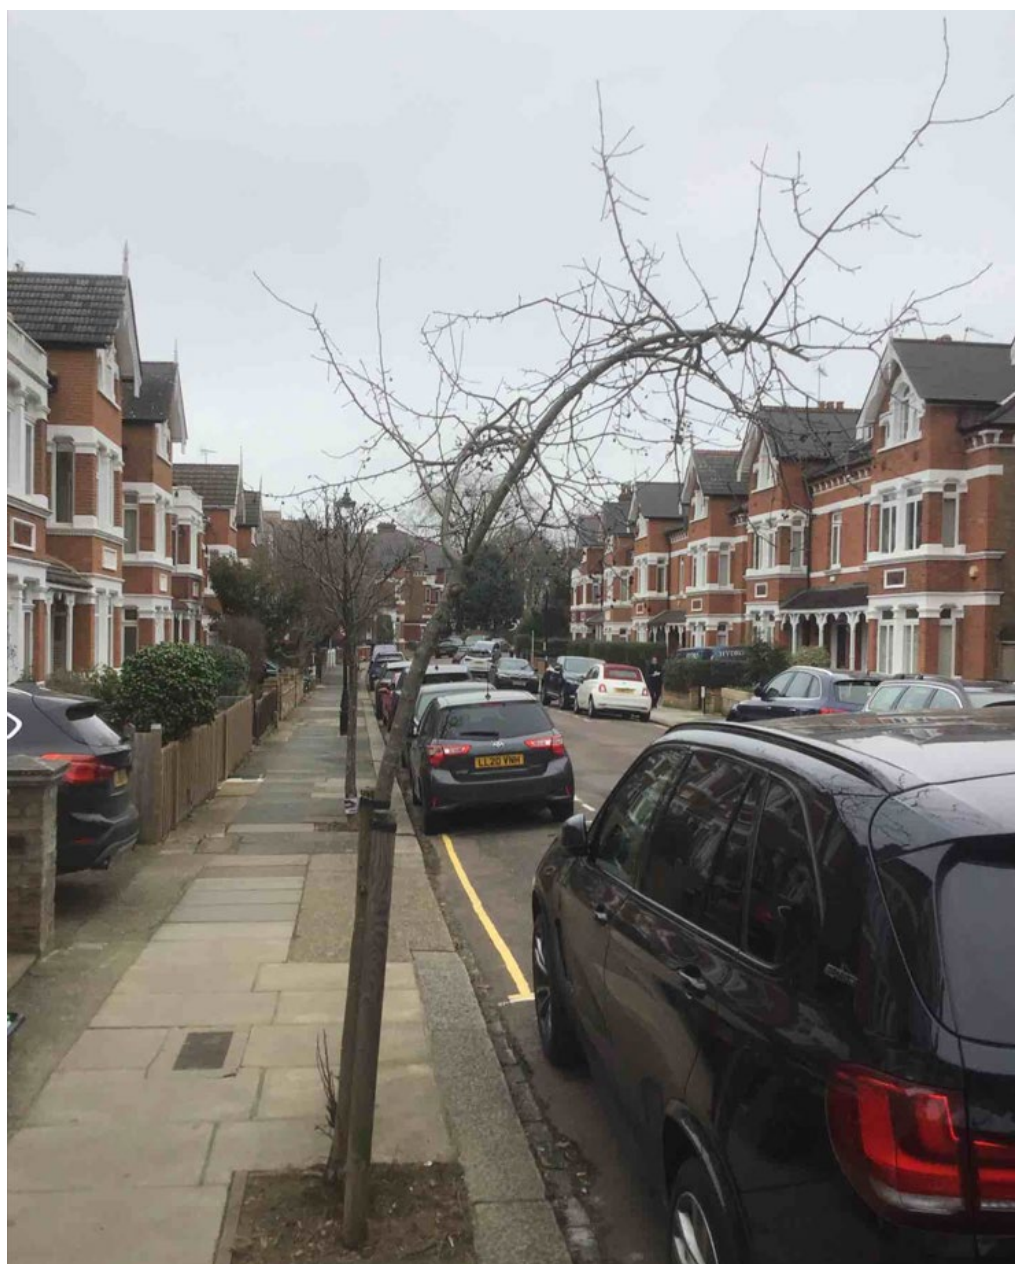
Tree number	3
Road	St Stephens Gardens
Location	Outside 23
Species	Crab Apple ( <i>Malus sp.</i> )
Height	3.5m
Physiological Condition	Good
Structural Condition	Poor
Inspection findings	This tree has poor form caused by low quality nursery stock. This will prevent the tree from forming a useful canopy. Removal is required to facilitate replanting.

Image shows tree in street scene with poor growth habit

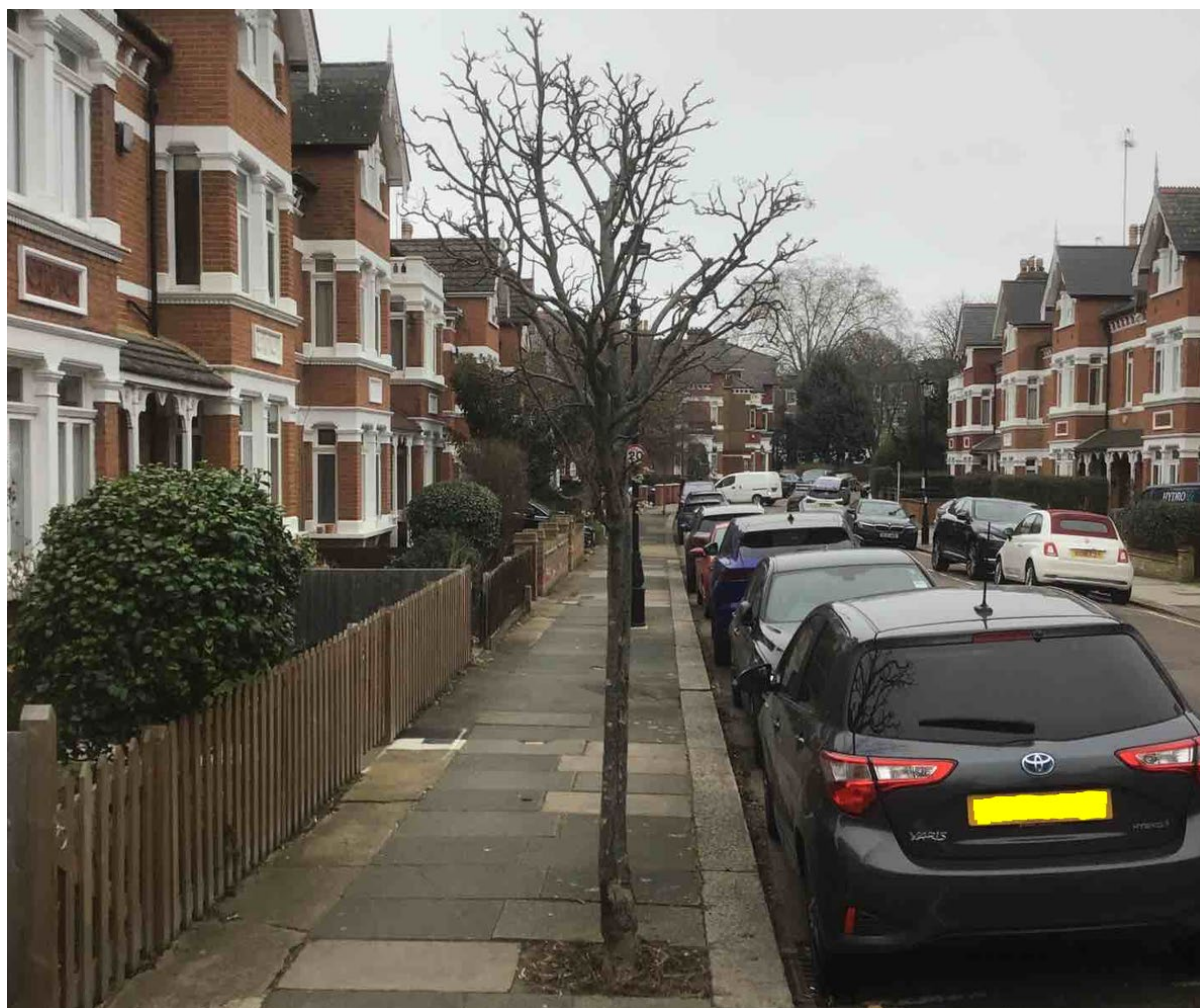
Tree number	4
Road	St Stephens Gardens
Location	Outside 21-23
Species	Rowan ( <i>Sorbus aucuparia</i> )
Height	3.5m
Physiological Condition	Poor
Structural Condition	Poor
Inspection findings	The main stem or trunk and roots are extensively decayed; the tree is moving in such a way that indicates that the structure is compromised presenting an unacceptable risk of failure.

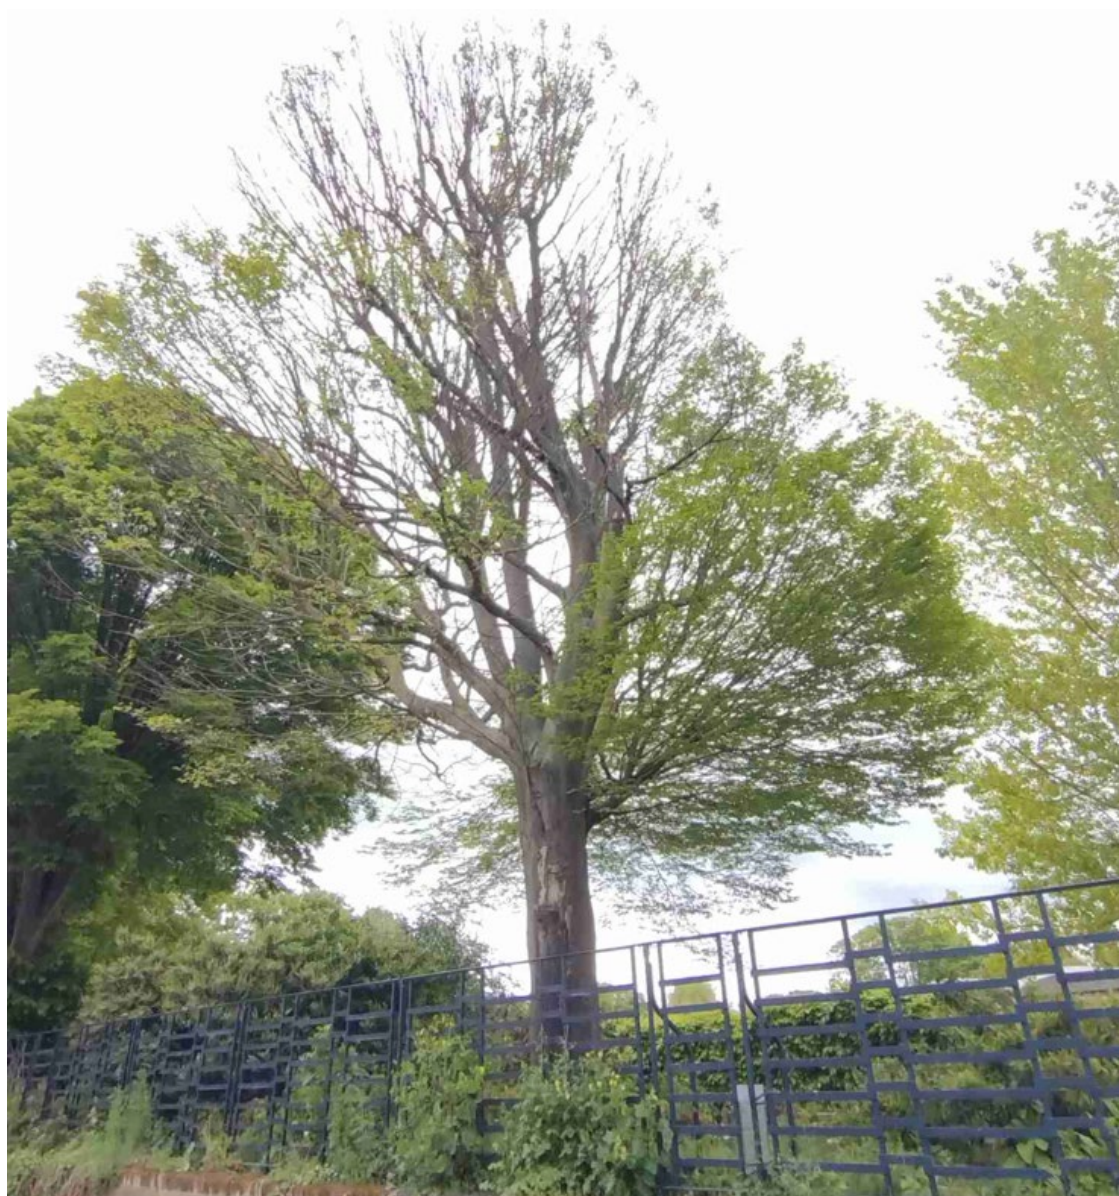
<b>Tree number</b>	600042.00
<b>Road</b>	The Embankment
<b>Location</b>	Diamond Jubilee Gardens, northwest corner. What3Words-///cool.faded.rather
<b>Species</b>	Hornbeam ( <i>Carpinus betula</i> )
<b>Height</b>	14.0m
<b>Physiological Condition</b>	Poor
<b>Structural Condition</b>	Poor
<b>Inspection findings</b>	This tree has cracked, peeling bark indicating necrosis and dysfunction of the trees vascular system. This tree is in a state of physiological decline and contains weak branches that are liable to collapse.

**Image shows tree with canopy in poor condition**

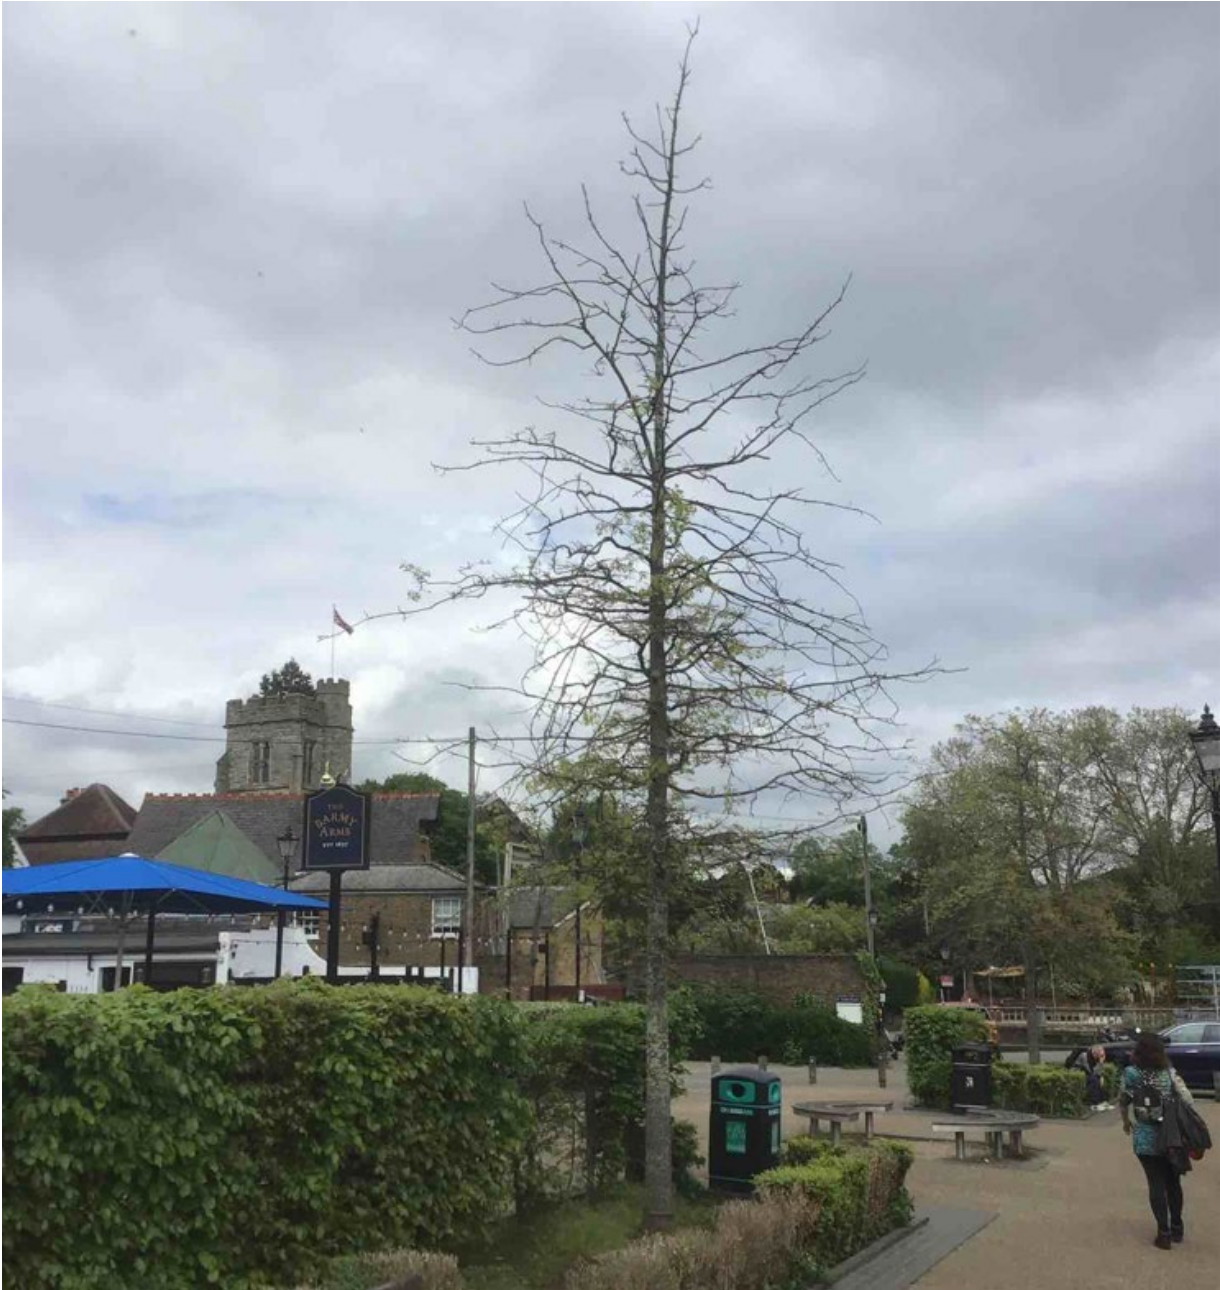
Tree number	8
Road	The Embankment
Location	The Embankment - What3Words-///beyond.sports.crowned
Species	Pin Oak ( <i>Quercus palustris</i> )
Height	10.0m
Physiological Condition	Poor
Structural Condition	Poor
Inspection findings	This tree is dying; deadwood is ubiquitous.

Image shows tree with minimal leaf set

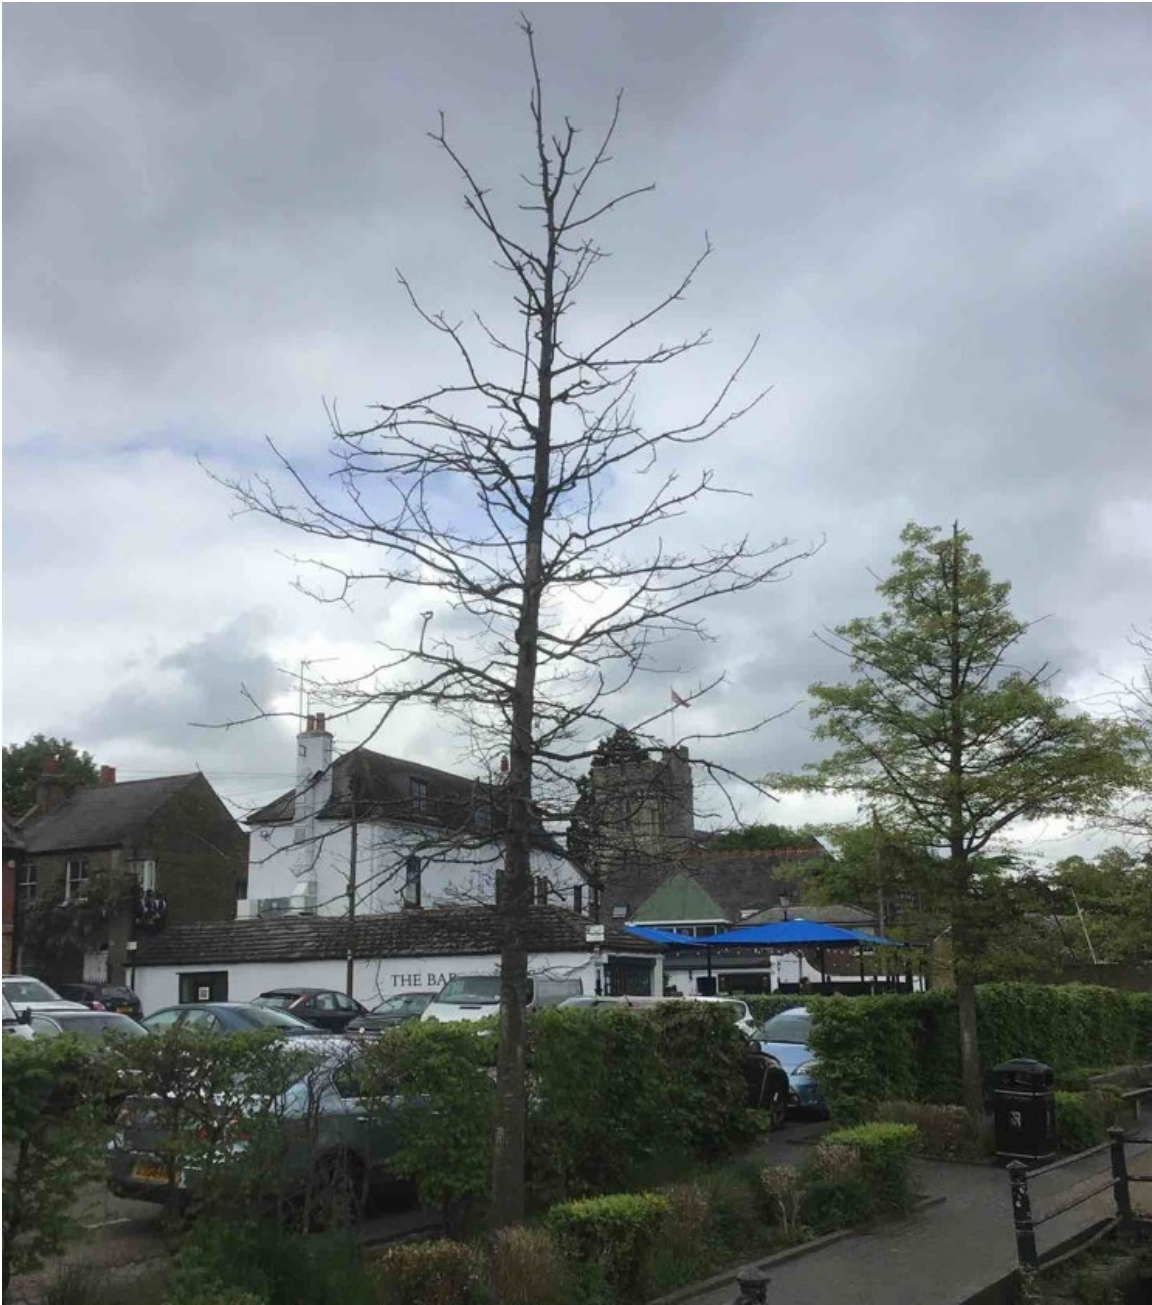
Tree number	6
Road	The Embankment
Location	The Embankment- ///What3Words- navy.trees.complains
Species	Pin Oak ( <i>Quercus palustris</i> )
Height	10.0m
Physiological Condition	Dead
Structural Condition	Dead
Inspection findings	This tree is dead; removal is required to prevent natural failure and facilitate replanting

Image shows dead tree

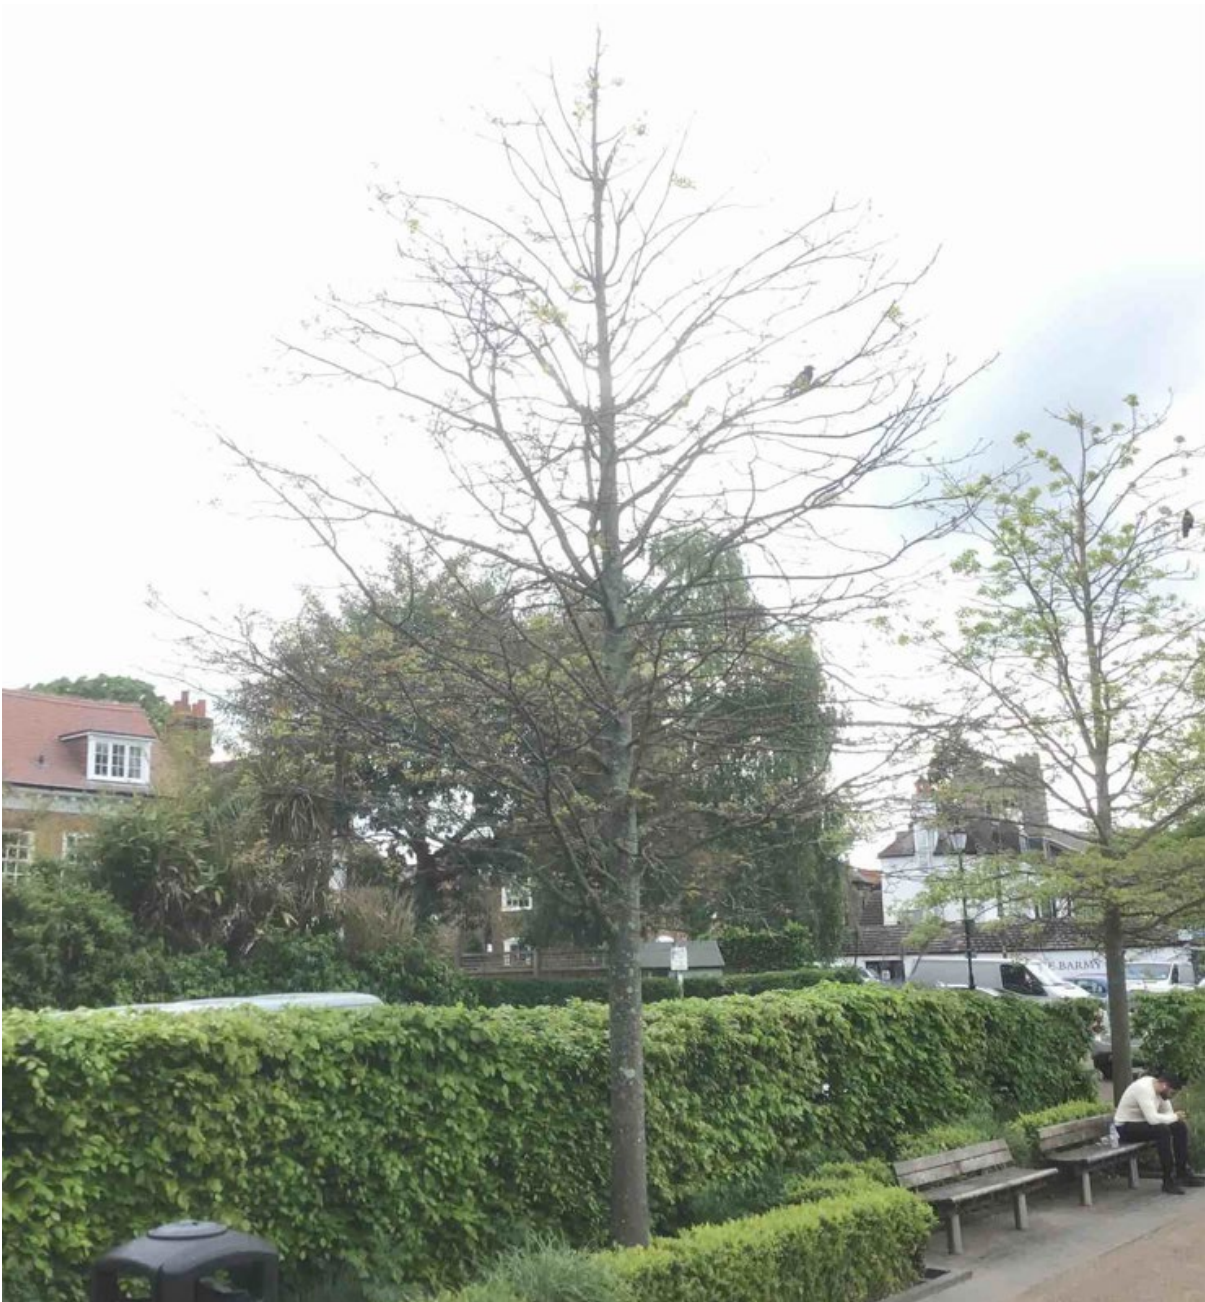
Tree number	3
Road	The Embankment
Location	The Embankment- ///What3Words- tidy.miles.asset
Species	Pin Oak ( <i>Quercus palustris</i> )
Height	10.0m
Physiological Condition	Poor
Structural Condition	poor
Inspection findings	This tree is dying; deadwood is ubiquitous.

Image shows tree with minimal leaf set

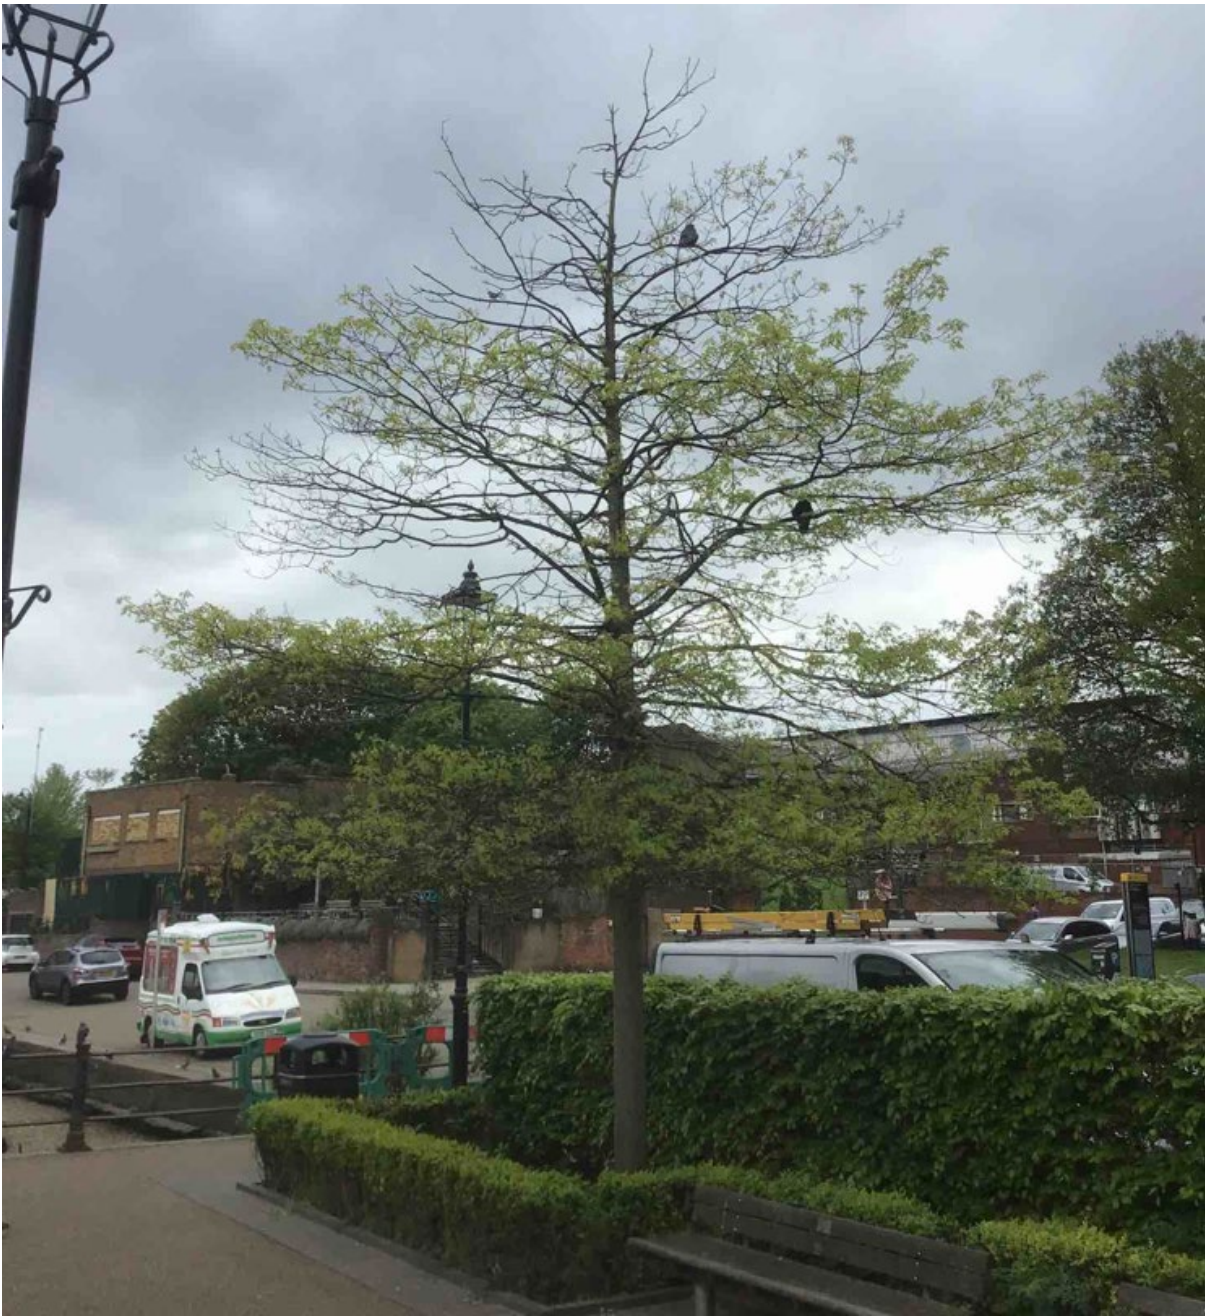
Tree number	1
Road	The Embankment
Location	The Embankment- ///What3Words- tape.losses.successes
Species	Pin Oak ( <i>Quercus palustris</i> )
Height	9.0m
Physiological Condition	Poor
Structural Condition	poor
Inspection findings	This tree is dying; deadwood is ubiquitous.

Image shows tree with minimal leaf set

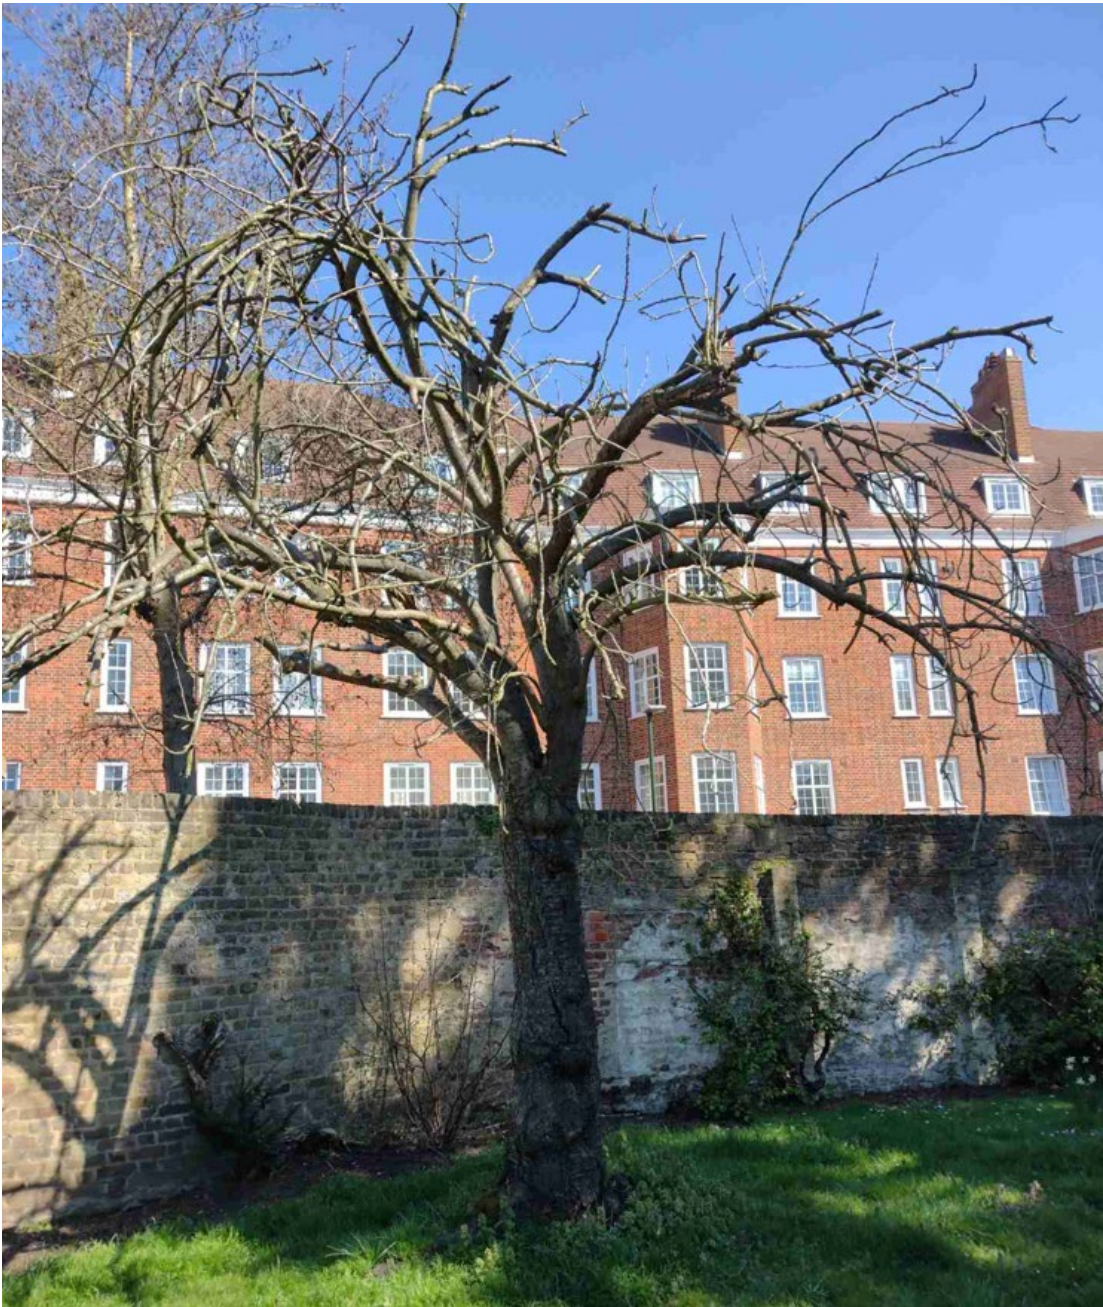
Tree number	600104.51
Road	York House Gardens
Location	What3Words-///drove.always.stops
Species	Wild Cherry ( <i>Prunus avium</i> )
Height	6.0m
Physiological Condition	Dead
Structural Condition	Dead
Inspection findings	This tree is dead; removal is required to prevent natural failure and facilitate replanting.

Image shows dead tree

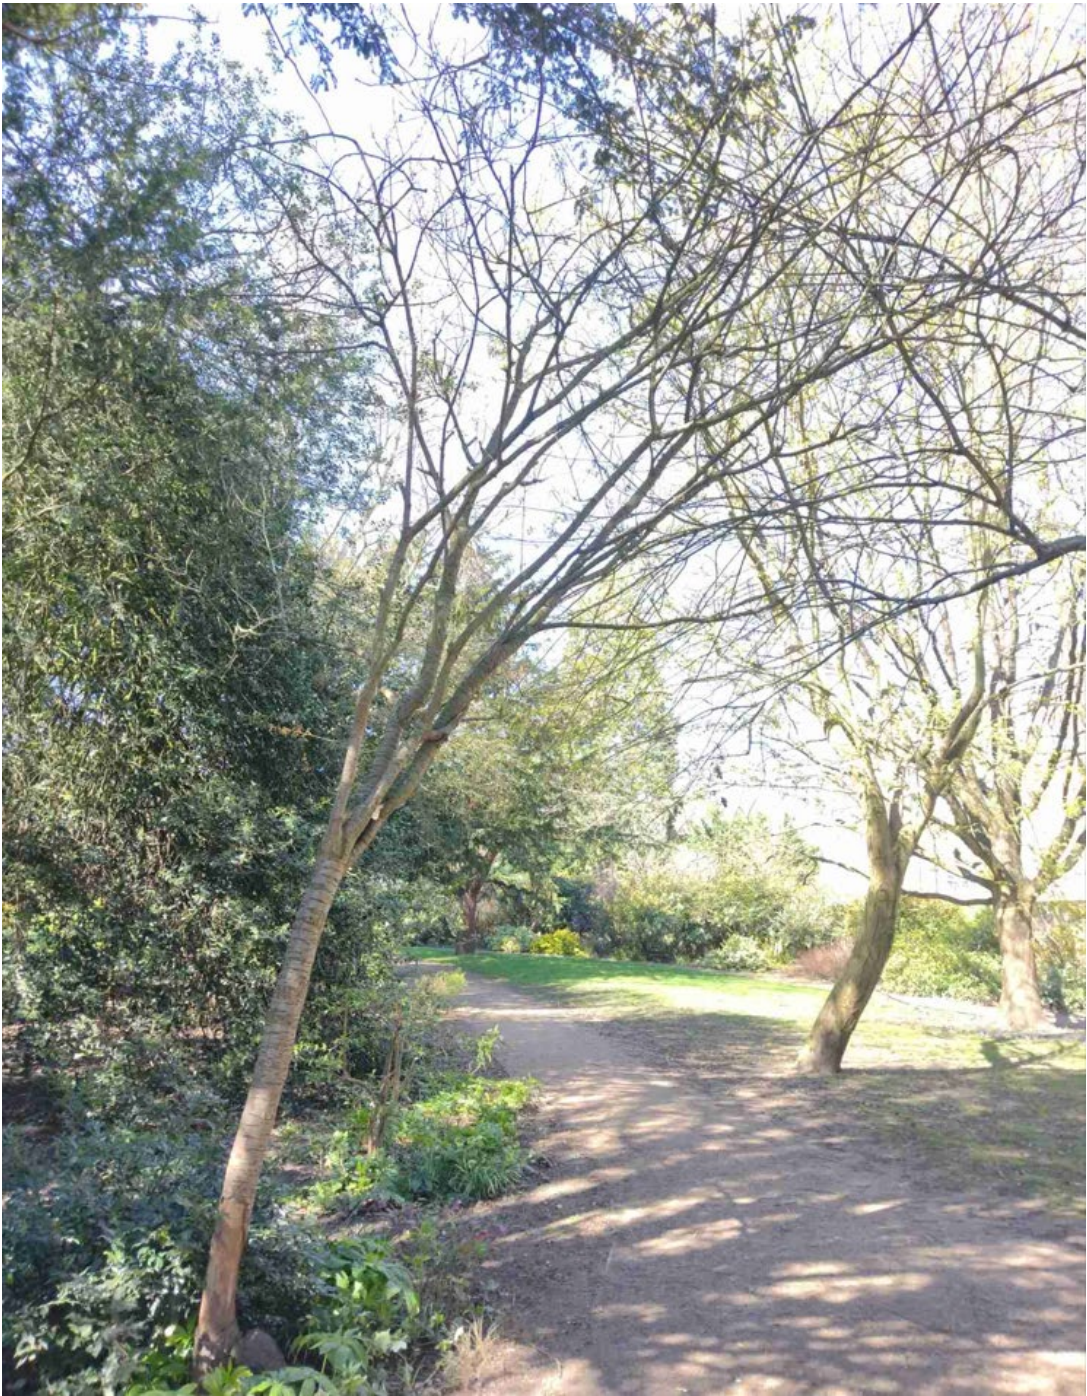
Tree number	600125.01
Road	York House Gardens
Location	What3Words-///feared.trap.sand
Species	Cherry ( <i>Prunus sp.</i> )
Height	6.5m
Physiological Condition	Dead
Structural Condition	Dead
Inspection findings	This tree is dead; removal is required to prevent natural failure and facilitate replanting.

Image shows dead tree

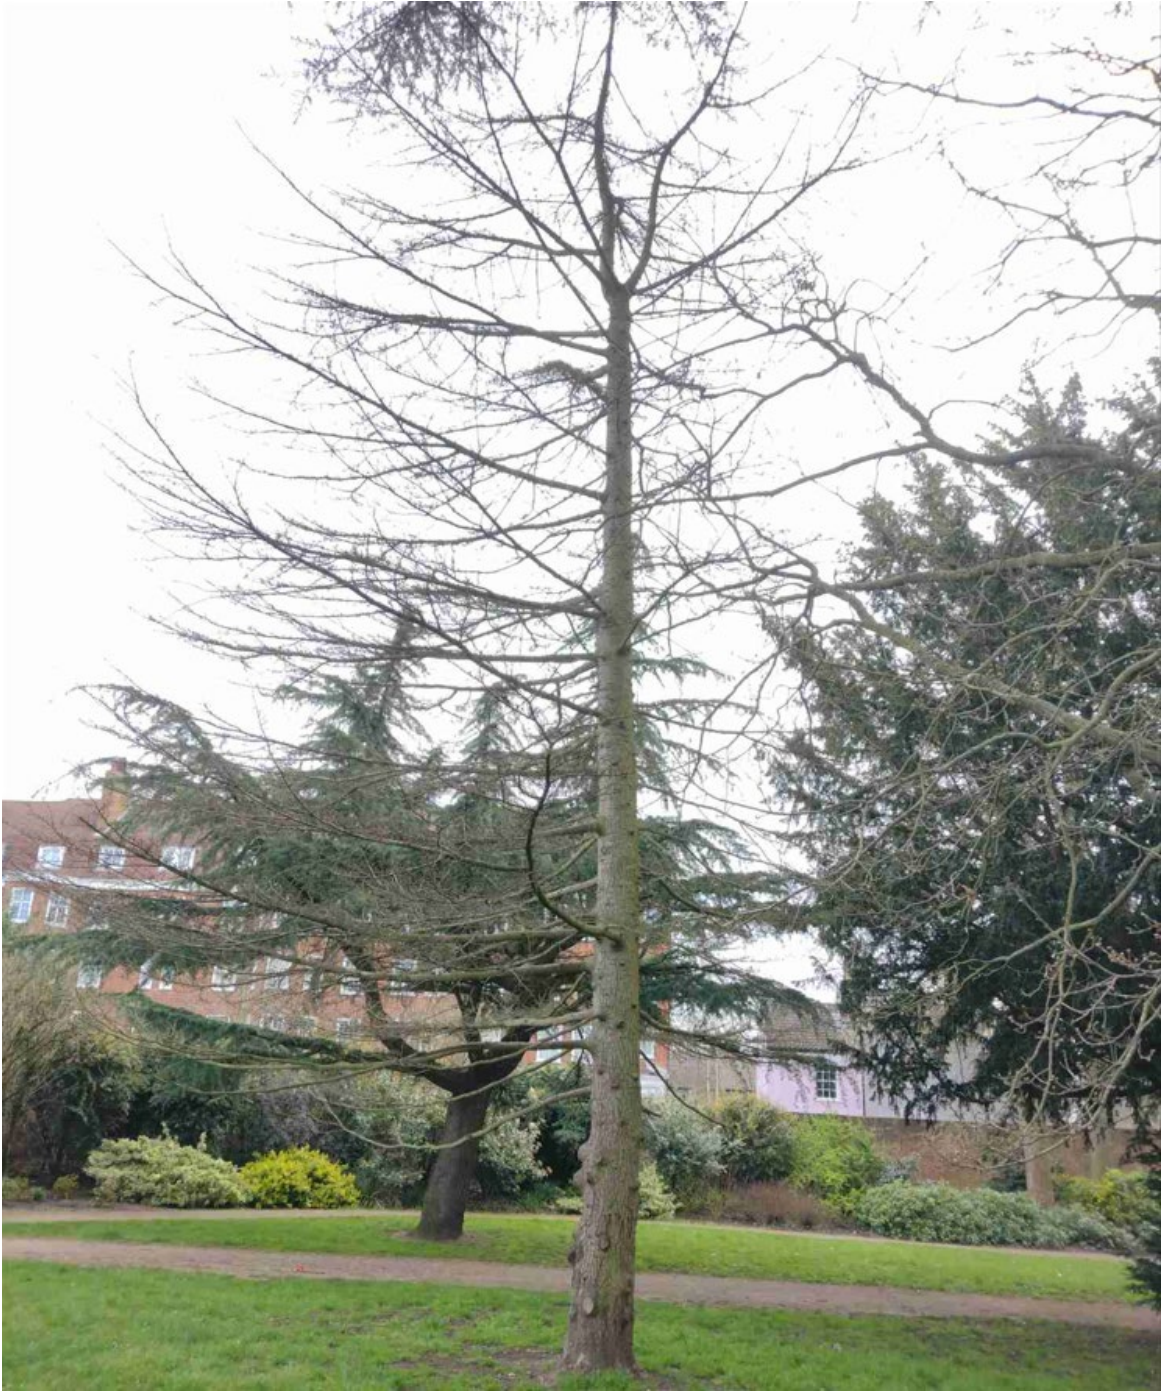
Tree number	600116.01
Road	York House Gardens
Location	What3Words-///afford.window.those
Species	Deodar Cedar ( <i>Cedrus deodara</i> )
Height	14m
Physiological Condition	Dead
Structural Condition	Dead
Inspection findings	This tree is dead; removal is required to prevent natural failure and facilitate replanting.

Image shows dead tree
