## **Twickenham Riverside - 2023 Ward Works and Tree Removals Programme**

### Introduction

Dated 23.05.2023

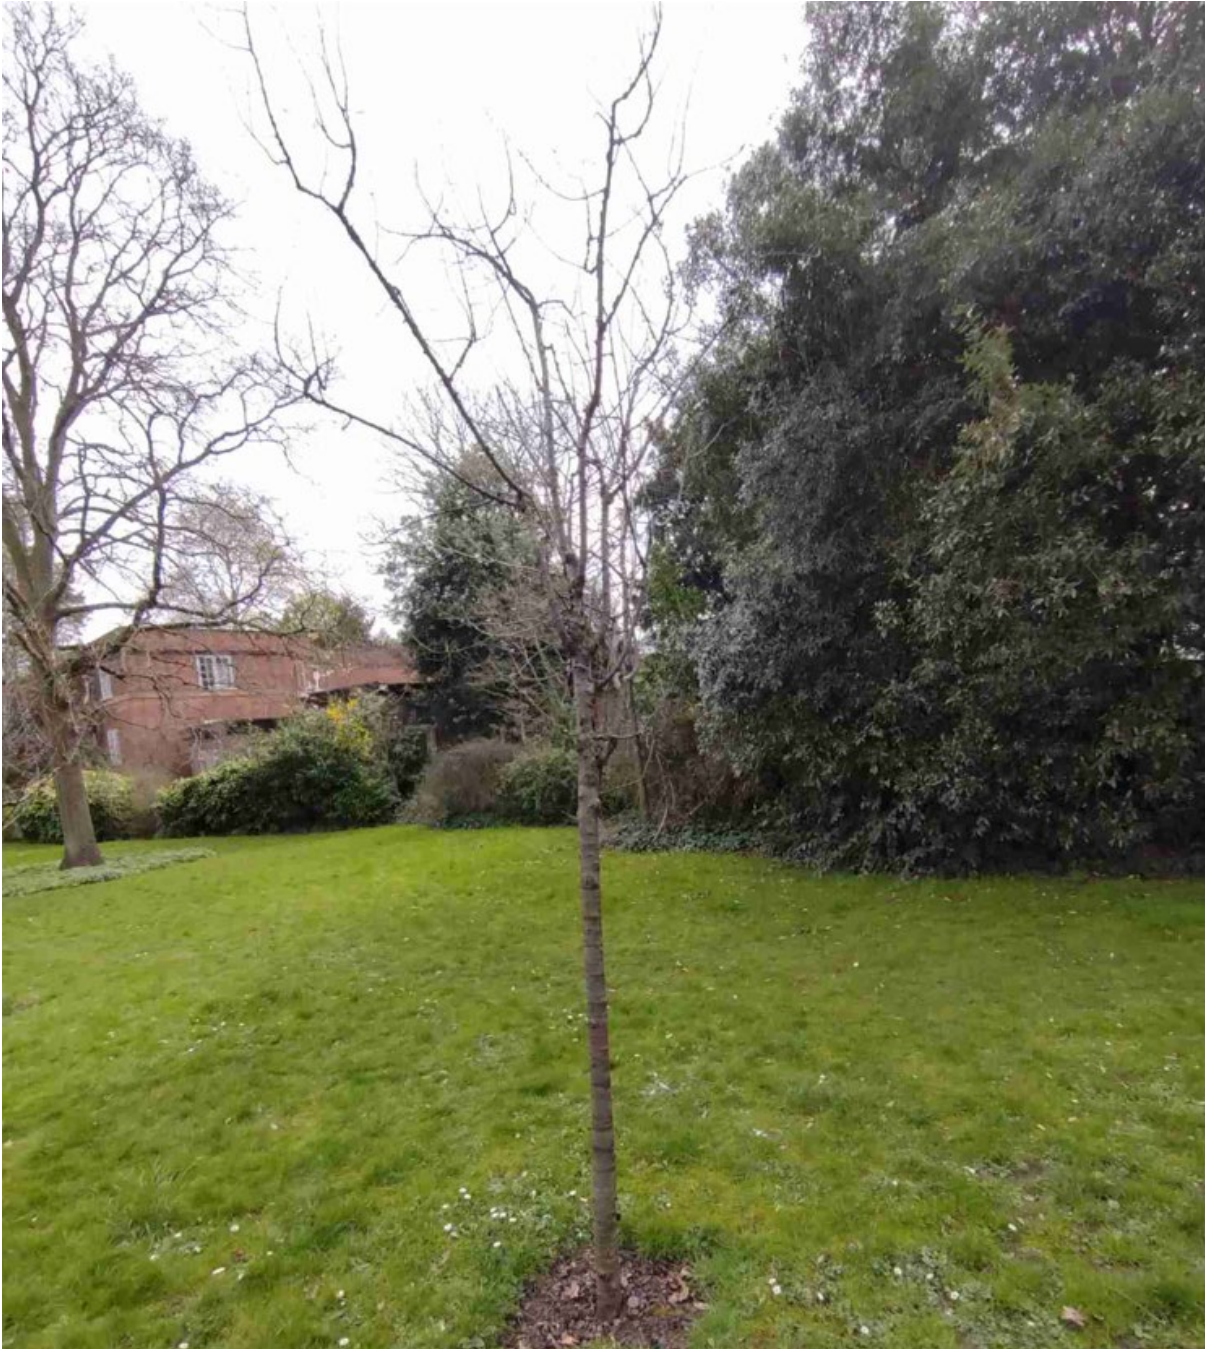
Tree number	600073.01
Road	York House Gardens
Location	What3Words-///frost.logo.guilty
Species	Cherry ( <i>Prunus sp.</i> )
Height	4.0m
Physiological Condition	Dead
Structural Condition	Dead
Inspection findings	This tree is dead; removal is required to prevent natural failure and facilitate replanting.

Image shows dead tree

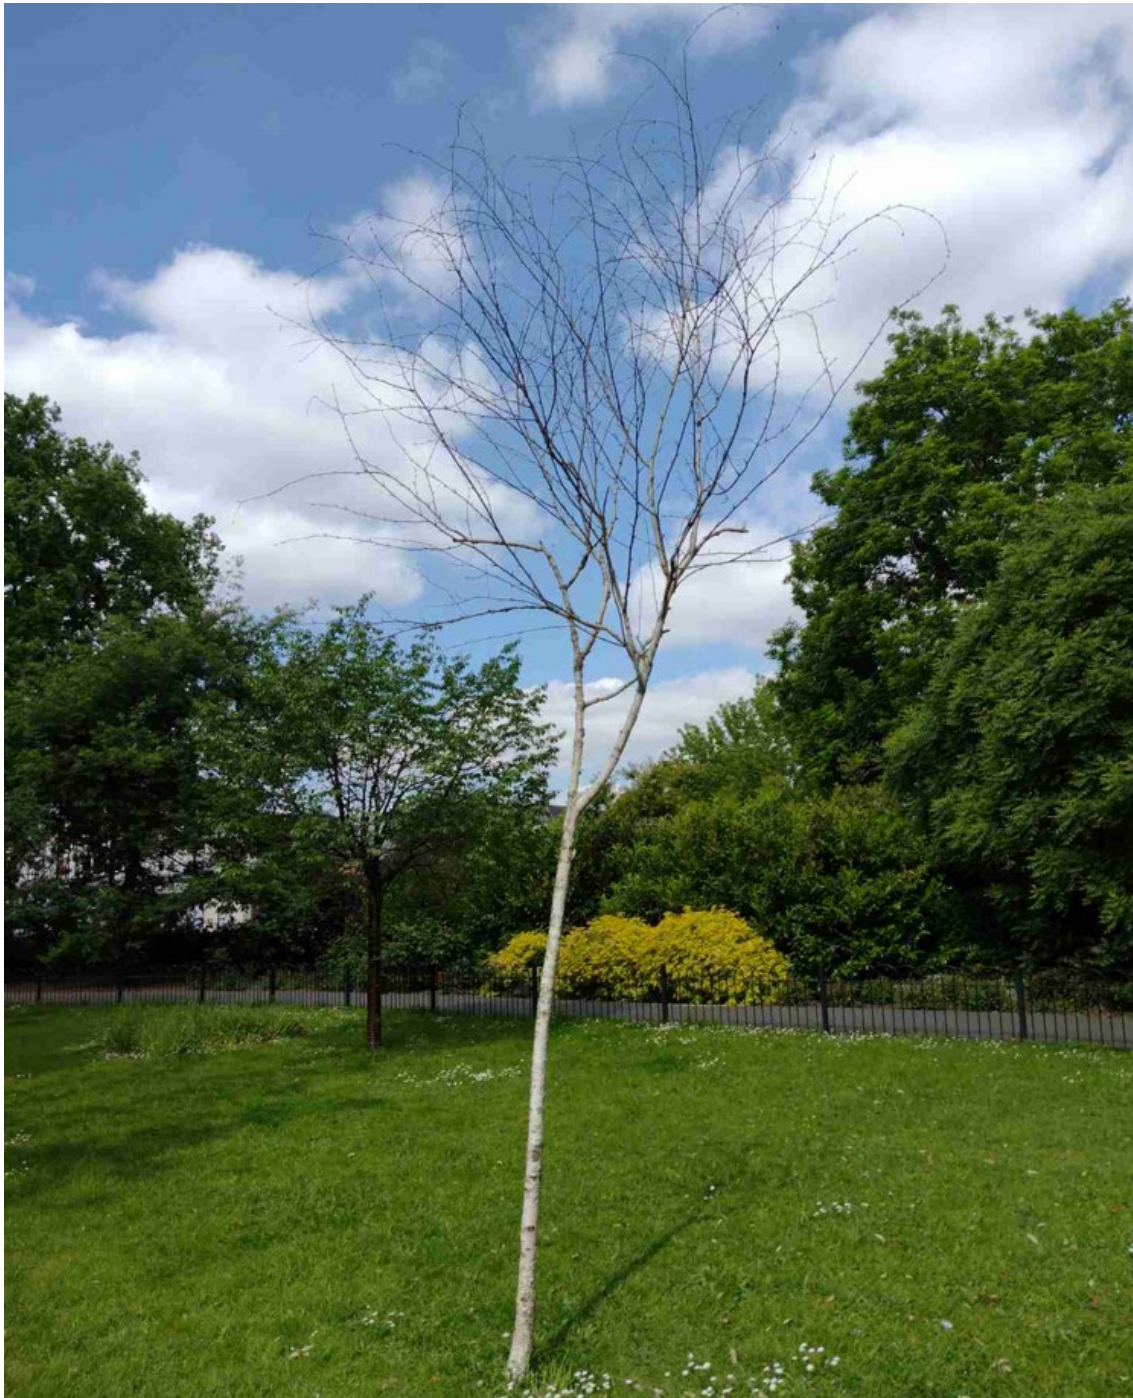
Tree number	600081.01
Road	York House Gardens
Location	What3Words-///woven.softly.divide
Species	Birch (Betula <i>sp.</i> )
Height	5.0m
Physiological Condition	Dead
Structural Condition	Dead
Inspection findings	This tree is dead; removal is required to prevent natural failure and facilitate replanting.

Image shows dead tree

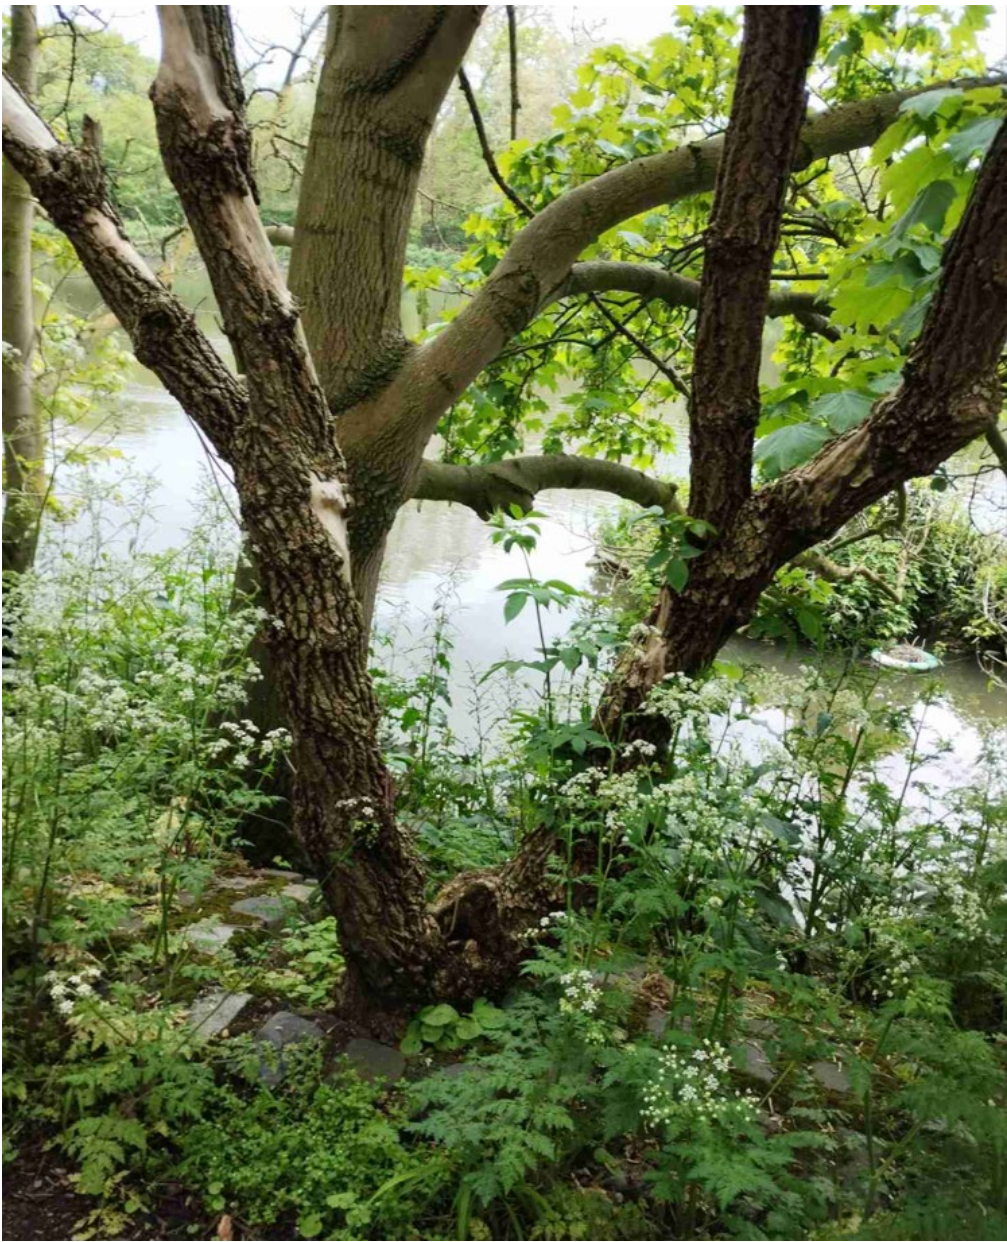
Tree number	650055.00
Road	Warren Footpath
Location	W3W – defeat.took.tube
Species	Elder ( <i>Sambucus nigra</i> )
Height	6.0m
Physiological Condition	Dead
Structural Condition	Dead
Inspection findings	This tree is dead; removal is required to prevent natural failure and facilitate replanting

Image shows dead tree in foreground

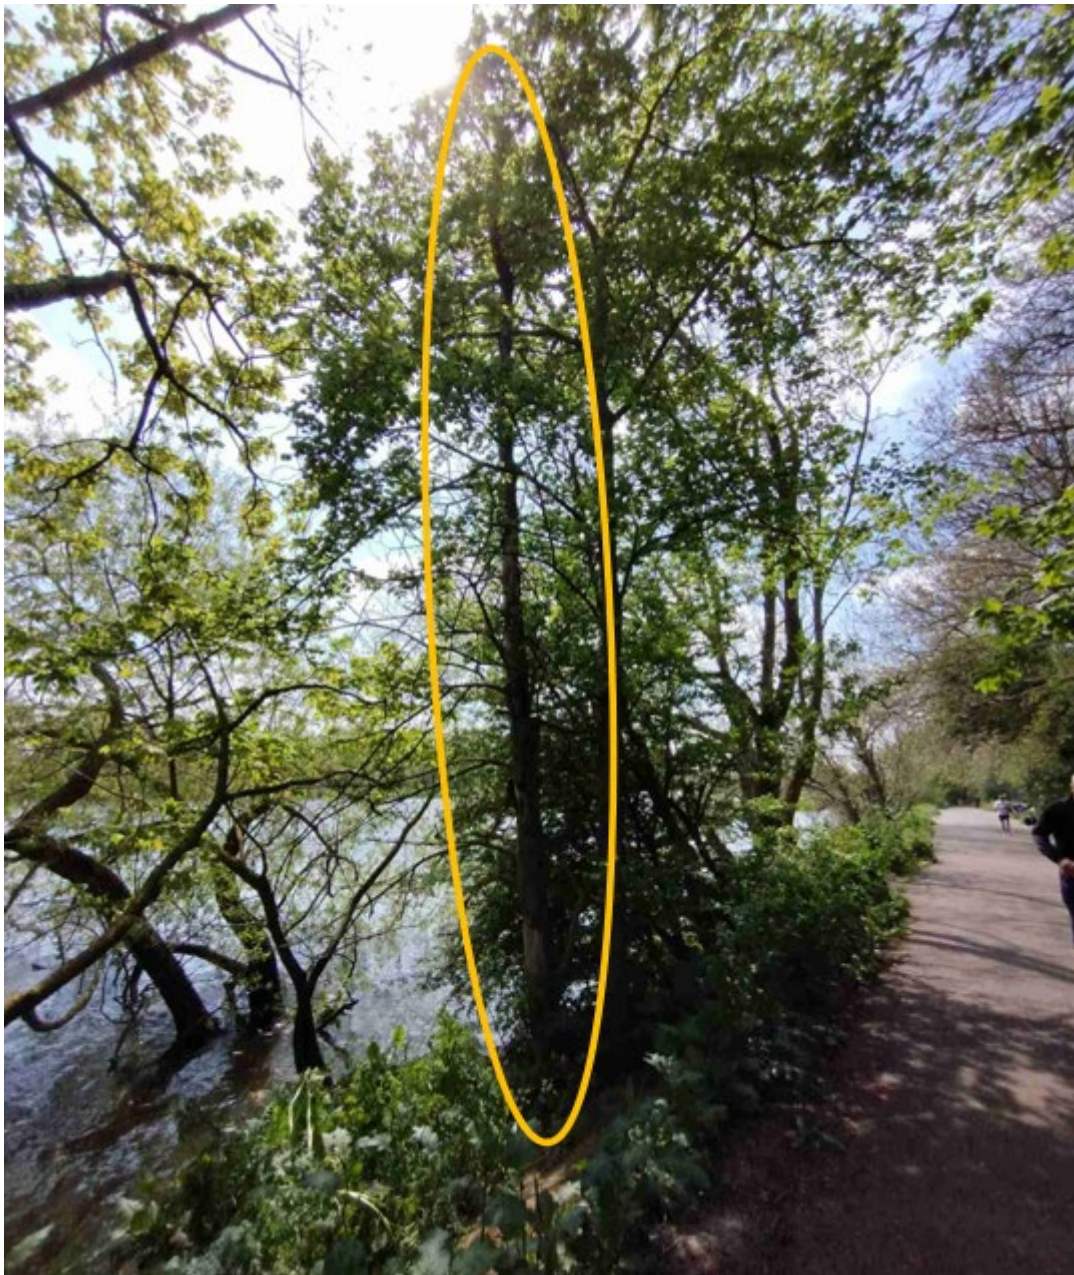
Tree number	650056.00
Road	Warren Footpath
Location	W3W – notion.bride.gives
Species	Elm ( <i>Ulmus sp.</i> )
Height	13.0m
Physiological Condition	Dead
Structural Condition	Dead
Inspection findings	This tree is dead; removal is required to prevent natural failure and facilitate replanting

Image shows dead tree circled

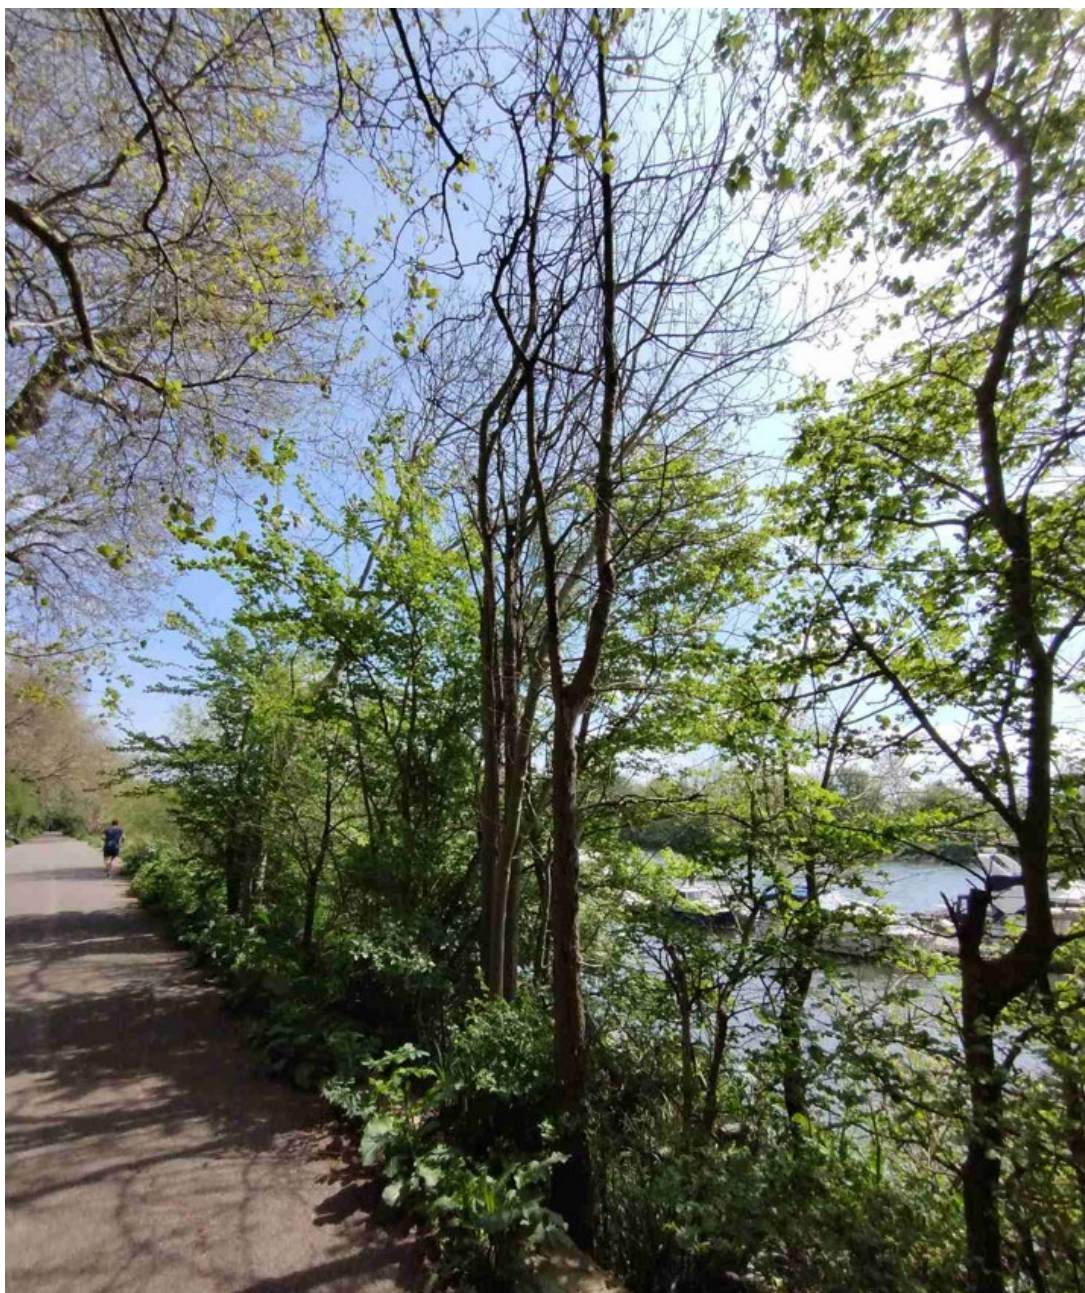
Tree number	650055.00
Road	Warren Footpath
Location	W3W – tbc
Species	Ash ( <i>Fraxinus excelsior</i> )
Height	10.0m
Physiological Condition	Dead
Structural Condition	Dead
Inspection findings	These trees are dead; removal is required to prevent natural failure and facilitate replanting

**Image shows group of dead trees**

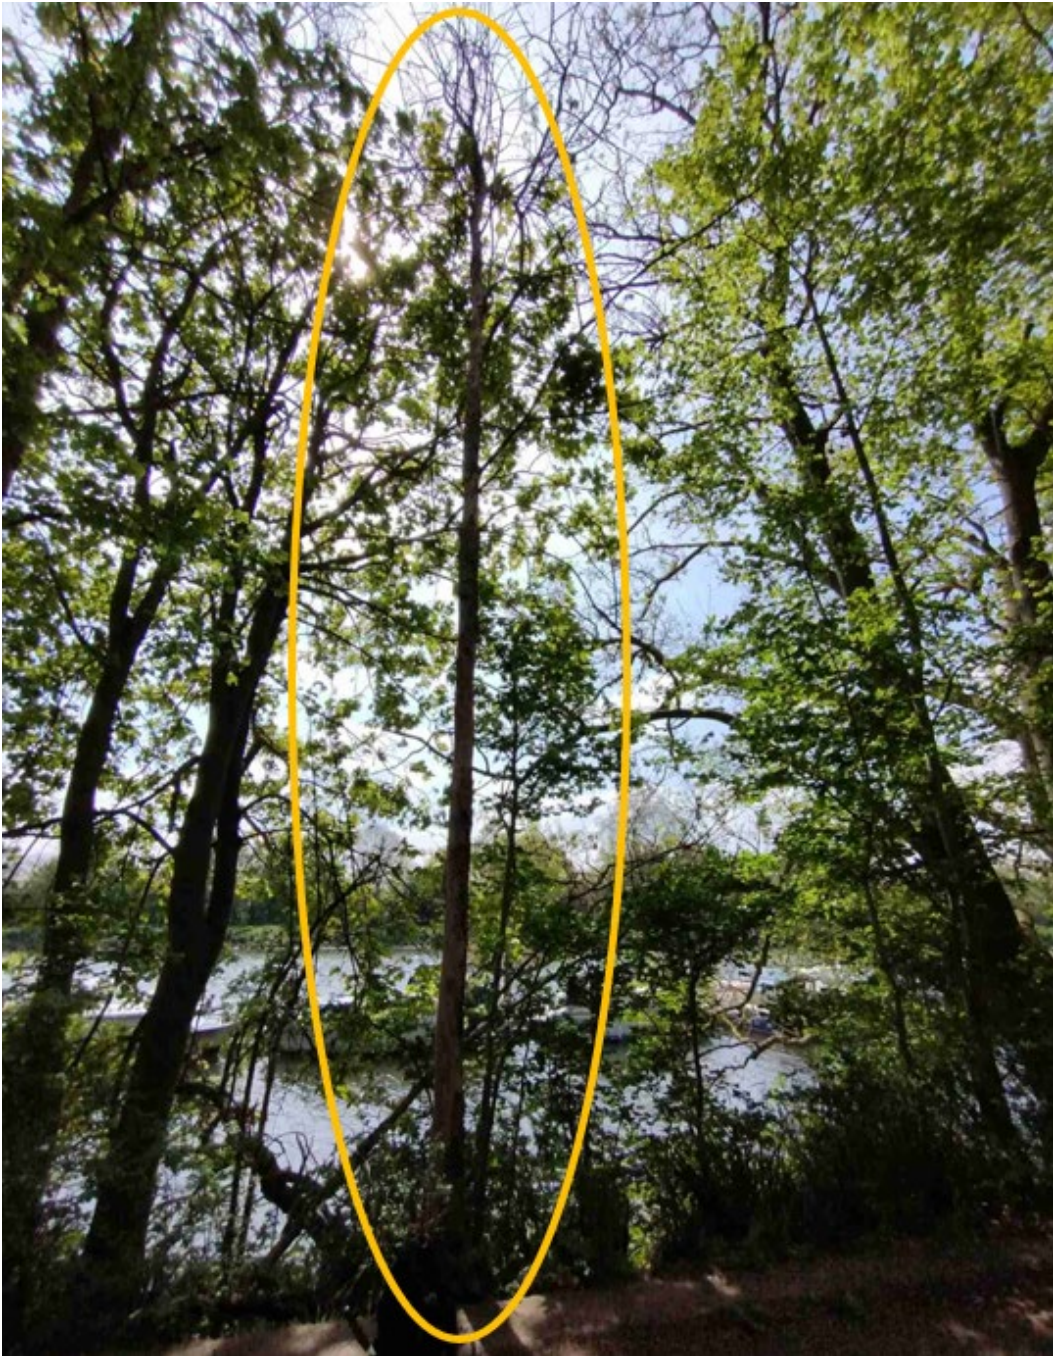
Tree number	650055.00
Road	Warren Footpath
Location	W3W – organs.hais.mole
Species	Elm ( <i>Ulmus sp.</i> )
Height	13.0m
Physiological Condition	Dead
Structural Condition	Dead
Inspection findings	This tree is dead; removal is required to prevent natural failure and facilitate replanting

Image shows dead tree circled

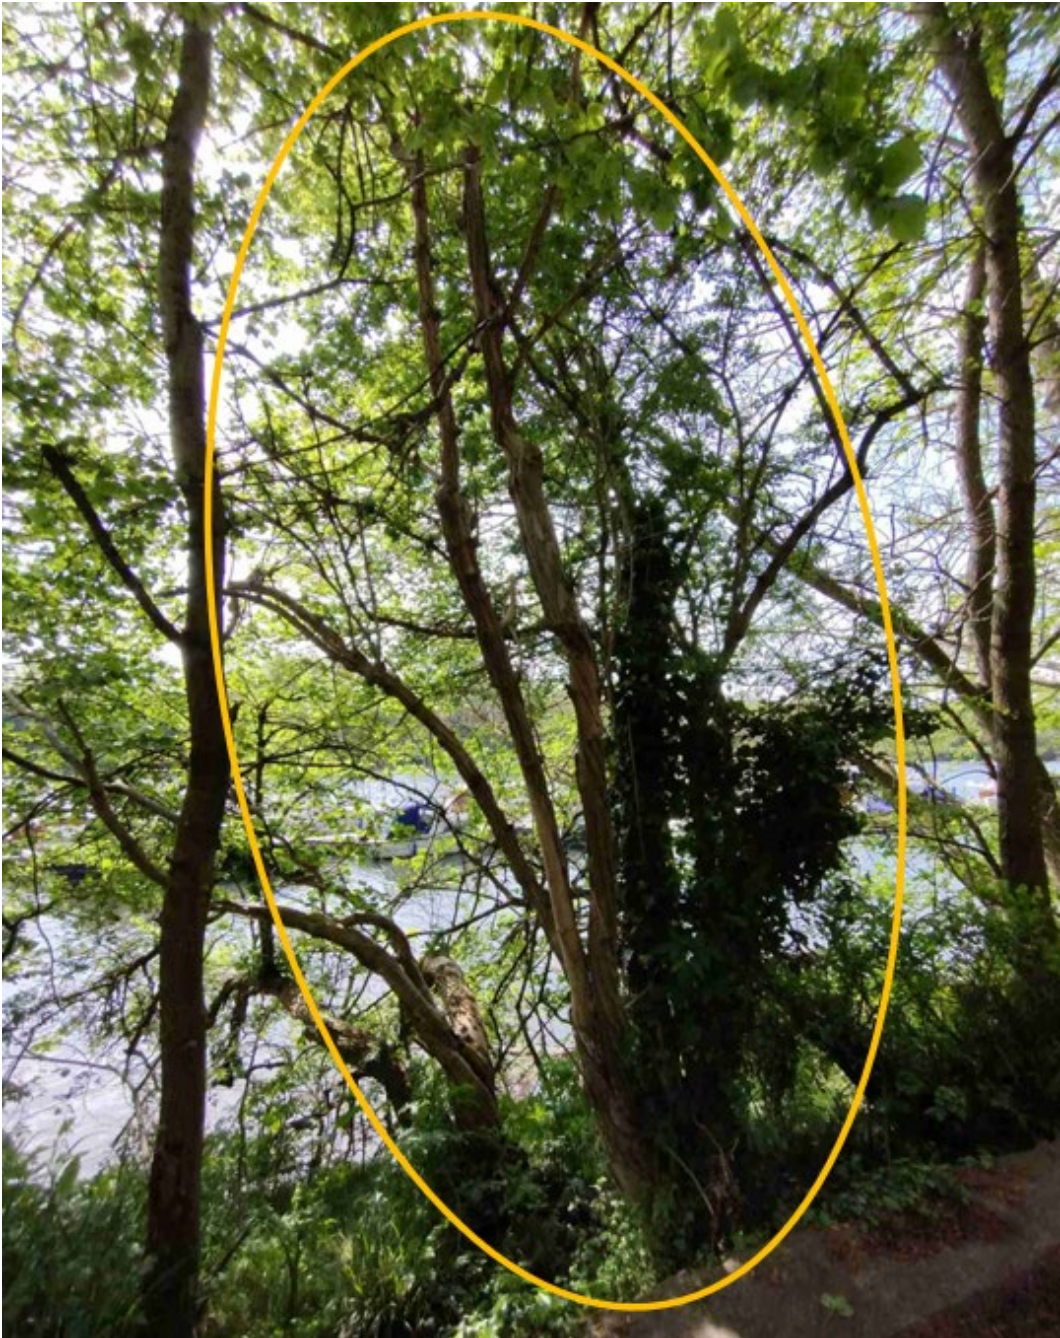
Tree number	650055.00
Road	Warren Footpath
Location	W3W – breath.crisis.hotels
Species	Elder ( <i>Sambucus nigra</i> )
Height	4.0m
Physiological Condition	Dead
Structural Condition	Dead
Inspection findings	This tree is dead; removal is required to prevent natural failure and facilitate replanting

Image shows dead tree circled
