# June 2026 phase 1 – HW Reactive Tree Works Programme

The following pages provide the locations of each tree that is to be removed, in addition photographs and descriptions of the inspection findings have been provided.

Dated 27.06.2026

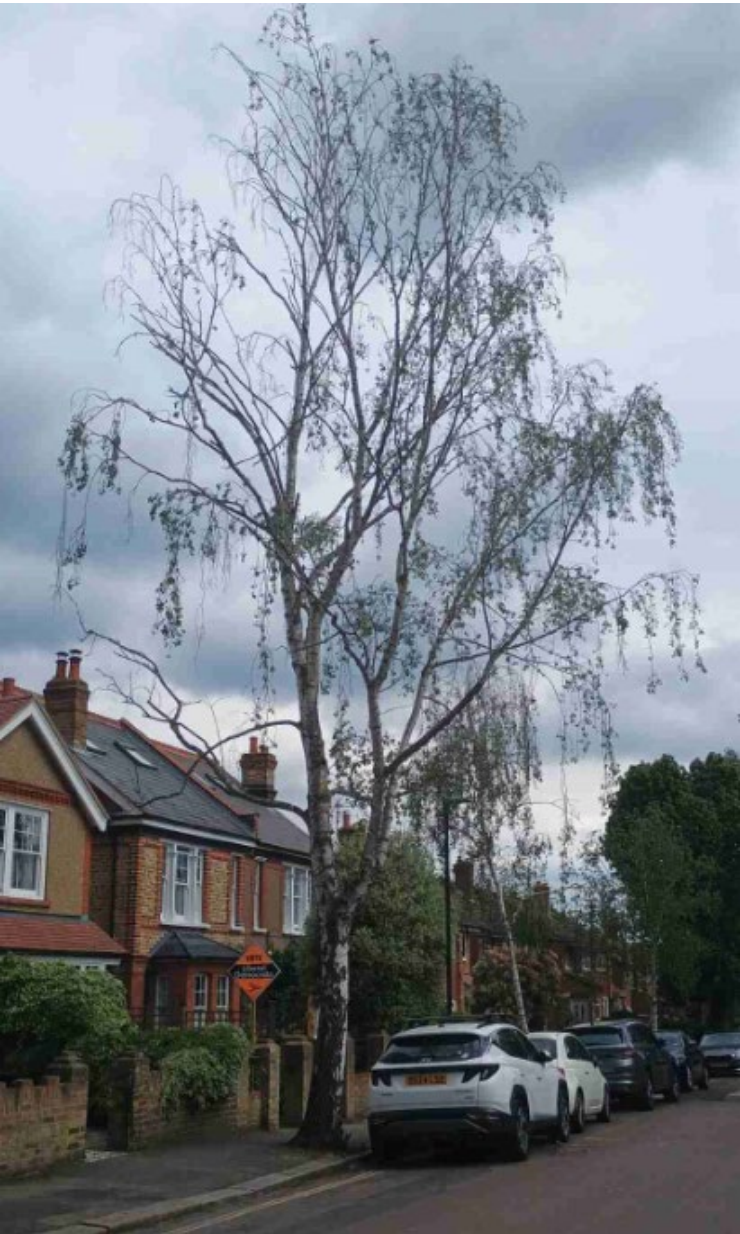
| Inspection findings/reason for exemption | This tree is moribund; removal is required to prevent natural failure, manage risk, and facilitate replanting |

Image shows moribund tree in street scene.

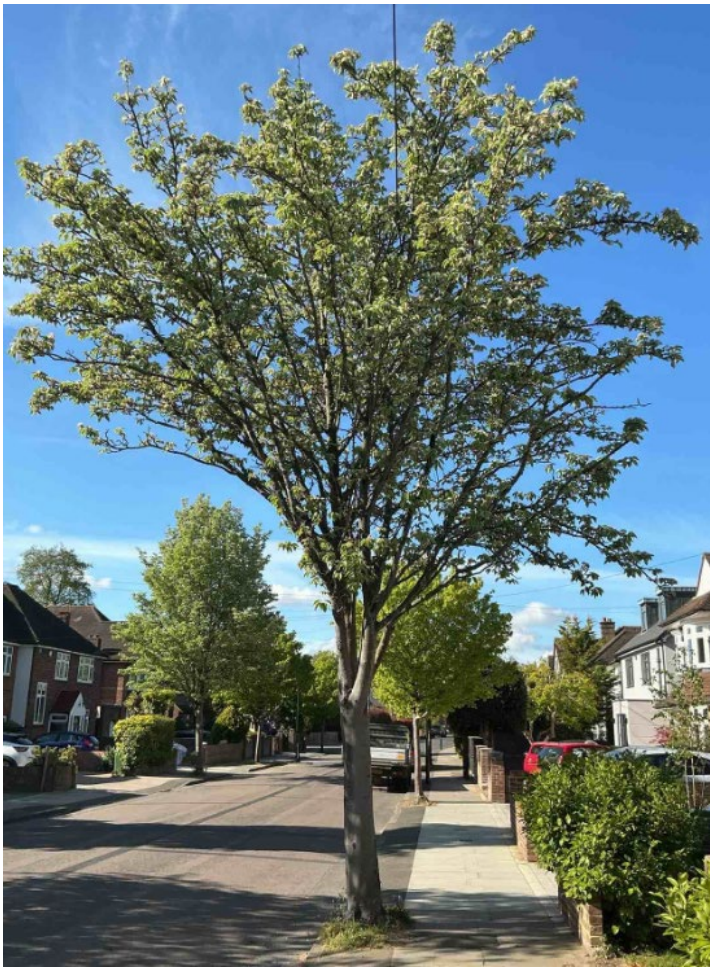
Image shows tree in street scene.

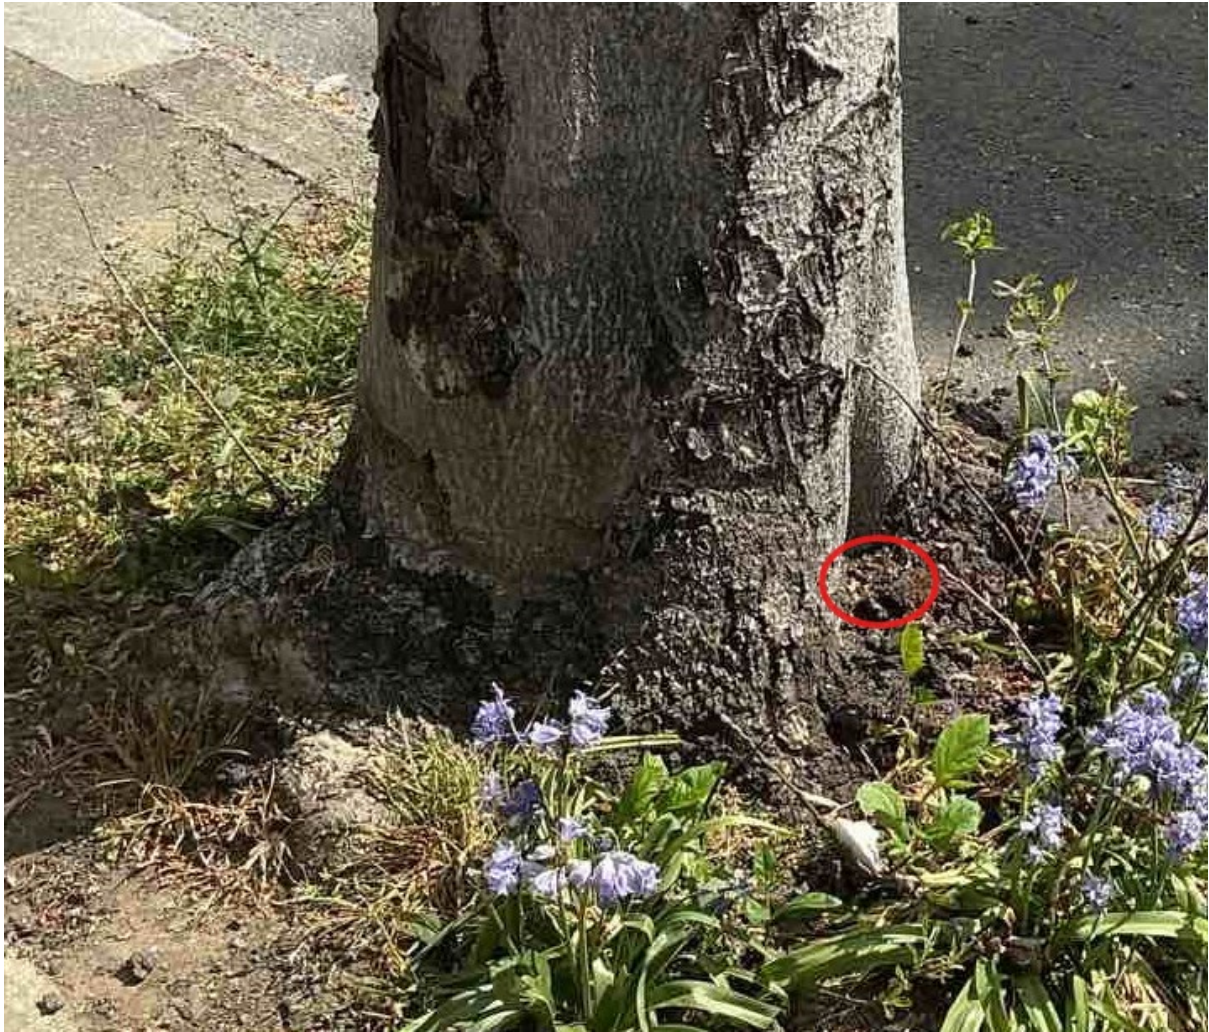
| Inspection findings/reason for exemption | A fungal fruiting body of the decay fungus <i>Ganoderma</i> sp. is present on the base of the trunk. Colonisation by this fungus results in white rot affecting the stem and root system, which can lead to structural failure through fracture or windthrow. A resonance test revealed an unacceptable degree of decay in the which correlates with the presence of the decay fungi. Removal of the tree is recommended to prevent natural failure, manage risk, and facilitate replanting. |

***Image shows fungal fruiting body circled.***

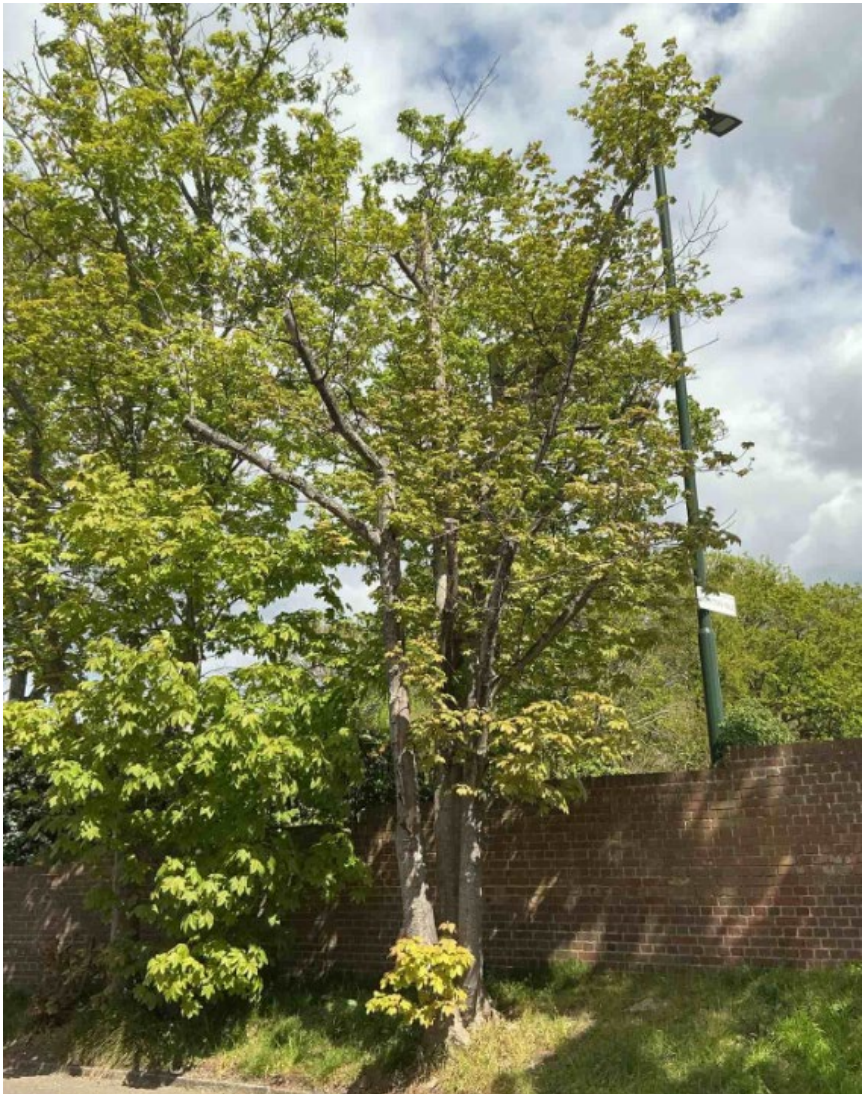
| Inspection findings/reason for exemption | This tree is moribund; removal is required to prevent natural failure, manage risk, and facilitate replanting |

Image shows moribund tree in street scene.

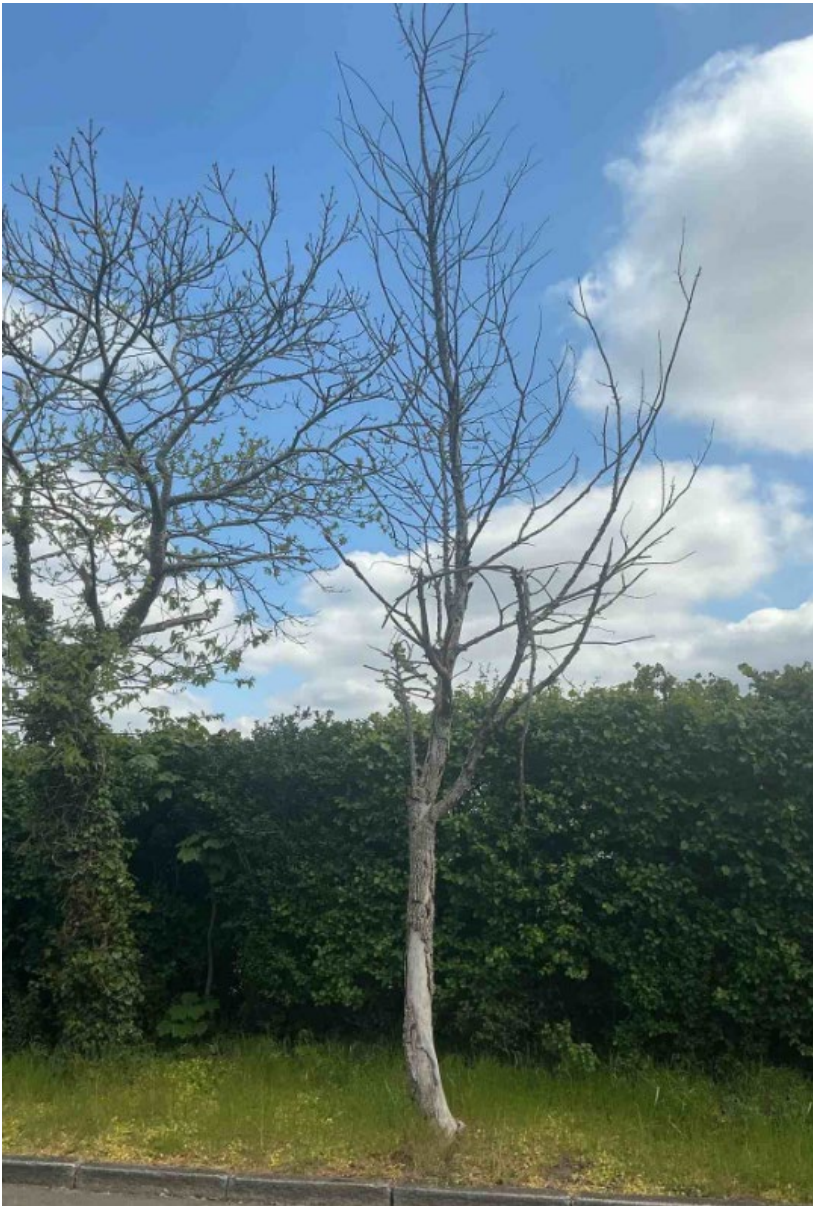
| Inspection findings/reason for exemption | This tree is dead; removal is required to prevent natural failure, manage risk, and facilitate replanting |

Image shows Dead tree in street scene.

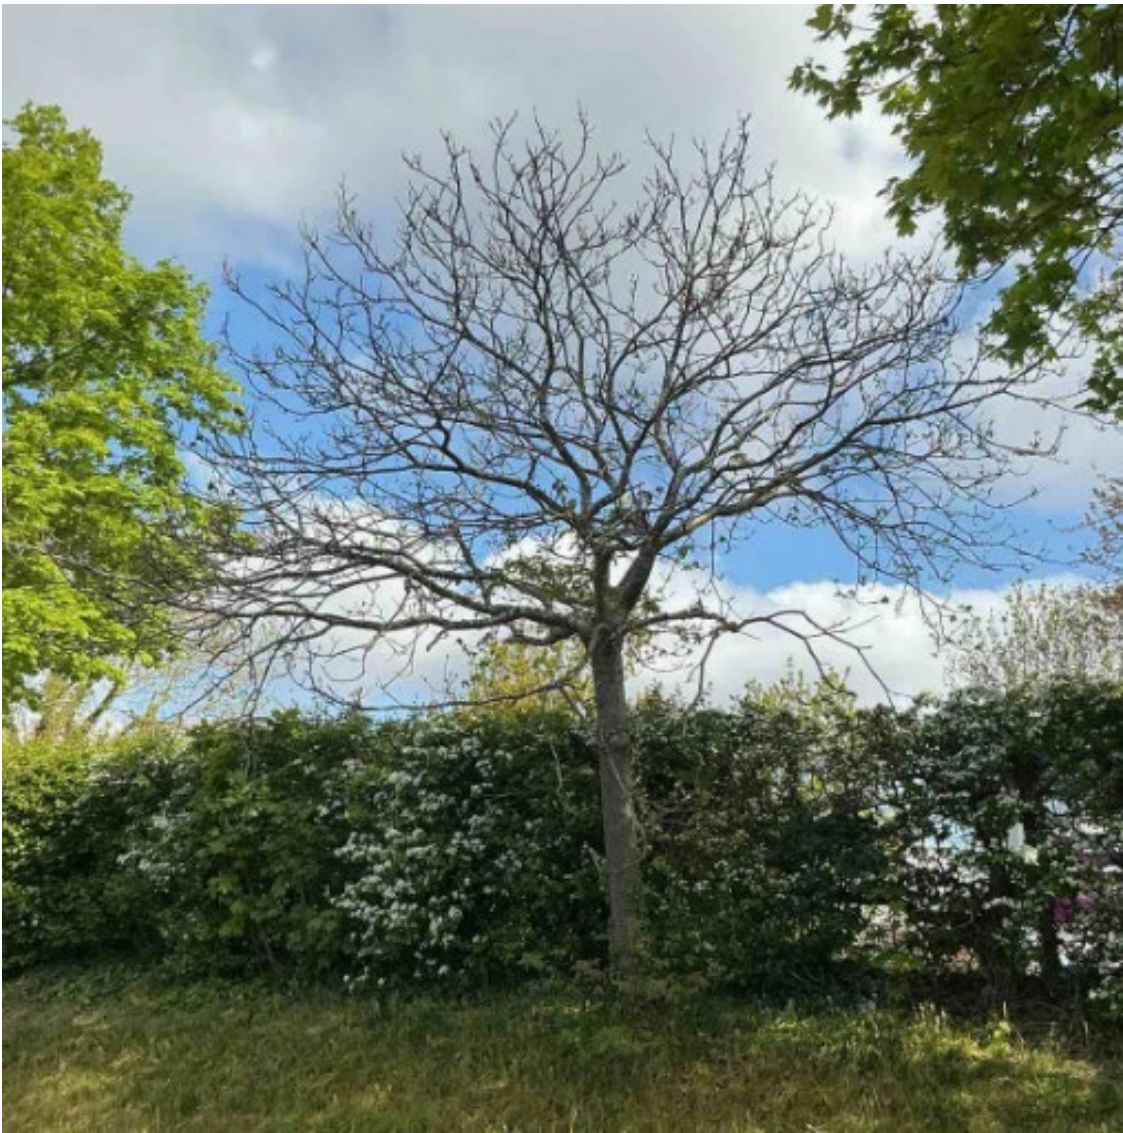
| Inspection findings/reason for exemption | This tree is moribund; removal is required to prevent natural failure, manage risk, and facilitate replanting |

Image shows moribund tree in street scene.

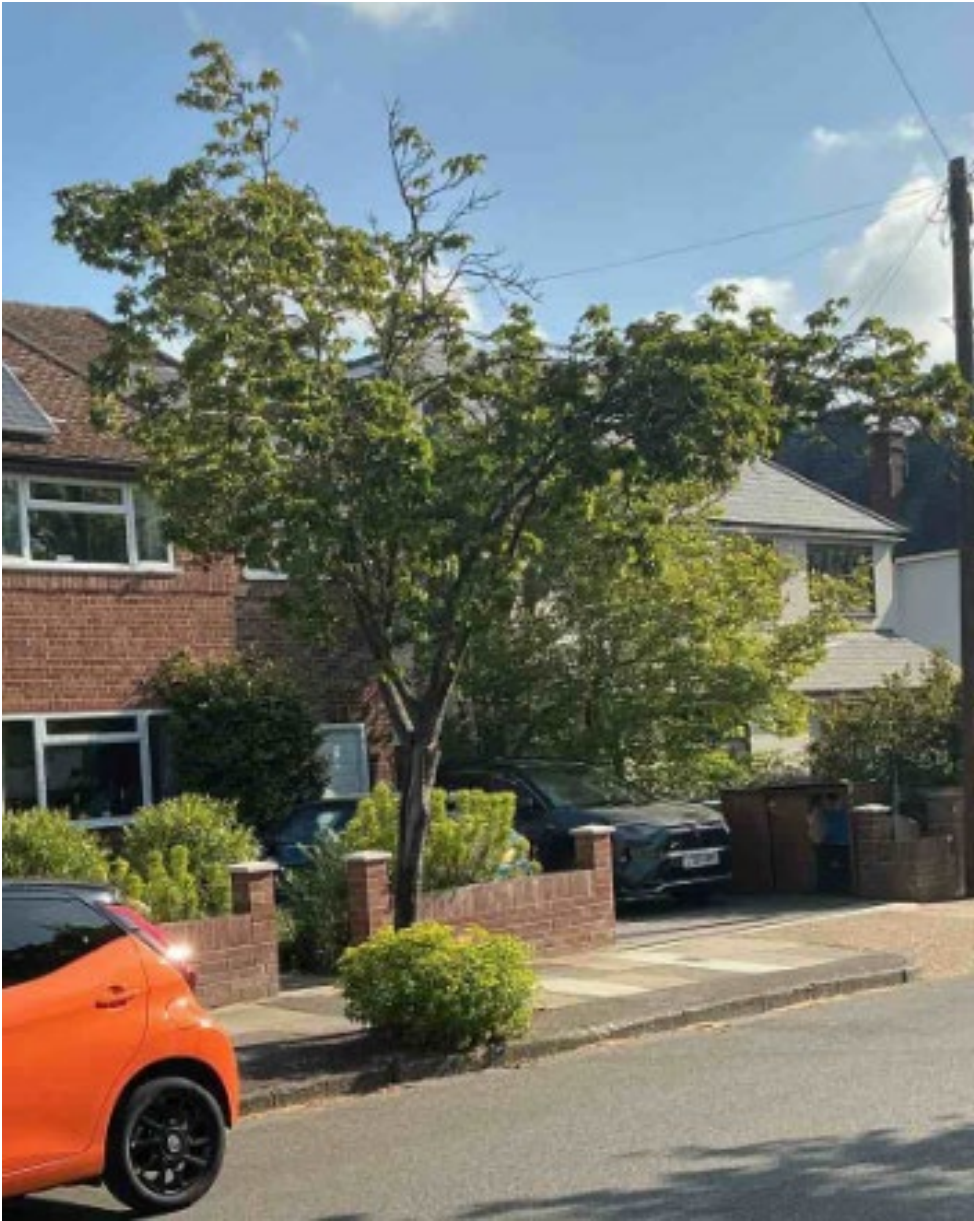
Image shows tree in street scene.

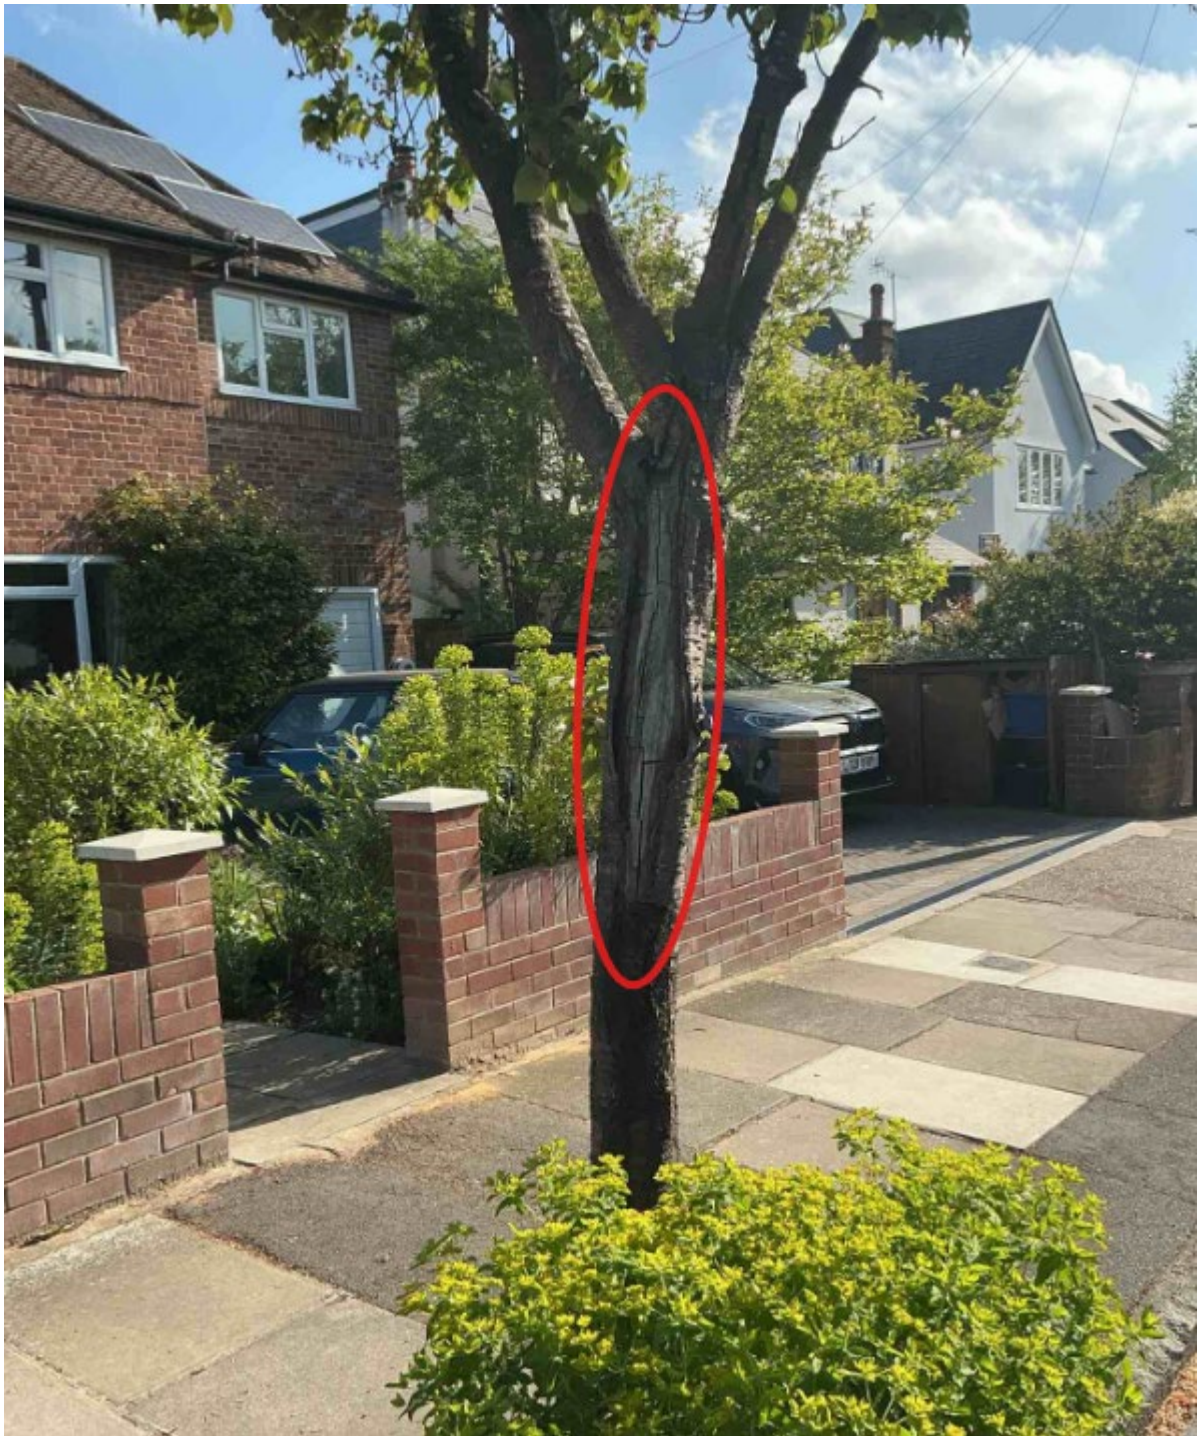
| Inspection findings/reason for exemption | Wounding to the main trunk has resulted in bark and vascular necrosis and crown dieback. Removal is required to prevent natural failure, manage risk, and facilitate replanting |

***Image shows wound on trunk circled.***

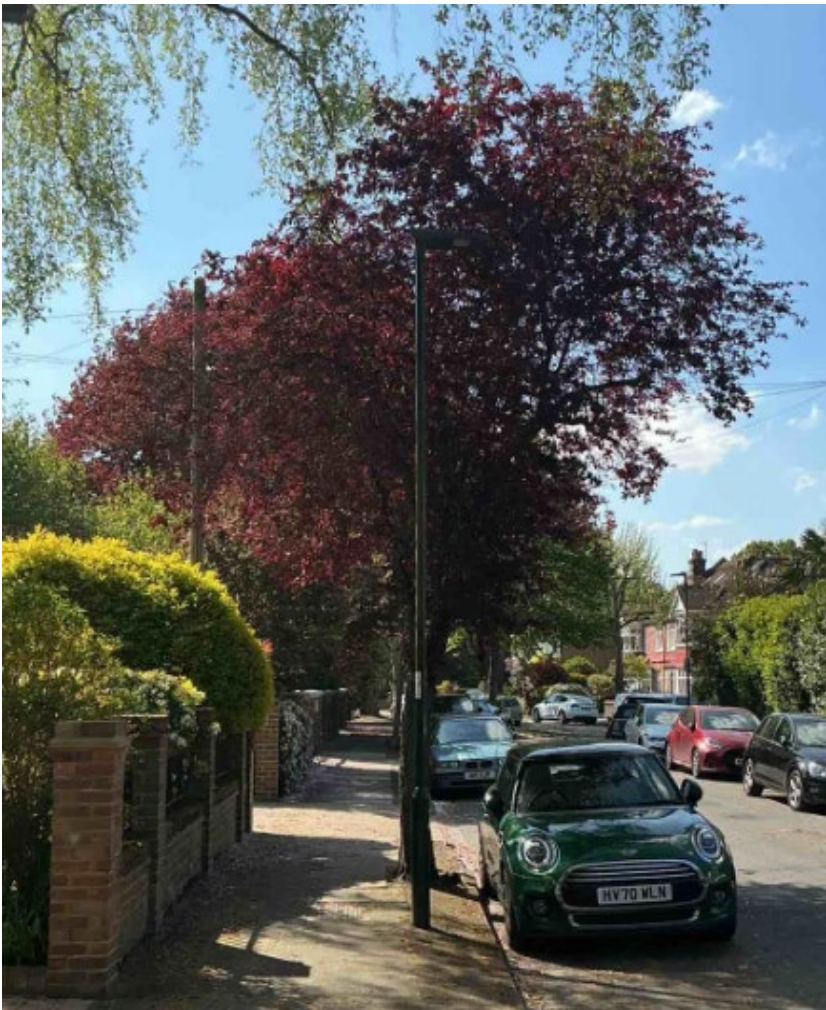
Image shows tree in street scene.

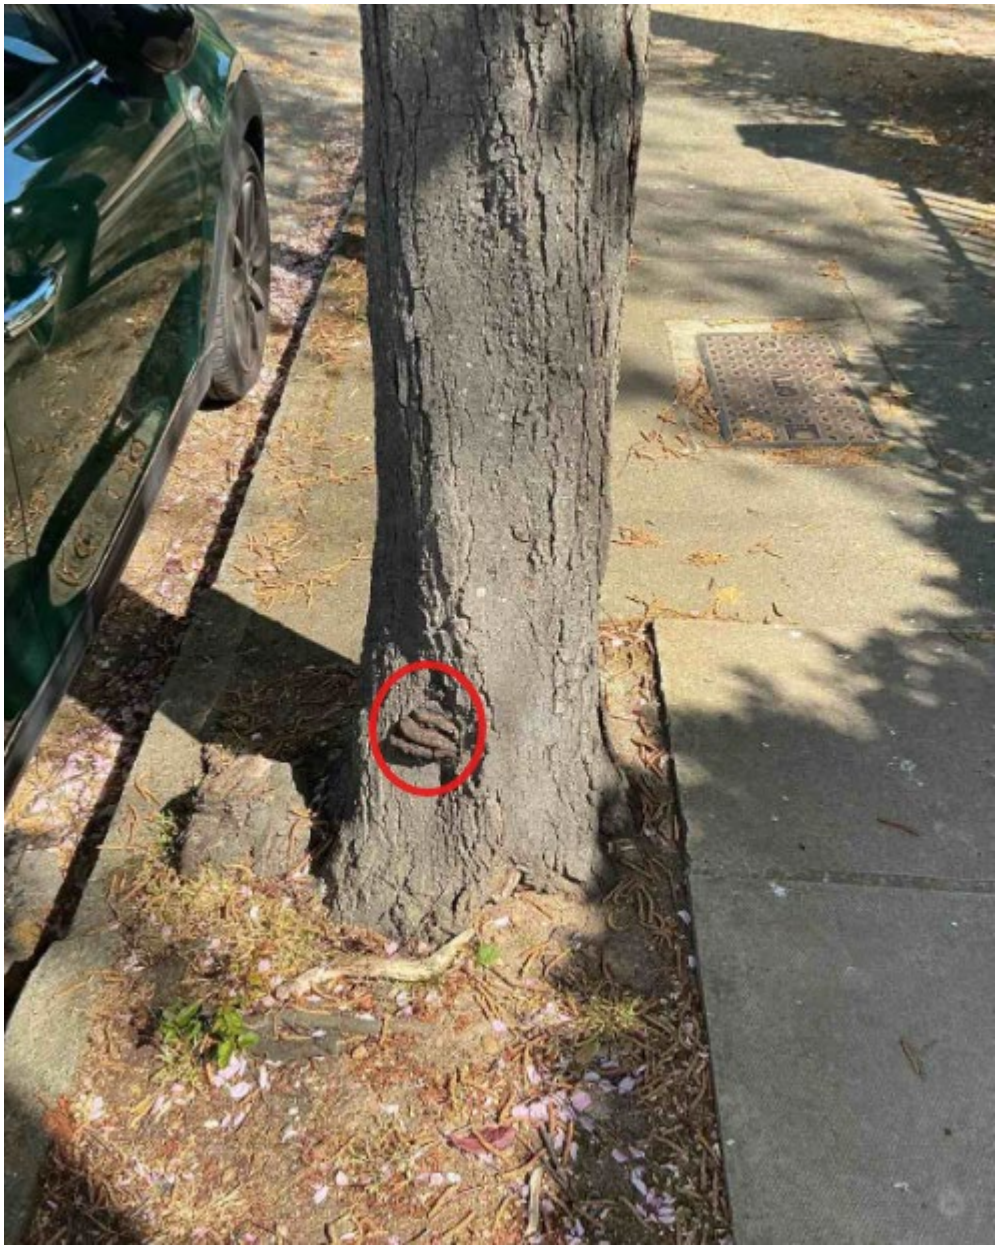
| Inspection findings/reason for exemption | A fungal fruiting body of the decay fungus <i>Ganoderma sp.</i> is present on the trunk. Colonisation by this fungus results in white rot affecting the stem and root system, which can lead to structural failure through fracture or windthrow. A resonance test revealed an unacceptable degree of decay in the which correlates with the presence of the decay fungi. Removal of the tree is recommended to prevent natural failure, manage risk, and facilitate replanting. |

***Image shows fungal fruiting body circled.***

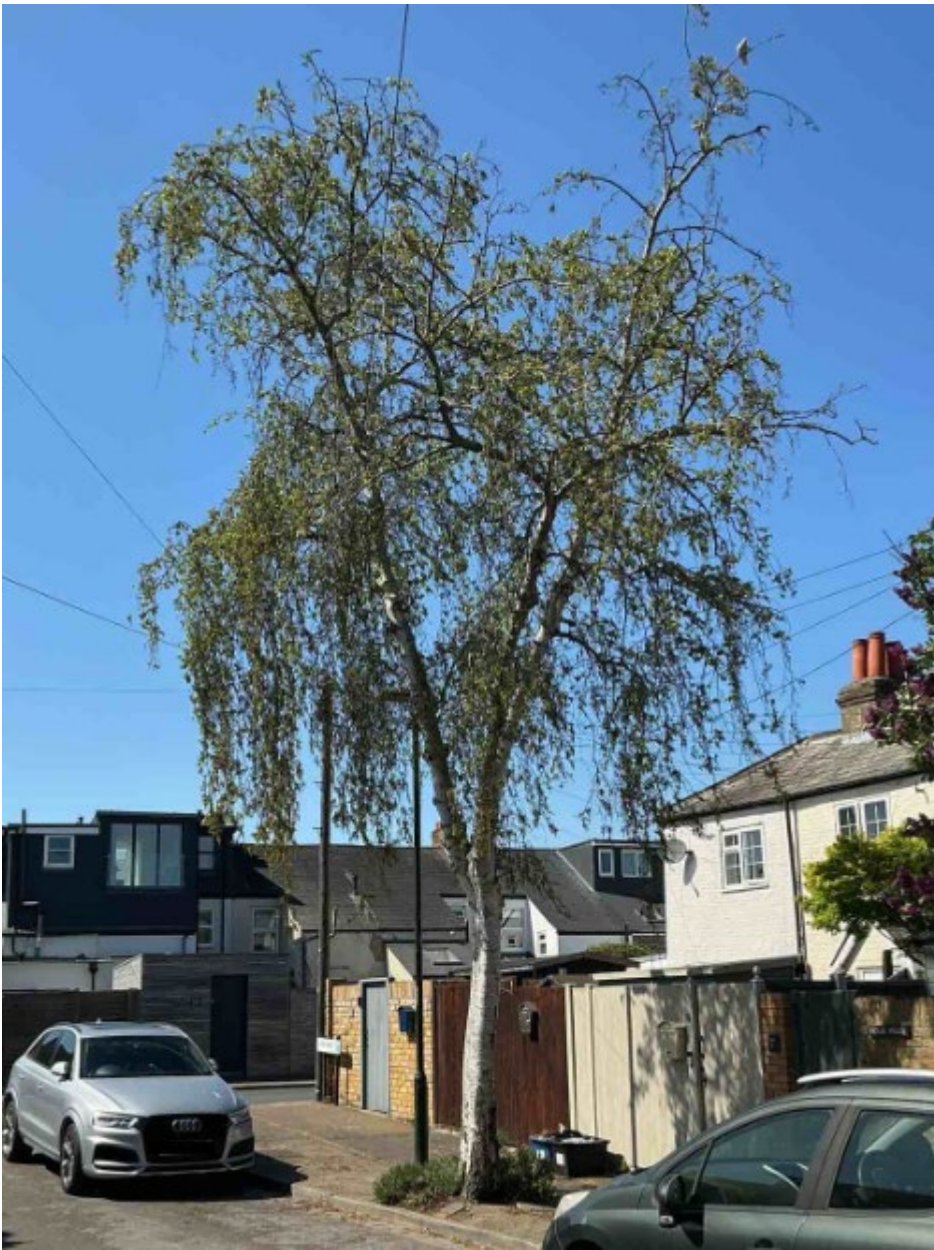
Image shows moribund tree in street scene.

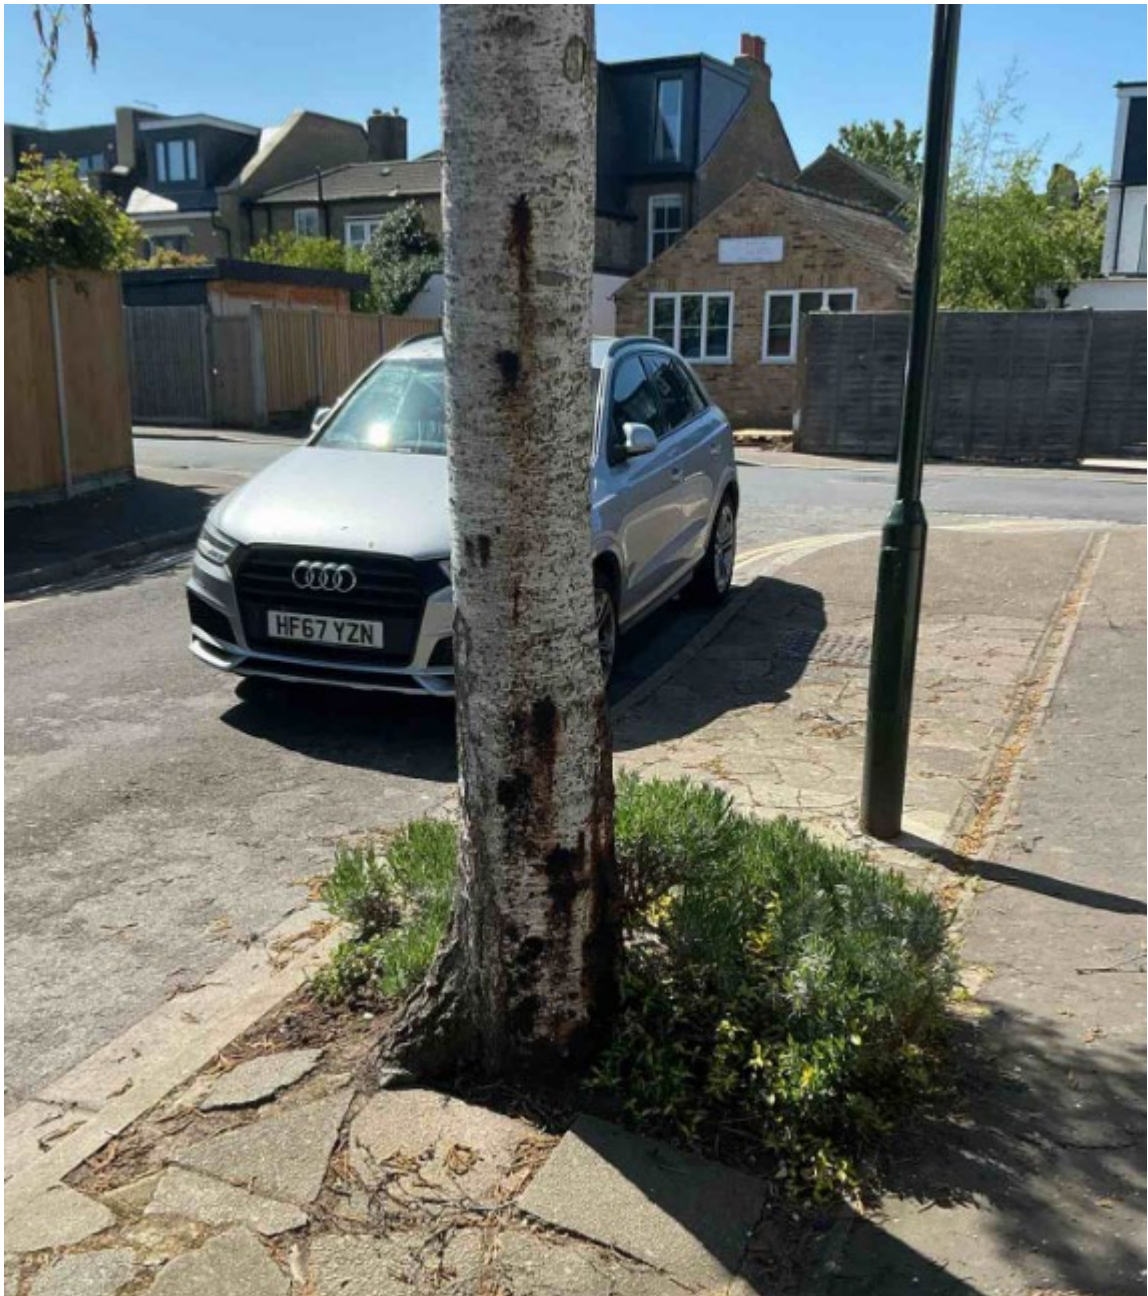
| Inspection findings/reason for exemption | This tree has bleeding bark on the main stem with associated bark necrosis, which correlates with dieback in the crown. Removal is required to prevent natural failure, manage risk, and facilitate replanting |

***Image shows bleeding bark on trunk***

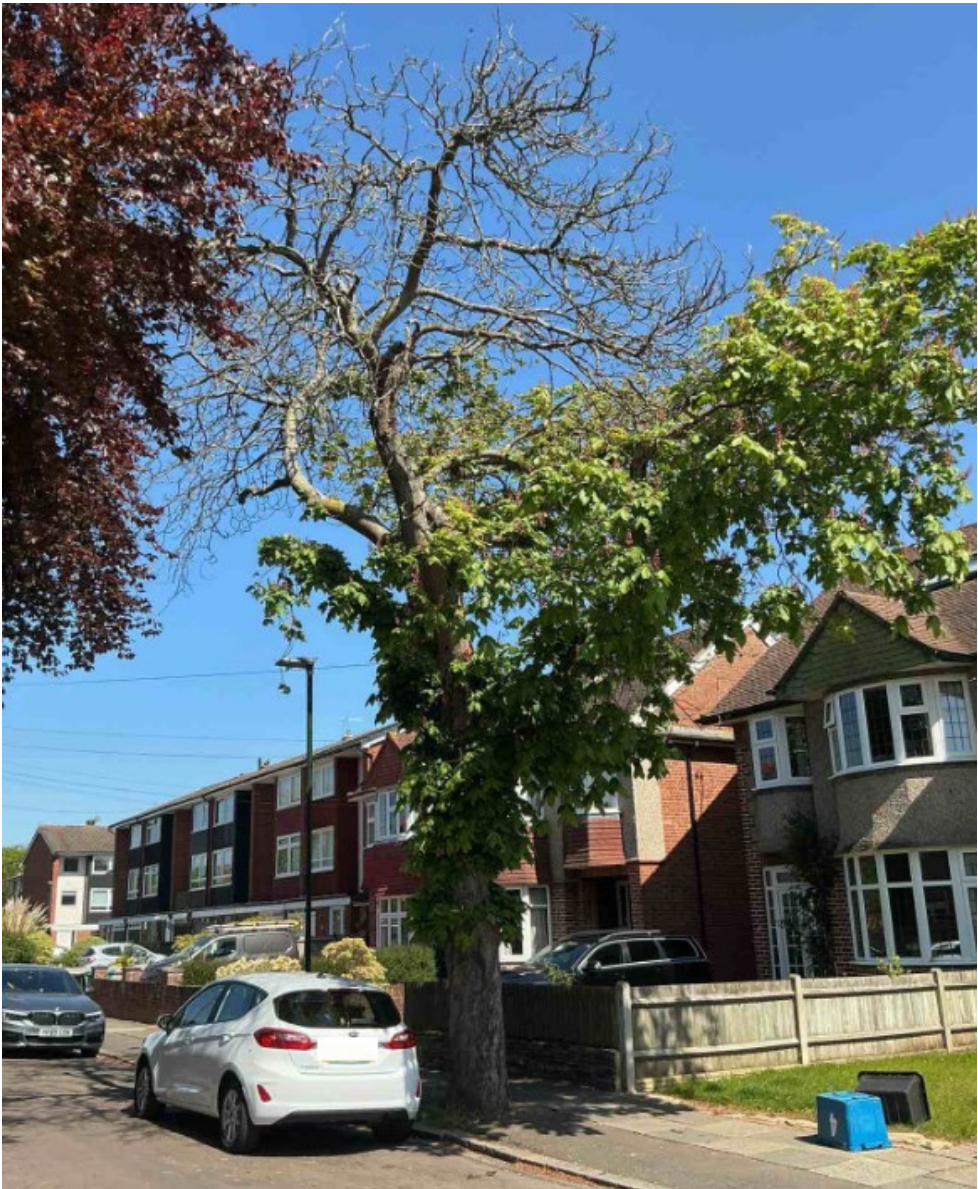
| Inspection findings/reason for exemption | This tree is moribund; removal is required to prevent natural failure, manage risk, and facilitate replanting |

Image shows moribund tree in street scene.

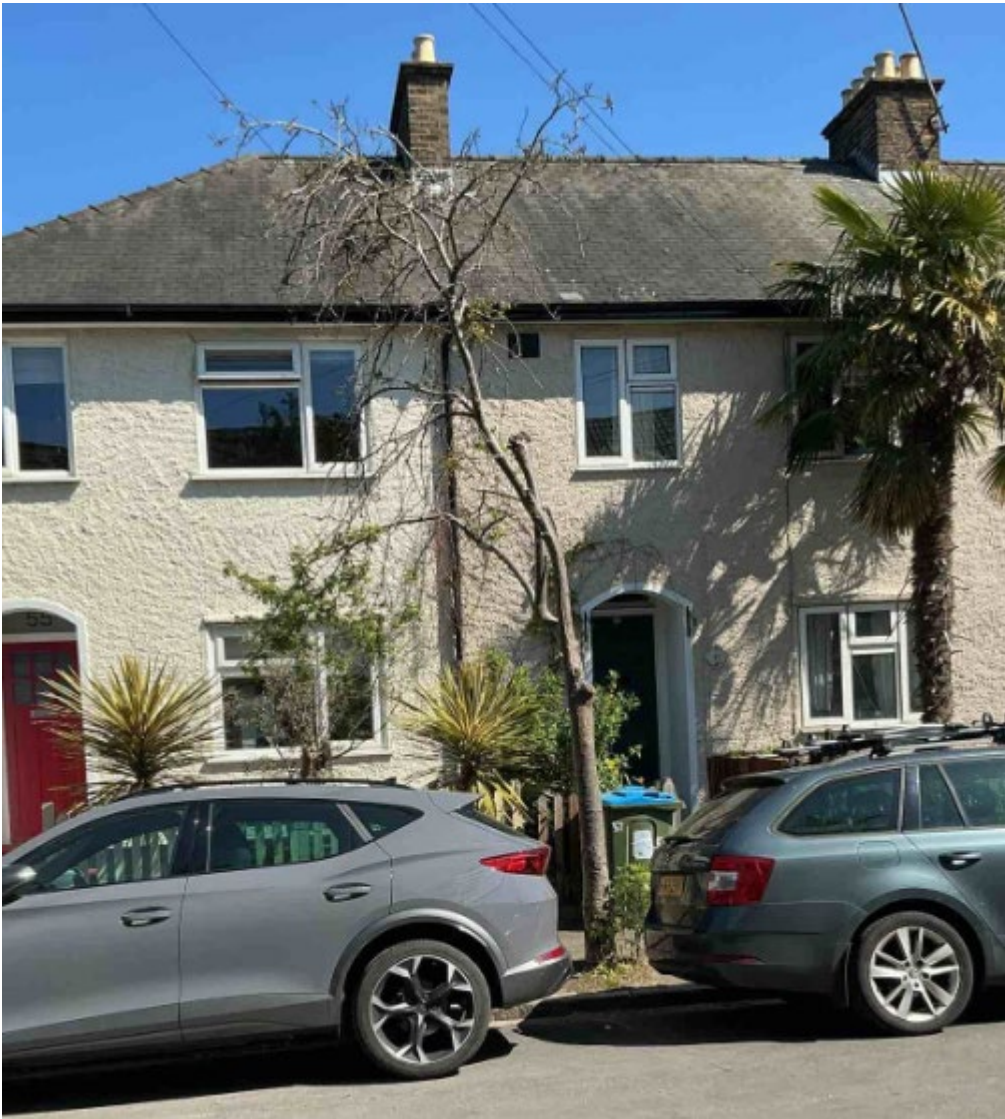
| Inspection findings/reason for exemption | This tree is moribund; removal is required to prevent natural failure, manage risk, and facilitate replanting |

Image shows moribund tree in street scene.

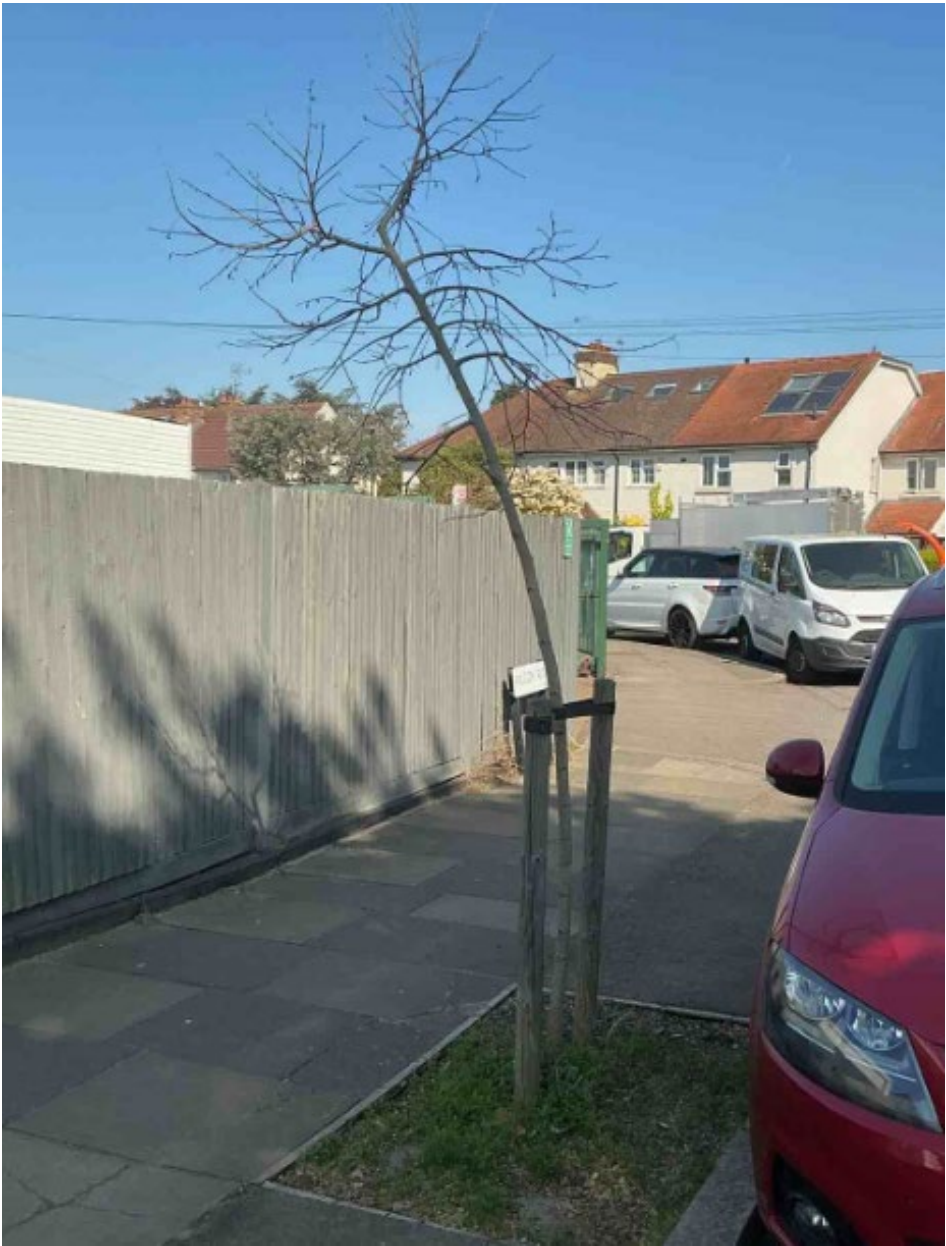
| Inspection findings/reason for exemption | This tree is dead; removal is required to prevent natural failure, manage risk, and facilitate replanting |

Image shows dead tree in street scene.

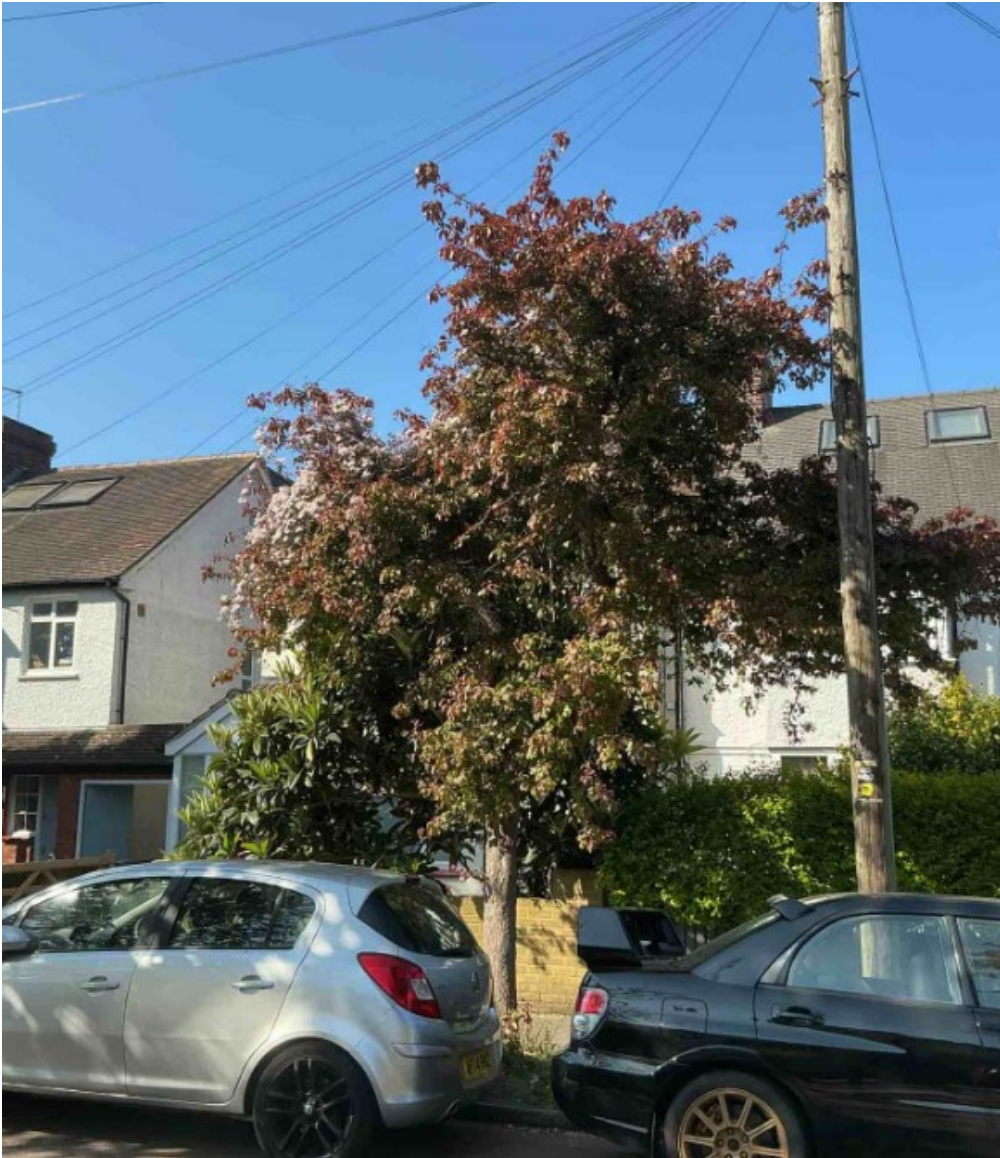
Image shows tree in street scene.

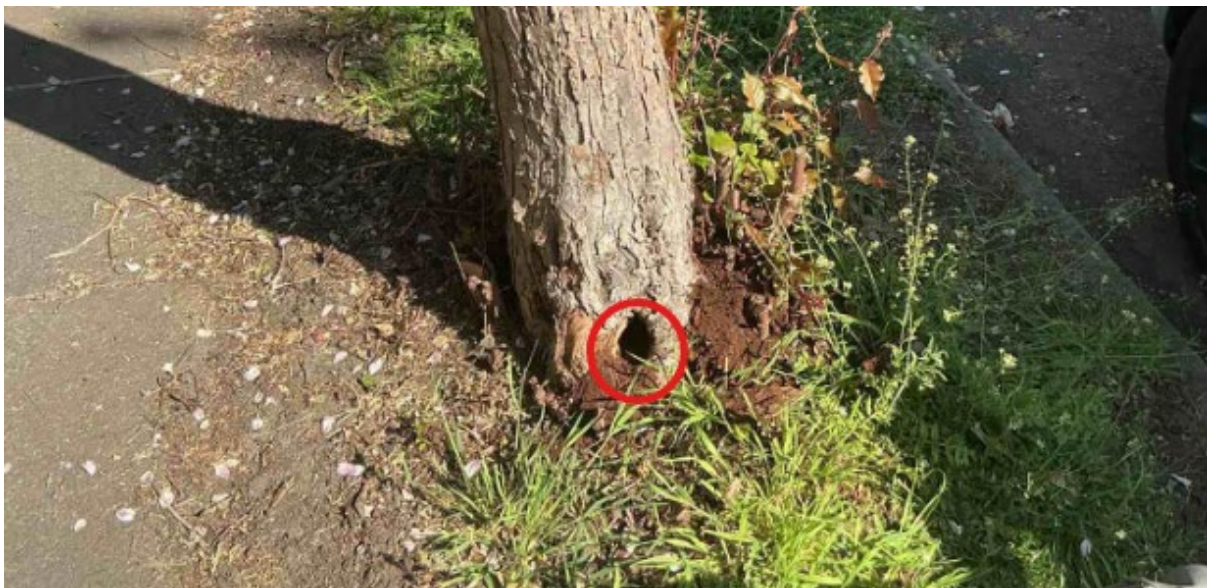
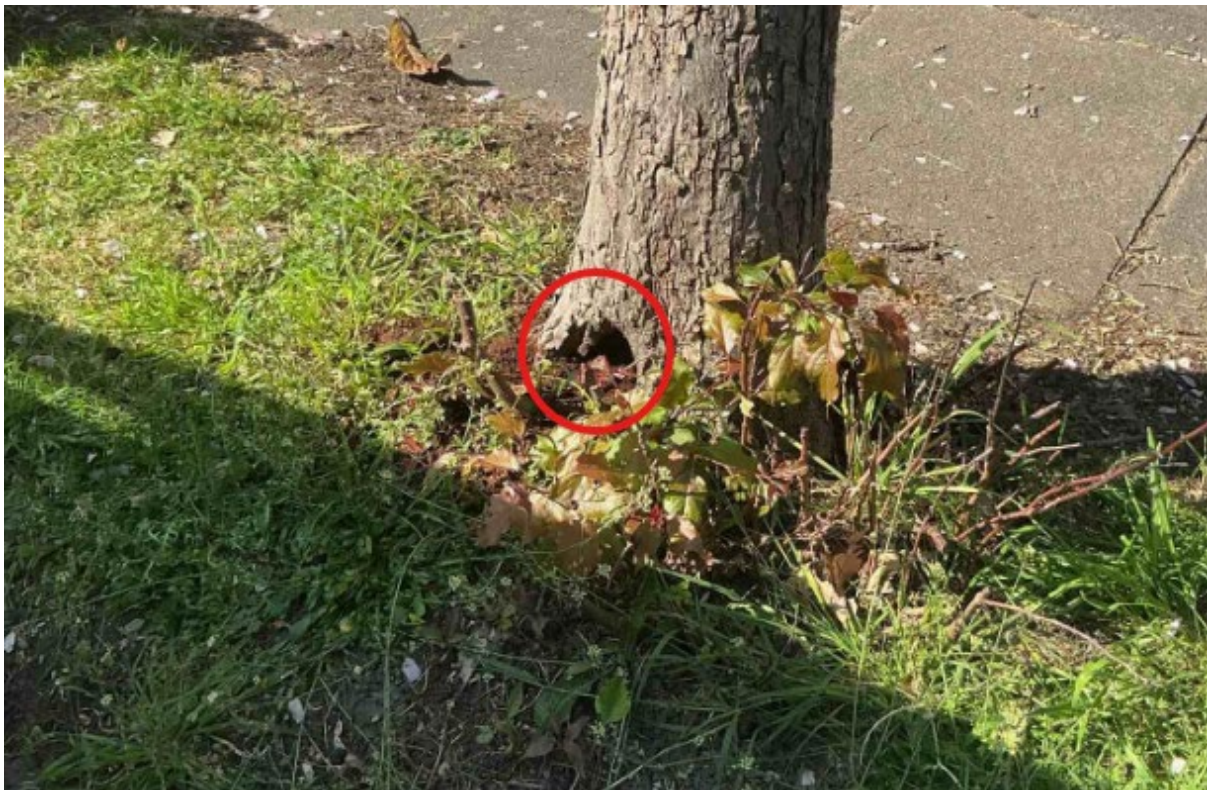
| Inspection findings/reason for exemption | Investigation with a probe and a resonance test with a sounding hammer has revealed an unacceptable amount of decay beyond the visible cavities at the base of the trunk. Removal is required to prevent natural failure, manage risk, and facilitate replanting. |

***Image shows cavity at base of trunk circled.***

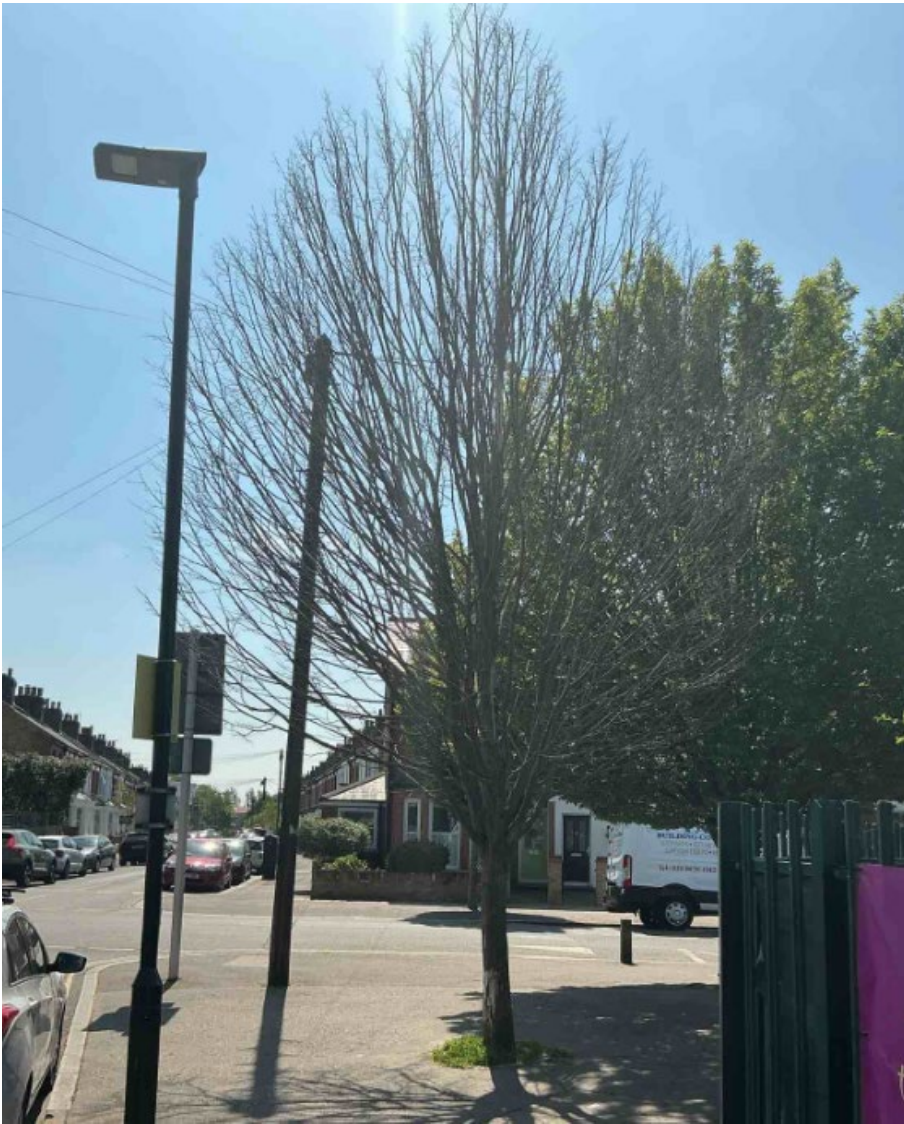
| Inspection findings/reason for exemption | This tree is dead; removal is required to prevent natural failure, manage risk, and facilitate replanting |

Image shows dead tree in street scene.
