# June 2026 phase 1 – HW Reactive Tree Works Programme

The following pages provide the locations of each tree that is to be removed, in addition photographs and descriptions of the inspection findings have been provided.

Dated 27.06.2026

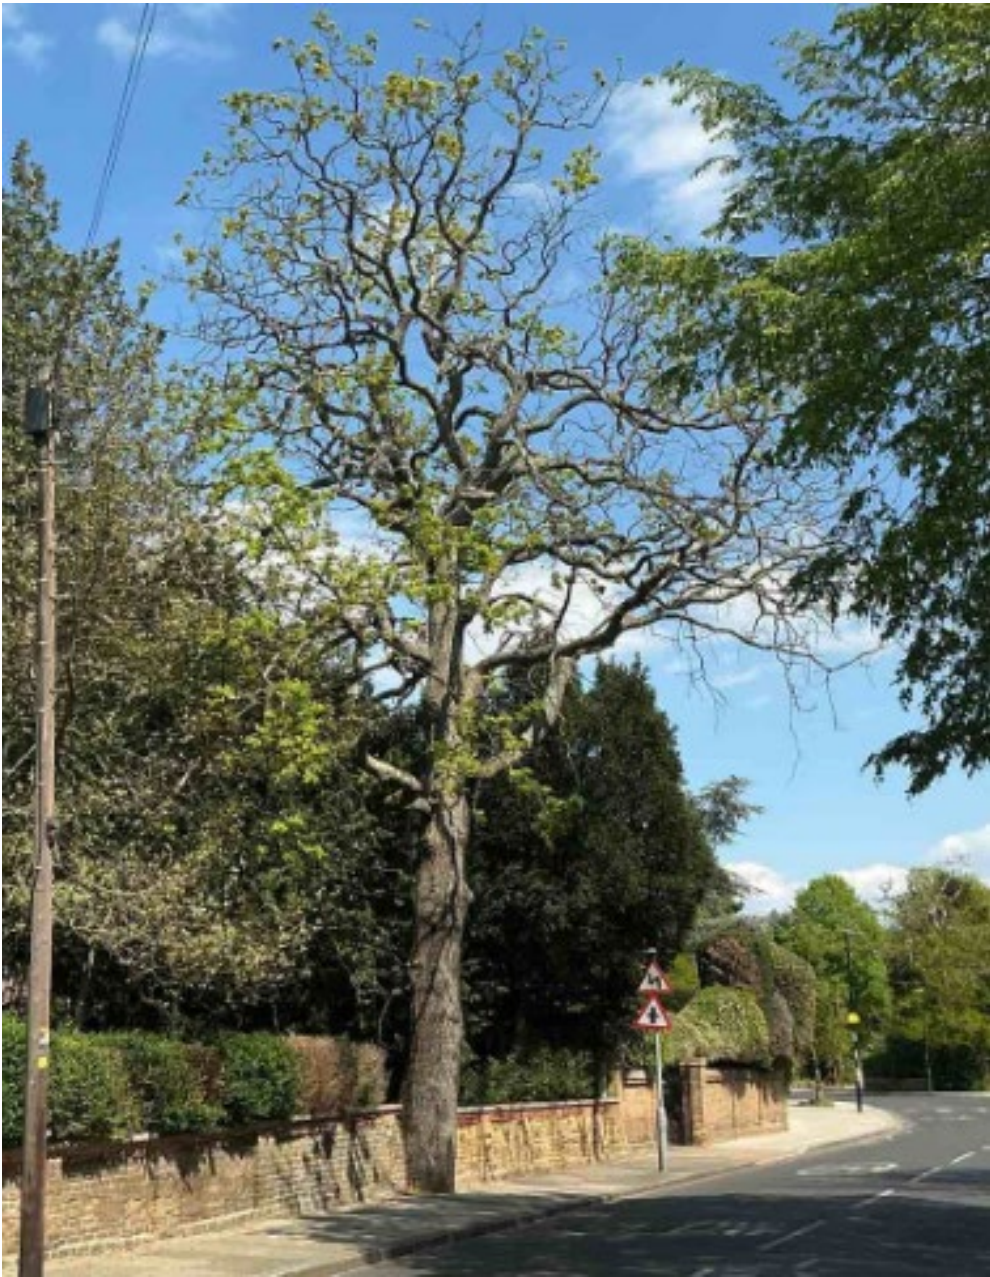
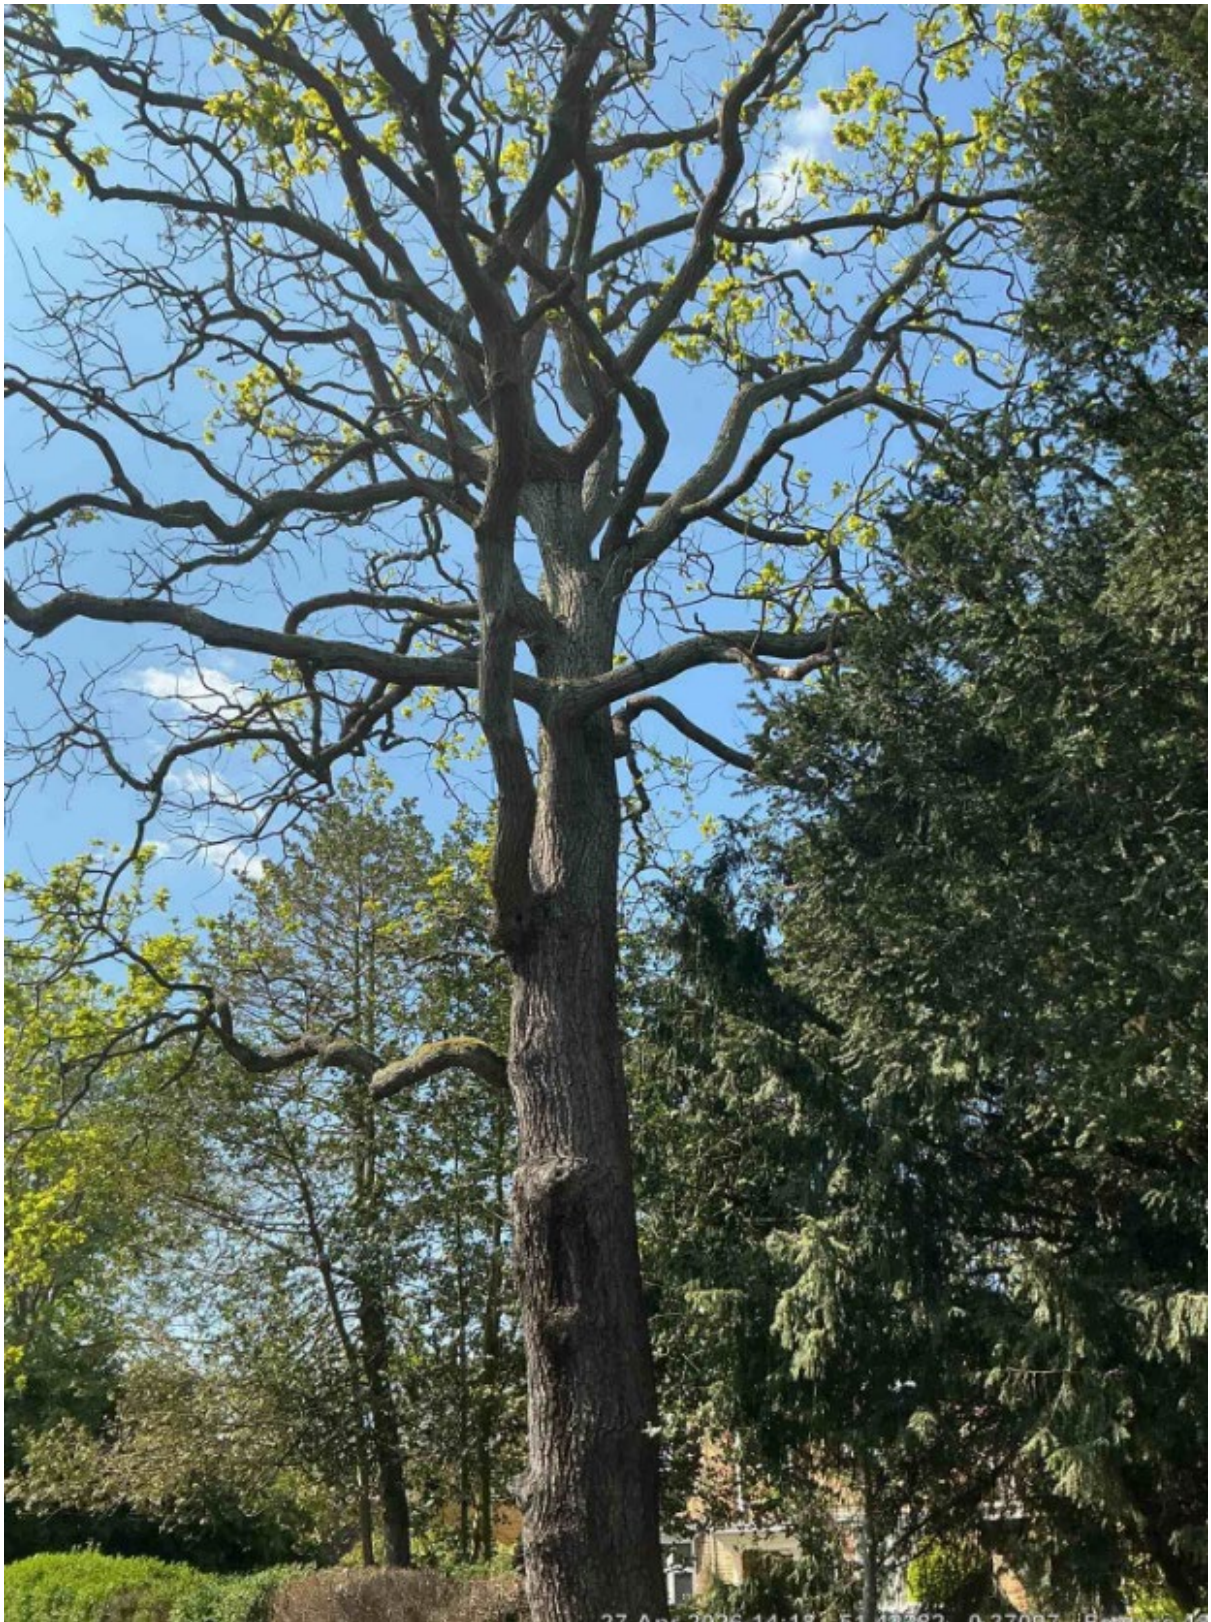
| Inspection findings/reason for exemption | This tree is moribund; removal is required to prevent natural failure, manage risk, and facilitate replanting. |

Image shows moribund tree in street scene.

*Image shows moribund tree in street scene.*

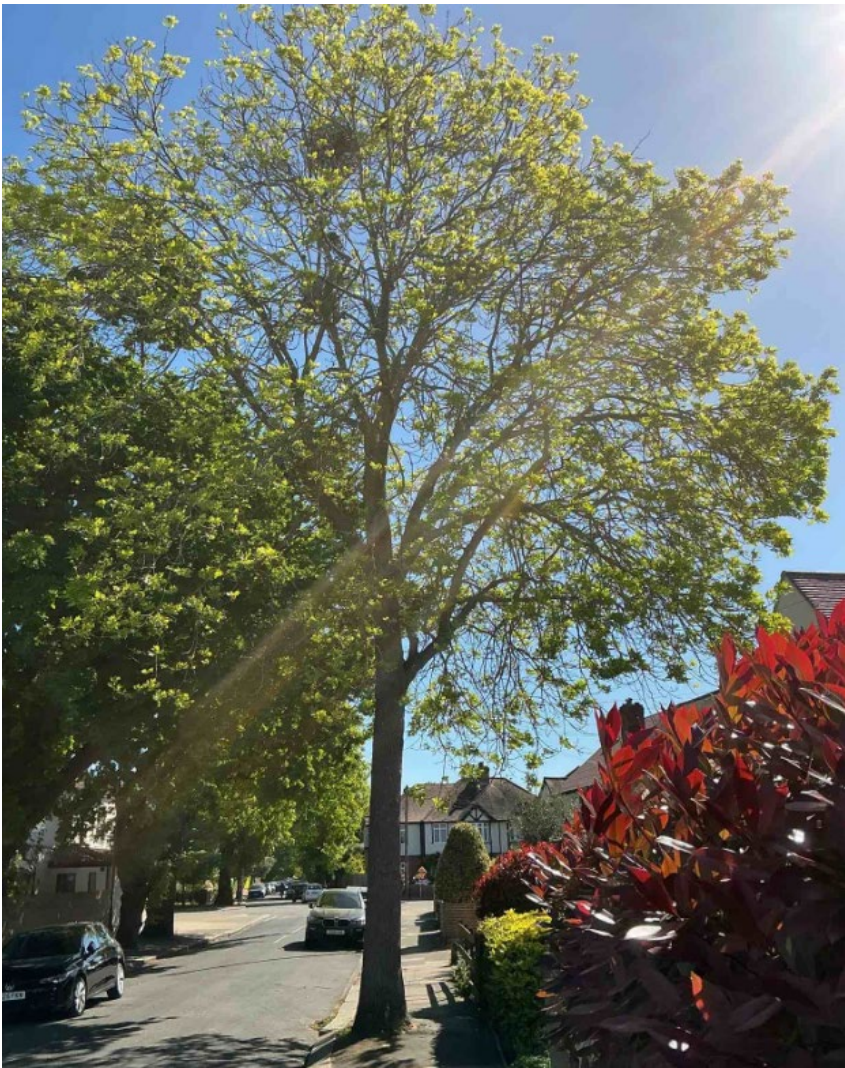
Image shows moribund tree in street scene.

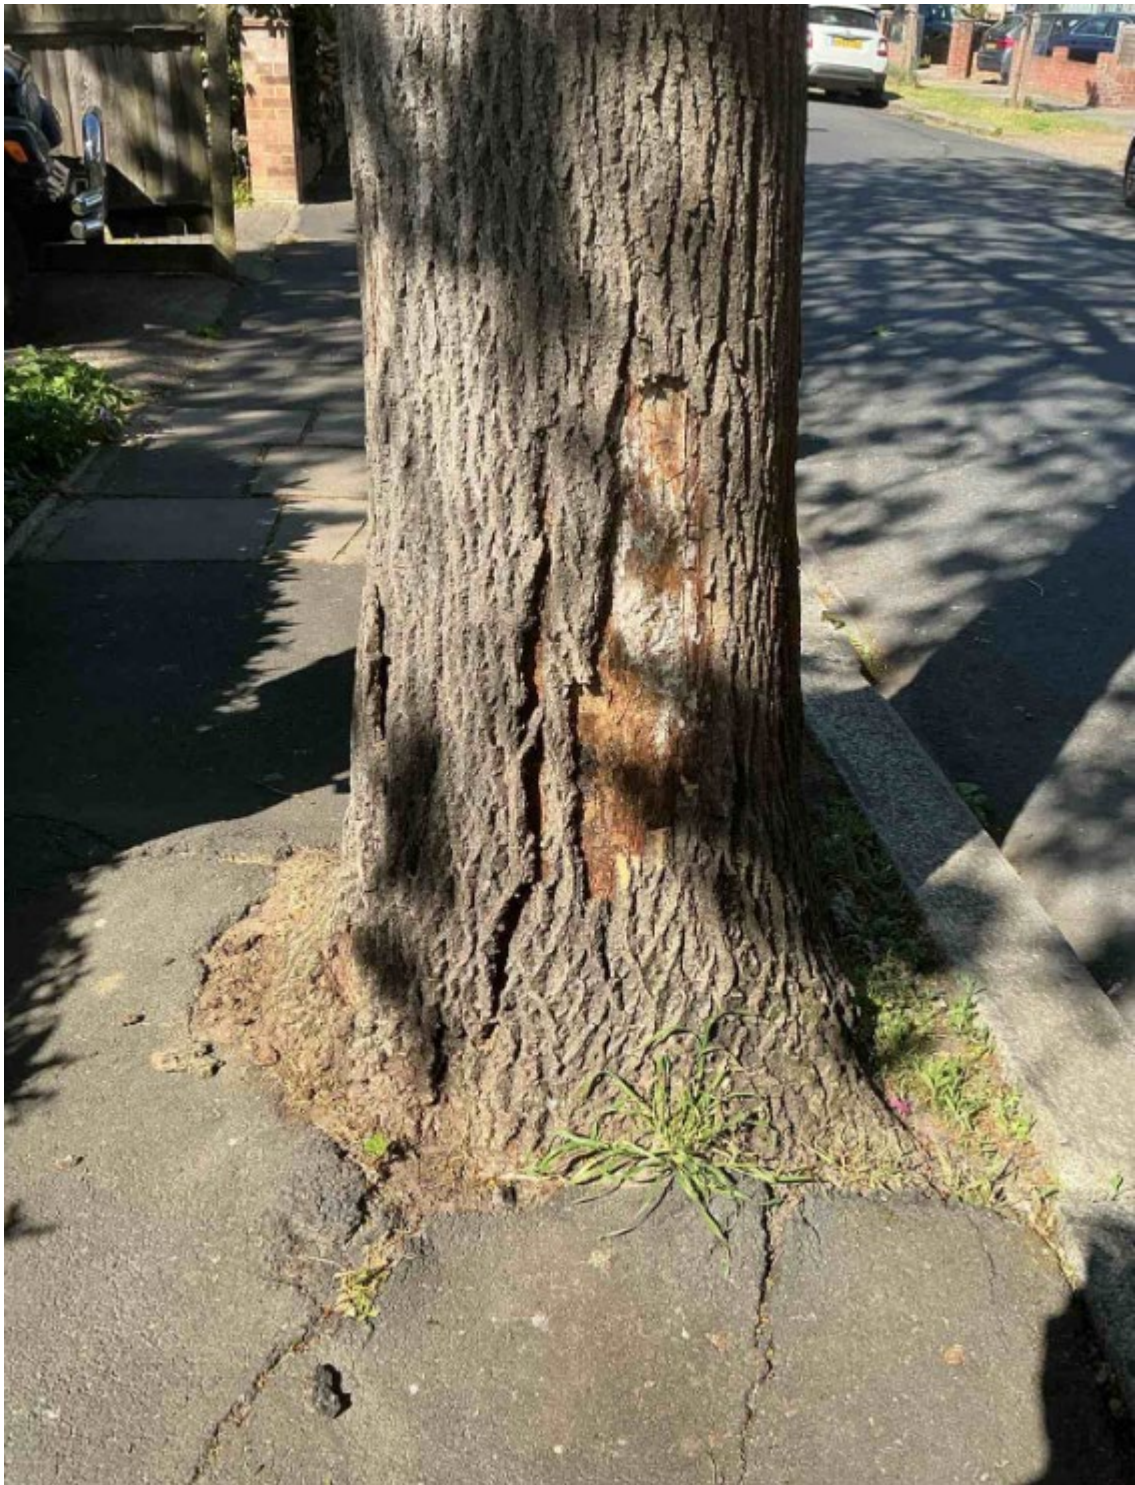
| Inspection findings/reason for exemption | This tree has cracked, peeling bark indicating necrosis and dysfunction of the trees vascular system which correlates with over 50% of the crown being dead. Removal is required to prevent natural failure, manage risk, and facilitate replanting |

***Image shows bark delamination on lower trunk.***

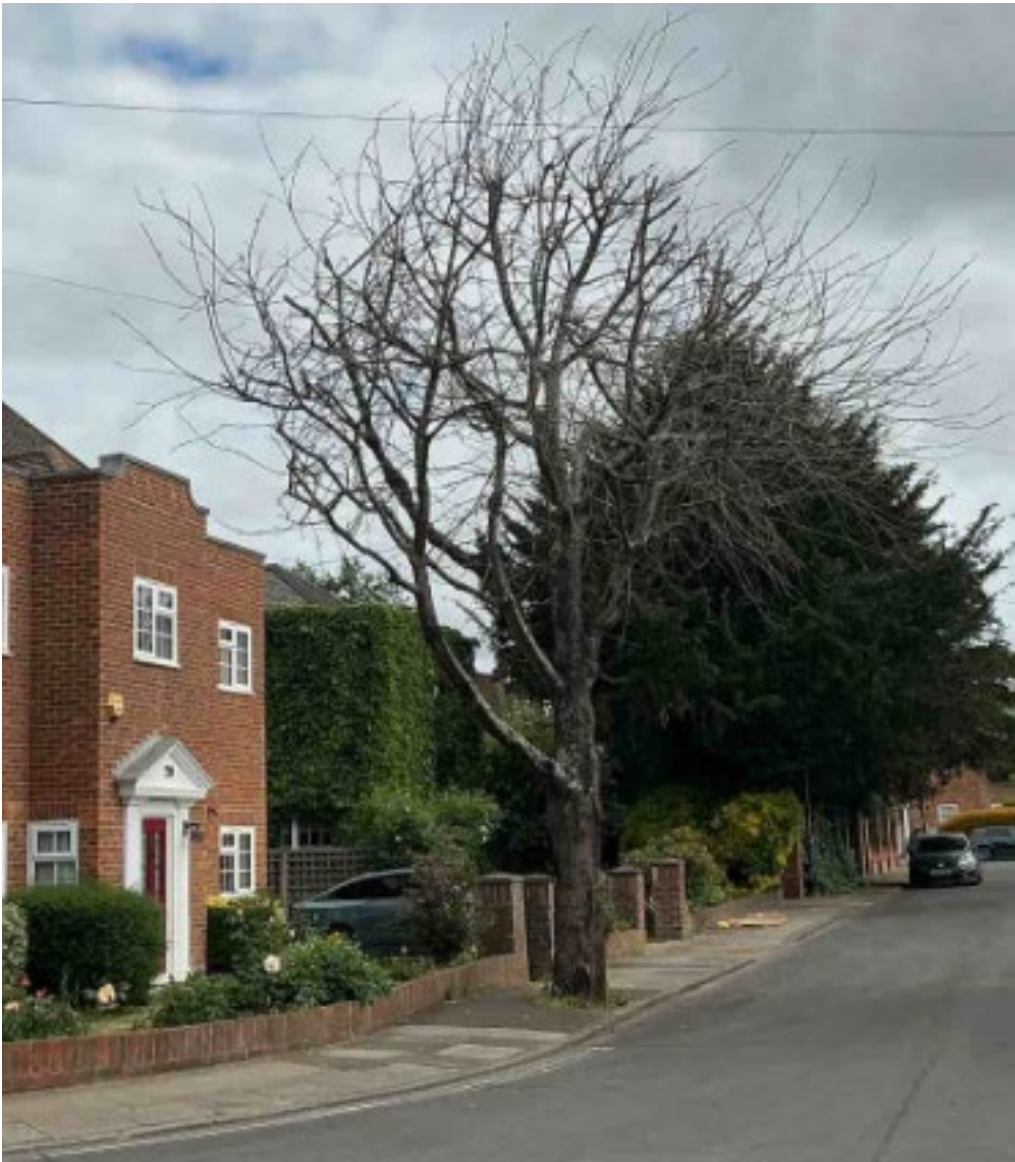
| Inspection findings/reason for exemption | This tree is dead; removal is required to prevent natural failure, manage risk, and facilitate replanting |

Image shows dead tree in street scene.

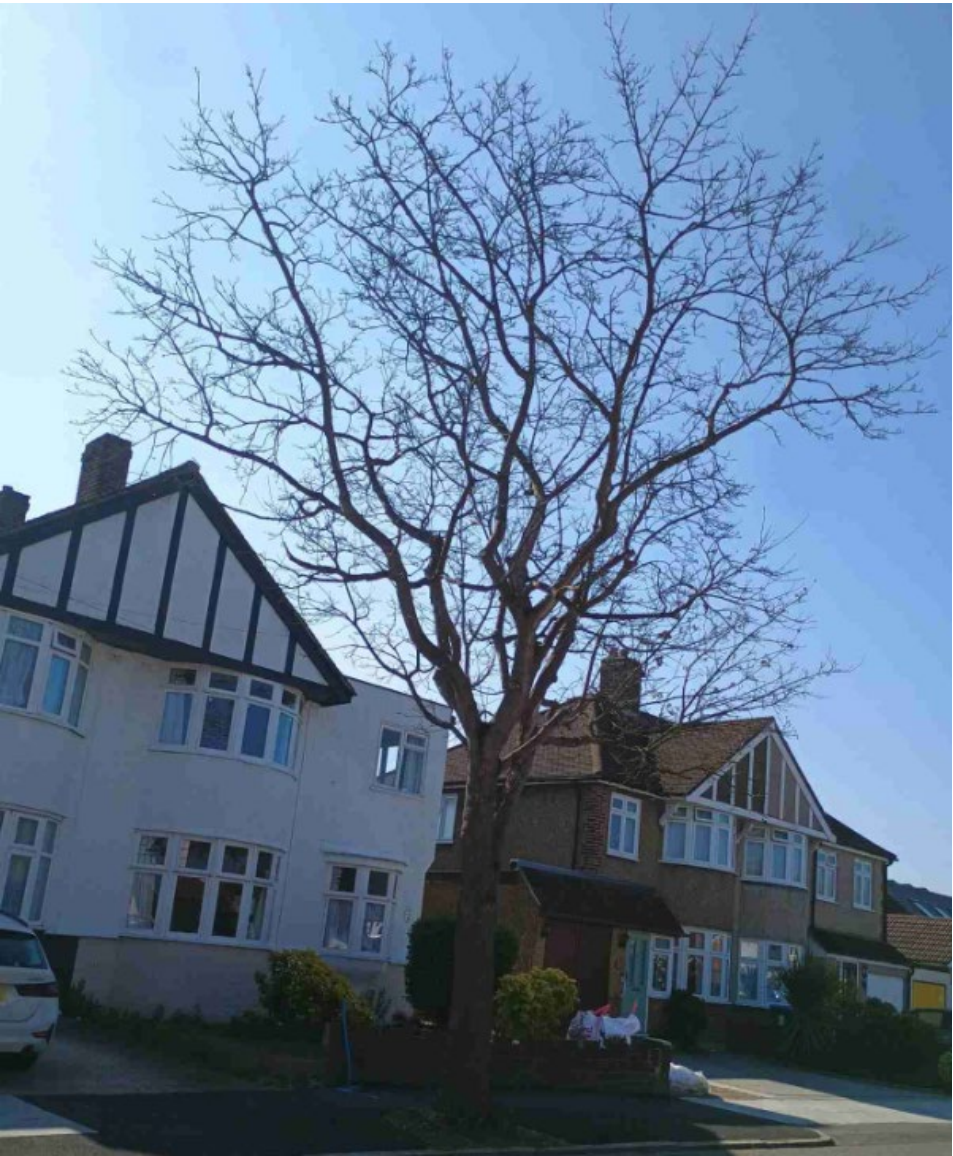
| Inspection findings/reason for exemption | This tree is dead; removal is required to prevent natural failure and facilitate replanting |

Image shows dead tree in street scene.

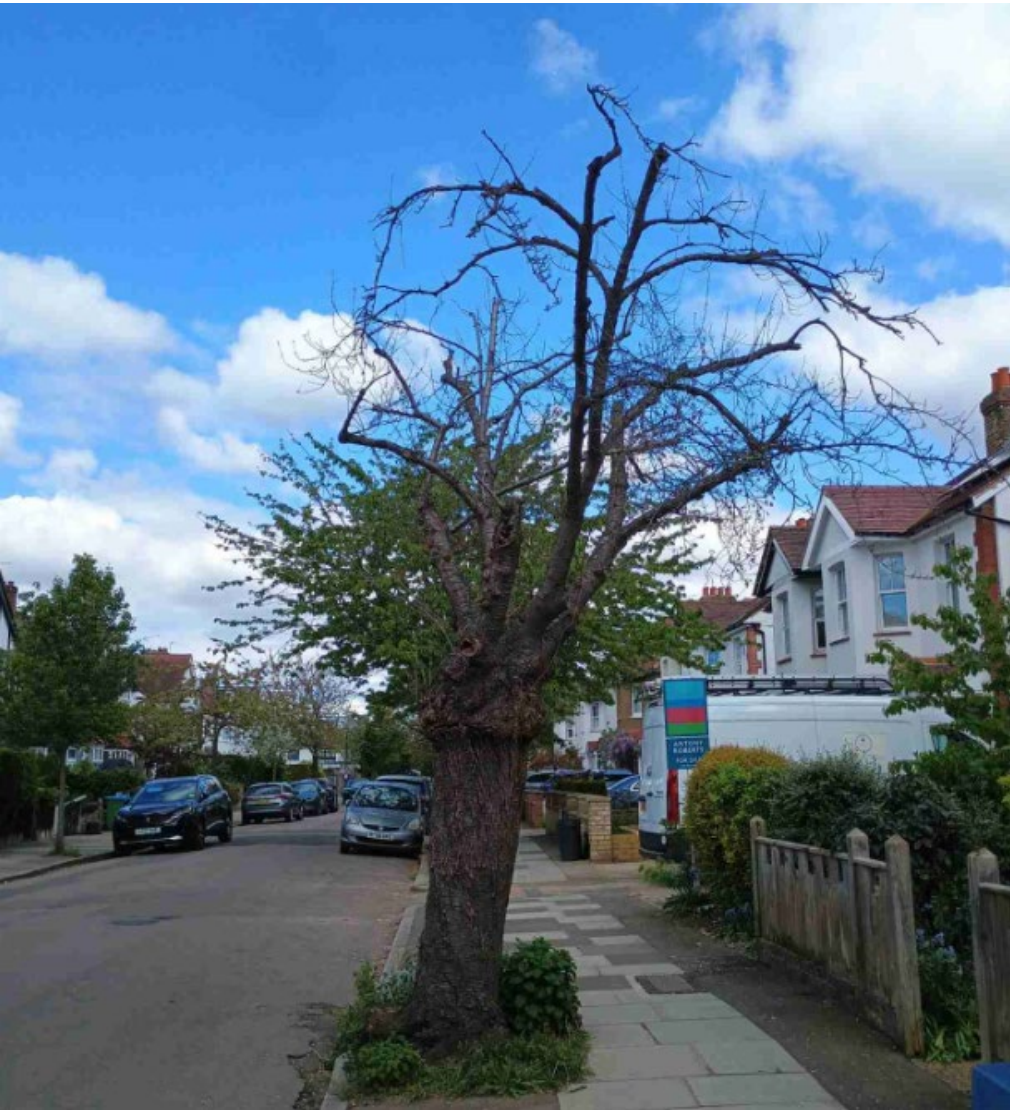
| Inspection findings/reason for exemption | This tree is dead; removal is required to prevent natural failure, manage risk, and facilitate replanting |

Image shows dead tree in street scene.

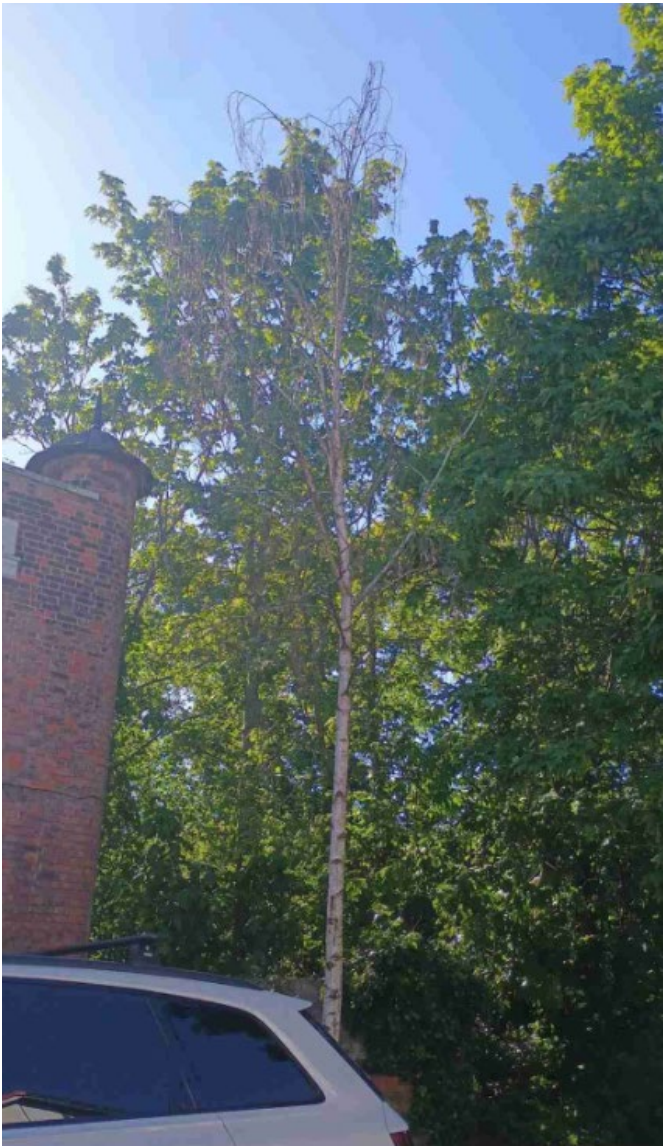
| Inspection findings/reason for exemption | This tree is dead; removal is required to prevent natural failure, manage risk, and facilitate replanting |

Image shows dead tree in street scene.

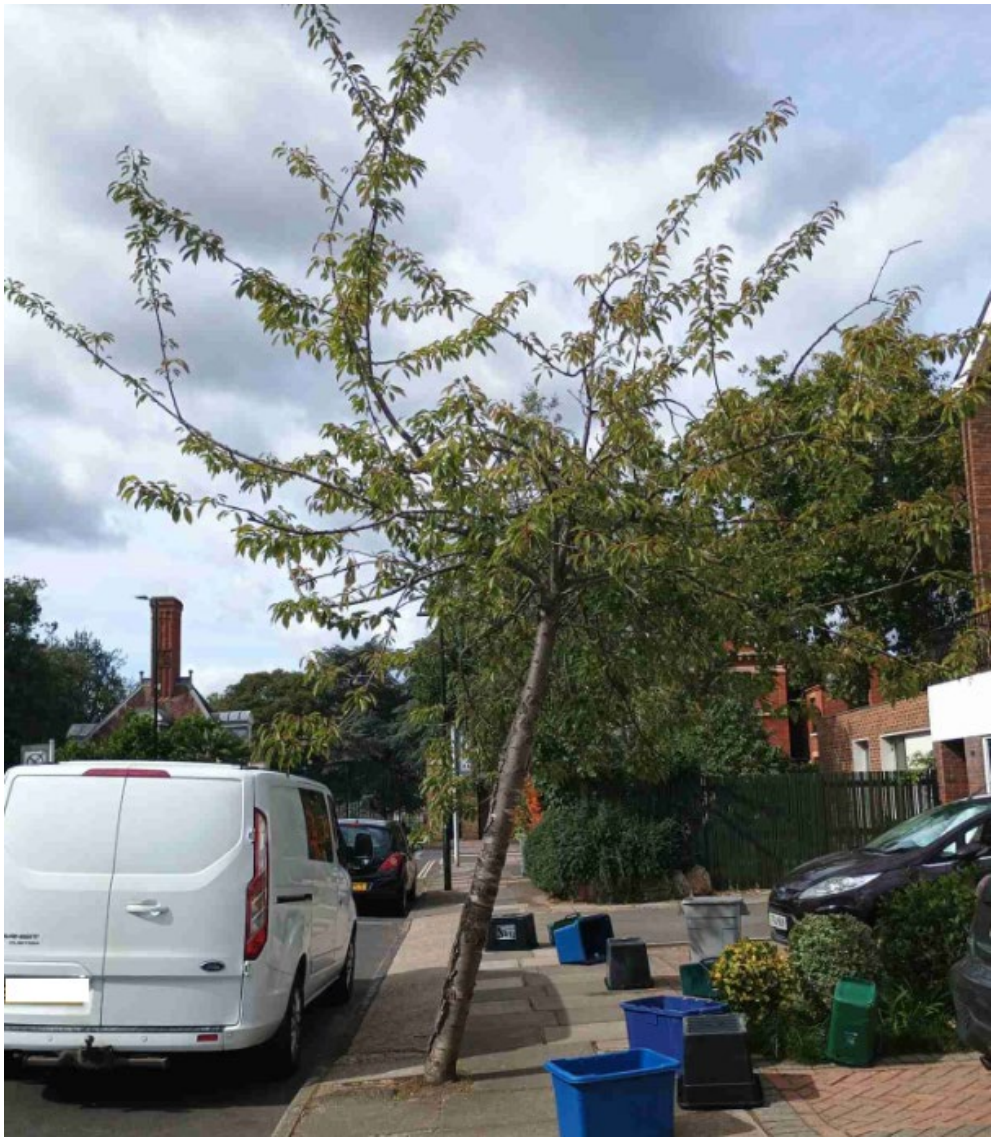
| Inspection findings/reason for exemption | This tree is leaning across the footway to an unacceptable degree and causing an unreasonable obstruction. Removal is required to manage the unacceptable risk of pedestrian injury and facilitate replanting |

Image shows leaning tree in street scene.

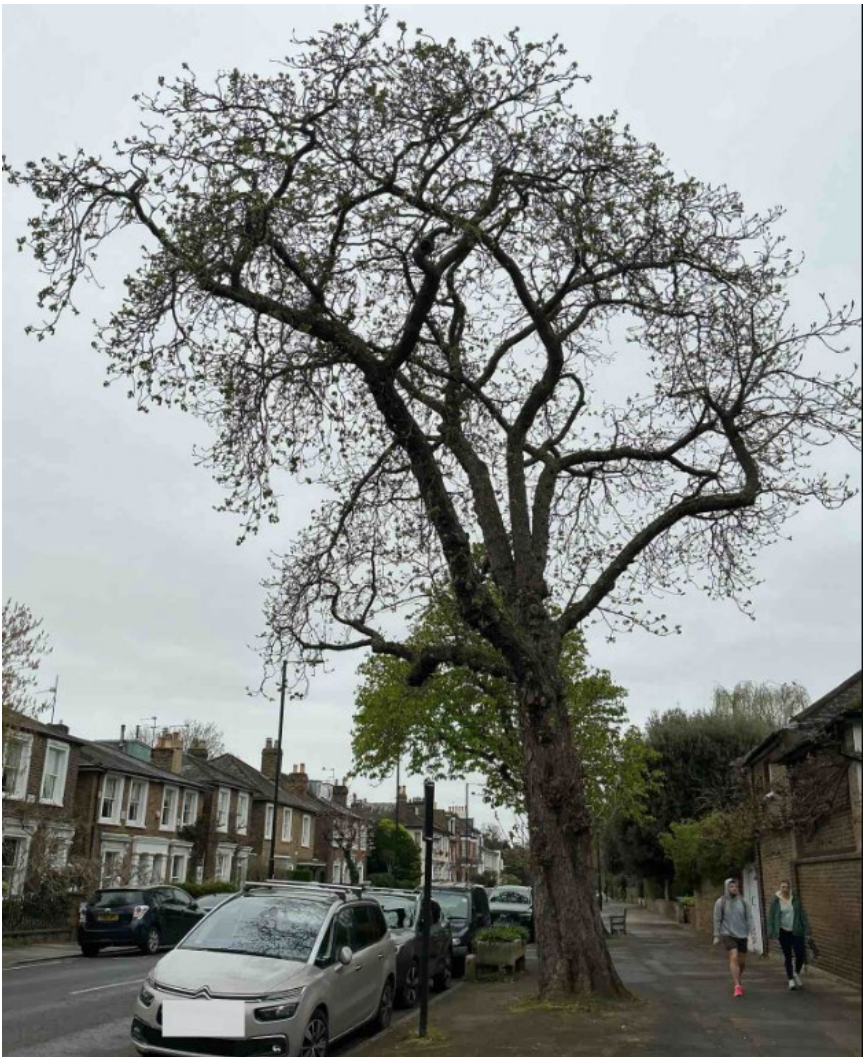
Image shows tree in street scene.

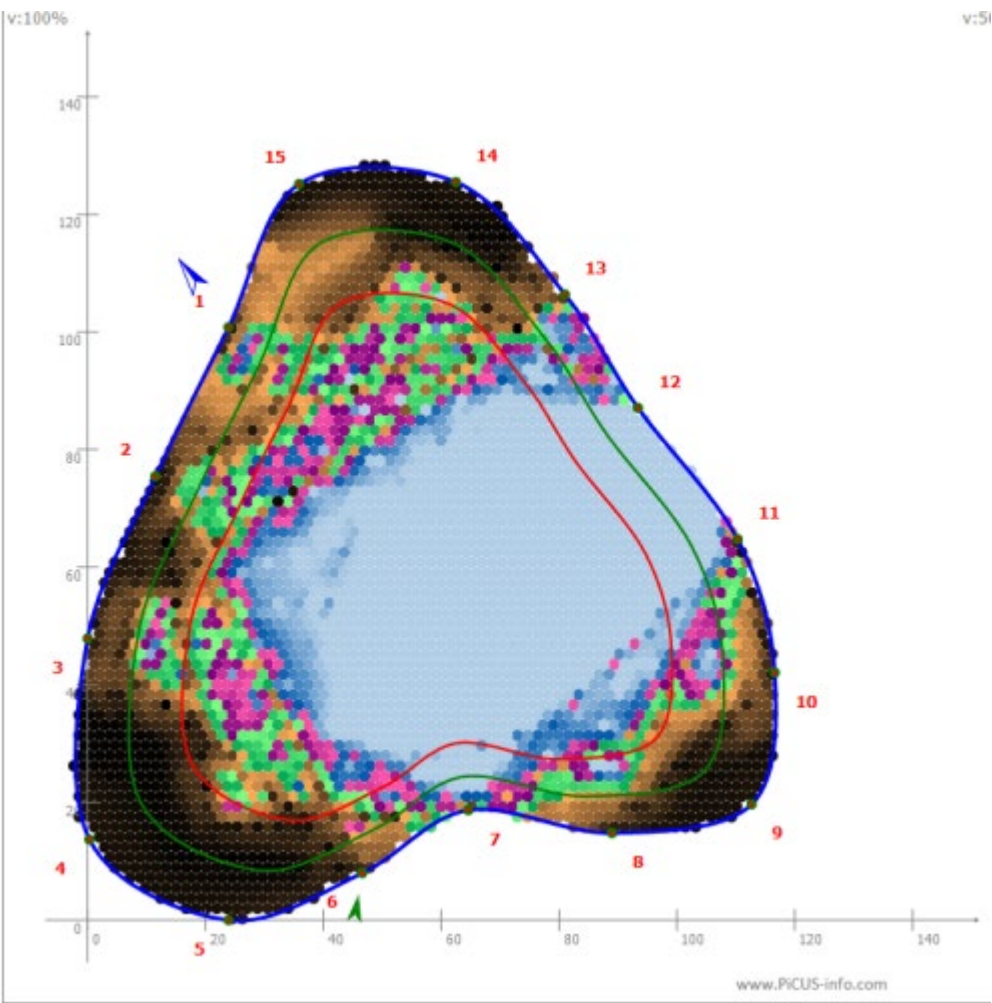
| Inspection findings/reason for exemption | A detailed investigation was conducted on the trunk of this tree using sonic tomography. The results of the detailed inspection identify significant decay, as shown in the light-coloured areas in the image of the cross-section of the stem below, spreading to the sound wood shown as darker-coloured areas. Removal is required to prevent natural failure and facilitate replanting |

**Image shows results from decay detection investigation at the base of the tree – green, blue and purple indicate decayed wood**

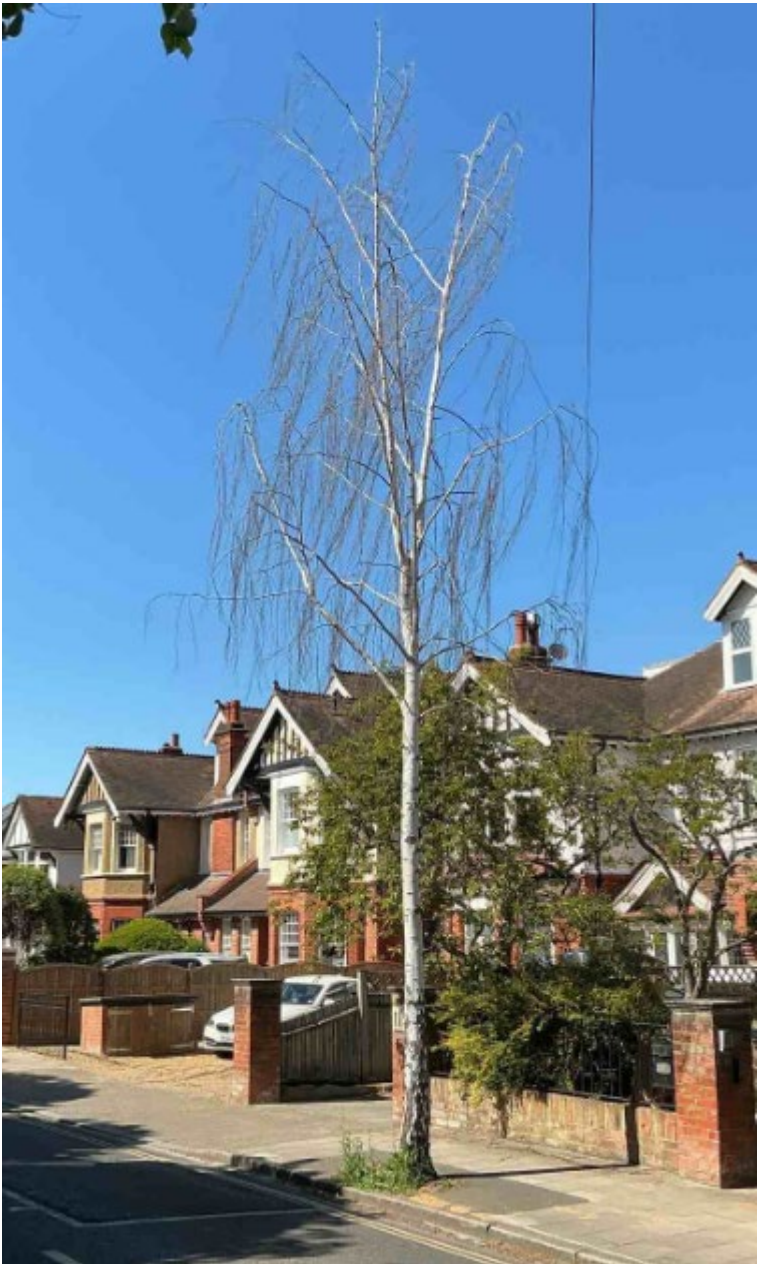
| Inspection findings/reason for exemption | This tree is dead; removal is required to prevent natural failure and facilitate replanting |

Image shows dead tree in street scene.

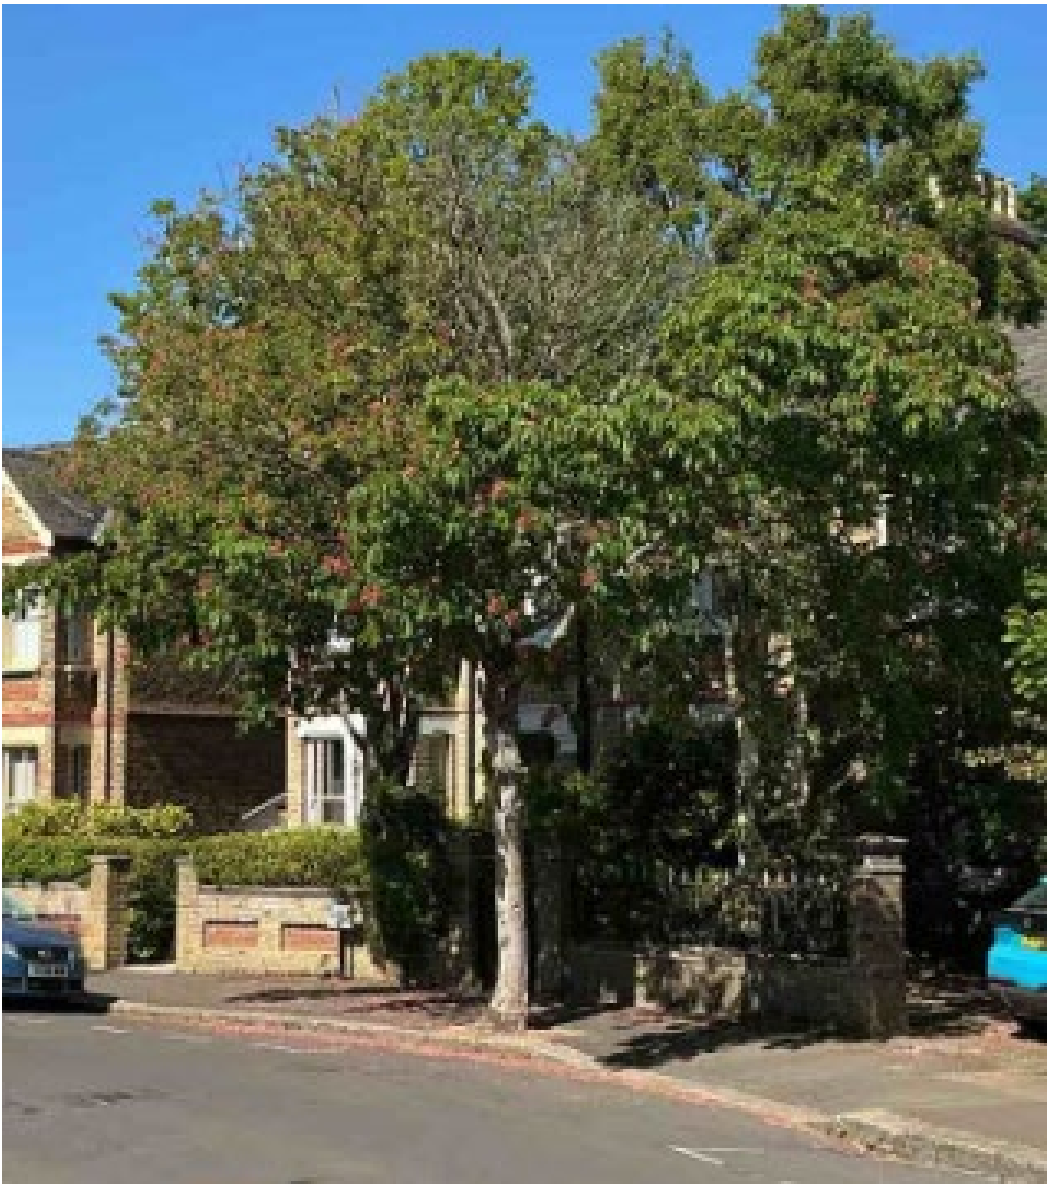
| Inspection findings/reason for exemption | This tree is moribund with over 50% of the crown being dead; removal is required to prevent natural failure and facilitate replanting |

Image shows moribund tree in street scene

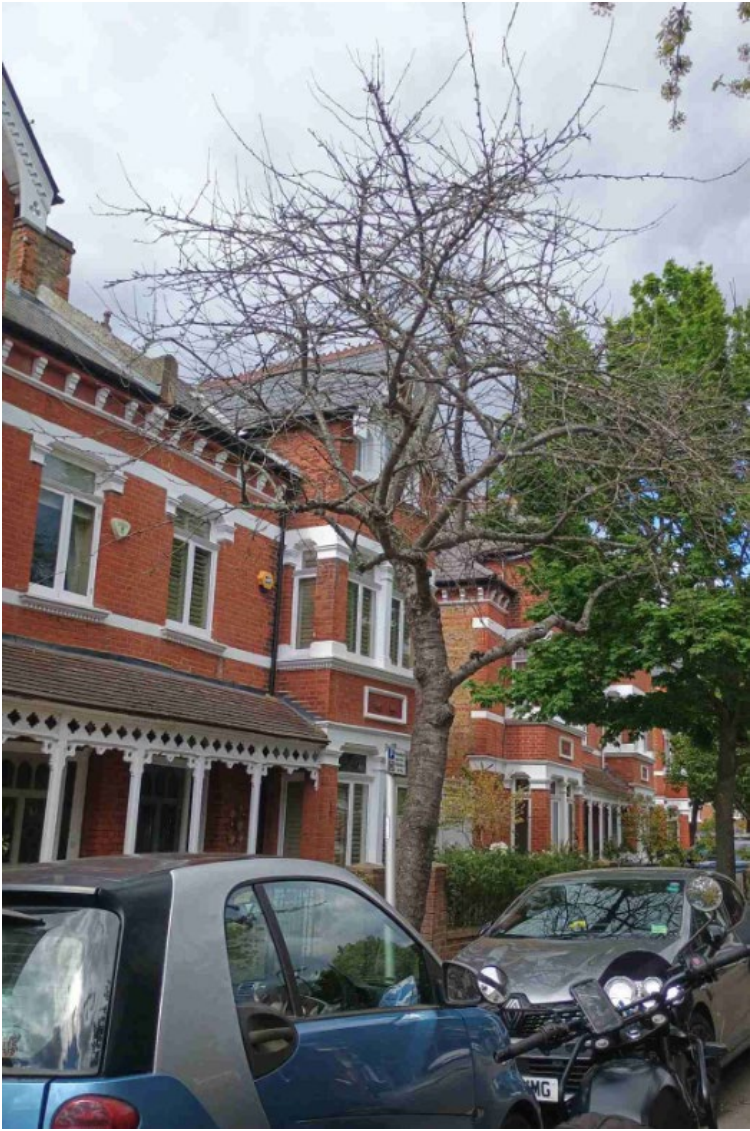
| Inspection findings/reason for exemption | This tree is dead; removal is required to prevent natural failure, manage risk, and facilitate replanting |

Image shows dead tree in street scene.

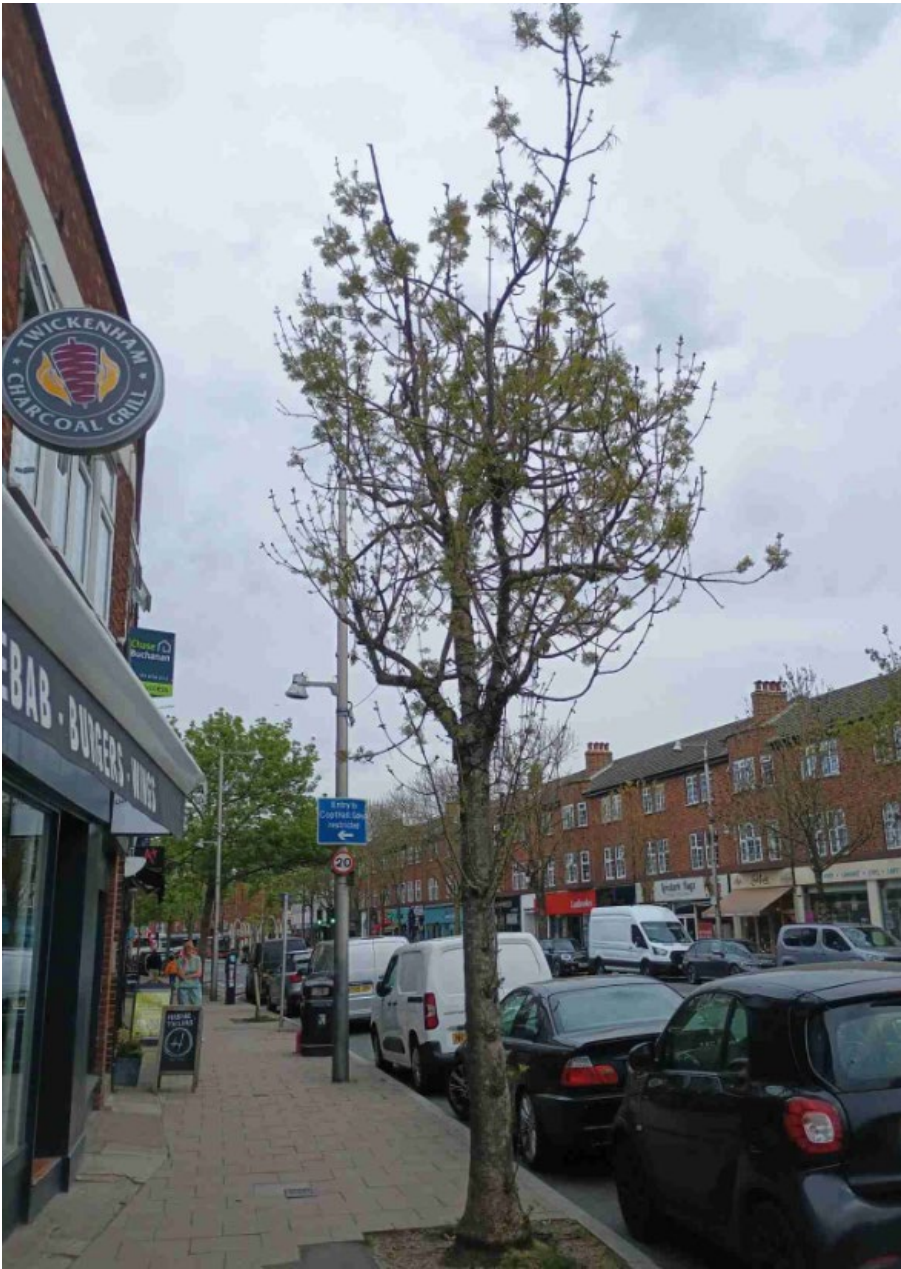
| Inspection findings/reason for exemption | This tree is moribund; removal is required to prevent natural failure, manage risk, and facilitate replanting |

Image shows moribund tree in street scene.

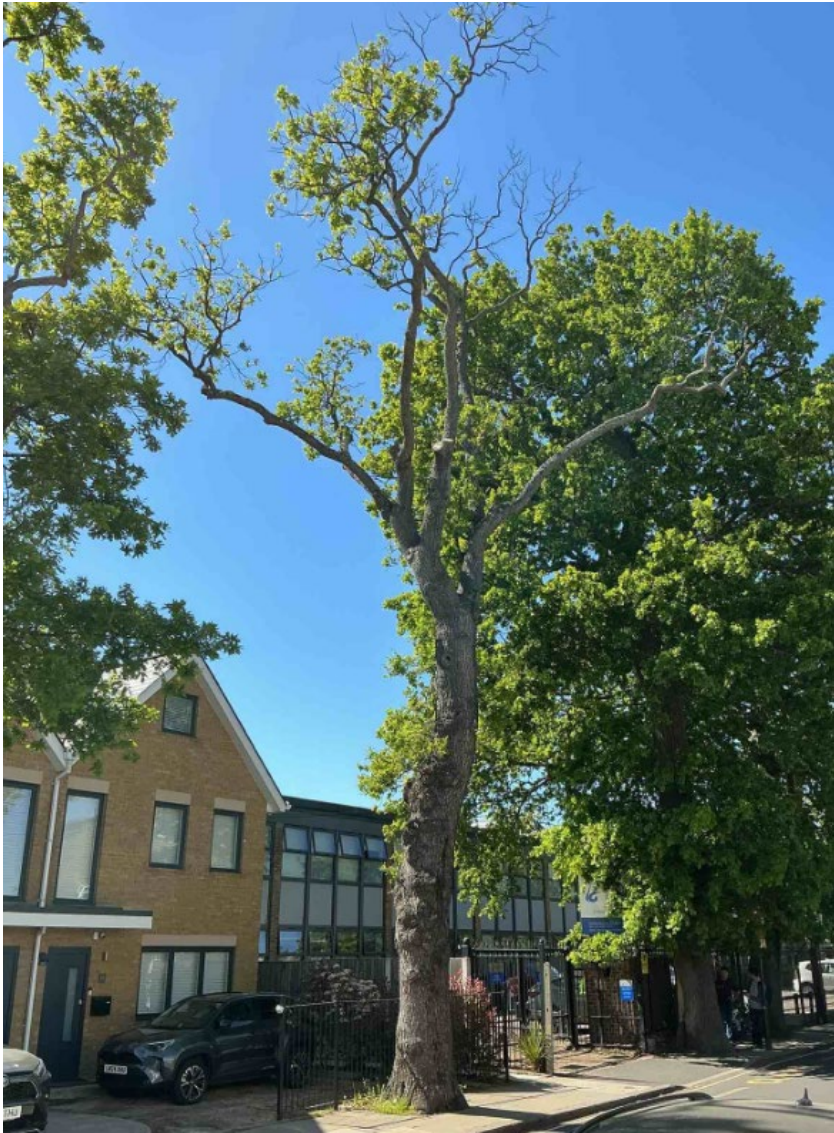
| Inspection findings/reason for exemption | This tree is moribund; removal is required to prevent natural failure, manage risk, and facilitate replanting |

Image shows moribund tree in street scene.

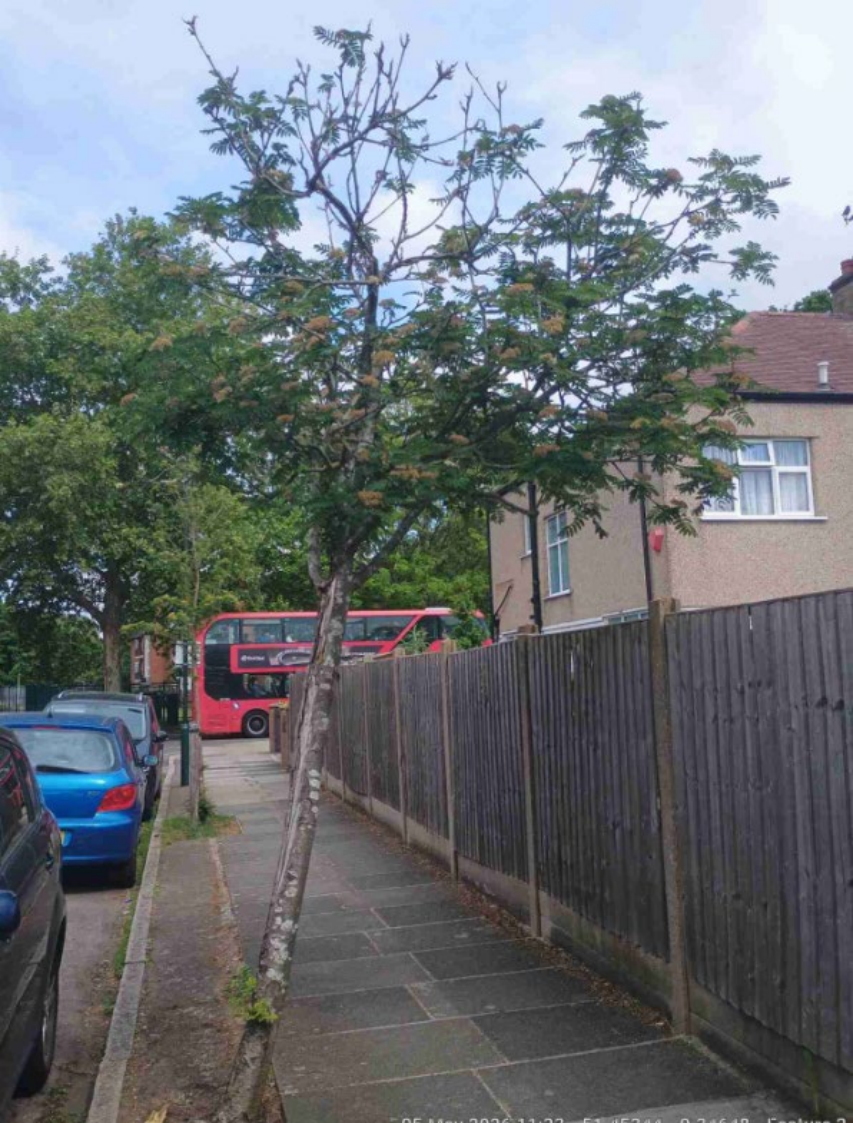
| Inspection findings/reason for exemption | This tree is leaning across the footway to an unacceptable degree and causing an unreasonable obstruction. Removal is required to manage the unacceptable risk and facilitate replanting |

Image shows tree in street scene.
