# July 2026 – Highways Reactive Tree Works Programme

A survey of trees in ward of Kew has been undertaken; this is being conducted by specialist arboricultural officers as part of the scheduled 4 yearly detailed inspection regime that has been devised for all Council highway and parks trees.

Dated 24.7.2026

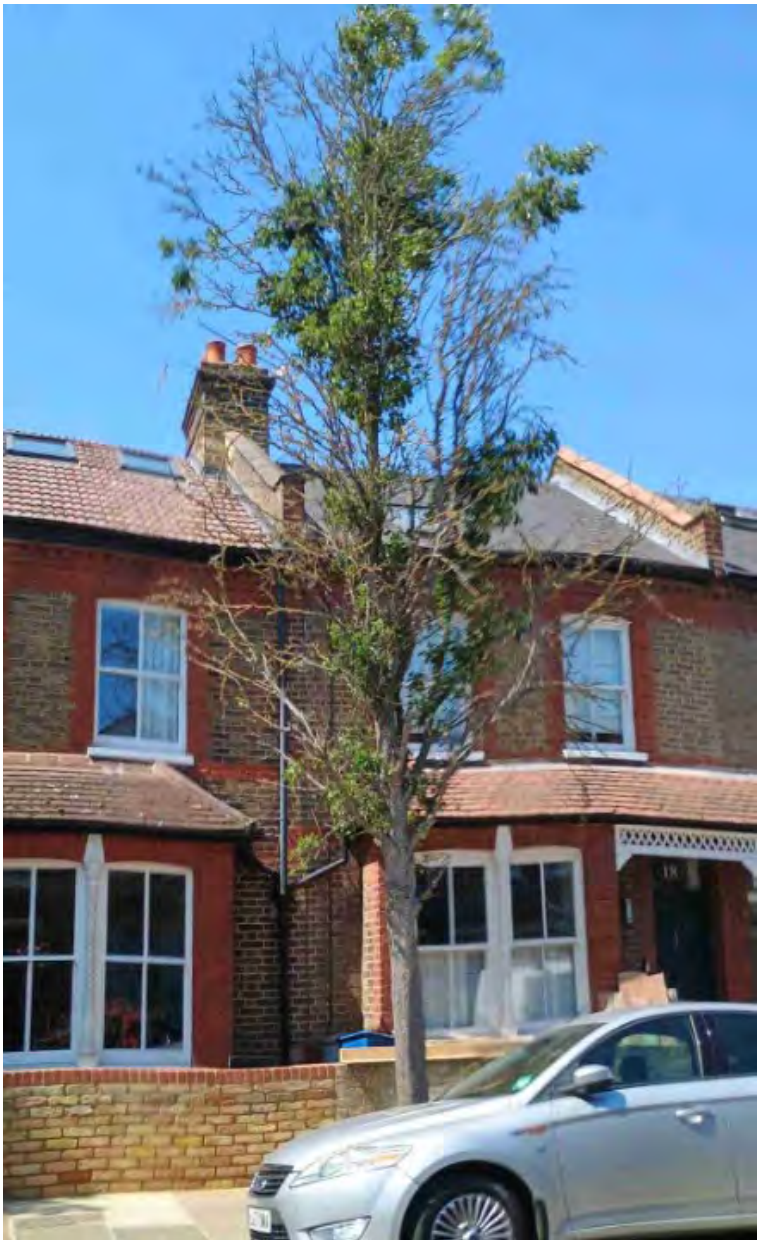
| Inspection findings/reason for exemption | This tree is moribund; removal is required to prevent natural failure, manage risk and facilitate replanting. |

Image shows moribund tree in street scene

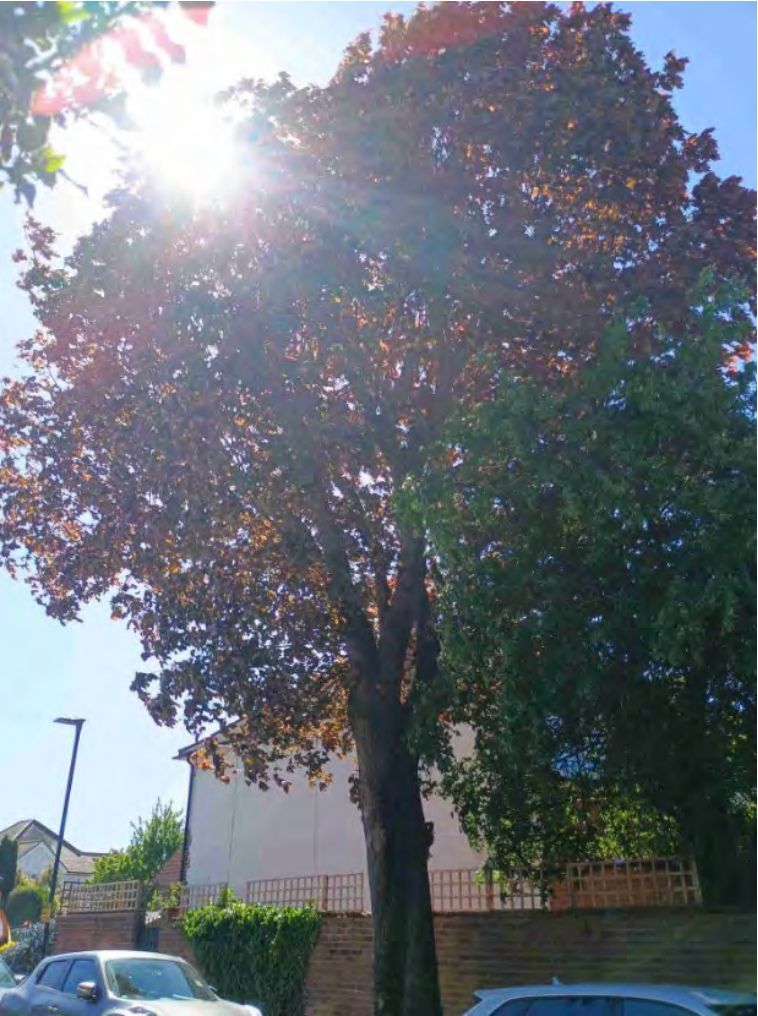
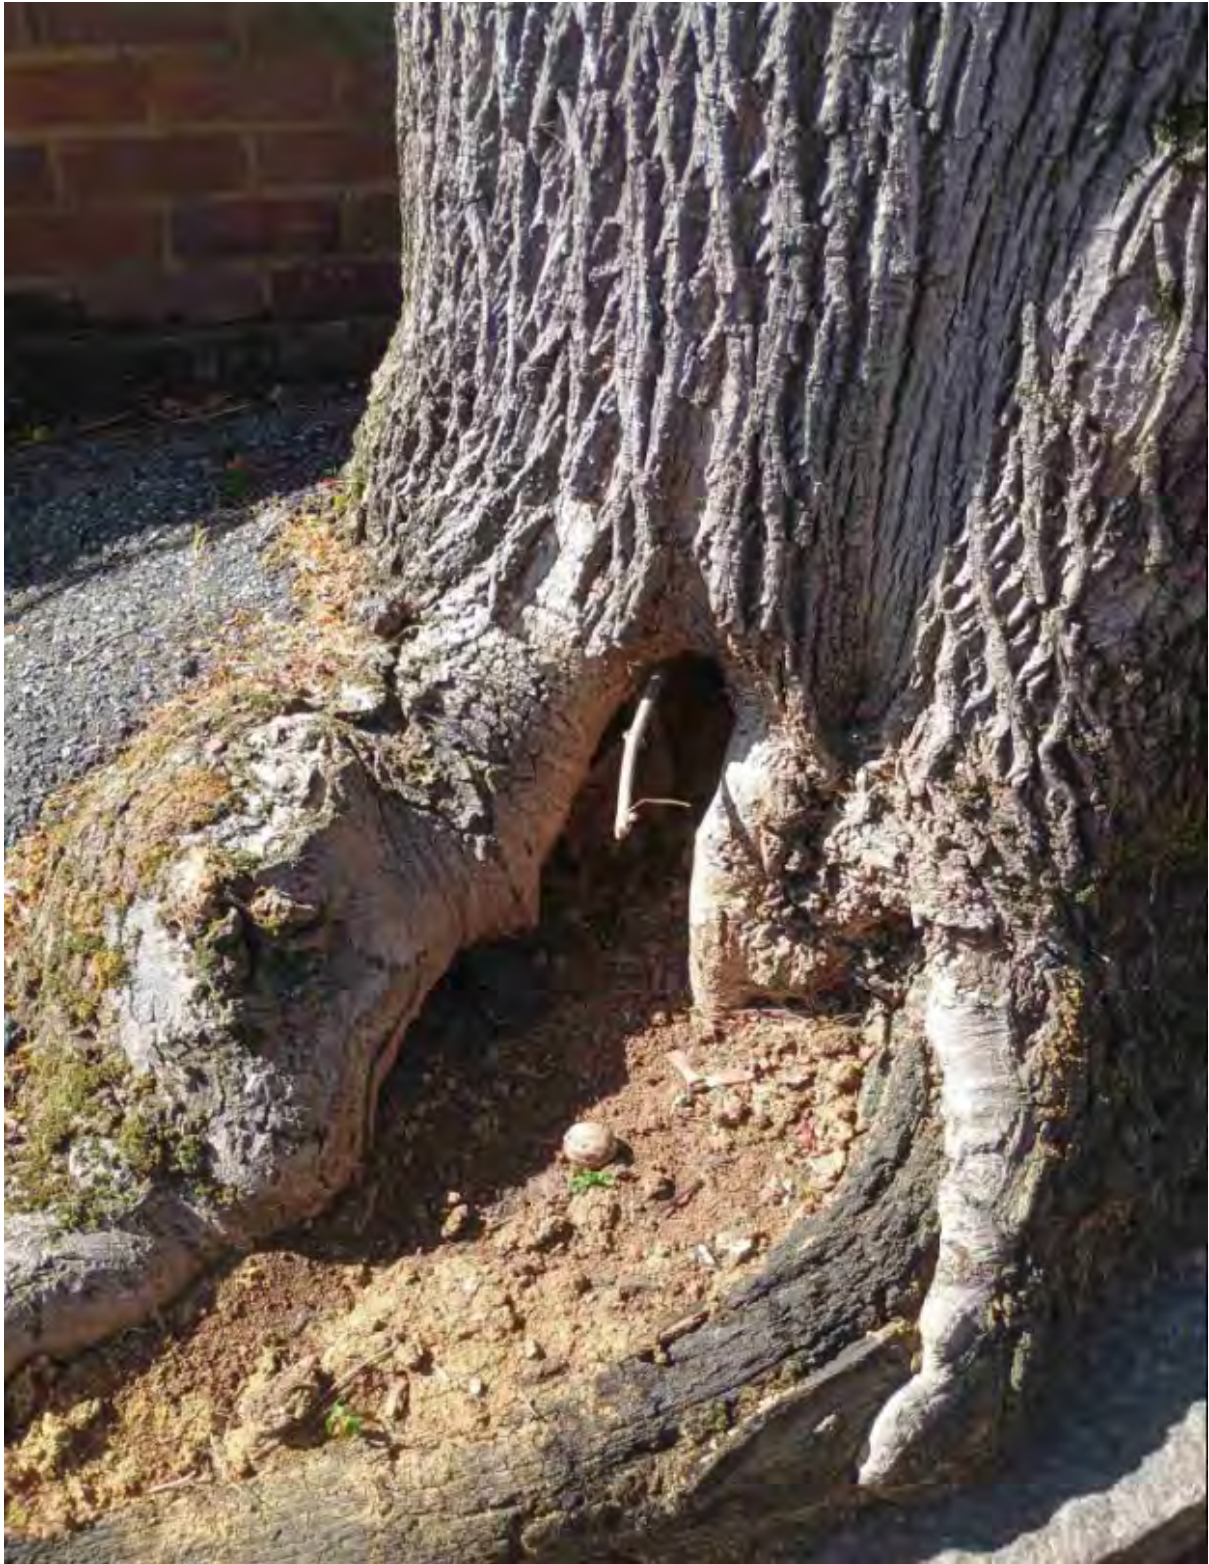
| Inspection findings/reason for exemption | Investigation with a probe and a resonance test with a sounding mallet has revealed an unacceptable amount of decay beyond the visible cavities at the base of the trunk. Removal is required to prevent natural failure, manage risk, and facilitate replanting. |

*Image shows cavity at base of trunk.*

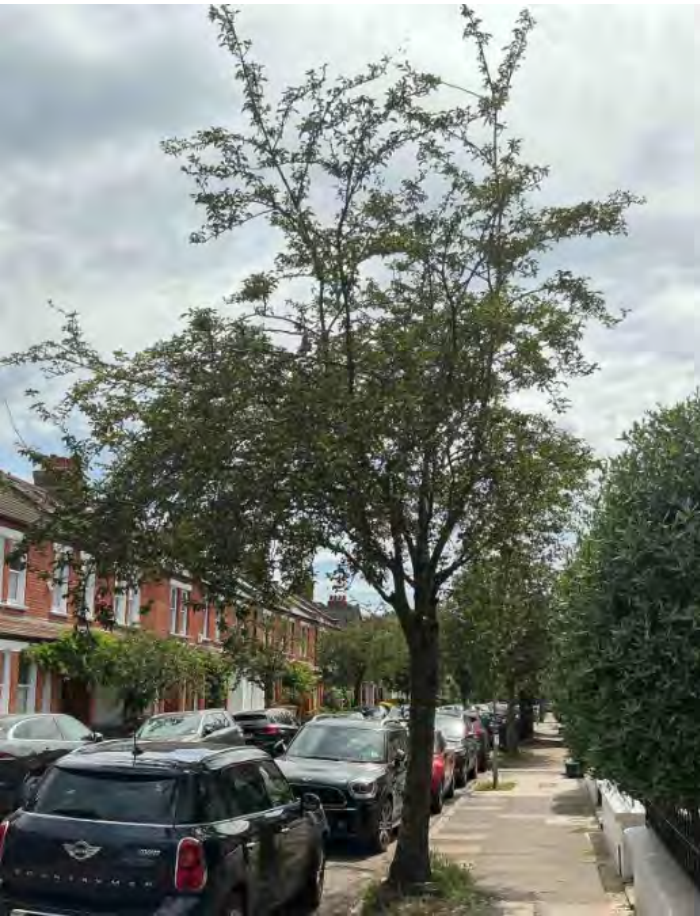
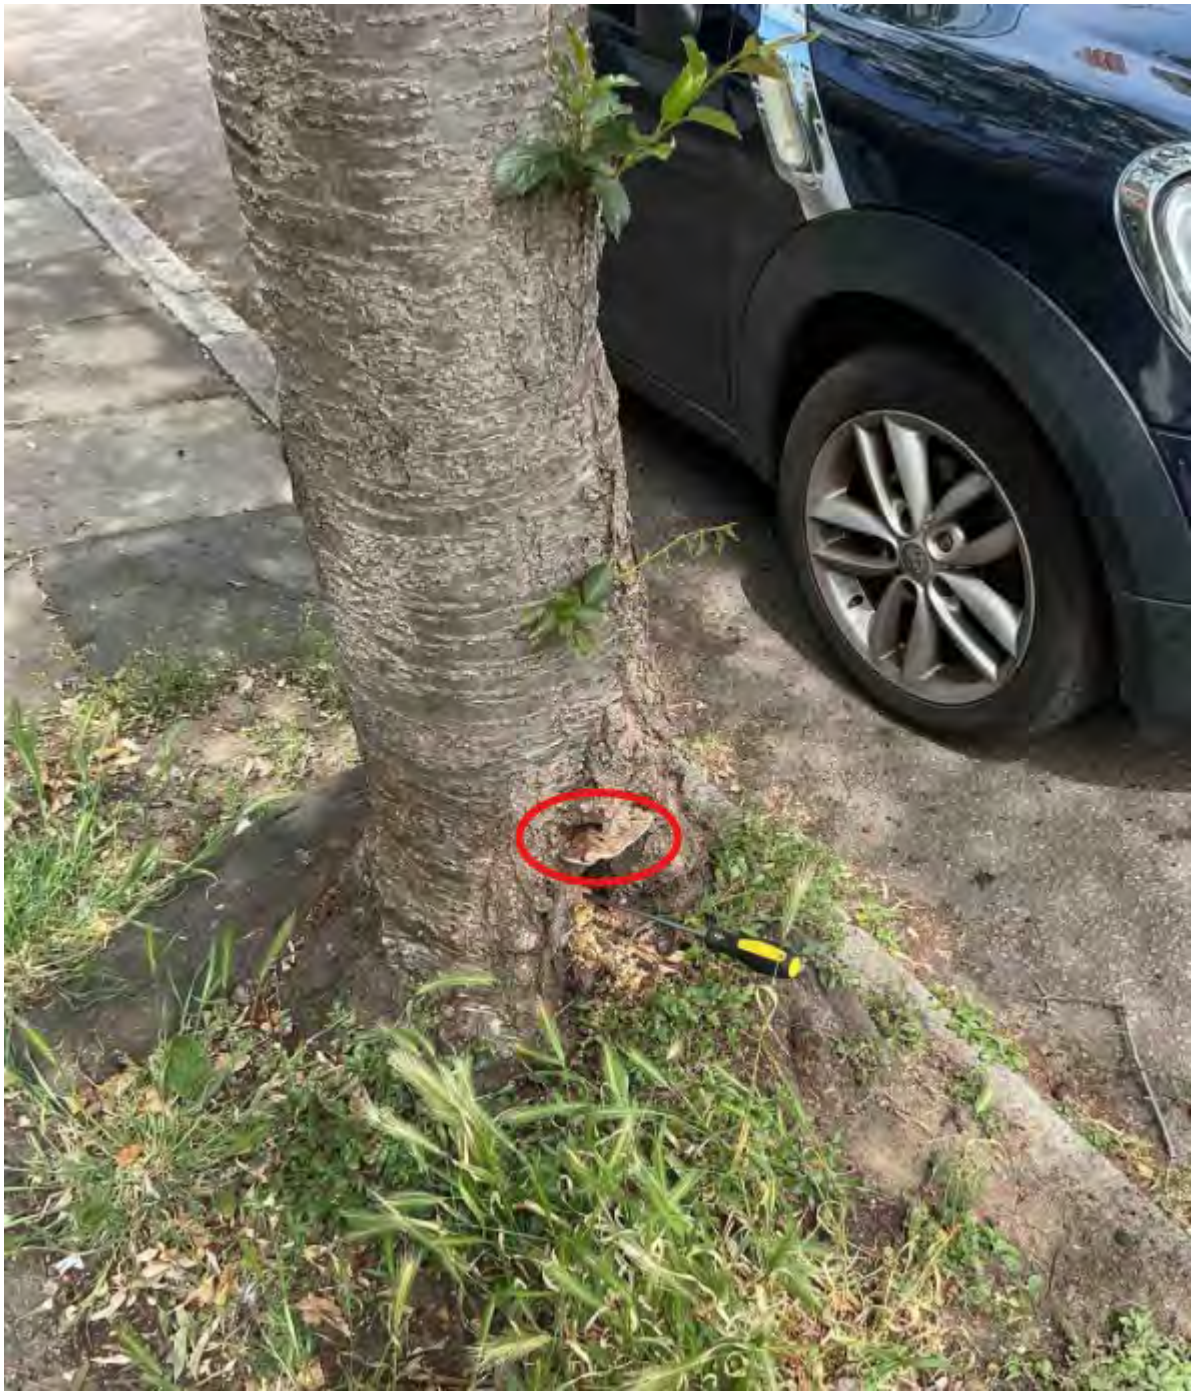
| Inspection findings/reason for exemption | A fungal fruiting body of the decay fungus <i>Ganoderma sp.</i> is present on the trunk. Colonisation by this fungus results in white rot affecting the stem and root system, which can lead to structural failure through fracture or windthrow. Investigation with a probe and a resonance test with a sounding hammer has revealed an unacceptable amount of decay beyond the visible cavities at the base of the trunk below the bracket. Removal of the tree is recommended to prevent natural failure, manage risk, and facilitate replanting. |

***Image shows tree with fungal fruiting body circled***

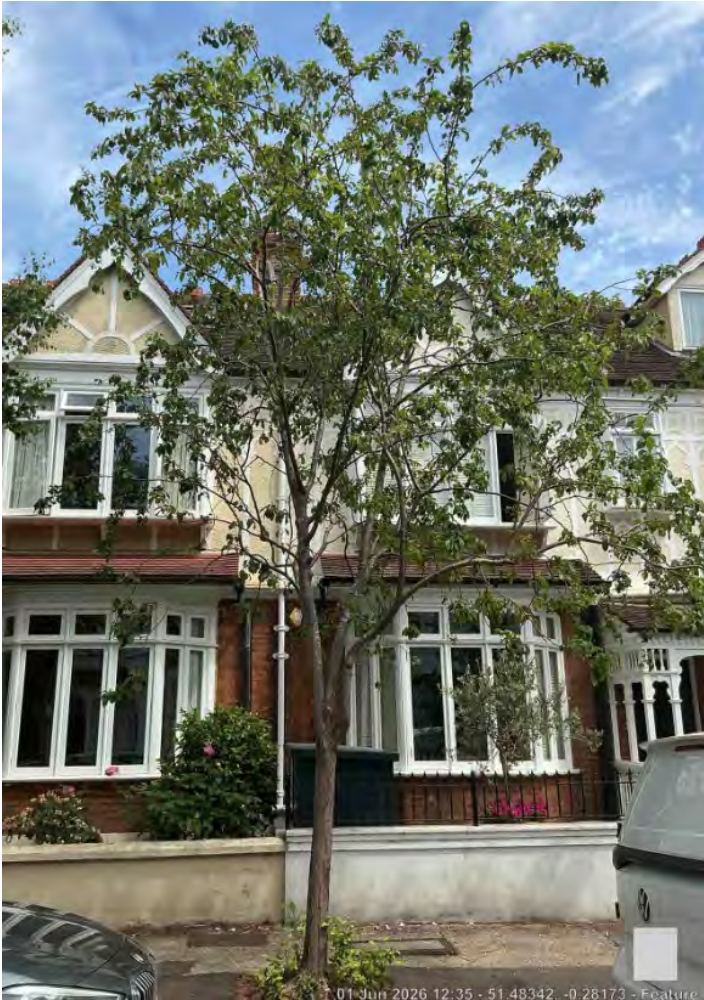
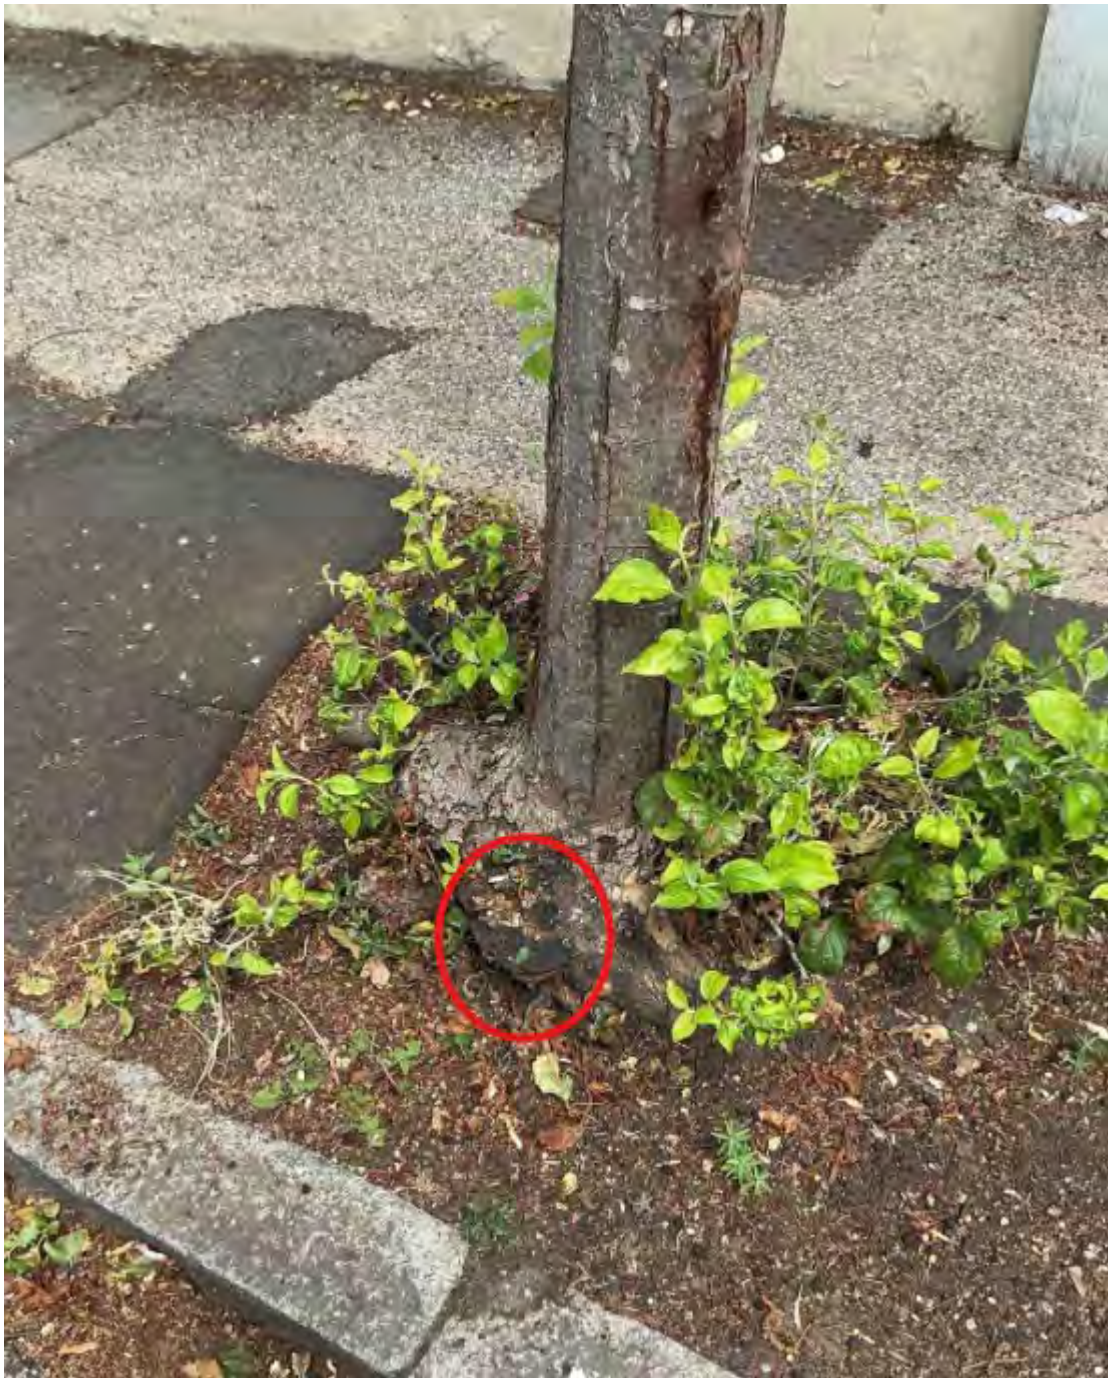
| Inspection findings/reason for exemption | A fungal fruiting body of the decay fungus <i>Ganoderma sp.</i> is present on the trunk. Colonisation by this fungus results in white rot affecting the stem and root system, which can lead to structural failure through fracture or windthrow. A resonance test with a sounding hammer has revealed an unacceptable amount of decay around the bracket. Removal of the tree is recommended to prevent natural failure, manage risk, and facilitate replanting. |

***Image shows tree wih fungal fruiting body circled***

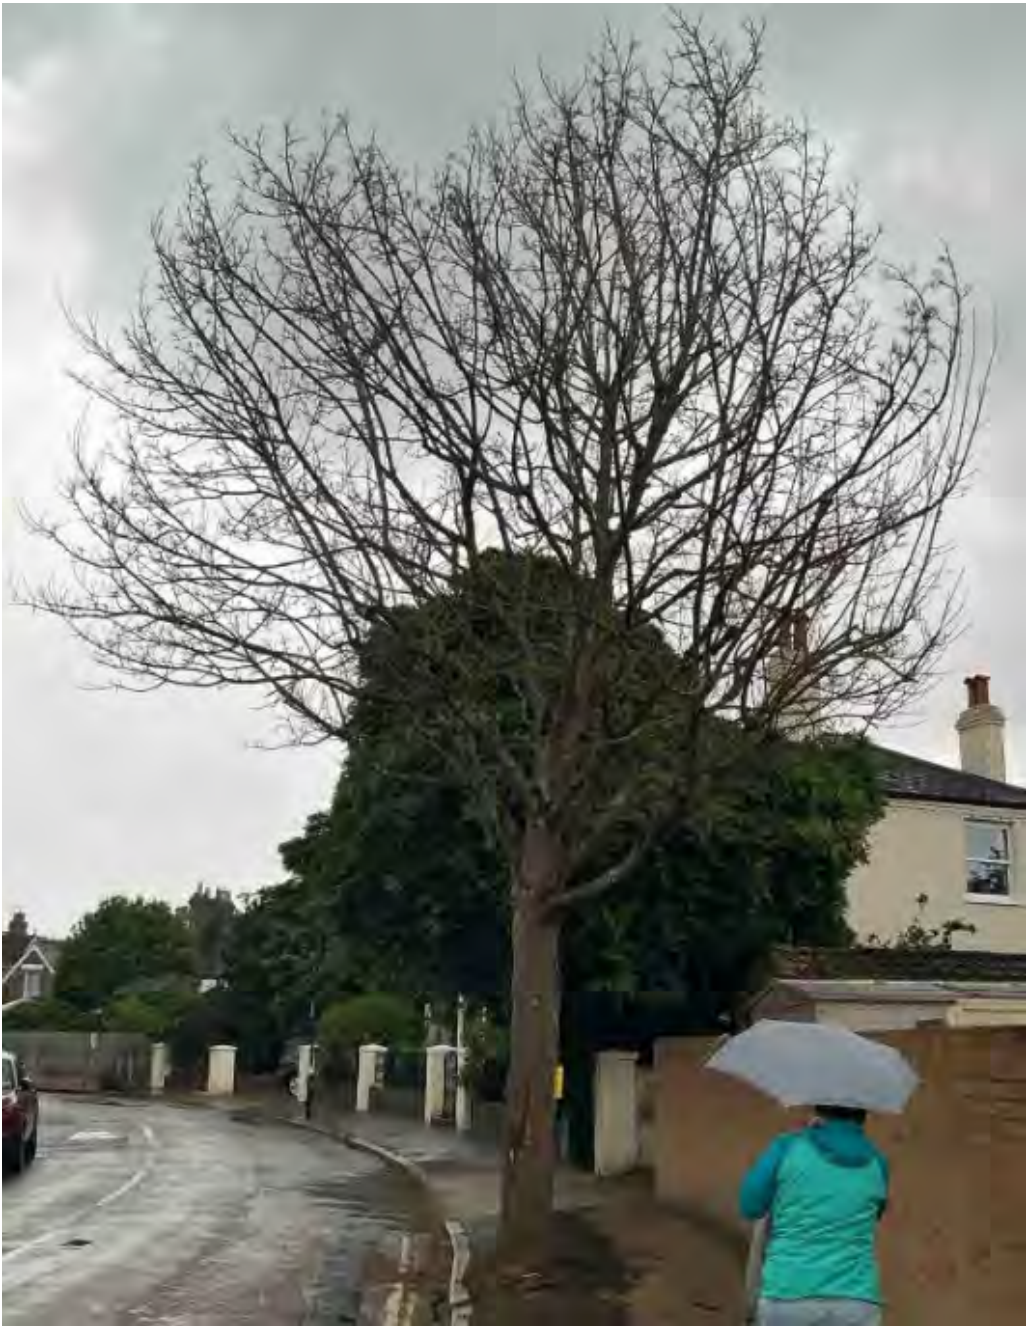
| Inspection findings/reason for exemption | This tree is dead; removal is required to prevent natural failure, manage risk, and facilitate replanting. |

Image shows dead tree in street scene.

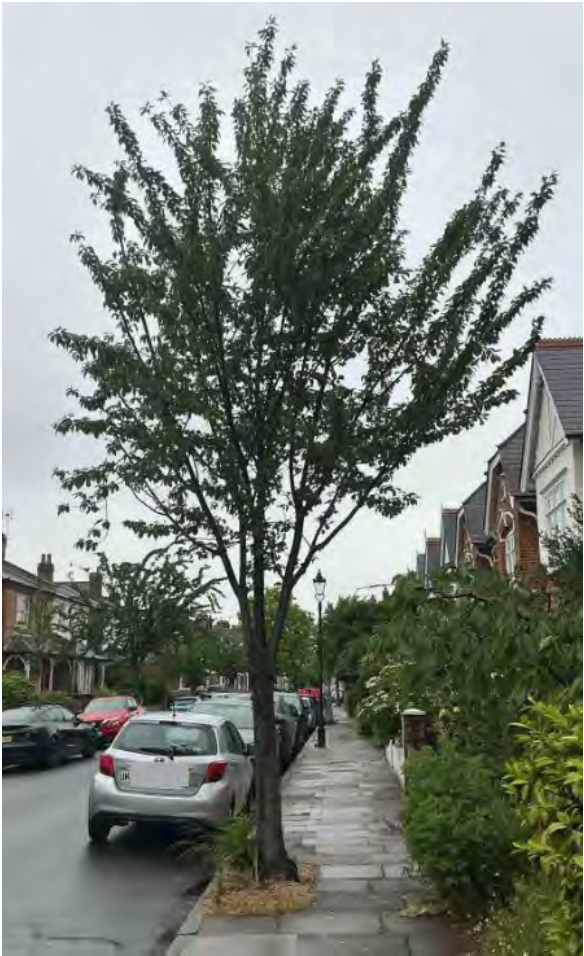
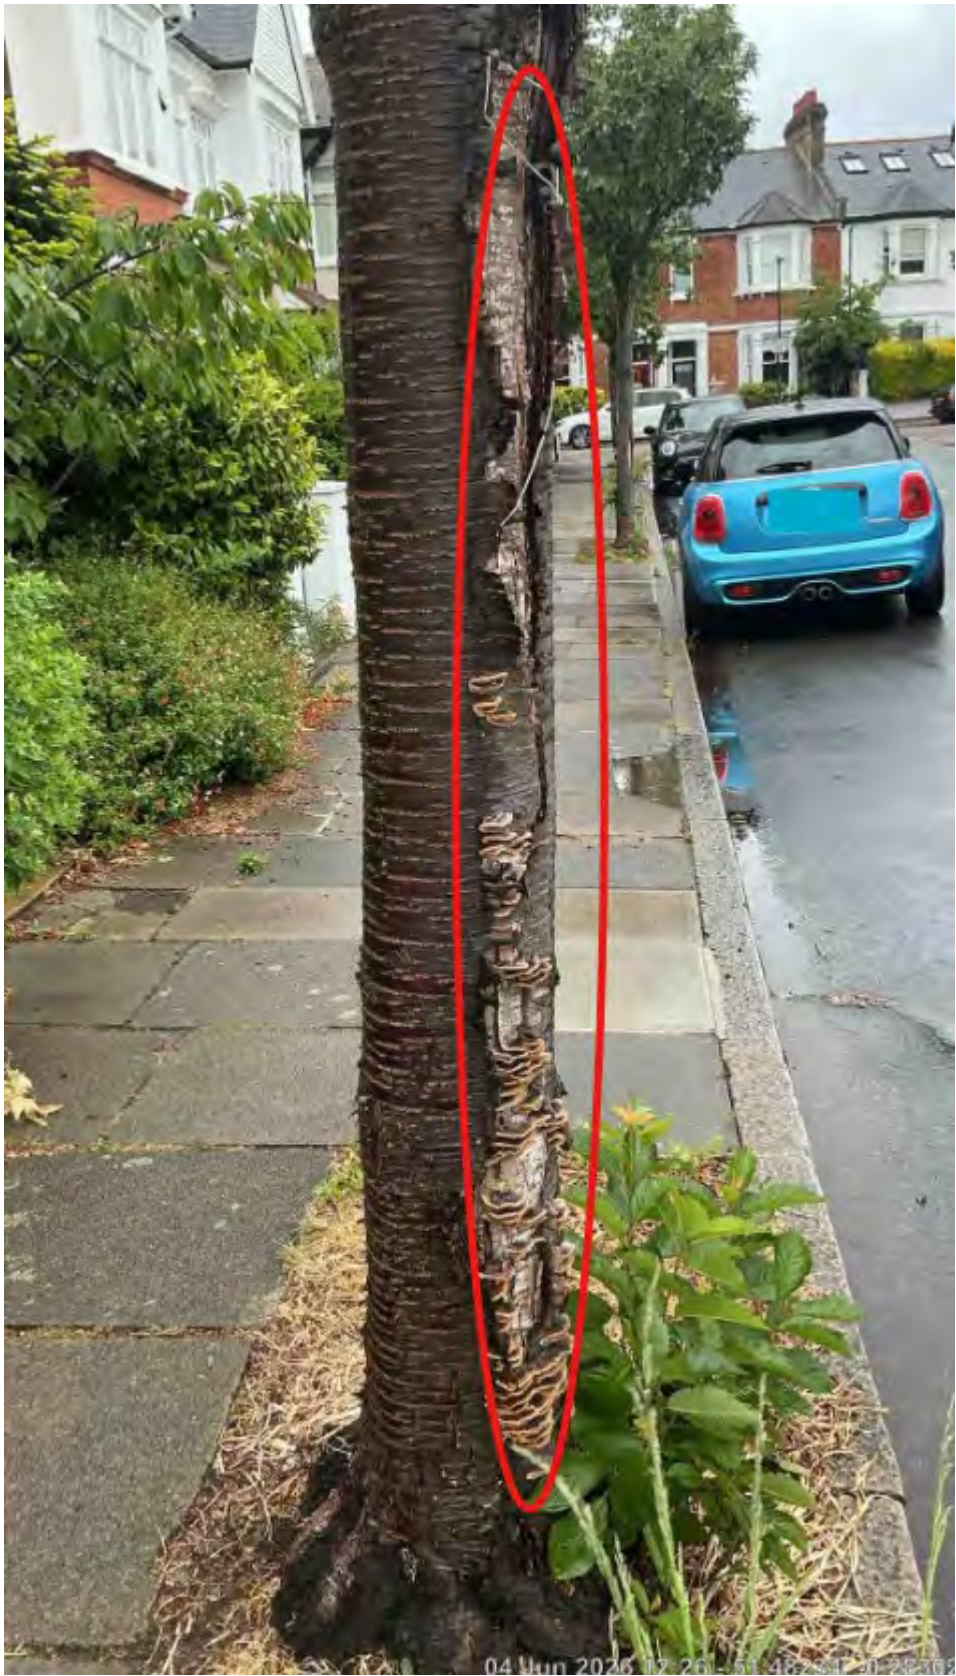
| Inspection findings/reason for exemption | Fruiting bodies of the decay fungus Turkey Tail ( <i>Trametes versicolor</i> ) are prolific on the trunk of this tree around bark damage. This fungus causes a selective white rot of the wood and when prolific is indicative of wider physiological dysfunction. Removal is required to prevent natural failure, manage risk, and facilitate replanting |

***Image shows bark damage with fruiting bodies circled.***

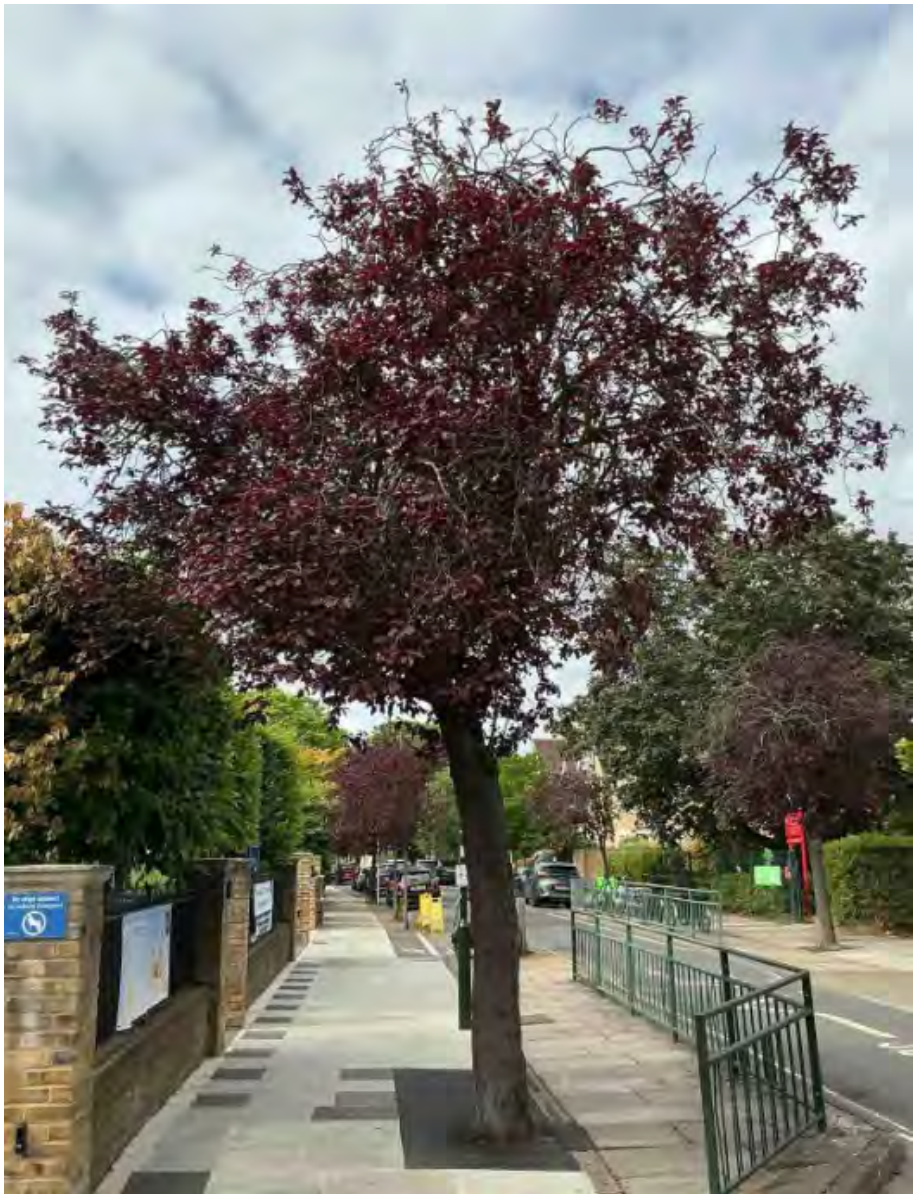
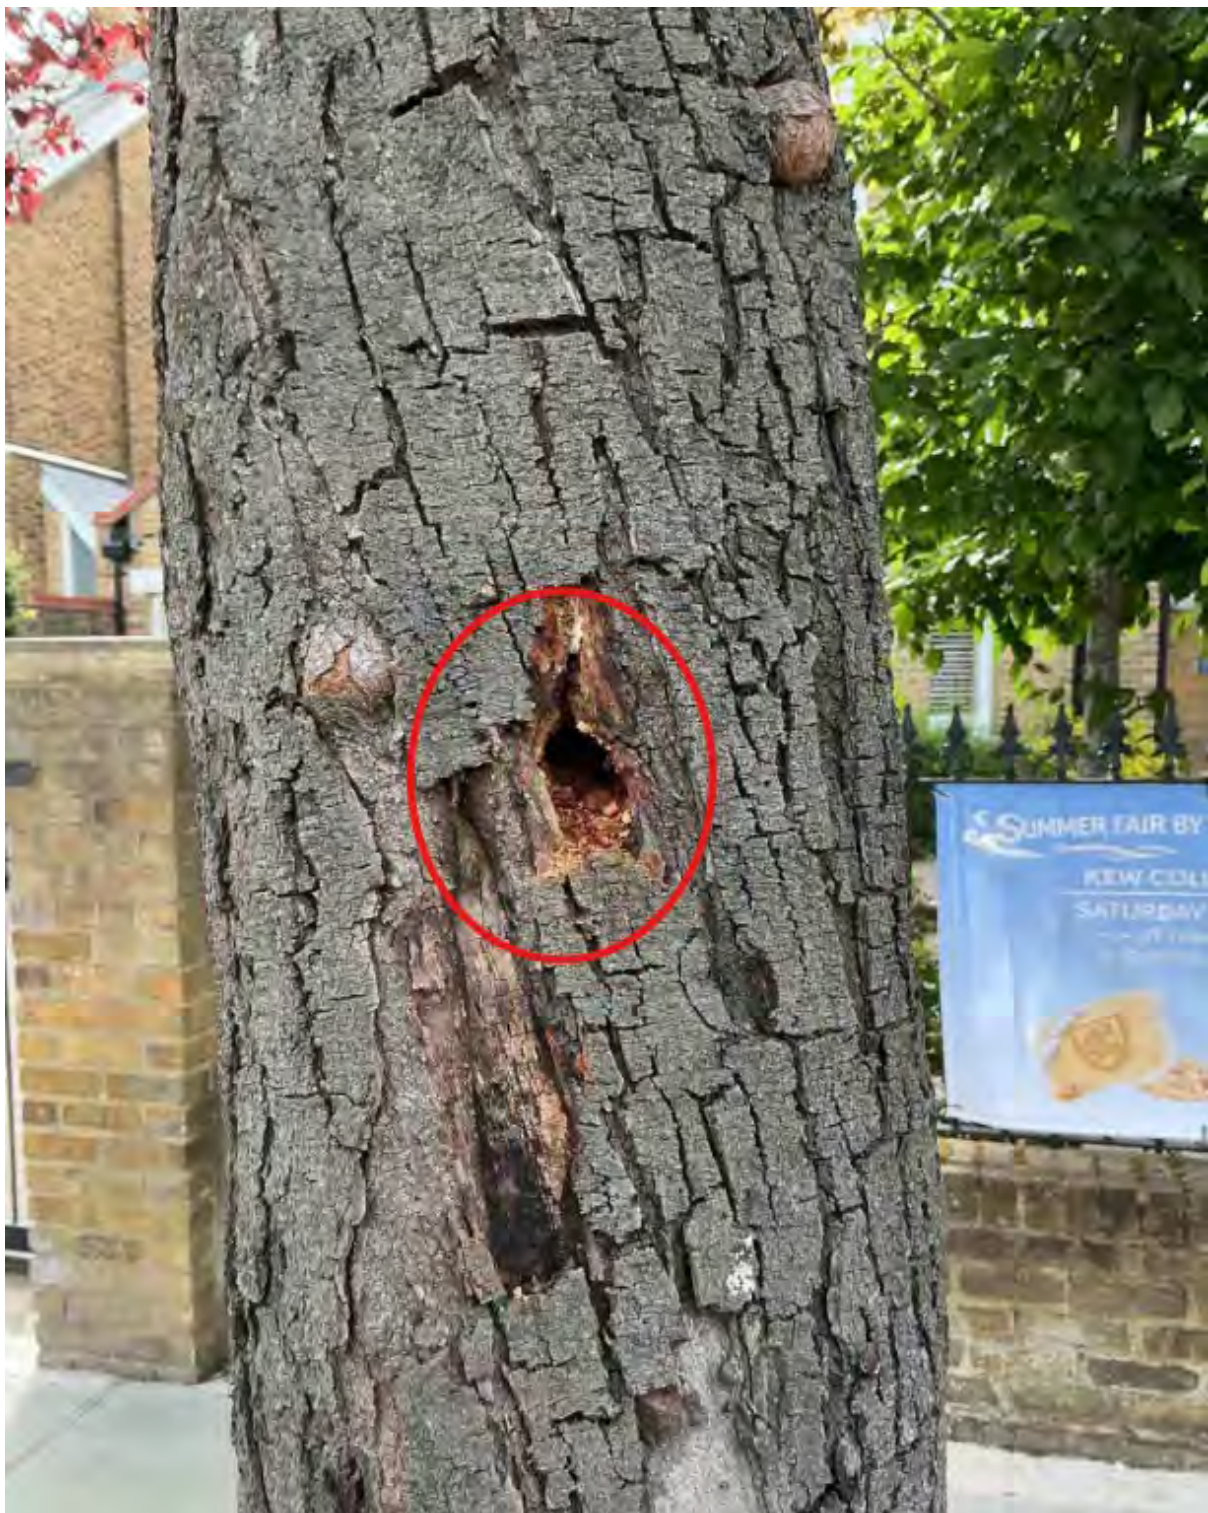
| Inspection findings/reason for exemption | Investigation with a probe and a resonance test with a sounding hammer has revealed an unacceptable amount of decay beyond the visible cavities on the trunk. Removal is required to prevent natural failure, manage risk, and facilitate replanting. |

***Image shows cavity on stem circled.***

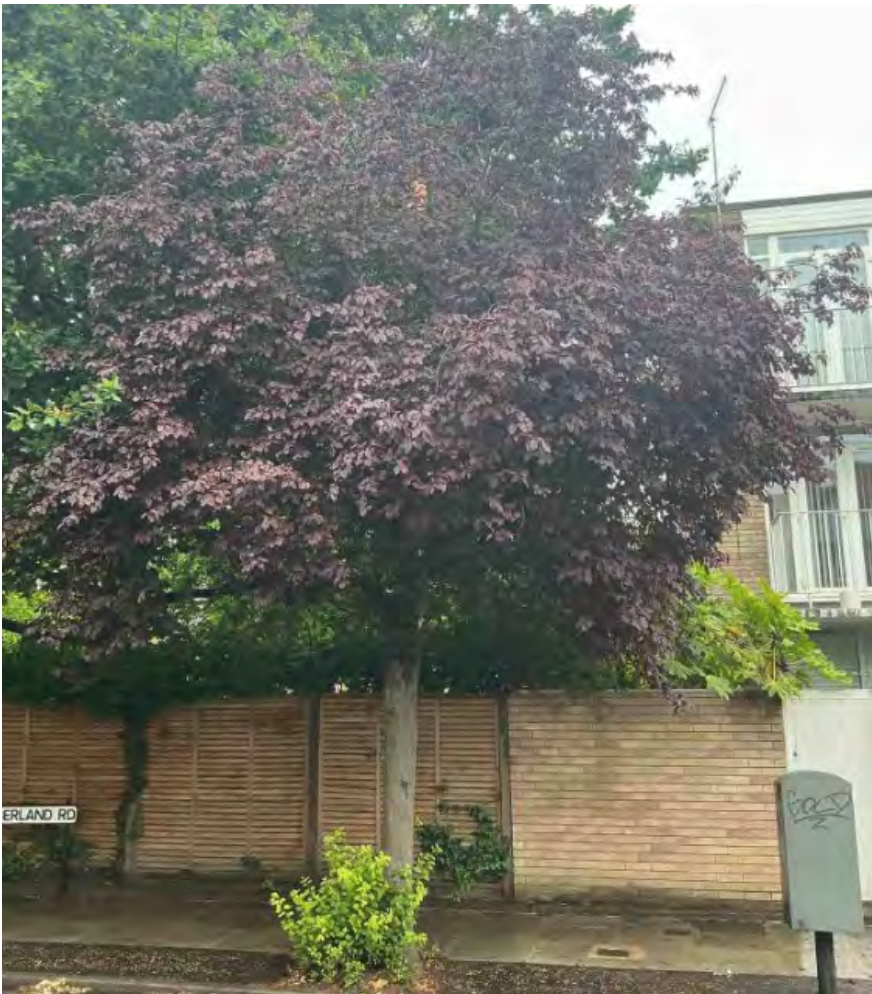
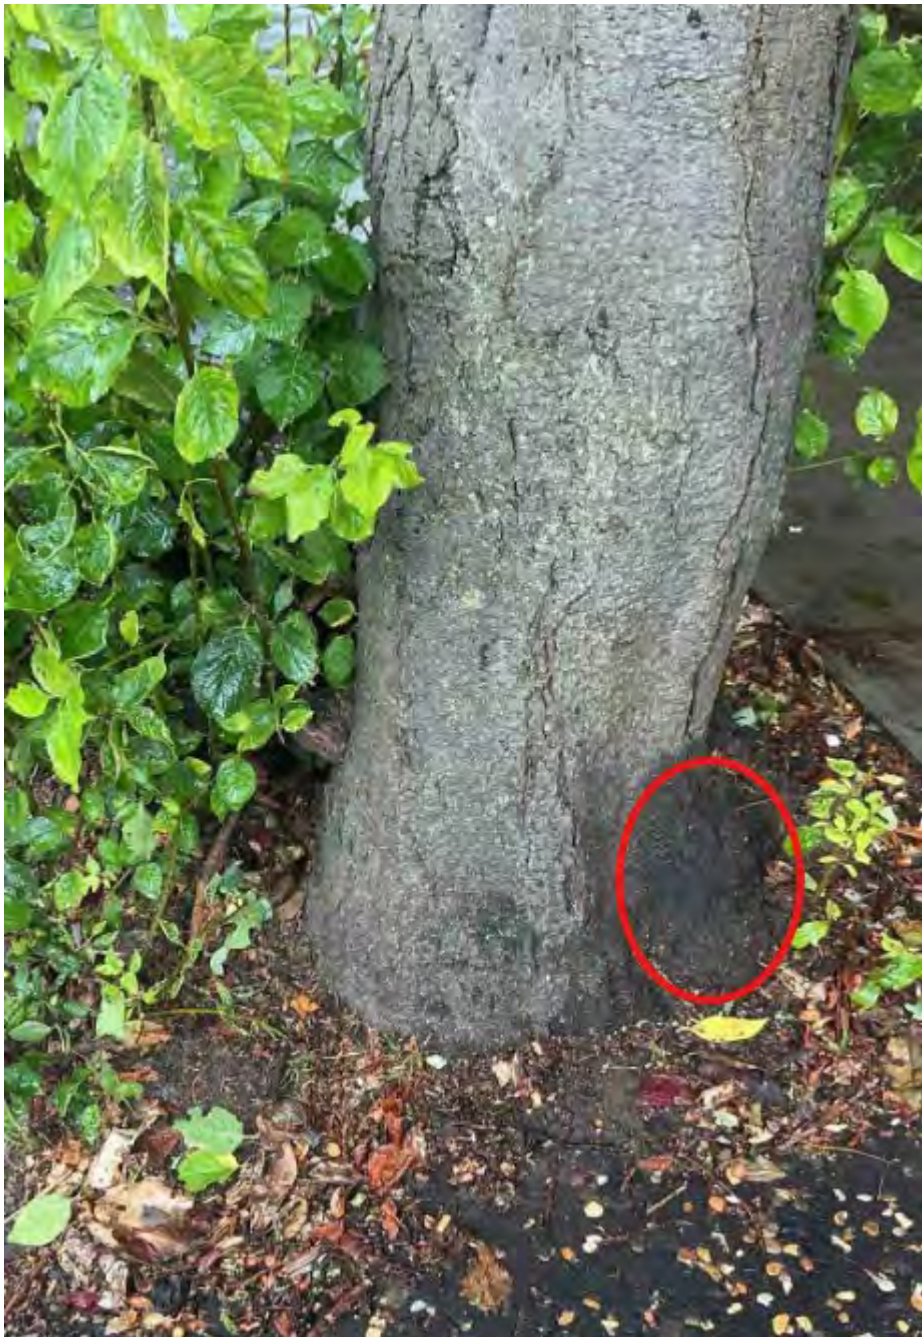
| Inspection findings/reason for exemption | A fungal fruiting body of the decay fungus <i>Ganoderma sp.</i> is present on the trunk. Colonisation by this fungus results in white rot affecting the stem and root system, which can lead to structural failure through fracture or windthrow. A resonance test with a sounding hammer has revealed an unacceptable amount of decay around the bracket. Removal of the tree is recommended to prevent natural failure, manage risk, and facilitate replanting. |

*Image shows tree base with fungal fruiting body circled*

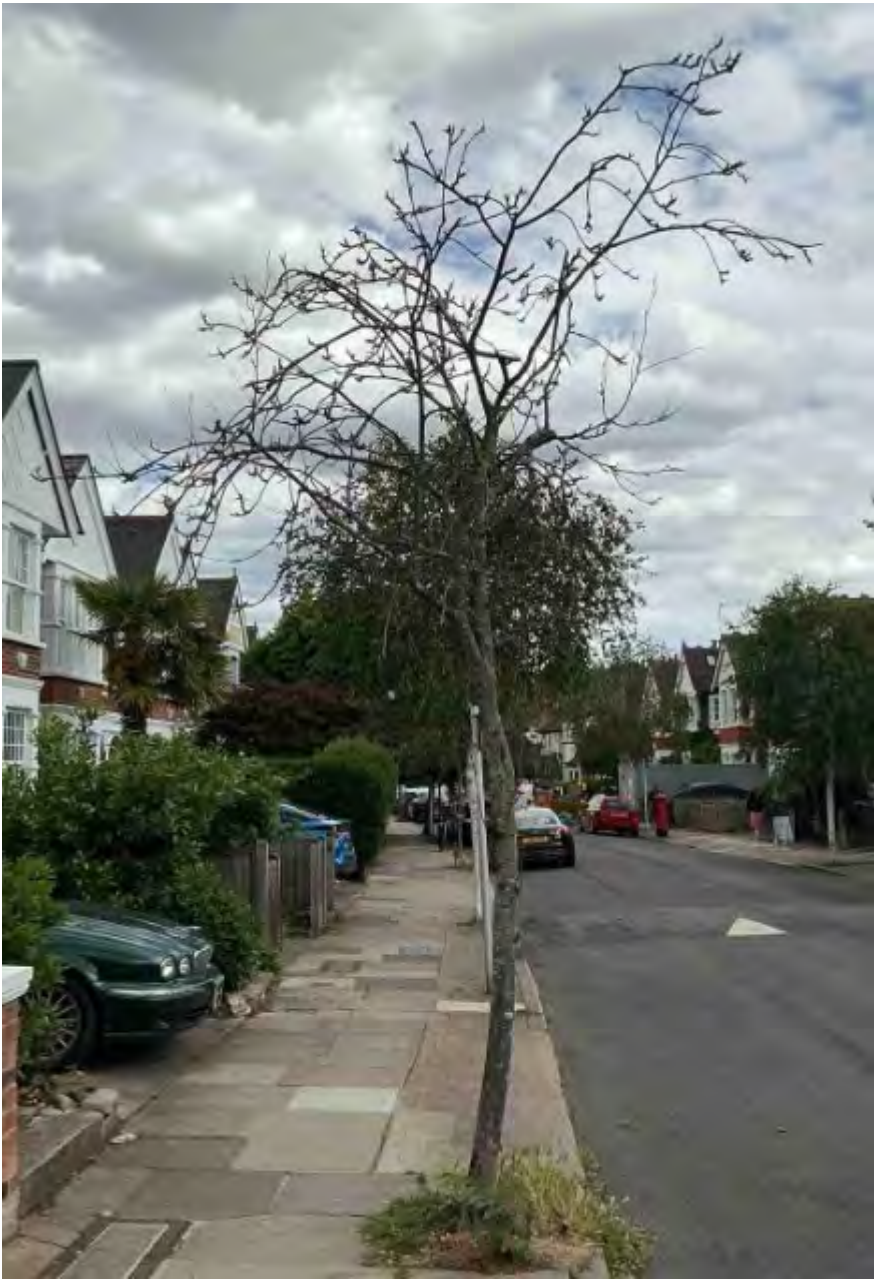
| Inspection findings/reason for exemption | This tree is dead; removal is required to prevent natural failure, manage risk, and facilitate replanting |

Image shows dead tree in street scene.

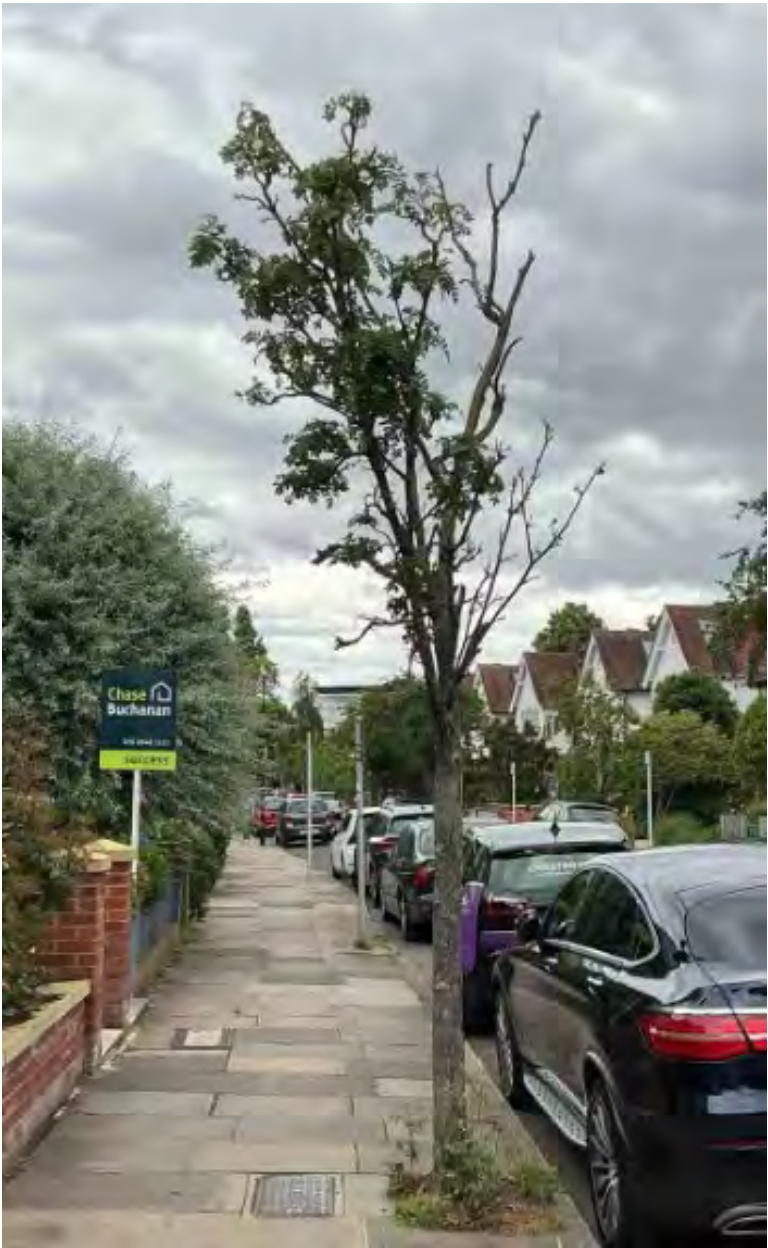
| Inspection findings/reason for exemption | This tree is moribund; removal is required to prevent natural failure, manage risk, and facilitate replanting. |

Image shows moribund tree in street scene.

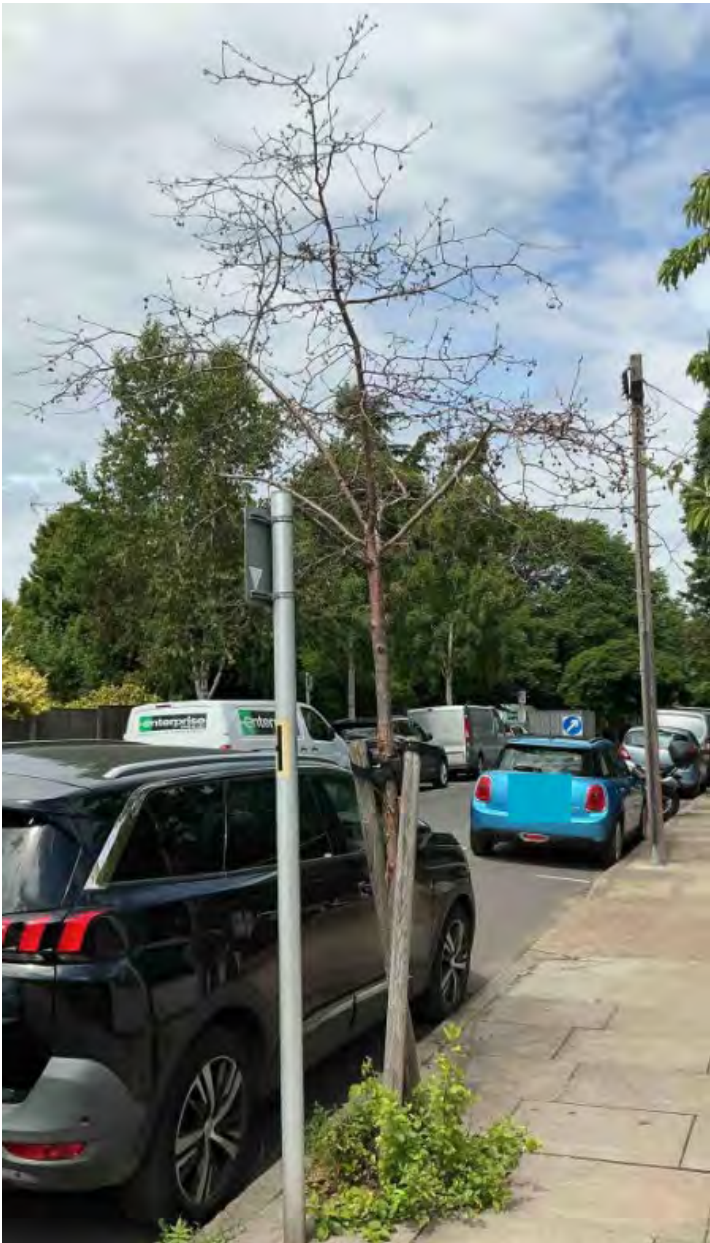
| Inspection findings/reason for exemption | This tree is dead; removal is required to prevent natural failure, manage risk, and facilitate replanting. |

Image shows dead tree in street scene.

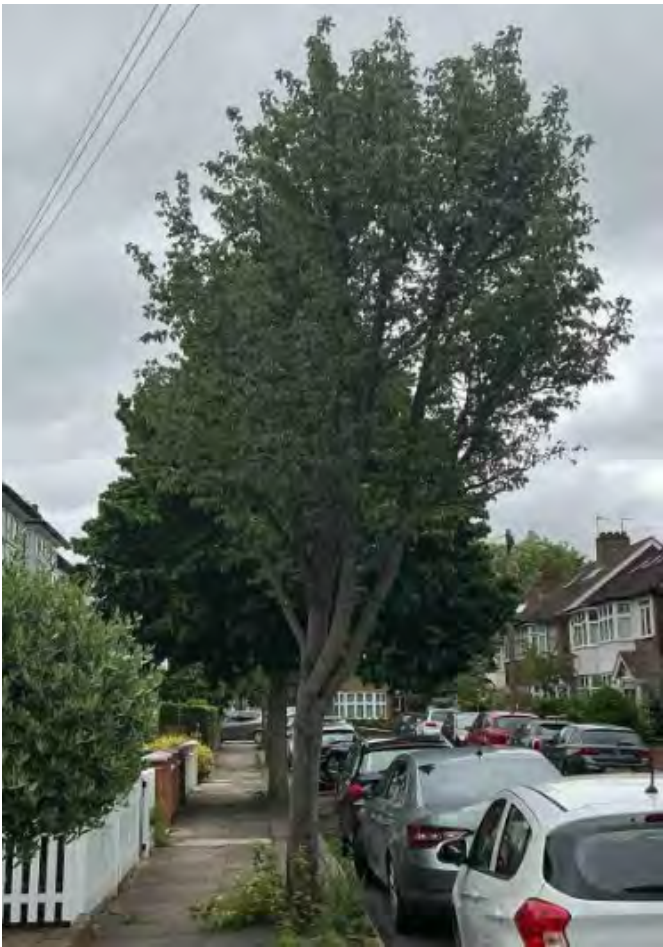
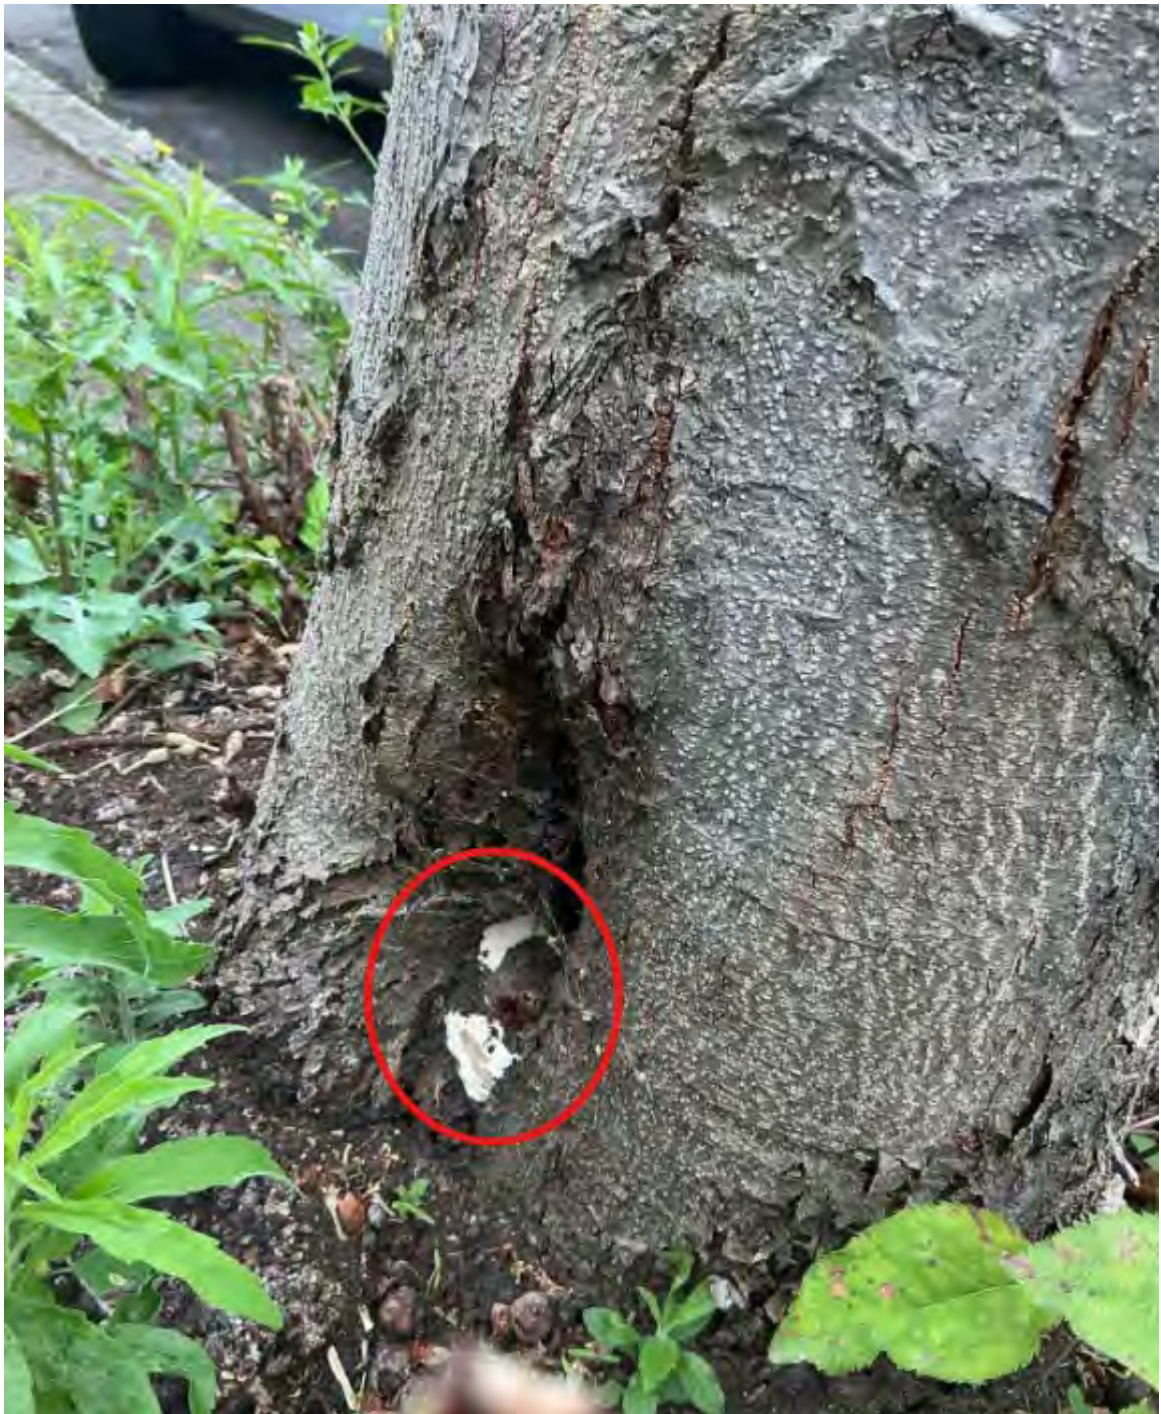
| Inspection findings/reason for exemption | A fungal fruiting body of the decay fungus <i>Ganoderma sp.</i> is present on the trunk. Colonisation by this fungus results in white rot affecting the stem and root system, which can lead to structural failure through fracture or windthrow. Investigation with a probe and a resonance test with a sounding hammer has revealed an unacceptable amount of decay beyond the visible cavities at the base of the trunk by the bracket. Removal of the tree is recommended to prevent natural failure, manage risk, and facilitate replanting. |

***Image shows tree with fungal fruiting body circled***
