# July 2026 – Highways Reactive Tree Works Programme

A survey of trees in ward of Kew has been undertaken; this is being conducted by specialist arboricultural officers as part of the scheduled 4 yearly detailed inspection regime that has been devised for all Council highway and parks trees.

Dated 24.7.2026

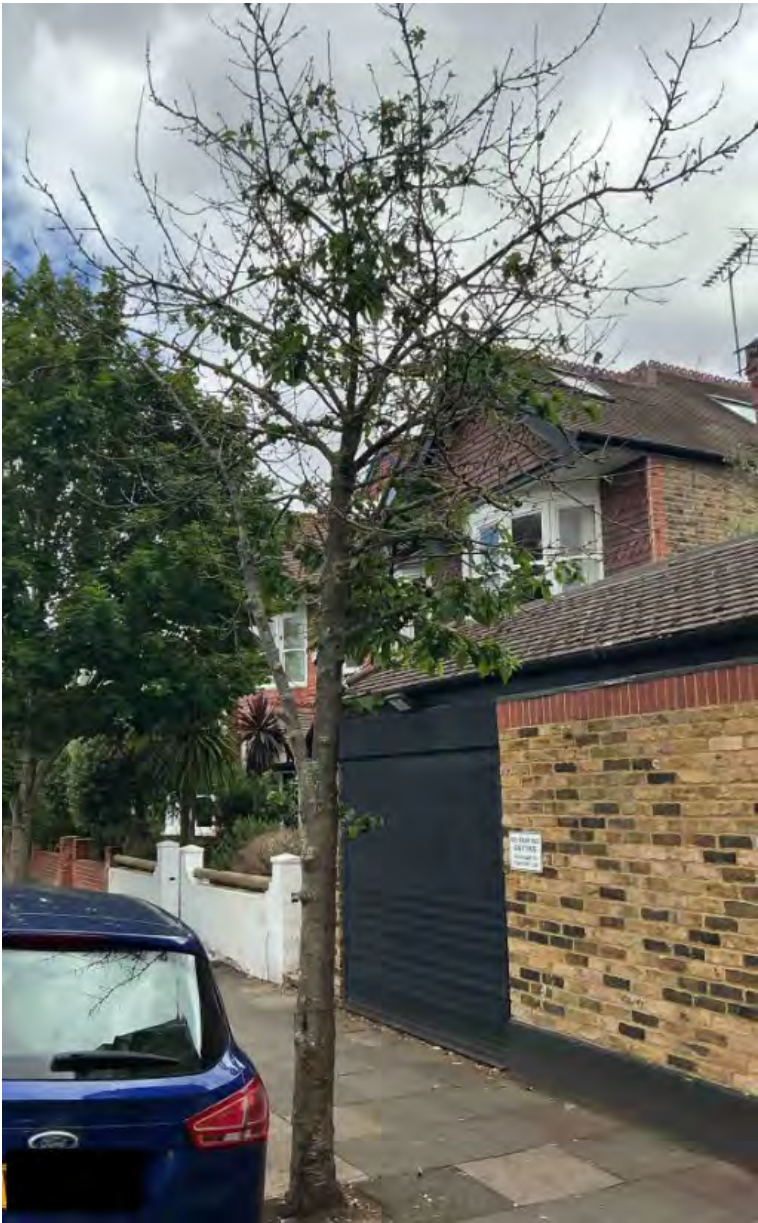
| Inspection findings/reason for exemption | This tree is moribund; removal is required to prevent natural failure, manage risk, and facilitate replanting. |

Image shows moribund tree in street scene.

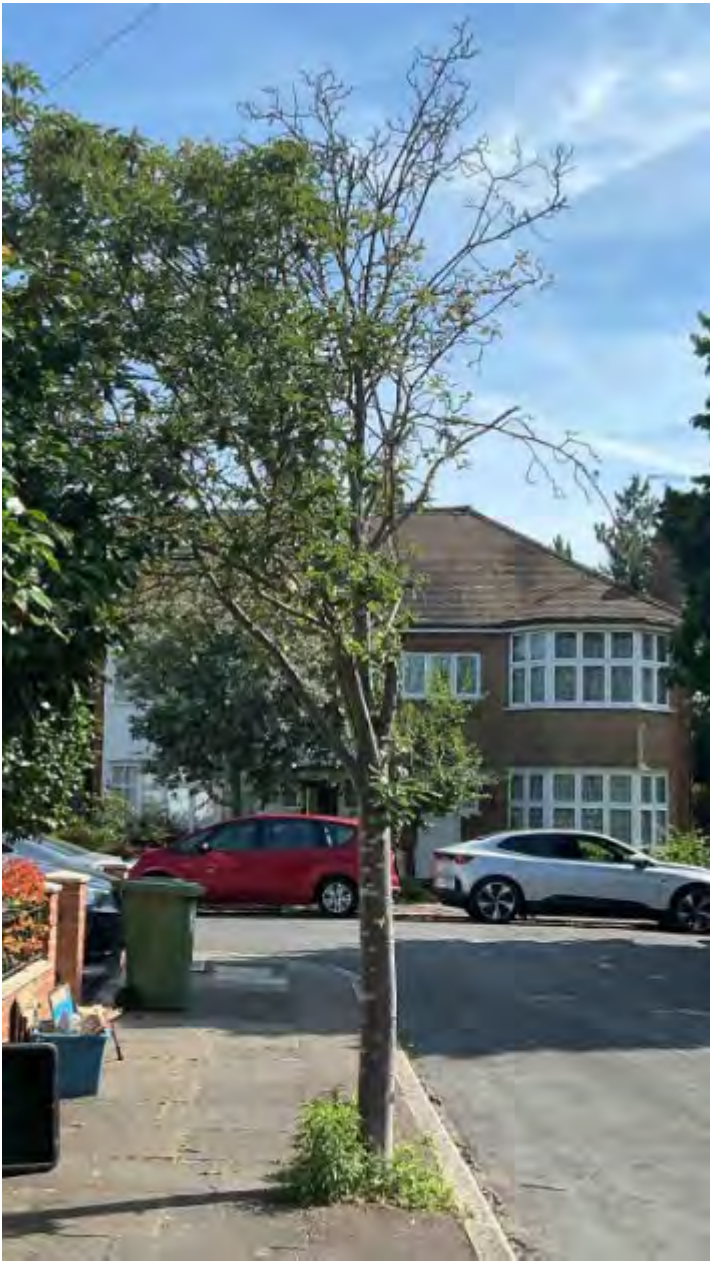
| Inspection findings/reason for exemption | This tree is moribund; removal is required to prevent natural failure, manage risk, and facilitate replanting. |

Image shows moribund tree in street scene.

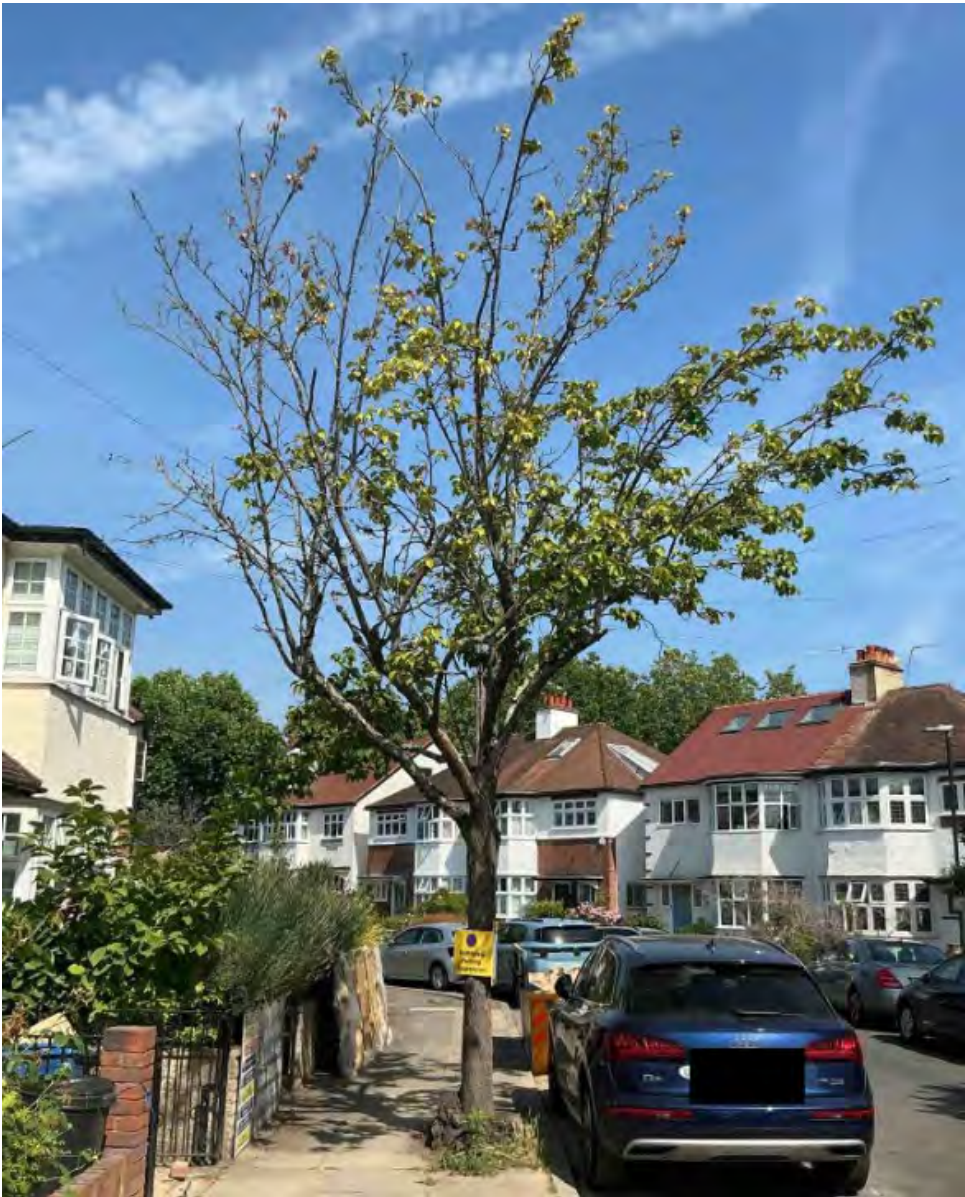
| Inspection findings/reason for exemption | This tree is moribund; removal is required to prevent natural failure, manage risk, and facilitate replanting. |

Image shows moribund tree in street scene.

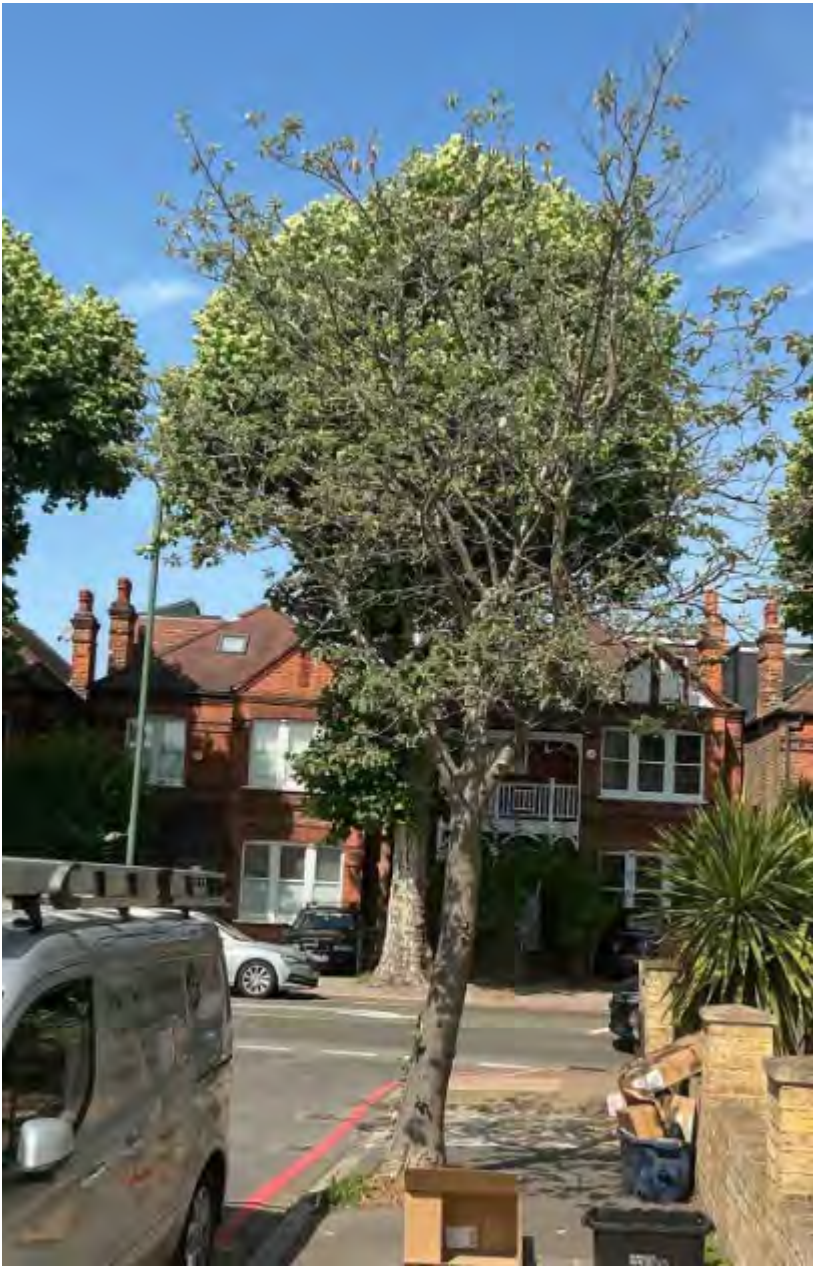
| Inspection findings/reason for exemption | This tree is moribund; removal is required to prevent natural failure, manage risk, and facilitate replanting. |

Image shows moribund tree in street scene.

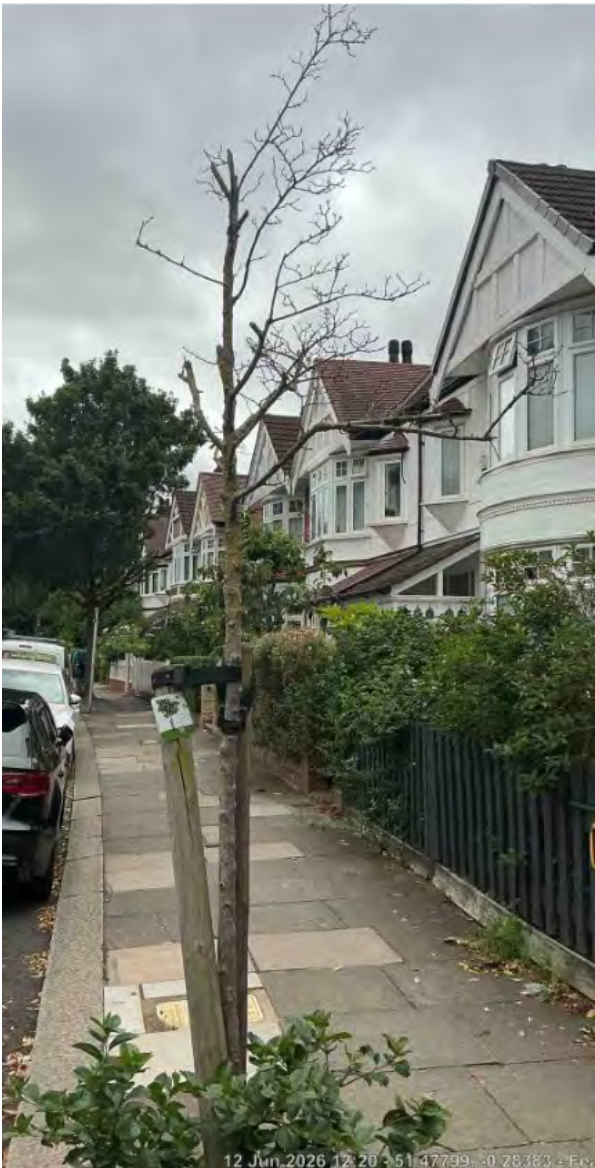
| Inspection findings/reason for exemption | This tree is dead; removal is required to prevent natural failure, manage risk, and facilitate replanting. |

Image shows dead tree in street scene.

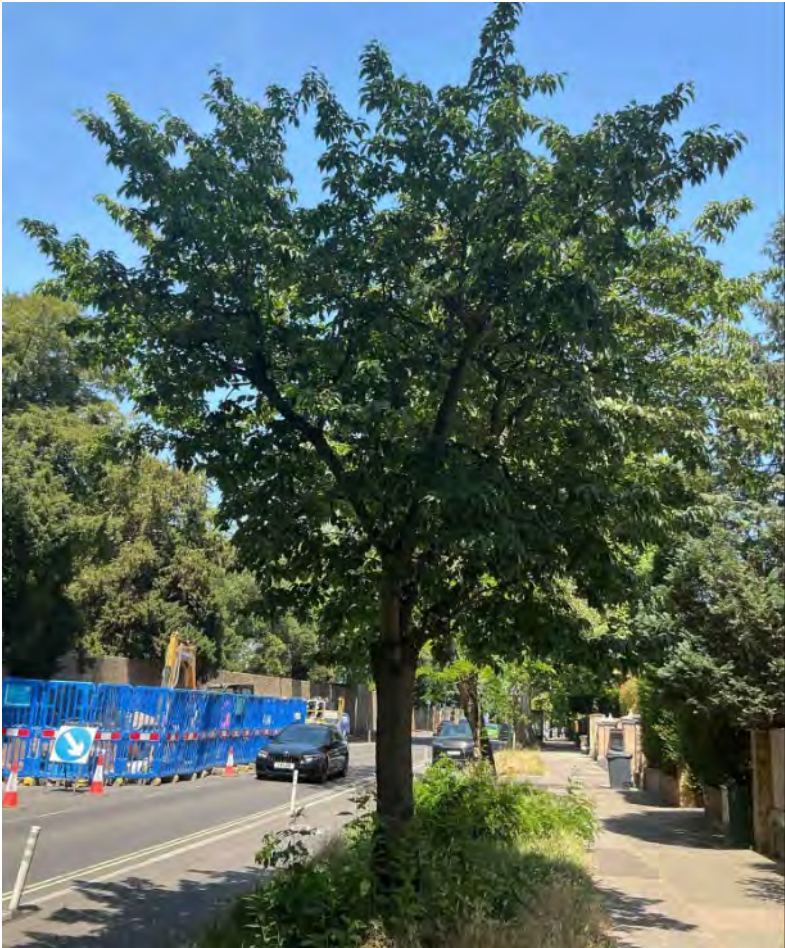
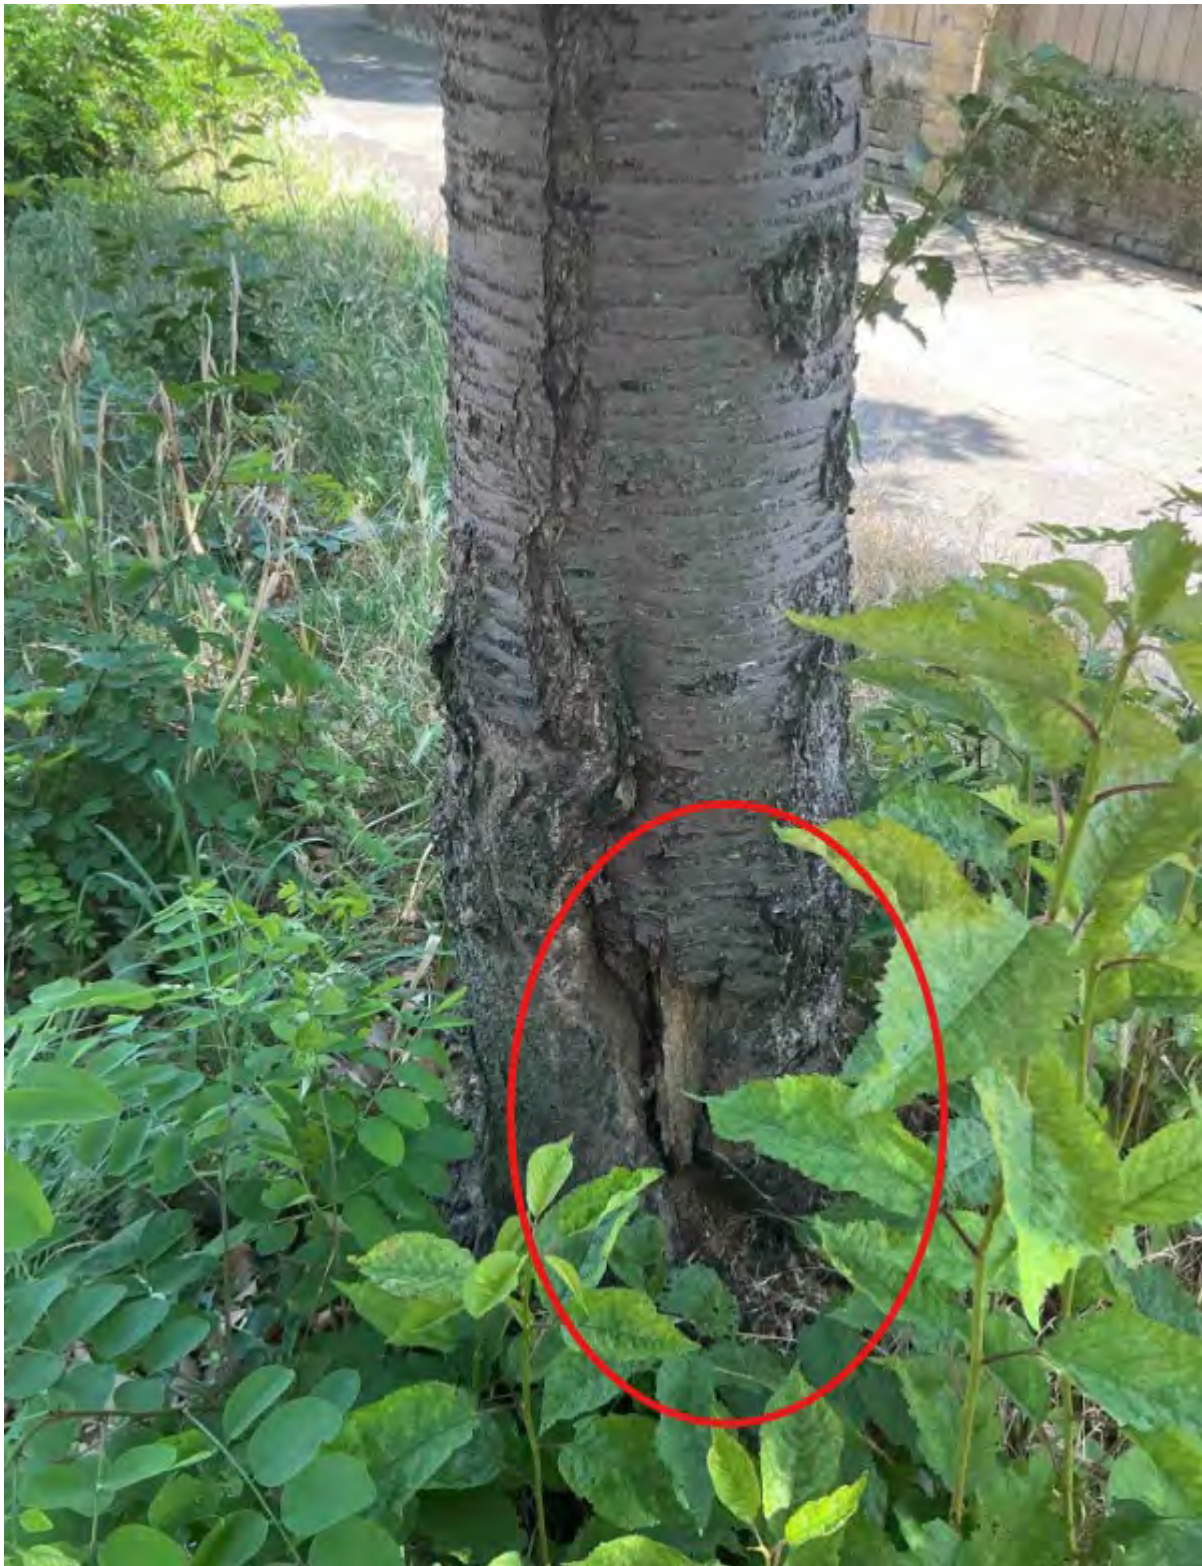
| Inspection findings/reason for exemption | Investigation with a probe and a resonance test with a sounding hammer has revealed an unacceptable amount of decay beyond the visible cavities at the base of the trunk. Removal is required to prevent natural failure, manage risk, and facilitate replanting. |

*Image shows cavity at base of trunk circled.*

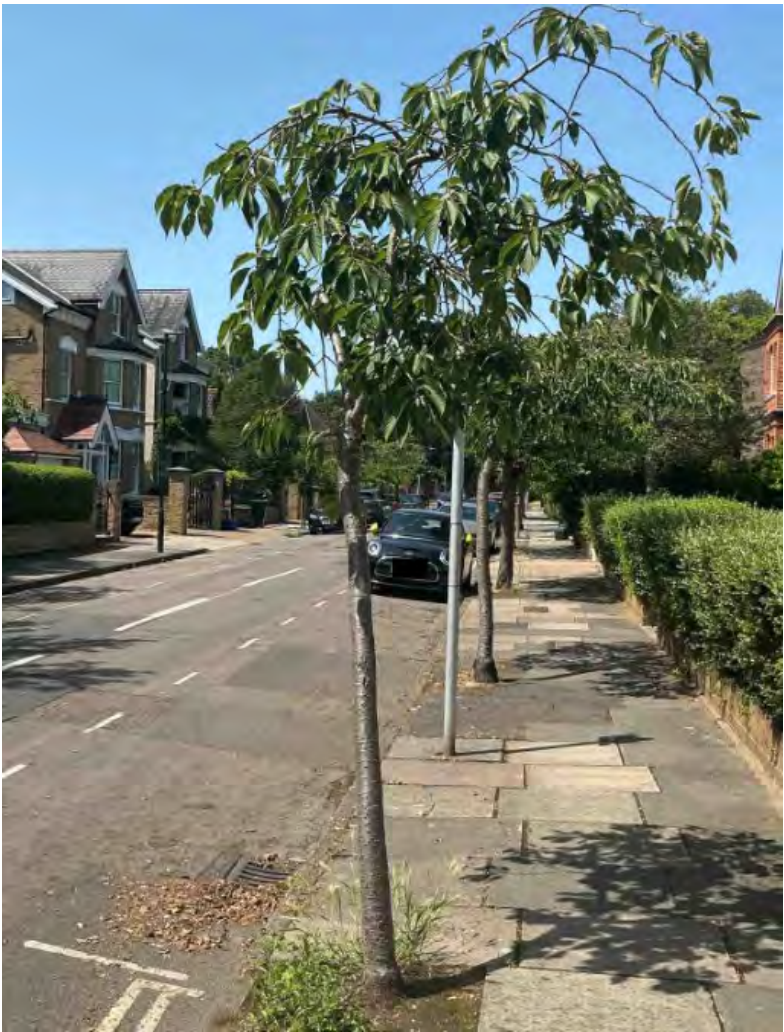
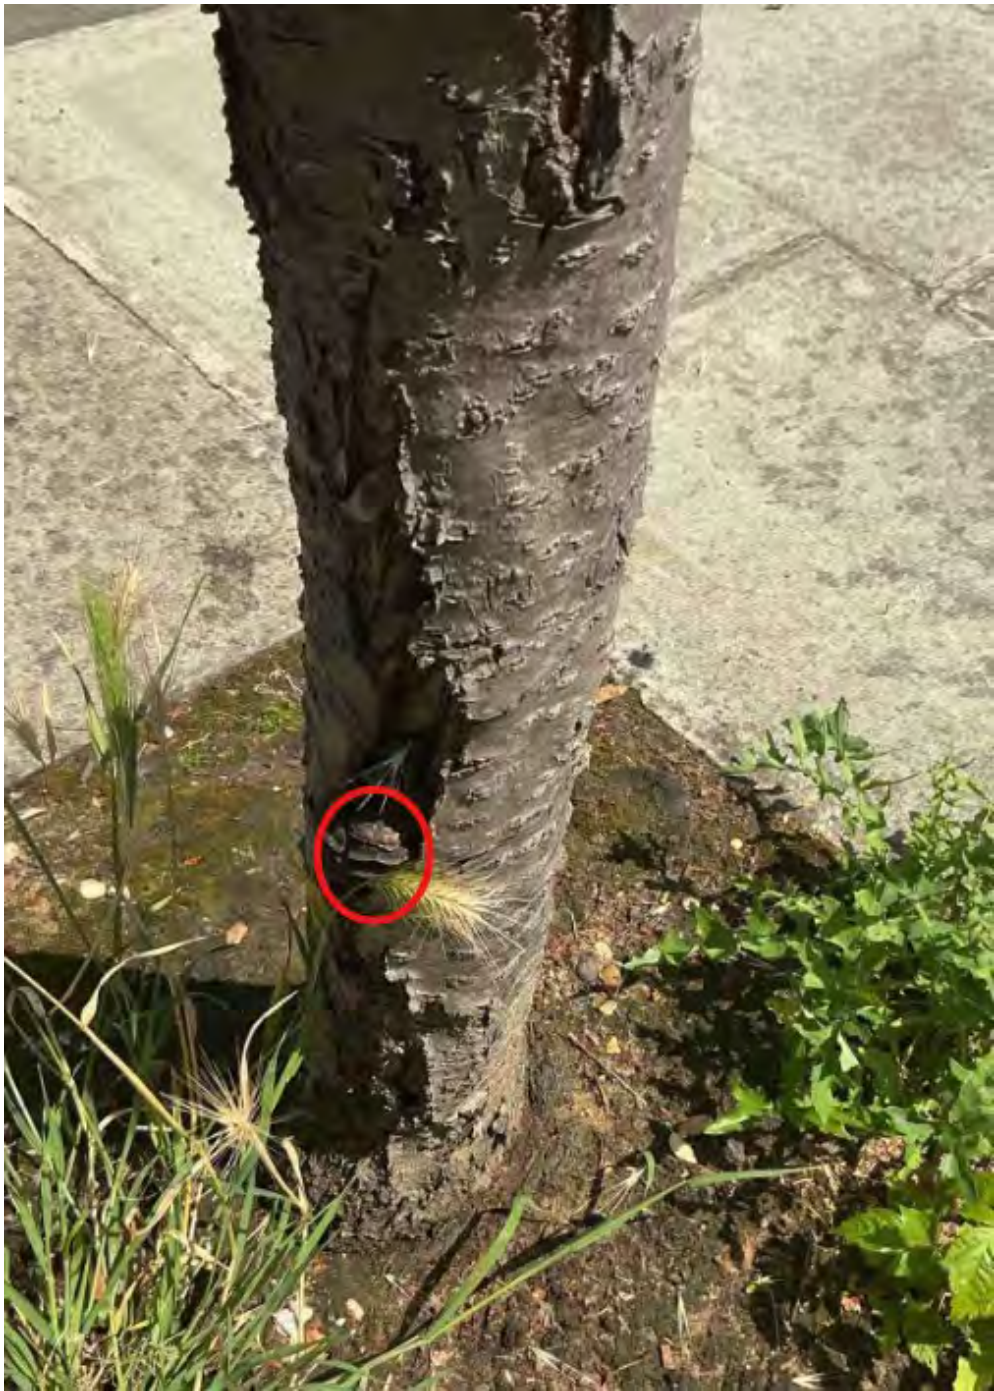
| Inspection findings/reason for exemption | A fungal fruiting body of the decay fungus <i>Ganoderma sp.</i> is present on the trunk. Colonisation by this fungus results in white rot affecting the stem and root system, which can lead to structural failure through fracture or windthrow. A resonance test with a sounding hammer has revealed an unacceptable amount of decay around the bracket. Removal of the tree is recommended to prevent natural failure, manage risk, and facilitate replanting. |

*Image shows fungal fruiting body on trunk circled.*

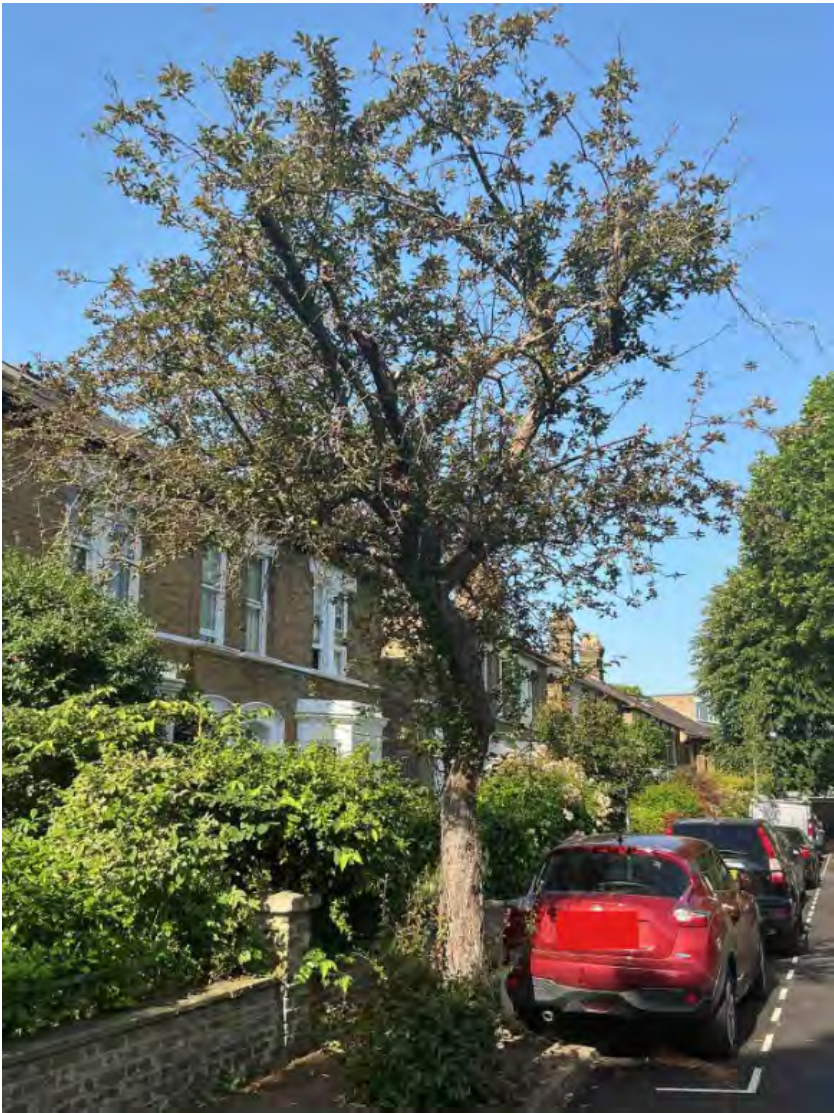
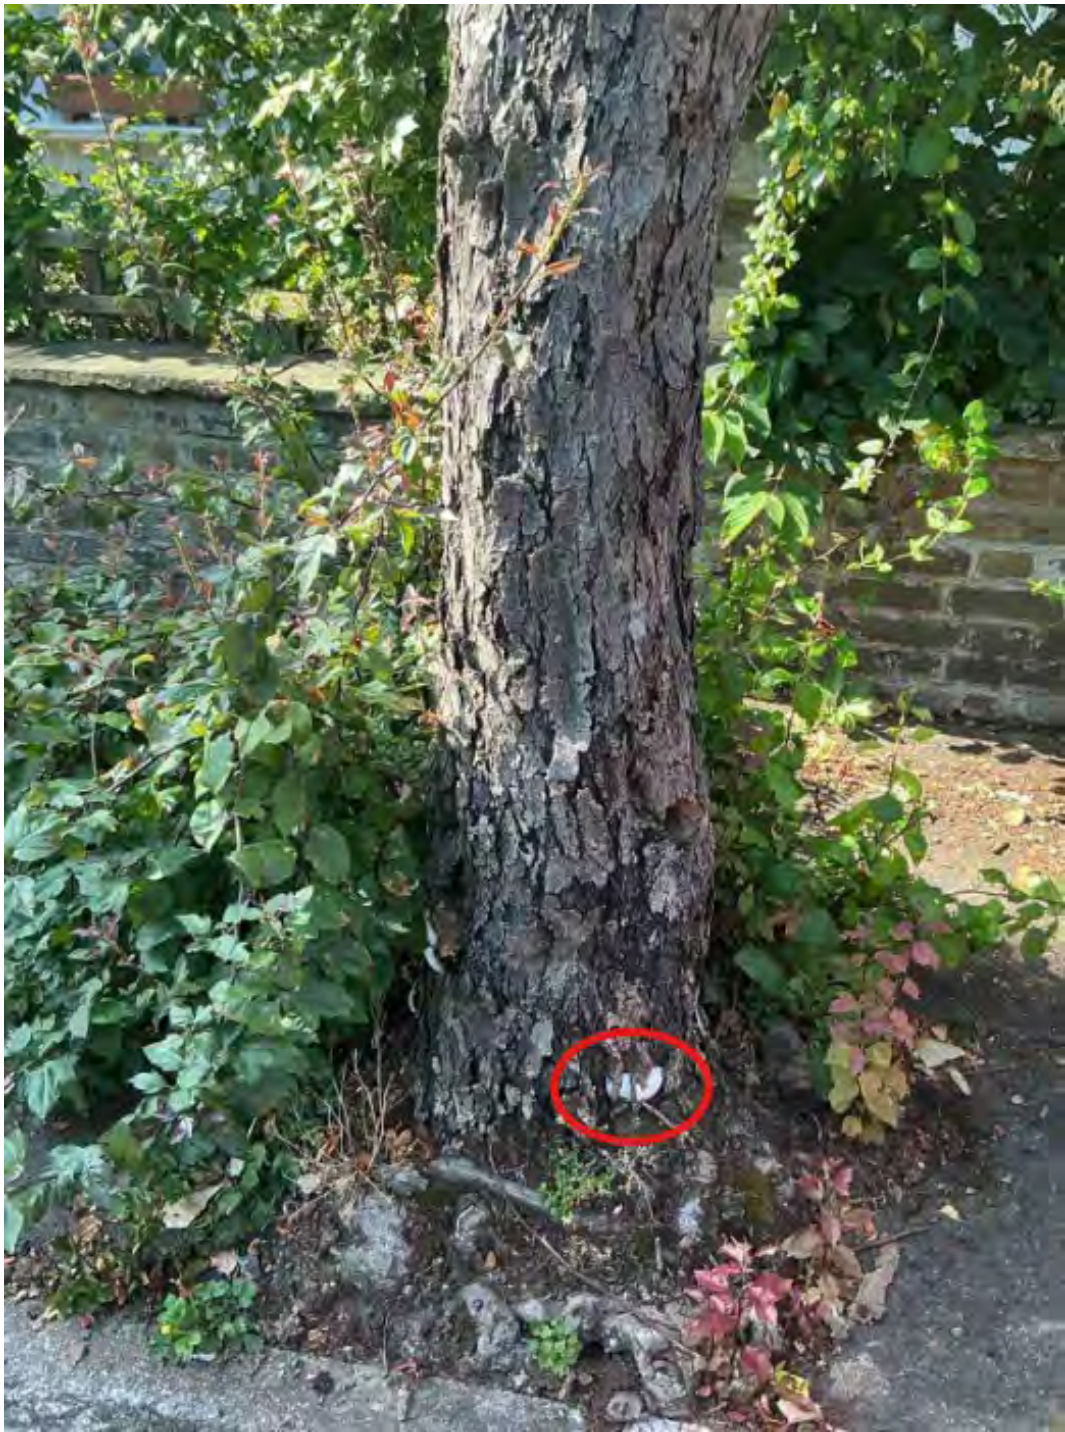
| Inspection findings/reason for exemption | A fungal fruiting body of the decay fungus <i>Ganoderma sp.</i> is present on the trunk. Colonisation by this fungus results in white rot affecting the stem and root system, which can lead to structural failure through fracture or windthrow. Crown dieback is evident and correlates with the presence of the decay fungi. Removal of the tree is recommended to prevent natural failure, manage risk, and facilitate replanting. |

***Image shows fungal fruiting body on trunk circled.***

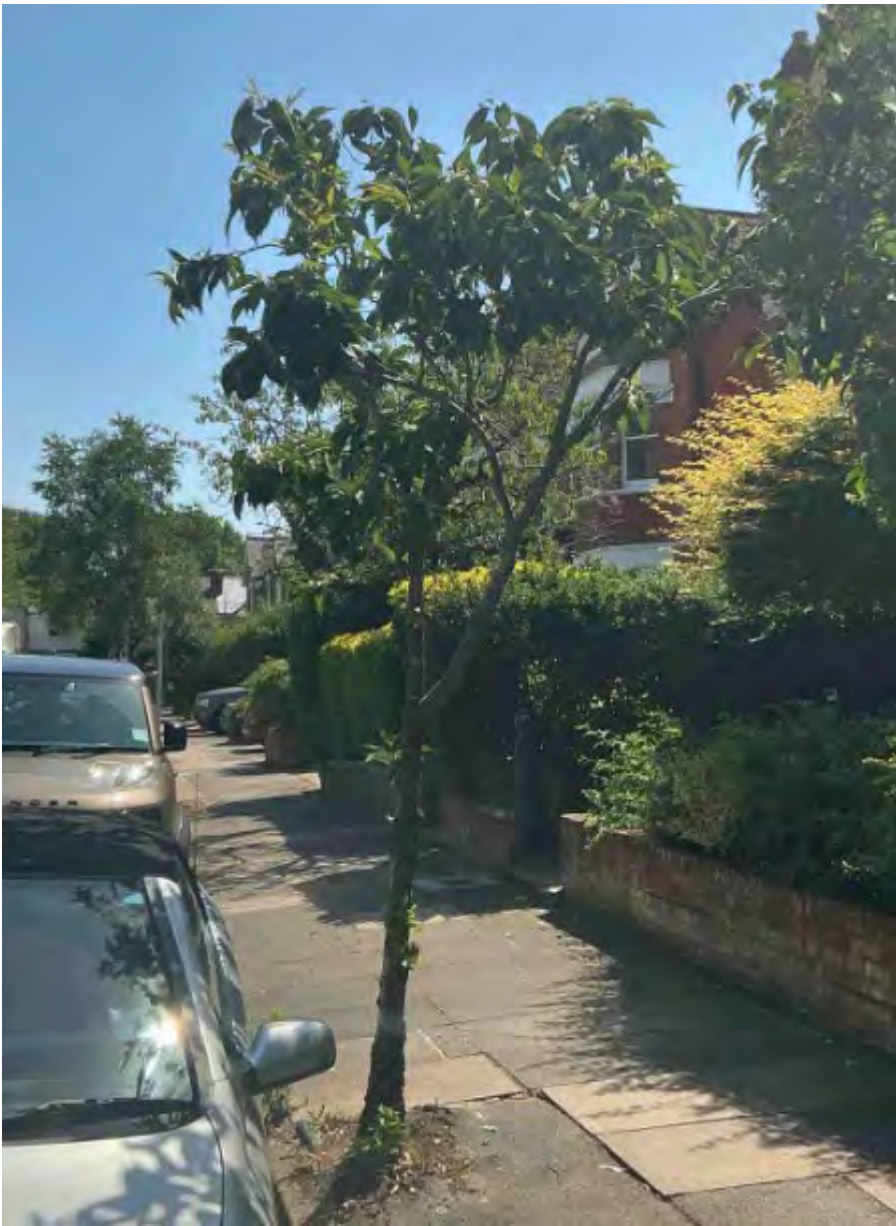
| Inspection findings/reason for exemption | This tree shows excessive movement of the root plate indicating that it is structurally compromised. Removal is required to prevent natural failure, manage risk, and facilitate replanting |

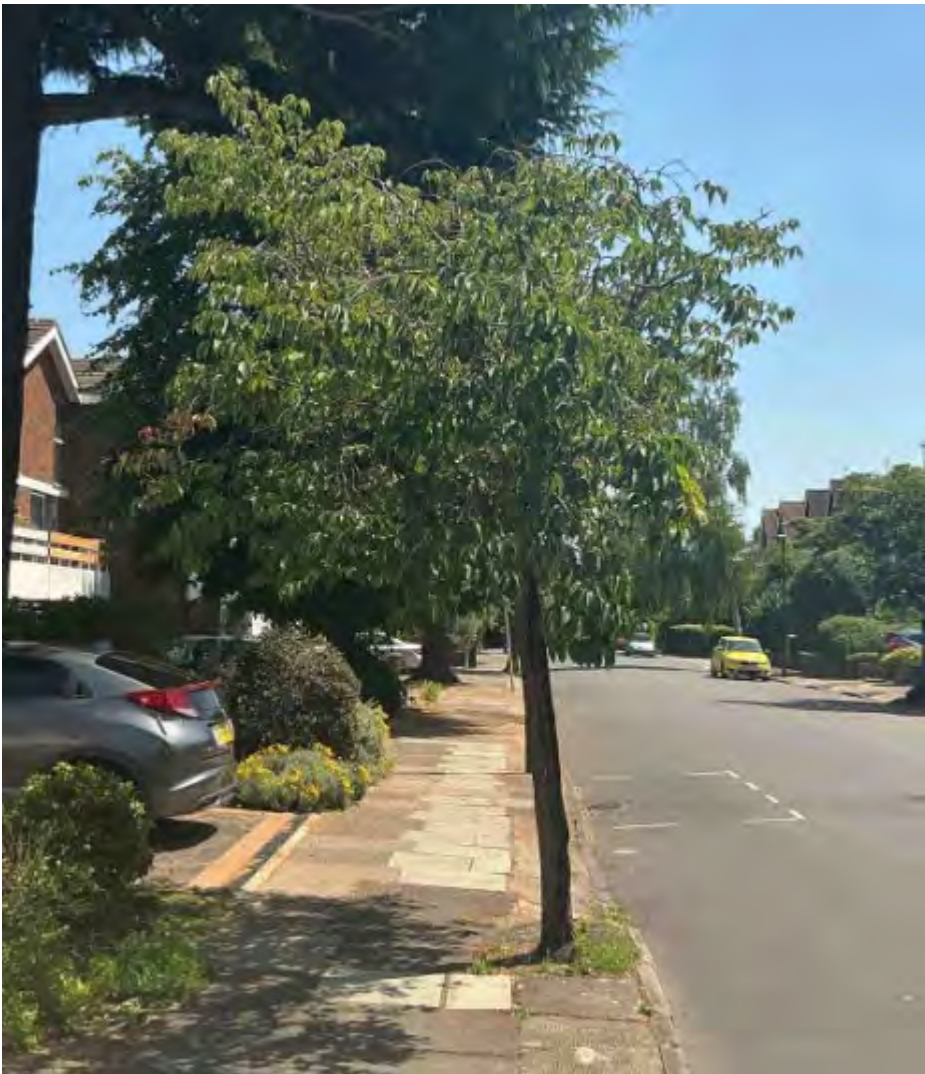
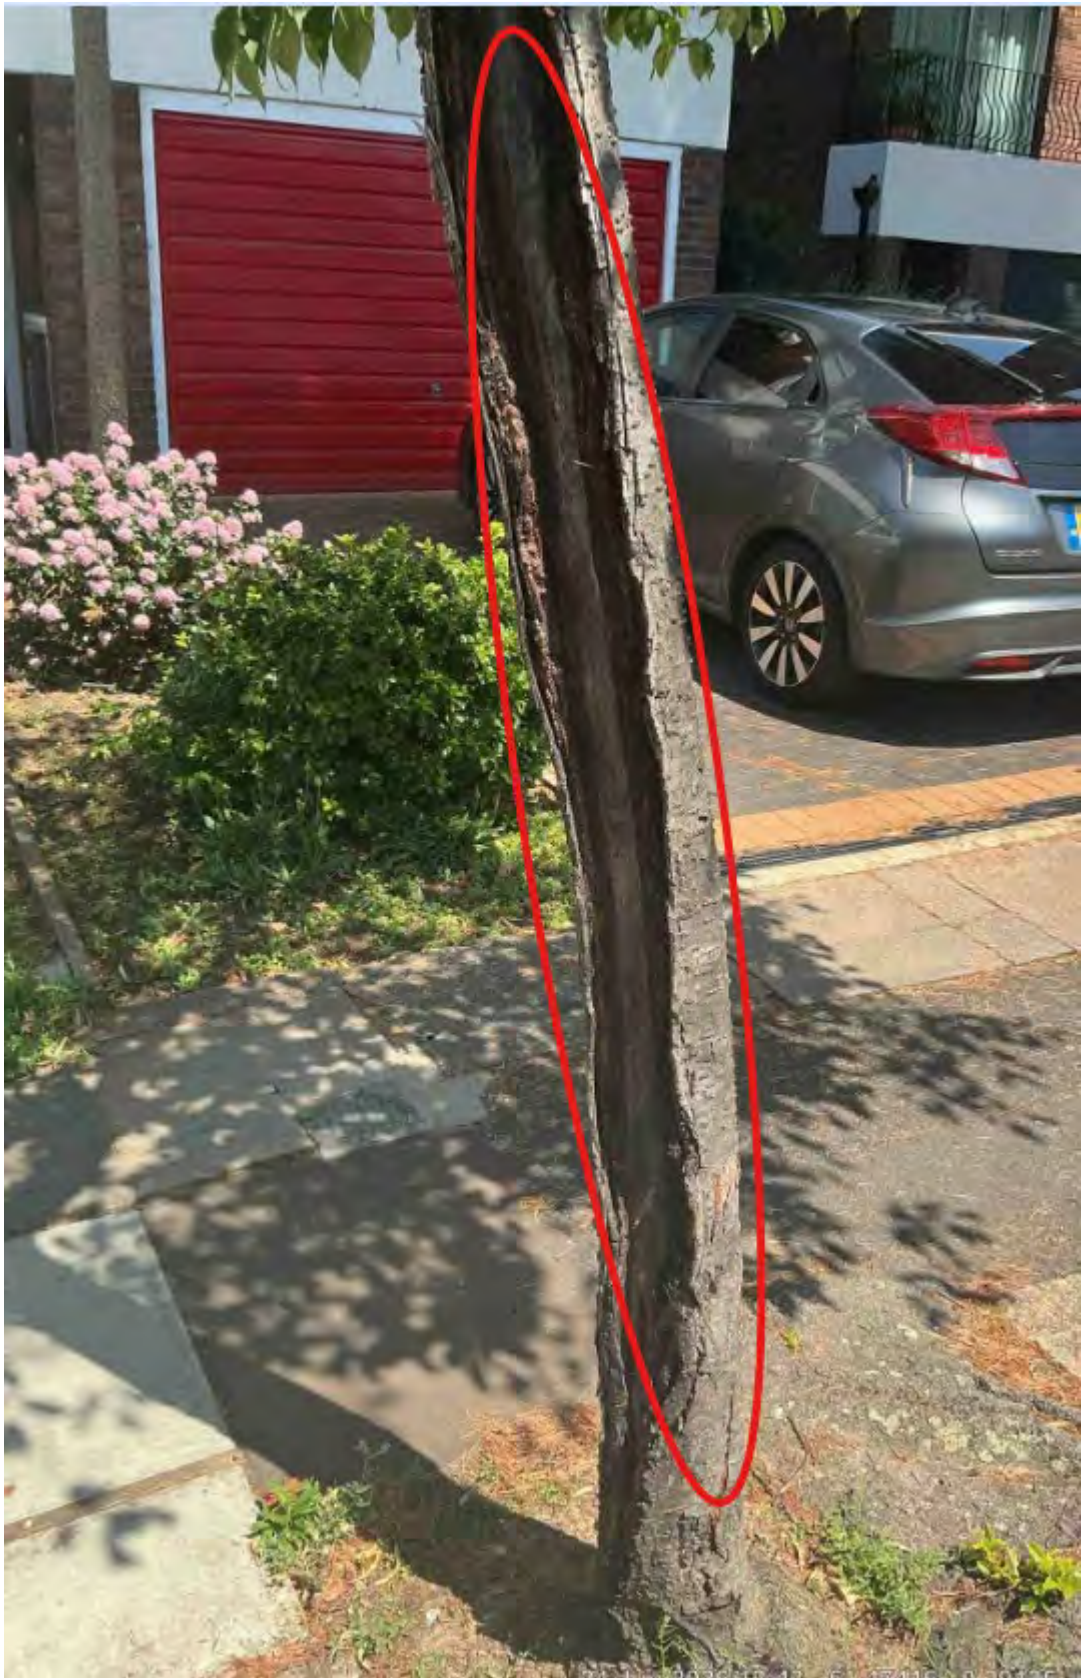
| Inspection findings/reason for exemption | Substantial wounding has occurred on the trunk and associated bark/vascular necrosis has taken place. Removal is required to prevent natural failure, manage risk, and facilitate replanting |

***Image shows wound on trunk circled.***

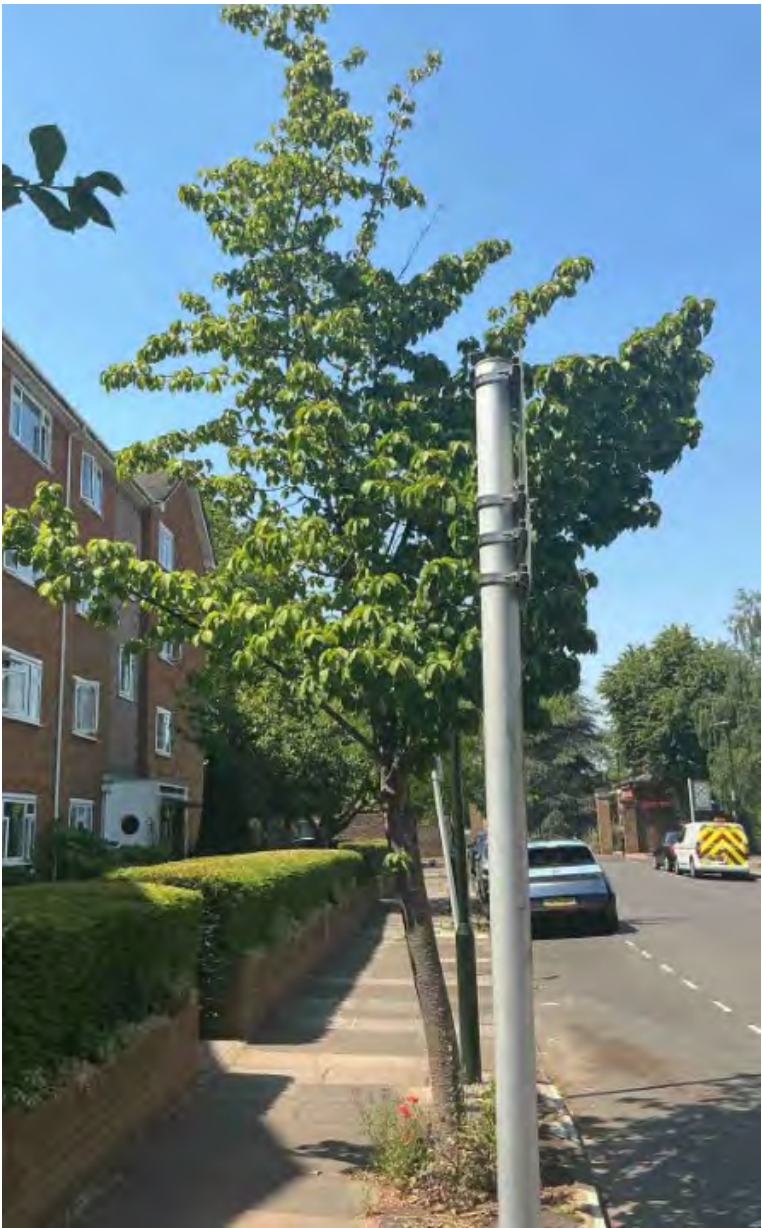
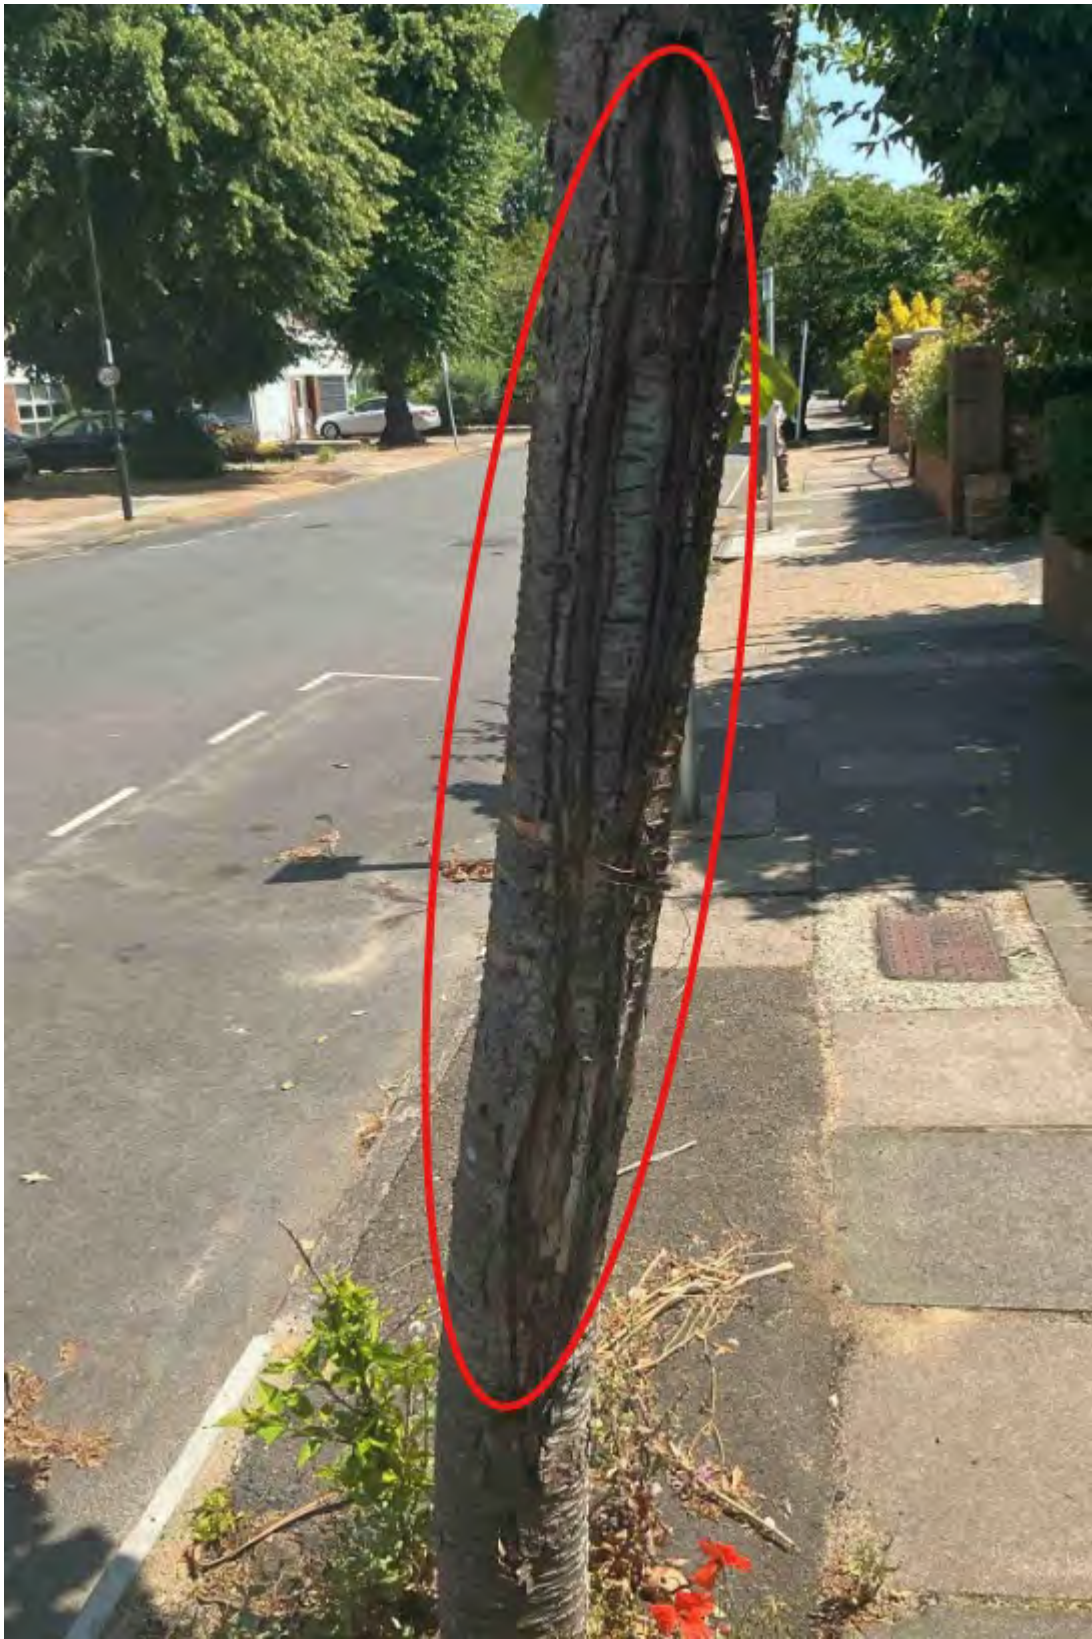
| Inspection findings/reason for exemption | Substantial wounding has occurred on the trunk and associated bark/vascular necrosis has taken place. Removal is required to prevent natural failure, manage risk, and facilitate replanting |

**Image shows wound on trunk circled.**

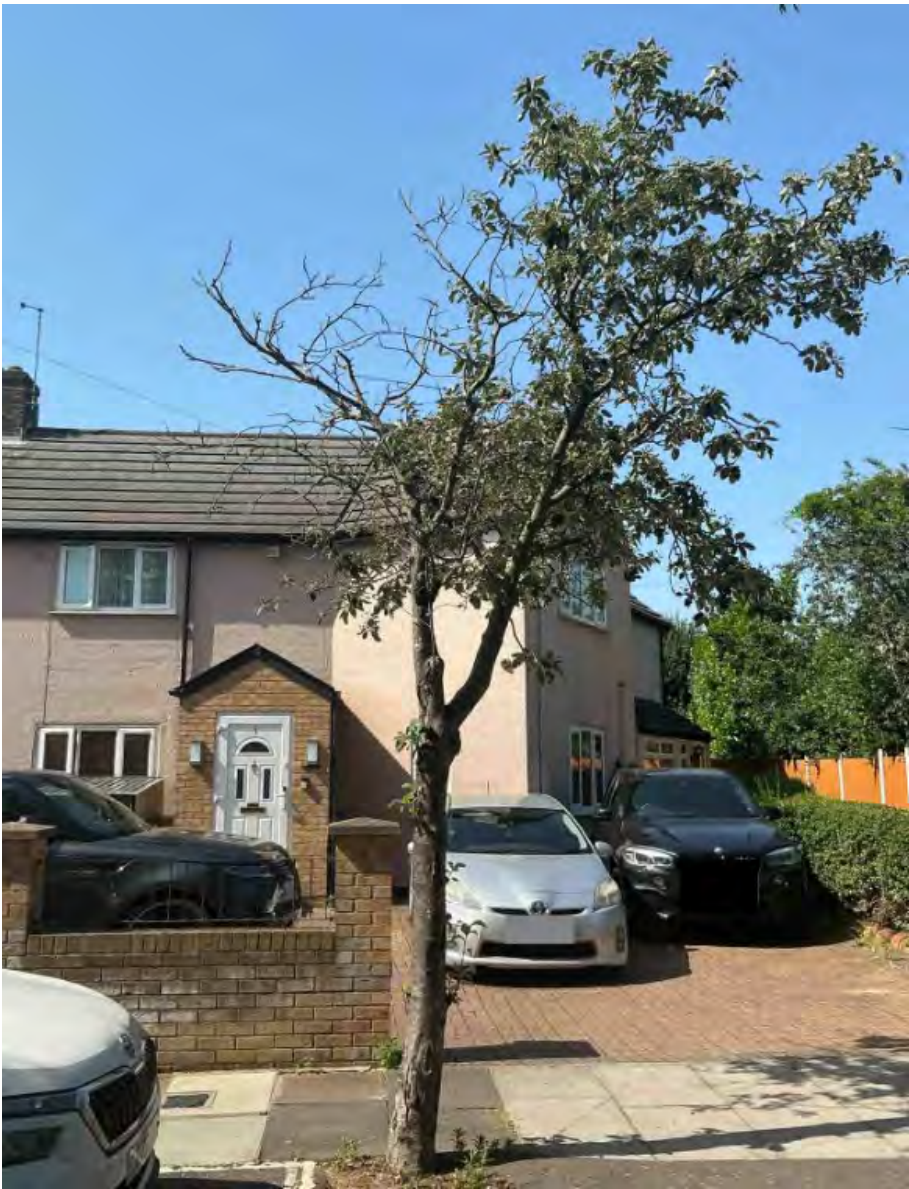
| Inspection findings/reason for exemption | This tree is moribund; removal is required to prevent natural failure, manage risk, and facilitate replanting |

Image shows moribund tree in street scene.
