# July 2026 – Highways Reactive Tree Works Programme

A survey of trees in ward of Kew has been undertaken; this is being conducted by specialist arboricultural officers as part of the scheduled 4 yearly detailed inspection regime that has been devised for all Council highway and parks trees.

Dated 24.7.2026

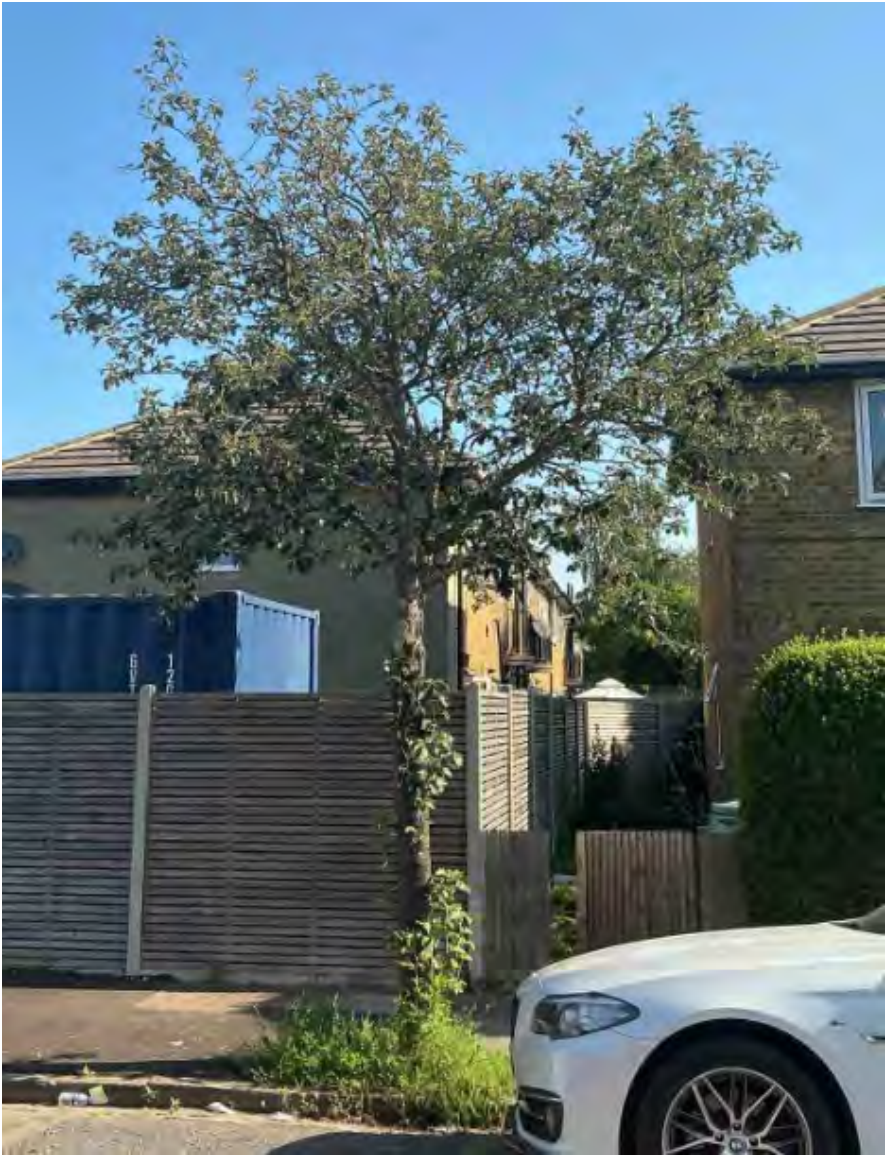
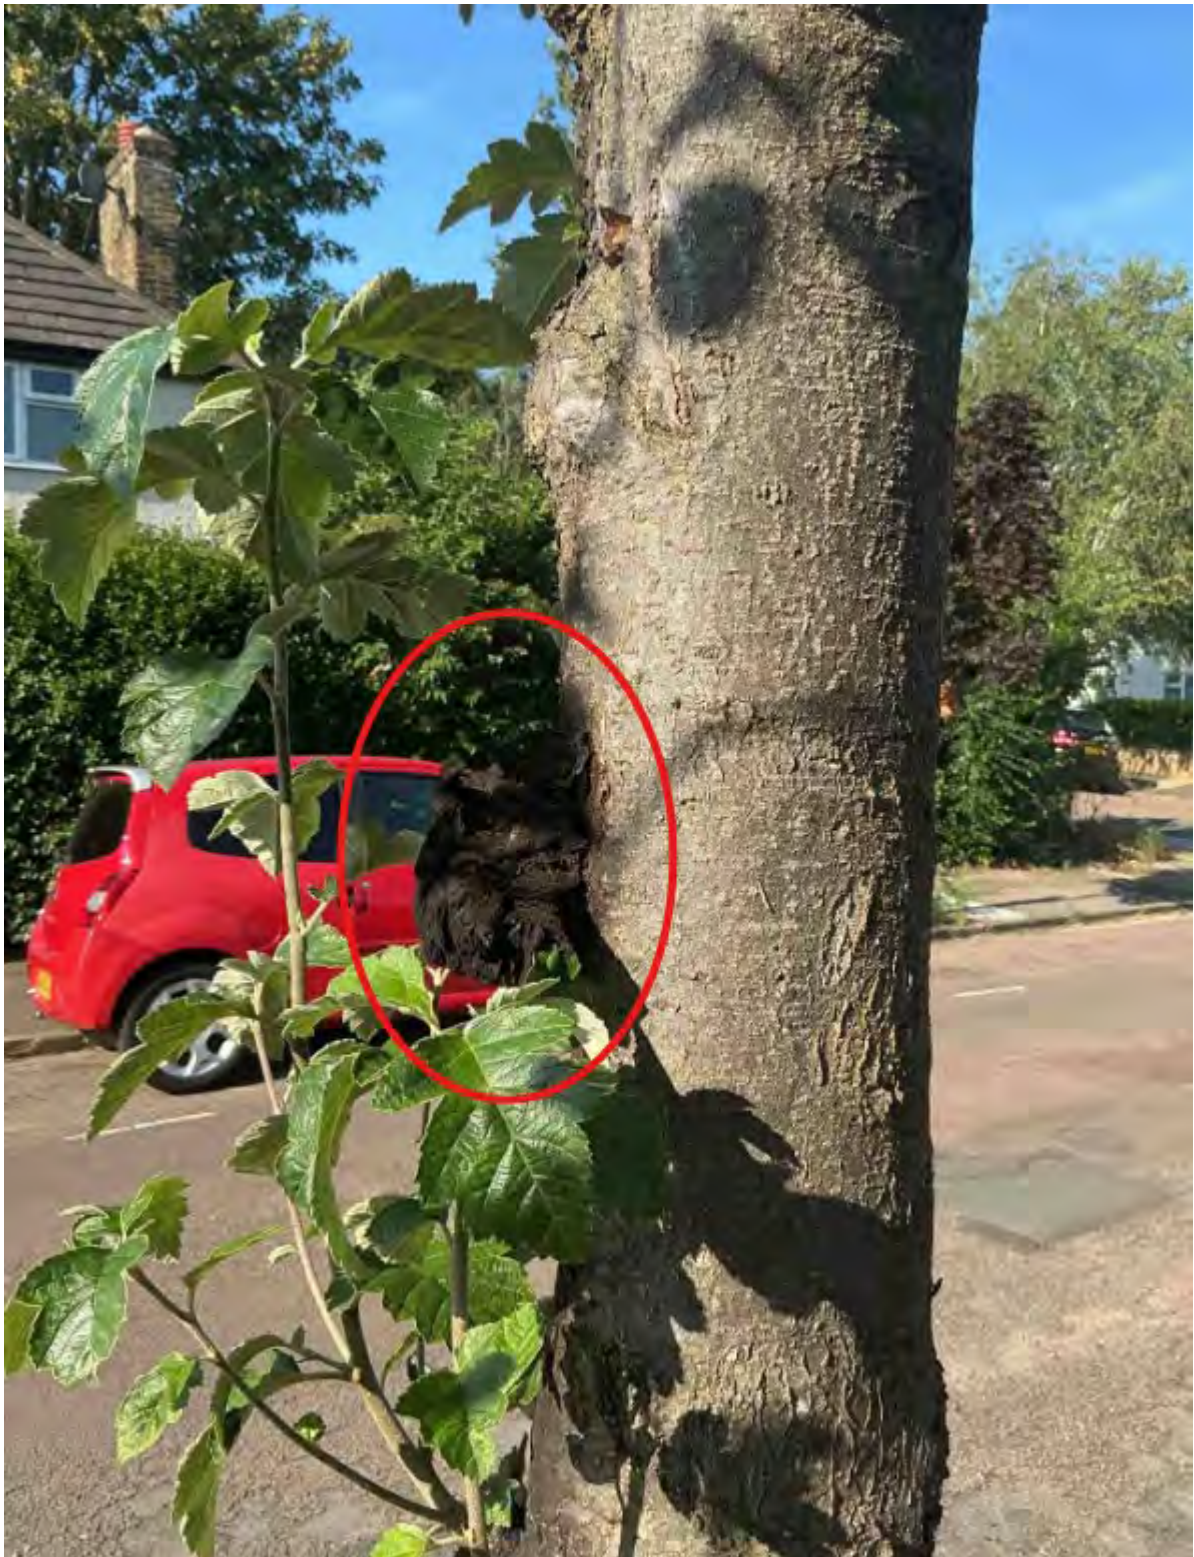
| Inspection findings/reason for exemption | A fungal fruiting body of the species Shaggy Polypore ( <i>Inonotus hispidus</i> ) is present on the trunk; this fungus causes a simultaneous white rot which can cause snapping of tree parts in this particular species. Removal is required to prevent natural failure, manage risk, and facilitate replanting |

***Image shows fungal fruiting body on trunk circled.***

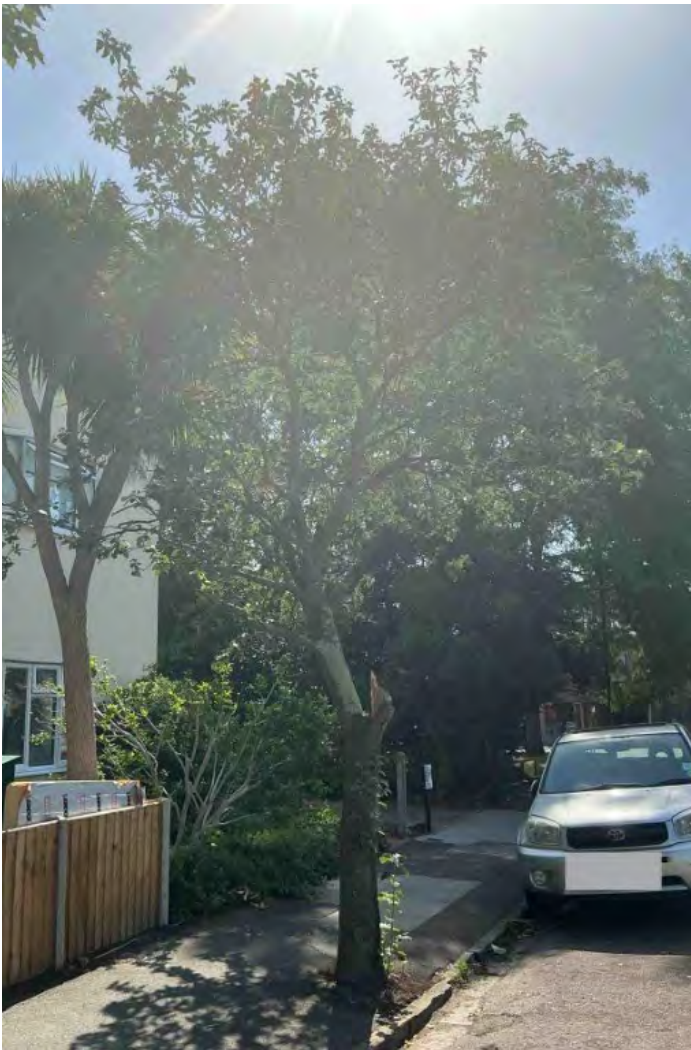
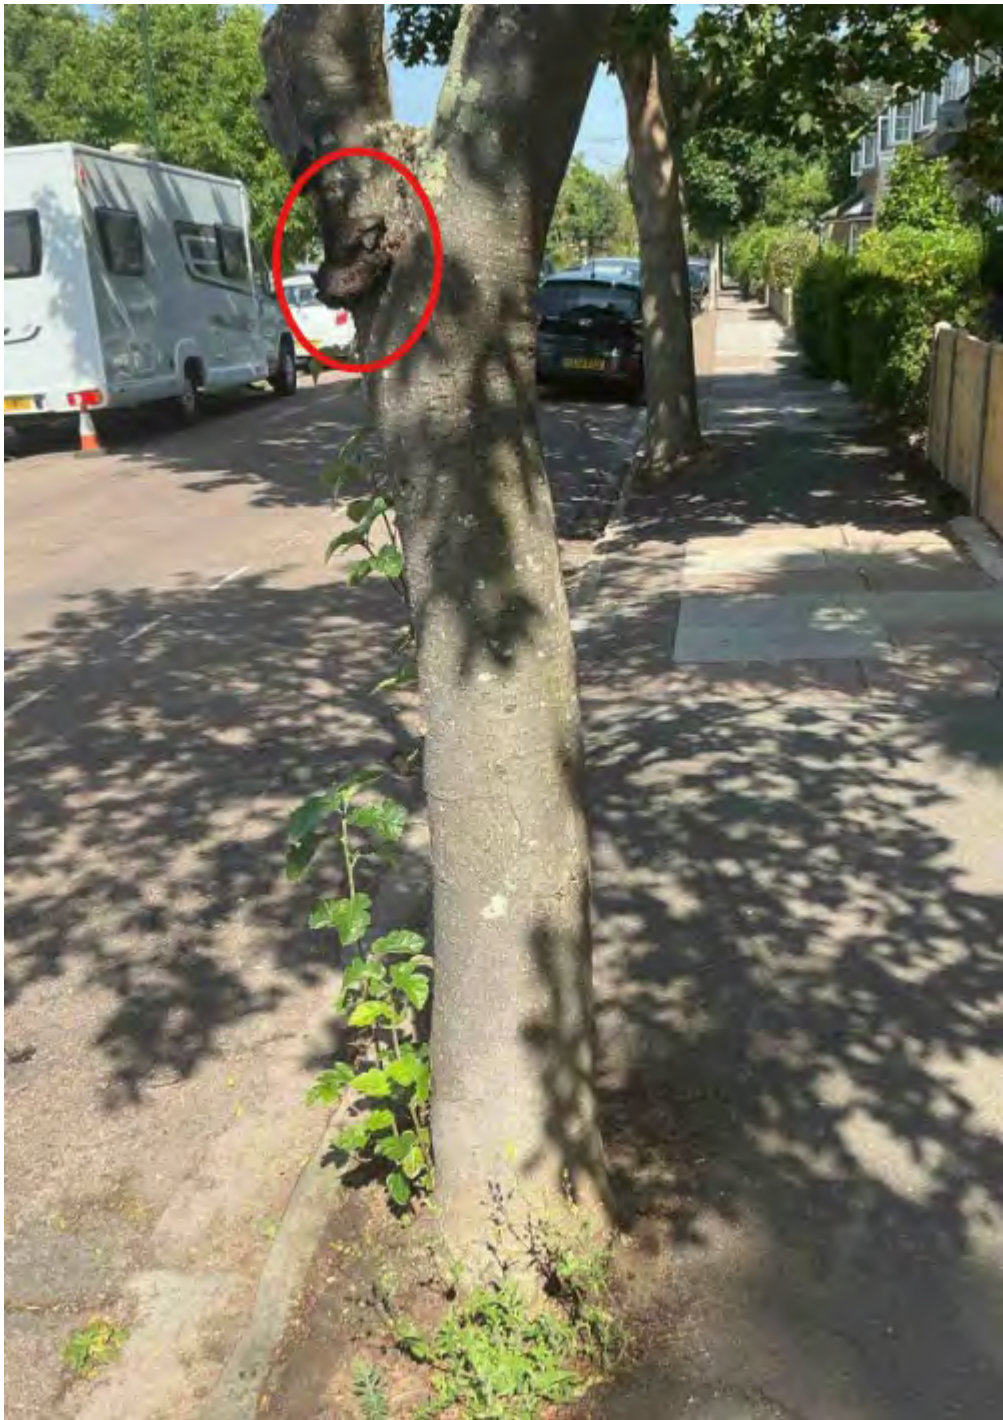
| Inspection findings/reason for exemption | A fungal fruiting body of the decay fungus <i>Ganoderma sp.</i> is present on the trunk. Colonisation by this fungus results in white rot affecting the stem and root system, which can lead to structural failure through fracture or windthrow. A resonance test with a sounding hammer has revealed an unacceptable amount of decay around the bracket. Removal of the tree is recommended to prevent natural failure, manage risk, and facilitate replanting. |

***Image shows fungal fruiting body on trunk circled.***

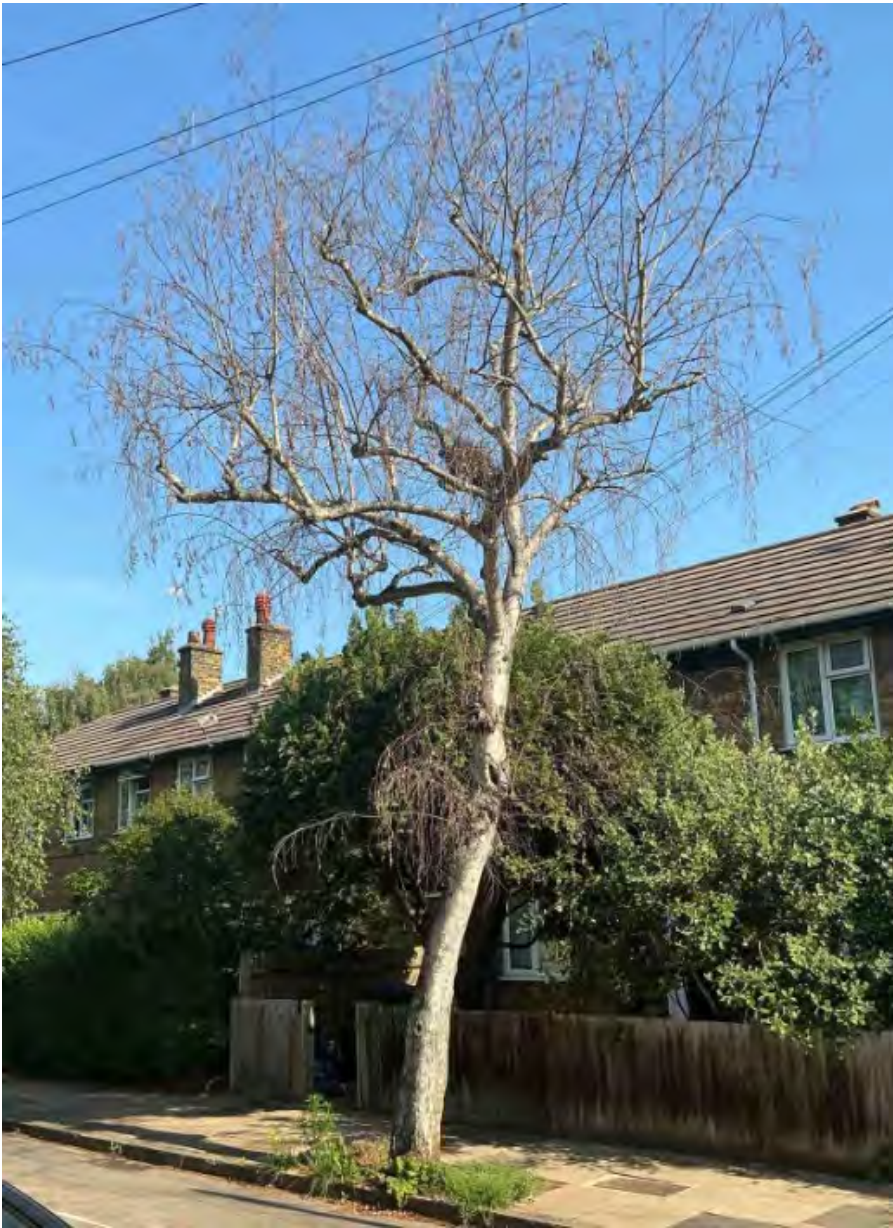
| Inspection findings/reason for exemption | This tree is dead; removal is required to prevent natural failure, manage risk, and facilitate replanting |

Image shows dead tree in street scene.

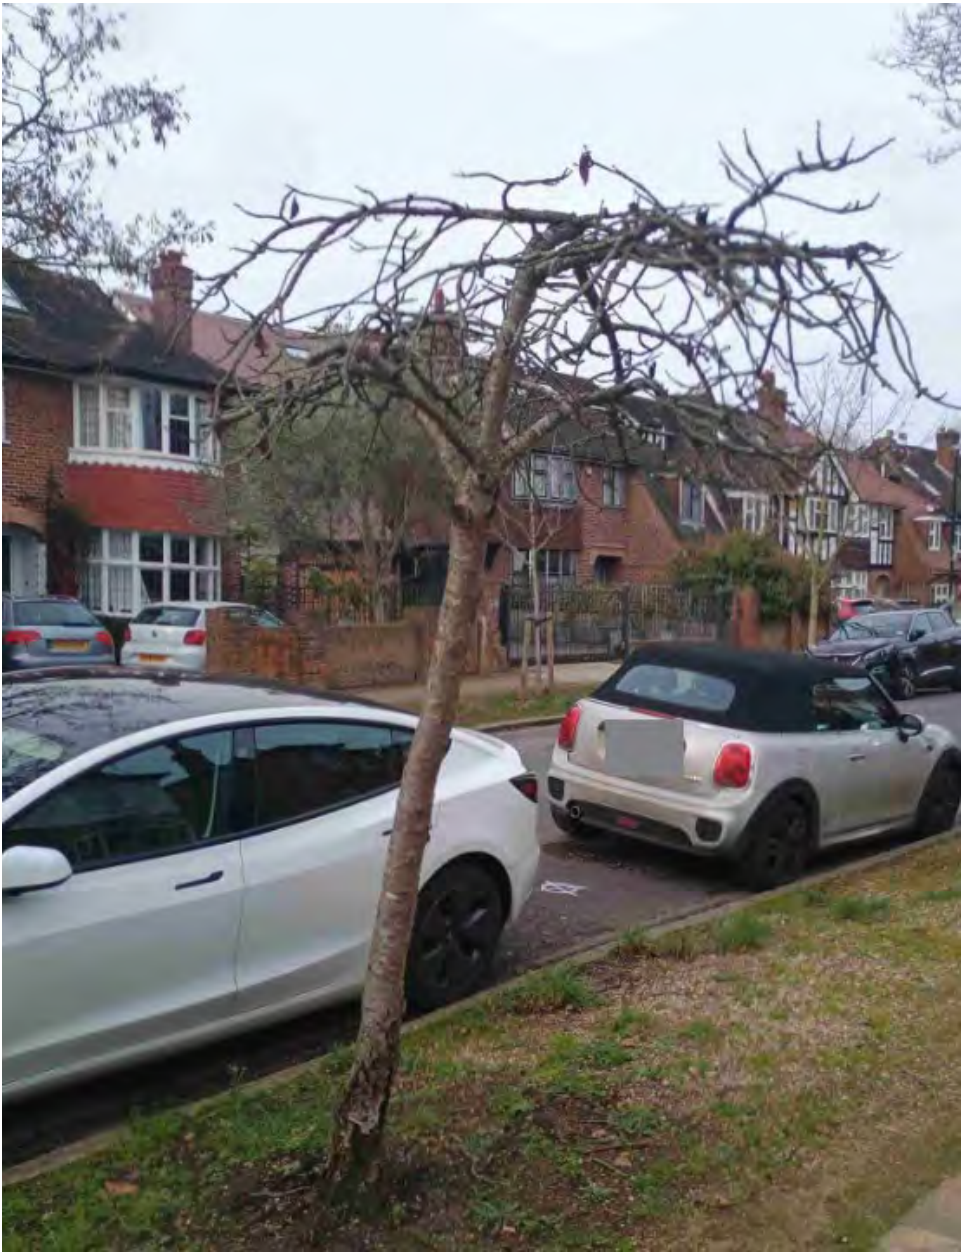
| Inspection findings/reason for exemption | This tree is dead; removal is required to prevent natural failure, manage risk, and facilitate replanting |

Image shows dead tree in street scene.

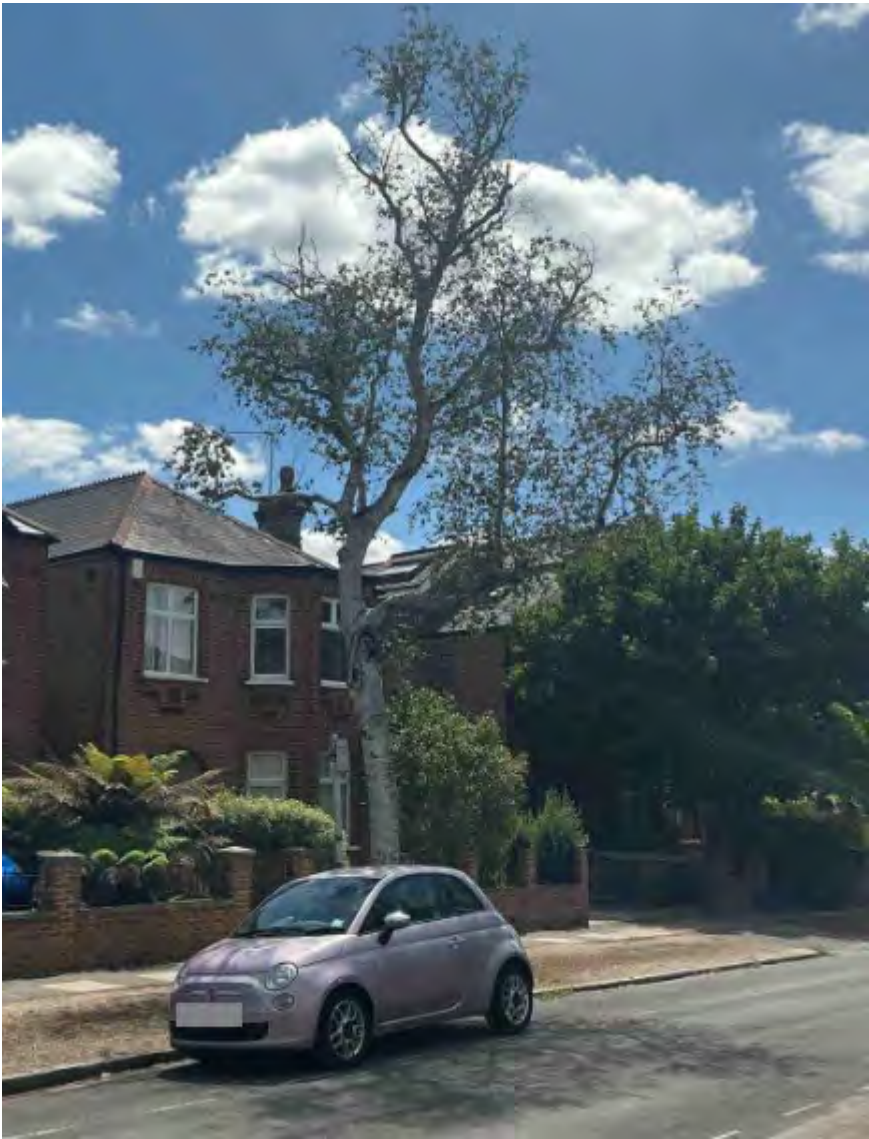
| Inspection findings/reason for exemption | This tree is moribund; removal is required to prevent natural failure, manage risk, and facilitate replanting |

Image shows moribund tree in street scene.

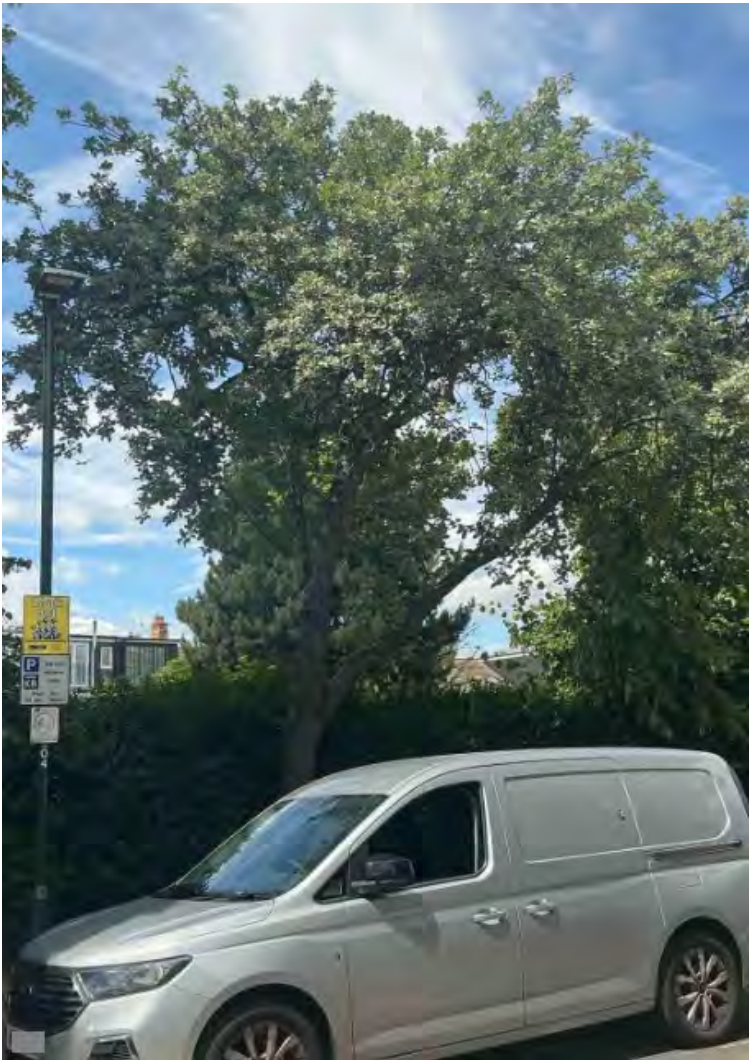
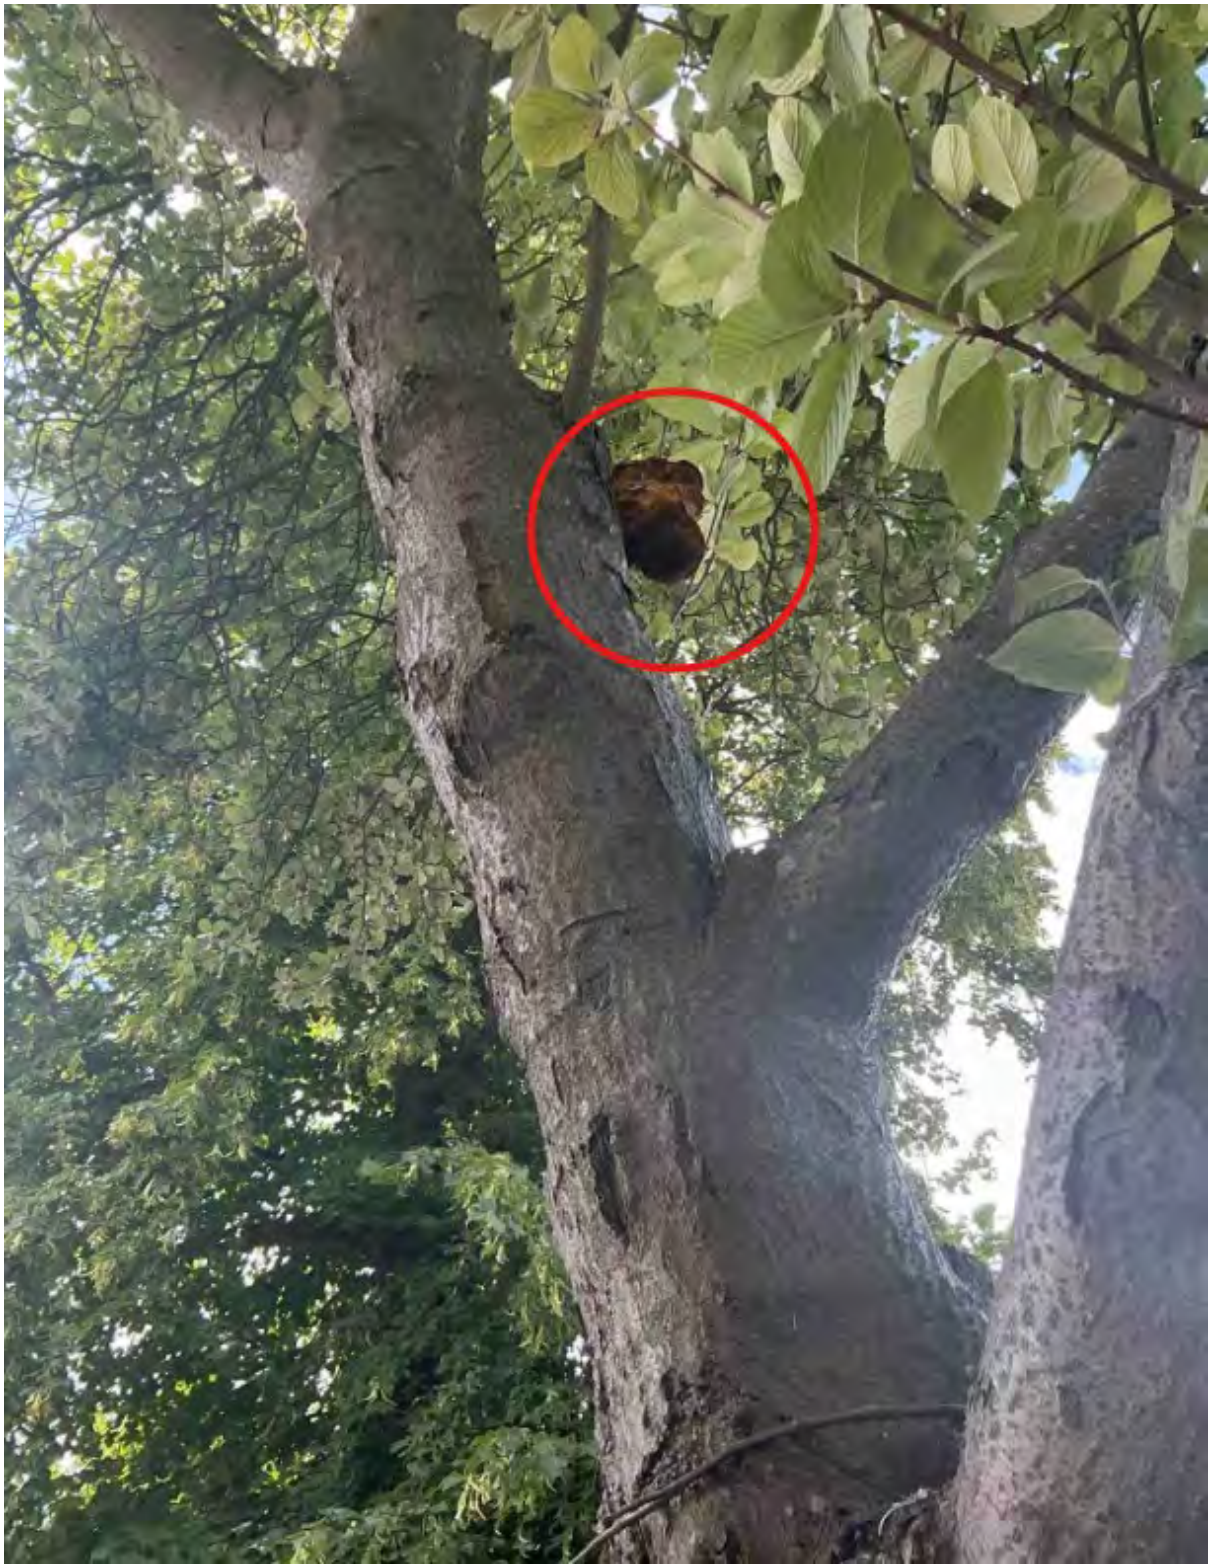
| Inspection findings/reason for exemption | A fungal fruiting body of the species Shaggy Polypore ( <i>Inonotus hispidus</i> ) is present on the main trunk; this fungus causes a simultaneous white rot which can cause snapping of tree parts in this particular species. Removal is required to prevent natural failure, manage risk, and facilitate replanting |

*Image shows fungal fruiting body on trunk circled.*

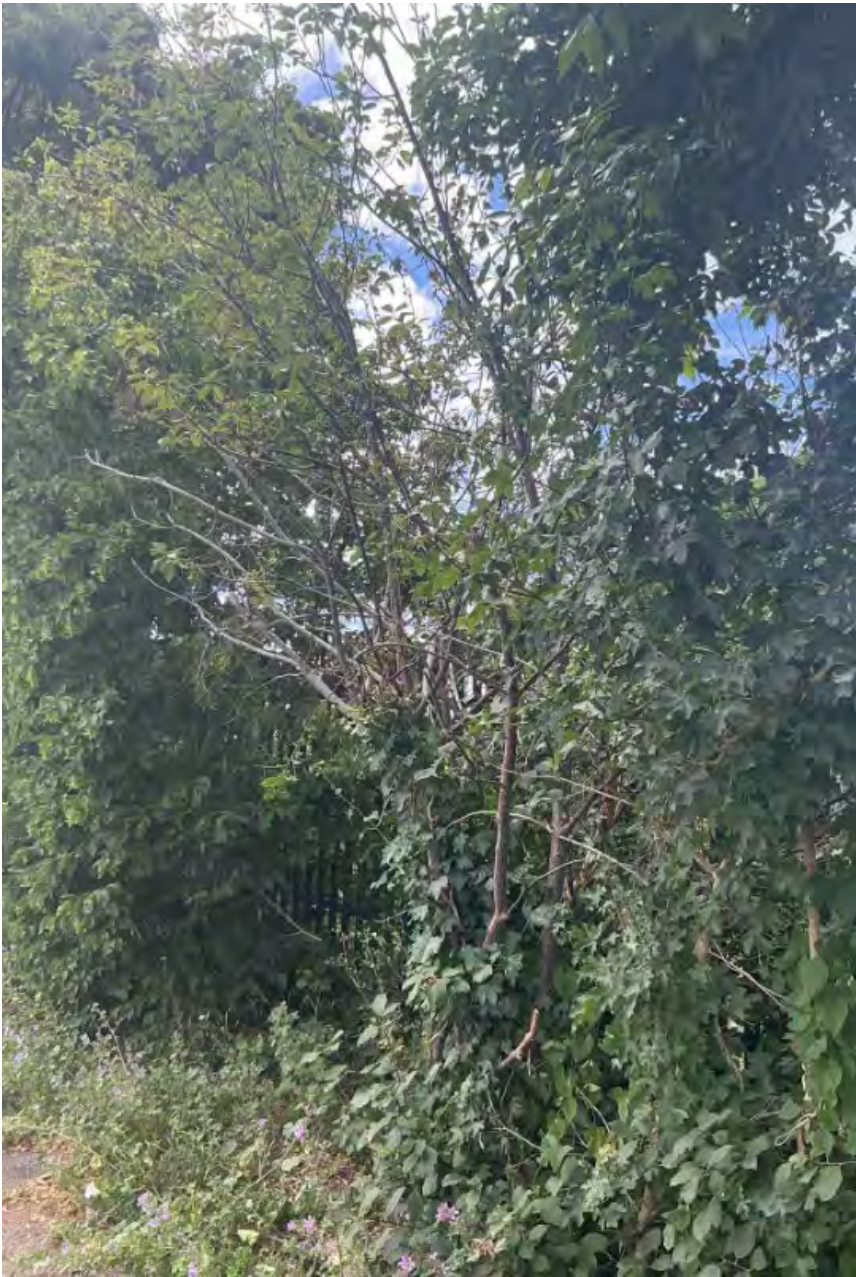
| Inspection findings/reason for exemption | This tree is moribund; removal is required to prevent natural failure, manage risk, and facilitate replanting |

Image shows moribund tree in street scene.

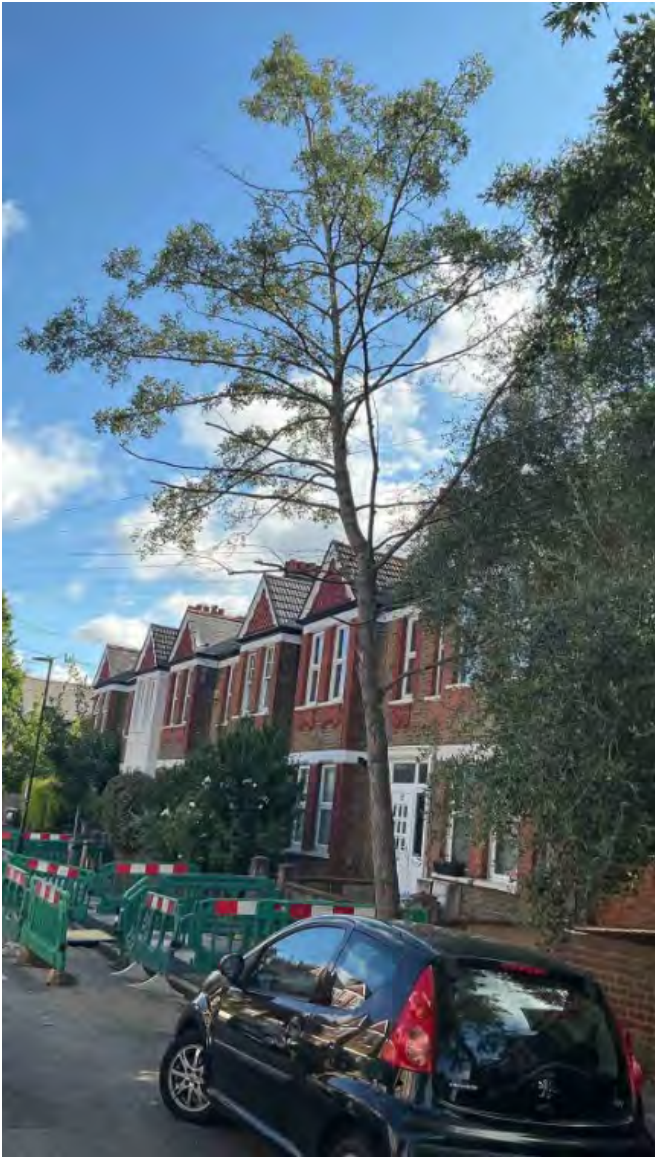
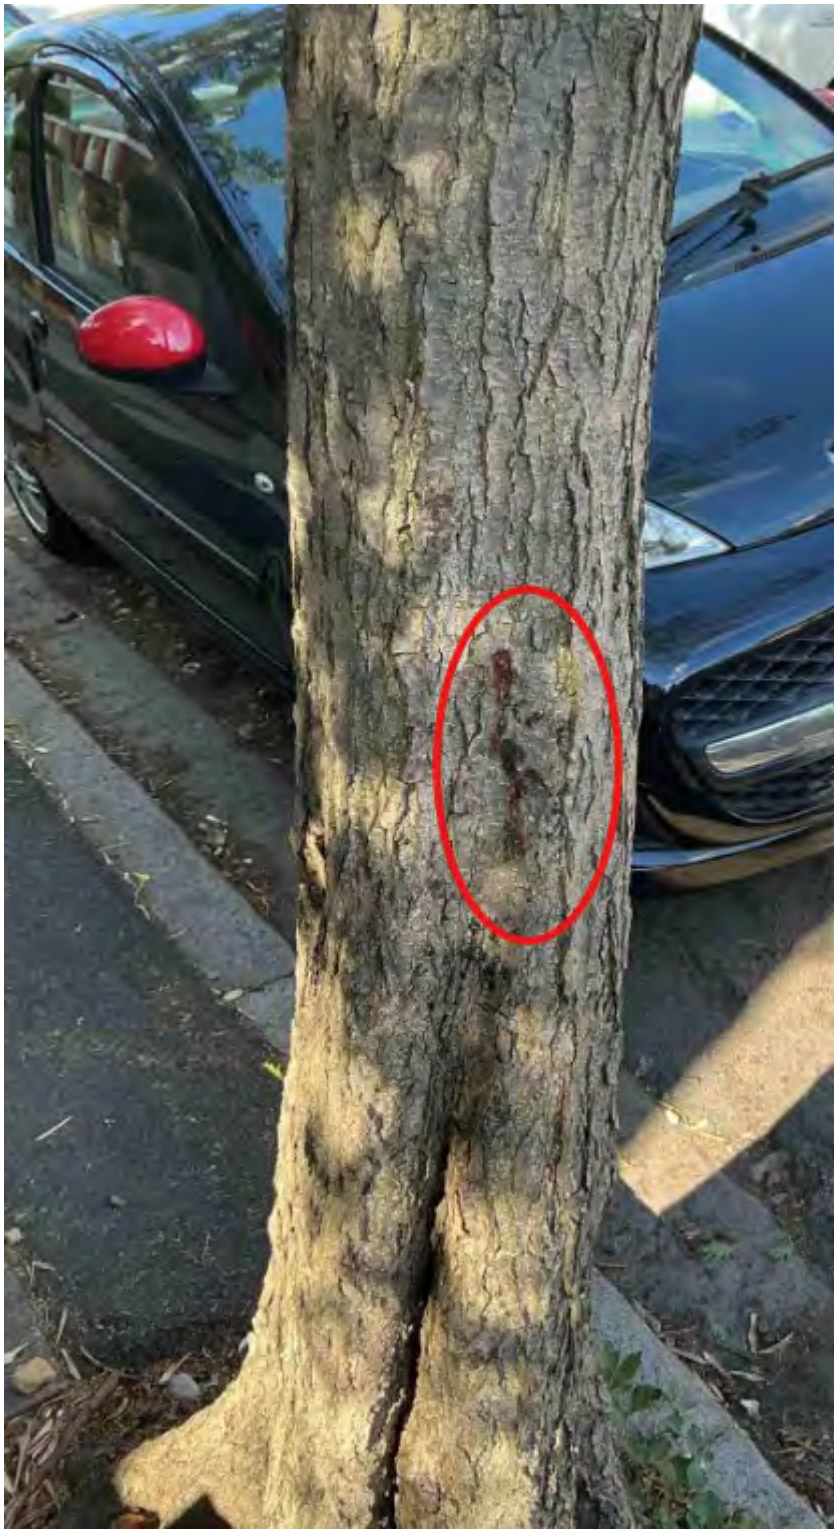
| Inspection findings/reason for exemption | This tree has bark discolouration that indicates the presence of pathogen Phytophthora sp. which causes rotting of the roots of hosts which can cause entire trees to fail. Crown dieback correlates with the pathogen on the trunk. Removal is required to prevent natural failure, manage risk, and facilitate replanting |

***Image shows pathogen exudate circled on trunk.***

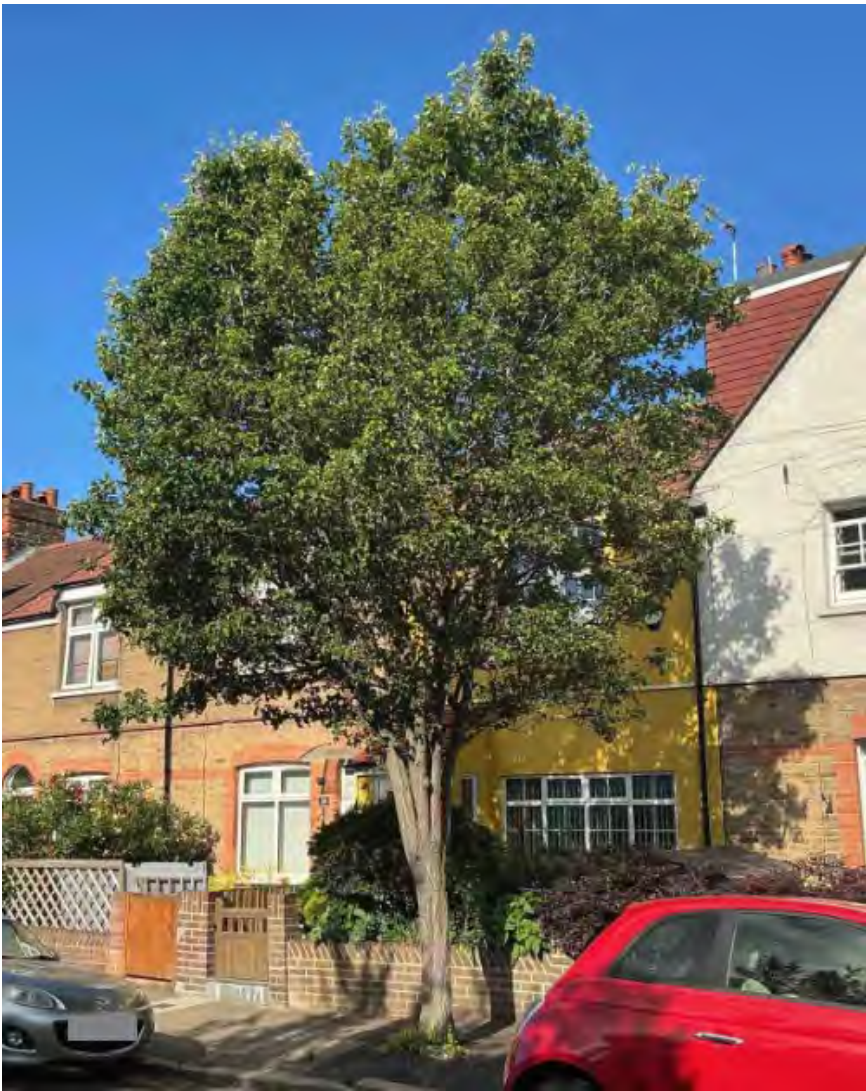
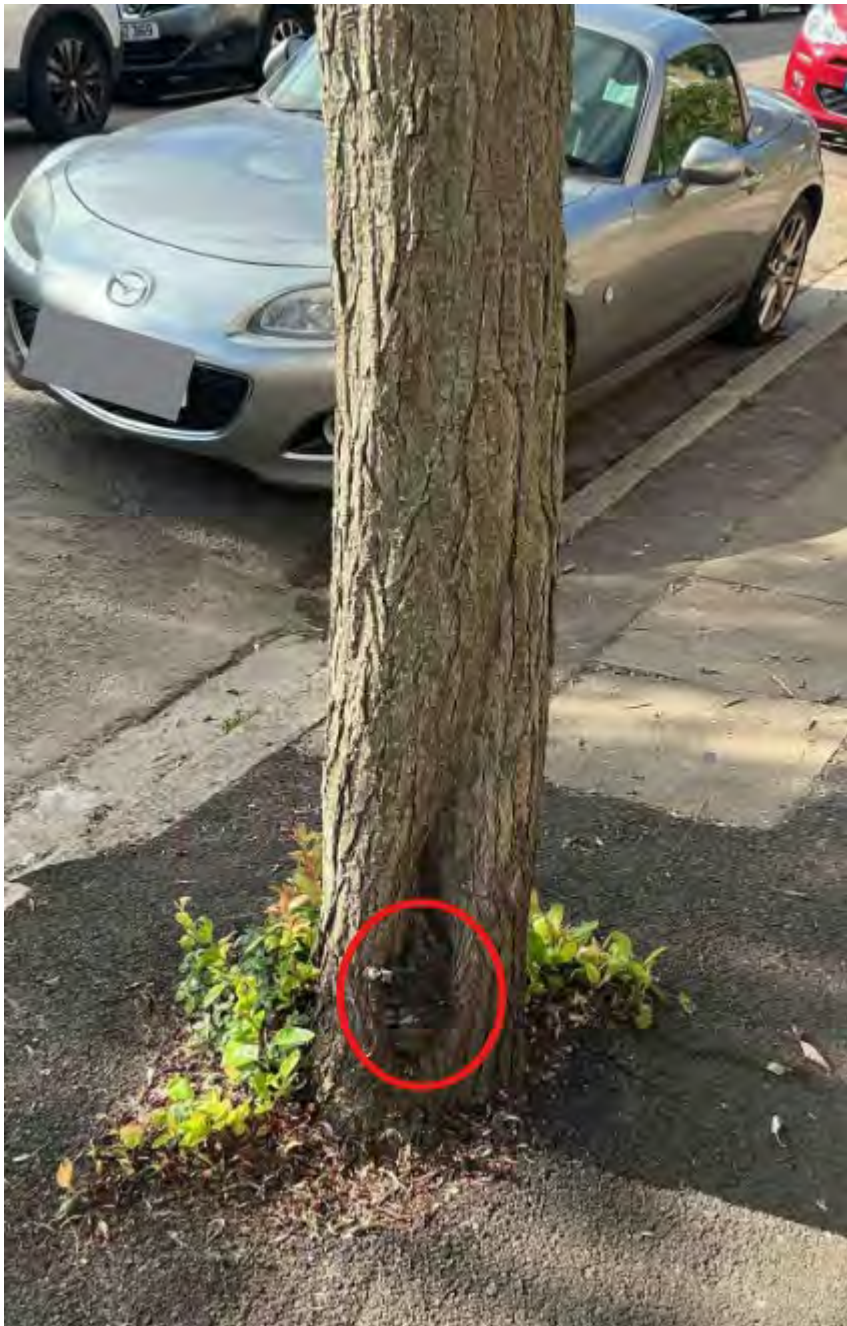
| Inspection findings/reason for exemption | A fungal fruiting body of the decay fungus <i>Ganoderma sp.</i> is present on the trunk. Colonisation by this fungus results in white rot affecting the stem and root system, which can lead to structural failure through fracture or windthrow. A resonance test with a sounding hammer has revealed an unacceptable amount of decay around the bracket in cavity. Removal of the tree is recommended to prevent natural failure, manage risk, and facilitate replanting. |

***Image shows fungal fruiting body on trunk circled.***

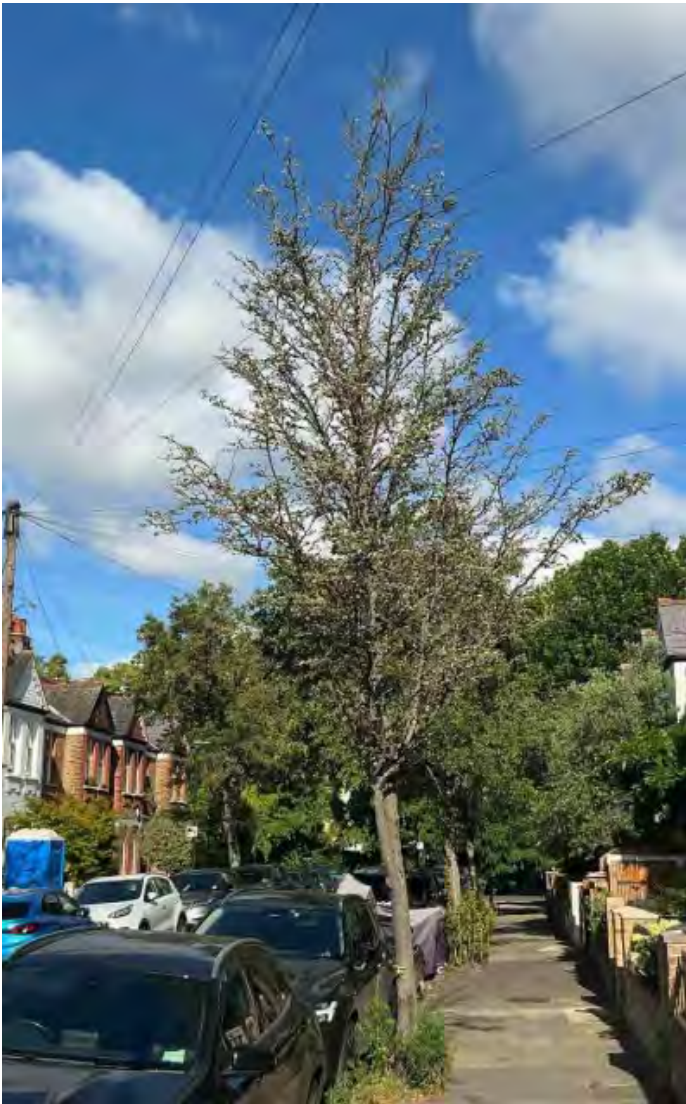
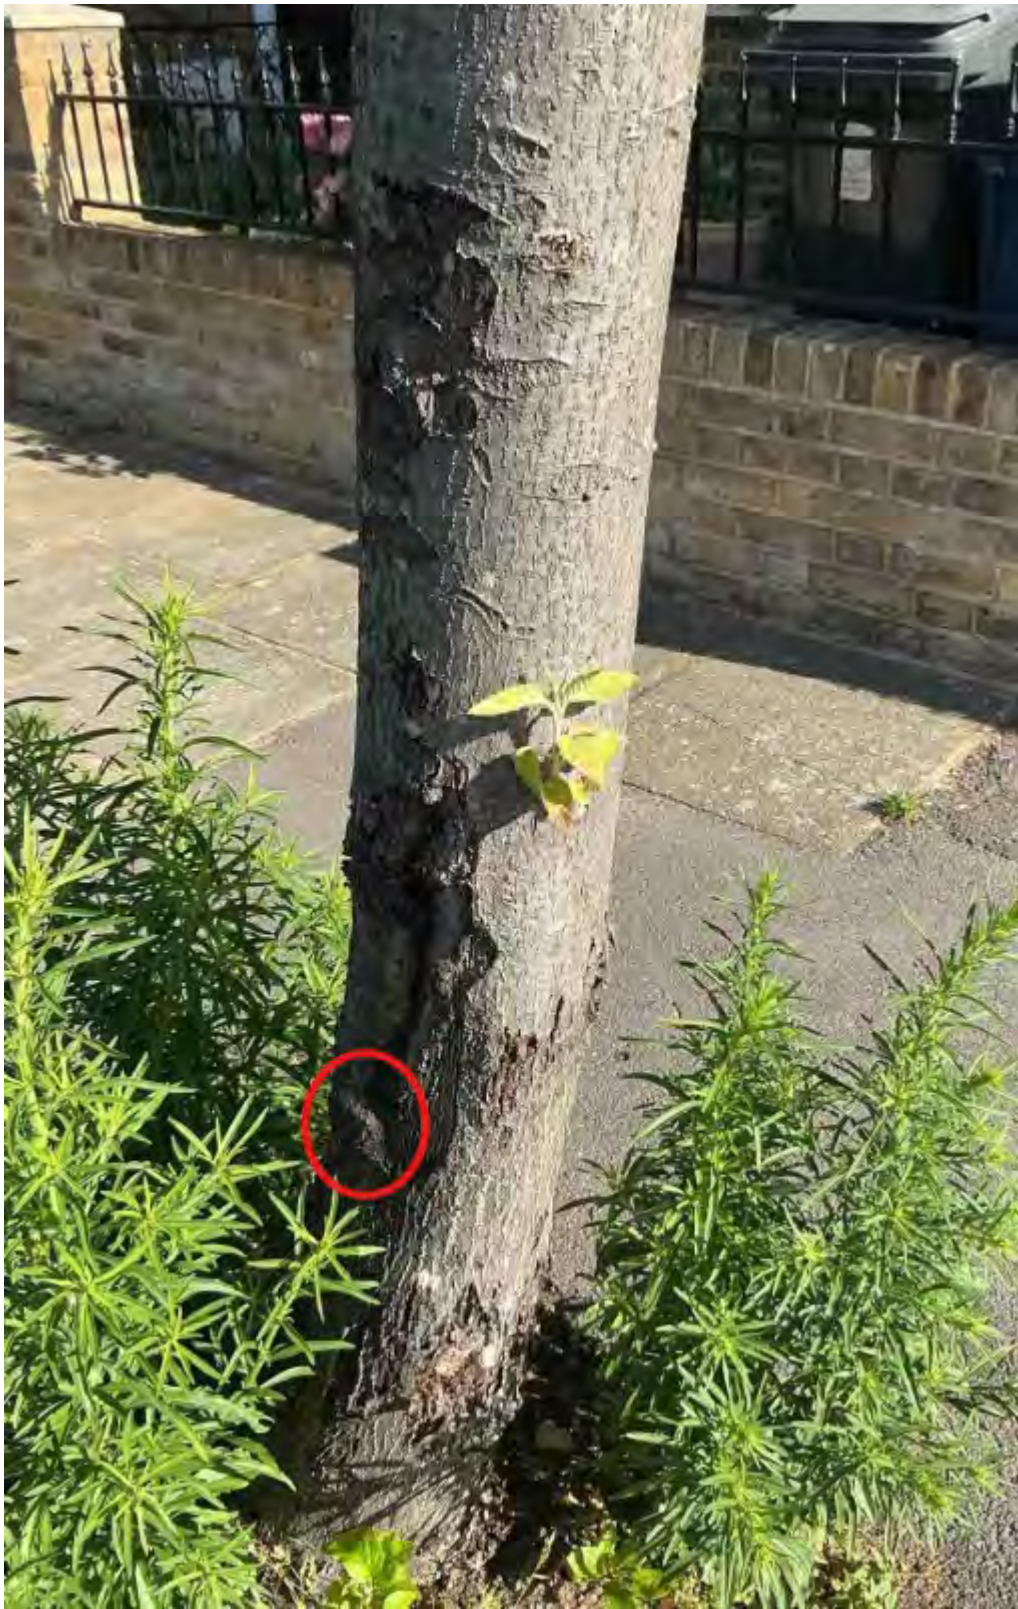
| Inspection findings/reason for exemption | A fungal fruiting body of the decay fungus <i>Ganoderma sp.</i> is present on the trunk. Colonisation by this fungus results in white rot affecting the stem and root system, which can lead to structural failure through fracture or windthrow. Crown dieback is evident and correlates with the presence of the decay fungi. Removal of the tree is recommended to prevent natural failure, manage risk, and facilitate replanting. |

***Image shows fungal fruiting body on trunk circled.***

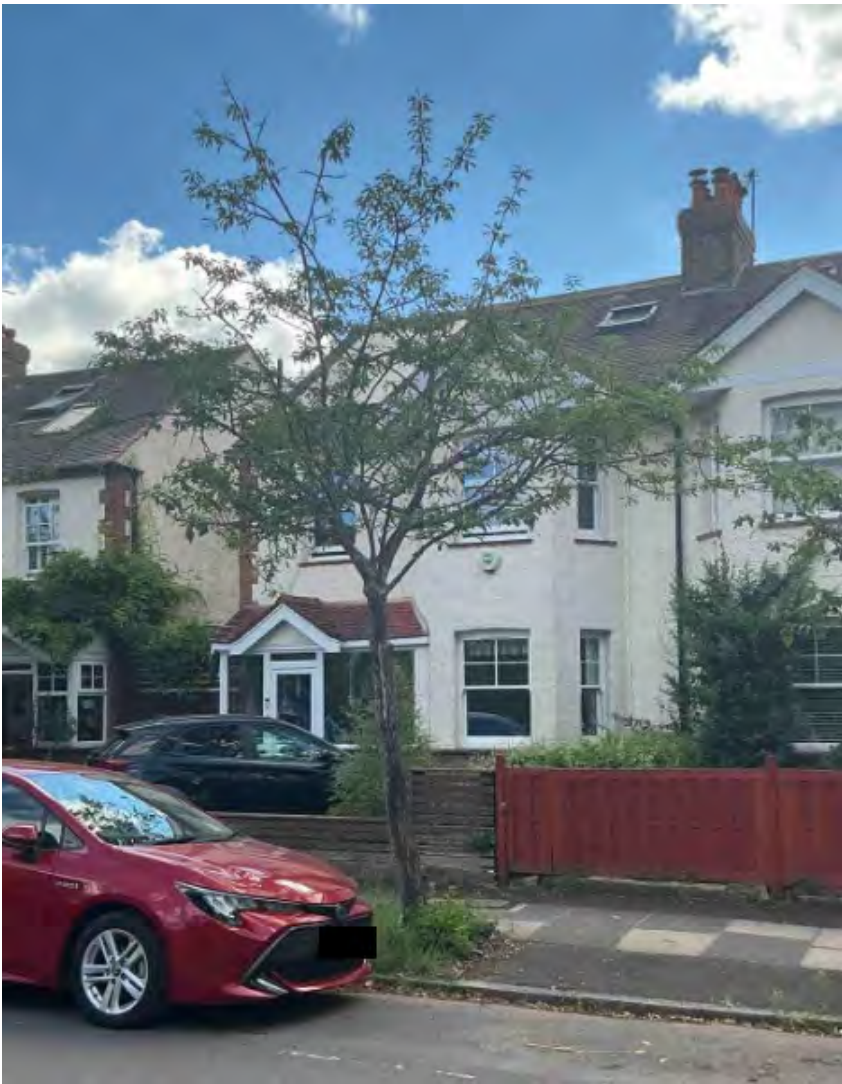
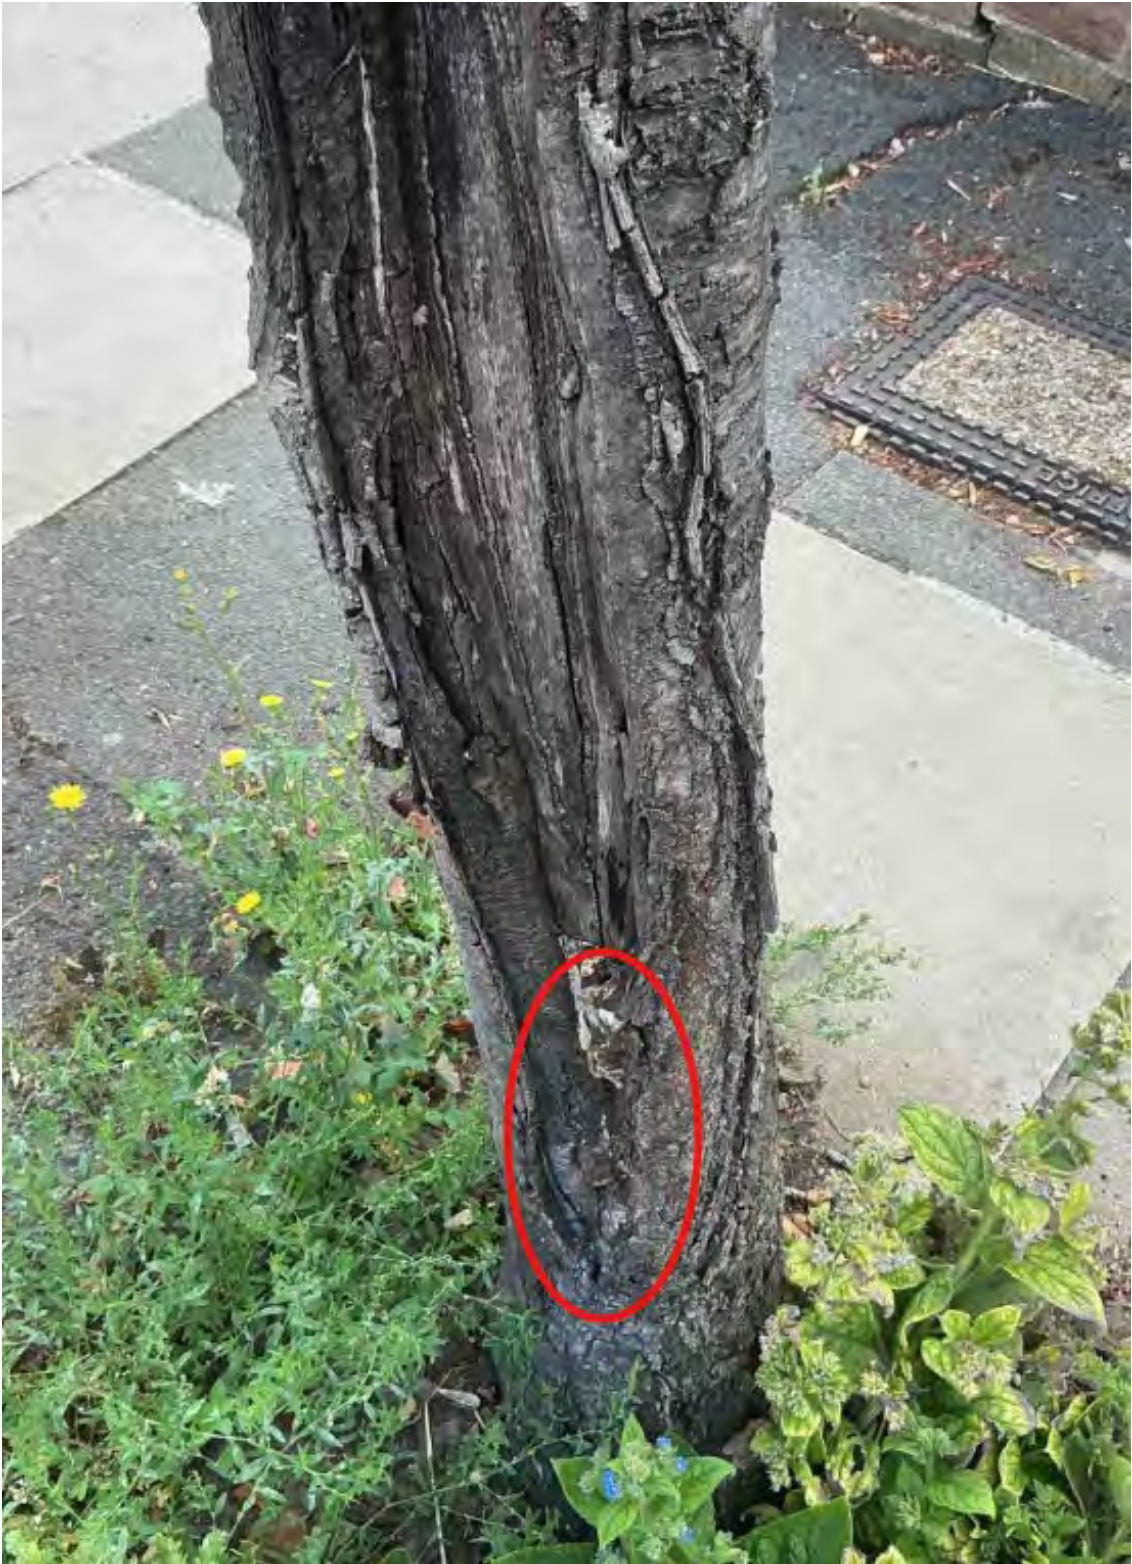
| Inspection findings/reason for exemption | A fungal fruiting body of the decay fungus Ganoderma sp. is present on the trunk. Colonisation by this fungus results in white rot affecting the stem and root system, which can lead to structural failure through fracture or windthrow A resonance test with a sounding hammer has revealed an unacceptable amount of decay around the bracket. Removal of the tree is recommended to prevent natural failure, manage risk, and facilitate replanting. |

***Image shows fungal fruiting body on trunk circled.***
