# July 2026 – Highways Reactive Tree Works Programme

A survey of trees in ward of Kew has been undertaken; this is being conducted by specialist arboricultural officers as part of the scheduled 4 yearly detailed inspection regime that has been devised for all Council highway and parks trees.

Dated 24.7.2026

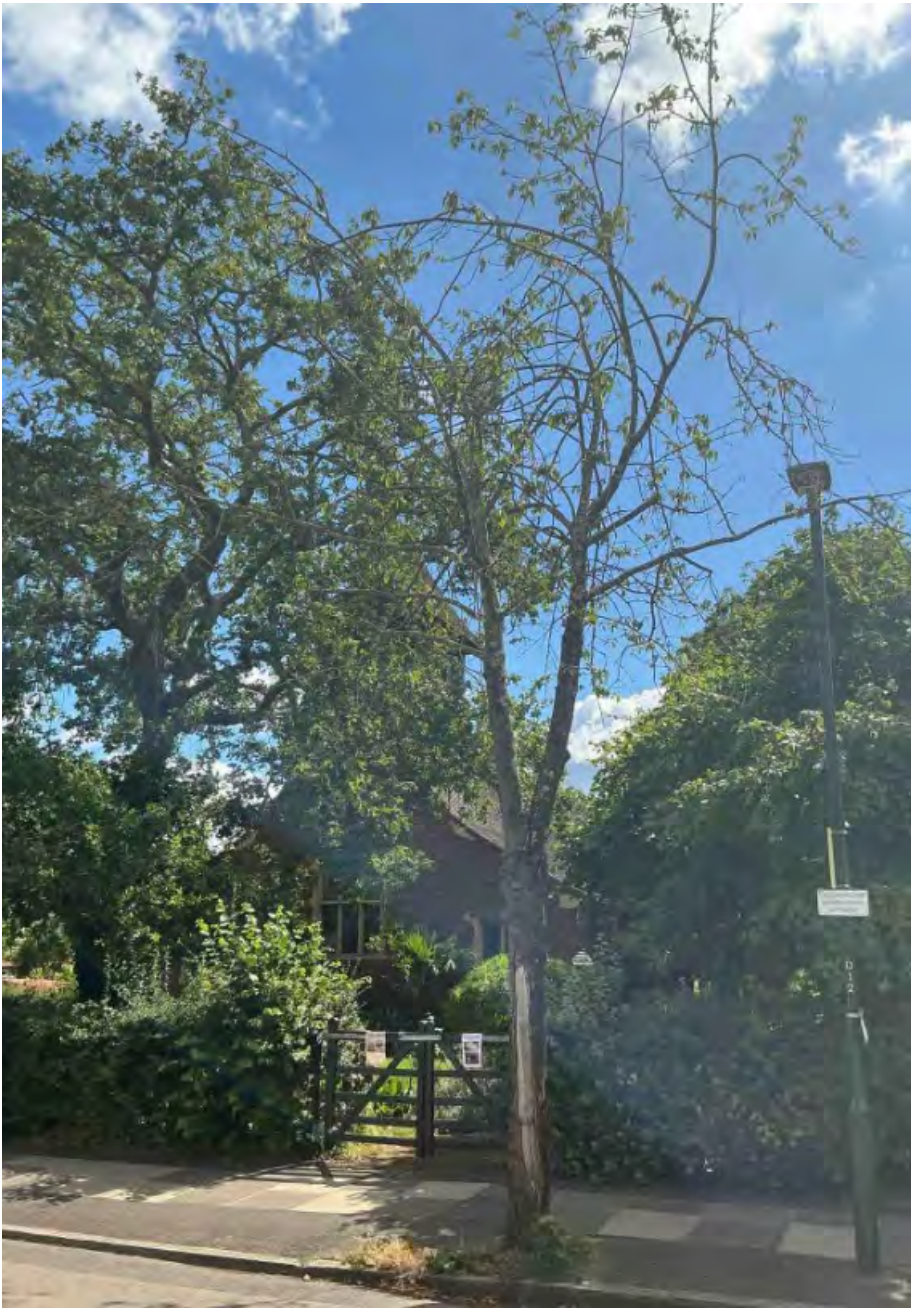
| Inspection findings/reason for exemption | This tree is moribund; removal is required to prevent natural failure, manage risk, and facilitate replanting |

Image shows moribund tree on street scene.

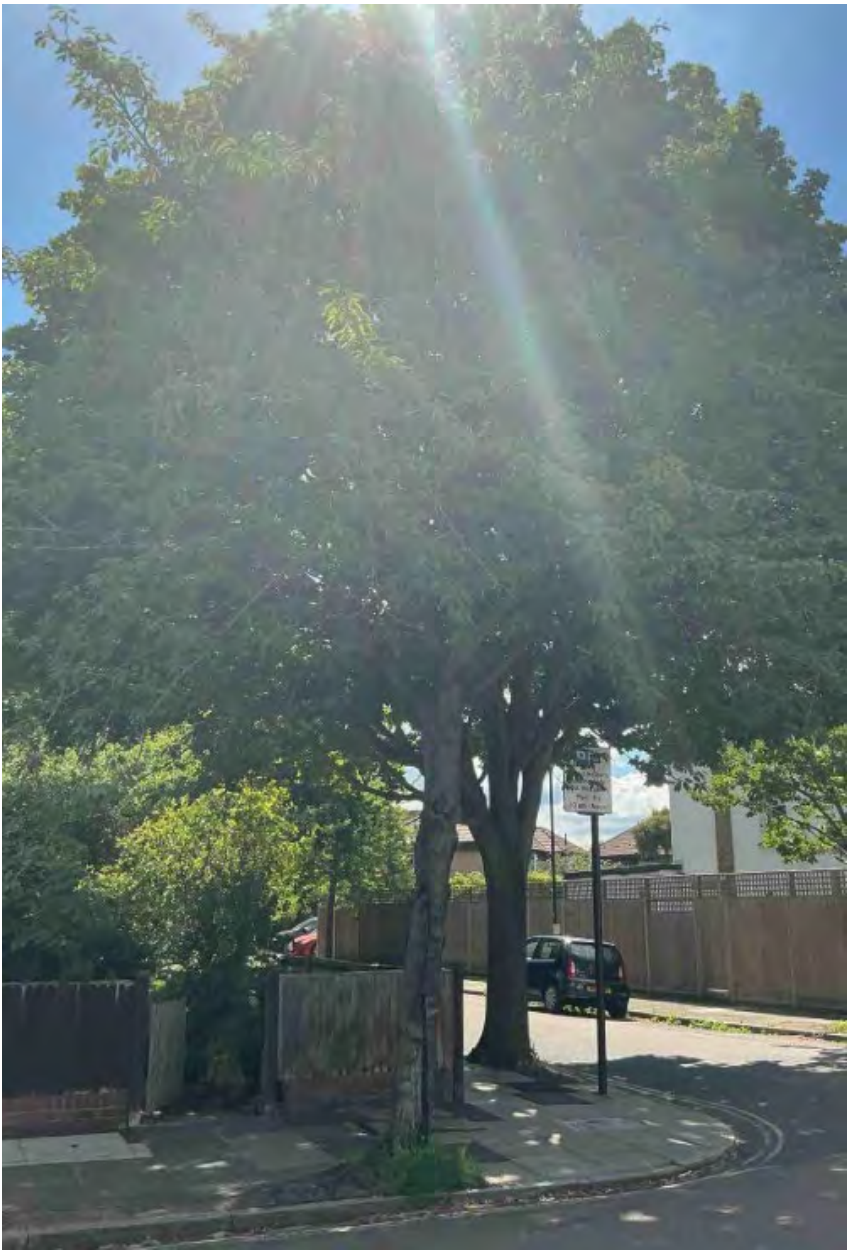
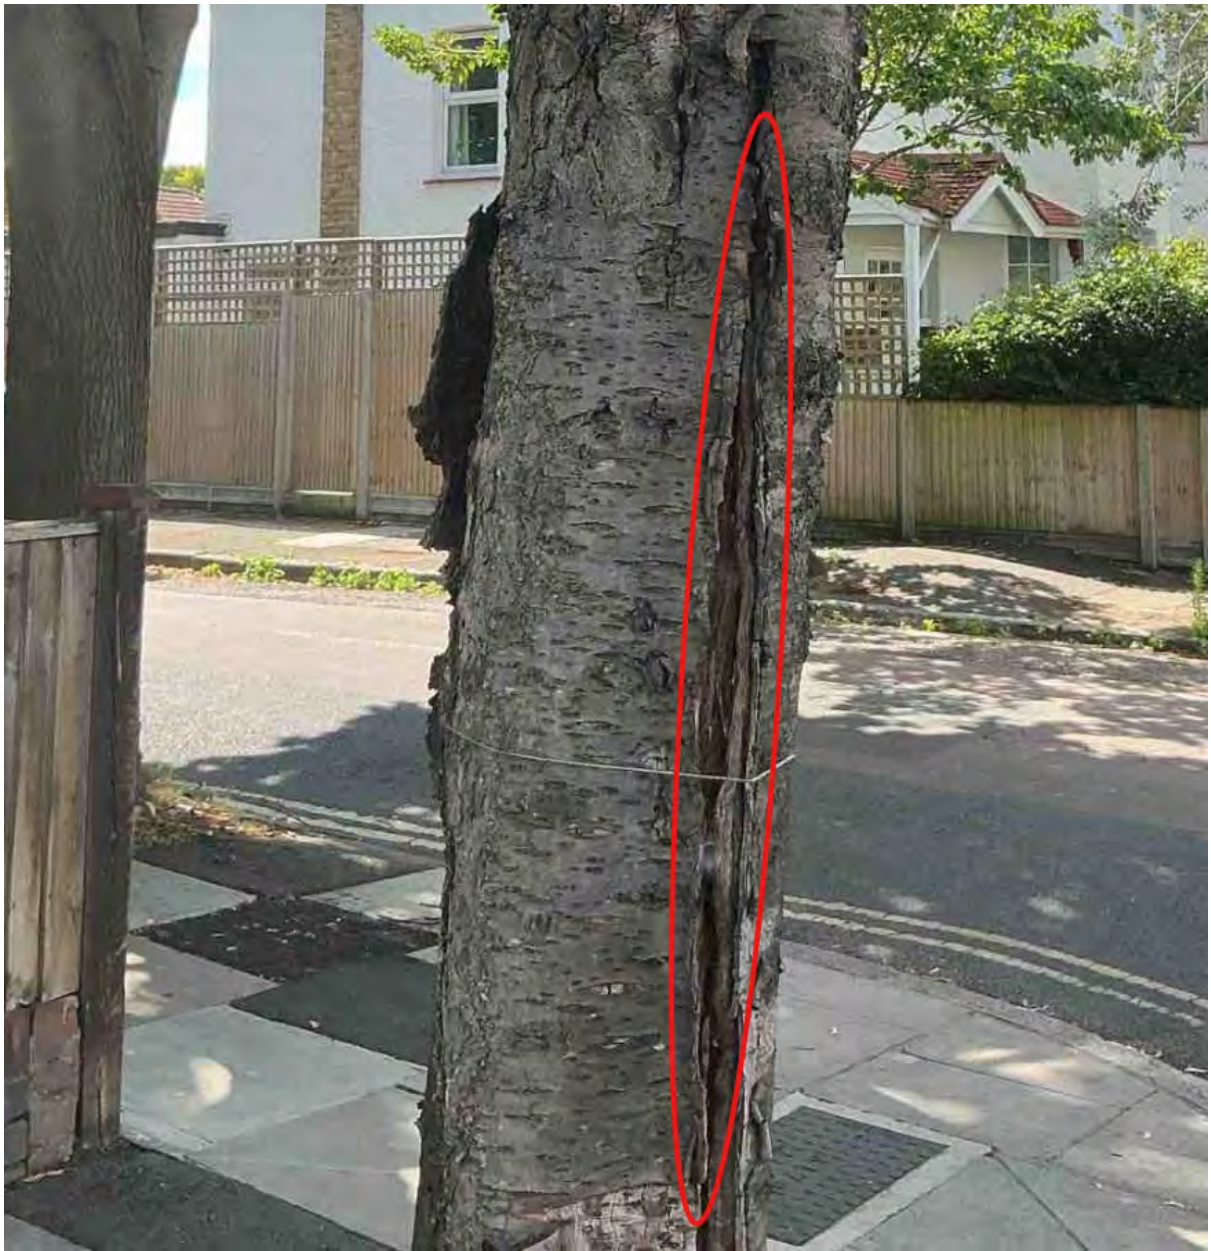
| Inspection findings/reason for exemption | Investigation using a probe and a resonance test with a sounding hammer has identified a longitudinal split within the main stem. Removal is required to prevent natural failure, manage risk, and facilitate replanting. |

***Image shows split in trunk circled***

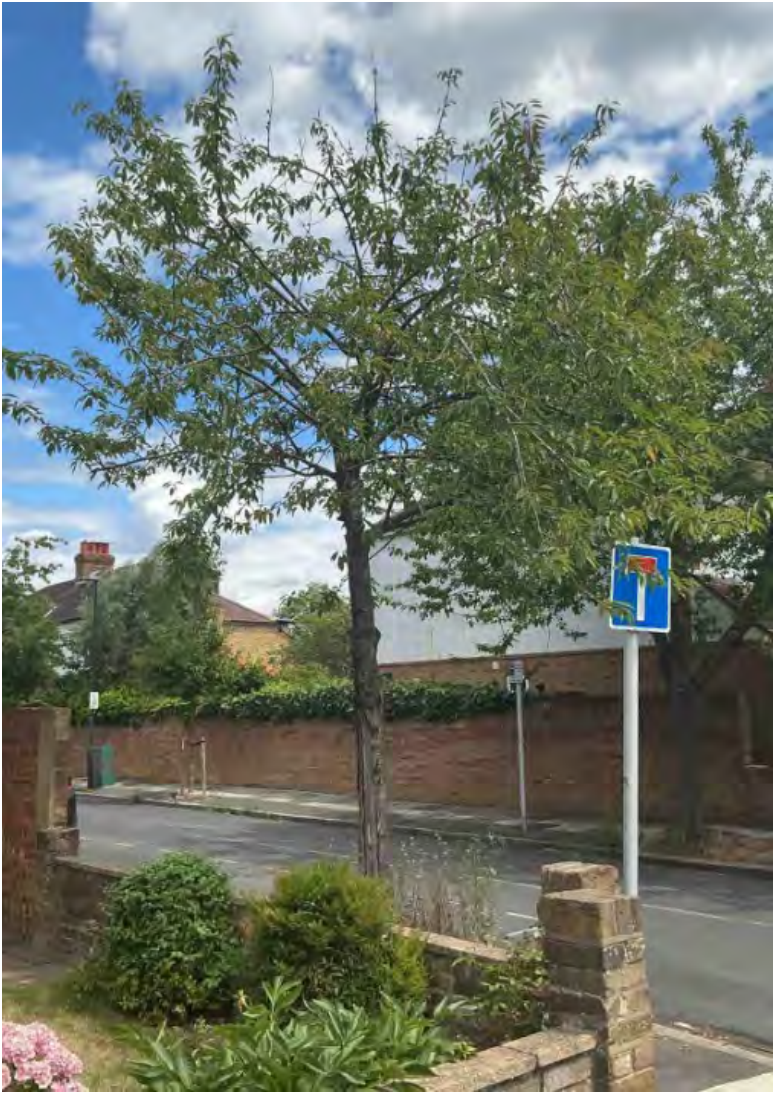
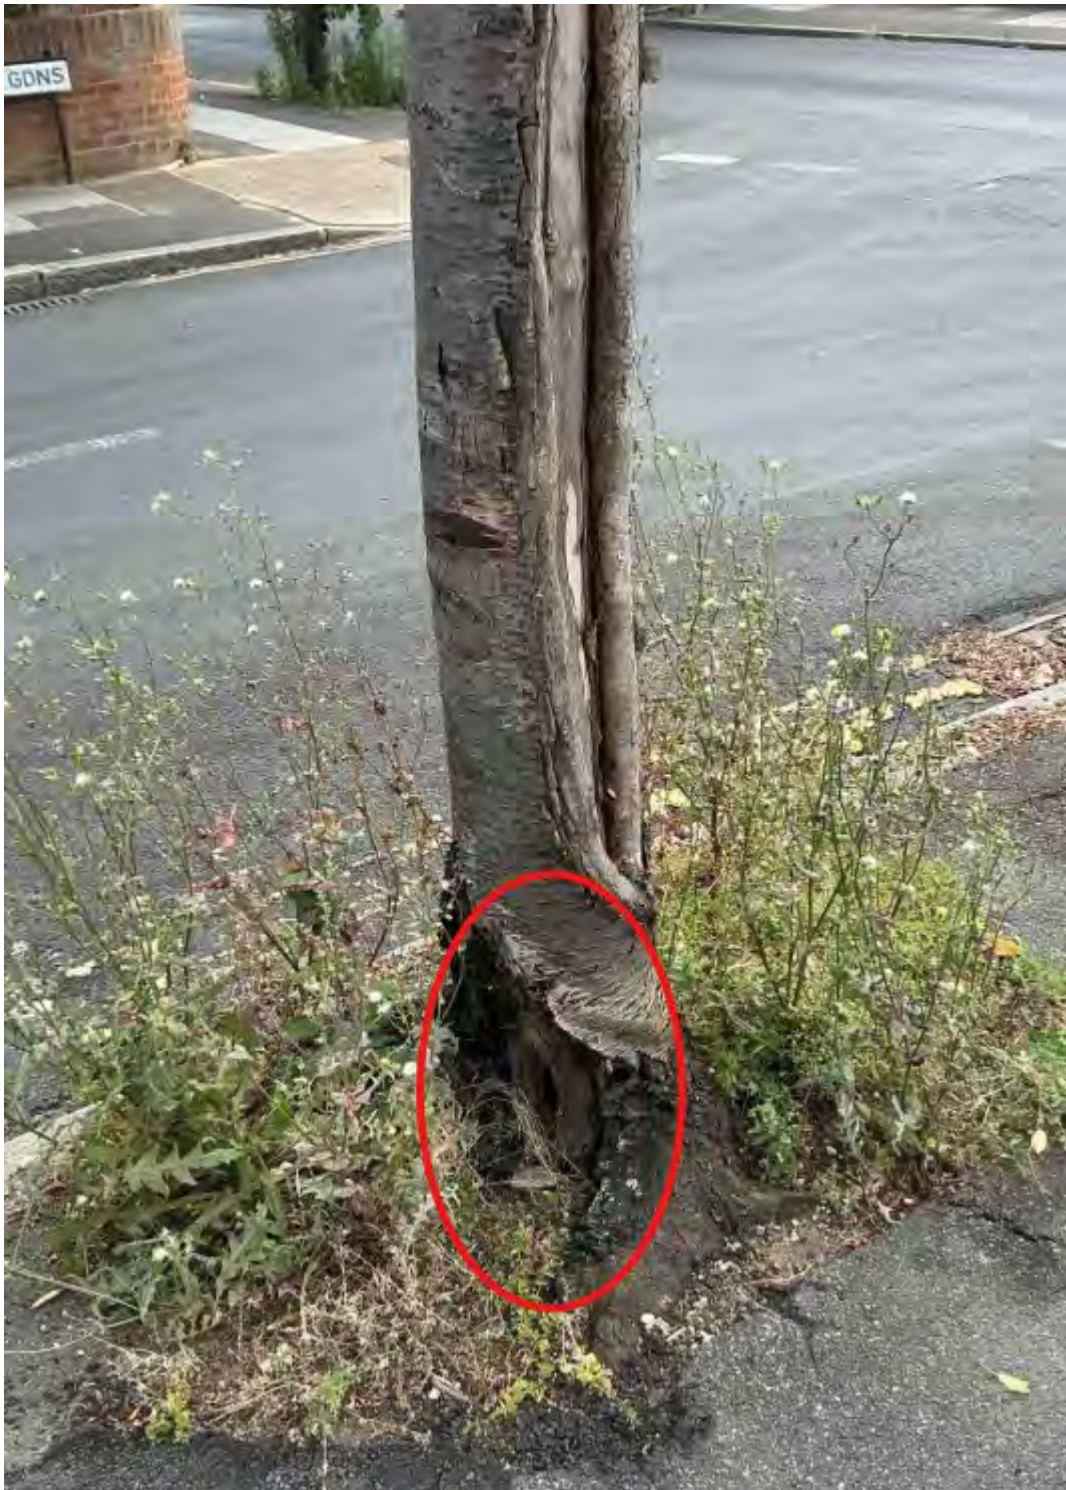
| Inspection findings/reason for exemption | Investigation with a probe and a resonance test with a sounding hammer has revealed an unacceptable amount of decay beyond the visible cavities at the base of the trunk. Removal is required to prevent natural failure, manage risk, and facilitate replanting. |

***Image shows cavity on trunk circled***

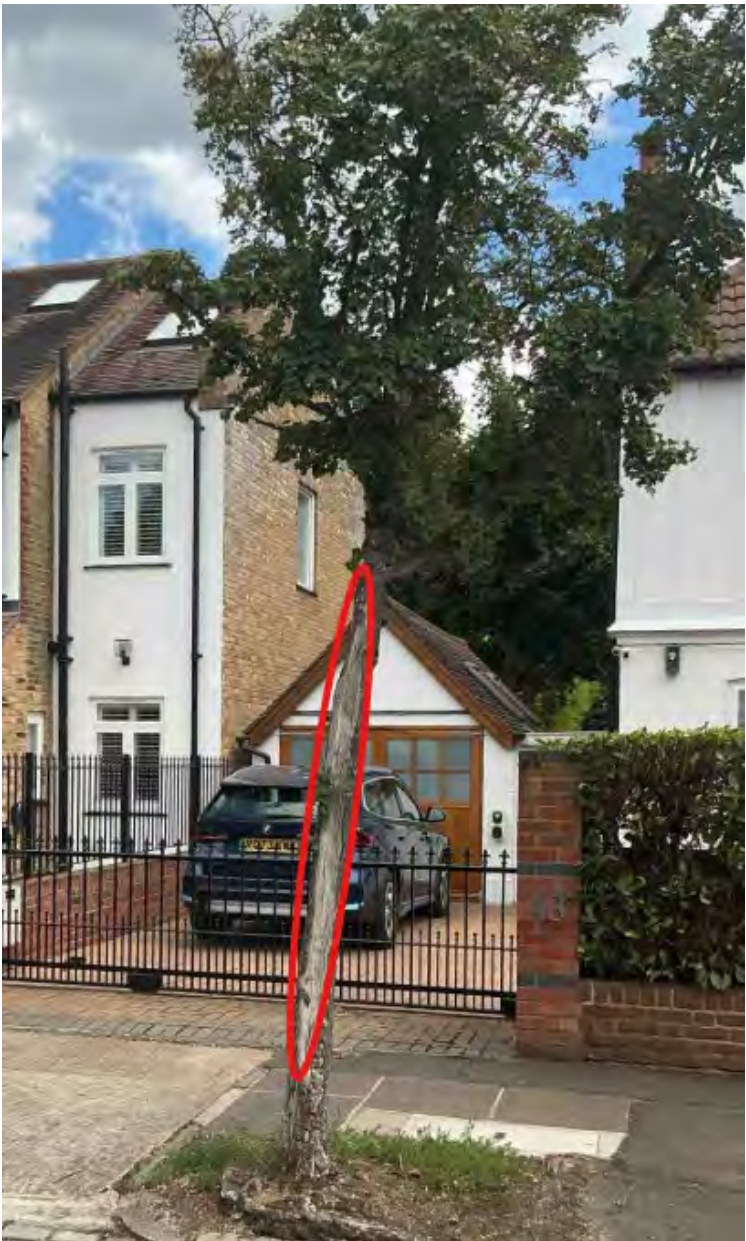
| Inspection findings/reason for exemption | This tree has sustained vehicle damage on the stem; this extensive wounding has caused necrosis and dysfunction of the trees vascular system. Removal is required to prevent natural failure, manage risk, and facilitate replanting. |

Image shows tree in street scene with wound circled.

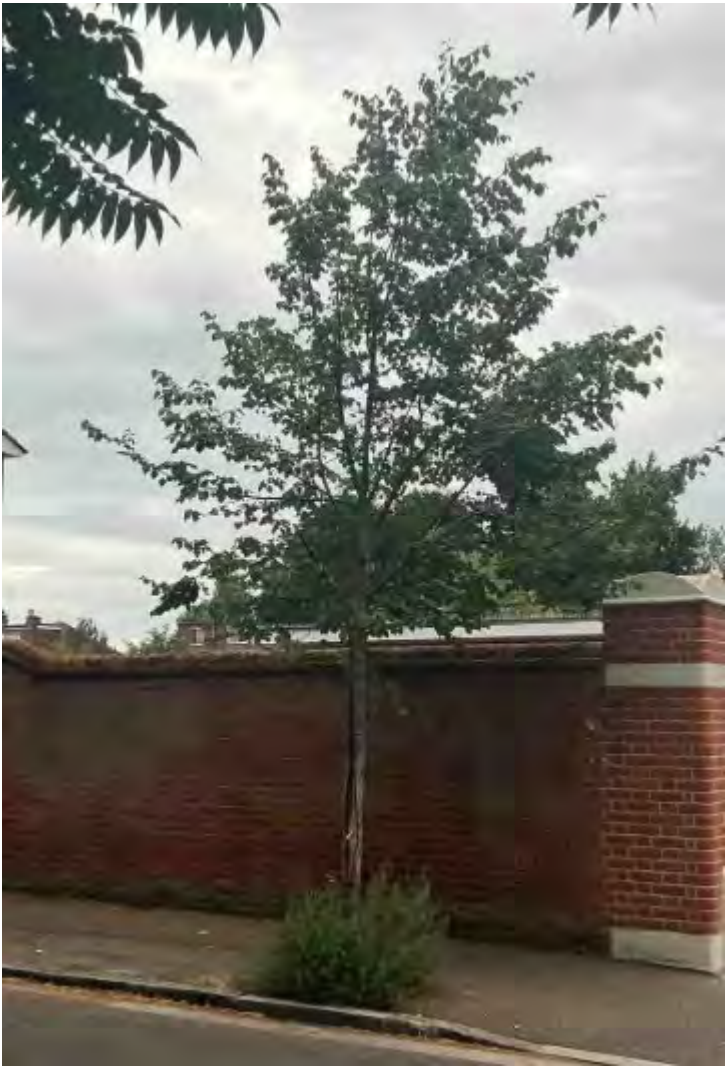
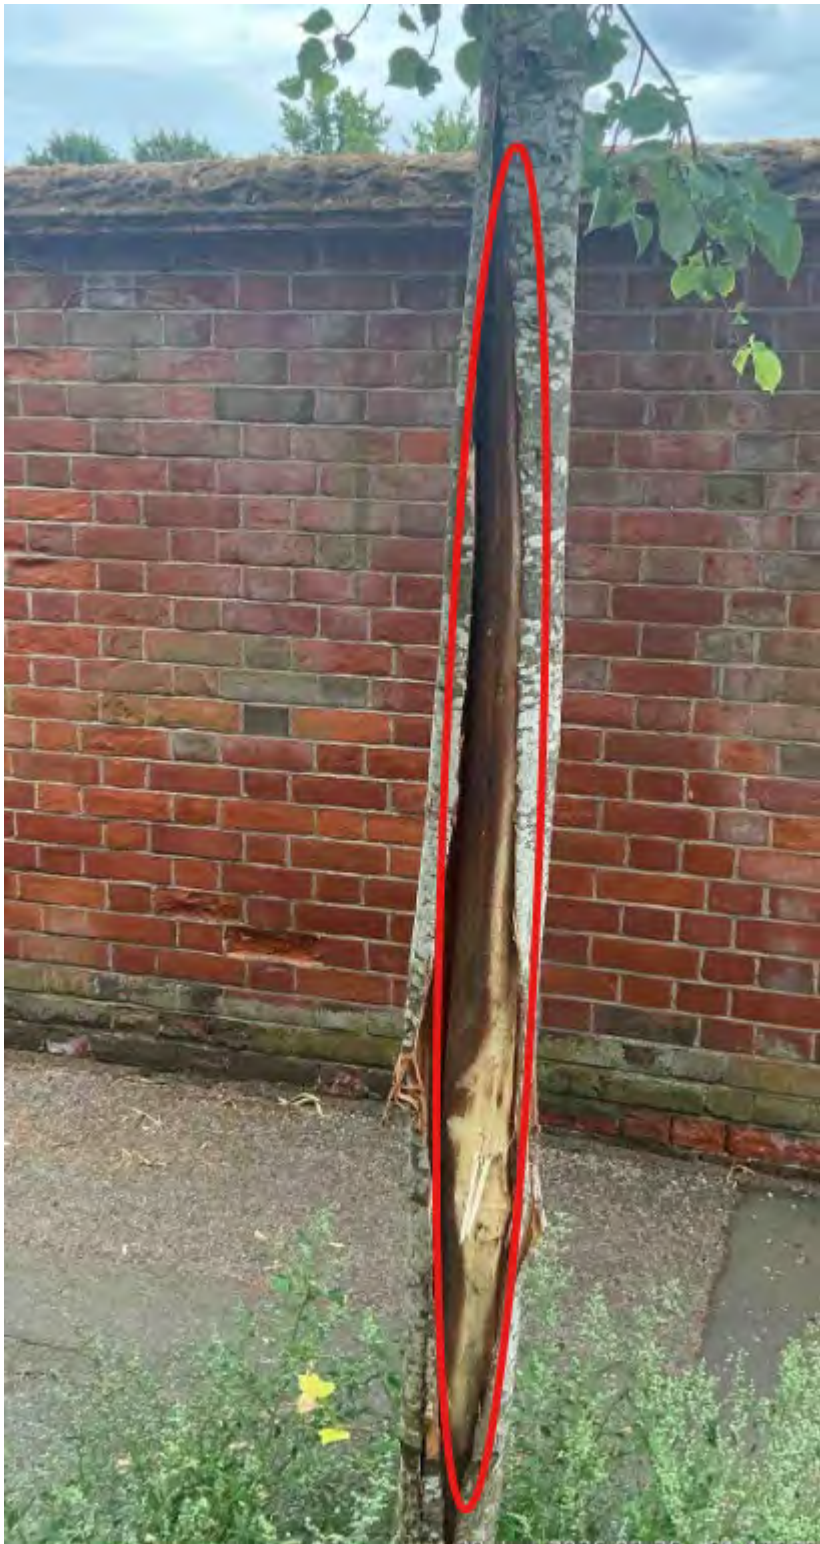
| Inspection findings/reason for exemption | This tree has sustained vehicle damage on the stem; this extensive wounding has caused necrosis and dysfunction of the trees vascular system. Removal is required to prevent natural failure, manage risk, and facilitate replanting |

***Image shows wound on trunk circled.***

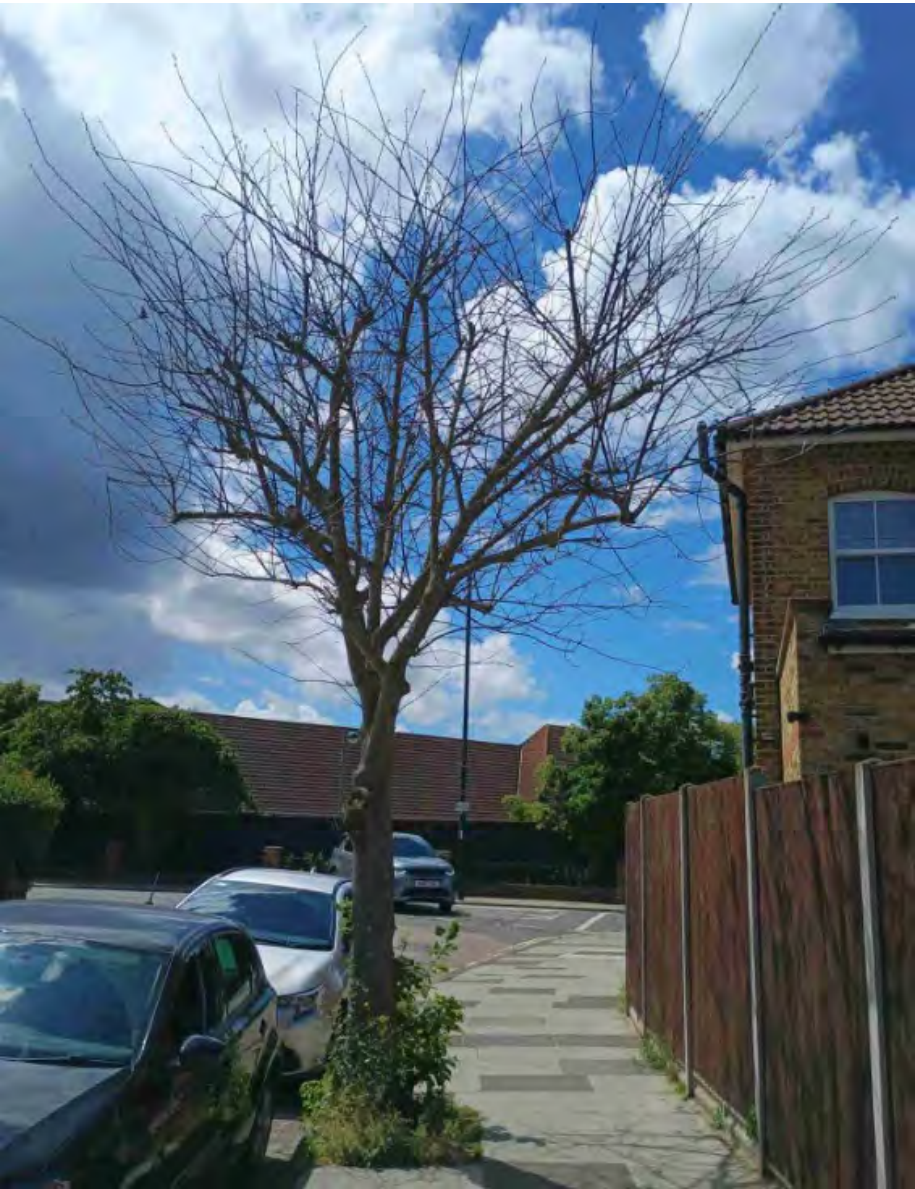
| Inspection findings/reason for exemption | This tree is dead; removal is required to prevent natural failure and facilitate replanting |

Image shows dead tree in street scene.

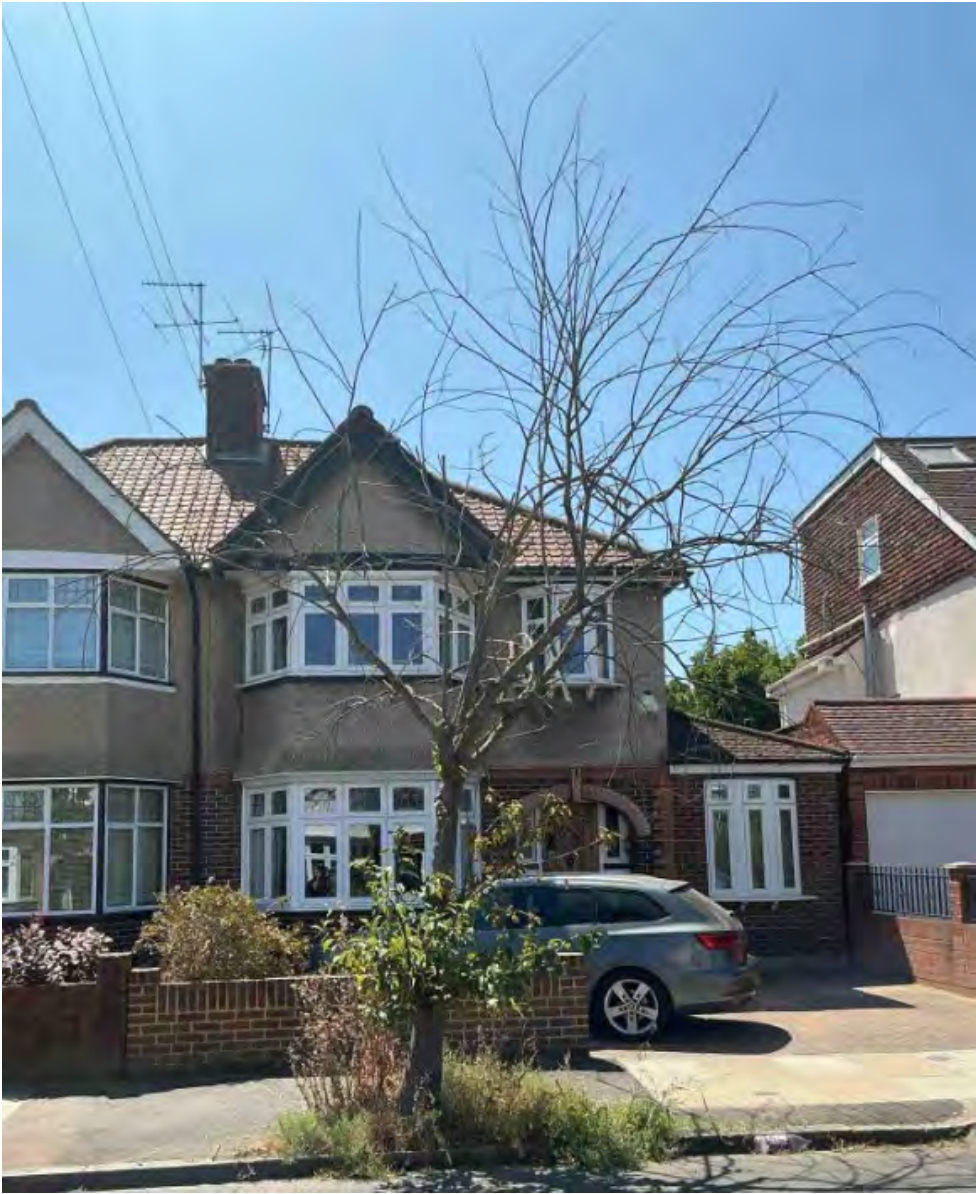
| Inspection findings/reason for exemption | This tree is dead; removal is required to prevent natural failure, manage risk, and facilitate replanting |

Image shows dead tree
