April 2023 - Reactive Tree Works Programme

Introduction

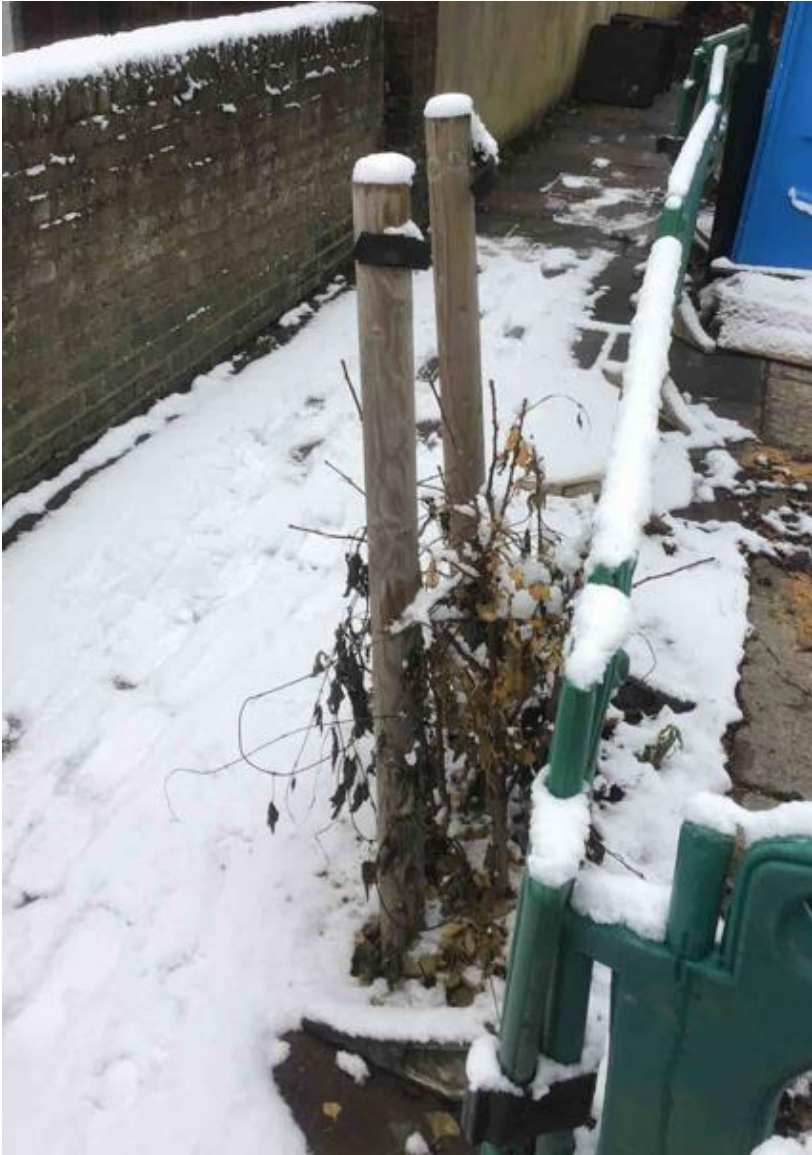
Ward	Barnes
Road	Baronsmead Road
Location	Adjacent to 25 Castelnau front driveway
Species	Maidenhair (<i>Ginkgo biloba</i>)
Height	0.5m
Physiological Condition	Poor
Structural Condition	Poor
Inspection findings	Tree has been vandalised with the main stem being snapped at approximately 0.5 meters from ground level. No viable tree remaining. Removal is required to facilitate replanting.

Image shows tree in street scene

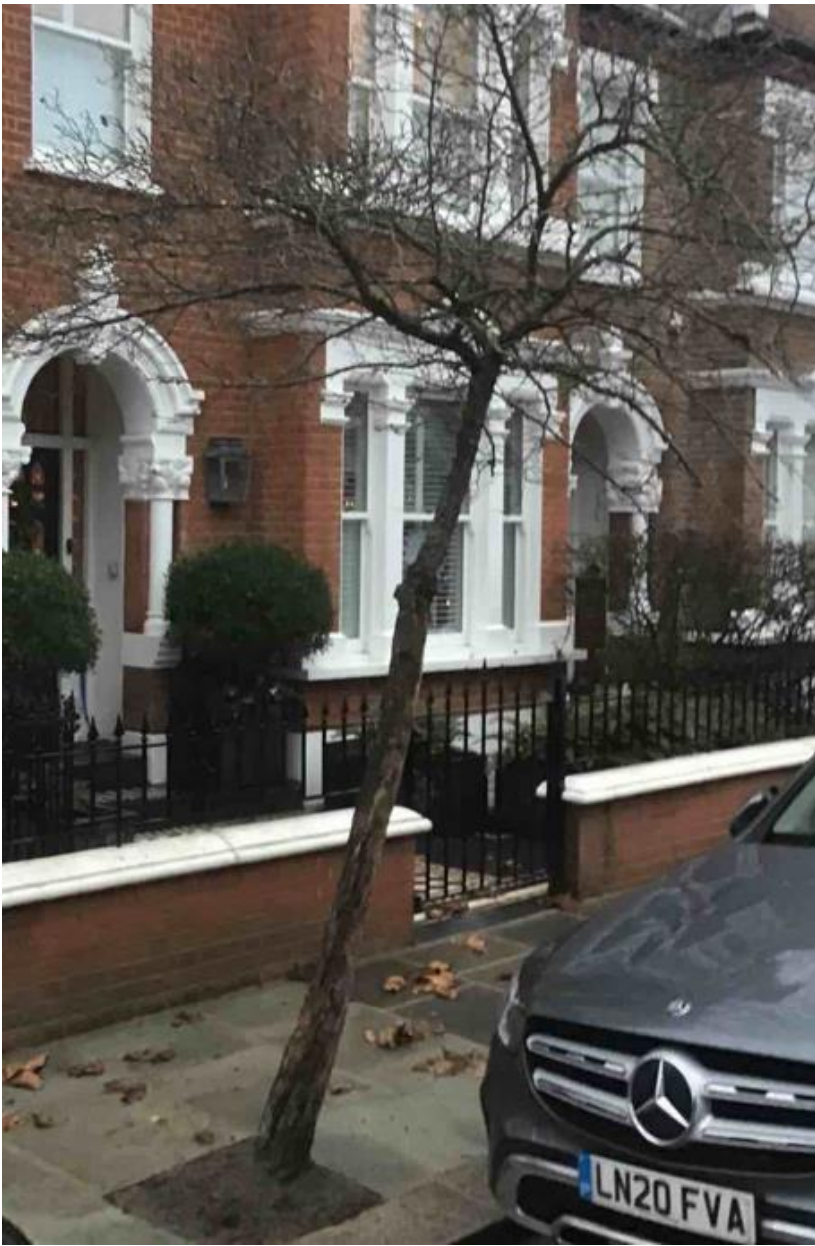
Ward	Barnes
Road	Baronsmead Road
Location	Adjacent to 25 Castelnau front driveway
Species	Hawthorne (<i>Crataegus</i> sp.)
Height	4
Physiological Condition	Fair
Structural Condition	Poor
Inspection findings	Tree roots are extensively decayed; tree is moving in such a way that indicates that the structure is compromised presenting unacceptable risk of failure

Image shows tree in street scene

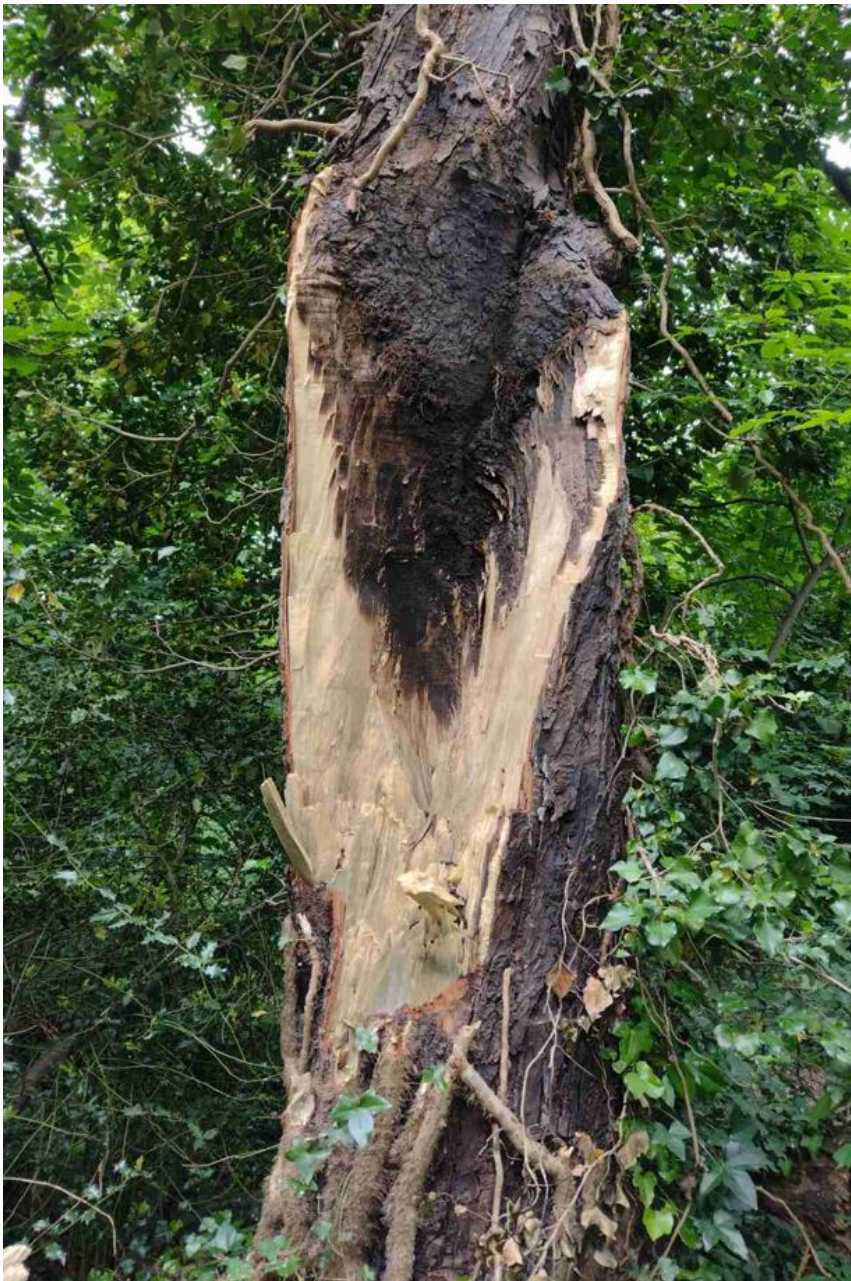
Ward	Barnes
Road	Rocks Lane
Location	Barnes Common What3words - ///makes.legend.decay
Species	Horse chestnut (<i>Aesculus hippocastanum</i>)
Height	15.0m
Physiological Condition	Fair
Structural Condition	Poor
Inspection findings	The main union on this tree has failed; the remainder presents an unacceptable risk of failure over woodland path

Images shows trees failed union

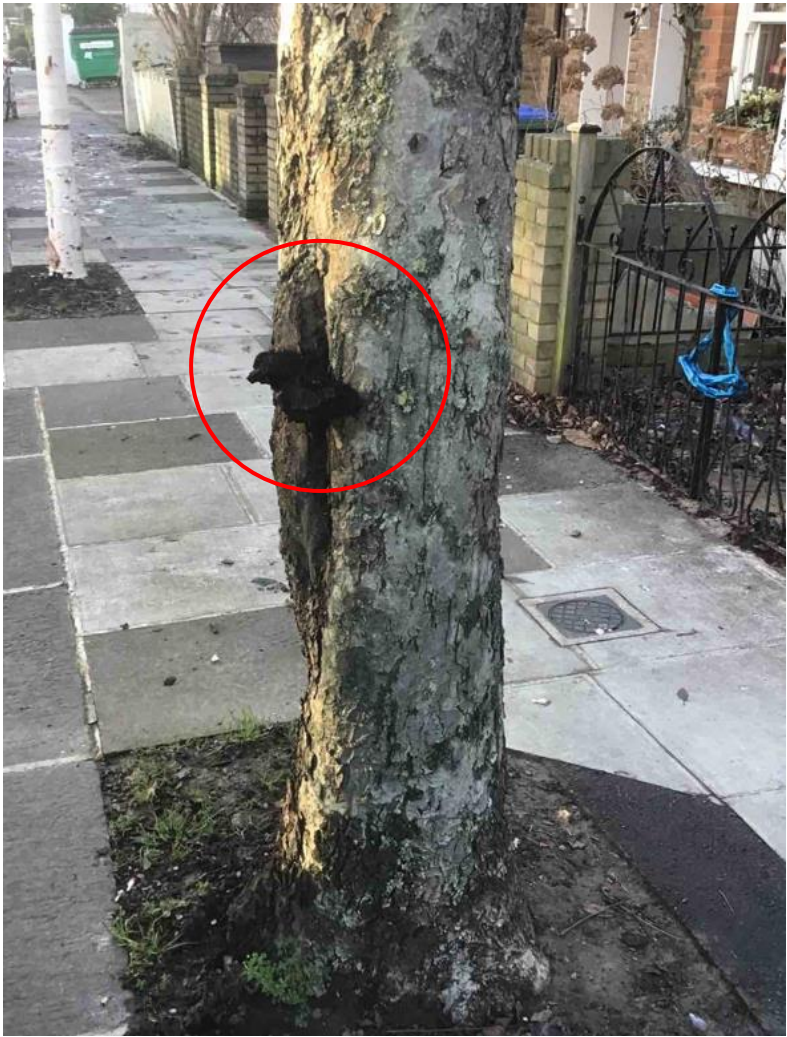
Ward	Fulwell and Hampton Hill
Road	Fulwell Road
Location	Outside 143/145
Species	Crab Apple (<i>Malus</i> sp.)
Height	4.0m
Physiological Condition	Fair
Structural Condition	Poor
Inspection findings	A fungal fruiting body of the species Shaggy Polypore (<i>Inonotus hispidus</i>) is present on the main stem or trunk, this fungus causes a simultaneous white rot which can cause snapping of tree parts in this particular species. The tree presents an unacceptable risk of failure and removal is required to mitigate this.

Image shows tree in street scene and fruiting body circled

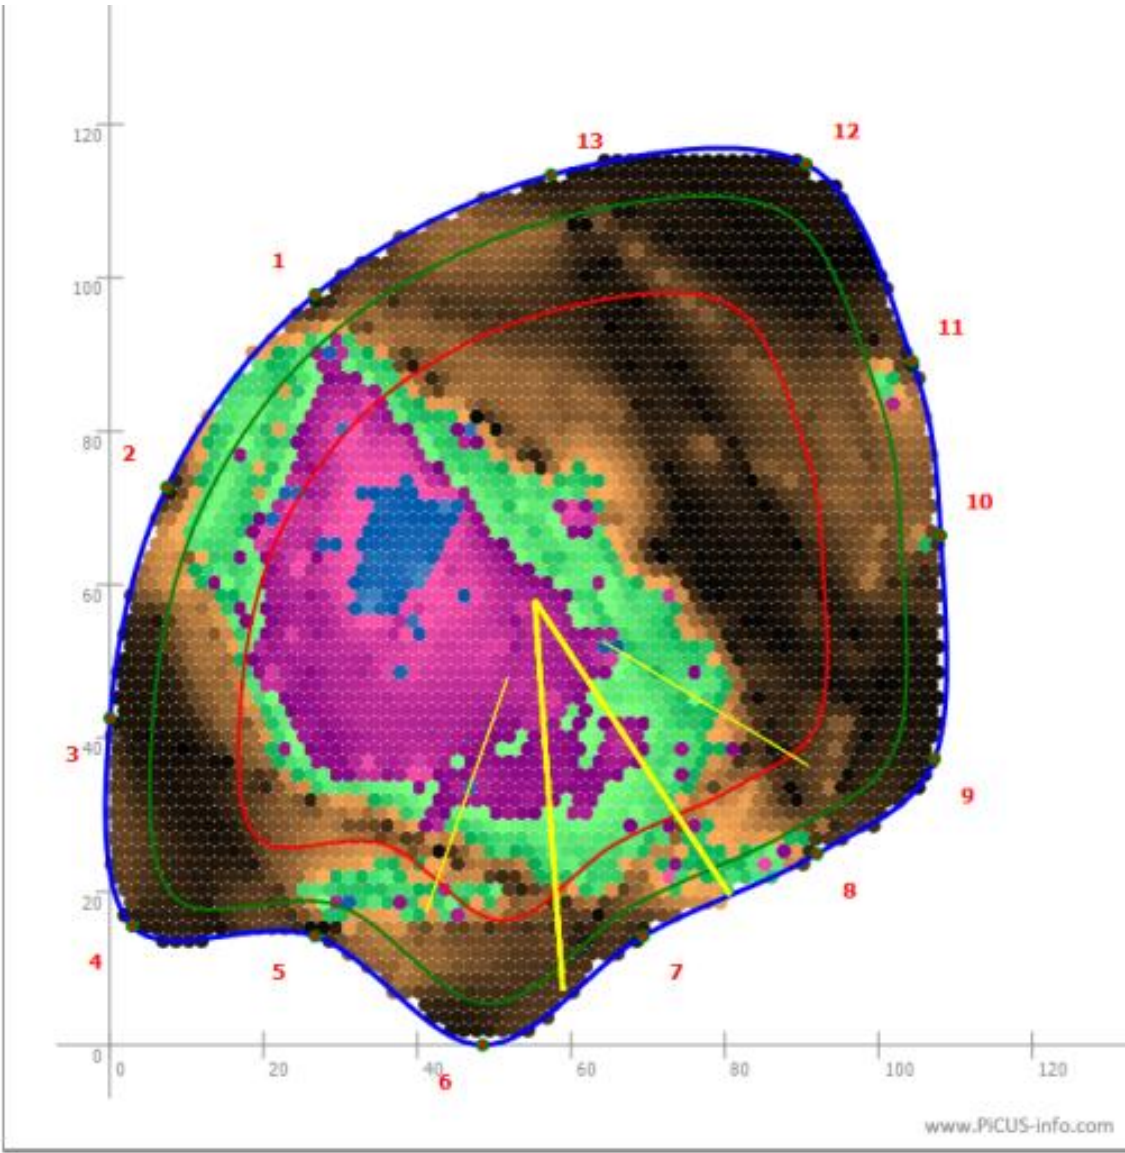
Ward	Fulwell and Hampton Hill
Road	Anlaby Road
Location	Opposite 64
Species	Common Lime (<i>Tilia x europaea</i>)
Height	16.0m
Physiological Condition	Fair
Structural Condition	Poor
Inspection findings	A detailed investigation of this tree using sonic tomography revealed an unacceptable degree of decay; removal is required to prevent natural failure and manage risk

Image shows Picus Results with decay shown in purple.

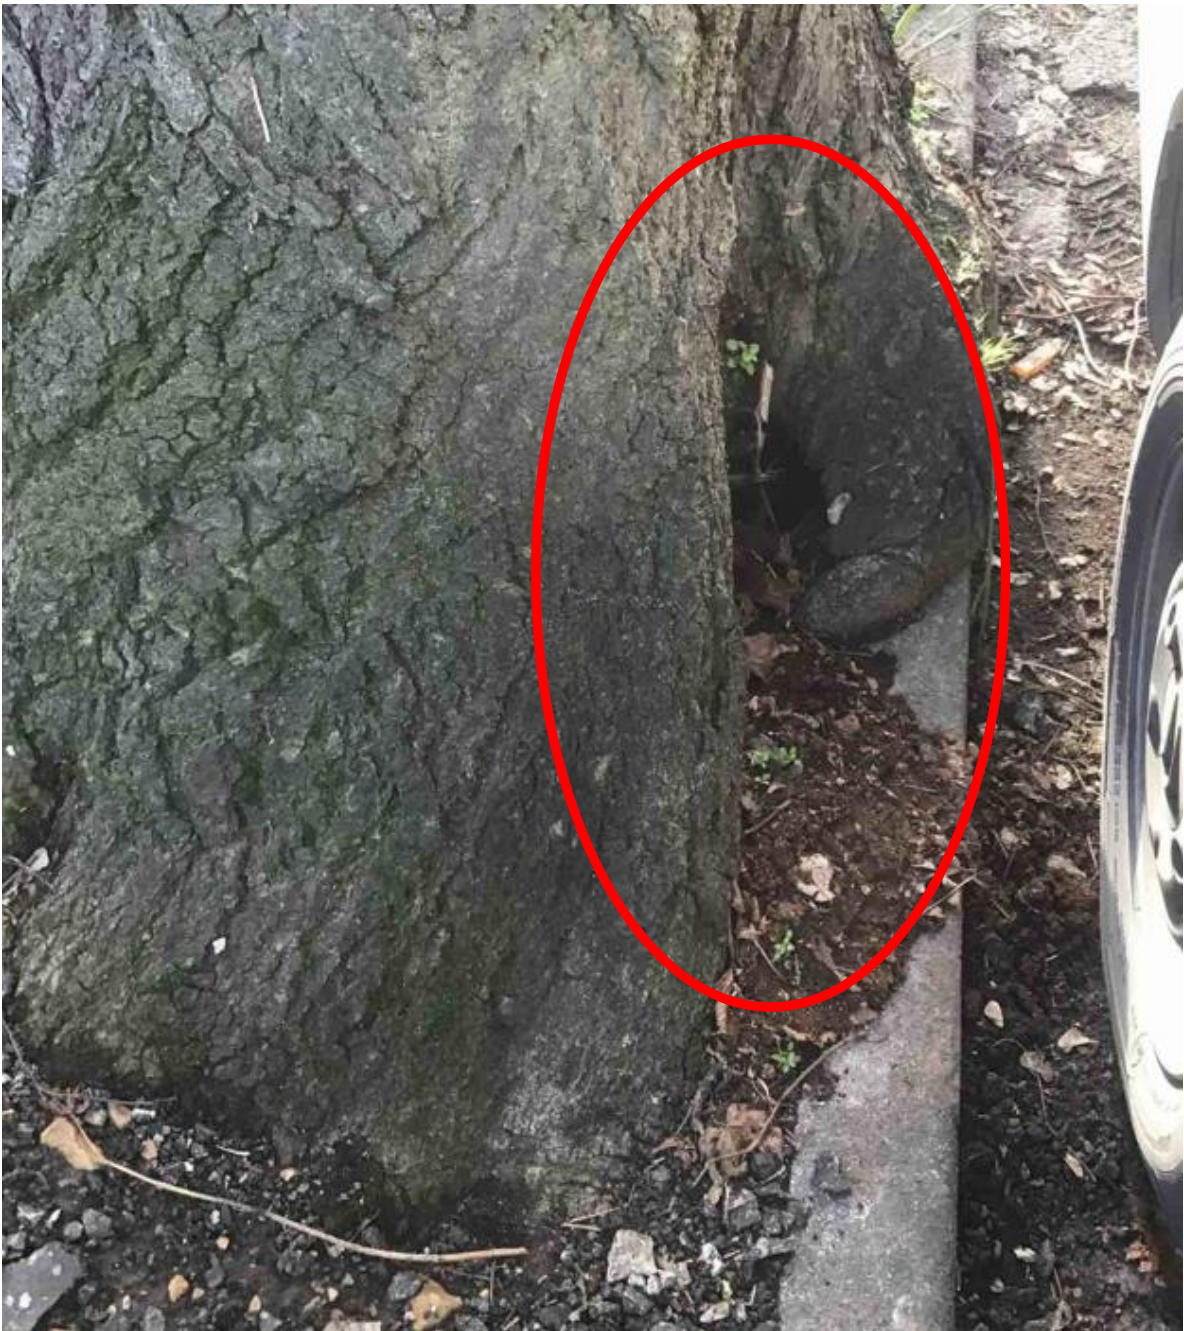
Image shows tree in street scene with cavity circled

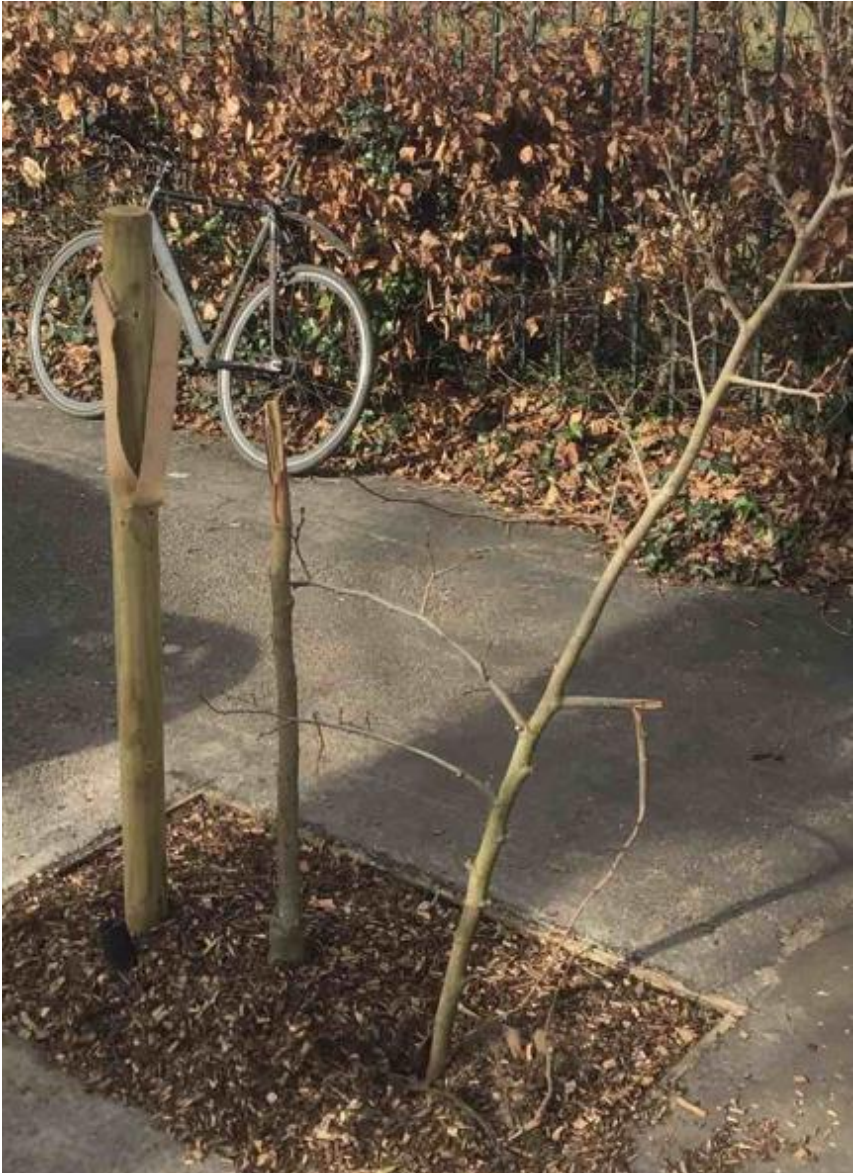
Ward	Hampton Wick
Road	Cromwell Road
Location	Opposite 36
Species	Norway Maple (<i>Acer platanoides</i>)
Height	1.0m
Physiological Condition	Dead
Structural Condition	Poor
Inspection findings	Tree has been vandalised with the main stem being snapped at approximately 0.5 meters from ground level. No viable tree remaining. Removal is required to facilitate replanting.

Image shows vandalised tree in street scene

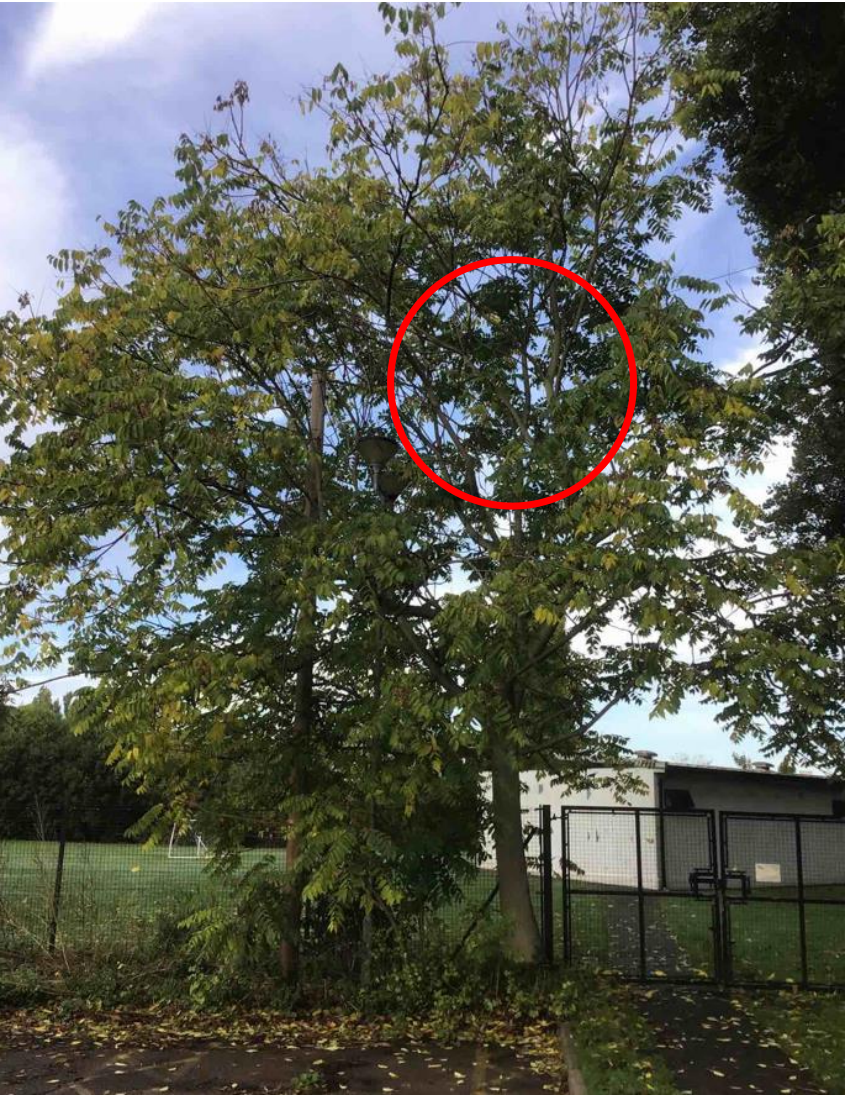
Ward	Kew
Road	Townmead Road
Location	Directly adjacent to gates to Kew Riverside Primary School playing field- /// What3Words- clear.news.paths
Species	Tree of Heaven (<i>Ailanthus altissima</i>)
Height	12m
Physiological Condition	Good
Structural Condition	Good
Inspection findings	This tree is in an in an unsuitable location with the truck damaging the adjacent playing field fence and shading the carpark lights with no pruning options.

Images shows tree damaging fence and shading lights circled

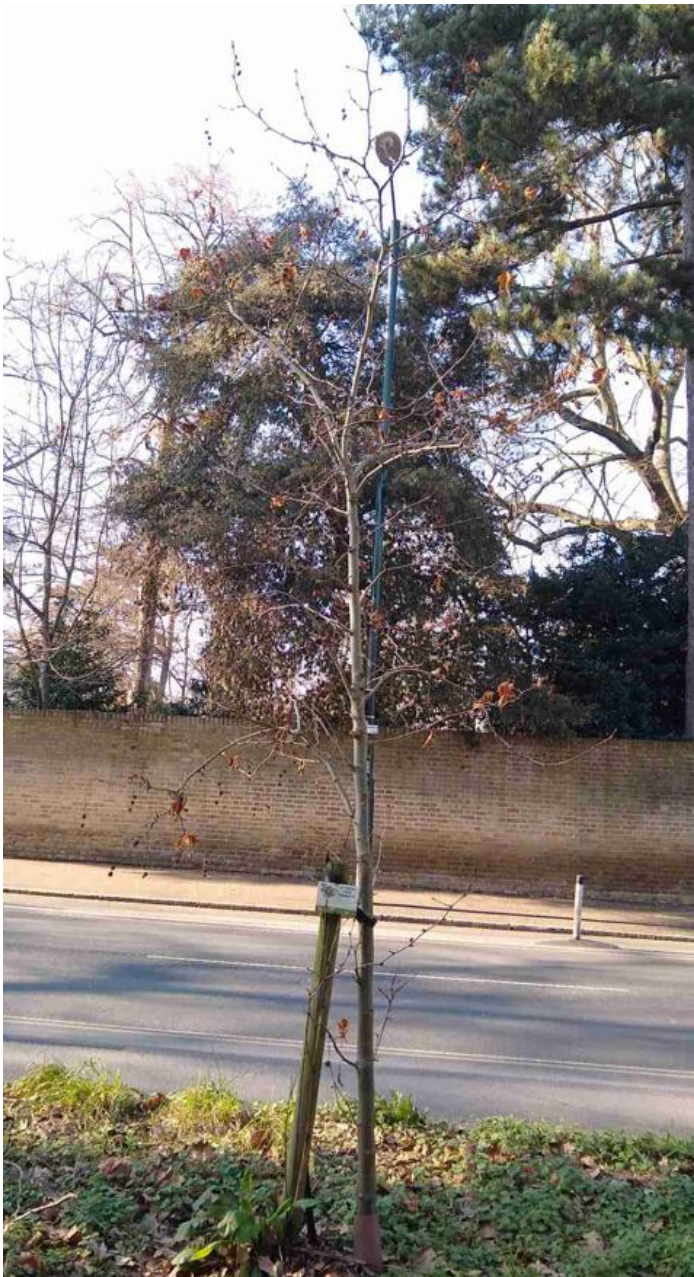
Ward	Kew
Road	Kew Road
Location	Outside Dunraven House
Species	Oriental Plane (<i>Platanus orientalis</i>)
Height	4.5m
Physiological Condition	Dead
Structural Condition	Poor
Inspection findings	This tree is dead; removal is required to prevent natural failure and facilitate replanting

Image shows dead tree in street scene

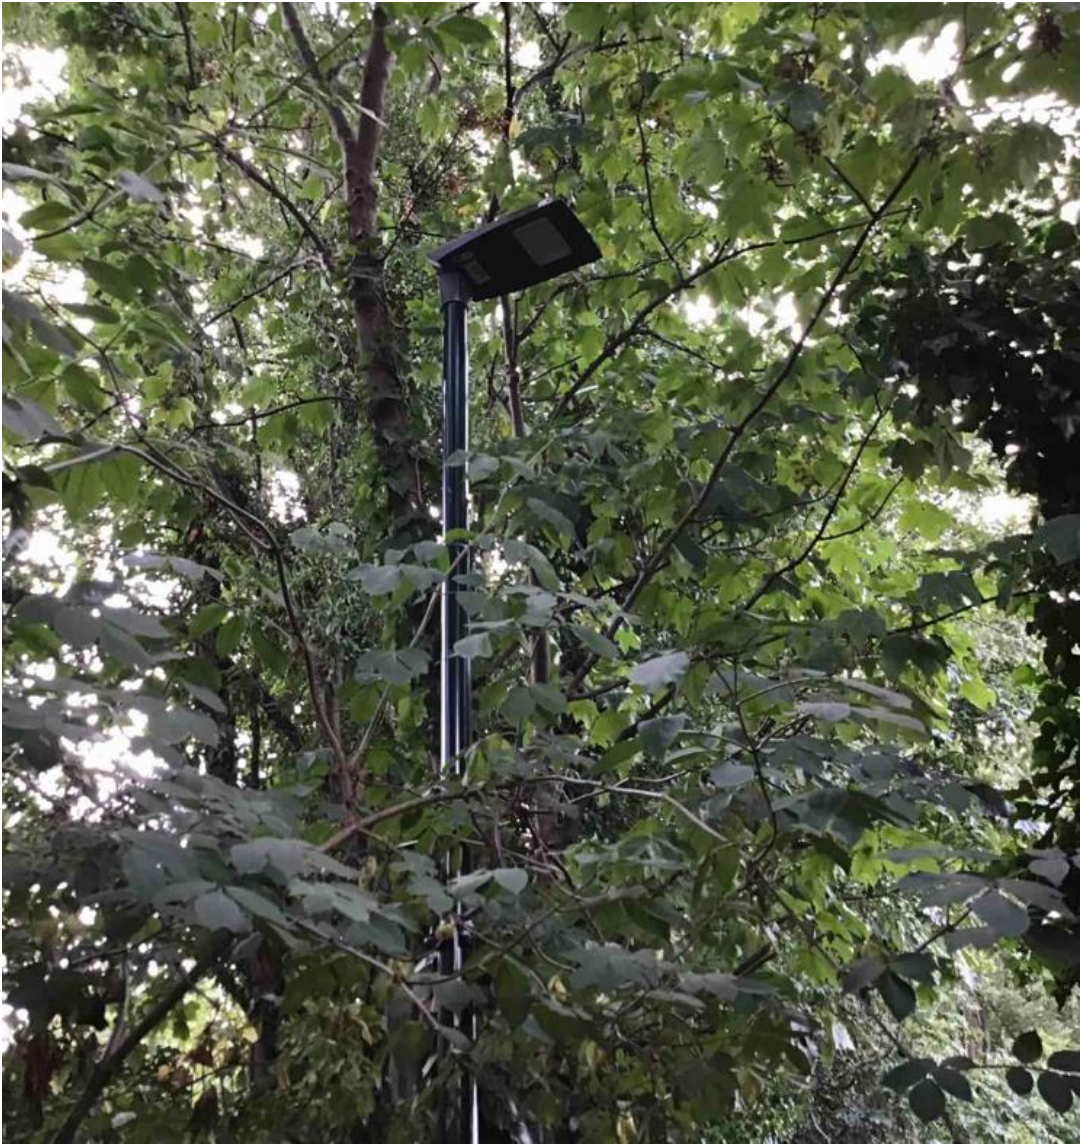
Ward	Mortlake and Barnes Common
Road	Long Walk
Location	Adjacent to Barnes train station and lamp column 010- ///What3Words- secret.makes.tubes
Species	Sycamore (<i>Acer pseudoplatanus</i>)
Height	8.0m
Physiological Condition	Good
Structural Condition	Poor
Inspection findings	This tree is growing in an unsuitable location; it is causing a obstruction of the streetlight and there are no suitable pruning remedies.

Image shows tree in context with streetlight

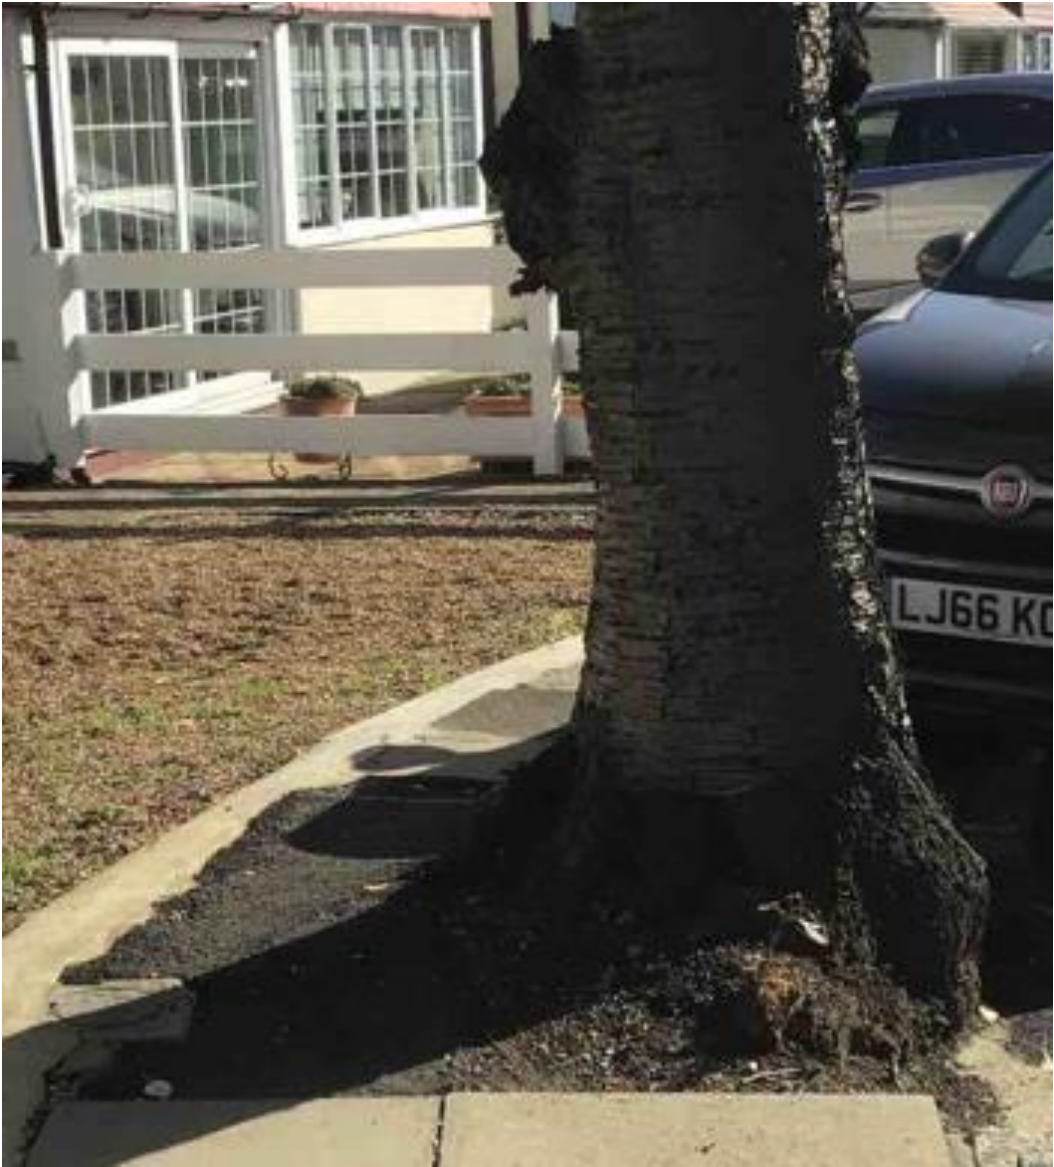
Ward	North Richmond
Road	Rothestay Avenue
Location	Outside 28
Species	Wild Cherry (<i>Prunus avium</i>)
Height	8.0m
Physiological Condition	Fair
Structural Condition	Fair
Inspection findings	This tree causing an unacceptable obstruction of the footway. There is no suitable engineering solution necessitating removal

Image shows tree in street scene

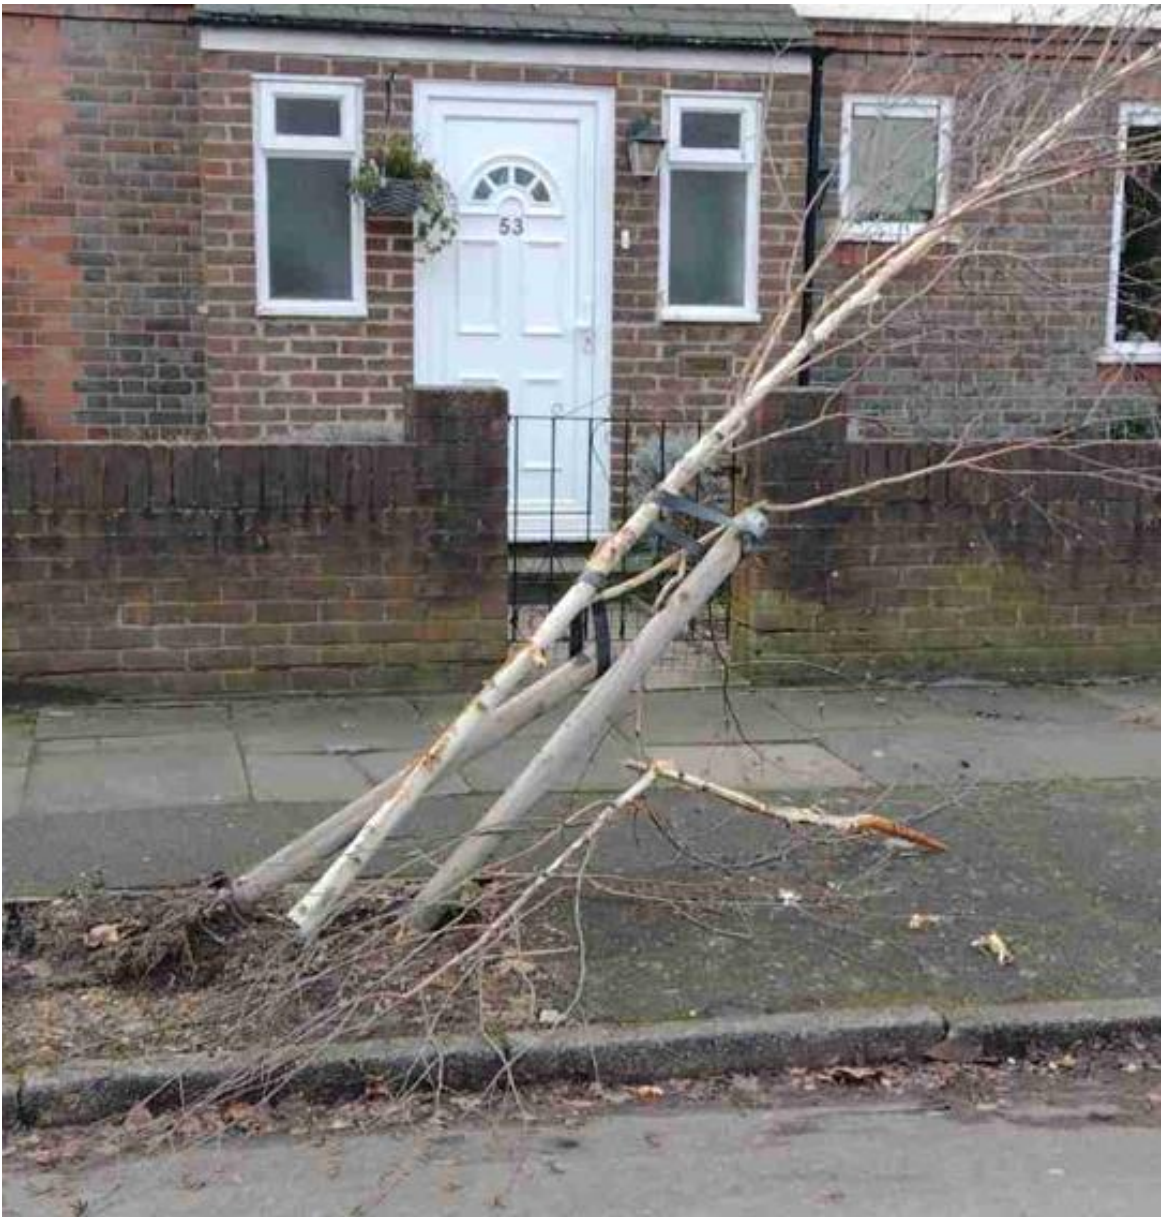
Ward	North Richmond
Road	Lambert Avenue
Location	Outside 53
Species	Silver Birch (<i>Betula pendula</i>)
Height	4.0m
Physiological Condition	Poor
Structural Condition	Poor
Inspection findings	This tree has been struck by a vehicle causing irreparable damage; No viable tree remaining. Removal is required to facilitate replanting.

Image shows tree in street scene

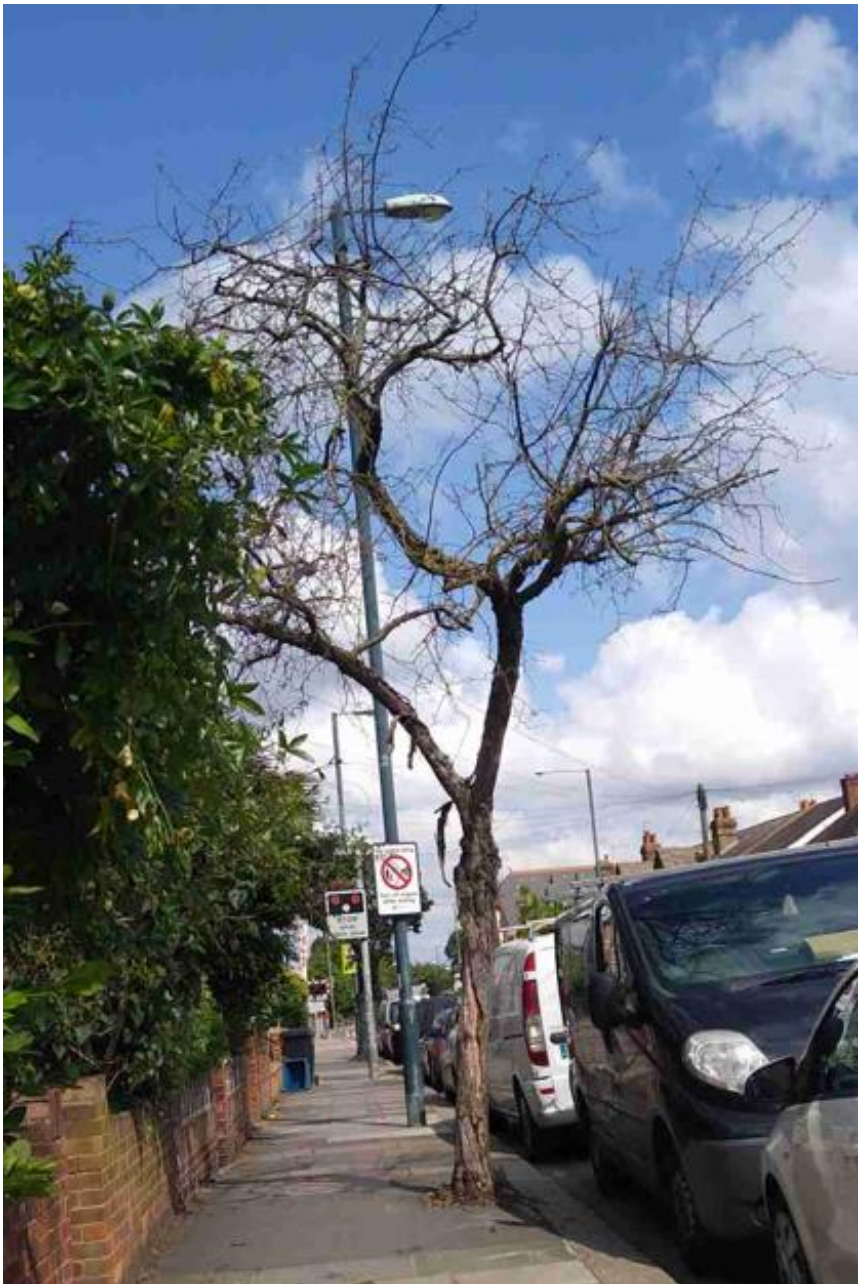
Ward	North Richmond
Road	Manor Road
Location	Outside 76/78
Species	Bird Cherry (<i>Prunus padus</i>)
Height	6.0m
Physiological Condition	Dead
Structural Condition	Poor
Inspection findings	This tree is dead; removal is required to prevent natural failure and facilitate replanting

Image shows dead tree in street scene

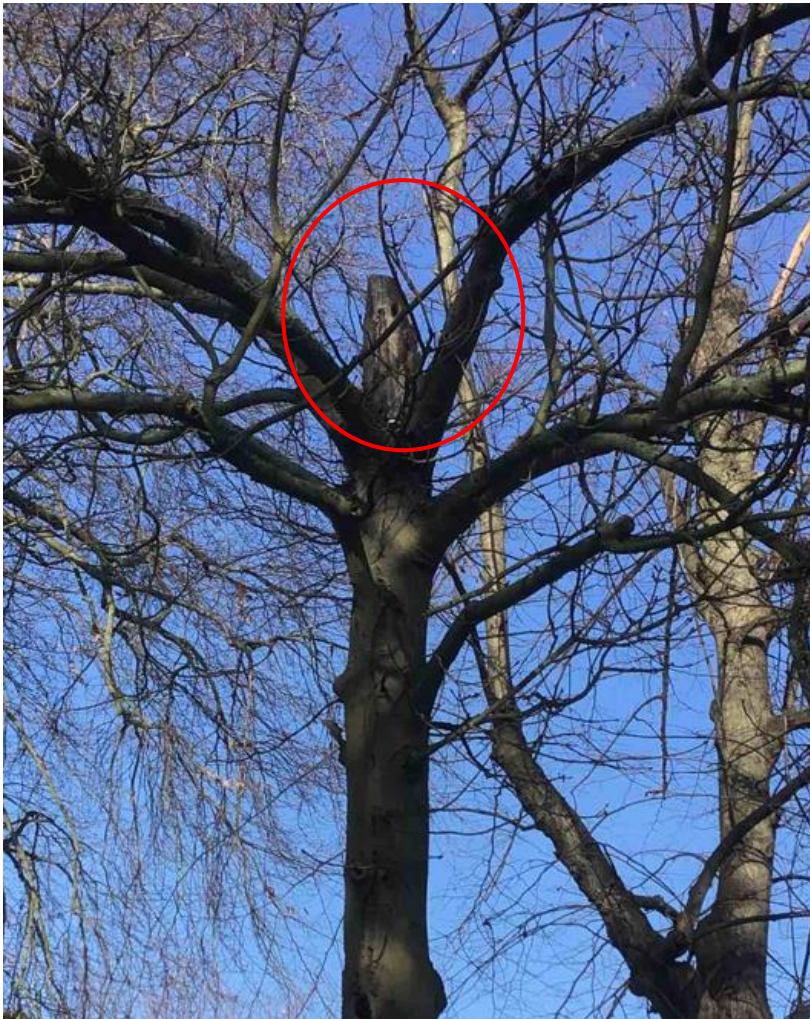
Ward	South Twickenham
Road	Wellesley Road
Location	Opposite side of road between Lamppost 015/016 and outside Thurnby Court
Species	Red Chestnut (<i>Aesculus x carnea</i>)
Height	10.5m
Physiological Condition	Poor
Structural Condition	Poor
Inspection findings	This tree has stem bleeding, necrotic bark and crown die back which is consistent with the pathogen <i>Pseudomonas syringae</i> . The extent of infection has permanently damaged this trees adaptive capacities and it now presents an unacceptable risk and requires removal.

Image shows tree with broken branch caused by destruction of vascular tissues by *Pseudomonas* pathogen circled

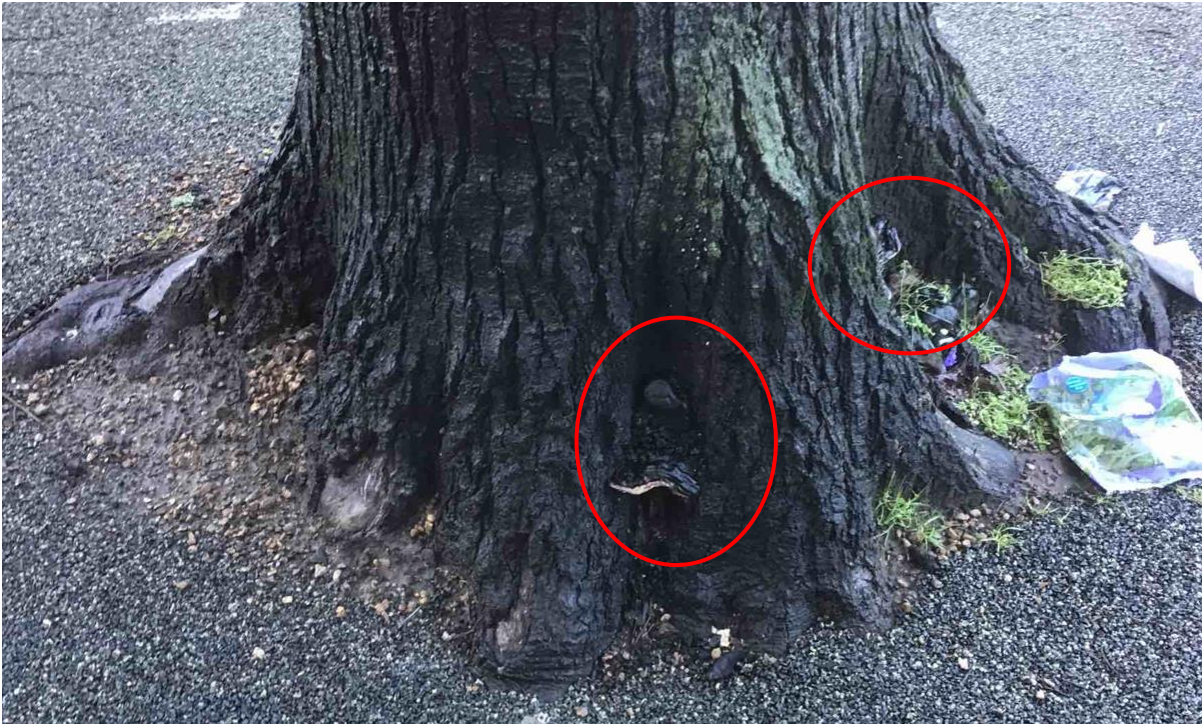
Ward	St Margarets and North Twickenham
Road	St Margarets Road
Location	Outside 17/19
Species	Red Oak (<i>Quercus rubra</i>)
Height	15.0m
Physiological Condition	Good
Structural Condition	Poor
Inspection findings	A fungal fruiting body of the decay pathogen <i>Ganoderma</i> sp. is present at the stem base. Colonisation by this fungus causes a white rot of the stem and root system that can cause entire trees to collapse through fracture or windthrow.

Image shows tree with location of fungal fruiting body circled

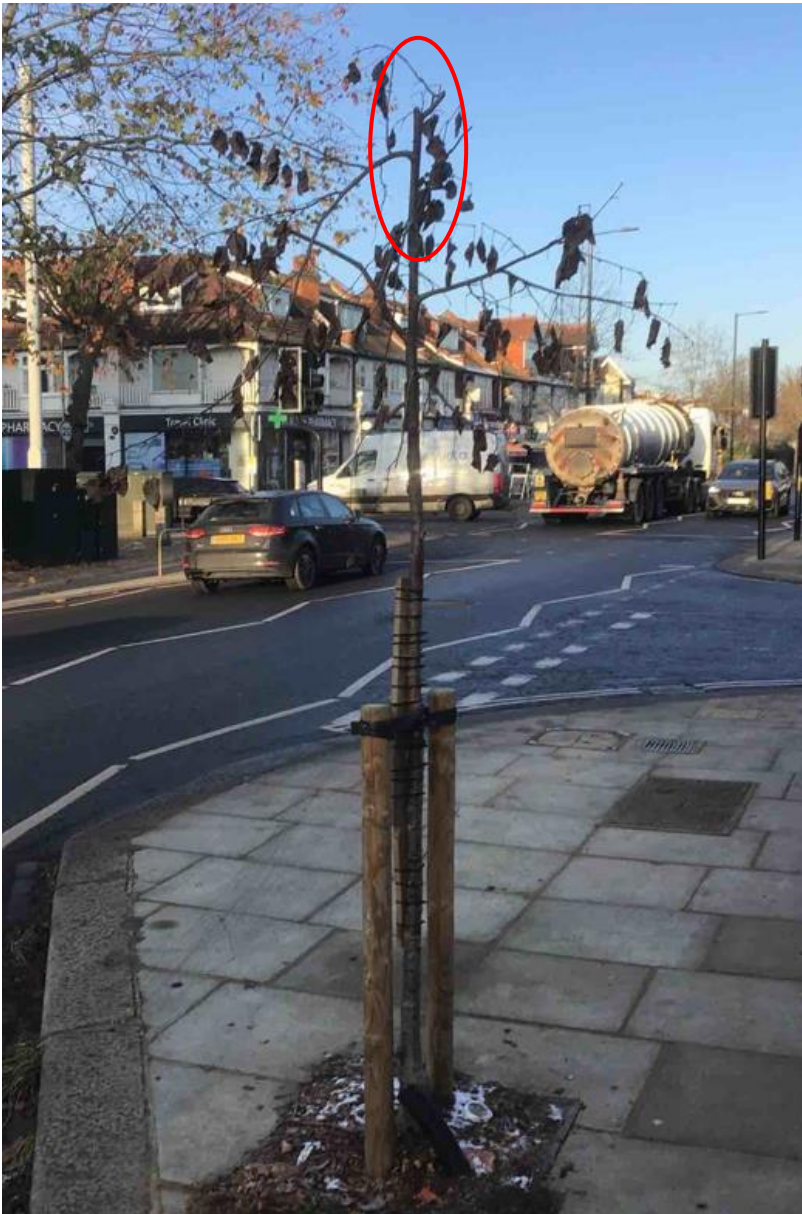
Ward	Teddington
Road	Kingston Road
Location	Adjacent to 2 Holmesdale Road
Species	Caucasian Lime(<i>Tilia euchlora</i>)
Height	2.5m
Physiological Condition	Poor
Structural Condition	Poor
Inspection findings	This tree has been vandalised; No viable tree remaining. Removal is required to facilitate replanting.

Image shows dead tree with attempt to repair broken stem circled

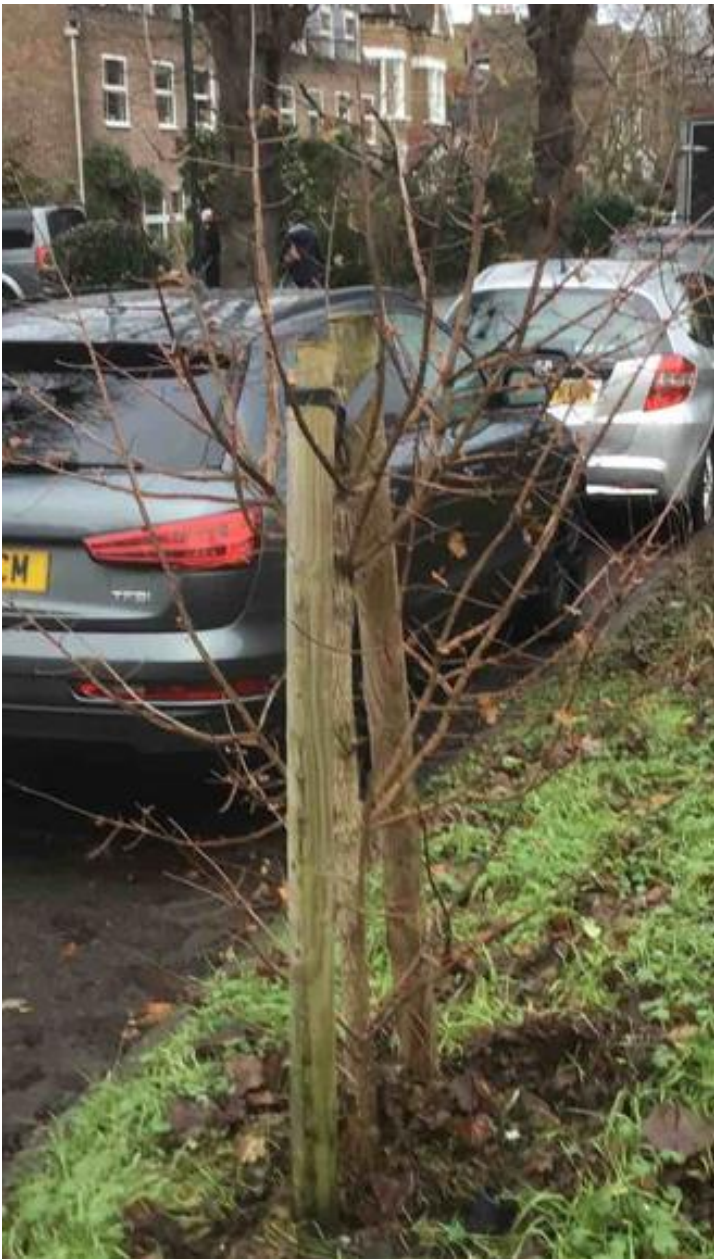
Ward	Teddington
Road	Udney Park Road
Location	Opposite 30D
Species	Field Maple (<i>Acer campestre</i>)
Height	7.0m
Physiological Condition	Dead
Structural Condition	Dead
Inspection findings	Tree has been vandalised with the main stem being snapped at approximately 1 meter from ground level. No viable tree remaining. Removal is required to facilitate replanting.

Image shows tree in street scene

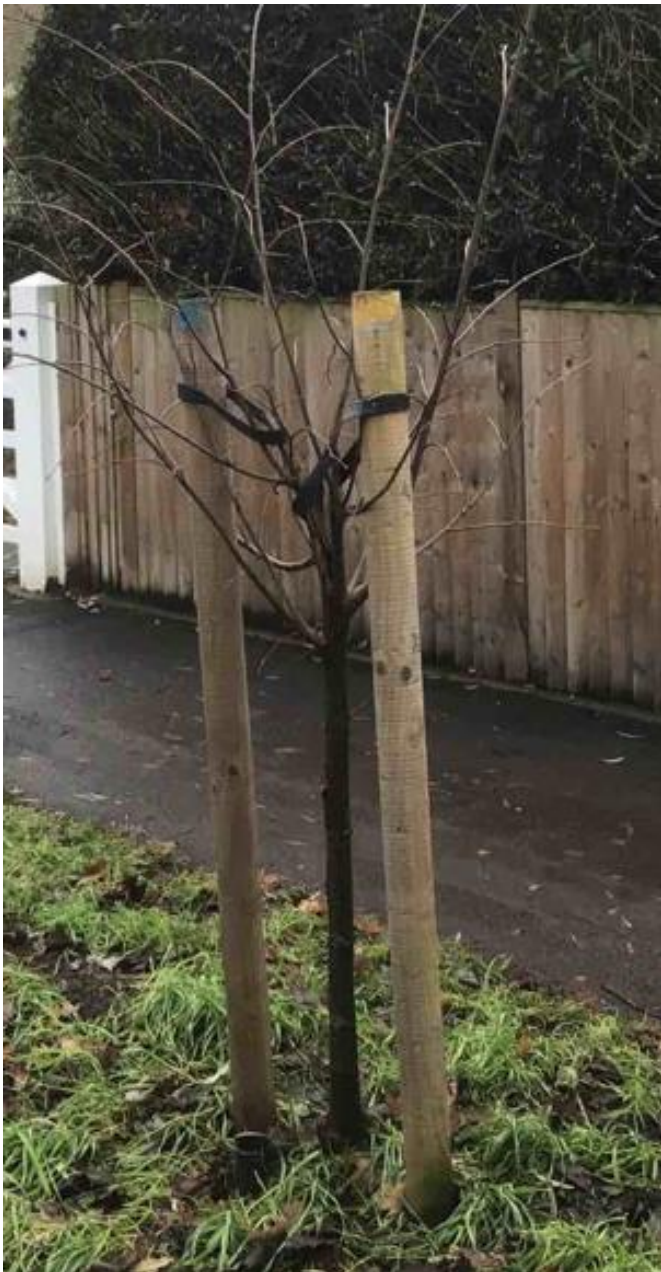
Ward	Teddington
Road	Udney Park Road
Location	Outside 34
Species	Small Leaf Lime (<i>Tilia cordata</i>)
Height	2m
Physiological Condition	Poor
Structural Condition	Poor
Inspection findings	Tree has been vandalised with the main stem being snapped at approximately 1 meter from ground level. No viable tree remaining. Removal is required to facilitate replanting.

Image shows tree in street scene

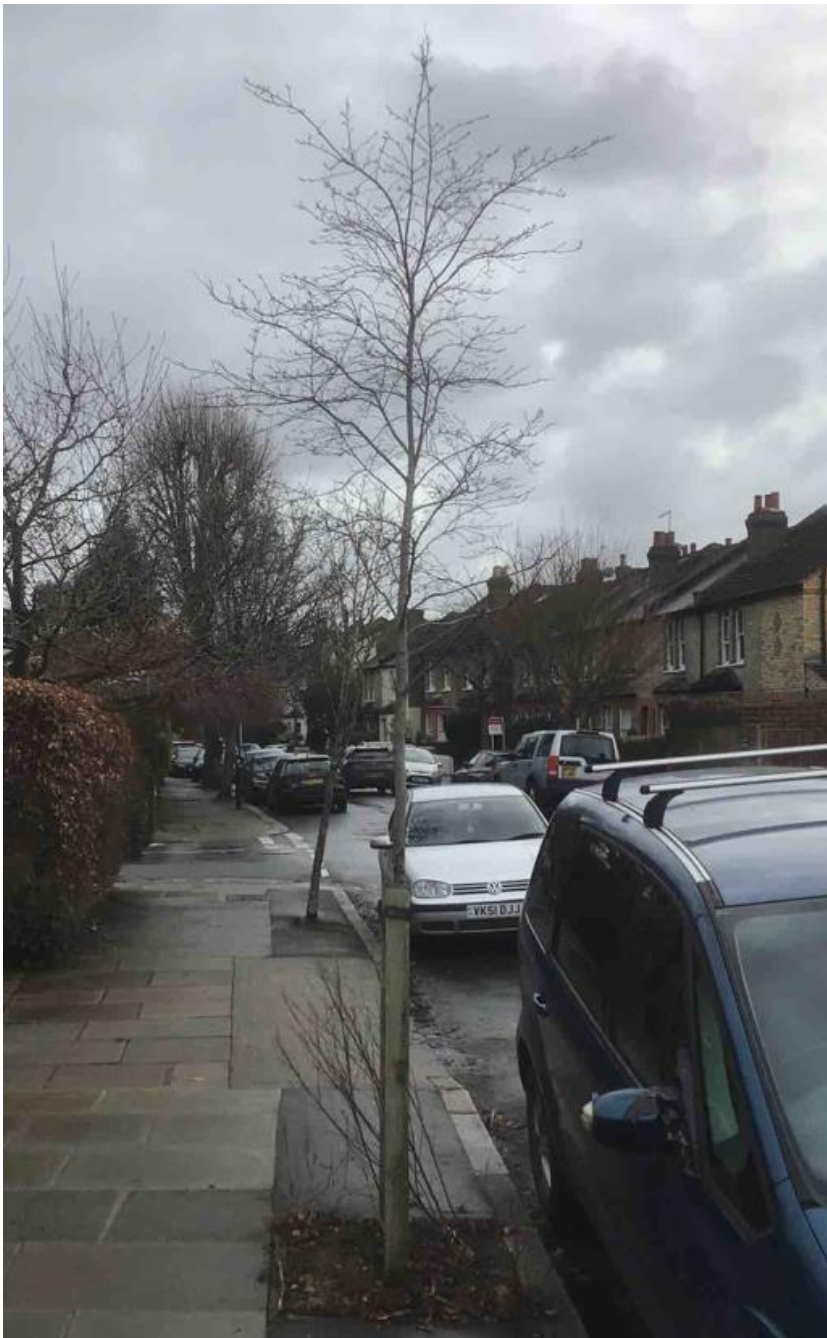
Ward	Teddington
Road	Fairfax Road
Location	Outside 18/20
Species	Hornbeam (<i>Carpinus betulus</i>)
Height	4m
Physiological Condition	Dead
Structural Condition	Dead
Inspection findings	This tree is dead; Removal is required to facilitate replanting

Image shows tree in street scene

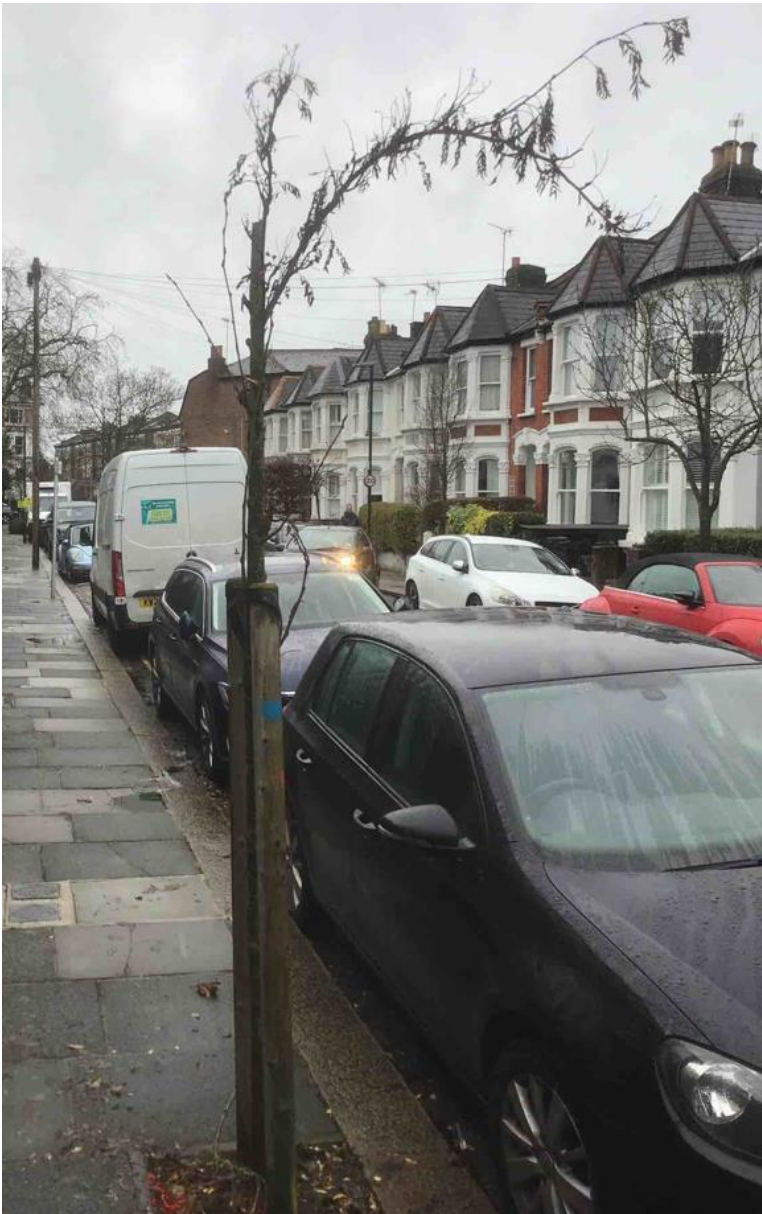
Ward	Twickenham Riverside
Road	Alexandra Road
Location	Outside 20
Species	Rowan (<i>Sorbus aucuparia</i>)
Height	4.0m
Physiological Condition	Poor
Structural Condition	Poor
Inspection findings	This tree is moribund, caused by drought in the previous summer; Removal is required to facilitate replanting

Image shows tree in street scene
