April 2023 - Reactive Tree Works Programme

Introduction

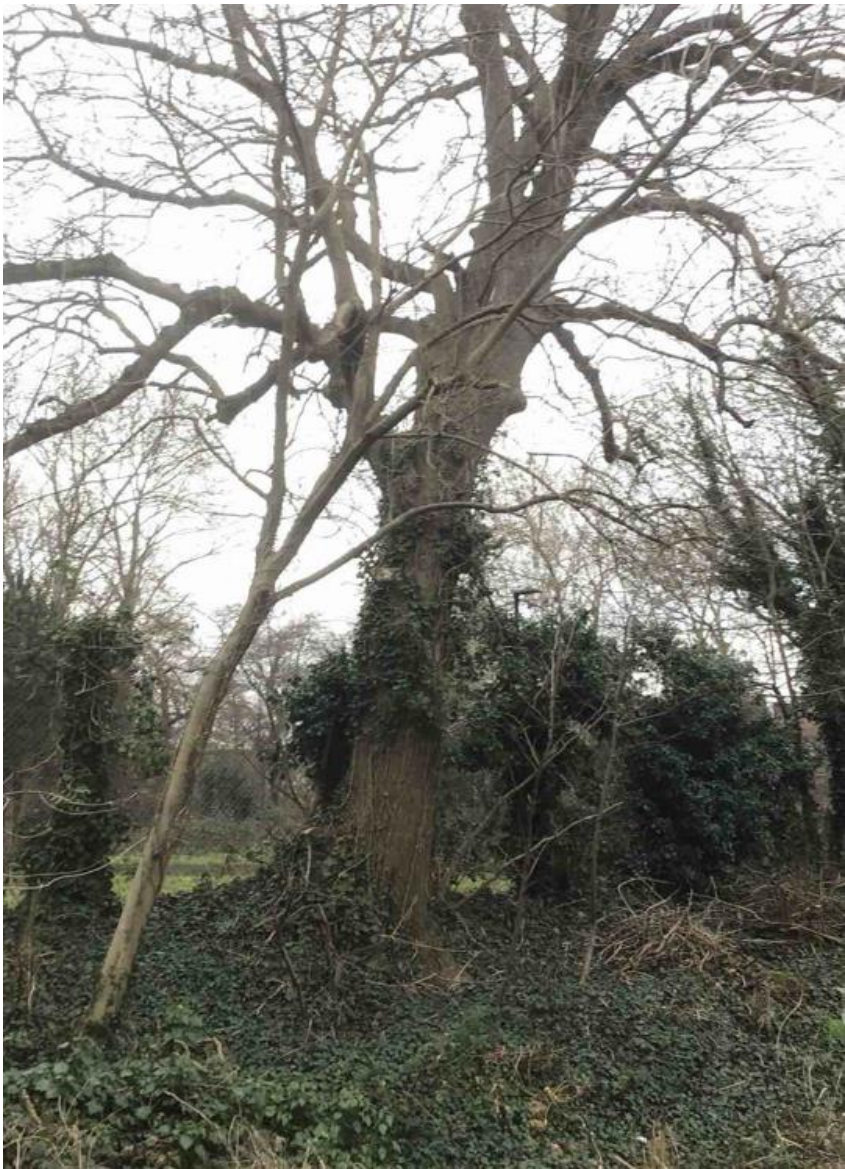
Ward	West Twickenham
Road	Mill Road
Location	Mill Road Allotments- /// What3Words- blaze.larger.trap
Species	Ash (<i>Fraxinus excelsior</i>)
Height	12.0m
Physiological Condition	Good
Structural Condition	Good
Inspection findings	Tree has been requested to be removed by the Richmond Allotment Officer as significant east lean to stem will cause the crown to overshadow the allotment area

Image shows tree in allotment scene

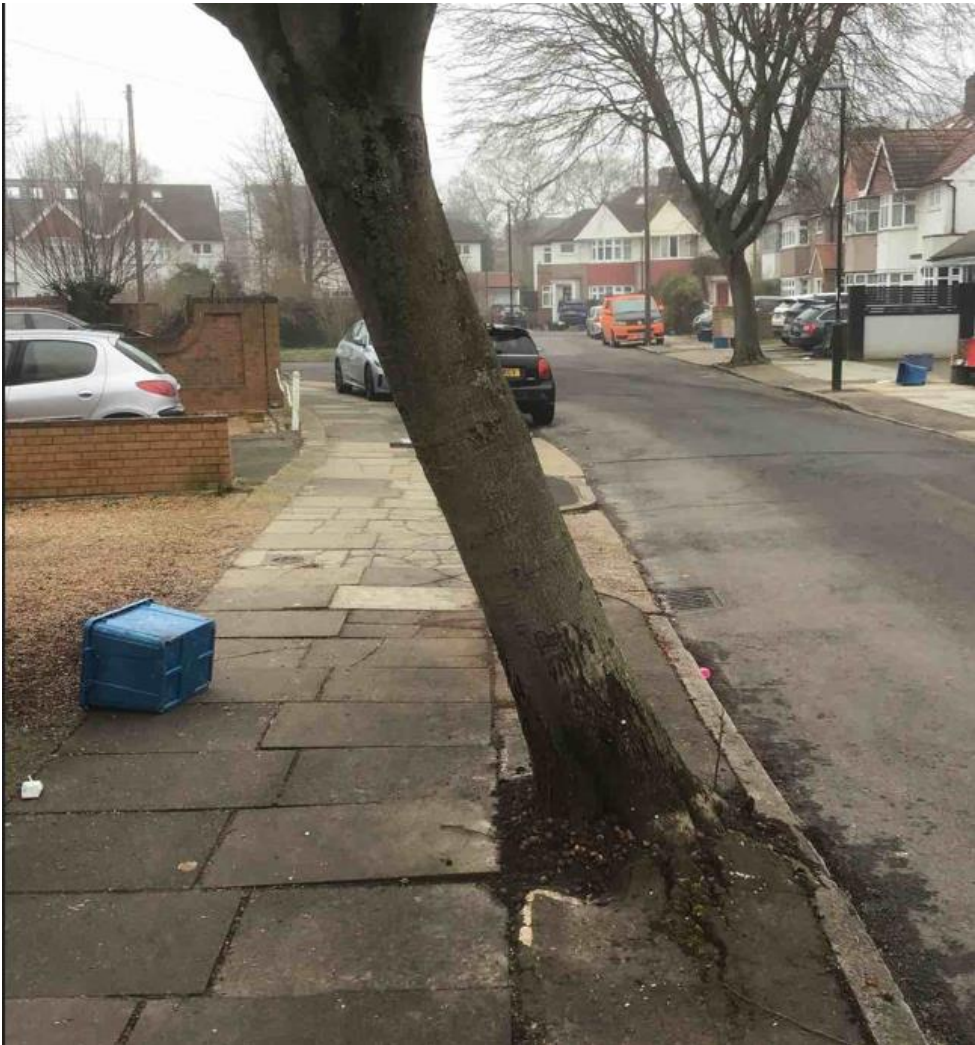
Ward	Whitton
Road	Argyle Avenue
Location	Outside 138
Species	Crab Apple (<i>Malus sp.</i>)
Height	11.5m
Physiological Condition	Good
Structural Condition	Poor
Inspection findings	This tree is leaning across the footway causing an unacceptable degree of obstruction. A fungal fruiting body of the decay pathogen <i>Ganoderma</i> sp. is present at the stem base. Colonisation by this fungus causes a white rot of the stem and root system that can cause entire trees to collapse through fracture or windthrow

Image shows tree in street scene

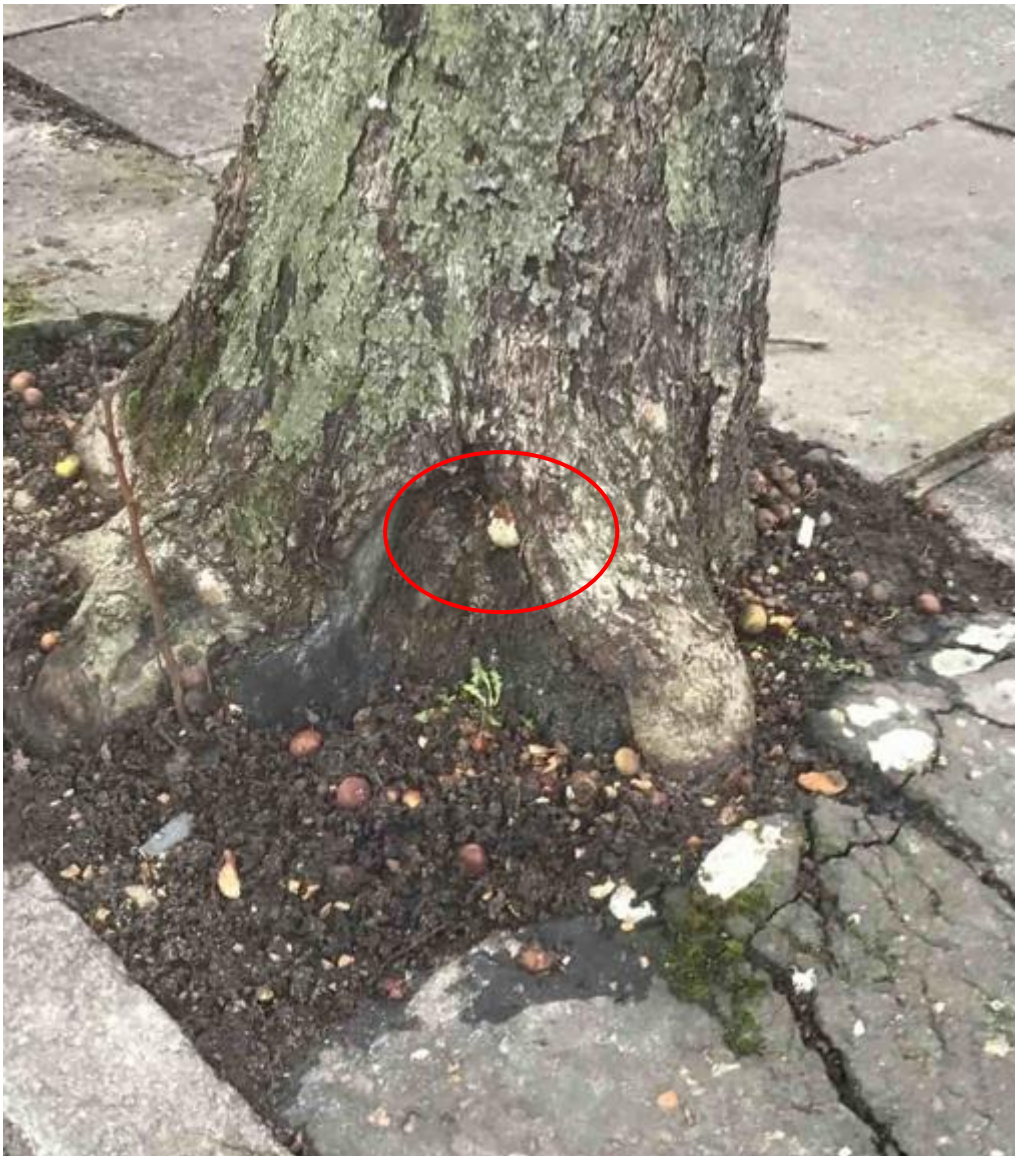
Image shows tree with location of fungal fruiting body circled

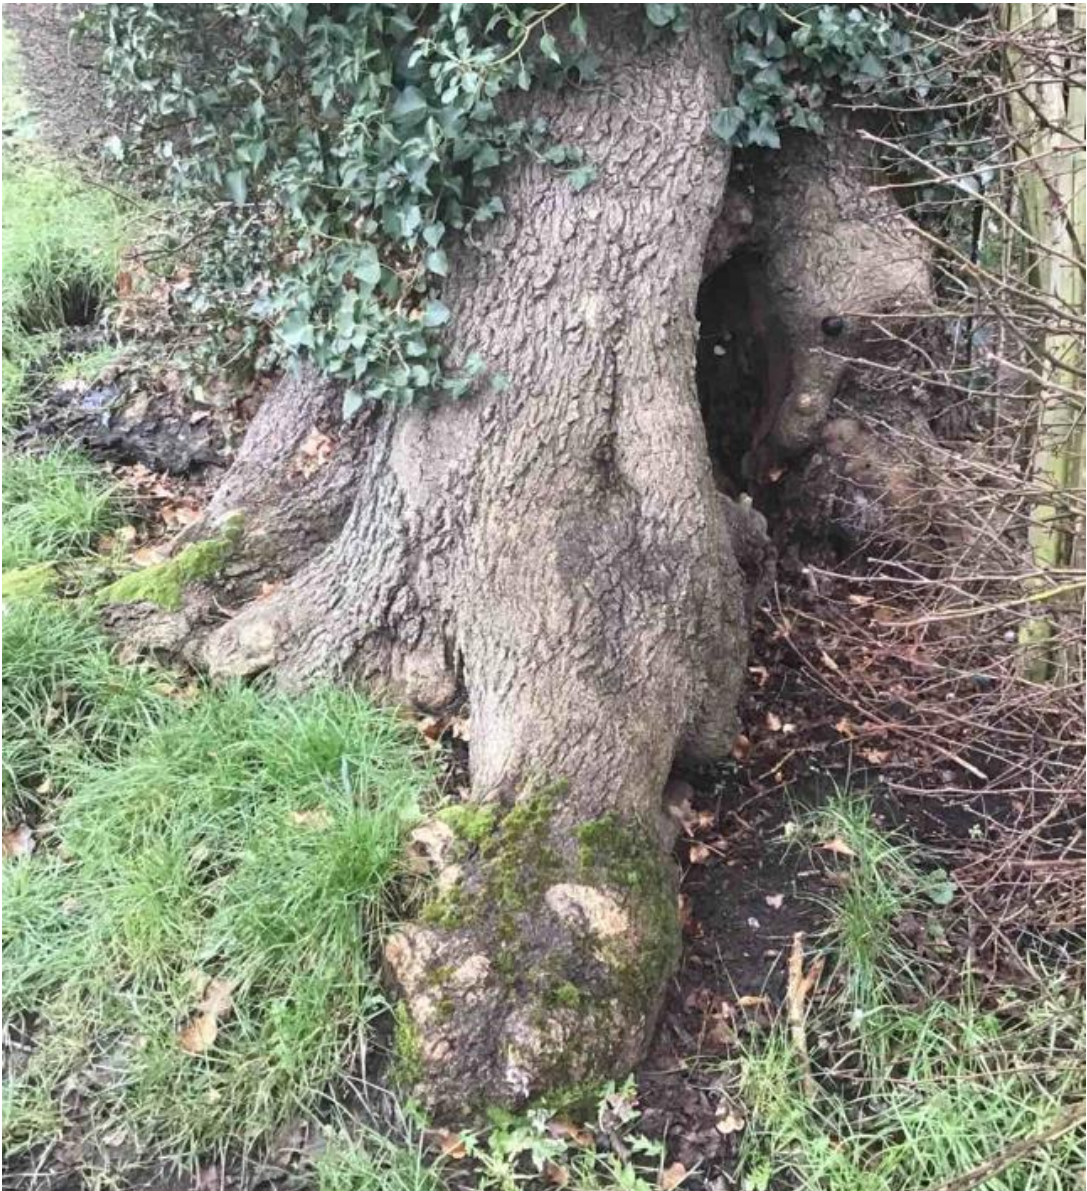
Ward	Whitton
Road	Kneller Road
Location	Murray Park///stones.insert.enhancement
Species	Ash (<i>Fraxinus excelsior</i>)
Height	10m
Physiological Condition	Fair
Structural Condition	Poor
Inspection findings	This tree is being removed due to the presence of extensive decay and fungal fruiting bodies of the decay pathogen <i>Armillaria</i> sp. at the base of this tree. Colonisation by this fungus causes a white rot of the roots and butt that can cause entire tree failure

Images shows extensive decay at base of tree

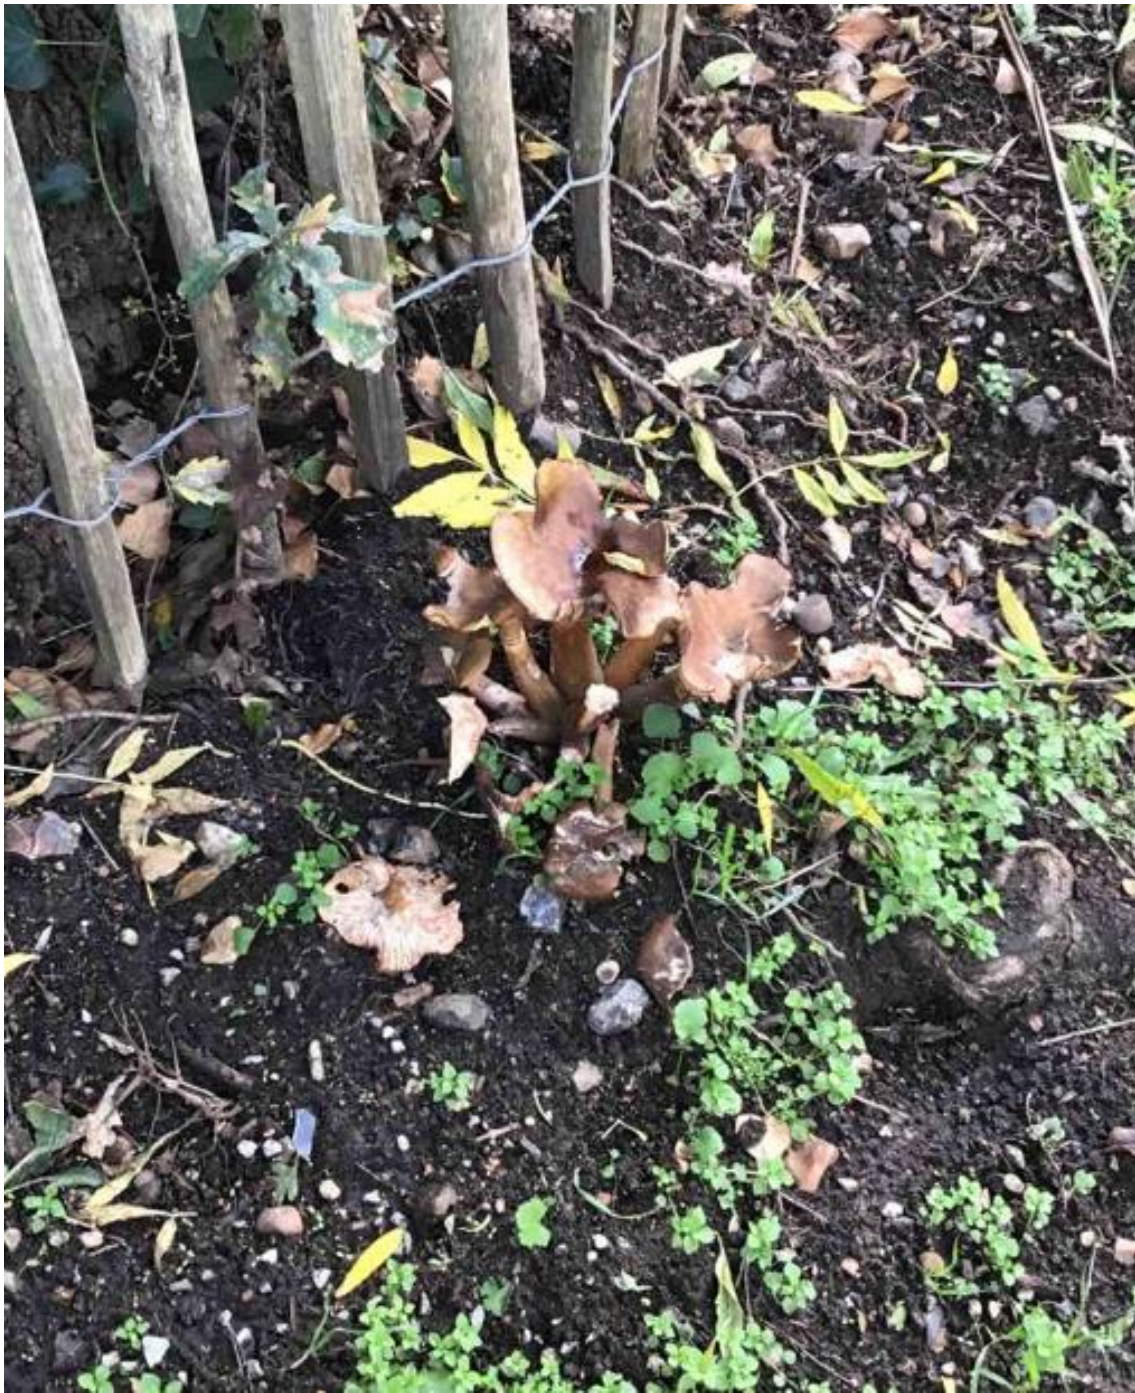
Image shows location of fungal fruiting body at base of tree

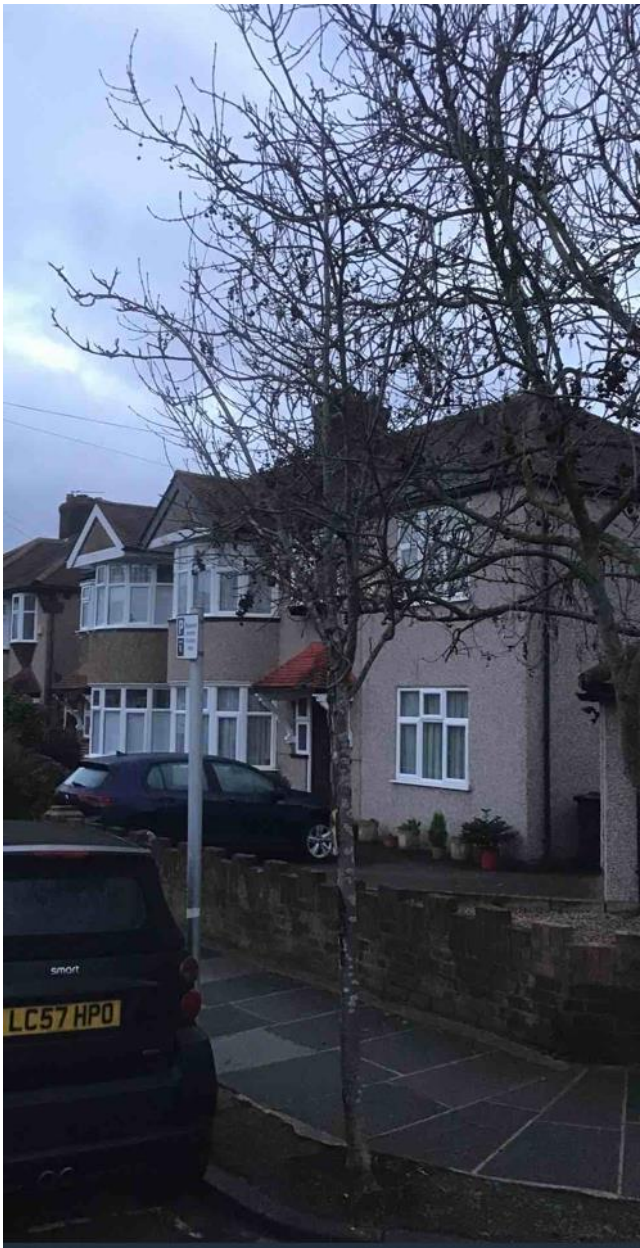
Ward	Whitton
Road	Chase Gardens
Location	Opposite 30
Species	Rowan (<i>Sorbus aucuparia</i>)
Height	5.0m
Physiological Condition	Poor
Structural Condition	Poor
Inspection findings	This tree is moribund; Due to structural defects and suppression from a neighbouring tree. Removal is required to prevent natural failure and facilitate replanting

Images shows moribund tree in street scene

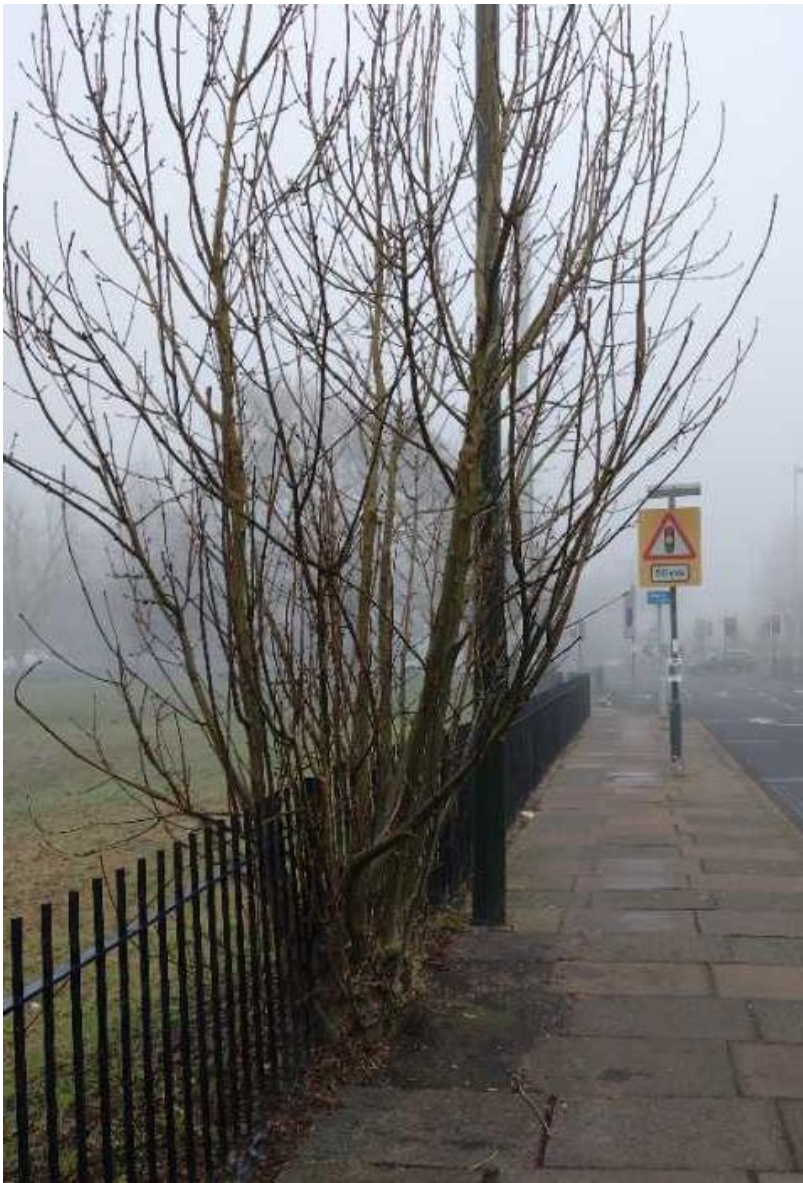
Ward	Whitton
Road	Hospital Bridge Road
Location	Adjacent to lamp column 119, 70m south of A316 roundabout
Species	Ash (<i>Fraxinus excelsior</i>)
Height	4.0m
Physiological Condition	Good
Structural Condition	Good
Inspection findings	This tree is growing in an unsuitable location and requires removal to prevent damage to the railings

Image shows tree in street scene
