October 2024 - Reactive Tree Works Programme

The following pages provide the locations of each tree that is to be removed, in addition photographs and descriptions of the inspection findings have been provided.

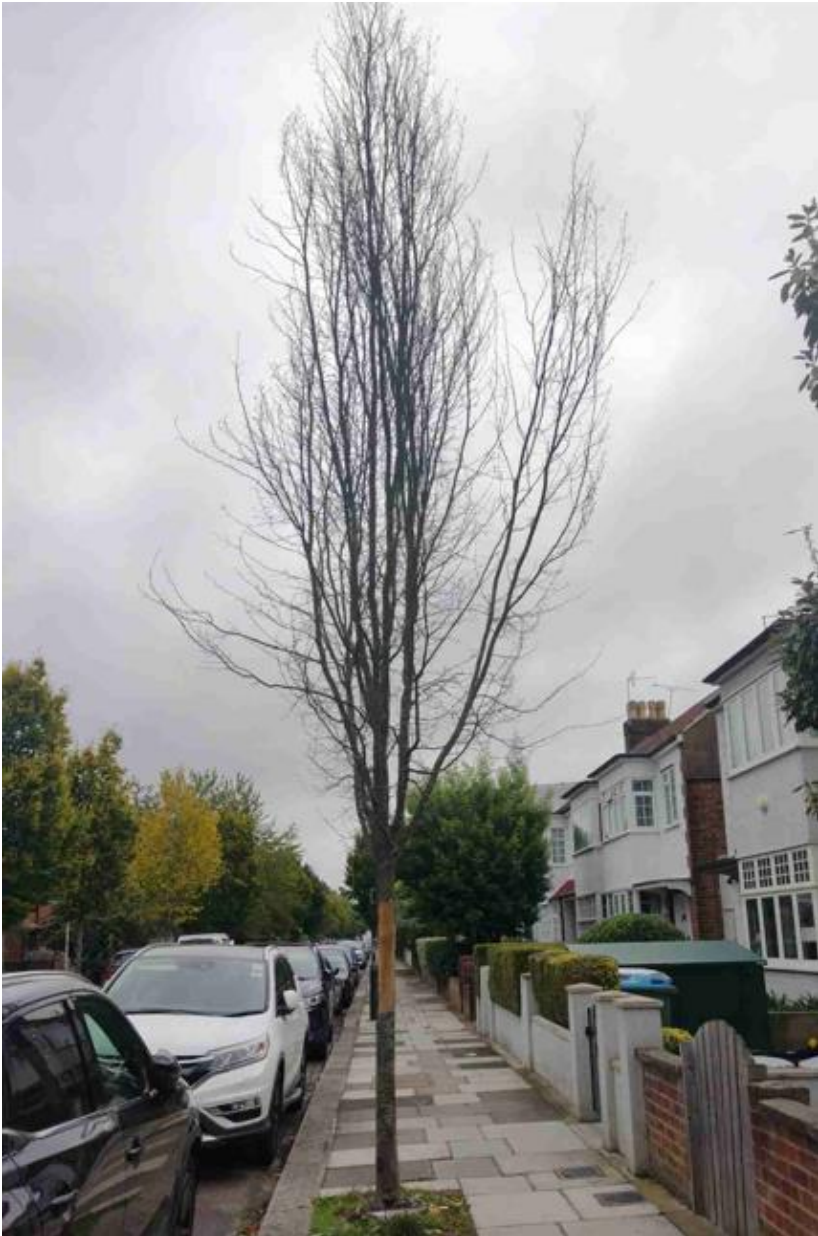
Ward	Barnes
Road	Boileau Road
Location	Outside 46/48
Species	Hornbeam (<i>Carpinus betulus 'Fastigiata'</i>)
Height	8.0m
Physiological Condition	Dead
Structural Condition	Dead
Inspection findings/reason for exemption	This tree is dead; removal is required to prevent natural failure, manage risk, and facilitate replanting

Image shows dead tree in street scene.

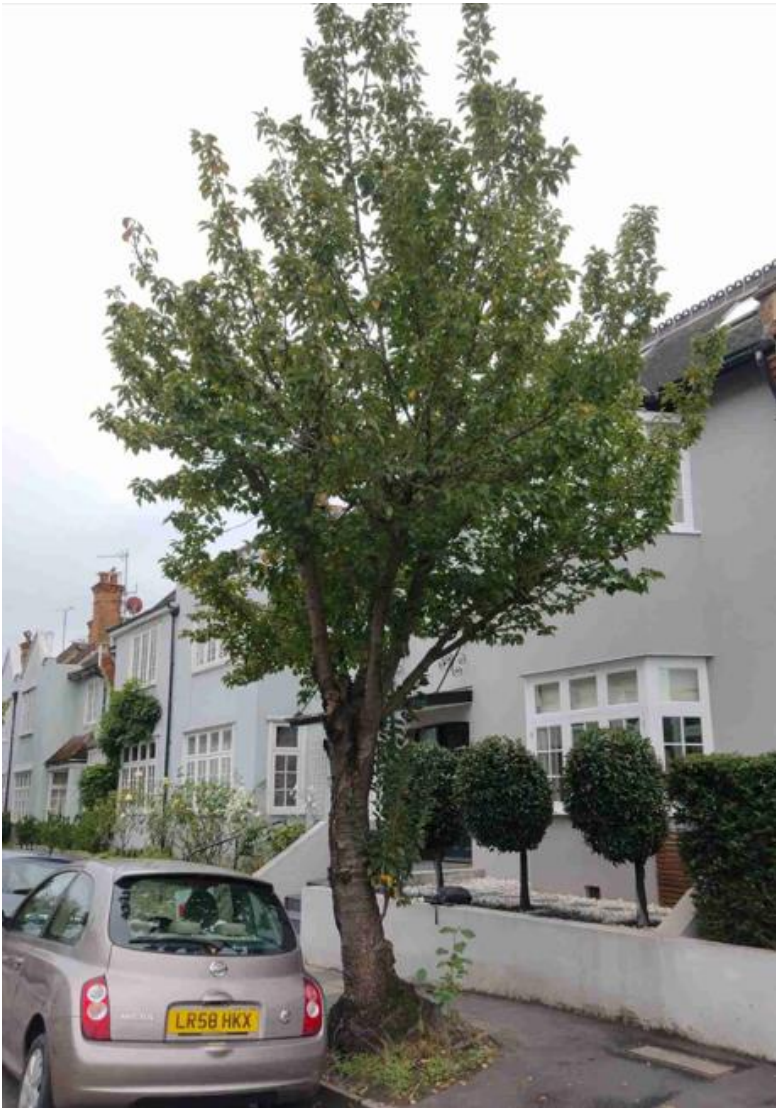
Ward	Barnes
Road	Clavering Avenue
Location	Outside 31
Species	Cherry (Prunus sp.)
Height	6.5m
Physiological Condition	Fair
Structural Condition	Poor
Inspection findings/reason for exemption	A fungal fruiting body of the decay pathogen <i>Ganoderma</i> sp. is present at the stem base. Colonisation by this fungus causes a white rot of the stem and root system that can cause entire trees to collapse through fracture or windthrow. A resonance test revealed an unacceptable degree of decay in the trunk of this tree. Removal is required to prevent natural failure, manage risk, and facilitate replanting

Image shows tree in street scene

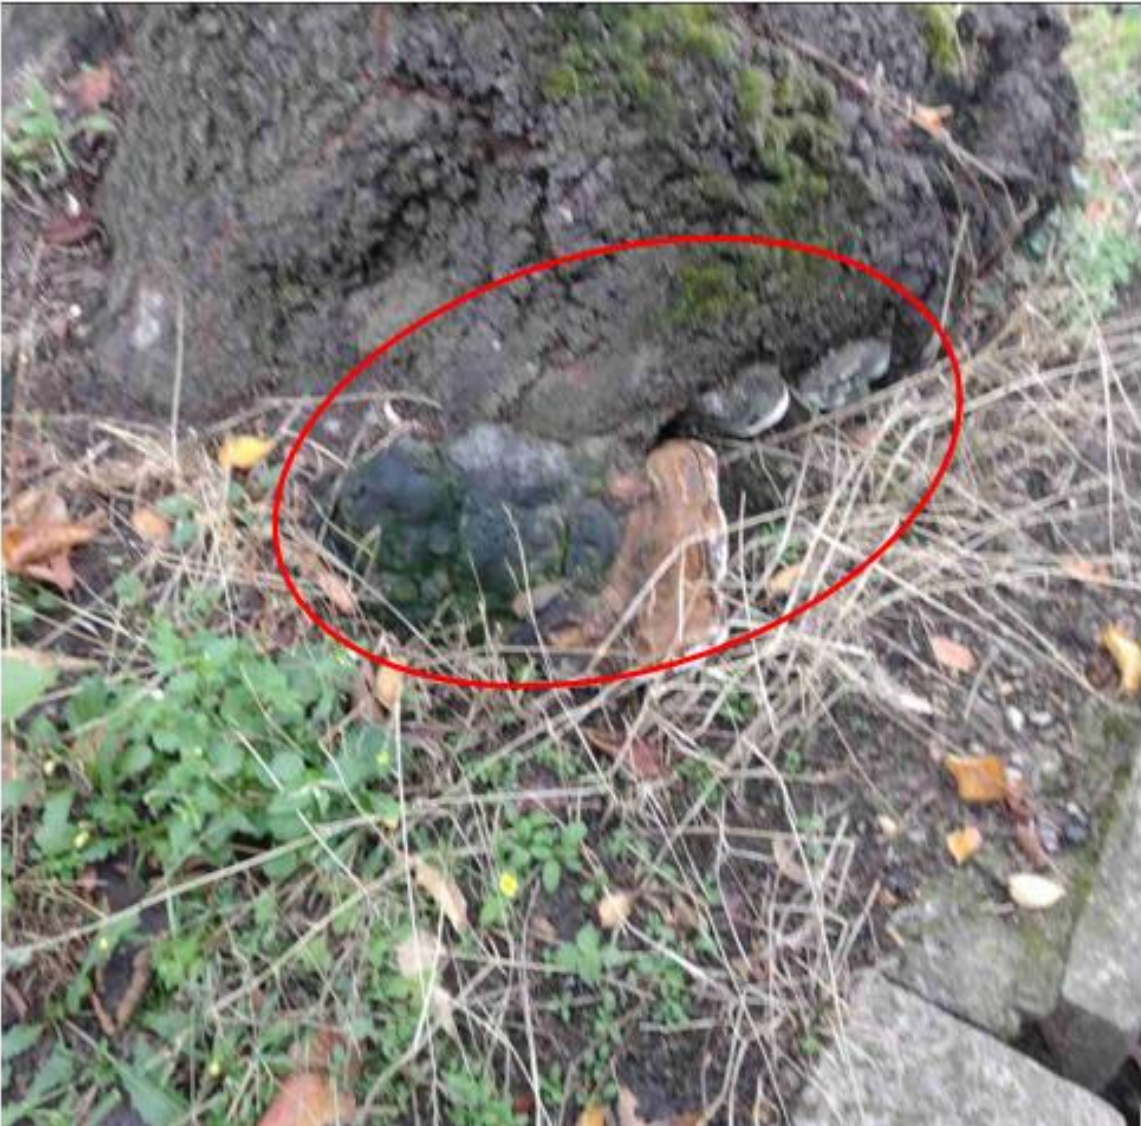
Image shows base of trunk with fruiting bodies circled.

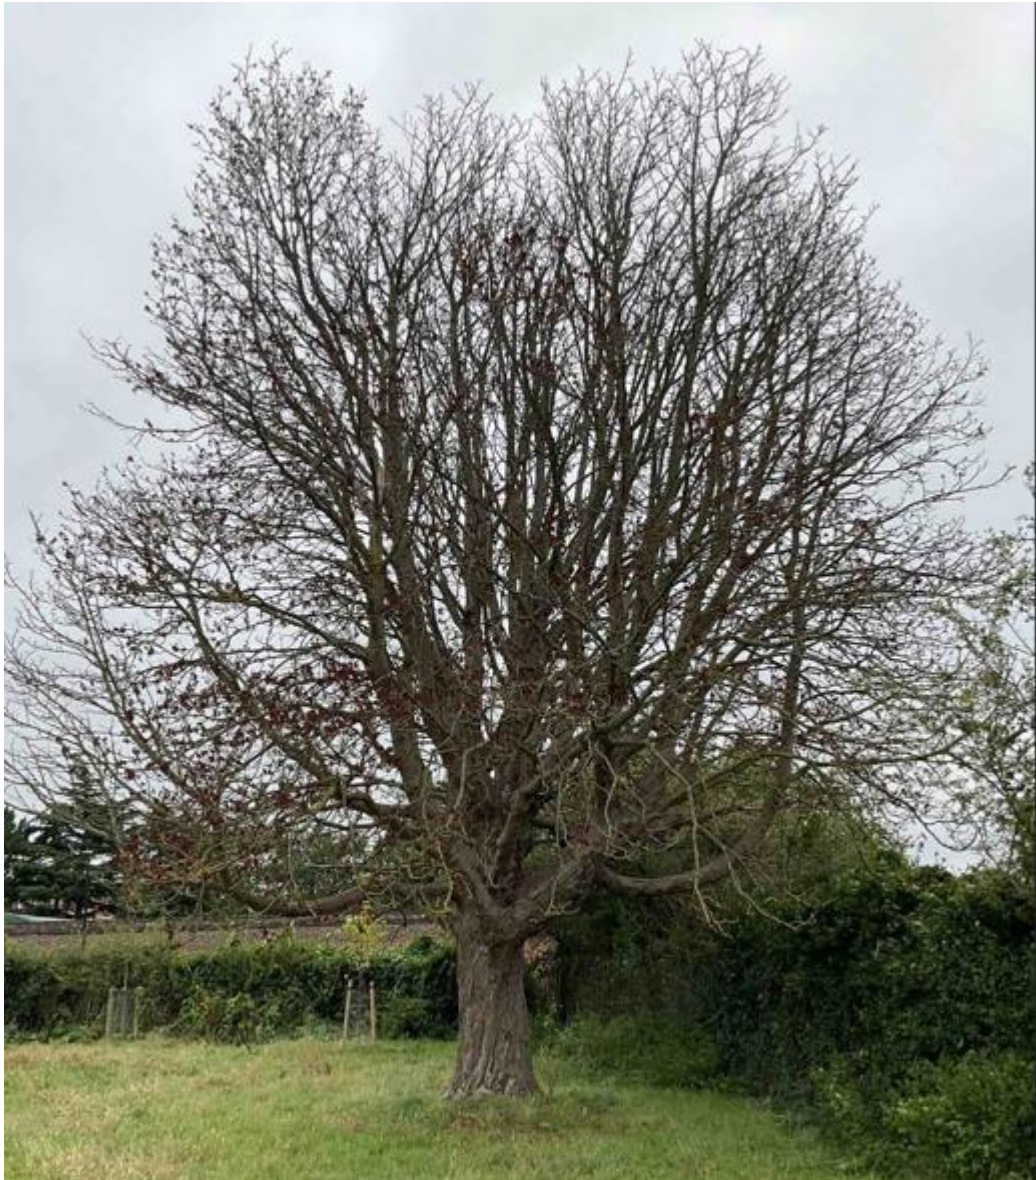
Ward	Ham, Petersham and Richmond Riverside
Road	Ham Street
Location	King Georges Field- ///bells.punchy.alarm
Species	Horse Chestnut (<i>Aesculus hippocastanum</i>)
Height	16.0m
Physiological Condition	Dead
Structural Condition	Dead
Inspection findings/reason for exemption	This tree is dead; removal is required to prevent natural failure, manage risk, and facilitate replanting.

Image shows dead tree in park scene

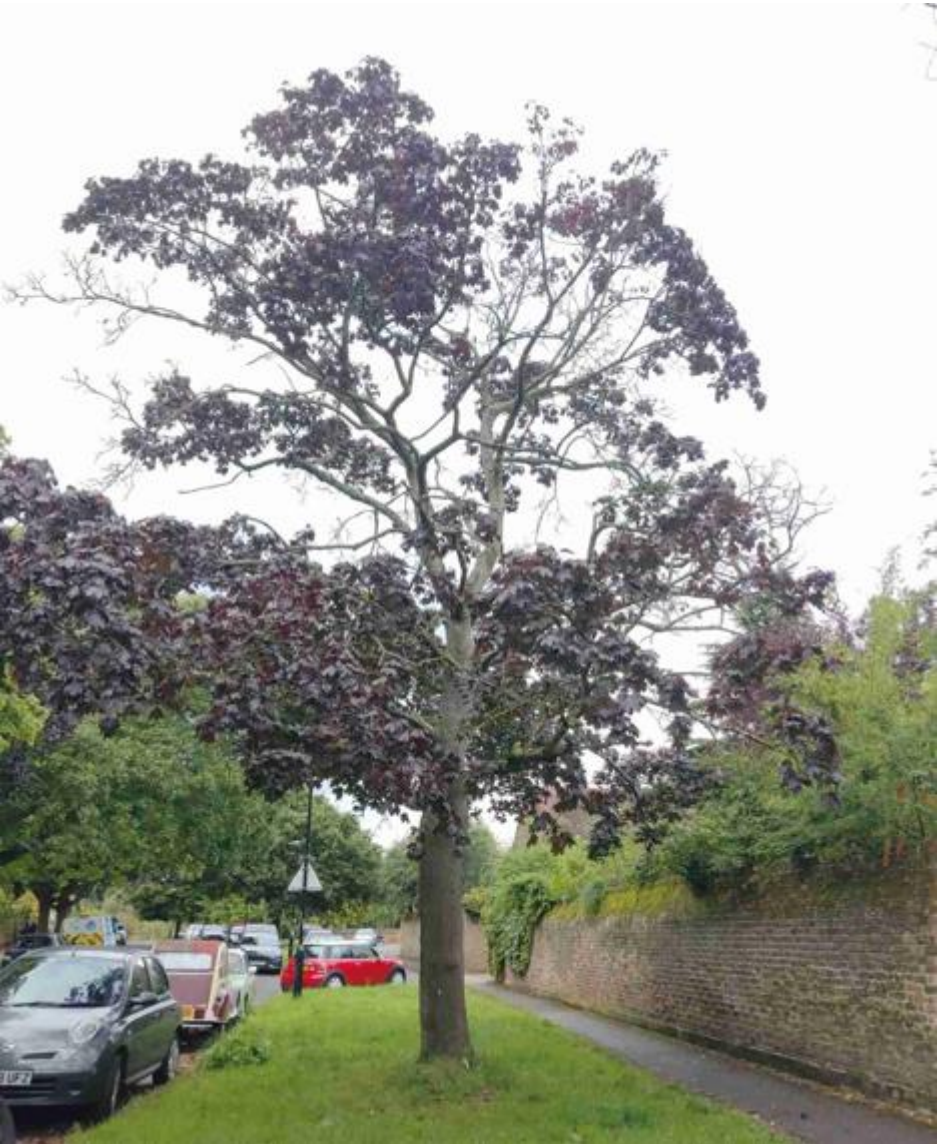
Ward	Ham, Petersham and Richmond Riverside
Road	Ham Street
Location	Opposite 1/ 8 Sutherland House- ///values.scars.angle
Species	Norway Maple (<i>Acer platanoides</i>)
Height	10.0m
Physiological Condition	Poor
Structural Condition	Poor
Inspection findings/reason for exemption	Fungal fruiting bodies of the decay pathogen <i>Armillaria</i> sp. are suspected to be present at the base of this tree. Colonisation by this fungus causes a white rot of the roots and butt that can cause entire tree failure. Crown dieback correlates with the fruiting body at the base of stem. Removal is required to prevent natural failure, manage risk, and facilitate replanting

Image shows tree in street scene with crown dieback.

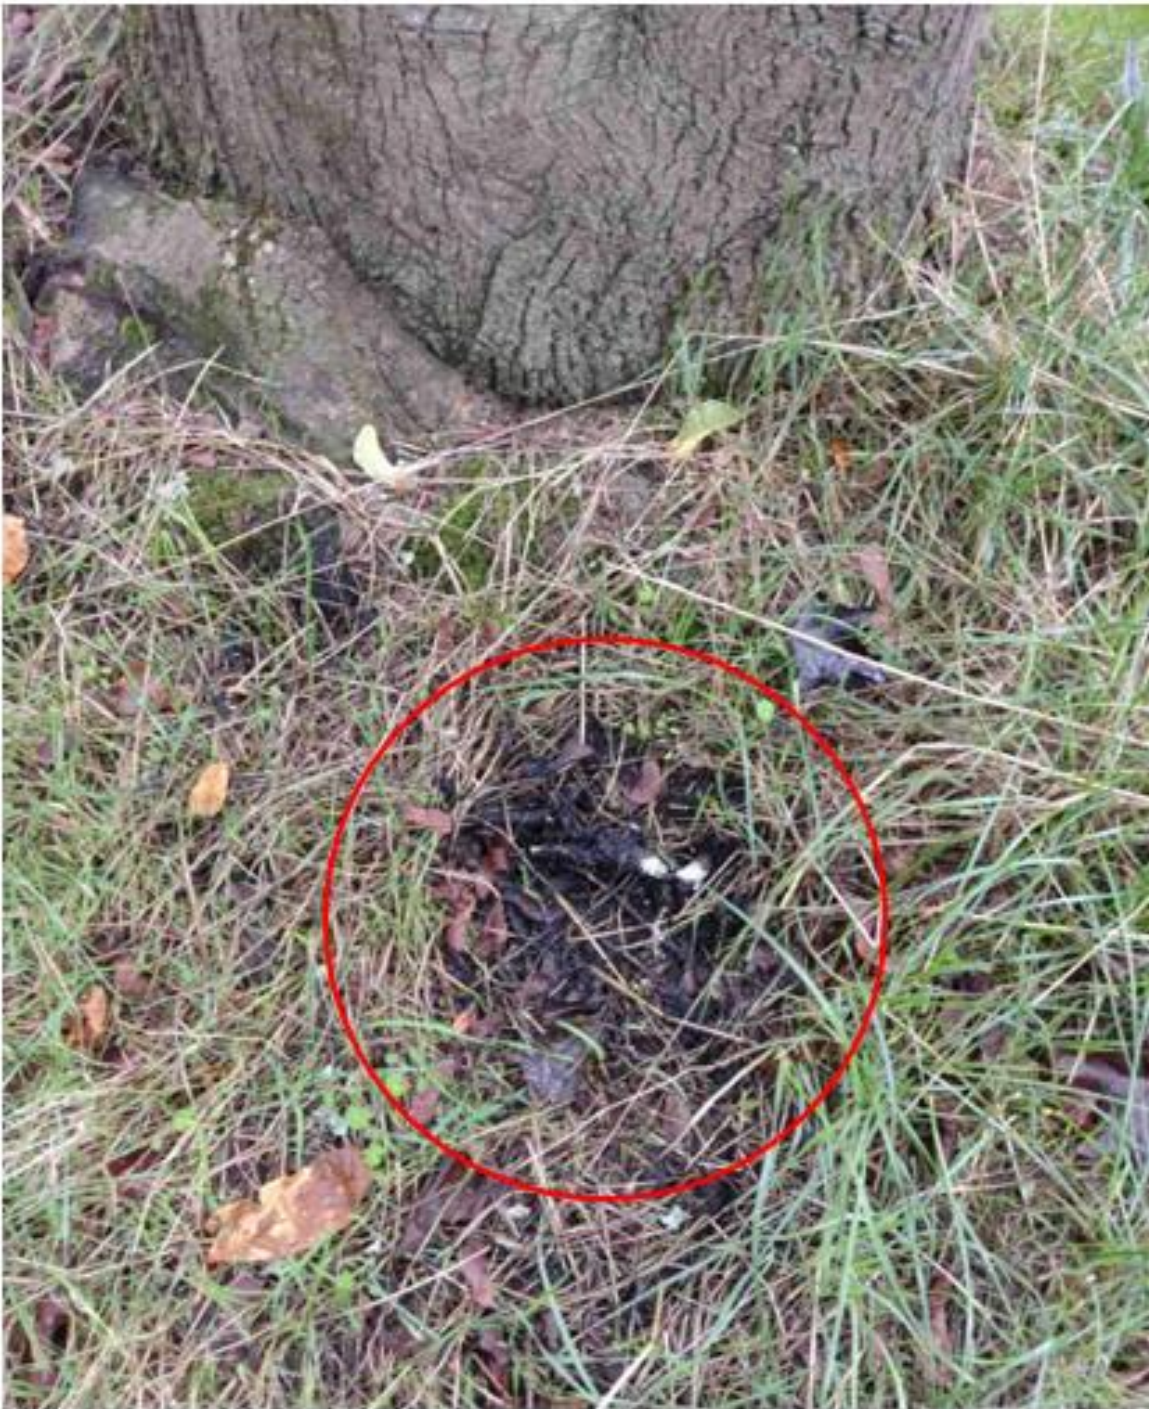
Image shows suspected Armillaria sp. fruiting bodies circled at base of trunk.

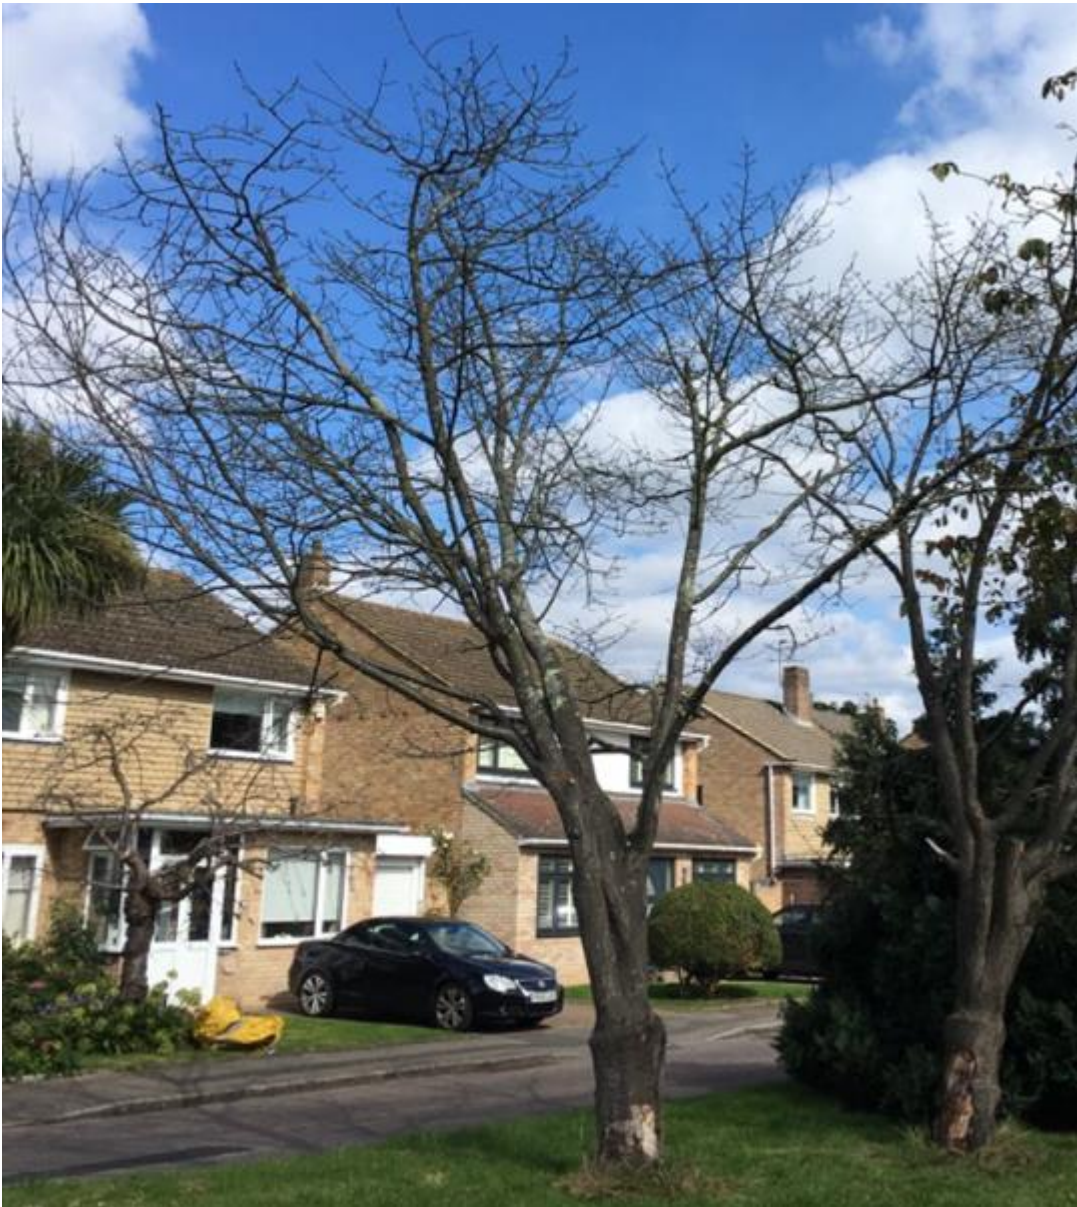
Ward	Hampton North
Road	Albury Close
Location	On Grass Island opposite 71
Species	Cherry (<i>Prunus sp.</i>)
Height	6.5m
Physiological Condition	Dead
Structural Condition	Dead
Inspection findings/reason for exemption	This tree is dead; removal is required to prevent natural failure, manage risk, and facilitate replanting.

Image shows dead tree in street scene.

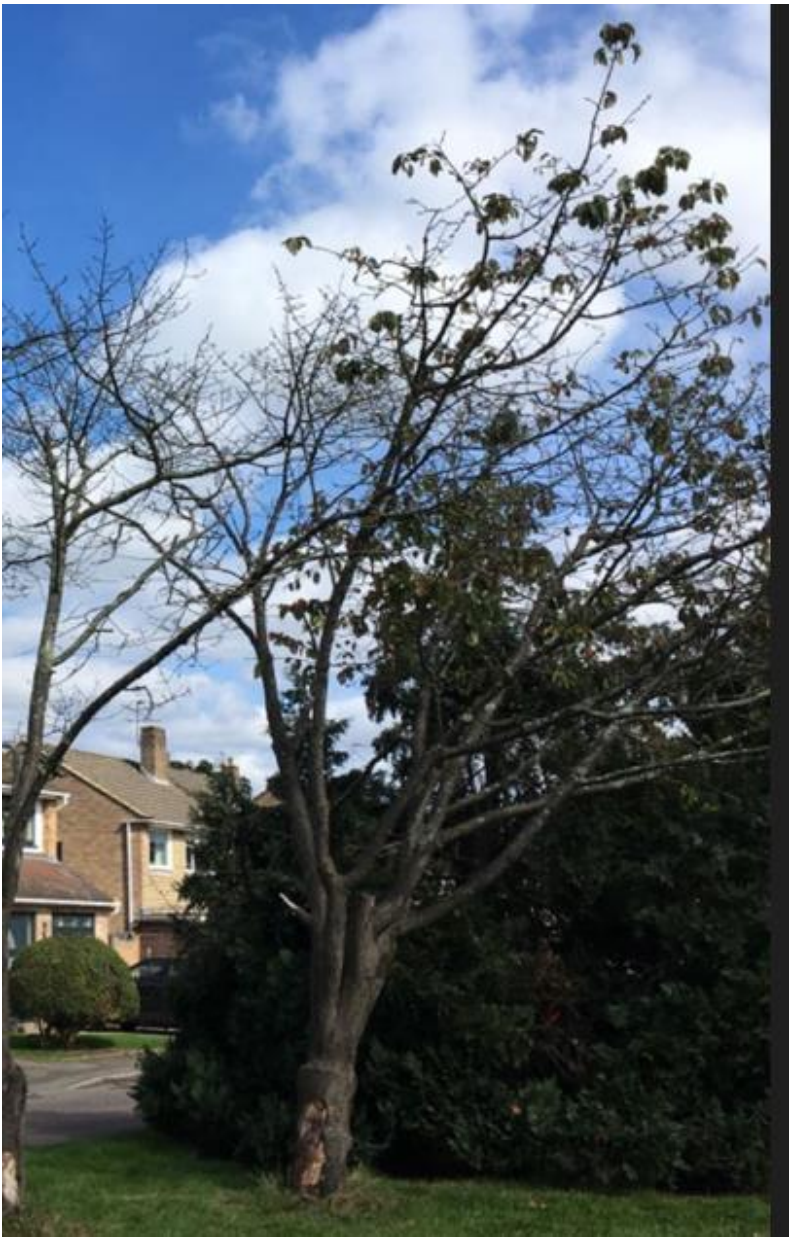
Ward	Hampton North
Road	Albury Close
Location	On Grass Island opposite 71
Species	Cherry (<i>Prunus sp.</i>)
Height	6.0m
Physiological Condition	Poor
Structural Condition	Fair
Inspection findings/reason for exemption	This tree is moribund with over 70% of the crown being dead. Removal is required to prevent natural failure, manage risk, and facilitate replanting.

Image shows dead tree in street scene.

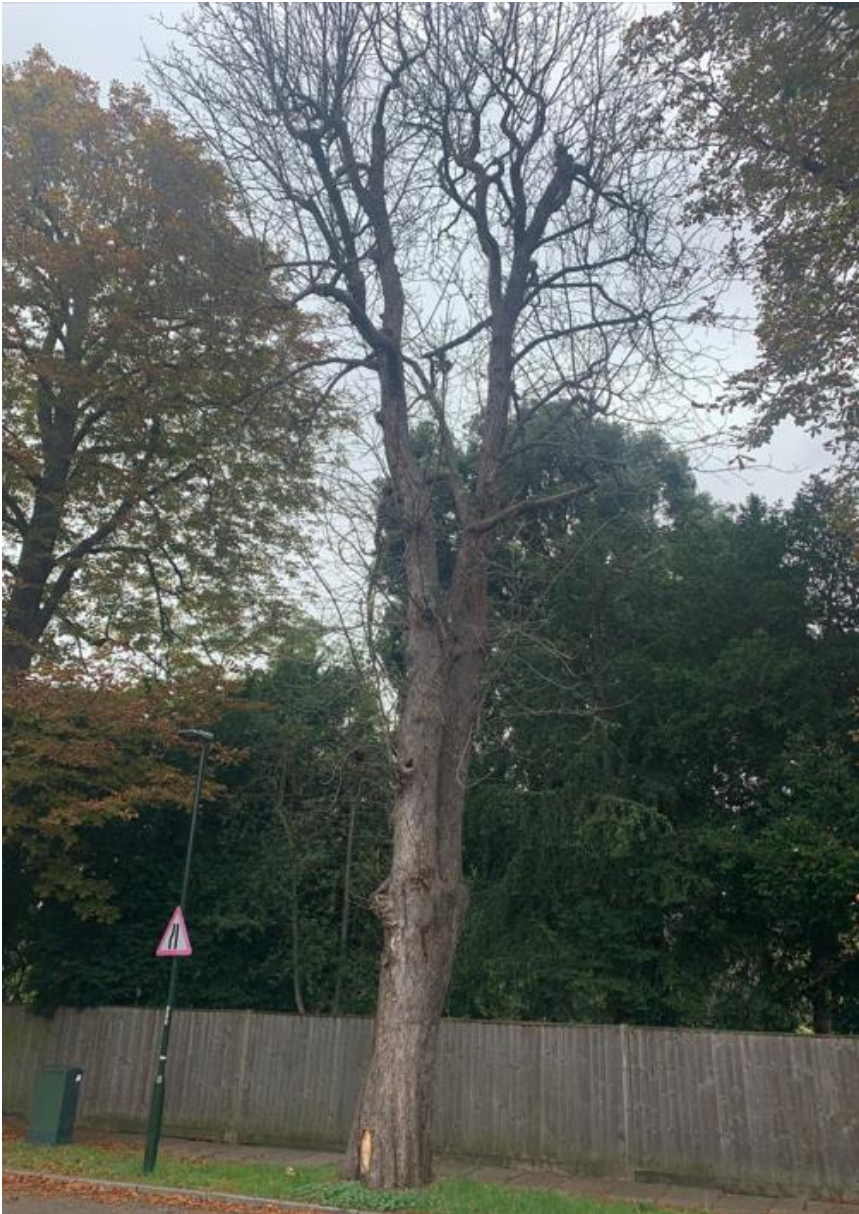
Ward	Hampton Wick and South Teddington
Road	Normansfield Avenue
Location	Opposite junction to Glamorgan Road- ///diner.love.prep
Species	Horse Chestnut (<i>Aesculus hippocastanum</i>)
Height	18.0m
Physiological Condition	Dead
Structural Condition	Dead
Inspection findings/reason for exemption	This tree is dead; removal is required to prevent natural failure, manage risk and facilitate replanting

Image shows dead tree in street scene.

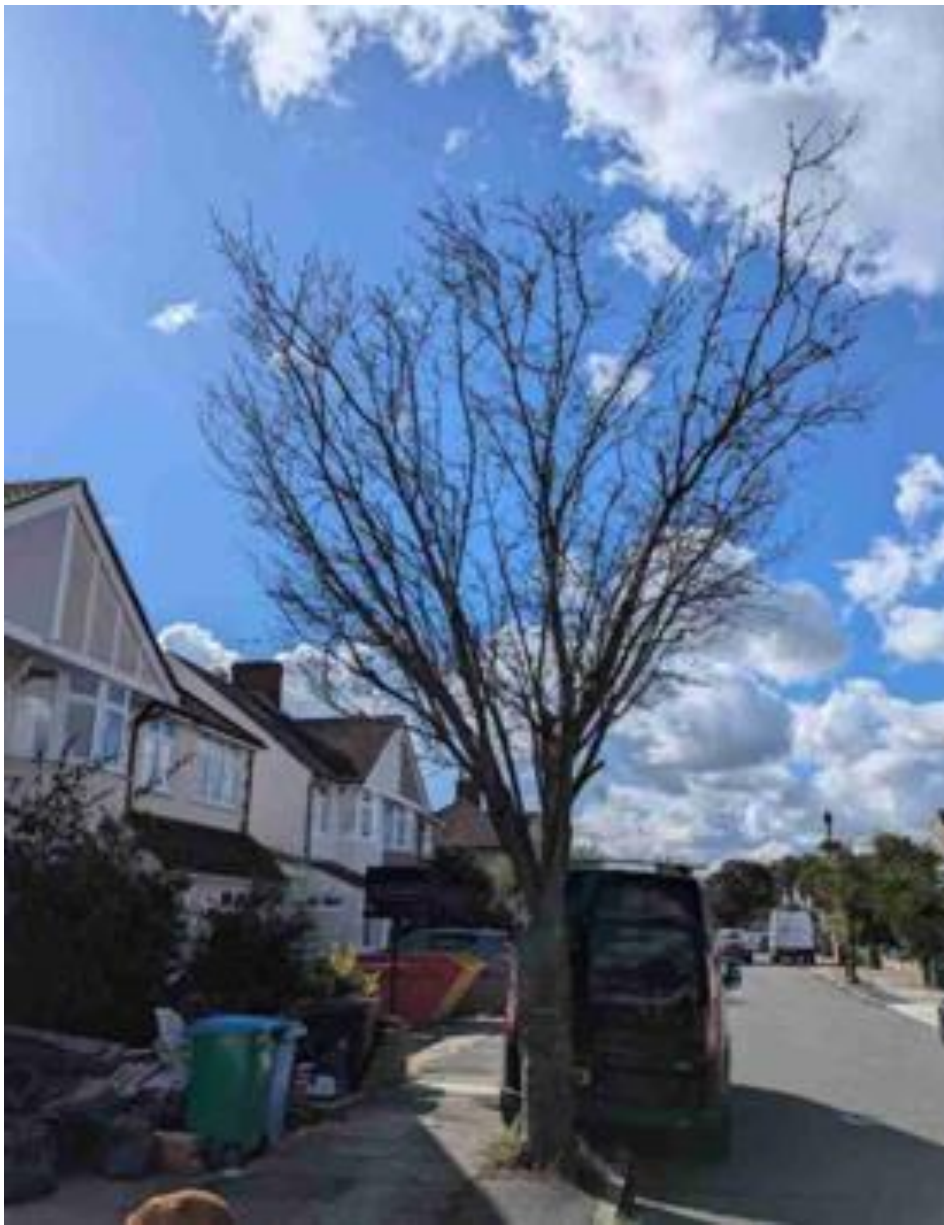
Ward	Heathfield
Road	Cheyne Avenue
Location	Outside 1
Species	Cherry (<i>Prunus sp.</i>)
Height	8.0m
Physiological Condition	Poor
Structural Condition	Poor
Inspection findings/reason for exemption	This tree is dead; removal is required to prevent natural failure, manage risk, and facilitate replanting

Image shows dead tree is street scene.

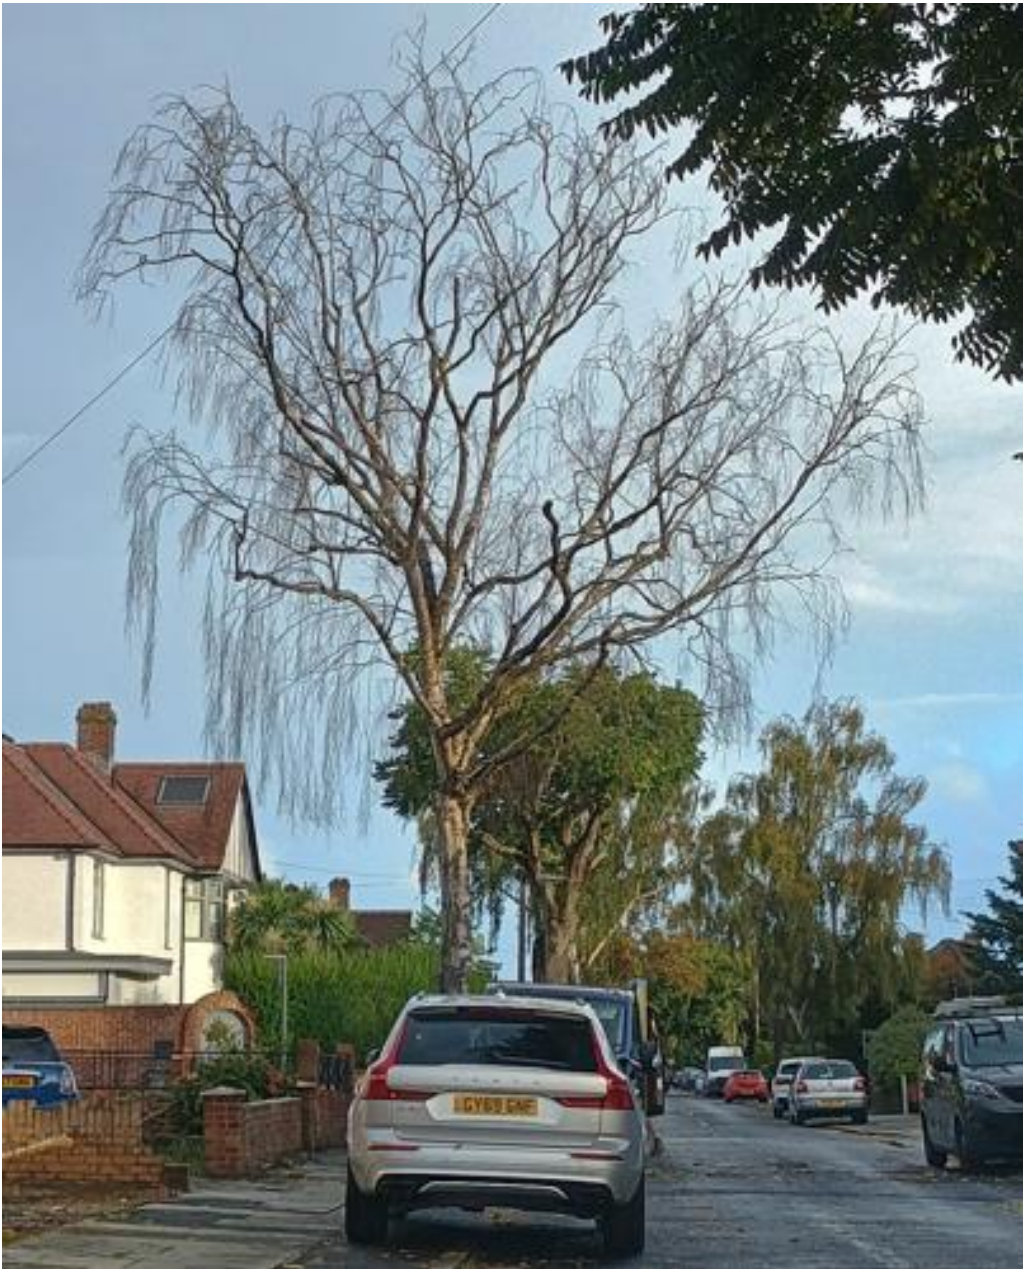
Ward	Heathfield
Road	Waverley Avenue
Location	Outside 194/196
Species	Silver Birch (<i>Betula pendula</i>)
Height	15.0m
Physiological Condition	Dead
Structural Condition	Dead
Inspection findings/reason for exemption	This tree is dead; removal is required to prevent natural failure, manage risk and facilitate replanting.

Images shows dead tree in street scene.

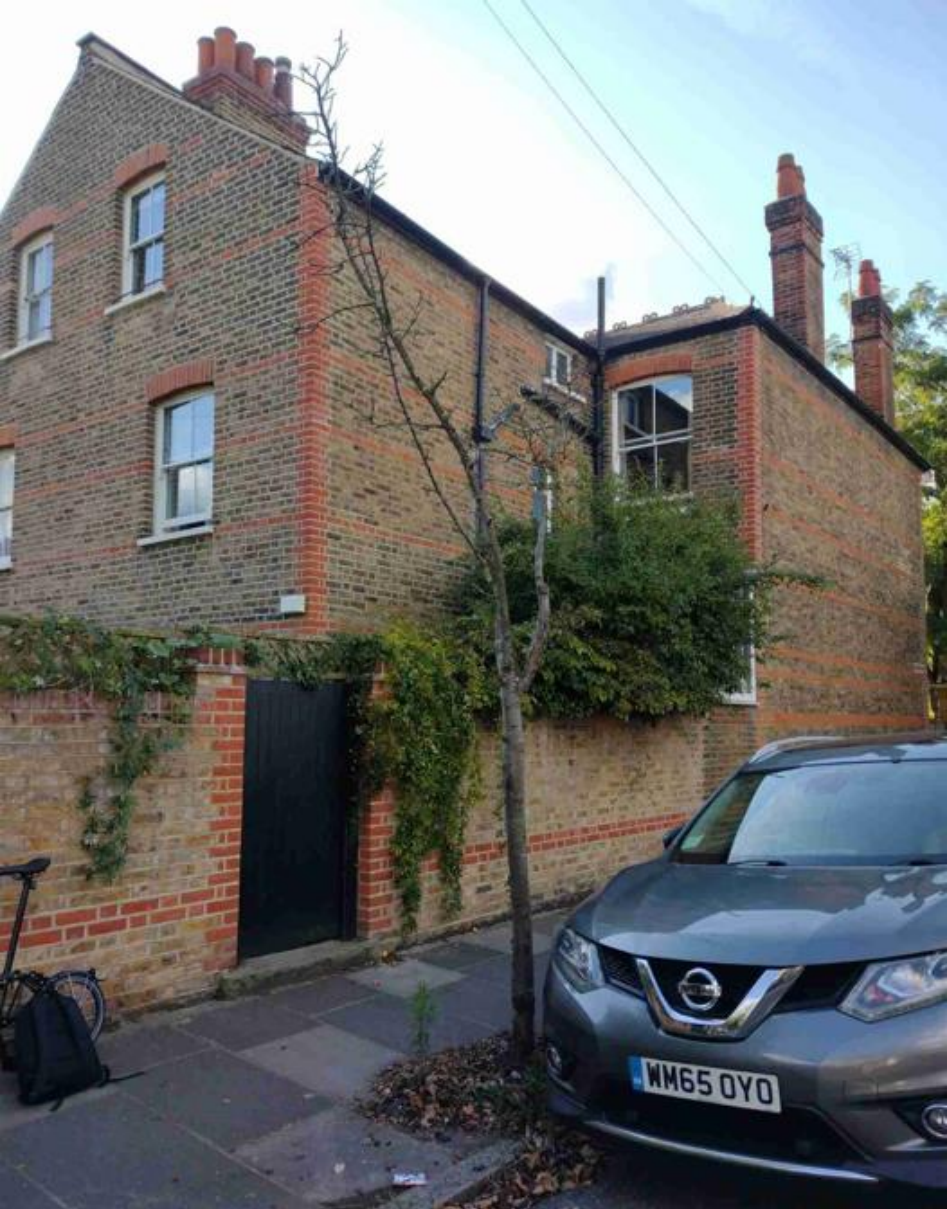
Ward	Kew
Road	Bushwood Road
Location	Adjacent to 46 Kew Green rear gardens
Species	Cherry (<i>Prunus sp.</i>)
Height	4.5m
Physiological Condition	Dead
Structural Condition	Dead
Inspection findings/reason for exemption	This tree is dead; removal is required to prevent natural failure, manage risk, and facilitate replanting

Image shows Dead tree in street scene.

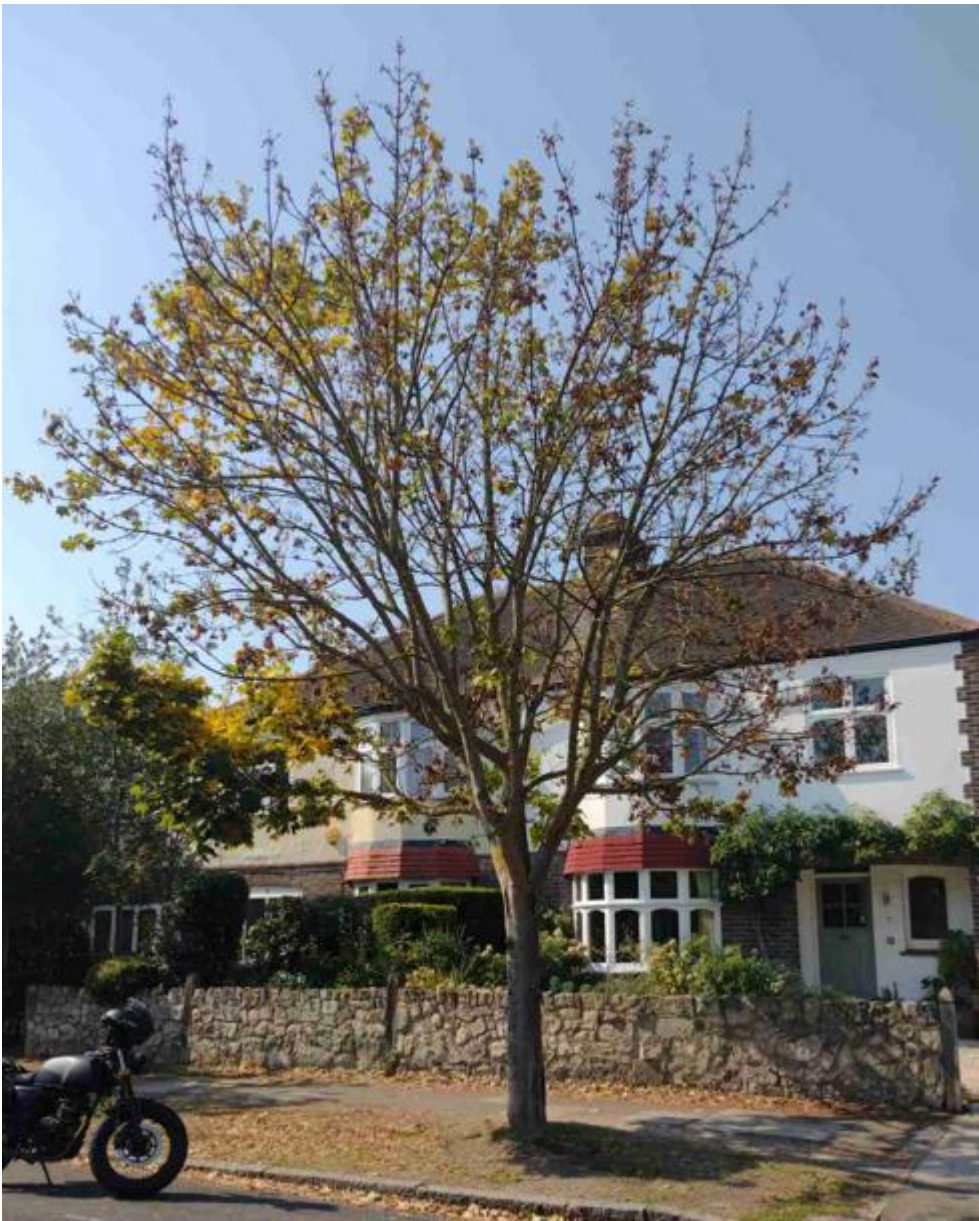
Ward	Kew
Road	Pensford Avenue
Location	Outside 7
Species	Norway Maple (<i>Acer platanoides</i>)
Height	8.5m
Physiological Condition	Poor
Structural Condition	Fair
Inspection findings/reason for exemption	This tree is in moribund state with over 80% of the crown being dead. Removal is required to prevent natural failure, manage risk, and facilitate replanting.

Image shows moribund tree in street scene.

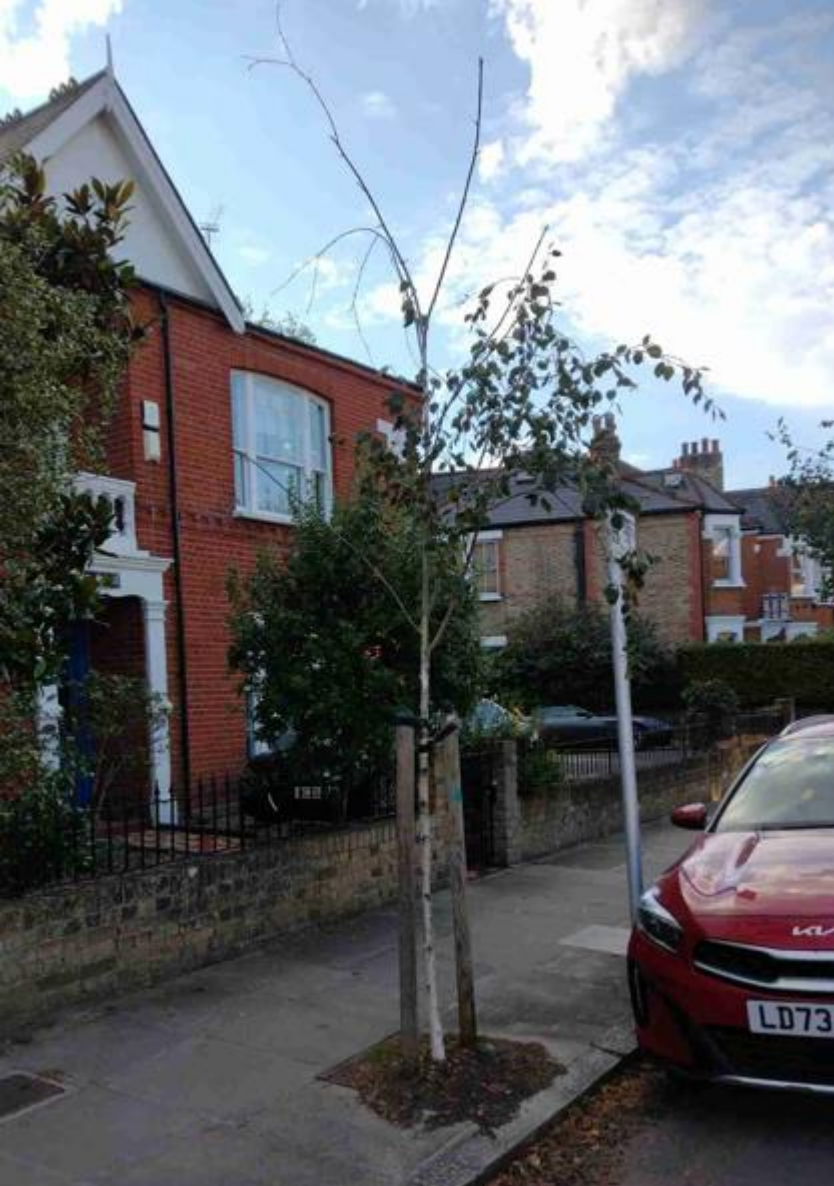
Ward	North Richmond
Road	Pagoda Avenue
Location	Outside Gra MaChree & No.14
Species	Silver Birch (<i>Betula pendula</i>)
Height	5.0m
Physiological Condition	Poor
Structural Condition	Poor
Inspection findings/reason for exemption	This tree is moribund; removal is required to prevent natural failure and facilitate replanting

Image shows moribund tree in street scene.

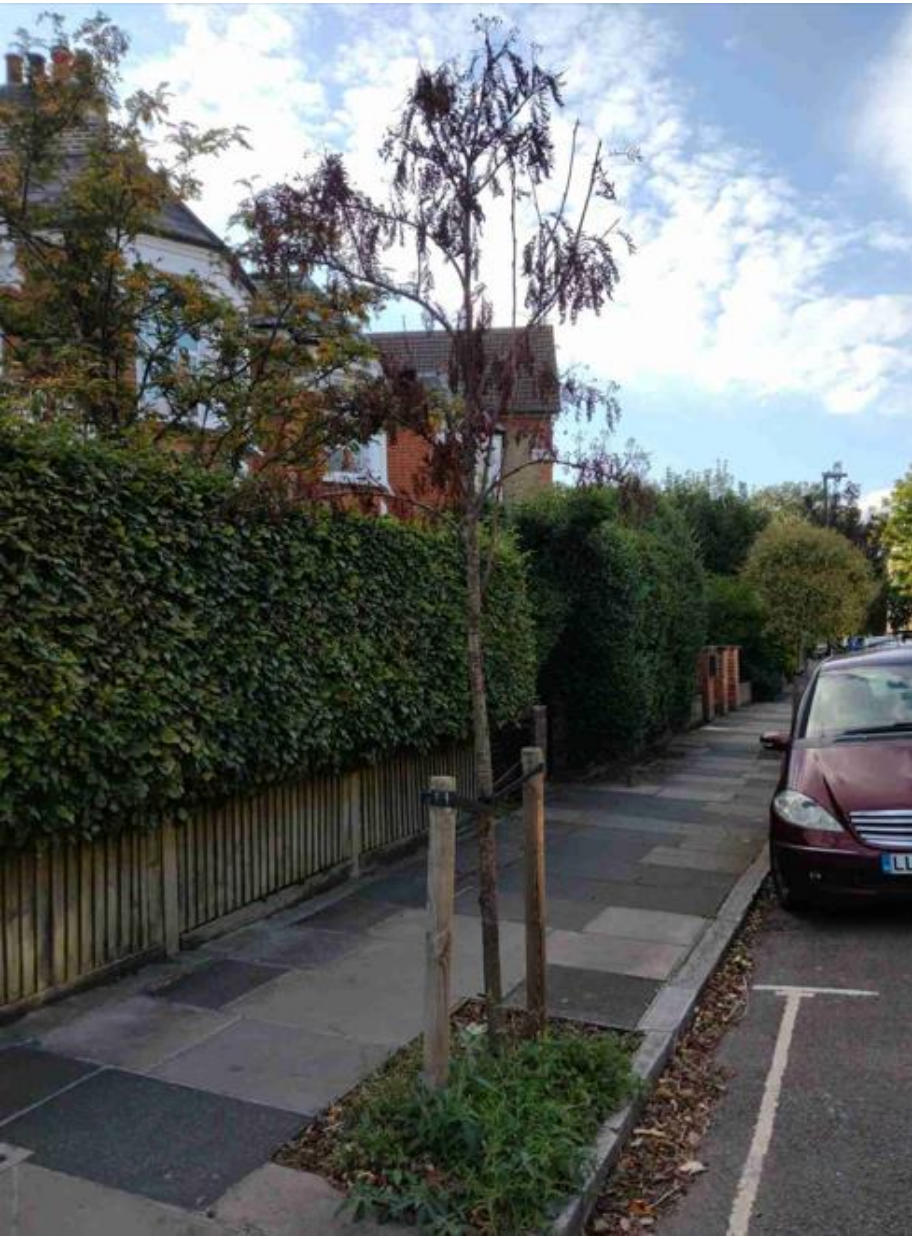
Ward	North Richmond
Road	Pagoda Avenue
Location	Outside 12
Species	Rowan (<i>Sorbus aucuparia</i>)
Height	5.0m
Physiological Condition	Dead
Structural Condition	Dead
Inspection findings/reason for exemption	This tree is dead; removal is required to prevent natural failure and facilitate replanting

Image shows moribund tree in street scene.

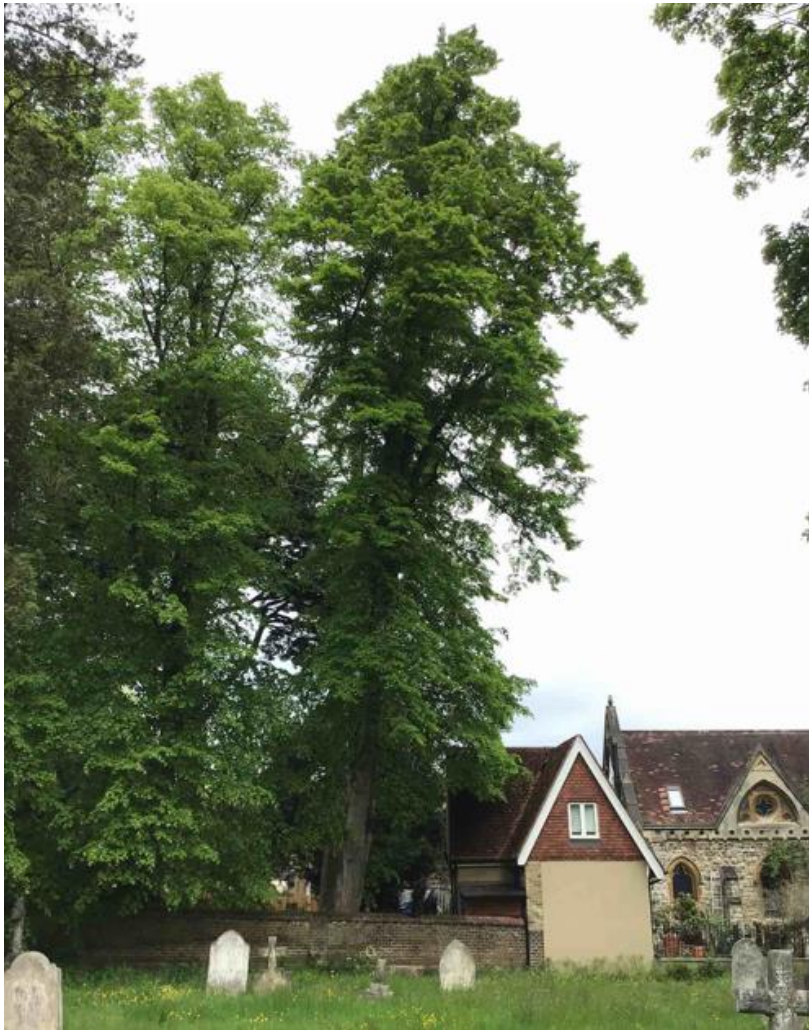
Ward	South Richmond
Road	Grove Road
Location	Grove Road Garden- ///dizzy.sorters.school
Species	Common Lime (<i>Tilia x europaea</i>)
Height	30.0m
Physiological Condition	Fair
Structural Condition	Poor
Inspection findings/reason for exemption	Fungal fruiting bodies of the decay pathogen <i>Kretzschmaria deusta</i> are present on the base of this tree. This fungus causes a white rot that can cause whole tree failure through a ceramic like fracture of the base. Removal is required to prevent natural failure and facilitate replanting.

Image shows tree in park scene.

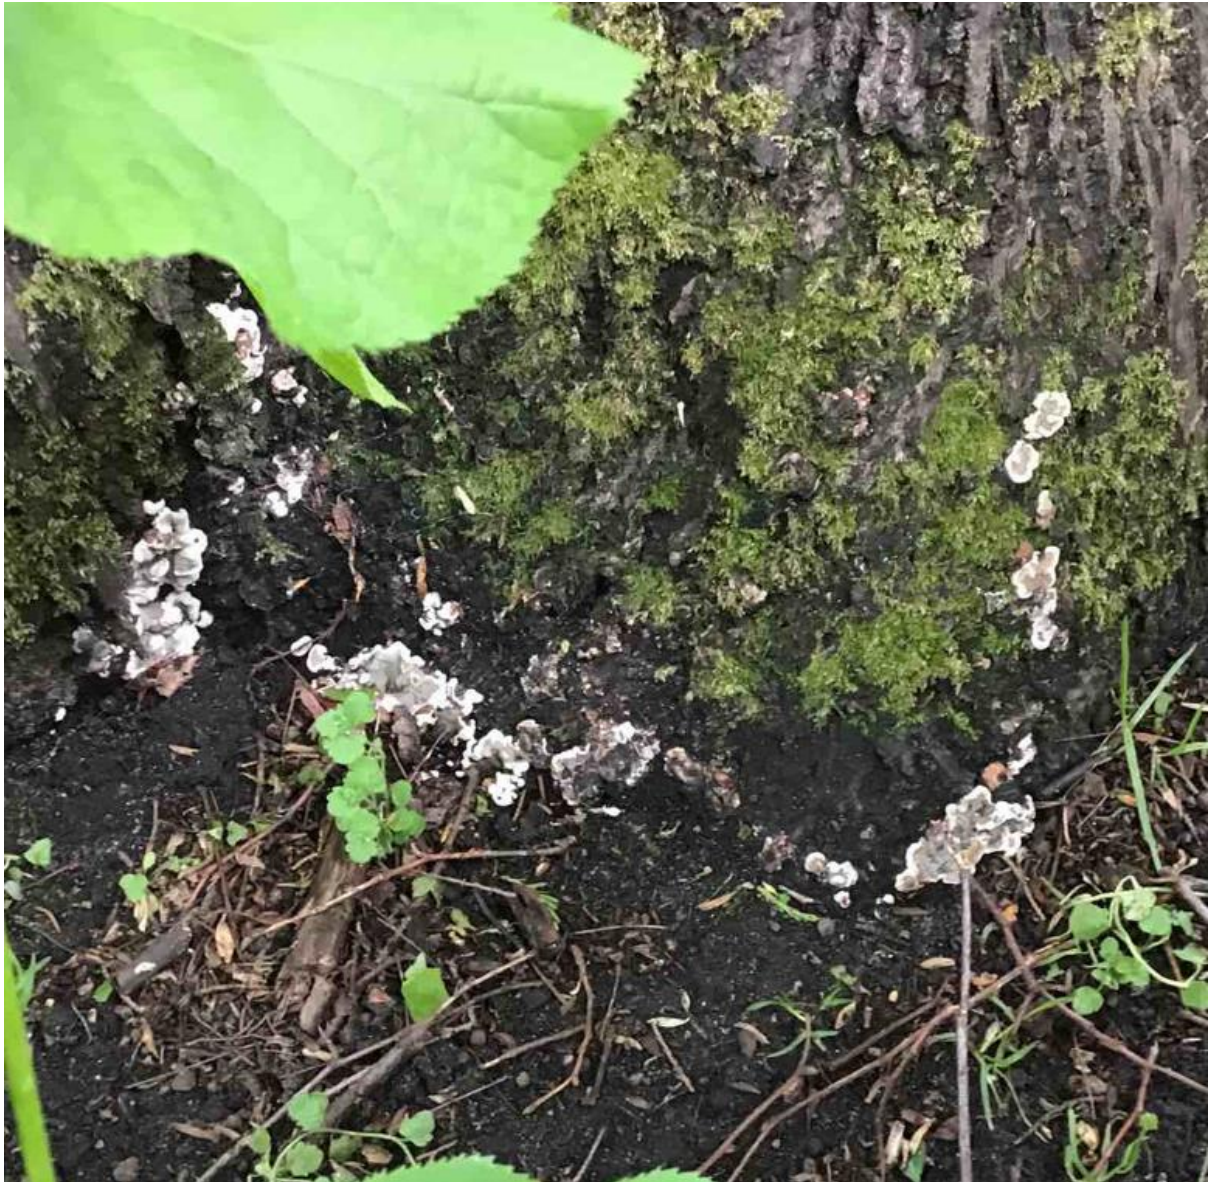
Image shows *Kretzschmaria deusta* pathogens at the base of trunk.

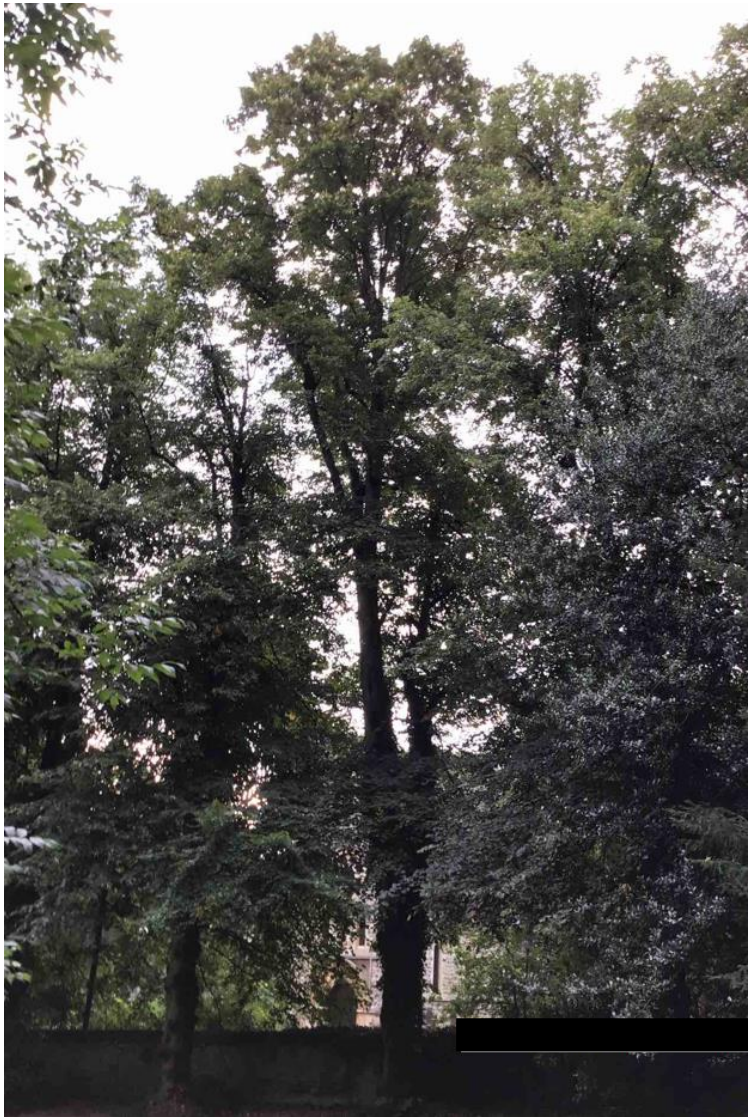
Ward	South Richmond
Road	Grove Road
Location	Grove Road Gardens- ///tribal.bride.wheels
Species	Common Lime (<i>Tilia x europaea</i>)
Height	26.0m
Physiological Condition	Fair
Structural Condition	Poor
Inspection findings/reason for exemption	Fungal fruiting bodies of the decay pathogen <i>Kretzschmaria deusta</i> are present on the base of this tree. This fungus causes a white rot that can cause whole tree failure through a ceramic like fracture of the base. Removal is required to prevent natural failure and facilitate replanting.

Image shows tree in park scene.
