October 2024 - Reactive Tree Works Programme

The following pages provide the locations of each tree that is to be removed, in addition photographs and descriptions of the inspection findings have been provided.

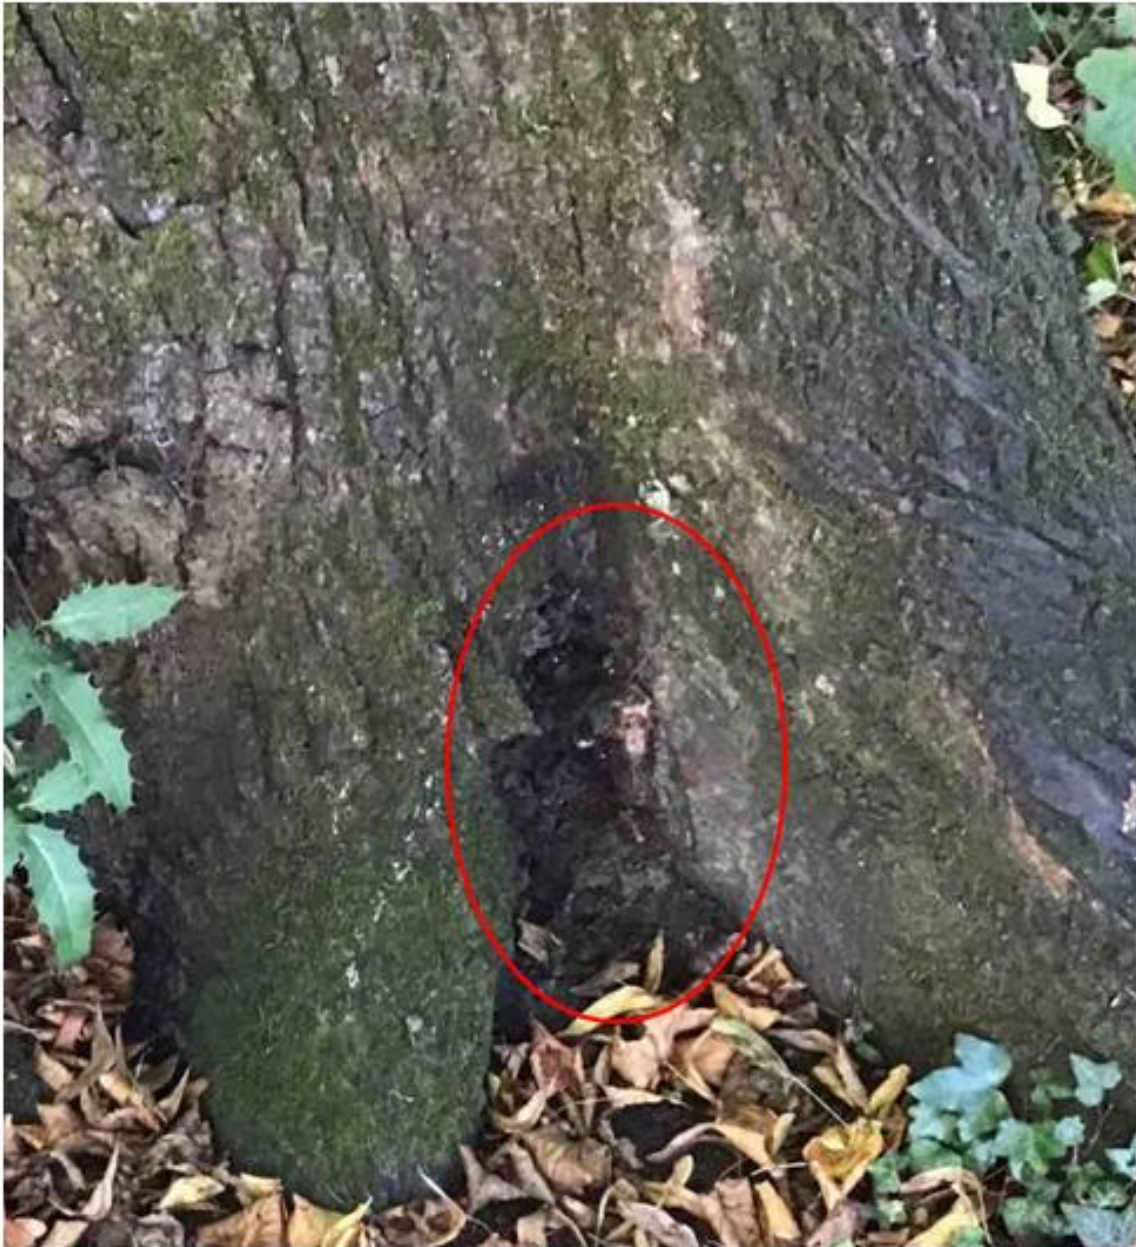
Ward	South Richmond
Road	Grove Road
Location	Grove Road Gardens- ///tribal.bride.wheels
Species	Common Lime (<i>Tilia x europaea</i>)
Height	26.0m
Physiological Condition	Fair
Structural Condition	Poor
Inspection findings/reason for exemption	Fungal fruiting bodies of the decay pathogen <i>Kretzschmaria deusta</i> are present on the base of this tree. This fungus causes a white rot that can cause whole tree failure through a ceramic like fracture of the base. Removal is required to prevent natural failure and facilitate replanting.

Image shows *Kretzschmaria deusta* pathogens at the base of trunk circled.

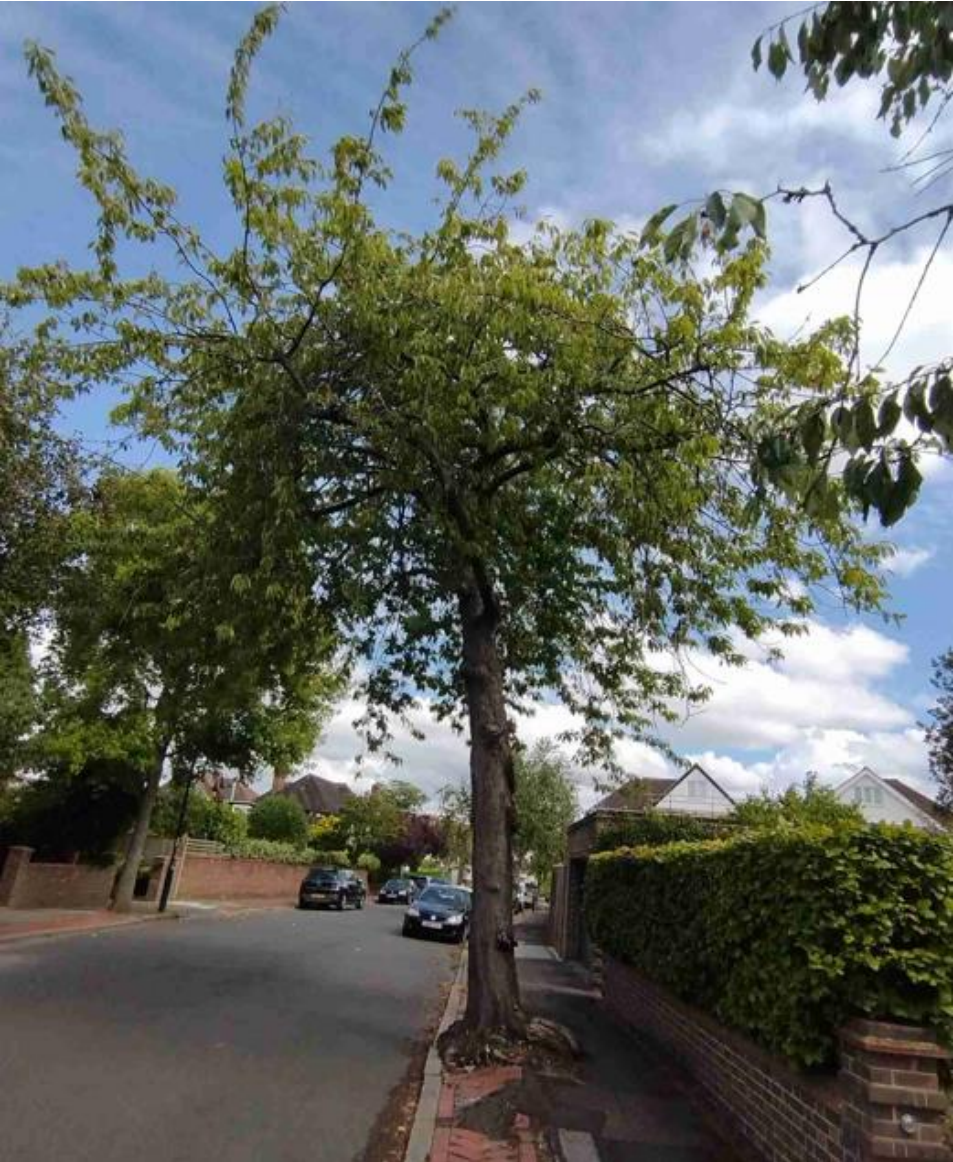
Ward	South Richmond
Road	Orchard Rise
Location	Outside 22
Species	Sweet Cherry (<i>Prunus avium</i>)
Height	11.0m
Physiological Condition	Fair
Structural Condition	Poor
Inspection findings/reason for exemption	Tree has raised and damaged roots causing trip hazards and an unacceptable obstruction to the pavement making an impasse for Prams & wheelchairs to safely pass. With no engineering solution available to resolve this issue, we are unable to meet our equality & diversity duties. For this reason, removal is required to manage risk and facilitate replanting.

Image shows tree in street scene.

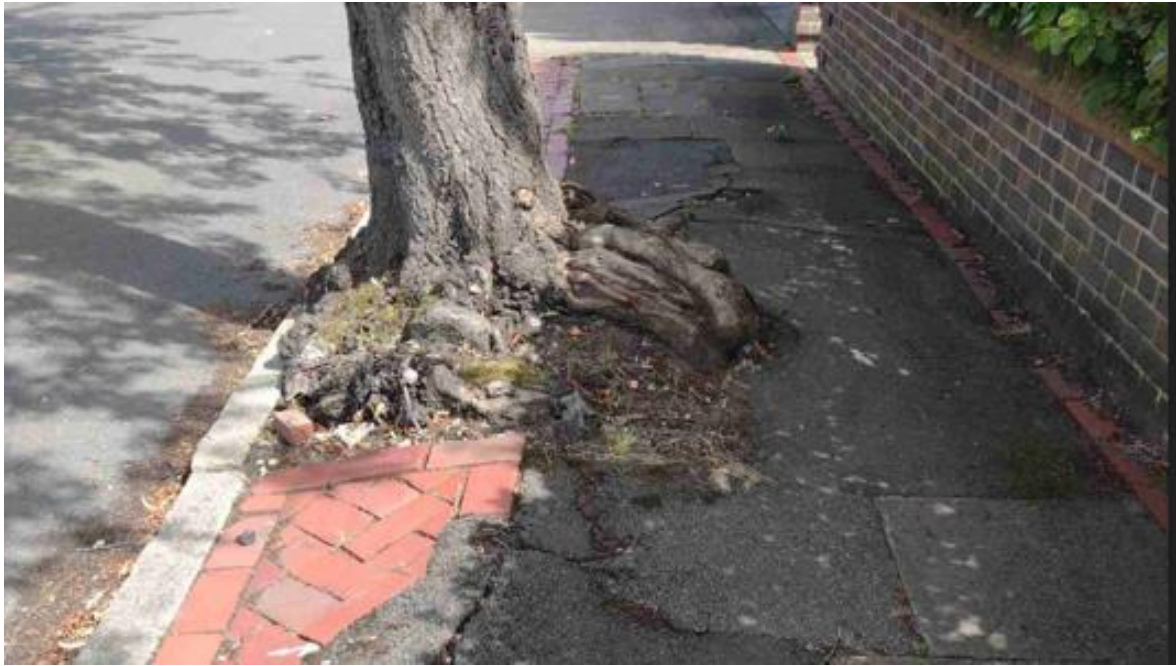
Image shows exposed damage roots at base of trunk obstructing pavement access.

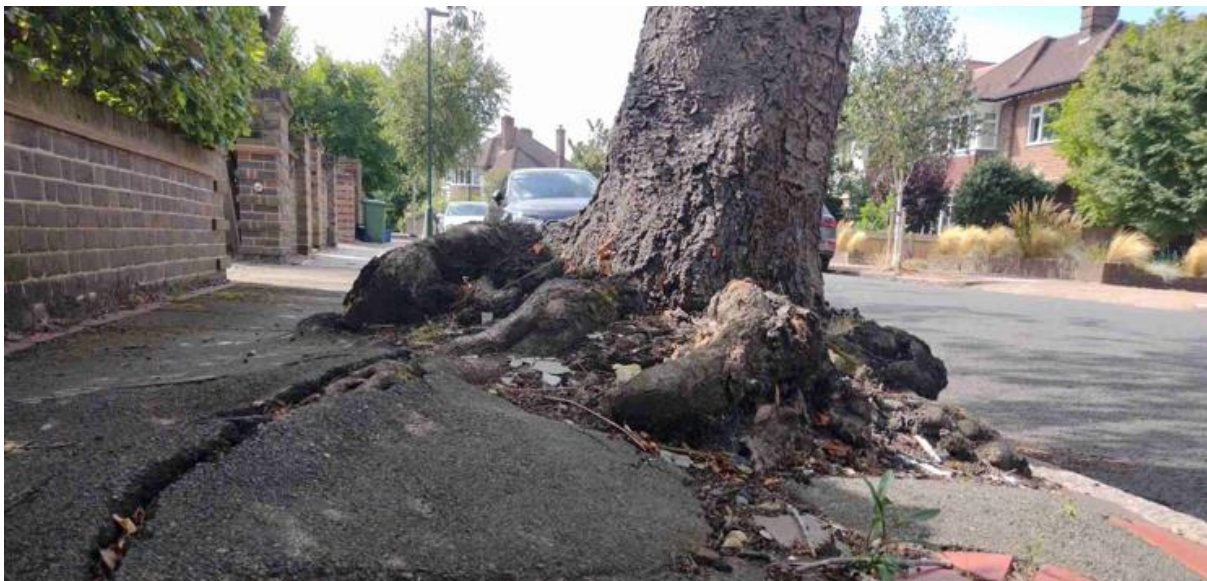
Image shows raised roots causing trip hazards and obstructing pavement.

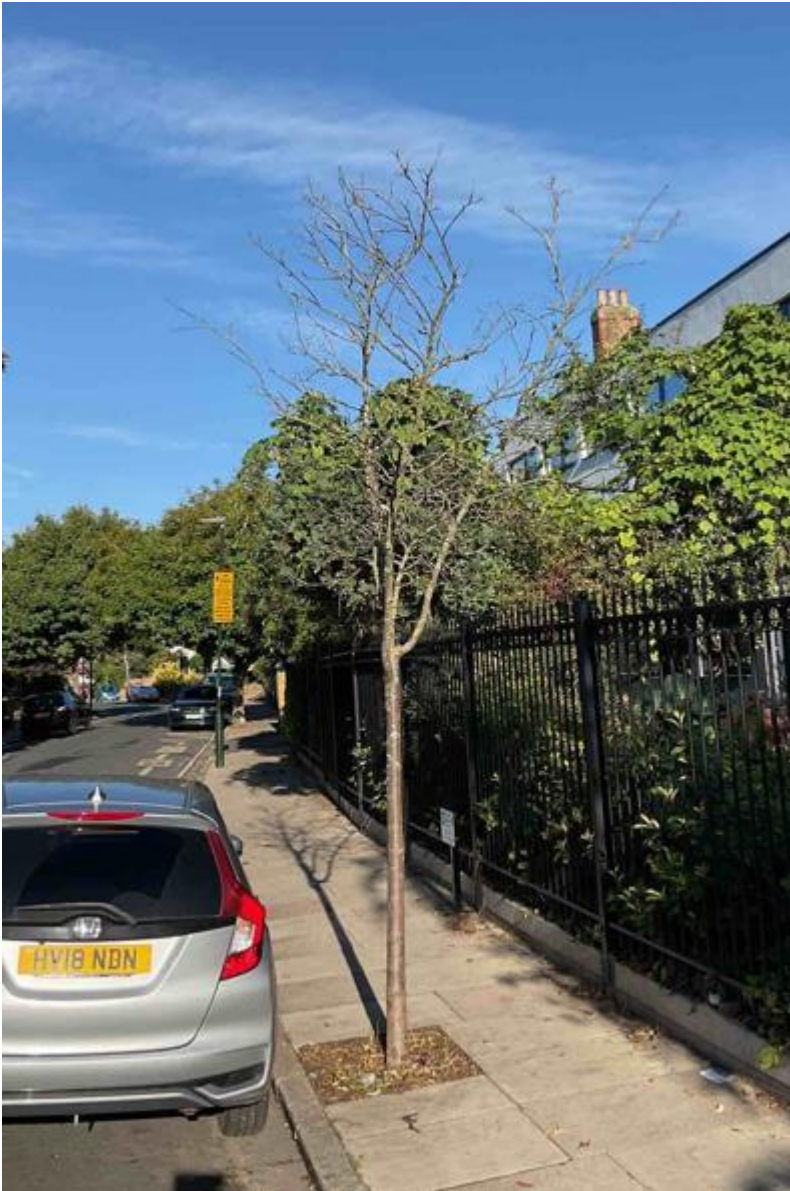
Ward	South Twickenham
Road	Popes Grove
Location	Opposite The Alexander Pope Public House staff entrance
Species	Swedish Whitebeam (<i>Sorbus intermedia</i>)
Height	4.5m
Physiological Condition	Dead
Structural Condition	Dead
Inspection findings/reason for exemption	This tree is dead; removal is required to prevent natural failure, manage risk, and facilitate replanting

Image shows dead tree in street scene.

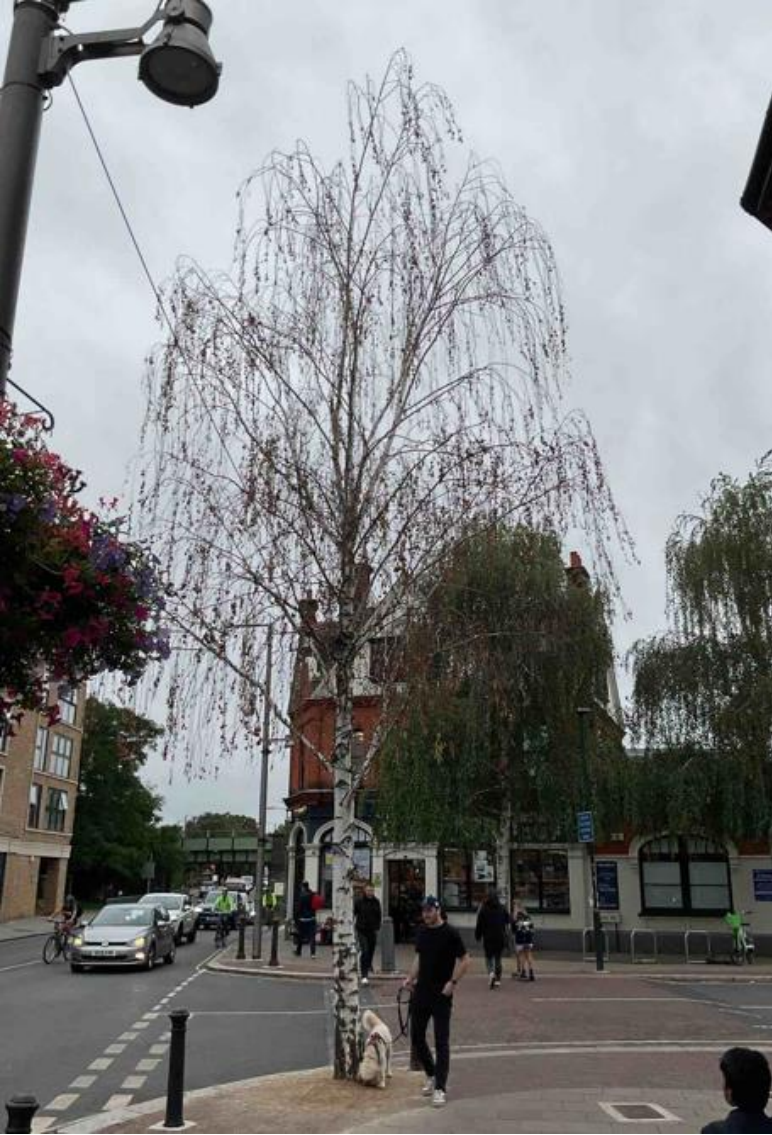
Ward	South Twickenham
Road	Heath Road
Location	Opposite junction to Heath Gardens
Species	Birch (Betula sp.)
Height	12.5m
Physiological Condition	Dead
Structural Condition	Dead
Inspection findings/reason for exemption	This tree is dead; removal is required to prevent natural failure, manage risk, and facilitate replanting

Image shows dead tree in street scene

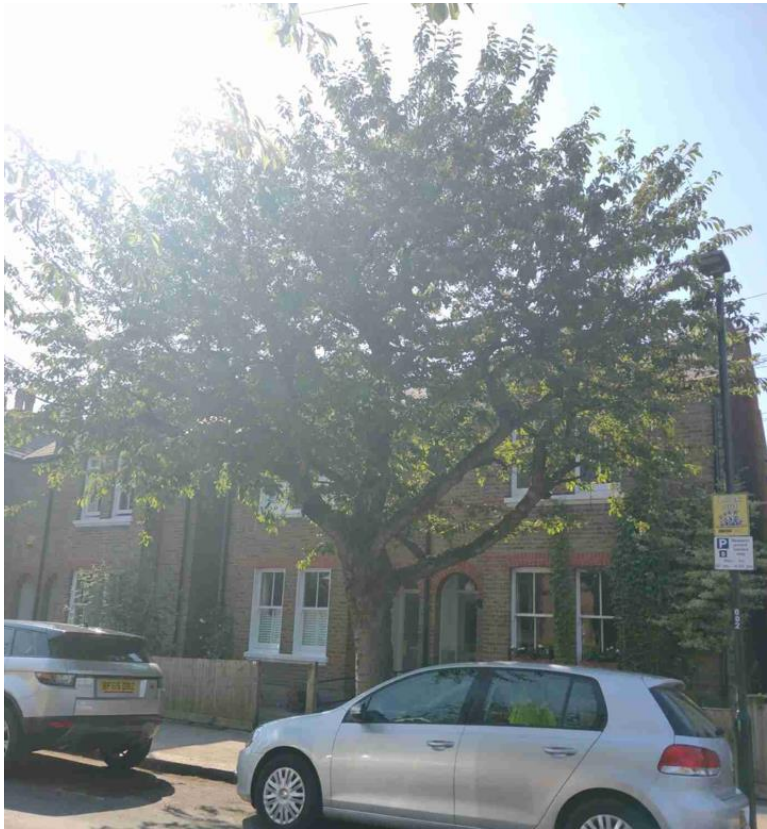
Ward	St Margarets and North Twickenham
Road	Bridge Road
Location	Outside 9
Species	Sweet Cherry (<i>Prunus avium</i>)
Height	8.5m
Physiological Condition	Fair
Structural Condition	Poor
Inspection findings/reason for exemption	An emerging fungal fruiting body displaying characteristics of decay pathogen <i>Ganoderma</i> sp. is present at the stem base. Colonisation by this fungus causes a white rot of the stem and root system that can cause entire trees to collapse through fracture or windthrow. There is also a substantial wound occurred on the base of the trunk and associated bark/vascular necrosis has taken place. Investigation with a probe revealed an unacceptable degree of decay to the trunk. Removal is required to prevent natural failure, manage risk, and facilitate replanting

Image shows tree in street scene.

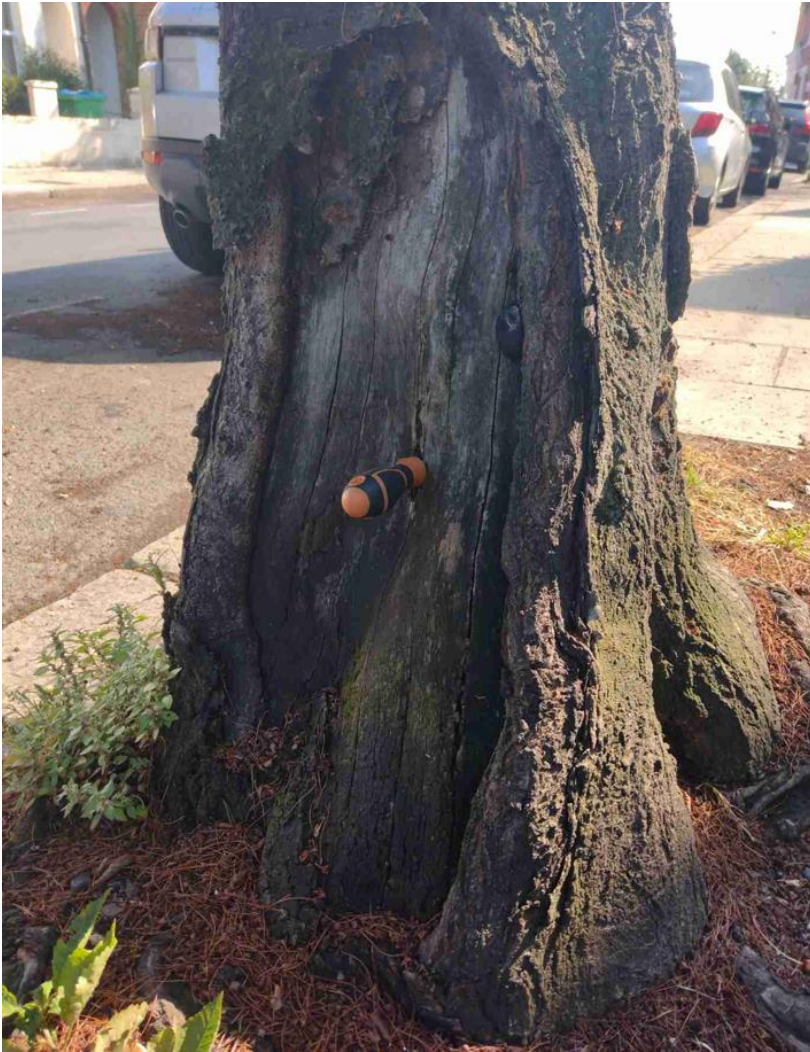
Image shows bark wounding at base of trunk.

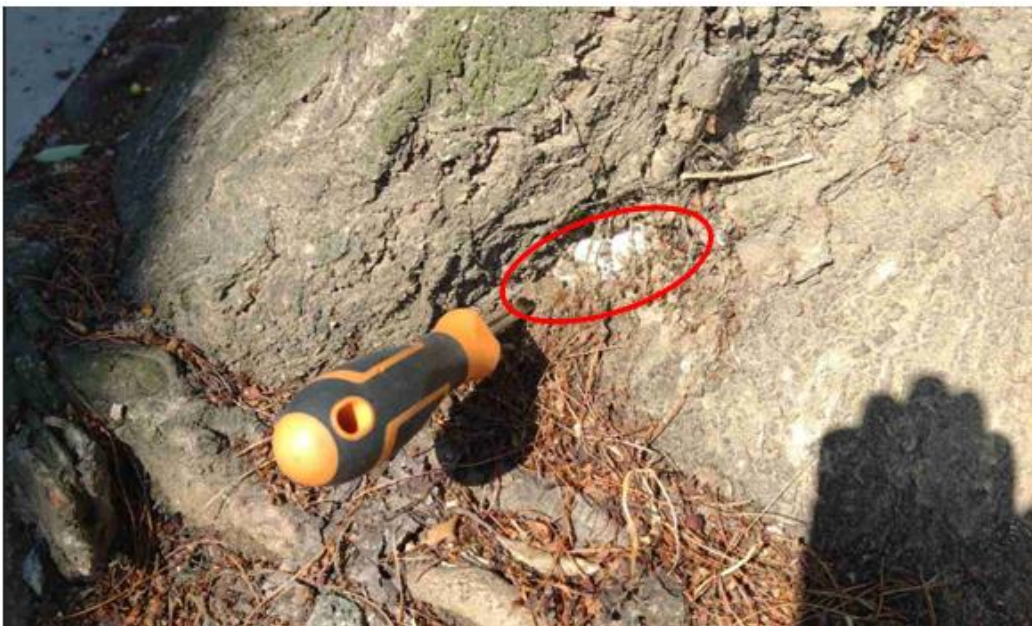
Image shows fungal fruiting body circled with prob showing decay in trunk.

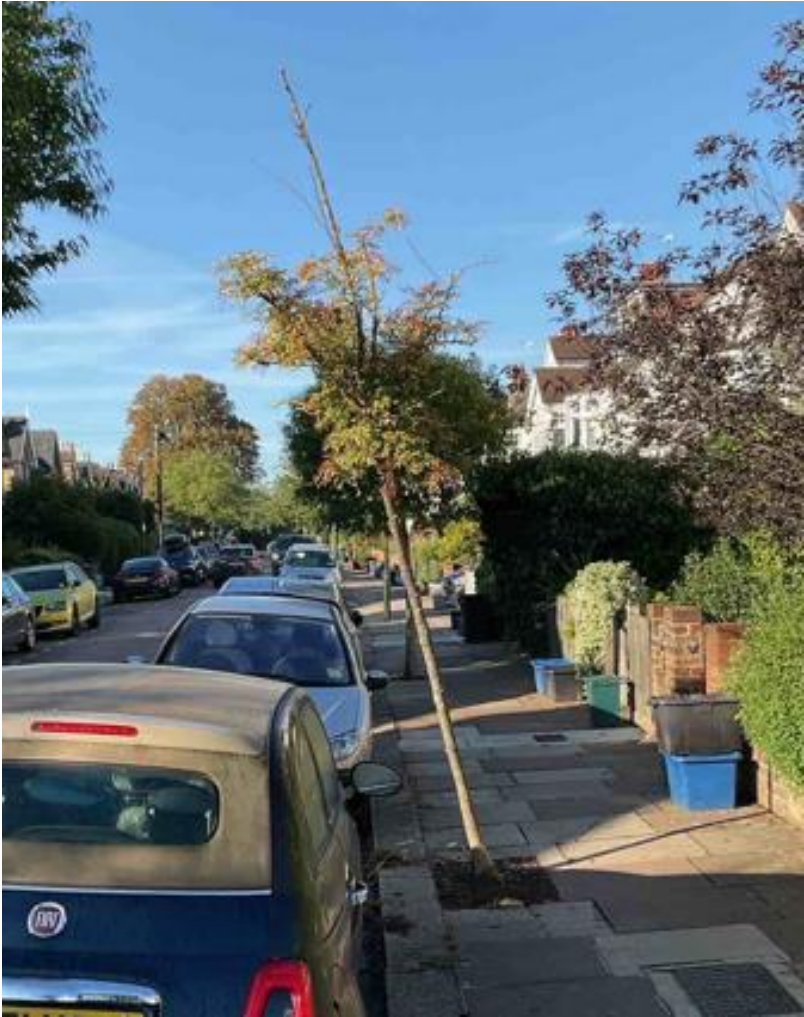
Ward	Teddington
Road	Teddington Park Road
Location	Outside 57-59
Species	Rowan (<i>Sorbus aucuparia</i>)
Height	4.0m
Physiological Condition	Poor
Structural Condition	Poor
Inspection findings/reason for exemption	The trees stem is moving in such a way that indicates that the root structure is compromised. Crown dieback could correlate with the degradation of the trees structural or supporting root system. Removal is required to prevent natural failure, manage risk, and facilitate replanting.

Image shows tree in street scene.

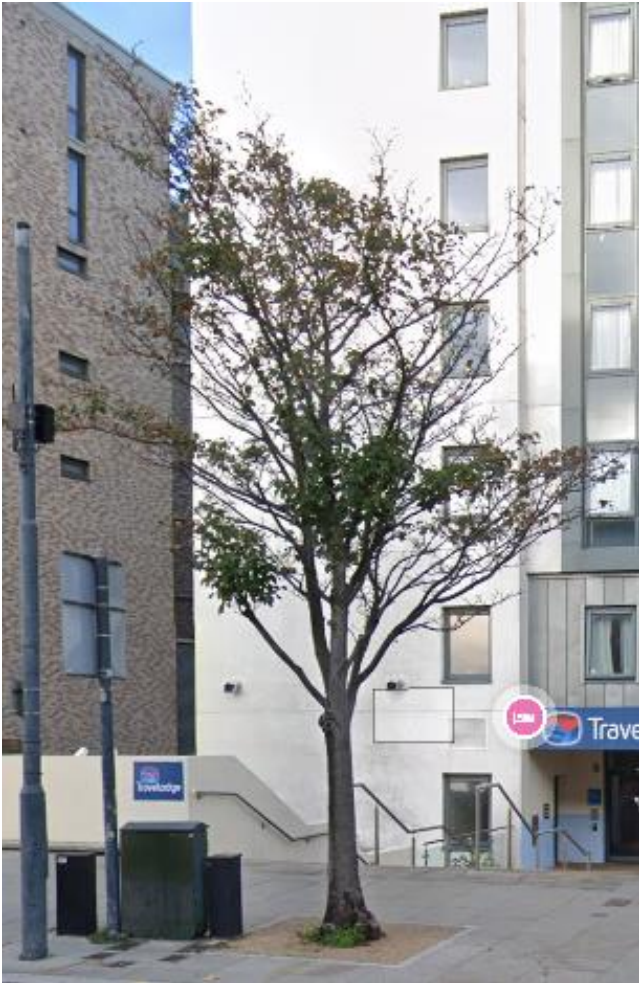
Ward	Twickenham Riverside
Road	London Road
Location	Outside 70 Regal House- ///shakes.punchy.hours
Species	Crab Apple (Malus sp.)
Height	8.0m
Physiological Condition	Poor
Structural Condition	Poor
Inspection findings/reason for exemption	An emerging fungal fruiting body displaying characteristics of decay pathogen <i>Ganoderma</i> sp. is present at the stem base. Colonisation by this fungus causes a white rot of the stem and root system that can cause entire trees to collapse through fracture or windthrow. Crown dieback correlates with the fruiting body at the base of stem. Removal is required to prevent natural failure, manage risk, and facilitate replanting

Images show tree in street scene

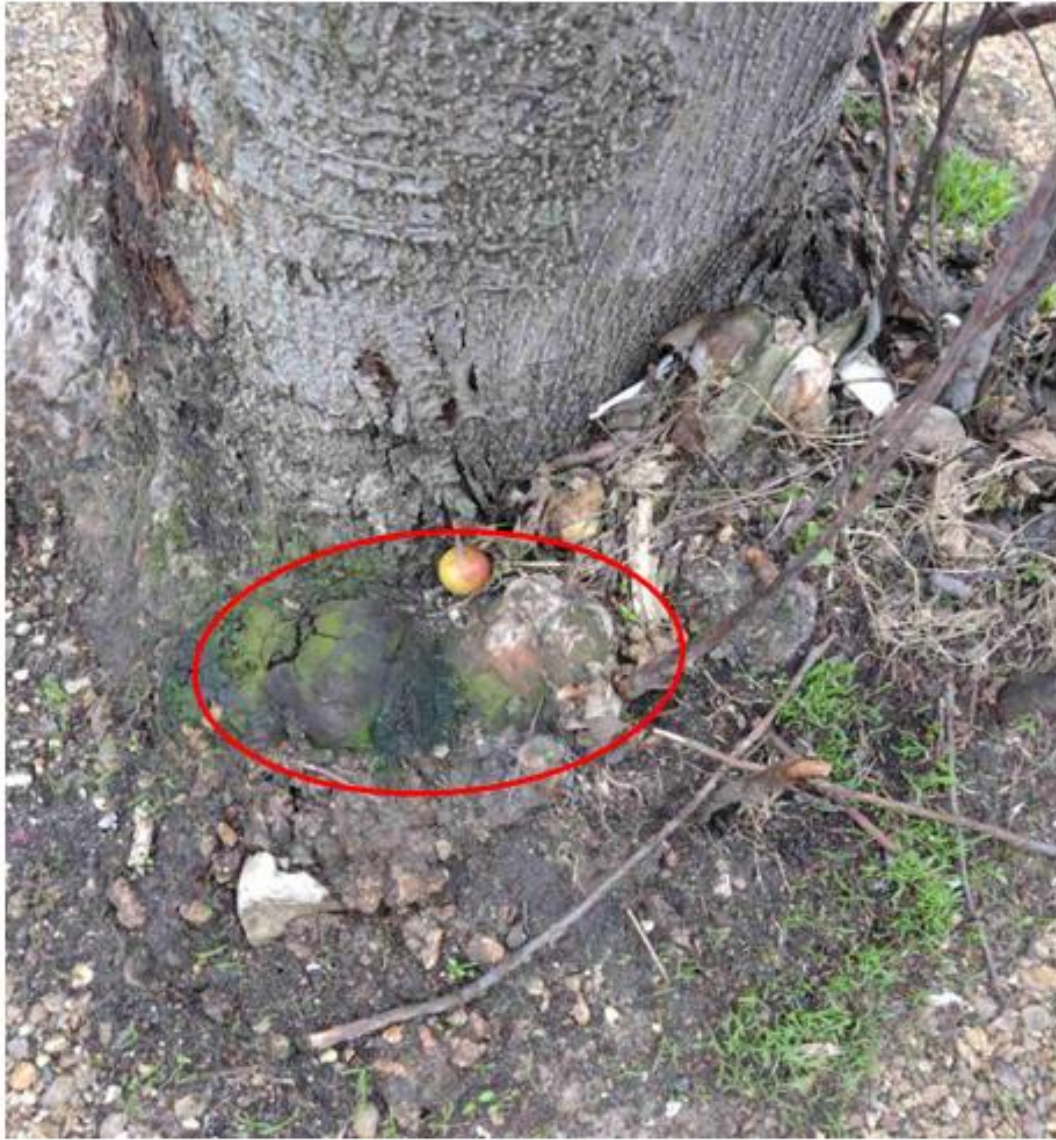
Images show fruiting body at base of stem circled in red.

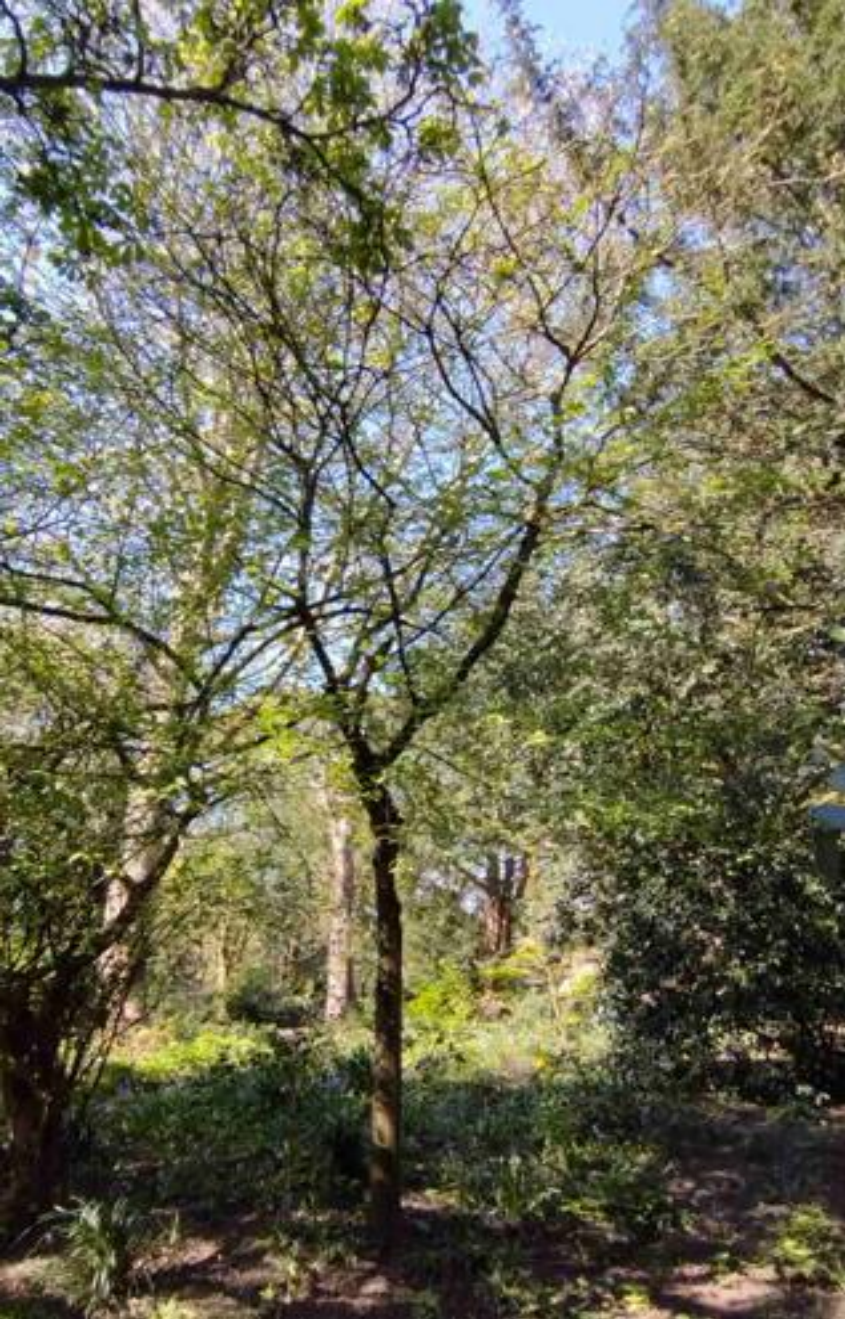
Ward	Twickenham Riverside
Road	York House Gardens
Location	York House Gardens - ///tasty.roses.reason
Species	Maple (Acer sp.)
Height	8.0m
Physiological Condition	Dead
Structural Condition	Dead
Inspection findings/reason for exemption	This tree is dead; removal is required to prevent natural failure, manage risk, and facilitate replanting.

Image shows dead tree in park scene
