March 2024 - Reactive Tree Works Programme

Introduction

28/03/2024

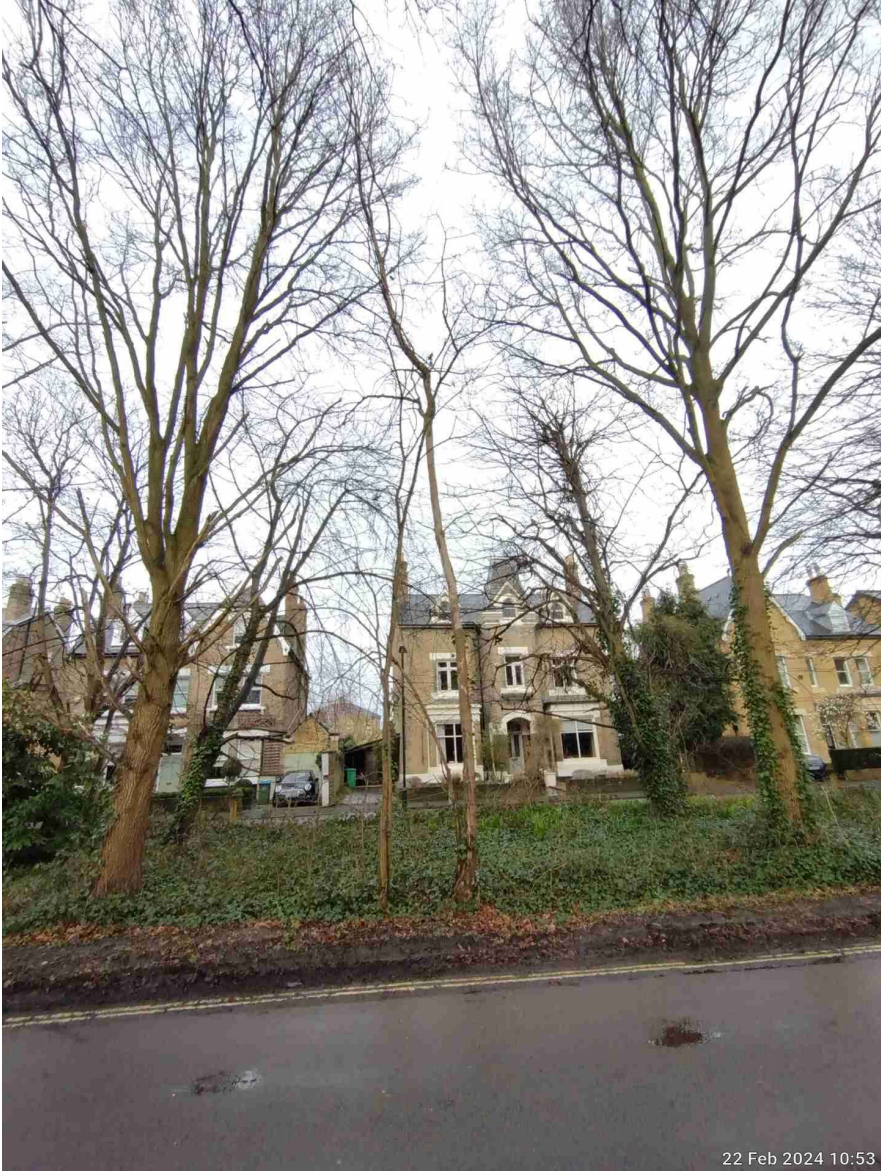
Ward	Barnes
Road	Vine road
Location	Barnes common What3Words-///filled.magic.cups
Species	Sycamore (<i>Acer pseudoplatanus</i>)
Height	17
Physiological Condition	Dead
Structural Condition	Poor
Inspection findings	This tree is dead and requires removal to facilitate replanting and prevent natural failure.

Image shows tree dead in street scene

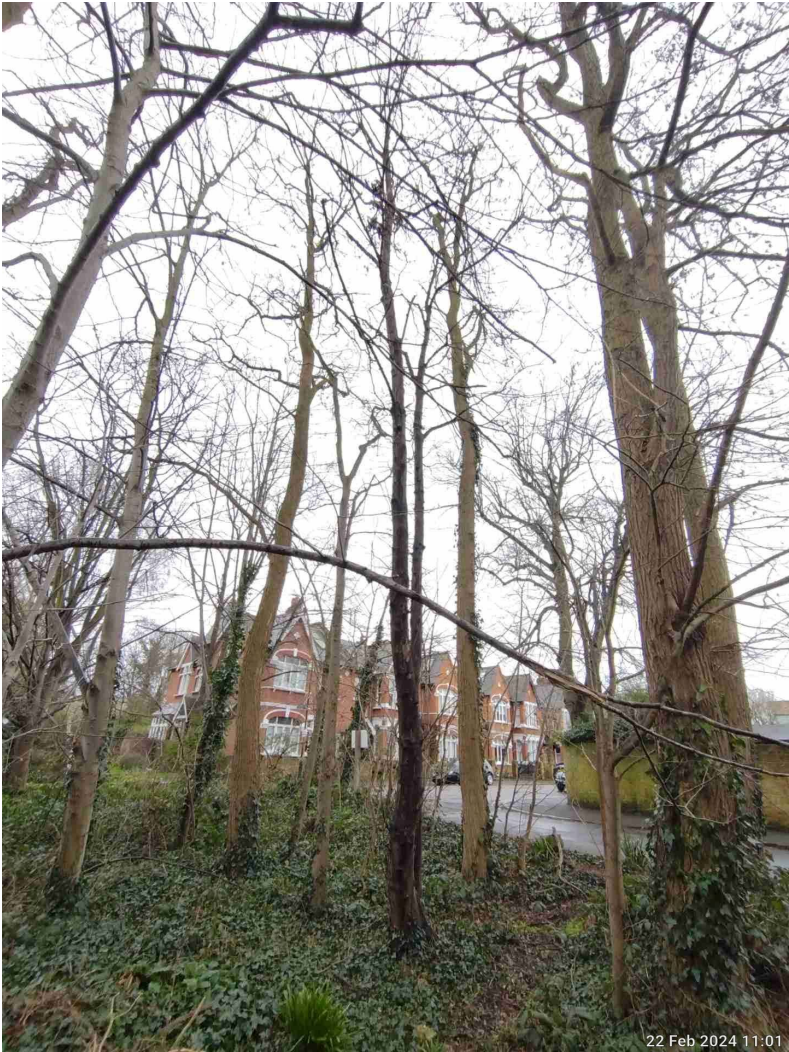
Ward	Barnes
Road	Vine road
Location	Barnes common What3Words-///mime.caves.area
Species	<i>Acer pseudoplatanus</i> - Sycamore
Height	15
Physiological Condition	Dead
Structural Condition	Poor
Inspection findings	This tree is dead and requires removal to facilitate replanting and prevent natural failure.

Image shows tree dead in street scene

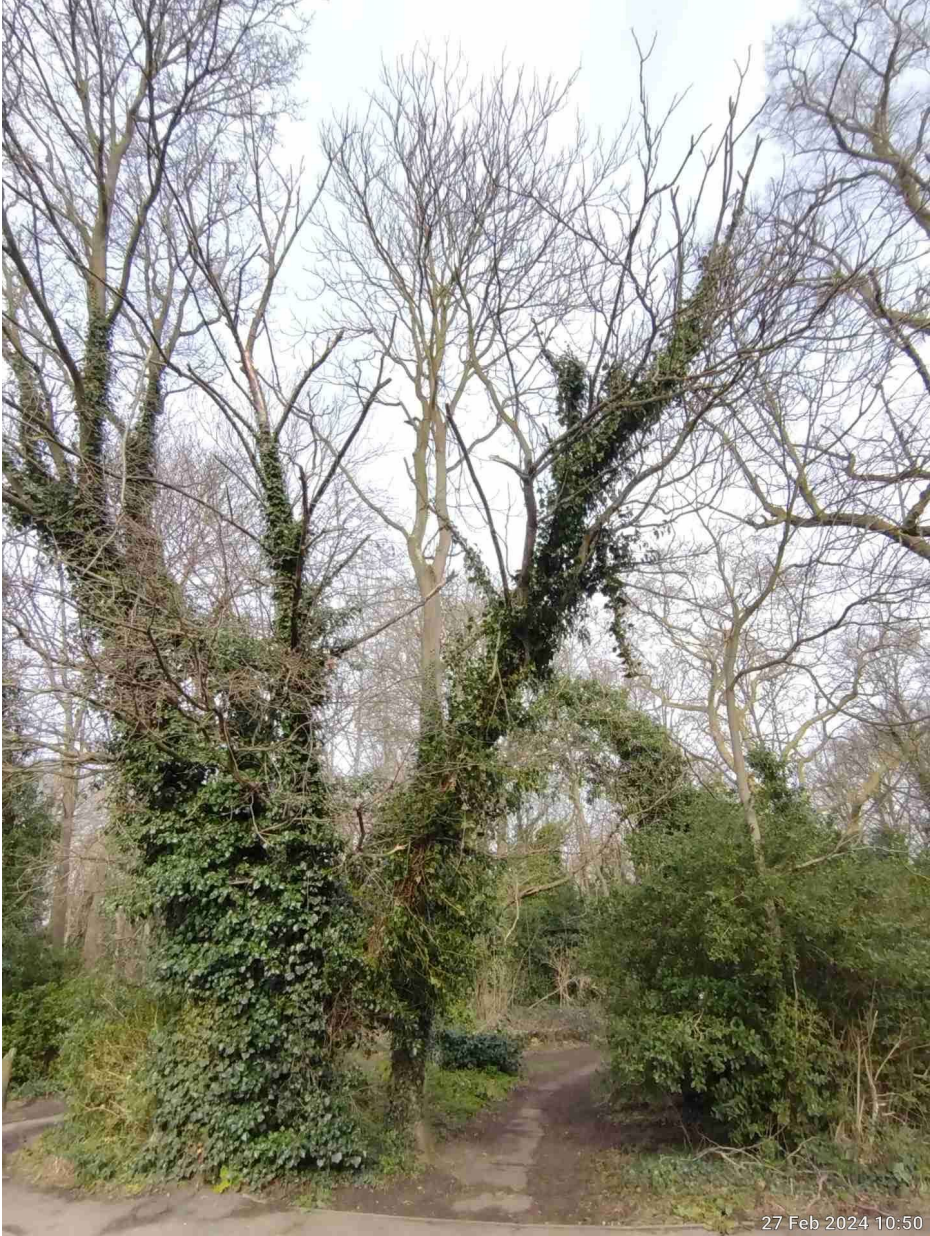
Ward	Barnes
Road	Station Road
Location	Barnes common (station road, opposite station) What3Words- ///stay.froze.caged
Species	Unknown
Height	11
Physiological Condition	Dead
Structural Condition	Poor
Inspection findings	This tree is dead and requires removal to facilitate replanting and prevent natural failure.

Image shows tree dead in street scene

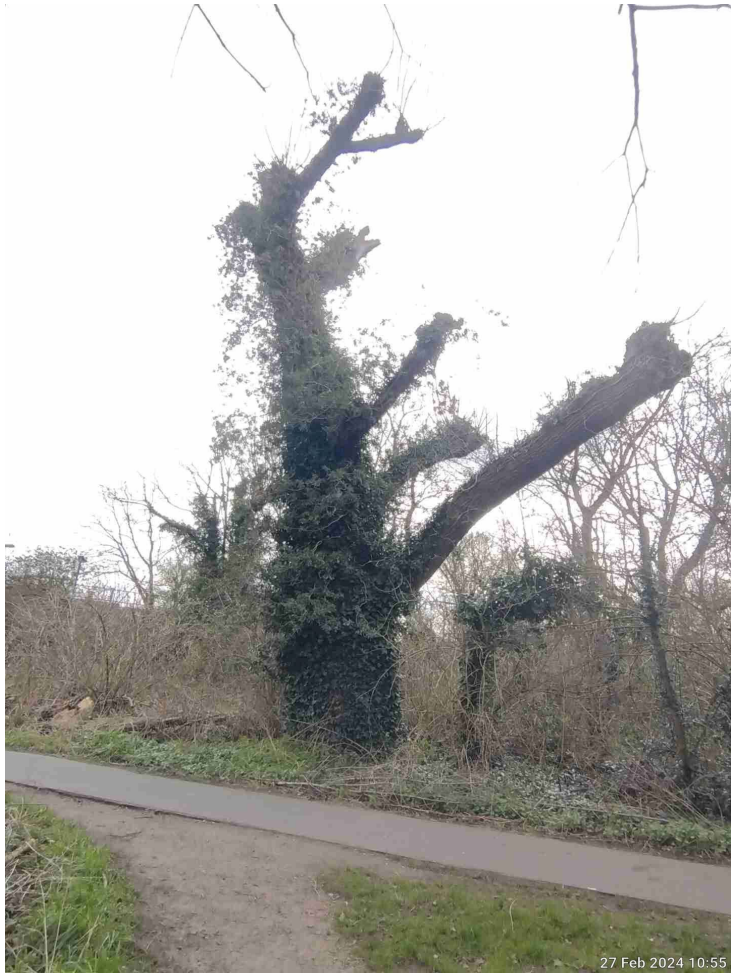
Ward	Barnes
Road	Station road
Location	Barnes Common What3Words-///called.lasted.lions
Species	Black Poplar (<i>Populus nigra</i>)
Height	15
Physiological Condition	Dead
Structural Condition	Poor
Inspection findings	This tree is dead and requires reduction in height to prevent natural failure, whilst retaining it as a monolith for habitat purposes.

Image shows tree dead in situ on the common

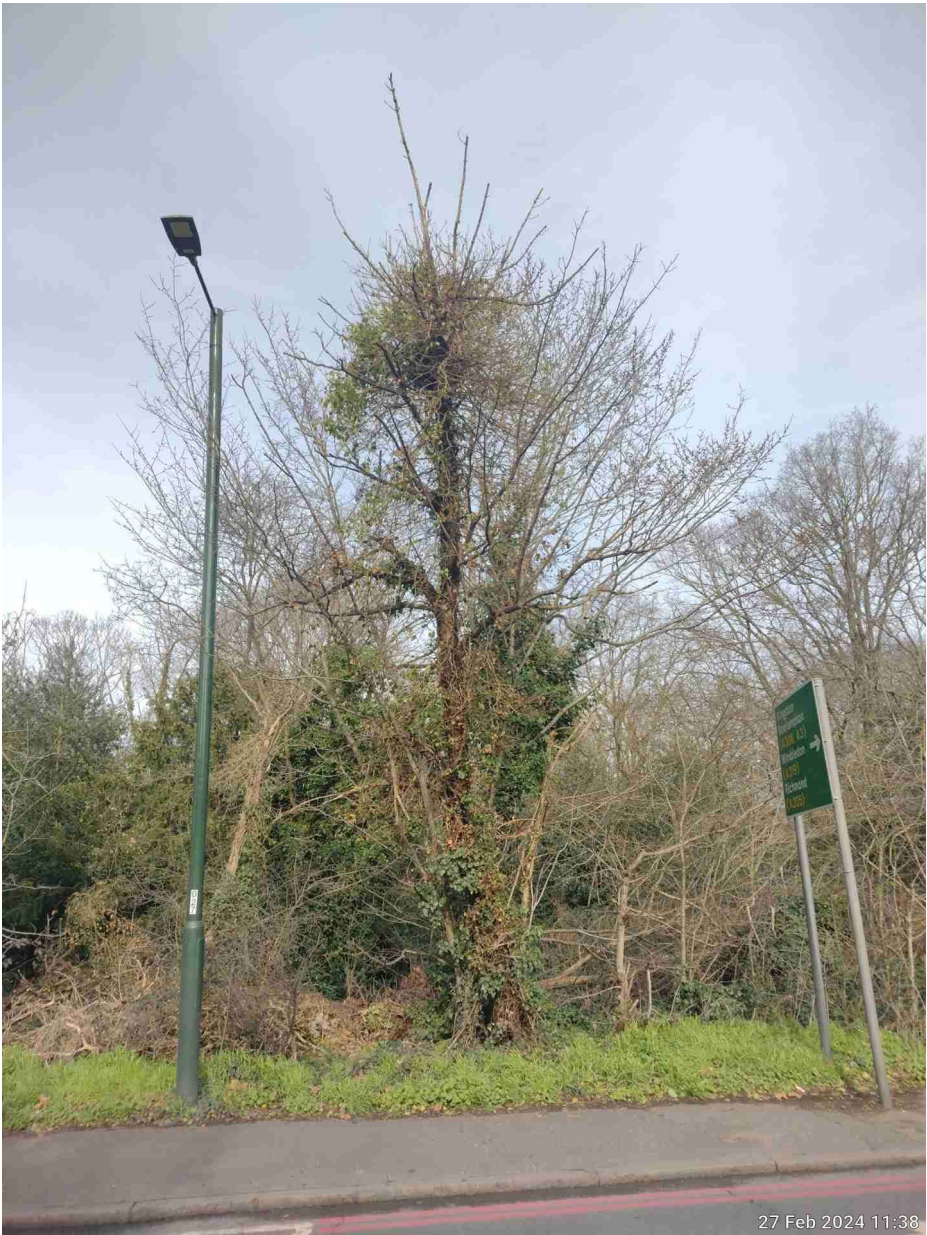
Ward	Barnes
Road	Queens Ride
Location	Barnes Common What3Words-///stores.volume.pokers Next to lamp post 027 on queens ride
Species	Sycamore (<i>Acer pseudoplatanus</i>)
Height	12
Physiological Condition	Dead
Structural Condition	Poor
Inspection findings	This tree is dead and requires removal to facilitate replanting and prevent natural failure

Image shows tree dead in street scene

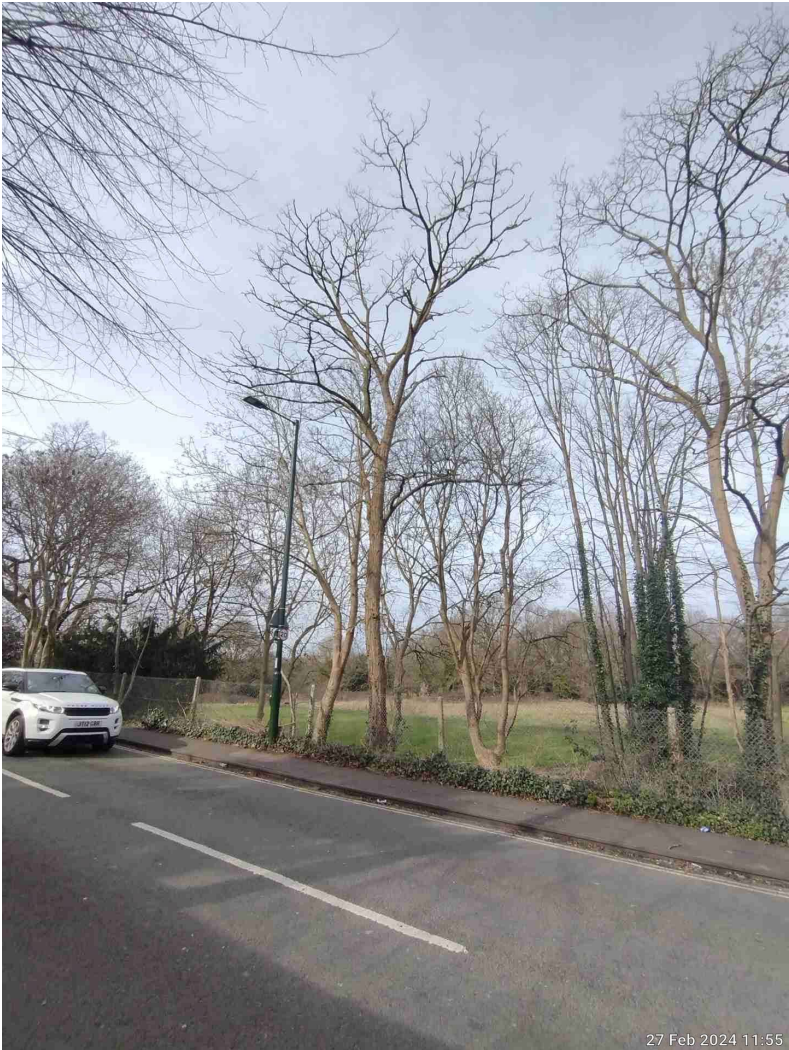
Ward	Barnes
Road	Queens ride
Location	Barnes common What3Words-///hoot.badge.ready Near lamp post 012 queens ride.
Species	<i>Robinia pseudoacacia</i>
Height	14
Physiological Condition	Dead
Structural Condition	Poor
Inspection findings	Tree in a moribund state. Fractures noted on stem with areas lacking live cambium layer when tested. 70% of crown has died back. Desk top assessment shows tree in decline from 2022. This tree is in a state of physiological decline and contains weak branches that are liable to collapse. The tree requires removal to prevent natural failure and facilitate replanting.

Image shows tree in a moribund state on the street scene

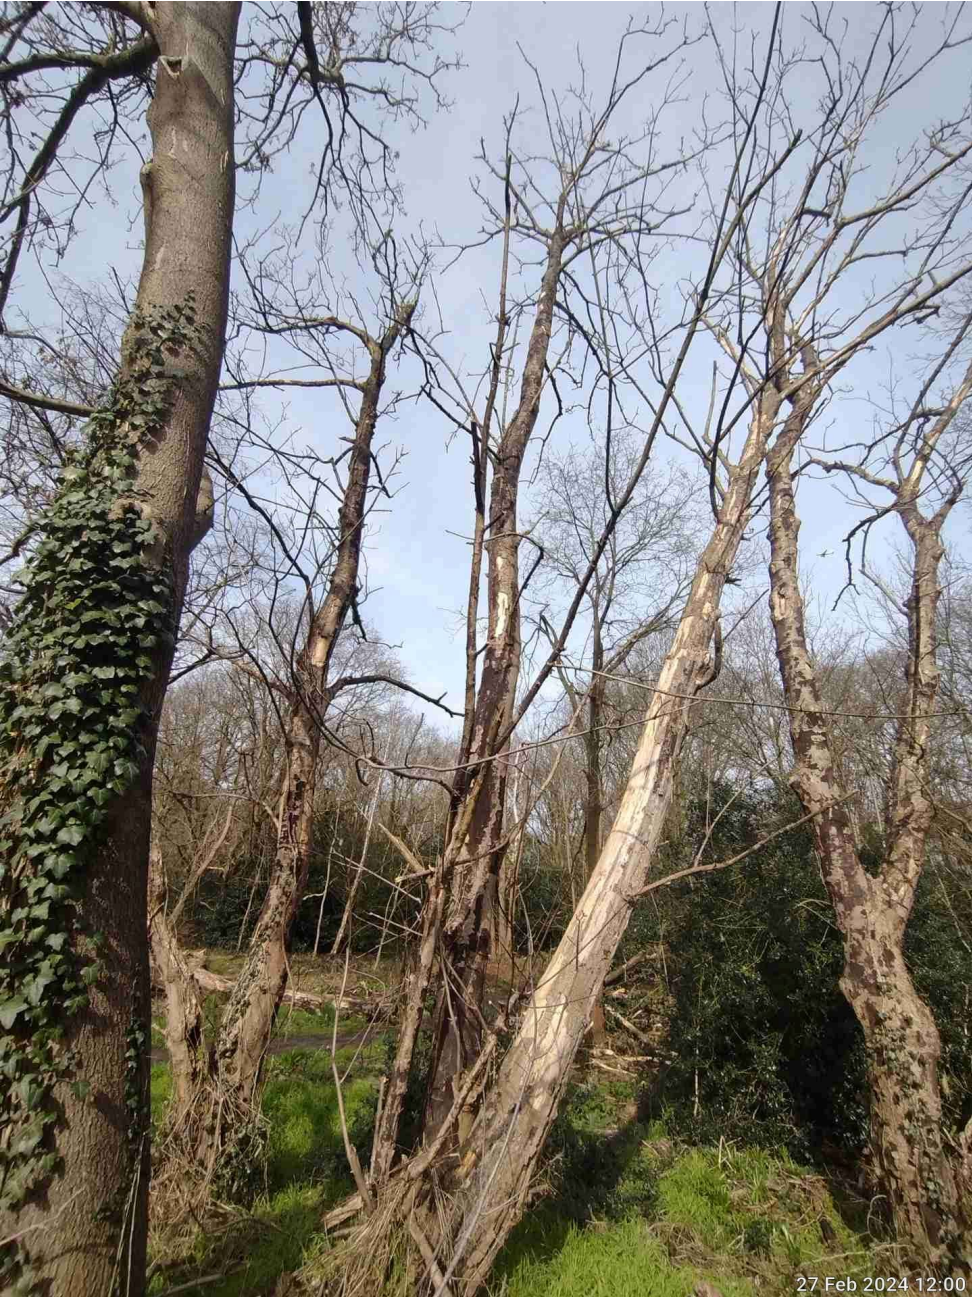
Ward	Barnes
Road	Queens ride
Location	Barnes Common What3Words-///quite.famous.rocks
Species	Sycamore (<i>Acer pseudoplatanus</i>)
Height	14
Physiological Condition	Dead
Structural Condition	Poor
Inspection findings	These four trees are dead and require removal to facilitate replanting and prevent natural failure

Image shows the group of dead in situ on the common.

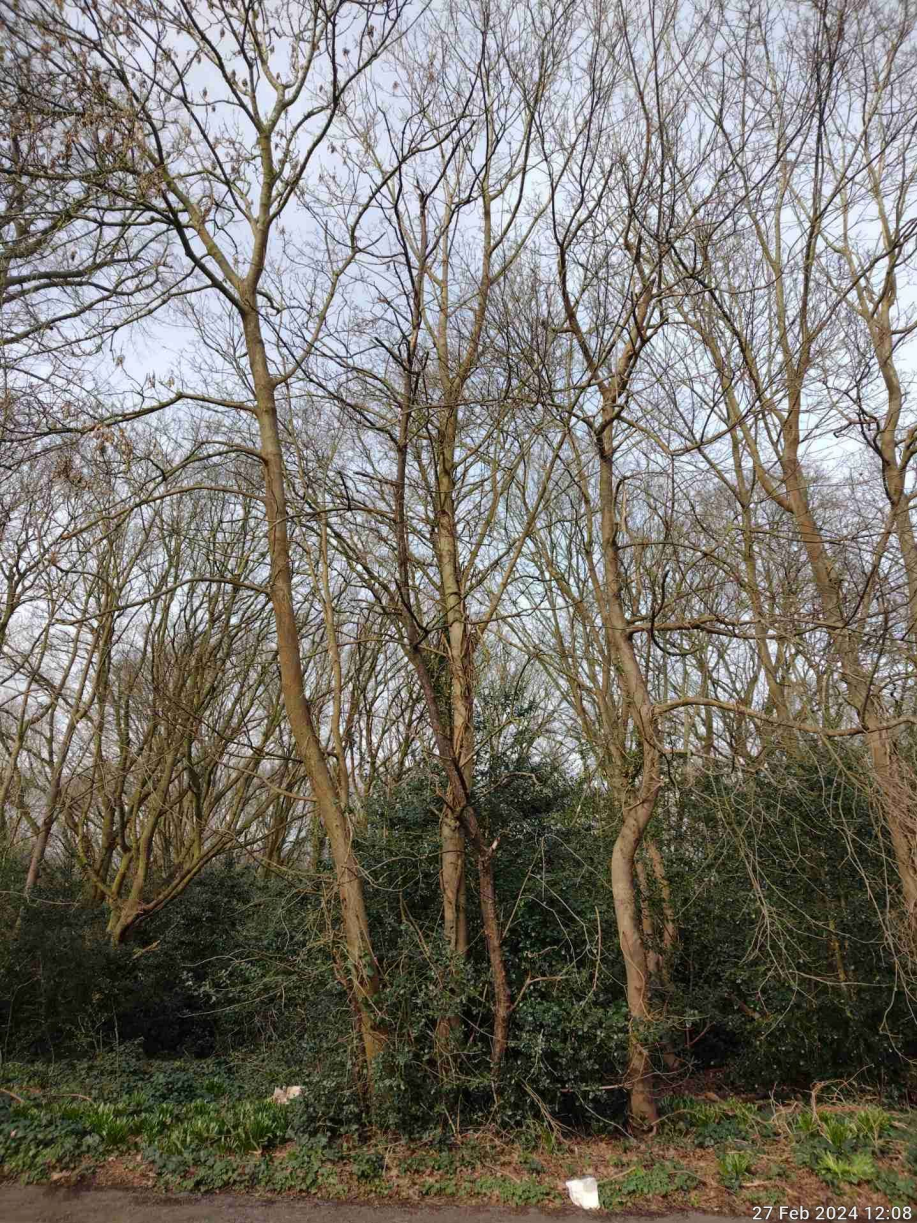
Ward	Barnes
Road	St Marys Grove
Location	Barnes common What3Words-///seat.stews.crate
Species	Sycamore (<i>Acer pseudoplatanus</i>)
Height	10m
Physiological Condition	Dead
Structural Condition	Poor
Inspection findings	This tree is dead and requires removal to facilitate replanting and prevent natural failure

Image shows tree dead in street scene

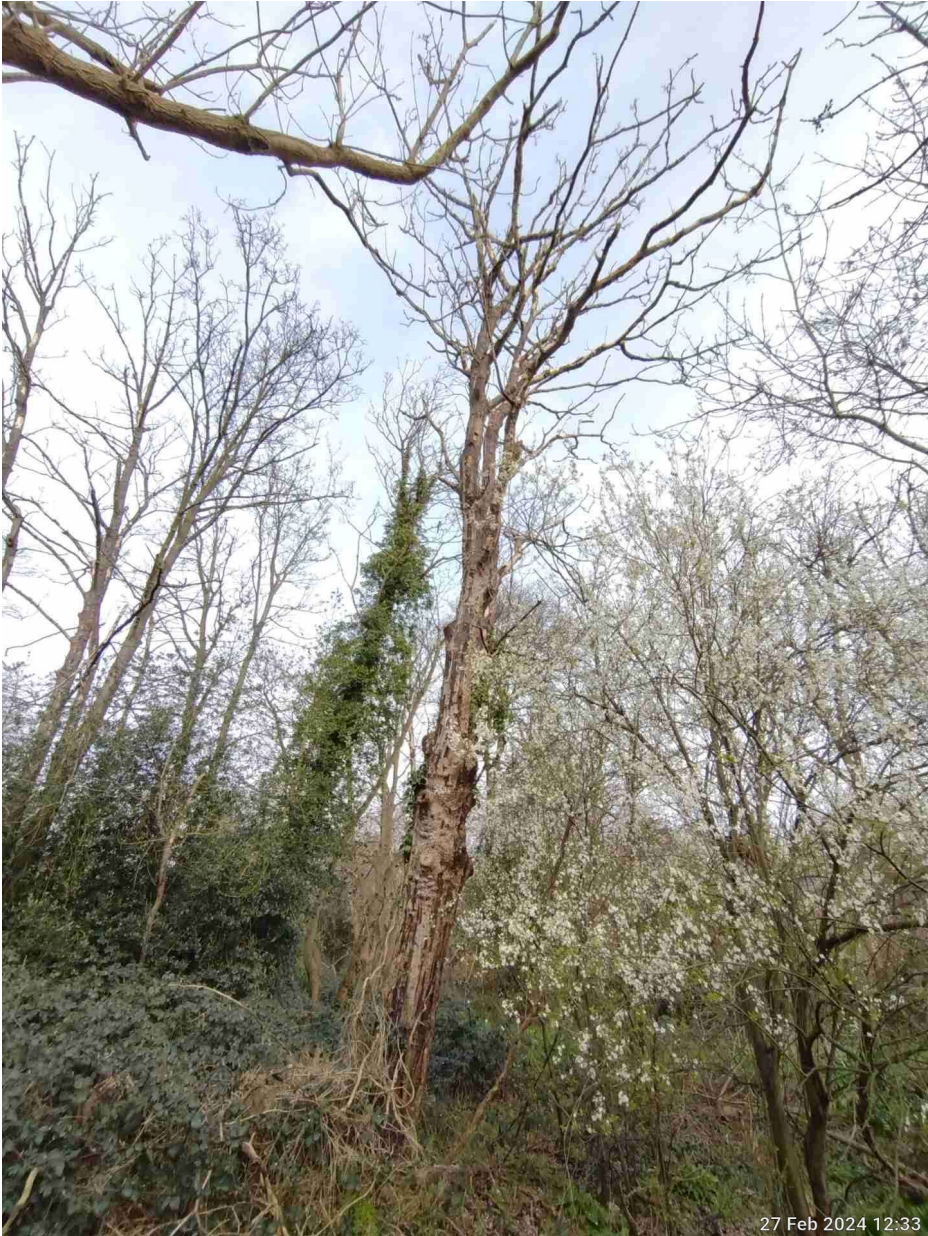
Ward	Barnes
Road	Queens Ride
Location	Barnes common What3Words-///short.twigs.weep
Species	Acer pseudoplatanus
Height	15.5
Physiological Condition	Dead
Structural Condition	Poor
Inspection findings	This tree is dead and requires removal to facilitate replanting and prevent natural failure

Image shows tree dead in situ in the common

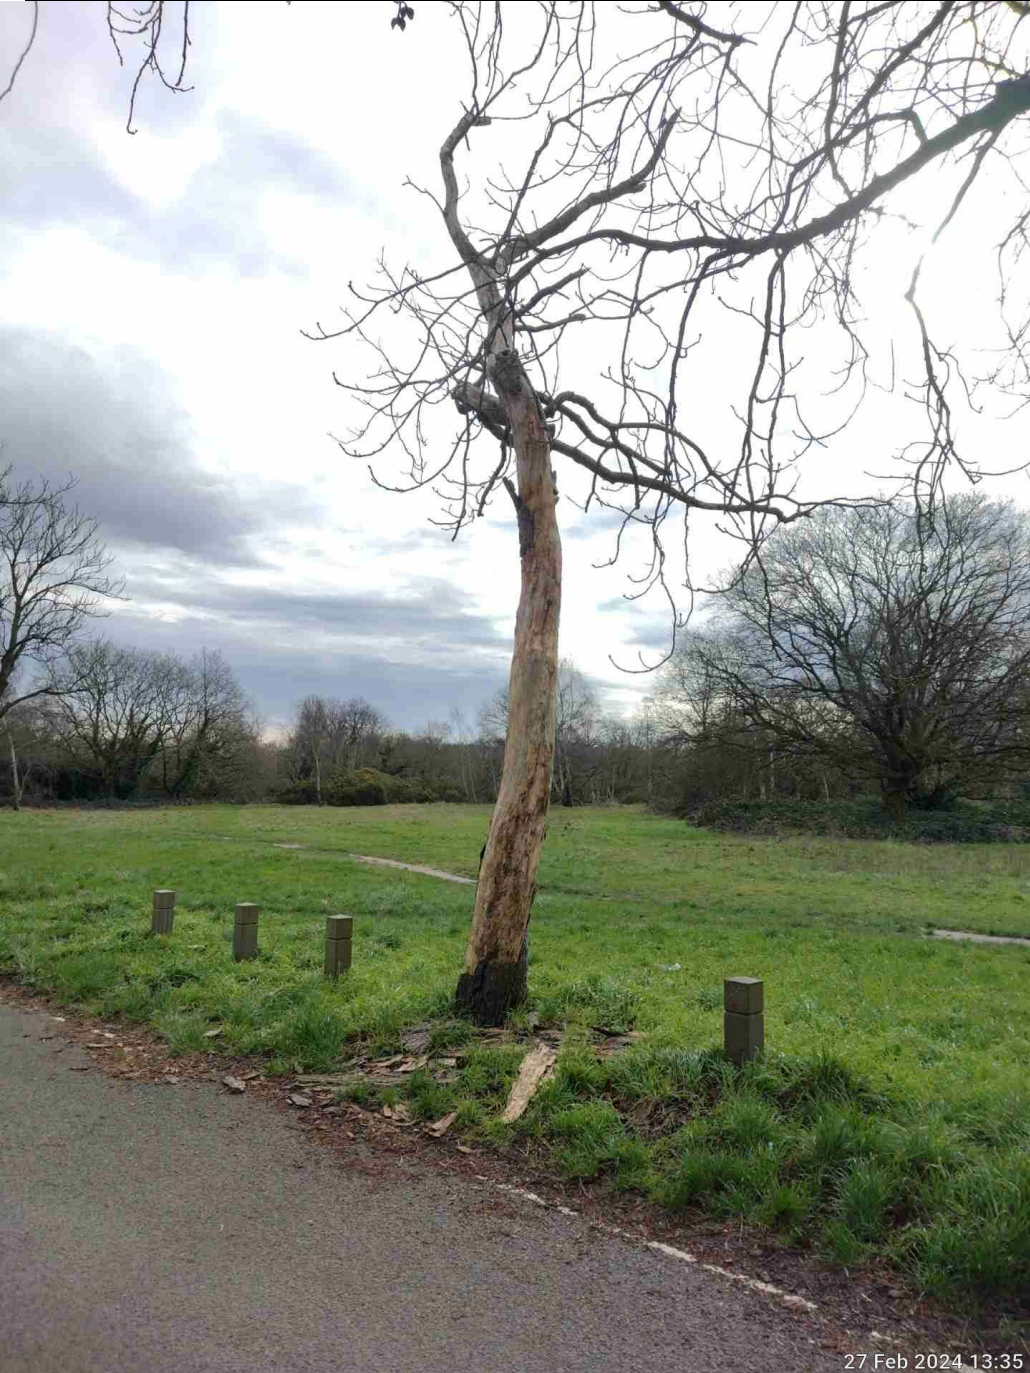
Ward	Barnes
Road	UNRD - Access To Old Barnes Cemetery
Location	Barnes Common What3Words-///trash.visual.hike
Species	Horse Chestnut (<i>Aesculus hippocastanum</i>)
Height	9m
Physiological Condition	Dead
Structural Condition	Poor
Inspection findings	This tree is dead and requires removal to facilitate replanting and prevent natural failure.

Image shows tree dead in street scene

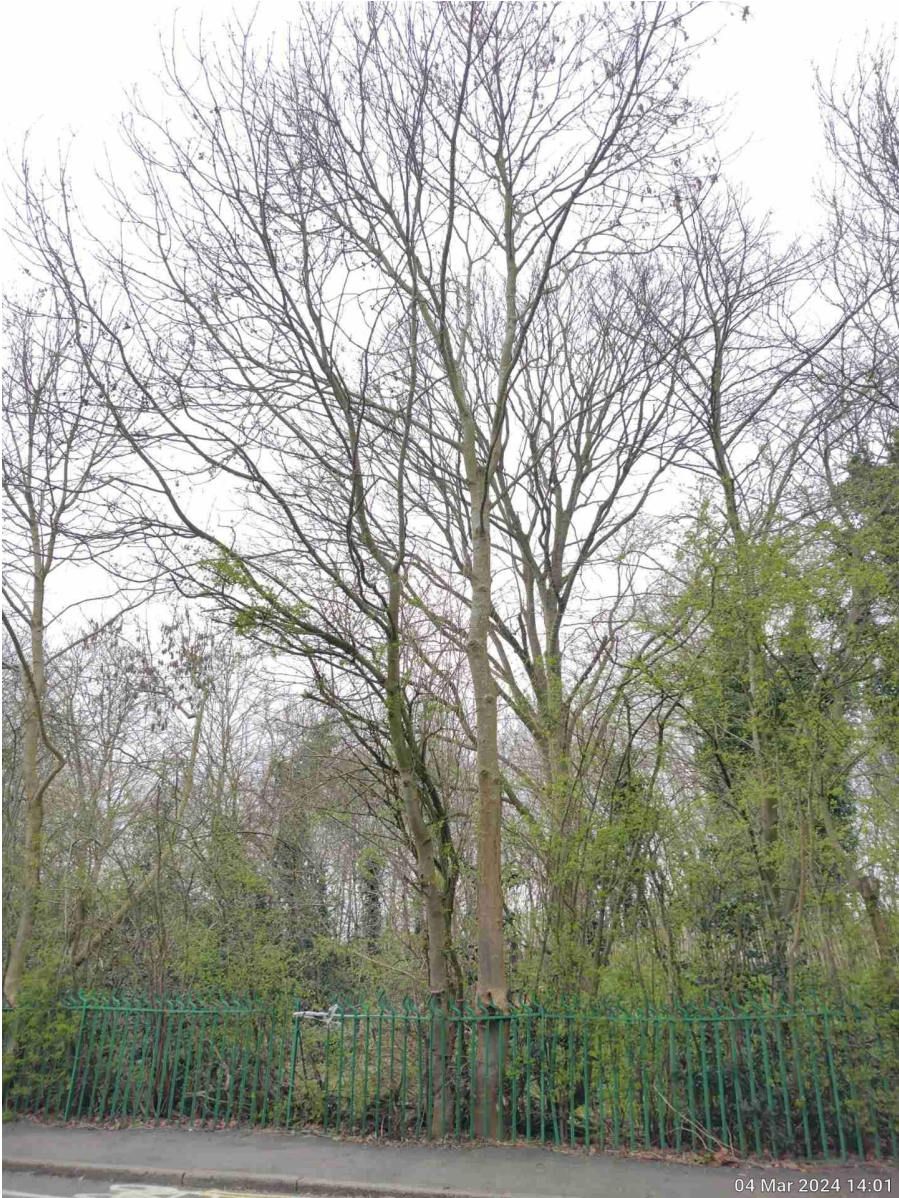
Ward	Barnes
Road	Lonsdale Road
Location	Leg of Mutton What3Words-///hunter.fantastic.uses
Species	Sycamore (<i>Acer pseudoplatanus</i>)
Height	14
Physiological Condition	Good
Structural Condition	Fair
Inspection findings	Tree is growing in an unsuitable location; it has significant growth potential and is damaging the fencing of the leg of button reserve in such a way that it presents an unacceptable risk to pedestrians and cyclists using the public right of way.

Image shows tree in street scene.

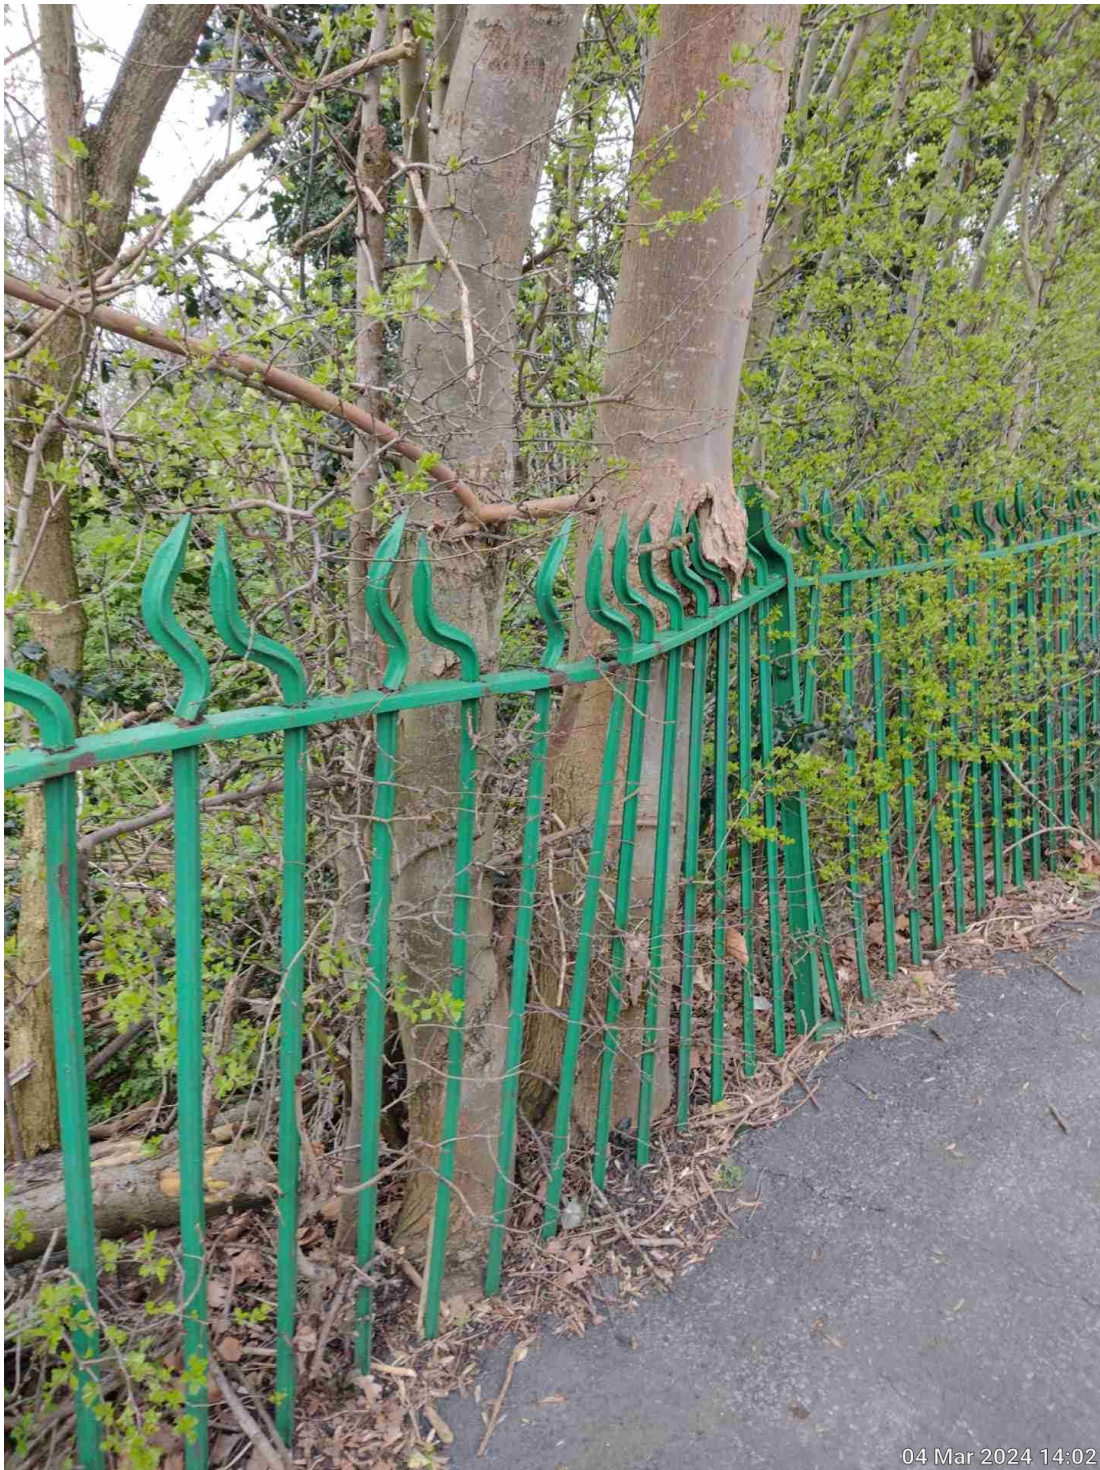
Image shows tree damaging the fence to obstruct the public highway

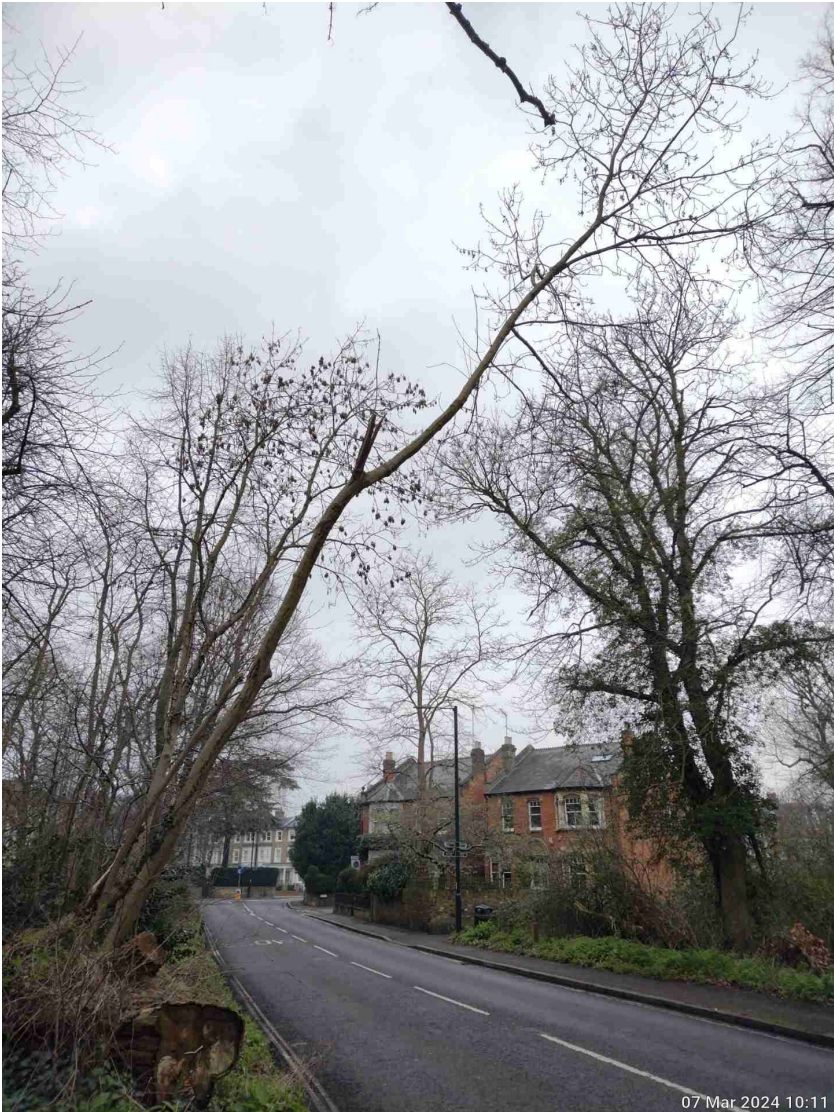
Ward	Barnes
Road	Mill Hill Road
Location	Barnes common What3Words-///intelligible.riders.copper
Species	Ash (<i>Fraxinus excelsior</i>)
Height	14.5m
Physiological Condition	Good
Structural Condition	Poor
Inspection findings	Adjacent failed tree has pushed this specimen to lean directly over roadside with remnants of the adjacent failed still pushing on stem of this ash at ground level. Removal is required to prevent natural failure.

Image shows tree heavily leaning over the highway

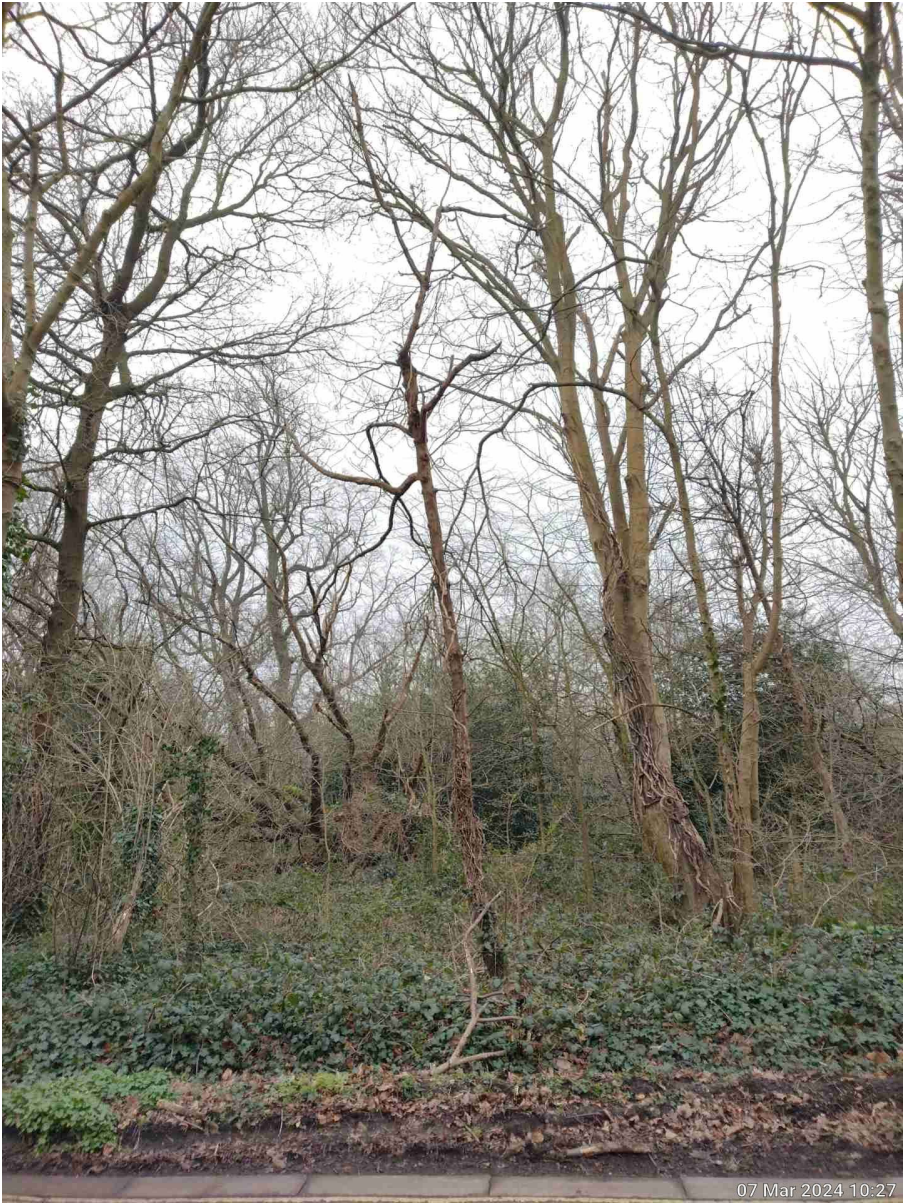
Ward	Barnes
Road	Station Road
Location	Barnes common What3Words-///stage.random.ideas
Species	Unknown species
Height	9m
Physiological Condition	Dead
Structural Condition	poor
Inspection findings	This tree is dead and requires removal to facilitate replanting and prevent natural failure.

Image shows tree dead in street scene

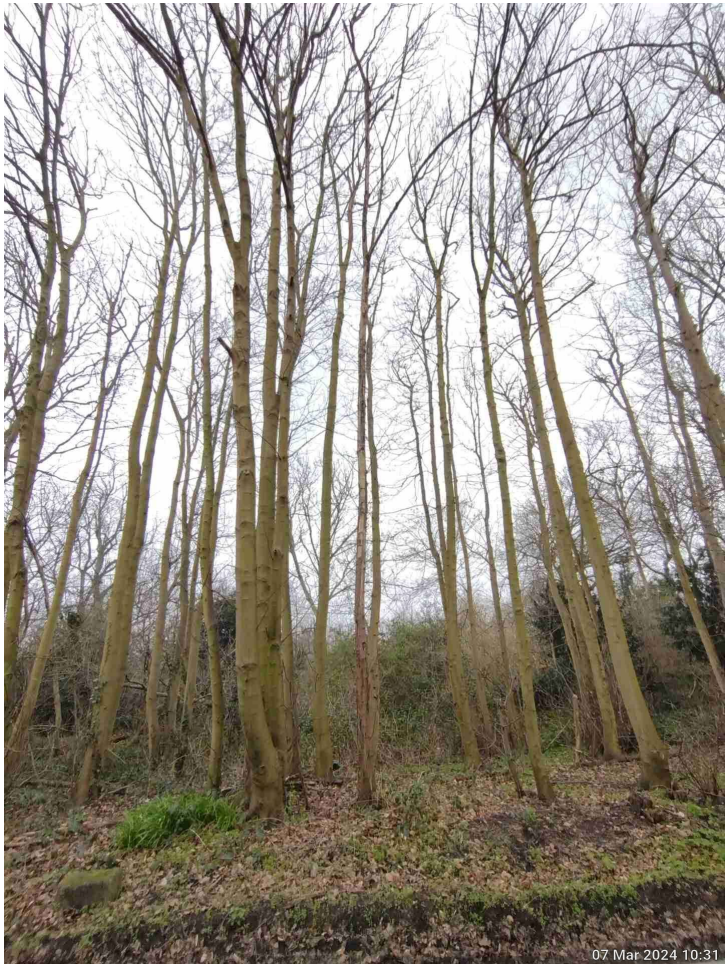
Ward	Barnes
Road	Vine Road
Location	Barnes common What3Words-///smashes.kinks.brand
Species	Sycamore (<i>Acer pseudoplatanus</i>)
Height	18m
Physiological Condition	Dead
Structural Condition	Poor
Inspection findings	This tree is dead and requires removal to facilitate replanting and prevent natural failure.

Image shows tree dead in situ on the common.

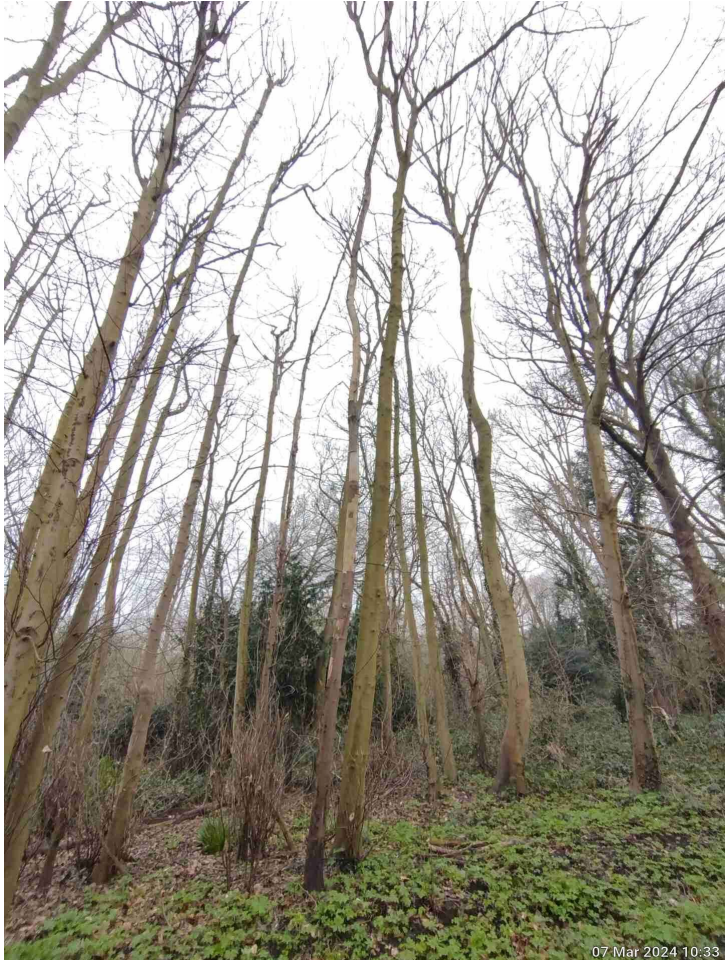
Ward	Barnes
Road	Vine Road
Location	Barnes common What3Words-///vest.quiz.sweat
Species	Sycamore (<i>Acer pseudoplatanus</i>)
Height	16m
Physiological Condition	Dead
Structural Condition	Poor
Inspection findings	This tree is dead and requires removal to facilitate replanting and prevent natural failure.

Image shows tree dead in situ on the common.

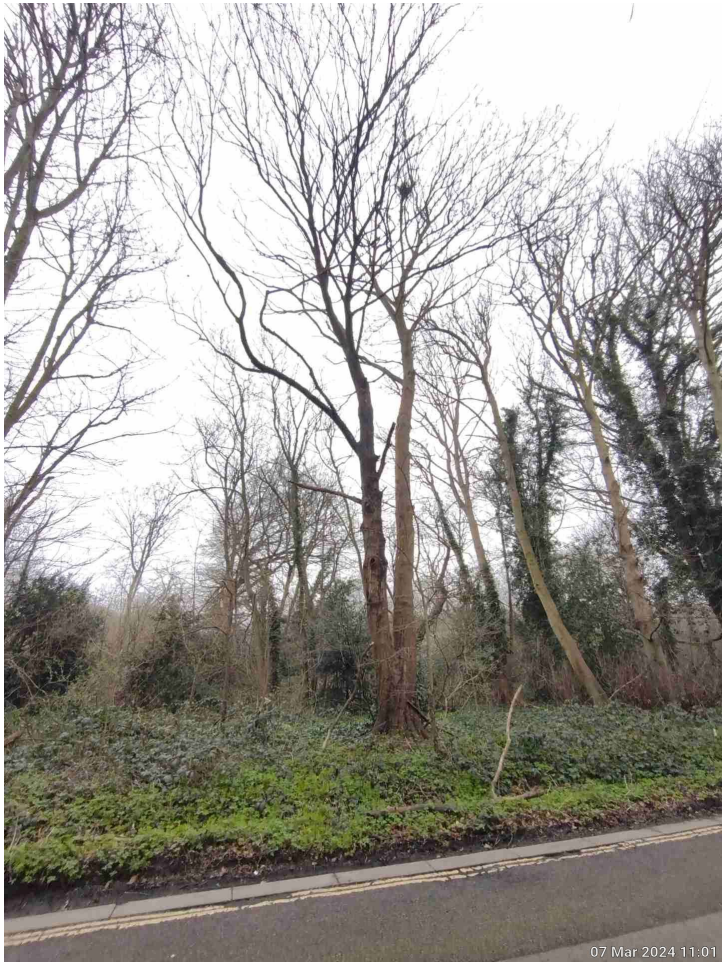
Ward	Barnes
Road	Vine Road
Location	Barnes common What3Words-///chair.caged.agent
Species	Sycamore (<i>Acer pseudoplatanus</i>)
Height	22.5m
Physiological Condition	Poor
Structural Condition	Poor
Inspection findings	This tree is moribund due to the presence of sooty bark disease; removal is required to prevent natural failure and facilitate replanting

Image shows tree located on the common next to Vine Road.

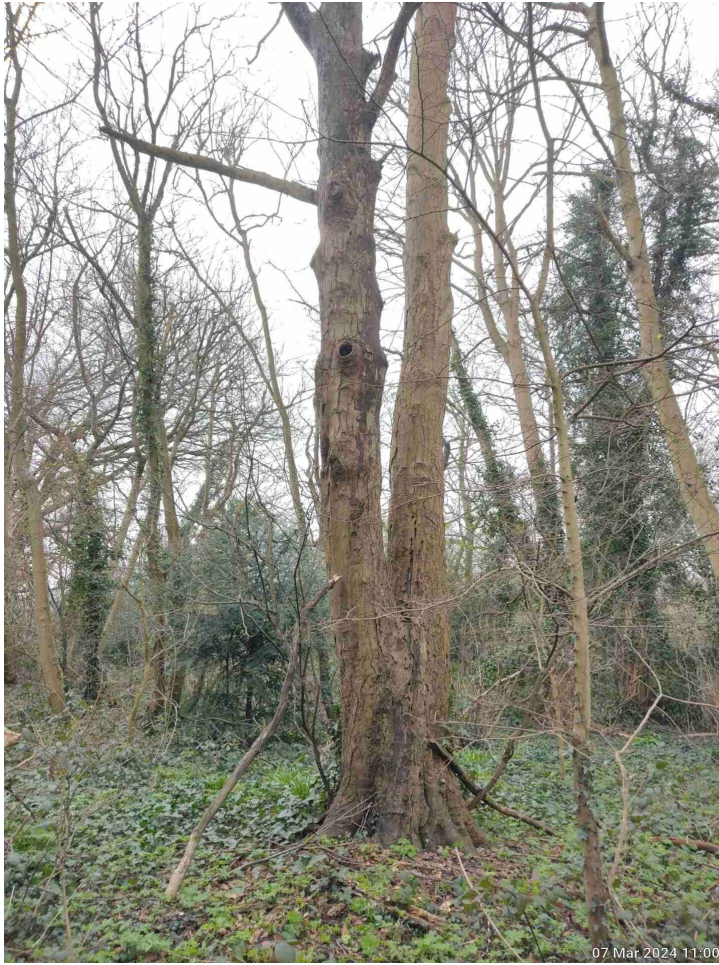
Image shows the left stem having died due to sooty bark disease.

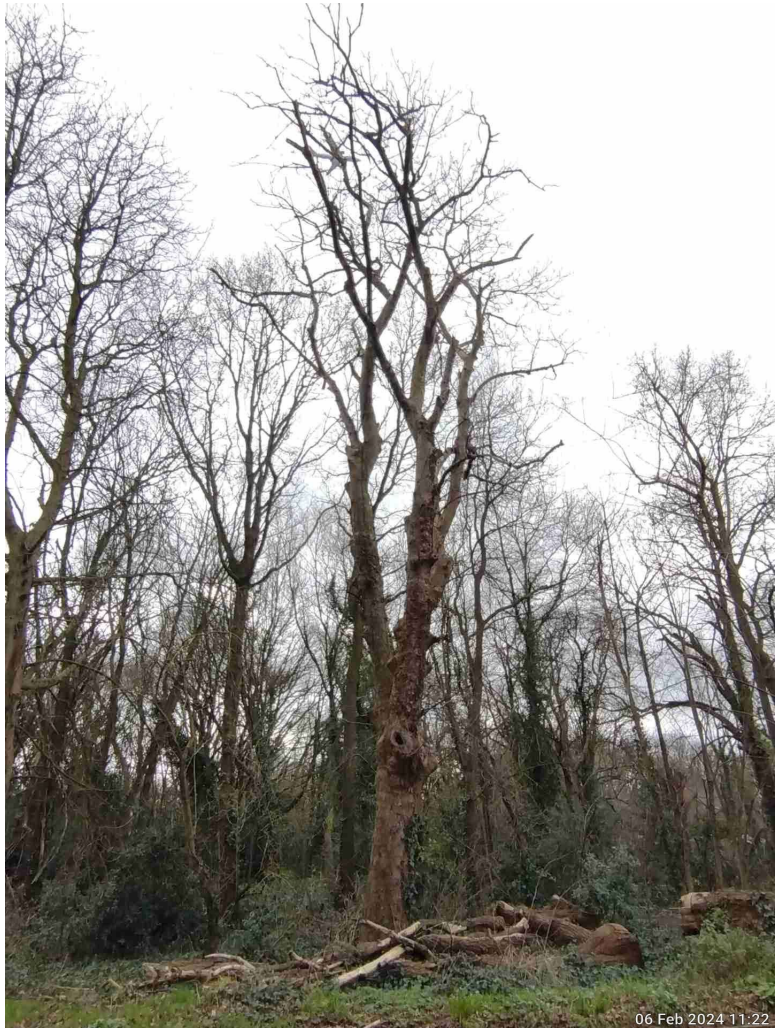
Ward	Barnes
Road	Mill Hill Road
Location	Barnes common What3Words ///brick.meant.slams
Species	Sycamore (<i>Acer pseudoplatanus</i>)
Height	21m
Physiological Condition	Poor
Structural Condition	Poor
Inspection findings	This tree is moribund due to the presence of sooty bark disease; removal is required to prevent natural failure and facilitate replanting

Image shows tree located on the common next to Mill Hill Road.

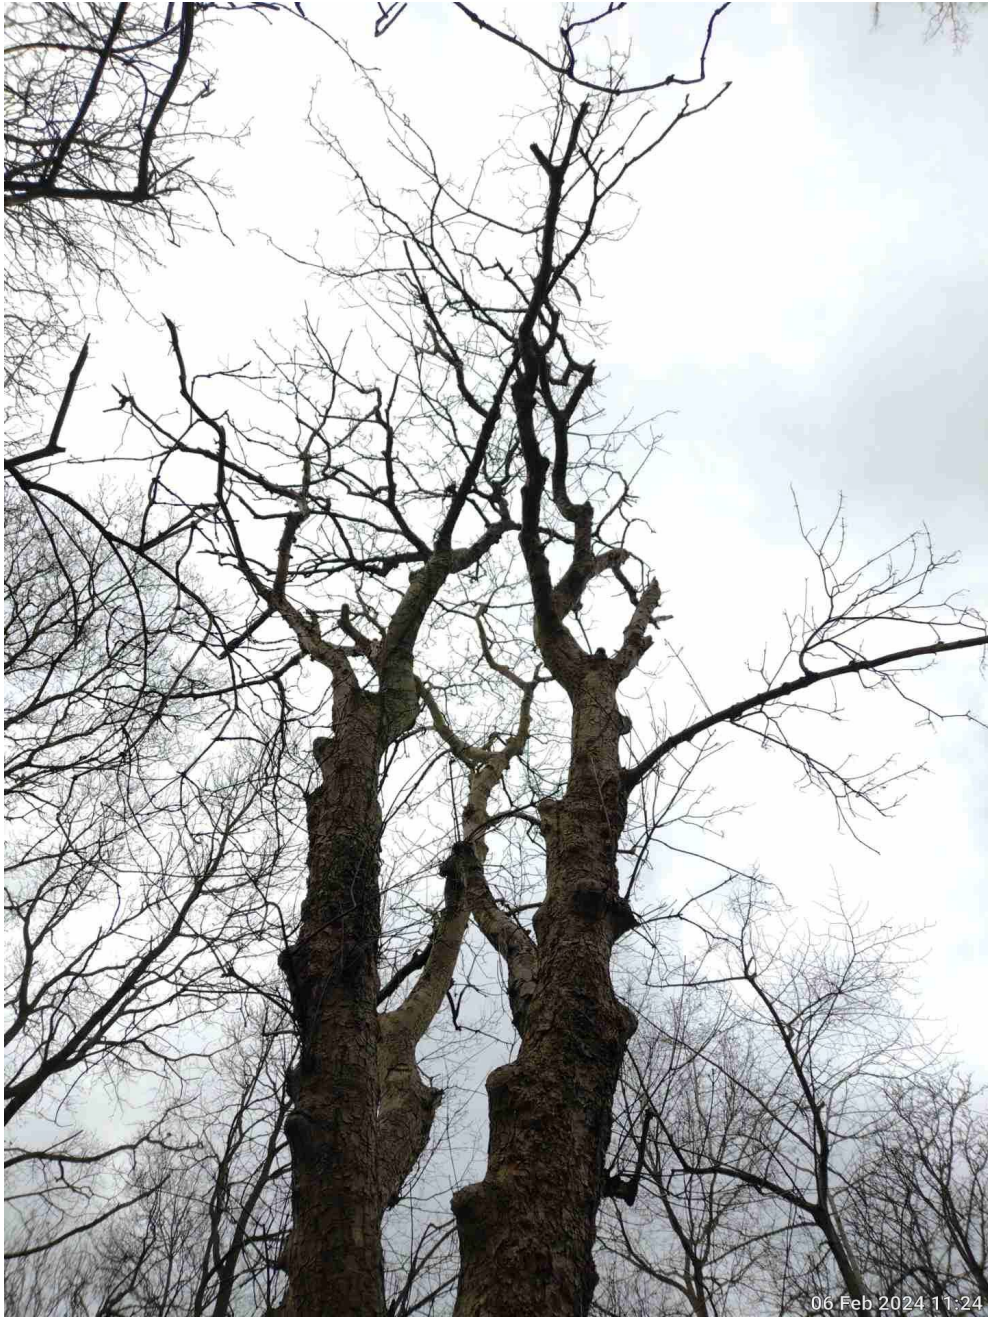
Image shows decline in the crown of tree

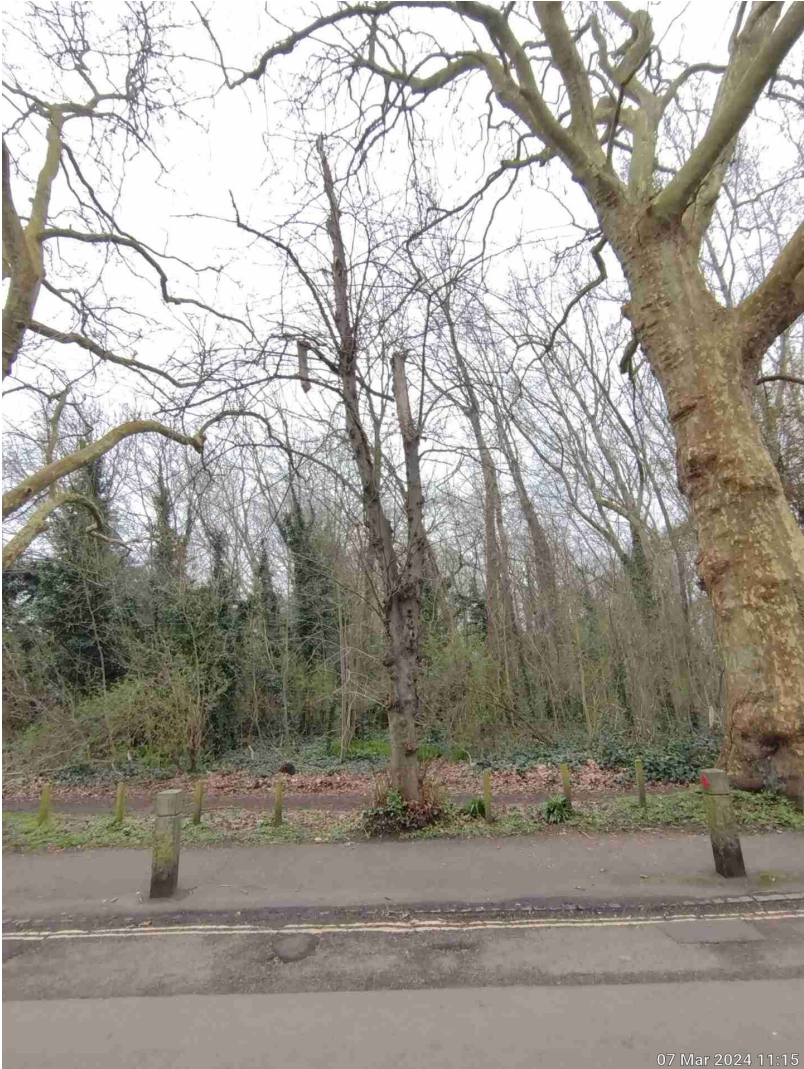
Ward	Barnes
Road	Vine Road
Location	Barnes Common What3Words-///discouraged.engage.aims
Species	European lime (<i>Tilia x europaea</i>)
Height	10m
Physiological Condition	Poor
Structural Condition	Poor
Inspection findings	Bark necrosis is present on the stem of this tree; the decline of the trees vascular system correlates with dieback within the crown of this declining specimen.

Image shows tree located on the street scene.
