March 2024 - Reactive Tree Works Programme

Introduction

28/03/2024

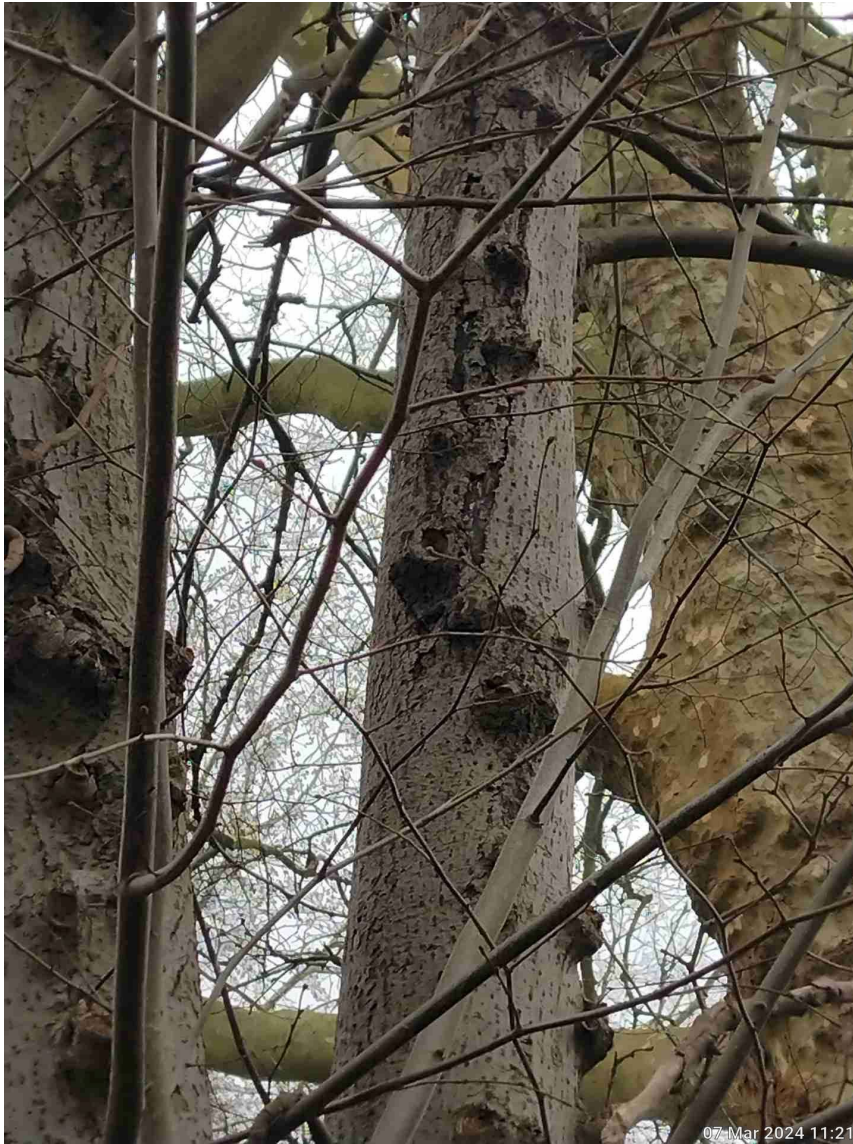
Image shows area of necrotic bark at approx. 4m from ground level.

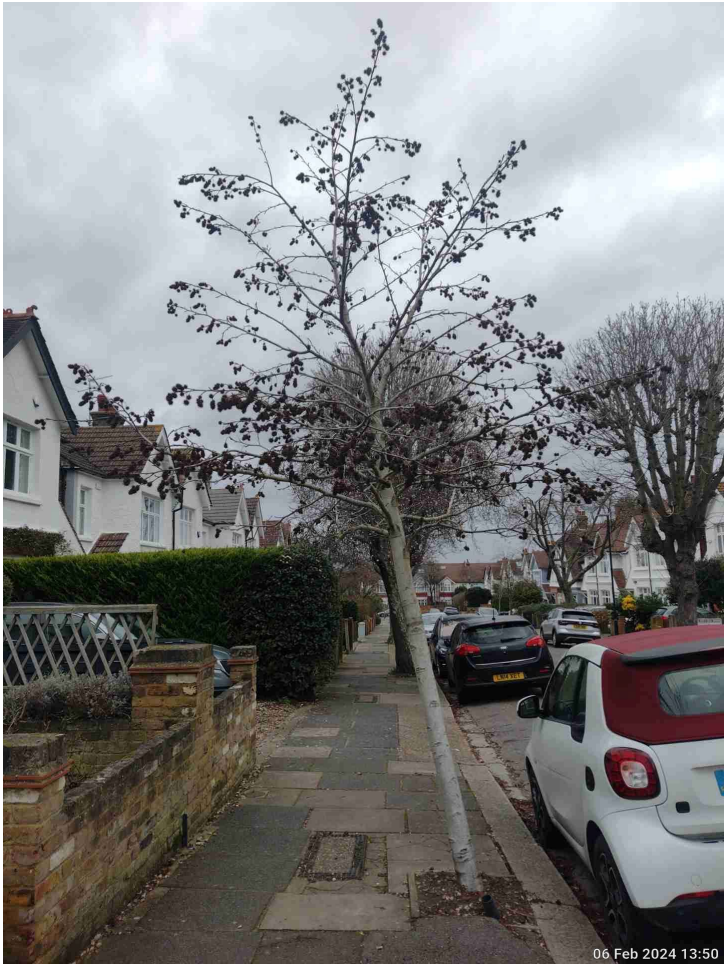
Ward	East Sheen
Road	Deanhill Road
Location	Outside 33
Species	Sweet gum (<i>Liquidambar styraciflua</i>)
Height	4.5m
Physiological Condition	Good
Structural Condition	Poor
Inspection findings	The tree has been recorded to have a progressive lean in a short period of time and is moving in such a way that indicates that the structure is compromised presenting increased risk of failure.

Image shows tree located on the street scene.

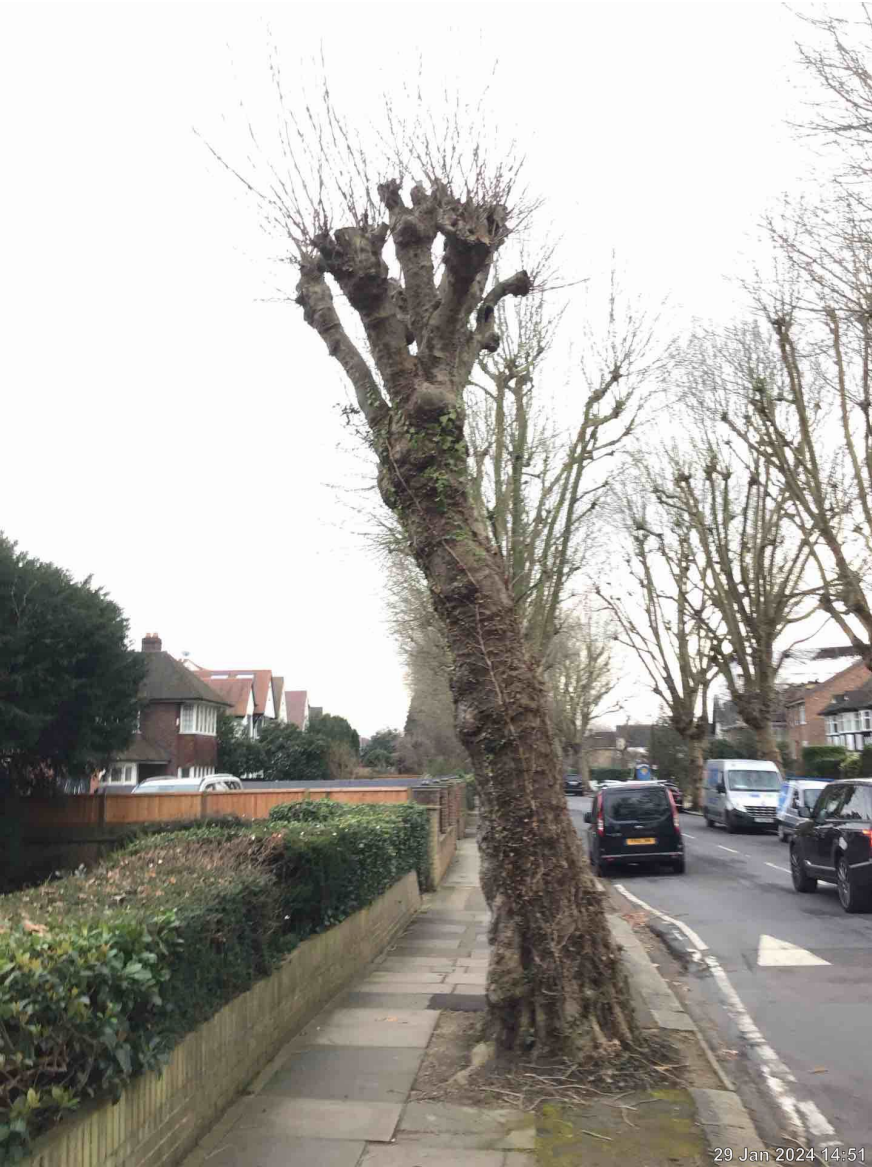
Ward	Hampton
Road	Wensleydale Road
Location	Outside 82
Species	<i>London Plane (Platanus x hispanica)</i>
Height	12m
Physiological Condition	Poor
Structural Condition	Poor
Inspection findings	Extensive decay around base of stem that looks to progressed since last inspection.

Image shows tree in the street scene.

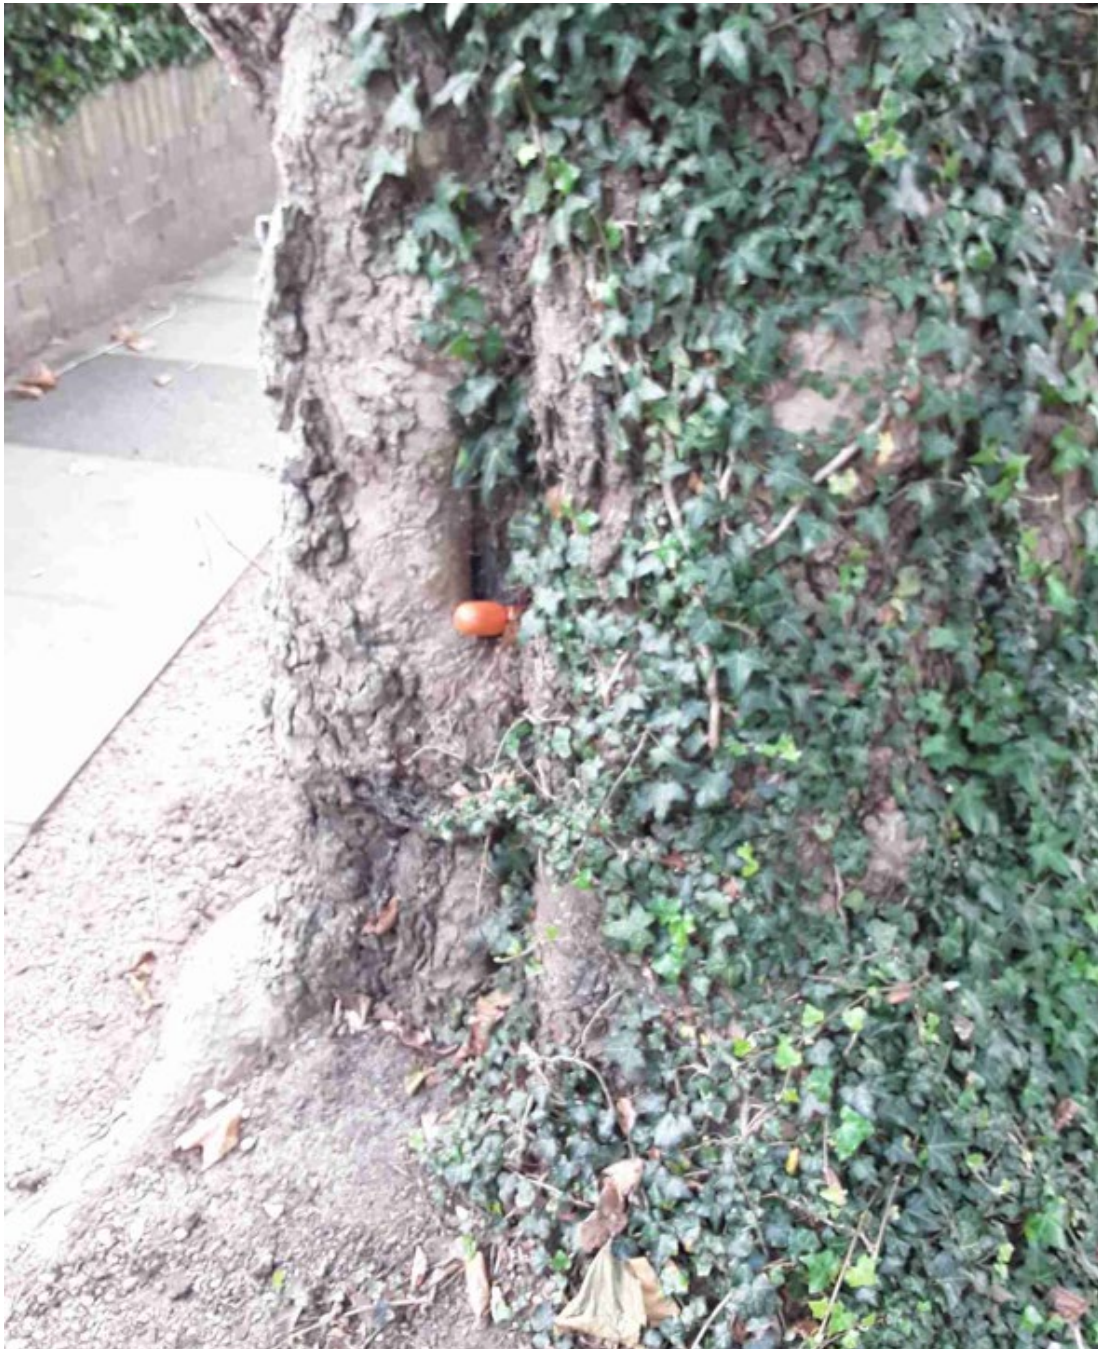
Image shows decayed area of the stem of the tree (end of orange probe visible in photo)

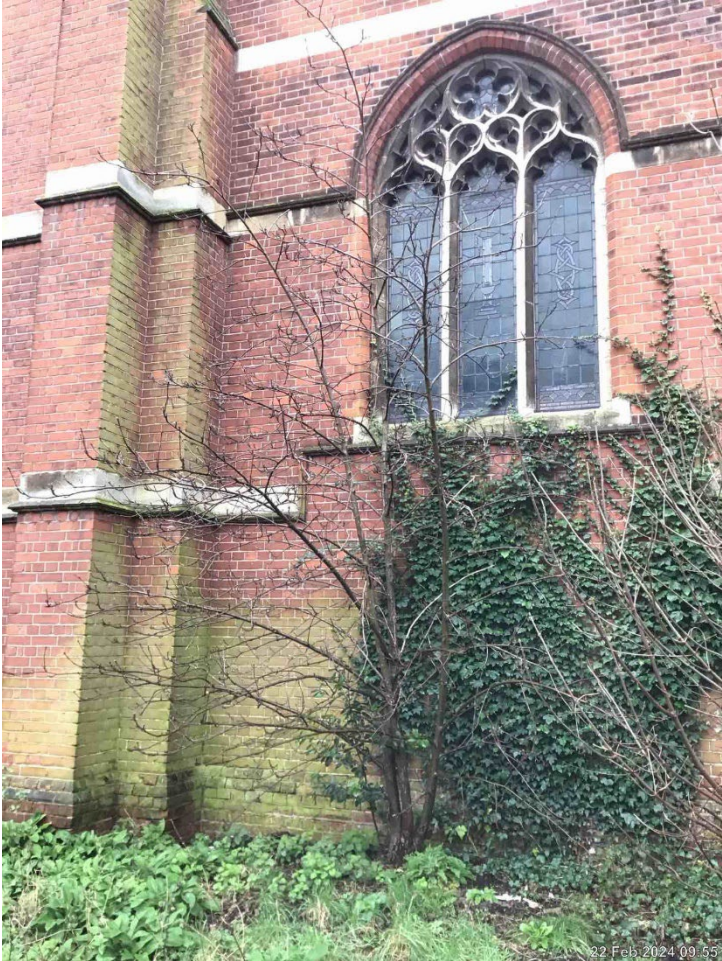
Ward	West Twickenham
Road	Churchview Road
Location	On Grass area outside All Saints Church- ///phones.skills.wicked
Species	Sorbus
Height	6m
Physiological Condition	Good
Structural Condition	Good
Inspection findings	This is a young self-sown sorbus that is growing directly adjacent to a structure; it has significant growth potential and in this location presents an unacceptable risk of damage to the property.

Images show tree in located in situ at the base of the wall of the church.

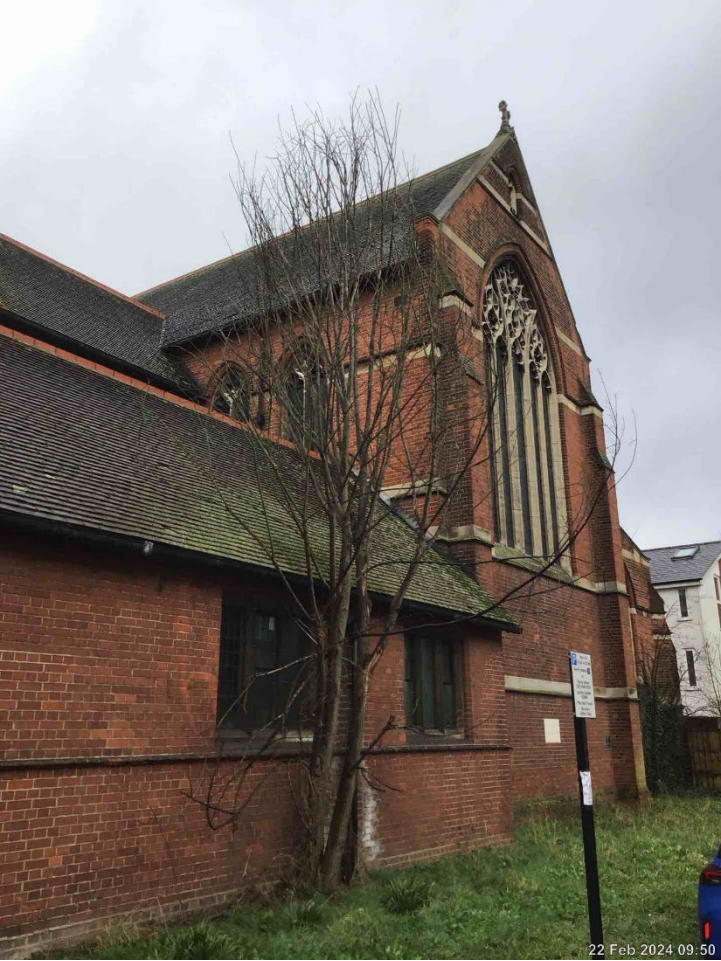
Ward	West Twickenham
Road	Churchview Road
Location	On Grass area outside All Saints Church- ///lifted.regime.encounter
Species	Elm (<i>Ulmus sp.</i>)
Height	12m
Physiological Condition	Dead
Structural Condition	Dead
Inspection findings	This tree is dead and requires removal to facilitate replanting and prevent natural failure.

Images shows the dead tree in situ.

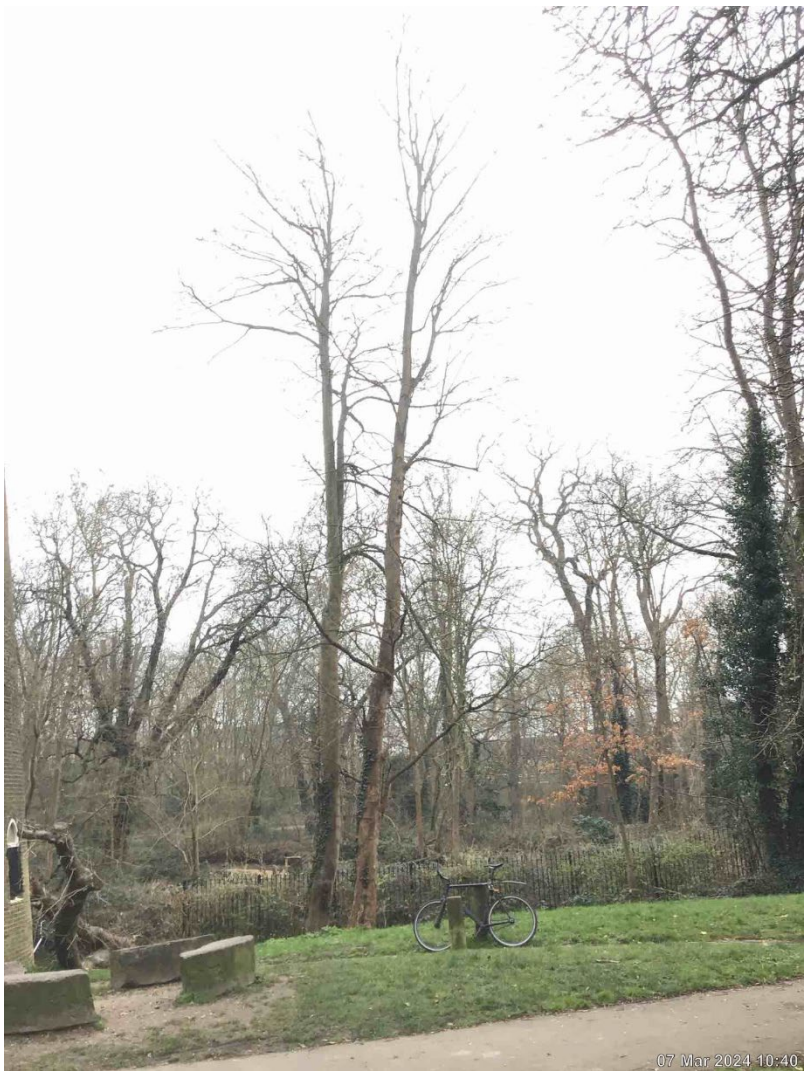
Ward	Whitton
Road	Hospital Bridge Road
Location	Crane Park- ///slope.fixed.proof
Species	Sycamore (<i>Acer pseudoplatanus</i>)
Height	21m
Physiological Condition	Fair
Structural Condition	Poor
Inspection findings	Extensive decay on North side of stem start spreading into base of tree approximately 40cm and spreading up stem to approximately 1.5m. The decay present is giving the tree an unacceptable amount of risk requires removal to prevent natural failure and facilitate replacement.

Images show tree in situ in crane park.

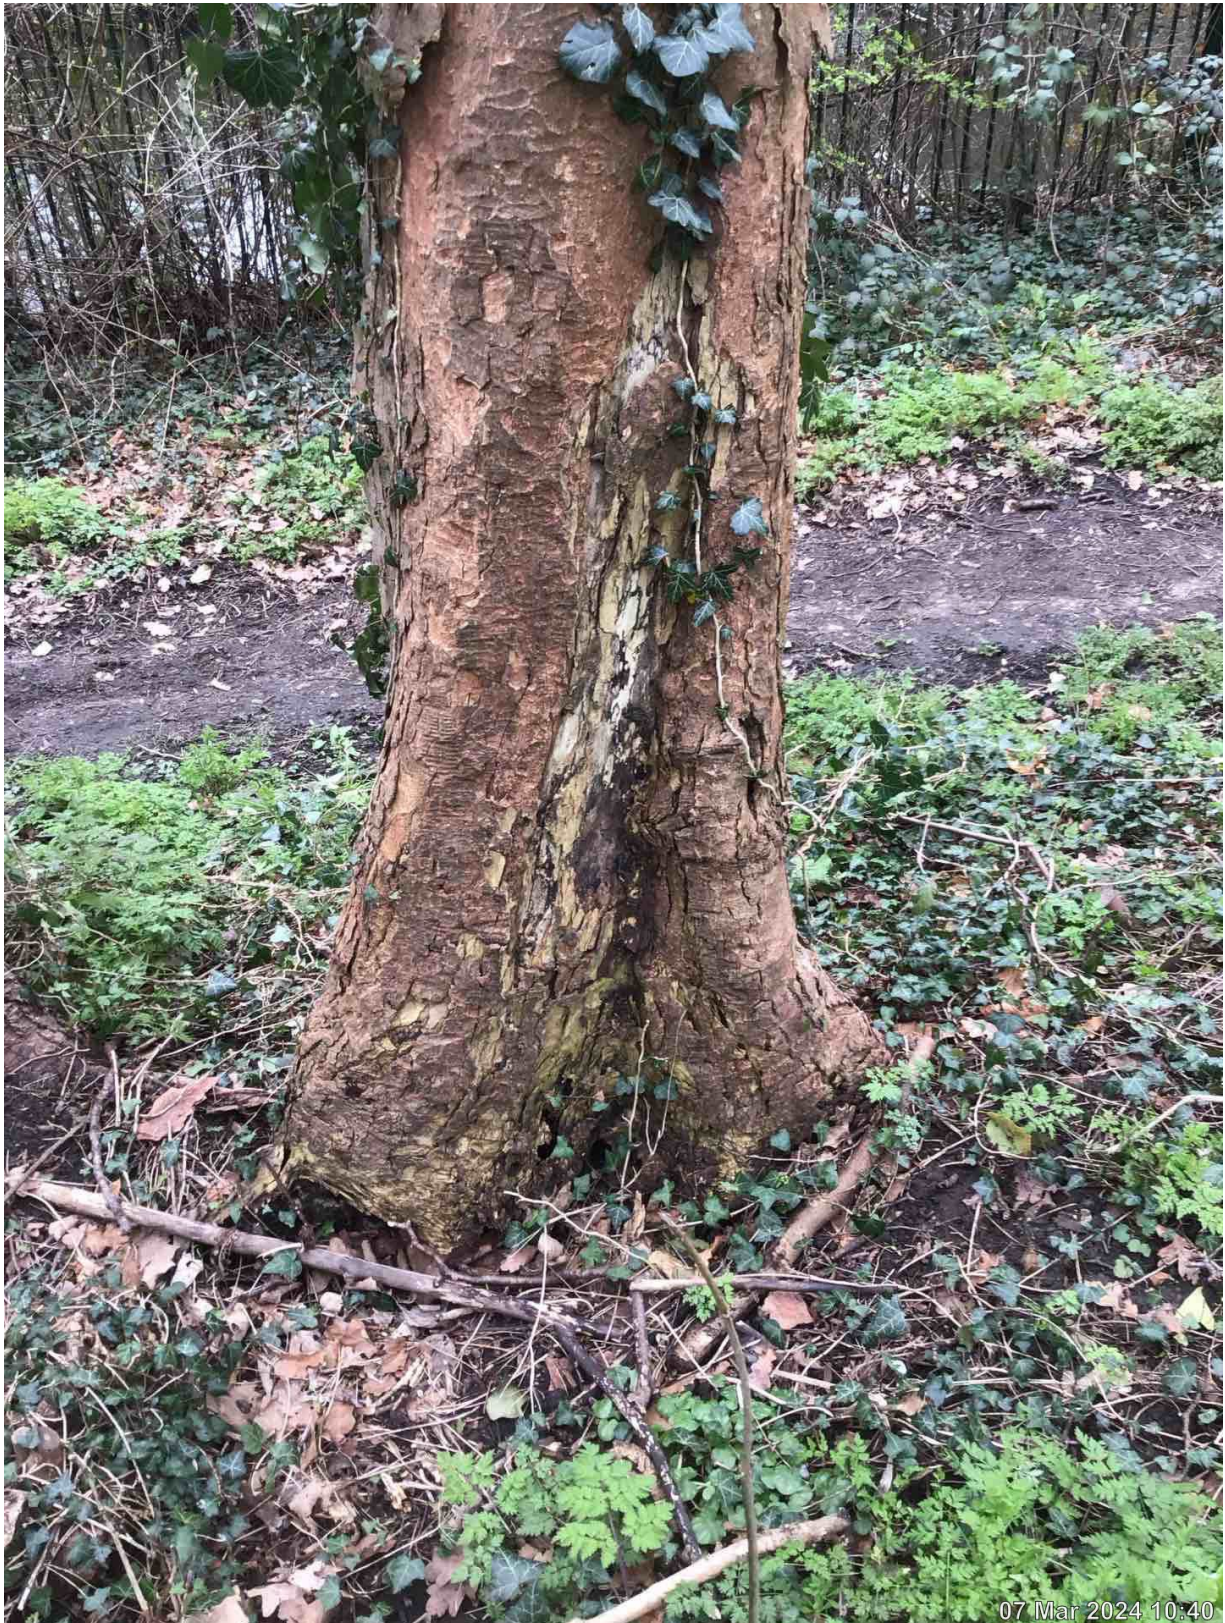
Images shows decayed area at the base of the stem.
