Works Order 6000467 - Reactive Tree Works Programme

Recent reactive inspections have identified the need for 17 individual tree work operations to take place. This work will now be issued to the Council's Arborist Contractor KPS, for completion over the Autumn period.

The following pages provide the locations of each tree that is to be removed, in addition photographs and descriptions of the inspection findings have been provided.

12/10/2023

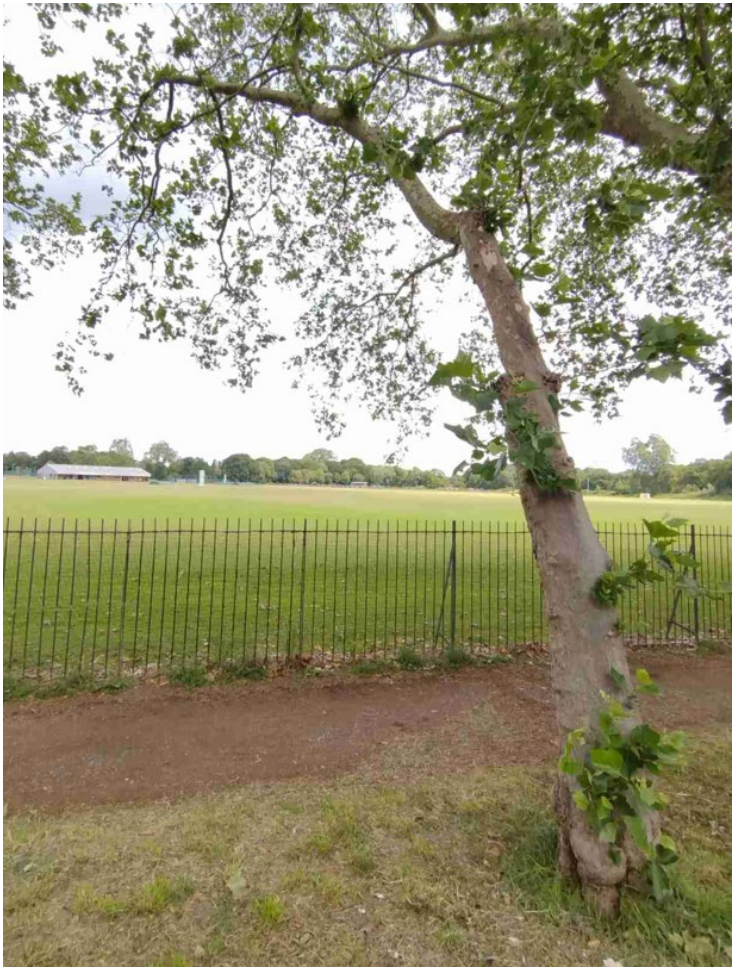
Ward	Barnes
Road	Rocks Lane
Location	Opposite 31/32
Species	London Plane (<i>Platanus x acerfolia</i>)
Height	12.0m
Physiological Condition	Poor
Structural Condition	Poor
Inspection findings	A fungal fruiting body of the species Shaggy Polypore (<i>Inonotus hispidus</i>) is present on the main stem or trunk, this fungus causes a simultaneous white rot which can cause snapping of tree parts in this species. A resonance test revealed an unacceptable degree of decay in the trunk of this tree where bracket was situated, removal is required to prevent natural failure and manage risk.

Image shows tree in street scene

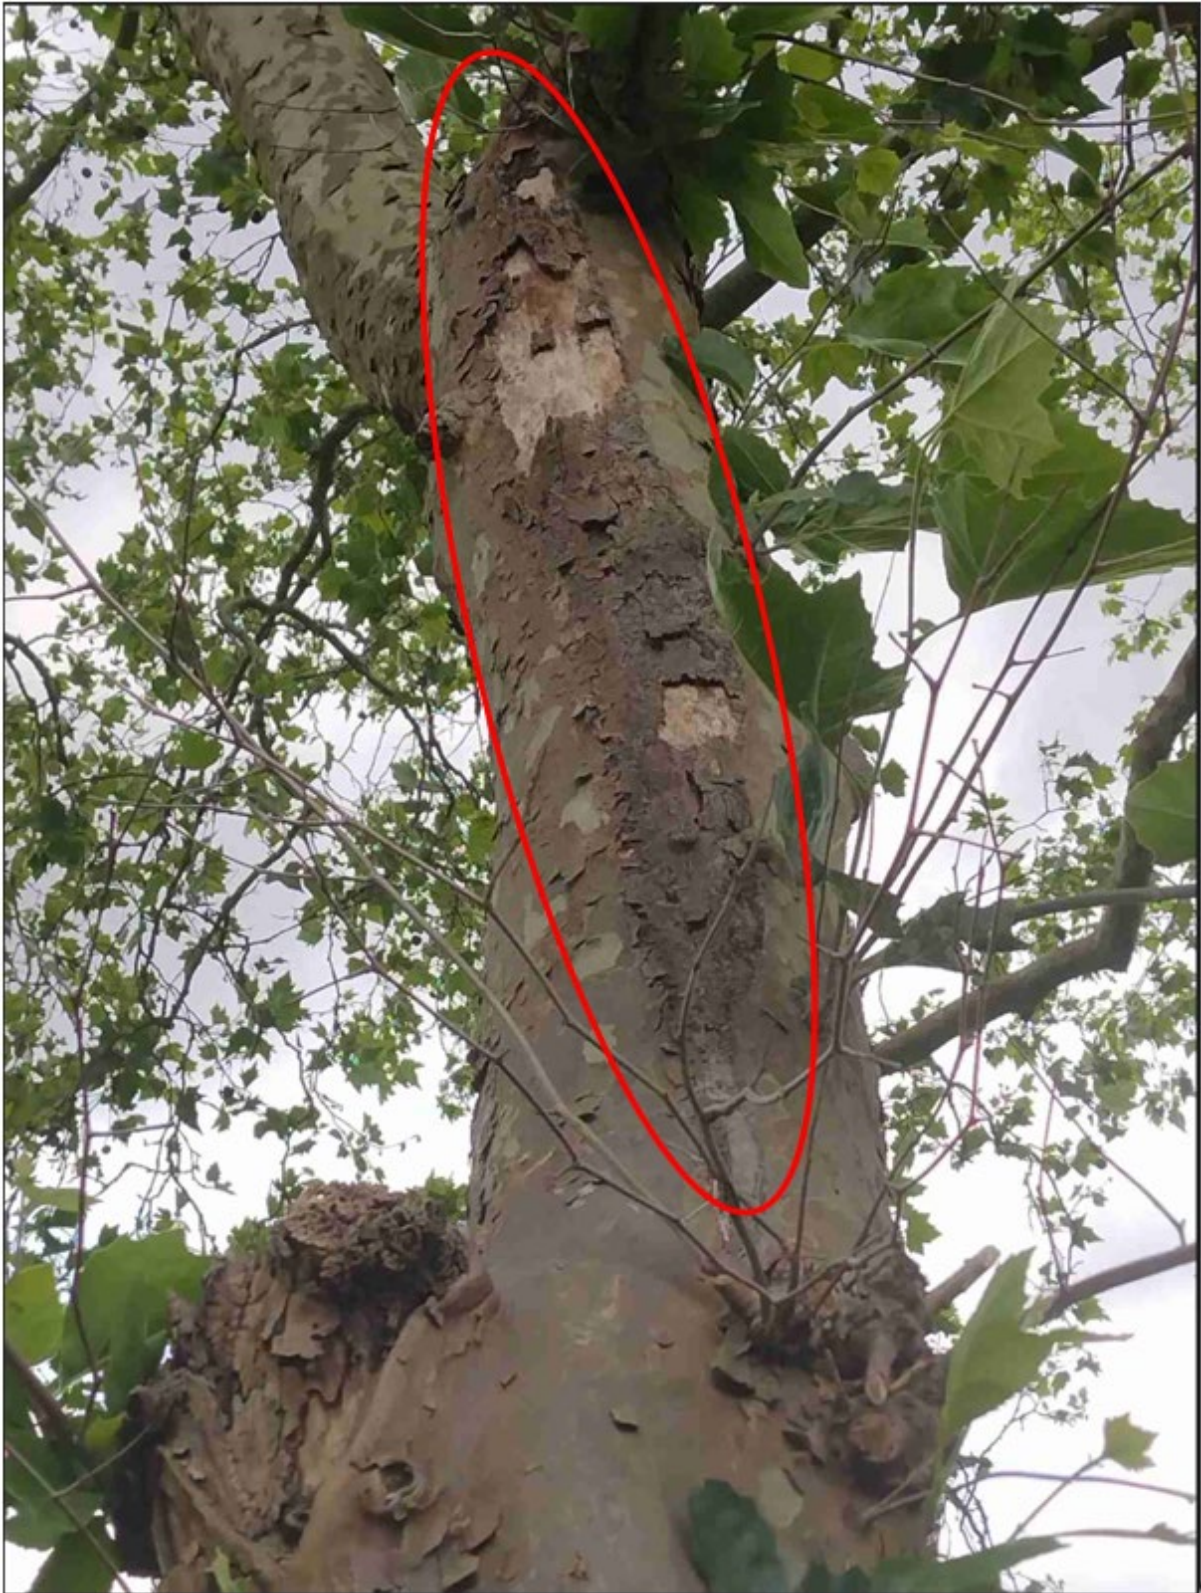
Image shows area of decay on stem

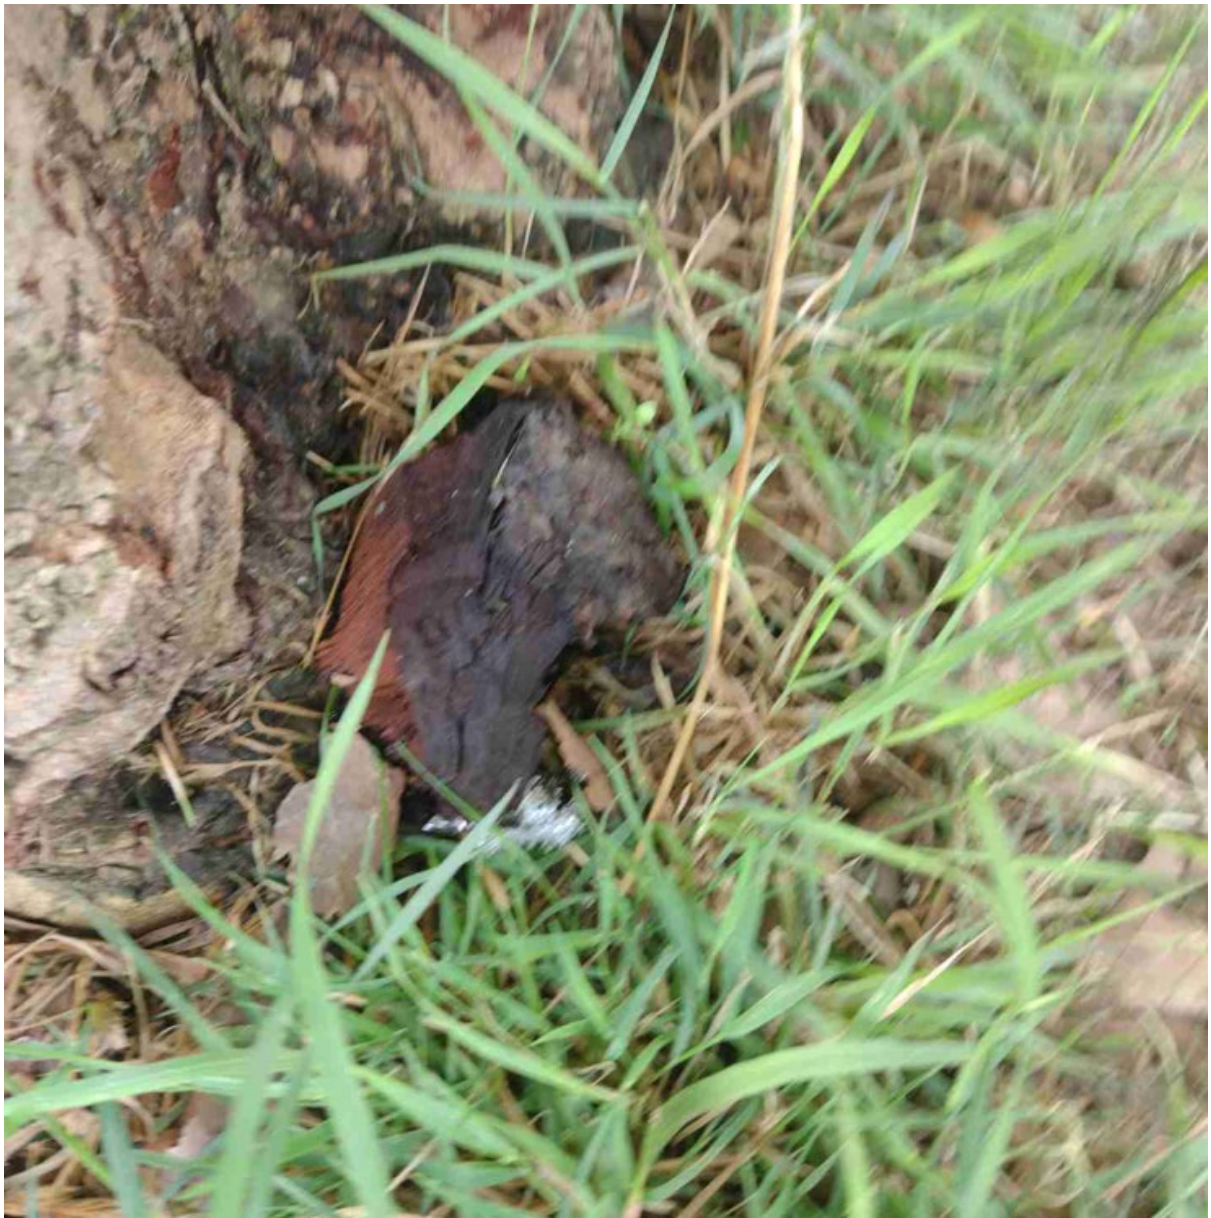
Image shows a fungal fruiting body that has fallen from the area of decay on stem

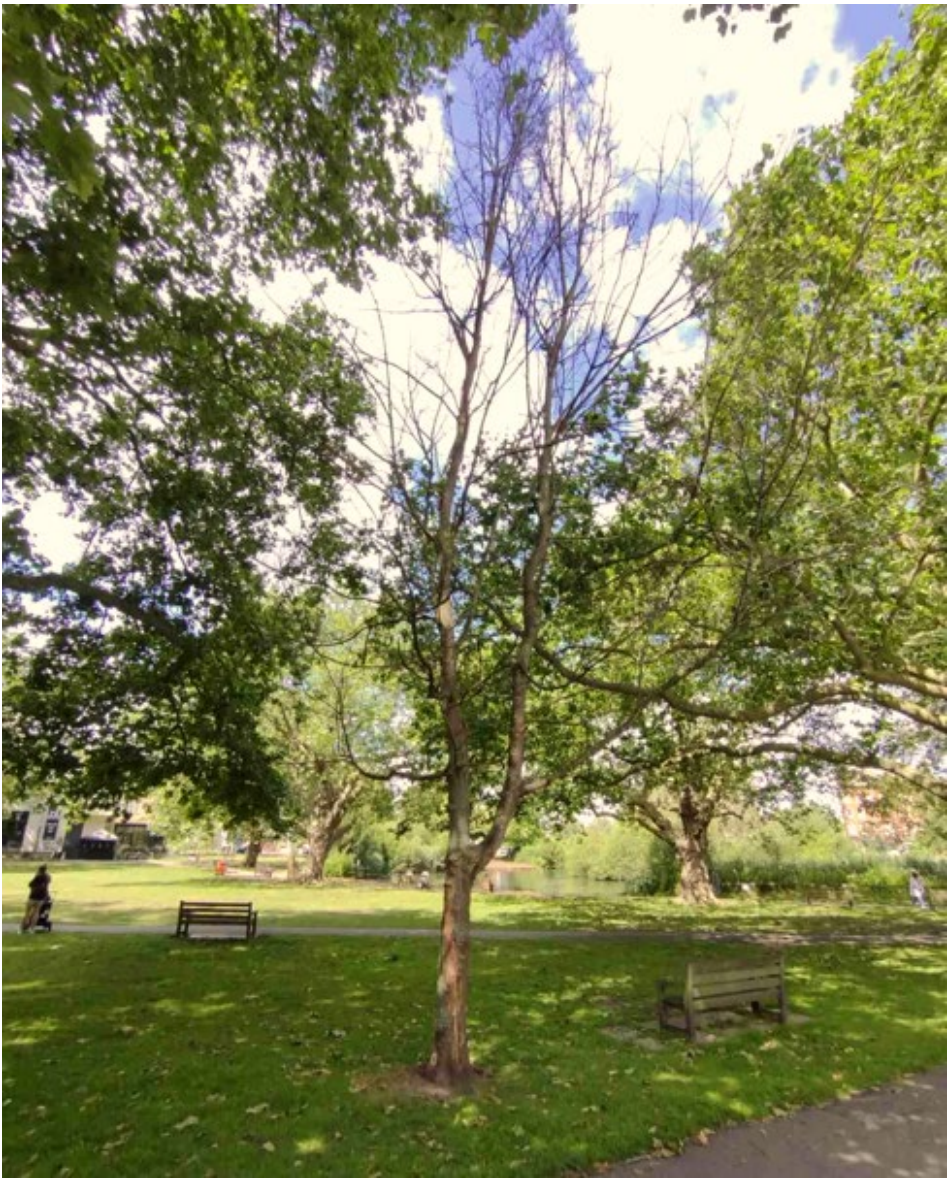
Ward	Barnes
Road	Church Road
Location	Opposite 30 The Crescent - What3Words-///shapes.pushed.school
Species	Norway Maple (<i>Acer platanoides</i>)
Height	12.5m
Physiological Condition	Dead
Structural Condition	Dead
Inspection findings	This tree is dead; removal is required to prevent natural failure and facilitate replanting

Image shows dead tree in park scene

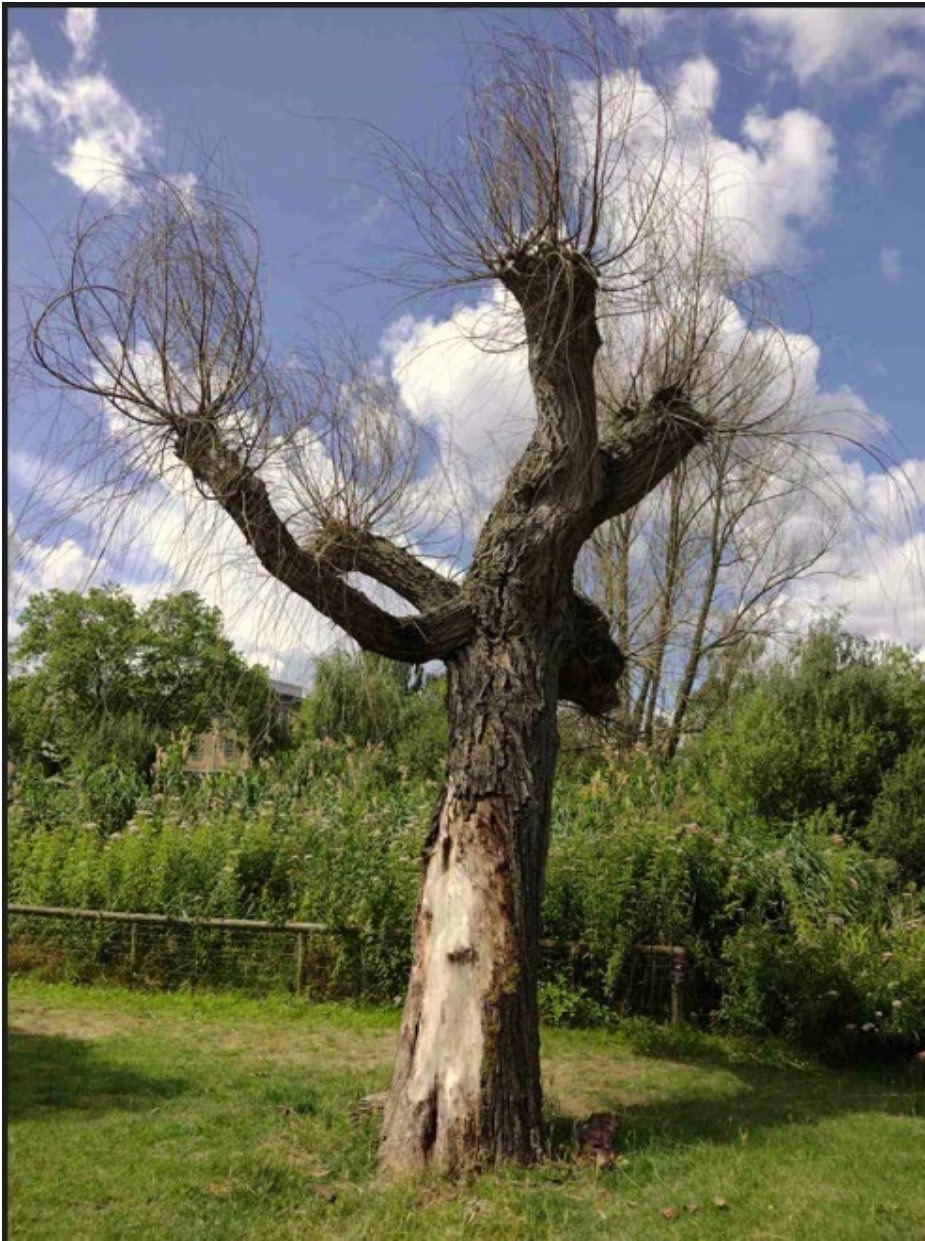
Ward	Barnes
Road	Church Road
Location	Barnes green What3Words-///whites.nights.cares
Species	Weeping Willow (<i>Salix x sepulcralis Simonkai</i>)
Height	10.5m
Physiological Condition	Dead
Structural Condition	Dead
Inspection findings	This tree is dead; removal is required to prevent natural failure, leaving a 1.5-meter stump for ecological purposes

Image shows dead tree in park scene

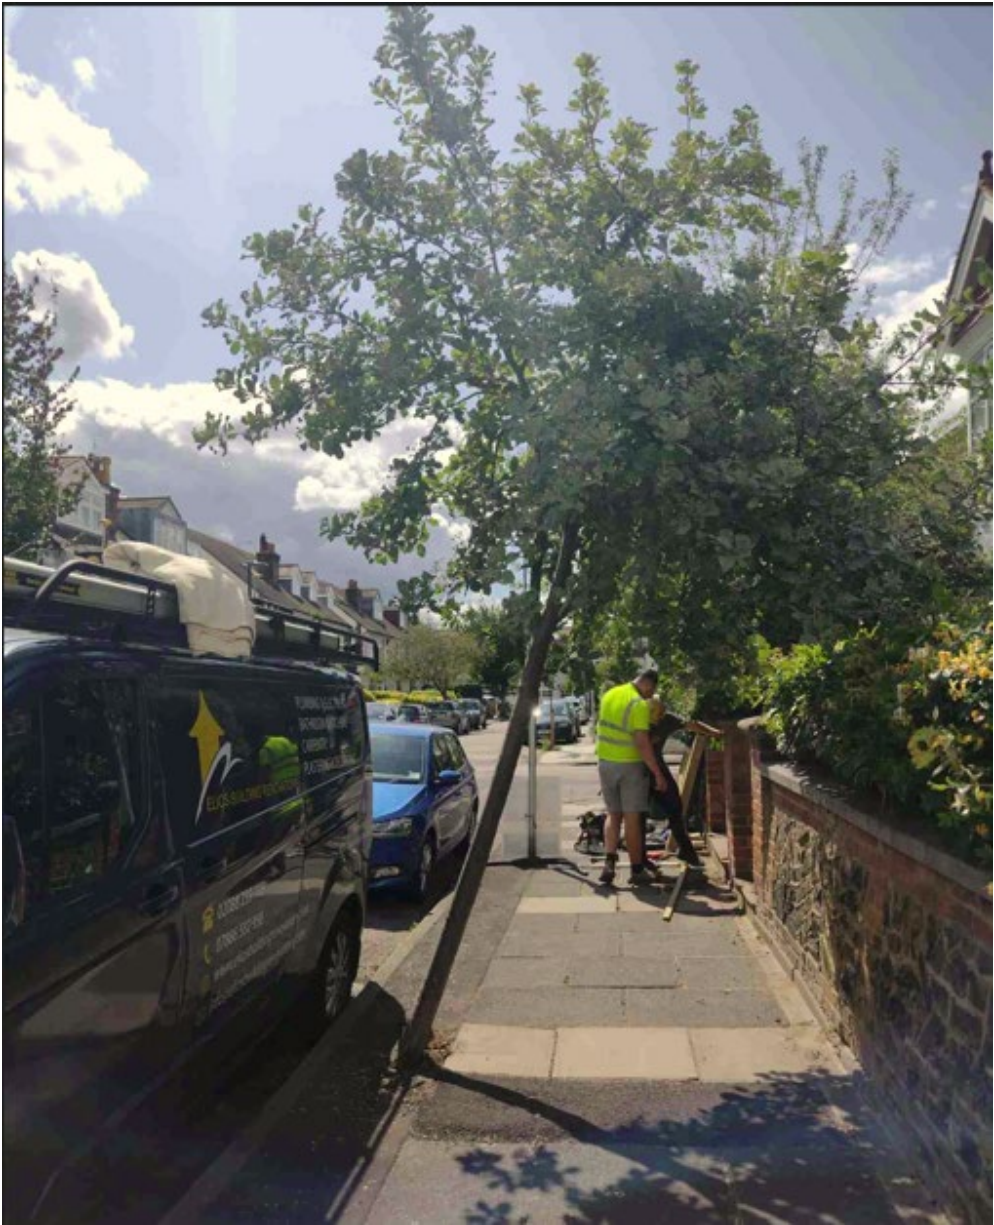
Ward	Barnes
Road	Bracken Gardens
Location	Outside 2
Species	Whitebeam (<i>Sorbus aria</i>)
Height	4.0m
Physiological Condition	Fair
Structural Condition	Poor
Inspection findings	Tree main stem or trunk of tree is leaning and moving in such a way that indicates that the root structure is compromised. Removal is required to prevent natural failure, manage risk, and facilitate replanting

Image shows leaning tree in street scene

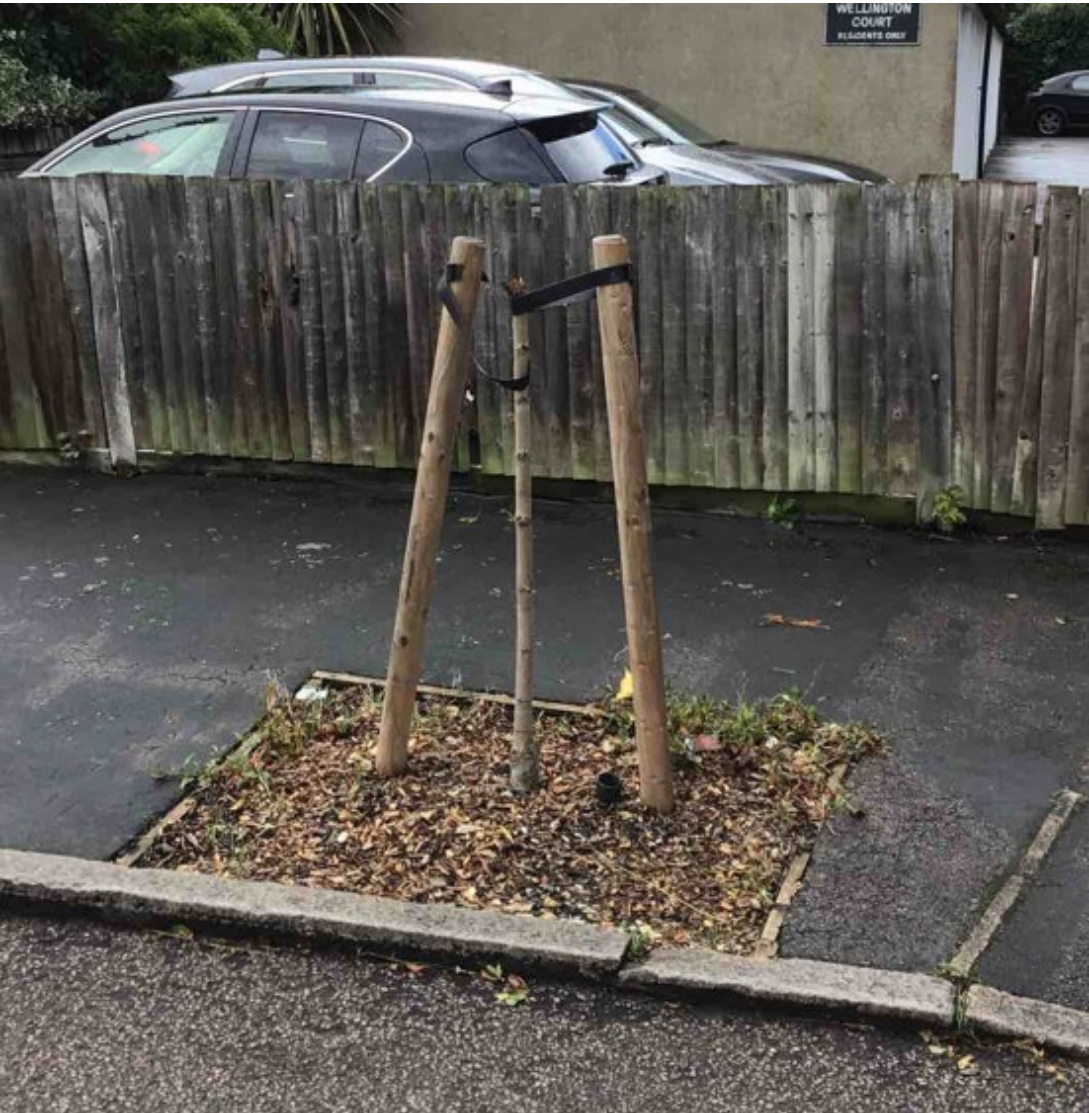
Ward	Fulwell and Hampton Hill
Road	Mays Road
Location	Opposite 34
Species	Lime (<i>Tilia sp.</i>)
Height	1.0m
Physiological Condition	Dead
Structural Condition	Dead
Inspection findings	This tree has been vandalised – the main stem has been snapped. This will prevent the tree from forming a useful specimen. Removal is required to facilitate replanting

Image shows vandalised dead tree in street scene

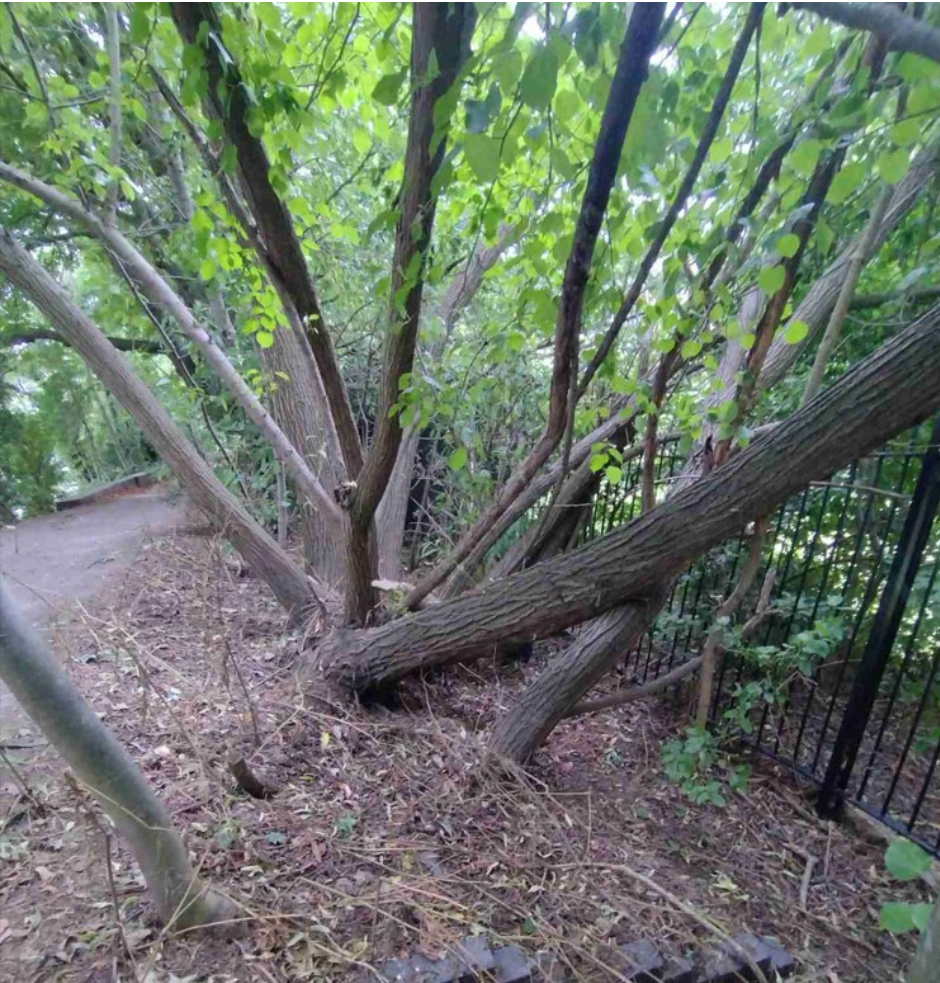
Ward	Kew
Road	UNFP - Riverside to Chiswick Bridge
Location	What3Words-///skill.scenes.shirts
Species	Willow (<i>Salix sp.</i>)
Height	5.0m
Physiological Condition	Good
Structural Condition	Poor
Inspection findings	This Willow is growing directly adjacent to a metal fence. The multi stemmed tree has now part failed at ground level with the stems now supported by the fence. Removal of the tree is required to manage risk and prevent damage to the fence.

Image shows tree in towpath scene.

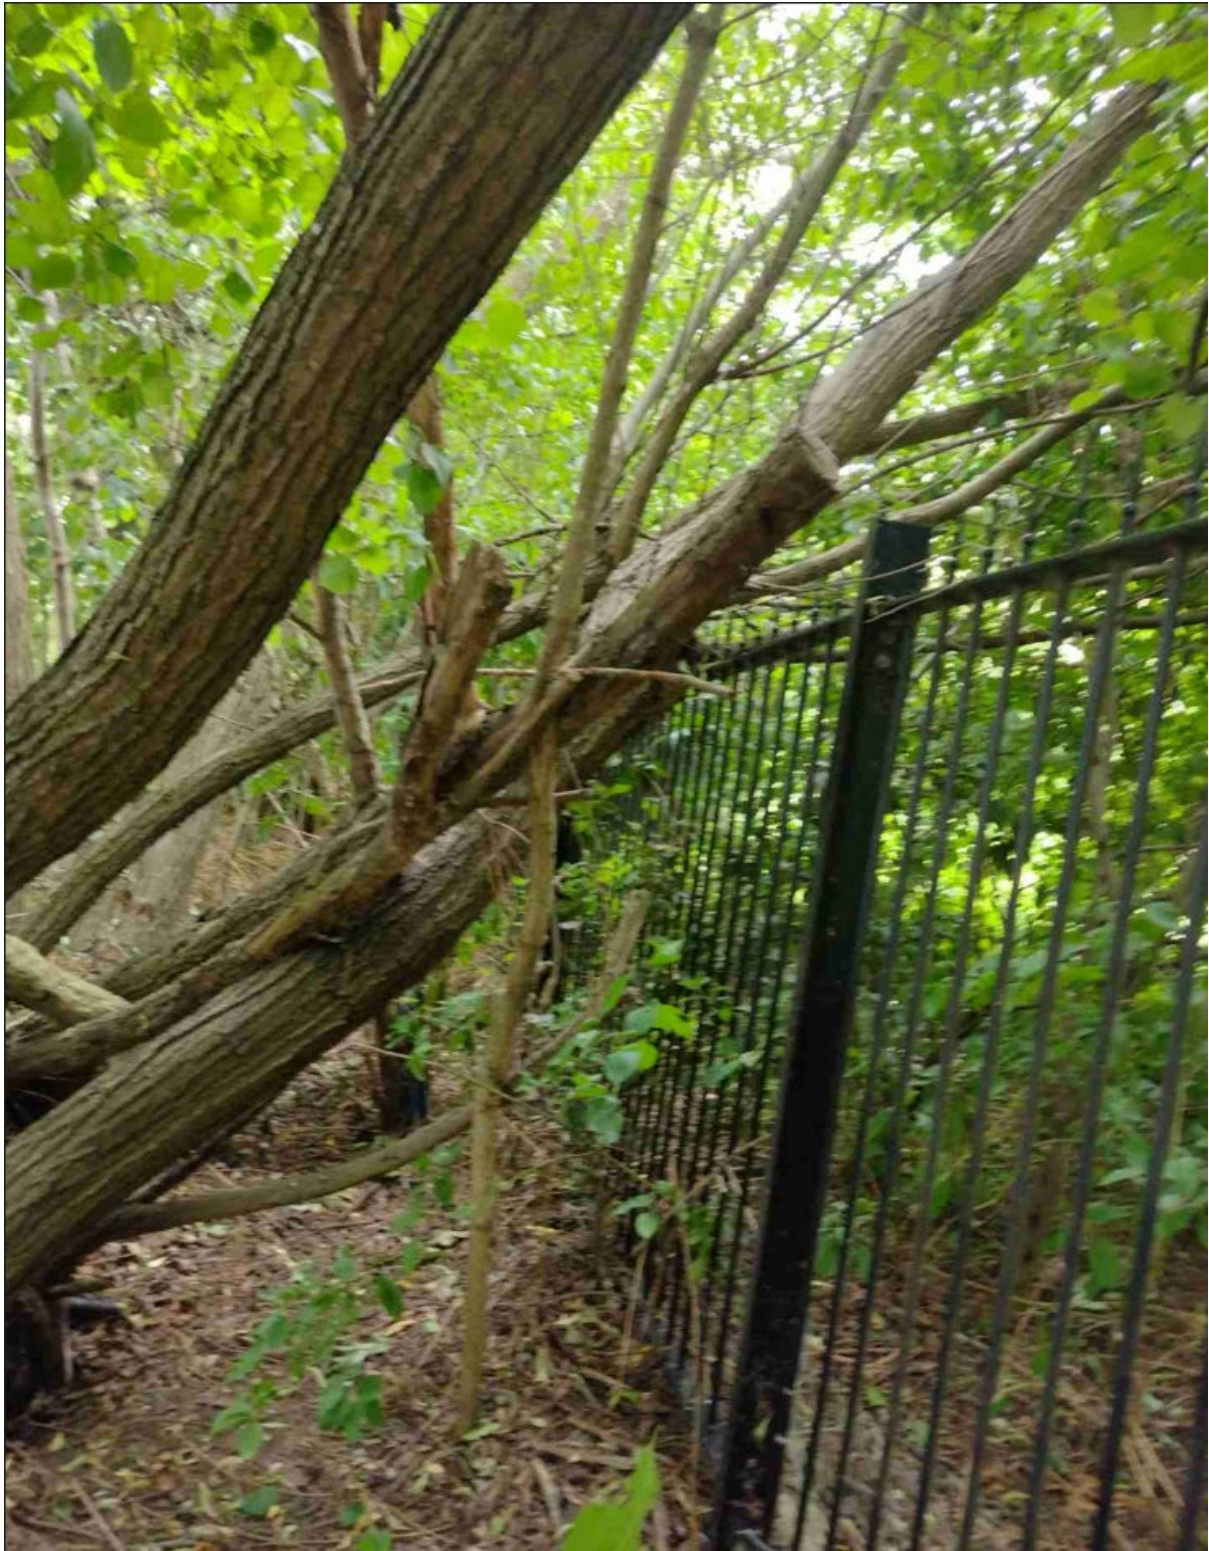
Image shows tree with failed stems resting on fence

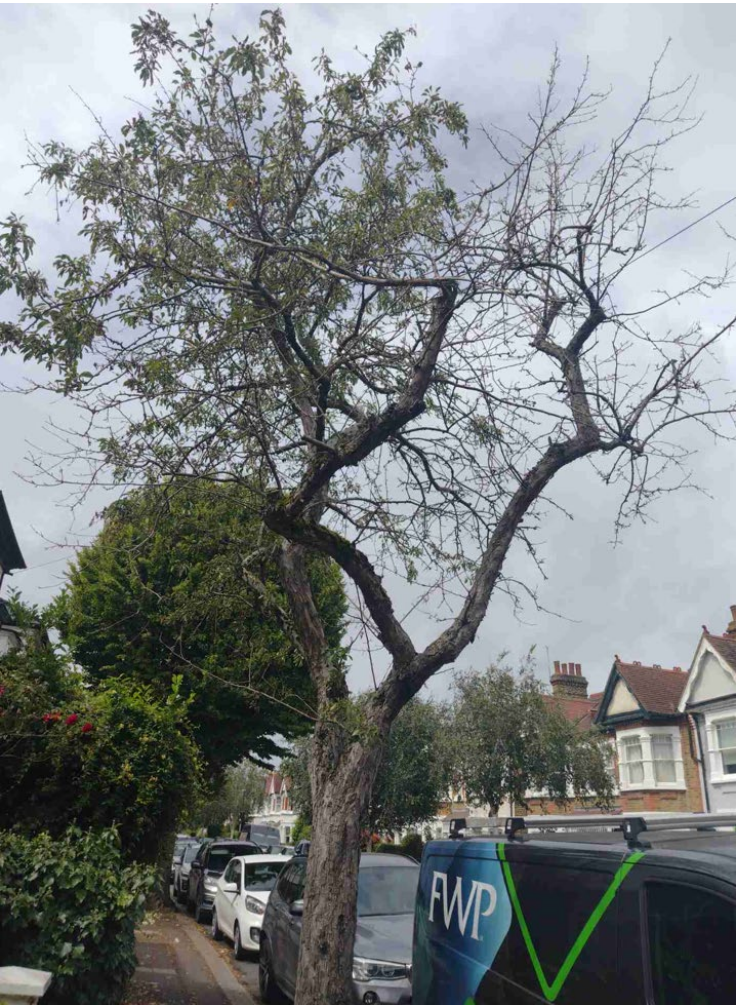
Ward	Mortlake and Barnes Common
Road	Shalstone Road
Location	Outside 5/7
Species	Apple (<i>Malus sp.</i>)
Height	8.0m
Physiological Condition	Poor
Structural Condition	Poor
Inspection findings	An emerging fungal fruiting body displaying characteristics of decay pathogen <i>Ganoderma</i> sp. is present at the stem base. Colonisation by this fungus causes a white rot of the stem and root system that can cause entire trees to collapse through fracture or windthrow. Tree is declining, significant deadwood and dieback is present and this correlates with the pathogen present.

Image shows tree in street scene with canopy die back evident.

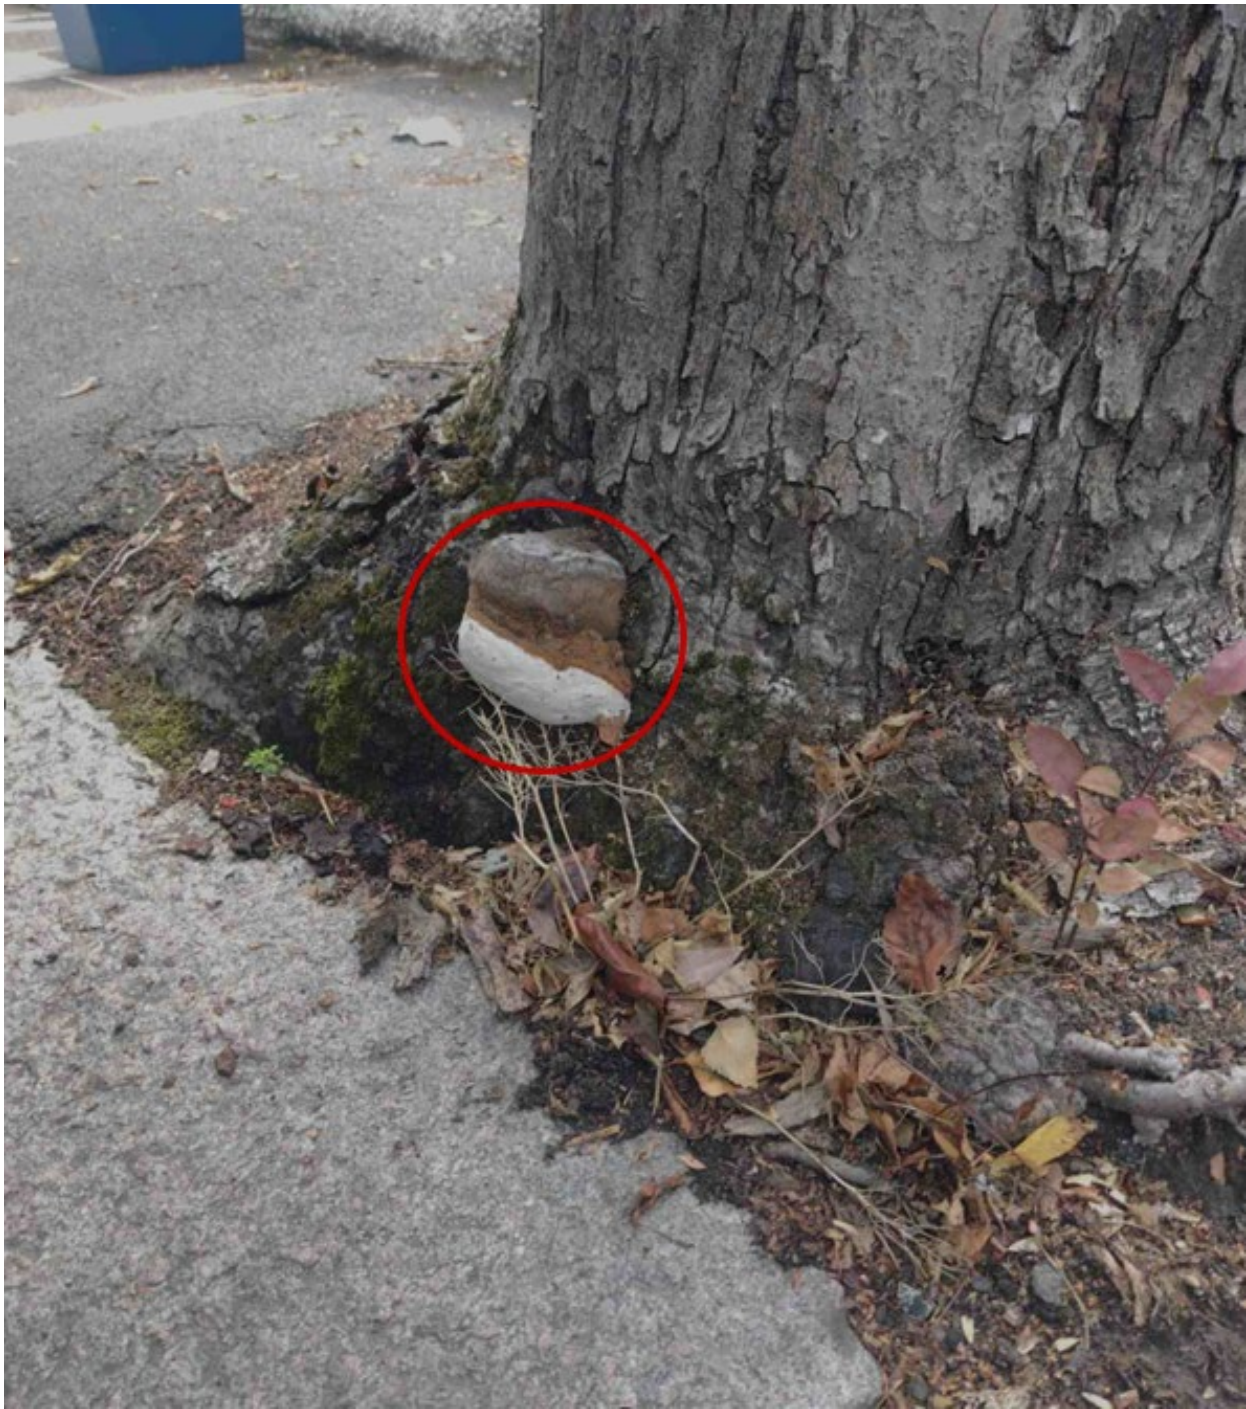
Image shows tree with location of fungal fruiting body circled

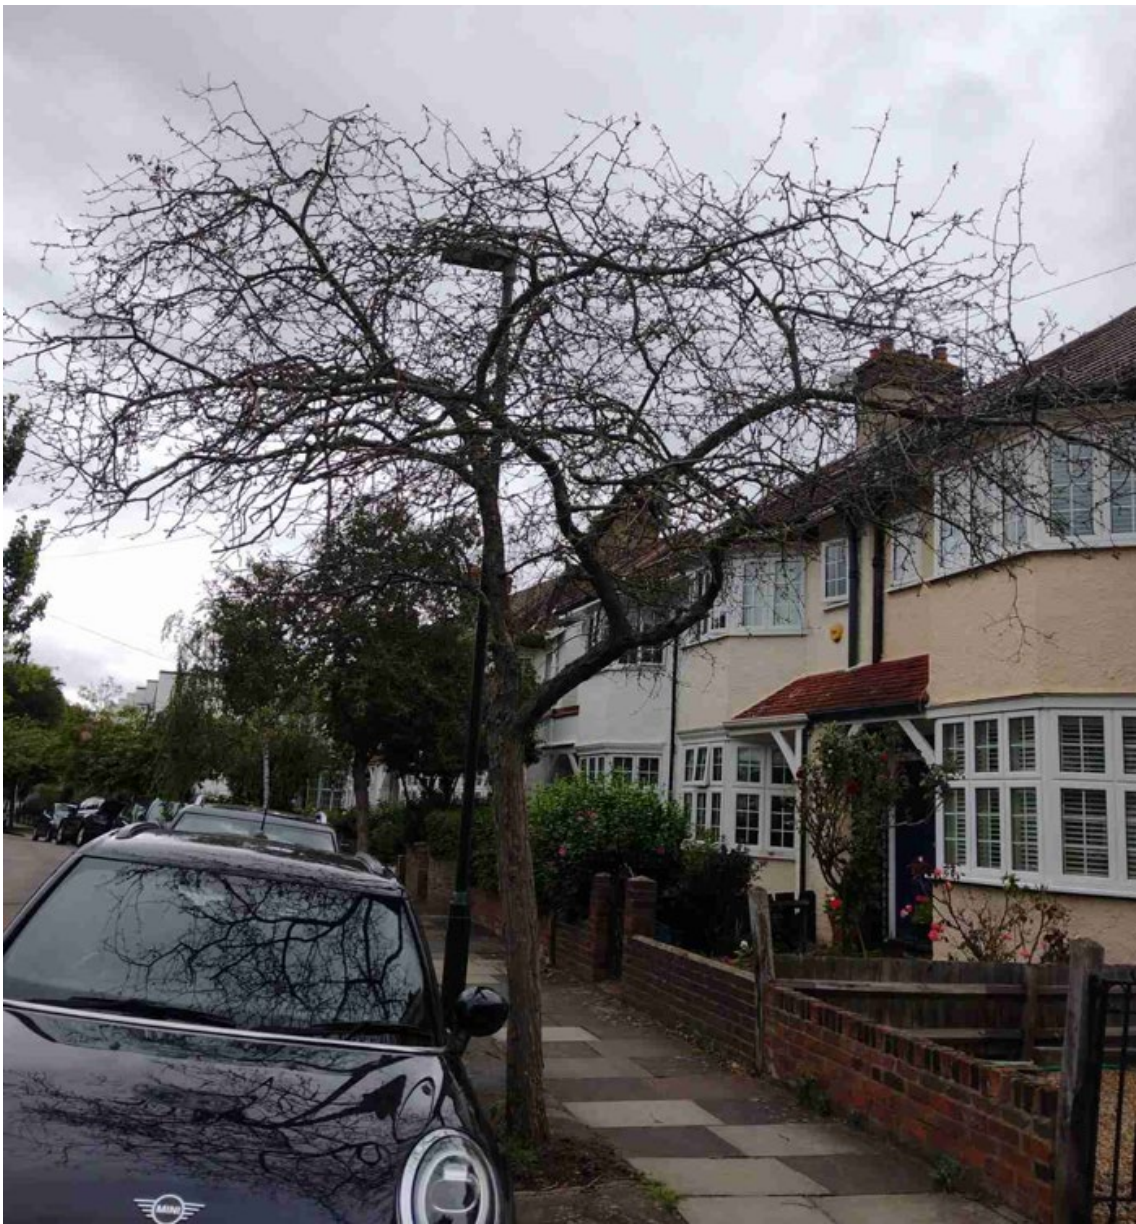
Ward	Mortlake and Barnes Common
Road	Shrewsbury Avenue
Location	Outside 2
Species	Crab Apple (<i>Malus sylvestris</i>)
Height	5.0m
Physiological Condition	Dead
Structural Condition	Dead
Inspection findings	This tree is dead; removal is required to prevent natural failure and facilitate replanting

Image shows dead tree in street scene.

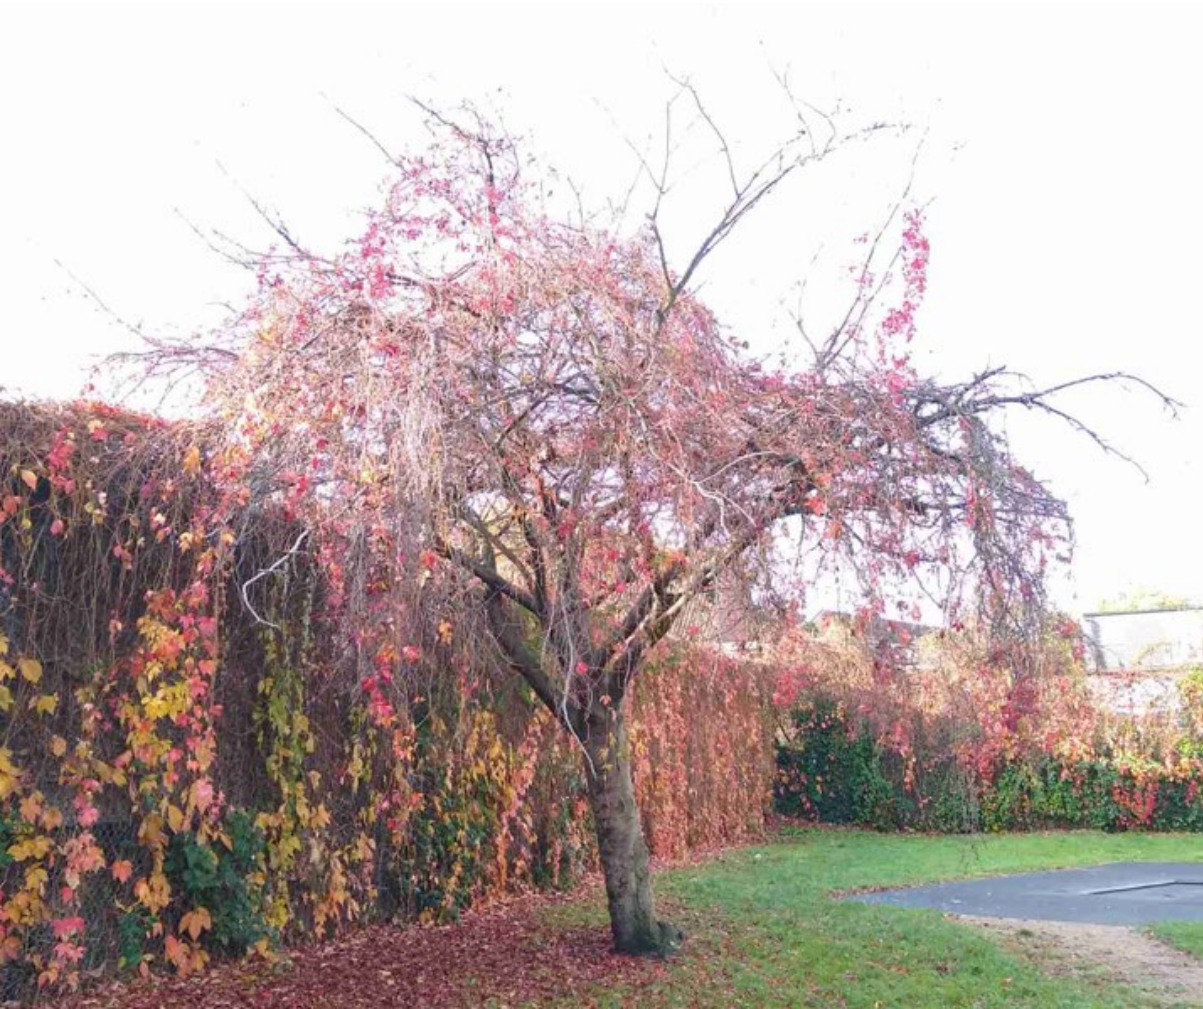
Ward	North Richmond
Road	Windham Road
Location	Raleigh Road Recreation Ground- ///What3Words-native.escape.worth
Species	Cherry (<i>Prunus sp.</i>)
Height	7.0m
Physiological Condition	Dead
Structural Condition	Dead
Inspection findings	This tree is dead; removal is required to prevent natural failure and facilitate replanting

Image shows dead tree in park scene.

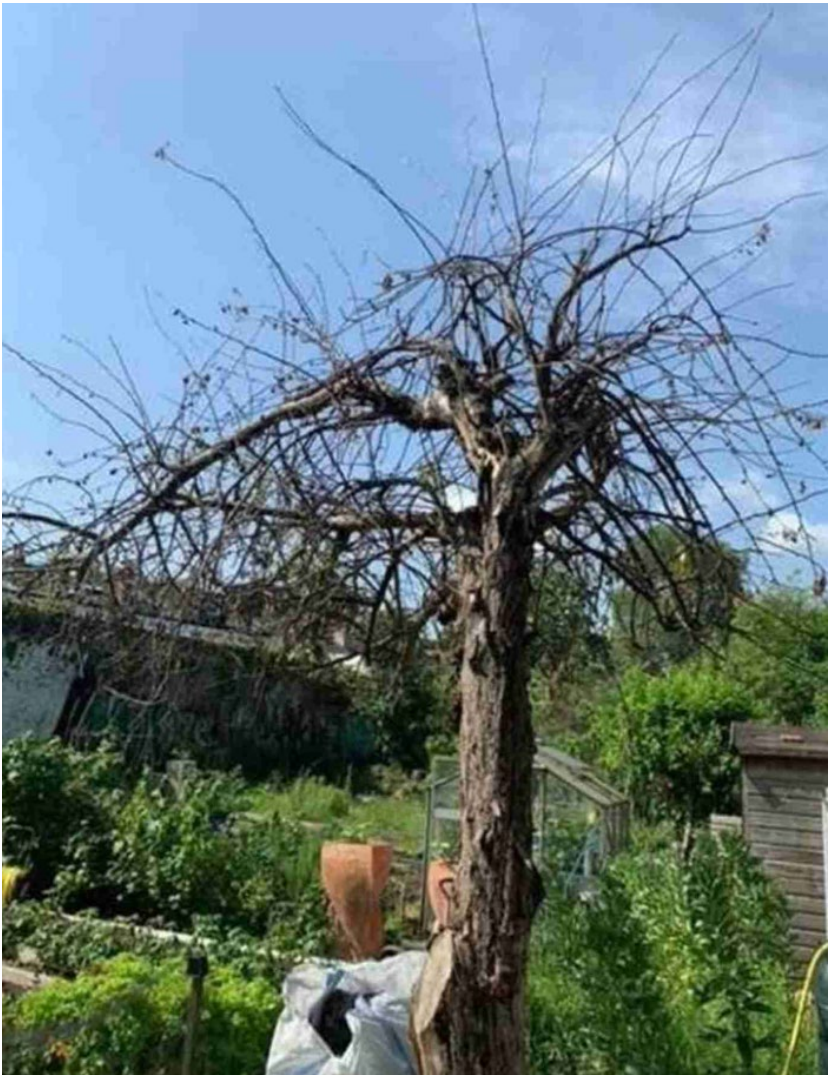
Ward	South Richmond
Road	Old Palace Lane
Location	Old palace lane allotments - Plot 11a behind 9 old palace lane What3Words-///hints.bunks.tour
Species	Apple (Malus sp.)
Height	5.0m
Physiological Condition	Dead
Structural Condition	Dead
Inspection findings	This tree is dead; removal is required to prevent natural failure and facilitate replanting

Image shows dead tree in allotment scene

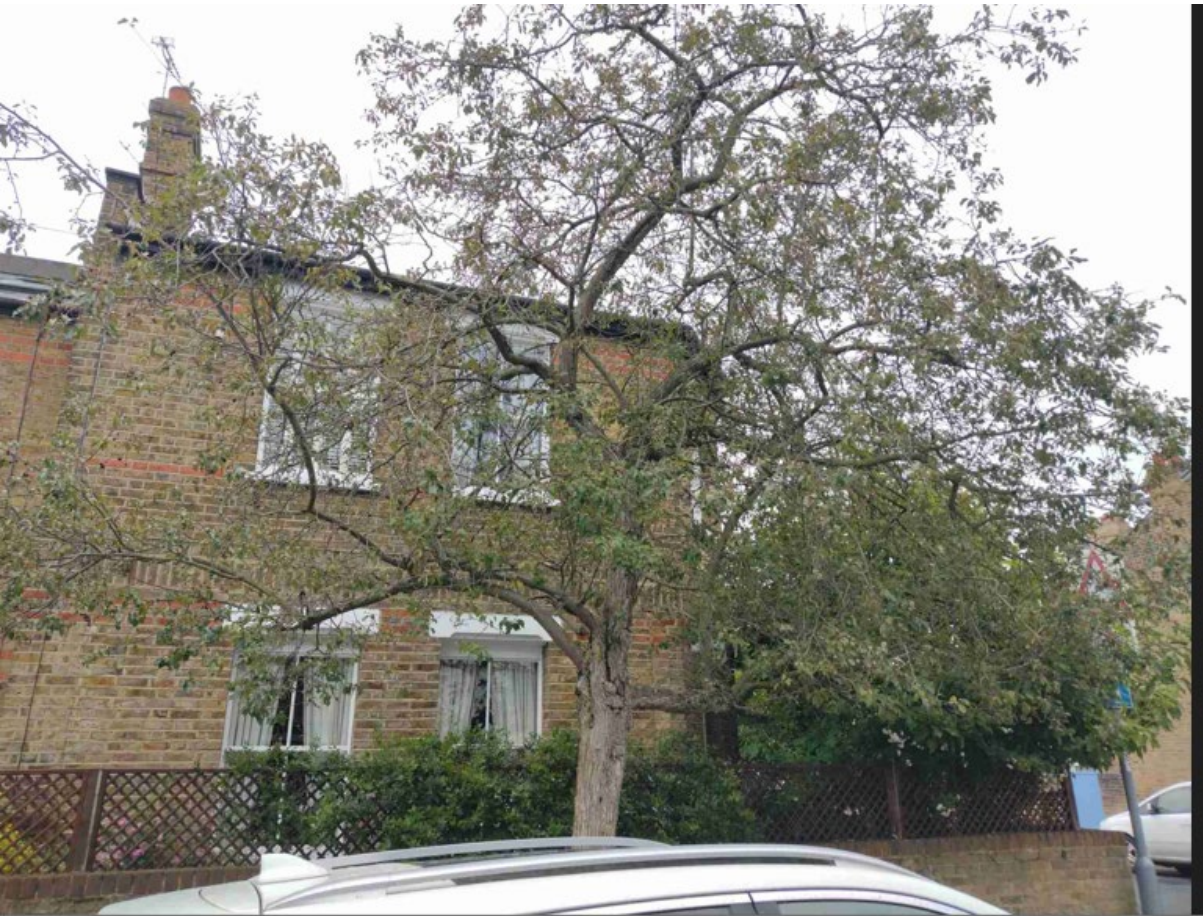
Ward	St Margarets and North Twickenham
Road	Winchester Road
Location	Outside 45
Species	Crab Apple (<i>Malus sp.</i>)
Height	7.0m
Physiological Condition	Poor
Structural Condition	Poor
Inspection findings	An emerging fungal fruiting body displaying characteristics of decay pathogen <i>Ganoderma</i> sp. is present at the stem base. Colonisation by this fungus causes a white rot of the stem and root system that can cause entire trees to collapse through fracture or windthrow. Crown dieback could correlate with the degradation of the trees structural or supporting root system. Removal of the tree is required to prevent natural failure and facilitate replanting

Image shows tree in street scene with decline to canopy evident.

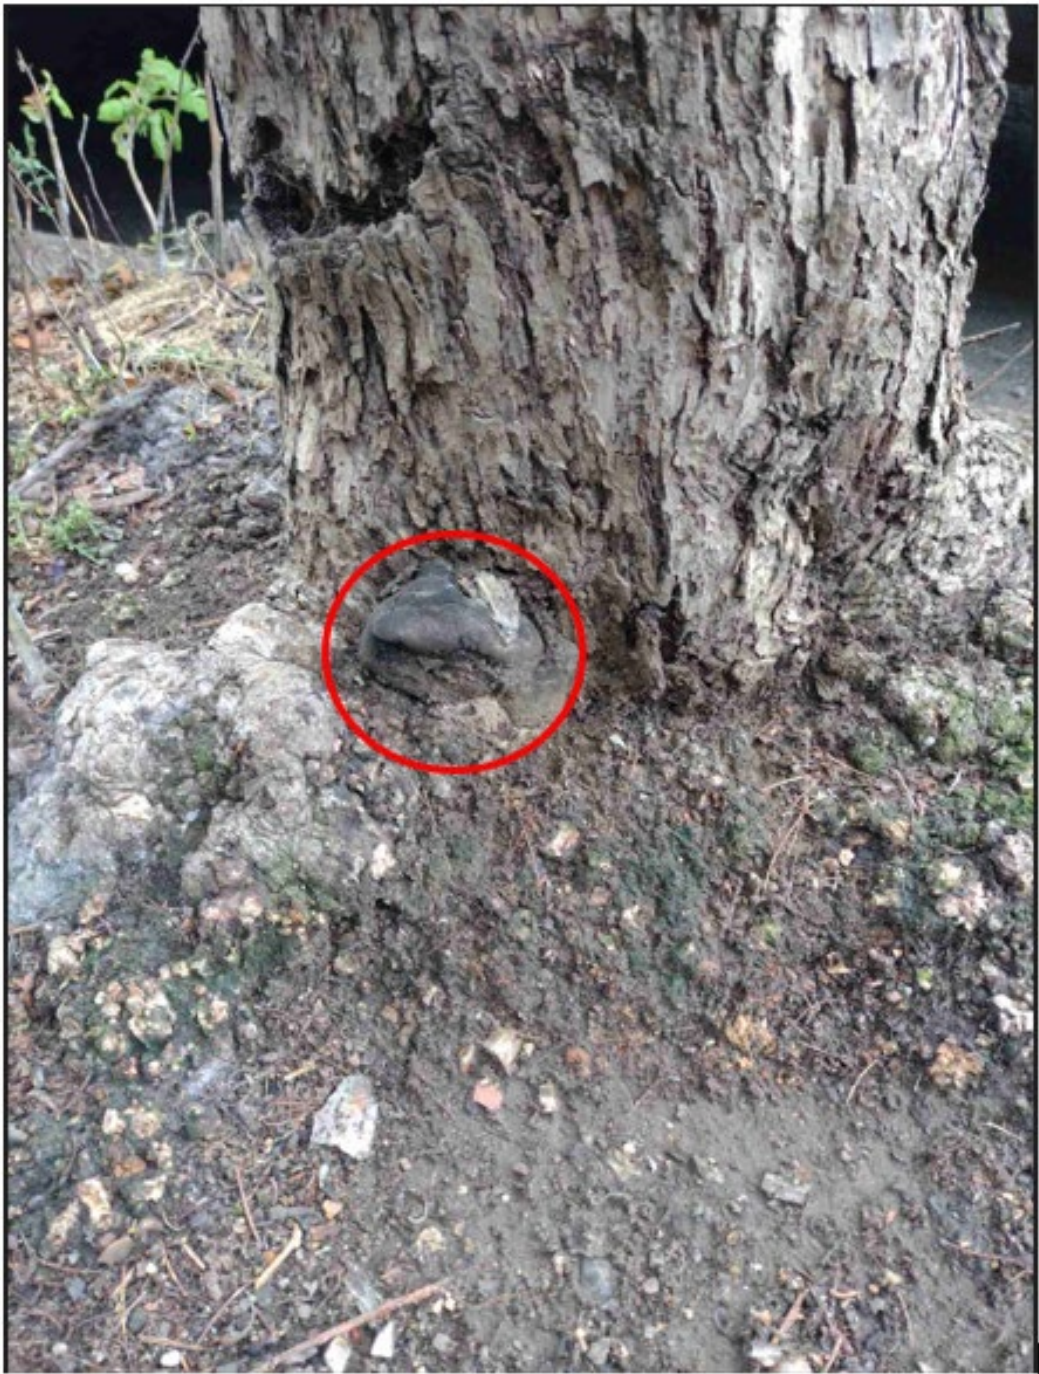
Image shows tree with location of fungal fruiting body circled

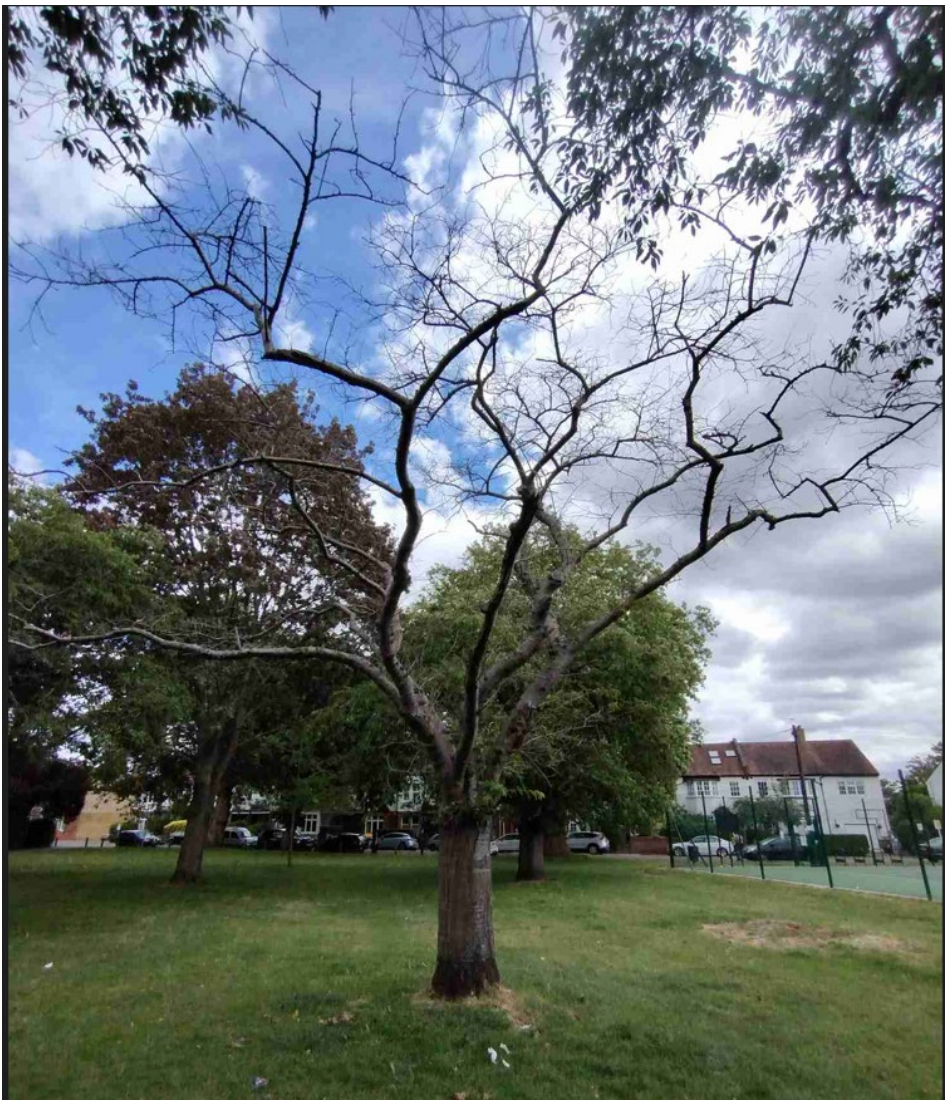
Ward	St Margarets and North Twickenham
Road	Moor Mead Road
Location	Moor mead Park- ///What3Words- swung.action.wacky
Species	Cherry (<i>Prunus sp.</i>)
Height	9.0m
Physiological Condition	Dead
Structural Condition	Dead
Inspection findings	This tree is dead, and removal is required to prevent natural failure and facilitate replanting

Image shows dead tree in park scene.
