Works Order 6000467 - Reactive Tree Works Programme

Recent reactive inspections have identified the need for 17 individual tree work operations to take place. This work will now be issued to the Council's Arborist Contractor KPS, for completion over the Autumn period.

The following pages provide the locations of each tree that is to be removed, in addition photographs and descriptions of the inspection findings have been provided.

12/10/2023

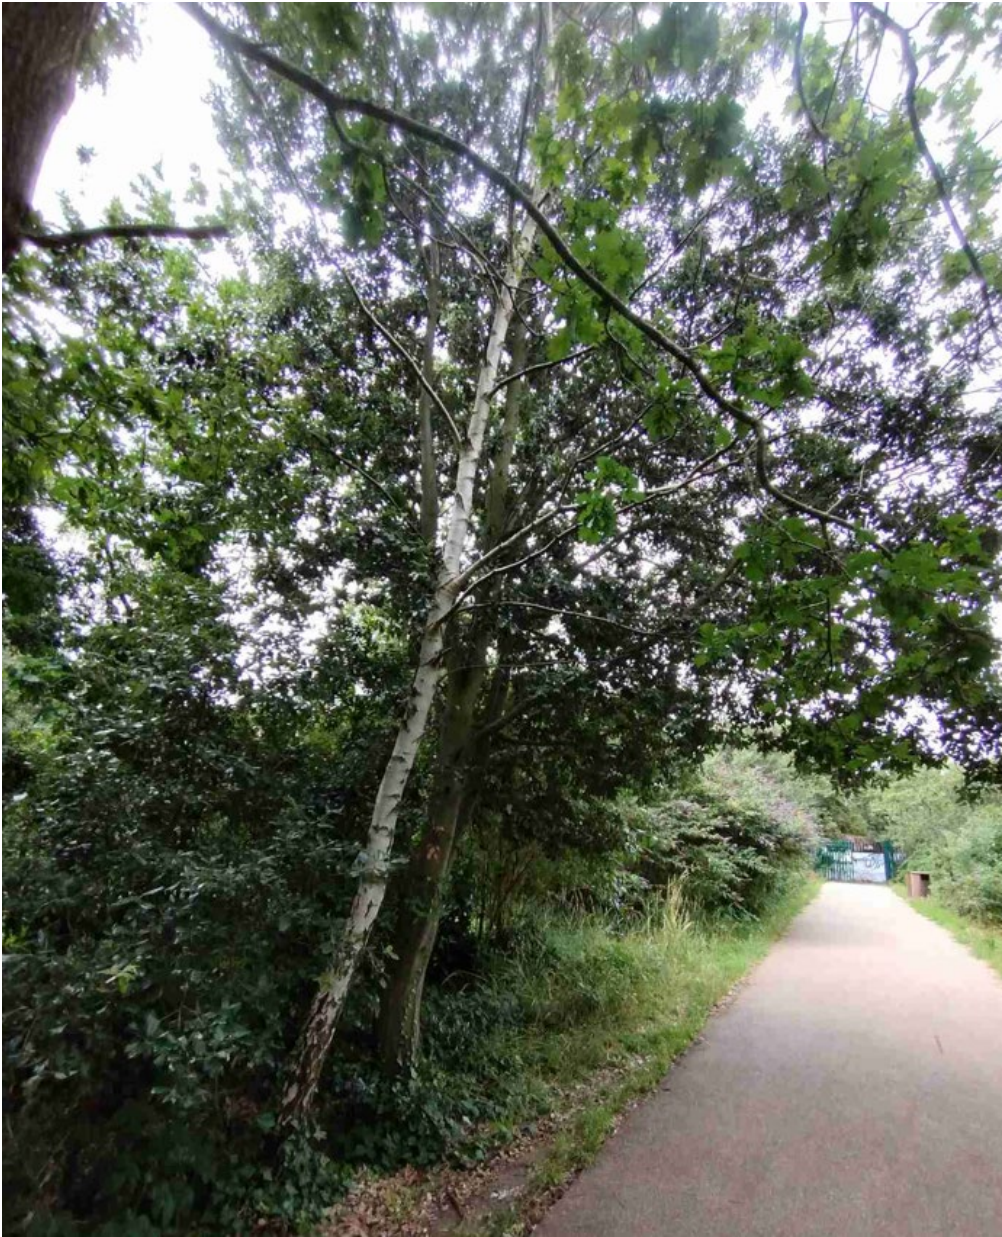
Ward	St Margarets and North Twickenham
Road	Marsh Farm Footpath
Location	///What3Words- slimy.jokes.takes
Species	Silver birch (<i>Betula pendula</i>)
Height	9.0m
Physiological Condition	Dead
Structural Condition	Dead
Inspection findings	This tree is dead, and removal is required to prevent natural failure and facilitate replanting

Image shows dead tree in park scene

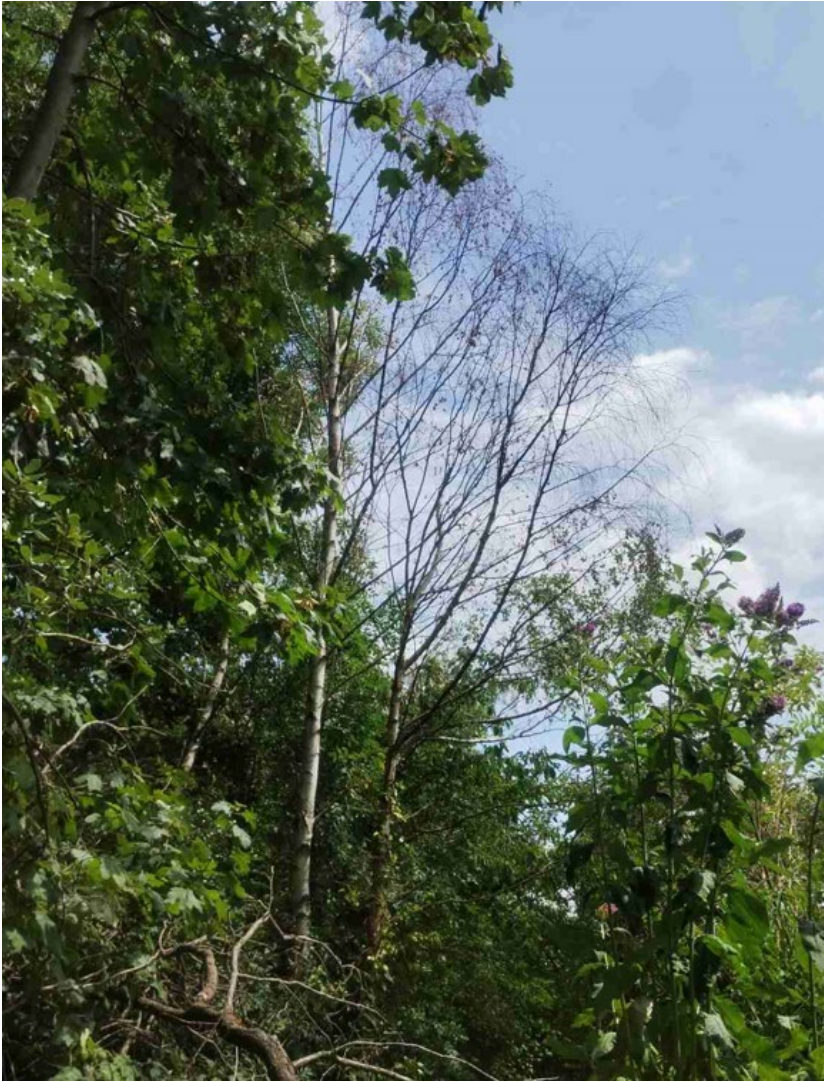
Ward	Twickenham Riverside
Road	Station Road
Location	On grass verge opposite Owen House- ///What3Words-nation.smashes.agree
Species	Deciduous Tree Group
Height	10.0m
Physiological Condition	Dead
Structural Condition	Dead
Inspection findings	These trees are dead, and removal is required to prevent natural failure and manage risk

Image shows dead tree in park scene

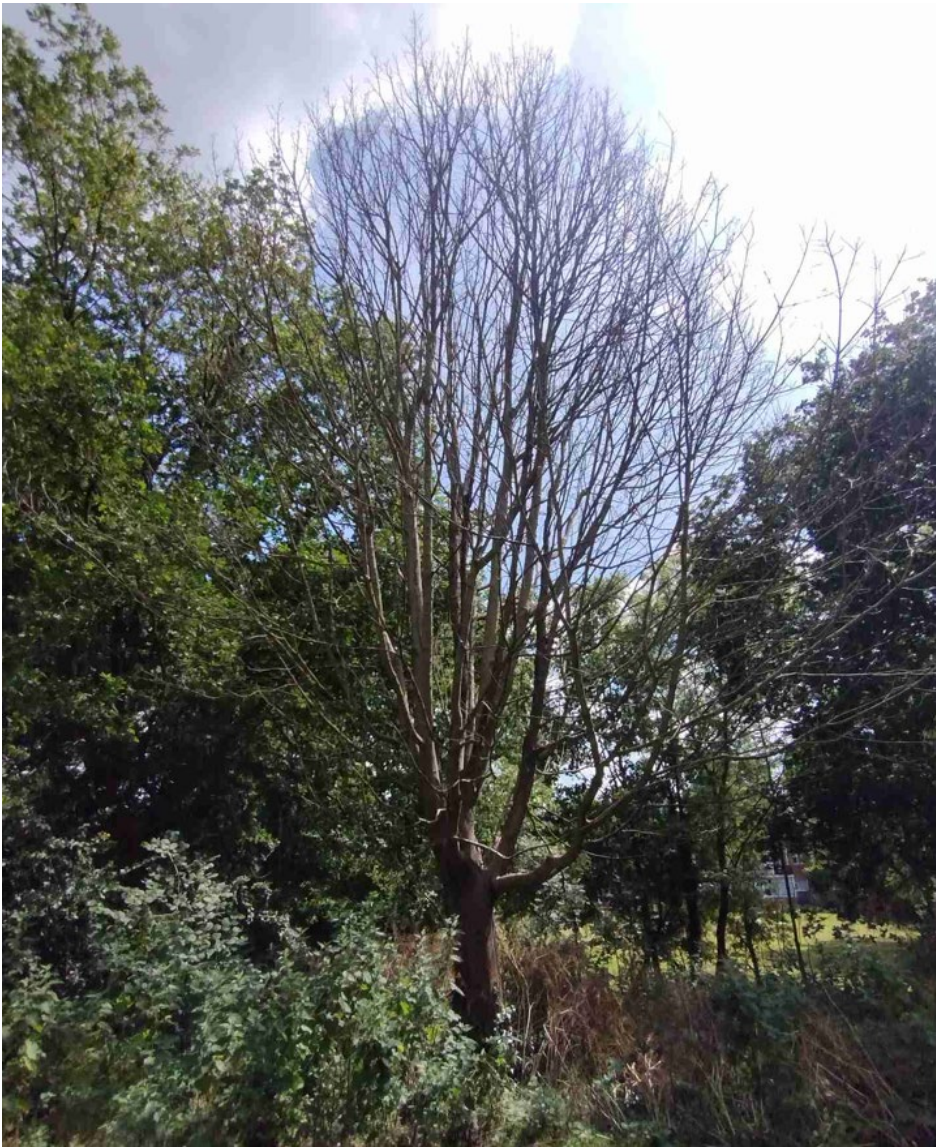
Ward	West Twickenham
Road	Meadway
Location	Crane Park - What3Words-///funded.payer.when
Species	Norway Maple (<i>Acer platanoides</i>)
Height	15.0m
Physiological Condition	Dead
Structural Condition	Dead
Inspection findings	This tree is dead, and removal is required to prevent natural failure and facilitate replanting

Image shows dead tree in park scene.

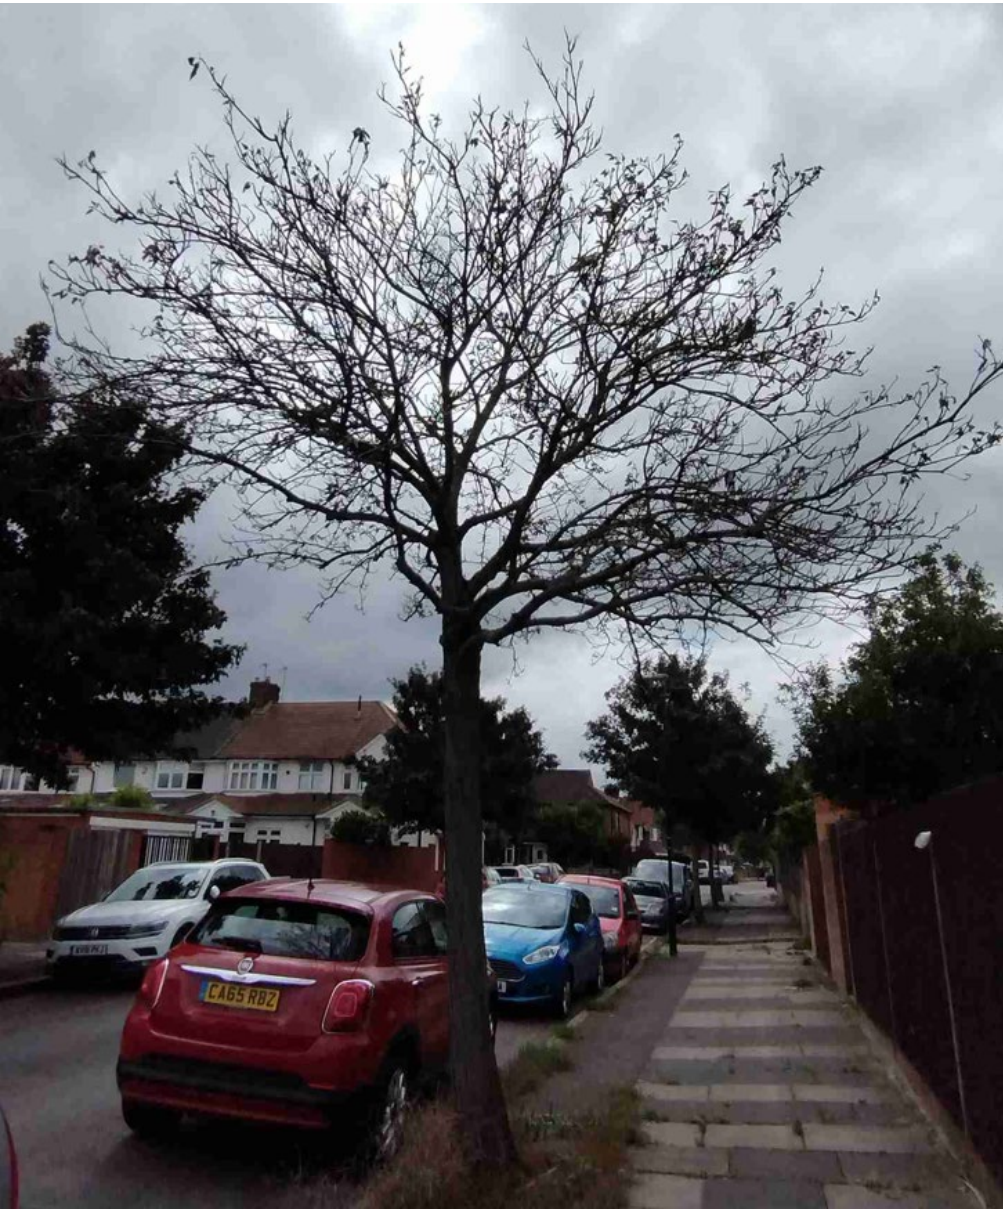
Ward	Whitton
Road	Redway Drive
Location	Adjacent to 85 Warren Road rear edge of building
Species	Whitebeam (<i>Sorbus aria</i>)
Height	6.5m
Physiological Condition	Dead
Structural Condition	Dead
Inspection findings	This tree is dead; removal is required to prevent natural failure and facilitate replanting

Image shows dead tree in street scene.

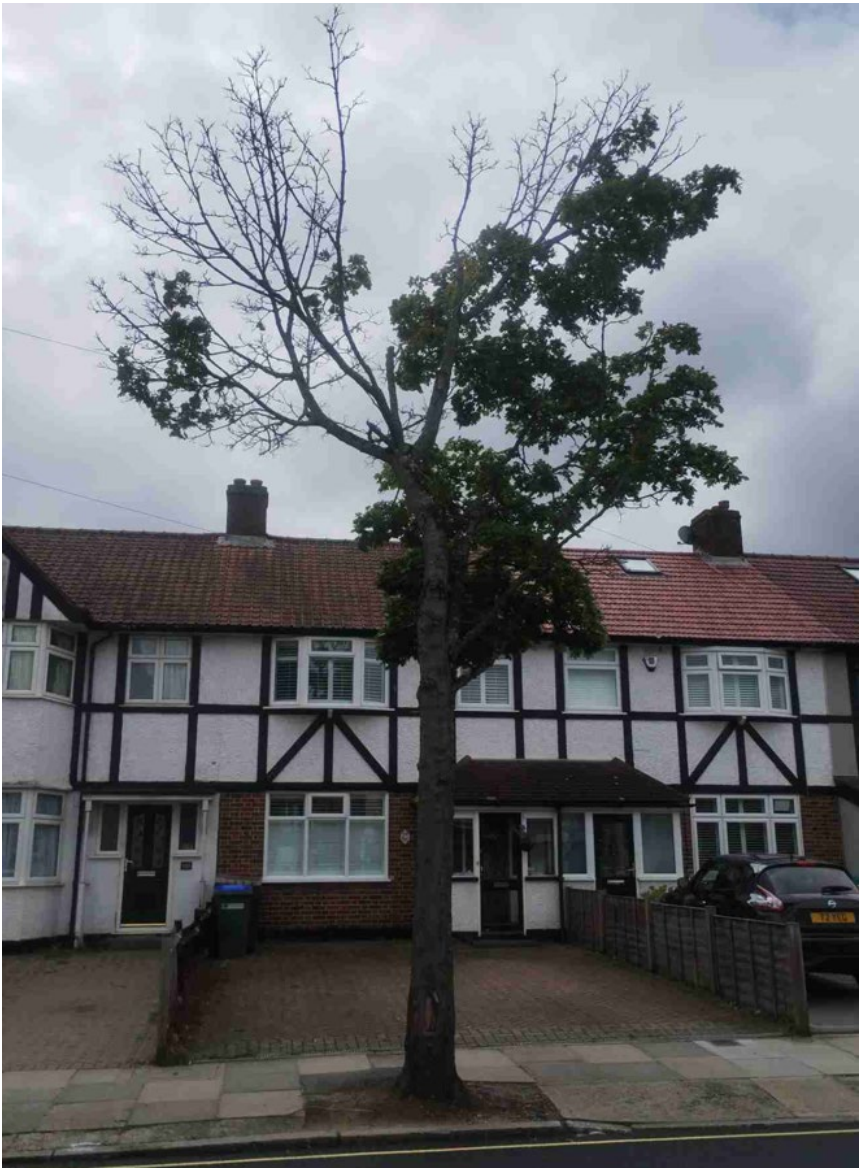
Ward	Whitton
Road	Warren Road
Location	Outside 125
Species	Norway Maple (<i>Acer platanoides</i>)
Height	8.5m
Physiological Condition	Poor
Structural Condition	Poor
Inspection findings	The Tree crown is displaying symptoms of an unacceptable level of physiological decline. This correlate with the Substantial wounding has occurred on the main trunk and associated bark/vascular necrosis has taken place. Removal is required to prevent natural failure and facilitate replanting

Images shows tree in street scene.

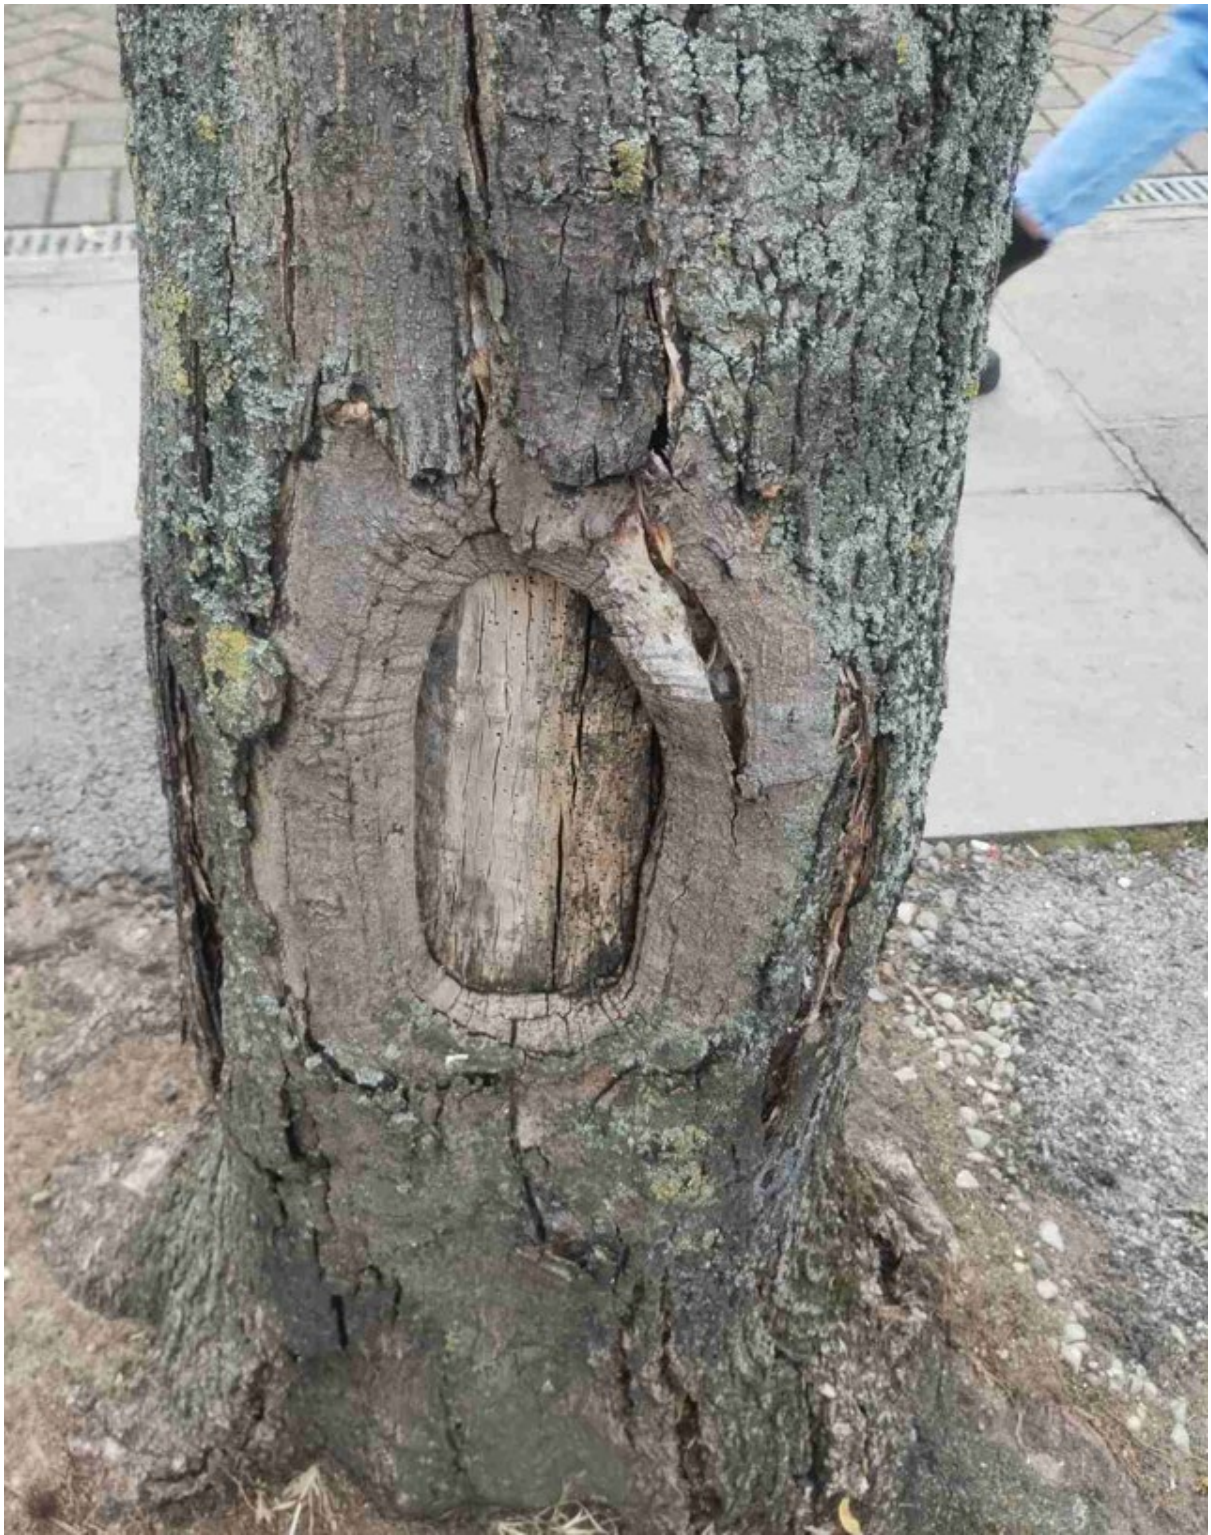
Images shows bark wound on trunk with delamination of bark around it.
