Elleray Hall and North Lane Car Park, Richmond upon Thames: An Archaeological Evaluation Report

Site Code: ERY22

AOC Project: 34437

Date: January 2024

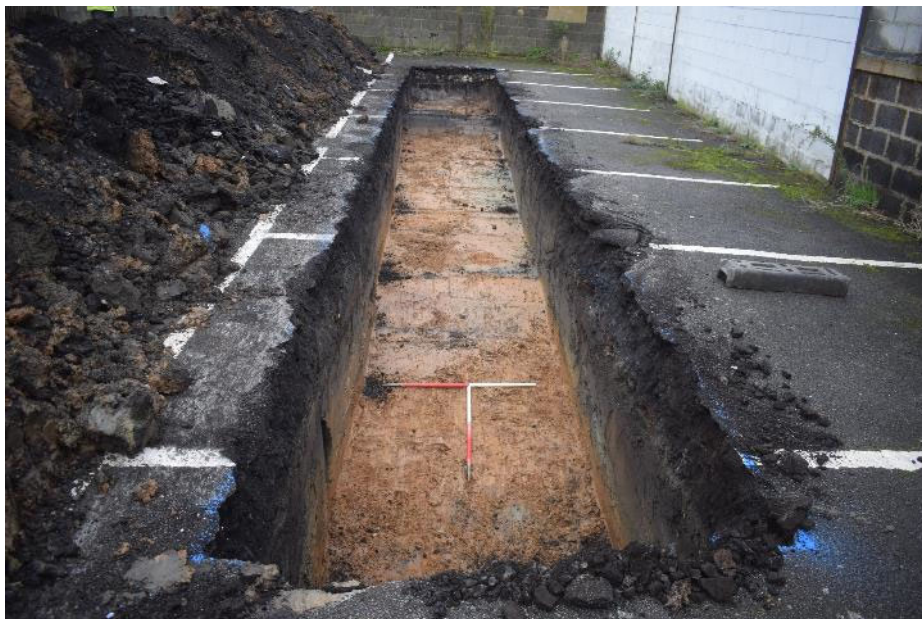
- 8.3. Trench 1 was located in the northeast extent of the site and measured 15m by 1.8m, it was orientated northwest to southeast (Figure 2, Plates 1 and 2).

Plate 1: Trench 1, looking north north-west.

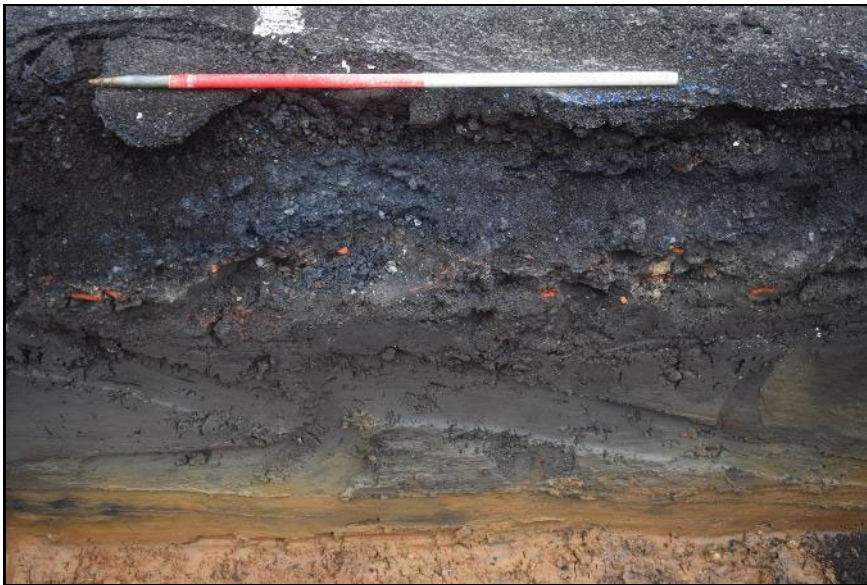
- 8.4. The lowest deposit was comprised of a friable, mid brown-yellow sandy clay with patches of mid grey clay and mid brown-red gravel (105), with a varying height of 7.51mOD and 8.04mOD. This has been

interpreted as a fine grain possible alluvial deposit with possible inclusions of Kempton Park Gravel Member. The natural (105), was overlain by (104), a 0.50m thick, friable dark grey-brown silty sand with some clay with inclusions of occasional CBM (ceramic building material) fragments and flecking. This layer maybe a dump of industrial by-product and used as made ground due to the colour and texture of the deposit. A complete late 19th century inkwell was recovered from this deposit.

- 8.5. Overlying (104) was (103), a 0.30m thick made ground layer composed of mid grey silty clay with modern CBM/tile fragments. This in turn was overlain by (102), a 0.20m thick black loose gravel bedding deposit for (101), a 0.10m thick layer of tarmac, which represents the sites most recent use as a car park.
- 8.6. No significant archaeological features or deposits were present in the trench. An out of service modern waste drain was identified and left in situ to avoid any contamination from residual waste.

Plate 2: Trench 1 sample section, looking northeast.

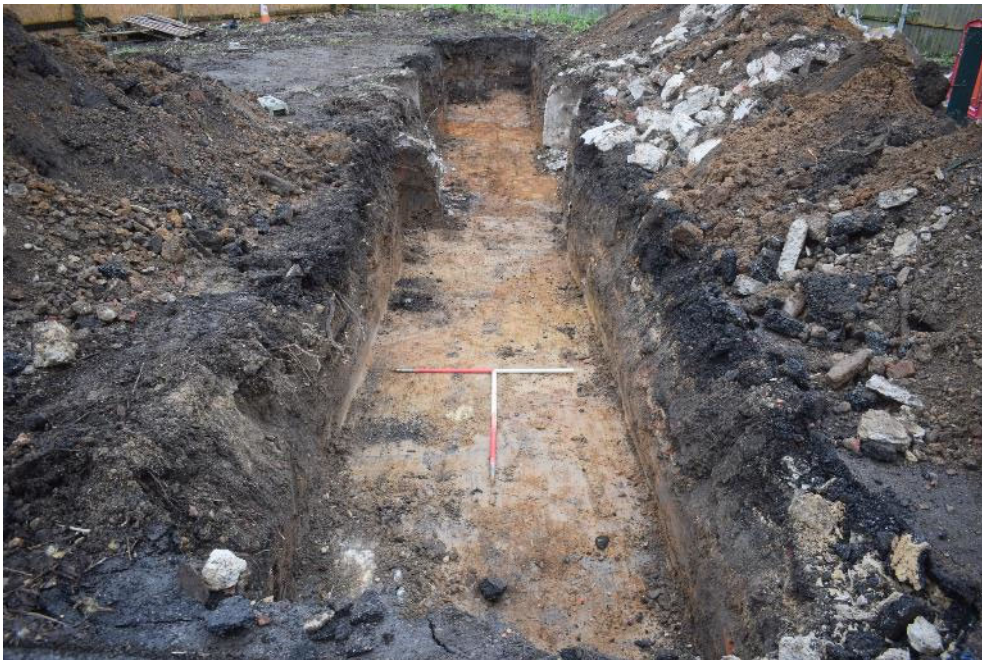
- 8.7. Trench 2 was located towards western extent of the site, measuring 15m by 1.80m, and was orientated northwest-southeast (Figure 2, Plates 3-6).

Plate 3: Trench 2, looking northwest

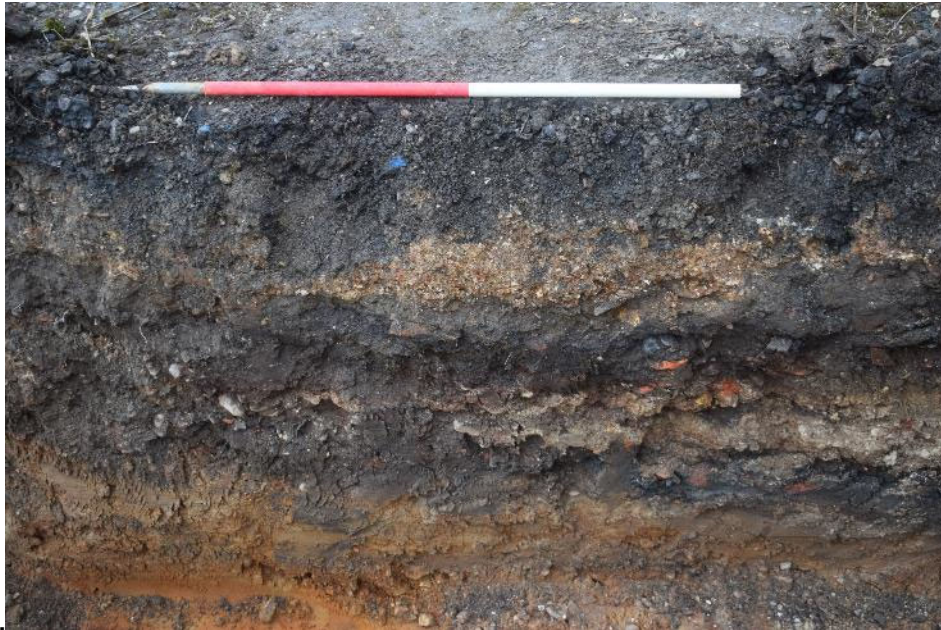
- 8.8. The lowest deposit was (208) comprised of a soft mid red brown to yellow brown sandy silty gravel recorded at between 7.32mOD and 7.89mOD. This has been interpreted to be part probably part of the Kempton Park Gravel Member sequence (Plates 3 and 4).
- 8.9. Overlying the above was a (207), a 0.10m thick layer of firm to friable light greyish-brown silty clay with occasional small CBM flecks. This has been interpreted as disturbed natural or redeposited natural.

Above (207), was a sequence of made ground deposits recorded as (203-206). The sequence is a mix of friable dark to light grey to yellow grey silty clay, with frequent small fragments of brick and tile, occasional small rounded stones, chalk, crushed chalky sandy mortar and industrial material debris. These represent ground raising and levelling activity.

Plate 4: Trench 2 sample section, looking southwest.

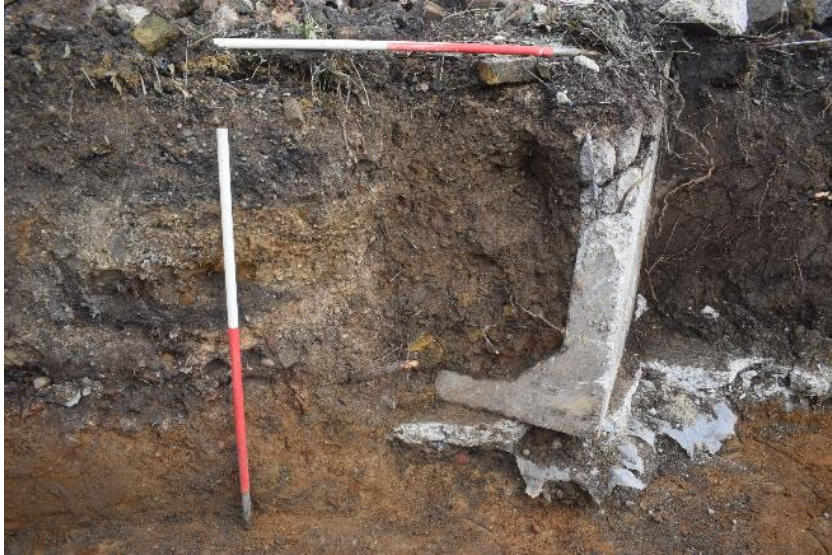
- 8.10. Cutting into the sequence of made ground layers were a series of concrete structures which are likely related to the previous council depot maintenance garage which formerly occupied the site. The cut [214], contained one backfill deposit (209), measuring 1.20m thick and comprised of a friable mid greyish-brown silty clay with frequent angular gravels, occasional CBM fragments and rare glazed white and blue/black pottery sherds.

- 8.11. In the base of the trench was part of a concrete slab or floor recorded as [211]. The slab or floor was poured onto a thick layer of plastic membrane and measured 4.0m x 2.40m x 0.15m to 0.47m thick. On top of the base was a number of prefabricated reinforced concrete structures [210], with the most expose section measuring 1.15m x 0.70m and 0.14m thick (Plate 5). The concrete structure located in the northern section (Plate 5), did not appear to be in situ and might have been moved from its original location during demolition. It is possible that this structure formed an inspection chamber in a larger semi basement chamber, as a drain was located nearby and recorded as [212]. The drain [212], measured 0.95m x 0.95m and 0.58m thick and was formed of red brick, measuring 230mm x 70mm x 110mm, mortared with sharp sand mortar. The drain appeared to have a chalk in fill (213) as well as (215), a dark grey sandy silt with plastic, glass and polystyrene (Plate 6). The drain sat in cut [217] with backfill in the cut (216), a grey sandy gritty silty clay with large fragments of brick and tile.

Plate 4: Modern concrete structure in Trench 2, looking northeast.

- 11.2. Concrete and brick remains of a structure were observed and recorded in Trench 2 and are likely part of the council depot, perhaps a semi basement.

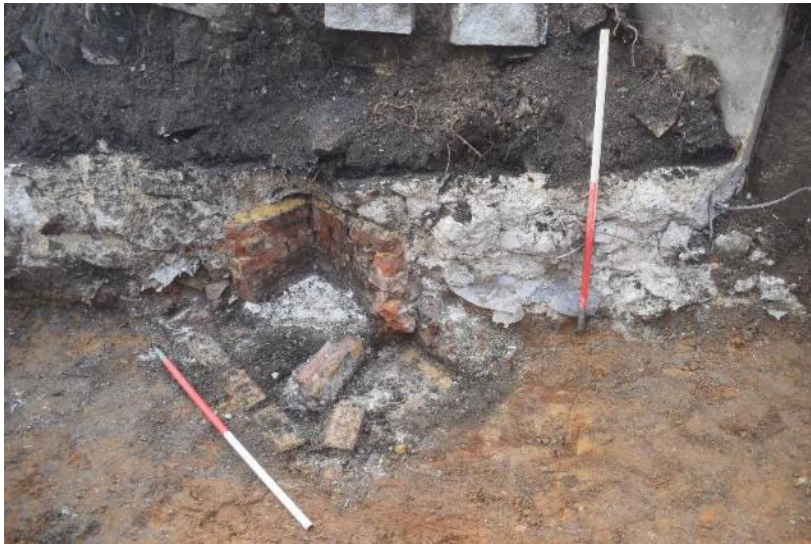
Plate 6: Modern brick and concrete structures in Trench 2, looking southwest.

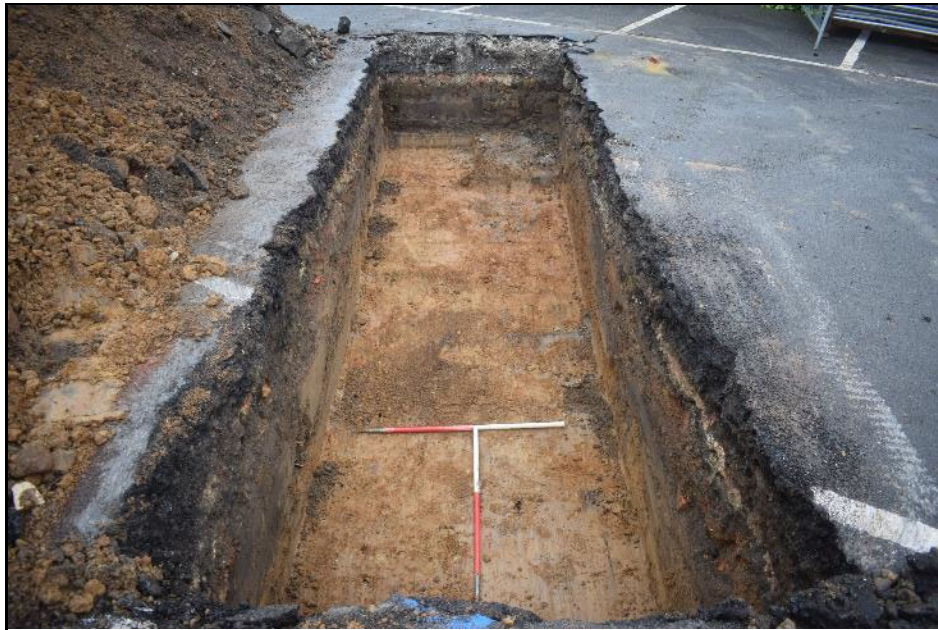
- 8.14. Trench 3 was located towards the southeastern extent of site, measuring 7m by 1.80m and was orientated northeast to southwest (Figure 2; Plates 7 and 8).

Plate 7: Trench 3, looking northeast.

- 8.15. The lowest deposit in Trench 3, comprised of a friable mid brown-yellow sandy clay with patches of grey clay and mid brown-red gravel (305), with a varying height of 7.57mOD and 8.01mOD. This has been interpreted to be part of the Kempton Park Gravel Member sequence with a possible alluvial clay deposit (Plates 7 and 8).

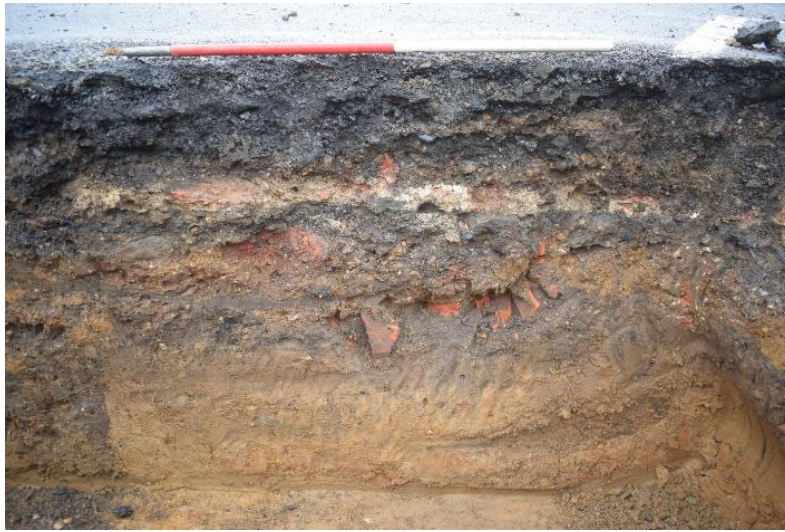
- 8.16. Overlying (305) was (304), a 0.20m thick layer of friable dark grey-brown silty clay with occasional CBM fragments and flecking and very occasional subangular to sub-rounded small stones. This has been interpreted as possibly disturbed natural, probably disturbed during the levelling activity of the site observed in overlying deposit (303), a 0.40m thick made ground deposit, formed of patchy and mixed deposits of friable grey silty clay with frequent small fragments of tile and brick CBM, mortar, occasional small rounded stones and industrial material debris.

- 8.17. Overlying the above was (302), a 0.20m thick layer of black gravel base for a 0.10m thick layer of tarmac (301), which represents the recent car park. A 1870-1880 Ginger beer or lemonade bottle was recovered from deposit (302).

Plate 5: Trench 3 sample section, looking southeast.

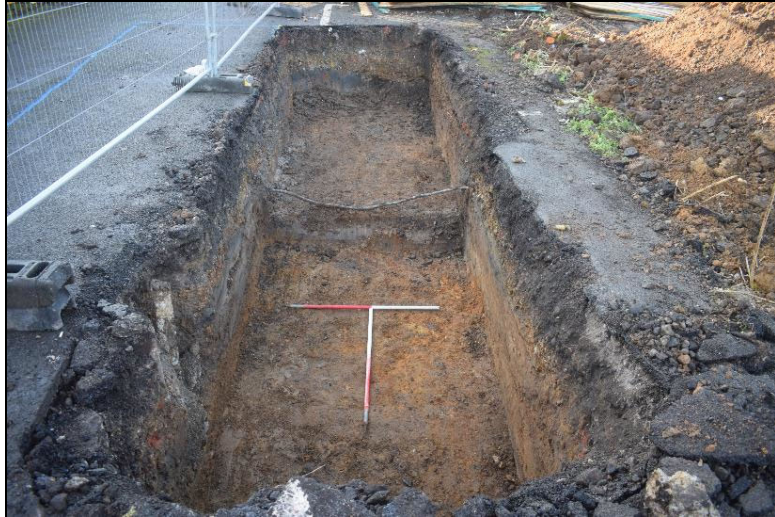
- 8.19. Trench 4 was located towards the southwestern extent of site, measuring 7m by 1.80m and was northeast to southwest orientated (Figure 2, Plates 8 and 9).

Plate 6: Trench 4, looking southwest.

- 8.20. The lowest deposit observed in Trench 4 was (405), a friable mid brown-yellow sandy clay with patches of mid grey clay and mid brown-red gravel, with a varying height of 7.45mOD to 7.58mOD. This has been interpreted to be part of the Kempton Park Gravel Member sequence with possible alluvial clay, (Plates 6 and 7).
