RIVER RESTORATION SUCCESS AT PEVENSEY-LITTLE PARK

RESTORATION MEASURES: In 2023, twenty-seven wood deflectors were installed along 500 m of the River Crane at Little Park.

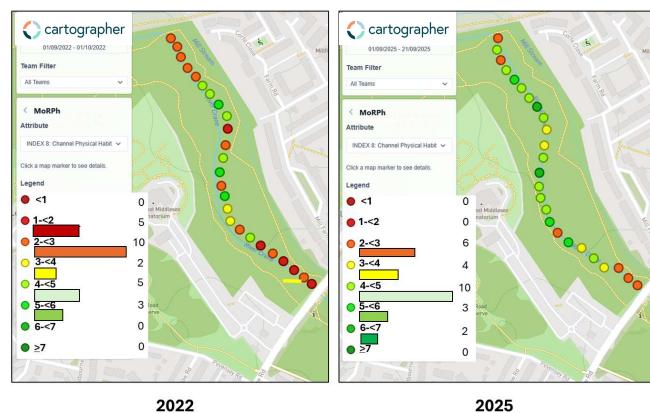
INDEX OF CHANNEL BED PHYSICAL HABITAT COMPLEXITY

There have been notable improvements in physical habitat complexity in virtually all of the 20m long reaches surveyed using MoRPh. These improvements are observed on the channel bed and also on the (riparian) bank faces and bank tops.

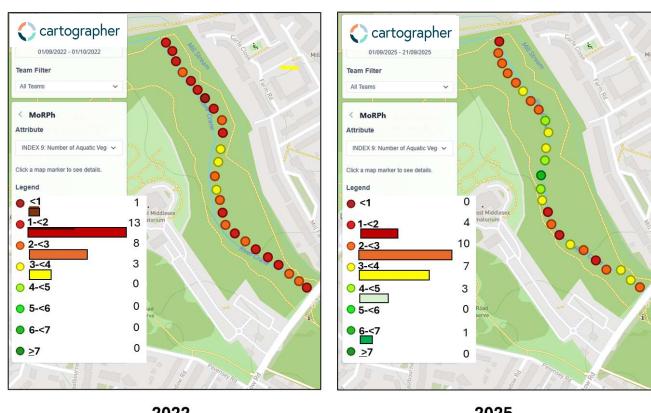
THE NUMBER OF AQUATIC PLANT MORPHOTYPES

The good news is that changes in physical habitat have been accompanied by an increase in the number of types of aquatic plant growing along the channel margins.

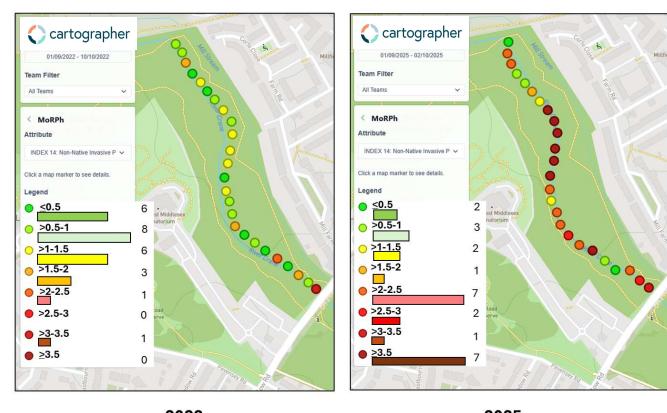
INDEX OF NNIPS INVASION SEVERITY

The not so good news is of a change that has not been directly caused by the restoration: an invasion of the bank tops, bank faces and in-channel bars by Himalayan balsam – a Non-native Invasive Plant Species (NNIPS). Fortunately, Himalayan balsam is a relatively straightforward NNIPS to control.
