Hammersmith Bridge

Engineering & Programme Overview

Grade II* Listed Structure

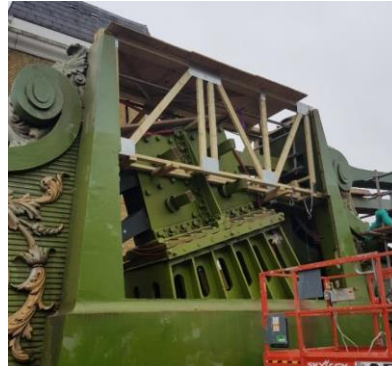
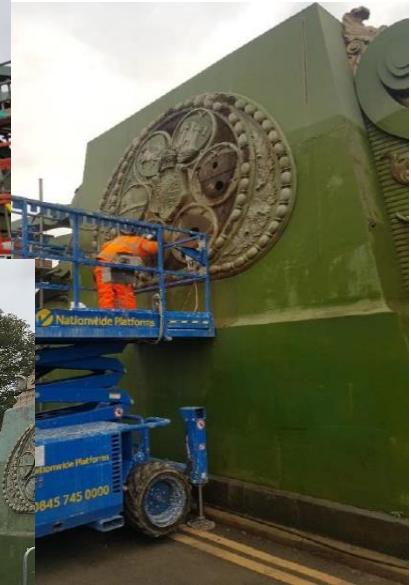
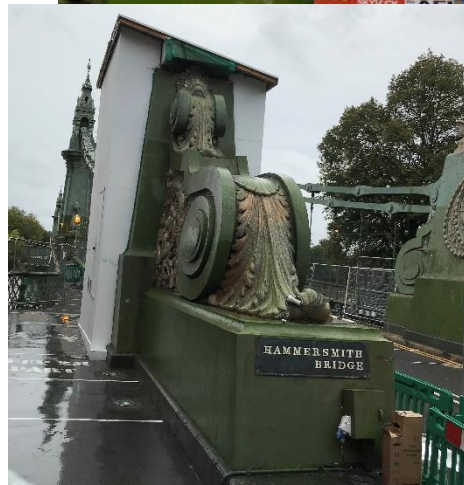
- Can't be sure of identifying all cracks until paint has been removed by blast cleaning.
- Have to temporarily remove decorative cast iron casings
- When removed from N.E pedestal new cracks were found (April 2019), triggering closure of bridge to vehicular traffic.
- Crack growing in N.E pedestal in Aug 2020 triggered complete closure.
- Now need to do the clean and inspect the NW and SW pedestals - 4 months duration.
- Also installing a temporary Temperature Control System to reduce risk of further damage caused by extreme temperatures.

- 137 year old aging structure with the immediate problem that the bearings have seized.
 - Seizure has resulted in lateral forces acting on the pedestals and towers which they were never designed to take.
 - Cracks have been found in all cast iron pedestals
 - These are not the only challenges, some 17 major defective elements need addressing before the bridge can be fully opened.
-

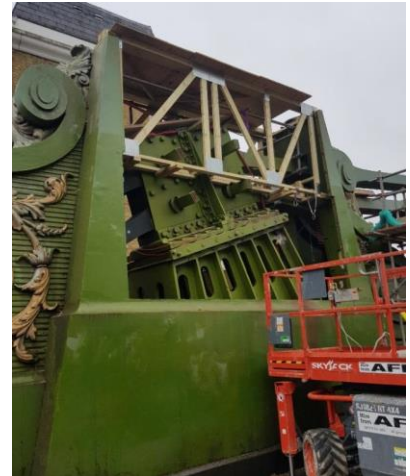
Emergency Stabilisation by External Frame

- Installing External frame allows the cracked pedestals to be by-passed providing temporary stabilisation to the bridge structure.
- This would allow us to install temporary bearings.
- Pedestrians will be able to use the bridge for a finite period whilst frames are in position.
- Prior to site works commencing the following must be completed:
 - Legal agreements
 - Tendering
 - Planning approvals
- **Overall Duration** - 7 months
- **Estimated Cost** - £13.9m
- Programme and costs subject to review & tender return
