# **Towpath – Champions Wharf to Railshead Road and Ham to Chiswick Bridge felling document**

## Introduction

Dated 18.9.2023

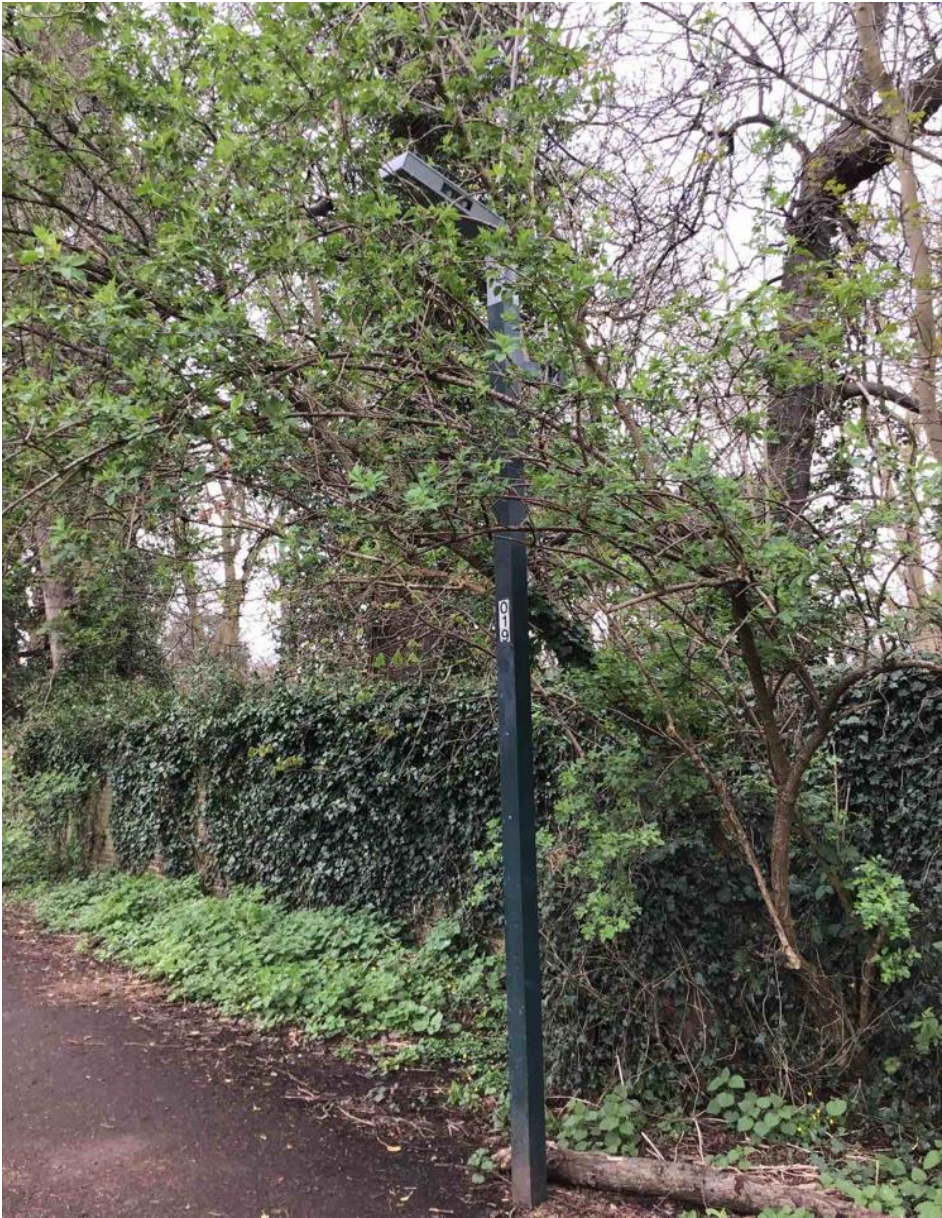
Ward	Twickenham Riverside
Road	Warren Footpath
Location	Thames Towpath – W3W - bother.flute.glitz
Species	Elder ( <i>Sambucus nigra</i> )
Height	6.0m
Physiological Condition	Good
Structural Condition	Fair
Inspection findings	This tree is growing against the wall and obstructing the streetlighting; the location is unsuitable, and removal is required

Image shows tree growing against wall and obstructing lighting.

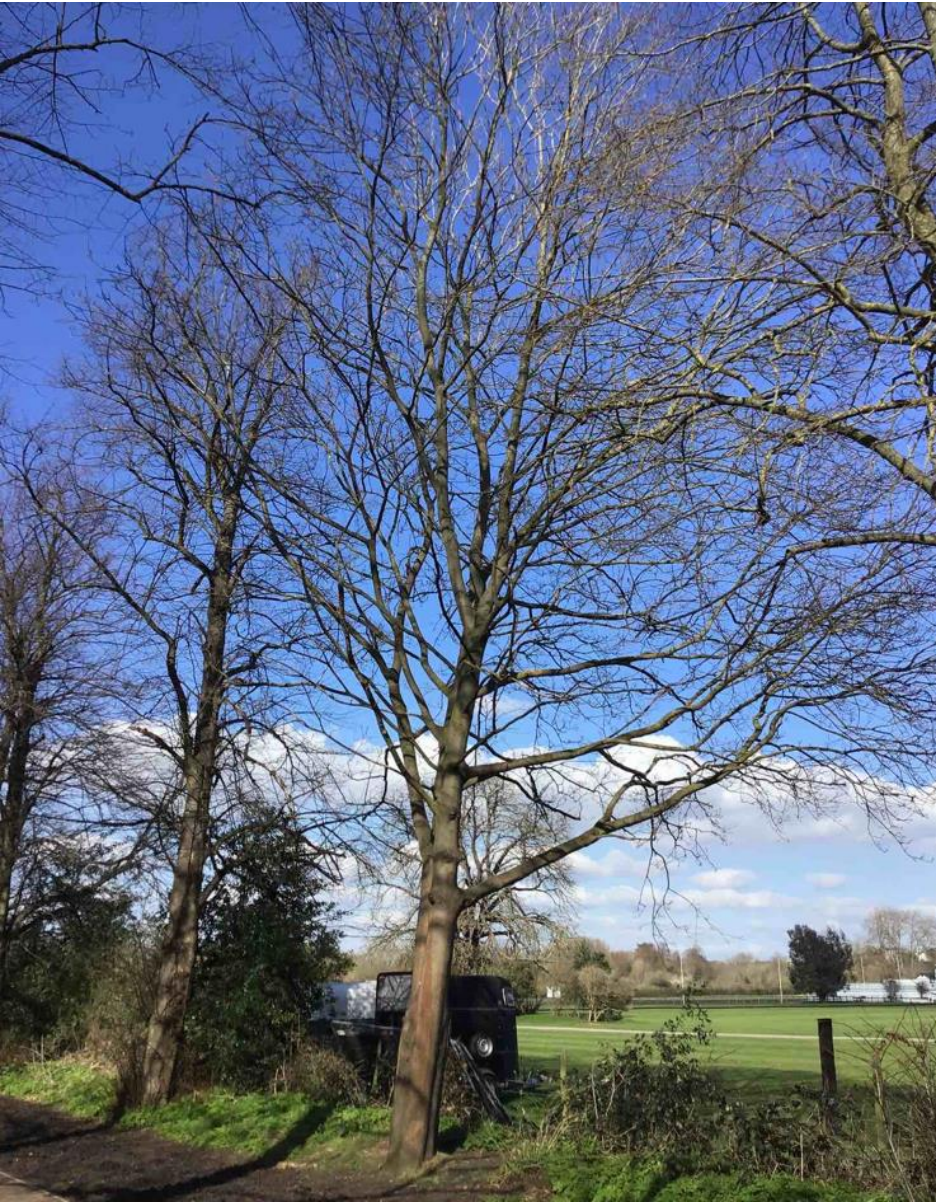
Image shows tree in good physiological condition

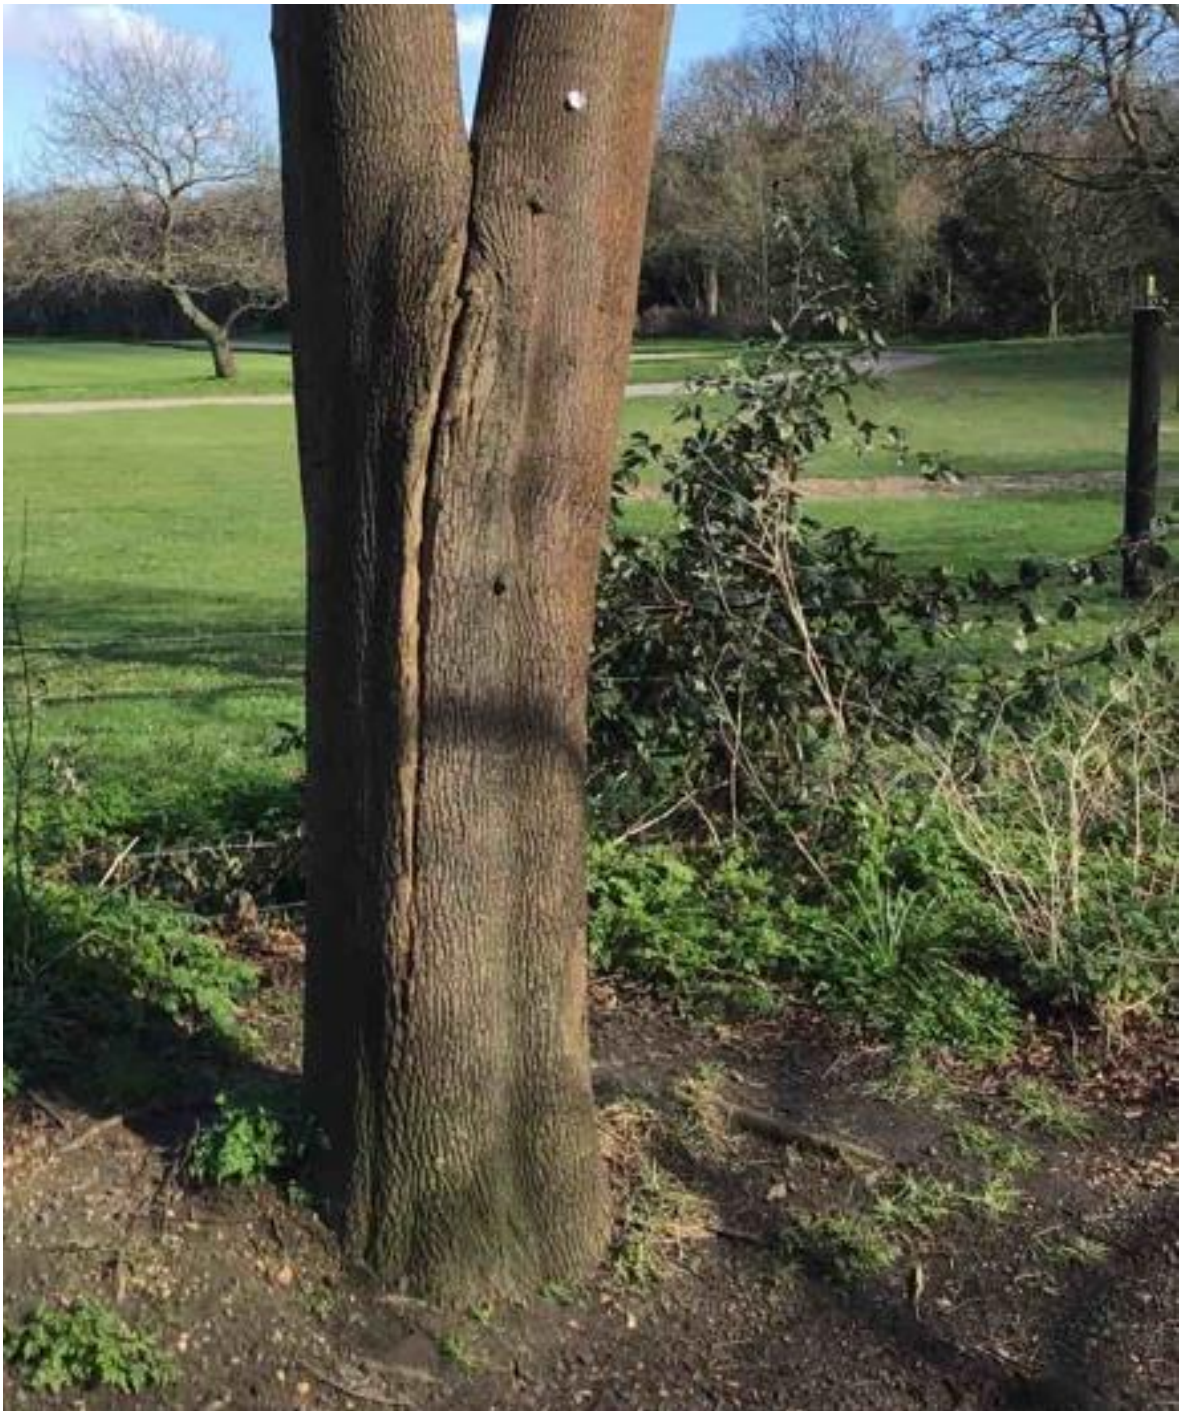
Ward	Ham, Petersham and Richmond Riverside
Road	Ham Avenues
Location	Melancholy Walk
Species	Norway Maple ( <i>Acer platanoides</i> )
Height	17.0m
Physiological Condition	Good
Structural Condition	Poor
Inspection findings	This tree has a wide mouthed bark included union in the main stem. This feature is a weak form of branch union that is a point for failure to occur from; the tree presents an unacceptable risk of harm and removal is required to mitigate this.

***Image shows main stem with split below first union.***

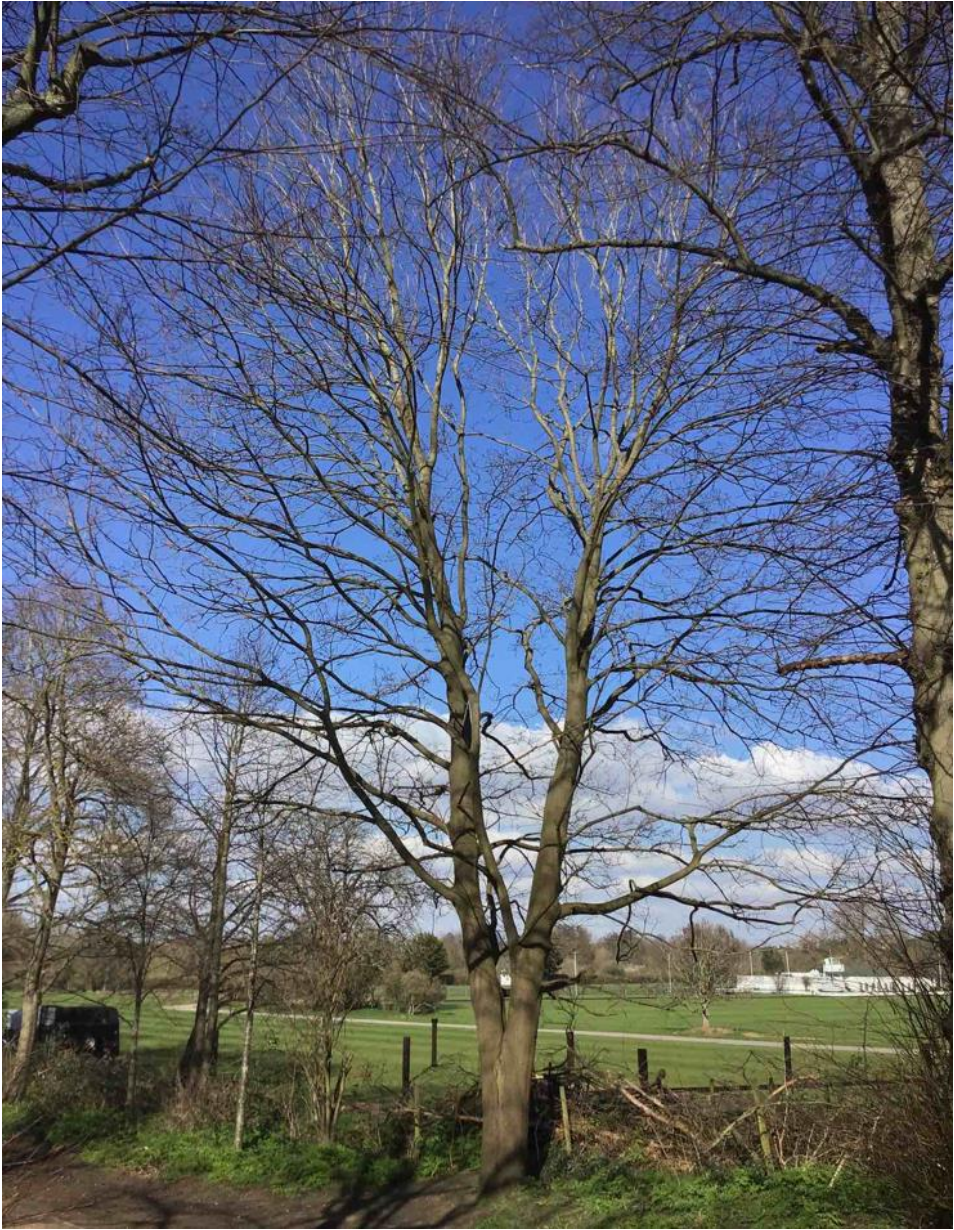
Image shows tree in good physiological condition

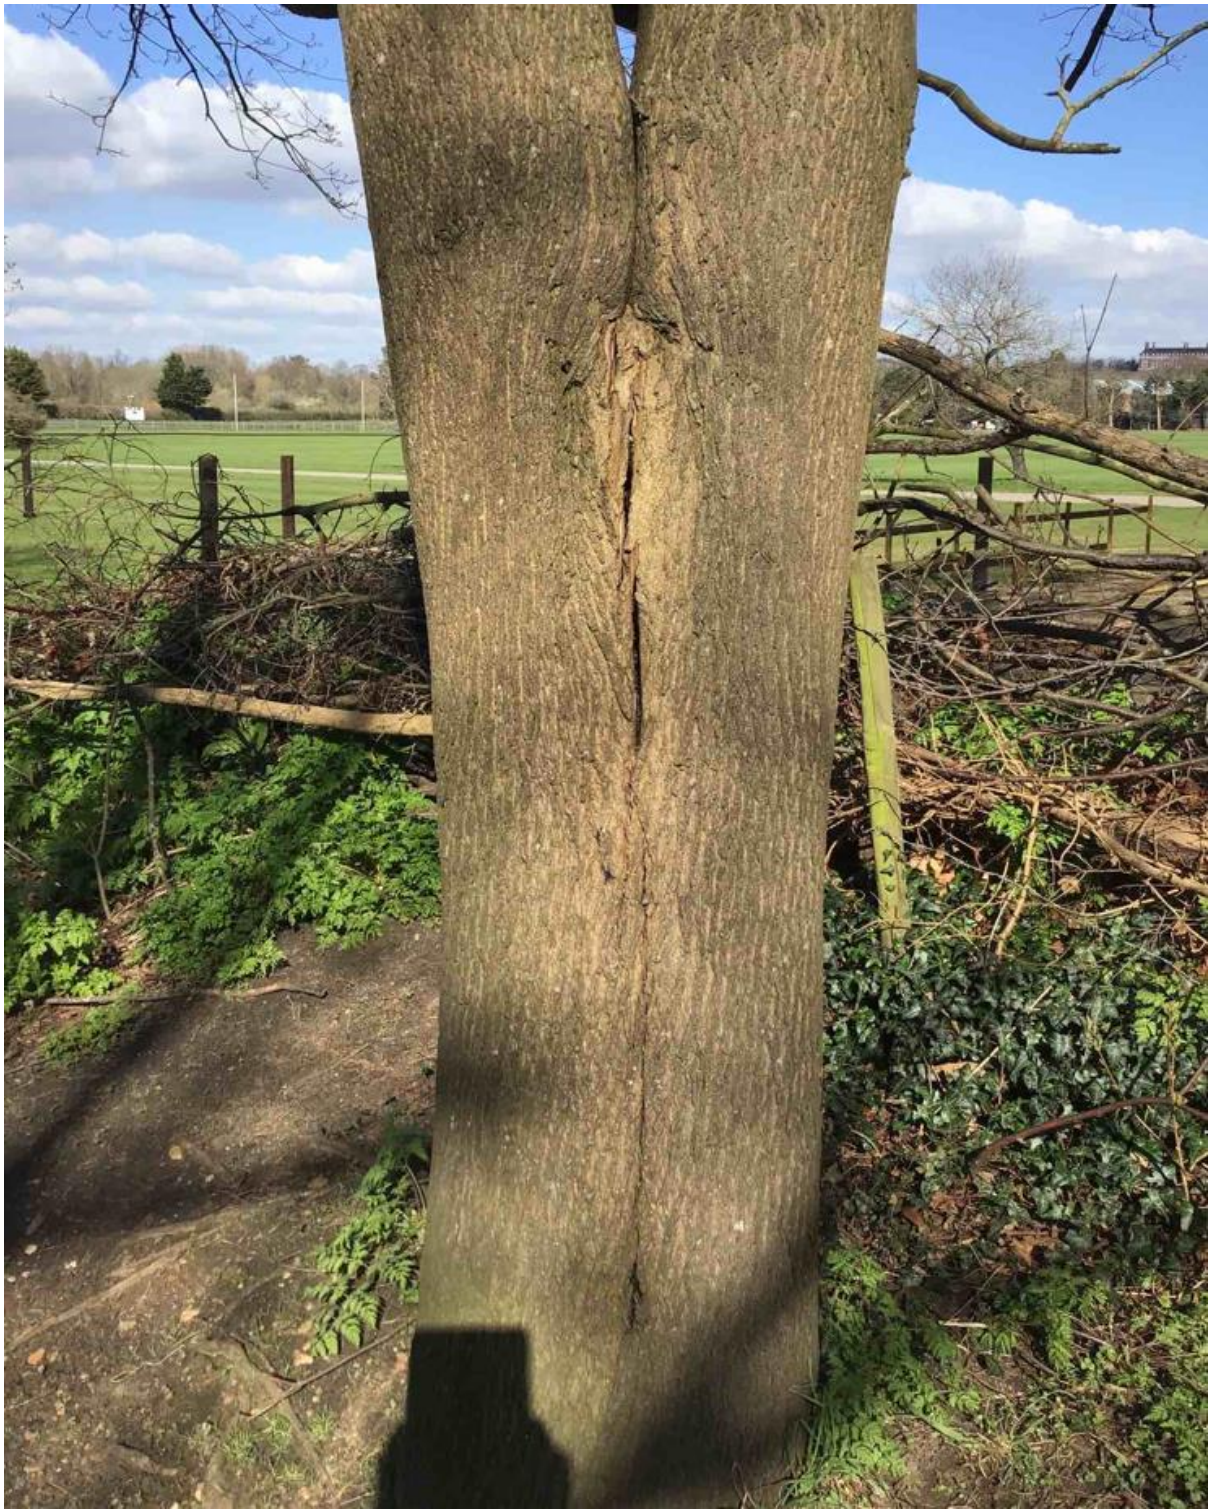
Ward	Ham, Petersham and Richmond Riverside
Road	Ham Avenues
Location	Melancholy Walk
Species	Norway Maple ( <i>Acer platanoides</i> )
Height	15.0m
Physiological Condition	Good
Structural Condition	Poor
Inspection findings	This tree has a wide mouthed bark included union in the main stem. This feature is a weak form of branch union that is a point for failure to occur from; the tree presents an unacceptable risk of harm and removal is required to mitigate this.

***Image shows main stem with split below first union.***

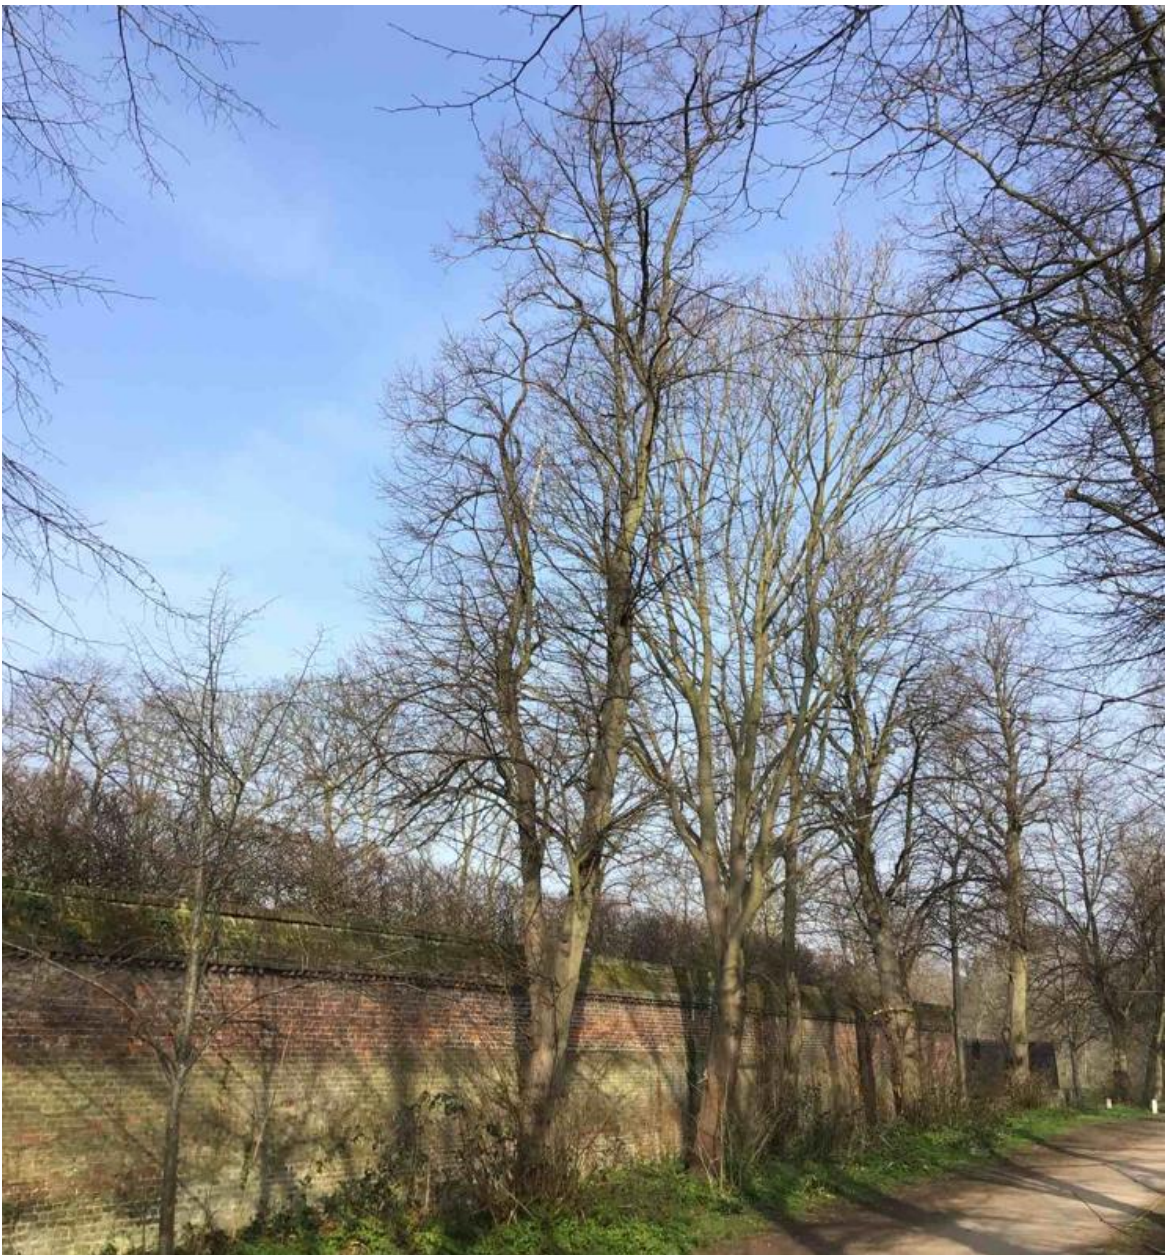
Image shows tree in good physiological condition

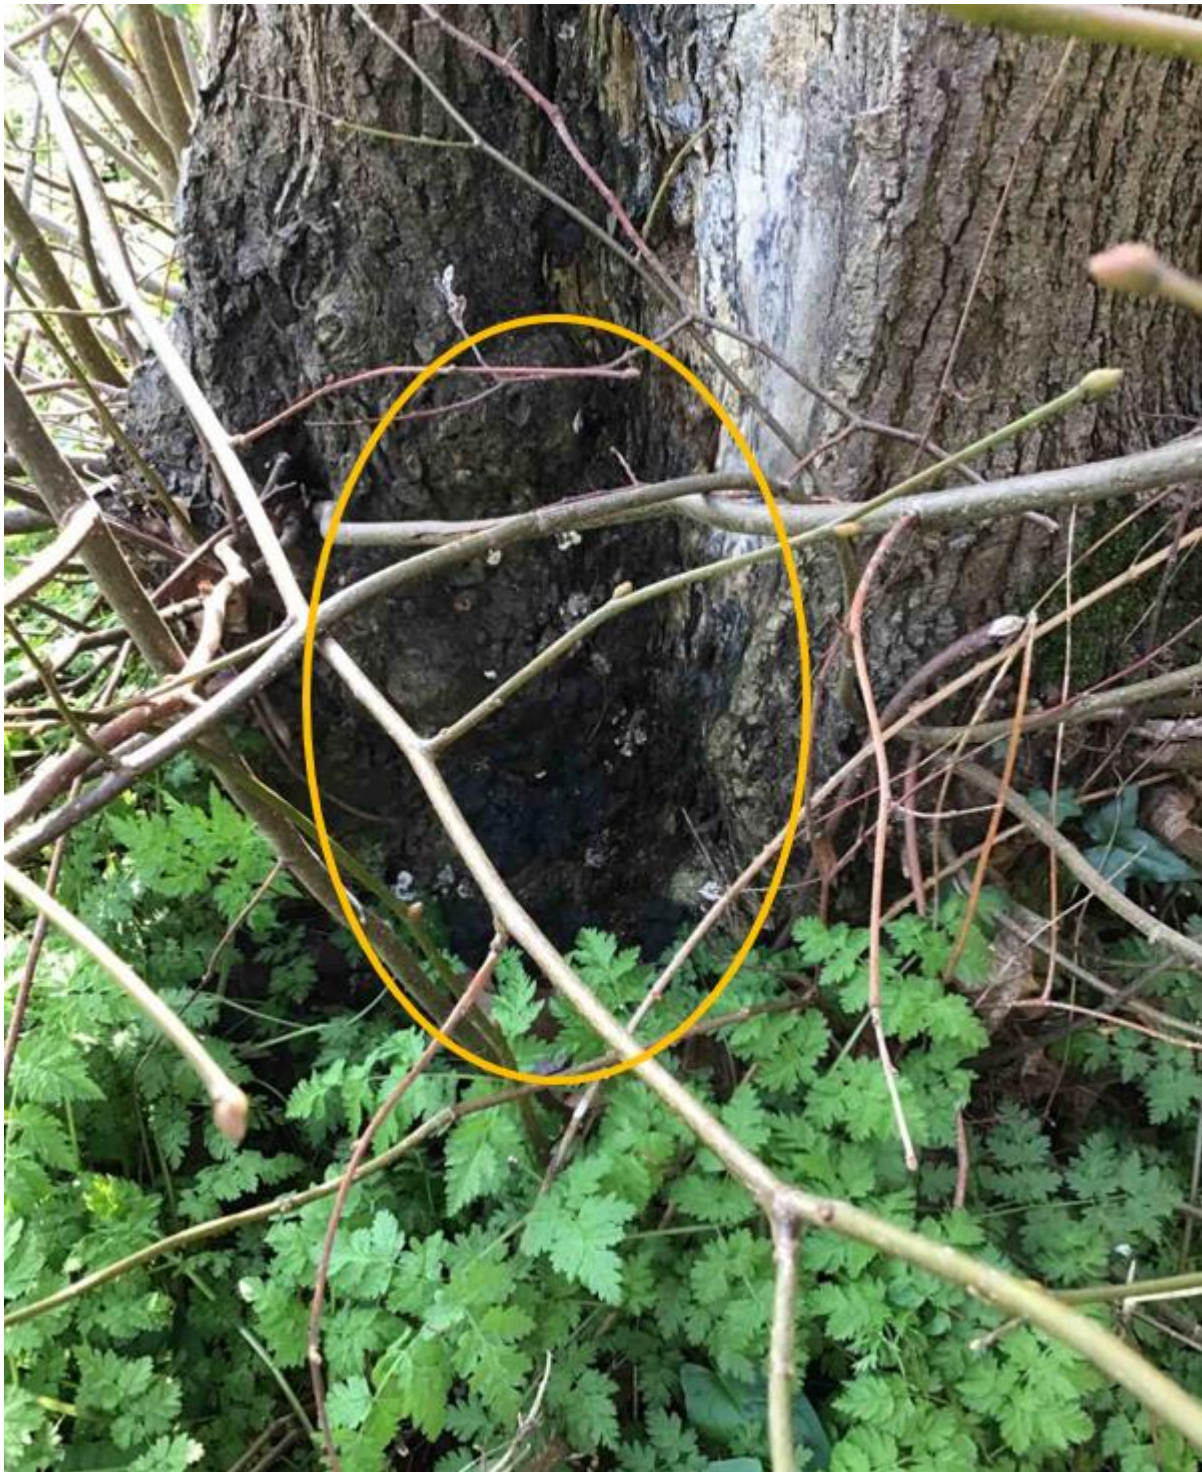
Ward	Ham, Petersham and Richmond Riverside
Road	Ham Avenues
Location	Melancholy Walk
Species	Lime ( <i>Tilia</i> sp.)
Height	17.0m
Physiological Condition	Good
Structural Condition	Poor
Inspection findings	Fungal fruiting bodies of the decay pathogen <i>Kretzschmaria deusta</i> are present on the base of this tree. This fungus causes a white rot that can cause whole tree failure through a ceramic like fracture of the base; the tree presents an unacceptable risk of harm and removal is required.

***Image shows base of tree with location of fruiting bodies circled.***

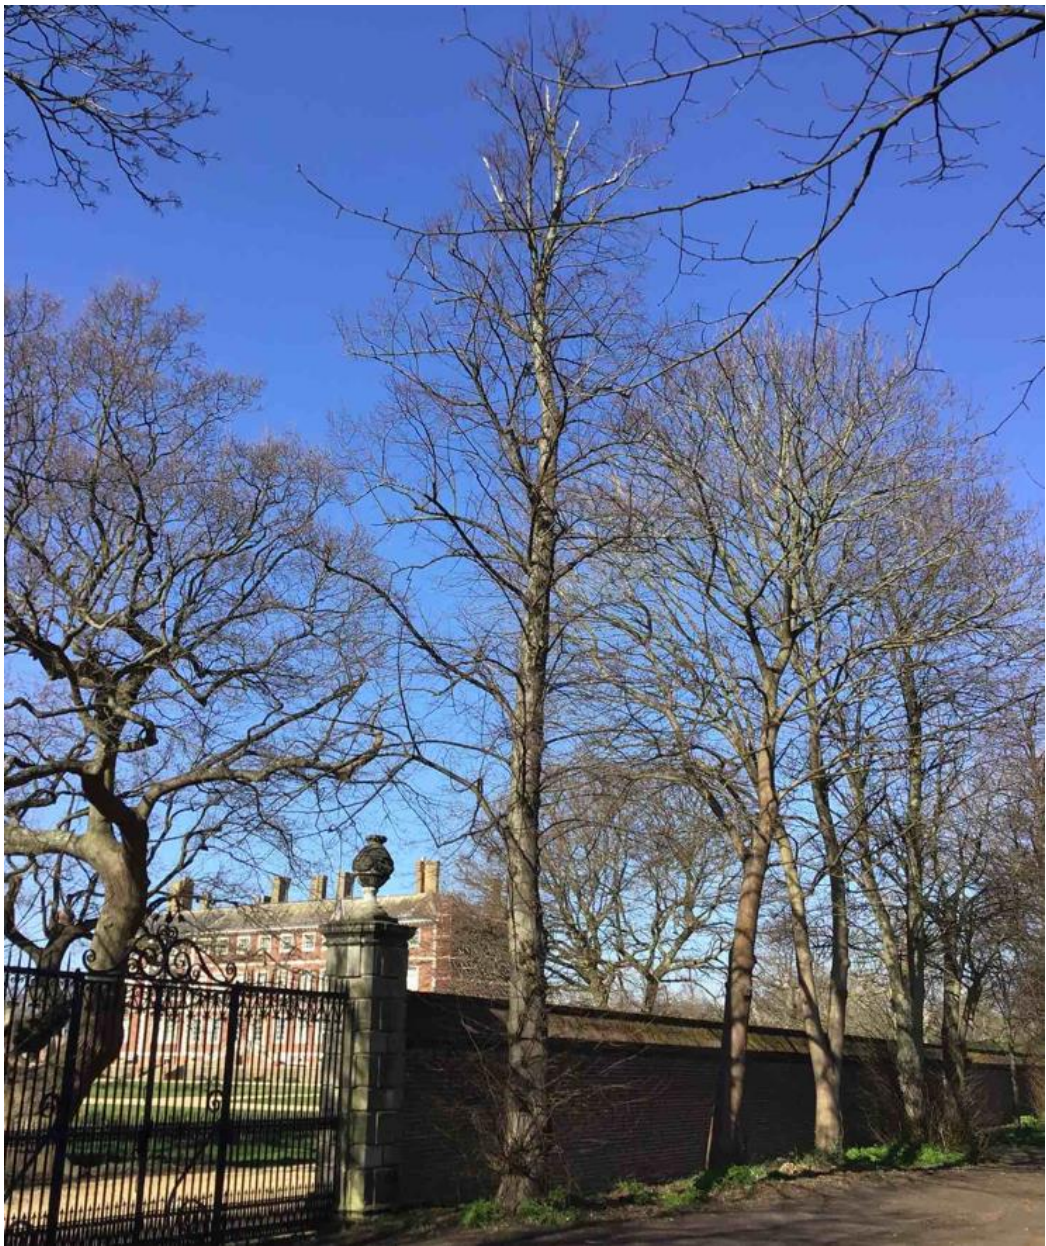
Image shows tree in good physiological condition

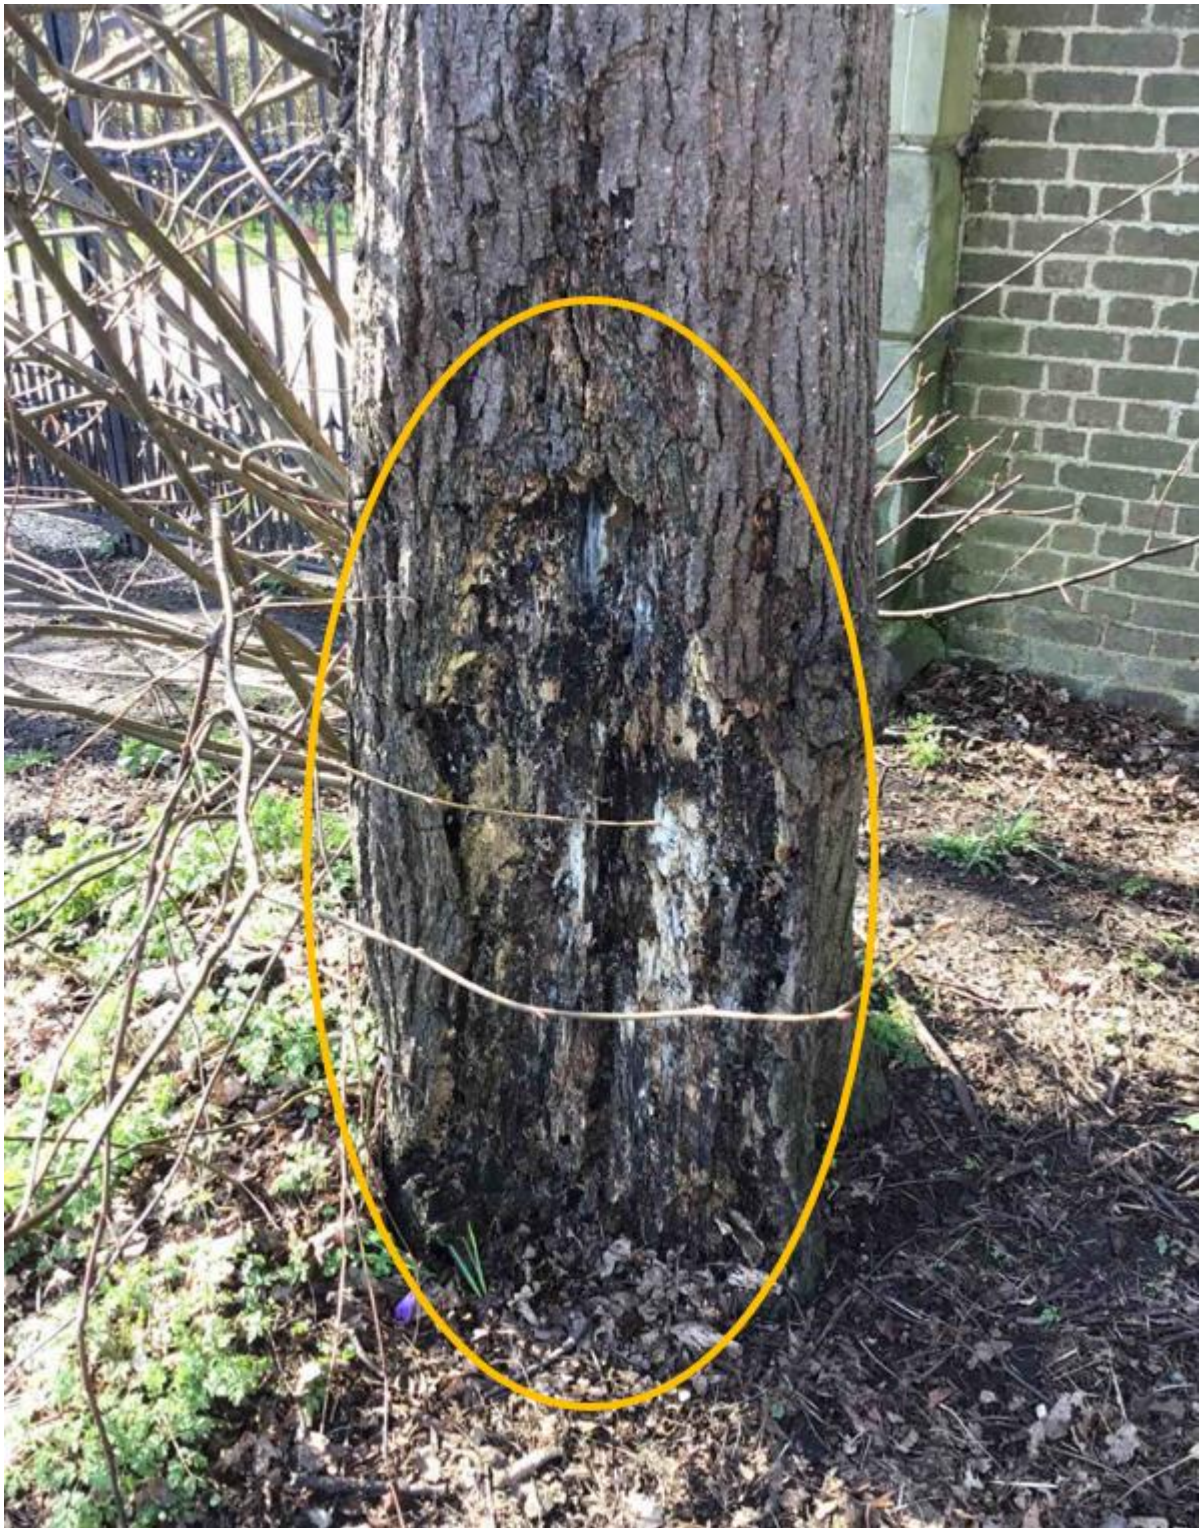
Ward	Ham, Petersham and Richmond Riverside
Road	Ham Avenues
Location	Melancholy Walk
Species	Lime ( <i>Tilia</i> sp.)
Height	17.0m
Physiological Condition	Good
Structural Condition	Poor
Inspection findings	Fungal fruiting bodies of the decay pathogen <i>Kretzschmaria deusta</i> are present on the base of this tree. This fungus causes a white rot that can cause whole tree failure through a ceramic like fracture of the base; the tree presents an unacceptable risk of harm and removal is required.

*Image shows base of tree with location of decay and fruiting bodies circled.*

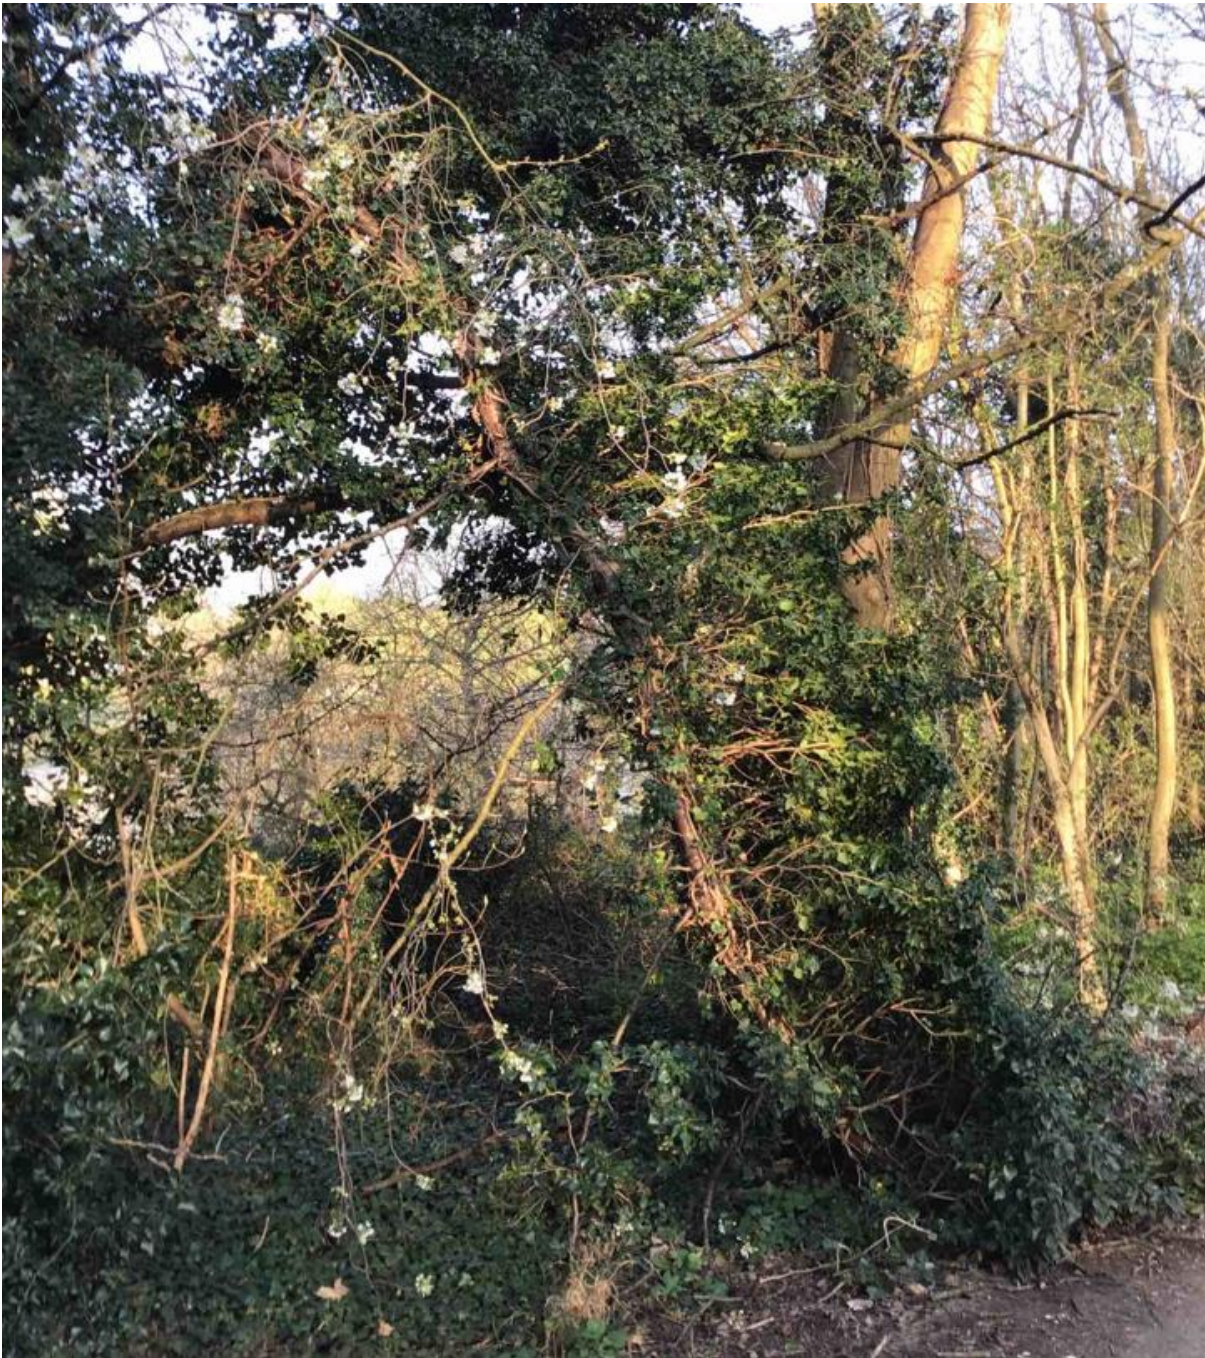
Ward	Ham, Petersham and Richmond Riverside
Road	River Lane
Location	Ham Towpath – W3W groom.valve.finds
Species	Cherry ( <i>Prunus</i> sp.)
Height	8.0m
Physiological Condition	Good
Structural Condition	Poor
Inspection findings	This tree has failed and is hung up in its neighbour presenting a hazard.

Image shows partially failed tree hung up in neighbouring tree.

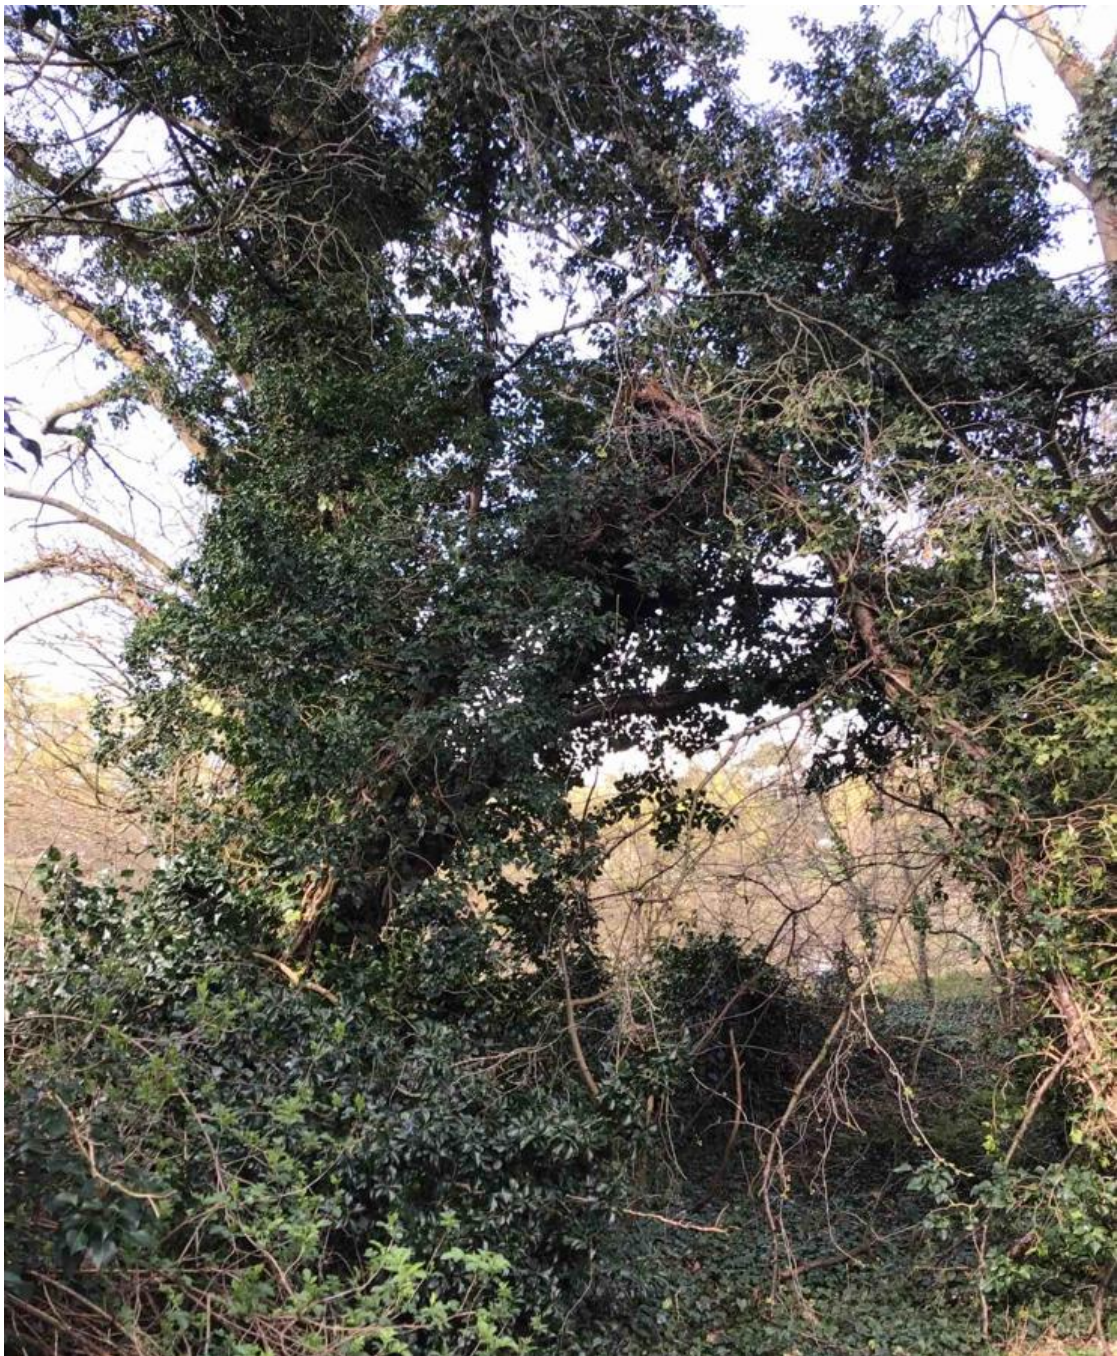
Ward	Ham, Petersham and Richmond Riverside
Road	River Lane
Location	Ham Towpath – W3W remove.belong.grapes
Species	Cherry ( <i>Prunus</i> sp.)
Height	8.0m
Physiological Condition	Good
Structural Condition	Poor
Inspection findings	This tree has failed and is hung up in its neighbour presenting a hazard.

Image shows partially failed tree hung up in neighbouring tree.

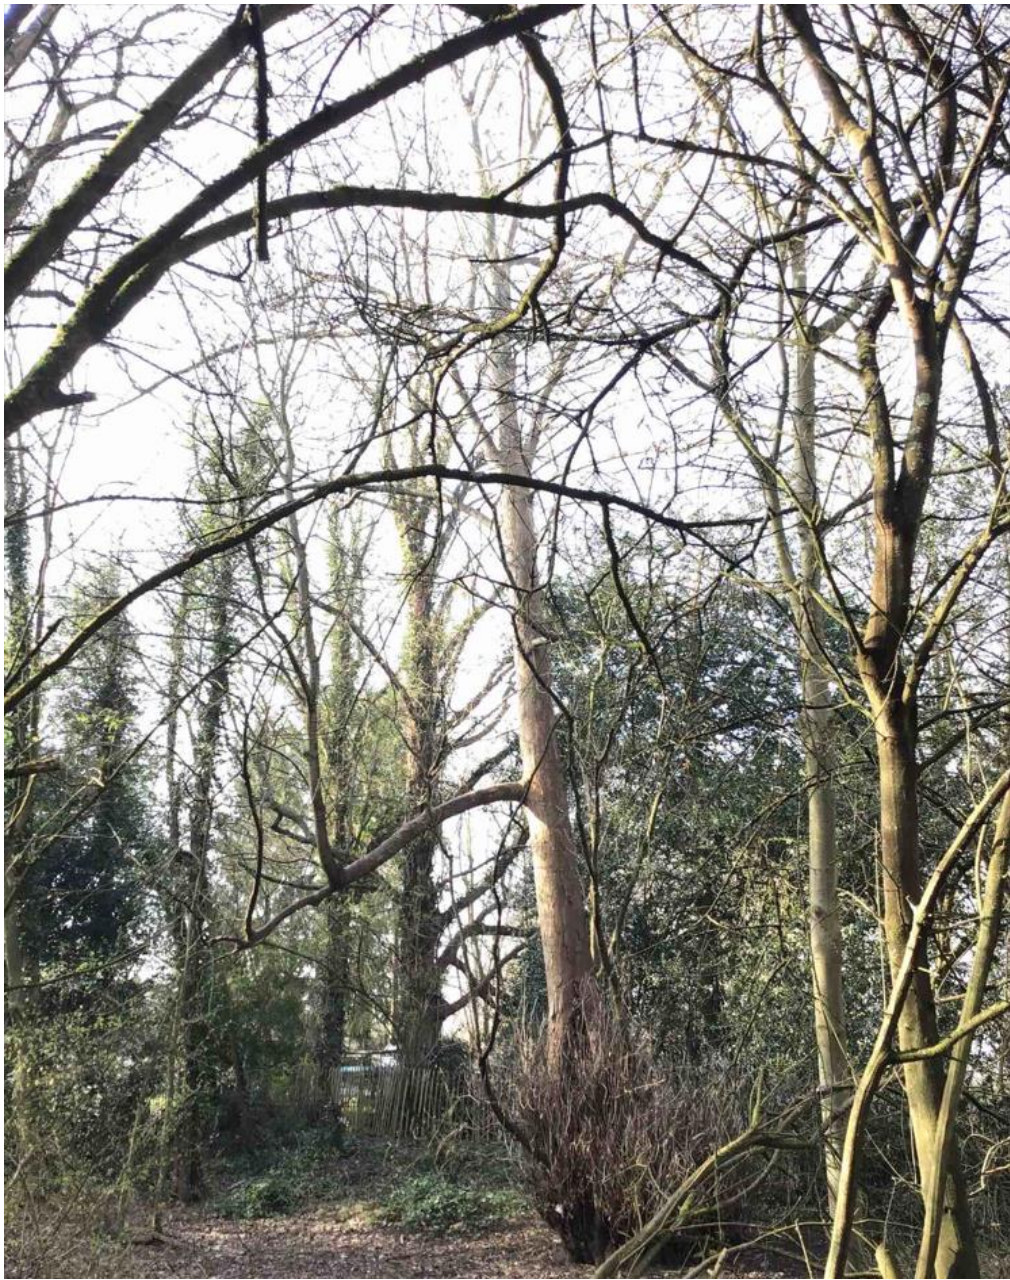
Image shows tree hung up in woodland setting.

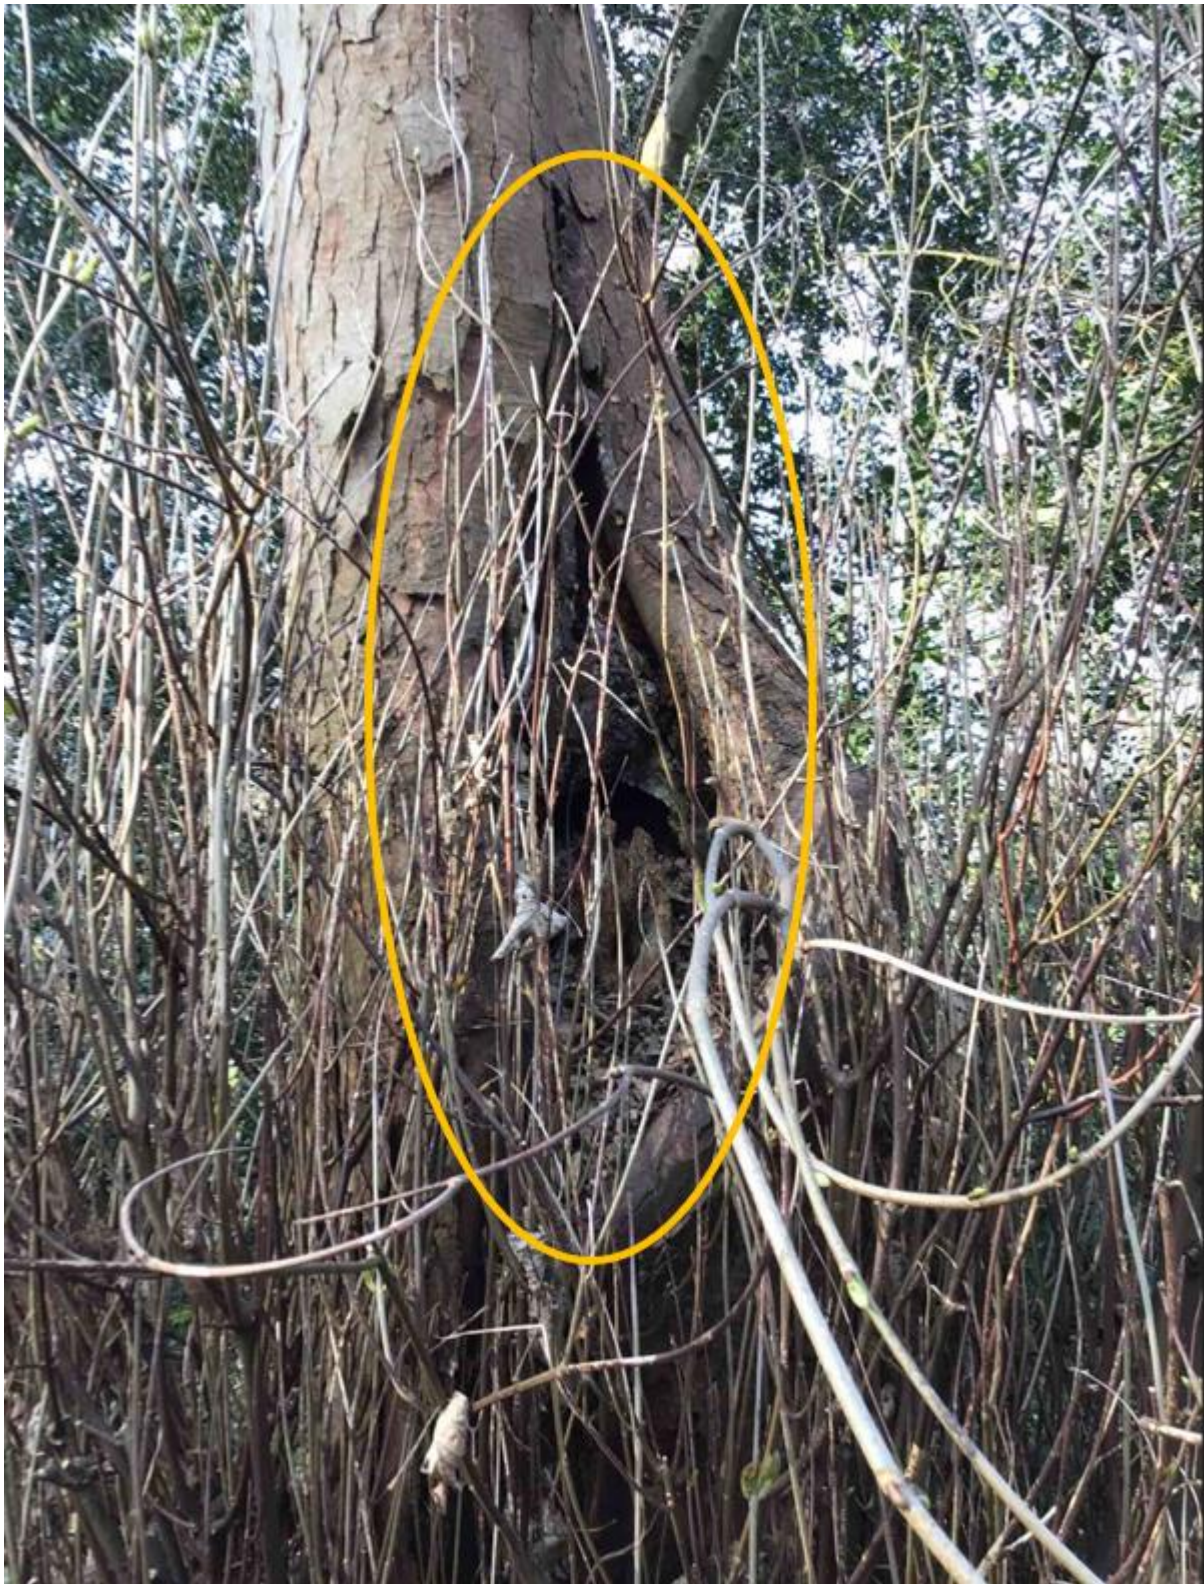
Ward	Ham, Petersham and Richmond Riverside
Road	River Lane
Location	Petersham Lodge Woods – W3W - prompting.plant.asleep
Species	Sycamore ( <i>Acer pseudoplatanus</i> )
Height	22.0m
Physiological Condition	Good
Structural Condition	Poor
Inspection findings	A cavity indicating root and lower stem decay is present at the base of this tree. A resonance test revealed an unacceptable degree of decay in the trunk of this tree, removal is required to prevent natural failure and manage risk.

*Image shows cavity at base of the tree circled.*

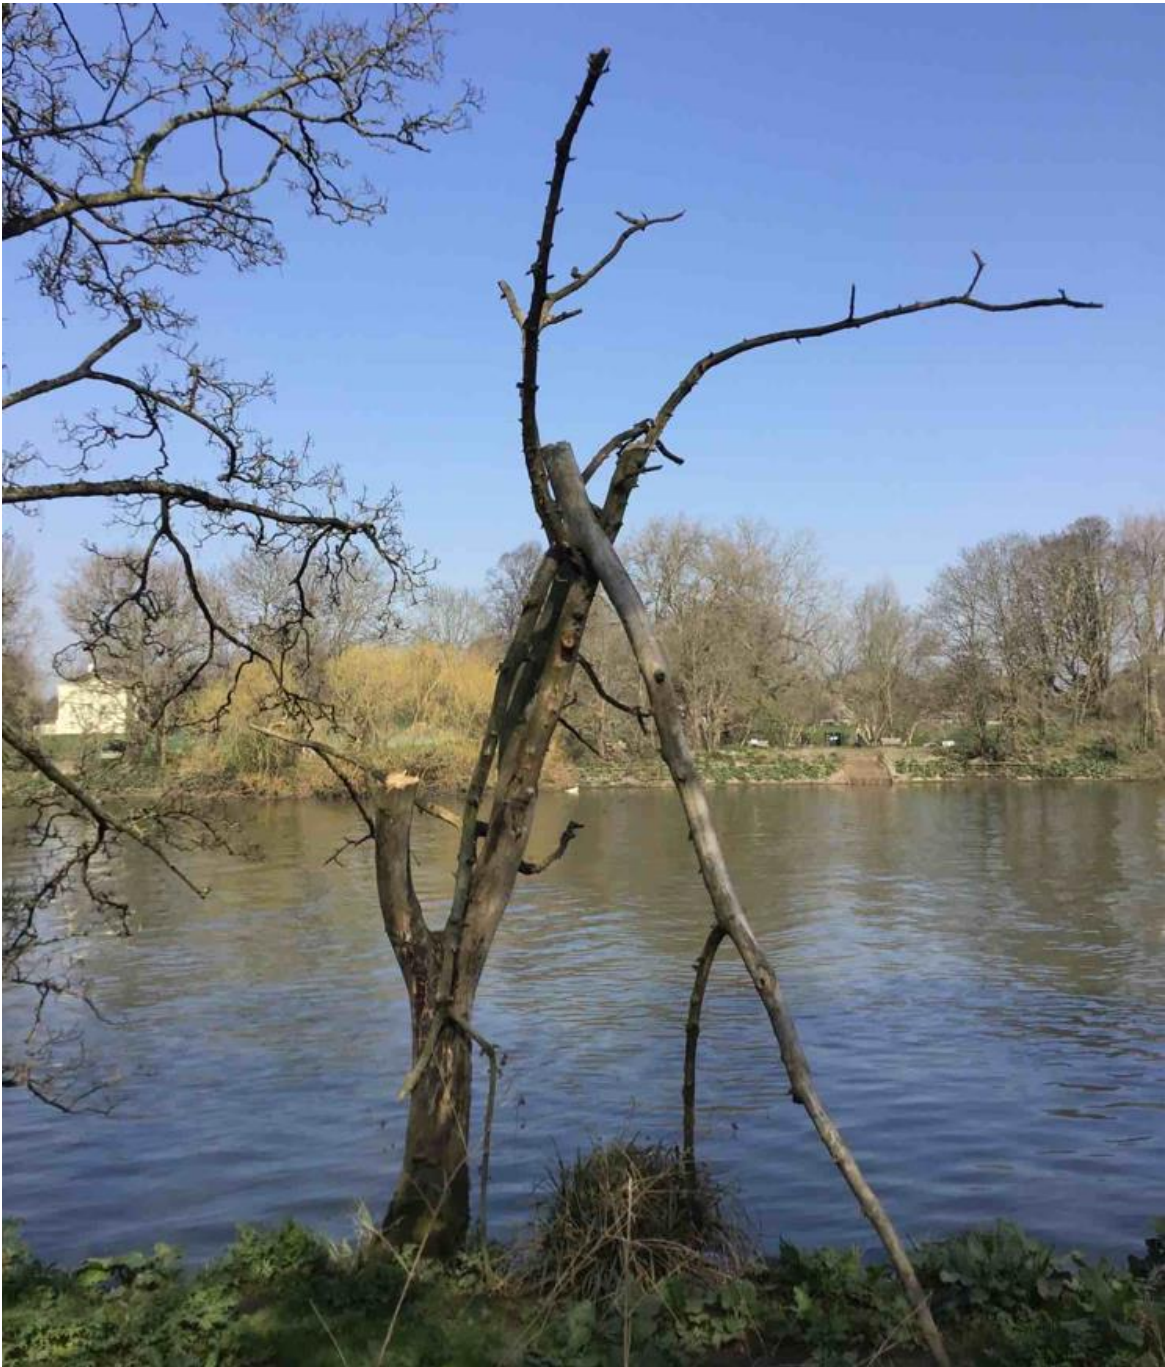
Ward	Ham, Petersham and Richmond Riverside
Road	River Lane
Location	Thames Towpath – W3W – city.truly.gaps
Species	Unknown dead
Height	5.0m
Physiological Condition	Dead
Structural Condition	Dead
Inspection findings	This tree is dead, and removal is required to prevent natural failure.

Image shows dead tree.
