# **Towpath – Champions Wharf to Railshead Road and Ham to Chiswick Bridge felling document**

## Introduction

Dated 18.9.2023

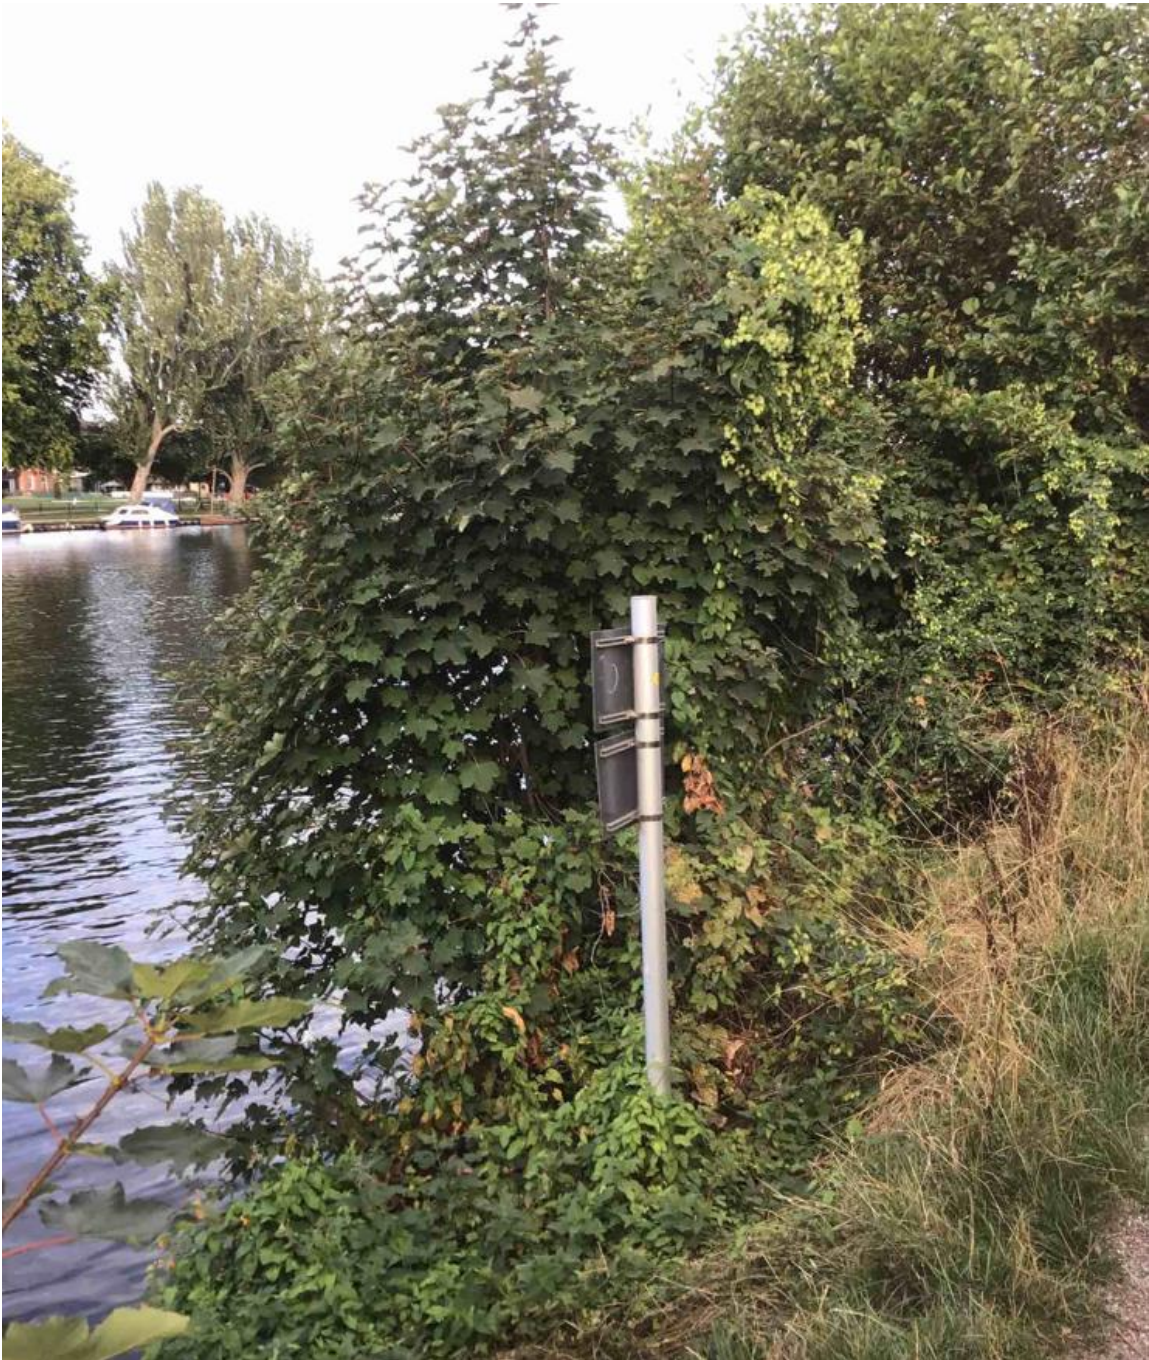
Ward	Ham, Petersham and Richmond Riverside
Road	River Lane to Borough boundary Kingston
Location	Thames Towpath – W3W – city.truly.gaps
Species	Sycamore ( <i>Acer pseudoplatanus</i> )
Height	5.0m
Physiological Condition	Good
Structural Condition	Good
Inspection findings	This tree is growing in an unsuitable location, causing an obstruction of waterway signage.

Image shows tree obstructing waterway signage

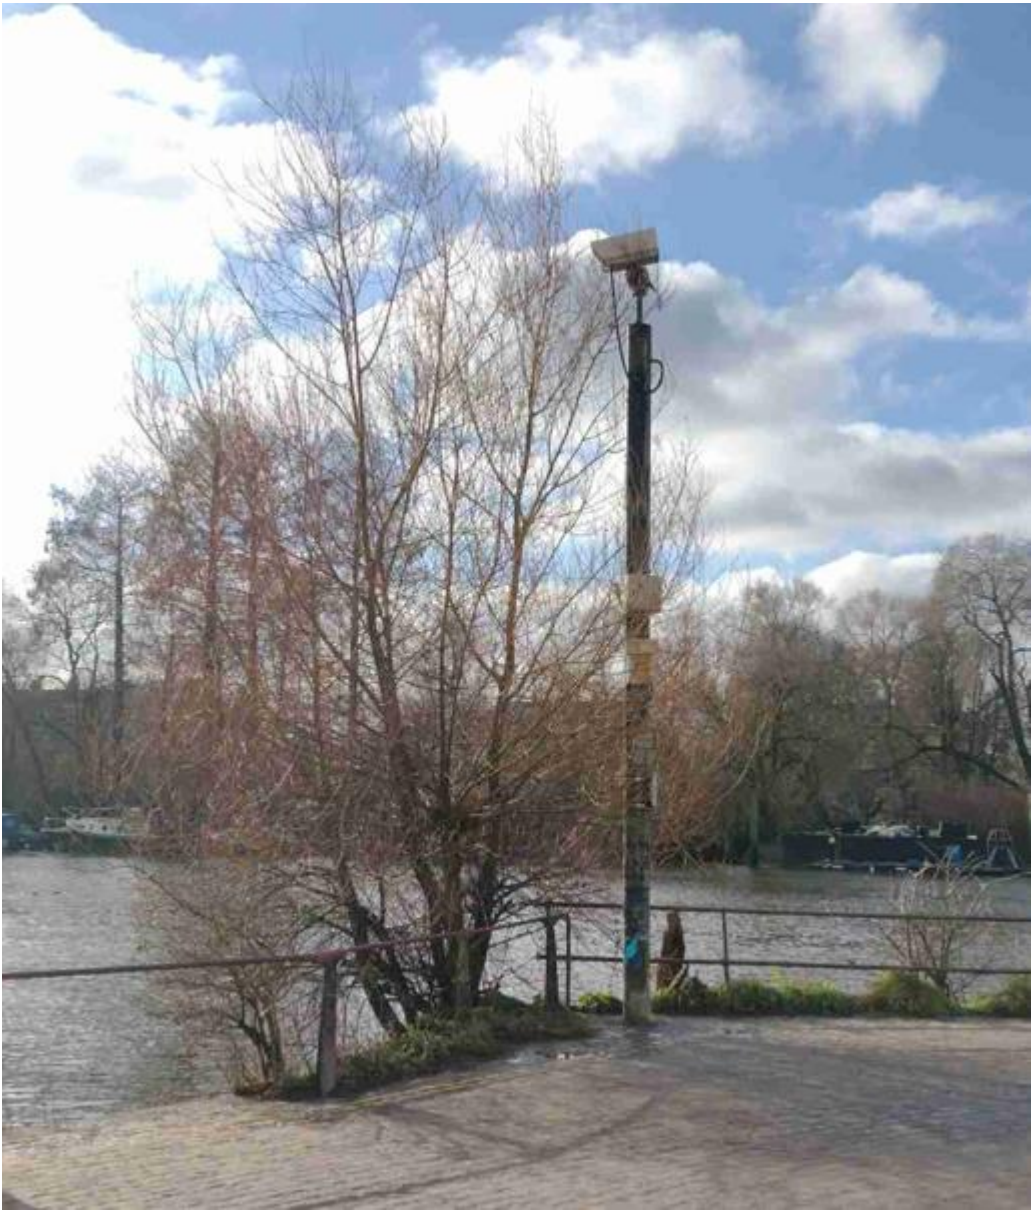
Ward	South Richmond
Road	Water Lane
Location	Thames Towpath - What3Words - maps.sweep.into
Species	Willow ( <i>Salix</i> sp.)
Height	5.5m
Physiological Condition	Good
Structural Condition	Good
Inspection findings	This tree is growing in the revetment and damaging the retaining wall; the location is unsuitable, and removal is required

Image shows tree growing in revetment

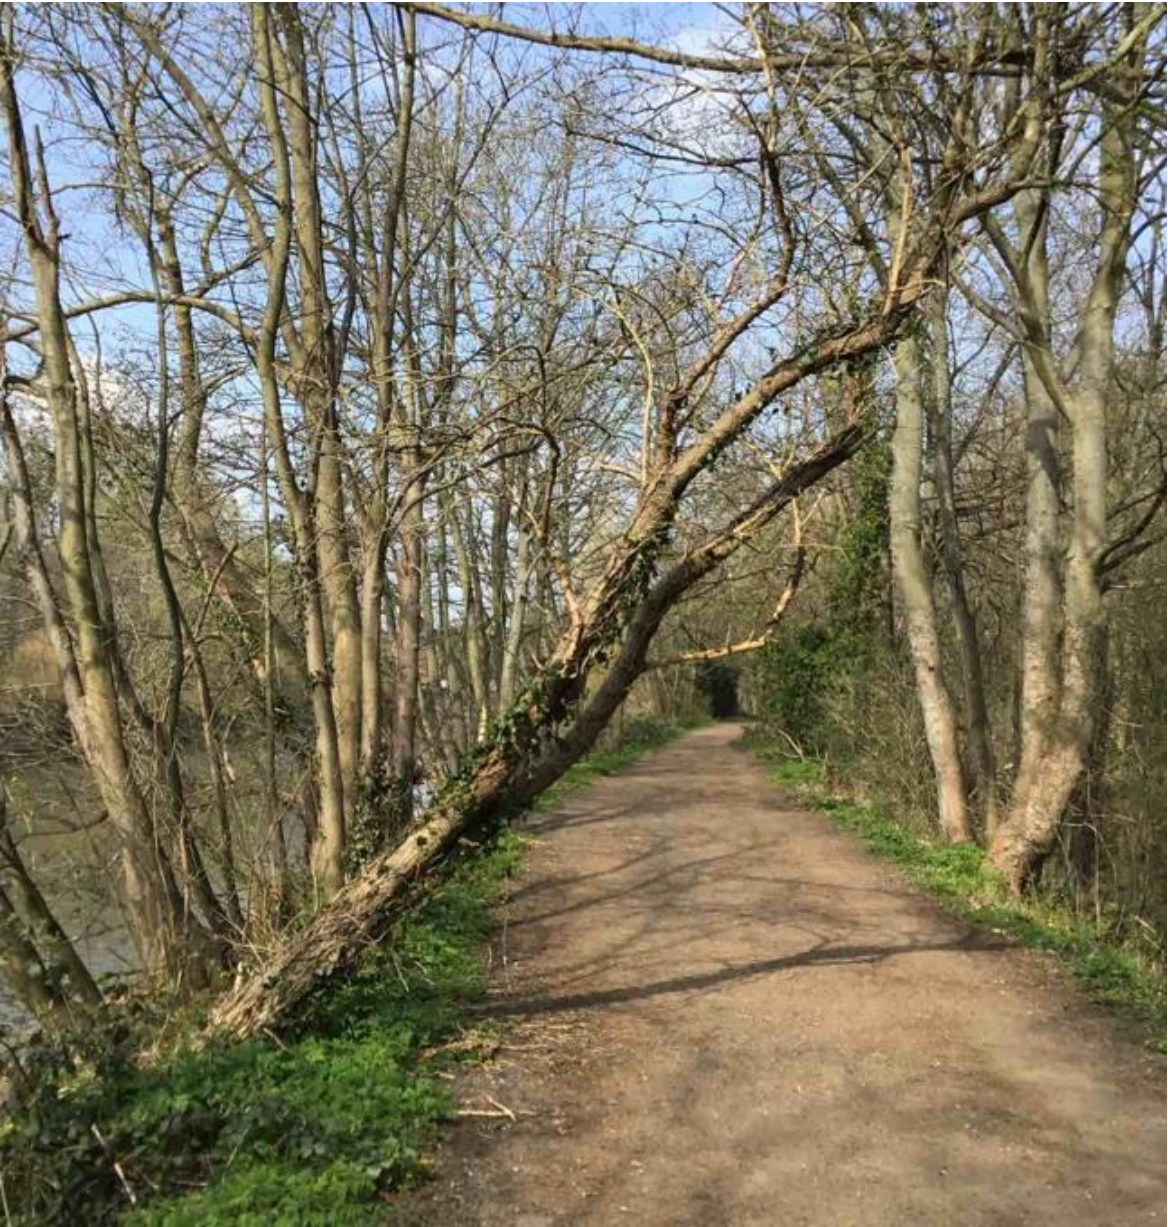
Ward	Kew
Road	Queens Cottage Grounds to Kew Bdg
Location	Thames Towpath – W3W branded.ashes.limit
Species	Elder ( <i>Sambucus nigra</i> )
Height	8.0M
Physiological Condition	Fair
Structural Condition	Poor
Inspection findings	This tree has failed and is hung up in a neighbouring tree.

Image shows partially failed tree hung up in neighbour over towpath.

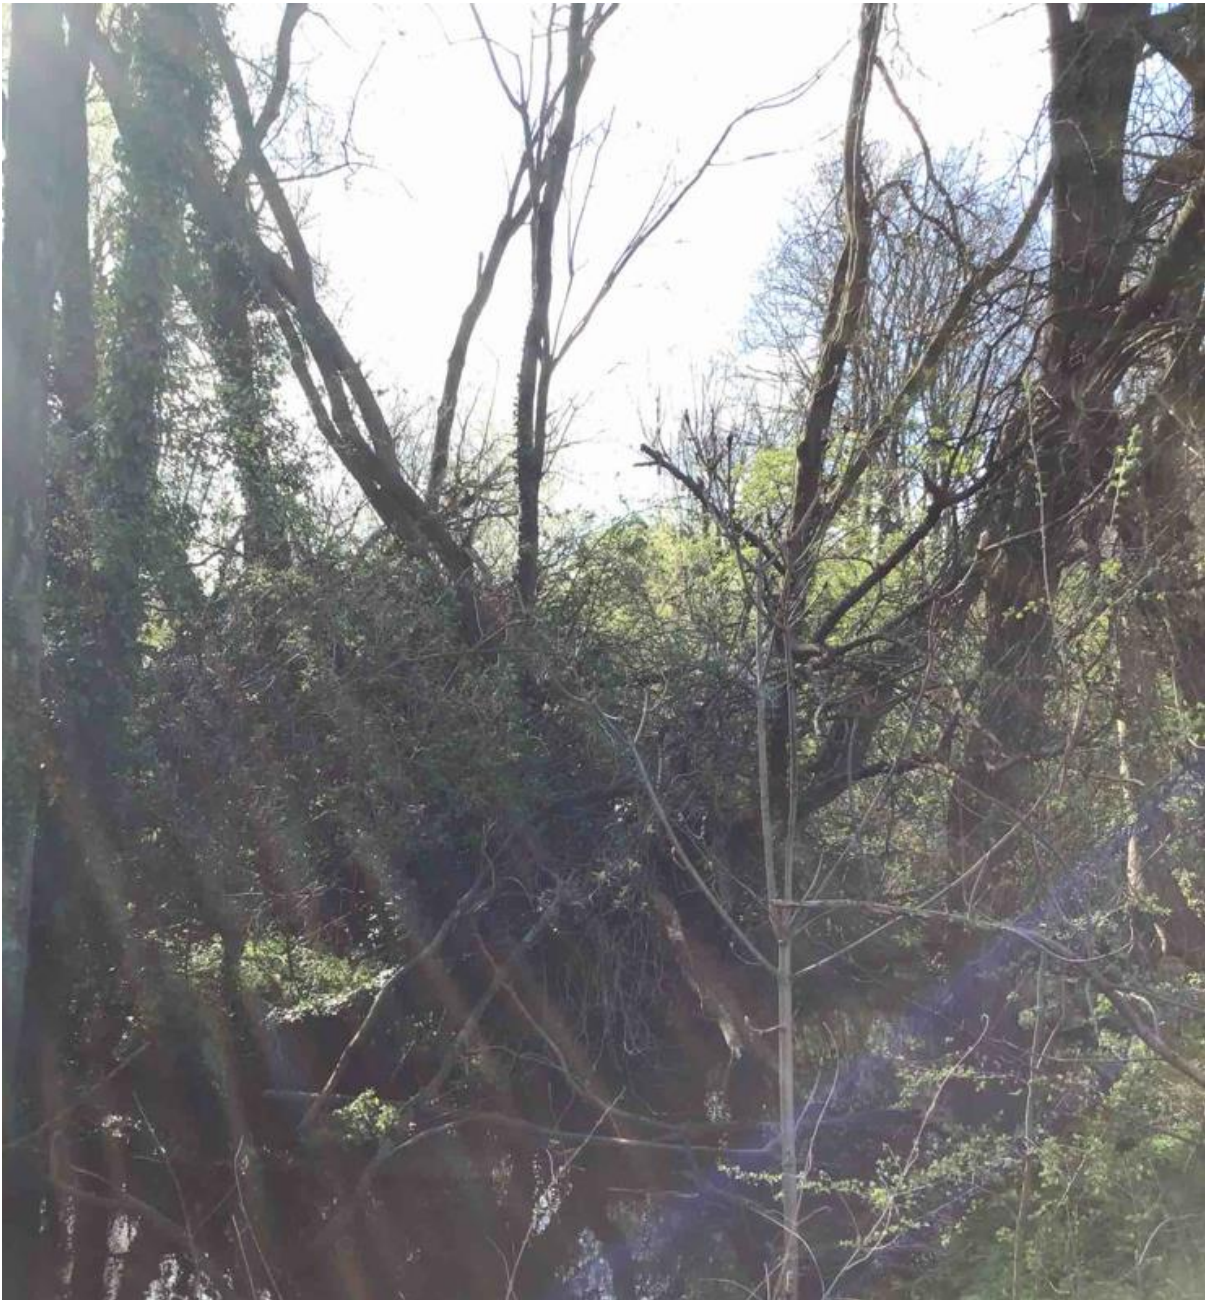
Ward	Kew
Road	Queens Cottage Grounds to Kew Bdg
Location	Thames Towpath – W3W head.coin.frozen
Species	Ash ( <i>Fraxinus excelsior</i> )
Height	21.0M
Physiological Condition	Fair
Structural Condition	Poor
Inspection findings	This tree has failed and is hung up in a neighbouring tree.

Image shows partially failed tree hung up in neighbour.

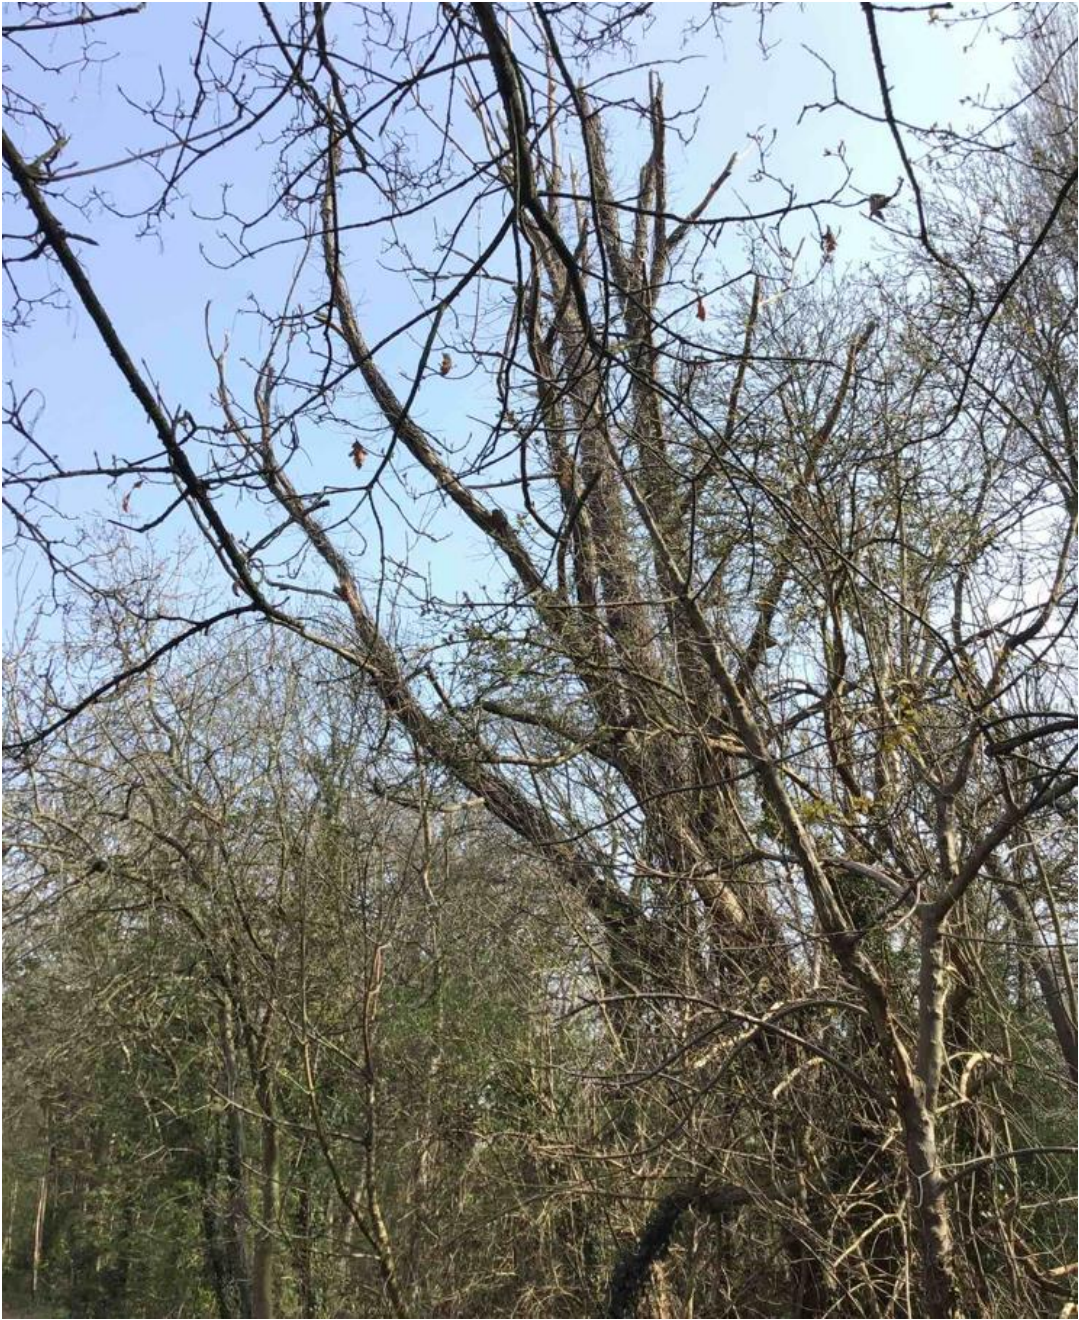
Ward	Kew
Road	Queens Cottage Grounds to Kew Bdg
Location	Thames Towpath – W3W drum.acted.moves
Species	Poplar ( <i>Populus</i> sp.)
Height	17.0M
Physiological Condition	Dead
Structural Condition	Dead
Inspection findings	This tree is dead, and removal is required to prevent natural failure.

Image shows dead tree.

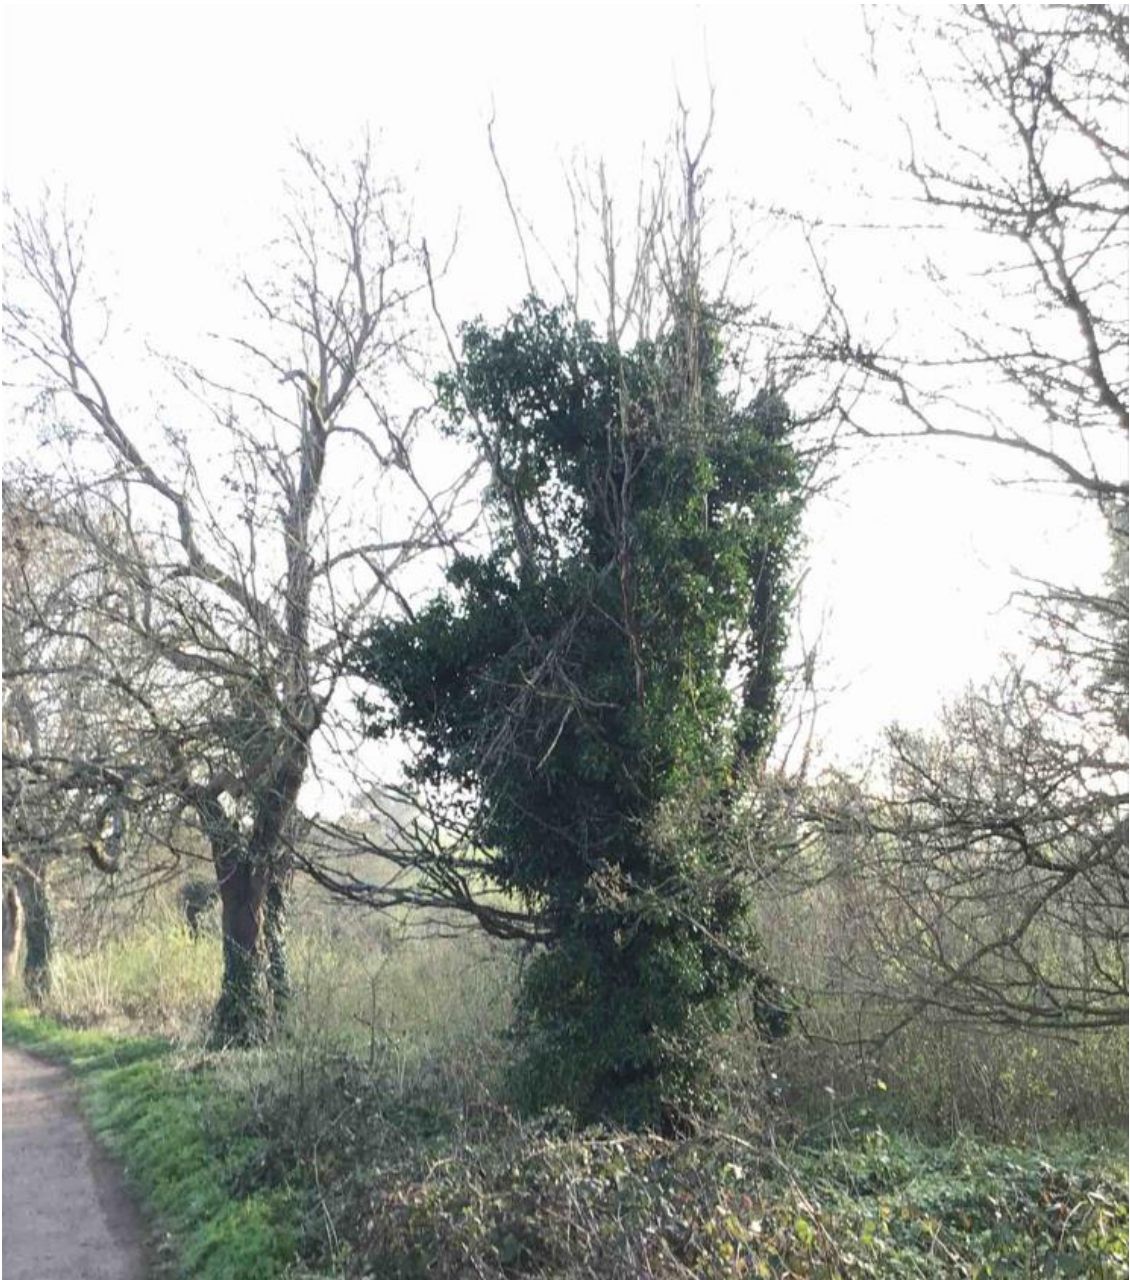
Ward	Kew
Road	Queens Cottage Grounds to Kew Bdg
Location	Thames Towpath – W3W jeep.facing.beats
Species	Unknown dead
Height	8.0M
Physiological Condition	Dead
Structural Condition	Dead
Inspection findings	This tree is dead, and removal is required to prevent natural failure.

Image shows dead tree.

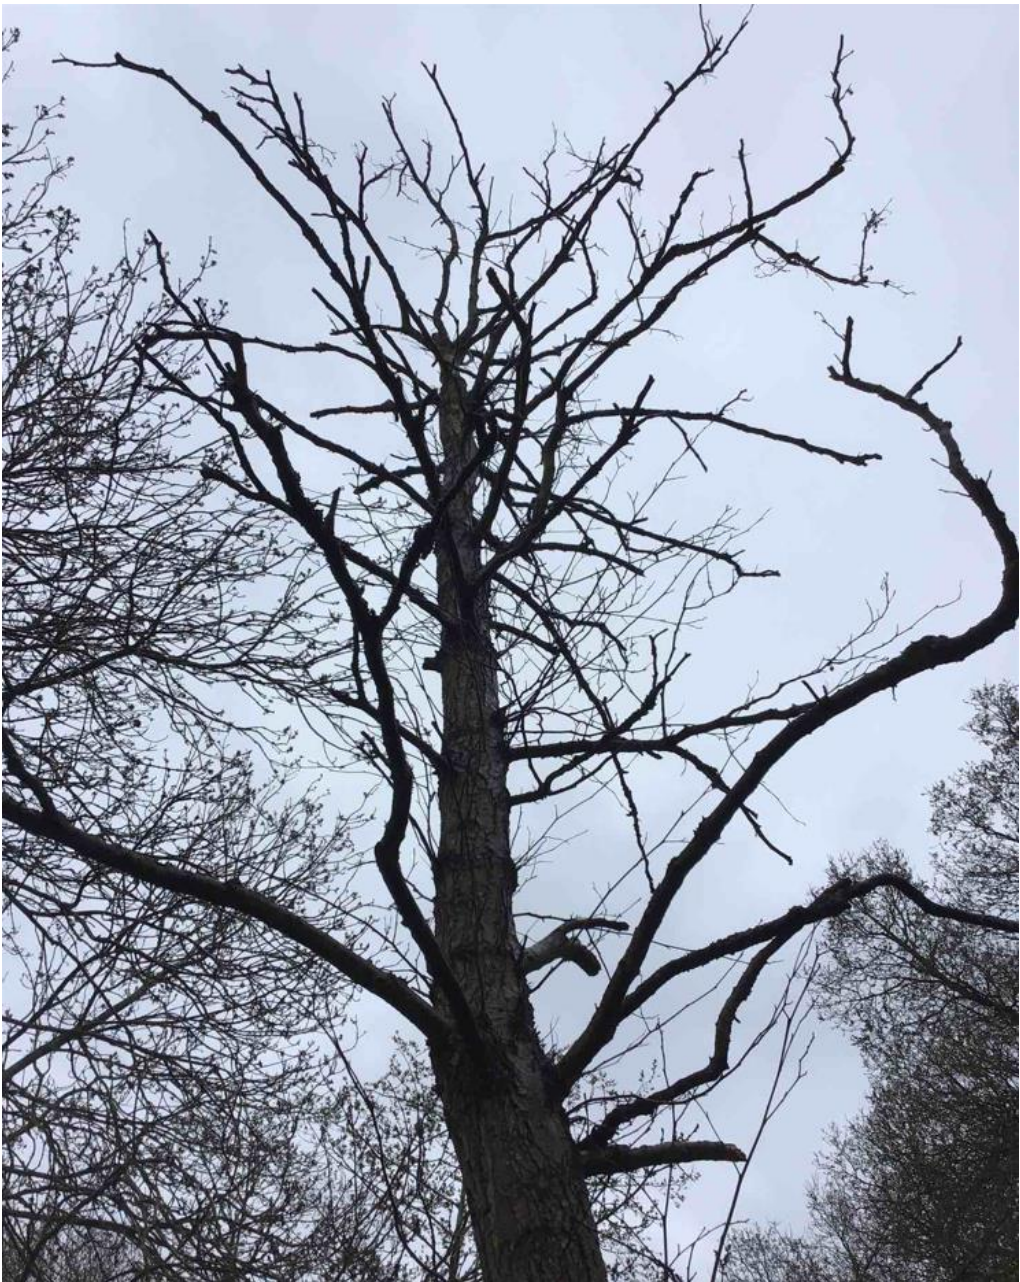
Ward	Kew
Road	Queens Cottage Grounds to Kew Bdg
Location	Thames Towpath – W3W space.ranks.ruins
Species	Alder ( <i>Alnus</i> sp.)
Height	9.5M
Physiological Condition	Dead
Structural Condition	Dead
Inspection findings	This tree is dead, and removal is required to prevent natural failure.

Image shows dead tree.

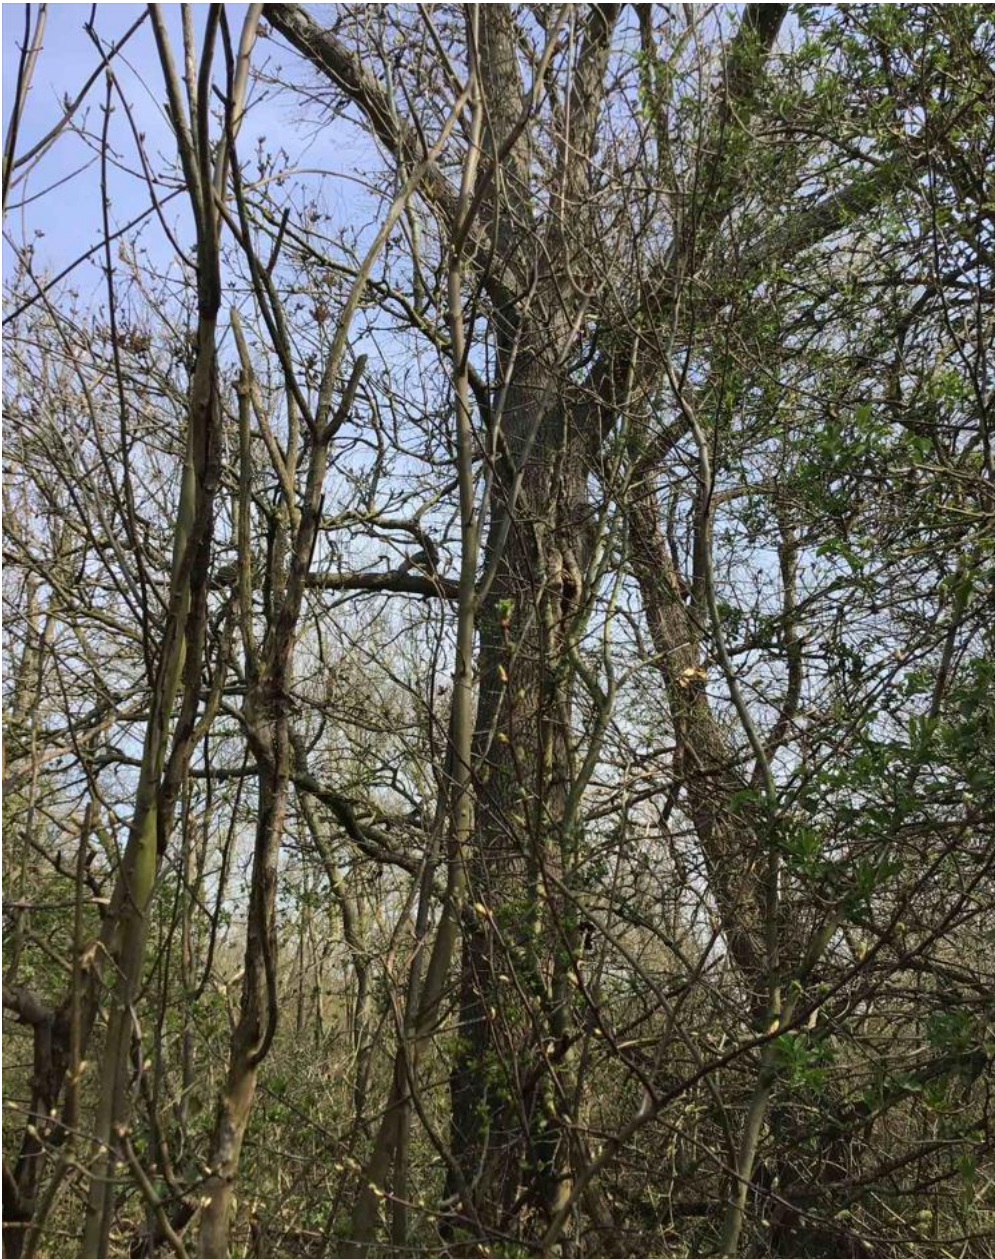
Ward	Kew
Road	Queens Cottage Grounds to Kew Bdg
Location	Thames Towpath – W3W - damp.wacky.stole
Species	Ash ( <i>Fraxinus excelsior</i> )
Height	17.0m
Physiological Condition	Poor
Structural Condition	Poor
Inspection findings	A fungal fruiting body of the species Shaggy Polypore ( <i>Inonotus hispidus</i> ) is present on the main stem or trunk, this fungus causes a simultaneous white rot which can cause snapping of tree parts in this species.

Image shows tree in woodland scene

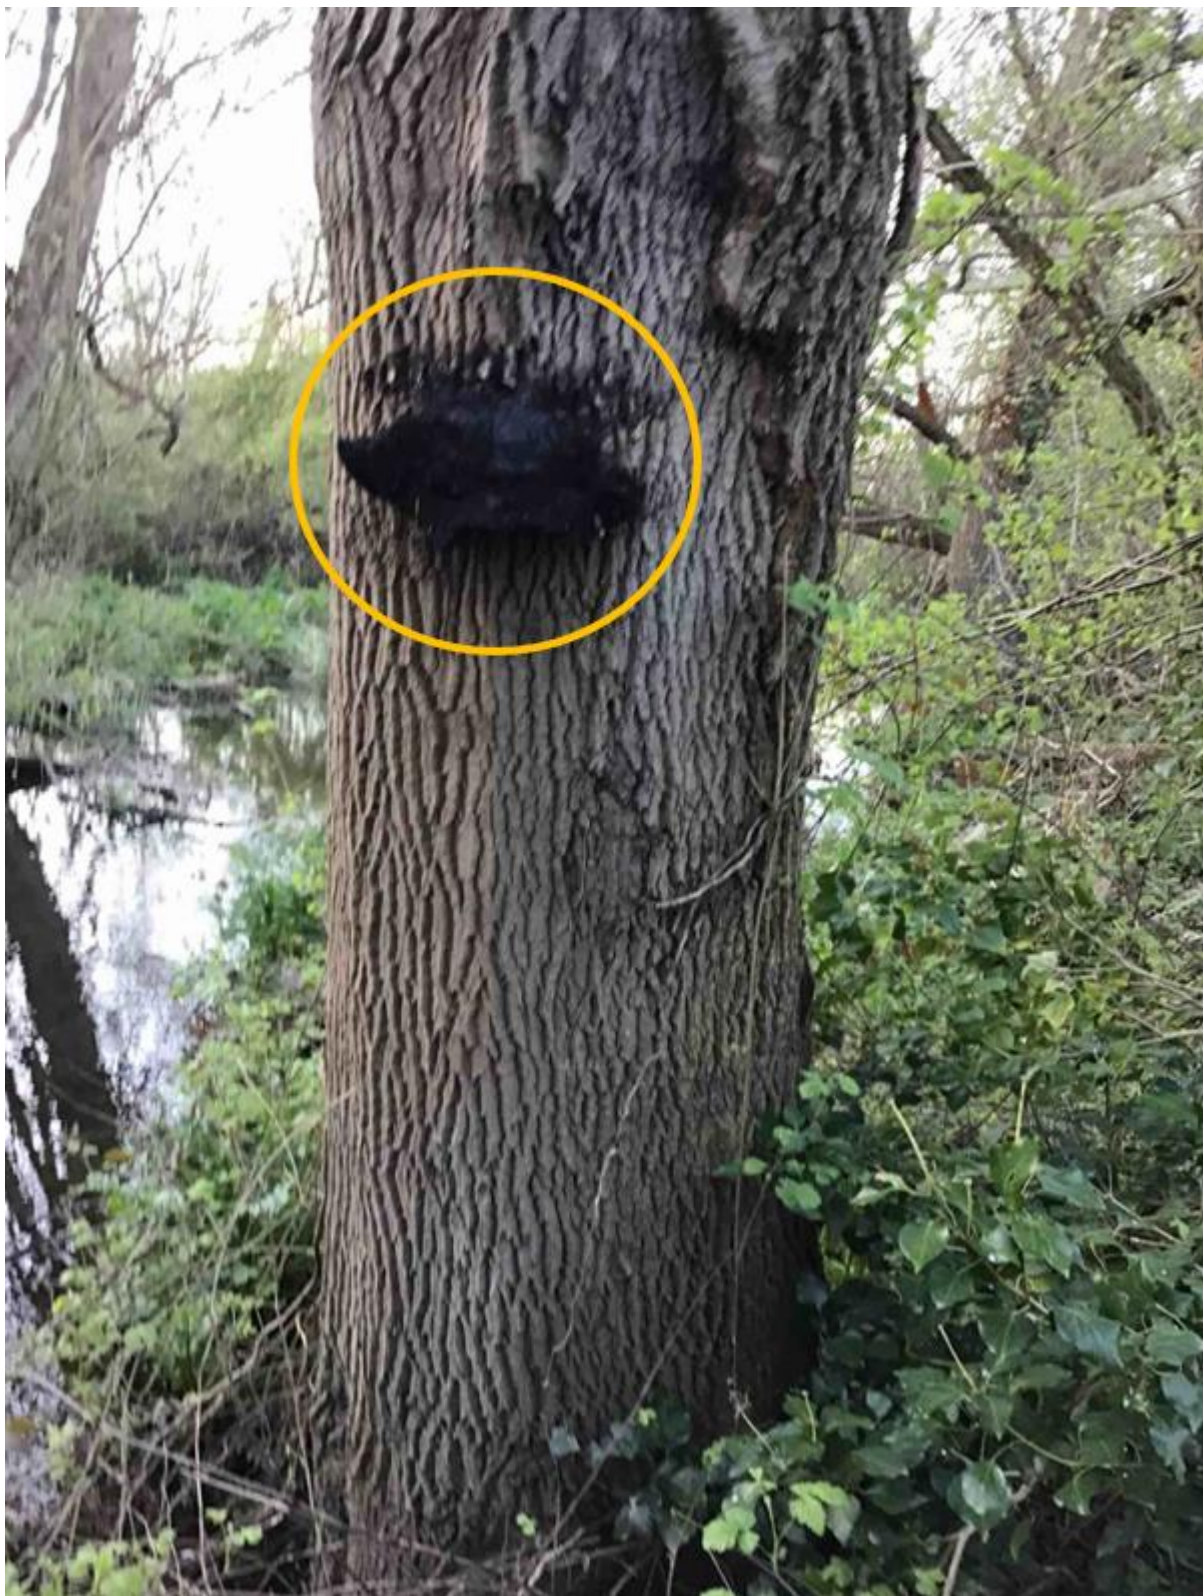
*Image shows stem of tree with senescent fungal fruiting body circled.*

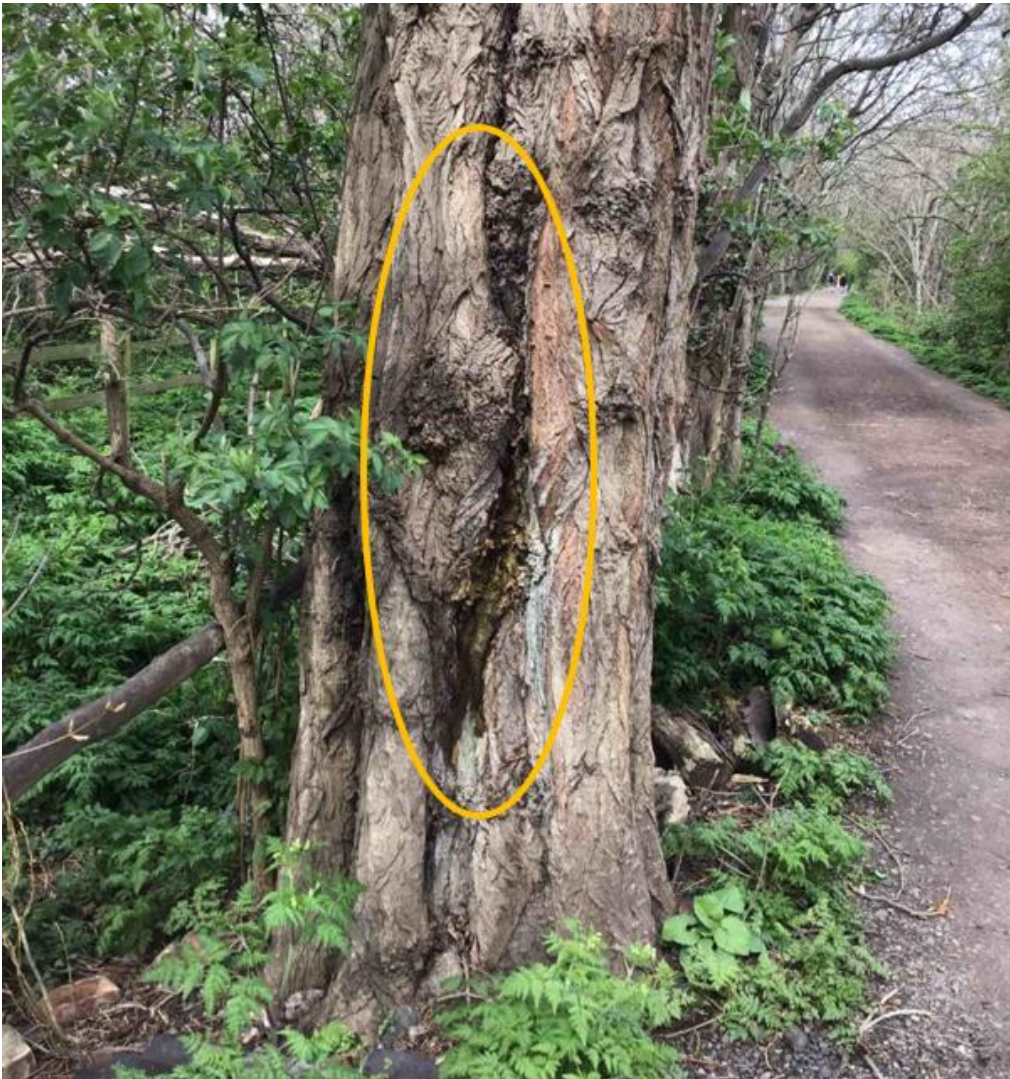
Ward	Kew
Road	Riverside to Chiswick Bridge
Location	Thames Towpath – W3W - verbs.punt.hang
Species	Lombardy Poplar ( <i>Populus nigra</i> var. <i>italica</i> )
Height	26.0m
Physiological Condition	Good
Structural Condition	Poor
Inspection findings	A cavity indicating decay is present in the trunk of this tree. A resonance test revealed an unacceptable degree of decay in the trunk of this tree, removal is required to prevent natural failure and manage risk.

Image shows base of tree with cavity opening and staining from exudate circled.

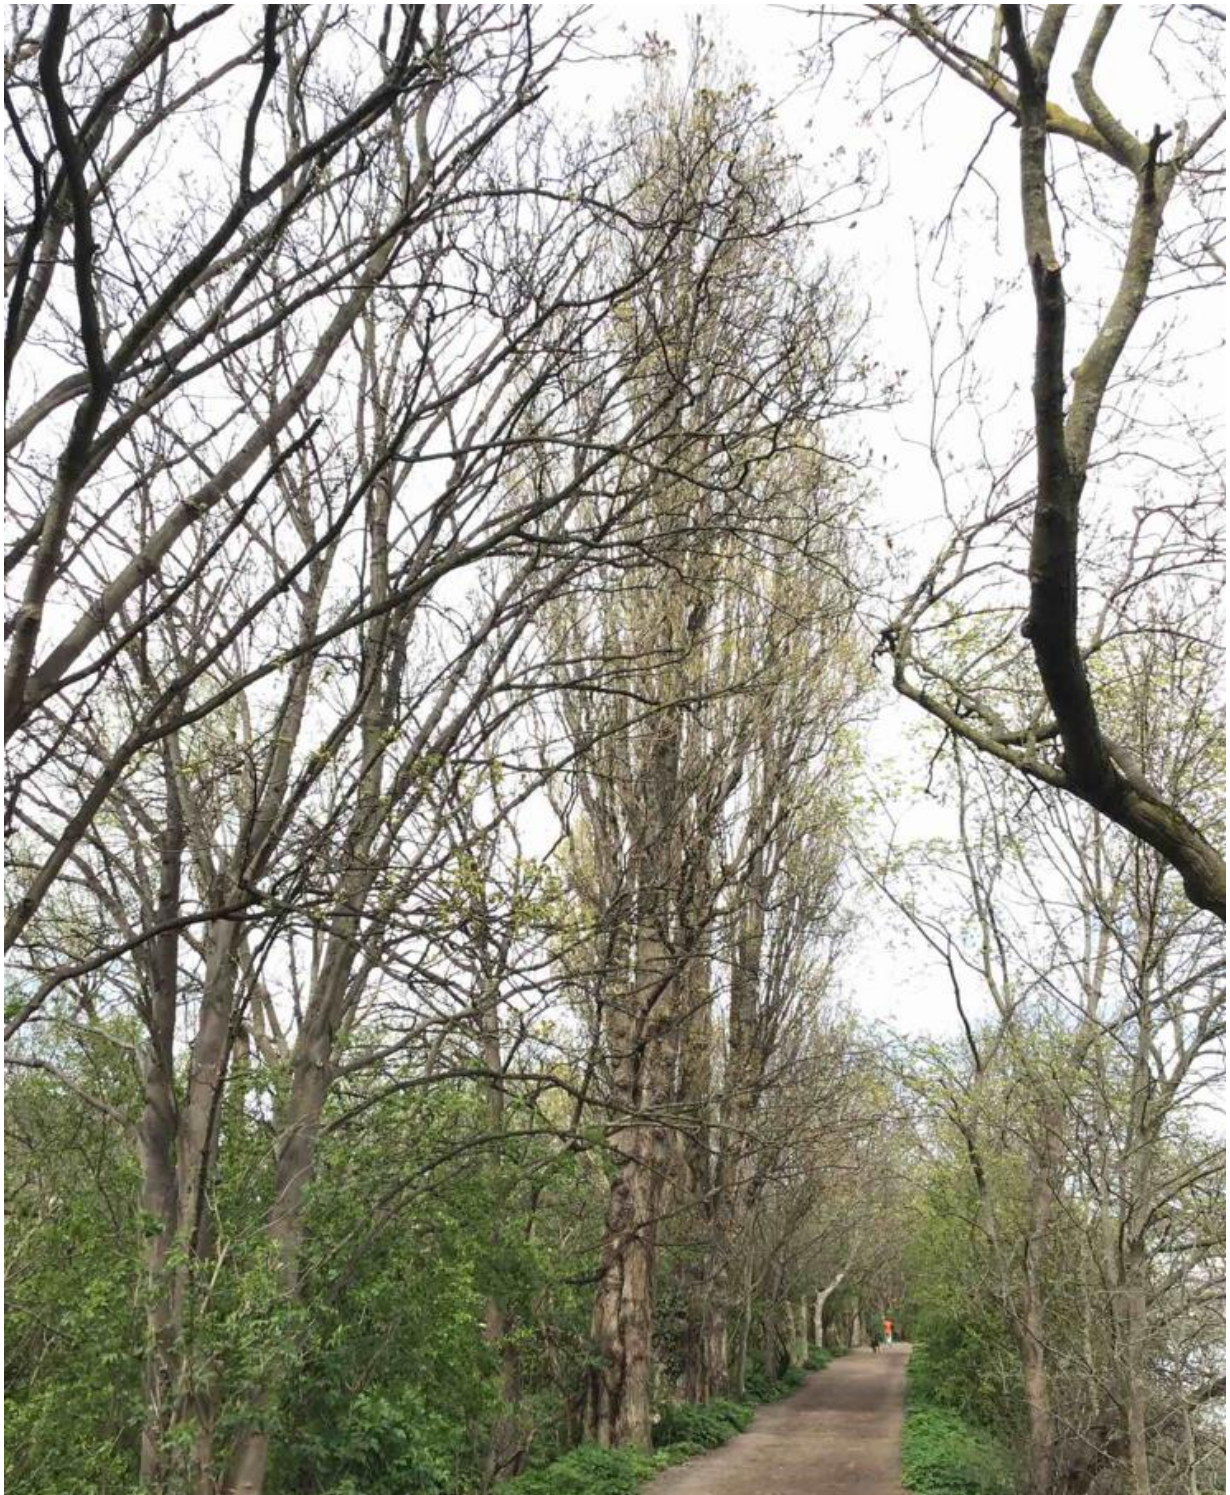
***Image shows tree in riverside scene***

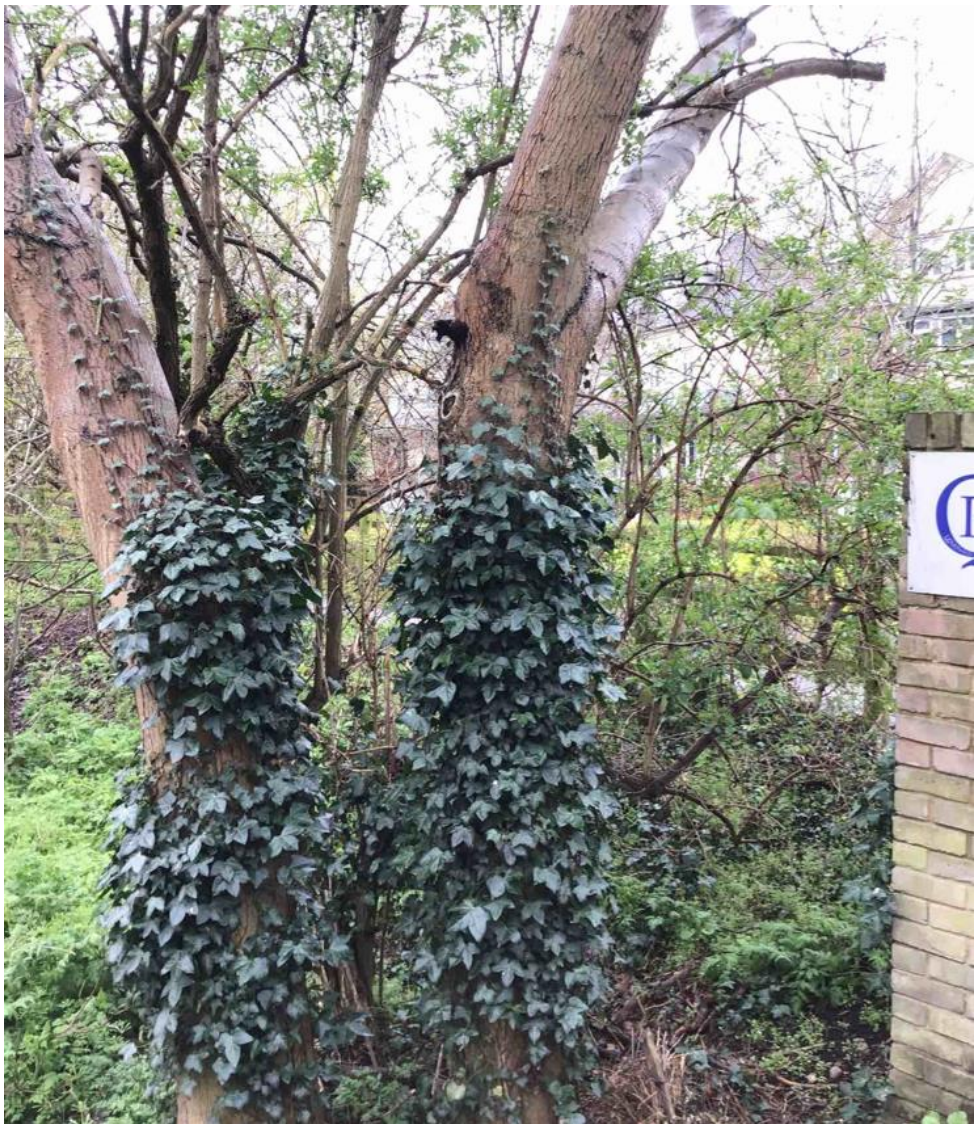
Ward	Kew
Road	Riverside to Chiswick Bridge
Location	Thames Towpath – W3W – water.basic.plug
Species	Ash ( <i>Fraxinus excelsior</i> )
Height	16.0m
Physiological Condition	Good
Structural Condition	Poor
Inspection findings	A fungal fruiting body of the species Shaggy Polypore ( <i>Inonotus hispidus</i> ) is present on the main stem or trunk, this fungus causes a simultaneous white rot which can cause snapping of tree parts in this species

Image shows base of tree with senescent fungal fruiting bodied on stem to right.

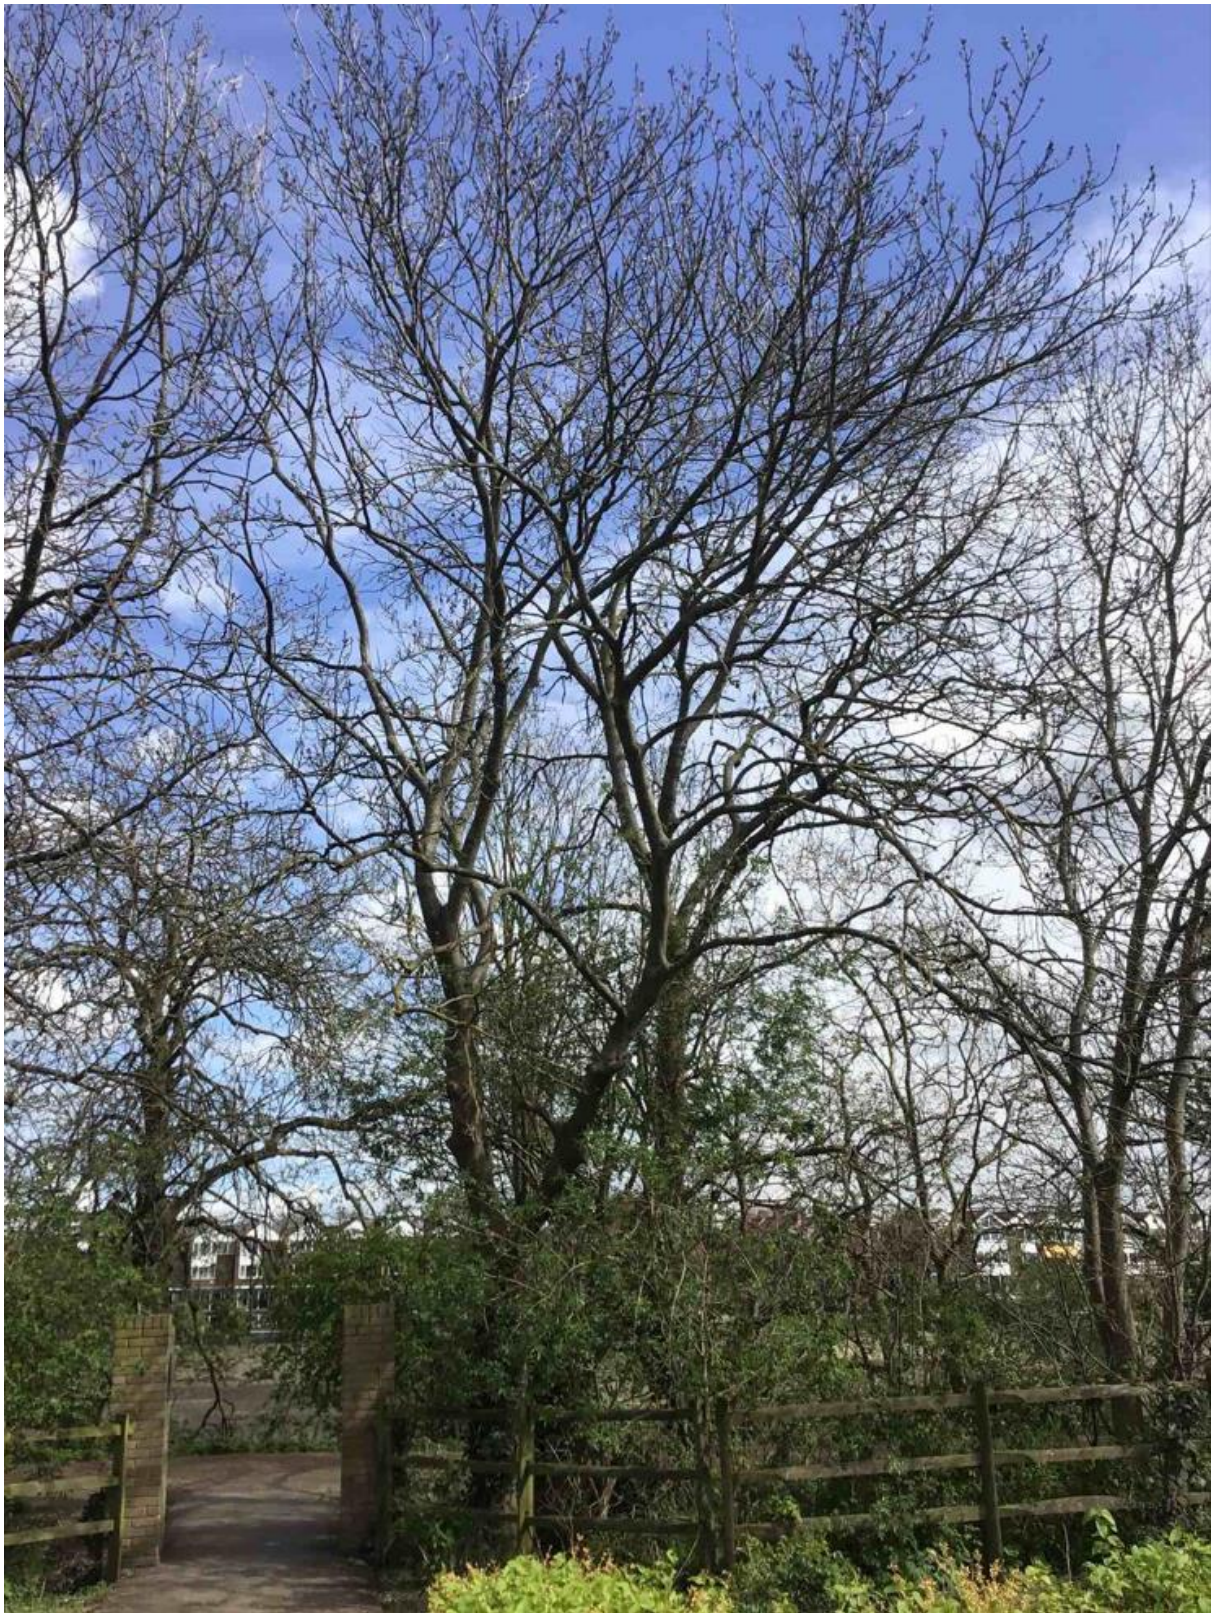
***Image shows tree by access to residential development***

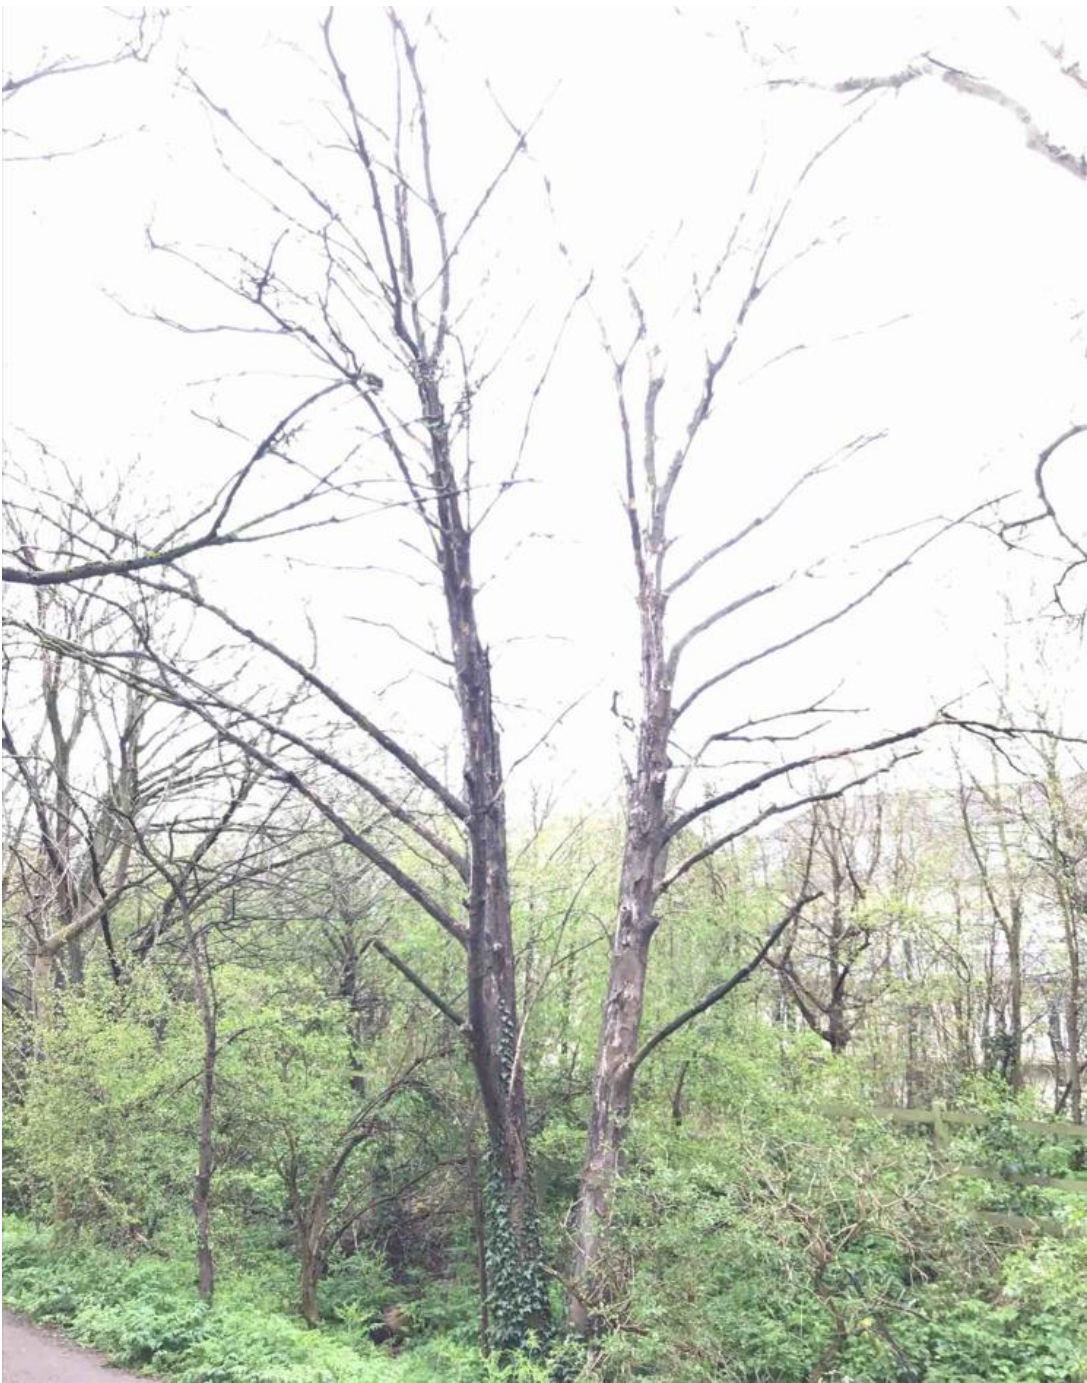
Ward	Kew
Road	Riverside to Chiswick Bridge
Location	Thames Towpath – W3W – baked.nurse.lofts
Species	Sycamore ( <i>Acer pseudoplatanus</i> )
Height	10.0m
Physiological Condition	Dead
Structural Condition	Dead
Inspection findings	This tree is dead; removal is required to prevent natural failure.

Image shows dead tree.
