# **Towpath – Champions Wharf to Railshead Road and Ham to Chiswick Bridge felling document**

## Introduction

Dated 18.9.2023

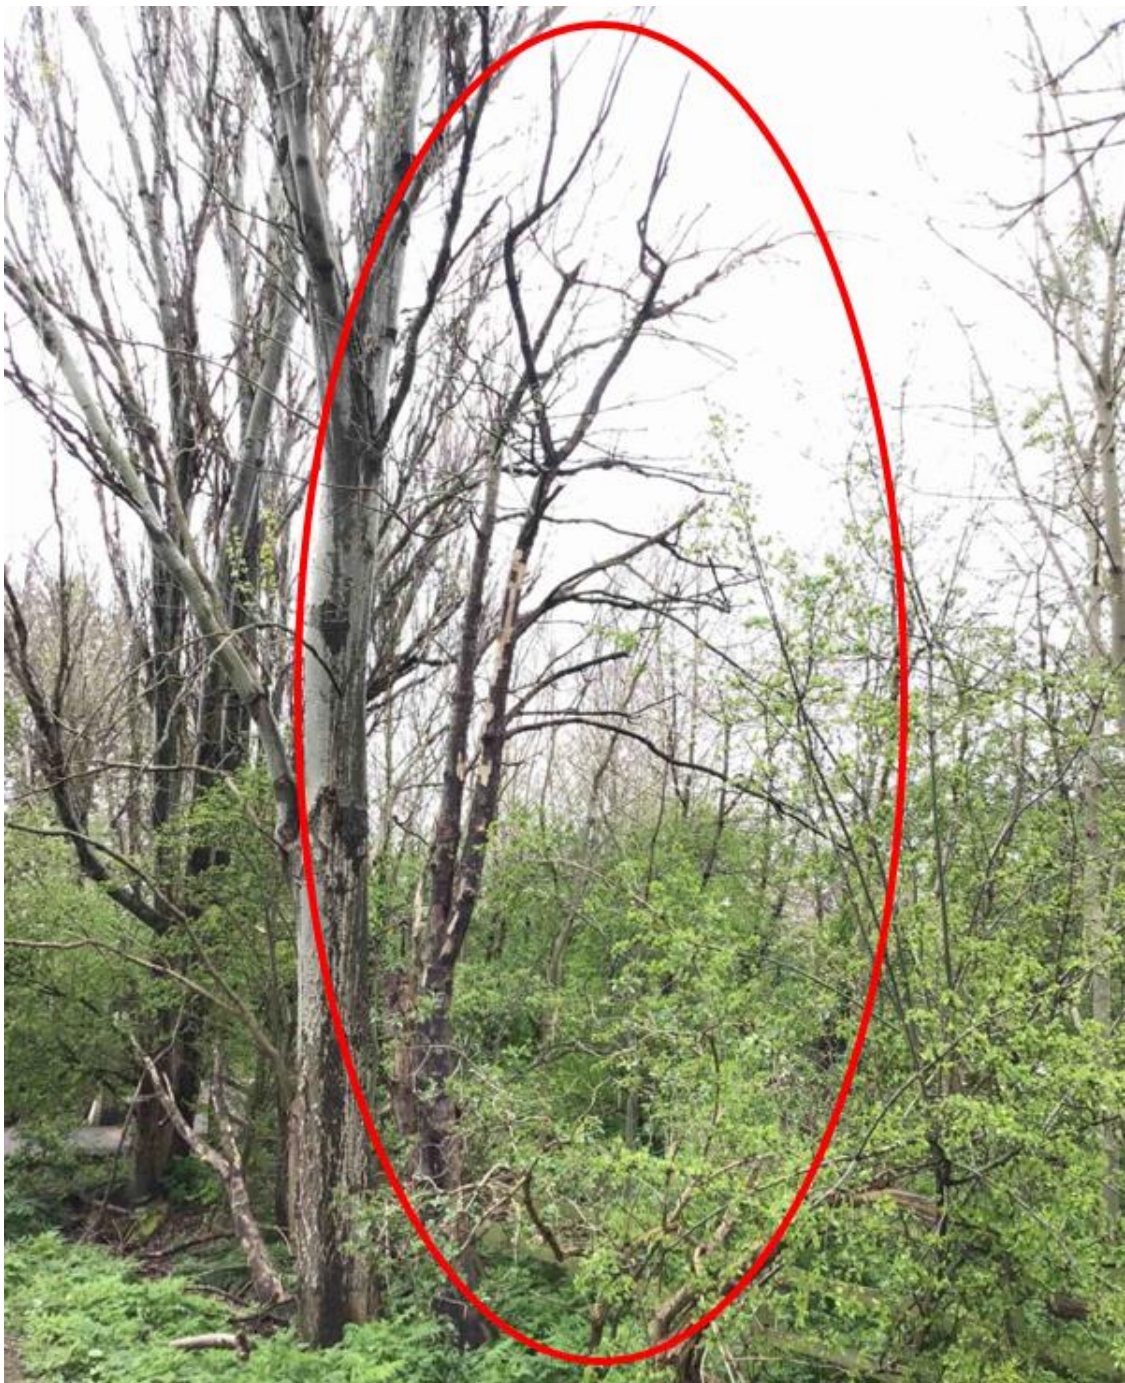
Ward	Kew
Road	Riverside to Chiswick Bridge
Location	Thames Towpath – W3W – shop.hooked.calls
Species	Sycamore ( <i>Acer pseudoplatanus</i> )
Height	7.0m
Physiological Condition	Dead
Structural Condition	Dead
Inspection findings	This tree is dead; removal is required to prevent natural failure.

Image shows dead tree circled in red

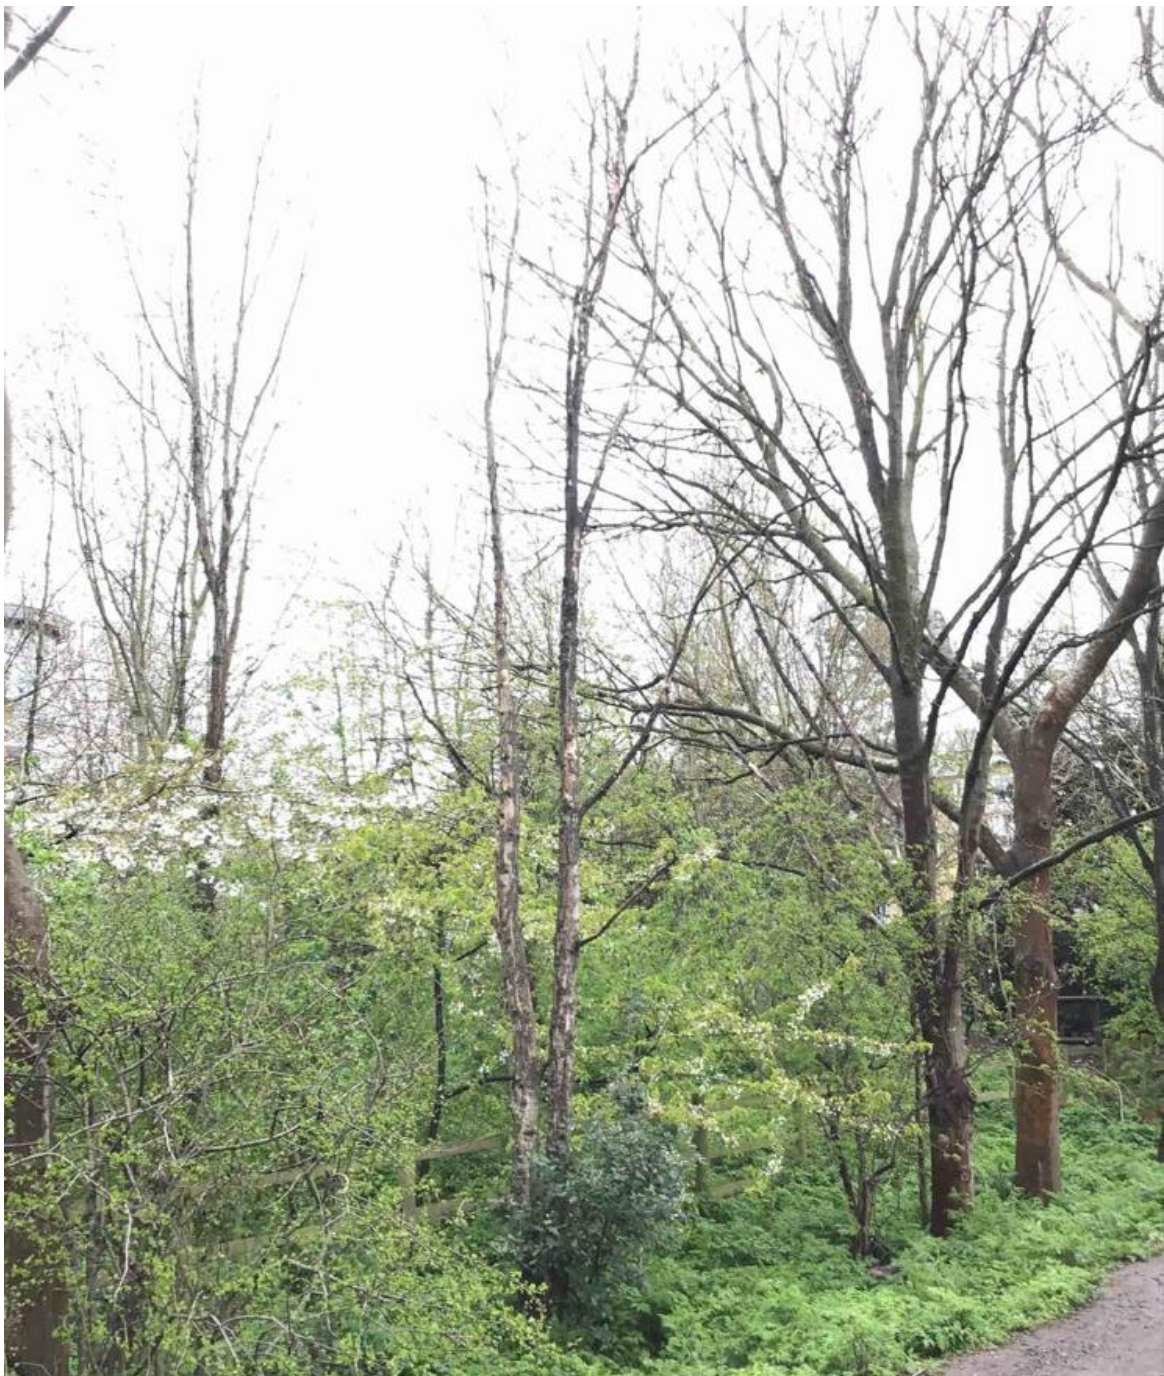
Ward	Kew
Road	Riverside to Chiswick Bridge
Location	Thames Towpath – W3W – stuck.flags.worry
Species	Sycamore ( <i>Acer pseudoplatanus</i> )
Height	9.0m
Physiological Condition	Dead
Structural Condition	Dead
Inspection findings	This tree is dead; removal is required to prevent natural failure.

Image shows dead tree

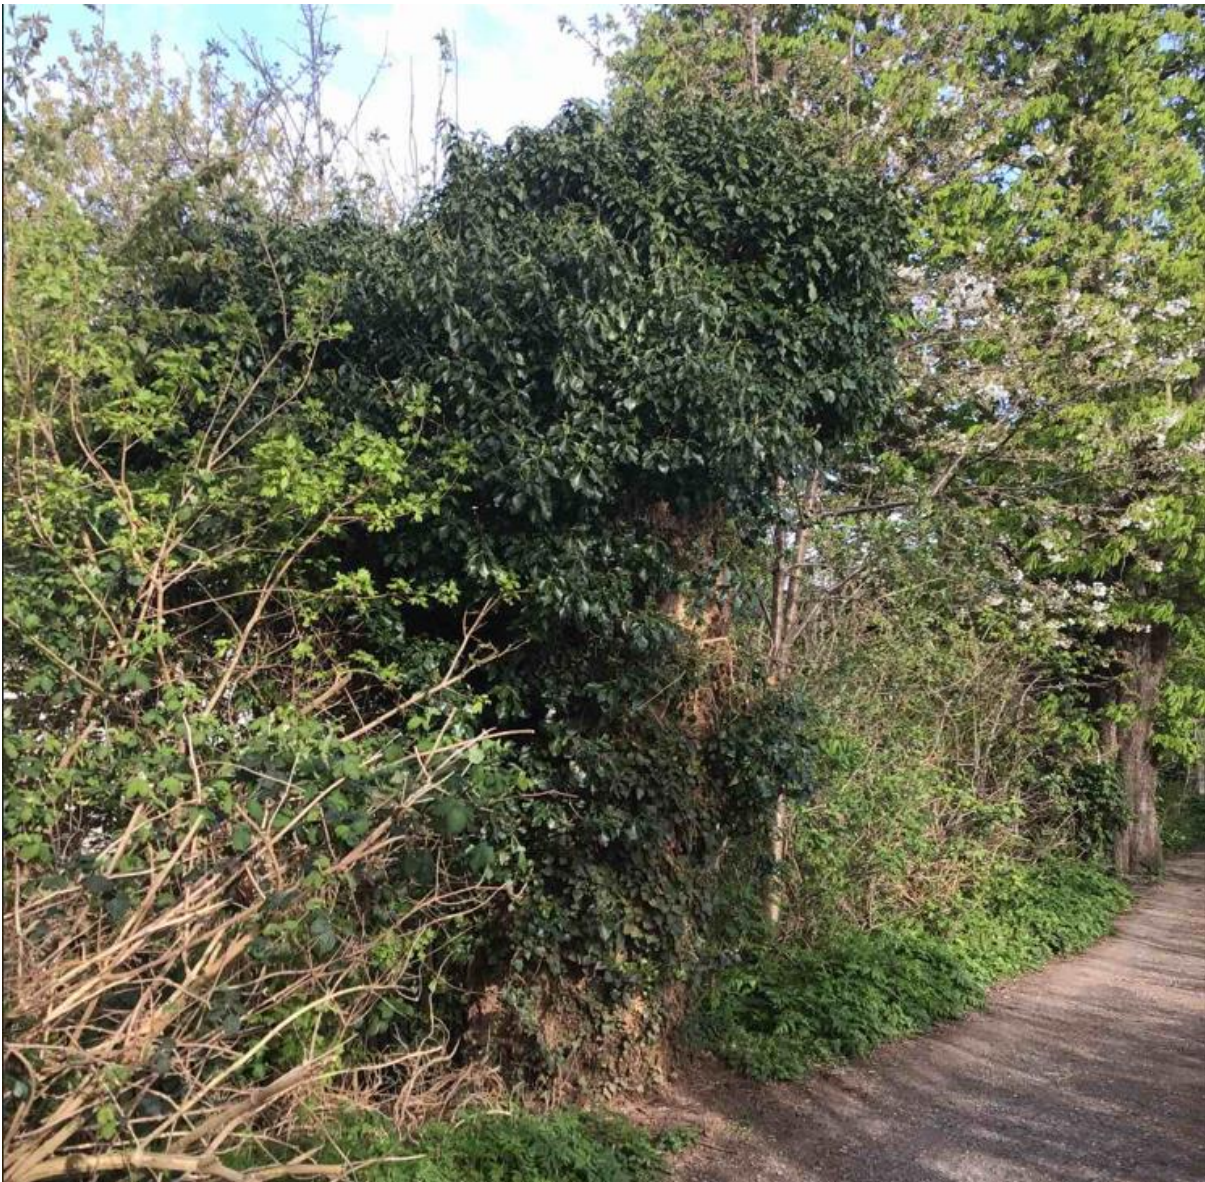
Ward	Kew
Road	Riverside to Chiswick Bridge
Location	Thames Towpath – W3W – reef.admire.pints
Species	Sycamore ( <i>Acer pseudoplatanus</i> )
Height	5.0m
Physiological Condition	Dead
Structural Condition	Dead
Inspection findings	This tree has been retained as a monolith. However, there is now an unacceptable degree of decay and removal is required

Image shows monolith covered with ivy.
