# September 2026 – Highways Reactive Tree Works Programme

Dated 18.9.2026

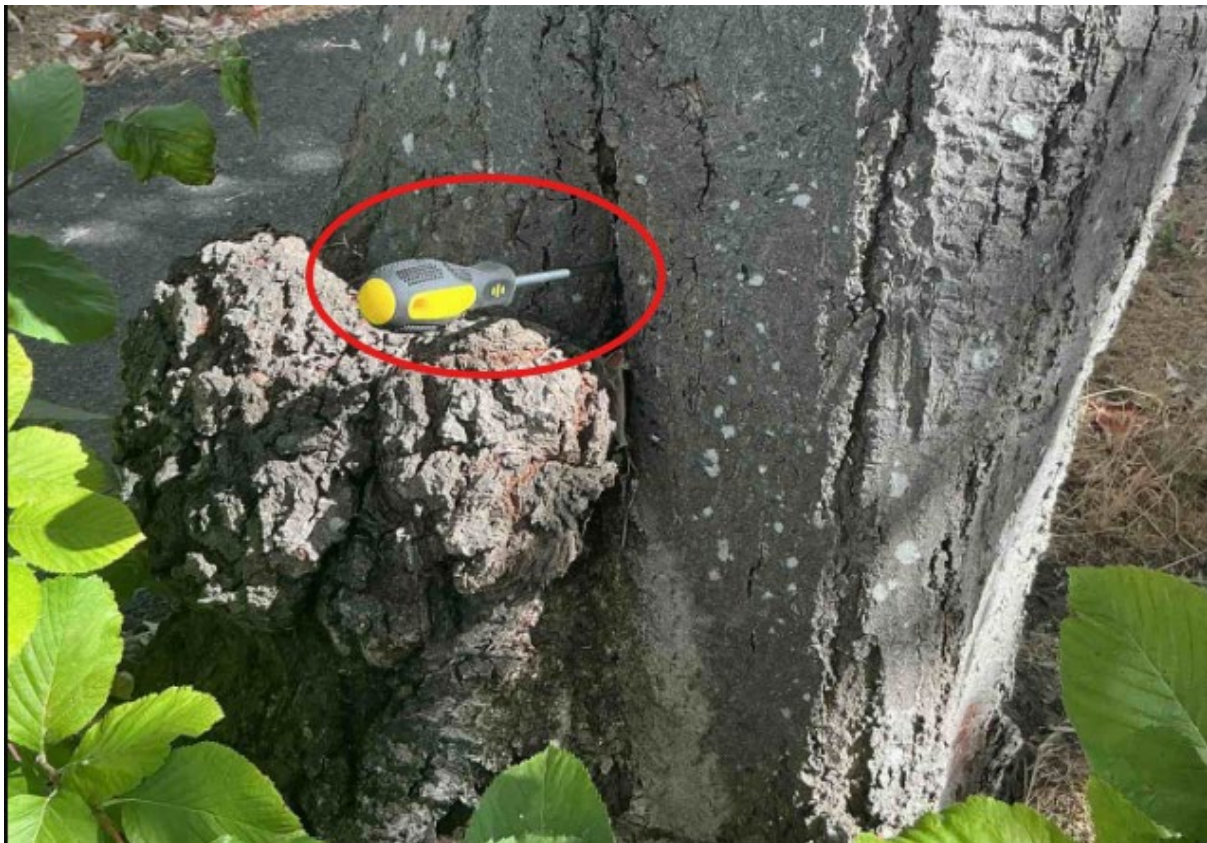
*Image shows probe highlighting cavity at base of trunk.*

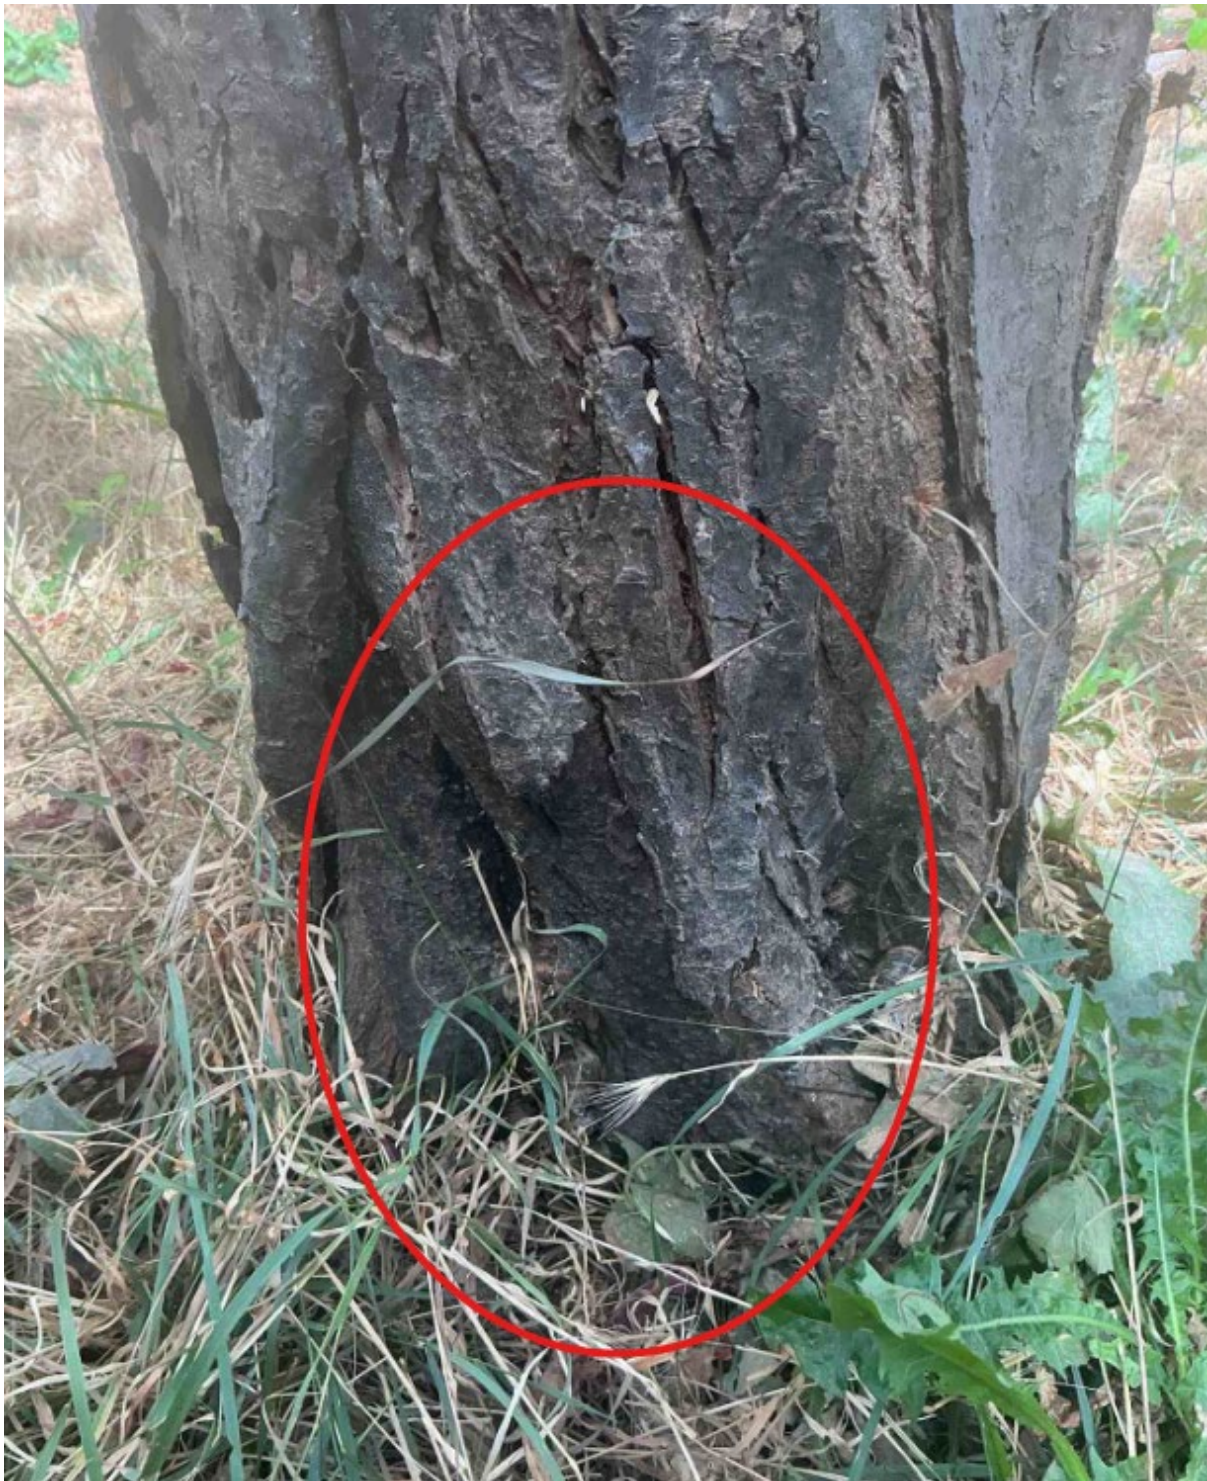
***Images show cavity at base of trunk circled.***

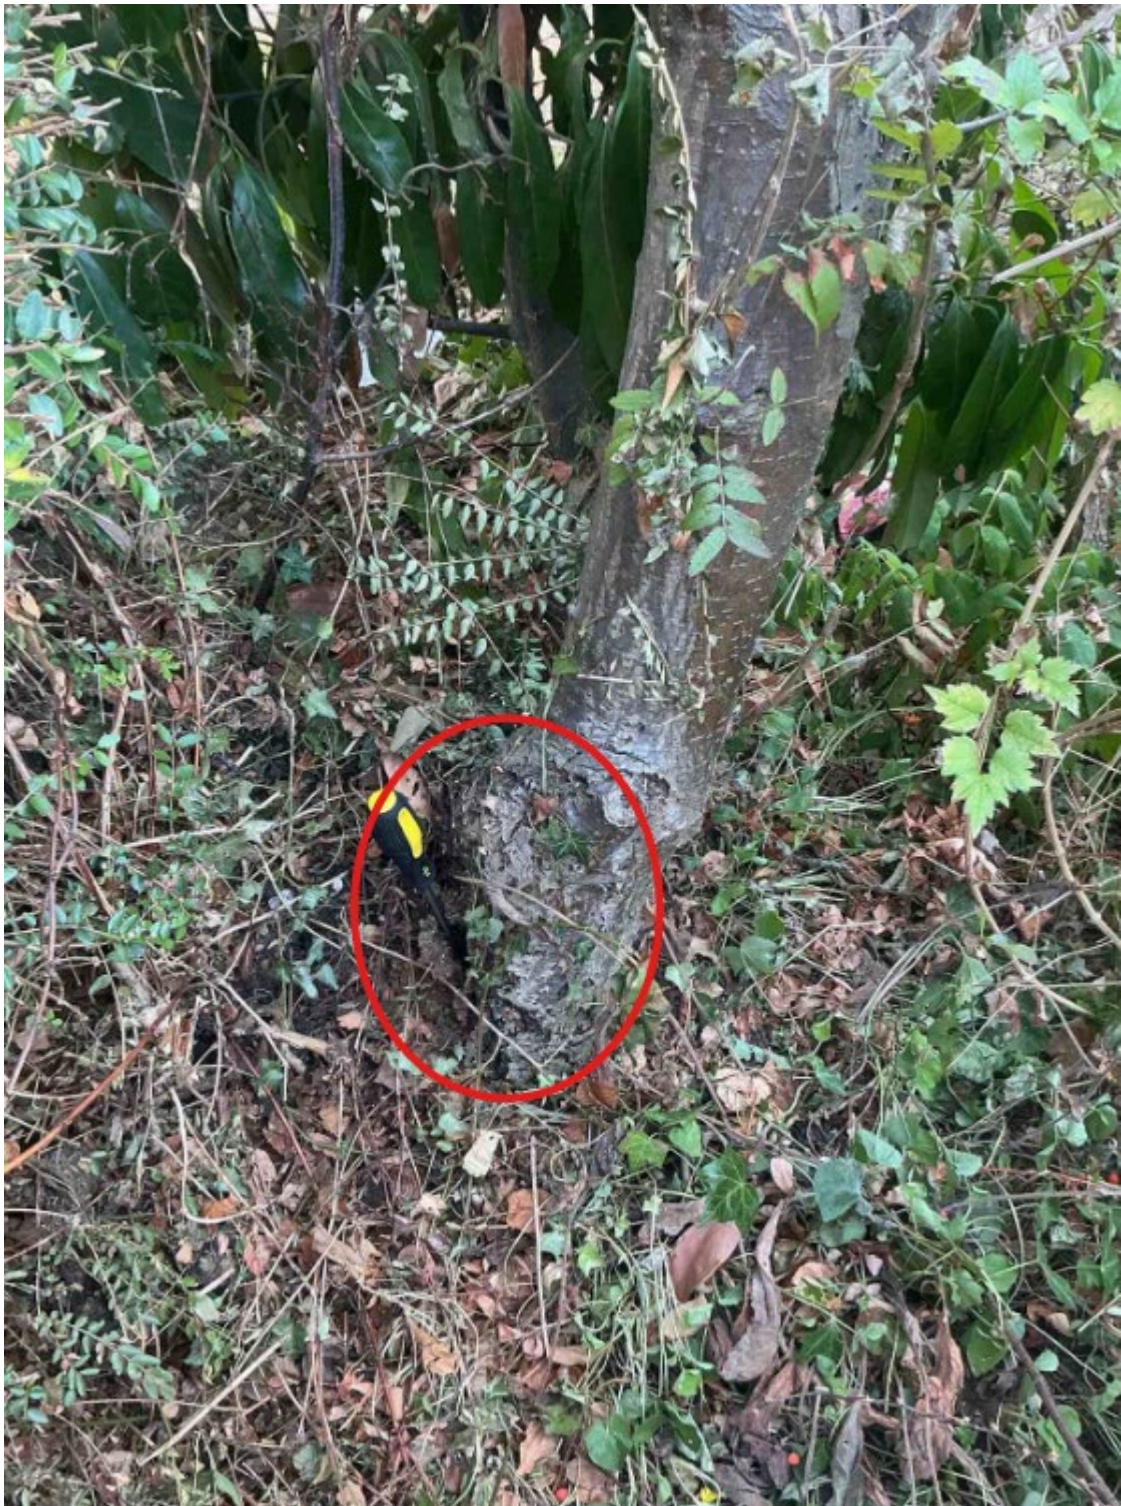
***Images show cavity and probe circled.***

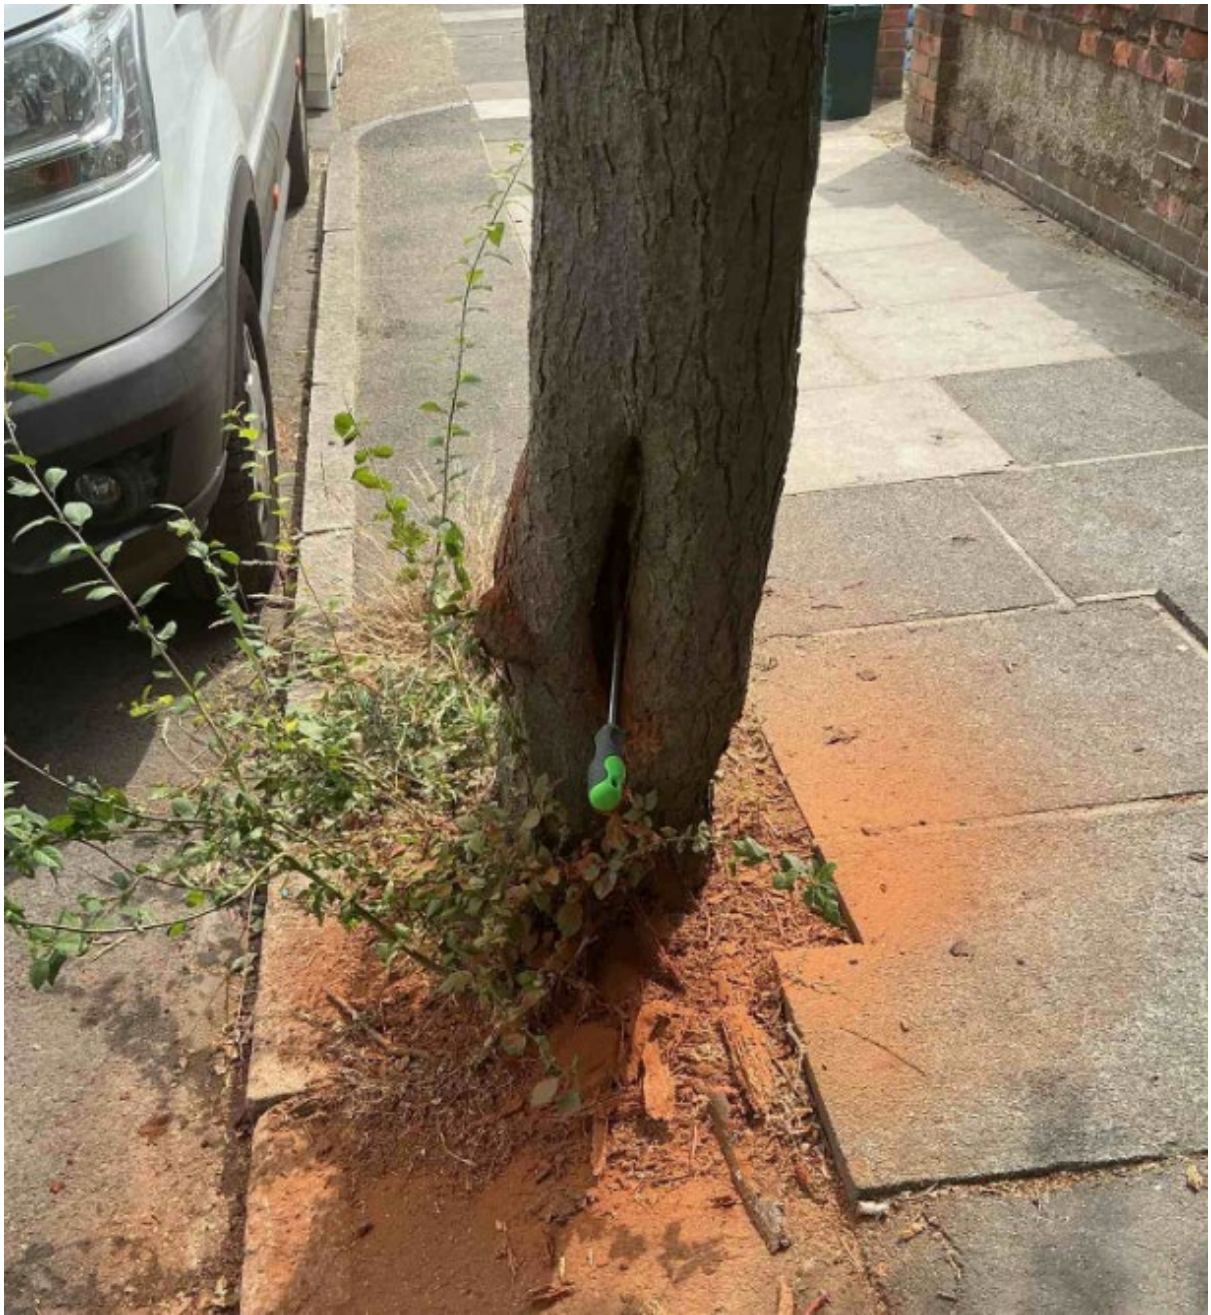
***Image shows cavity at base of trunk.***
