RICHMOND SECTION 19 FLOOD INVESTIGATION

PREPARED FOR LONDON BOROUGH OF
RICHMOND UPON THAMES

Authored by Michael McCarthy
Reviewed by: Tom Whitworth
Approved by Mike Mair
Date June 2023
Version 2.0

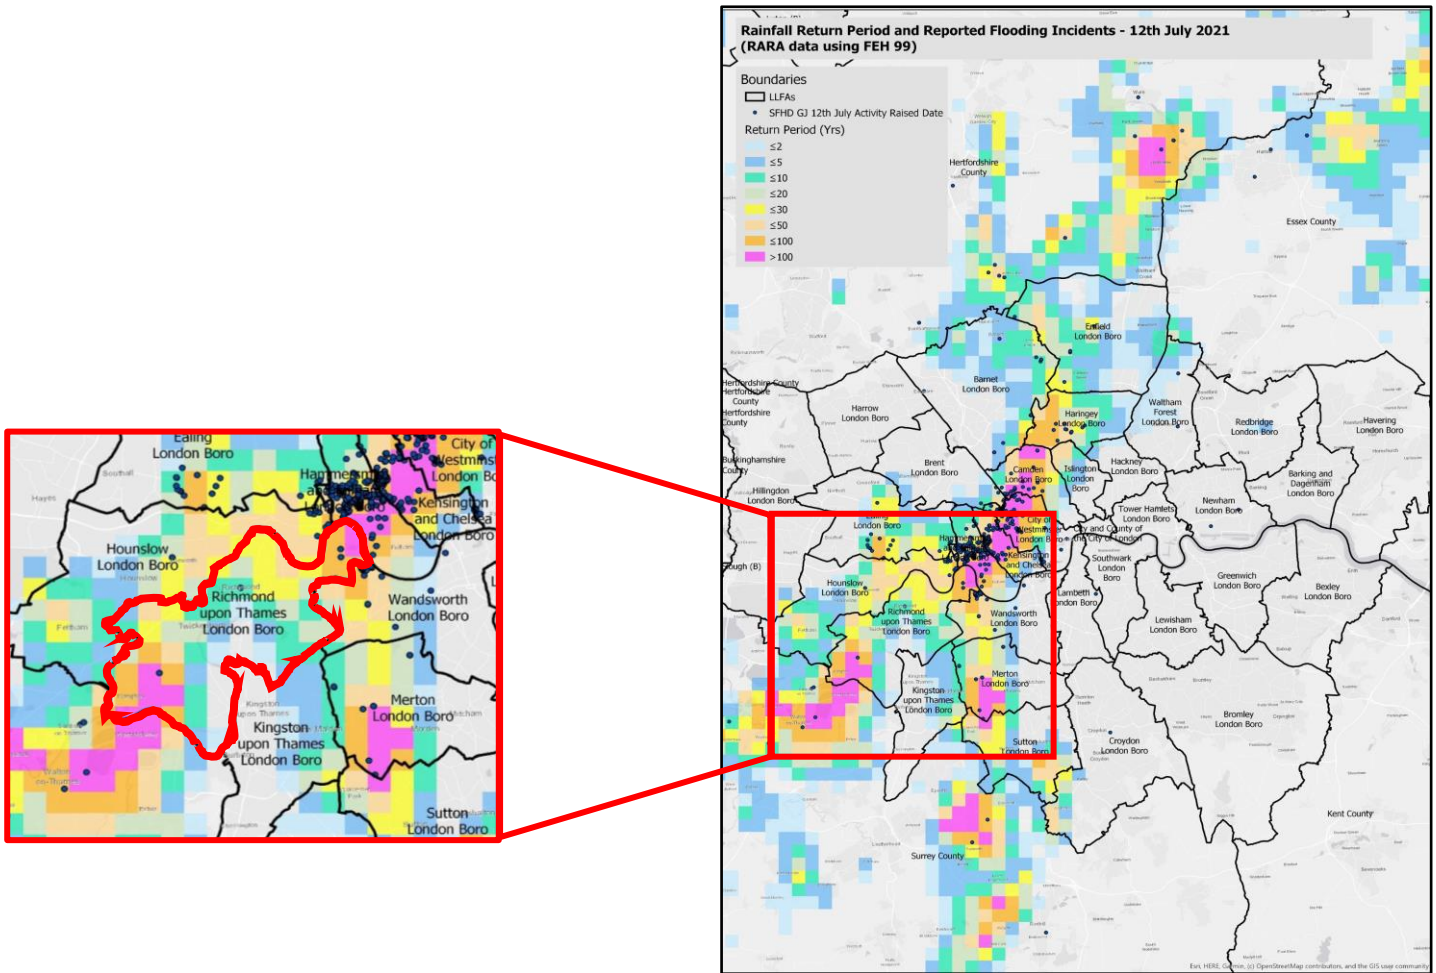
Figure 3-1 July 12th Rainfall return periods in Richmond

The rainfall event that occurred on 12th of July 2021 caused widespread flooding across the South-East of England and London, including in Richmond. Thames Water’s ‘Rainfall Return Period and Reported Flooding Incidents’ data shown in the map in *Figure 3-1* demonstrates the general trend that the North-East and the West of Richmond experienced higher return periods of (greater than 1 in 20 year) on average. In particular, Barnes (North-East) and Hampton (South-East) had the greatest return periods from the event (greater than 1 in 100 year). Central Richmond generally experienced less intense rainfall as shown by the lower return periods of (less than 1 in 10 year). The maps were produced using RaRA data from the Met Office using Flood Estimation Handbook (FEH) 99 calculations for the spatial visualisation. Some limitations to the accuracy of this map were explored in 1.2.

The most likely source of flooding on Chestnut Road during the 12th of July 2021 was sewer flooding. The estimated return period at Chestnut Road was a 1 in 20 year event as seen in *Figure 3-1*. However, it should be noted that the return period at this location may have been greater since Chestnut Road is located close to the border of the 1 in 50 year return period grid square to the South. The limitations to data such as the RaRa data is further discussed in the methodology in 1.2. The flooding report made to Richmond by a resident living on Chestnut Road suggested that the “drains” on Chestnut Road back up quickly during heavy rain, implying that either the surface water sewer on Chestnut Road was surcharging, or that the gullies on Chestnut Road were not free flowing. TWUL surface water sewers are typically designed with a return period of up to a 1 in 30 year event, therefore it should be less likely to surcharge in a 1 in 20 year rainfall event. However, without any specific design records available for the sewer network Chestnut Road this is not possible to confirm either way. Therefore, it is likely that the flooding to Chestnut Road stemmed from a blockage or capacity issue within the surface water sewer or to gullies on the surface. As mentioned in 4.1.2, the topography of Chestnut Road slopes away from Staines Road which suggests that surface water would pond on the surface of the road and not dissipate until the sewer system could receive it, exacerbating the flooding. The resident’s report did not provide details to suggest that groundwater would have contributed as a source of flooding to Chestnut Road in this event. However, Chestnut Road is located in an area of medium to high susceptibility to groundwater flooding, and as mentioned in 4.1.3.2, Chestnut Road is located in the Strawberry Hill Throughflow Catchment, which may have implications to groundwater flooding. Further investigation into the geology and groundwater flow paths is required to quantify the risk of groundwater flooding at Chestnut Road. Whilst it is not possible to conclude with certainty that sewer flooding was the source of flooding at Chestnut Road, the local flood risk information discussed, in combination with the details from the flooding report, suggest that a blockage or capacity issue within the sewer is likely to be the cause.

Sewer flooding is the most likely cause of flooding to Eleanor Grove during the 12th of July 2021 rainfall event. *Figure 3-1* suggests that the return period at Eleanor Grove was a 1 in 100 year event. This substantial volume of rainfall would likely have overwhelmed the TWUL local sewer network which is not typically designed to retain such volumes. This would have resulted in surcharging of the surface water and combined sewers on Eleanor Road. The topography on Eleanor Road slopes away from White Hart Lane which leads to significant ponding further down the road. The CAF

The estimated return period at Lower Mortlake Road was a 1 in 30 year event as seen in *Figure 3-1*, which led to the internal flooding of a single property. The resident report states that blocked gullies in the main road caused water to back up over the pavement and into the property. There was no further information received about the flooding at this location.

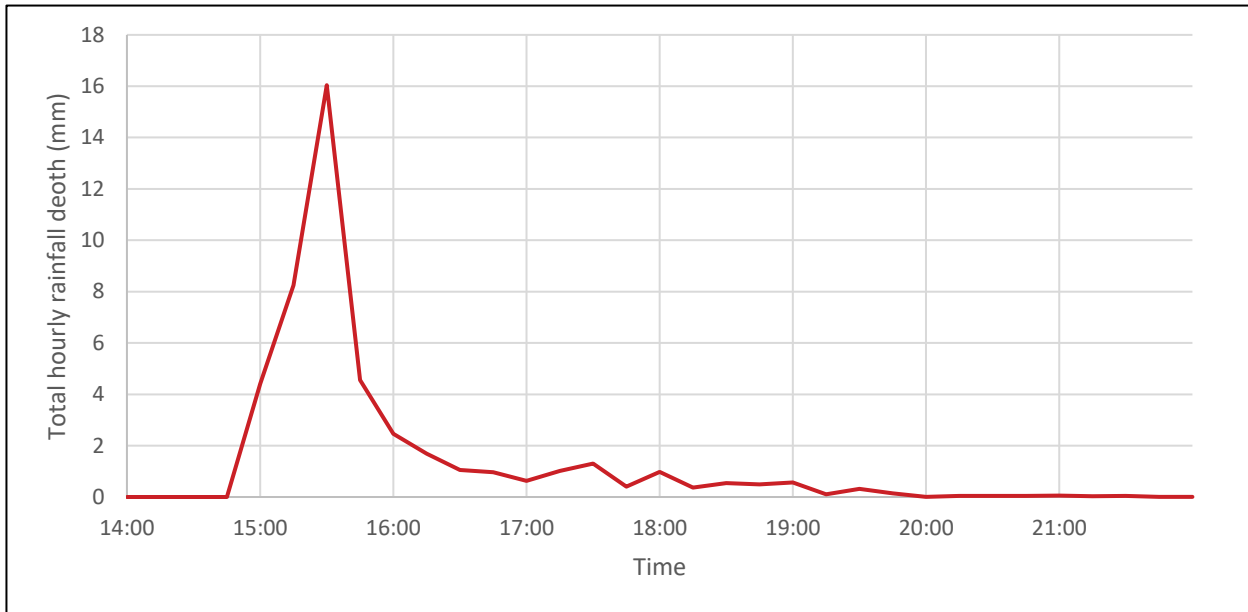
Figure 3-2 Rainfall at Putney Village on 12th of July 2021

Rainfall data as recorded by a nearby rain gauge in Putney Heath has been collated for the rainfall event by the EA. The location of the Putney Village rain gauge lies to the East, outside of the Richmond boundary, and can be seen in *Figure 3-3*. There was no available rain gauge data from within Richmond. The rain gauge provided rainfall data at 15-minute intervals throughout the 12th of July 2021. The graph in *Figure 3-2* shows that the rainfall began intensifying at approximately 14:45 before peaking over Putney Village at approximately 15:30 for a brief period. It then quickly subsided by approximately 16:00. At its peak the rain gauge recorded 16mm of rainfall, while there was a prolonged period of lighter rainfall between 16:00 and 20:00.

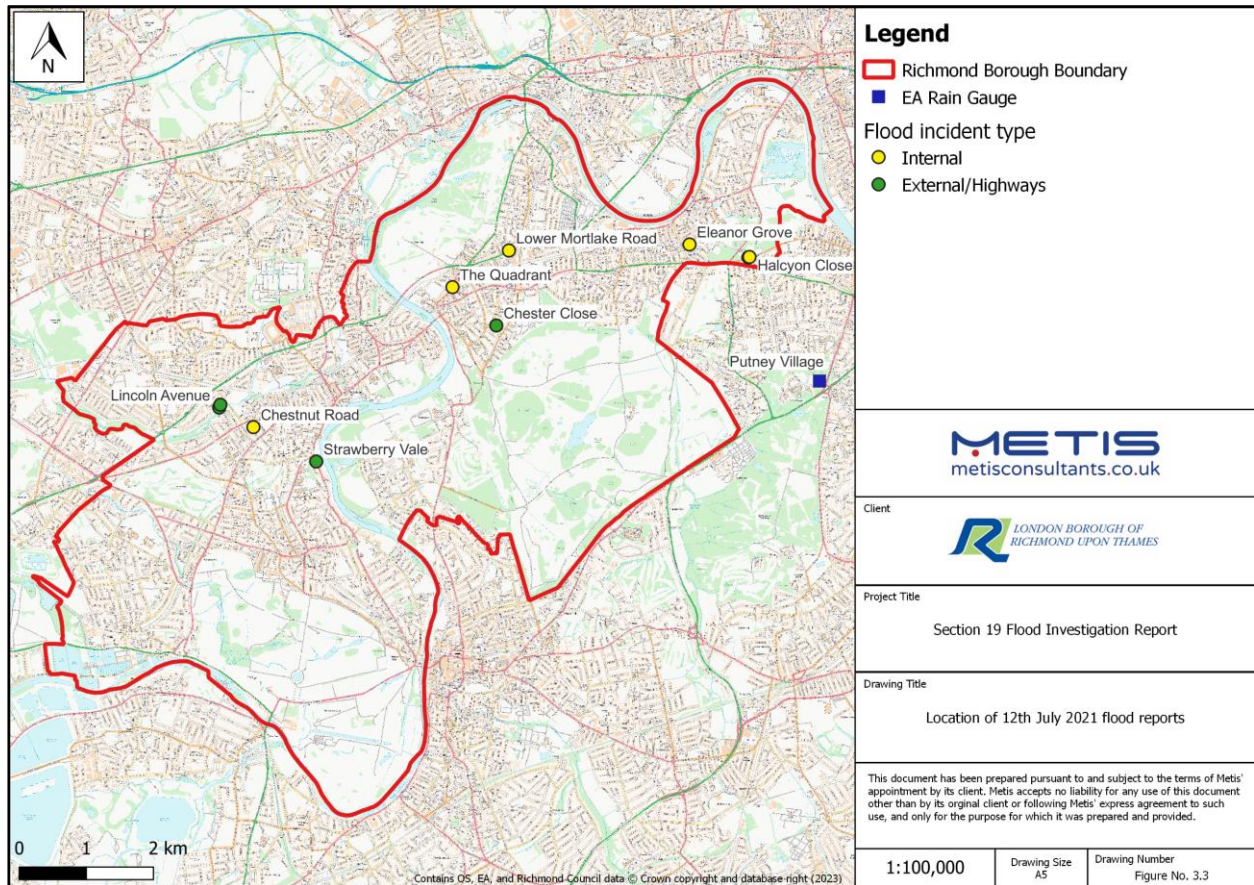
Figure 3-3 Location of 12th of July 2021 flood reports

The LFB received a total of 36 calls from properties within Richmond regarding flooding, although some of these calls may have been duplicate calls from the same address. The most affected area was SW13 in Barnes, where the LFB attended ten addresses to assist with flooding on the 12th of July 2021. Once the rain had subsided and the gullies and sewers were able to cope the LFB received calls to cancel their attendance.

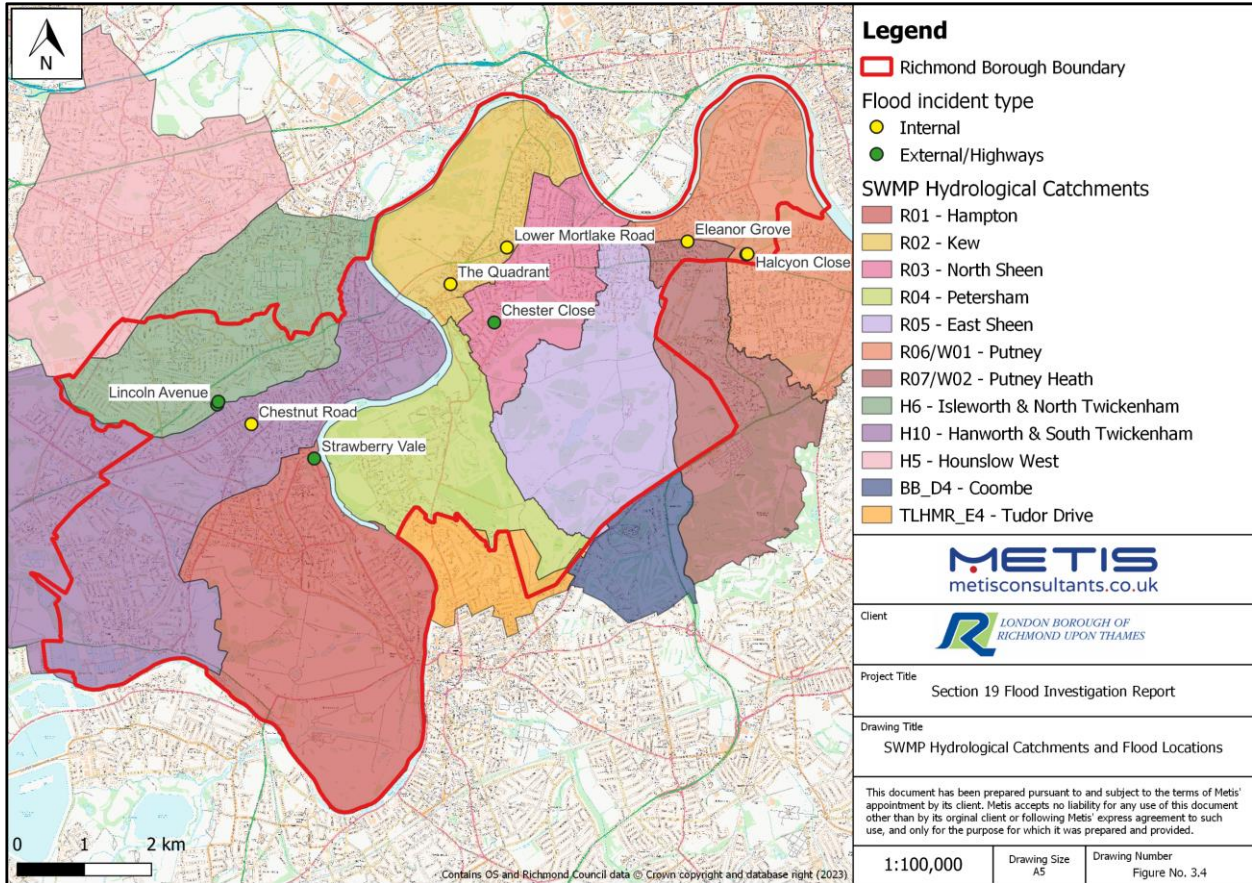
Figure 3-4 SWMP Hydrological Catchments and flood locations

London Borough of Hounslow, The London Borough of Wandsworth (Wandsworth), and the Royal Borough of Kingston upon Thames, but share an overlapping area with Richmond. The flooding reports from the 12th of July event are distributed between four catchments, as seen in *Figure 3-4*. Chestnut Road is located in the Hanworth and South Twickenham catchment, The Quadrant and Lower Mortlake Road are both located within the Kew catchment, Eleanor Grove is located within the Putney Heath Catchment, and Halcyon Close is located within the Putney catchment.

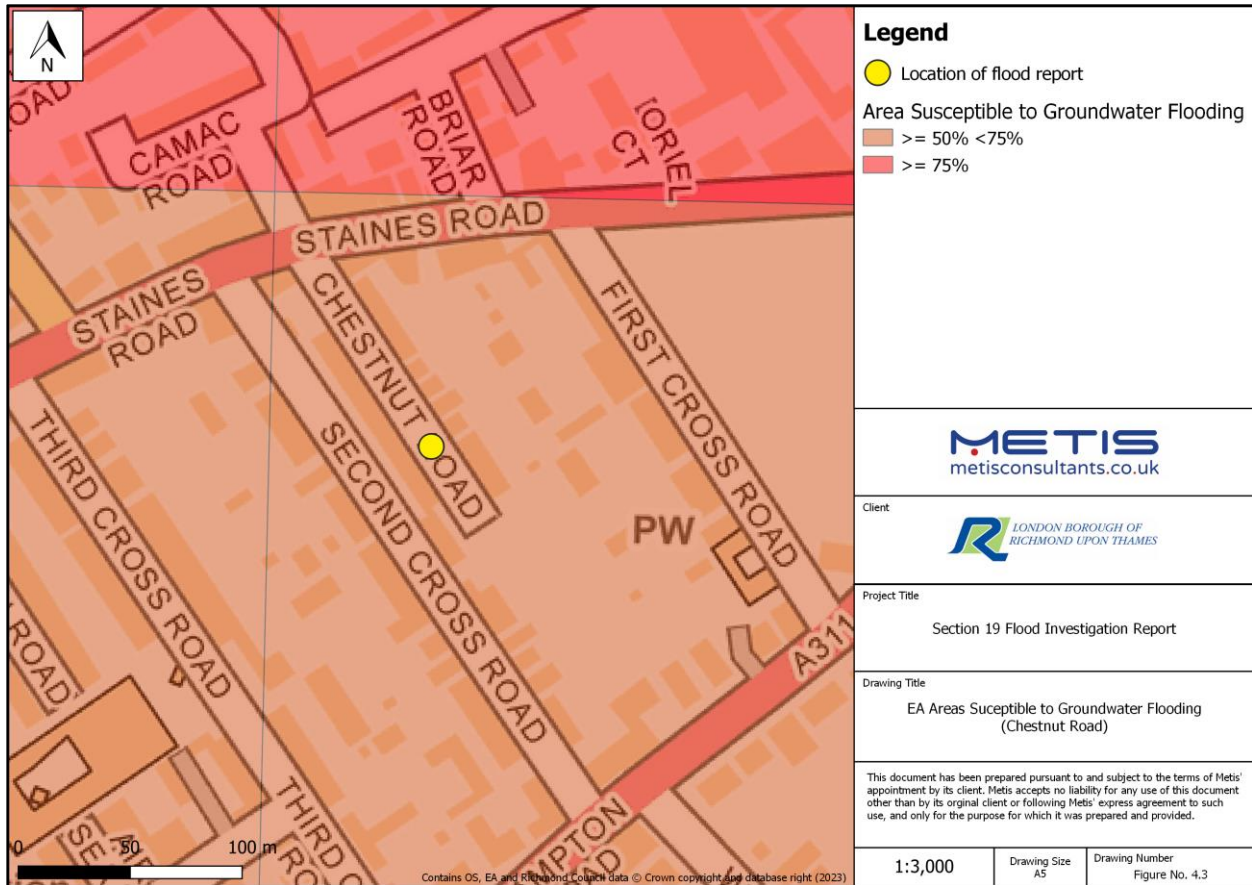
Figure 4-3 Areas susceptible to groundwater flooding (Chestnut Road)

following prolonged periods of heavy rain, however the response time to rainfall may vary with the local geology. Mapping data from the EA, termed Areas Susceptible to Groundwater Flooding, shows the susceptibility of each 1km² to the emergence of groundwater. Chestnut Road is situated within an area of medium to high susceptibility of groundwater emergence (between 50% and 75% susceptibility) as shown in *Figure 4-3*. Chestnut Road also falls within the Strawberry Hill Throughflow Catchment as defined in Richmond’s [Further Groundwater Investigations report](#). Throughflow Catchment areas are catchments that change geographically with the change in Topography.

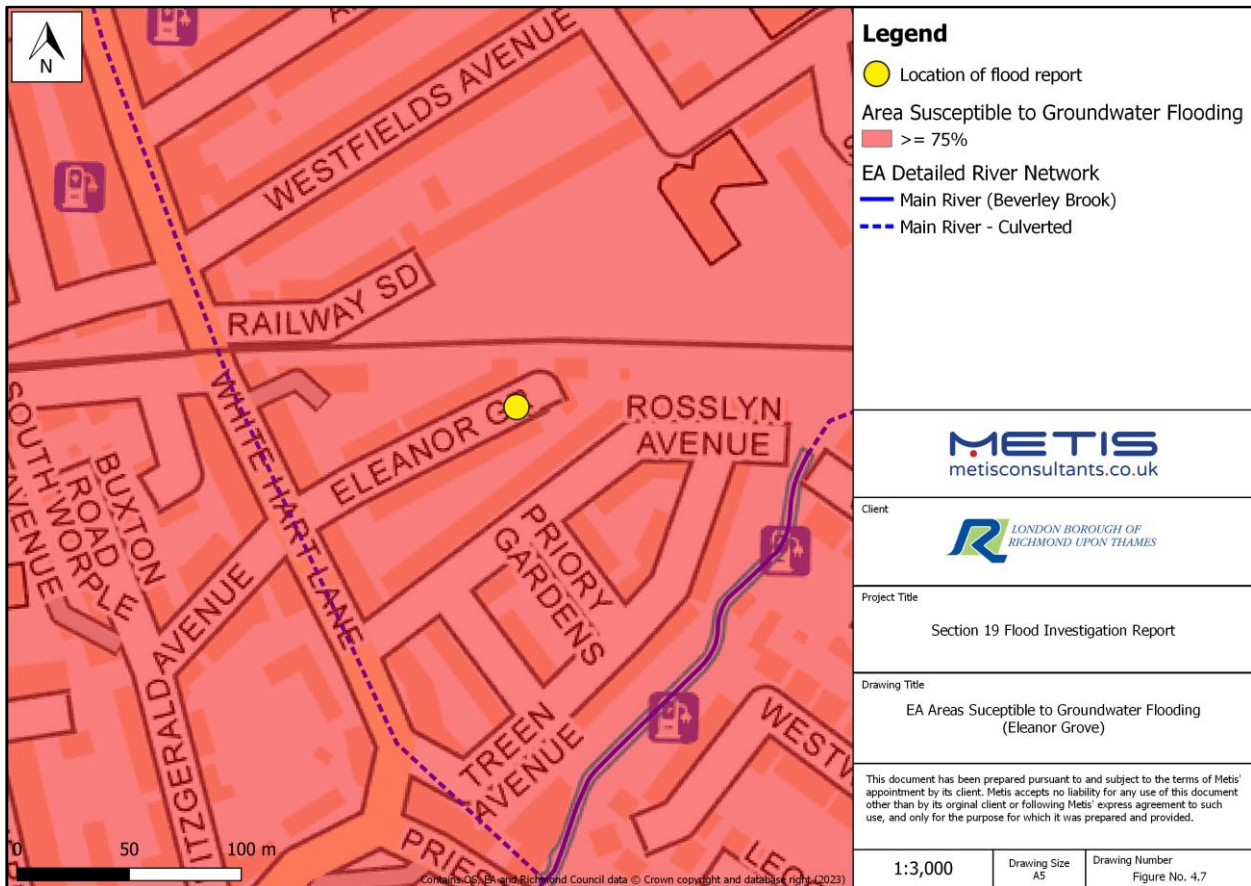
Figure 4-7 Areas susceptible to groundwater flooding (Eleanor Grove)

As previously described in 4.1.3.2, flooding from groundwater occurs when the underground water table rises above the surface of the ground. The EA’s Areas Susceptible to Groundwater Flooding mapping shown below in *Figure 4-7* predicts that Eleanor Grove is highly susceptible to groundwater emergence, with a predicted susceptibility of greater than or equal to 75%. The [Further Groundwater Investigations Report](#) shows that Eleanor Grove is not located within a Throughflow Catchment.

The resident report also mentions that there was 30mm deep flooding to the below ground kitchen. This flooding could have been caused by groundwater since Eleanor Grove is shown to be in an area of high susceptibility to groundwater emergence. However, there are no details within the report which describe how the water entered the below ground kitchen. A more likely explanation, in line with the suggestion that the highway "drains" were unable to cope, could be that surface water had entered the kitchen from one of the property entrances.

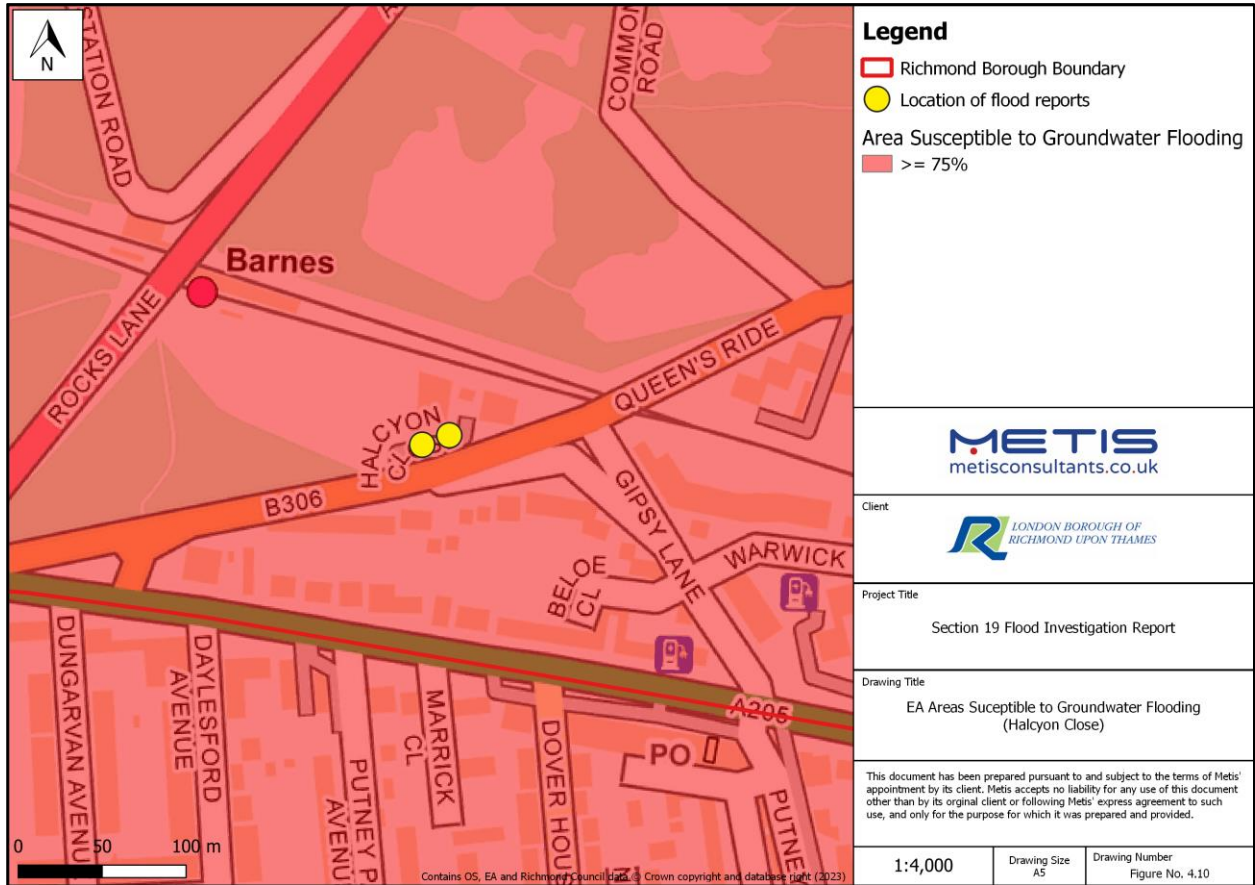
Figure 4-10 Areas susceptible to groundwater flooding (Halcyon Close)
*The pink circle is part of the base map and represents Barnes Train Station

As previously described in 4.1.3.2, flooding from groundwater occurs when the underground water table rises above the surface of the ground. The EA's Areas Susceptible to Groundwater Flooding mapping shown below in *Figure 4-10* predicts that Halcyon Close and the surrounding area are highly susceptible to groundwater emergence, with a susceptibility of greater than or equal to 75%.

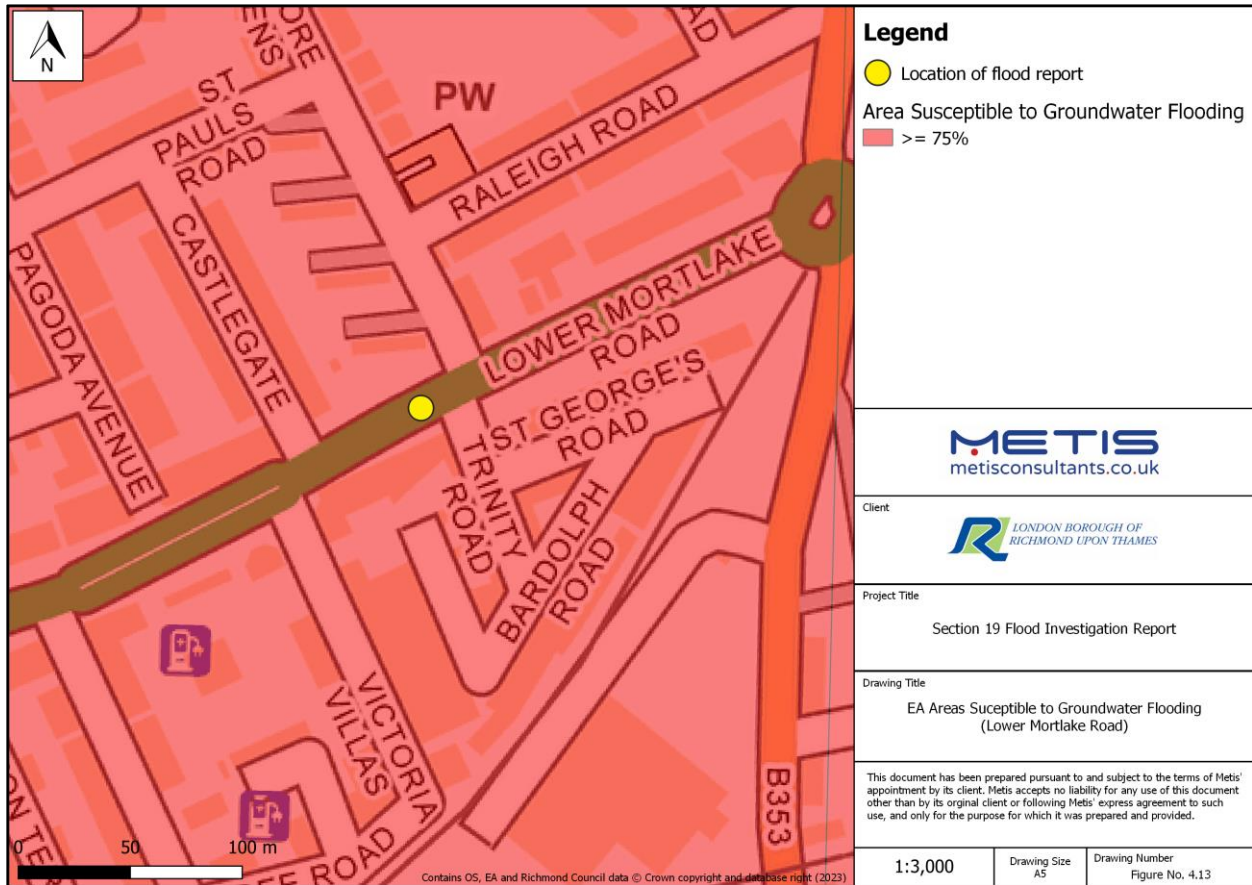
Figure 4-13 Areas susceptible to groundwater flooding (Lower Mortlake Road)

As previously described in 4.1.3.2, flooding from groundwater occurs when the underground water table rises above the surface of the ground. The EA's Areas Susceptible to Groundwater Flooding mapping shown below in *Figure 4-13* predicts that Lower Mortlake Road and the surrounding area are highly susceptible to groundwater emergence, with a susceptibility of greater than or equal to 75%. Lower Mortlake Road also falls within the Richmond Hill Throughflow Catchment as defined in Richmond's [Further Groundwater Investigations report](#). As previously described in 4.1.3.2, Throughflow Catchment areas are catchments that change geographically with the change in Topography.

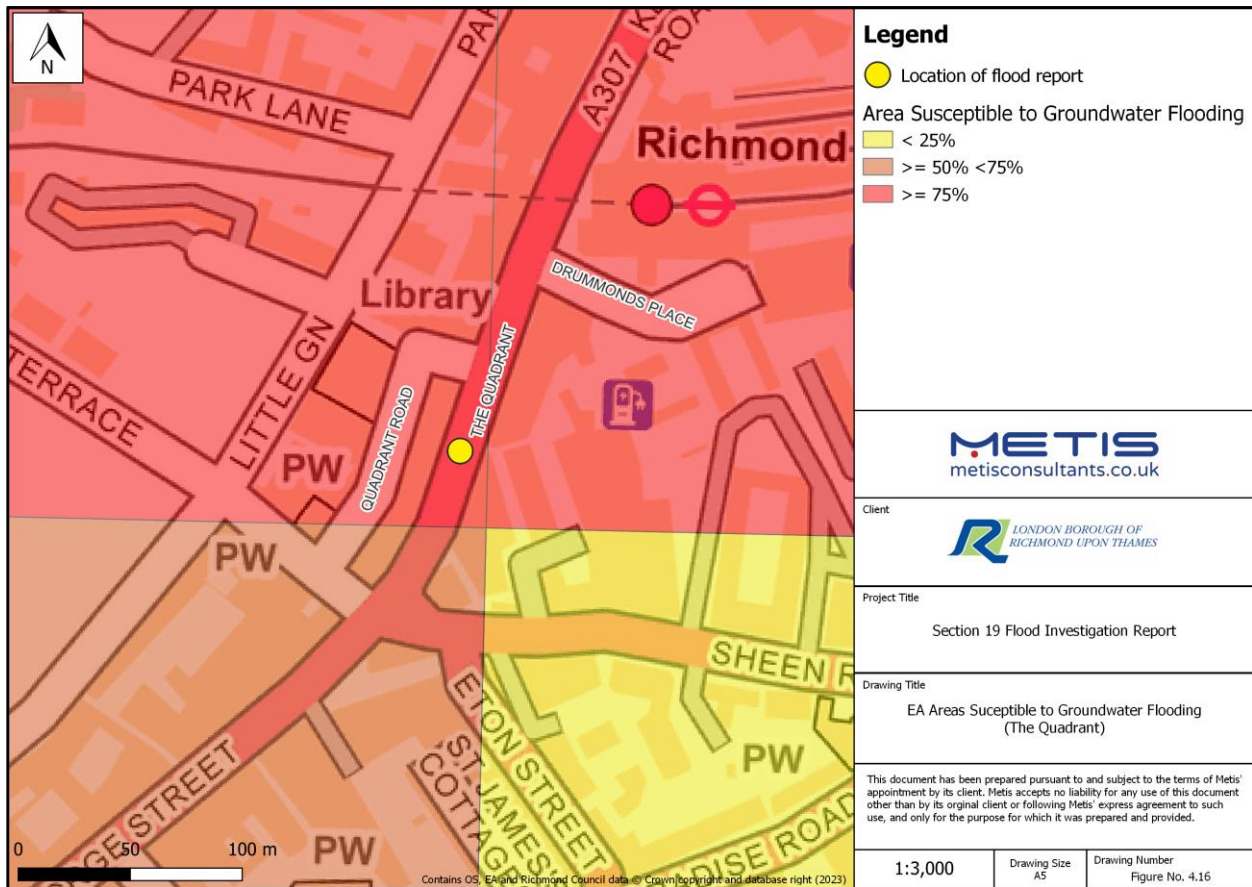
Figure 4-16 Areas susceptible to groundwater flooding (The Quadrant)
 *The pink circle is part of the base map and represents Richmond Train Station

As previously described in 4.1.3.2, flooding from groundwater occurs when the underground water table rises above the surface of the ground. The EA’s Areas Susceptible to Groundwater Flooding mapping shown below in *Figure 4-16* predicts that The Quadrant has a high susceptibility to groundwater emergence of greater than or equal to 75%. The susceptibility of groundwater emergence is less in the Southern end of the Quadrant where there is a medium susceptibility (between 50% and 75%). There is also a low susceptibility to groundwater emergence (less than 25%) to the South-East of The Quadrant. The Quadrant also falls within the Richmond Hill Throughflow Catchment as defined in Richmond’s [Further](#)

[Groundwater Investigations report](#). As previously described in 4.1.3.2, Throughflow Catchment areas are catchments that change geographically with the change in Topography.

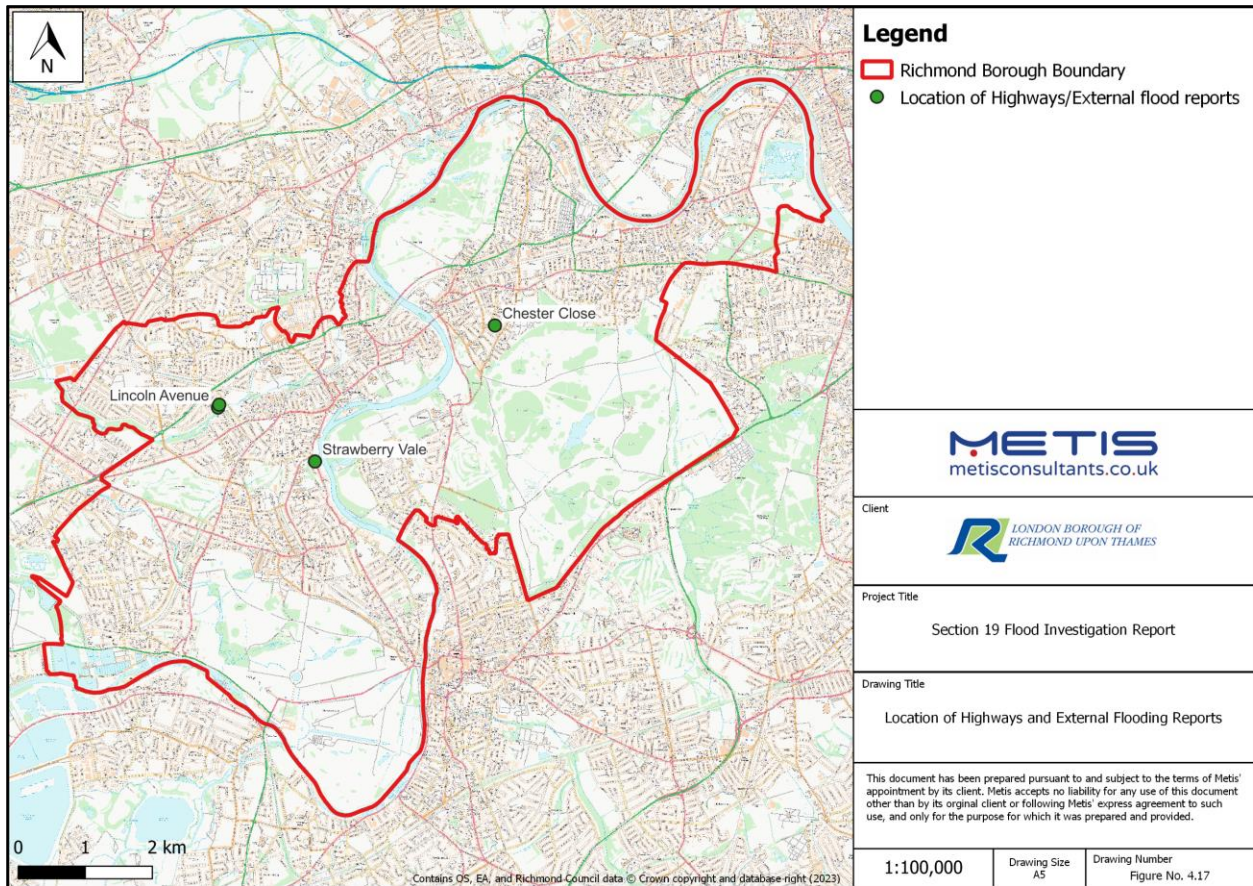
Figure 4-17 Location of Highways / External flooding reports

Whilst Richmond’s S19 criteria defined in 1.1 does not account for external / highways flooding unless it impacts on an identified item of critical infrastructure, there were four reports external / highways flooding as shown in *Figure 4-17*. There were individual reports at Chester Close, Strawberry Vale, and two reports at Lincoln Avenue. These locations are not individually investigated in detail within this report, however it is important to record that they flooded as a result of the 12th of July rainfall event. There was also anecdotal evidence of flooding on Barnes Green and to properties along the River Thames, although no official resident reports were received for these locations, hence their exclusion from this report. It is believed that flooding to the Barnes Green area occurred because of tide locking of the River Thames, and that the green acted as floodplain and flooded as intended. There were also mentions of highway flooding to Second Cross Road and Rosslyn Avenue within the reports Richmond had received for Chestnut Road and Eleanor Grove respectively. These roads may have been affected by the same sources discussed in this report, although further investigation will be required.
