# August 2026 - Reactive Tree Works Programme

A survey of trees in the Kew, South Richmond and Whitton wards are currently being undertaken; this is being conducted by specialist arboricultural officers as part of the scheduled 4 yearly detailed inspection regime that has been devised for all Council highway and parks trees.

Recent reactive inspections have identified the need for 106 individual tree work operations to take place. This work will now be issued to the Council’s Arborist Contractor KPS, for completion over the Autumn period.

The following pages provide the locations of each tree that is to be removed, in addition photographs and descriptions of the inspection findings have been provided.

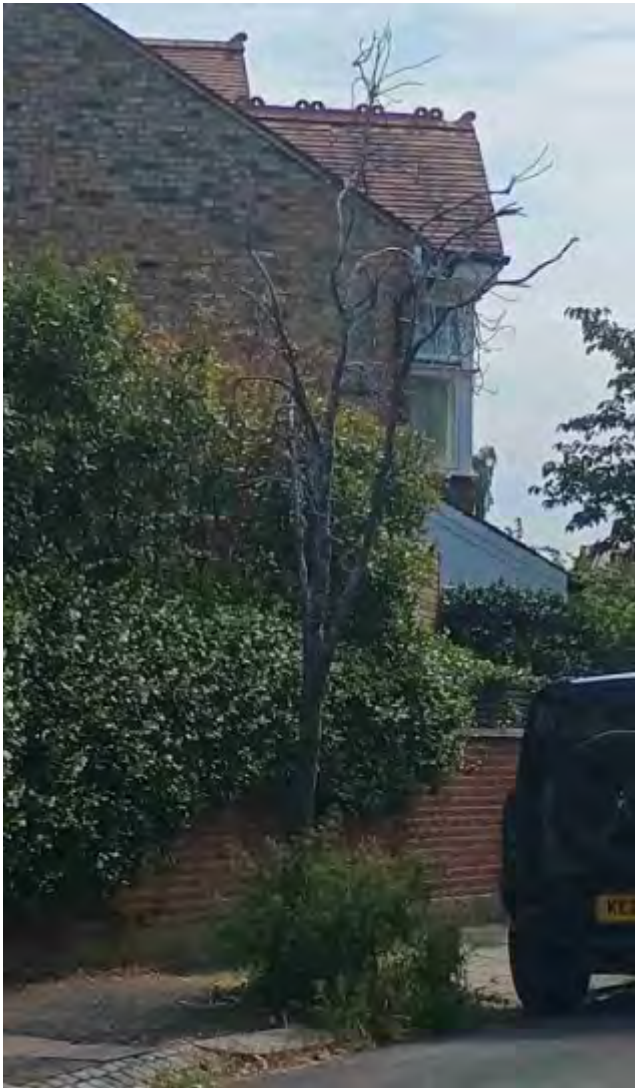
| Inspection findings/reason for exemption | This tree is dead; removal is required to prevent natural failure, manage risk, and facilitate replanting. |

Image shows dead tree in street scene.

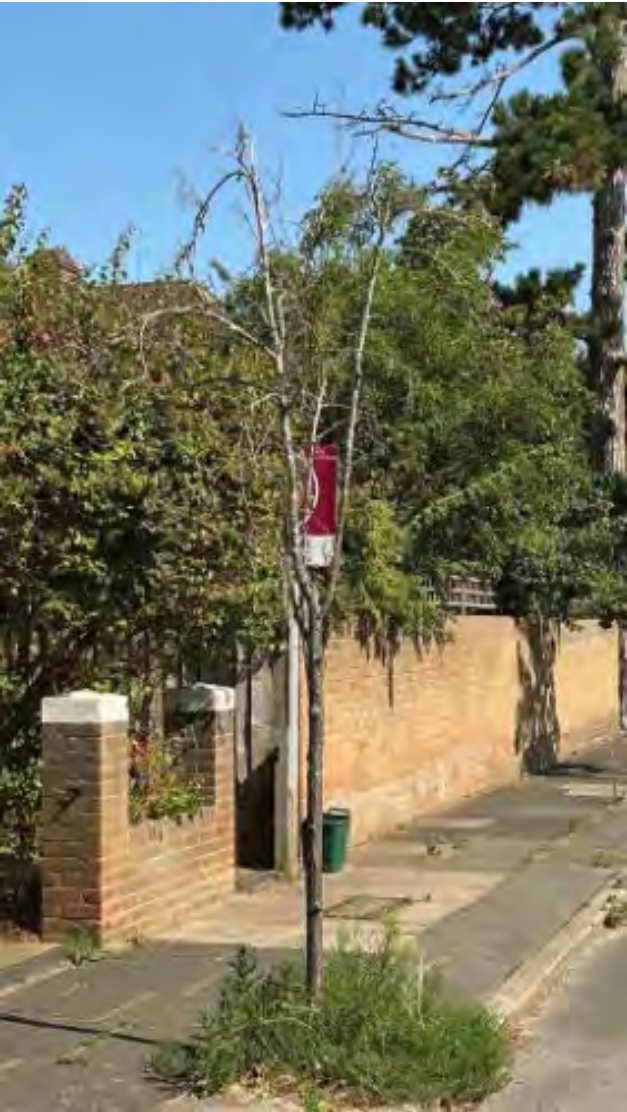
| Inspection findings/reason for exemption | This tree is dead; removal is required to prevent natural failure, manage risk, and facilitate replanting. |

Image shows dead tree in street scene.

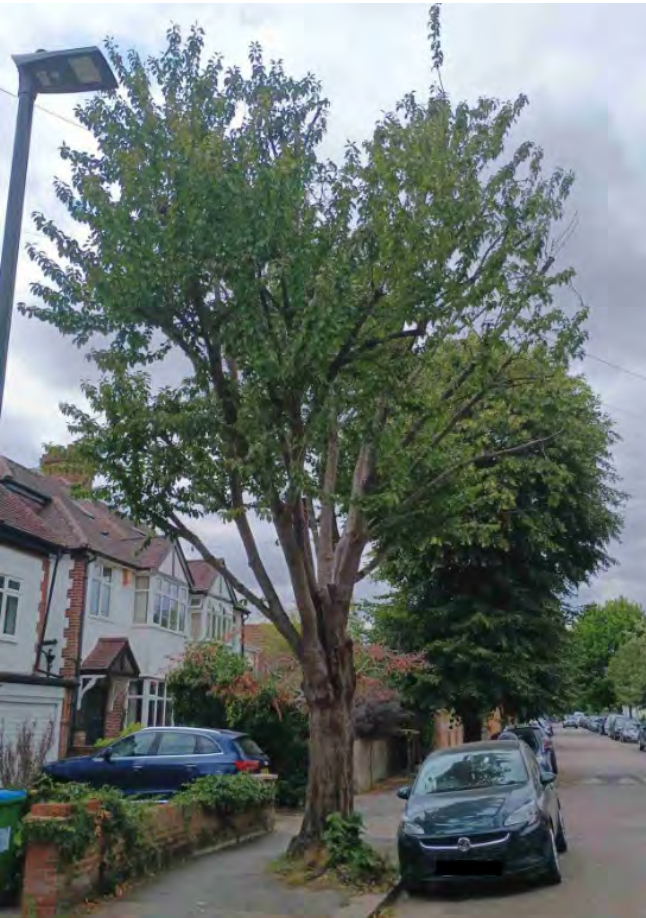
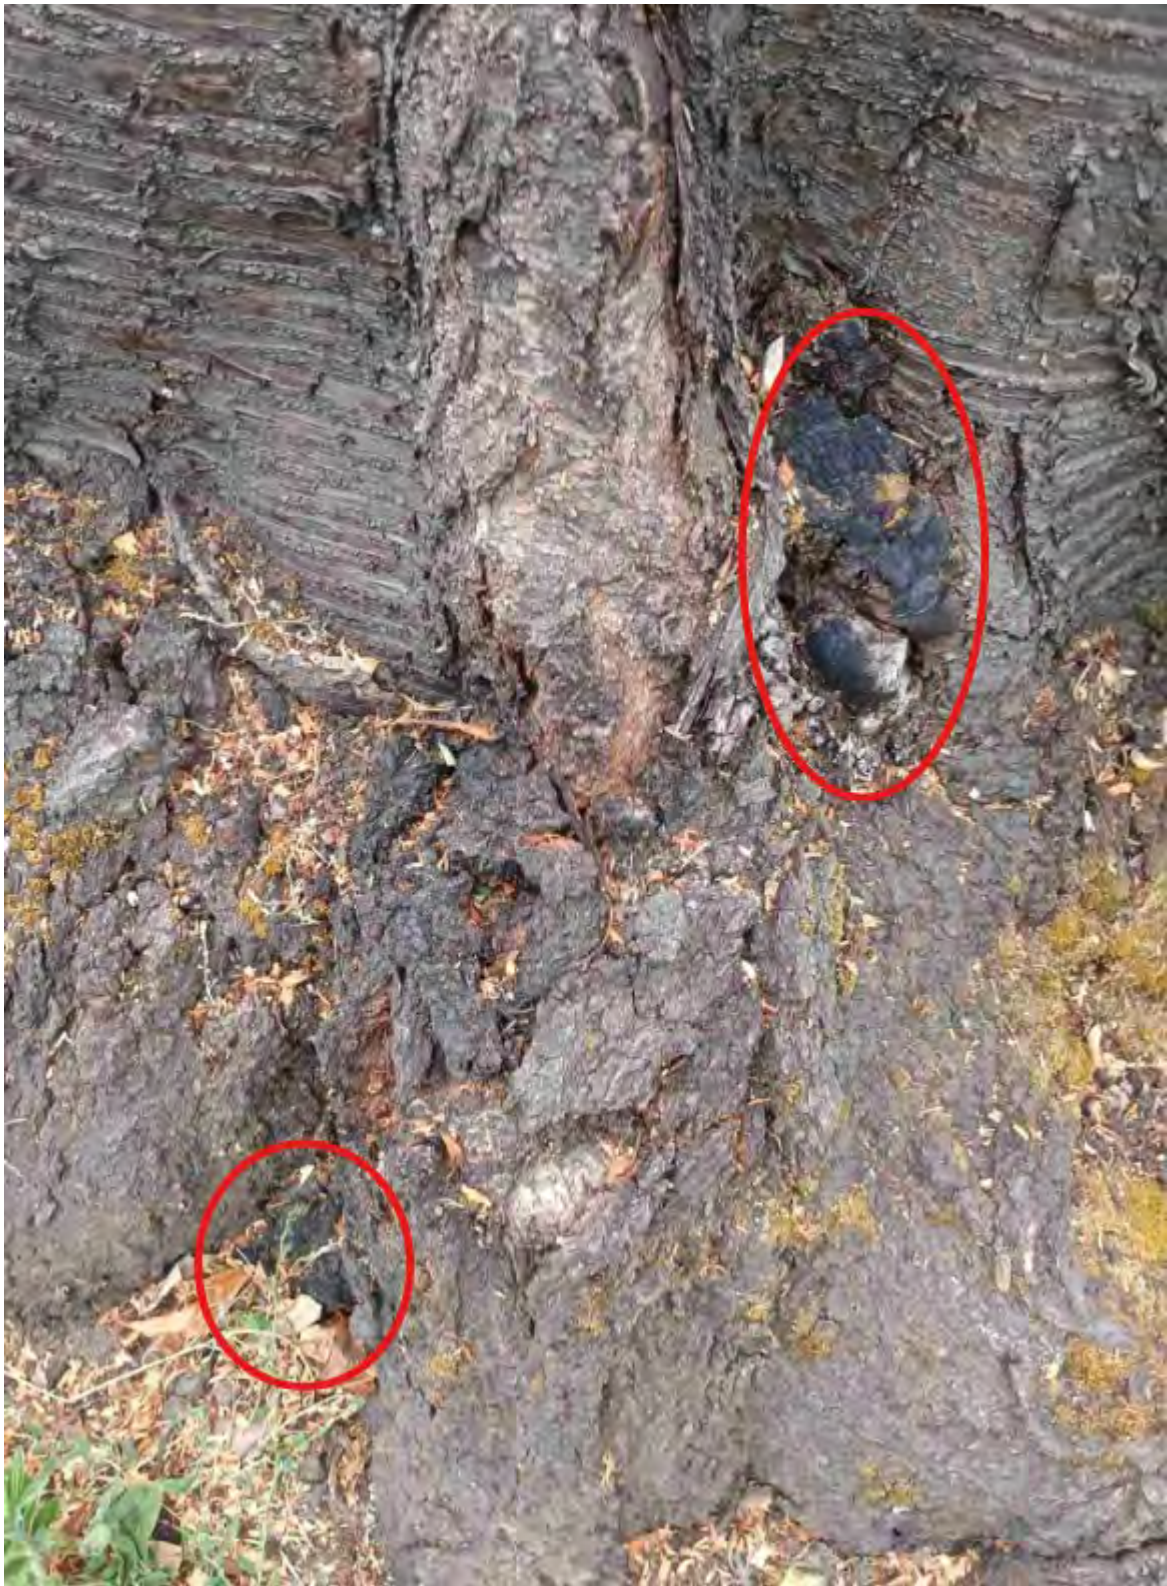
| Inspection findings/reason for exemption | A fungal fruiting body of the decay fungus <i>Ganoderma sp.</i> is present on the trunk. Colonisation by this fungus results in white rot affecting the stem and root system, which can lead to structural failure through fracture or windthrow. A resonance test with a sounding hammer has revealed an unacceptable amount of decay around the bracket. Removal of the tree is recommended to prevent natural failure, manage risk, and facilitate replanting. |

***Image shows fungal fruiting bodies circled.***

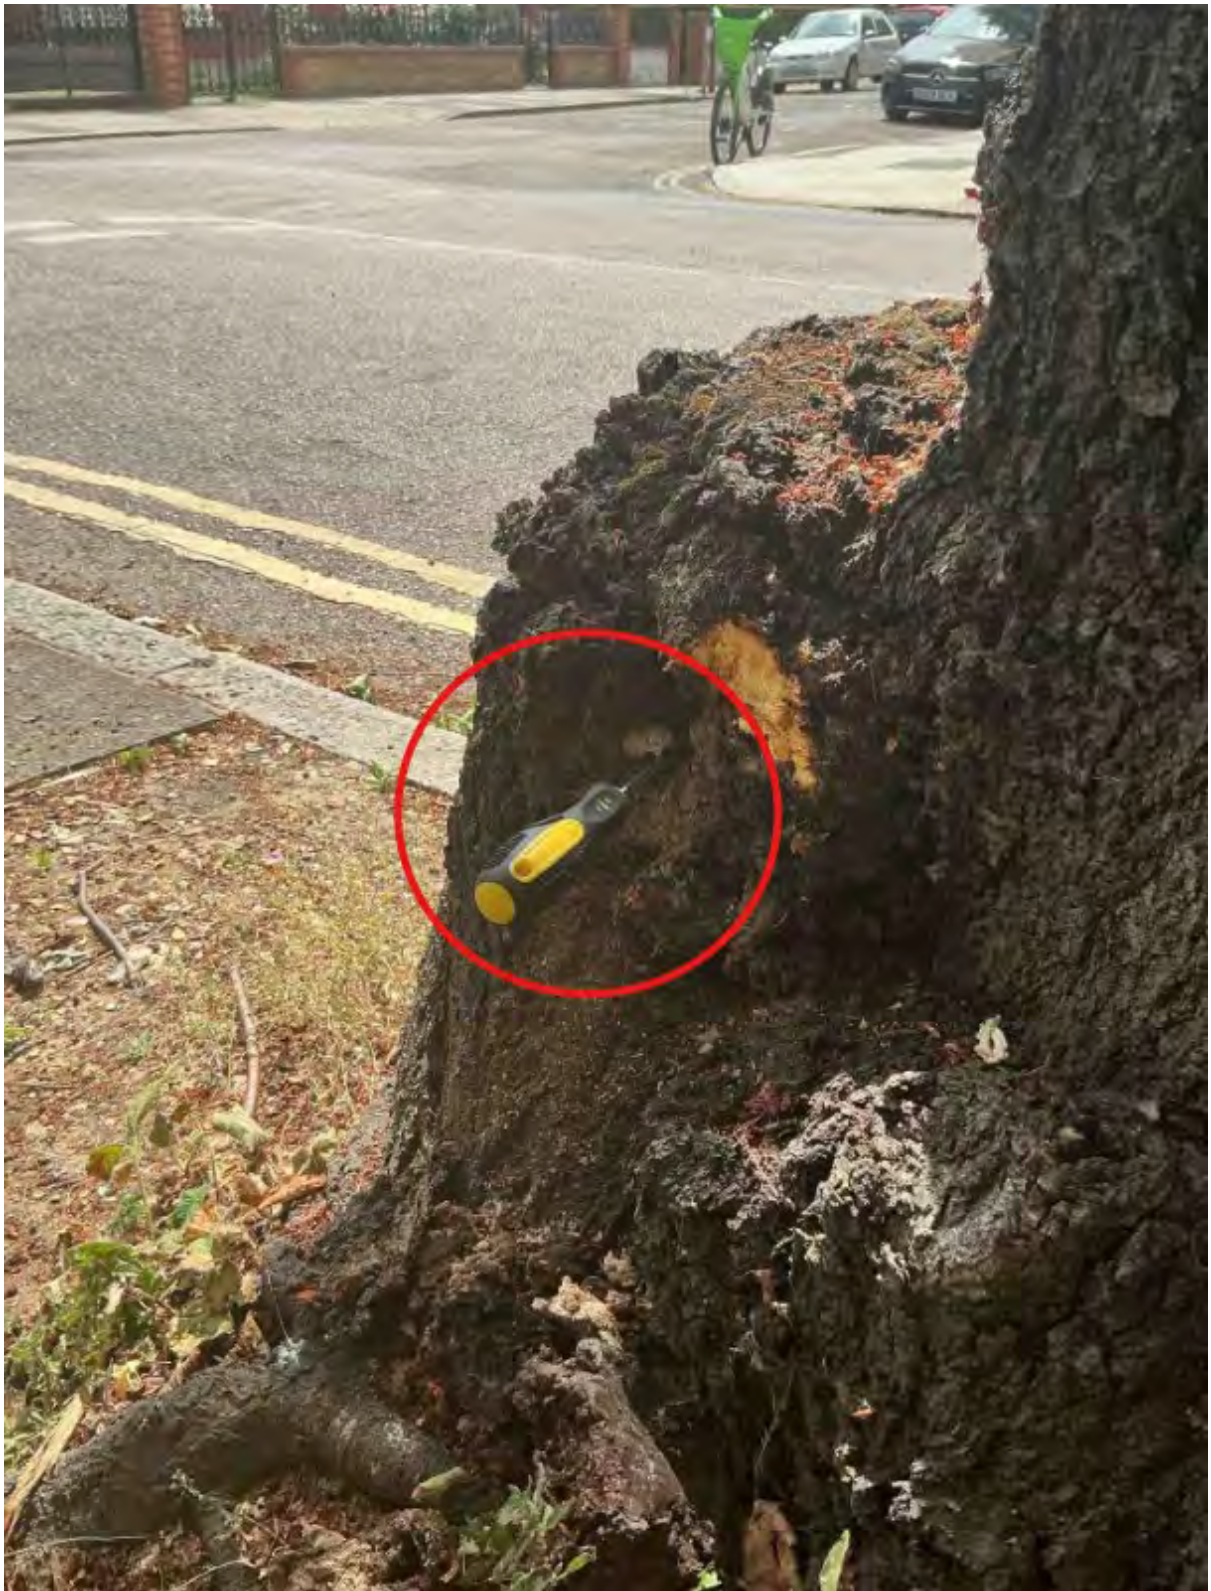
| Inspection findings/reason for exemption | A fungal fruiting body of the decay fungus <i>Ganoderma sp.</i> is present on the base of the trunk. Colonisation by this fungus results in white rot affecting the stem and root system, which can lead to structural failure through fracture or windthrow. A resonance test with a sounding hammer has revealed an unacceptable amount of decay around the bracket. Removal of the tree is recommended to prevent natural failure, manage risk, and facilitate replanting. |

***Image shows probe and fungal fruiting body circled.***

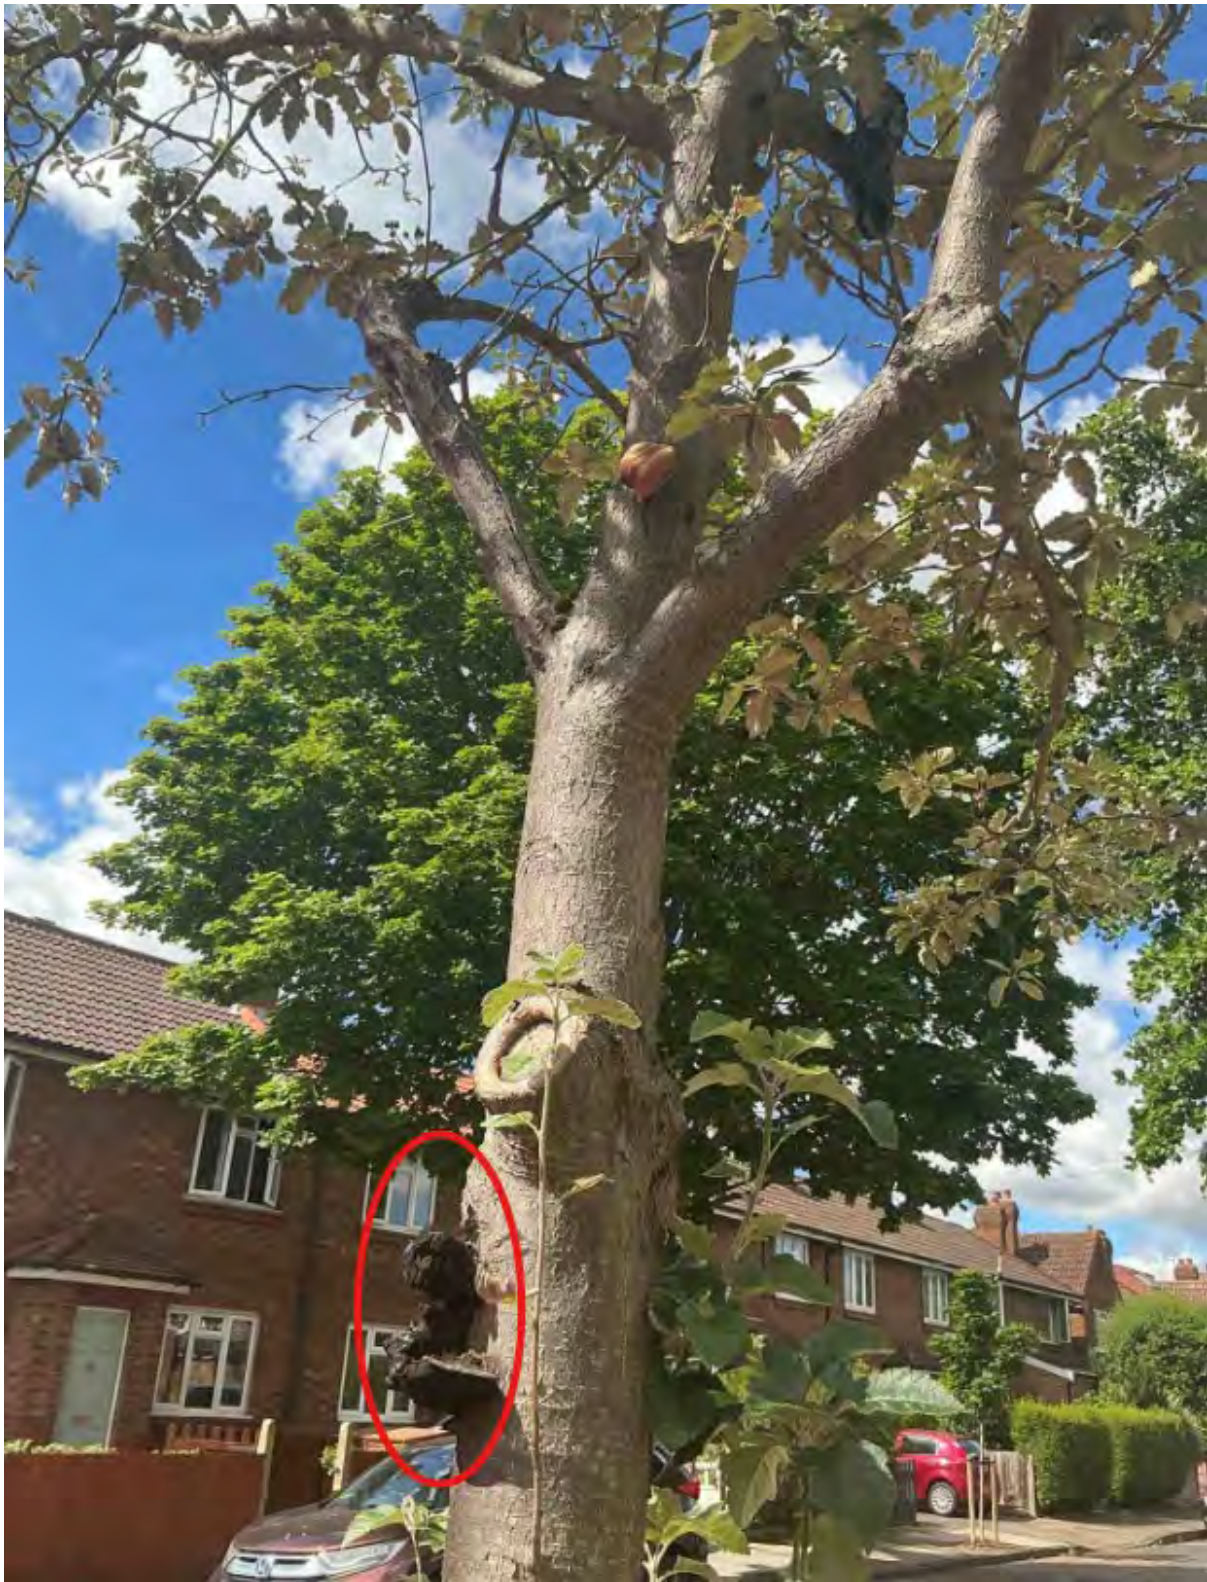
| Inspection findings/reason for exemption | A fungal fruiting body of the species Shaggy Polypore ( <i>Inonotus hispidus</i> ) is present on the trunk; this fungus causes a simultaneous white rot which can cause snapping of tree parts in this particular species. Removal of the tree is recommended to prevent natural failure, manage risk, and facilitate replanting. |

***Image shows fungal fruiting body circled.***

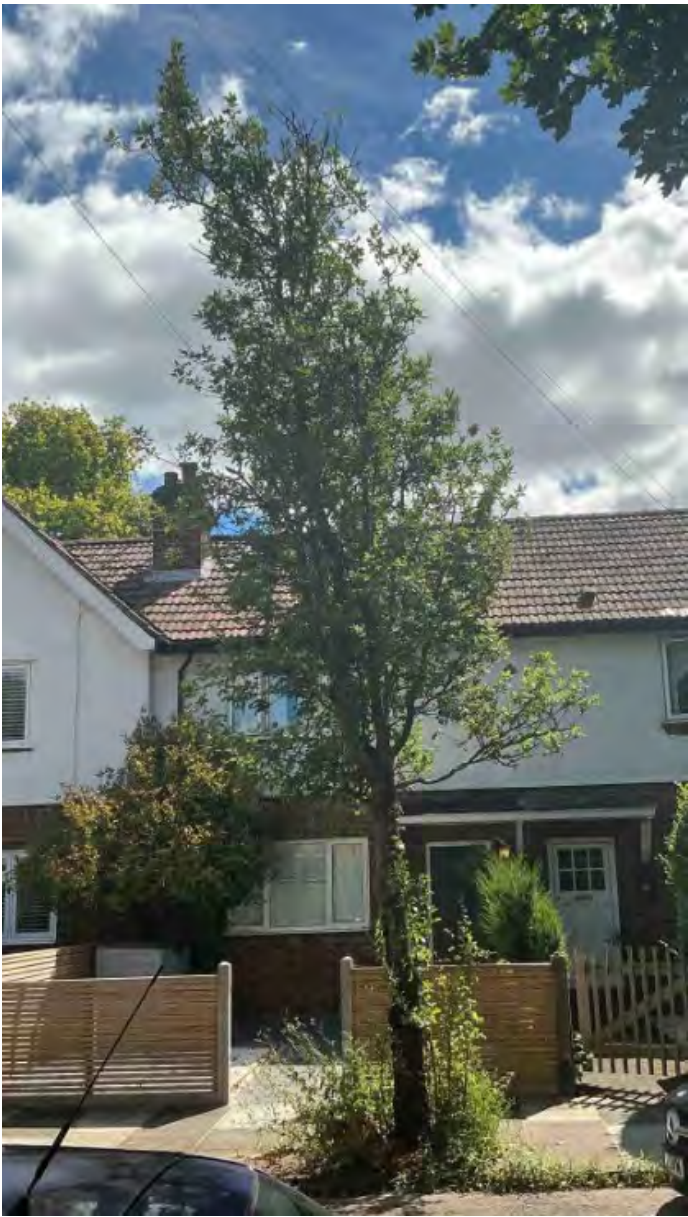
| Inspection findings/reason for exemption | Substantial wounding has occurred on the trunk and associated bark/vascular necrosis has taken place. Removal of the tree is recommended to prevent natural failure, manage risk, and facilitate replanting. |

Image shows tree in street scene.

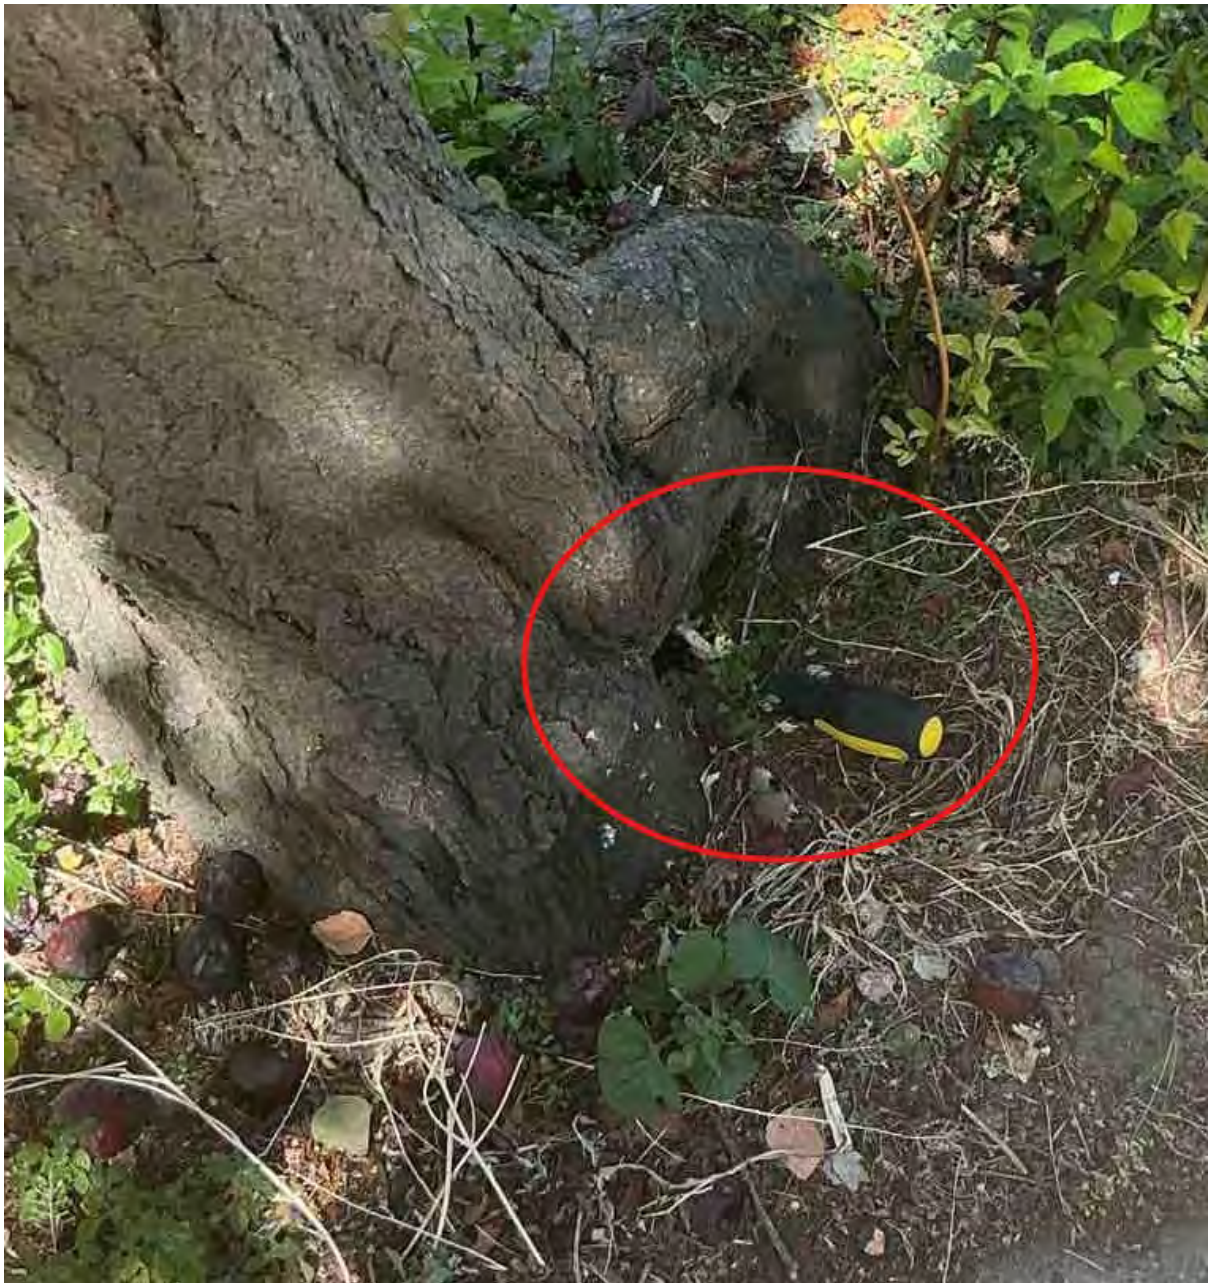
| Inspection findings/reason for exemption | Investigation with a probe and a resonance test with a sounding hammer has revealed an unacceptable amount of decay beyond the visible cavities at the base of the trunk. Removal is required to prevent natural failure, manage risk, and facilitate replanting. |

***Image shows probe in cavity circled.***

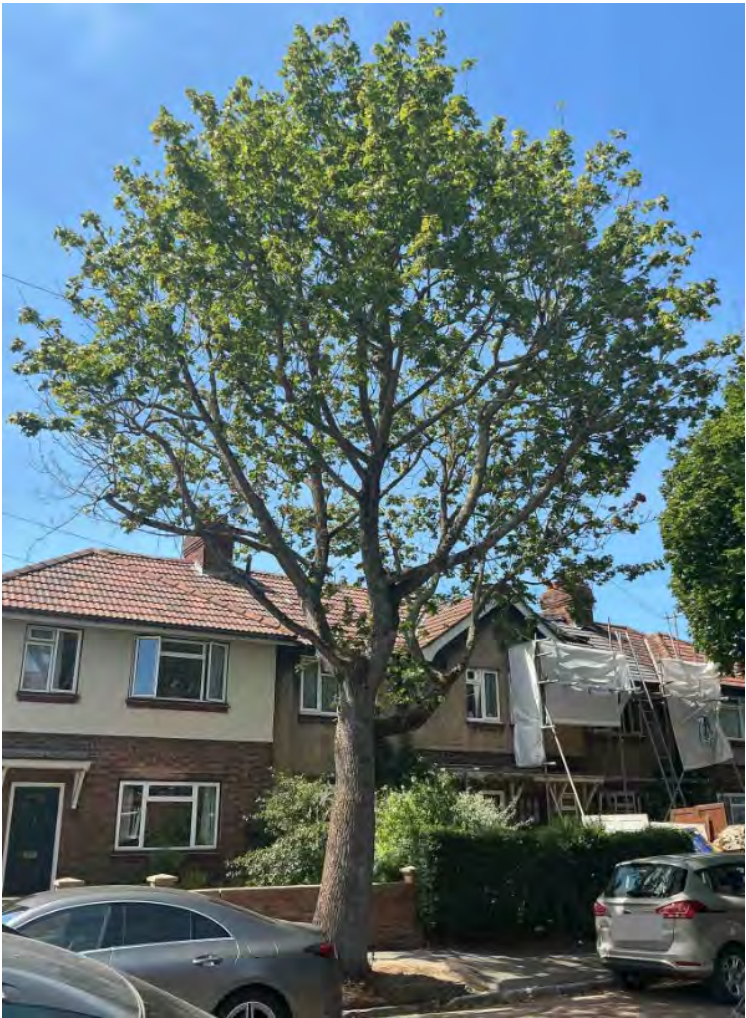
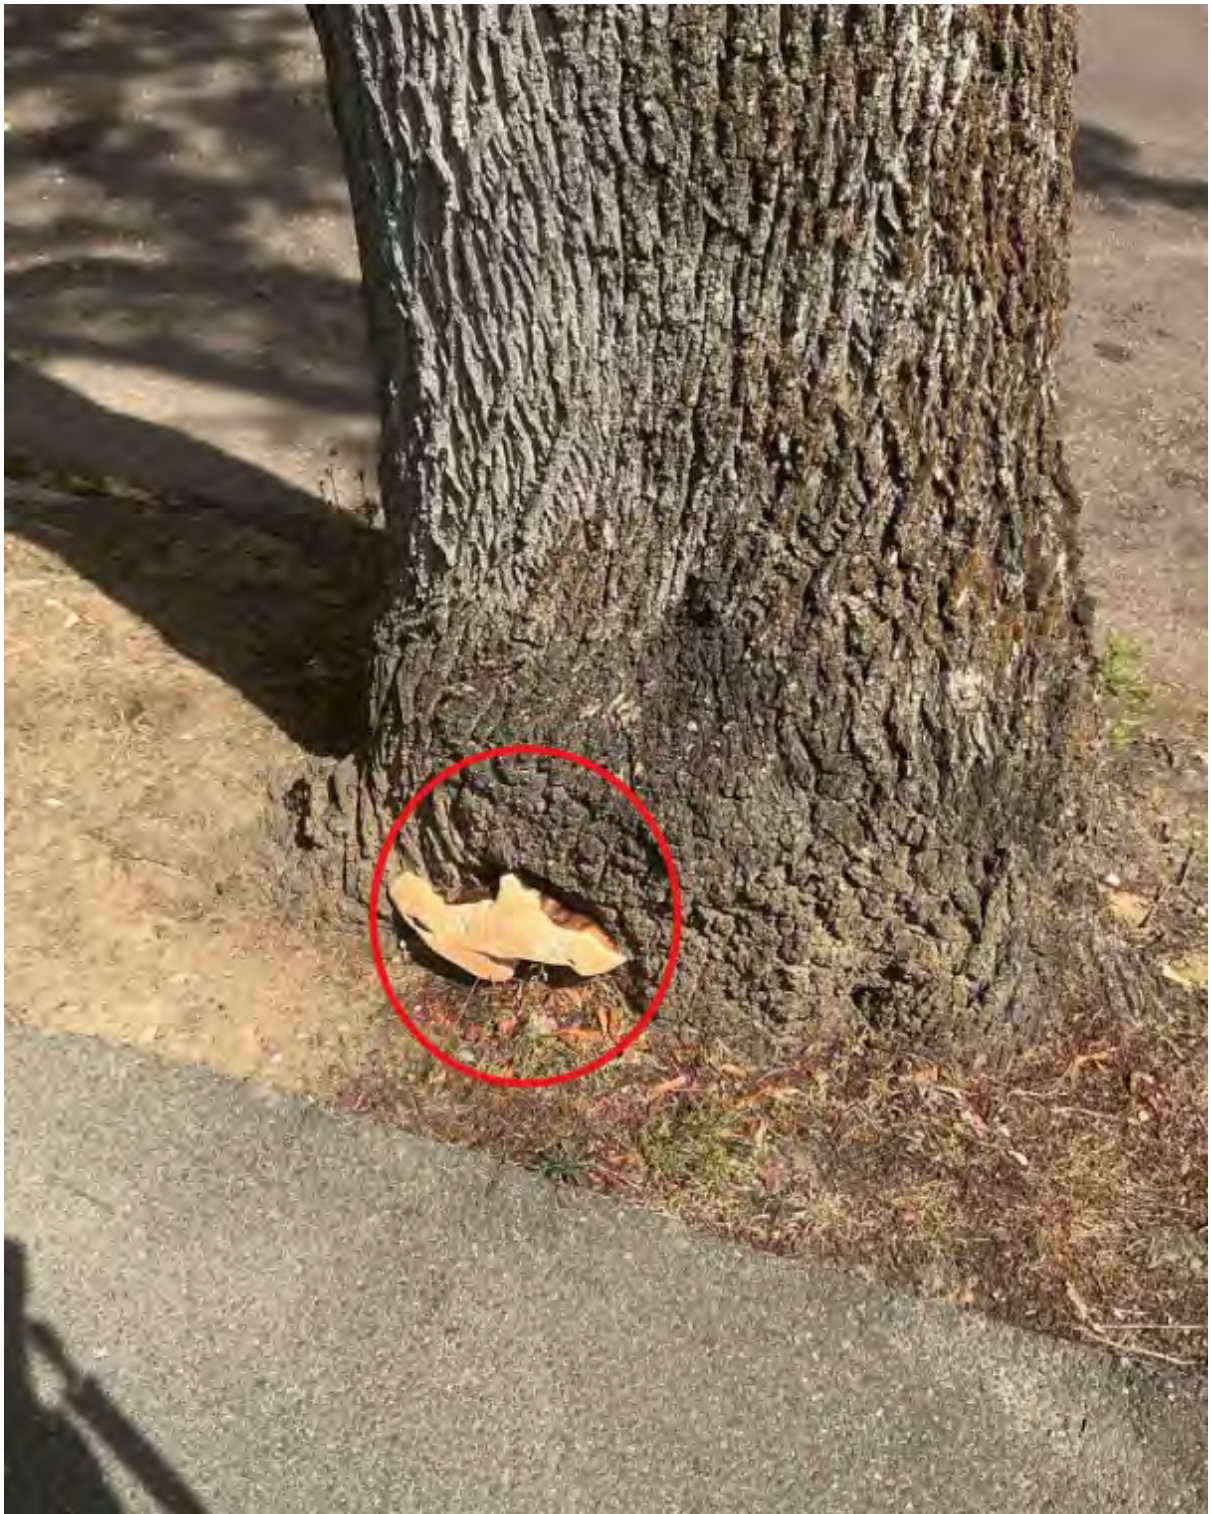
| Inspection findings/reason for exemption | A fungal fruiting body of the decay fungus Ganoderma sp. is present on the trunk. Colonisation by this fungus results in white rot affecting the stem and root system, which can lead to structural failure through fracture or windthrow A resonance test with a sounding hammer has revealed an unacceptable amount of decay around the bracket. Removal of the tree is recommended to prevent natural failure, manage risk, and facilitate replanting. |

***Image shows fungal fruiting body circled.***

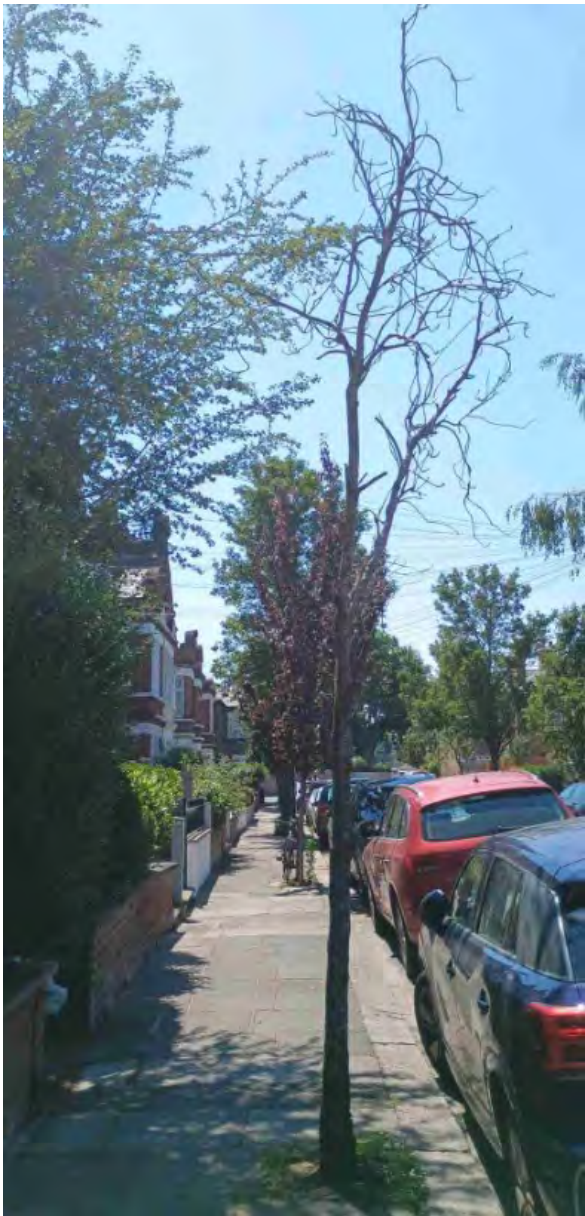
| Inspection findings/reason for exemption | This tree is dead; removal is required to prevent natural failure and facilitate replanting |

Image shows dead tree in street scene.

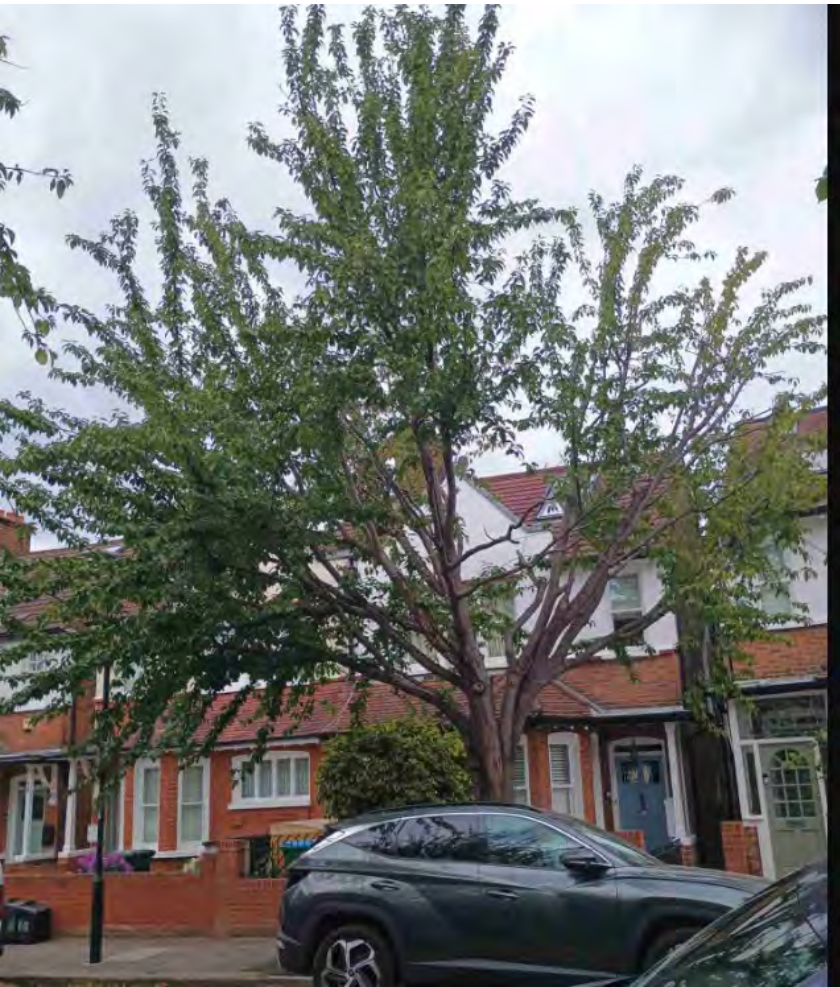
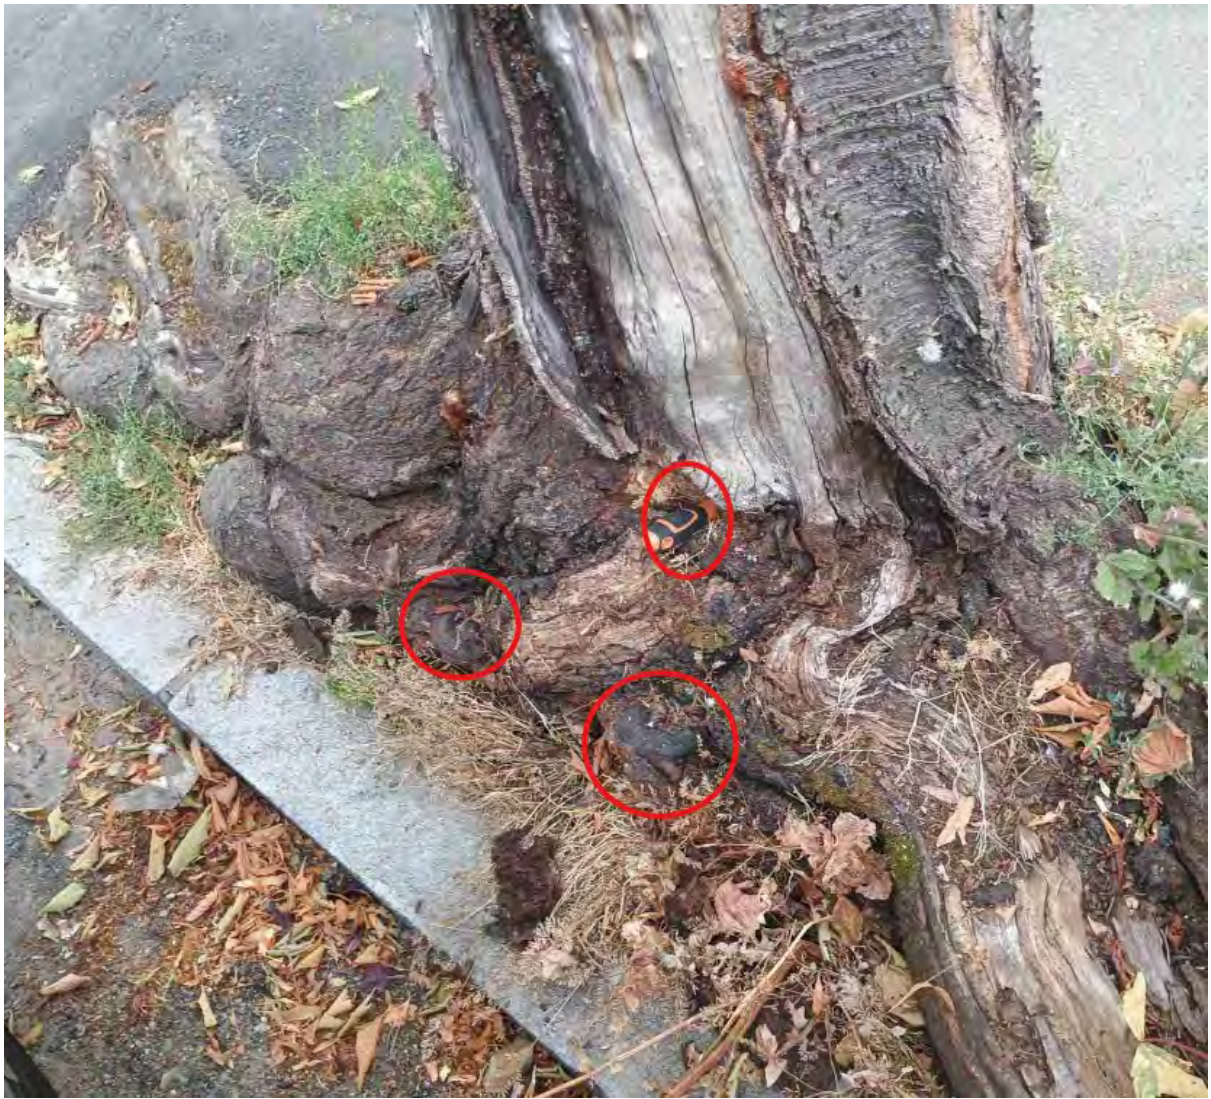
| Inspection findings/reason for exemption | A fungal fruiting body of the decay fungus <i>Ganoderma sp.</i> is present on the trunk. Colonisation by this fungus results in white rot affecting the stem and root system, which can lead to structural failure through fracture or windthrow. A resonance test with a sounding hammer has revealed an unacceptable amount of decay around the bracket. Removal of the tree is recommended to prevent natural failure, manage risk, and facilitate replanting. |

***Image shows probe and fungal fruiting bodies circled.***

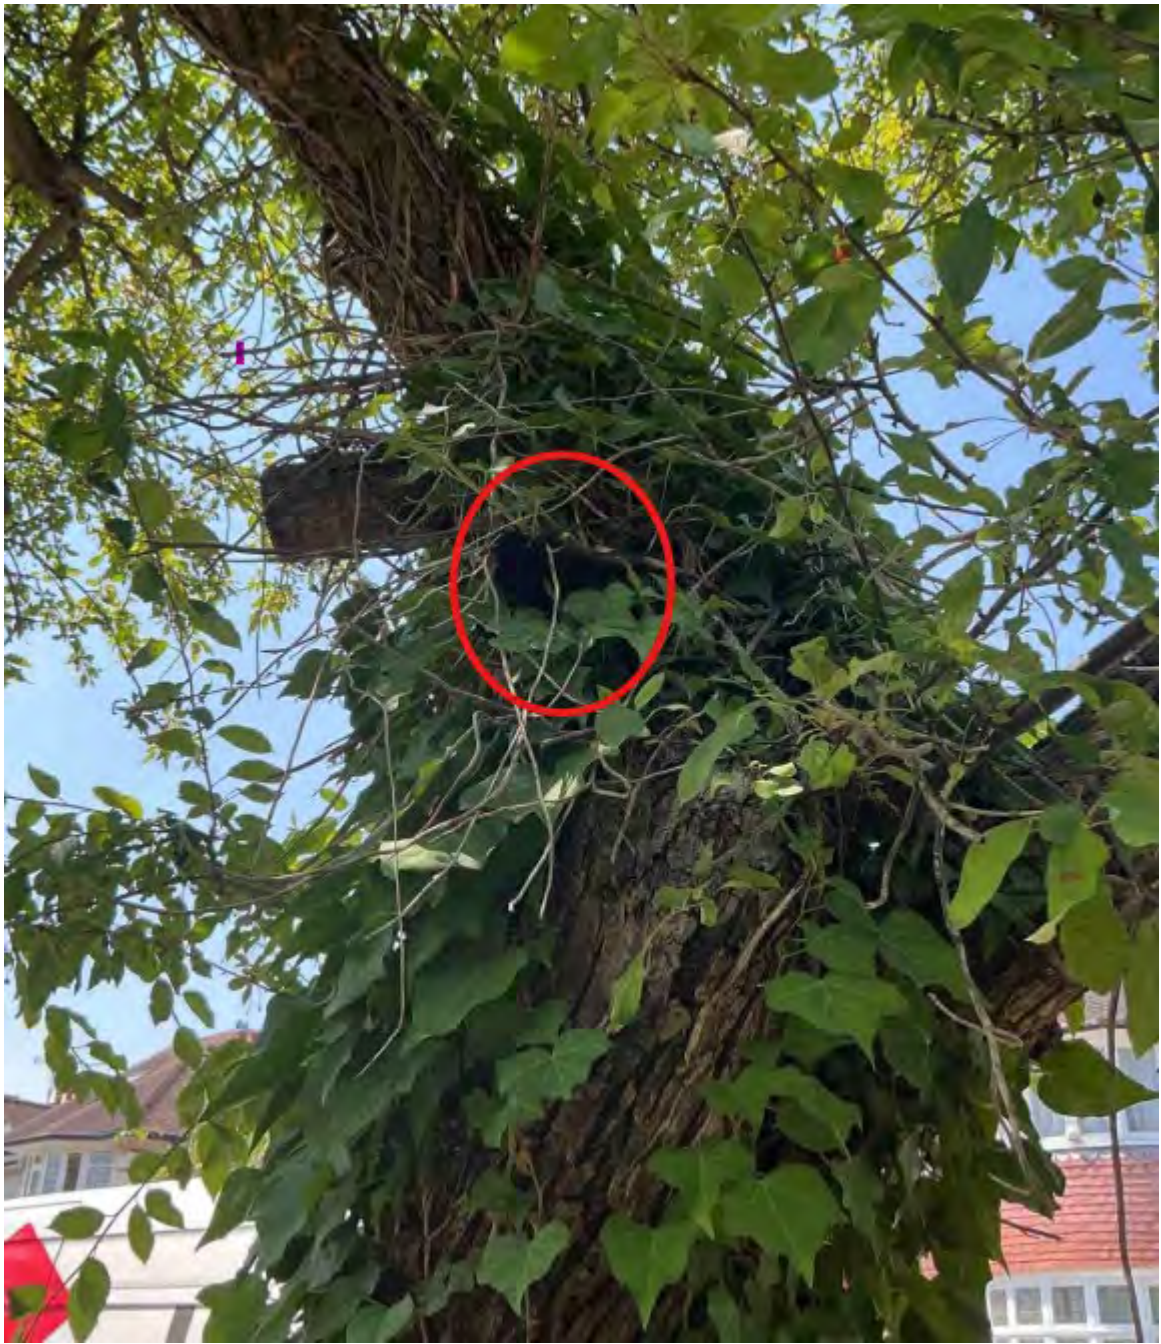
| Inspection findings/reason for exemption | A fungal fruiting body of the species Shaggy Polypore ( <i>Inonotus hispidus</i> ) is present on the main stem; this fungus causes a simultaneous white rot which can cause snapping of tree parts in this particular species. Removal is required to prevent natural failure, manage risk, and facilitate replanting |

***Image shows fungal fruiting body circled.***

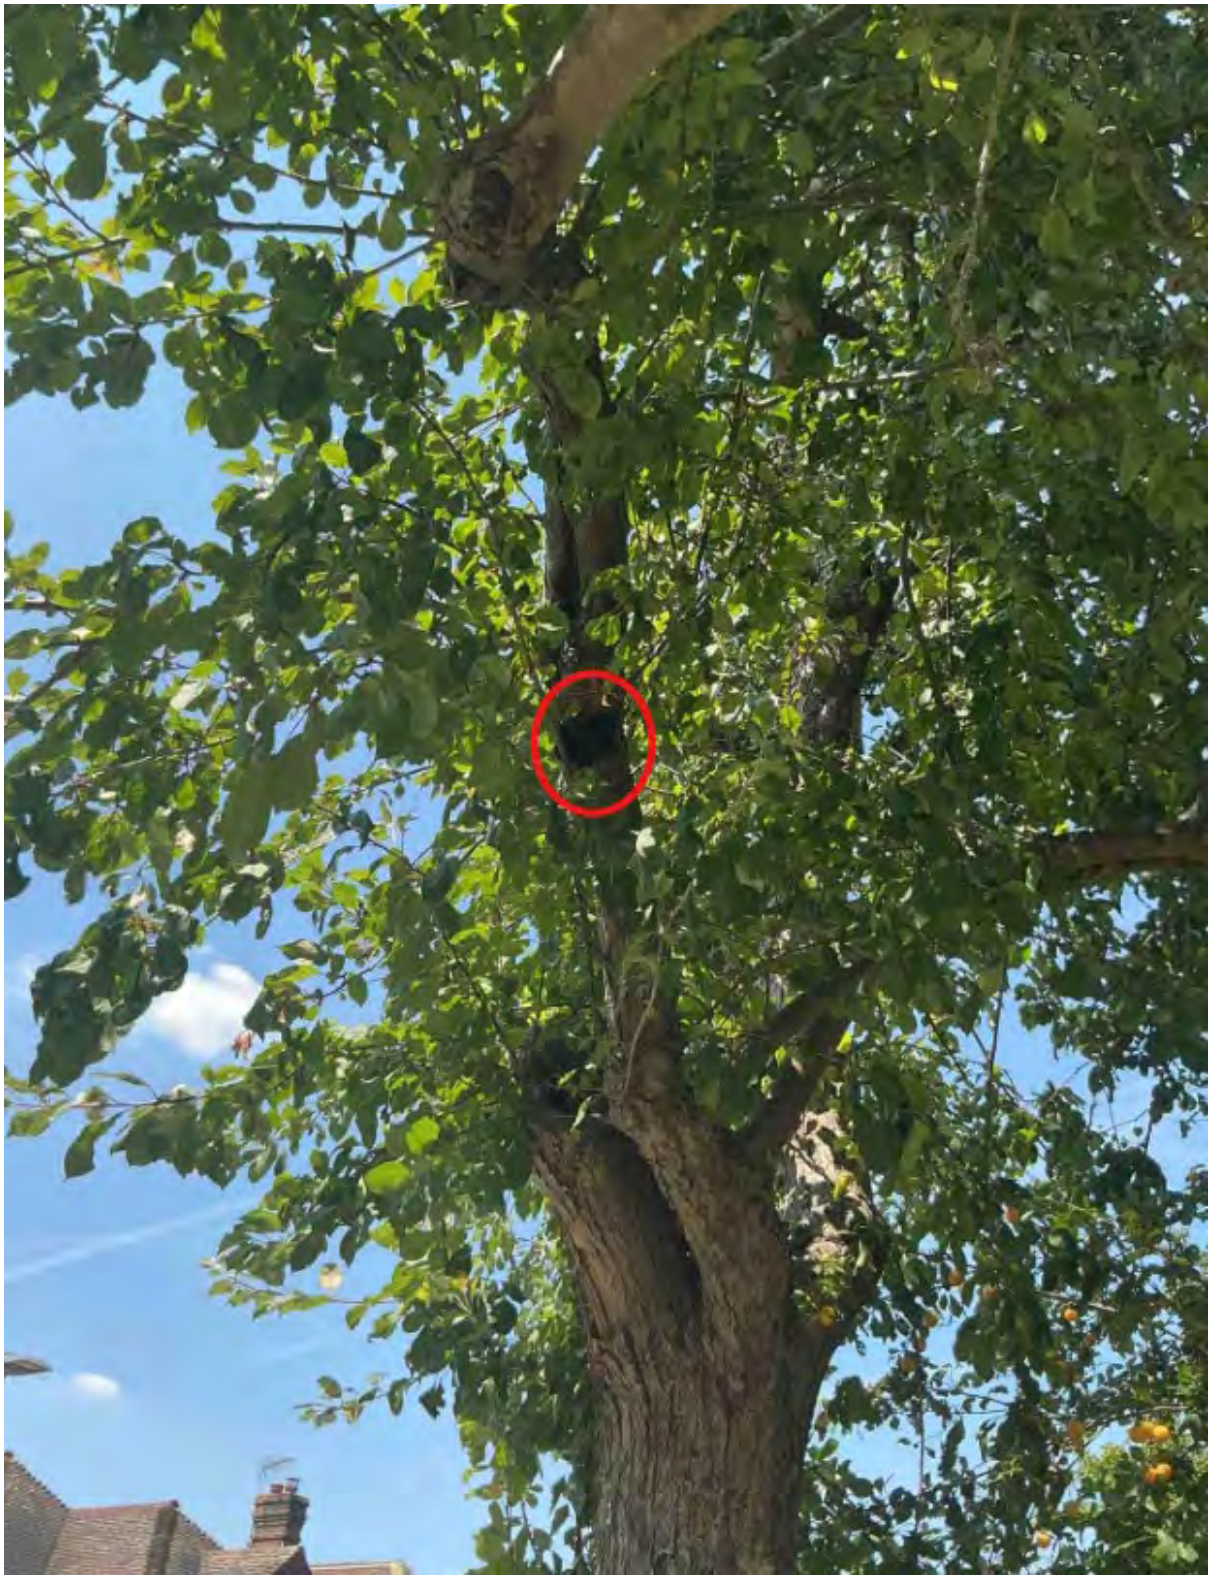
| Inspection findings/reason for exemption | A fungal fruiting body of the species Shaggy Polypore ( <i>Inonotus hispidus</i> ) is present within the crown. This fungus causes a simultaneous white rot which can result in the failure of branches and other tree parts in this species. Following a previous branch failure and the extent of fungal colonisation, removal is required to manage the risk of further failure and facilitate replanting. |

***Image shows fungal fruiting body circled.***

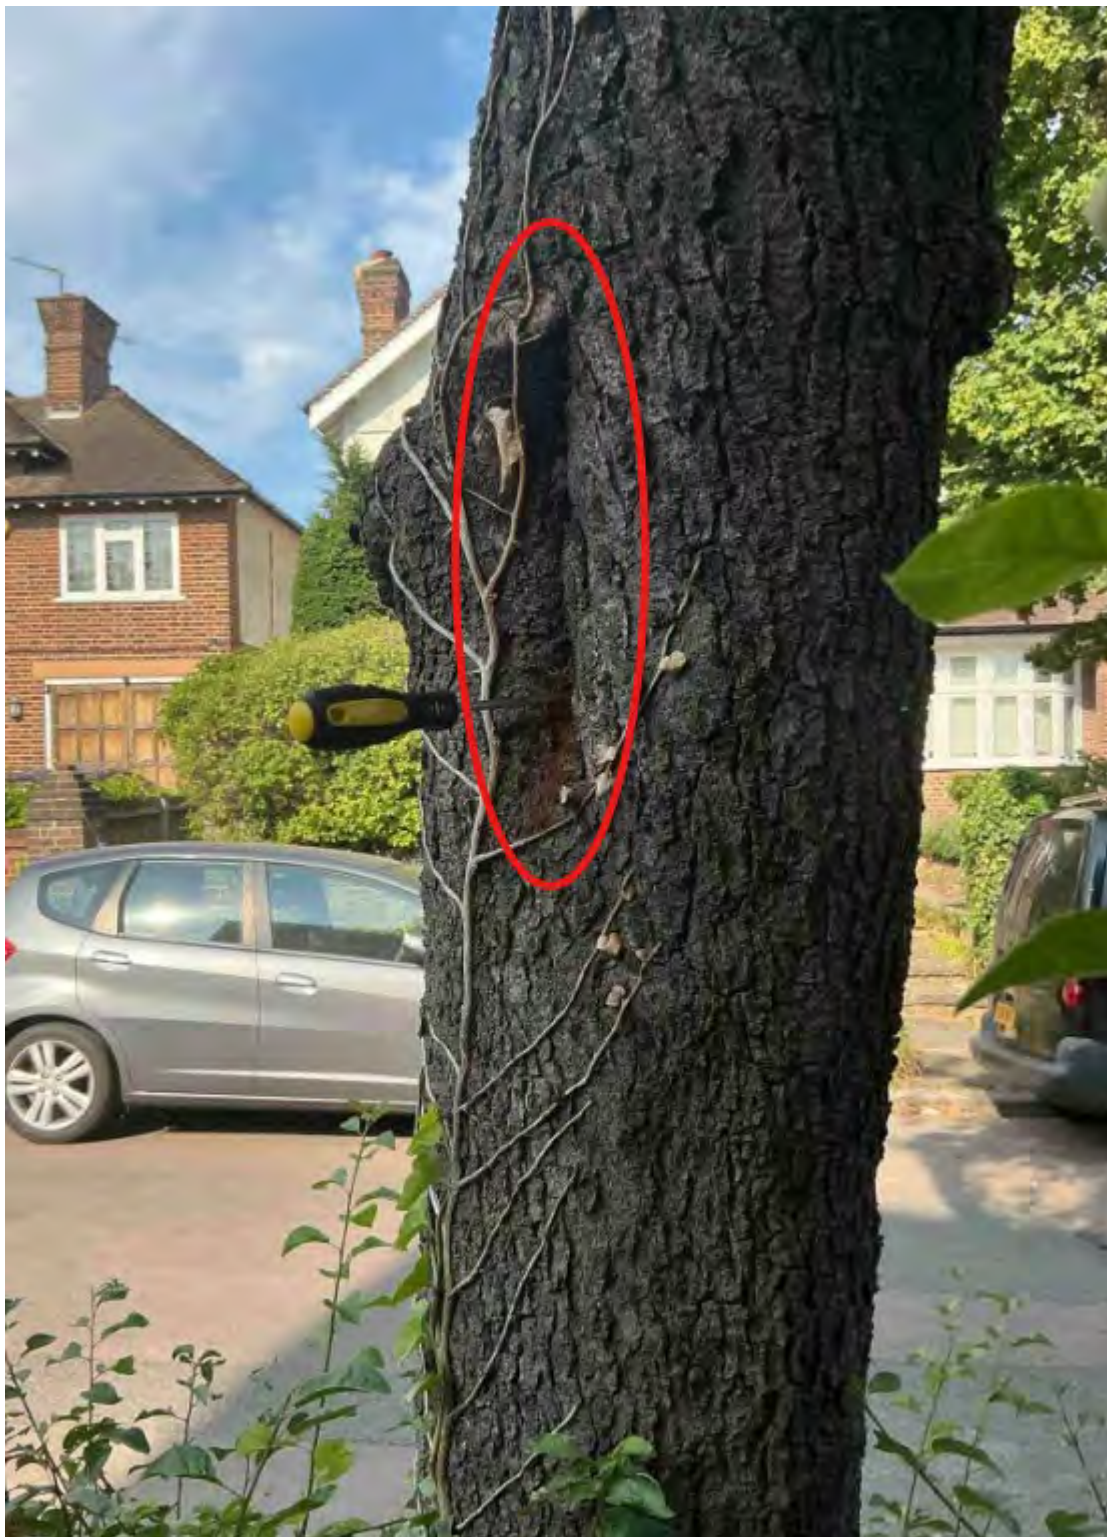
| Inspection findings/reason for exemption | Investigation using a probe and a resonance test with a sounding hammer has revealed an unacceptable extent of decay beyond the visible cavities on the trunk. The presence of crown dieback is consistent with this condition. Removal is required to prevent natural failure, manage risk, and facilitate replanting. |

***Image shows cavity on trunk circled.***
