# August 2026 - Reactive Tree Works Programme

A survey of trees in the Kew, South Richmond and Whitton wards are currently being undertaken; this is being conducted by specialist arboricultural officers as part of the scheduled 4 yearly detailed inspection regime that has been devised for all Council highway and parks trees.

Recent reactive inspections have identified the need for 106 individual tree work operations to take place. This work will now be issued to the Council’s Arborist Contractor KPS, for completion over the Autumn period.

The following pages provide the locations of each tree that is to be removed, in addition photographs and descriptions of the inspection findings have been provided.

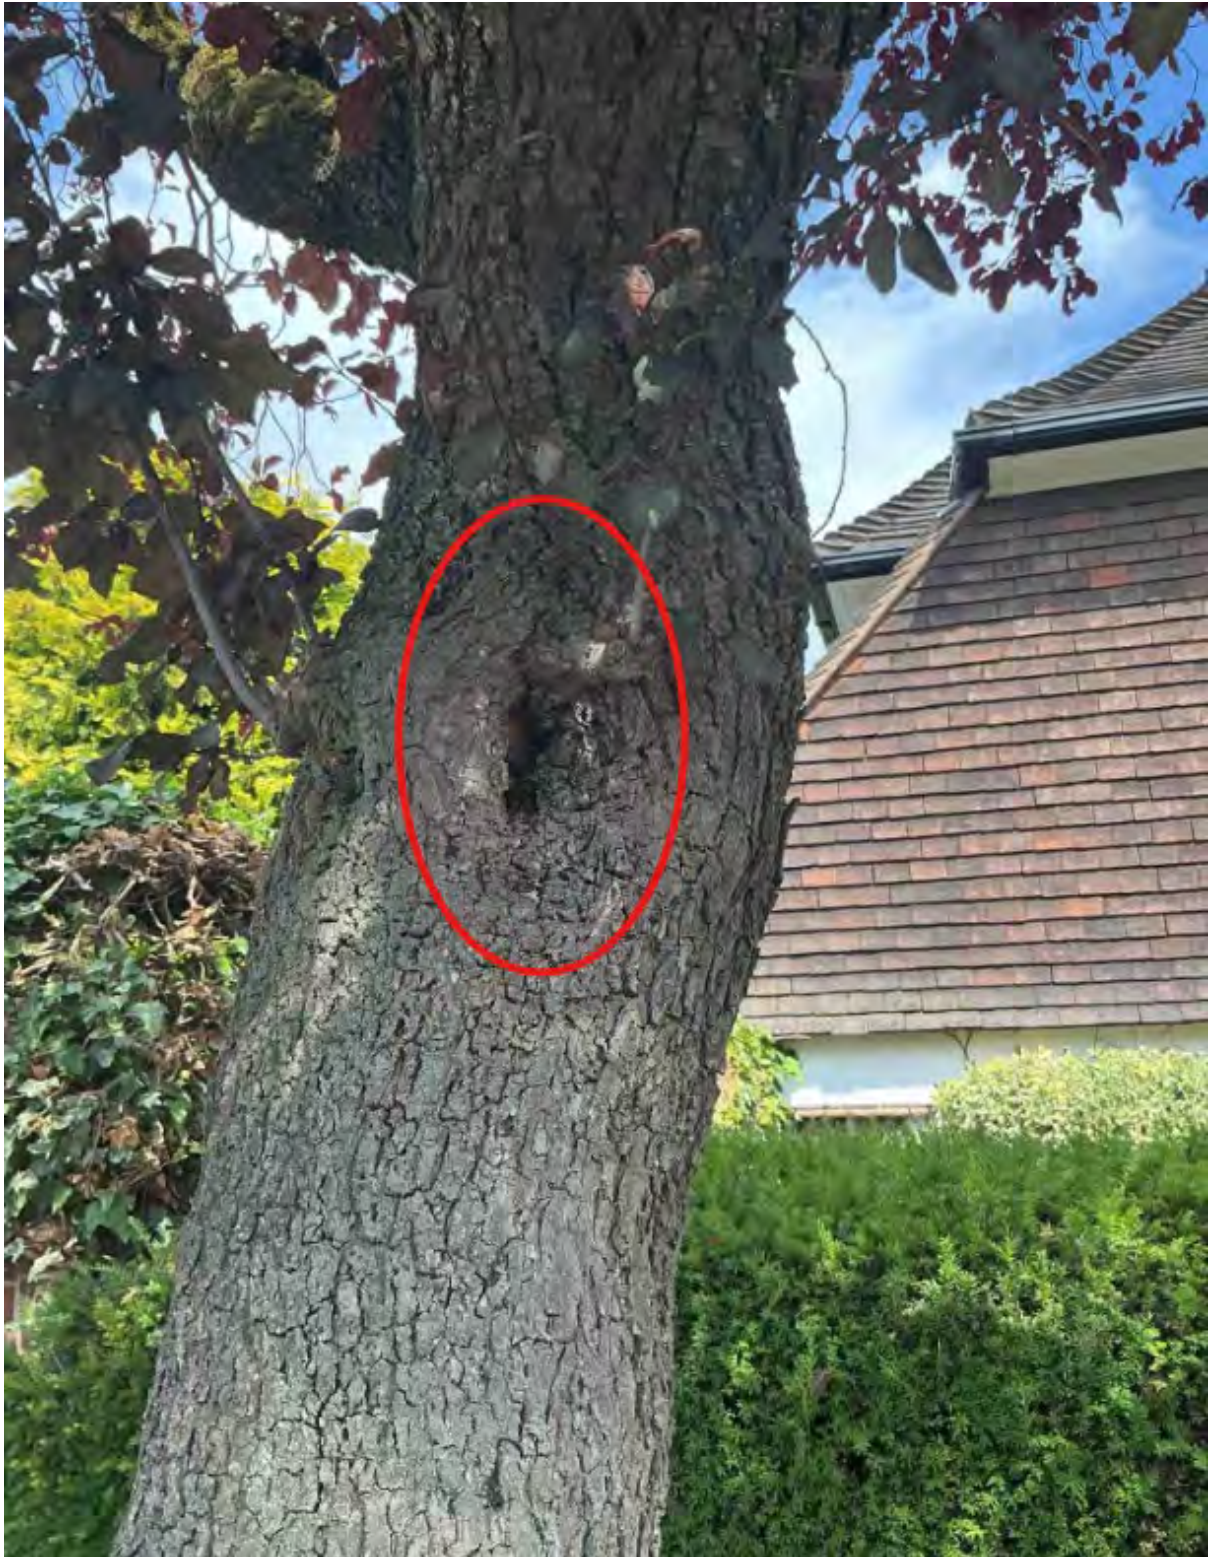
| Inspection findings/reason for exemption | Investigation with a probe and a resonance test with a sounding hammer has revealed an unacceptable amount of decay beyond the visible cavities at the base of the trunk. Removal is required to prevent natural failure, manage risk, and facilitate replanting. |

***Image shows cavity on trunk circled.***

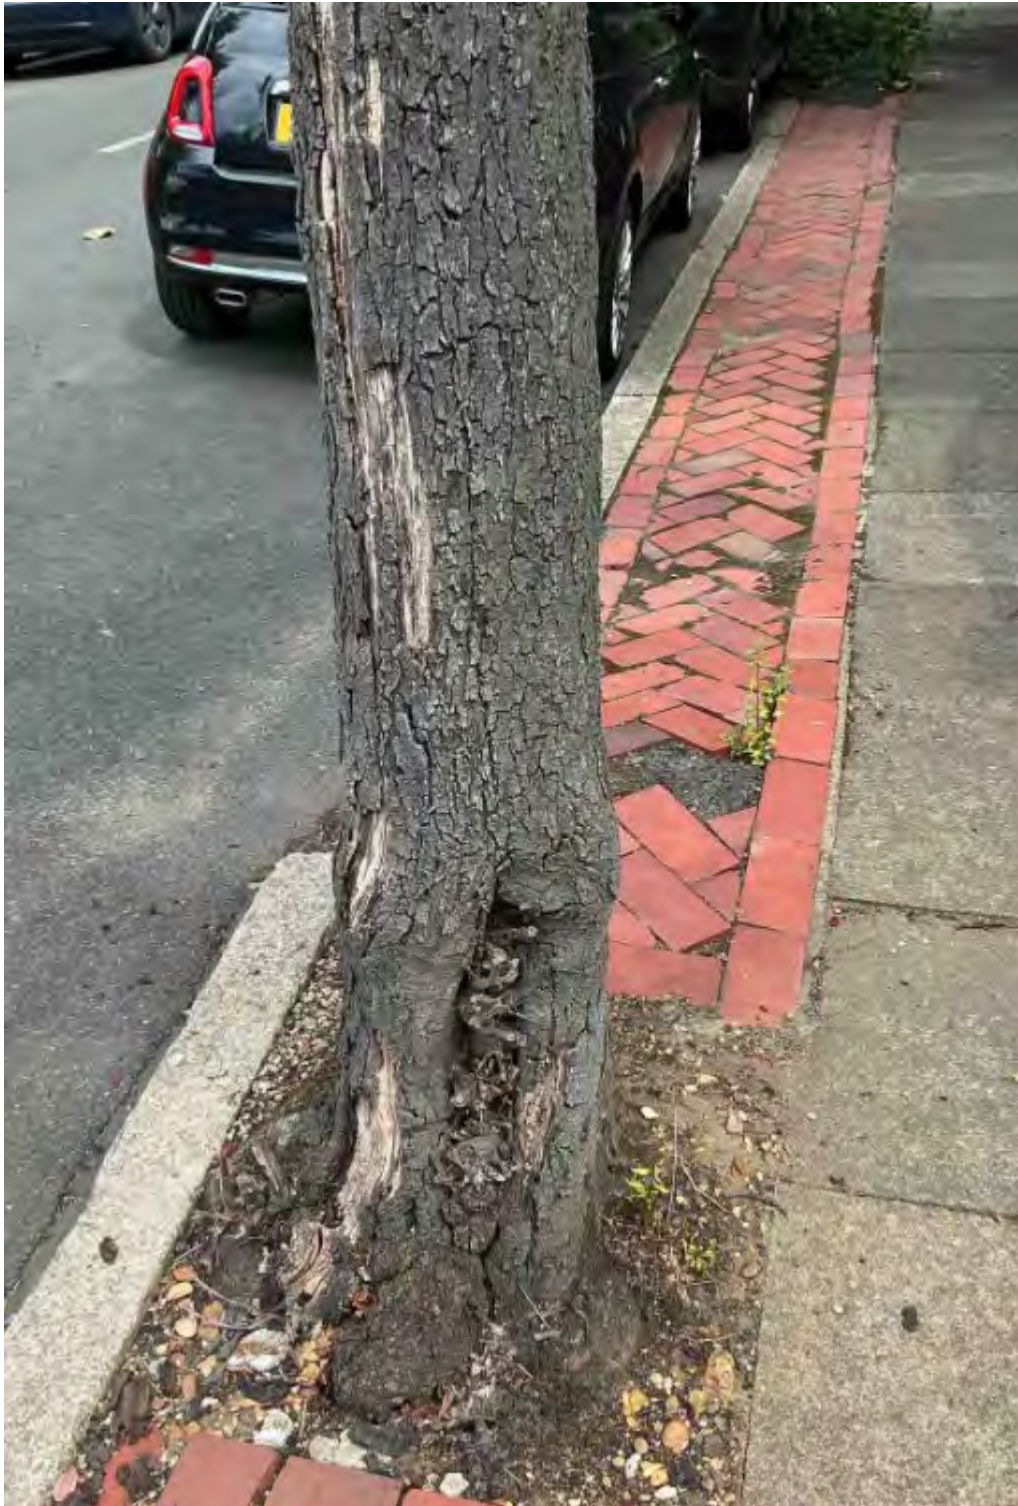
| Inspection findings/reason for exemption | Bark necrosis is present on the stem of this tree; the decline of the trees vascular system correlates with crown dieback. Removal is required to prevent natural failure, manage risk, and facilitate replanting |

***Image shows bark necrosis on trunk.***

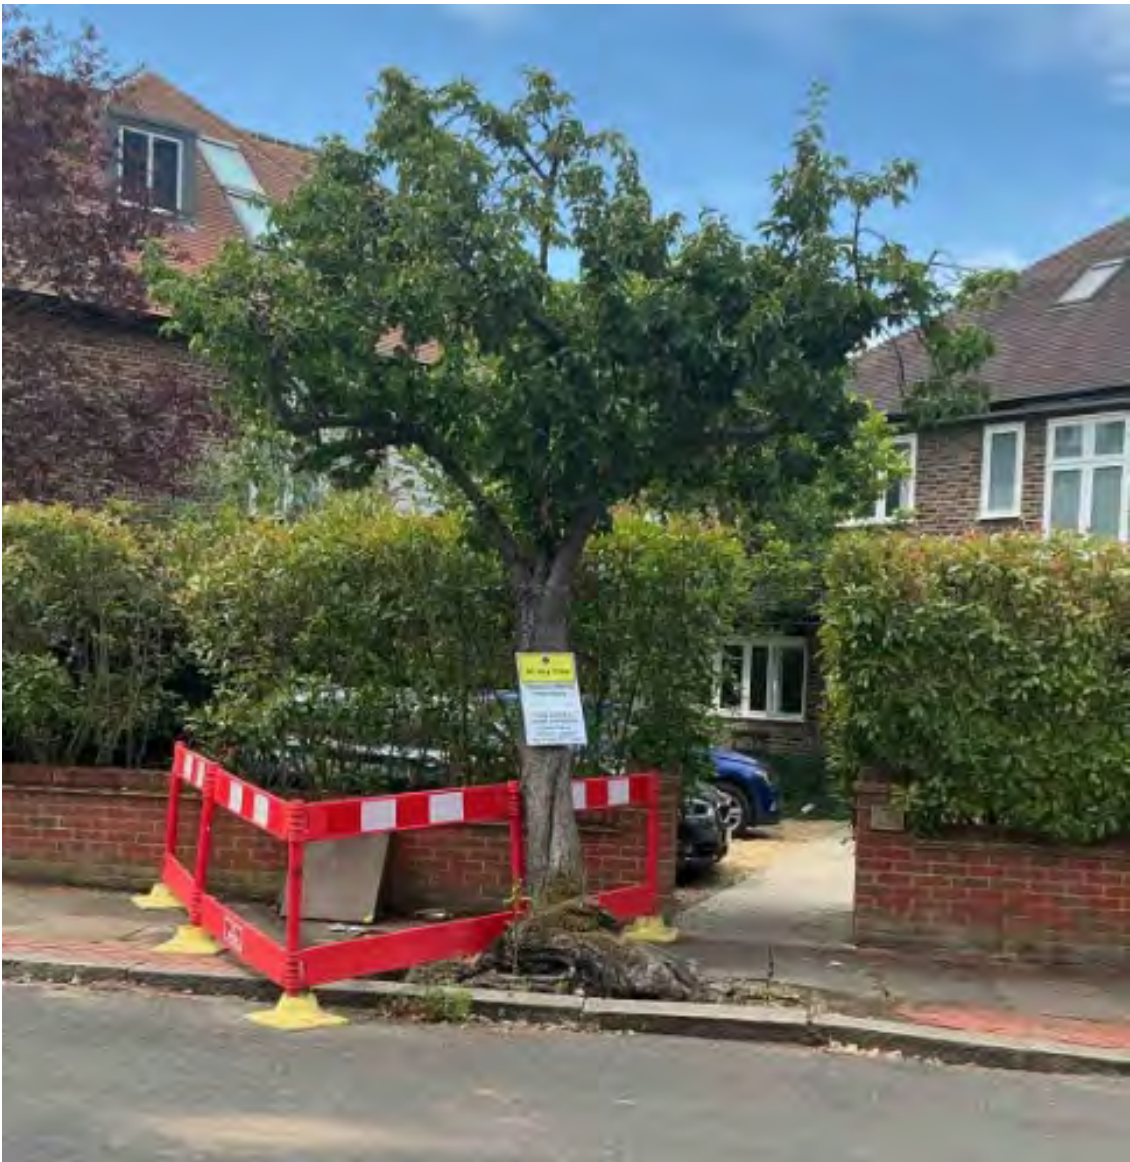
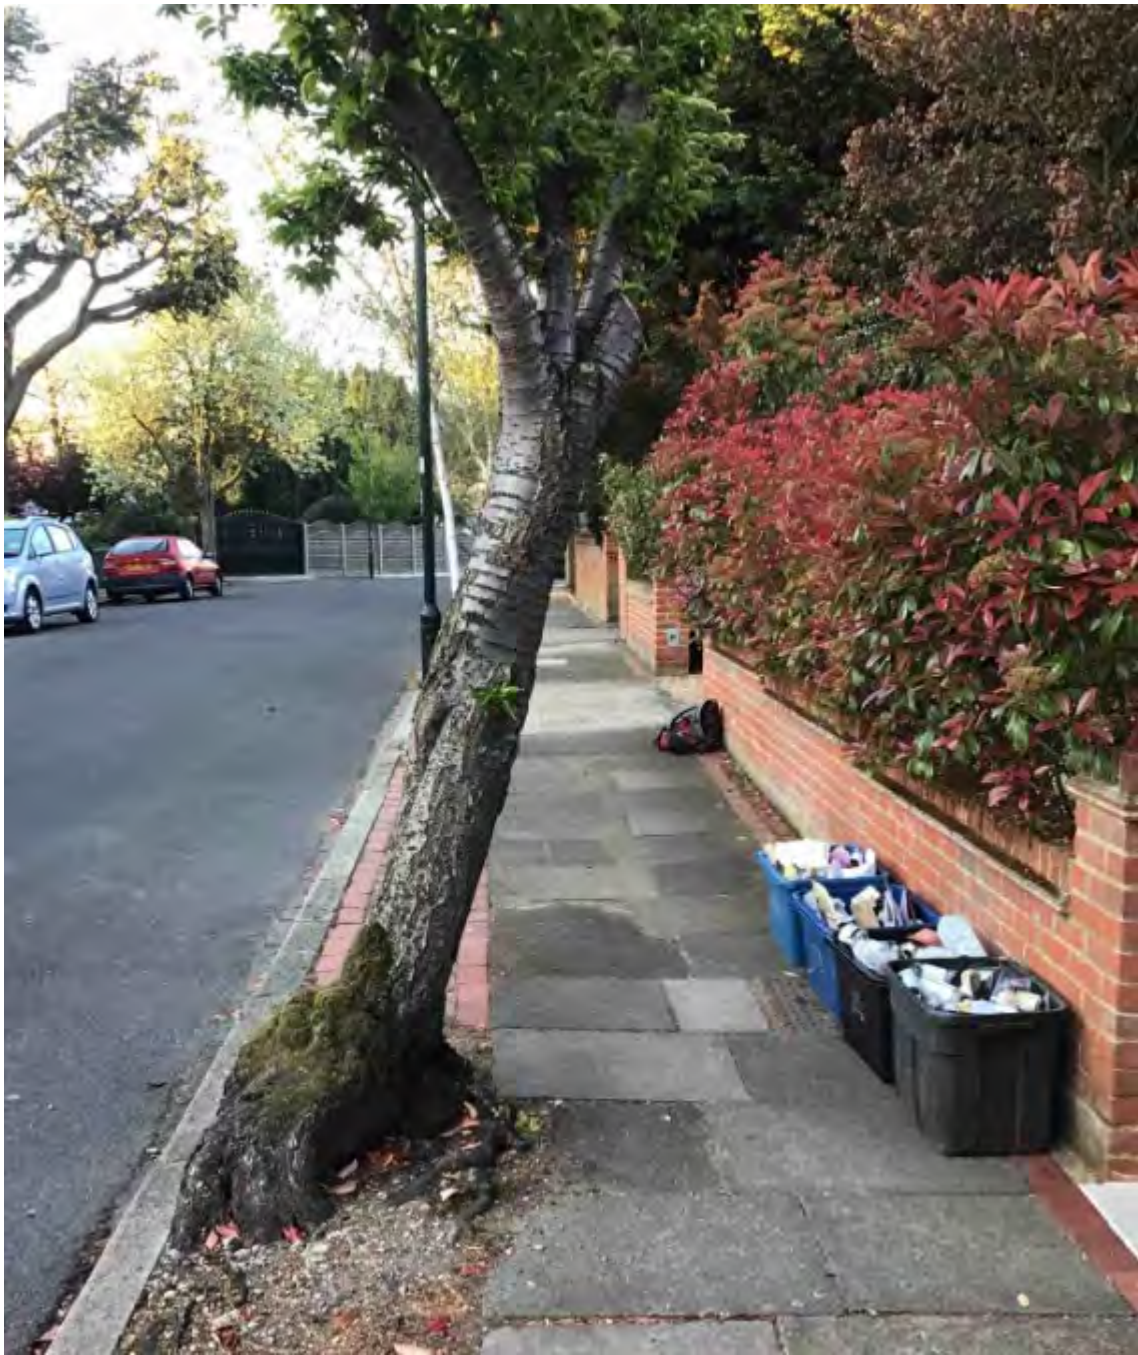
| Inspection findings/reason for exemption | This tree is leaning into the road, creating an unacceptable obstruction to highway users. Removal is required to eliminate the obstruction and facilitate replanting. |

*Image shows leaning trunk over pavement.*

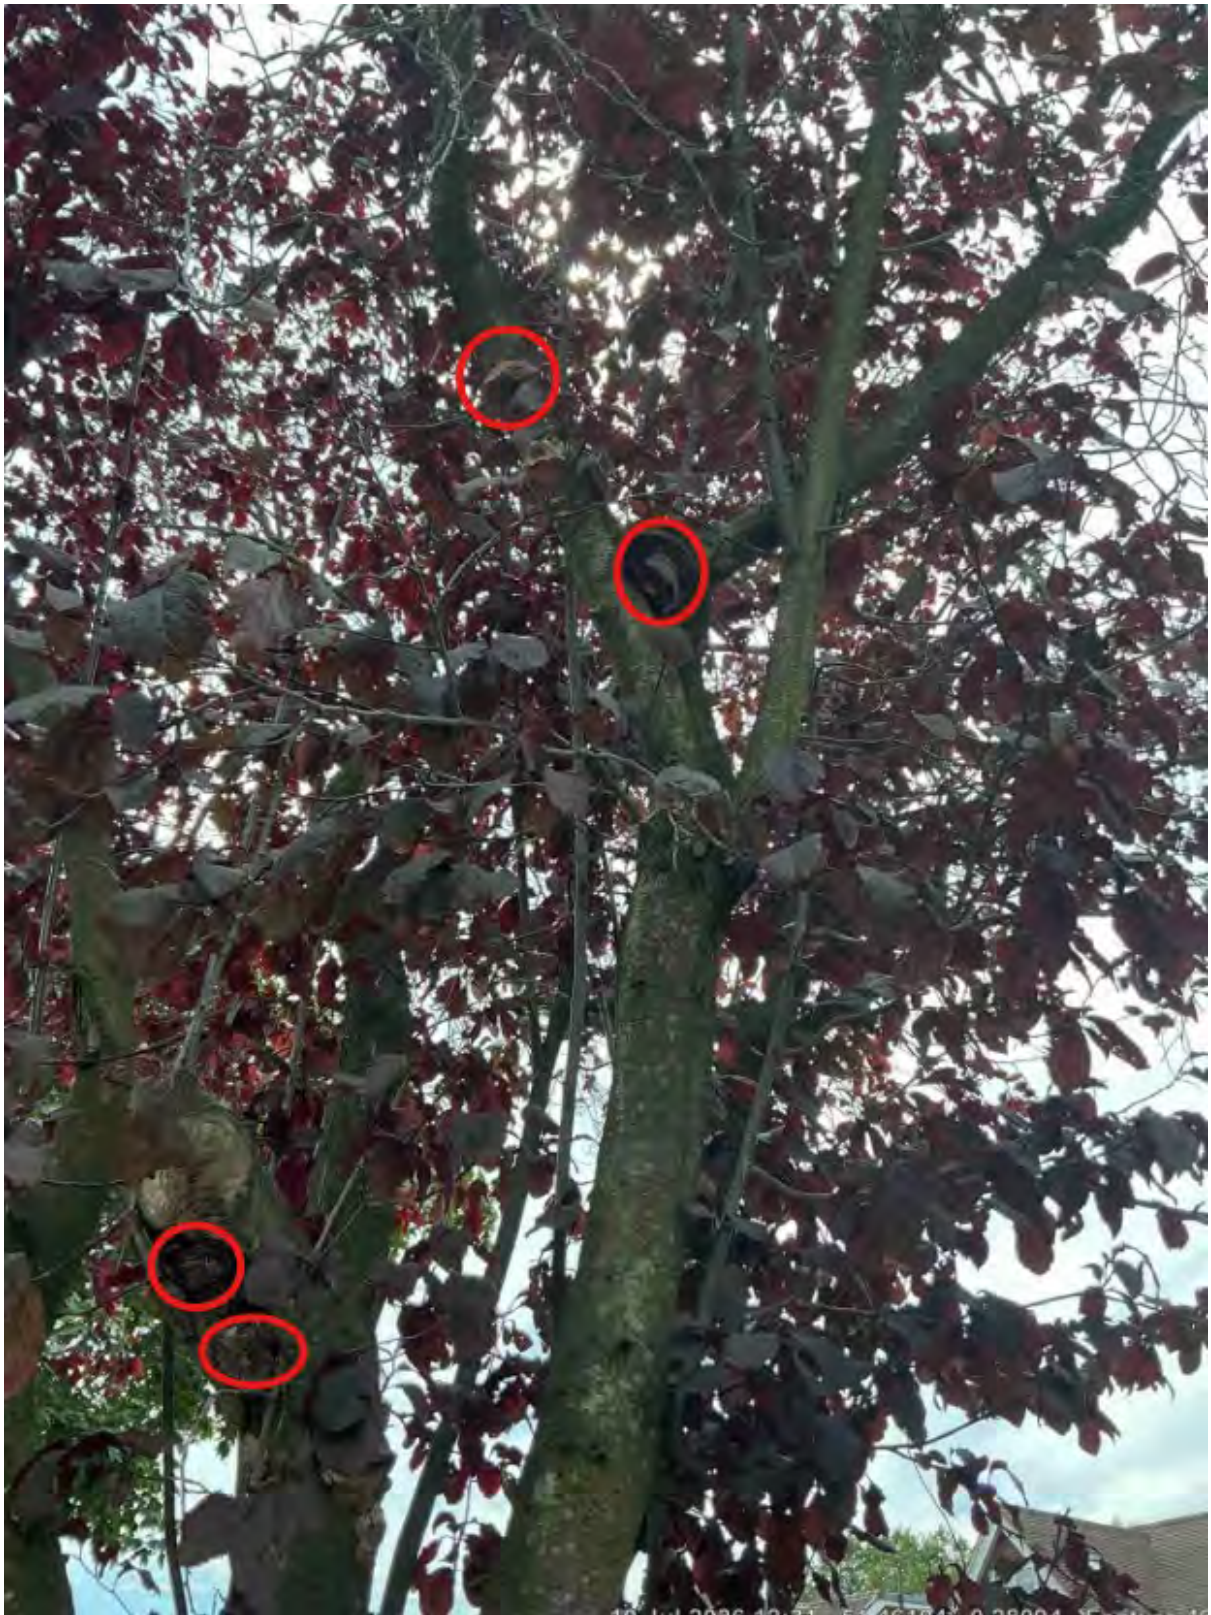
| Inspection findings/reason for exemption | Fungal fruiting bodies of the cushion fungus ( <i>Phellinus pomaceus</i> ) is present throughout the crown of this tree. This fungus causes a crumbly white rot that commonly causes this species of tree to snap. Crown dieback also correlates with this. Removal is required to prevent natural failure, manage risk, and facilitate replanting |

*Image shows fungal fruiting bodies in crown circled.*

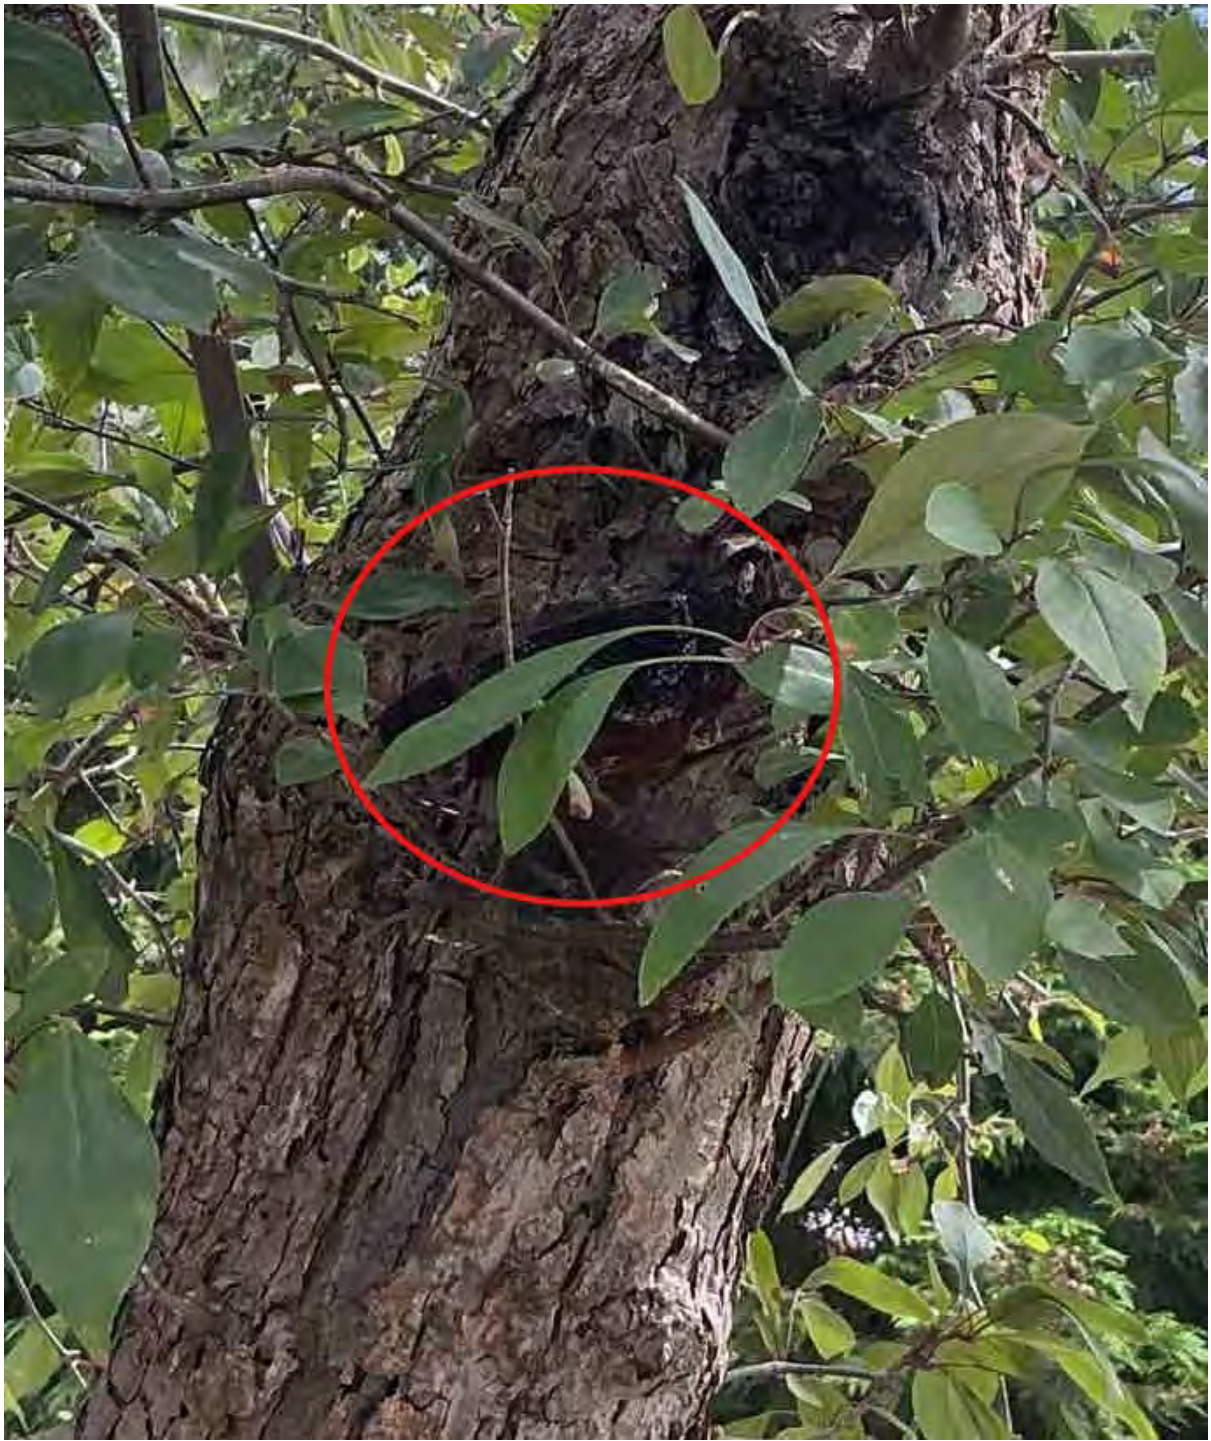
| Inspection findings/reason for exemption | A fungal fruiting body of the species Shaggy Polypore ( <i>Inonotus hispidus</i> ) is present within the crown. This fungus causes a simultaneous white rot which can result in the failure of branches and other tree parts in this species. There is die back of the crown indicating poor condition which correlates with the presence of the pathogen. Removal is required to manage the risk of further failure and facilitate replanting. |

***Image shows fungal fruiting body in trunk circled.***

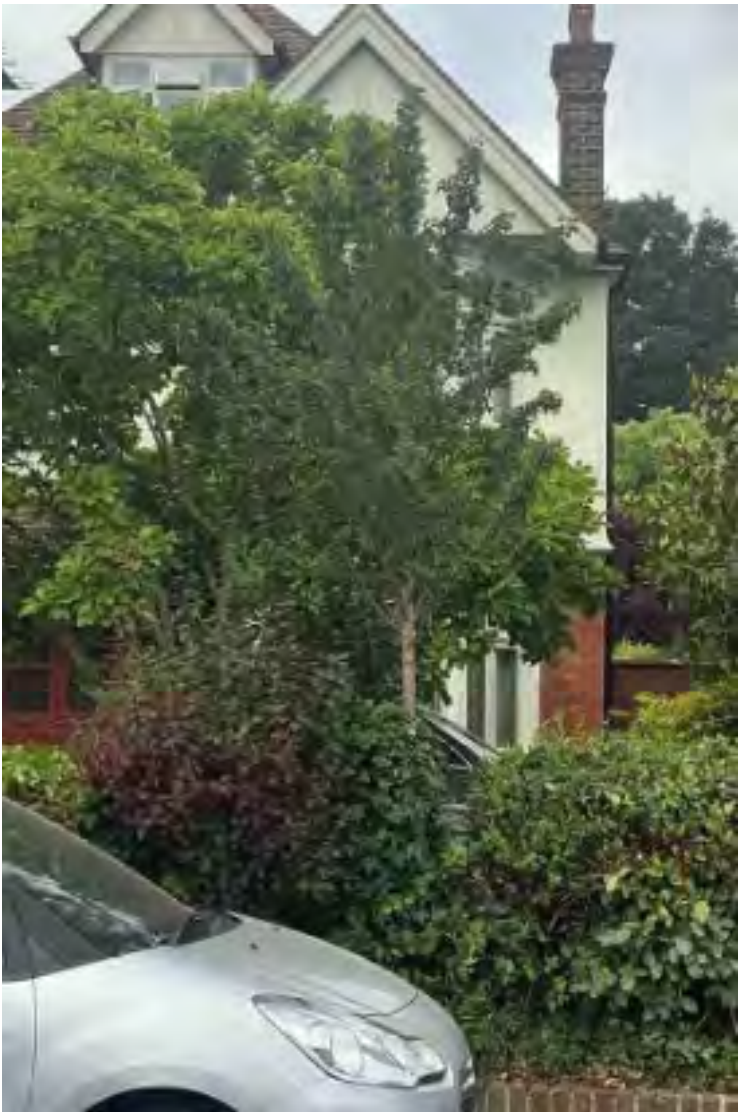
| Inspection findings/reason for exemption | This tree has an unacceptable movement at root plate and has become unstable. Removal is required to prevent natural failure, manage risk, and facilitate replanting |

Image shows tree in street scene.

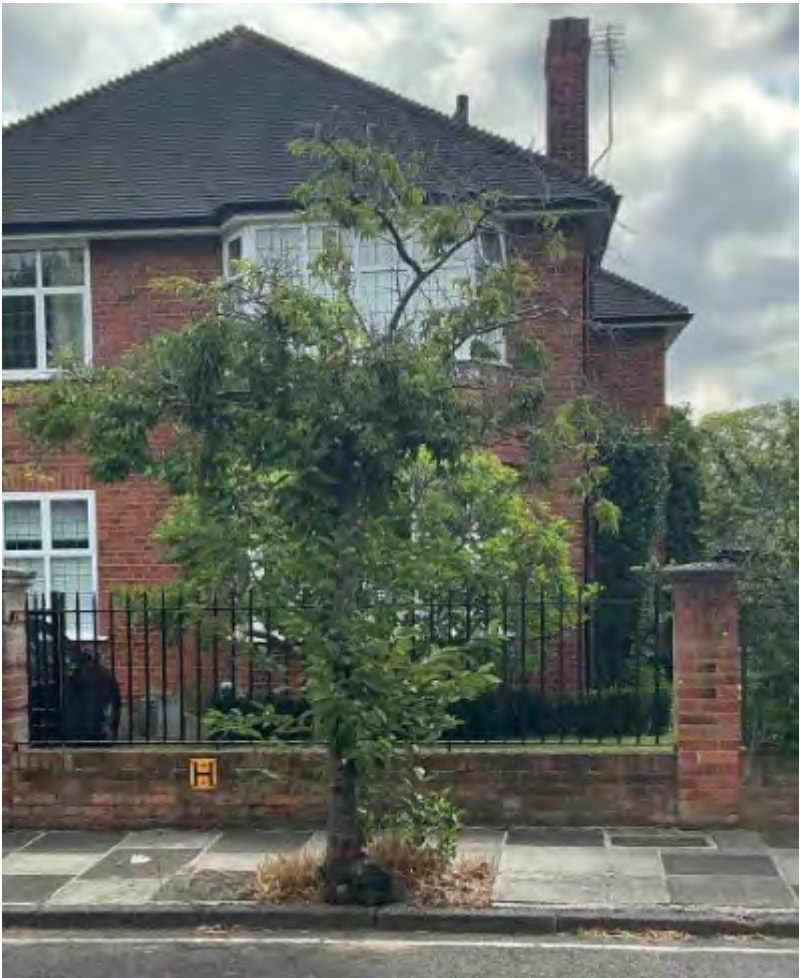
| Inspection findings/reason for exemption | Fruiting bodies of the decay fungus Turkey Tail ( <i>Tramates versicolor</i> ) are prolific on the trunk of this tree. This fungus causes a selective white rot of the wood and when prolific is indicative of wider physiological dysfunction. This correlates with crown dieback and decay pockets on trunk. Removal is required to prevent natural failure, manage risk, and facilitate replanting |

Image shows tree in street scene.

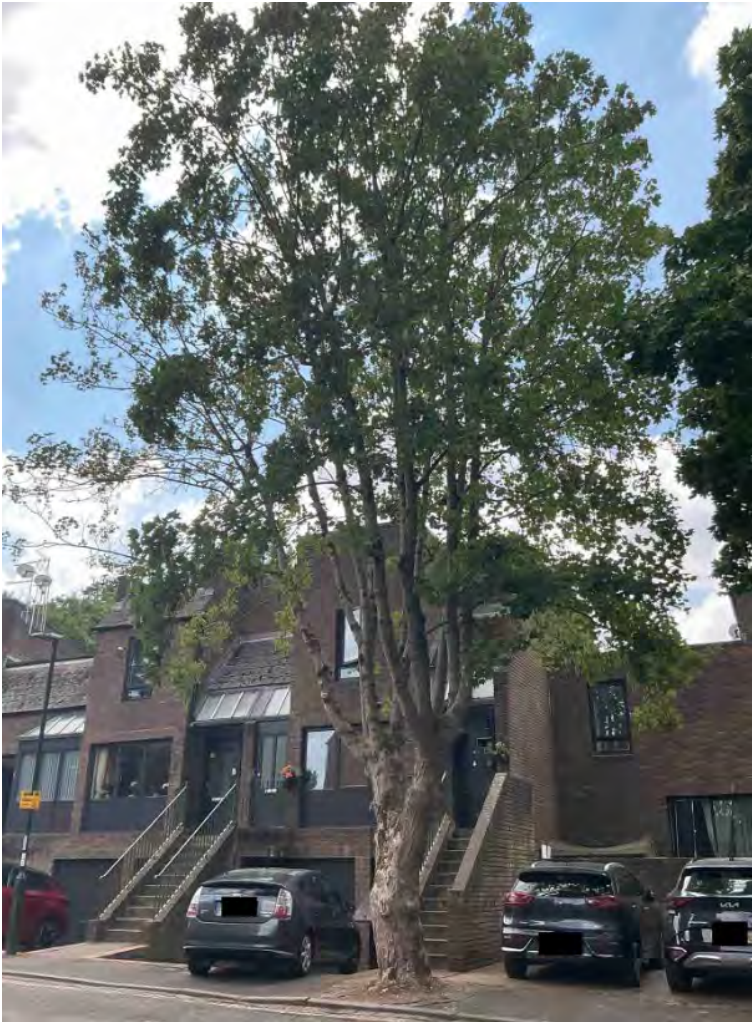
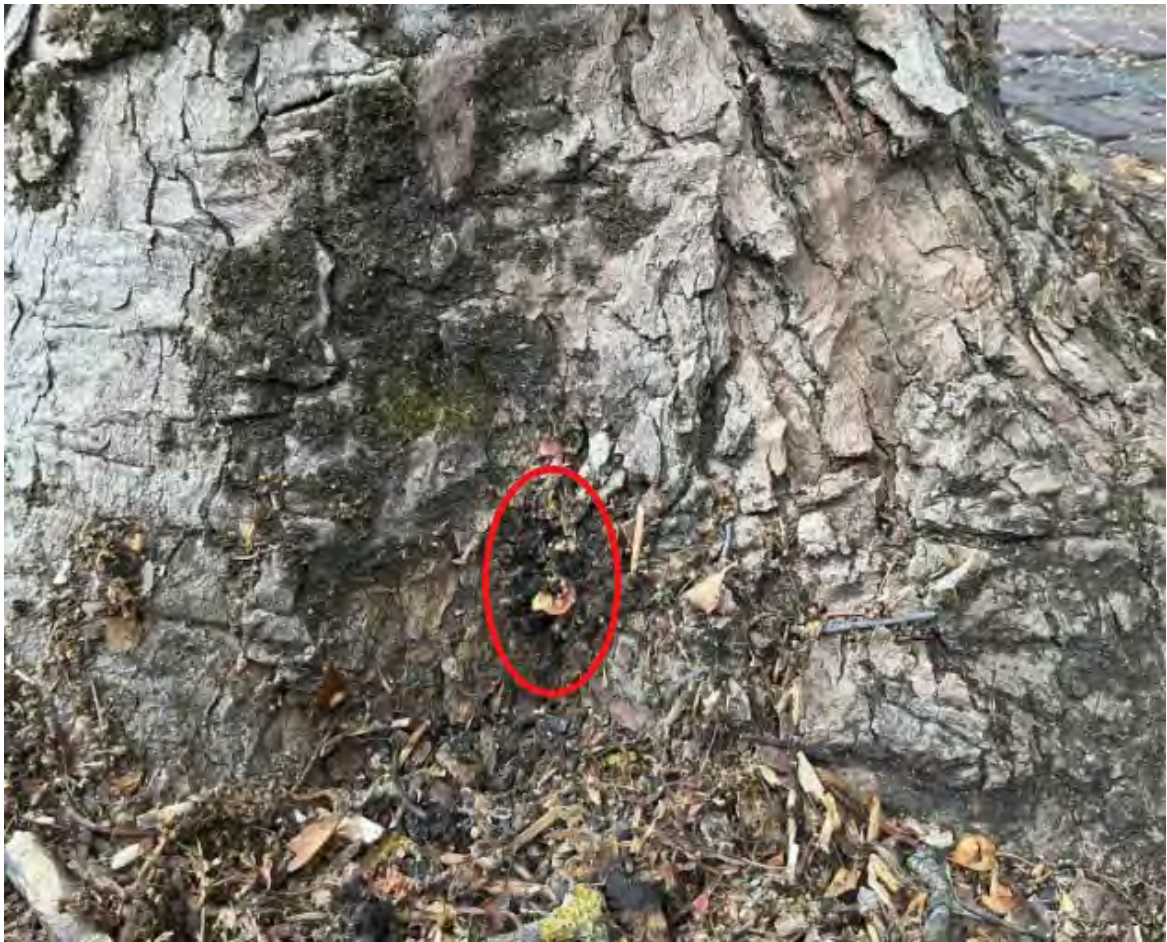
| Inspection findings/reason for exemption | Fungal fruiting bodies of the decay pathogen <i>Kretzschmaria deusta</i> are present on the base of this tree. This fungus causes a white rot that can cause whole tree failure through a ceramic like fracture of the base. Removal is required to prevent natural failure, manage risk, and facilitate replanting |

***Image shows fungal fruiting body on trunk circled.***

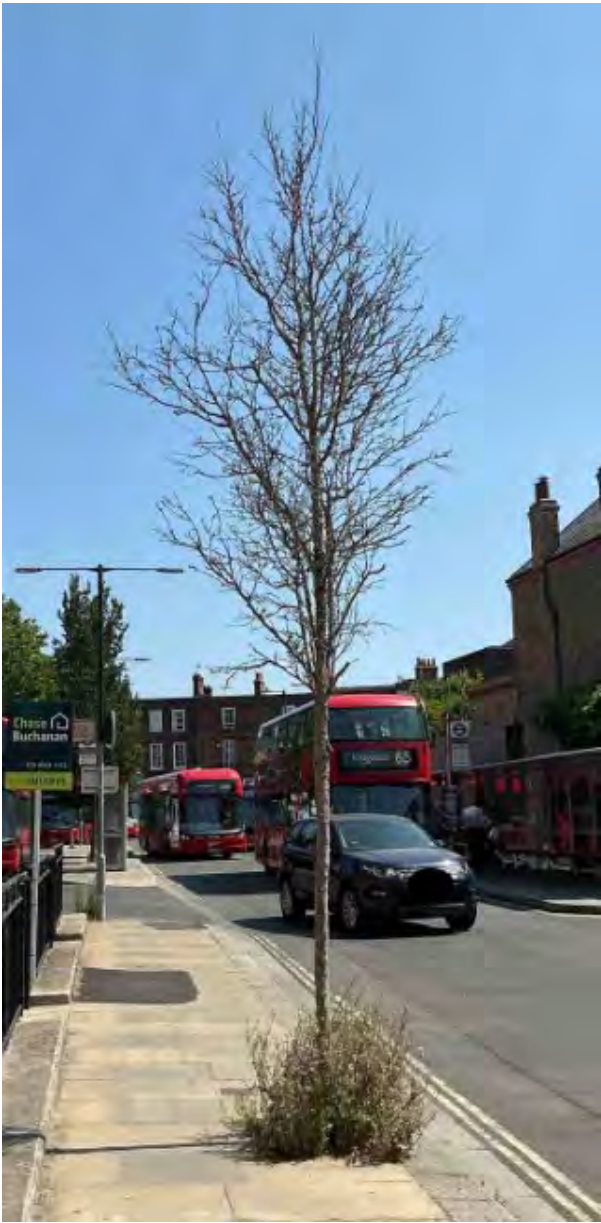
| Inspection findings/reason for exemption | This tree is dead; removal is required to prevent natural failure, manage risk, and facilitate replanting |

Image shows dead tree in street scene.

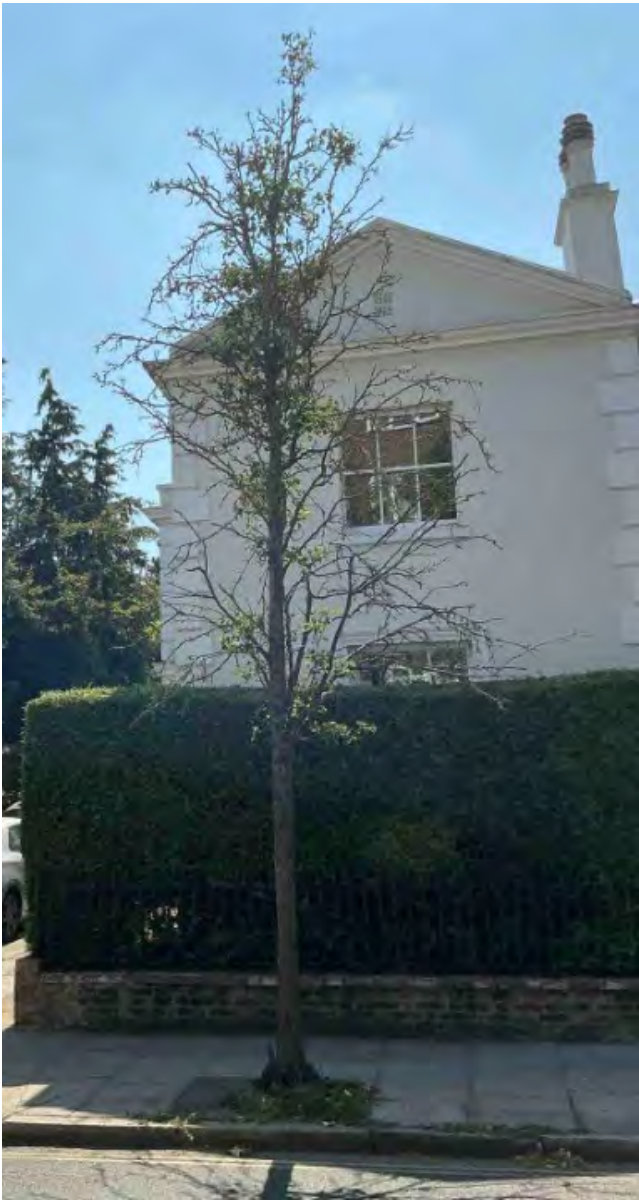
| Inspection findings/reason for exemption | This tree is moribund; removal is required to prevent natural failure, manage risk, and facilitate replanting |

Image shows moribund tree in street scene.

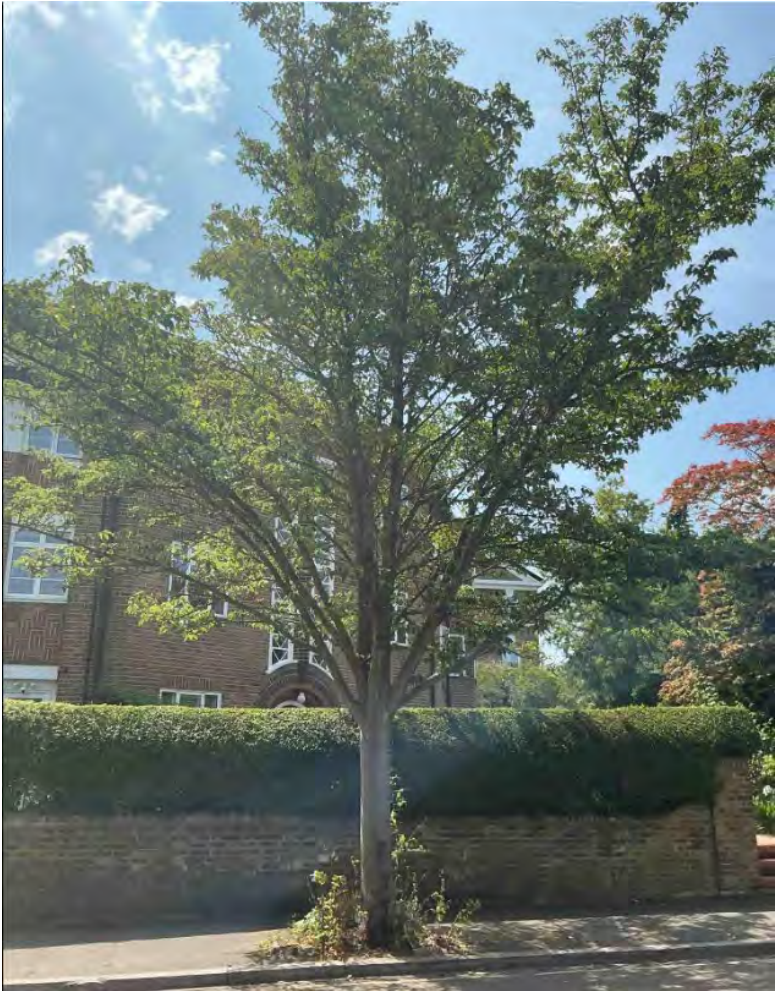
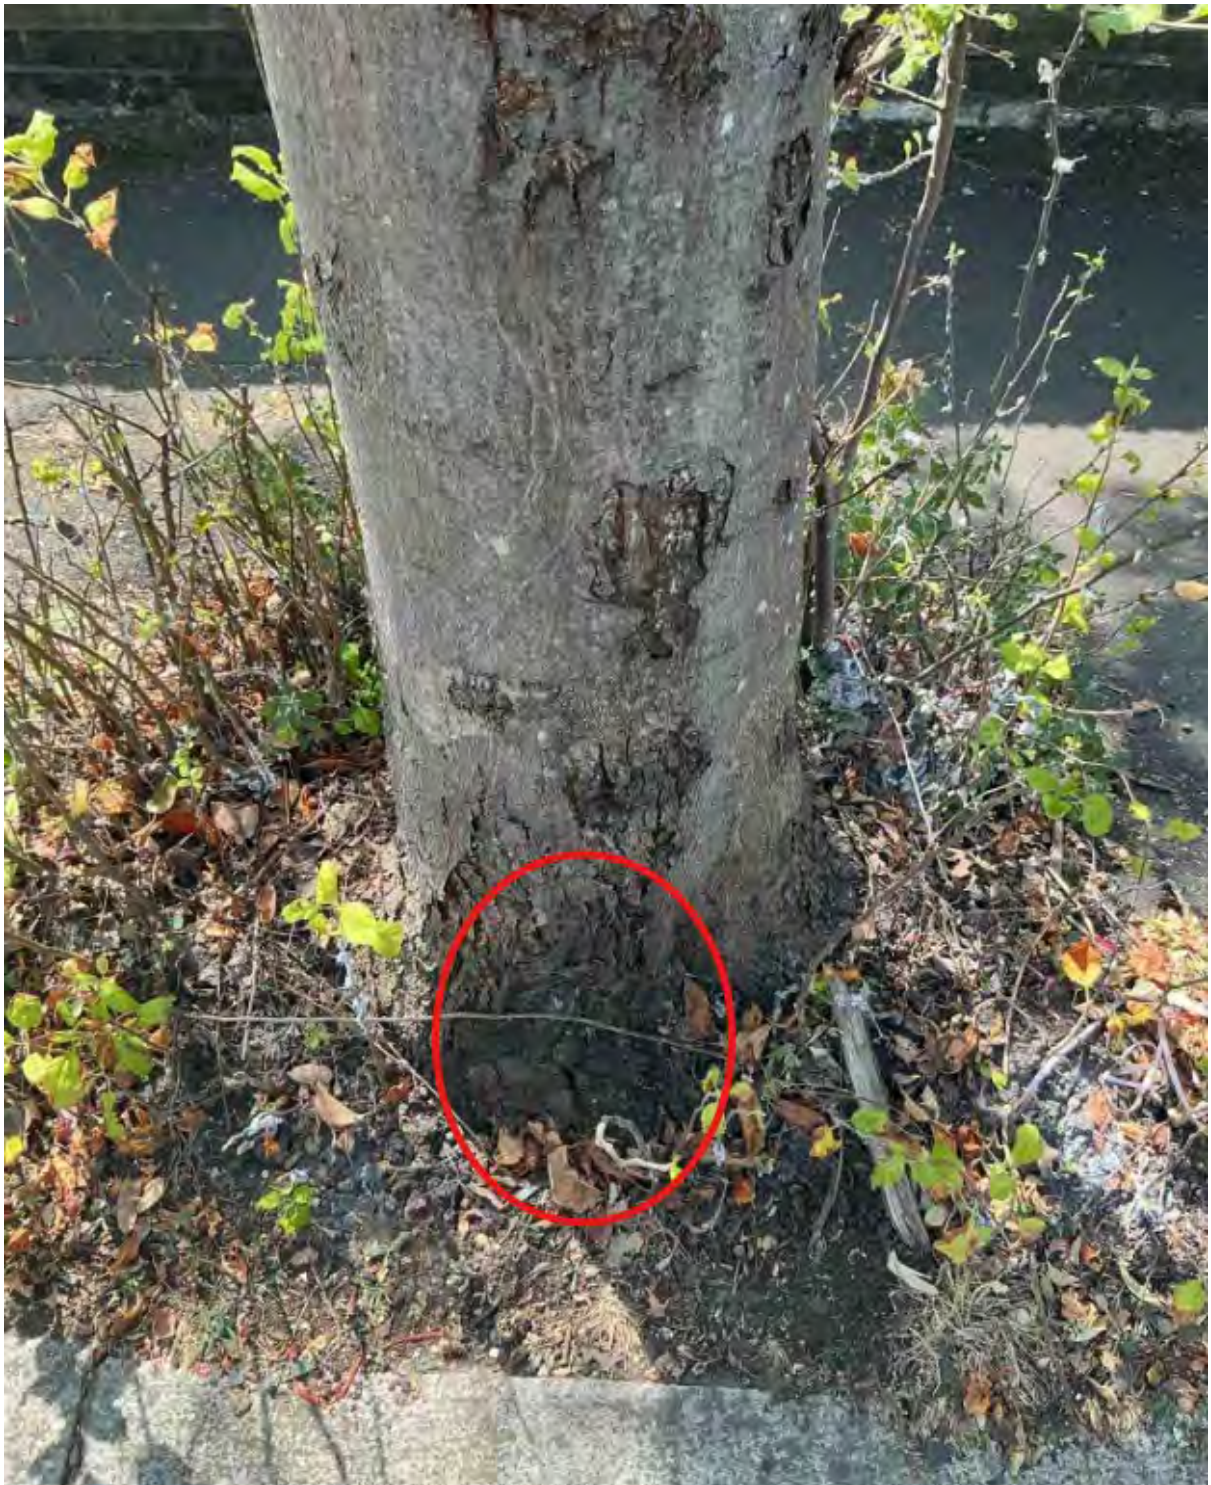
| Inspection findings/reason for exemption | A fungal fruiting body of the decay fungus <i>Ganoderma sp.</i> is present on the trunk. Colonisation by this fungus results in white rot affecting the stem and root system, which can lead to structural failure through fracture or windthrow. A resonance test with a sounding hammer has revealed an unacceptable amount of decay around the bracket. Removal of the tree is recommended to prevent natural failure, manage risk, and facilitate replanting. |

*Image shows fungal fruiting body on trunk circled.*

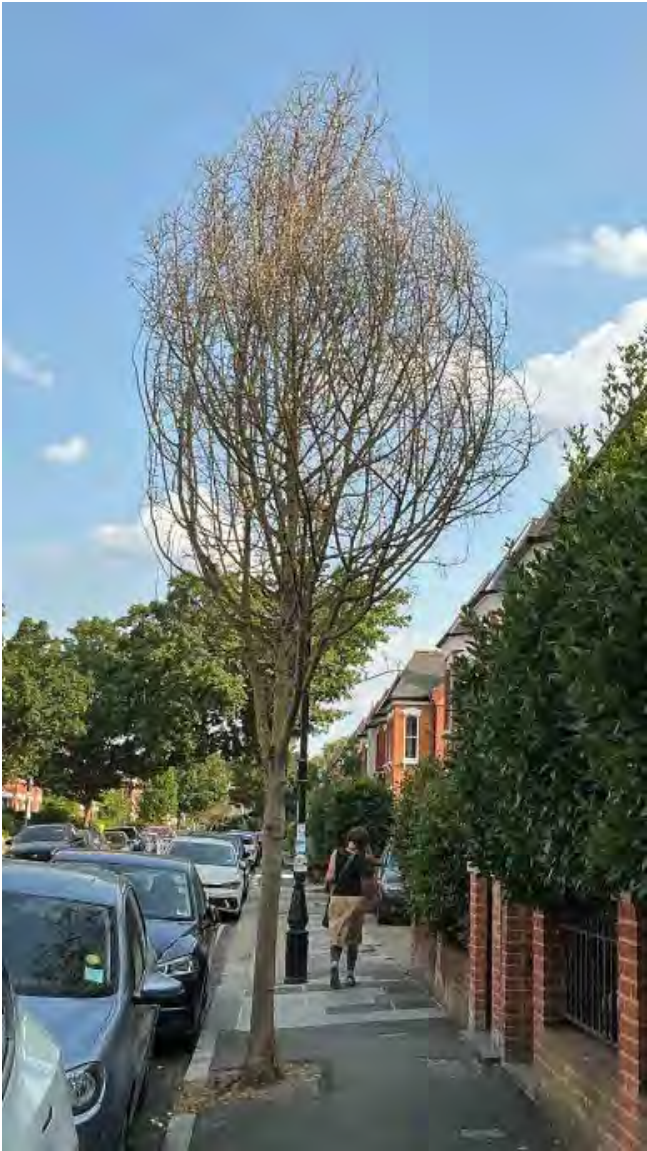
| Inspection findings/reason for exemption | This tree is dead; removal is required to prevent natural failure, manage risk, and facilitate replanting |

Image shows dead tree in street scene.

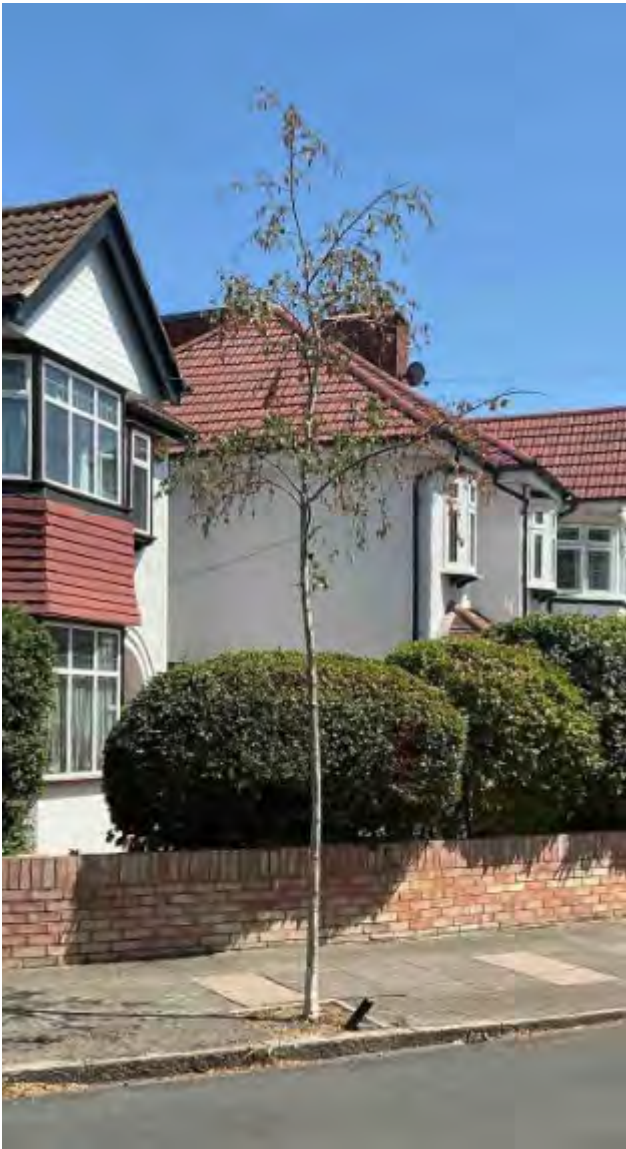
| Inspection findings/reason for exemption | This tree is moribund; removal is required to prevent natural failure, manage risk, and facilitate replanting |

Image shows moribund tree in street scene.

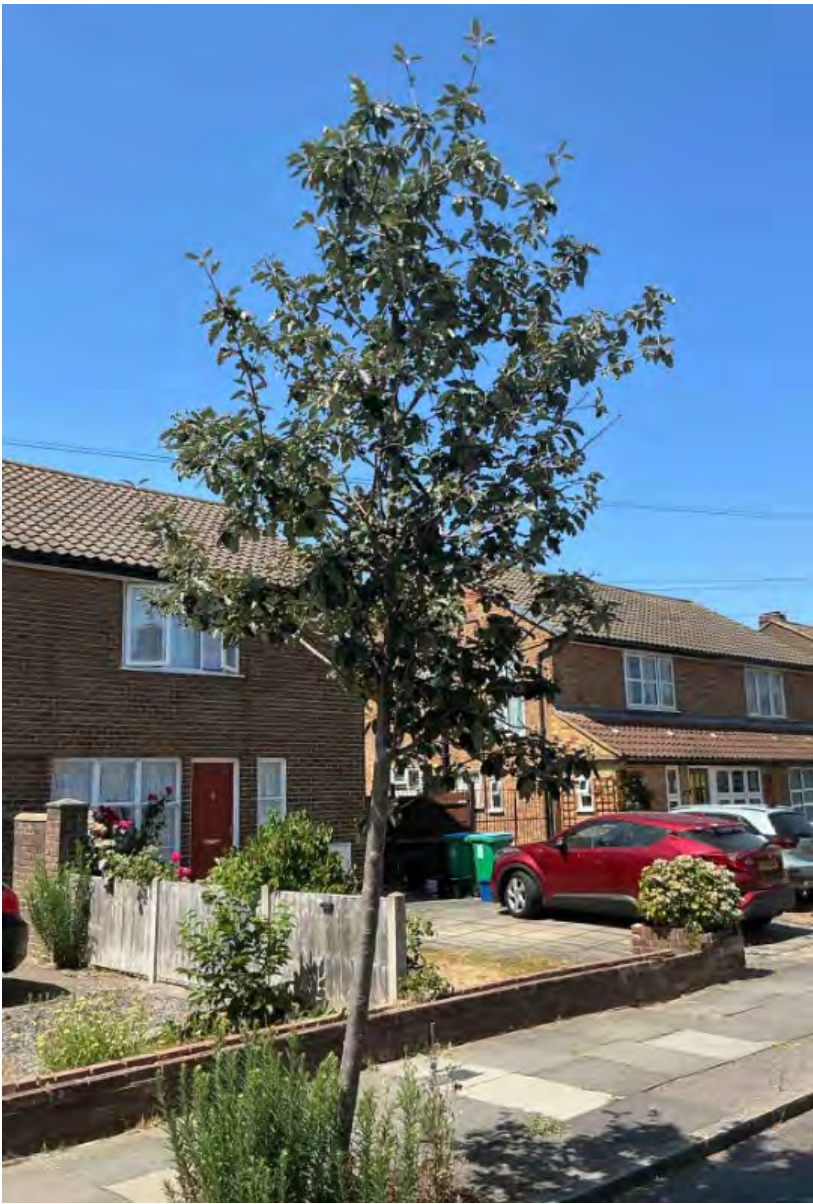
| Inspection findings/reason for exemption | This tree has an unacceptable movement at root plate and has become unstable. Removal is required to prevent natural failure, manage risk, and facilitate replanting |

Image shows tree in street scene.

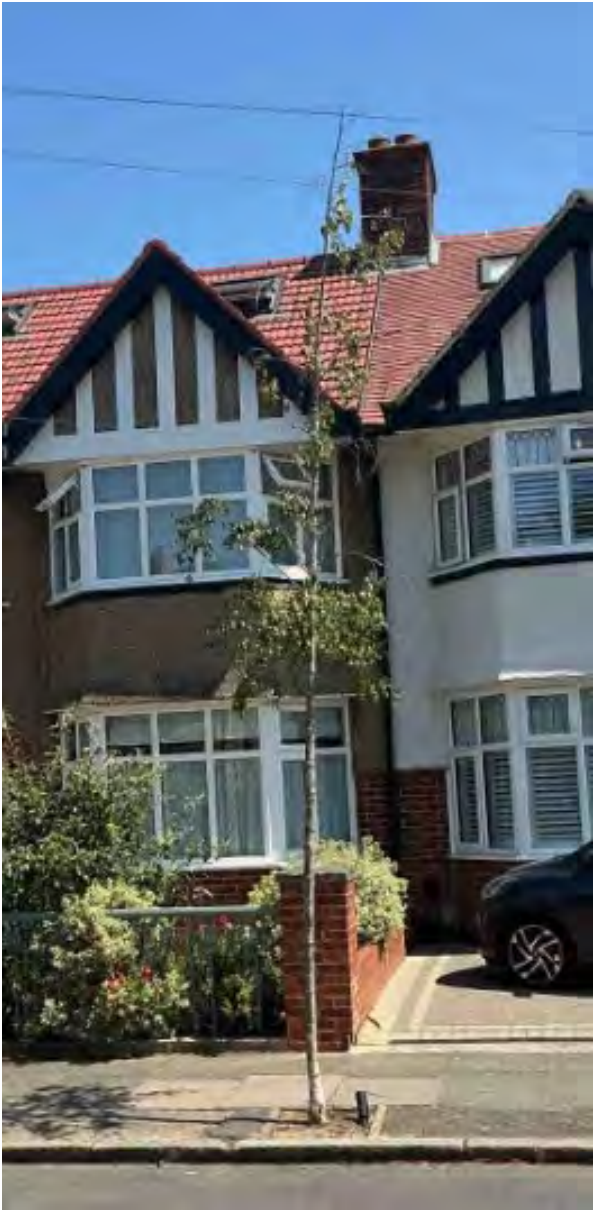
| Inspection findings/reason for exemption | This tree is moribund; removal is required to prevent natural failure, manage risk, and facilitate replanting |

Image shows moribund tree in street scene.
