# August 2026 - Reactive Tree Works Programme

A survey of trees in the Kew, South Richmond and Whitton wards are currently being undertaken; this is being conducted by specialist arboricultural officers as part of the scheduled 4 yearly detailed inspection regime that has been devised for all Council highway and parks trees.

Recent reactive inspections have identified the need for 106 individual tree work operations to take place. This work will now be issued to the Council’s Arborist Contractor KPS, for completion over the Autumn period.

The following pages provide the locations of each tree that is to be removed, in addition photographs and descriptions of the inspection findings have been provided.

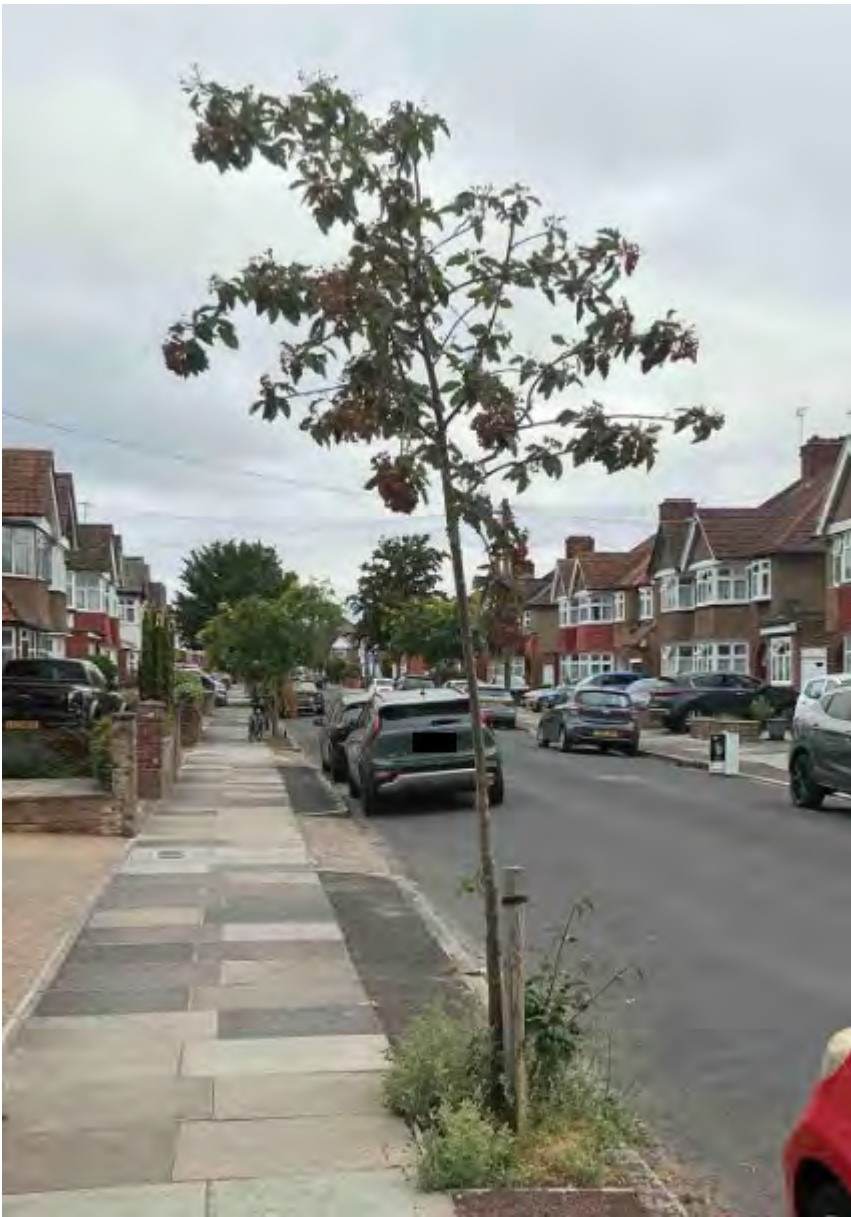
| Inspection findings/reason for exemption | This tree has an unacceptable movement at root plate and has become unstable. Removal is required to prevent natural failure, manage risk, and facilitate replanting |

Image shows tree in street scene.

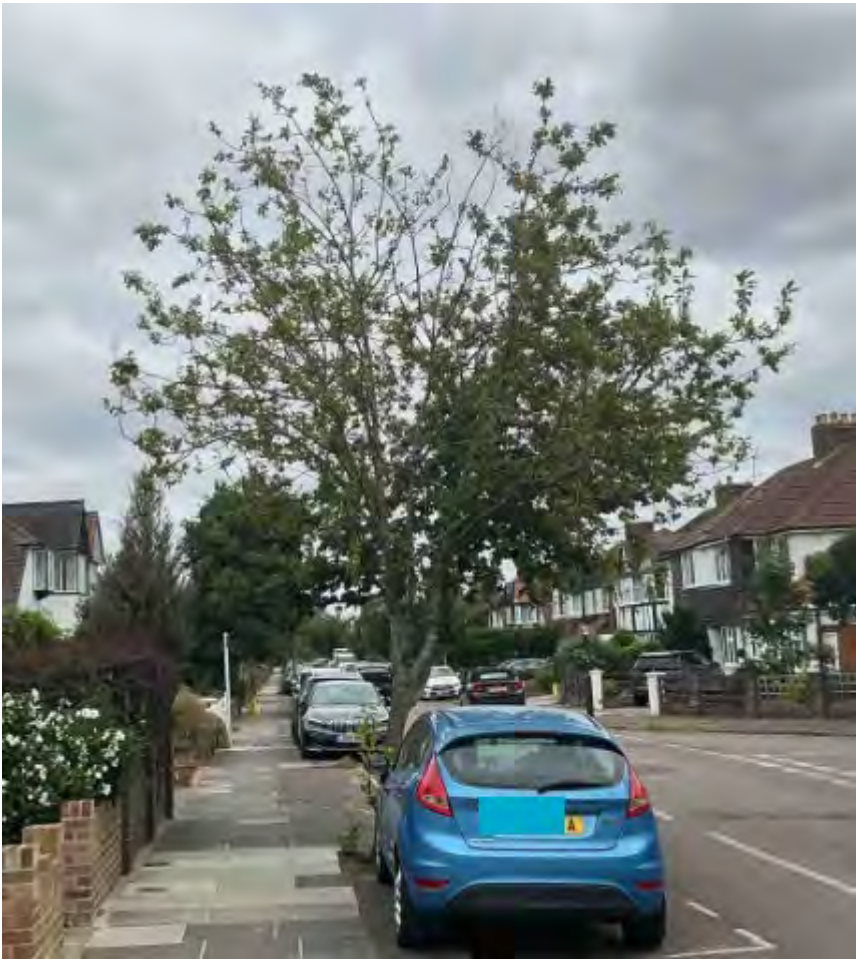
| Inspection findings/reason for exemption | This tree is moribund; removal is required to prevent natural failure, manage risk, and facilitate replanting |

Image shows moribund tree in street scene.

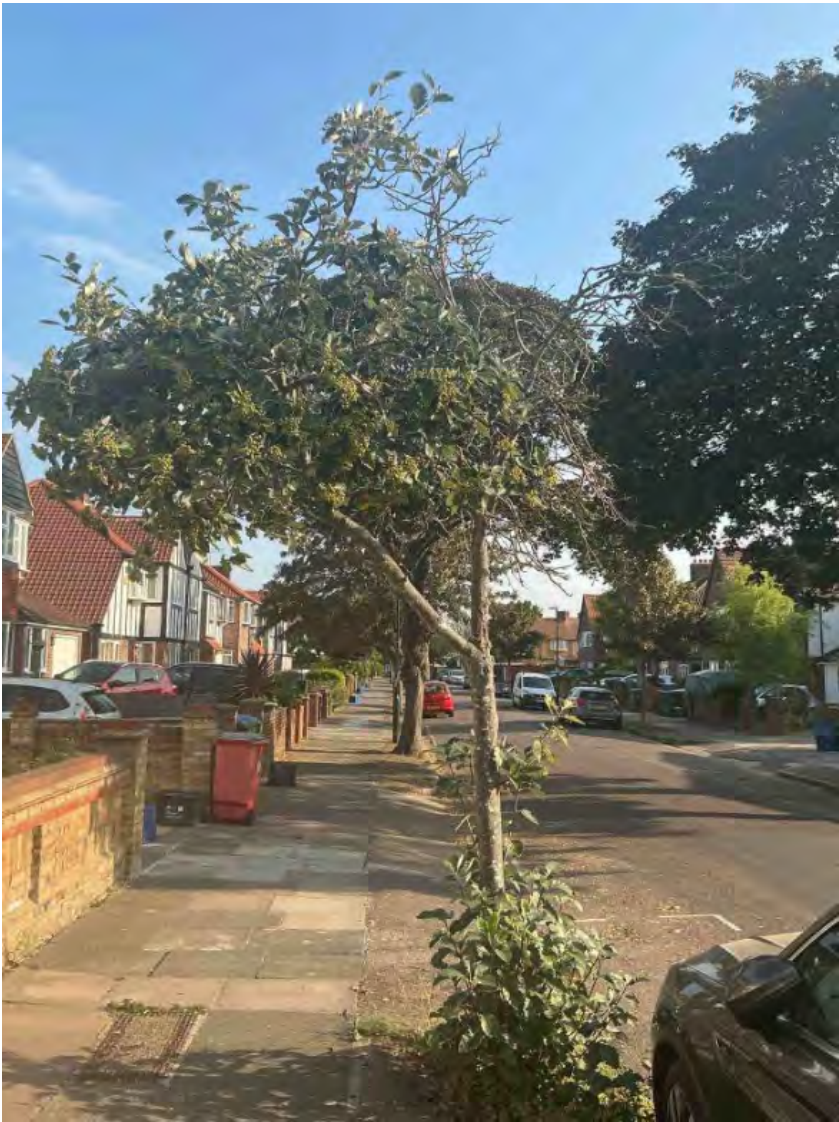
| Inspection findings/reason for exemption | This tree is moribund; removal is required to prevent natural failure, manage risk, and facilitate replanting |

Image shows moribund tree in street scene.

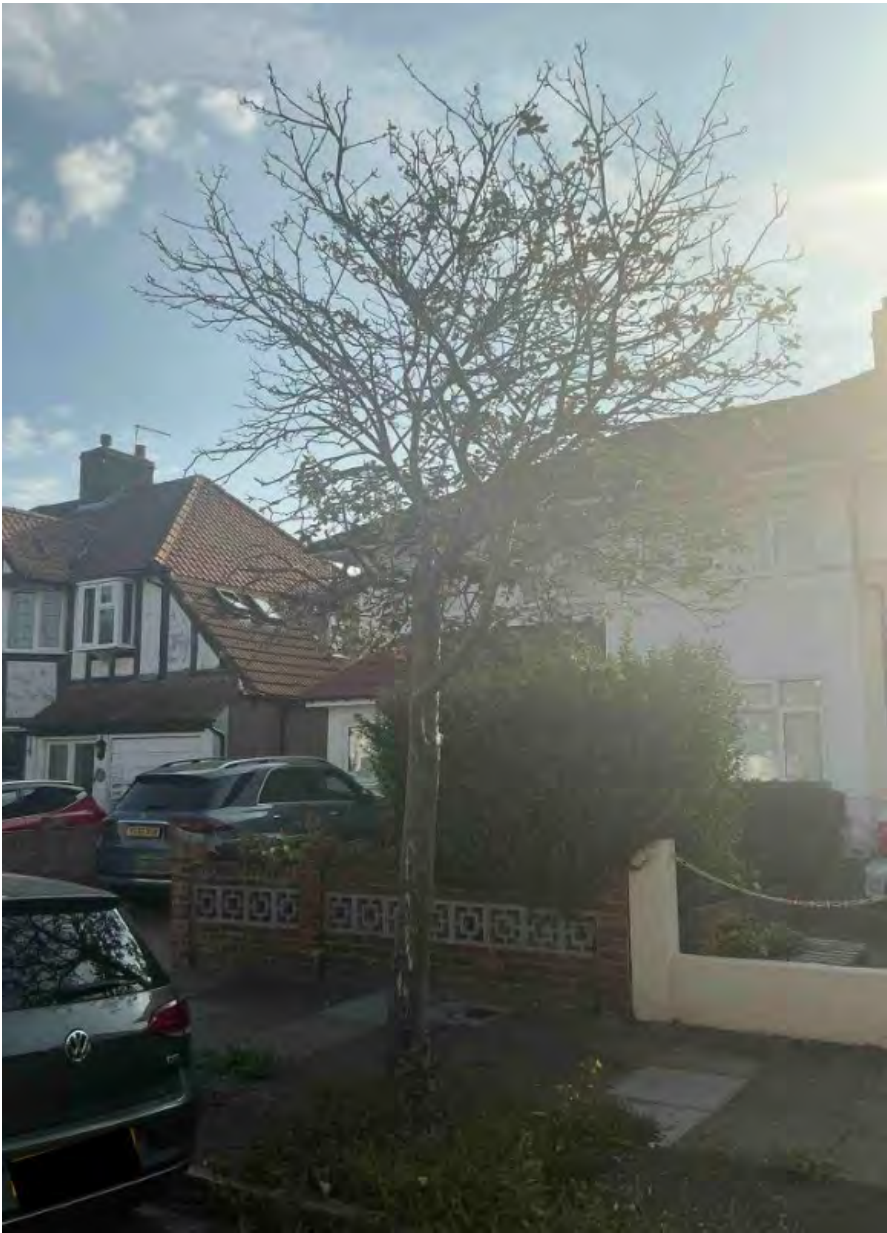
| Physiological Condition | Poor |
| Structural Condition | Fair |
| Inspection findings/reason for exemption | This tree is moribund; removal is required to prevent natural failure, manage risk, and facilitate replanting |

Image shows moribund tree in street scene.

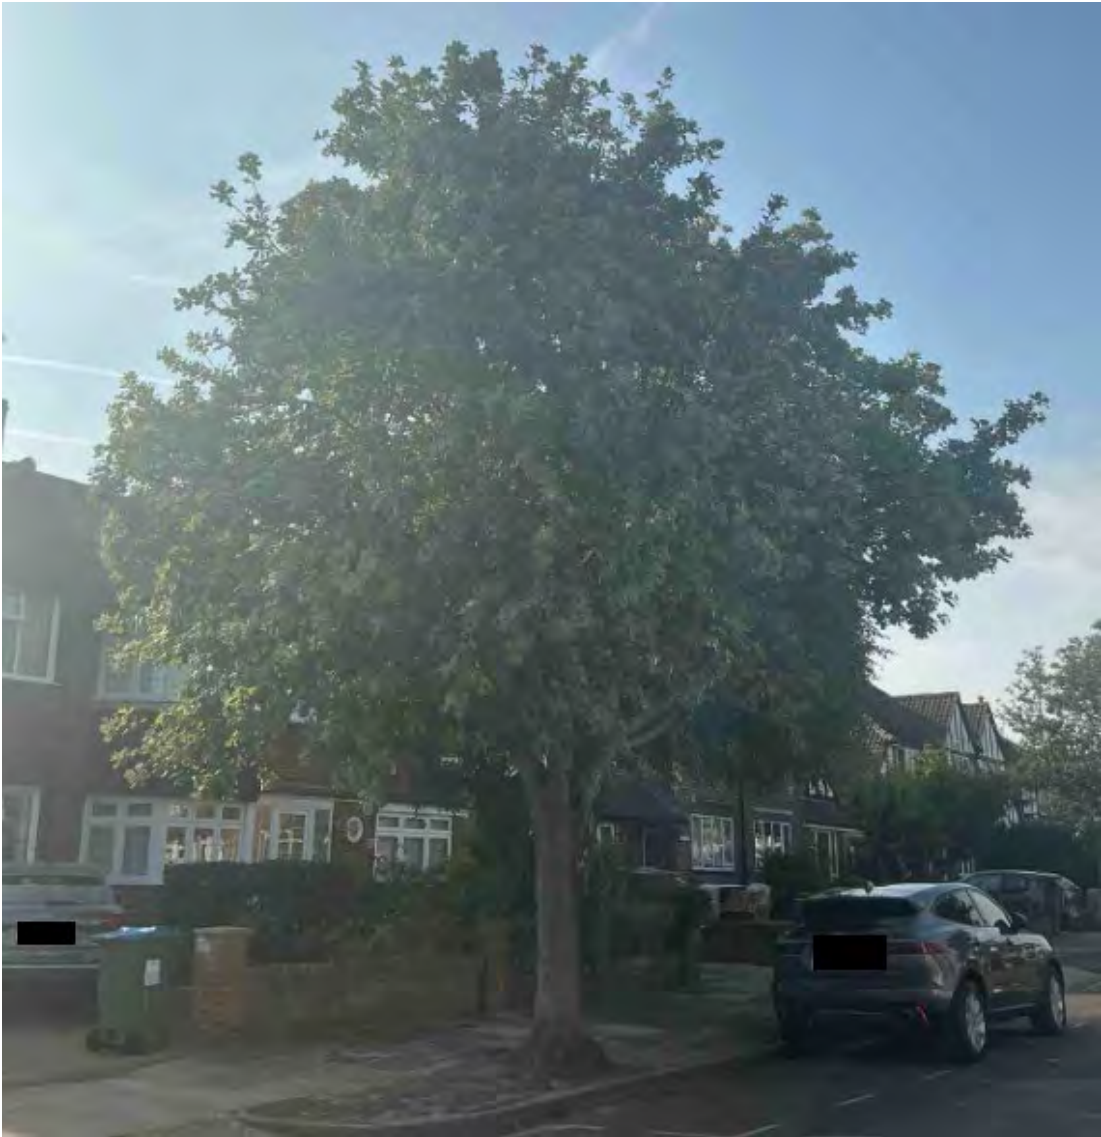
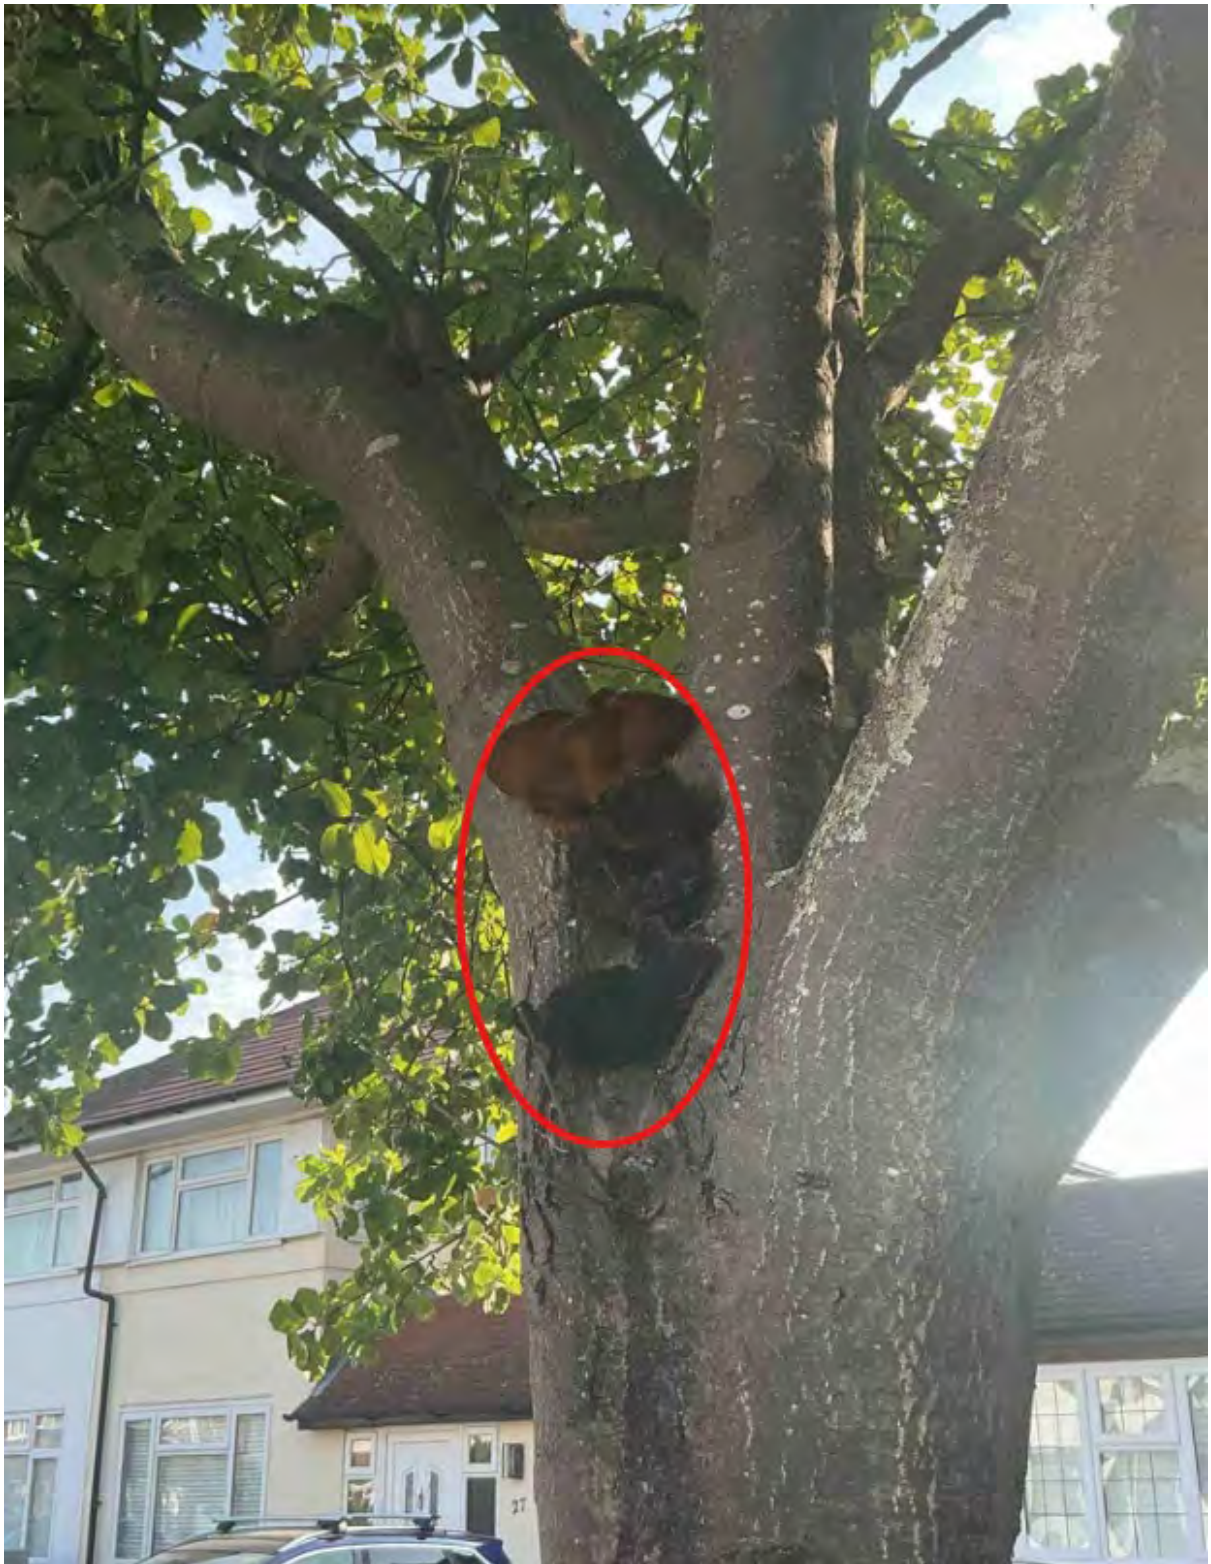
| Physiological Condition | Fair |
| Structural Condition | Poor |
| Inspection findings/reason for exemption | A fungal fruiting body of the species Shaggy Polypore ( <i>Inonotus hispidus</i> ) is present on the in the primary union of the trunk. This fungus causes a simultaneous white rot which can cause snapping of tree parts in this particular species. Removal is required to prevent natural failure, manage risk, and facilitate replanting |

Image shows tree in street scene.

***Image shows fungal fruiting bodies circled.***

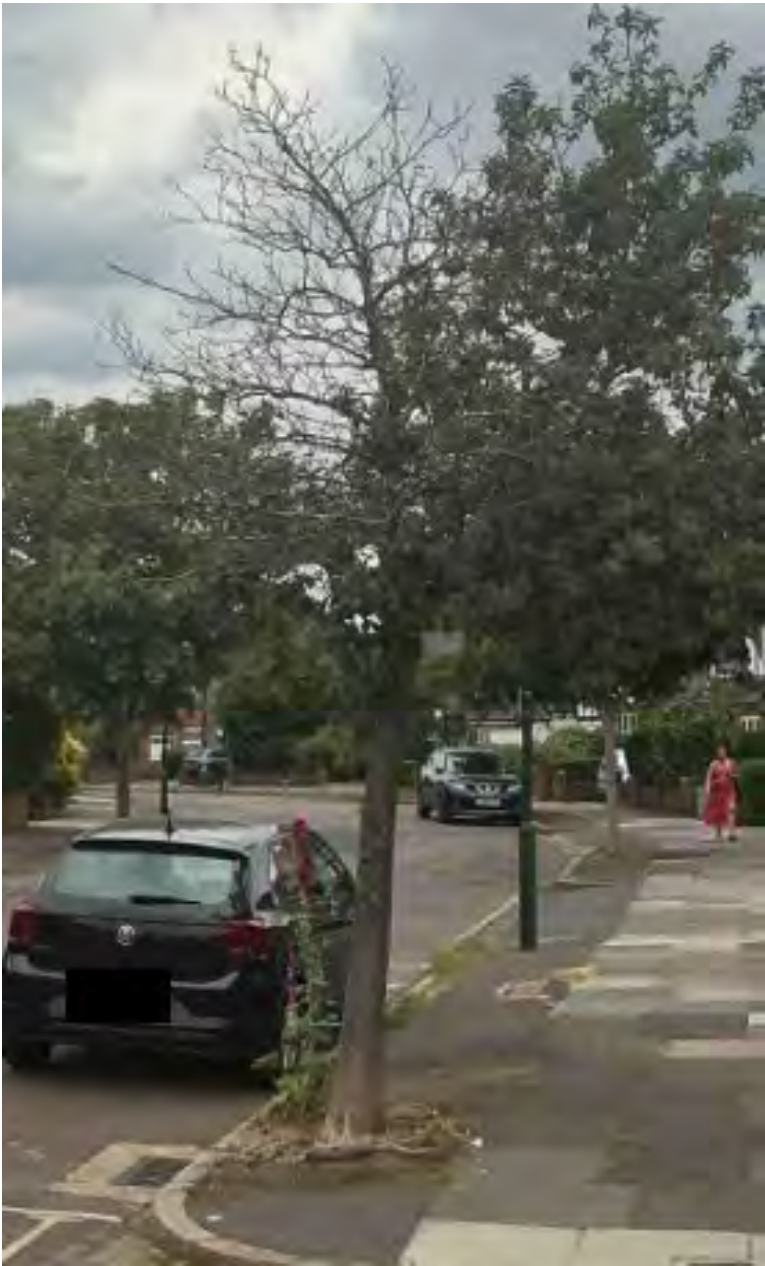
| Physiological Condition | Poor |
| Structural Condition | Fair |
| Inspection findings/reason for exemption | This tree is moribund; removal is required to prevent natural failure, manage risk, and facilitate replanting |

Image shows moribund tree in street scene.

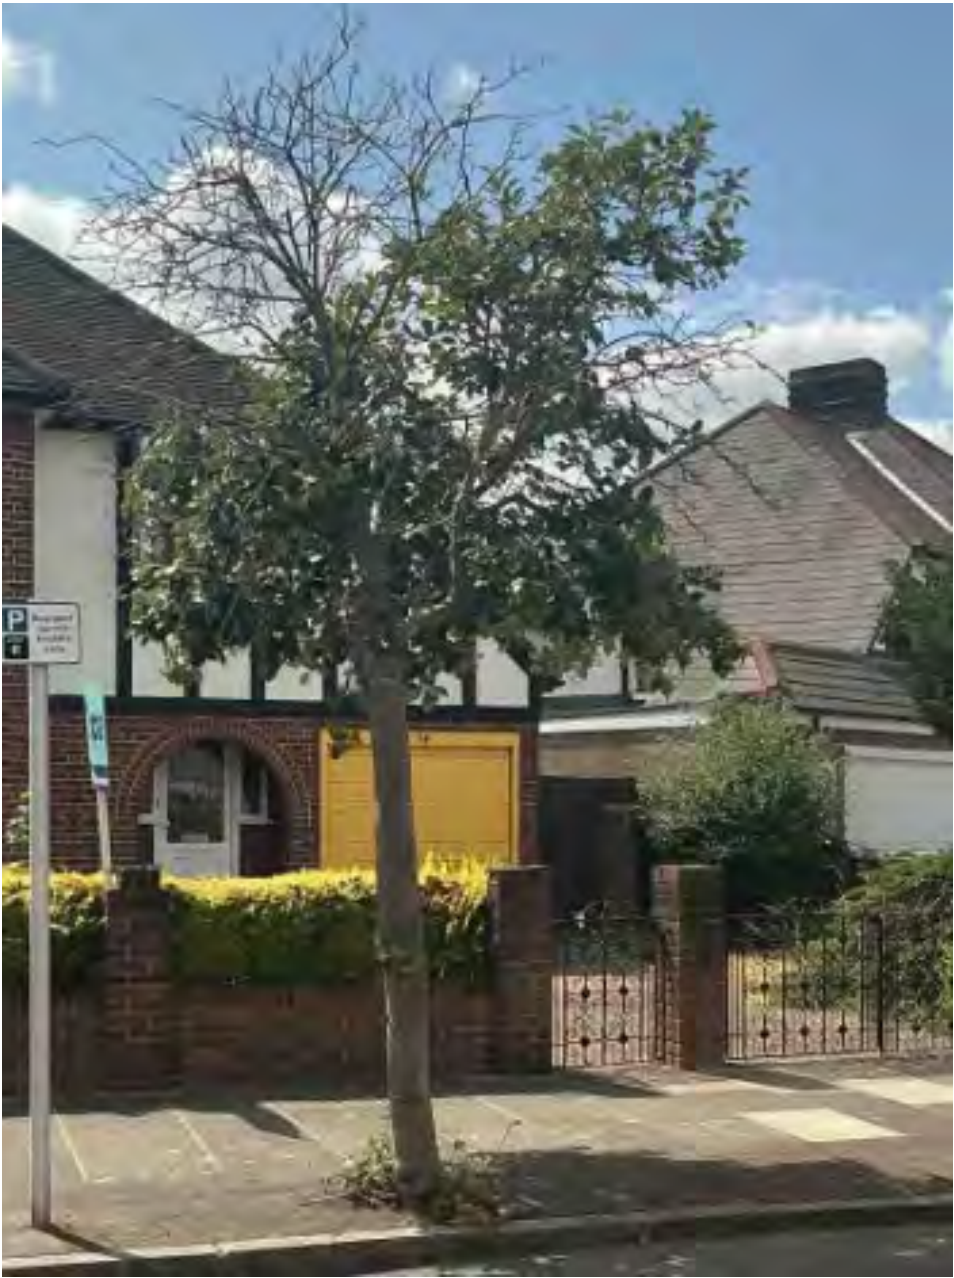
| Physiological Condition | Poor |
| Structural Condition | Fair |
| Inspection findings/reason for exemption | This tree is moribund; removal is required to prevent natural failure, manage risk, and facilitate replanting |

Image shows moribund tree in street scene.

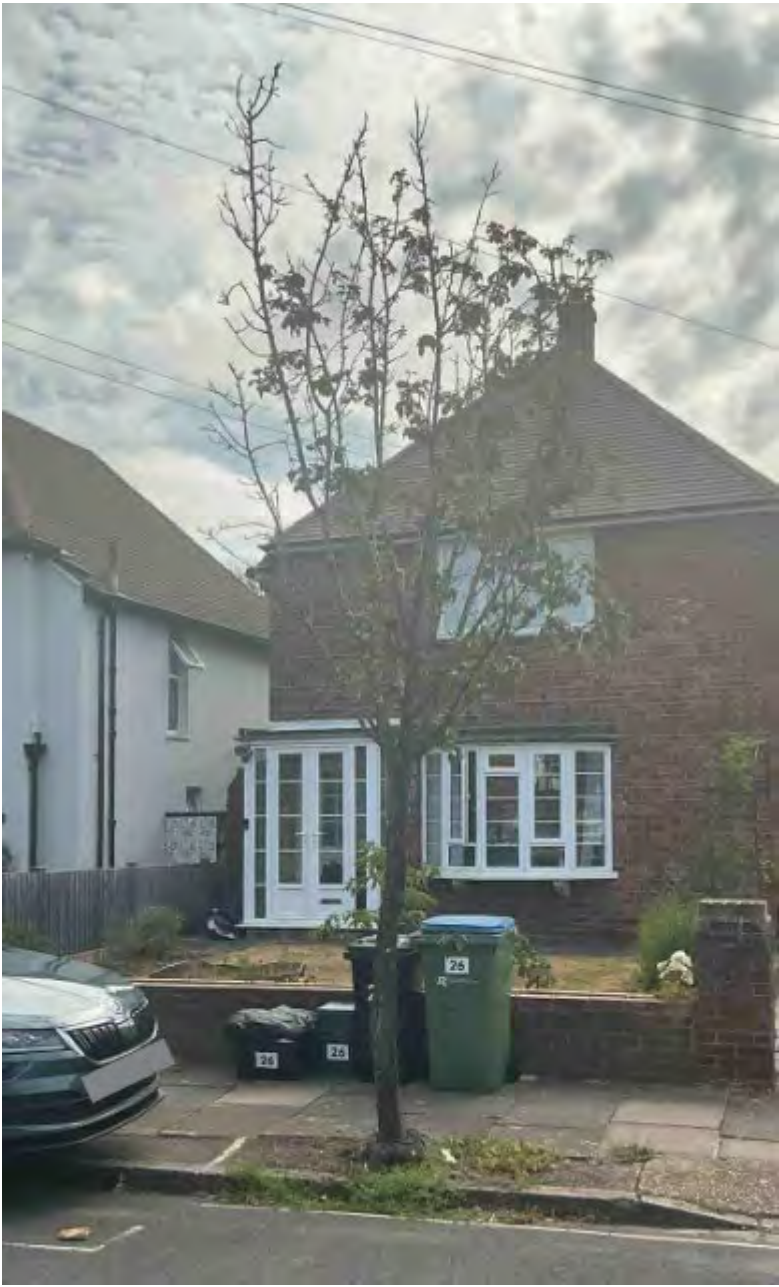
| Physiological Condition | Poor |
| Structural Condition | Fair |
| Inspection findings/reason for exemption | This tree is moribund; removal is required to prevent natural failure, manage risk, and facilitate replanting |

Image shows moribund tree in street scene.

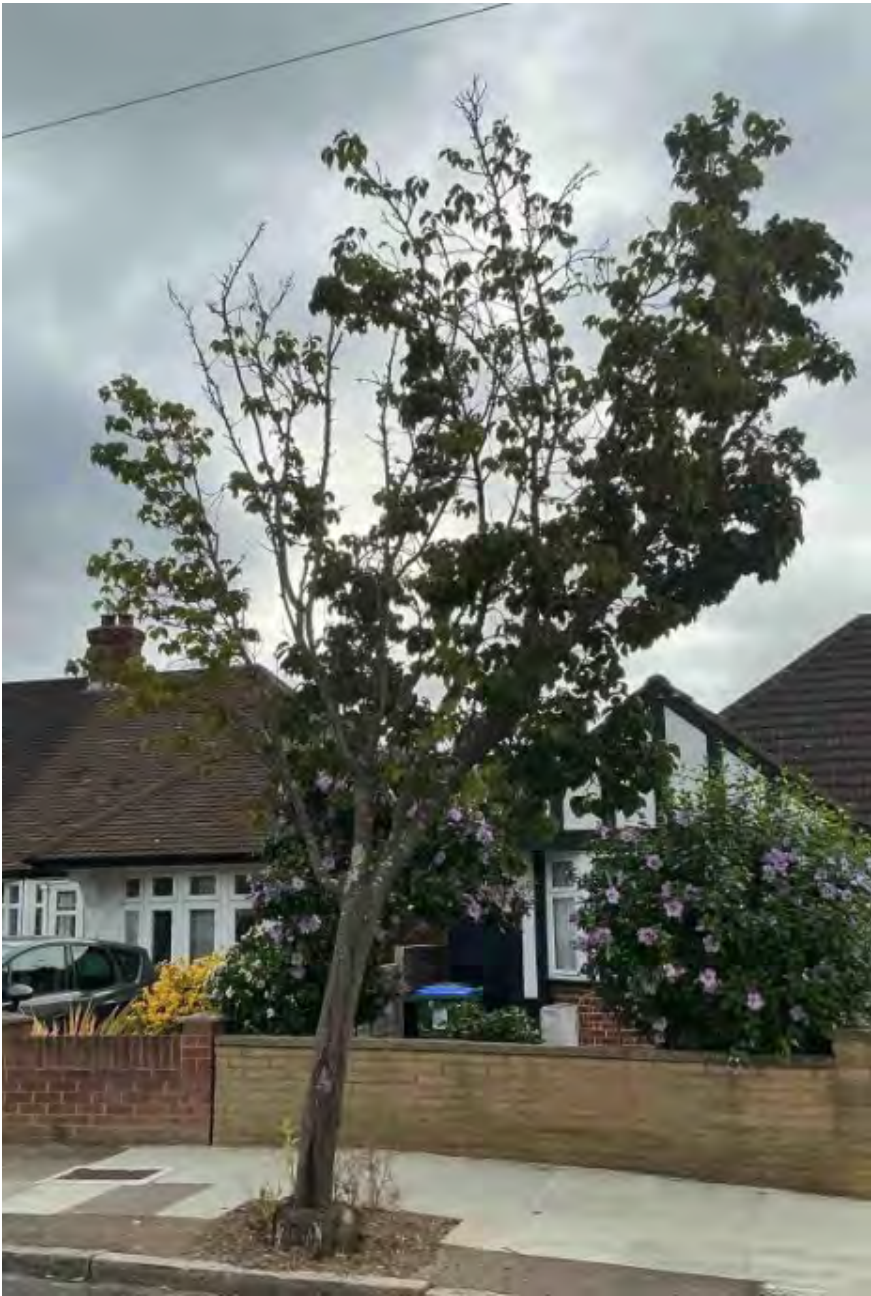
| Physiological Condition | Poor |
| Structural Condition | Fair |
| Inspection findings/reason for exemption | This tree is moribund; removal is required to prevent natural failure, manage risk, and facilitate replanting |

Image shows moribund tree in street scene.

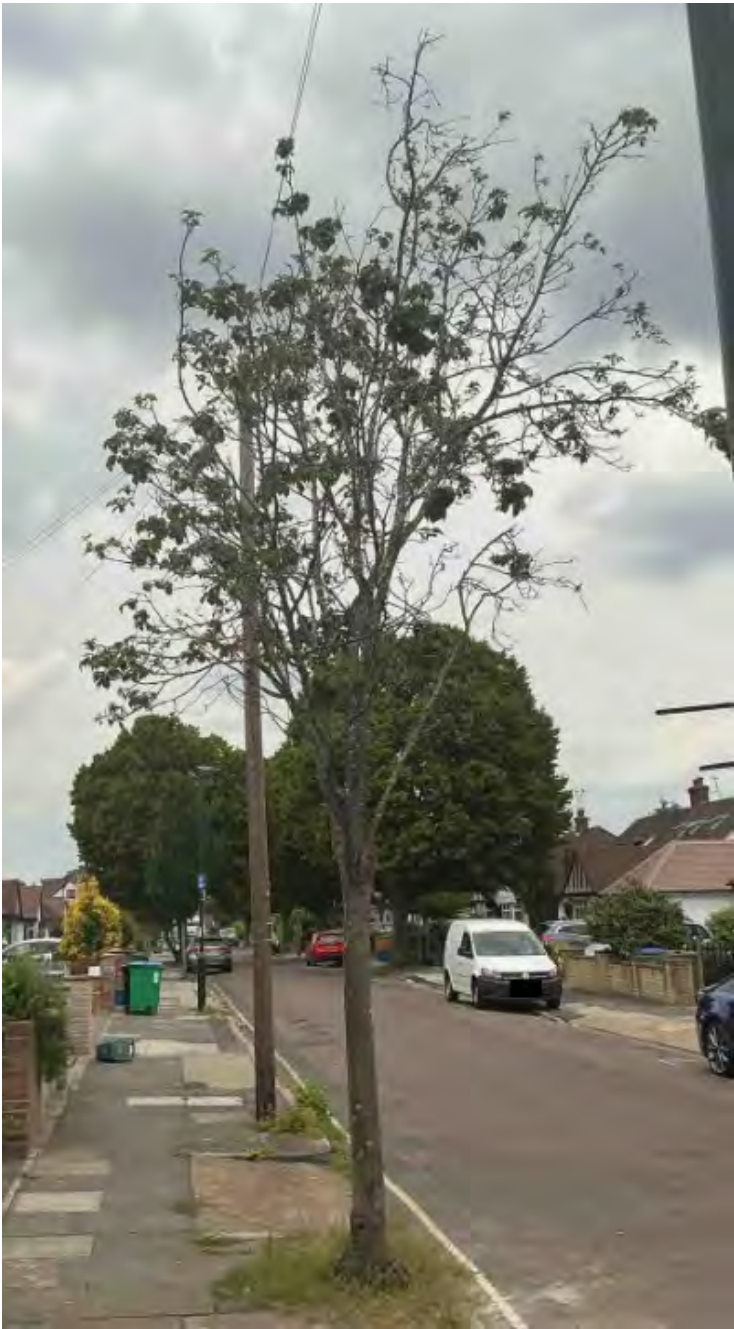
| Physiological Condition | Poor |
| Structural Condition | Fair |
| Inspection findings/reason for exemption | This tree is moribund; removal is required to prevent natural failure, manage risk, and facilitate replanting |

Image shows moribund tree in street scene.

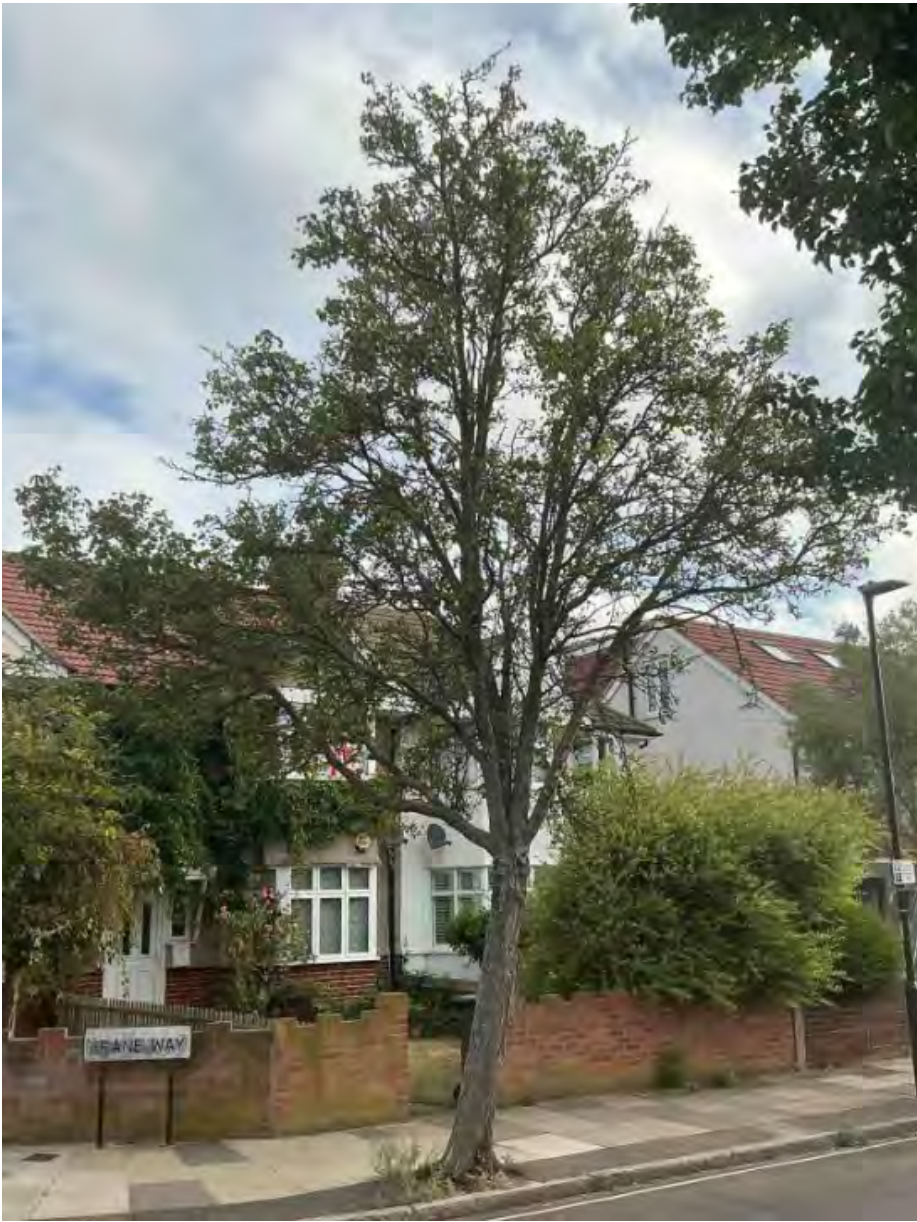
| Physiological Condition | Poor |
| Structural Condition | Fair |
| Inspection findings/reason for exemption | This tree is moribund; removal is required to prevent natural failure, manage risk, and facilitate replanting |

Image shows moribund tree in street scene.

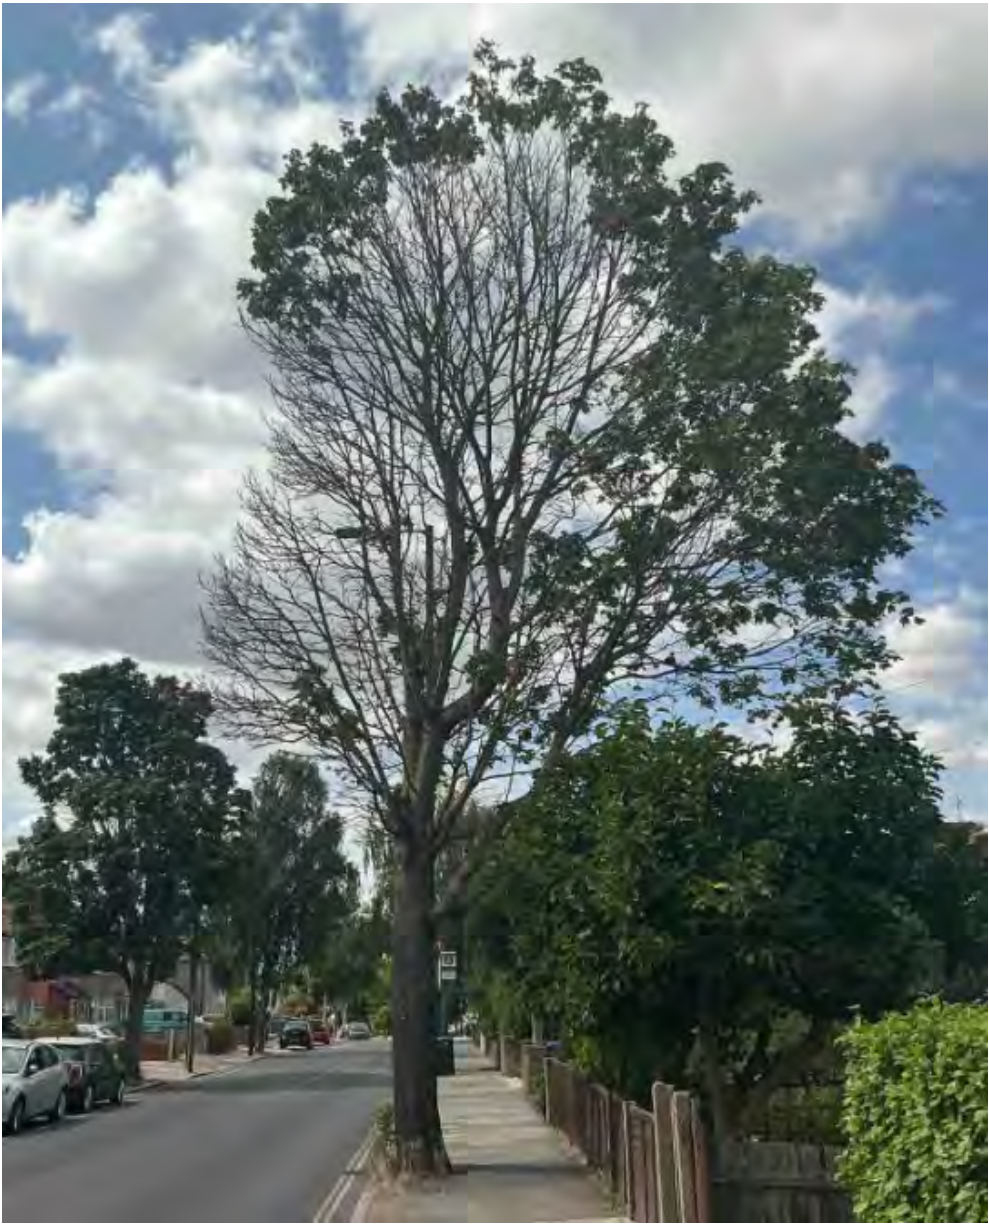
| Physiological Condition | Poor |
| Structural Condition | Fair |
| Inspection findings/reason for exemption | This tree is moribund; removal is required to prevent natural failure, manage risk, and facilitate replanting |

Image shows moribund tree in street scene.

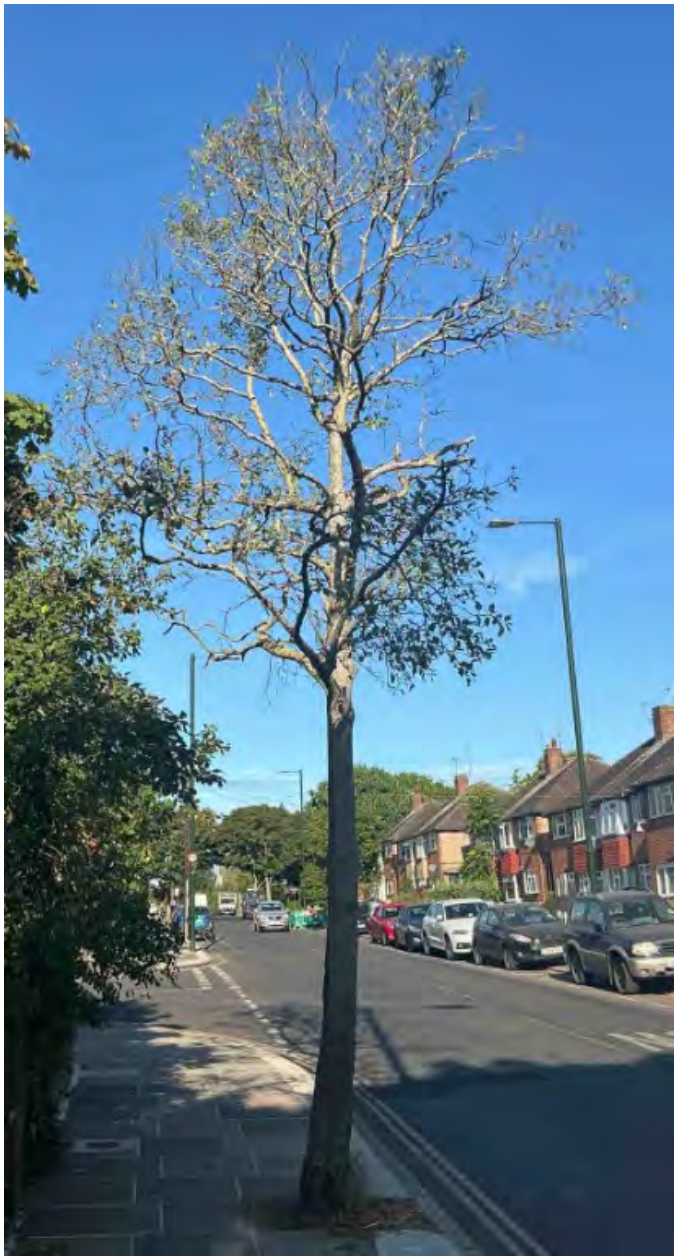
| Physiological Condition | Poor |
| Structural Condition | Fair |
| Inspection findings/reason for exemption | This tree is moribund; removal is required to prevent natural failure, manage risk, and facilitate replanting |

Image shows moribund tree in street scene.

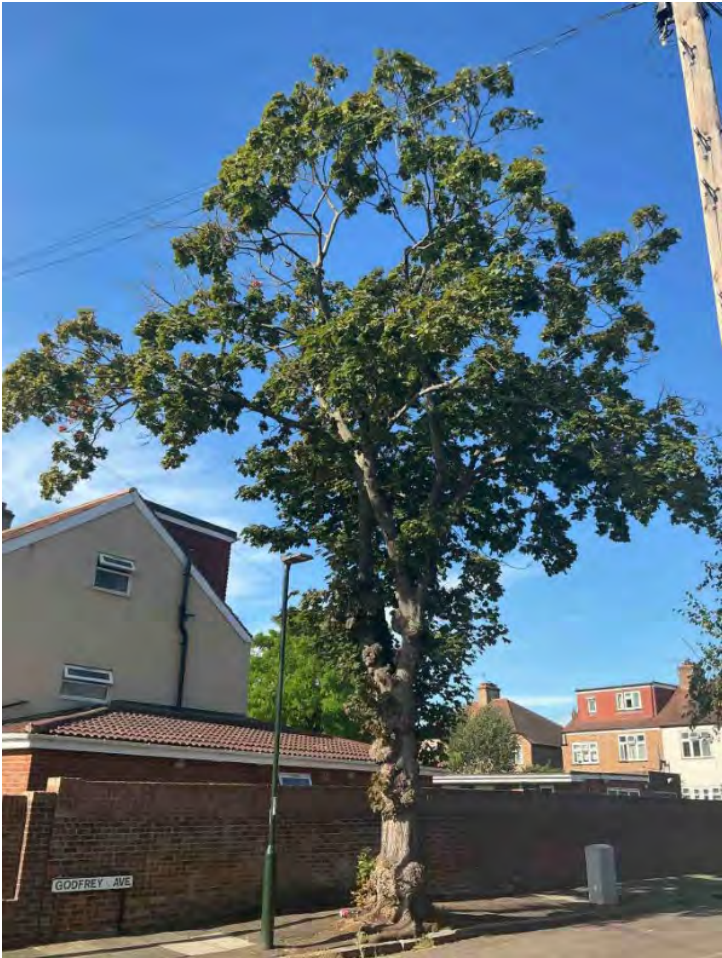
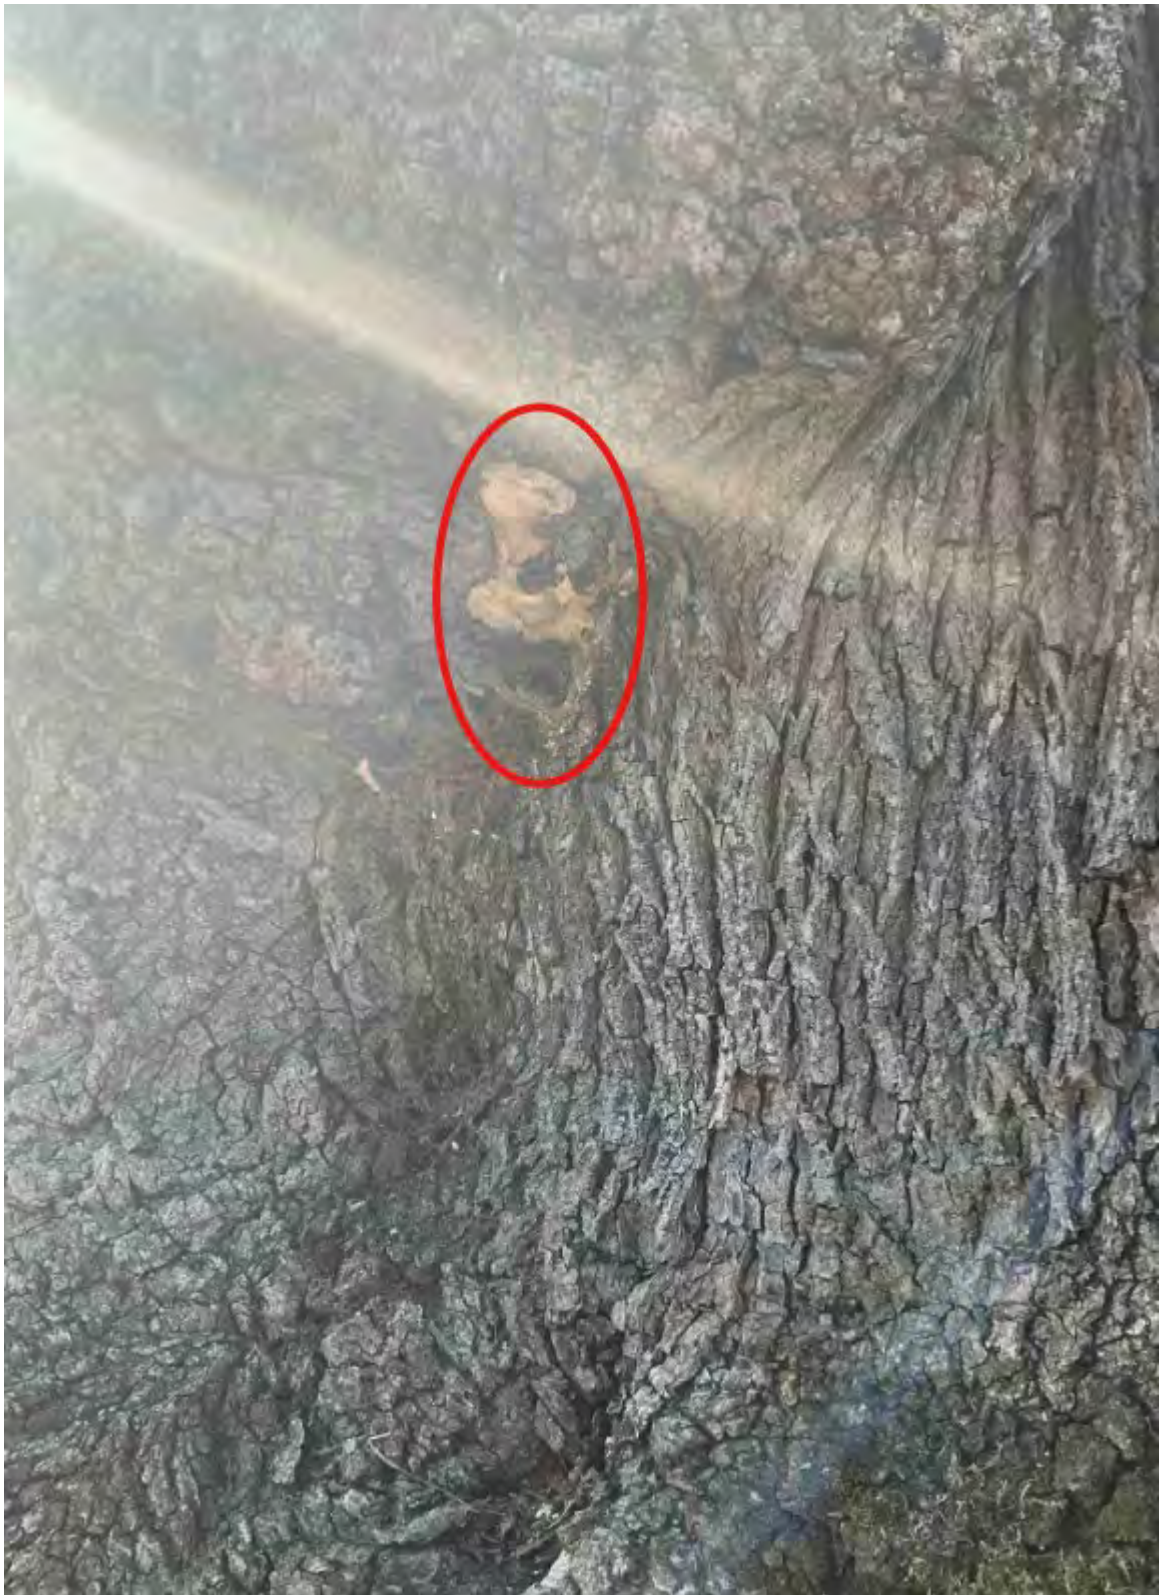
| Physiological Condition | Fair |
| Structural Condition | Poor |
| Inspection findings/reason for exemption | A fungal fruiting body of the decay fungus <i>Ganoderma sp.</i> is present on the trunk. Colonisation by this fungus results in white rot affecting the stem and root system, which can lead to structural failure through fracture or windthrow. A resonance test with a sounding hammer has revealed an unacceptable amount of decay around the bracket. Removal of the tree is recommended to prevent natural failure, manage risk, and facilitate replanting. |

Image shows tree in street scene.

*Image shows fungal fruiting body circled.*

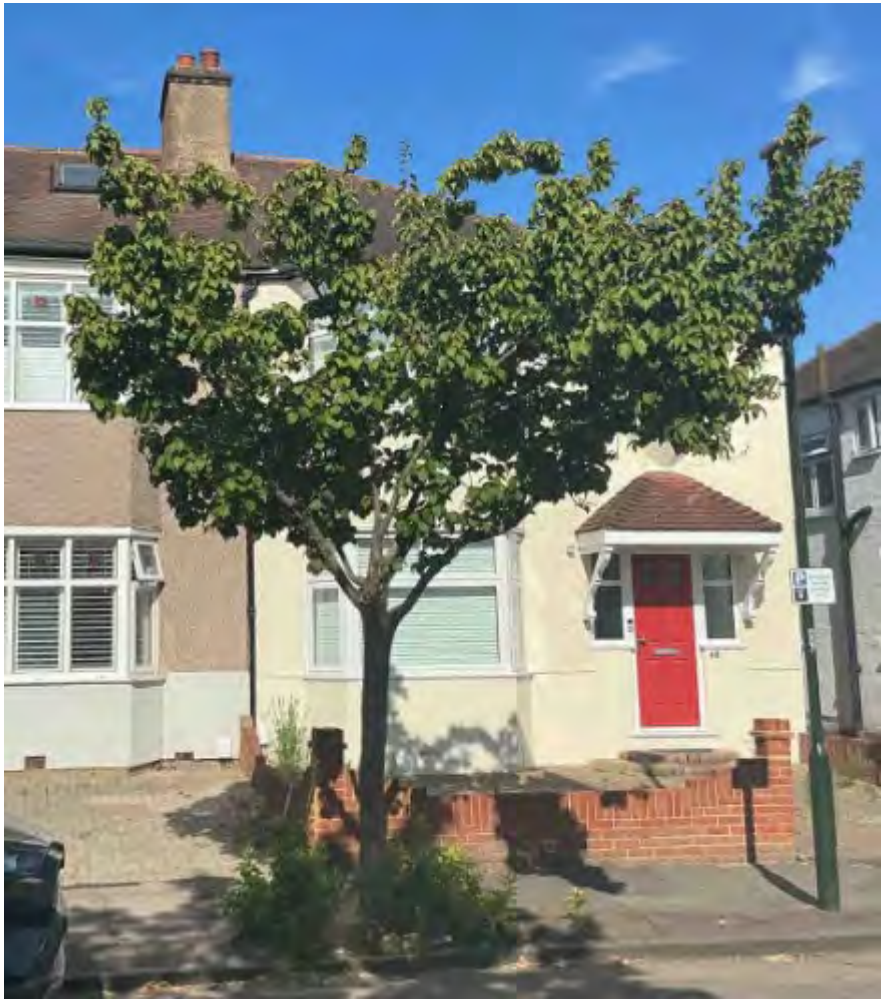
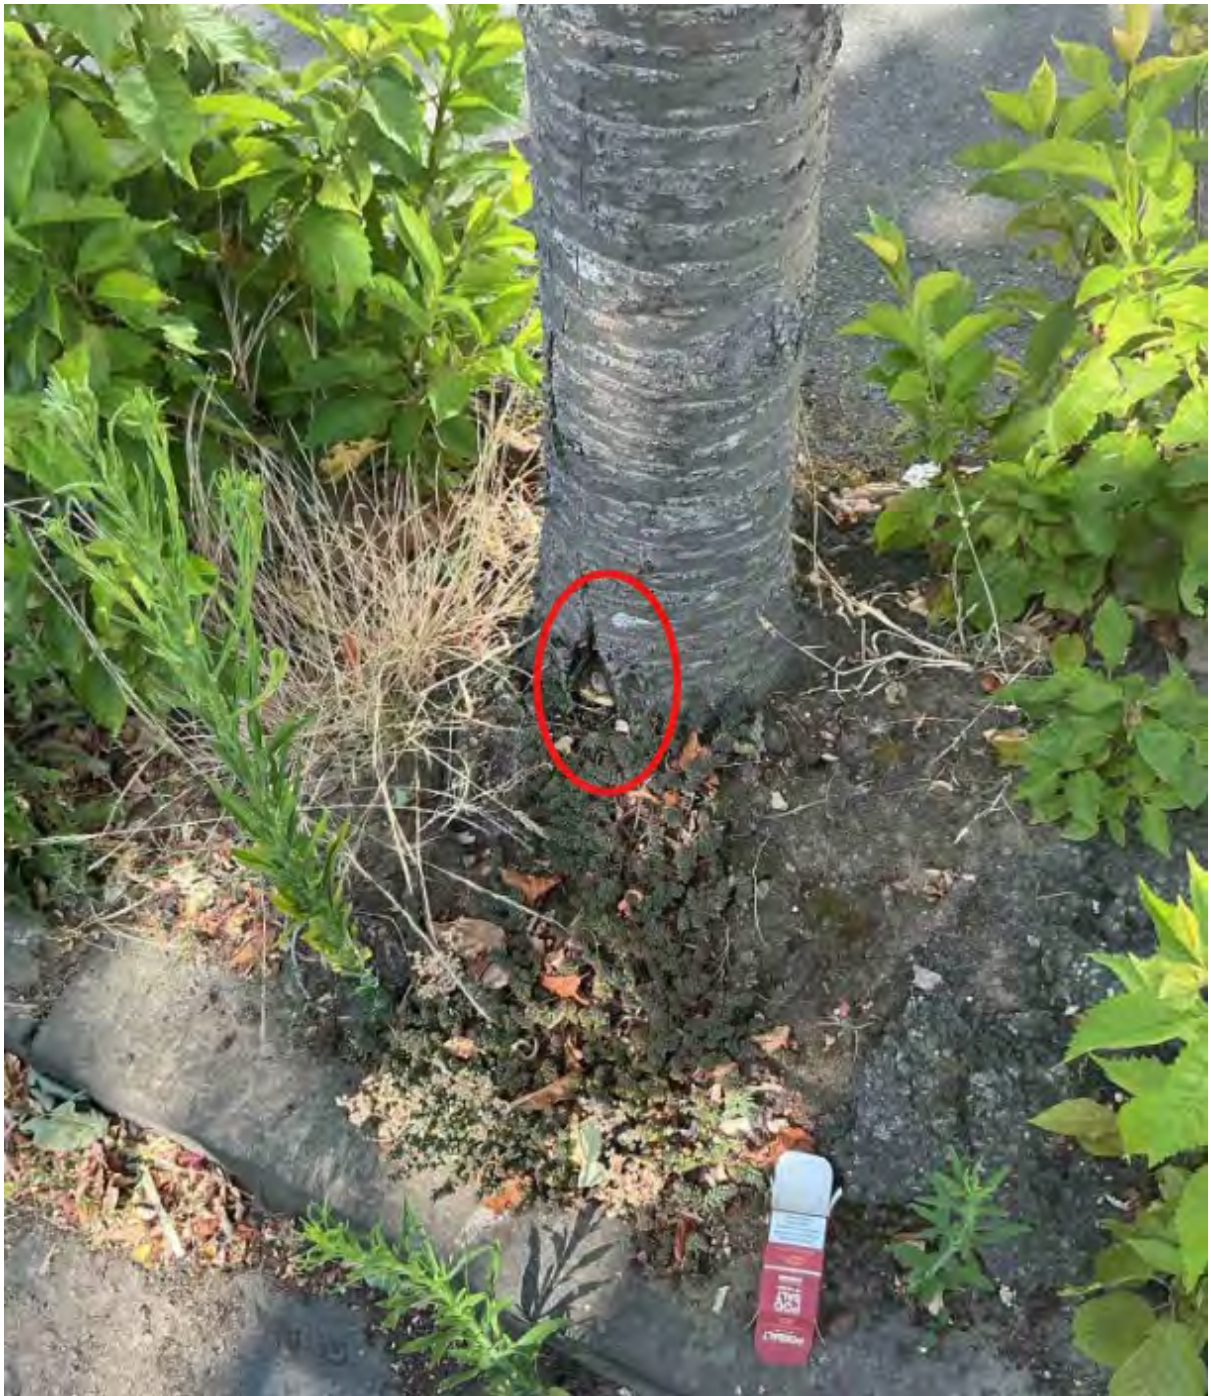
| Physiological Condition | Good |
| Structural Condition | Poor |
| Inspection findings/reason for exemption | Investigation with a probe and a resonance test with a sounding hammer has revealed an unacceptable amount of decay beyond the visible cavities at the base of the trunk. Removal is required to prevent natural failure, manage risk, and facilitate replanting. |

Image shows tree in street scene.

***Image shows cavity at base of trunk circled.***
