# August 2026 - Reactive Tree Works Programme

A survey of trees in the Kew, South Richmond and Whitton wards are currently being undertaken; this is being conducted by specialist arboricultural officers as part of the scheduled 4 yearly detailed inspection regime that has been devised for all Council highway and parks trees.

Recent reactive inspections have identified the need for 106 individual tree work operations to take place. This work will now be issued to the Council’s Arborist Contractor KPS, for completion over the Autumn period.

The following pages provide the locations of each tree that is to be removed, in addition photographs and descriptions of the inspection findings have been provided.

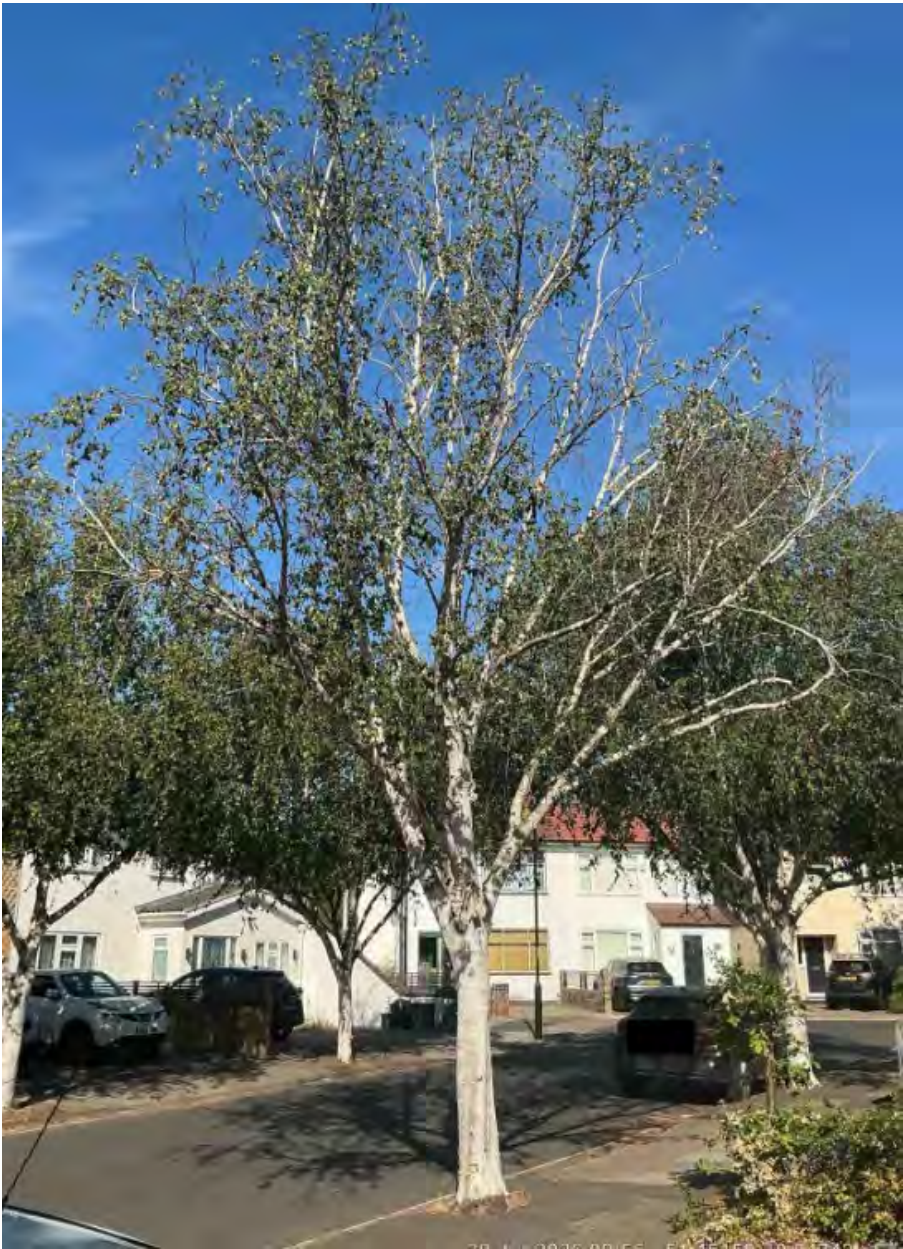
| Physiological Condition | Poor |
| Structural Condition | Fair |
| Inspection findings/reason for exemption | This tree is moribund; removal is required to prevent natural failure, manage risk, and facilitate replanting |

Image shows moribund tree in street scene.

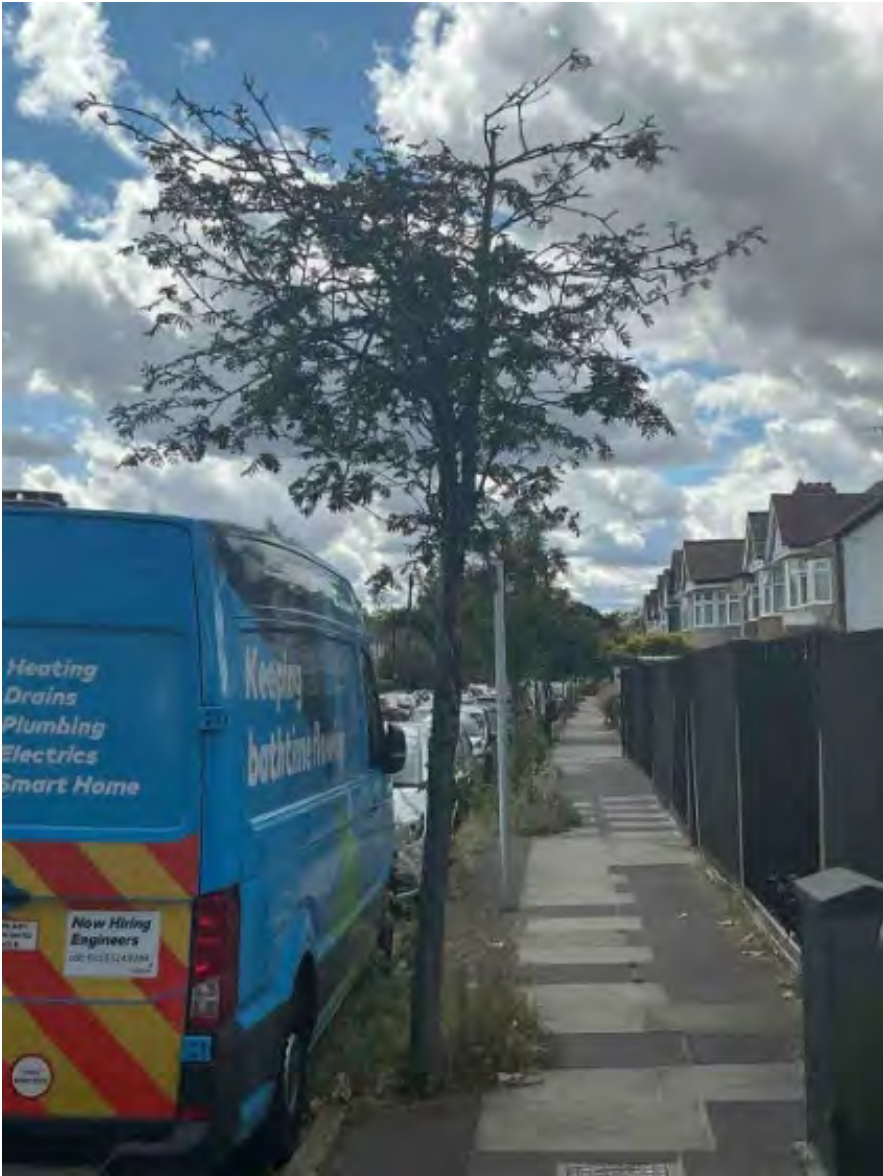
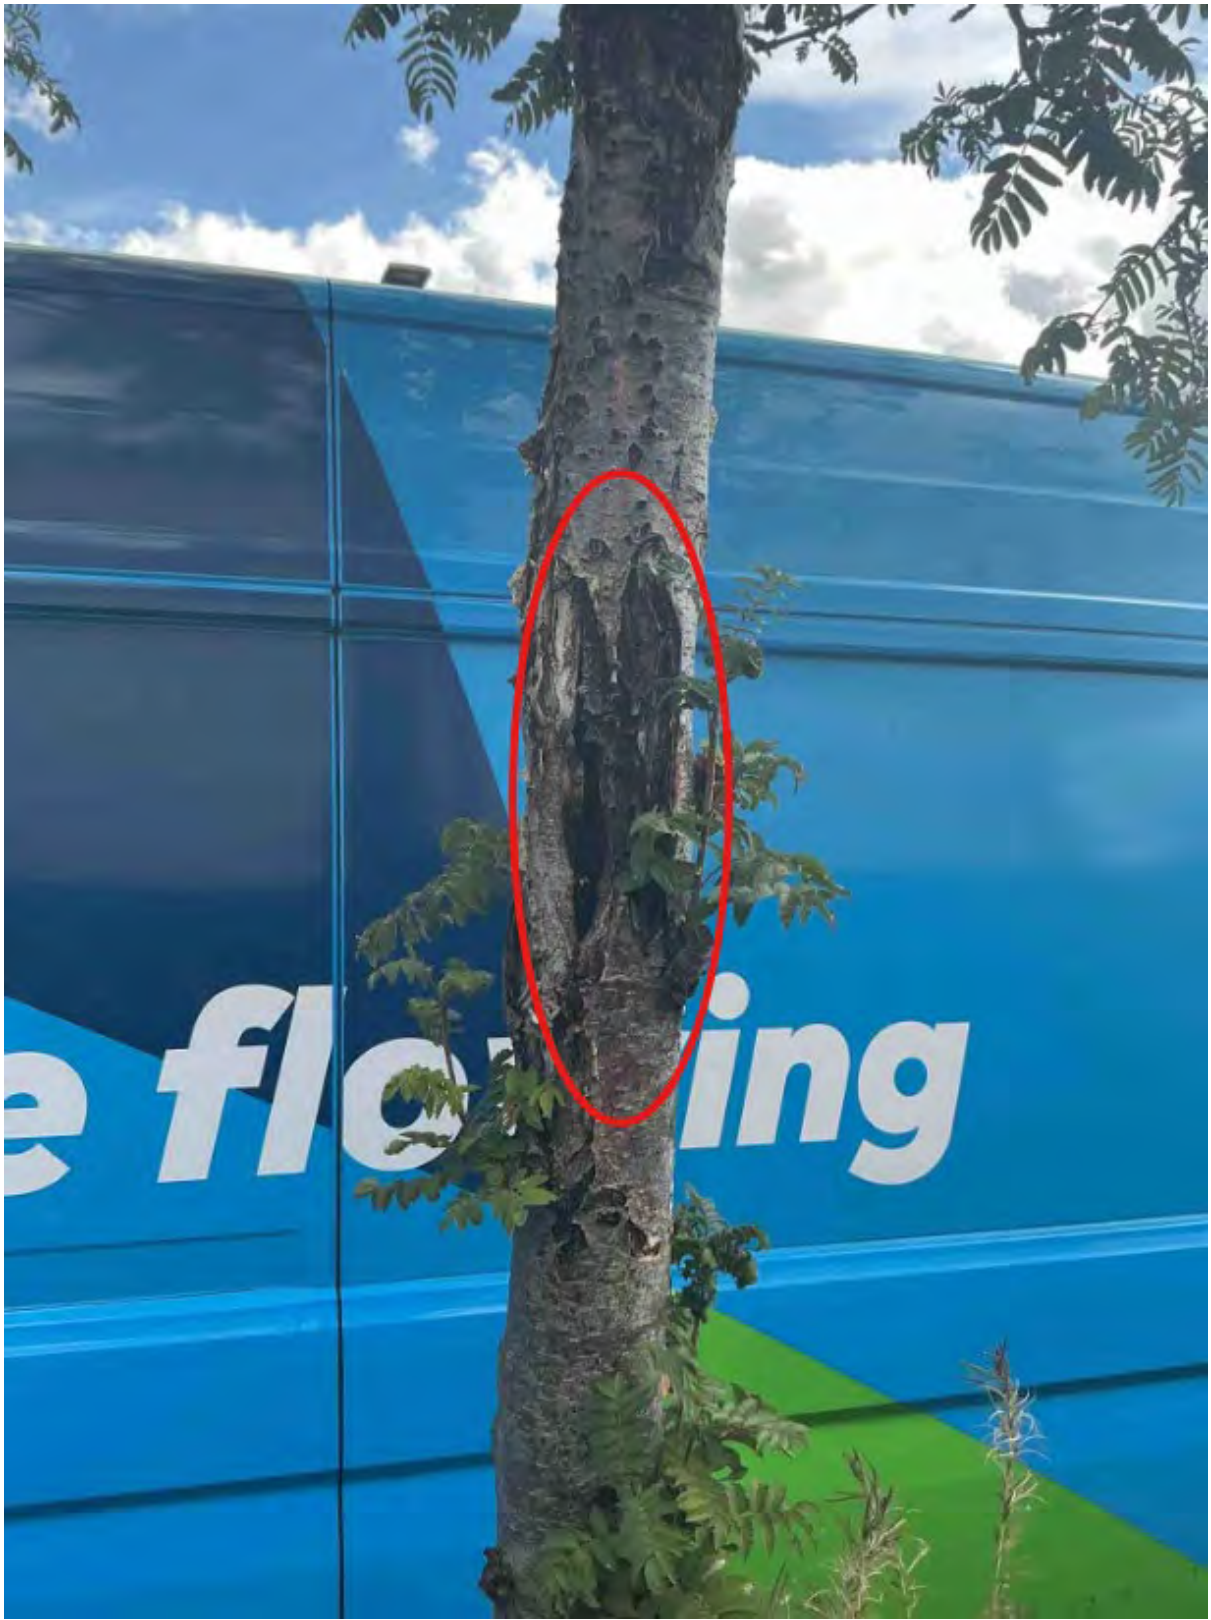
| Physiological Condition | Fair |
| Structural Condition | Poor |
| Inspection findings/reason for exemption | Investigation with a probe has revealed an unacceptable amount of decay beyond the visible cavities at on the trunk. Removal is required to prevent natural failure, manage risk, and facilitate replanting. |

Image shows tree in street scene.

***Image shows cavity on trunk circled.***

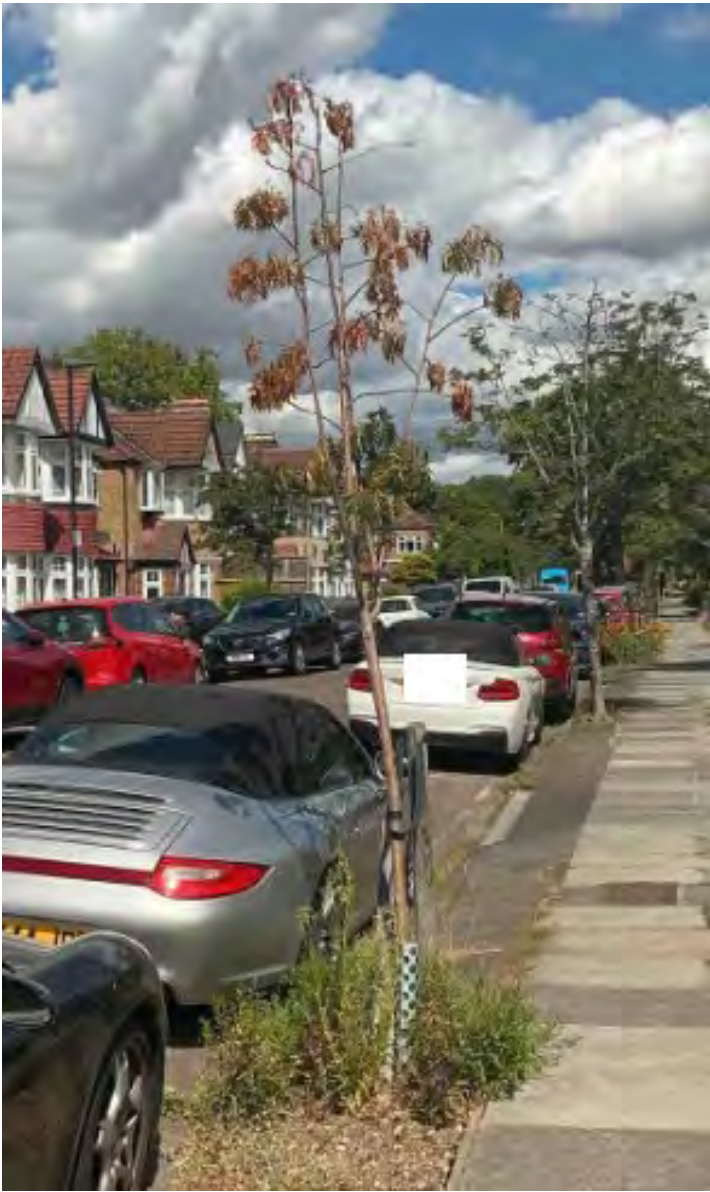
| Physiological Condition | Dead |
| Structural Condition | Fair |
| Inspection findings/reason for exemption | This tree is moribund; removal is required to prevent natural failure, manage risk, and facilitate replanting |

Image shows moribund tree in street scene.

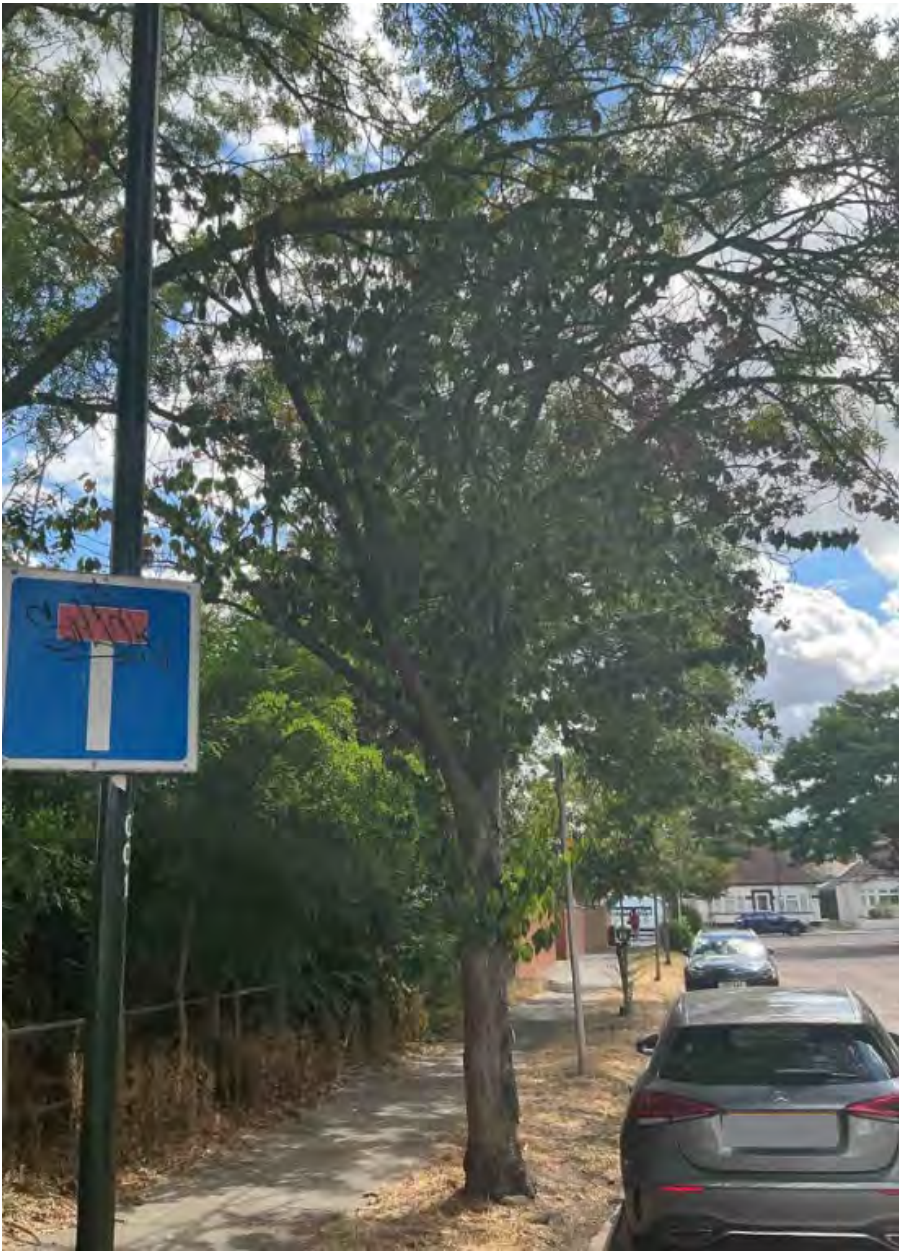
| Physiological Condition | Poor |
| Structural Condition | Fair |
| Inspection findings/reason for exemption | This tree is moribund; removal is required to prevent natural failure, manage risk, and facilitate replanting |

Image shows moribund tree in street scene.

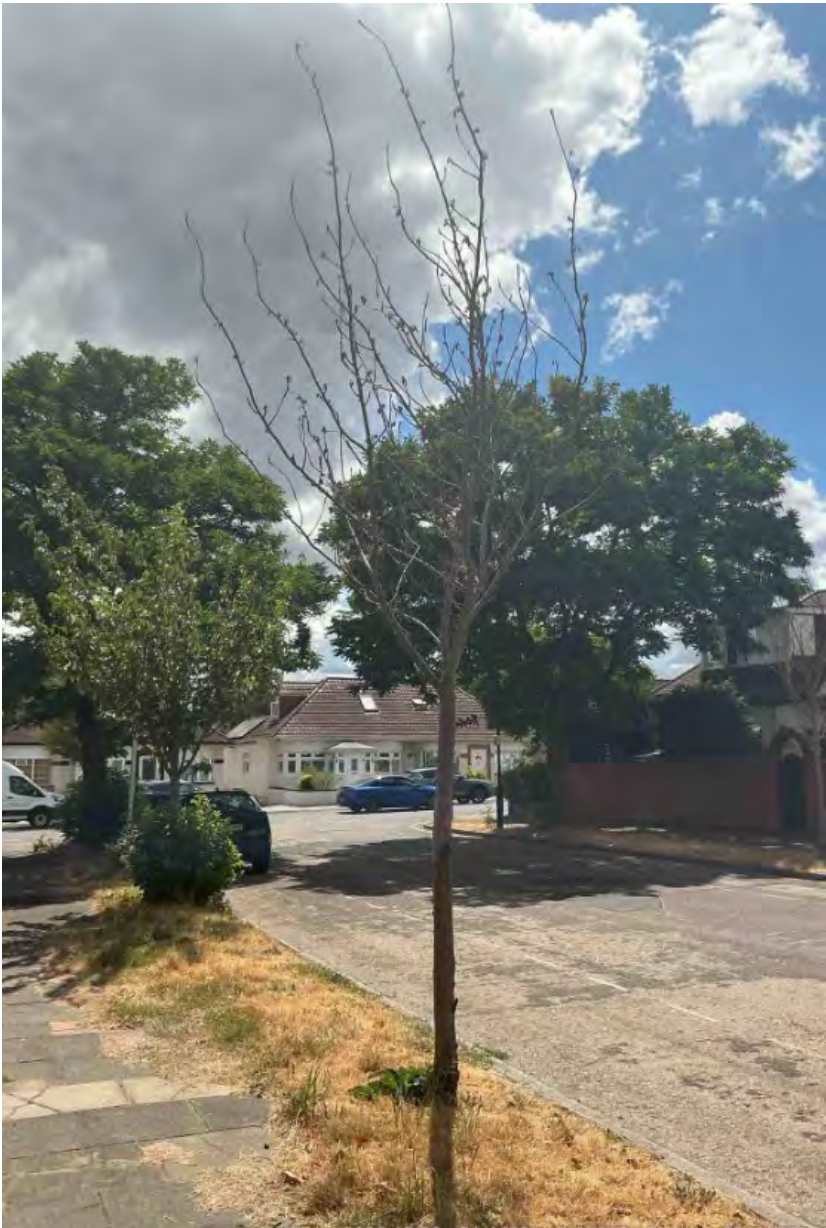
| Physiological Condition | Dead |
| Structural Condition | Fair |
| Inspection findings/reason for exemption | This tree is dead; removal is required to prevent natural failure, manage risk, and facilitate replanting |

Image shows dead tree in street scene.

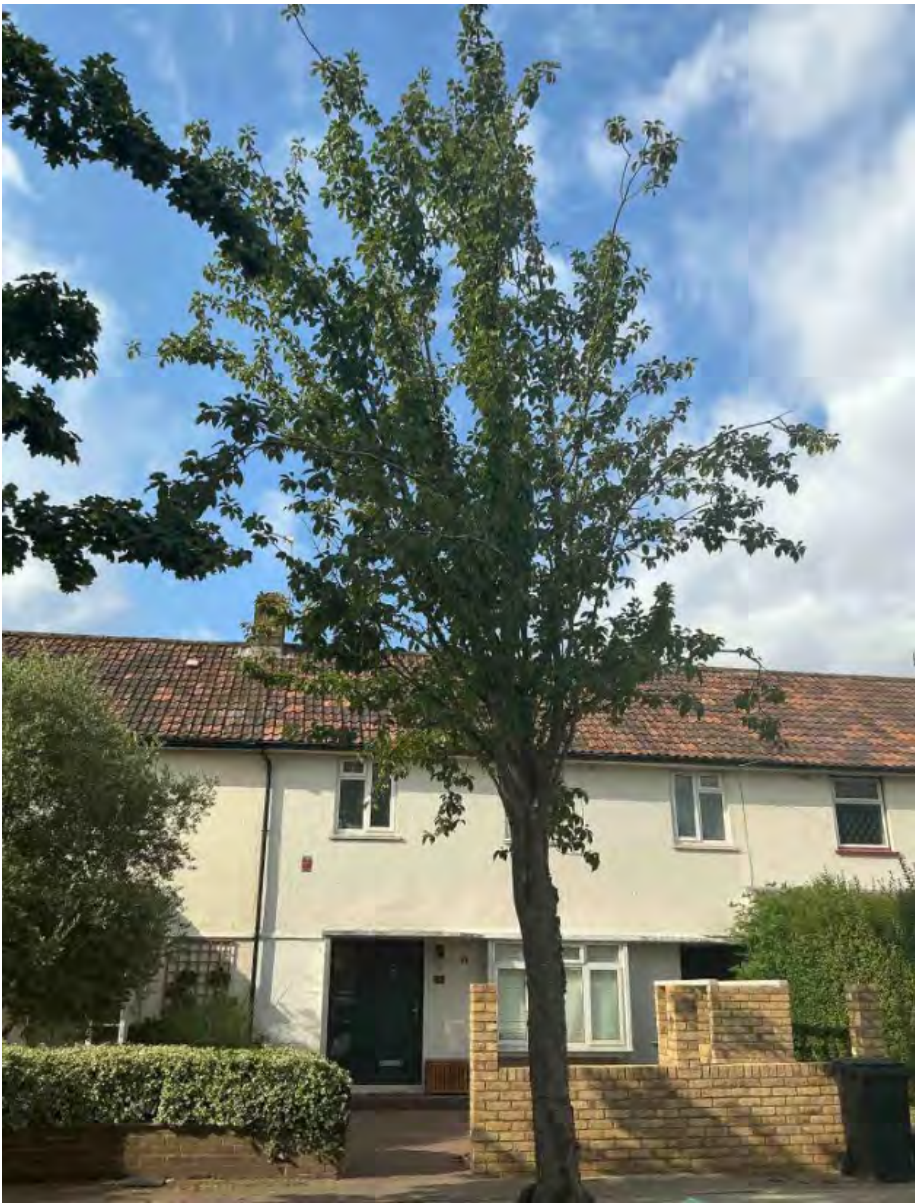
| Physiological Condition | Fair |
| Structural Condition | Poor |
| Inspection findings/reason for exemption | This tree has cracked, peeling bark indicating necrosis and dysfunction of the trees vascular system. Removal is required to prevent natural failure, manage risk, and facilitate replanting |

Image shows tree in street scene.

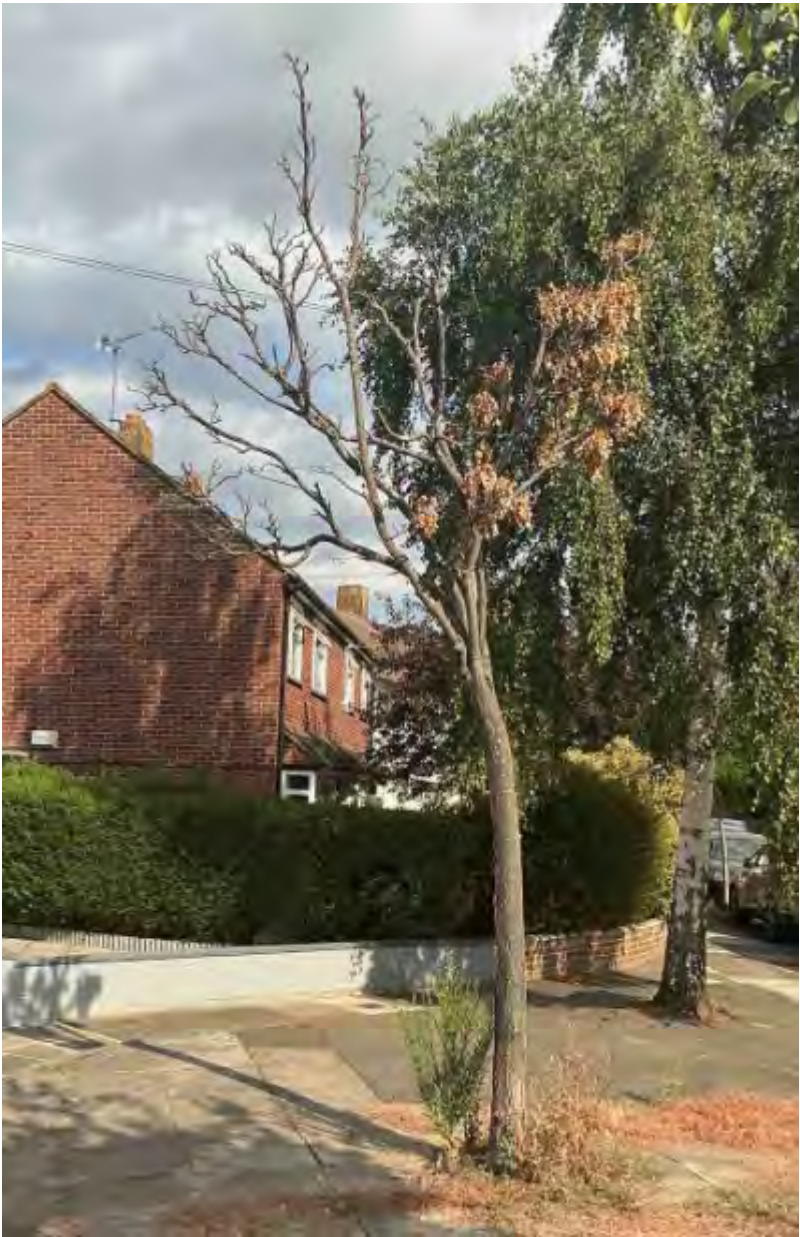
| Physiological Condition | Dead |
| Structural Condition | Fair |
| Inspection findings/reason for exemption | This tree is dead; removal is required to prevent natural failure, manage risk, and facilitate replanting |

Image shows dead tree in street scene.

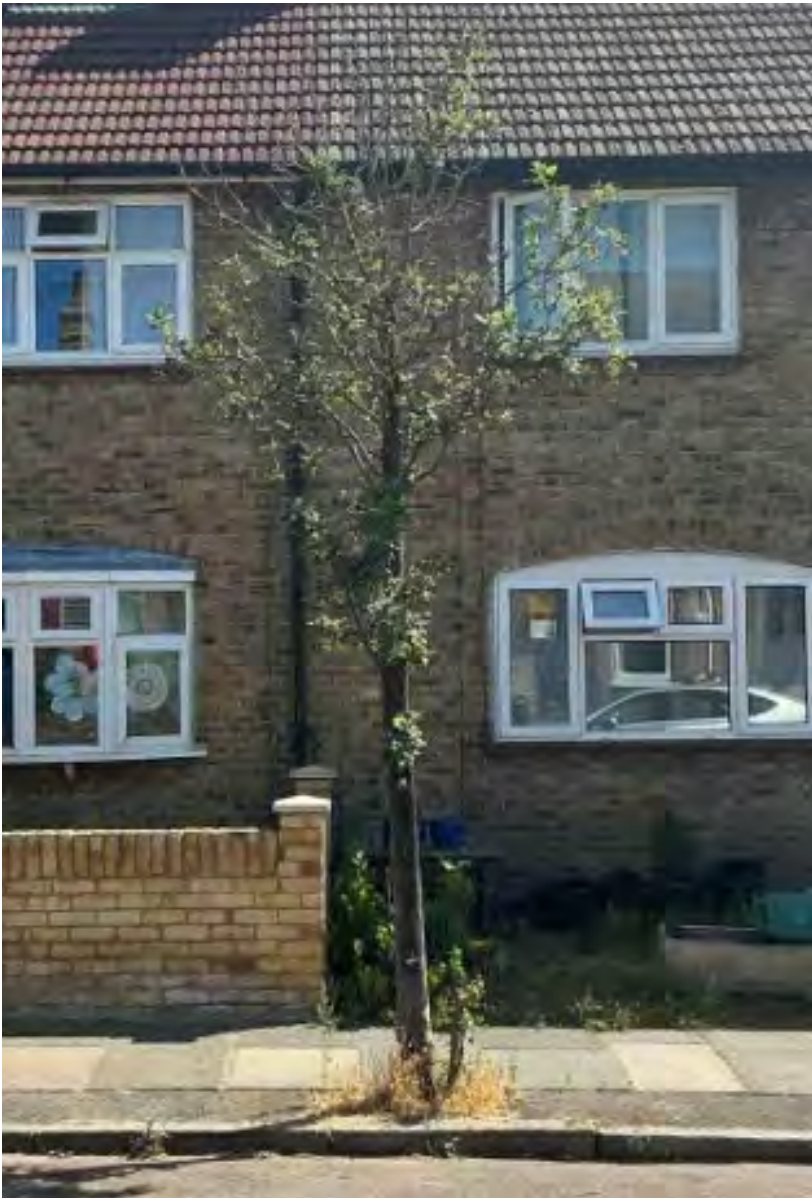
| Physiological Condition | Poor |
| Structural Condition | Fair |
| Inspection findings/reason for exemption | This tree is moribund; removal is required to prevent natural failure, manage risk, and facilitate replanting |

Image shows moribund tree in street scene.

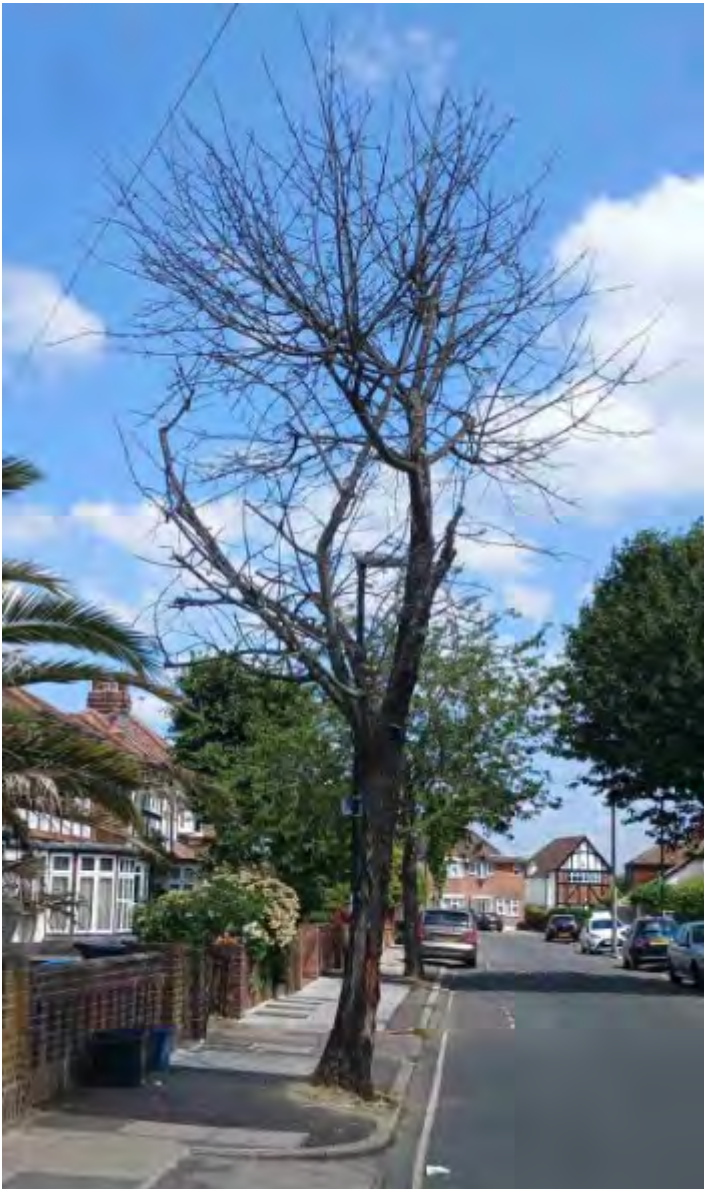
| Physiological Condition | Dead |
| Structural Condition | Poor |
| Inspection findings/reason for exemption | This tree is dead; removal is required to prevent natural failure, manage risk, and facilitate replanting |

Image shows dead tree in street scene.

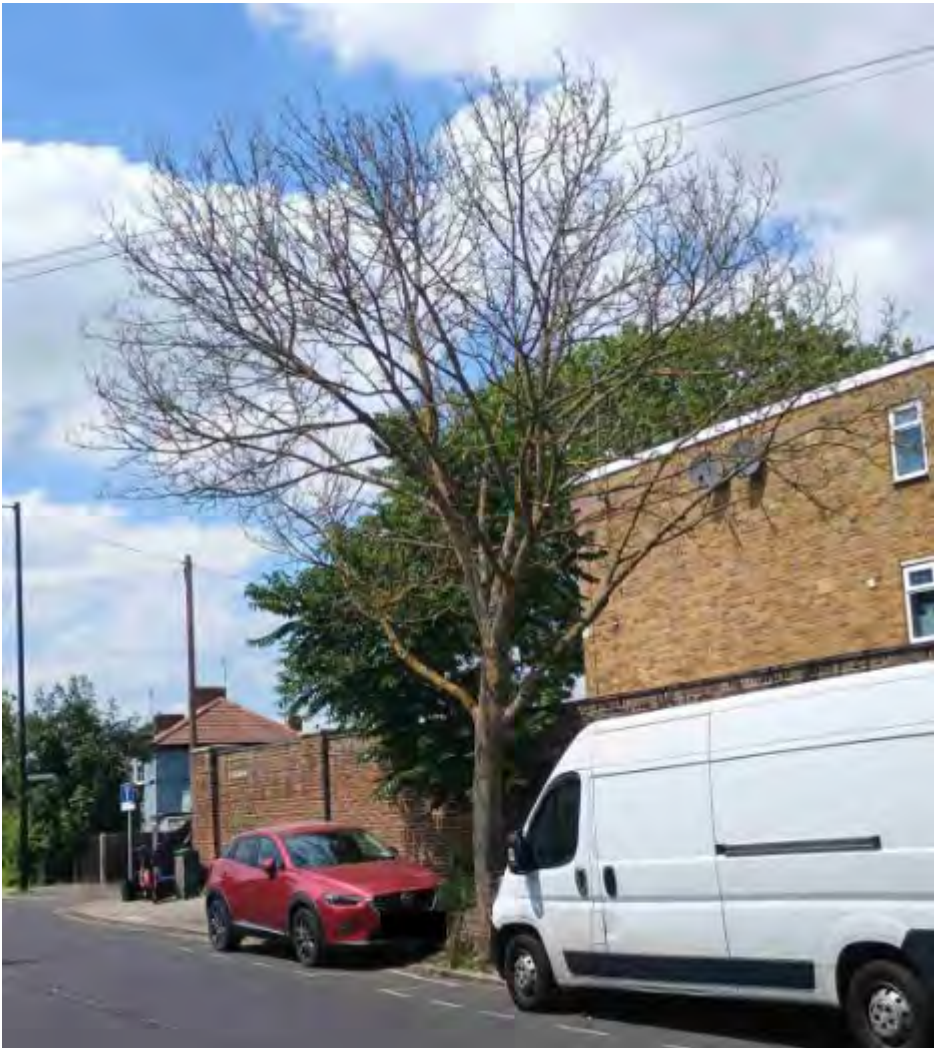
| Physiological Condition | Dead |
| Structural Condition | Poor |
| Inspection findings/reason for exemption | This tree is dead; removal is required to prevent natural failure, manage risk, and facilitate replanting |

Image shows dead tree in street scene.
