Pell	Frischmann
Project:	Hammersmith Bridge – Temporary Ferry Proposal		
Document Title:	Land Contamination Desk Study – Technical Note		
Client:	TFL		
Document Reference:	102963-PEF-BAS-ZZZ-REP-EN-10010		
Revision Reference:	001		
Date:	03 June 2021

Hammersmith Temporary Pedestrian and Cycle Bridge

Phase 1 Land Contamination Desk Study Planning Application

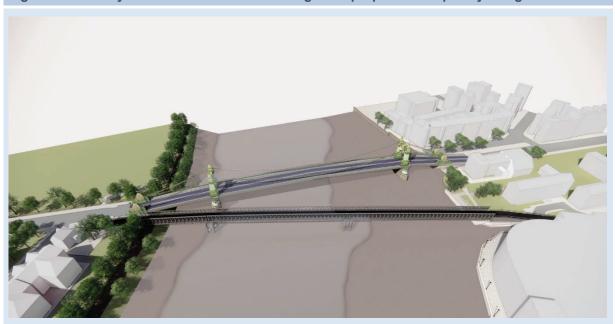
Figure 2: Birds eye view of Hammersmith Bridge and proposed Temporary Bridge

Once the Temporary Bridge and ramps are complete (**Figure 2**, they will be tied into the existing pedestrian and cycle network to provide a seamless connection for pedestrians and cyclists. Seating will be provided at both ends of the Temporary Bridge. A temporary hard and soft landscaping scheme will be provided. The Thames Towpaths on both the north and south of the River Thames will be temporarily diverted during works but reopened during the operation of the temporary bridge.

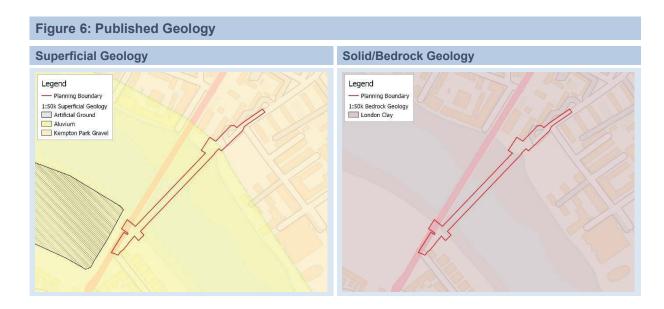
The published geology of the area is shown on the geological map for South London (Sheet 270, scale 1:50,000), published by the BGS. Derivatives of the BGS mapping are included in the Geology Report (Landmark) and also shown in **Figure 6**. Further geological information has also been obtained from the BGS website.

The maps indicate that the majority of the Site is directly underlain by superficial deposits of Alluvium and River Terrace Deposits of Kempton Park Gravel on the north bank. Bedrock strata of London Clay is indicated to underlie the entire site.

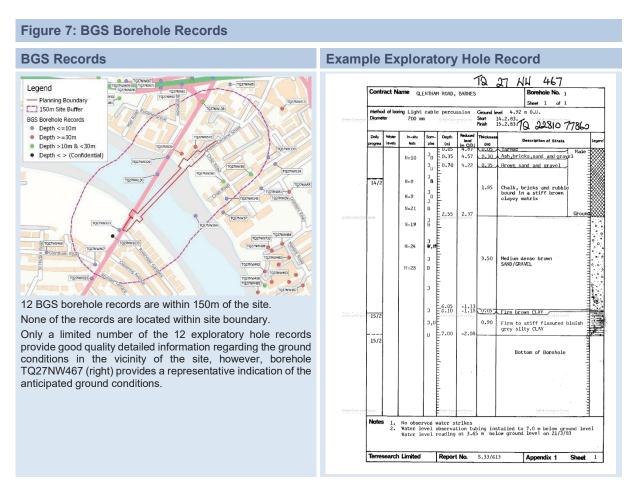
The BGS maintains an archive of historic boreholes. The locations of the available borehole records (extracted from Envirocheck Analysis) are shown in **Figure 7**. There are records of 12 boreholes within 150m of the Site. The log for TQ27NW467 on the south bank is included in **Figure 7**.

The closest borehole records to the site do not generally provide detailed strata descriptions. The general indications of ground conditions confirmed by TQ27NW467 above and TQ27NW130 on the north bank predominantly indicate the presence of some 5-6m depth of granular superficial deposits described as sands and gravel over brown becoming blue/grey CLAY of the London Clay formation. The presence of cohesive alluvium is not widely recorded except in more detailed distant boreholes on the south bank.

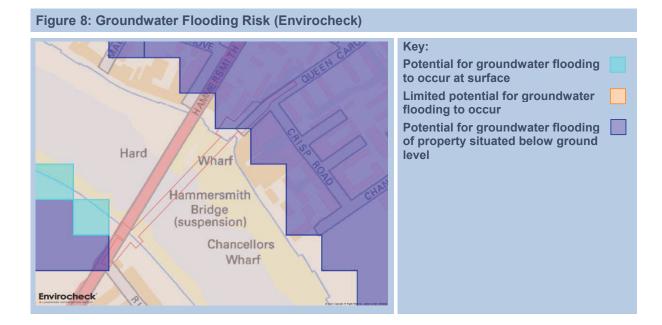
- The Site is not within a Source Protection Zone (SPZ);
- ➤ There are no groundwater abstraction licences within 1km of the site.
- The Site is in an area at risk of groundwater flooding 'for properties situation below ground level, and is not within an area where groundwater flooding may occur at surface; as shown in **Figure 8**.

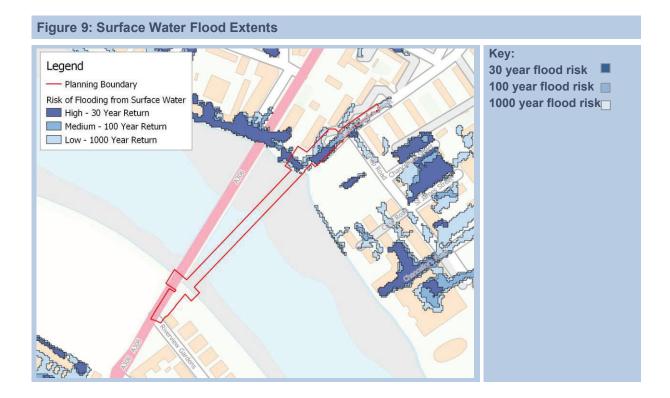
The Envirocheck Report surface water flood risk map (extract included in **Figure 9**), indicates some flood risk in low-lying areas within the site, most notably at the southern end of Queen Caroline Street on the north bank. Further consideration of flood risk is beyond the scope of this report.

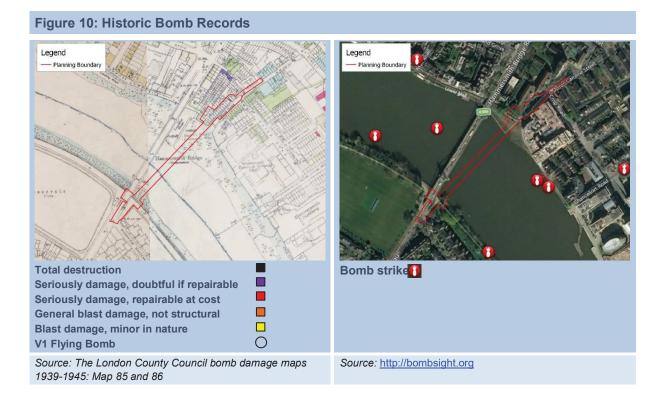
- no historic military land-uses have been identified in proximity to the area from the historic maps and aerial photographs reviewed and described in **Section 3.3**;
- Figure 10 includes an extract of the London County Council [WW2] Bomb Damage Maps 85 & 86, which indicates that only limited bomb damage, in the immediate surroundings of the site was recorded. The Bomb Sight website (http://bombsight.org) has also been consulted which plots all known aerial bombs that fell during the period of the London Blitz.
- > The Bomb Sight maps indicate that at least five high explosive bombs fell within 150m of the site boundary, with the two closest recorded as falling approximately 90m to the north west and south east of the site.
- A UXB risk map for the site has been downloaded from Zetica², the map indicates a moderate to high potential bomb risk at the site.

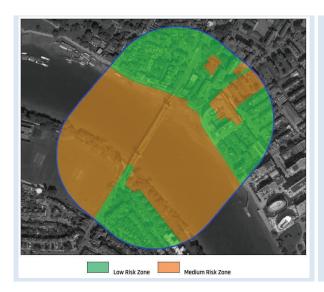
Detailed Unexploded Ordnance Risk Assessment Report (extract) by SafeLane Global, October 2019

PF commissioned a 'Detailed Unexploded Ordnance Risk Assessment" report by SafeLane Global (Ref. 8307RA) for the Hammersmith Bridge Refurbishment, which also covers the area of the Temporary Bridge. An extract of the Risk Map from the report is included in **Figure 10**, which identified medium and low risk zones within the proposed site boundaries. A copy of the report including a proposed risk mitigation strategy is included in **Appendix B**.
