Sheen Gate Gardens

Located on the pavement near the corner of Sheen Gate Gardens and Upper Richmond Road West, from November 1998 to January 1999. The limit values for all three pollutants were not exceeded.

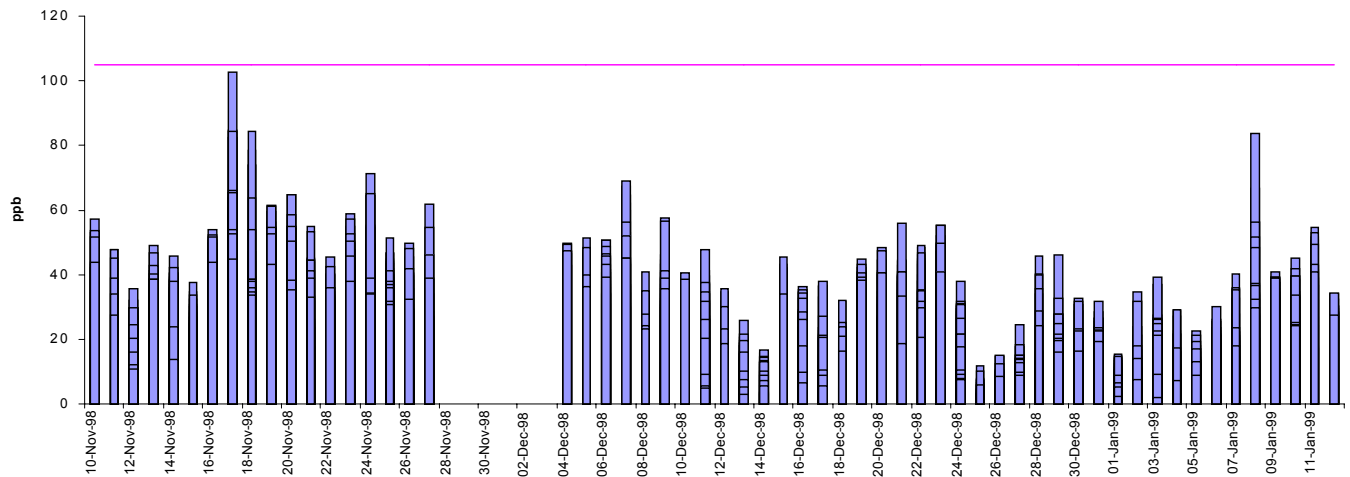
Nitrogen Dioxide (NO₂)
Hourly Mean Limit=105ppb

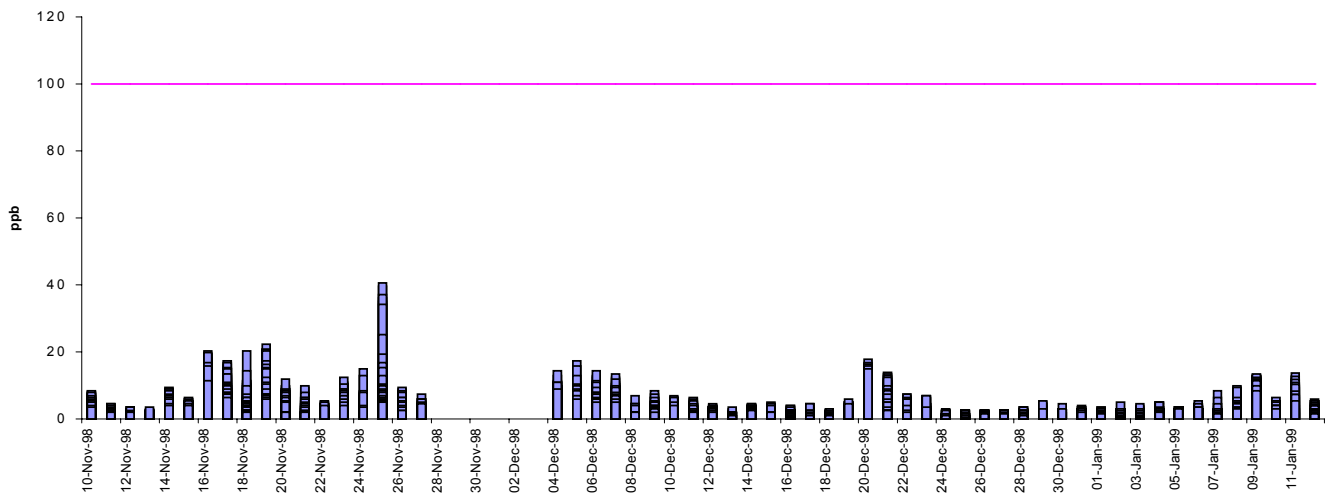
Sulphur Dioxide (SO₂)
15 min mean
low up to 100ppb

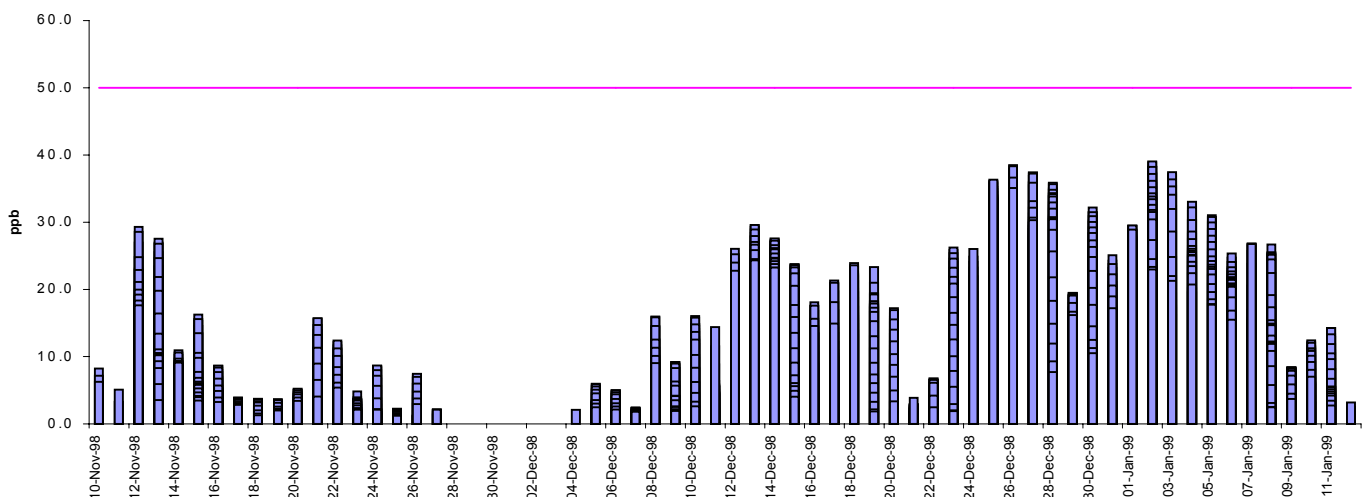
Ozone (O₃)
Running 8 Hour Mean
low to 50ppb
