**Richmond upon Thames College: Request for a Screening Opinion under Regulation 5 of the Town and County Planning (Environmental Impact Assessment) Regulations 2011 (the EIA Regulations) for the demolition of the Music, Science, Z, LRC and A blocks at Richmond upon Thames College, Twickenham.**

Project Title:  
Richmond Upon Thames College: EIA Screening

Figure Title:  
Phase 1b Demolition Site Boundary

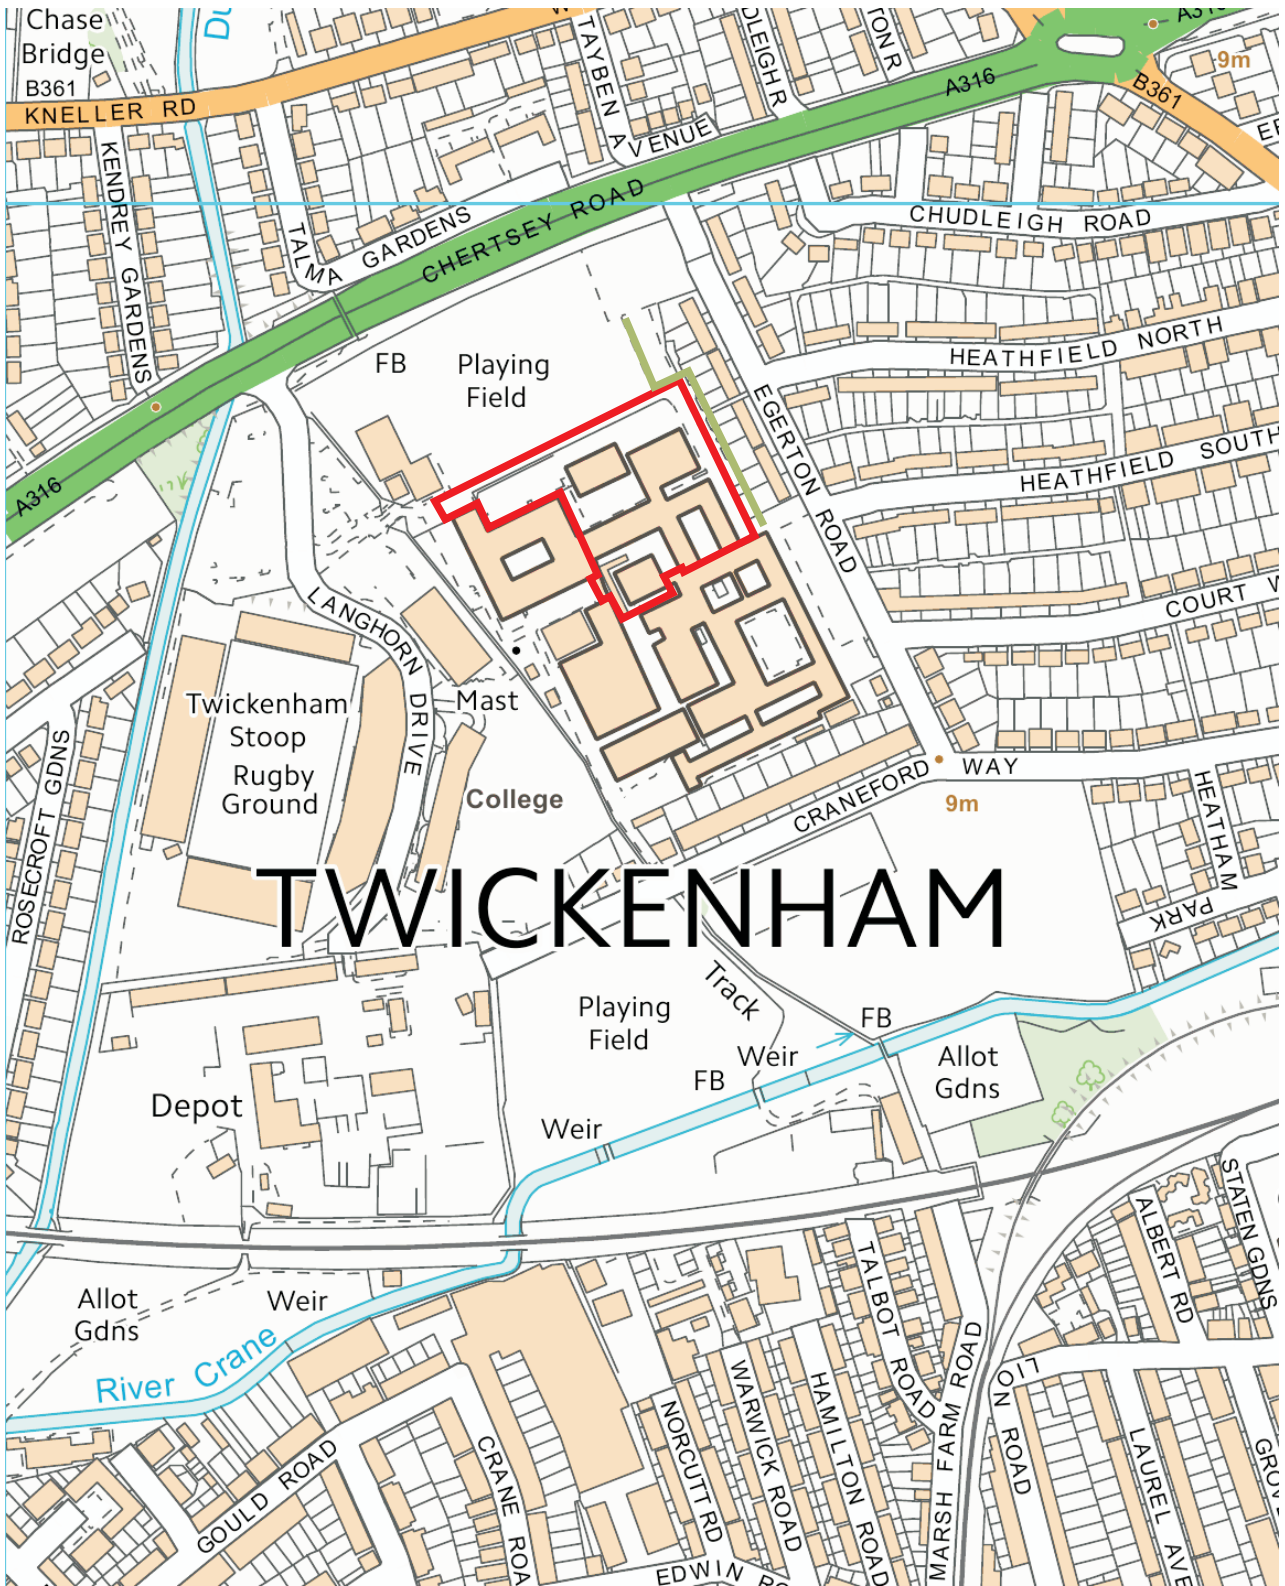
Figure Number: Date:  
Figure 1 October 2015

**Figure 1** identifies the site for the proposed works to which this screening opinion request relates. The demolition site comprises numerous academic and facilities buildings associated with RuTC. Staff car parking is located along the eastern side of the site, which will be lost during the demolition works (see Section 3.3.3 for further details).

The southern and western boundary of the demolition site are bordered by existing RuTC buildings which will remain in use throughout the demolition. Hoarding will separate the demolition site from the rest of the college site to ensure segregation between users of the college site and the activities associated with the demolition process. A grass sports pitch is located to the north of the site and will remain in use by RuTC throughout the demolition period. The east of the demolition site is bordered by residential properties.

The site is located within the RuTC site, to the north west of Twickenham town centre (see **Figure 1**). It falls within the administrative area of the London Borough of Richmond upon Thames.

The site proposed for demolition is bounded by playing fields to the north, residential properties immediately to the east along Egerton Road, and other RuTC buildings to the south and west.
