# September 2026 – Highways Reactive Tree Works Programme

Dated 18.9.2026

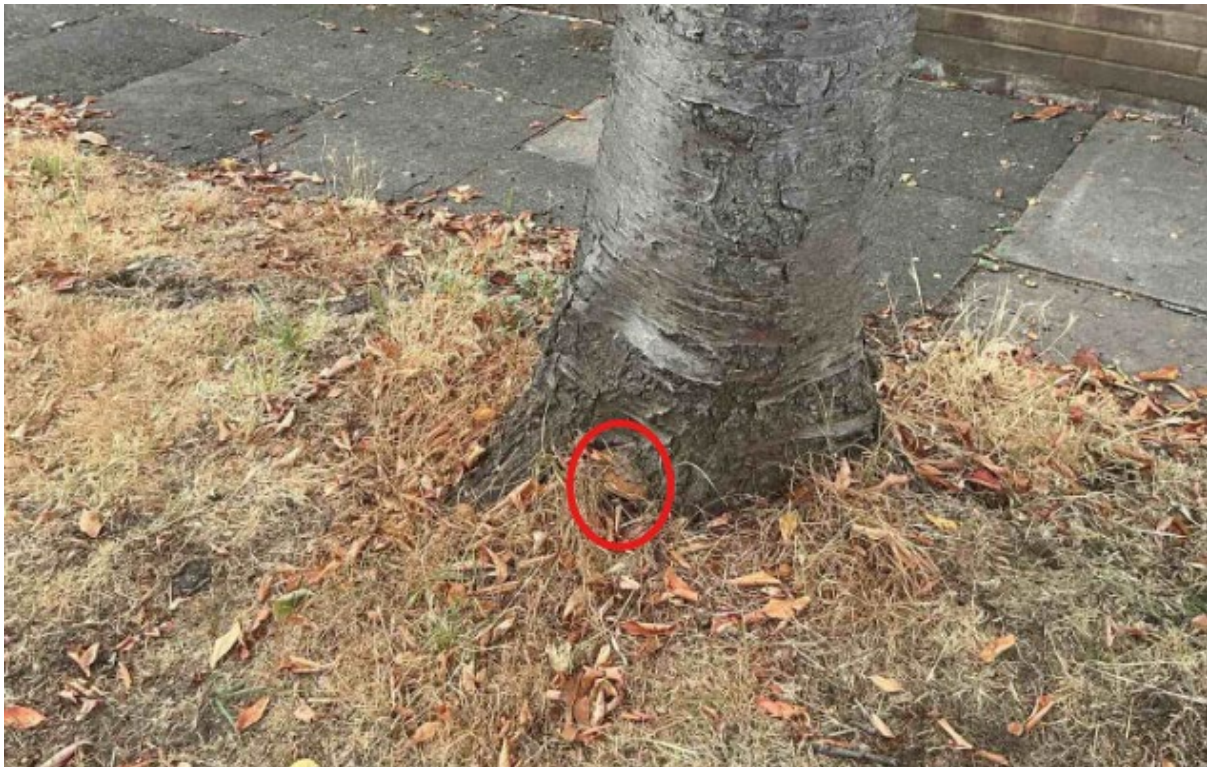
***Image shows tree fungal fruiting body at base of trunk.***

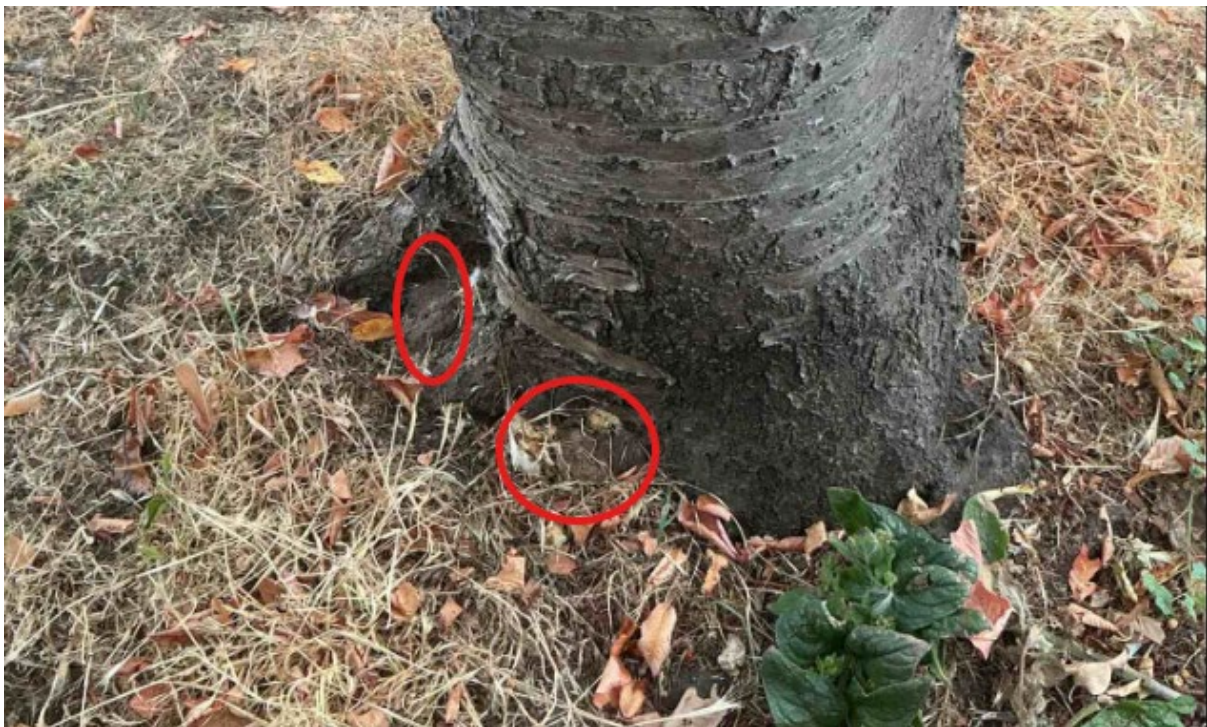
***Image shows tree fungal fruiting bodies at base of trunk.***

| Inspection findings/reason for exemption | A fungal fruiting body of the decay fungus <i>Ganoderma sp.</i> is present on the trunk. Colonisation by this fungus results in white rot affecting the stem and root system, which can lead to structural failure through fracture or windthrow. Crown dieback is evident and correlates with the presence of the decay fungi. Removal of the tree is recommended to prevent natural failure, manage risk, and facilitate replanting. |

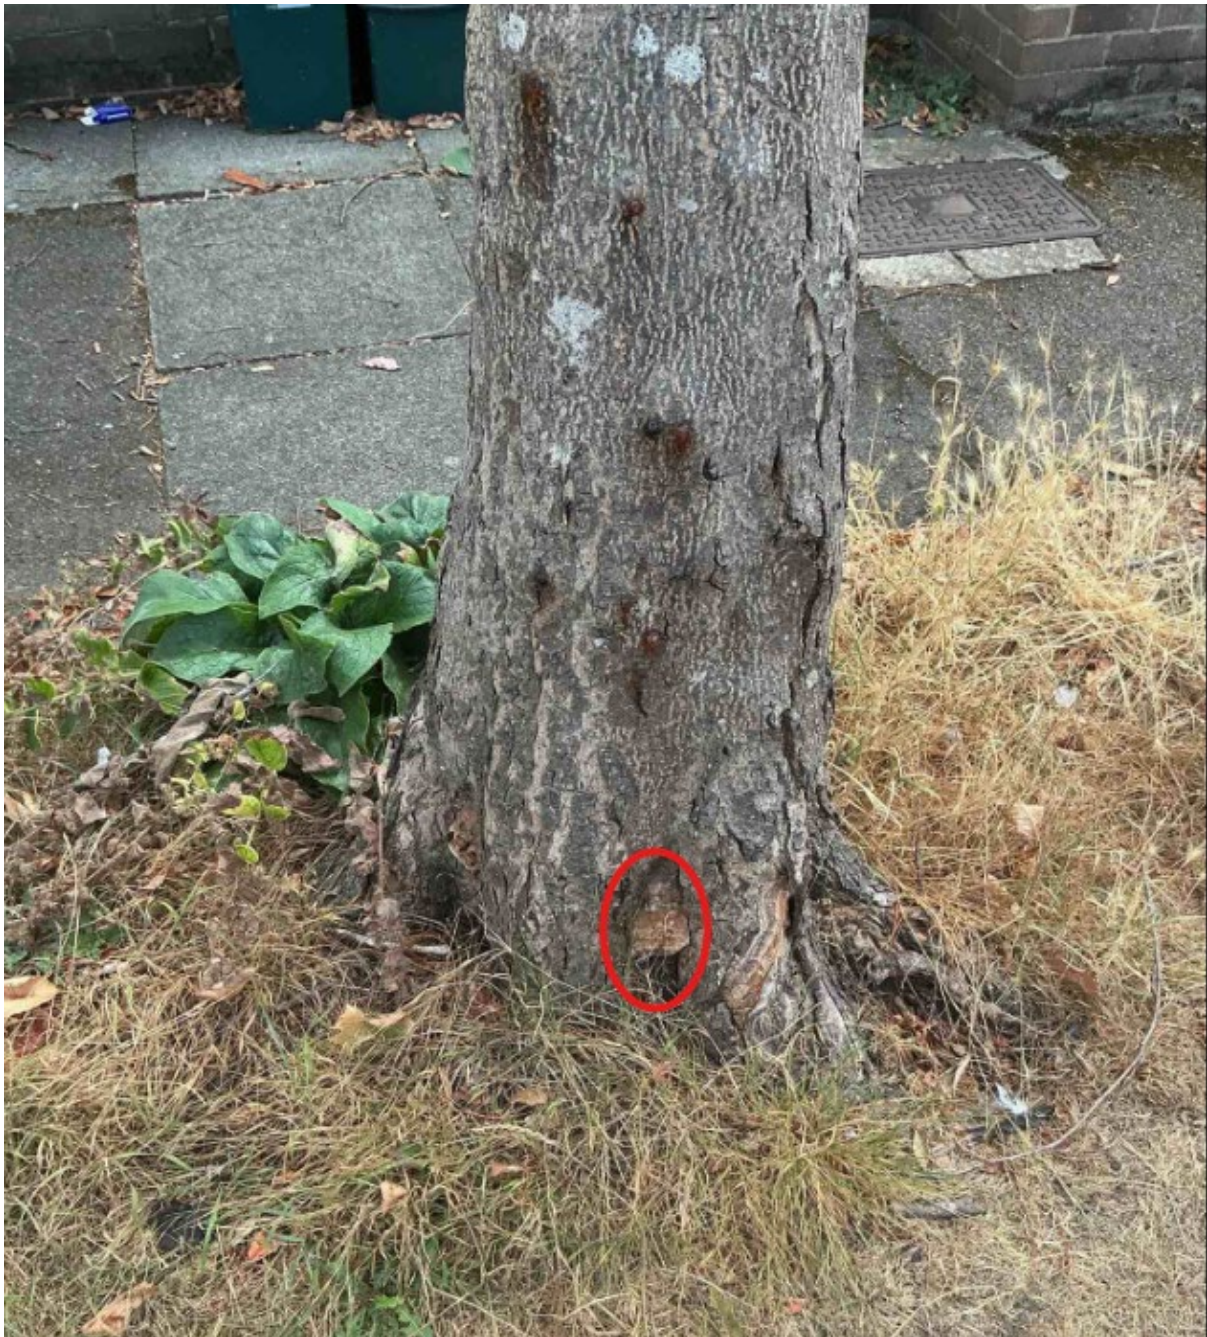
*Image shows tree fungal fruiting body at base of trunk.*

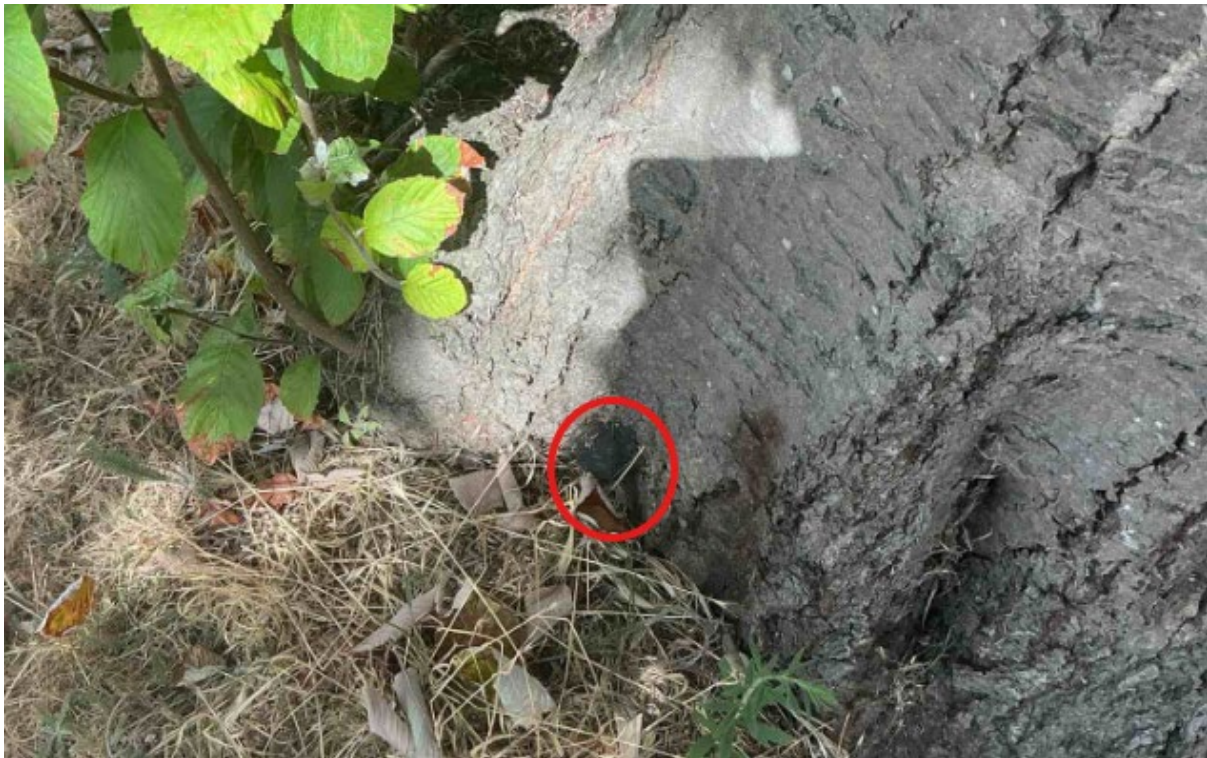
*Image shows fungal fruiting body at base of trunk.*

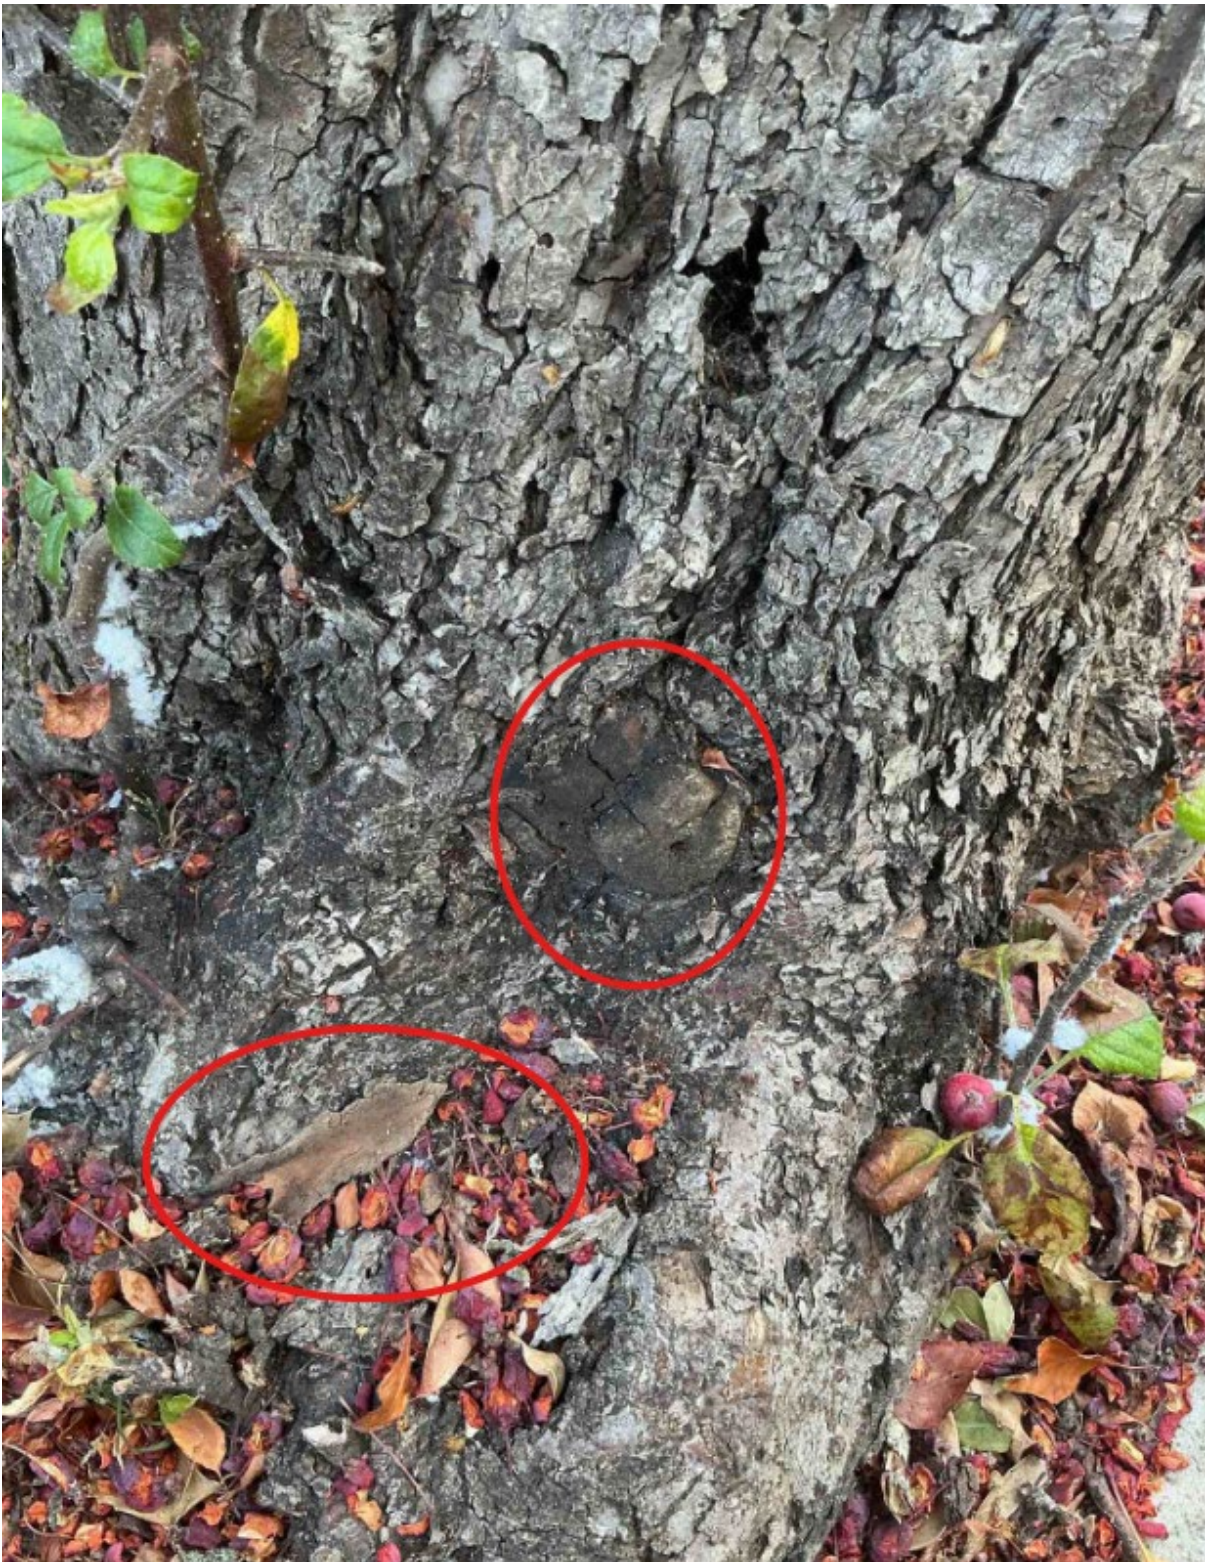
*Image shows fungal fruiting bodies at base of trunk circled.*

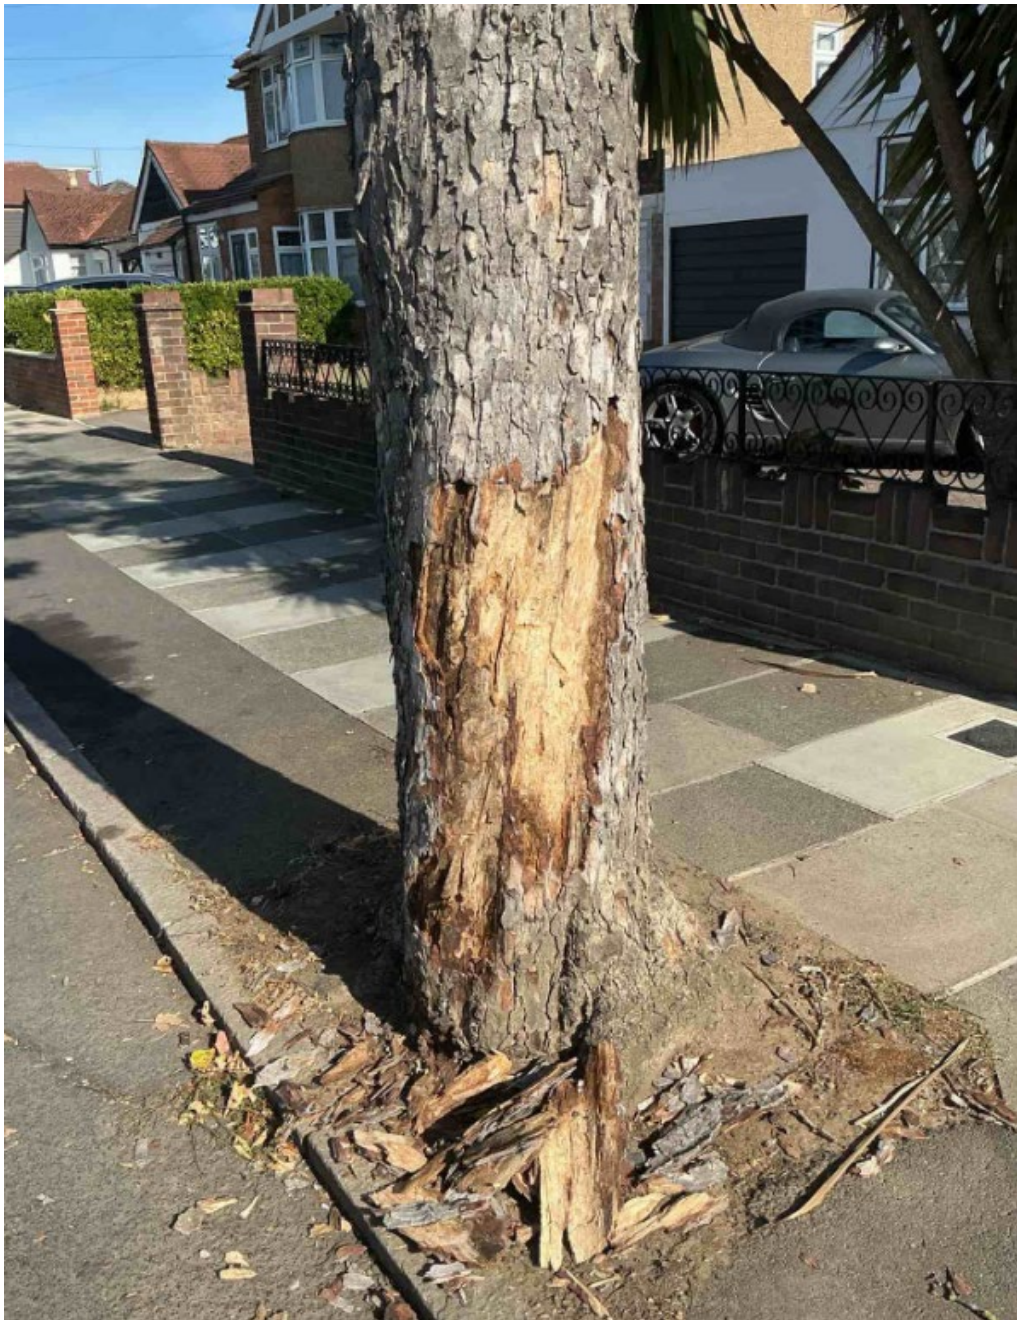
***Images show delamination of bark on trunk.***

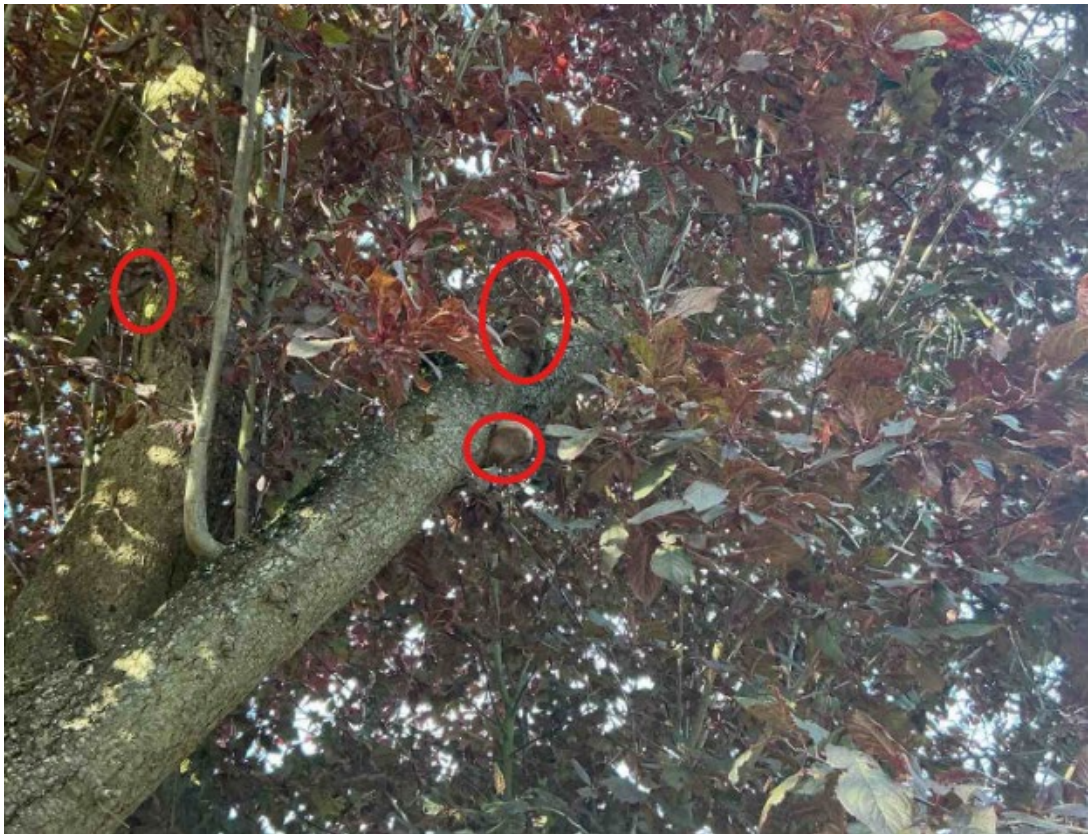
*Image shows fungal fruiting bodies in crown circled.*

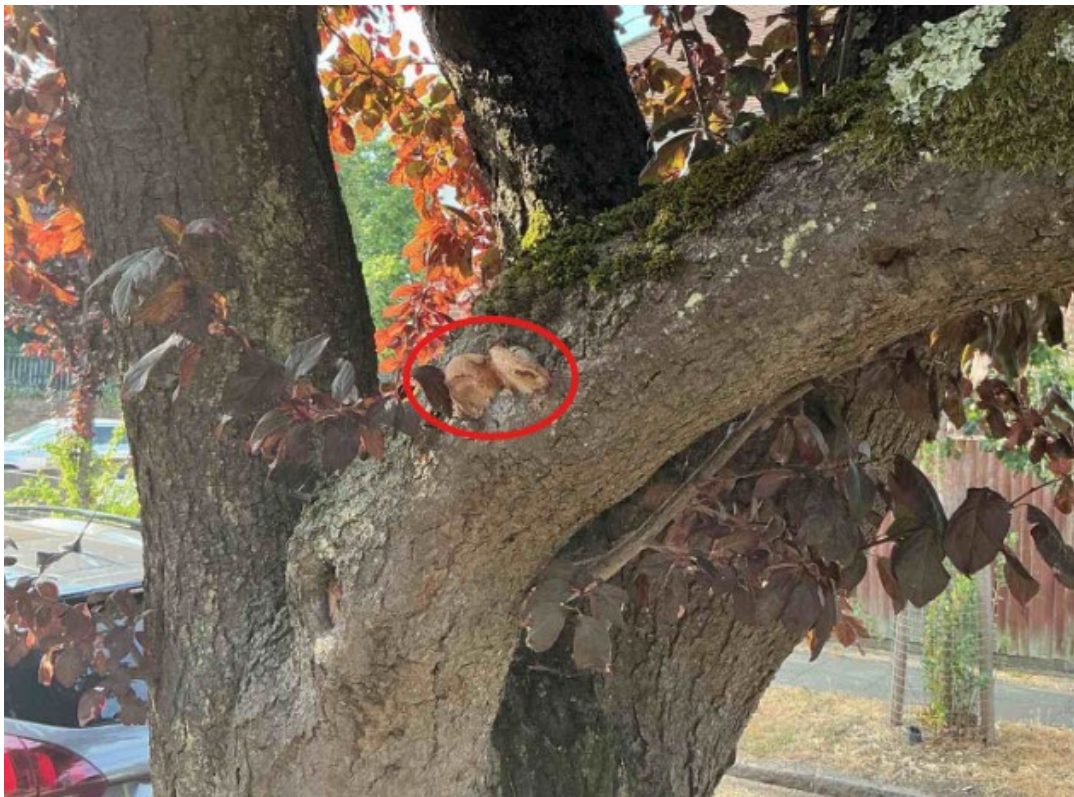
*Image shows fungal fruiting bodies on stem circled.*

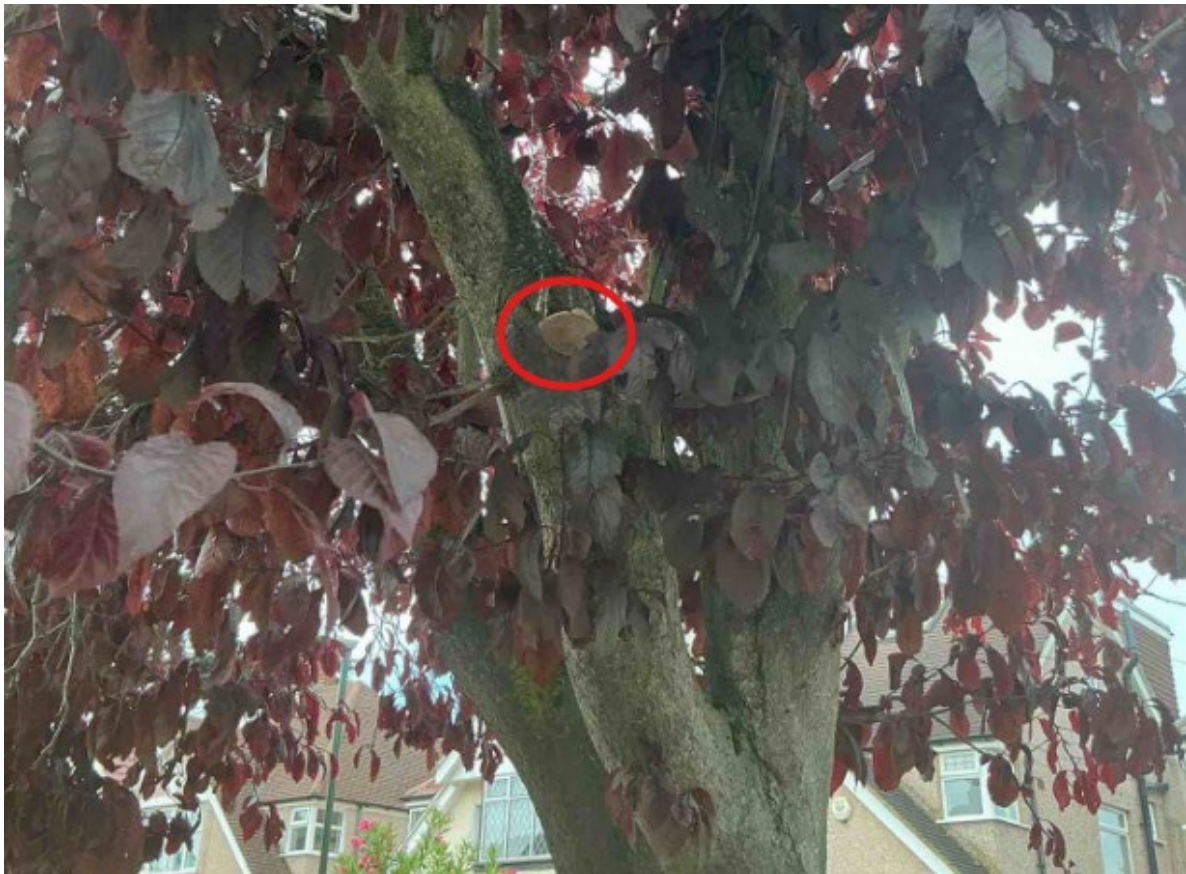
*Image shows fungal fruiting bodies in crown circled.*

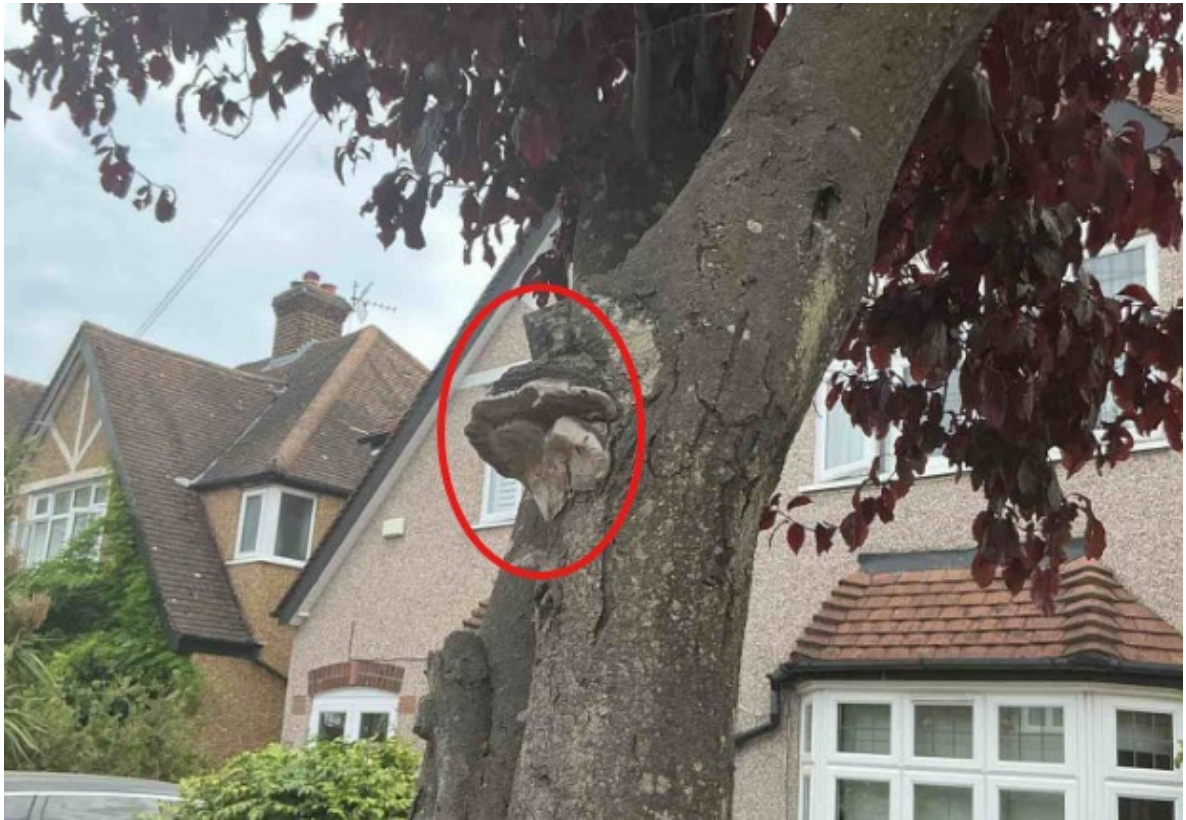
*Image shows fungal fruiting bodies on stem circled.*

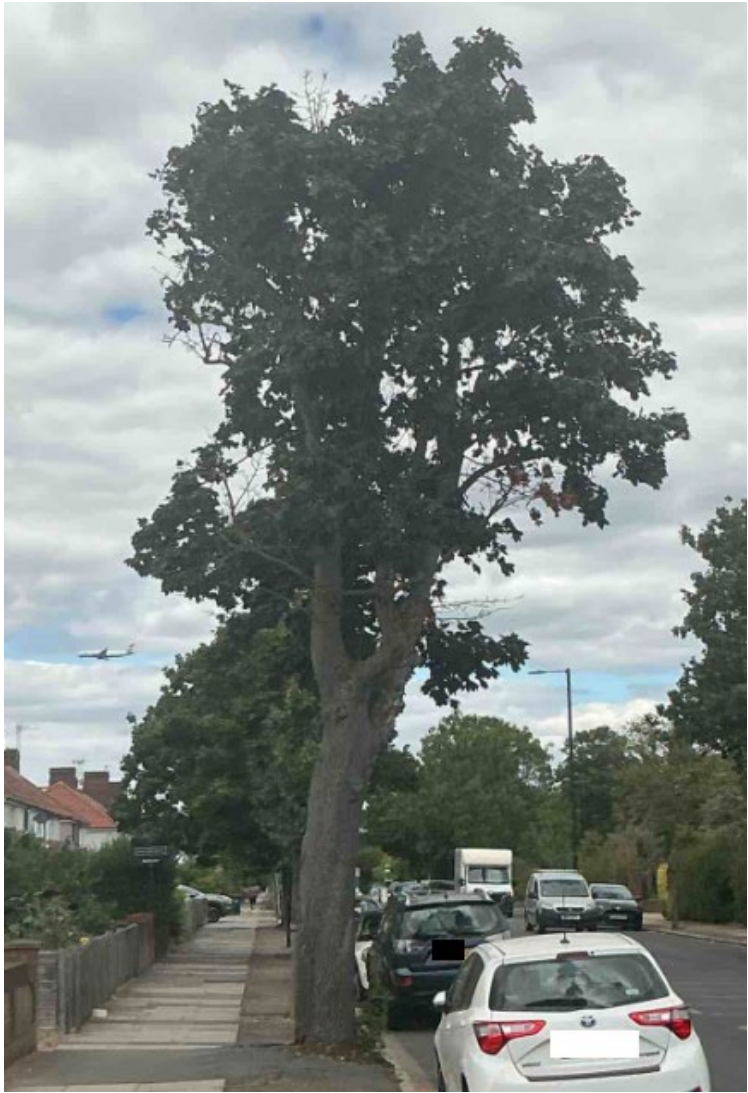
| Inspection findings/reason for exemption | Fungal fruiting bodies of the decay fungi 'Honey fungus' <i>Armillaria</i> sp. are present at the base of this tree. Colonisation by this fungus causes a white rot of the roots and butt that can cause entire tree failure. Crown dieback could correlate with the parasite present. Removal is required to prevent natural failure, manage risk, and facilitate replanting |

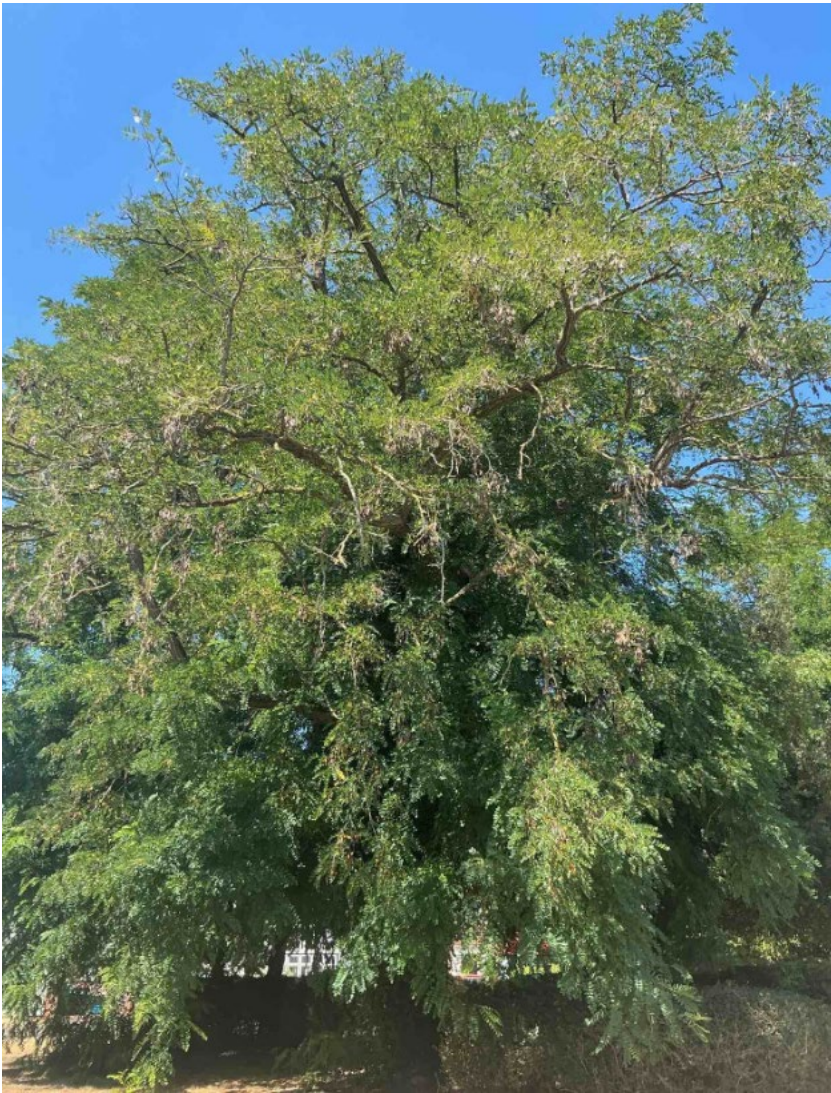
| Inspection findings/reason for exemption | A fungal fruiting body of the decay fungus <i>Ganoderma sp.</i> is present on the trunk. Colonisation by this fungus results in white rot affecting the stem and root system, which can lead to structural failure through fracture or windthrow A resonance test with a sounding hammer has revealed an unacceptable amount of decay around the bracket. Removal of the tree is recommended to prevent natural failure, manage risk, and facilitate replanting. |
