September 2023 - Reactive Tree Works Programme

The following pages provide the locations of each tree that is to be removed, in addition photographs and descriptions of the inspection findings have been provided.

Dated 18.9.2023

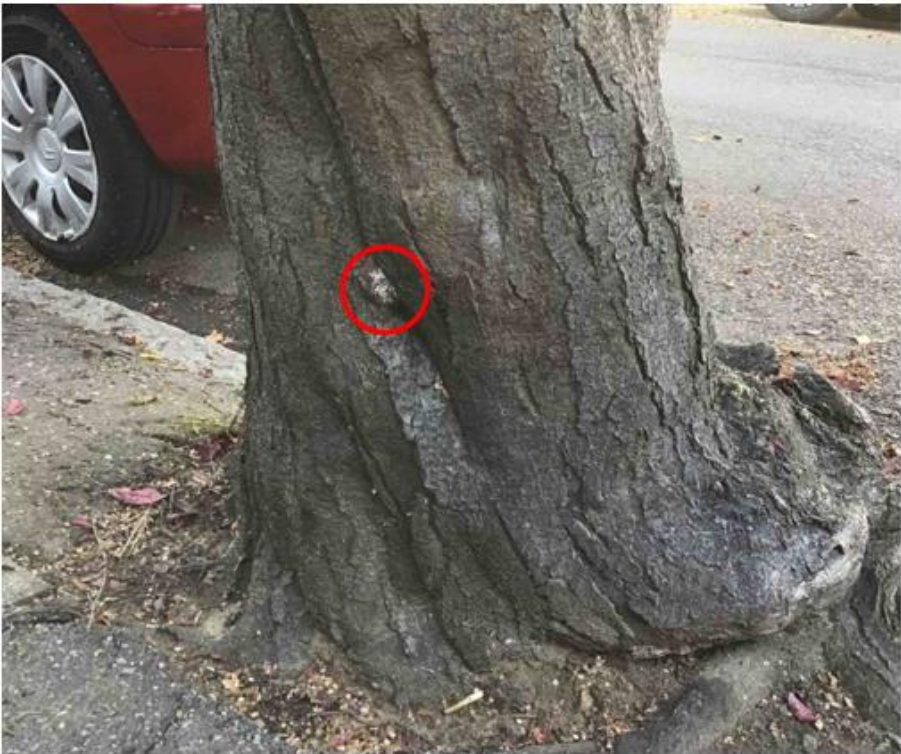
Image shows stem with location of fungal fruiting body circled.

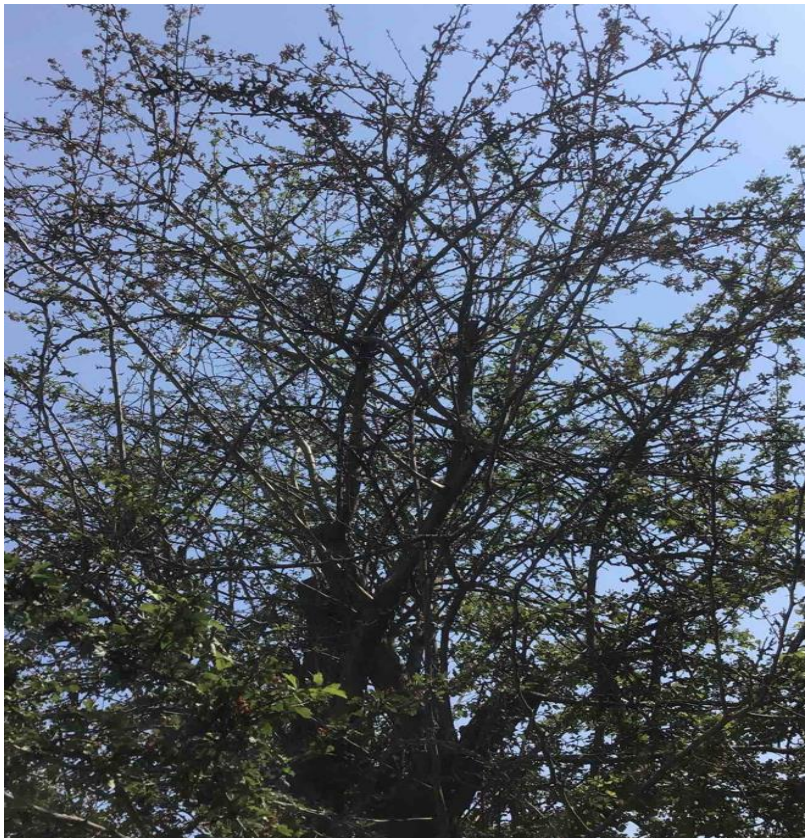
Image shows central crown which has recently died.

Ward	St Margarets and North Twickenham
Road	Normanhurst Drive
Location	Whatthreewords-///image.marble.port
Species	Hazel (<i>Corylus avellana</i>)
Height	5.0m
Physiological Condition	Good
Structural Condition	Poor
Inspection findings	This tree has part failed at base of stem and is now leaning on adjacent shrubs. This is due to roots with extensively decayed. This tree requires removal to facilitate replanting and prevent natural failure.

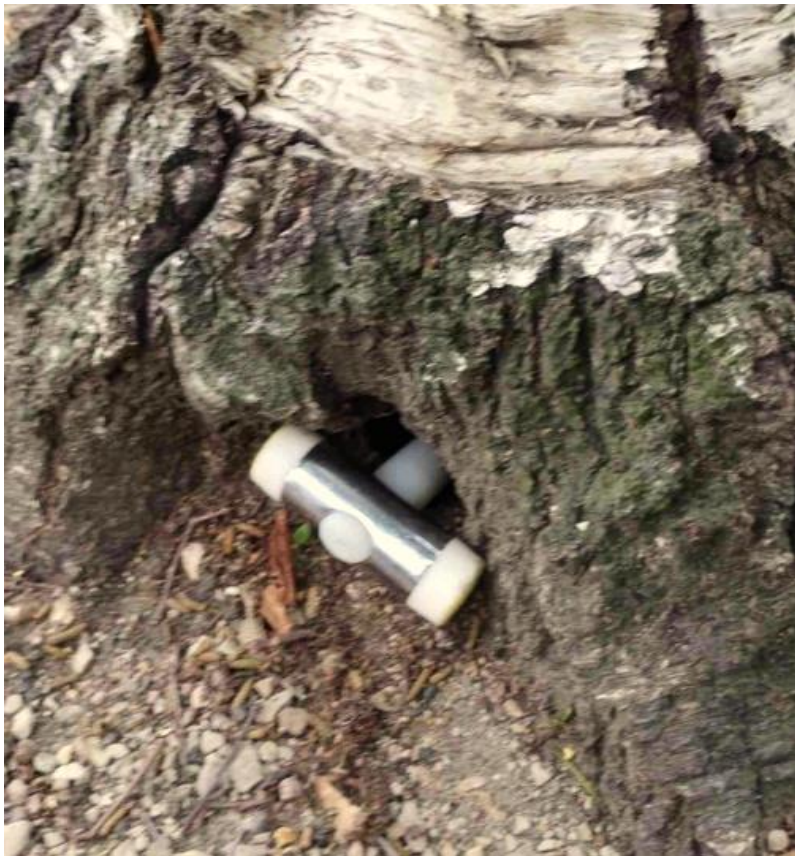
Image shows Cavity viewed from West side at base of tree.
