March 2024 - Reactive Tree Works Programme

Introduction

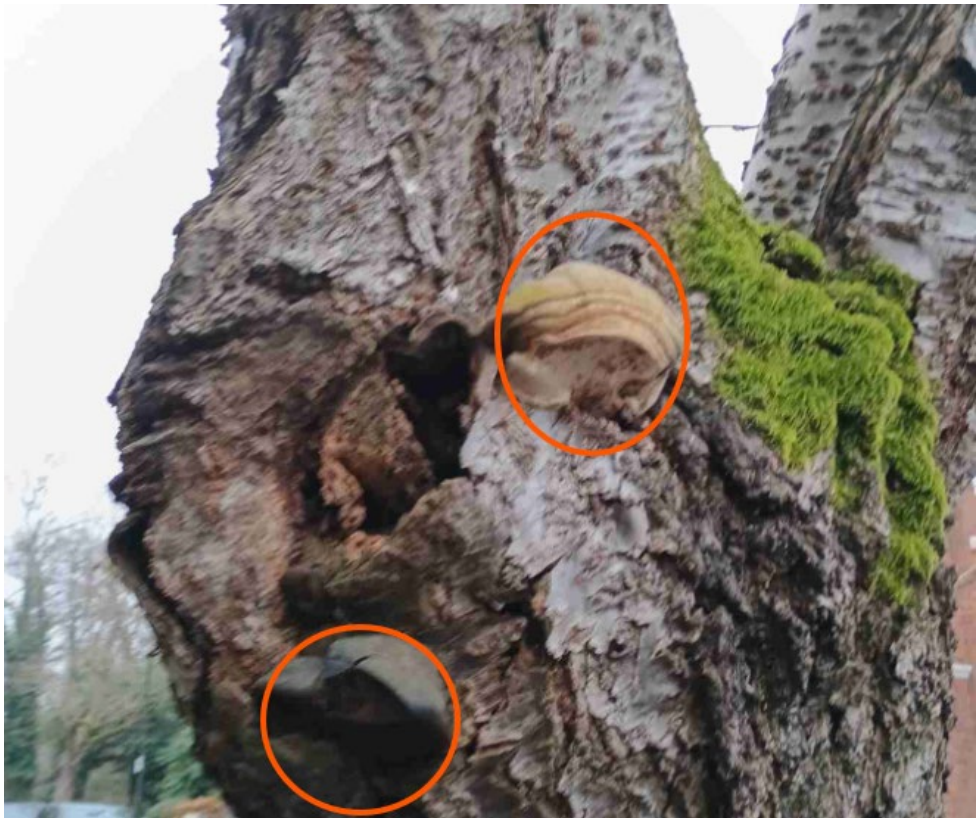
Image shows cavity on trunk with fruiting bodies circled

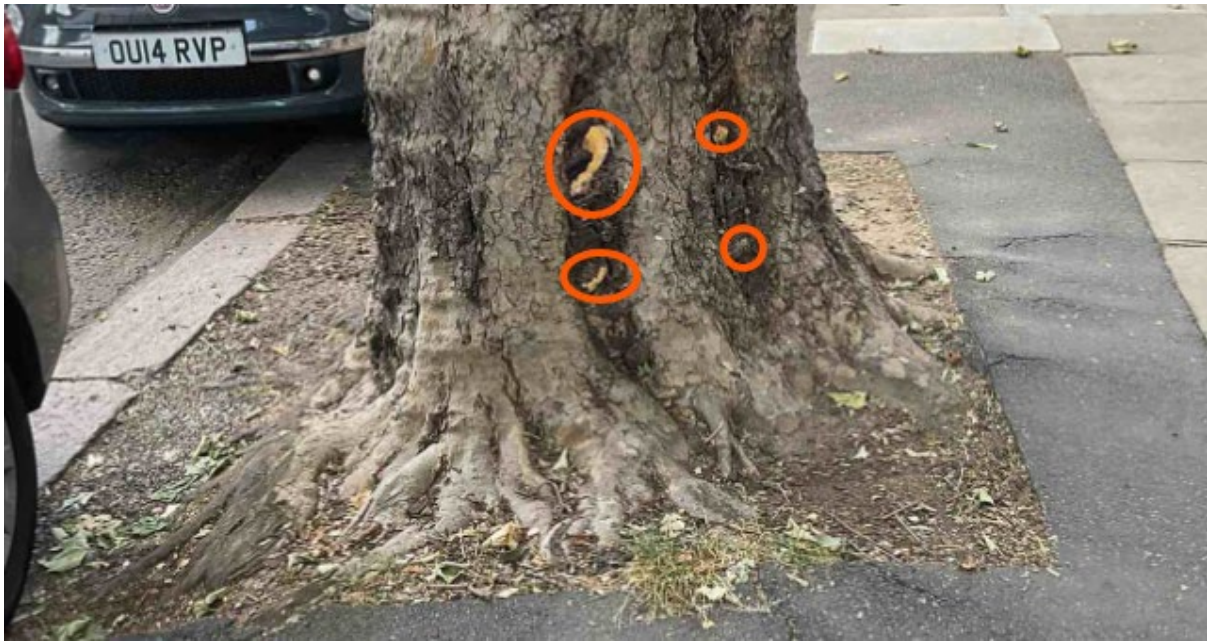
Image shows fruiting bodies circled.

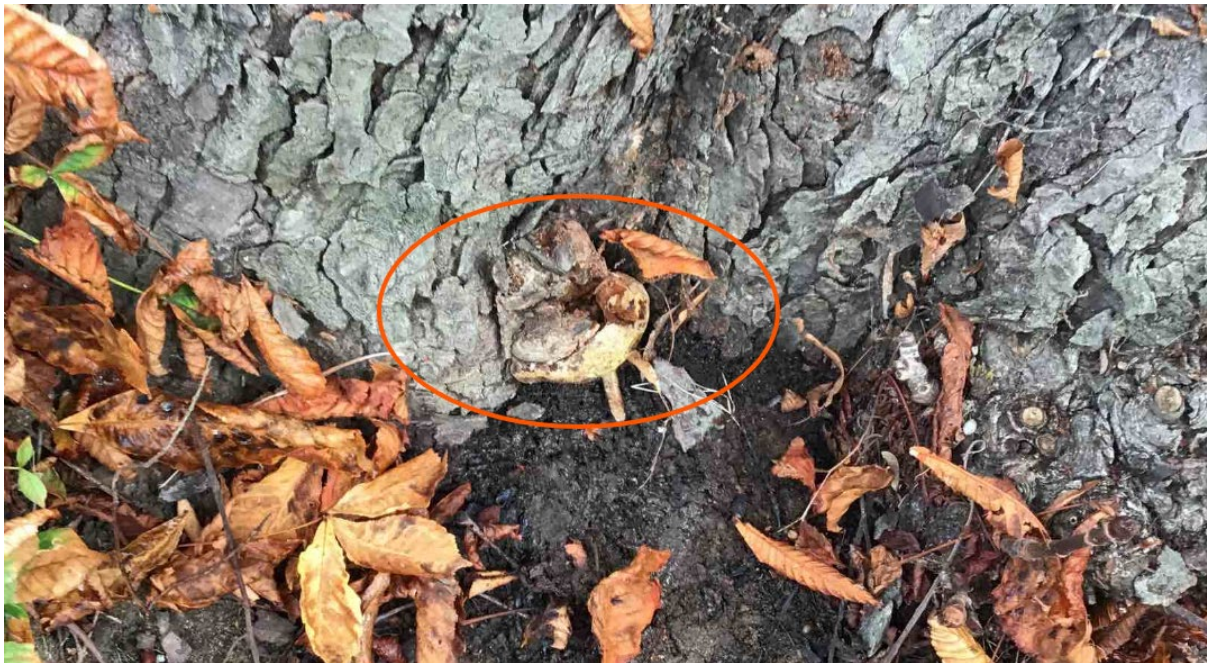
Image shows fungal fruiting body circled.

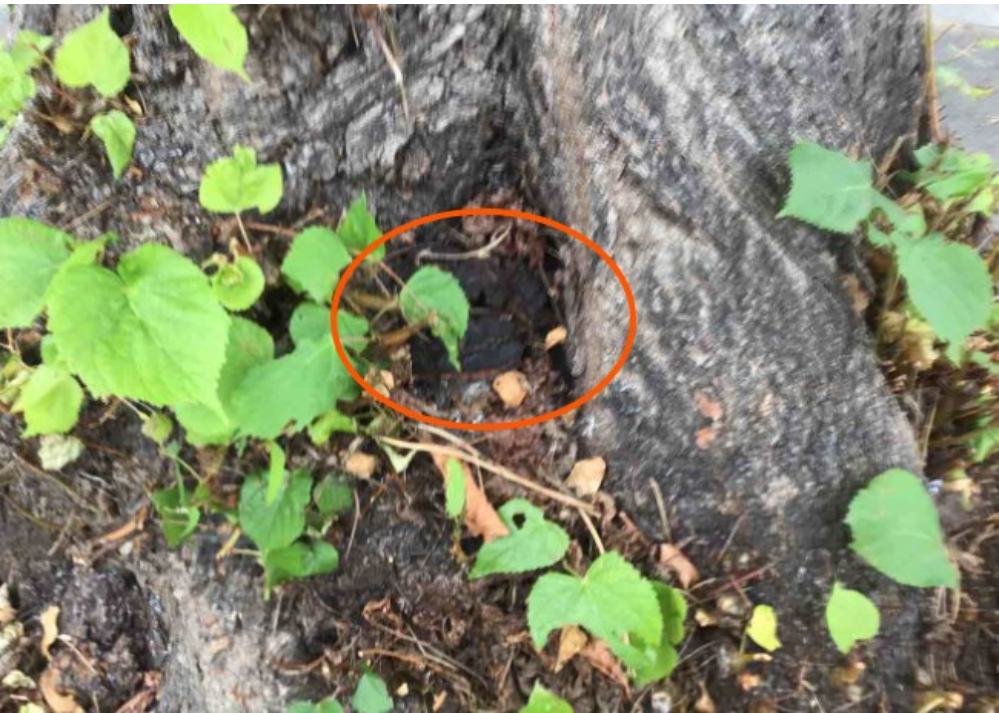
Image shows fungal fruiting body on trunk circled.

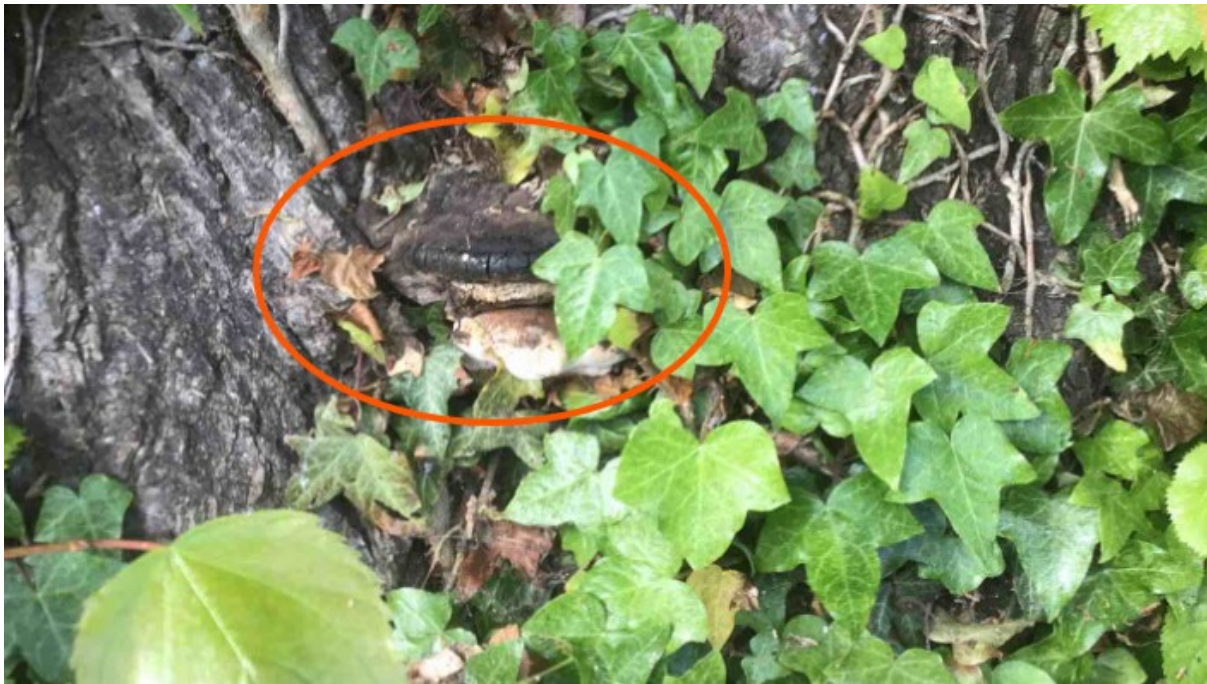
Image shows fungal fruiting body on trunk circled.

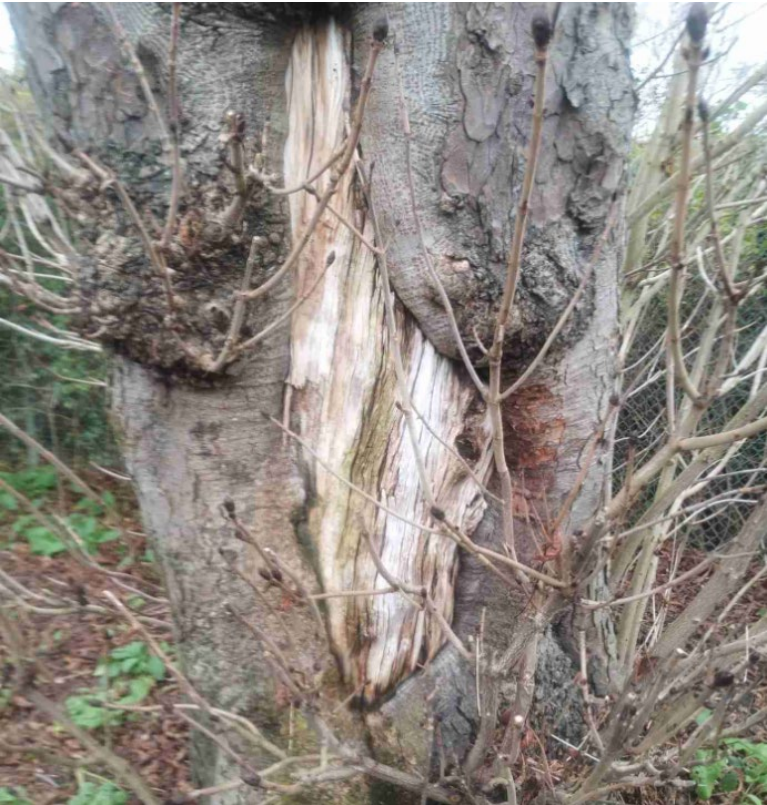
Image shows wound on lower trunk.
